North Carolina Department of Natural and Cultural Resources
State Historic Preservation Office

MEMORANDUM

SUBJECT: Historic Structures Survey Report, Improvements to NC 268, PA 16-11-0003,
R-3309, Wilkes County, ER 17-1692

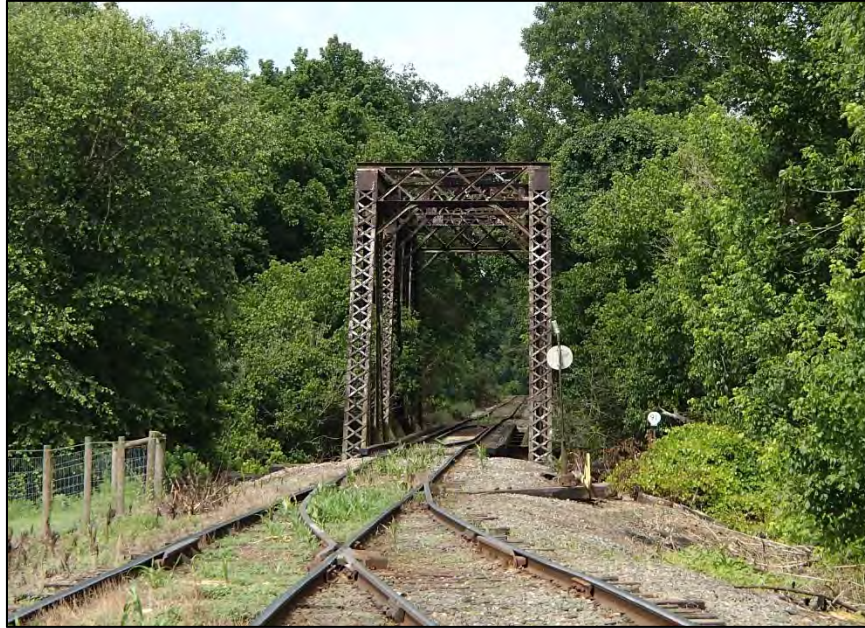
Figure 4: Roaring River Railroad Bridge, east elevation

The Roaring River Railroad Bridge is a steel, Warren through-truss railroad bridge (figures 4 and 5). Although this type of bridge structure is not exactly what James Warren and Willoughby Monzani patented in 1848, “Warren Truss” has become the universally accepted name for the structure type.¹ (Warren and Monzani’s design included decks across the top and bottom.) This bridge was manufactured by the Phoenix Bridge Company.

The Roaring River Bridge is approximately 200 feet long and 15 feet wide. The steel structure consists of vertical and diagonal members on the sides of the structure, creating a series of triangles. The structure is constructed from pairs of I-beams that are linked by a crossed lattice. The sides of the structure are connected across the top by struts and sway bracing created from I-beams connected with crossed lattice. Beams placed in X formations between the struts and side walls create lateral bracing. Floor beams connect the sides under the track deck. The bridge's components appear to be connected with pins rather than rivets; the bridge's construction year, 1900, is the year in which Phoenix Bridge Company switched from pins to rivets.²

The span clears Roaring River without the use of piers. The bridge rests on the ground on either side of the river, with railroad cross ties acting as a retaining wall to support the embankment directly under the ends of the bridge.

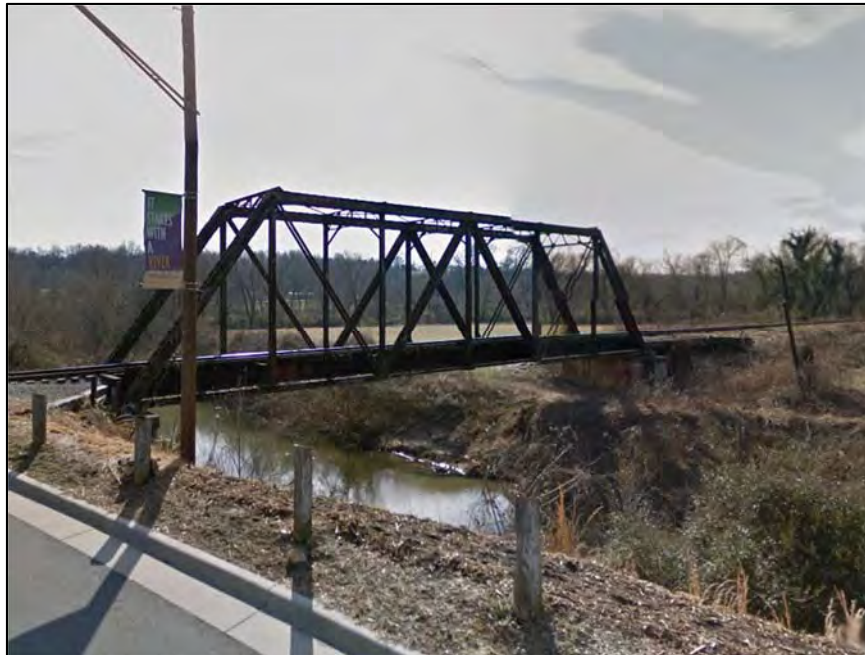
Figure 6: Big Elkin Creek Bridge, north elevation

The Roaring River Railroad Bridge is one of two through-truss bridges on the railroad between Elkin and North Wilkesboro and the two bridges are comparable examples of turn-of-the-twentieth-century bridges. The bridges are nearly identical, with the second bridge located in Surry County, crossing Big Elkin Creek (figure 6). Phoenix Bridge Company, the manufacturer of the Roaring River Railroad Bridge, also produced the Big Elkin Creek Bridge. Its plaque dates it to 1899. Because Wilkes County contains only one railroad, there are no other comparable bridges in Wilkes County. Additionally, only one railroad bridge in North Carolina is listed individually on the National Register of Historic Places and that example is a stone arch structure.

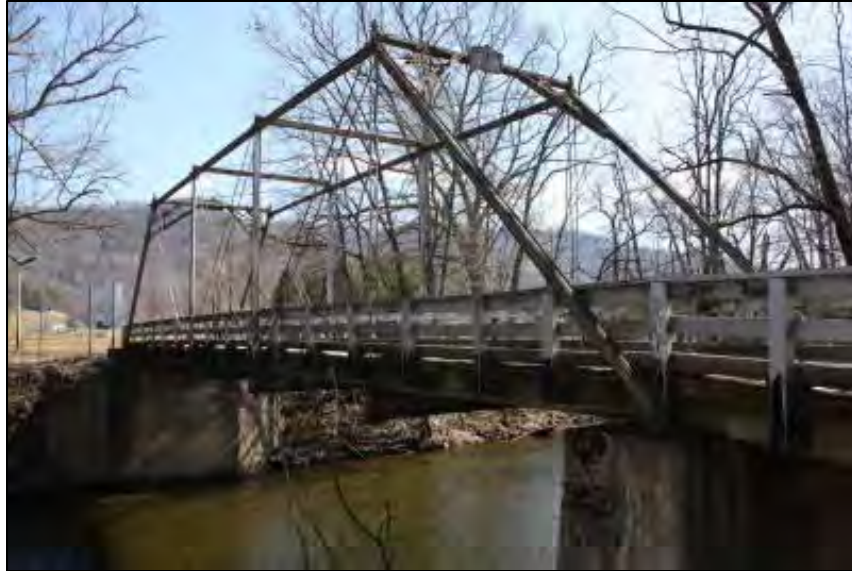
Figure 7: Haywood County Bridge No. 79, HW 22, over West Fork Pigeon Creek, photo by C. Hanchey, accessed via <https://bridgehunter.com/nc/haywood/870079/>

Sixteen through-truss road or highway bridges are documented in NCDOT’s Historic Bridges Inventory available through NCDOT’s website. Three of these are closed to traffic or have been removed. All examples appear to be Pratt trusses rather than Warren trusses, but architecturally (as opposed to structurally) Pratt and Warren trusses are visually similar. Several were built by the Phoenix Bridge Company, including Truss Bridge No. 79 (HW 22, Study List 1983, DOE 1979) in Haywood County, which is the state’s oldest metal truss bridge (figure 7).

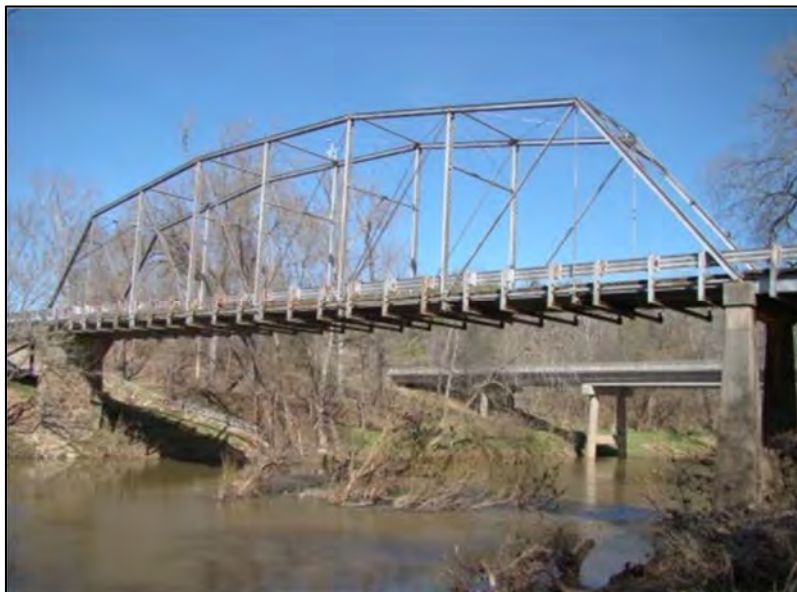
Figure 8: Deep River Camelback Bridge, photo by Matthew B. Ridpath, published at <https://sites.google.com/site/matthewbridpath/bridges-and-highways-1/truss-bridges/deep-river-camelback-truss-bridge>

Only the Deep River Camelback Truss Bridge (figure 8) in Lee and Chatham Counties is individually listed in the National Register and it is listed under Criterion A for its association with transportation improvements in the early twentieth century in North Carolina and Criterion C as an important example of metal truss engineering. This bridge is extant and maintained.

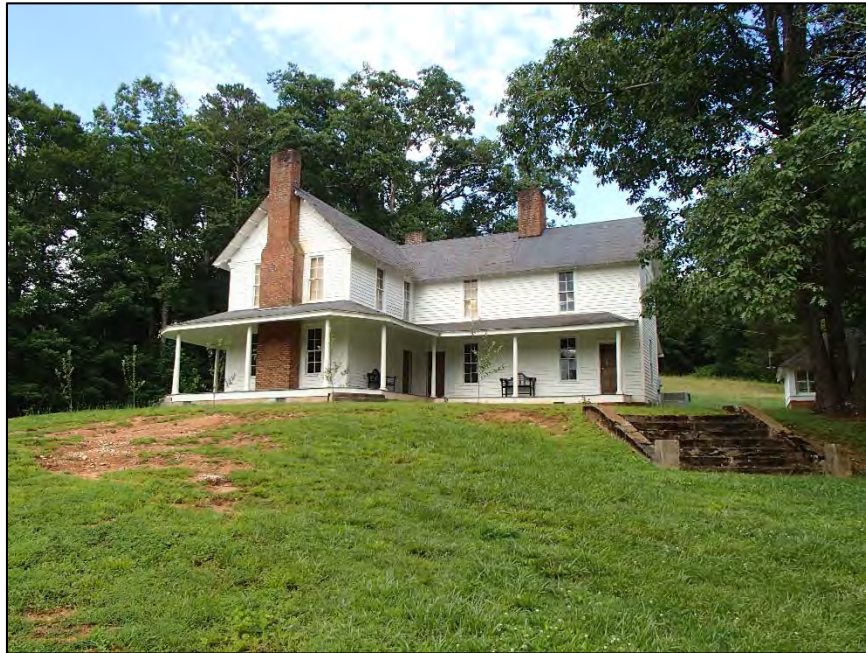
Figure 12: Reves-Greenwood Complex, Reves-Greenwood House, west elevation

The house consists of a two-story saddlebag structure with a massive central brick chimney to which an I-house was added. During the expansion, the earlier section was re-sided, a new roof with eave detailing to match the new construction was added, and new windows were installed. A porch was wrapped around all but one gable end to further create a unified design.

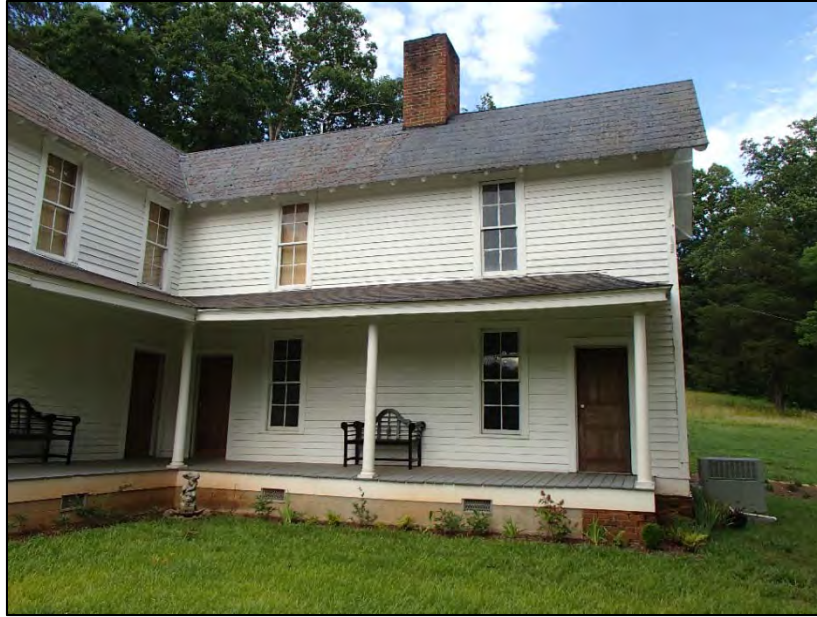
Figure 13: Reves-Greenwood Complex, Reves-Greenwood House, west elevation, original section detail

On the Cotton Mill Road (west) elevation of the original section, now the rear ell, two doors open to the exterior at the first floor level (figure 13). Two windows are located between the two doors, and two windows occupy the second floor of the ell.

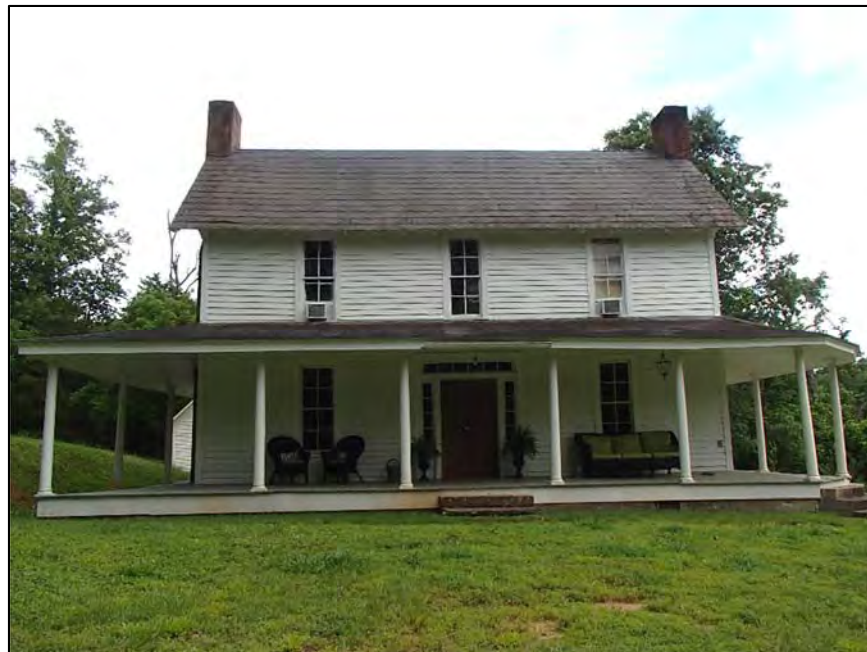
Figure 14: Reves-Greenwood Complex, Reves-Greenwood House, north elevation

On the north façade, which does not face a road or road bed, the house presents a traditional I-house form with brick, single-shoulder chimneys flanked by windows on each gable end (west and east) (figures 14, 15, and 16). The three-bay elevation has a double-leaf door at the center on the first floor. Both leaves feature two arched panels above two rectangular panels (figure 15). Sidelights and a transom surround the door. While this elevation does not face a road as would be expected, it does look toward the mill site just to the northwest.

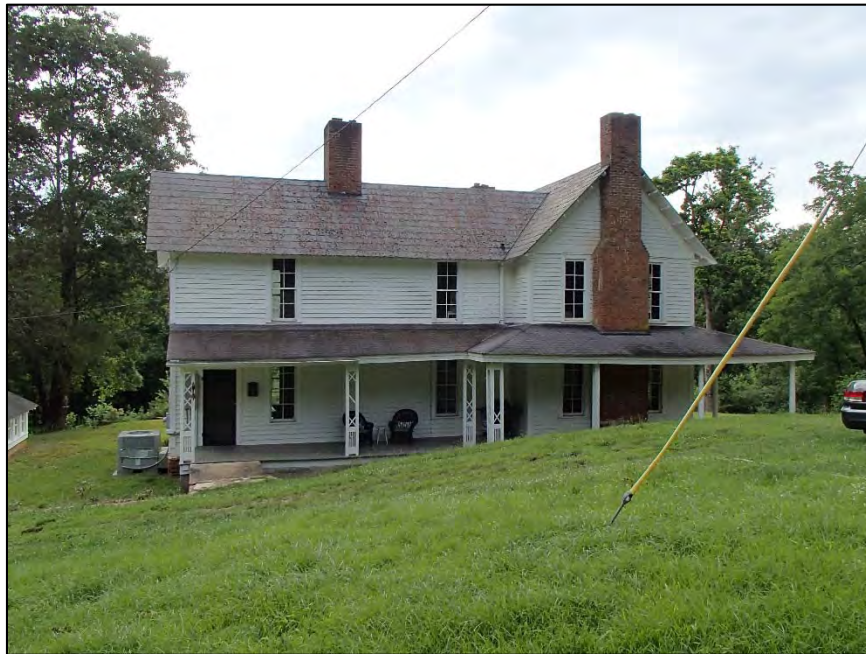
Figure 17: Reves-Greenwood Complex, Reves-Greenwood House, east elevation

On the east elevation, the rear ell (the original section of the house) contains two windows upstairs and two downstairs with one door situated toward the rear or south end of the ell (figures 17 and 18).

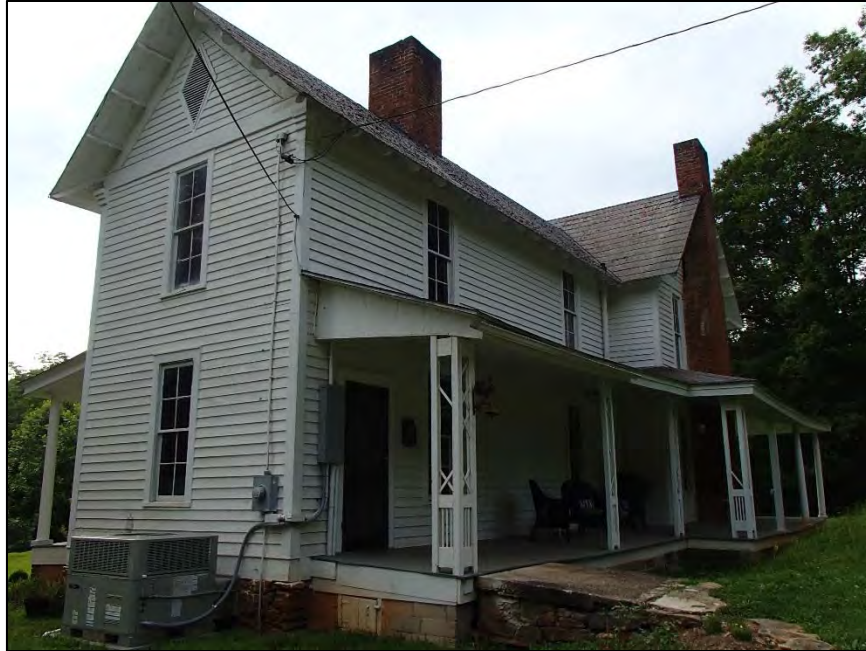
Figure 19: Reves-Greenwood Complex, Reves-Greenwood House, southeast corner

On the south elevation, the original house's gable end features a window centered on both the first and second floors and an elongated, diamond-shaped, louvered attic vent (figures 19 and 20).

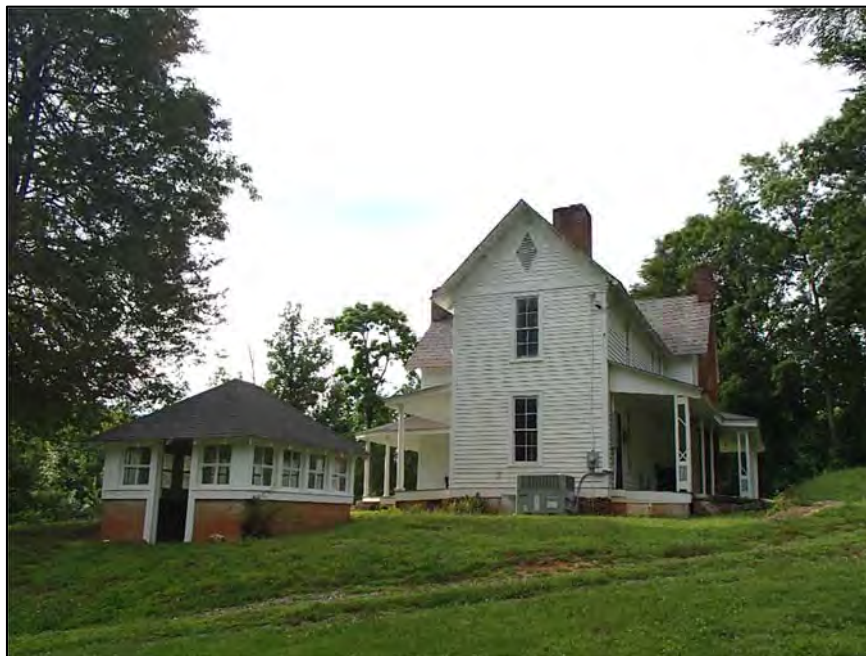
Figure 20: Reves-Greenwood Complex, Reves-Greenwood House, south elevation and flower pit

To the house's south is a pyramidal-roof flower pit (figures 11 and 20). The flower pit is a square structure. It consists of a concrete wall set into a bank so that the north, east, and west sides are partially below grade. Above this foundation wall is a frame structure of four-pane windows that create the north, east, and west walls. On the south elevation, a single-leaf door is centered between two four-light windows. Asphalt shingles cover the pyramidal roof, and the interior floor is covered in gravel. The Greenwood's 1923 plat identifies this as a flower pit. The flower pit matches similar outbuildings at two other area houses also expanded in the late 1800s.

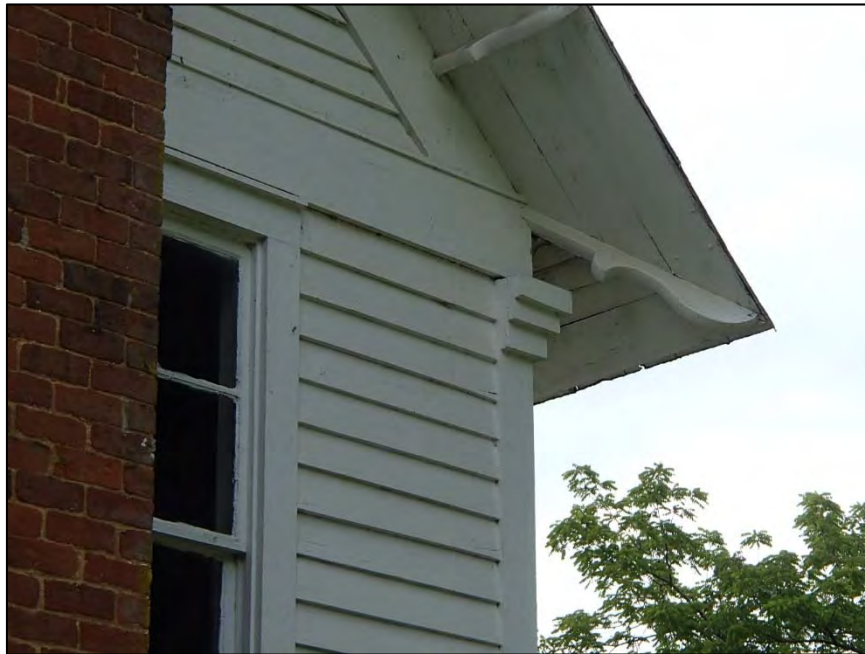
Figure 21: Reves-Greenwood Complex, Reves-Greenwood House, cornerboard and soffit detail

Another detail shared among some of this carpenter's other houses in the area, including Claymont Hill and the Johnson-Hubbard House (see History section below), are cornerboards that terminate at stacked or corbeled capitals (figure 21).

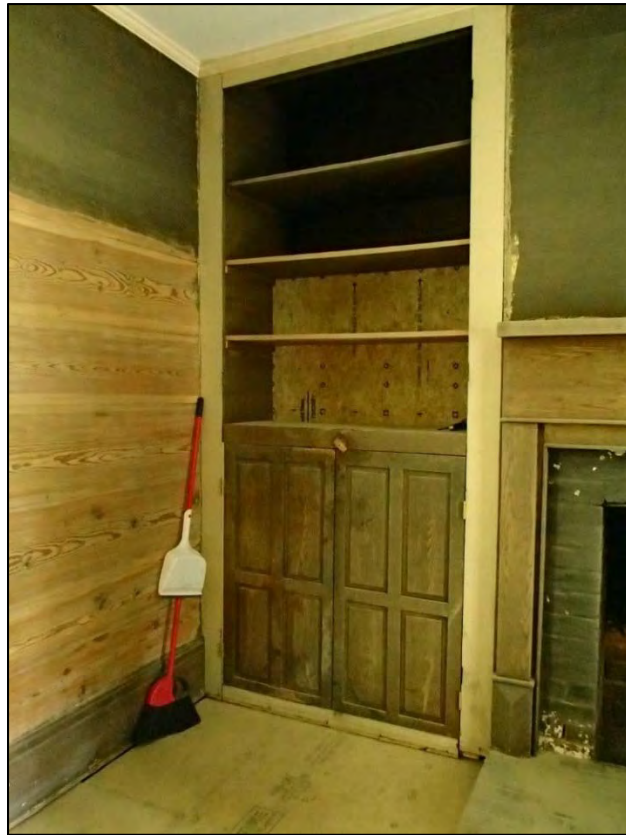
Figure 22: Reves-Greenwood Complex, Reves-Greenwood House, built-in cabinet

In the ell, a built-in cabinet is located beside the center chimney (figure 95). This cabinet has paneled doors below a double-leaf glazed door. This configuration is nearly identical to the built-in cabinets added to the Reves-Greenwood House in the late 1800s (figure 22).

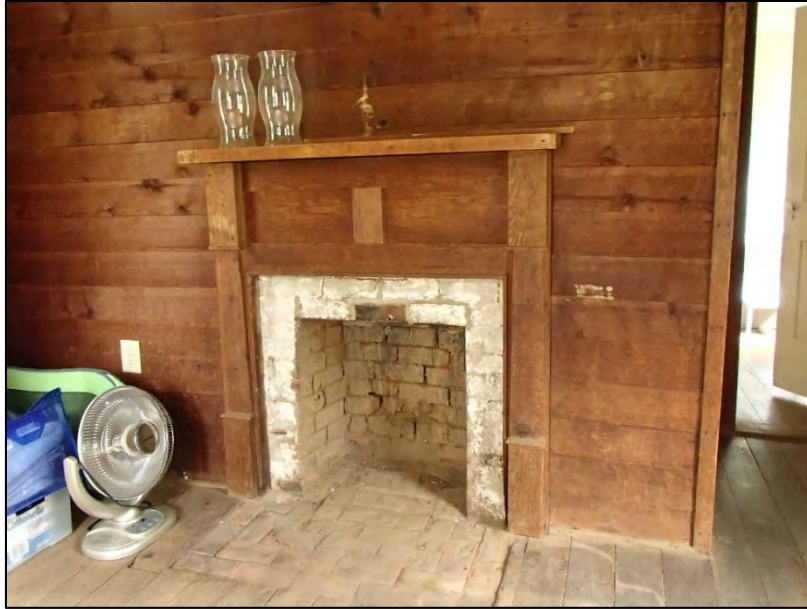
Figure 23: Reves-Greenwood Complex, Reves-Greenwood House, upstairs 1850s mantel

Inside, the house retains original finishes and woodwork throughout. In the older section, mantelpieces are simple post-and-lintel style. On the first floor, they are tall and wide, but feature plinths embellished with a hipped or pyramidal raised panel used frequently by the unidentified carpenter. Also, on both sides of the original section's chimney, paneled cabinets below shelves were added during the late-nineteenth-century remodeling (figure 22). In the southernmost room, this configuration has been removed to create space for a refrigerator. Upstairs, the mantels are smaller with a post-and-lintel form with flat panels below the mantel shelf (figure 23).

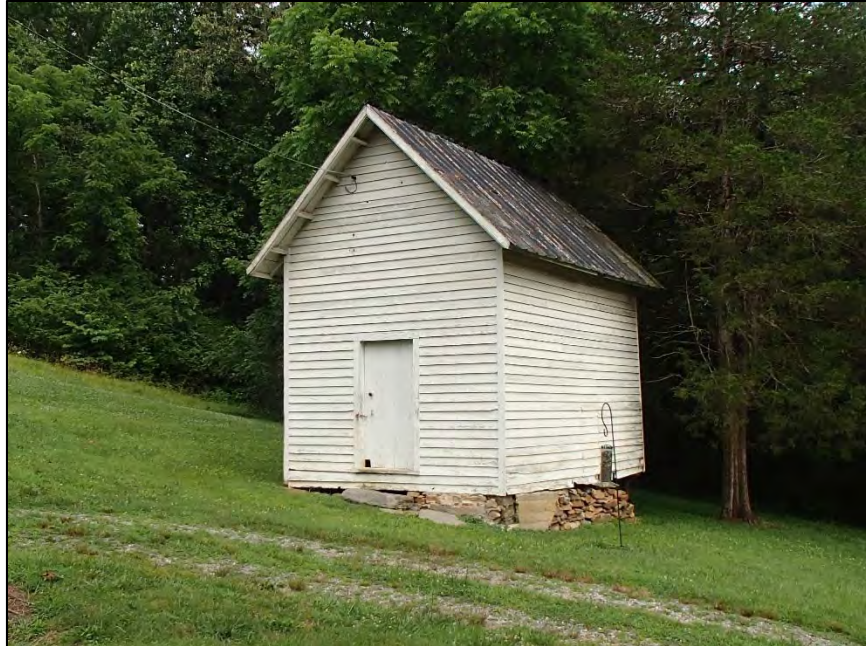
Figure 26: Reves-Greenwood Complex, Reves-Greenwood House, outbuilding

Immediately to the south of the flower pit is a frame, gable-front, windowless outbuilding (figure 26). Weatherboards cover the exterior, the door is batten construction, and it stands on a precarious stone and brick foundation. This building appears to date from the late 1800s.

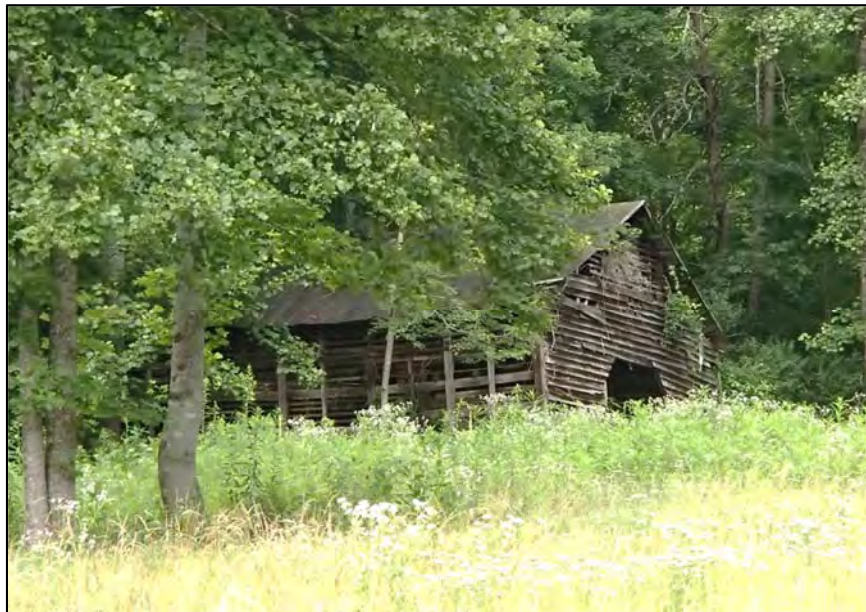
Figure 27: Reves-Greenwood Complex, Reves-Greenwood House, barn

Farther east, uphill from the house, is a frame barn marked as a stable on the 1923 plat (figure 27). This structure probably dates from the turn-of-the-twentieth century.

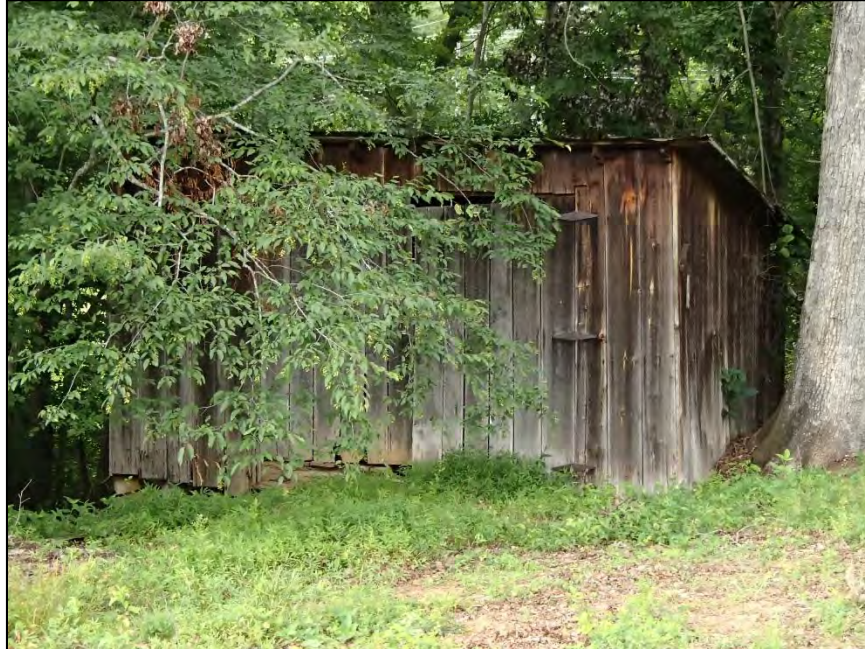
Figure 28: Reves-Greenwood Complex, Reves-Greenwood House, shed

On the property's north edge, to the north-northeast of the house and the southwest of the stable, is a shed-roof outbuilding sheathed in vertical wood (figure 28). This building is not shown on the 1923 plat, although a spring is noted in this vicinity. This building probably dates from the late 1920s or mid-twentieth century.

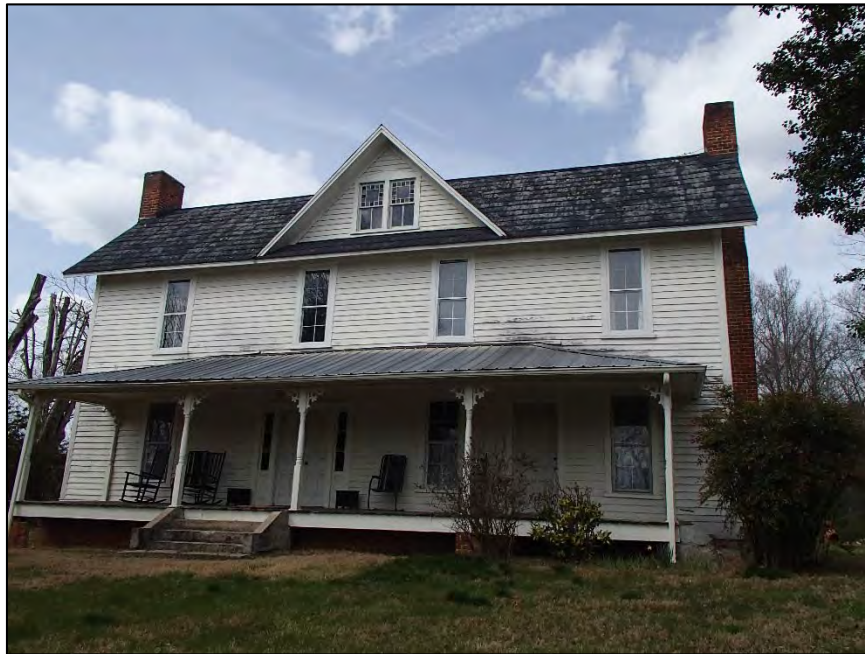
Figure 30: Reves-Greenwood Complex, J.E. and Matilda Greenwood House, south elevation

When the original house was enlarged, the building was covered uniformly in weatherboard siding so that any exterior expression of the original form is limited to the single-leaf front door and asymmetry of the first floor façade.

A hip-roof porch with turned posts and sawnwork brackets extends across the front of the house. The double-leaf front door features four-panel doors, with arched upper panels, and is surrounded by sidelights and a transom. The single-leaf door also contains four-panels, but the top panels are rectangular rather than arched. A roof gable housing a pair of attic windows punctuates the front slope of the side-gable roof. The attic windows comprise a multi-paned upper sash containing stained-glass square lights around a central panel of clear glass over a two-light sash.

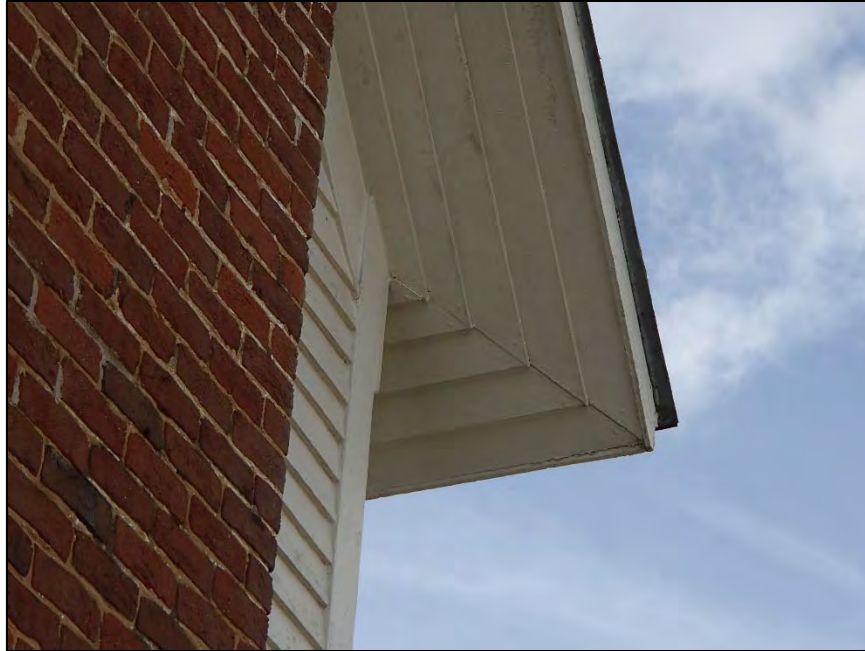
Figure 32: Reves-Greenwood Complex, J.E. and Matilda Greenwood House, soffit detail

The rakes and eaves are finished with flush planks that are offset slightly and mitered at the corners to create a concentric appearance (figure 32). This particular detail is one of the signatures of the as-yet unidentified carpenter whose work can be seen throughout this project area.

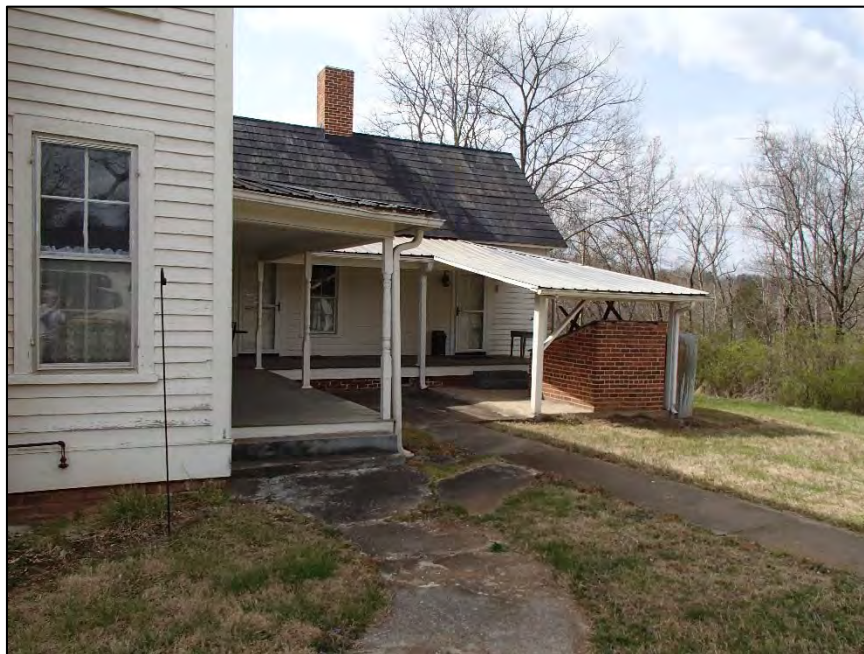
Figure 33: Reves-Greenwood Complex, J.E. and Matilda Greenwood House, rear ell

From the rear elevation, a one-story ell extends to the north (figure 33). A hip-roof porch with turned posts, but no brackets, extends across the main block's north elevation and turns to run along the ell's east elevation. A brick wall surrounds a well and is located adjacent to the back porch under a roof that extends from the porch roof.

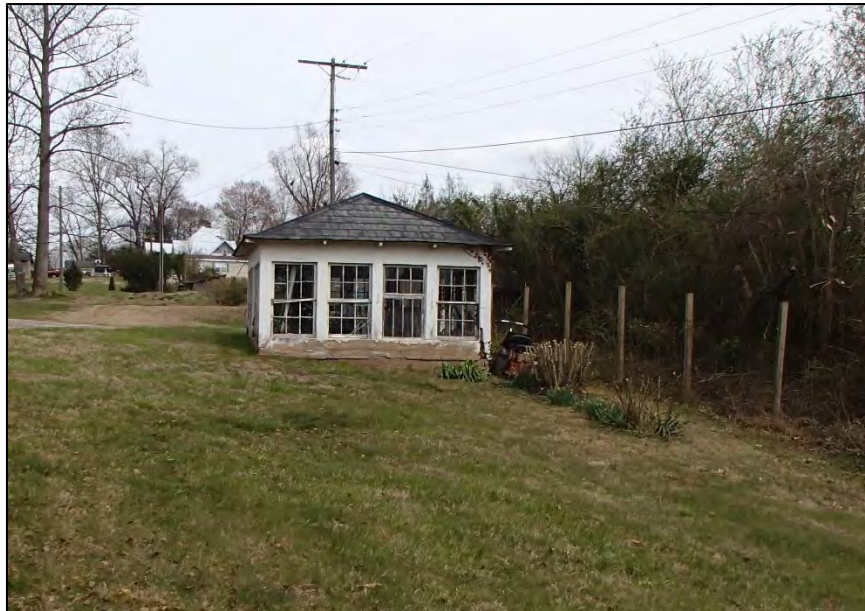
Figure 34: Reves-Greenwood Complex, J.E. and Matilda Greenwood House, flower pit

The property retains two historic outbuildings and one modern outbuilding. Closest to the house is a flower-pit building (figure 34). This structure is partially below grade with a concrete foundation and concrete block walls. The north, west, and east walls are occupied by banks of six-over-six sash windows. On the south wall, the banks of windows continue, but a door is centered on this elevation. Pressed metal shingles cover the pyramidal roof, which terminates at a slight kick on all four elevations.

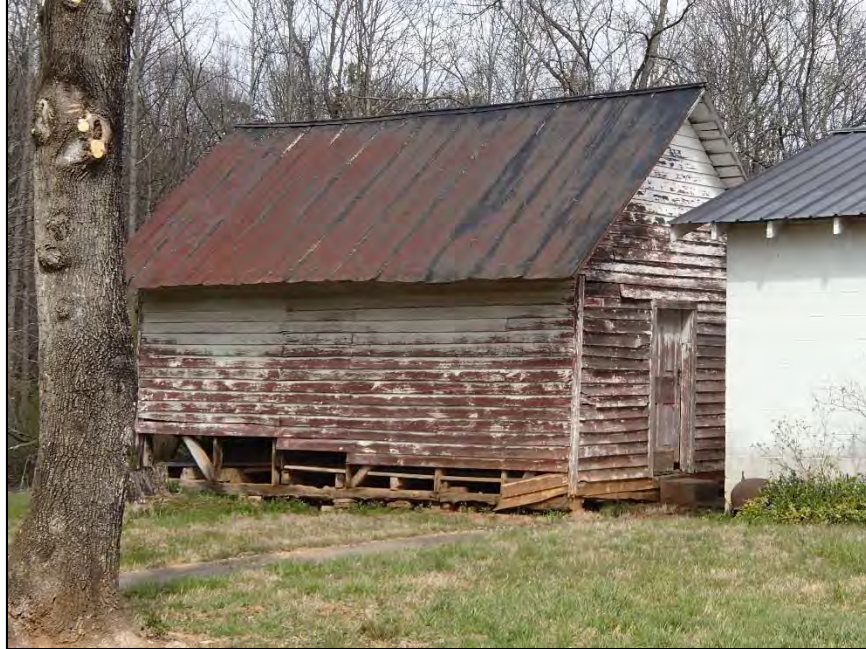
Figure 35: Reves-Greenwood Complex, J.E. and Matilda Greenwood House, outbuilding

To the east of the ell stands a gable-front, frame outbuilding that appears to date from the late-nineteenth or early twentieth century, contemporary with the house's expansion (figure 35). Weatherboards cover the exterior, and the door features four panels. Seams in the weatherboards suggest a window or door once stood in the west elevation.

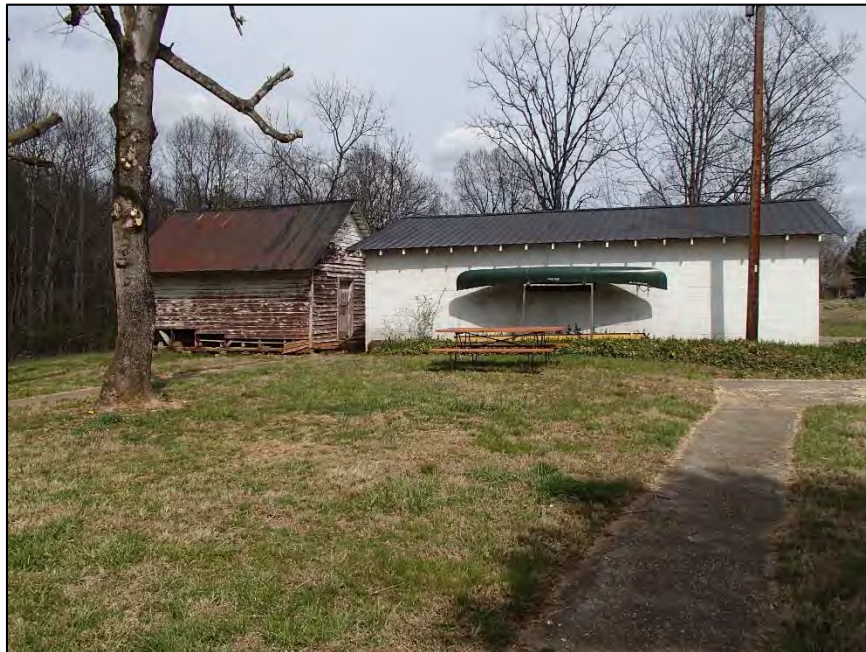
Figure 36: Reves-Greenwood Complex, J.E. and Matilda Greenwood House, outbuilding and concrete block garage

Just a few feet in front of the gabled outbuilding is a larger, concrete block garage and storage building with a garage door in the gable front end (figure 36). This building was probably built in the mid-twentieth century.

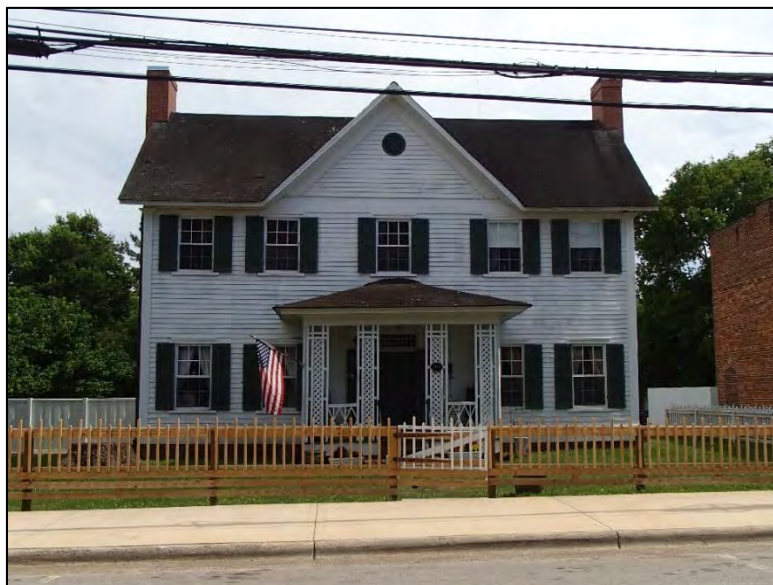
Figure 37: Johnson-Hubbard House, WK 40, 113 E. Main Street, Wilkesboro

The intact Johnson-Hubbard House (figure 37) (WK 40) in Wilkesboro is a good comparison to the Reves-Greenwood and J.E. and Matilda Greenwood houses because the same carpenter appears to have updated it. This house was listed in the National Register in 1982 and is significant for its architecture and interior decorative painting. It also contributes to the Downtown Wilkesboro National Register Historic District (WK 271) and local historic district, both of which were designated in 2009. The house is a mid-1850s Greek Revival house updated in 1887, according to a newspaper article published that year, and it features the work of the carpenter who also appears to have been working at the Reves-Greenwood and J.E. and Matilda Greenwood houses.

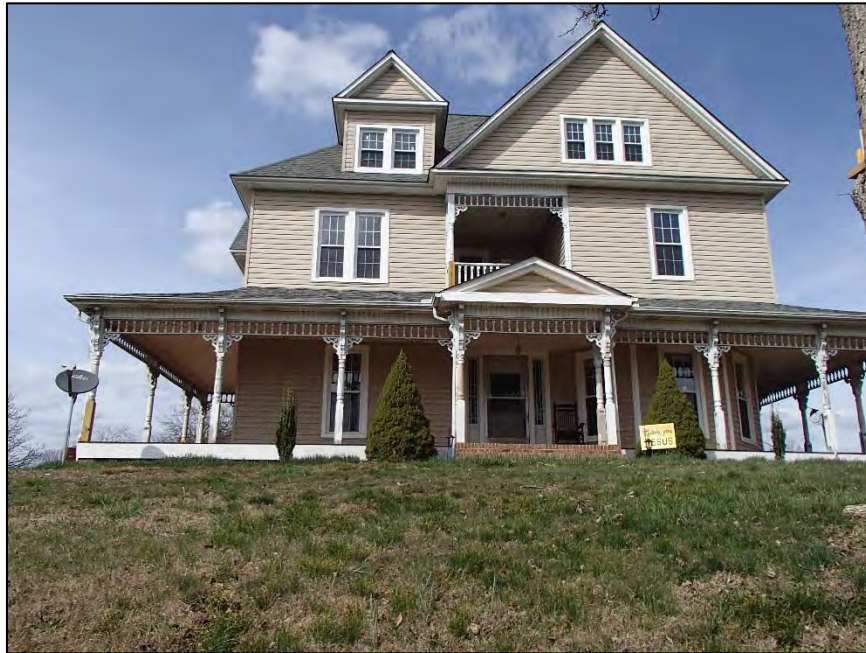
Figure 38: House, 8285 Elkin Highway, Roaring River

In Roaring River, specifically, several late-nineteenth-century houses are extant, including examples with more complex roofs suggesting a higher-style interpretation of Victorian-era fashion when they were completed, but none remain intact; all have been altered with vinyl siding and replacement windows. The best example of a Queen Anne house in Roaring River is an unnamed and unsurveyed house at 8285 Elkin Highway (figure 38). It retains a Queen Anne porch and asymmetrical plan, but it has been covered in vinyl siding and all windows are modern replacements. This house, however, is not a good comparison to the houses in the Reves-Greenwood Complex because both those houses are more vernacular interpretations of the Queen Anne style.

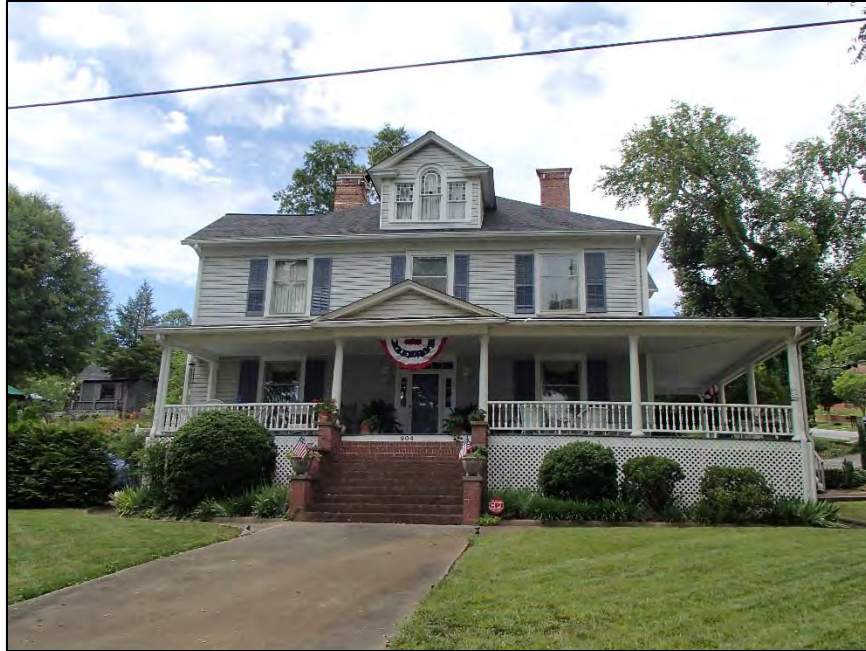
Figure 39: Rector House, WK 154, 904 E Street, North Wilkesboro

Other higher style houses can be found throughout Wilkesboro and North Wilkesboro and characterize the styles and forms that the carpenter interpreted at the Reves-Greenwood and J.E. and Matilda Greenwood houses. Good examples include the Rector House (figure 39), the Caudill House (figure 40), and the Carter Winkler House (WK 57) (figure 41). The Rector and Caudill houses, like so many others, have been covered in vinyl siding.

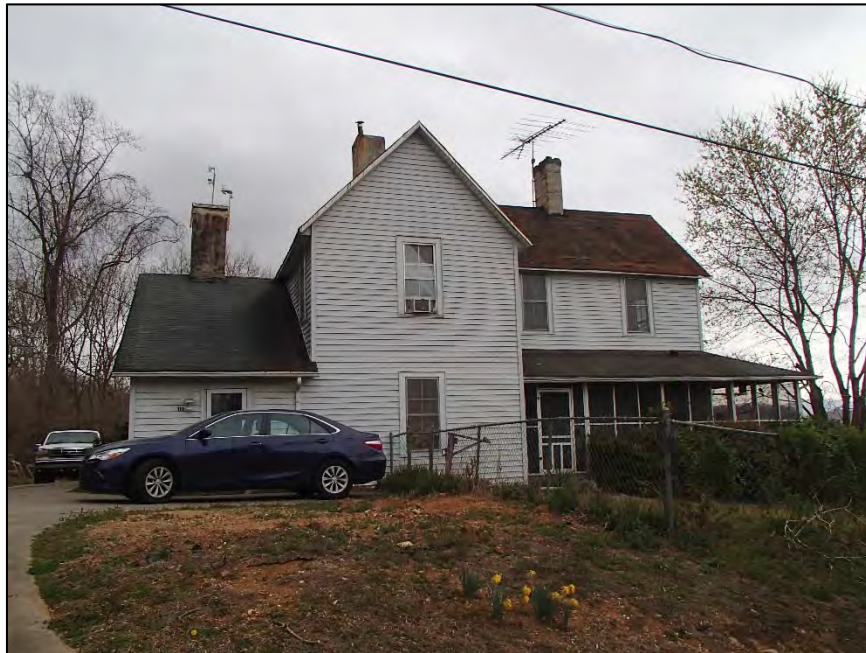
Figure 42: House, 116 Summit Street, Ronda

An unnamed and unsurveyed house in Ronda (figure 42, 116 Summit Street) is a T-plan house with very few Queen Anne references.

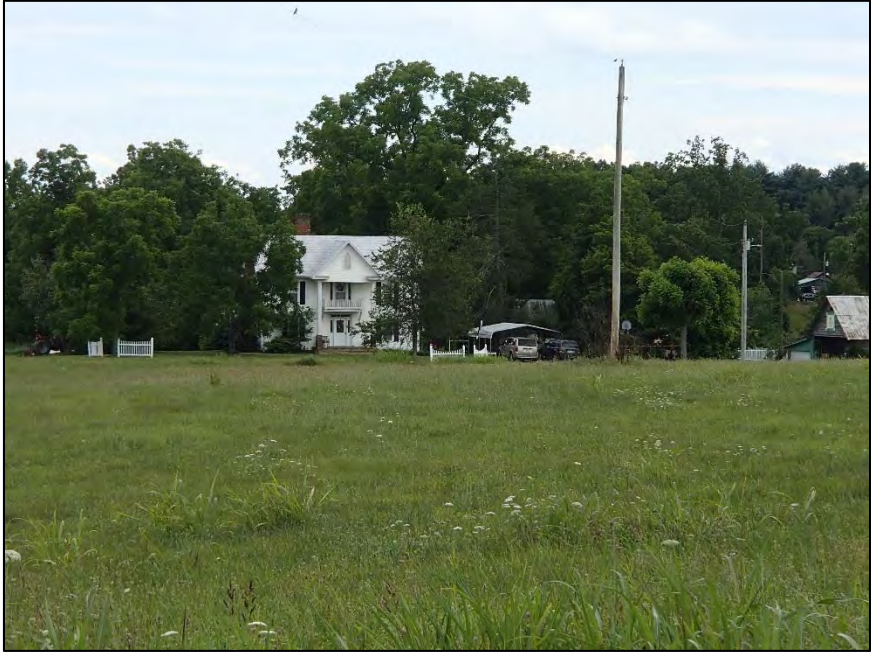
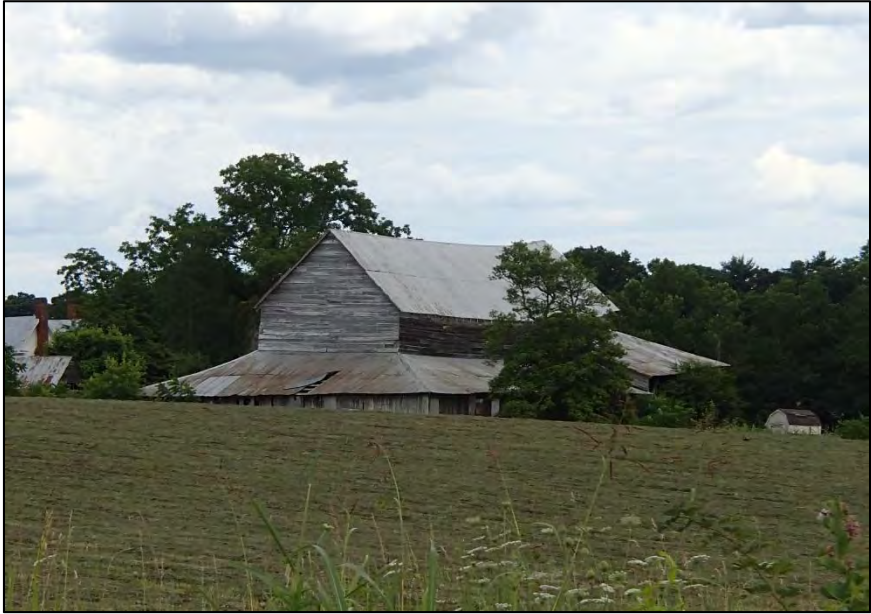
Figure 43: Farm, 2226 Tharpe Rd.

One farm on Tharpe Road appears to retain integrity and significant outbuildings (figures 43 and 44). Like many residences of this era, this house appears to have evolved and features a variety of gables. The property has not been documented in any past surveys, but it was one of the more intact, late-nineteenth-century farmsteads the investigator saw in the county. At least some of its windows have been replaced with modern sash, but overall, it retains a high degree of integrity.

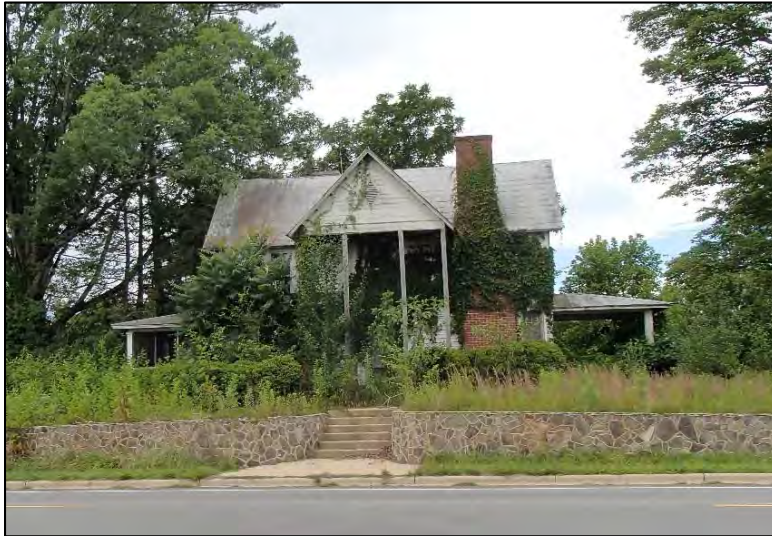
Figure 45: Jones Farm, WK 274

The Jones Farm (figure 45) (WK 274) was determined eligible for the National Register but has suffered significant neglect and deterioration since that evaluation in 2004.

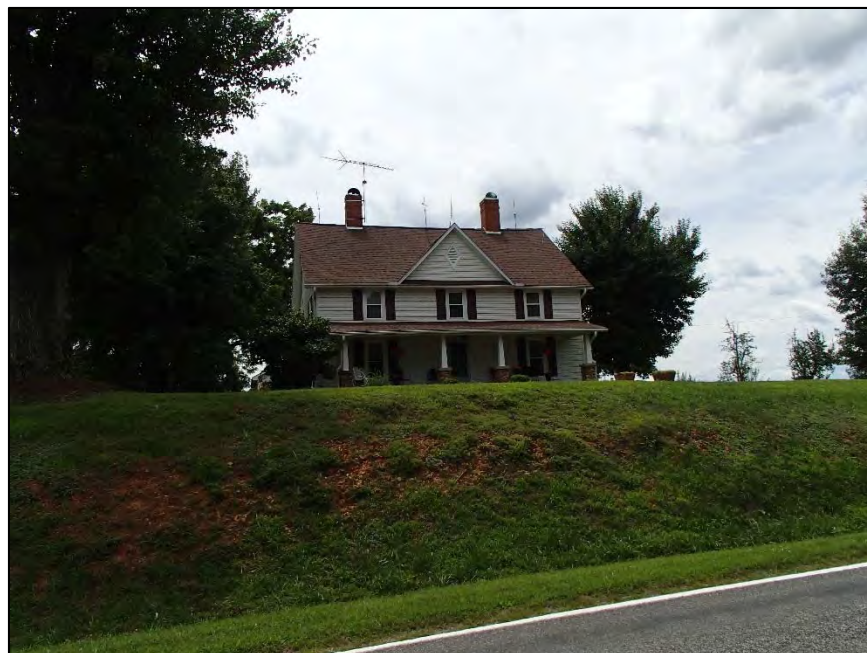
Figure 46: House, 5262 Lomax Jolly Rd.

Other I-houses and other examples of older homes that have been enlarged can be found throughout the county, but vinyl siding and replacement windows are ubiquitous. The following two unnamed, unsurveyed examples (figures 46 and 47) provide typical examples of rural, nineteenth century houses.

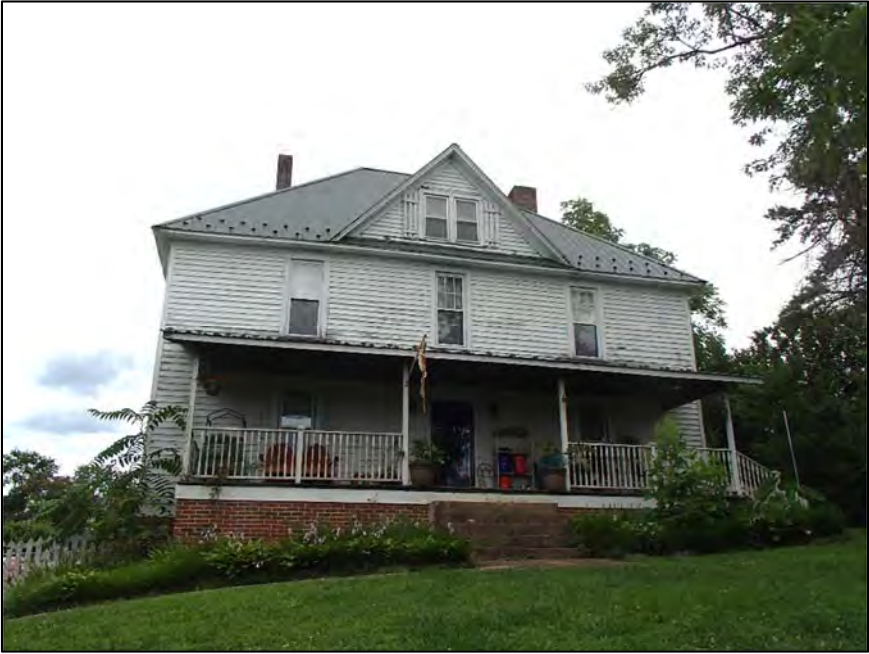
Figure 50: R.A. Reves House, south elevation

The Reves House is a three-bay-wide, double-pile house with a center passage (figure 50). The symmetrical south façade features a centered front entrance with a single-leaf, four-panel door. The shed-roof front porch is a complete and non-historic replacement of the original and features modern turned posts and balustrade with a continuous brick foundation.

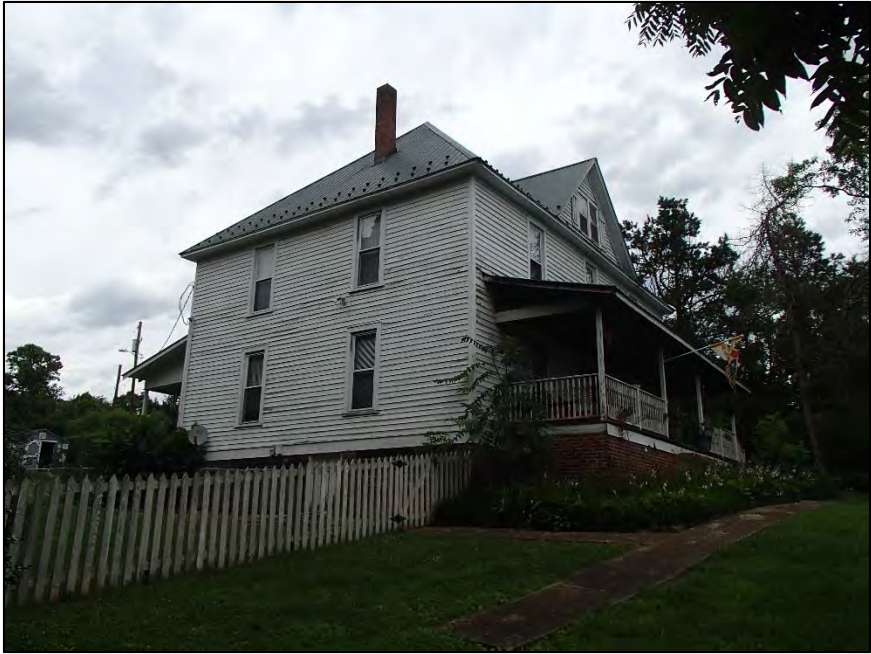
Figure 51: R.A. Reves House, southwest corner

Both side elevations feature a symmetrical arrangement of windows with two windows upstairs and two downstairs (figure 51).
