North Carolina Department of Natural and Cultural Resources
State Historic Preservation Office

MEMORANDUM

SUBJECT: Historic Structures Survey Report, Improvements to NC 268, PA 16-11-0003,
R-3309, Wilkes County, ER 17-1692

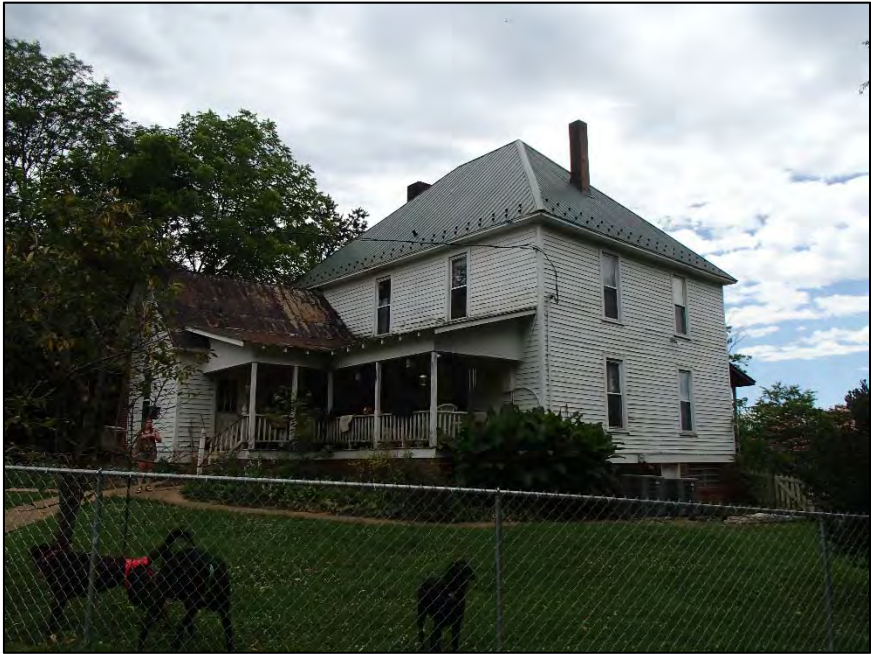
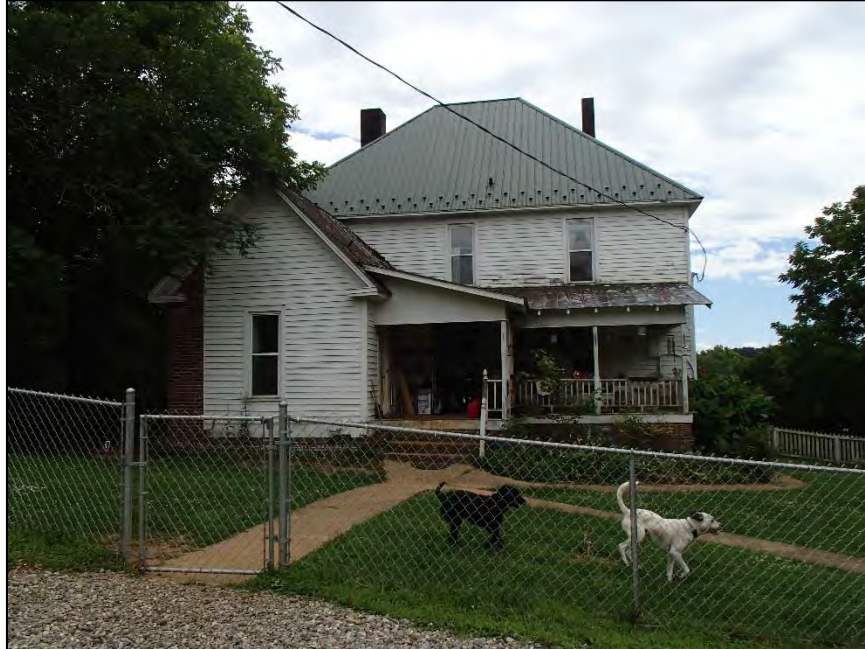
Figure 53: R.A. Reves House, north elevation

A one-story gabled ell projects from the north elevation (figures 52 and 53). A shed-roof porch follows the interior corner of the junction of the ell and house and extends along the ell's west elevation and the main block's north elevation. Here, too, the porch materials appear to be modern replacements.

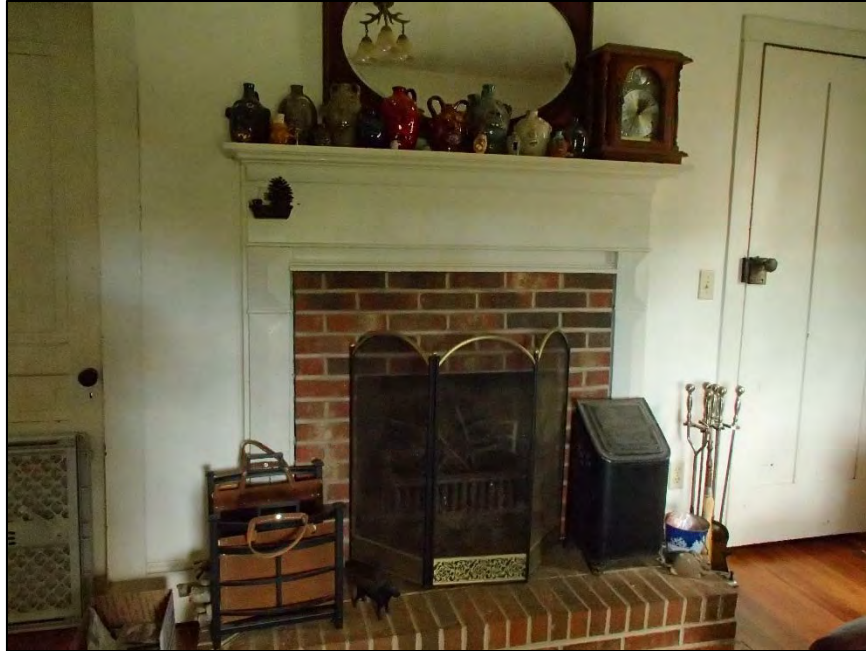
Figure 54: R.A. Reves House, mantelpiece

Inside, the house has undergone some changes, but it retains mantelpieces in three of the primary rooms downstairs, and those mantels display the raised pyramidal panels (figures 54 and 55) seen at other houses built by the as-yet-unidentified carpenter previously mentioned in this report. The staircase is trimmed with panels of beaded board along the stringer. The railing terminates as a substantial, square-in-plan newel post (figure 56). In two downstairs rooms, closets feature two-panel, Greek Revival doors probably salvaged from an earlier house.

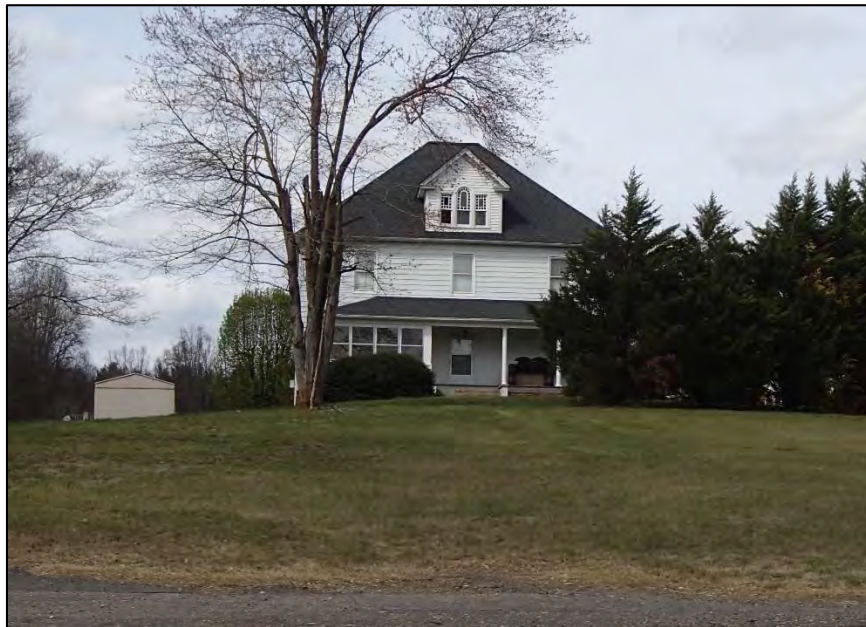
Figure 58: House, 8201 Elkin Highway, Roaring River

An unsurveyed and unnamed house on Elkin Highway in Roaring River may have been built by the same carpenter as the R.A. Reves House. It retains Colonial Revival features such as a Palladian attic window and Doric porch columns, but it also has older style, two-over-two sash windows. This house has been covered in vinyl siding and the porch is partially enclosed.

Particularly good comparative houses are the Rector House at 904 E Street in North Wilkesboro (figure 57) and a hip-roof house (figure 58) at 8201 Elkin Highway in Roaring River that share many features with the R.A. Reves House.

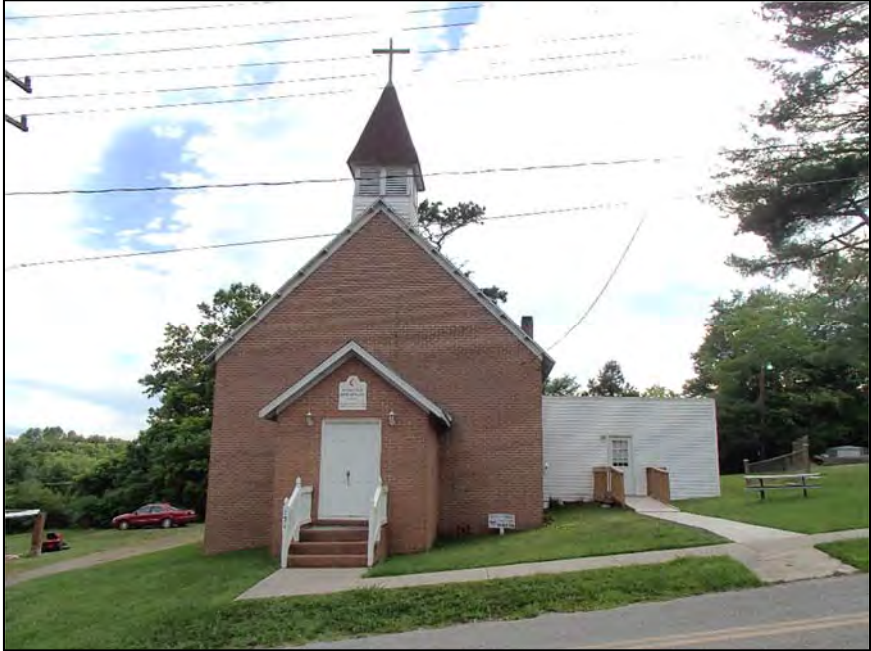
Figure 60: Roaring River United Methodist Church and Parsonage, east facade

The building is a gable-front building with a one-story, flat-roof addition. The east façade features a diminutive gable-front vestibule projection with a double-leaf front door (figure 60). A stoop with a modern vinyl balustrade projects from the vestibule. A sign with the church’s name and meeting times is centered above the front door.

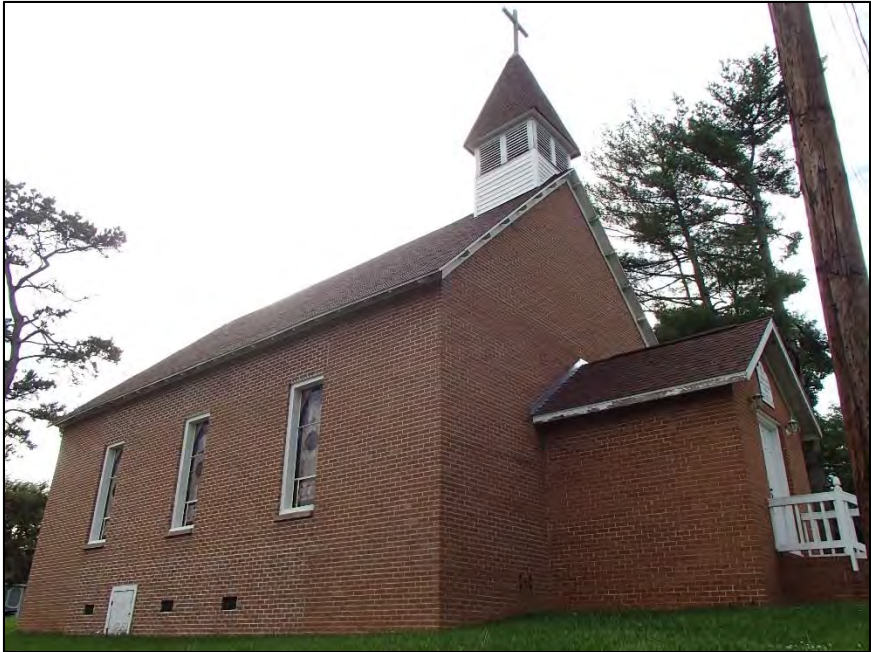
Figure 61: Roaring River United Methodist Church and Parsonage, southeast corner

The south elevation features three bays with stained glass windows (figure 61).

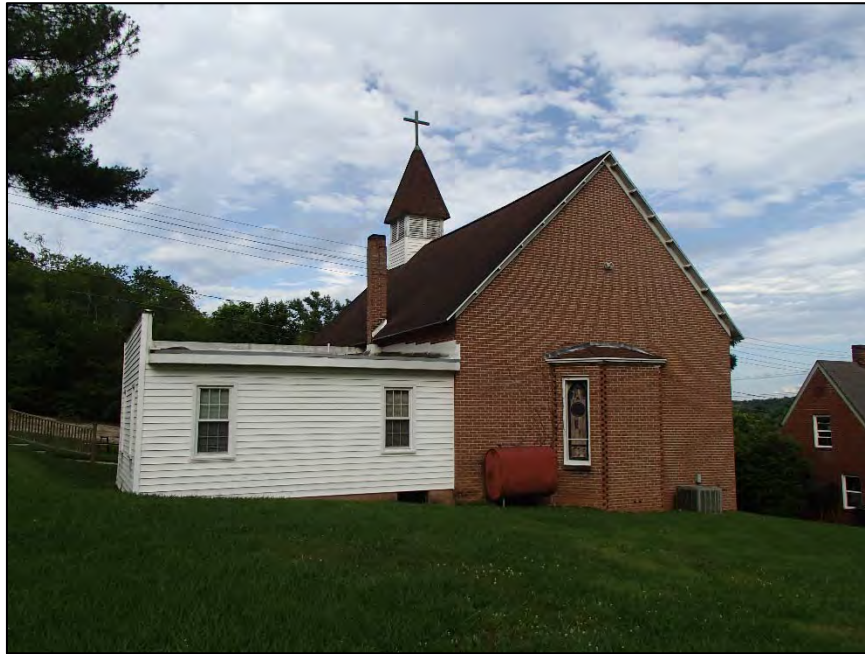
Figure 62: Roaring River United Methodist Church and Parsonage, west elevation

A small three-sided apse with a hip roof protrudes from the west elevation (figure 62).

The north elevation originally matched the south, with three bays, but the rear bay has been obscured with a one-story, flat-roof addition clad in vinyl siding (figures 62 and 63). Windows in the addition are modern vinyl sash. A chimney flue extends between the sanctuary and the addition.

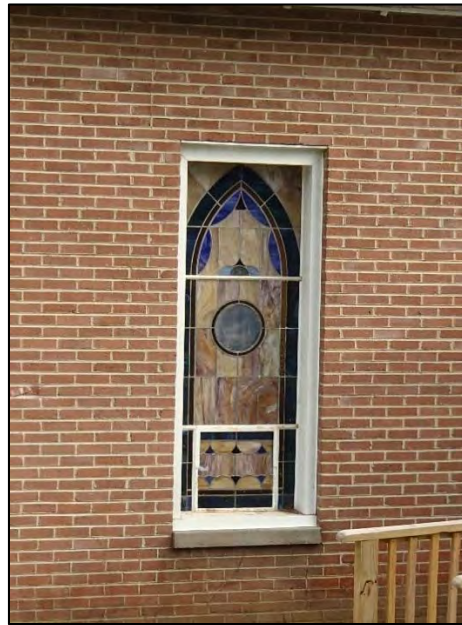
Figure 64: Roaring River United Methodist Church and Parsonage, typical stained glass window

Brick veneer covers the building and the front vestibule is likely an addition. It is probable the brick veneer was added to update the building at the time the vestibule was added, probably in the mid-twentieth century. The stained glass windows (figure 64) may also date from this era.

Shortly after the 1925 purchase, the congregation moved the 1875 sanctuary downhill to its current location. In the mid-twentieth century, the church decided to veneer the exterior in brick. The existing stained glass windows appear to date from that era, too.

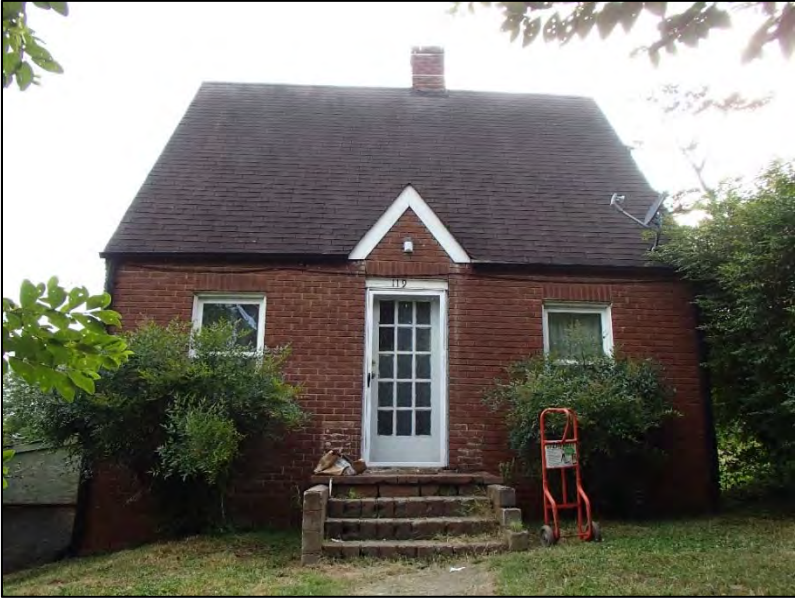
Figure 66: Roaring River United Methodist Church and Parsonage, house, east elevation

Downhill, to the south, stands a brick cottage with a steeply pitched side-gable roof that may have served as the parsonage (figures 66 and 67). The house has a symmetrical façade with a single-leaf French door centered below a small gable. Windows flank the door, and the windows and doors are finished with a soldier course above each opening. A concrete and brick stoop is missing its low brick balustrade. A shed roof, partially missing, springs from the rear roof slope to shelter an addition and a porch with a square brick post. A chimney flue rises through the middle of the house.

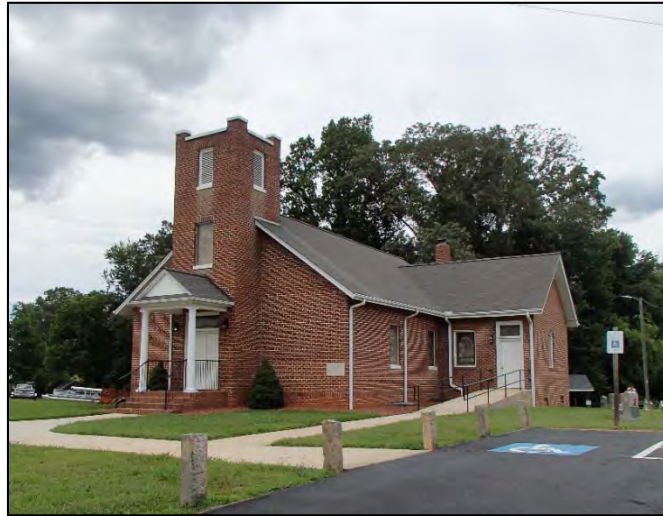
Figure 68: Charity United Methodist Church, 6440 Austin-Traphill Rd.

The Roaring River Methodist Church was originally a frame building. Charity United Methodist (figure 68) is a good comparative example because its cornerstone reveals that it was built in 1896, but was covered with brick veneer in 1949. It also has an addition to the side elevation and mid-century stained glass windows. The two buildings differ in design however, with Charity featuring a square bell tower and added pedimented portico. Charity is also a wider building. Overall, however, they represent the

same building type: a late-nineteenth-century sanctuary updated with new windows and new siding in the mid-twentieth century. Both construction and the mid-century alterations occurred during periods of relative prosperity for white residents of Wilkes County who prospered from the railroad's economic stimulus in the late 1800s and the industrial and poultry boom that the county experienced in the post-World War II years.

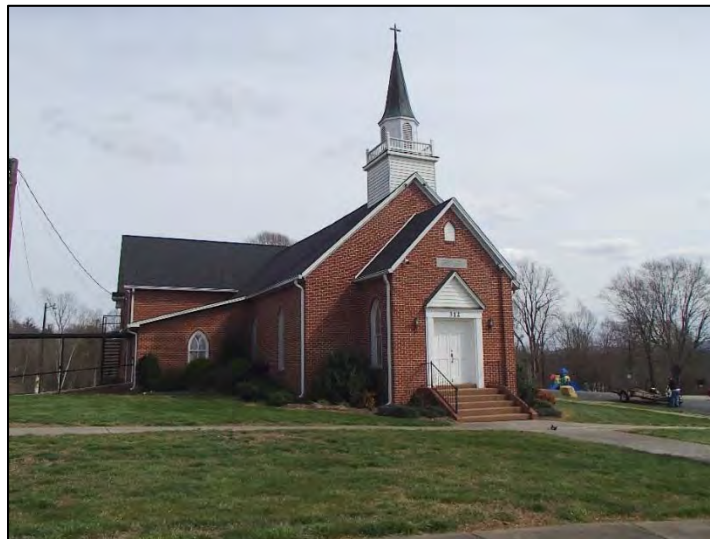
Figure 69: Roaring River Baptist Church, 124 White Plains Rd.

Roaring River Baptist Church (figure 69) dates from the early 1900s and was covered with brick veneer in 1949 (figure 67). Because Roaring River Baptist has a steeple rather than a bell tower, it is a somewhat better comparison to Roaring River Methodist. Roaring River Baptist Church, however, has had a significantly larger addition made to the rear elevation where a two-story section houses classrooms. Its gable end is closer in width to the diminutive Roaring River Methodist Church. Both churches were covered in brick veneer in the mid-twentieth century, but vinyl siding has covered all wood trim at Roaring River Baptist Church, rather than only the steeple as at Roaring River Methodist Church.

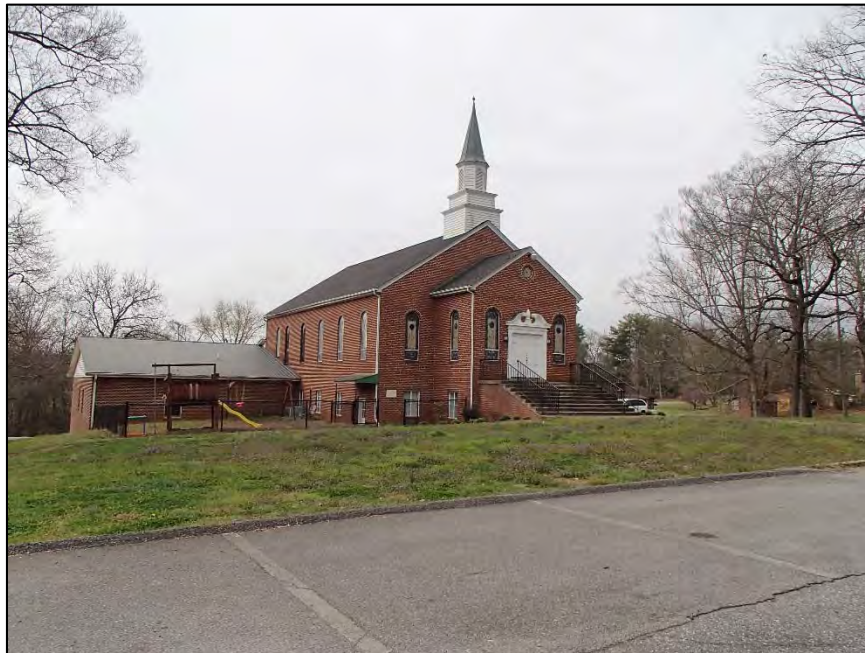
Figure 70: Ronda First Baptist Church, 12094 Elkin Highway, Ronda

Ronda First Baptist (figure 70) is one of the county's higher-style Colonial Revival style churches and is a better example of mid-twentieth-century church design, but it, too, is not outstanding and is one of many mid-century, Colonial Revival churches found in Wilkes County.

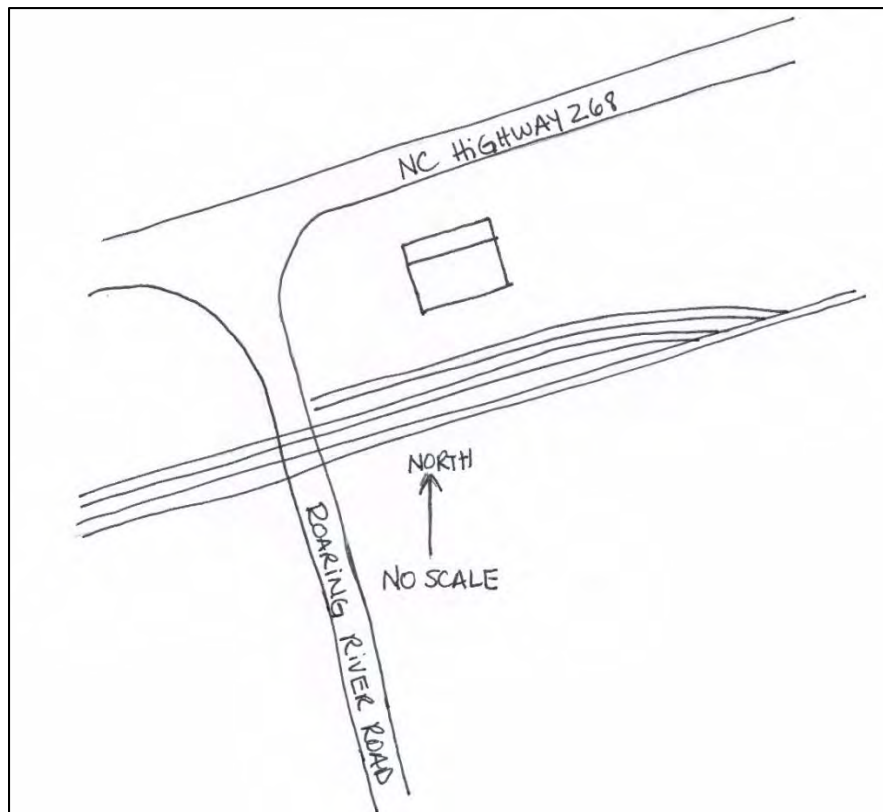
Figure 71: Roaring River Milling Company site plan

The Roaring River Milling Company is a two-story building over a full basement. The building stands on the southeast corner of N.C. Highway 268 and Roaring River Road, between N.C. Highway 268 and the railroad corridor. Roaring River's depot stood to the west of this site, just across Roaring River Road.

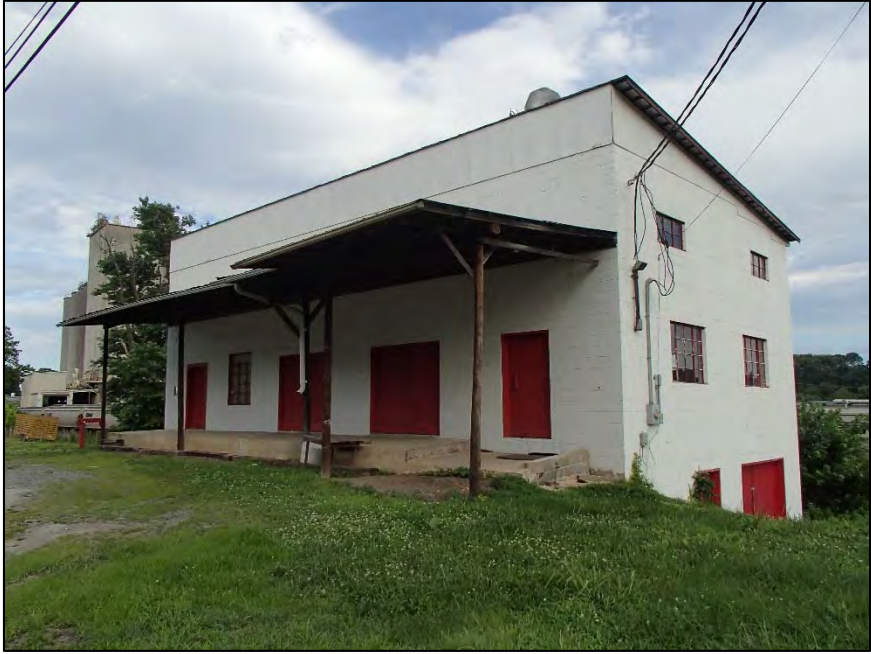
Figure 72: Roaring River Milling Company, northwest corner

The façade (north elevation) features an asymmetrical arrangement of two wide cargo bays with wooden, double-leaf doors, two wooden pedestrian doors, and a metal casement window (figures 72 and 73). A metal shed roof porch with a concrete floor and metal, bracketed posts shelters this fenestration. Above the porch roof, four small metal casement windows occupy the façade's second floor.

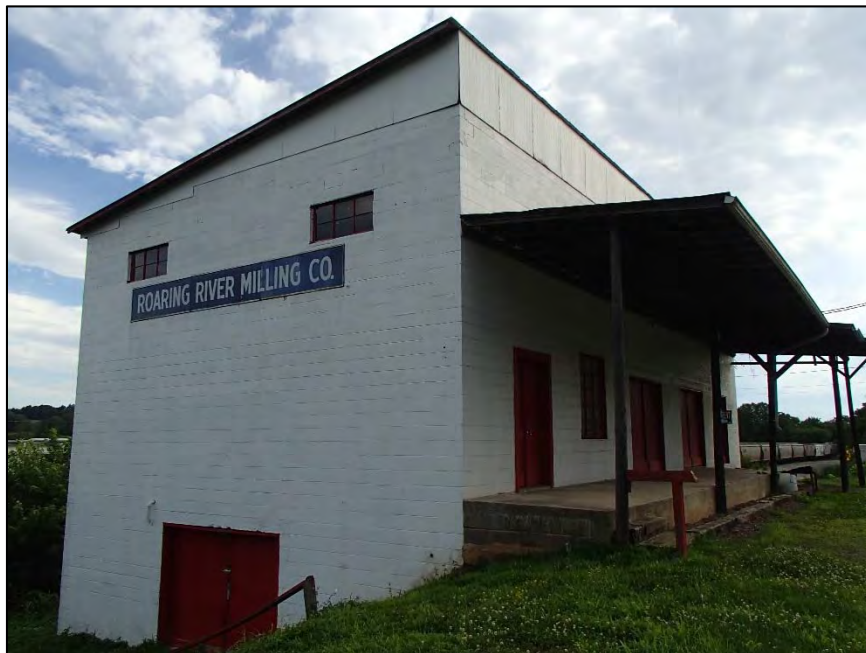
Figure 75: Roaring River Milling Company, east elevation

On the east elevation, two small metal casement windows are situated at the upper level above a sign reading Roaring River Milling Company (figure 75). A garage door occupies the basement level of the east elevation.

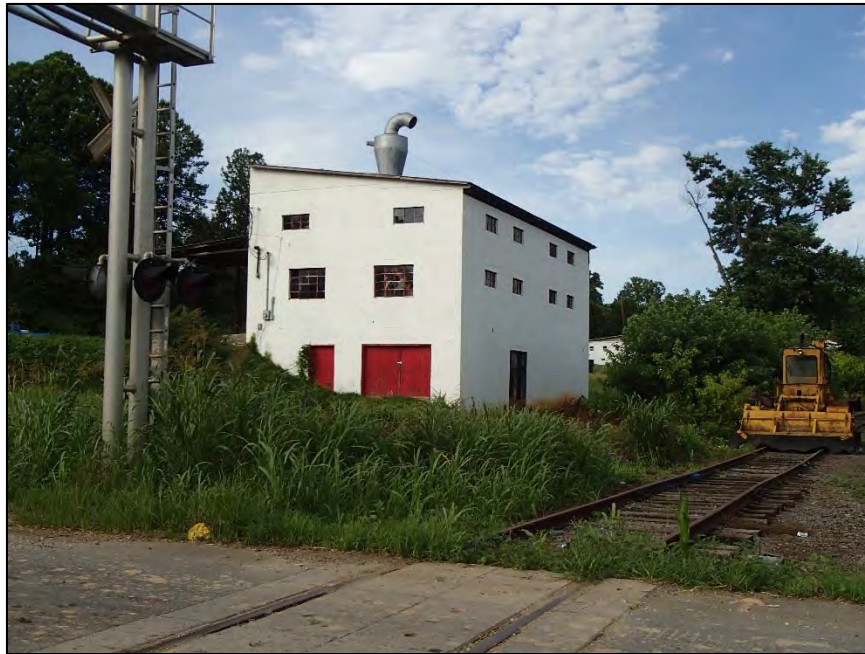
Figure 76: Roaring River Milling Company, southwest corner

Small, six-light metal casement windows occupy the south elevation with four windows on both the first and second floors (figure 76). A single door is located at the basement level on this elevation.

The west elevation features a garage door and pedestrian door at the basement level, sixteen-light metal casement windows at the first floor level, and six-light windows upstairs (figure 76).

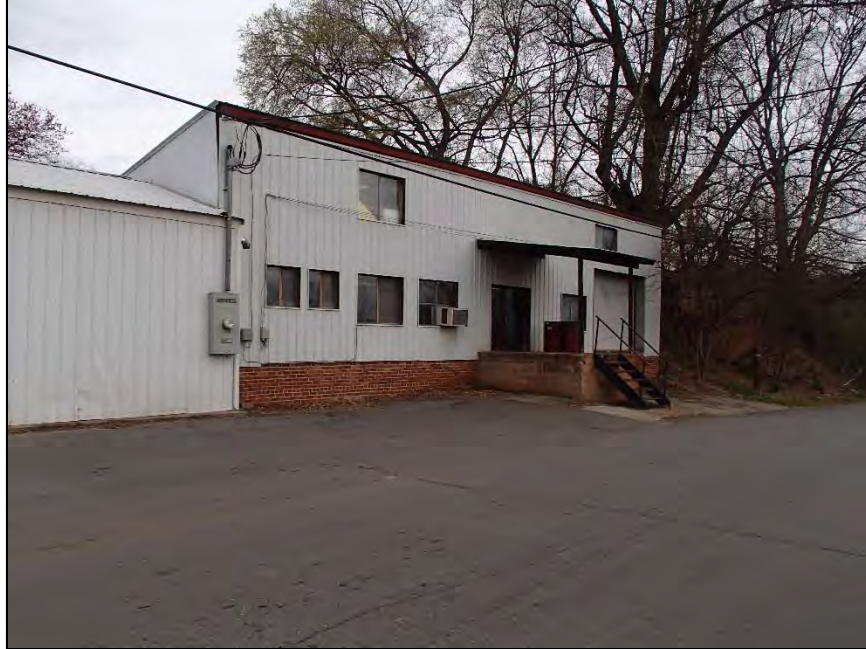
Figure 77: Small, light industrial building in Ronda

Several unsurveyed, small industrial buildings remain in Ronda (figure 77), but most of these are more recent or heavily altered buildings, while Tyson Foods' larger scale milling operation is extant in Roaring River (figure 78). The Tyson plant is also unsurveyed.

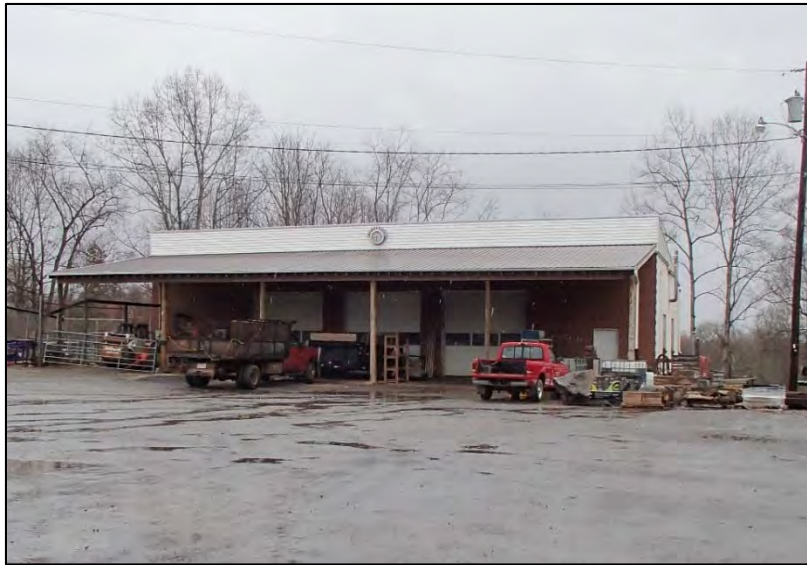
Figure 79: Possible feed mill building at the Farm Supply Store, 15846 Elkin Highway

A feed and farm supply store along NC Highway 268, west of Elkin, includes a detached building that could have housed milling operations in its past (figure 79). This building has not been surveyed.

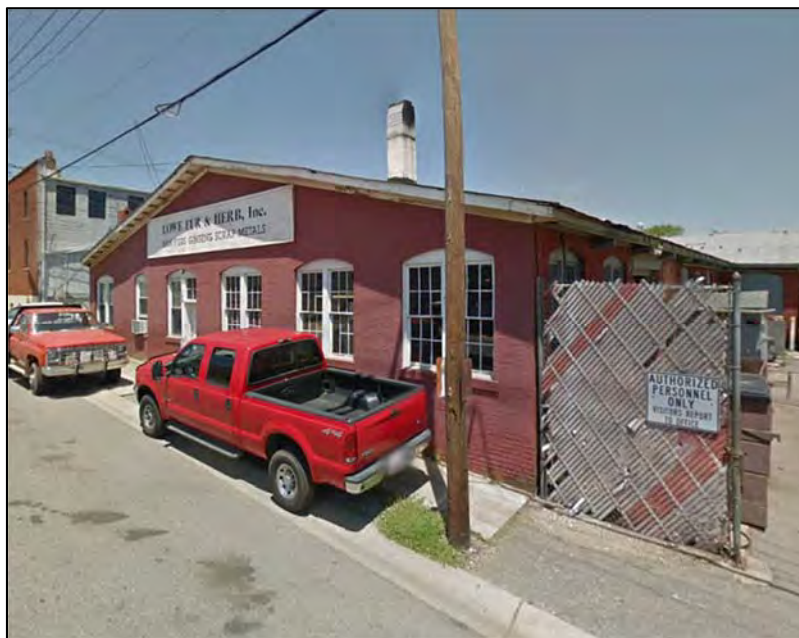
Figure 80: New Williams Mill, (WK 181), 108 Fifth Street, North Wilkesboro, Google Streetview photo, May 2013

Additionally, numerous industrial buildings of all kinds stand in North Wilkesboro. Among them is the New Williams Mill (figure 181) (WK 181) which is a brick, one-story, gable-front building with paired, six-over-six sash windows in segmentally arched openings. It is similar to the Roaring River Feed Mill in that it is a masonry building in a small town, but, architecturally, it is much more closely aligned with the state's textile mills. This factory also produced small grist mills rather than producing feed. This building has been surveyed but is otherwise undocumented.

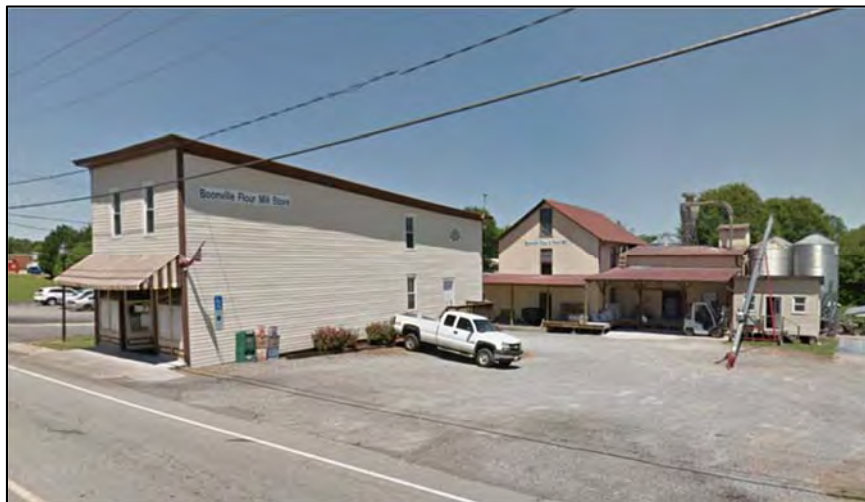
Figure 81: Booneville Feed Mill, YD 477), southeast corner of South Carolina Avenue and Academy Street, Google Streeview photograph, June 2016

Outside the county, in Booneville in Yadkin County, the Booneville Feed Mill (figure 81) (YD 477, DOE 2006) is a frame commercial building and a frame, gable-front mill building used for milling flour and feed from flour by-products.

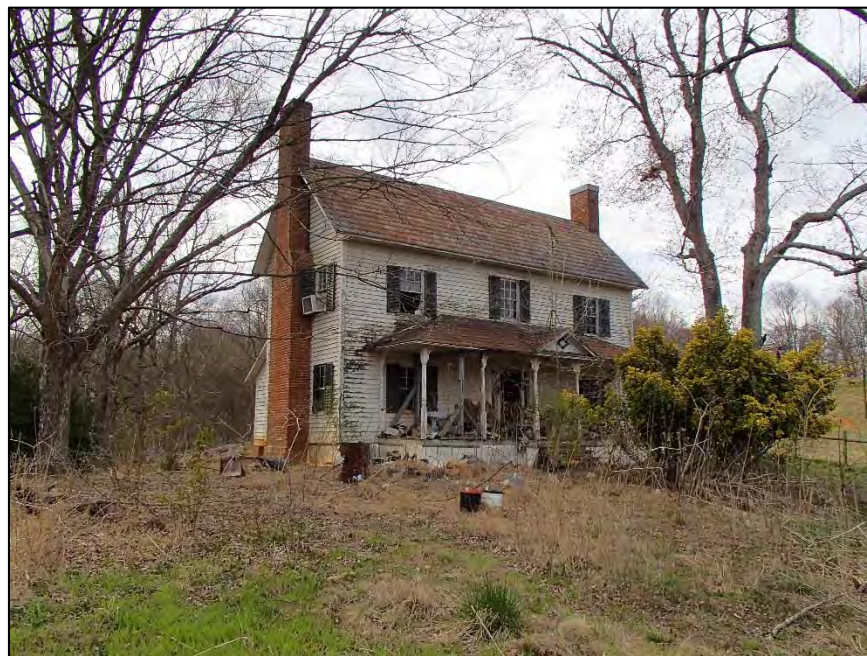
Figure 84: William and Diana Edwards House, southeast corner

The house is a two-story, three-bay I-house (figures 84 and 85). A porch with turned posts and modest brackets extends across the east façade. Its hip roof is accented with a gable above the entrance bay. The center window upstairs is elevated slightly suggesting that the existing porch may have replaced an earlier gable-front portico.

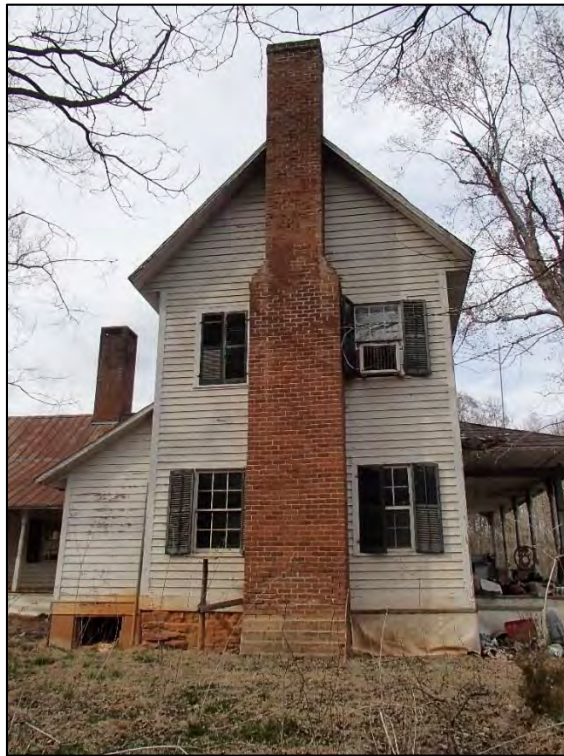
Figure 86: William and Diana Edwards House, south gable end

On the gable ends, windows flank single shoulder chimneys at each level (figures 86 and 87).

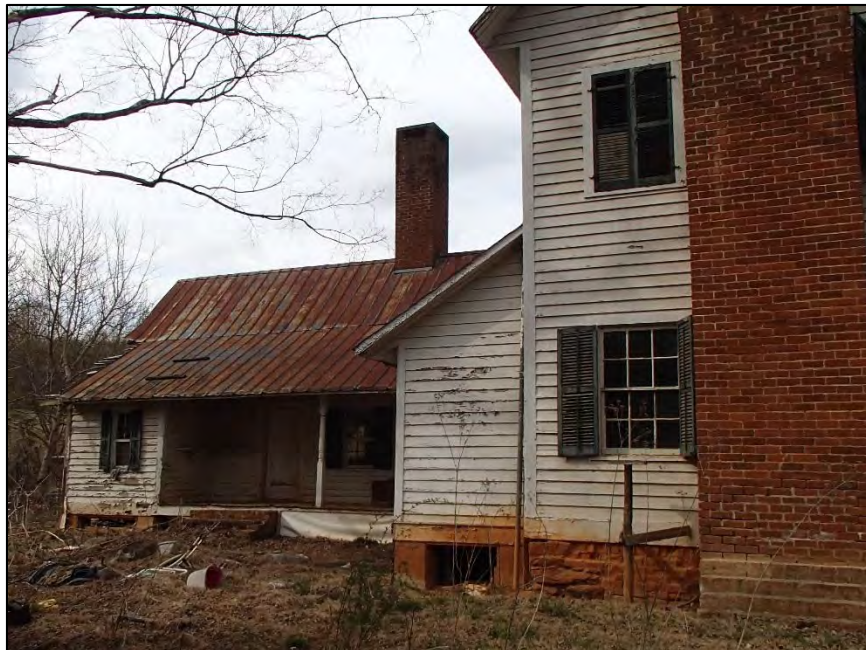
Figure 88: William and Diana Edwards House, south elevation

A one-story, gabled ell with a tall center chimney extends to the rear (figure 88). A shed roof porch runs along the main block's rear elevation and turns to follow the ell's south elevation. Along the main block, the porch has been enclosed, and an enclosed room is also located at the porch's west end along the ell.

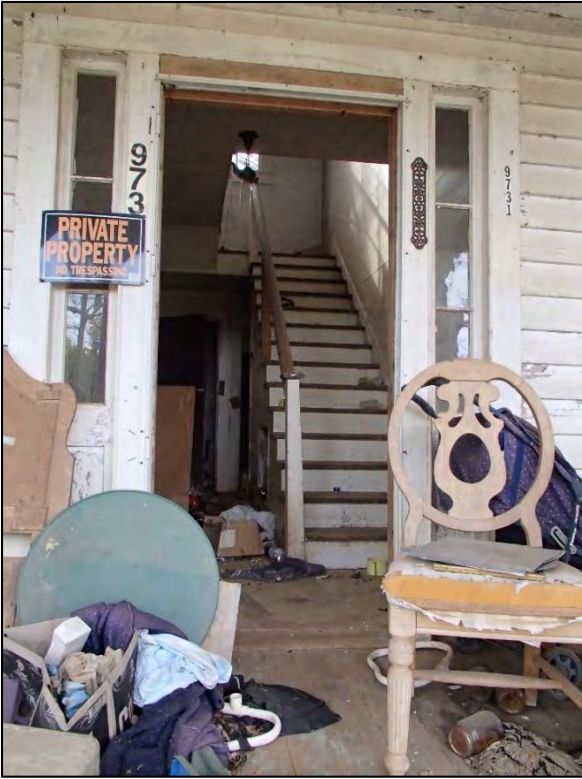
Figure 89: William and Diana Edwards House, front entrance

Windows throughout the house are original six-over-six windows. The front door is missing, but the opening includes sidelights (figure 89). The porch door on the ell is a two-panel, Greek Revival door (figure 90).

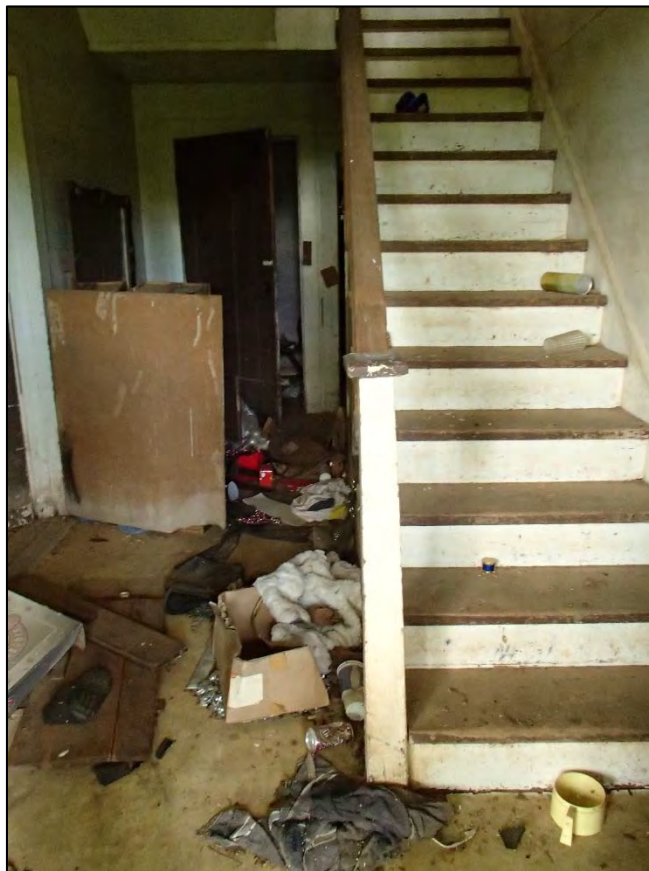
Figure 91: William and Diana Edwards House, staircase

Inside, the house follows a traditional center-hall plan. Doors throughout are two-panel, Greek Revival configurations. The staircase retains some tapered, rectangle-in-plan balusters and a spartan rectangle-in-plan, tapered newel post (figures 91 and 92). The railing, which makes two delicate, swooping slopes as it follows the turn of the stairs at the landing, terminates at the newel with a square pad on top of the newel post. This staircase is very similar to the one found at the Johnson-Hubbard House in Wilkesboro. Interior walls are finished with horizontal flush wood sheathing.

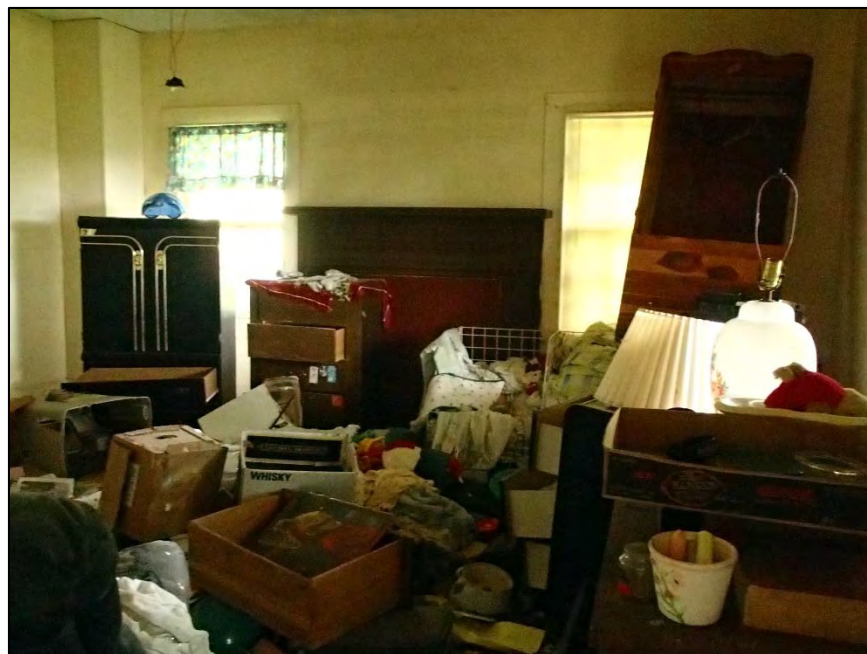
Figure 93: William and Diana Edwards House, north room, downstairs

Mantels throughout are relatively simple post-and-lintel pieces, with the main block's north room featuring transitional Federal-Greek Revival gouging (figures 93 and 94). All rooms are finished with tall, plain baseboards and plain window surrounds. There is no crown molding. In the main block's two downstairs rooms, boxed-in corners hint at heavy timber frame construction.

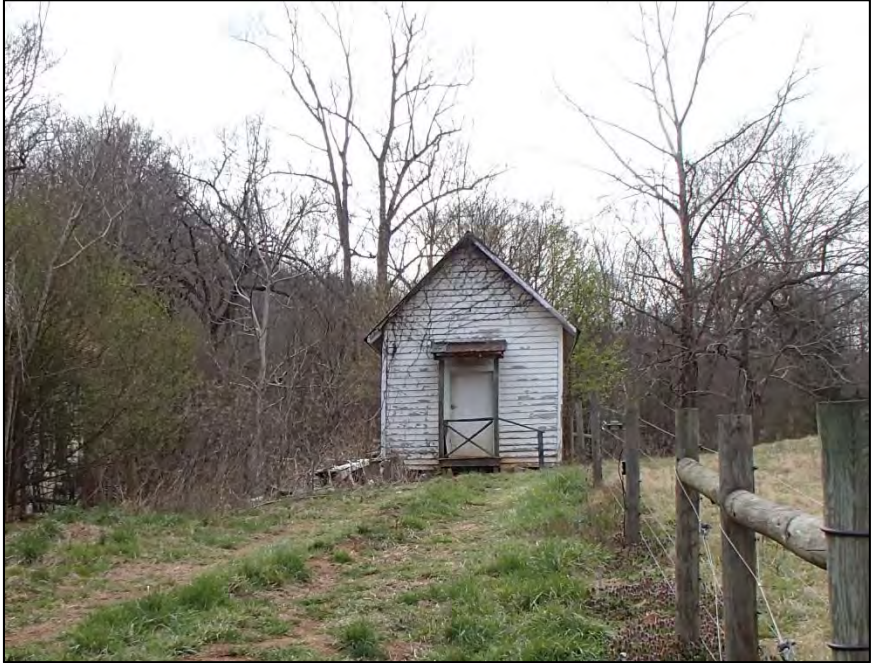
Figure 96: William and Diana Edwards House, gable-front outbuilding

Off the house's northwest corner is a gable-front, frame outbuilding with a batten door (figure 96). Like the gable-front, frame, weatherboarded outbuildings at the Reves-Greenwood and J.E. and Matilda Greenwood houses (figures 26 and 35), this outbuilding is windowless and does not have a chimney.

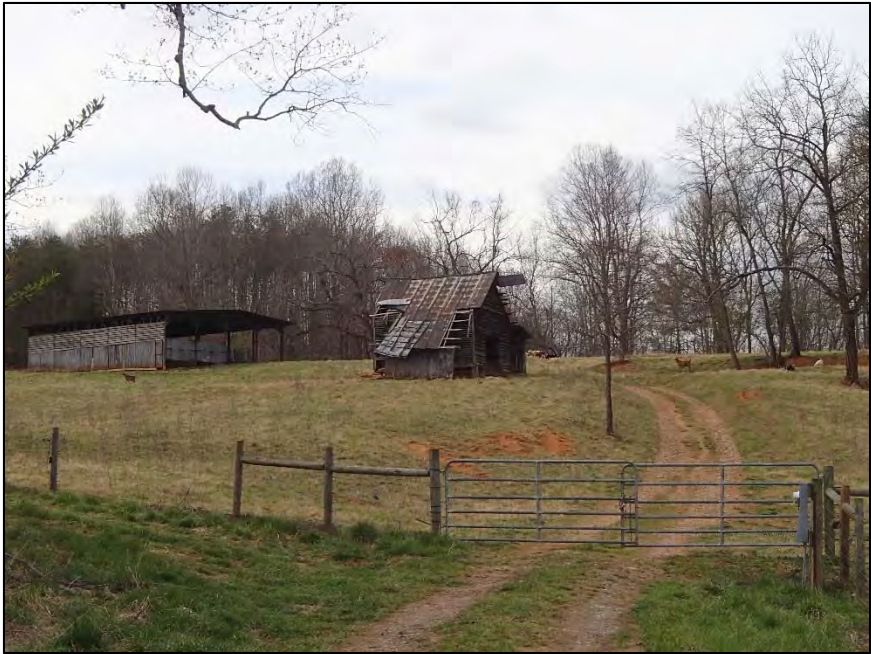
Figure 97: William and Diana Edwards House, barn and open sided shed

Farther north, in a pasture, is a ruinous frame barn and a large, open pavilion probably used for hay storage (figure 97).

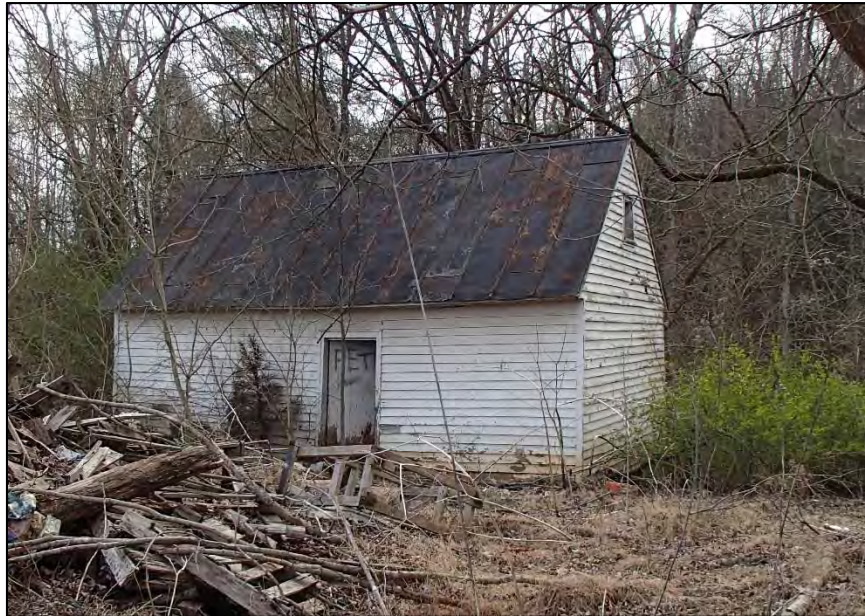
Figure 98: William and Diana Edwards House, possible store or warehouse

To the south of the house is a side-gable building of undetermined use (figures 98 and 99). It has flush gable ends and a boxed cornice, suggesting it was built around the time of the main house's construction. A batten door is centered on the front and a single window occupies the south gable end. The window has an interior batten shutter, and it is unclear if it was glazed. A small attic window or vent occupied a now-vacant opening in the gable end. No signs of a chimney were observed. Its location toward the front of the house and addressing a now-defunct road suggest the building may have been a store, warehouse, or office.

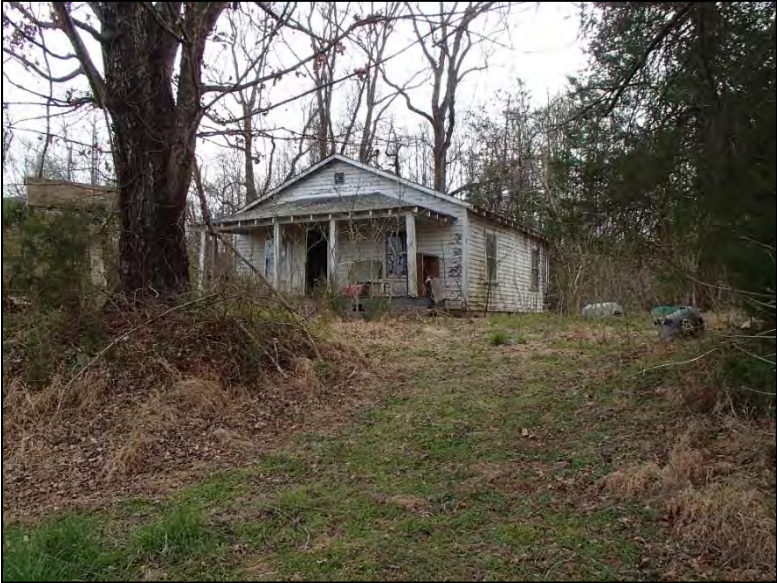
Figure 100: William and Diana Edwards House, bungalow

To the south of the store is a gable-front bungalow probably dating from the 1920s (figure 100). It is simply finished with weatherhboard siding, six-over-six sash windows, exposed raftertails, and a full-width, hip roof porch with square posts. Asphalt shingles cover the roof and a chimney extends from a point near the center of the house. Adjacent to the bungalow, to the south, is one frame wall of a ruinous building that may have been a garage.

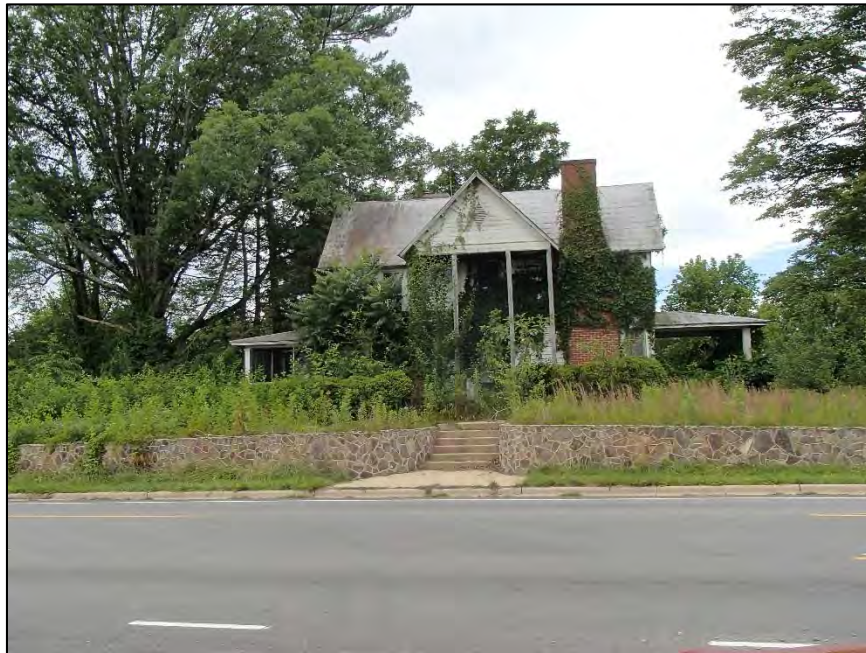
Figure 107: Jones Farm, WK 274

The Jones Farm (figure 107) (WK 274) was determined eligible for the National Register but has suffered significant neglect and deterioration since that designation in 2004.

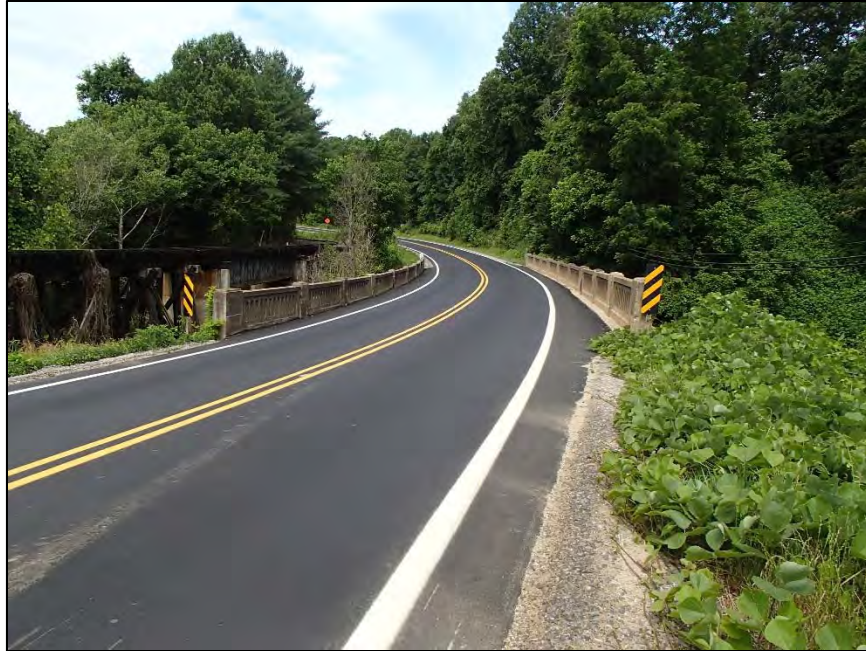
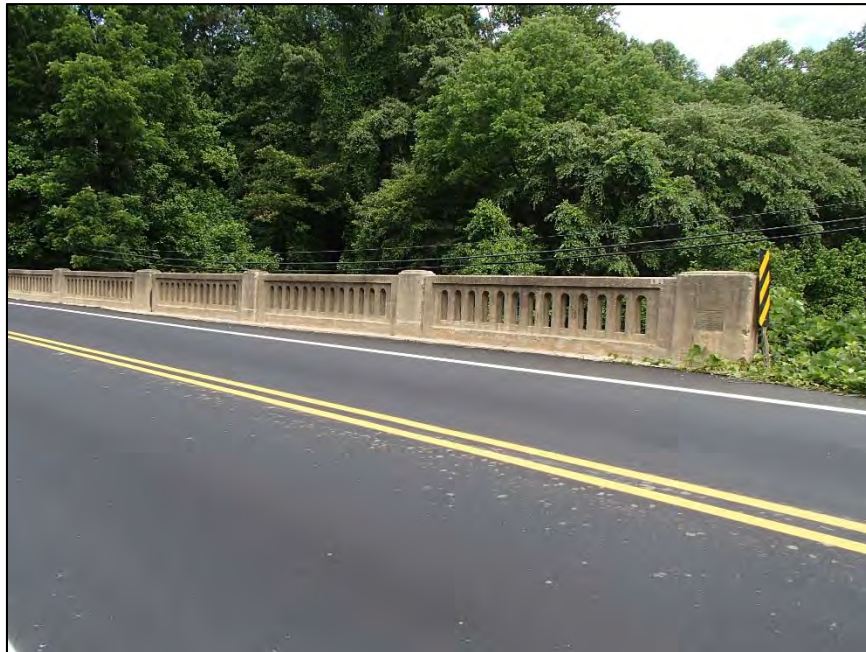
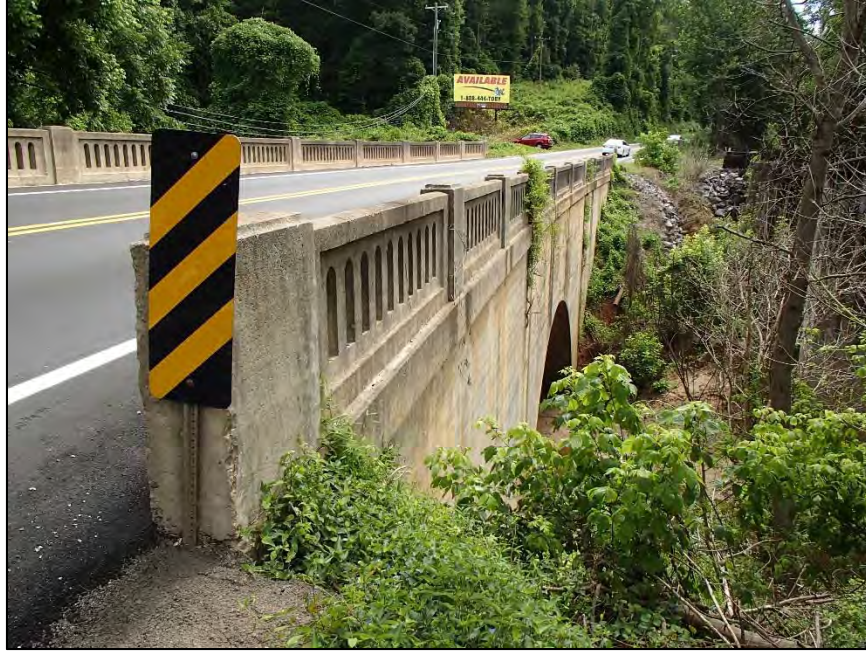
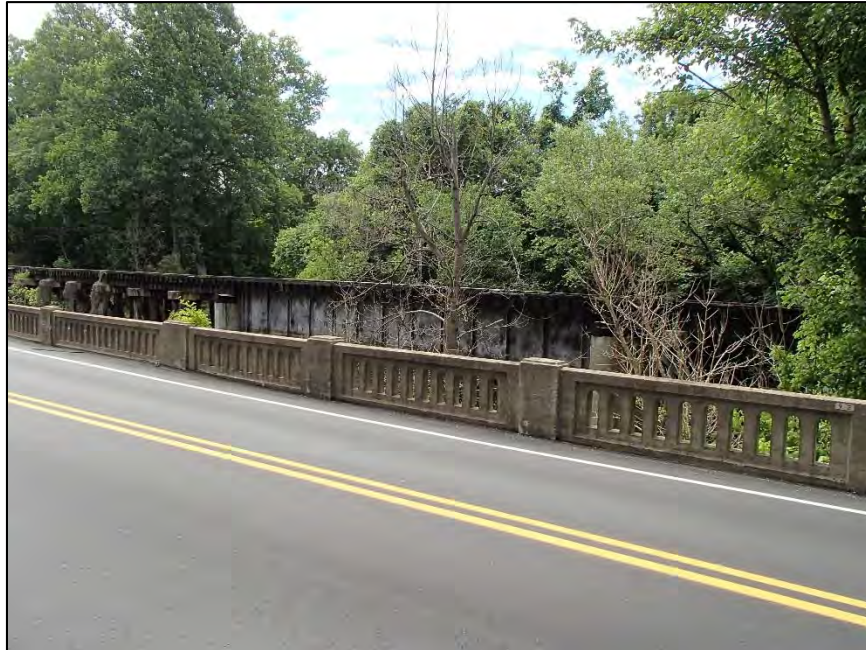
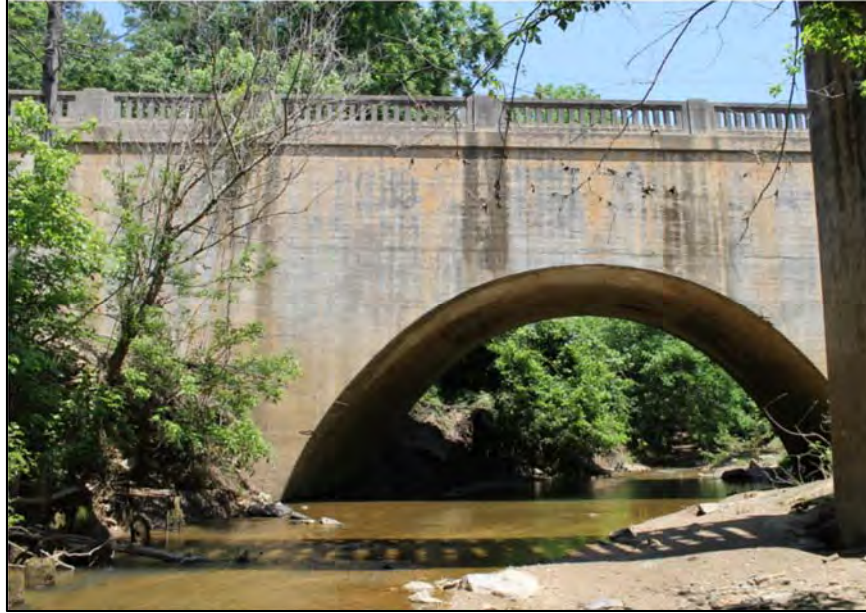
The Bugaboo Creek Bridge spans Big Bugaboo Creek with concrete railings composed of panels with arched openings between cast concrete piers (figures 112-116). Below, a concrete, closed-spandrel arch supports the bridge. The bridge is an earth-filled, reinforced concrete arch.¹⁷
