North Carolina Department of Natural and Cultural Resources
State Historic Preservation Office

MEMORANDUM

SUBJECT: Historic Structures Survey Report, Improvements to NC 268, PA 16-11-0003,
R-3309, Wilkes County, ER 17-1692

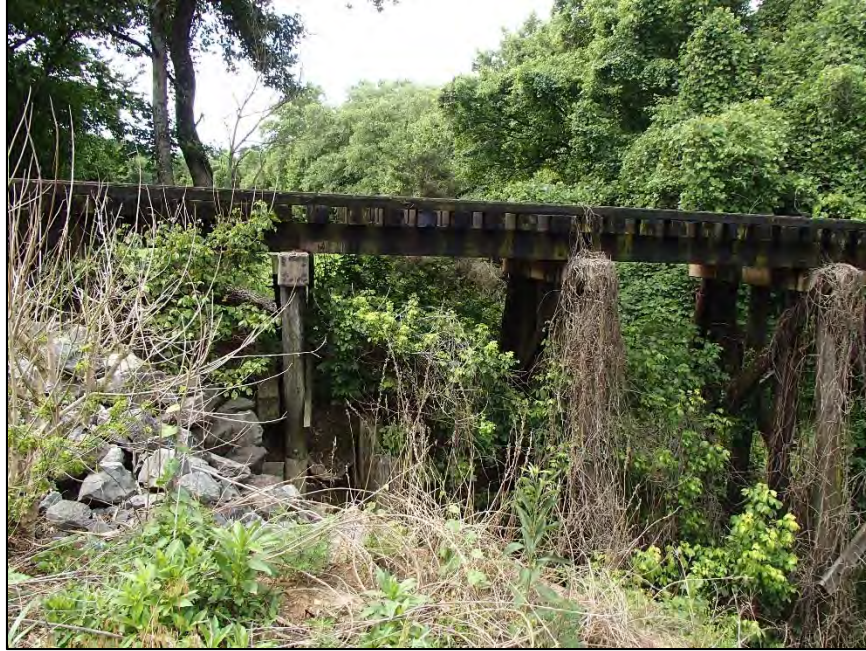
Figure 119: Bugaboo Creek Railroad Bridge, north elevation, east trestle section

The Bugaboo Creek Railroad Bridge spans Bugaboo Creek via a wooden trestle and a girder bridge (figures 119-122). Cast concrete piers support the girder bridge, which is located over the creek. The girder bridge is approached from both banks by wooden trestle bridges. The eastern trestle is approximately 102 feet long. The girder bridge is approximately 42 feet long, and the western trestle is about 60 feet in length.

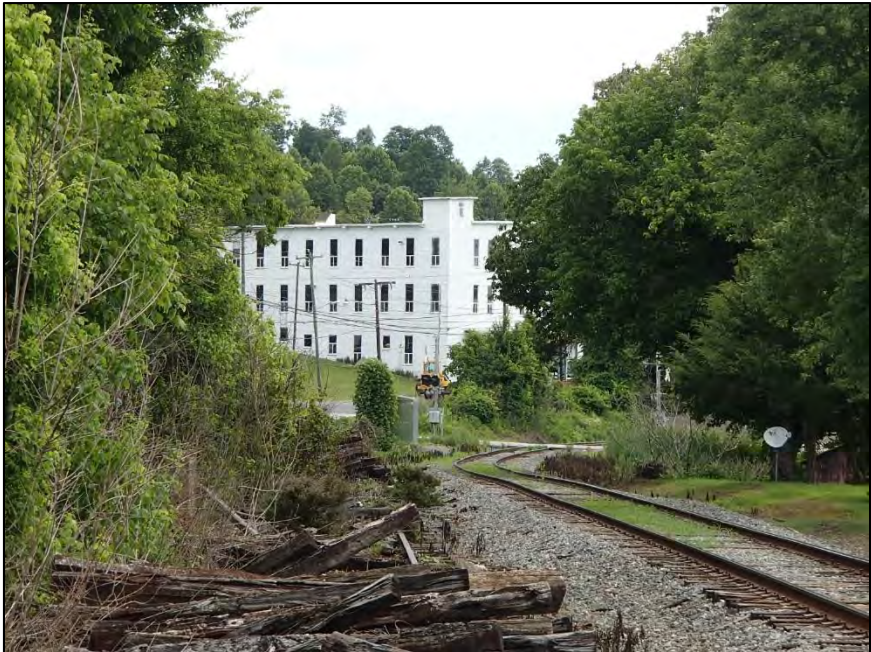
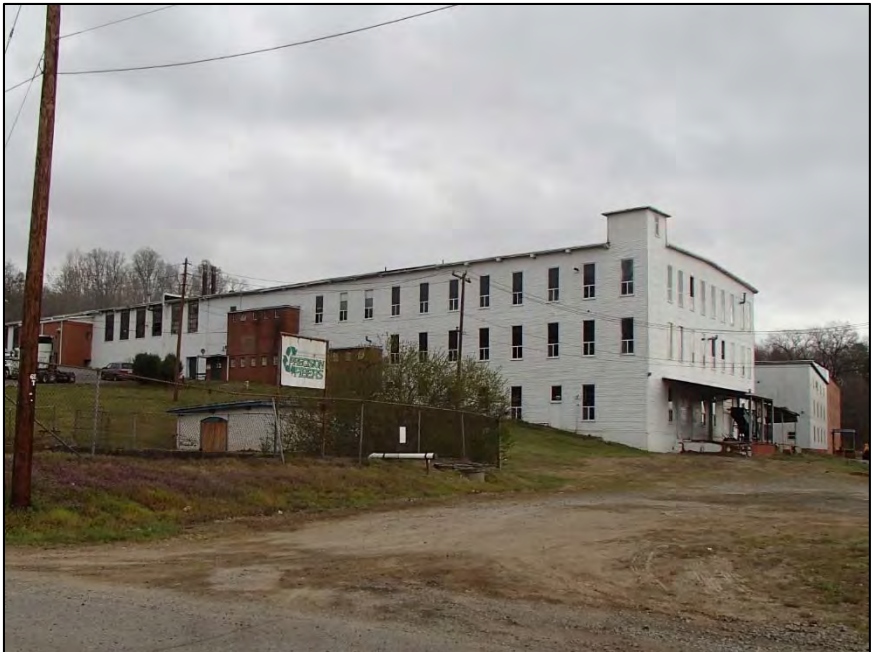
These buildings include the Home Chair Company (figures 130 and 131), which is an imposing three-story, frame landmark building located toward the east end of town, and two churches near the

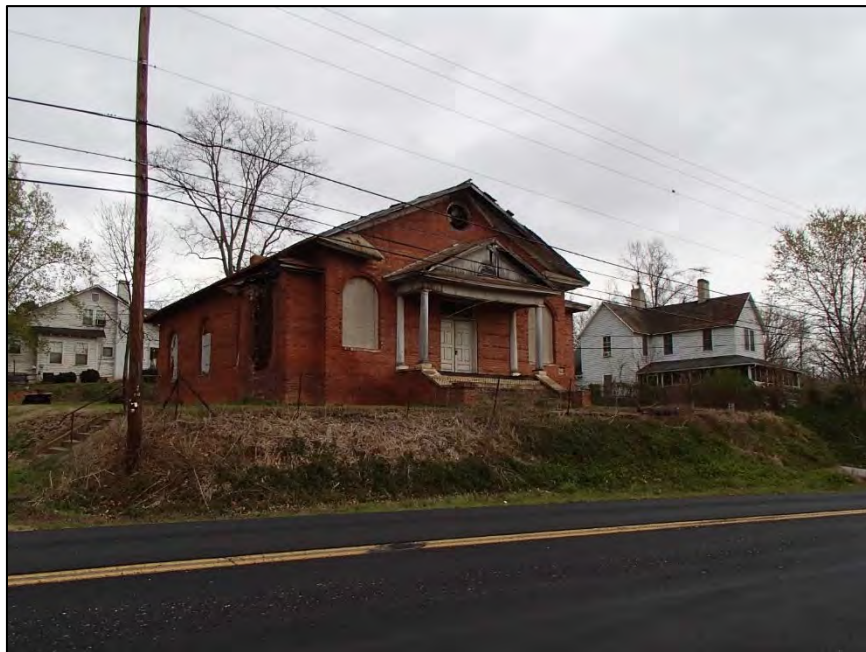
Figure 133: Ronda Historic District, former Ronda Methodist Church, Elkin Highway (N.C. Highway 268)

community’s present-day center: Ronda First Baptist Church (figure 132), a mid-twentieth-century, gable-front sanctuary and Ronda Methodist Church (figure 133), an extremely deteriorated building dating from the 1920s. Also near the town’s center is the late-twentieth-century fire department building (figure 134), which replaced the 1897 All Saint’s Episcopal Church, a gas station, and small non-historic businesses. At the west end of town, the high school’s 1950s gym now serves as a community center and town hall (figure 135). Like so many other buildings in Ronda, this gym has been covered in vinyl siding.

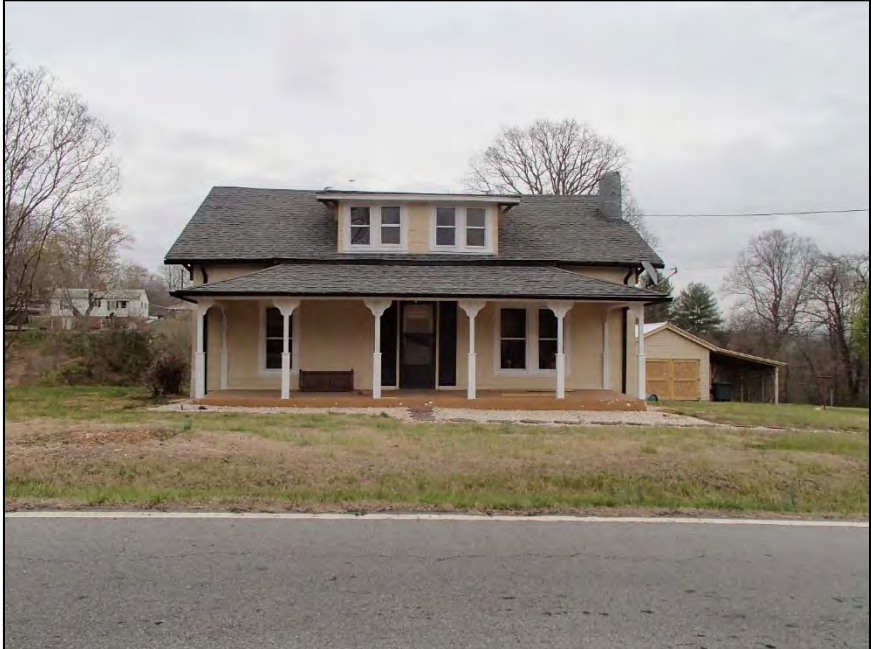
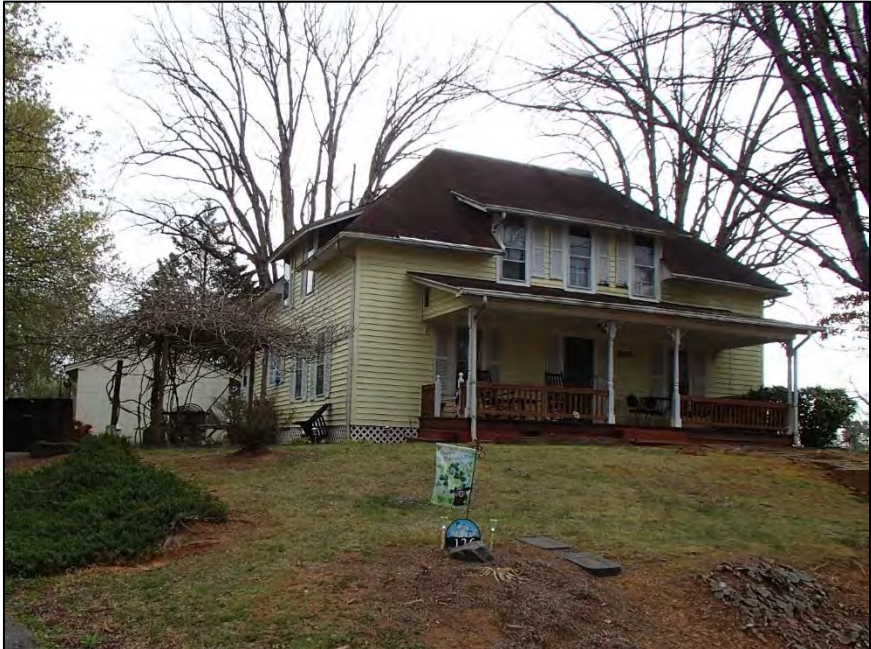
three of these streets come together. A few late-nineteenth-century houses (figures 138-140) and numerous 1920s and 1930s bungalows line these north-south streets (figures 141-143). Almost all of these houses have been altered with vinyl siding, replacement windows, and replacement porch materials.

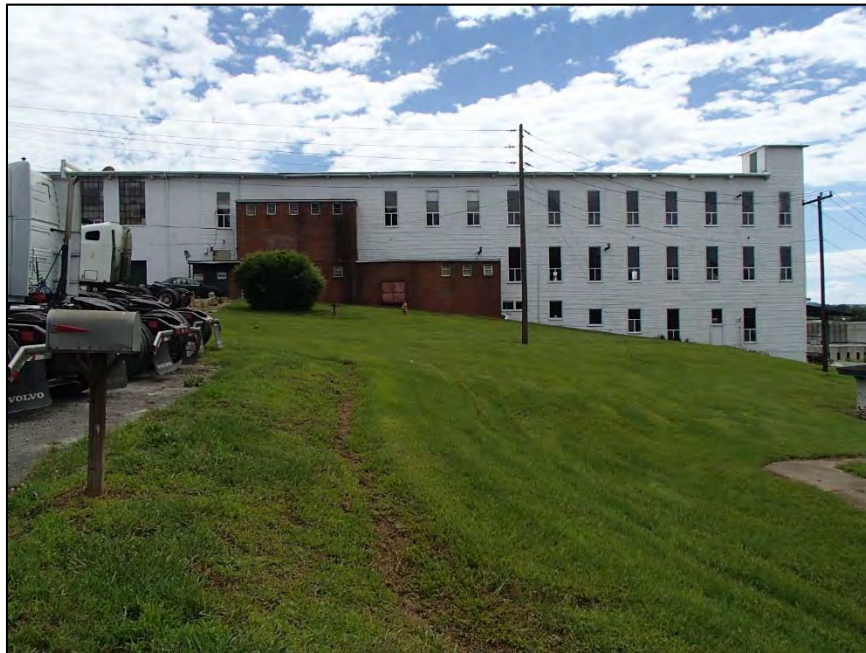
Figure 152: Home Chair Company, original section, west elevation

The front (south) section was built in 1919-1920 as a cotton mill (figures 152 and 153). It is a three-story frame building with a very low sloped gable-front roof and a corner tower that projects one story above the main building's height. The façade is nine bays wide with a loading dock sheltered by a metal shed roof with square wooden posts extending across the front (figure 155). Two wide garage doors with tall multi-light transoms open onto the loading dock. The original section's side elevations are ten bays deep and the building is built into the slope so that, toward the back of the original section, only two stories are above grade (figure 152). Almost all windows in the frame section have been replaced, and vinyl siding covers the original weatherboards (figure 154). On the east elevation, a small loading dock area features two original six-over-six-over-six triple-sash windows and a wooden double-leaf cargo door topped with a multi-light transom (figure 156).

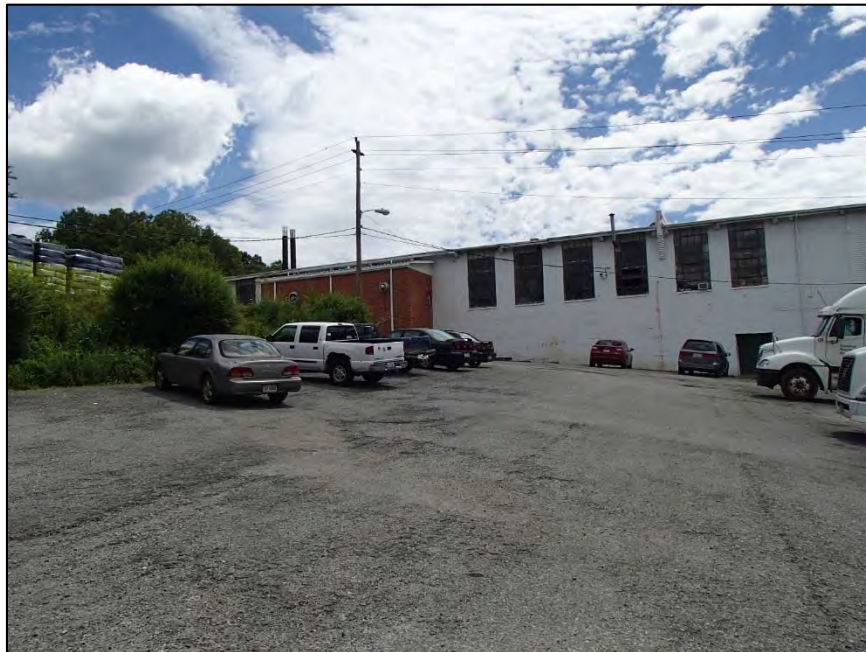
Figure 158: Home Chair Company, 1940s junction between original section and the ca. 1960 addition, west elevation

To the north, behind the original section, a brick addition features large metal casement windows and matches the height of the original building (figures 158 and 159). This addition probably dates to the Home Chair Company expansion in 1940-1941.

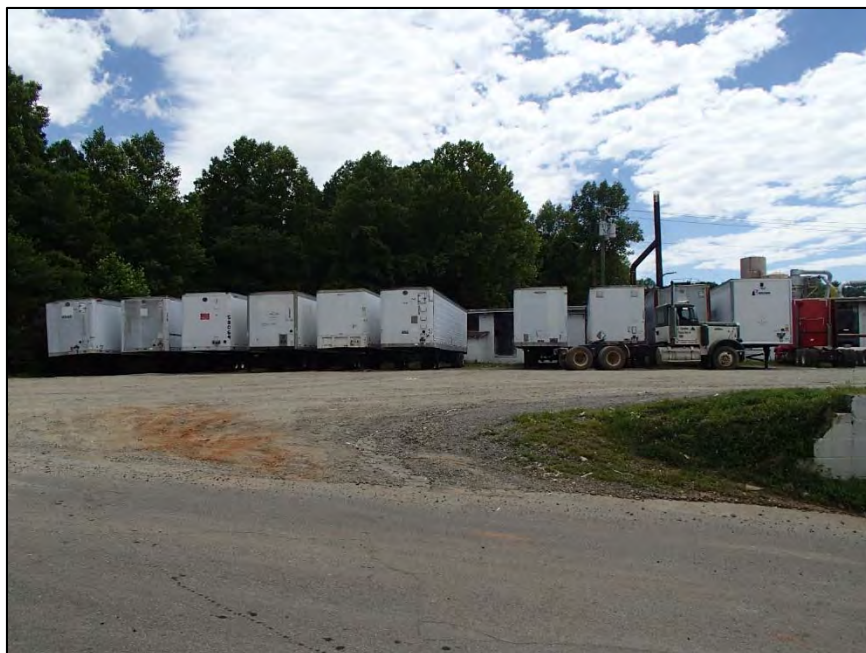
Figure 160: Home Chair Company, ca. 1960 section, west elevation behind trucks

The 1940 addition was expanded on the north with a brick structure that appears to date from around 1960 (figure 160). This addition is one-story in height with a flat roof.

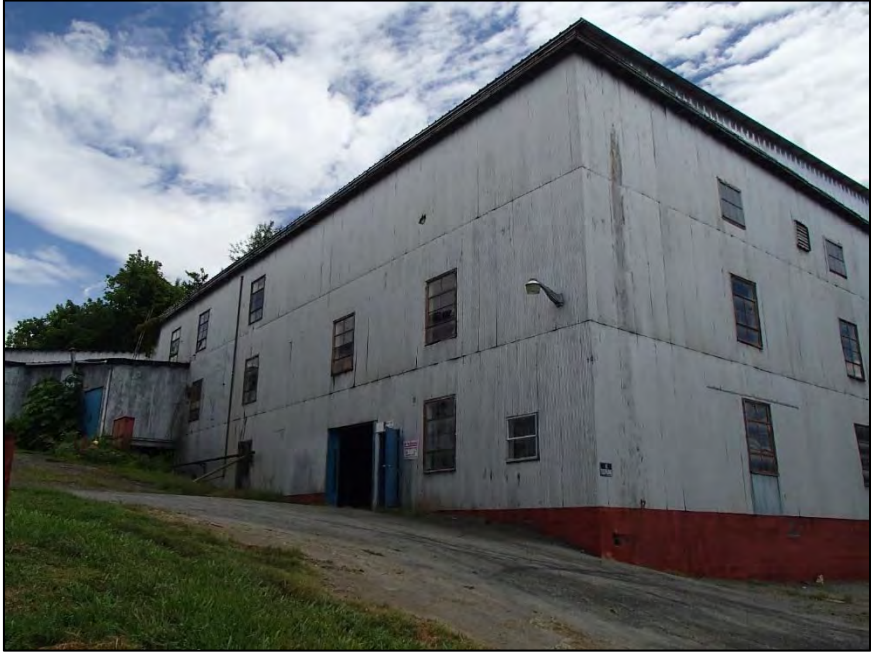
Figure 161: Home Chair Company, ca. 1940 building, southwest corner

To the east is a three-story building covered in metal siding (figure 161). This building retains original metal casement windows and was probably built around 1940. A kneewall was added to extend the building's walls to allow for a sloped roof.

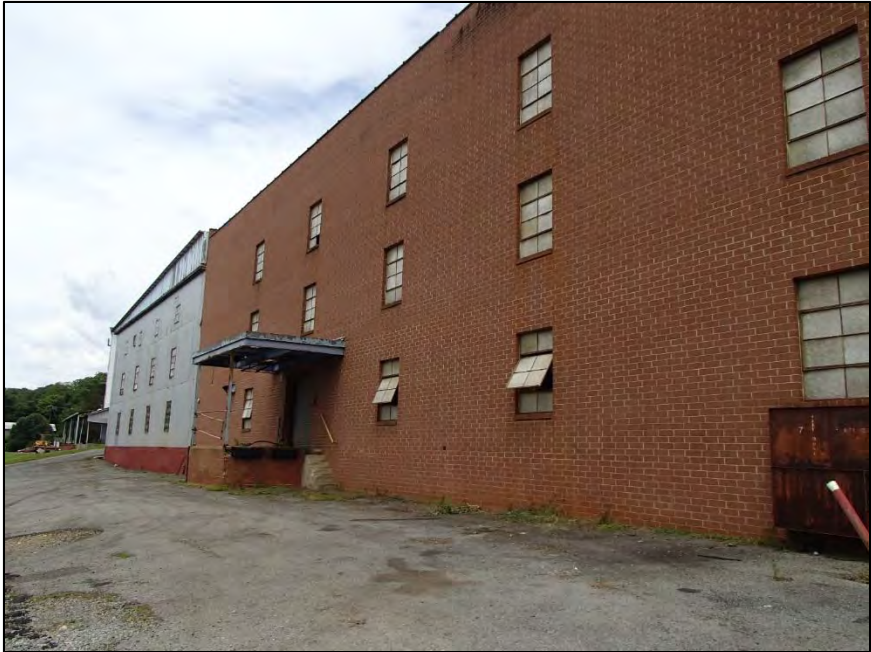
Figure 162: Home Chair Company, 1940s section with ca. 1950 addition, south elevation

A brick addition, also three-stories and possibly dating from ca. 1950, is attached to this building's east elevation (figures 162 and 163). The brick addition retains metal windows with center sections that tilt open.

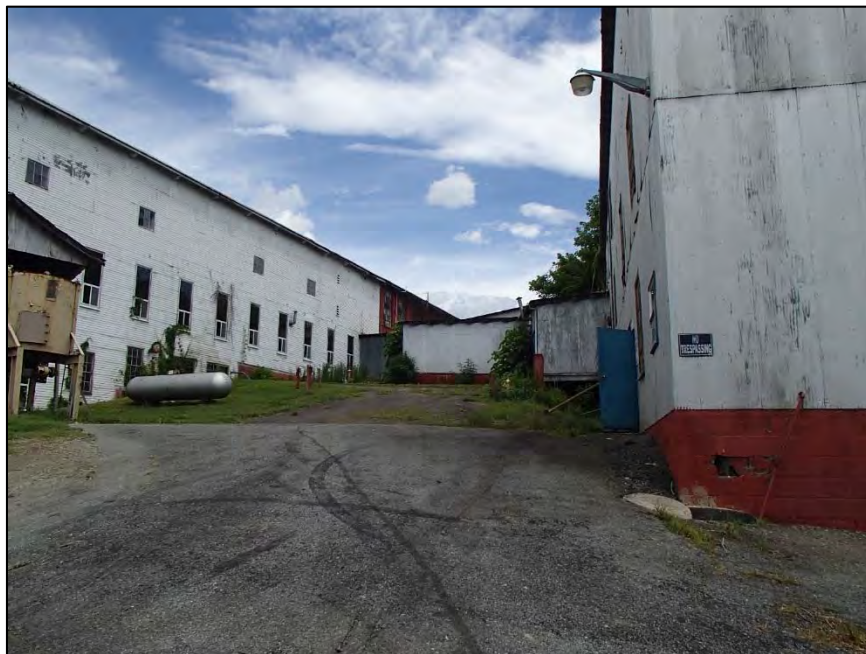
Figure 164: Home Chair Company, original section to the left; ca. 1940 building to right

A hyphen building and an enclosed conveyor belt connect the original west building (the original building plus the 1940s and ca. 1960 additions) to the east building (the 1940s building plus the ca. 1950 addition) (figure 164). The hyphen and enclosed conveyor belt are both clad in corrugated metal sheeting.

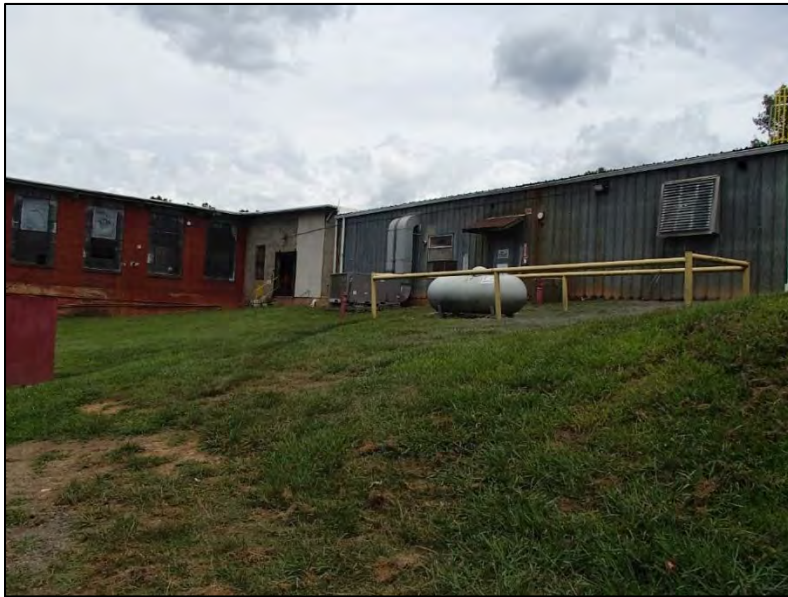
Figure 165: Home Chair Company, additions joining 1940 expansion of the original building

At the back of the complex, a group of smaller buildings and storage tanks are connected to the west building's north end (figure 165).

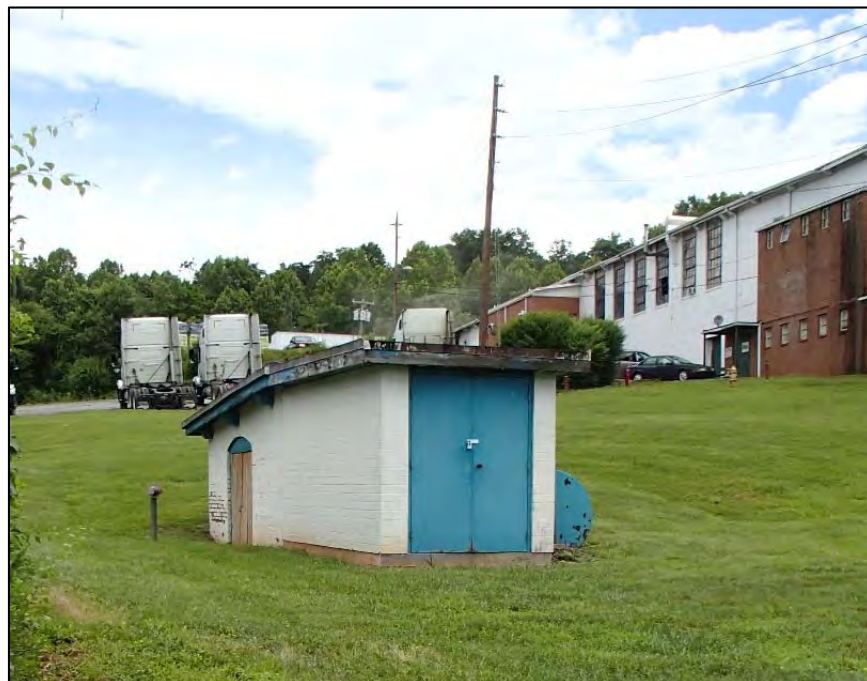
Figure 166: Home Chair Company, pump house

To the west of the original building is a small retaining pond and a small brick pump house (figure 166). These buildings are believed to date from the original 1920 construction. Also to the west is a one-story, hip-roof office building with modest Colonial Revival detailing including an eyebrow attic vent (figure 167). The office probably dates from the 1940s.

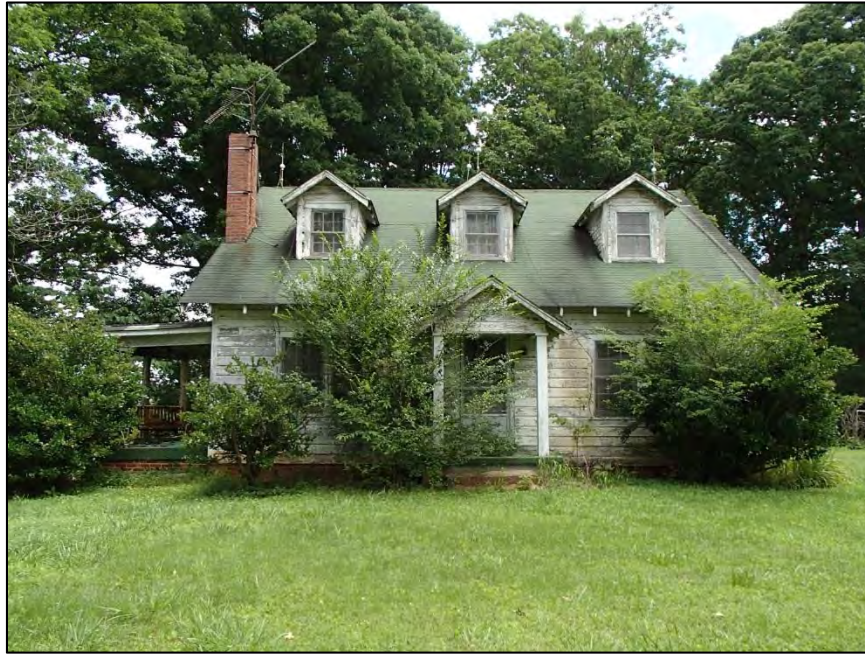
Figure 176: Poplin Family Farm, main house, west elevation

The farm's buildings are clustered behind the main house, which is a one-story, side-gable cottage with a three-bay façade with both Craftsman and Colonial Revival stylistic elements (figure 176). The single-leaf front door features three horizontal panels below a three-light glazed panel. A small, attached

gable-front portico with square posts and exposed raftertails shelters the front door. Pairs of six-over-six sash windows flank the front door. Three gable-front dormers, each with six-over-six sash windows, punctuate the front roof slope.

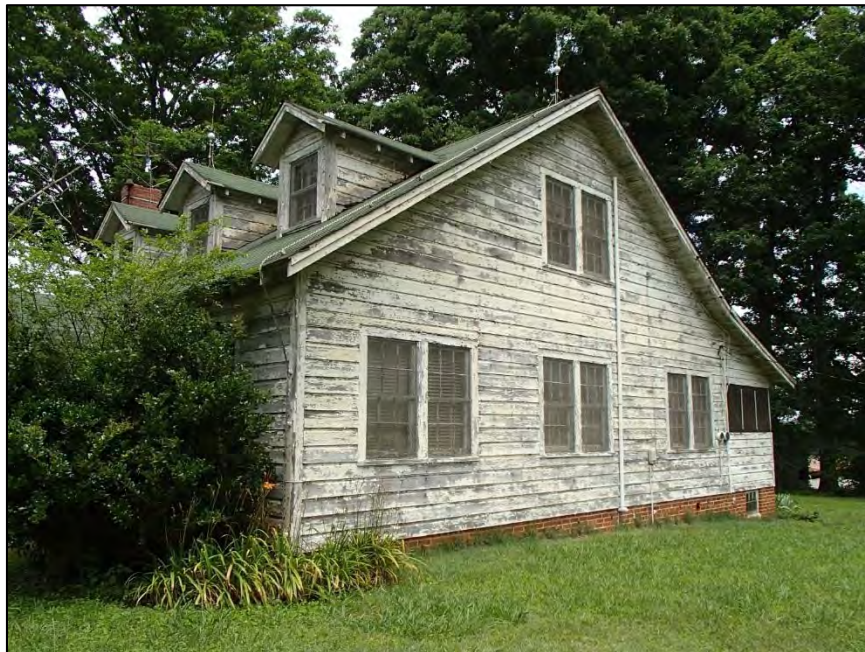
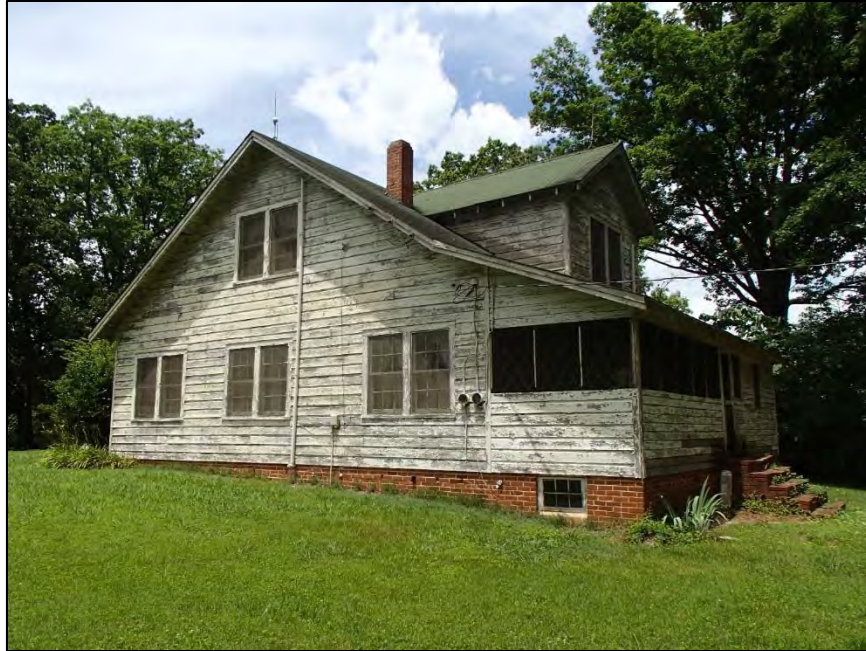
The south elevation is three bays wide with three pairs of windows and paired attic windows. All windows have original six-over-six sash (figures 177 and 178).

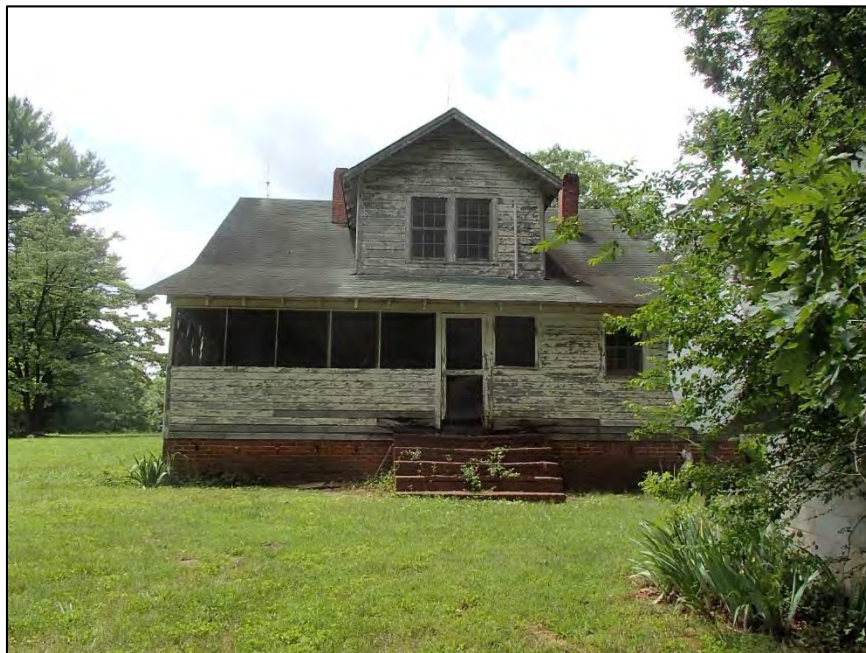
Figure 179: Poplin Family Farm, main house, east elevation

On the east elevation, the rear roof slope breaks to extend over a screened porch that is partially enclosed. A large gabled dormer occupies the rear roof slope (figure 179).

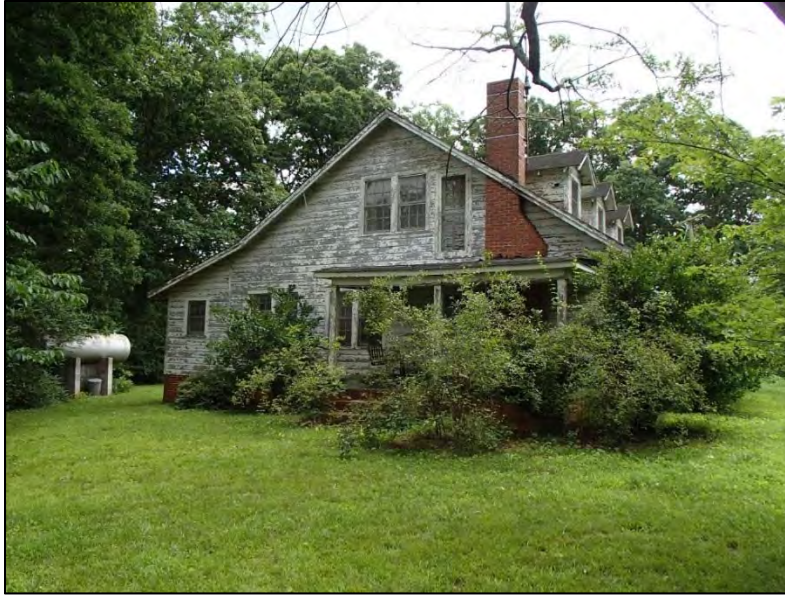
Figure 180: Poplin Family Farm, main house, north elevation

The north elevation contains paired and single six-over-six sash windows, an asymmetrical brick chimney, and a flat-roof side porch with square posts. An attic-level door opens onto the porch roof (figure 180).

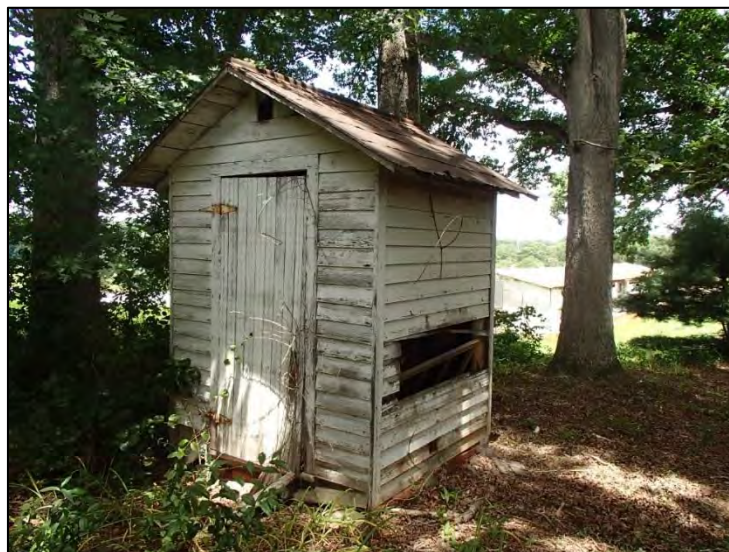
Figure 181: Poplin Family Farm, carbide generator house

A full complement of outbuildings is located behind the house. Closest to the house is a carbide generator house (figure 181). This small, frame, gabled building was constructed to house a carbide generator that provided the farm with acetylene gas for gas light fixtures. This building was constructed for use with a previous house on the site and probably dates to the turn of the twentieth century. The generator equipment was set into the ground and stored items now fill the shed so that the floor, and therefore any remaining equipment, could not be documented. The owner could not confirm if any generator parts remained.

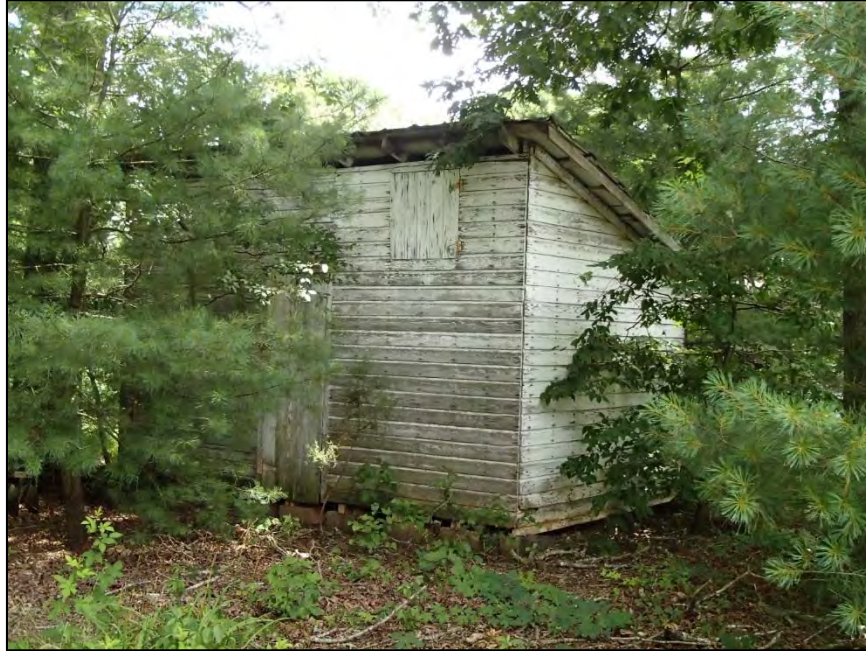
Figure 182: Poplin Family Farm, granary

To the house's southeast are two frame shed-roof buildings. The granary features drop siding, a batten door, and a hatch door just below the eave (figure 182). The other shed is vertically sided with wood, has a four-panel door, and a small four-over-four window (figure 183). This was used as a cottage for the sibling of one of the owners. Both date to the 1940s.

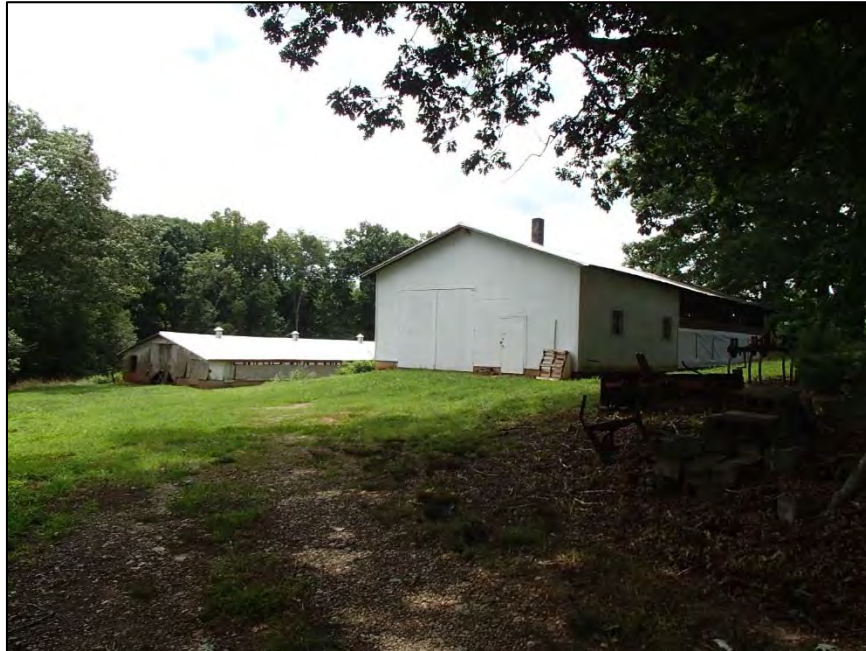
Farther south are two poultry houses (figures 184 and 185). These are long, gable-roof pavilions where chickens were housed. The house closer to the yard is a small structure built around 1948, but the southernmost house is the farm's longest extant chicken house and dates from the 1950s. A longer house was blown down in a windstorm in the 1960s.

Figure 184: Poplin Family Farm, south chicken houses; 1948 house is closer, 1960s house in distance

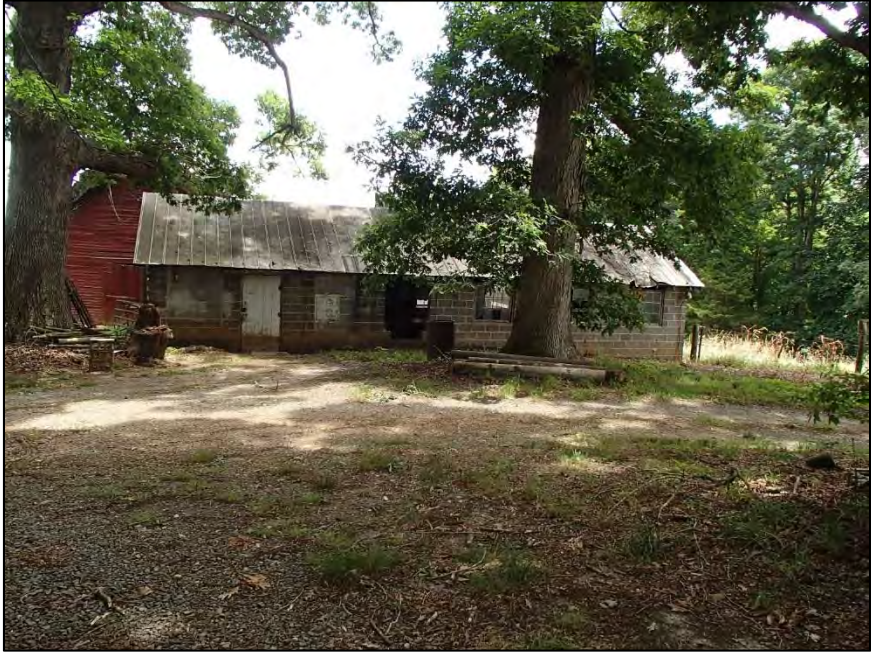
Figure 186: Poplin Family Farm, milking parlor

Directly to the east of the house and beyond the generator building and shed-roof cottage are a concrete block milking parlor (figure 186) and a large barn (figure 187). The milking parlor was built in 1948 as a Grade A parlor, and has metal casement windows and wooden batten doors.

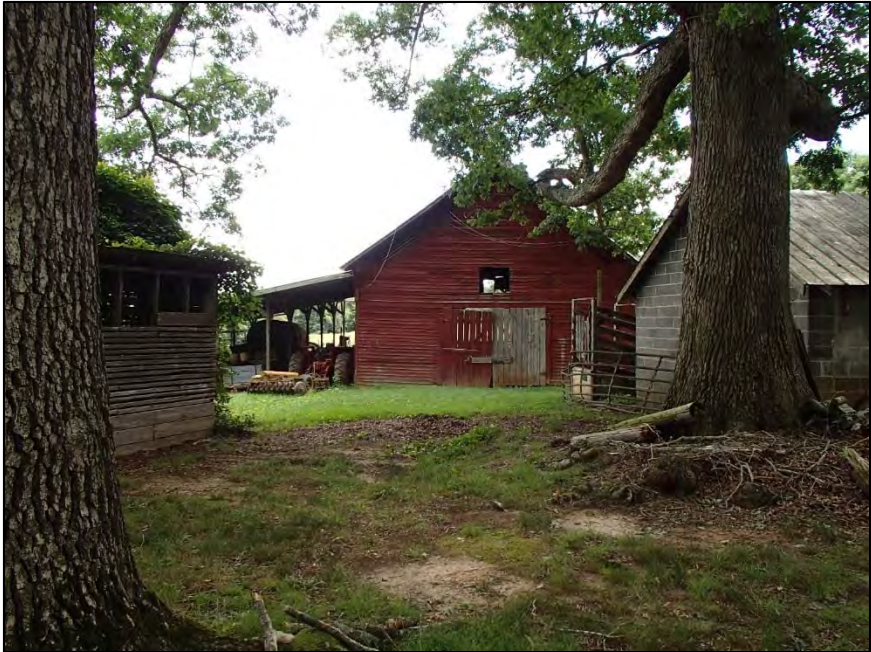
Figure 187: Poplin Family Farm, barn

The barn is a substantial gable-front structure with an open central driveway. Shed wings are attached to both sides. The barn pre-dates the house, and was likely built around 1900 when the family’s earlier dwelling was still standing.

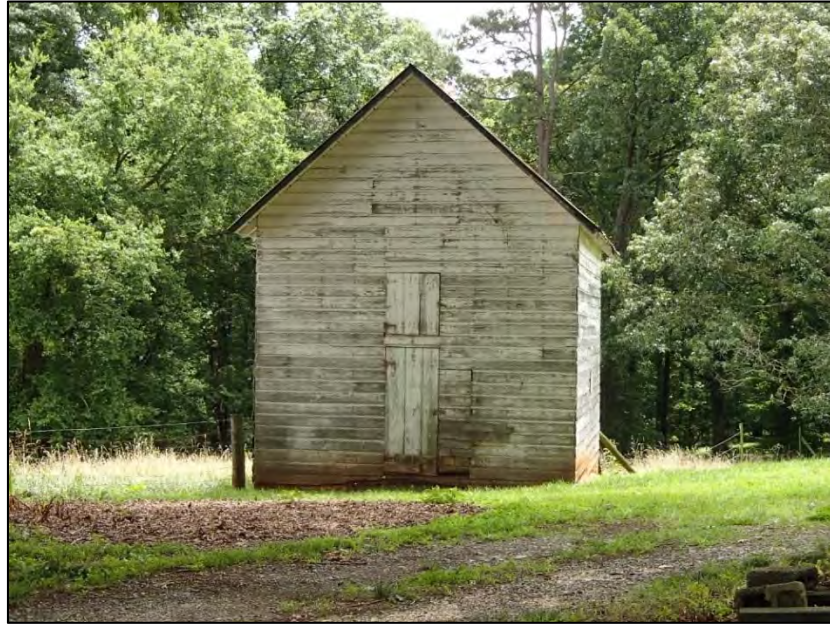
Figure 188: Poplin Family Farm, tobacco pack house

To the milking parlor's southwest is a gable-front tobacco pack house built in the 1940s (figure 188). The gable-front, frame building stands two short stories over a basement. Drop siding covers the building and a batten door is centered on the gable end. Above this door is a smaller hatch door. Metal roofing covers the building. Cured tobacco was stored or packed in the upper level. It was sorted or graded on the main level, and then "ordered" in the basement. Ordering or bringing tobacco to order means allowing leaves to reabsorb moisture to become more pliable before being shipped to market.

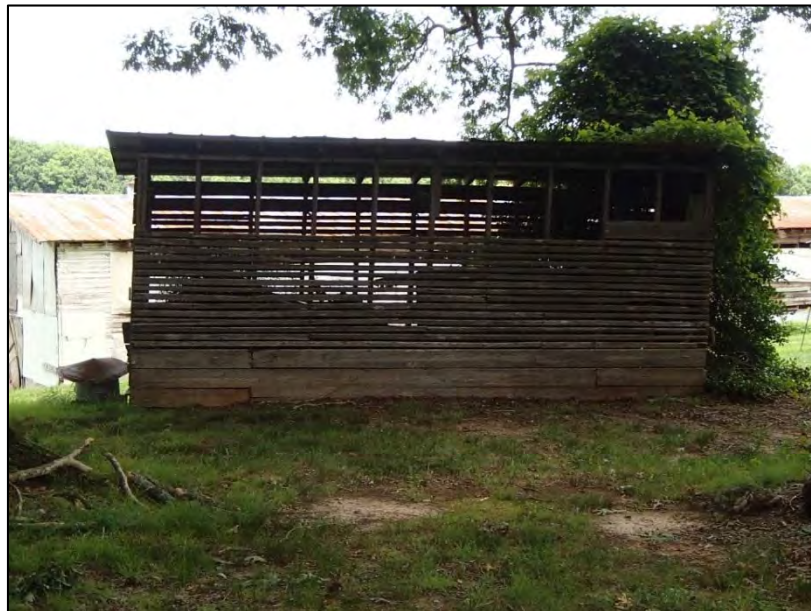
Figure 189: Poplin Family Farm, corn crib

A frame corn crib with slatted walls and a shed roof is located between the generator building and the barn (figure 189).

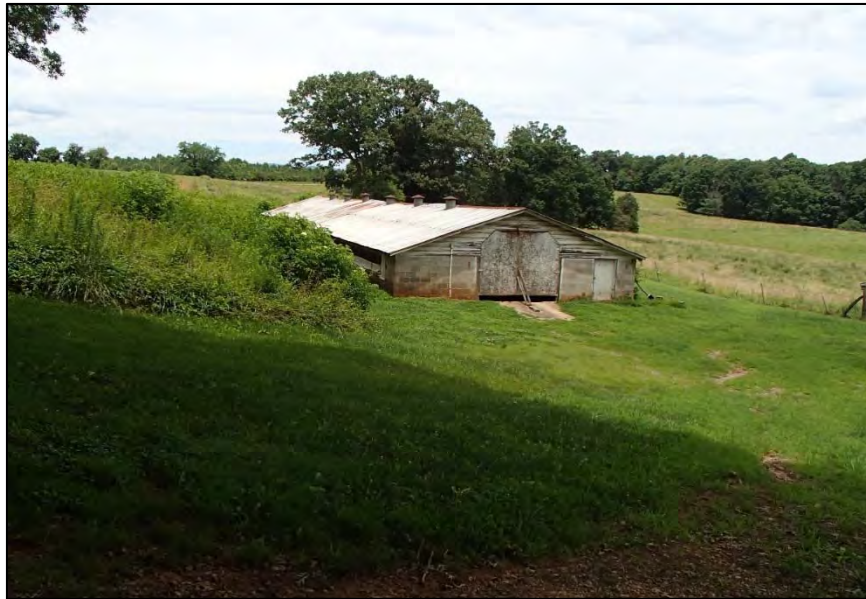
Figure 190: Poplin Family Farm, north chicken house

To the north are two more long, gable-roof poultry houses built in the 1950s (figure 190).

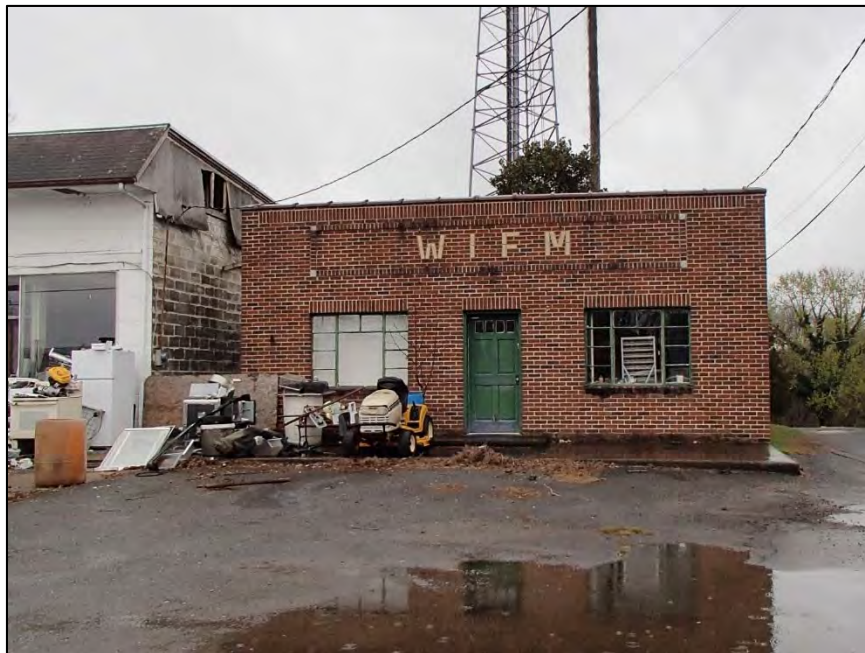
Figure 200: WIFM Radio Station, north elevation

The façade is three bays wide with a single-leaf front door flanked by metal casement windows composed of a single central pane surrounded on the sides and top by a frame of square panes. The front door is a modern replacement. Brick soldier courses highlight the tops of the door and windows. Above the door and windows soldier courses trimmed with concrete squares creates a long rectangular sign plane in which the letters WIFM are spelled in blonde-colored brick.

The building's side elevations are concrete block with casement windows that match those on the front.

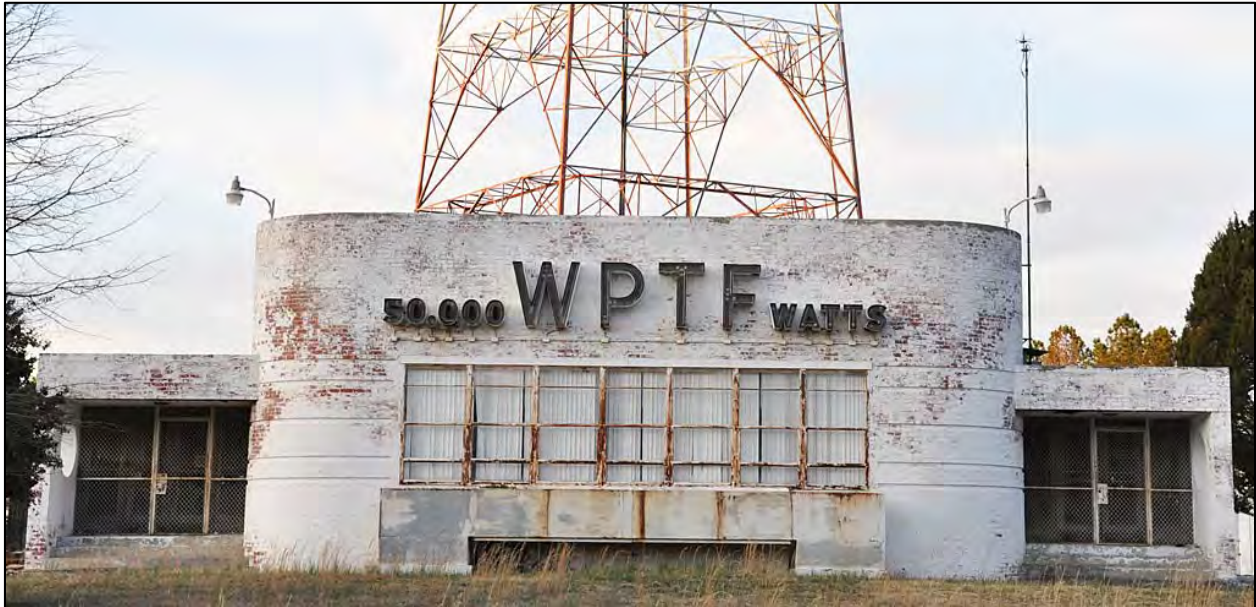
WPTF was organized as one of the earlier AM radio stations in the state in 1927, taking its call letters from We Protect The Family, because Durham Life Insurance Company owned the station. The existing transmitter building (figure 205) (WA 2257) dates from 1934 and underwent significant remodeling in the 1940s. It remains in operation as a transmitter site, although the use of the actual building is uncertain; it is located on Chatham Street between Raleigh and Cary in Wake County.

Figure 205: WPTF Transmitter Building, WA 2257, 833 East Chatham Street, Cary, photograph from [roadsidearchitecture.com](http://www.roadsidearchitecture.com), accessed <http://www.roadarch.com/deco/nc.html>

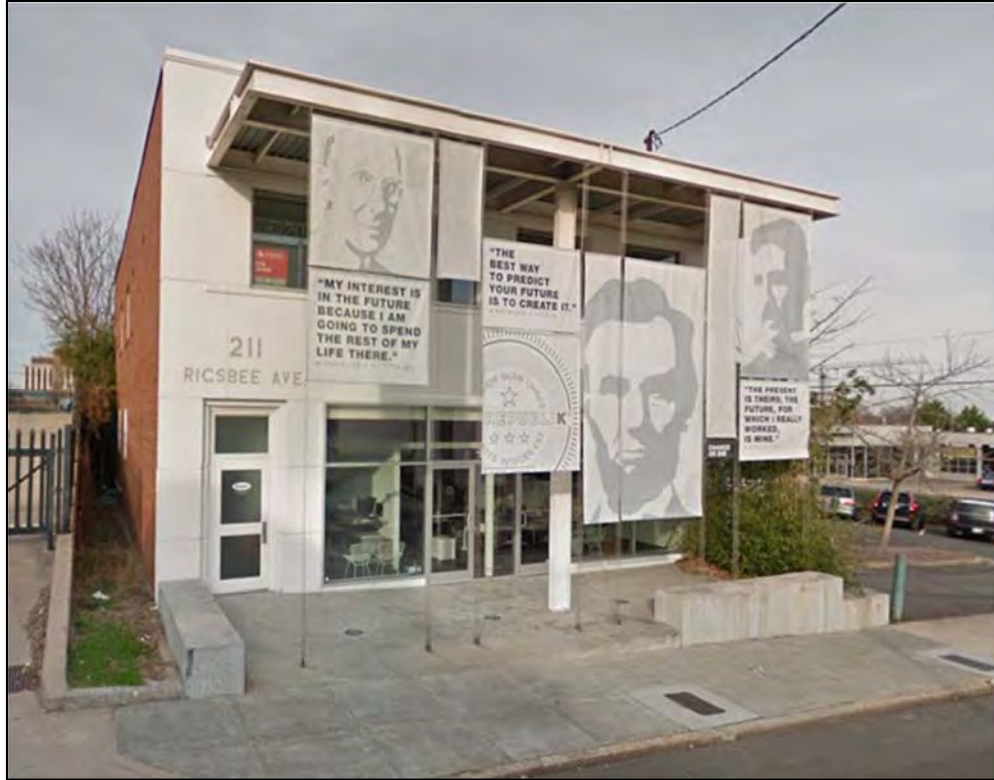
The WSSB radio station building (figure 206) (DH 3413) was constructed in 1948, the same year as WIMF. This station, too, was owned by the Durham Life Insurance Company. The building is two stories in height and has been heavily renovated. Its original appearance is not known.

Figure 206: WSSB Radio Station, DH 3413, 211 Rigsbee Street, Durham
