RE: Historic Structures Survey Report for replacement of Bridge 16 on SR 1145 over
Buckhorn Creek, Sampson County, ER 17-1920

National Register Eligibility Evaluation of the Boney House and Mill for the Replacement of Bridge No. 16 on SR 1145 (Boney Mill Road) over Buckhorn Creek

Sampson County, North Carolina

September 27, 2017 • **Final Report**
New South Associates Technical Report 2756

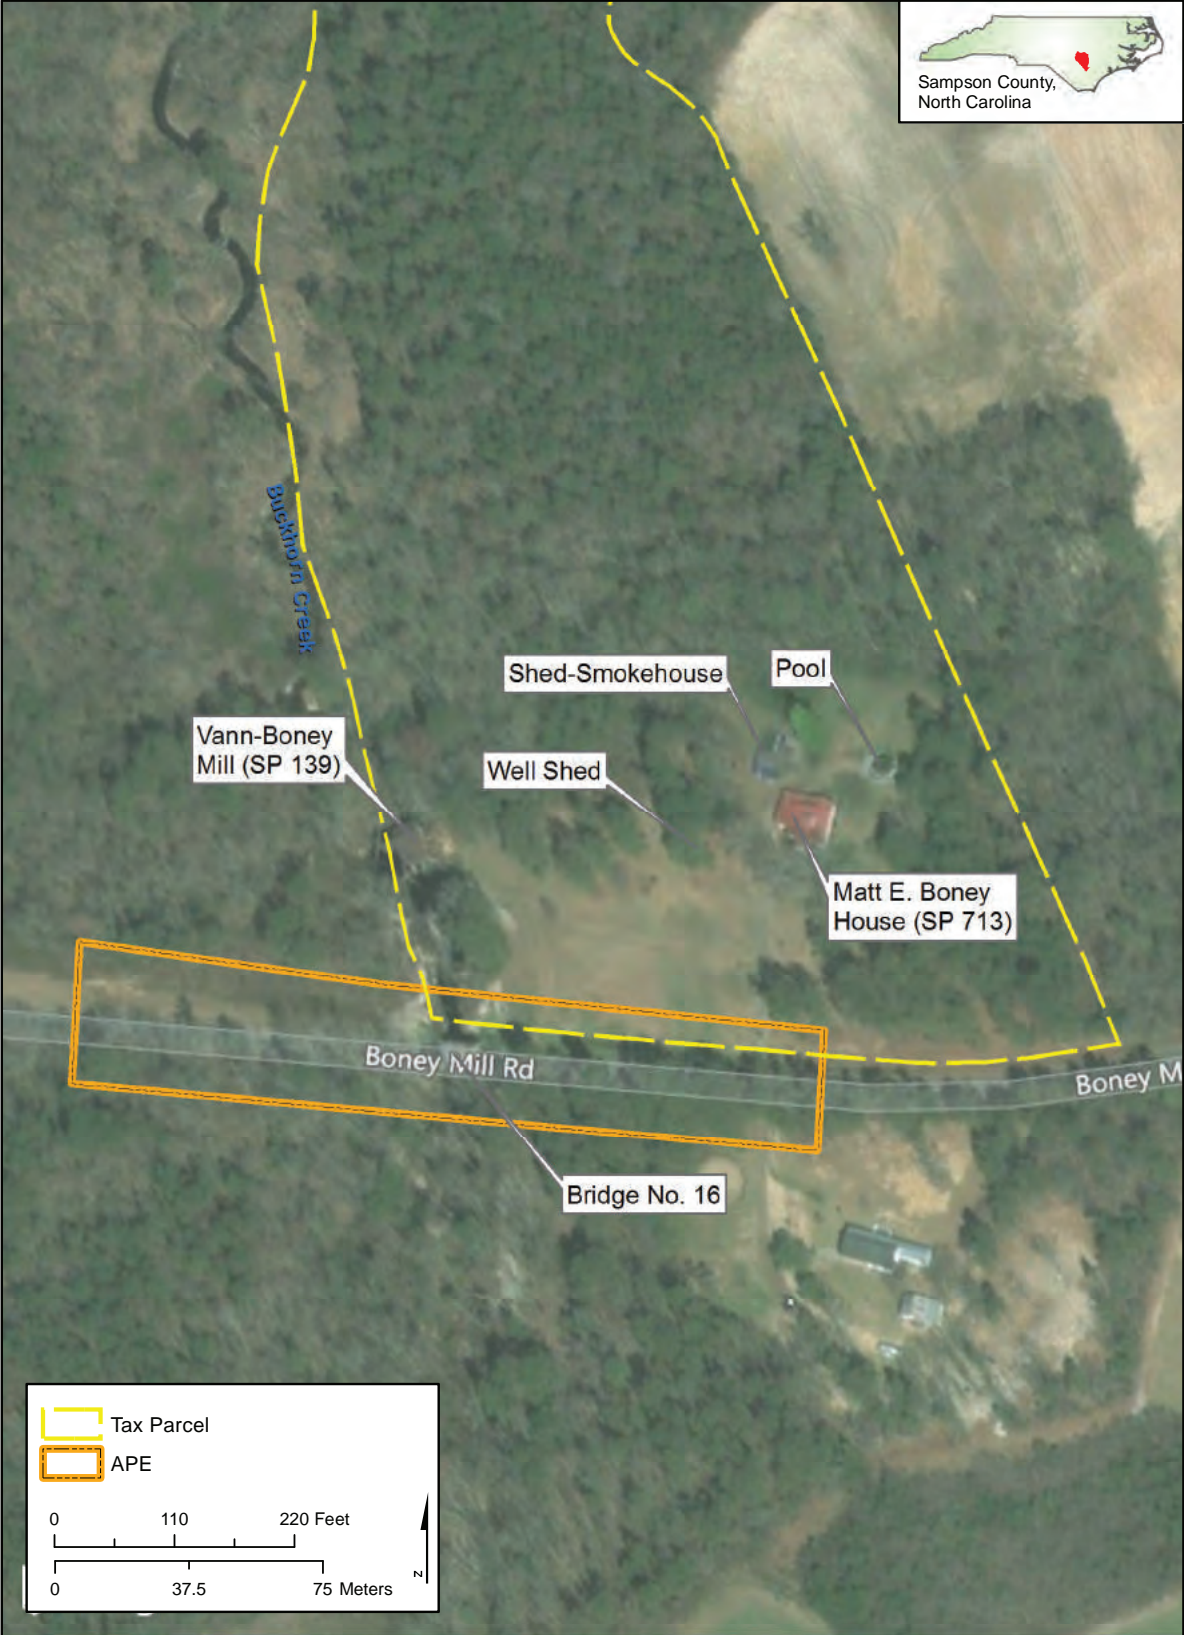
Figure 2. Aerial Photograph of the Boney House and Mill

The parcel is mostly wooded, except for the cleared area around the house, which slopes down to the road and to Buckhorn Creek and the mill. There are five resources on site: the dwelling and gristmill, both circa 1935; a shed-smokehouse built in two stages around 1935 and 1970; a circa 1997 well shed; and an above-ground swimming pool which dates to circa 2012 (Figure 2). The sheds and pool are situated near the dwelling, while the mill is approximately 320 feet west of the dwelling on Buckhorn Creek. An unpaved driveway runs north for about 200 feet from Boney Mill Road to an irregularly-shaped gravel parking pad south of the house.

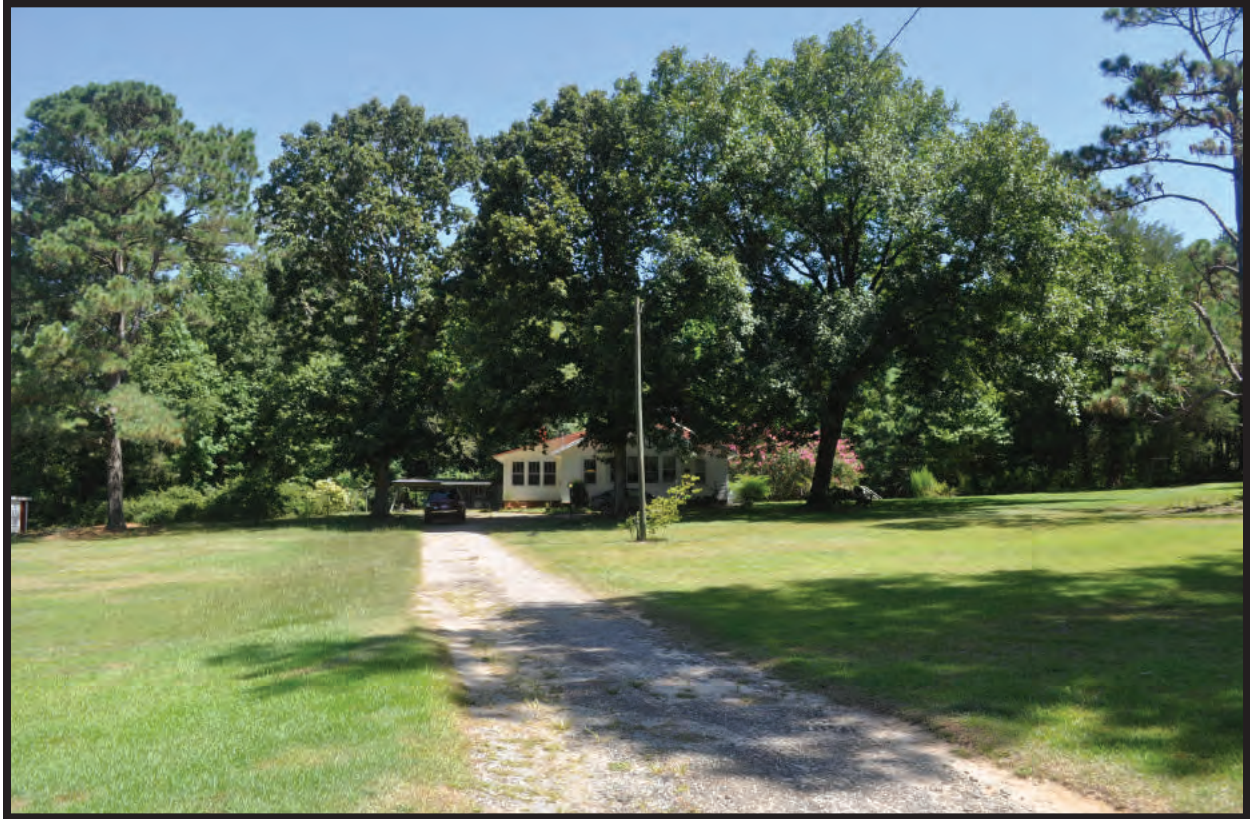
Figure 3. Boney House Setting

The circa 1930 Matt E. Boney House is a 1,616 square-foot one-story altered Craftsman-influenced bungalow (Figure 3 and 4). Its exterior appearance suggests there have been three additions to the house over the years. Aerial photographs also suggest it reached its current configuration by 1951, although the order of the additions was not confirmed. The original front-gable block has a gabled dormer with a pair of east-facing one-over-one windows on top of the ridgeline (Figure 5). On the front (south side) of the main entrance is an enclosed front porch, or sunroom, with four-over-one Craftsman windows on the east and west sides, and a large single, fixed-pane picture window flanked by four-over-one sashes on the south side. On the east side of the enclosed porch is a small, open inset porch with a square post at the southeast corner. Under the porch are the glazed-and-paneled main entrance door and a four-over-one window south of it. The east wall of the original block has two four-over-one Craftsman windows.

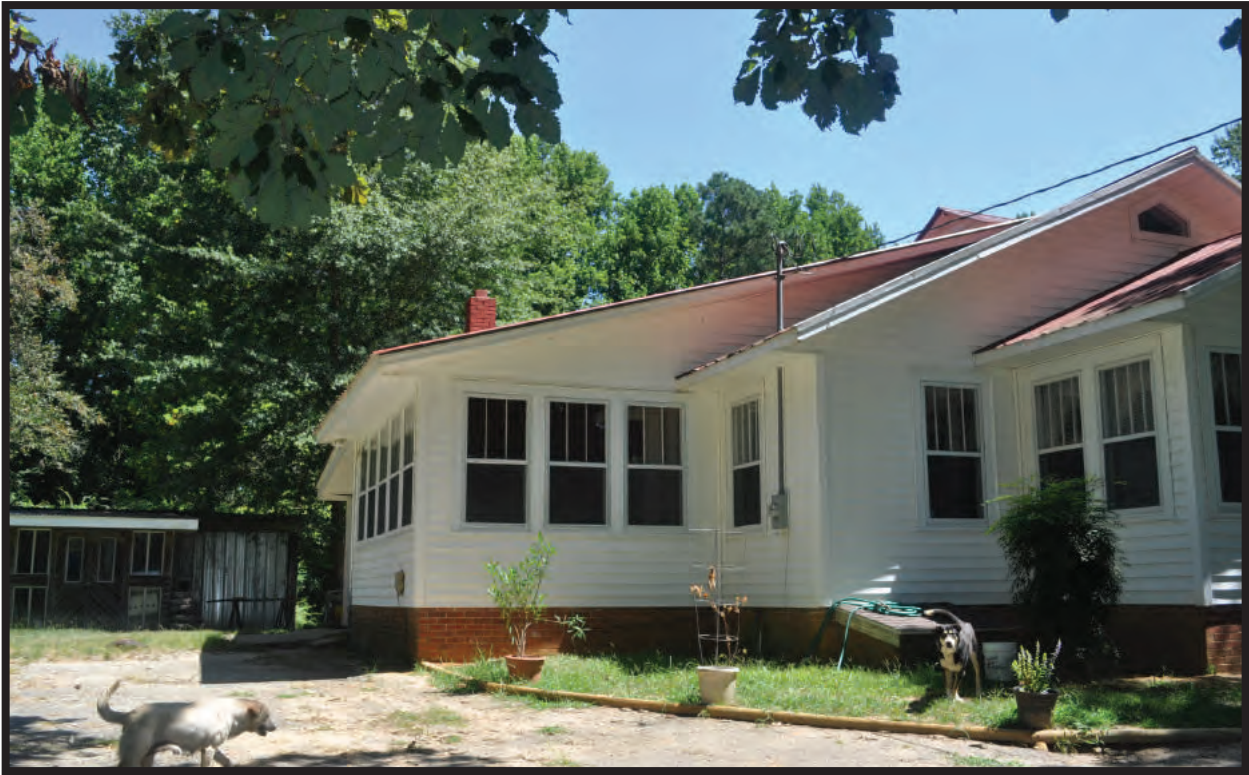
Figure 6. Boney House West Side

A shed addition was built on the west side of the house sometime prior to 1951 (Figure 6). This addition is set back from the front wall (south) of the house but is flush with the rear wall and extends the rear roofline (Figure 7). Triple and quintuple bands, respectively, of four-over-one

Craftsman windows are on the front (south) and west sides of this addition (See Figure 6). A lower shed addition abuts from the north, rear wall of the west shed addition (See Figure 7). A brick chimney flue is visible is sandwiched between the two additions. A square post at the northwest corner supports the projecting roofline of the north shed addition. There are two four-over-one Craftsman windows on the north side. A gabled addition was built on the rear of the house, flush with the east exterior wall (See Figure 5). Its ridgeline is lower than that of the main block. It has one four-over-one Craftsman window on the east side.

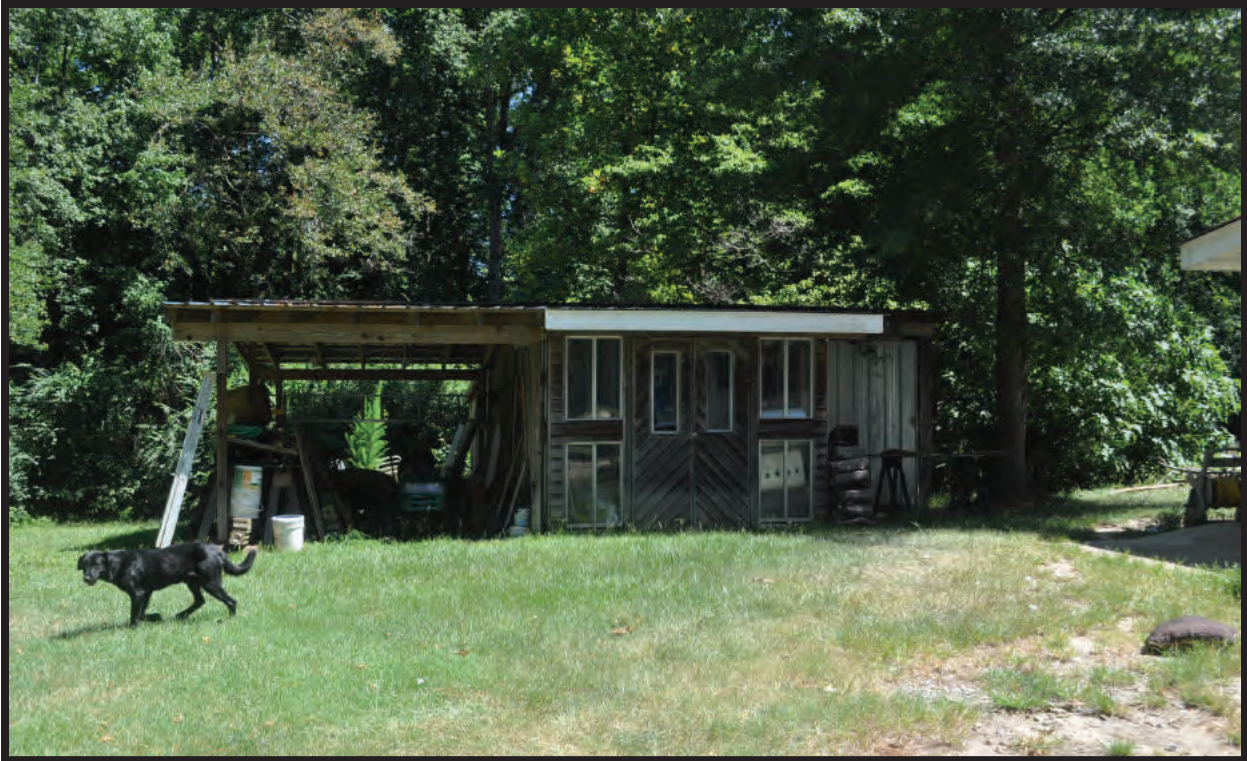
Figure 8. Shed-Smokehouse South Side

Approximately 10 feet northwest of the house is a two-part building built in two phases (Figure 8). On the east side is a concrete block shed with a shed roof (Figure 9). Matt E. Boney built this section. On the west side is a frame, shed-roof smokehouse built by Claxton Pearson around 1970 (Terry Pearson, personal communication 2017). It has an open shed on the west side. The smokehouse has weatherboard siding, a set of double doors with diagonal weatherboards on the south side, and aluminum sash windows. The roof of both sections covered with 5V metal sheets. The foundation was not visible.

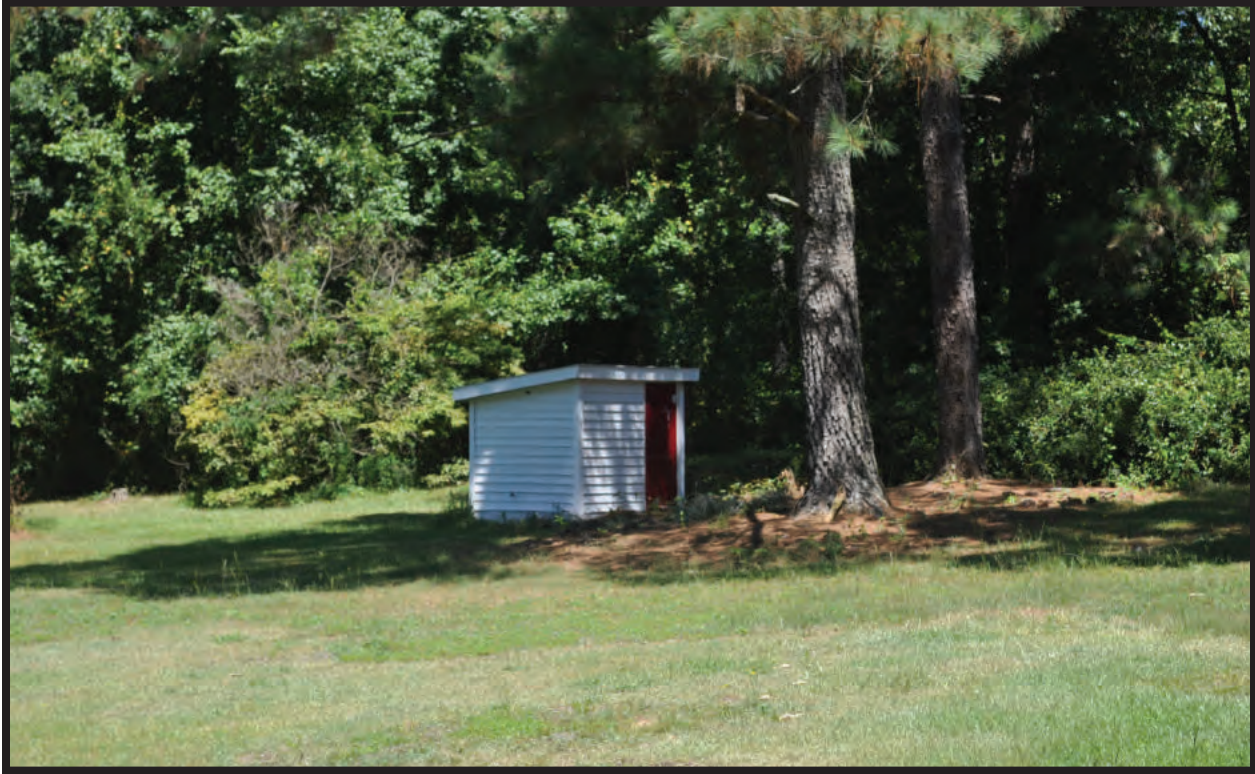
Figure 10. Well Shed South and East Sides

Approximately 75 feet southwest of the house is a windowless shed-roof well shed (Figure 10). White vinyl siding covers the exterior walls. There is a door on the east side. The shed sits on a concrete block foundation and the roof is covered with 5V metal sheets.

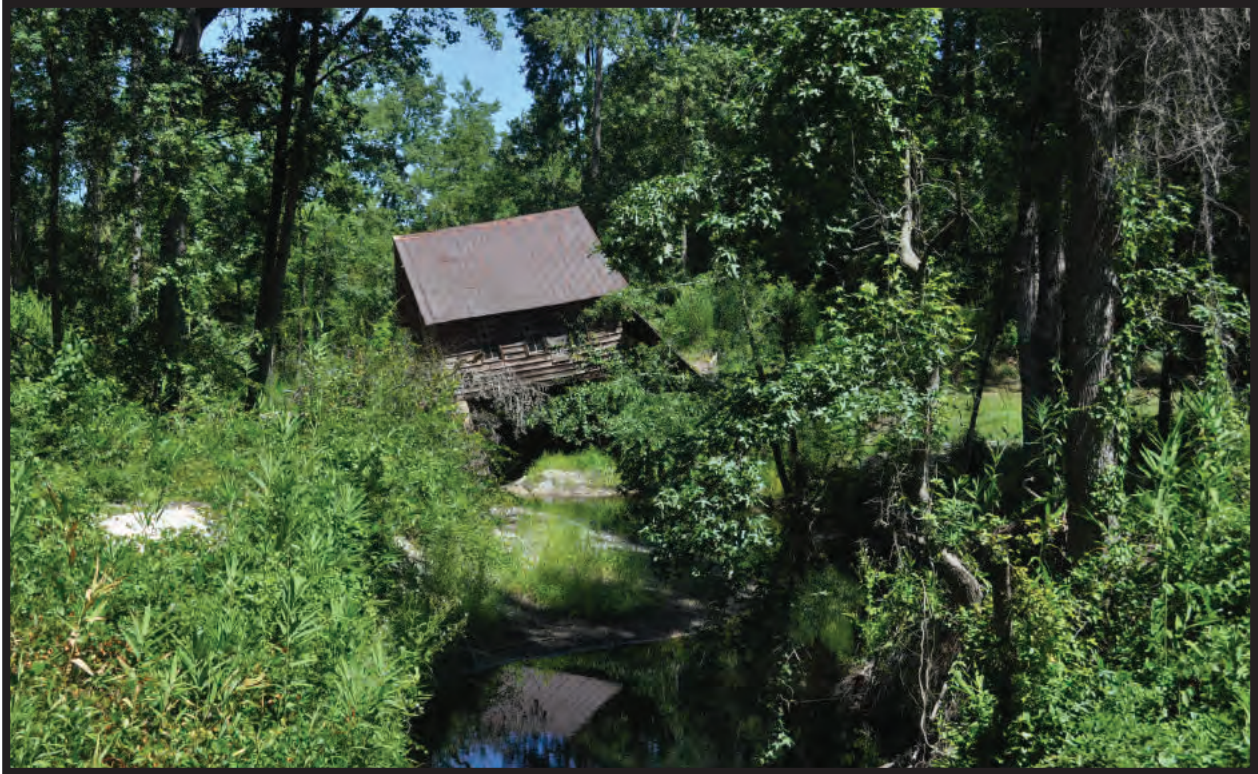
Figure 11. Mill Looking North Up Buckhorn Creek

This mill was erected around 1935 on the east bank of Buckhorn Creek (Figure 11). Flooding caused by Hurricane Matthew in October 2016 damaged the building and site. Due to the current condition of the building, the exterior was not closely inspected and the interior was not accessed. The description below is based on field observations, the 1979 HPO survey file, a documentary photograph, and a conversation with the present owner, Mr. Terry Pearson.

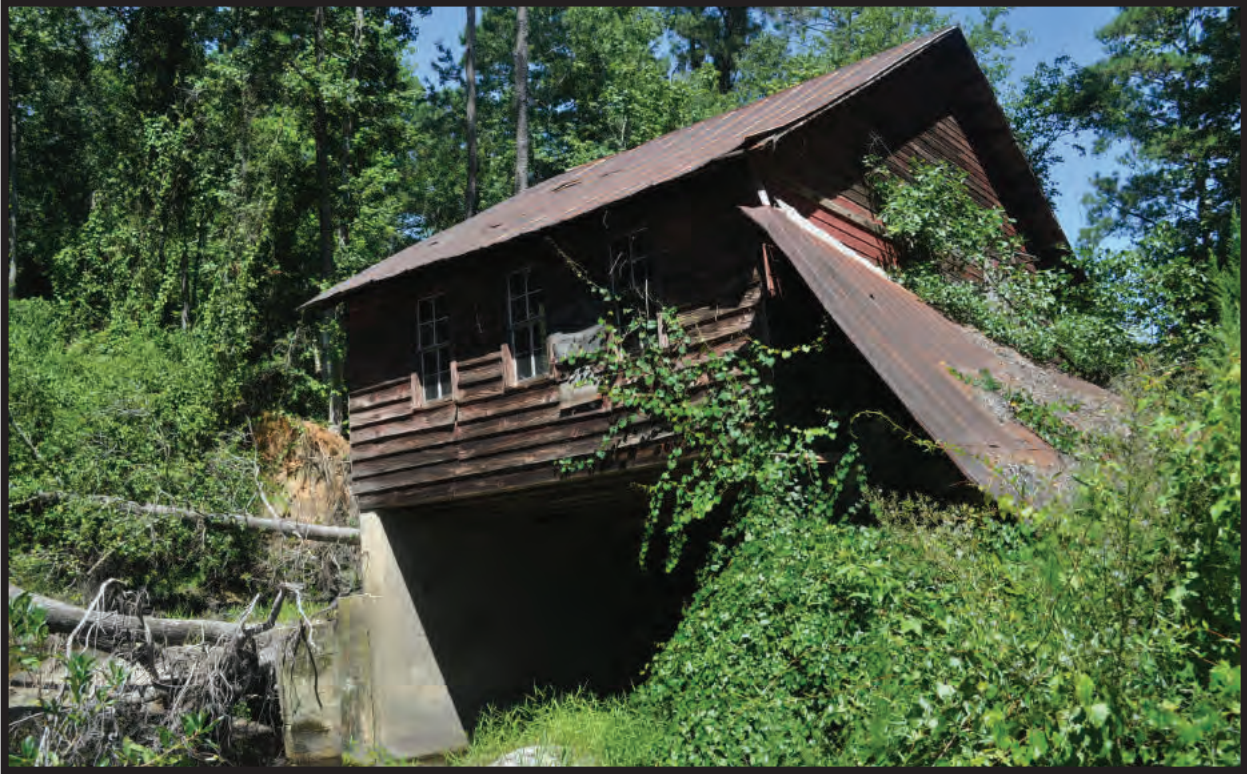
Figure 12. Mill South and East Sides

The rectangular, 25x20-foot, bi-level mill has a steeply-pitched gabled roof and, until October of 2016, an open shed on the west side (Figures 12 and 13). The building is covered with plain weatherboard siding, with the exception of the west side, which is covered with German siding. The roof is covered with 5V metal sheets over wood skip sheathing that is visible in the gable ends. There are three four-over-four window sashes on the north and south sides. One four-over-four light window sash and one door opening with a solid door were observed on the west side (Figure 14). Prior to the flood, an open shed on the east side sheltered a loading area of hard packed earth (See Figure 12). Above the shed is a four-over-four window and north of it is a board-and-batten entry door. Floodwaters collapsed the shed and deposited a wall of sand and vegetative debris on the north and east sides of the building, altering the grade on these sides.

The foundation of the Vann-Boney Mill was severely damaged by Hurricane Matthew 2016. The damage has caused the building to list severely to the west. The hurricane also resulted in the loss of the dam and the collapse of the open shed on the east side of the mill. Despite this, the mill retains varying degrees of integrity of location, design, setting, materials, workmanship, feeling, and association. The mill remains on its original location, and its immediate setting on the east bank of Buckhorn Creek and downslope from the Matt E. Boney House is intact. The associated millpond was drained in 1965. The mill is strongly associated with the context of twentieth-century grist milling in Sampson County. The mill substantially retains its original side-gable form and possesses a high degree of original or historic exterior materials including board siding, a concrete foundation, doors, windows, and metal roofing. Known missing features include the dam, gates, and turbines that were under the mill. The design and workmanship of the builders is evident in the building's simple yet functional appearance and depicts how twentieth-century gristmills were constructed and operated.

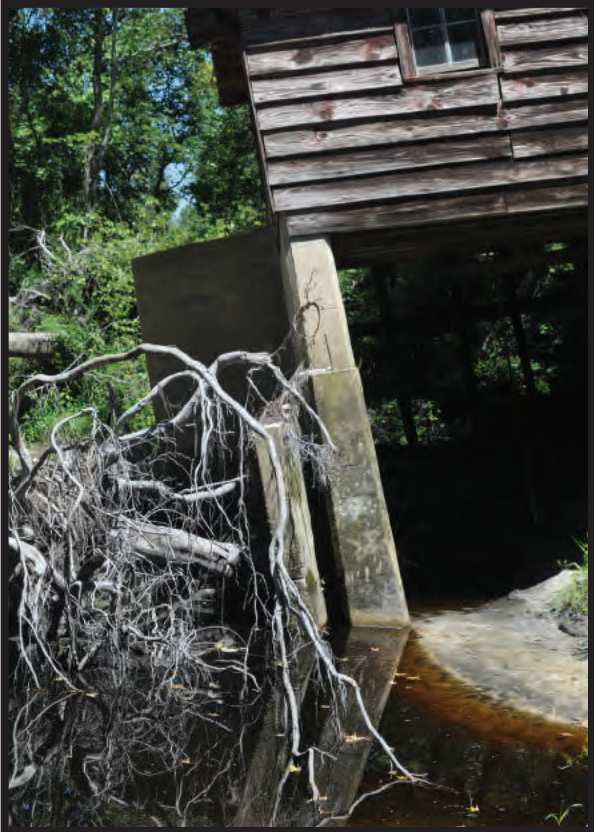
Figure 15. Detail of West Foundation Wall

The rectangular frame building sits on two parallel, bi-level concrete foundation walls on the east and west sides, that formed a millrace through which water was channeled to the turbines under the mill (Figure 15). According to the property owner, the millstones, sluice gates and turbines were removed many years ago. The 65-acre millpond north of the mill was drained in 1965, but Mr. Pearson states that the dam spanning Buckhorn Creek remained partially in place until the 2016 flooding. Photographs taken in 1979 show that the dam was built of log cribbing and earth. The flood damaged the foundation leaving the mill listing severely to the west side.

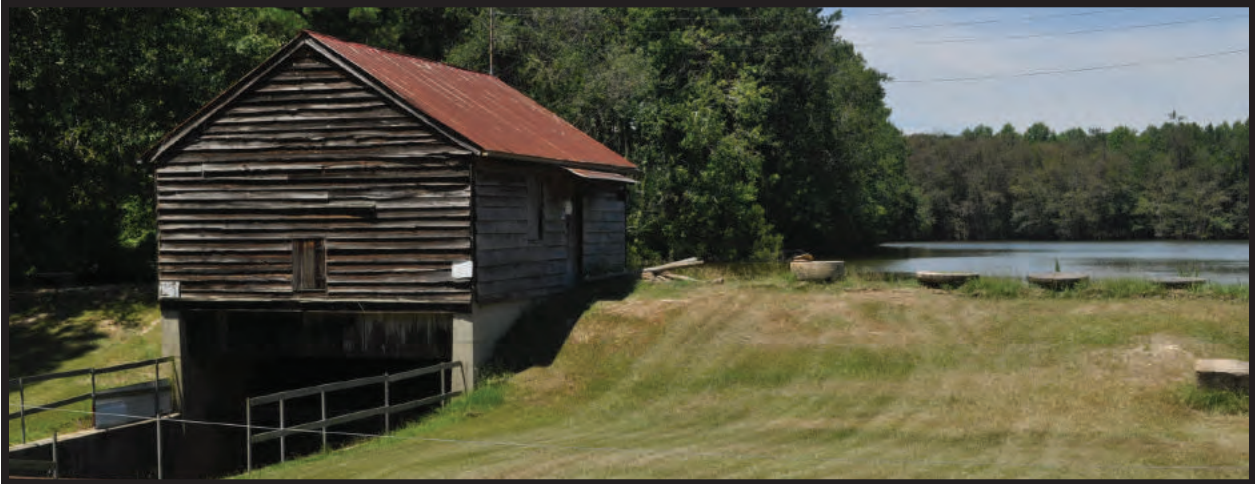
Figure 17. Stacy Crumpler Mill

Surviving twentieth-century water powered grist mills documented or noted by Butchko included the 1935 Vann-Boney Mill (SP 139); the 1924 Stacy Crumpler Mill (SP 513) (Figure 17); the 1935 Rob Crumpler Mill (SP 512) (Figure 18); the 1965 Turlington-Riley Grist Mill (SP 520); the circa 1920s and 1930s Tart Mill (SP 199); the circa 1930 Preston Jernigan Mill (SP 197); and the Lewis Jernigan Mill, which was subsequently correctly identified as the Malcolm Jernigan Mill and recorded as a dependency to the Malcolm Jernigan Property (SP 711) (Figure 19). All of these mills, with the exception of the Vann-Boney Mill, were located in the northwest part of the county in the area between Newton Grove and Spivey's Corner. Butchko also identified a number of former mill sites. An attempt was made to locate each of these mills during the fieldwork phase of this project for the purpose of comparing the Boney Mill to structures similar in age and construction. The Turlington-Riley Grist Mill is no longer standing; the Tart Mill was on private property and was not visible from the public right-of-way; and the Preston Jernigan Mill could not be located and is also assumed to be demolished. The Malcolm Jernigan Mill does not have an individual entry in the HPOWEB, and therefore was not identified as a potential comparable property prior to fieldwork, and was not field checked. Aerial photography from 2017 shows the

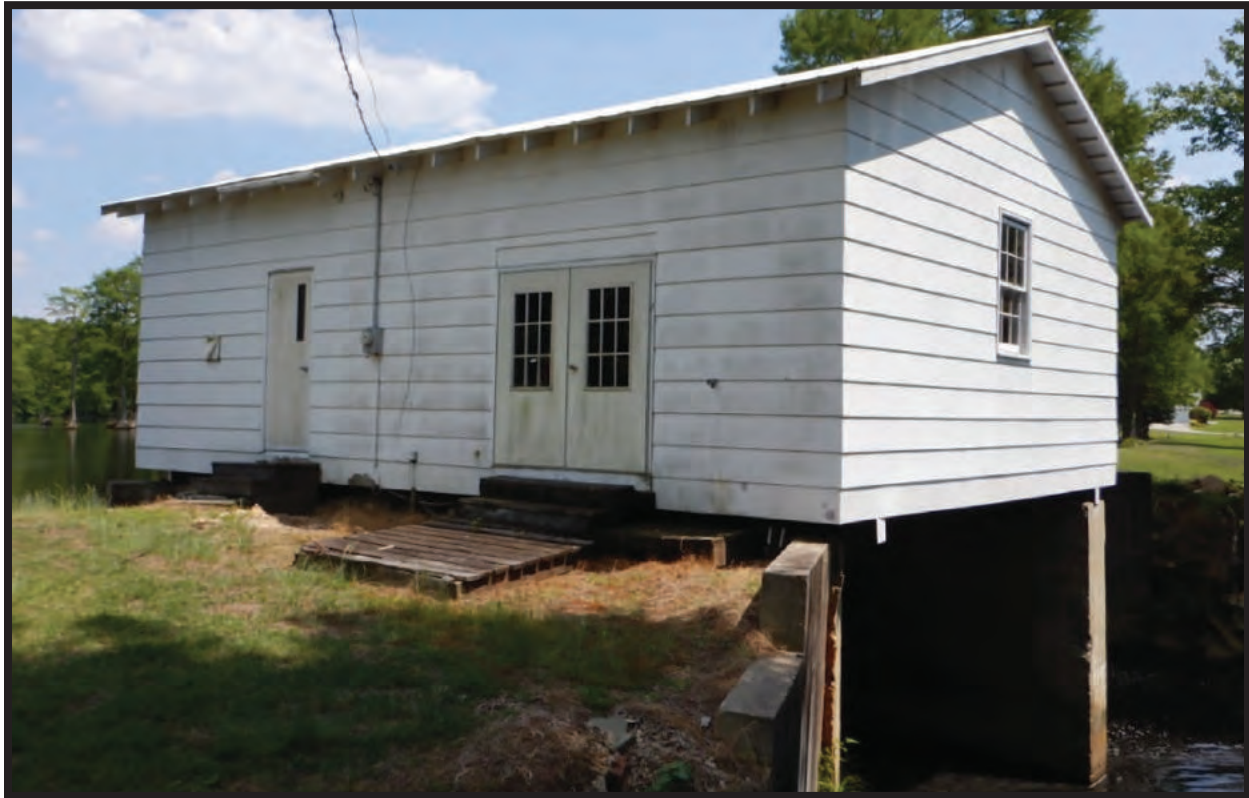
Figure 19. Malcolm Jernigan Mill

mill standing. None of the eight twentieth-century gristmills identified by Butchko were evaluated for NRHP eligibility at that time. In 2016, the Malcolm Jernigan Mill was determined not eligible for the NRHP due to alterations (Richmond 2016).

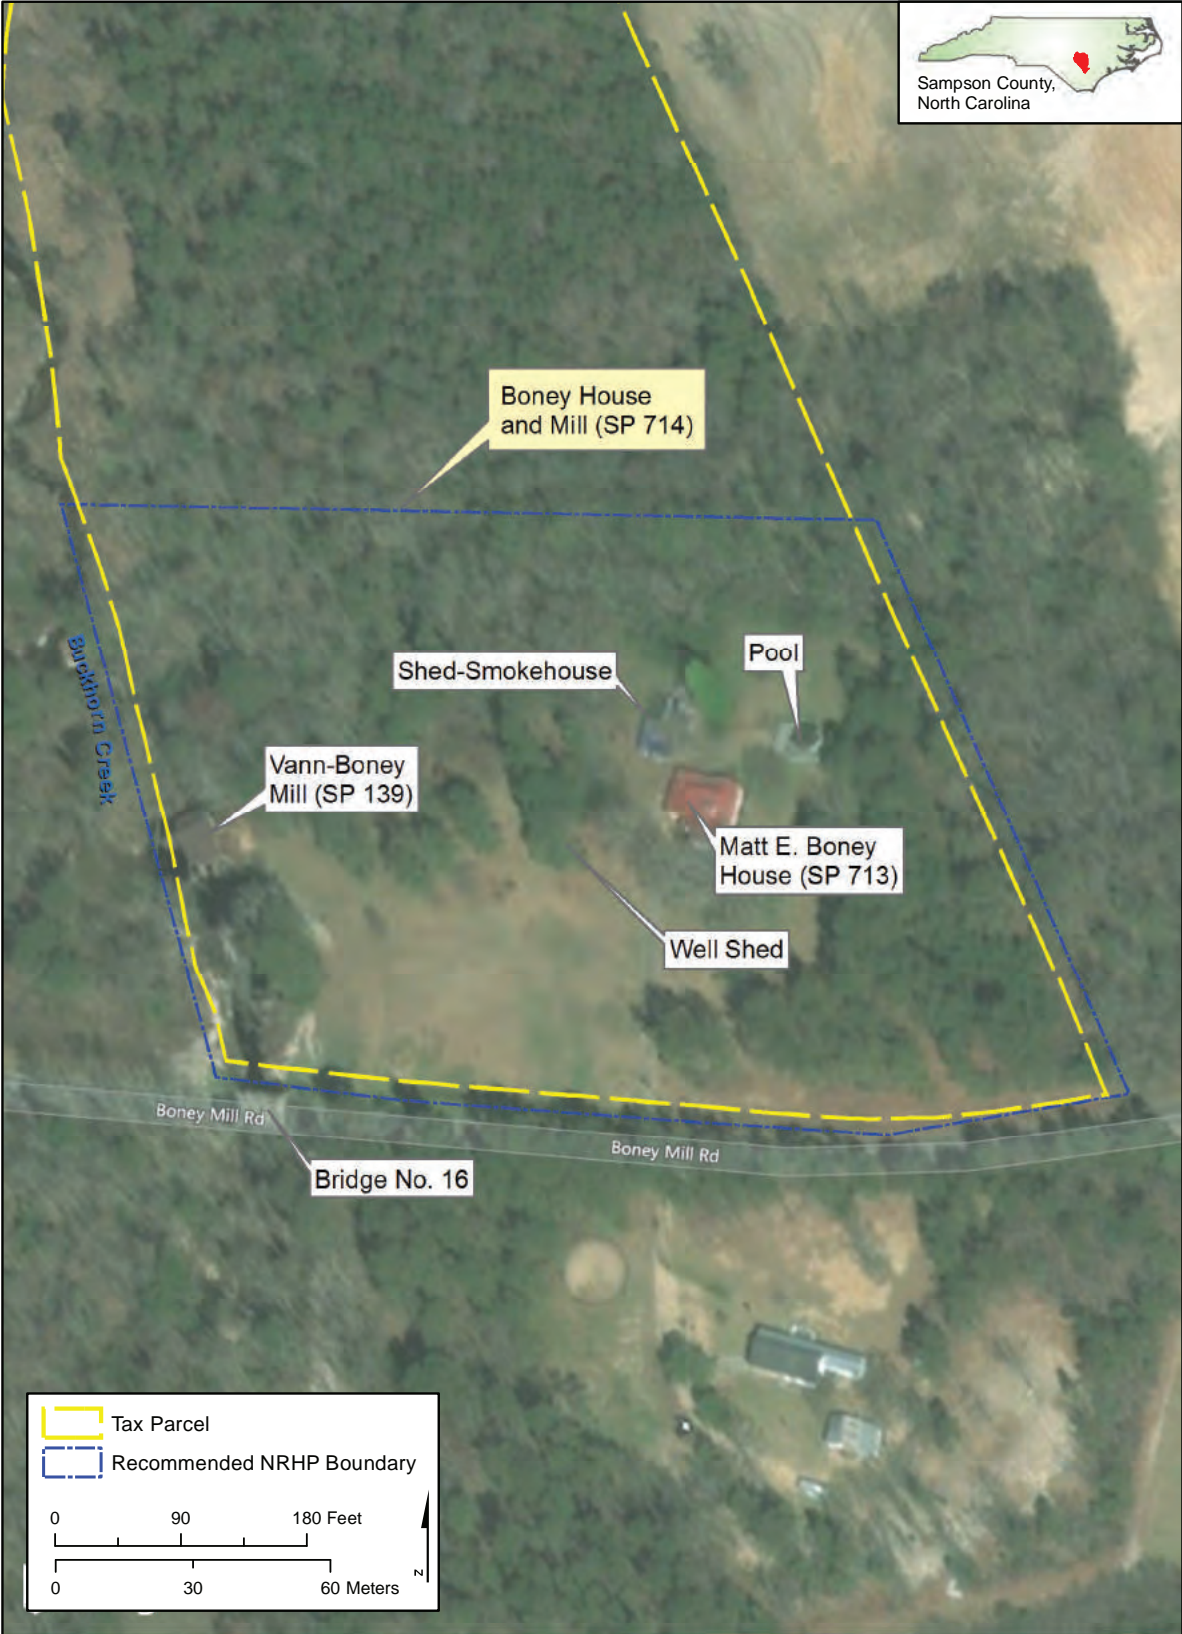
Figure 22. Recommended NRHP Boundary of Boney House and Mill

The recommended NRHP boundary contains approximately five acres at the south end of the 29-acre legal parcel (Figure 22). The boundary corresponds with the north edge of pavement of Boney Mill Road and the west bank of Buckhorn Creek. The east boundary follows the legal parcel line. The north boundary begins approximately 200 feet north of the mill building and connects the west and east boundary lines. The parcel contains the mill, house and yard, outbuildings and a segment of Buckhorn Creek.
