SUBJECT: Historic Structures Survey Report, Build on New Location, Airport Parkway from
SR1710 to US 70/US 601 to SR 2539 at US 29, U-5901, PA 17-08-0002,
Rowan County, ER 17-2008

The North Carolina Department of Transportation (NCDOT) proposes to build on a new location Airport Parkway. S&ME prepared the attached Eligibility Report and recommends one of the properties surveyed eligible for the National Register of Historic Places, the Plantation Pipeline Pumping Station (RW2185).

On behalf of the NCDOT, S&ME has completed a historic architectural analysis of seven resources located within the project area for the construction on a new location of Airport Parkway, from SR 1710 (Harrison Road) at US 70/US 601 to SR 2539 (Peach Orchard Road) at US 29 in Rowan County (TIP No. U-5901, WBS No. 44705.1.1, PA No. 17-08-0002) (Figures 1.1 and 1.2). Work was conducted in general accordance with the agreed-upon scope, terms, and conditions presented in the Proposal No. 42-1800186, dated February 16, 2018.

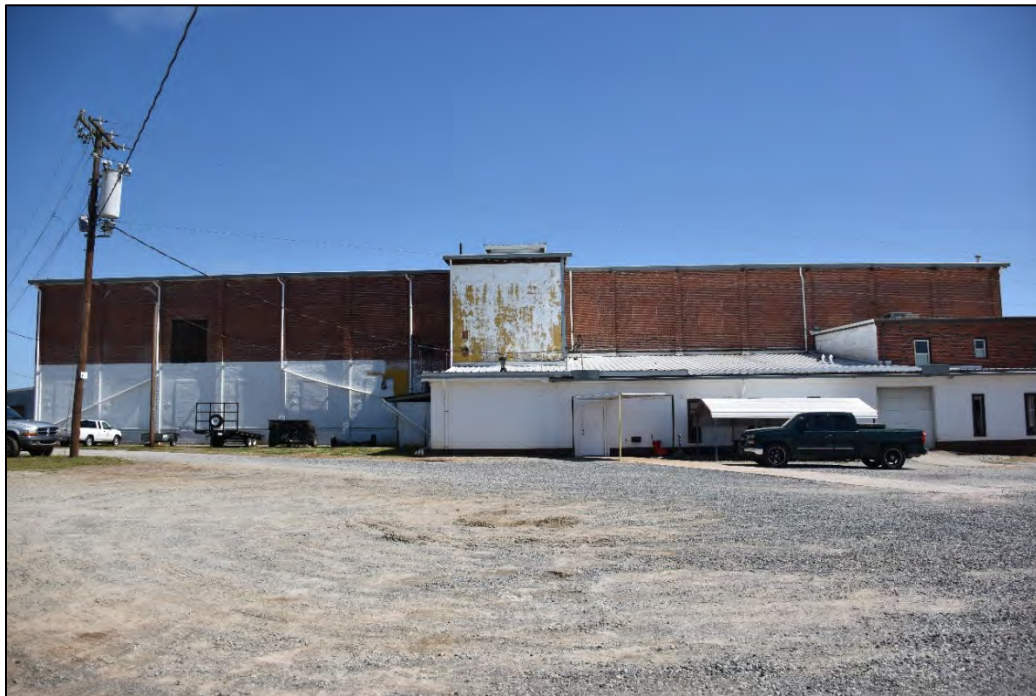
Figure 2.1.1. View of the Salisbury Race Track Grandstand (RW2179), facing east.

The Salisbury Race Track Grandstand is recommended as ineligible for inclusion in the NRHP under Criterion A, as it does not have a significant association with a particular event or broad pattern of history. Although it represents early-to-mid-twentieth-century entertainment in Rowan County and the Salisbury area, there have been such significant alterations to the building and the surrounding area, specifically the removal of the racing oval, that the integrity of this association has been compromised. The grandstand building is recommended ineligible under Criterion B, as it does not have an association with a prominent person. Although it was part of a Salisbury Speedway race that was organized by notable race promotor Bruton Smith, its short association with Smith and the significant alteration to the building after the race undermine the significance of this association. Although the Salisbury Race Track Grandstand is an example of an early-twentieth-century entertainment structure, it has undergone alterations that have compromised its original architectural form and detail, as well as losing materials and workmanship; additionally, it is not a significant example of a particular architectural style or the work of a master, making it ineligible under Criterion C. The grandstand is unlikely to yield important historical information, so it is considered ineligible under Criterion D, for building technology.

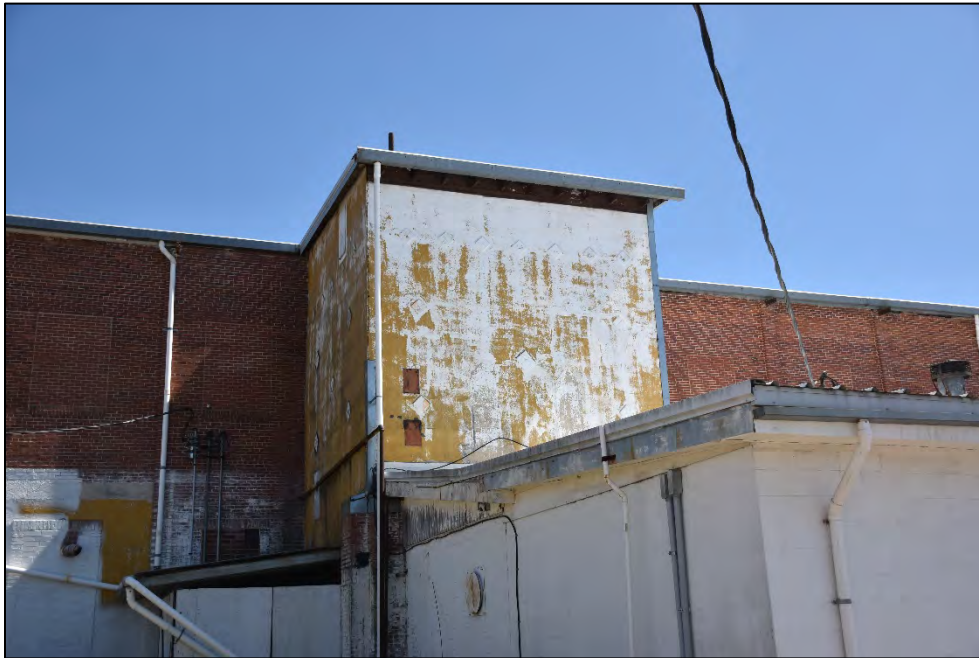
Figure 2.1.2. Salisbury Race Track Grandstand, tower, facing east.

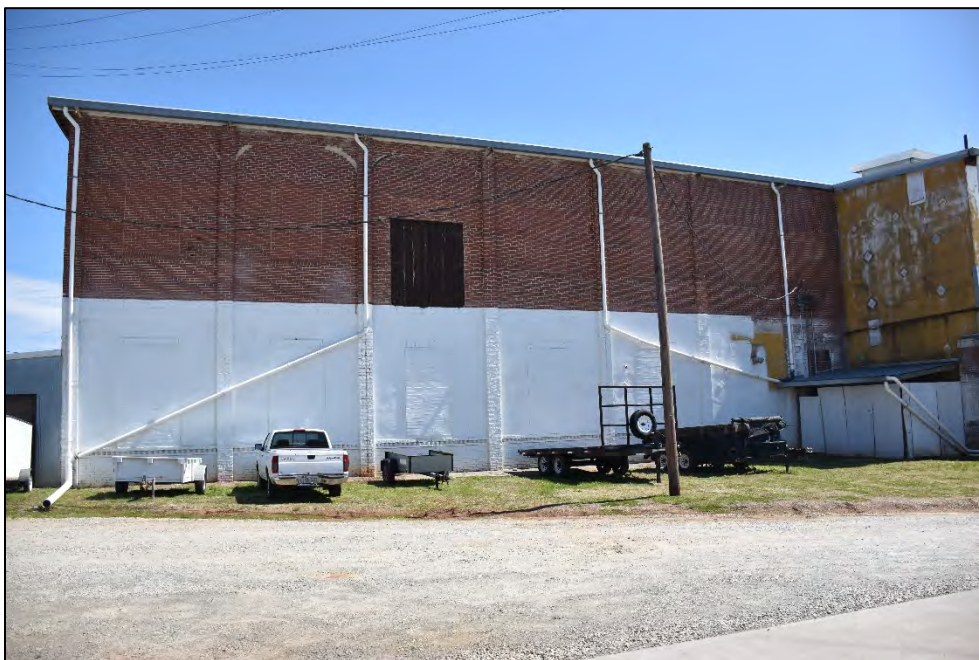
Figure 2.1.3. Salisbury Race Track Grandstand, west elevation, facing east.

near the tops of each bay, as well as a decorative dogs-tooth brick course along the foundation line (Figures 2.1.3 and 2.14). Each bay on this elevation has a window opening on both the first and second story, which have all been bricked in since the original construction of the building. A large, shed-roofed, one-story addition, of concrete block construction, has been appended to the southwestern portion of the building.

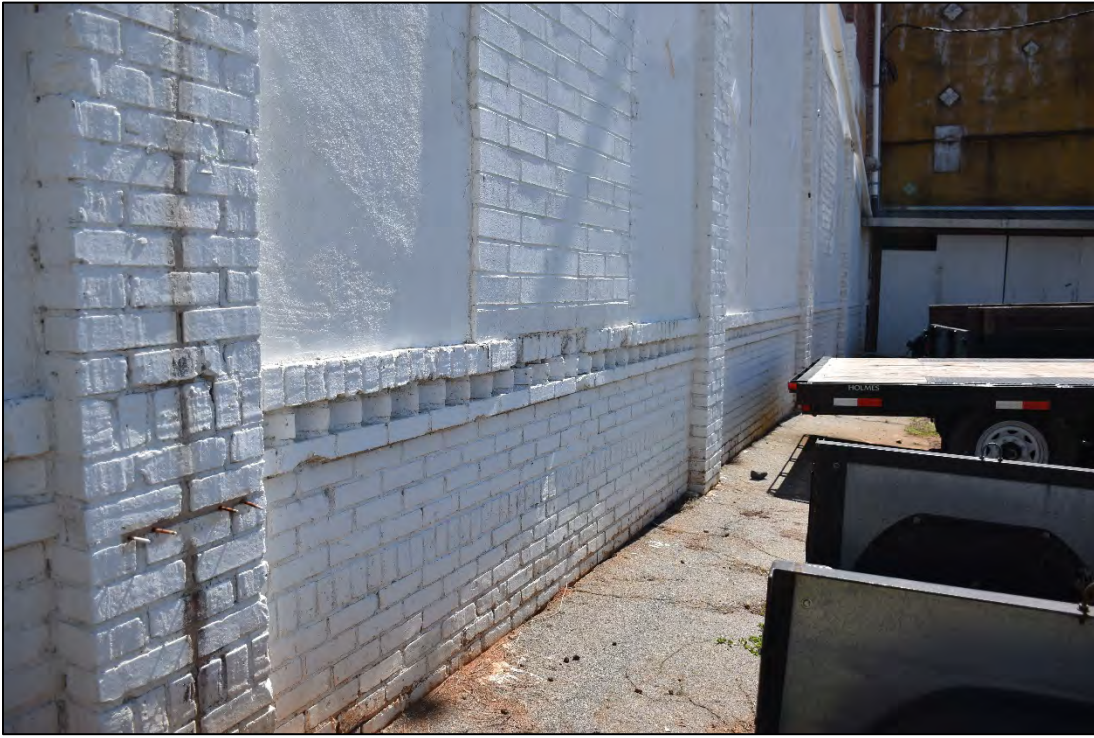
Figure 2.1.4. Salisbury Race Track Grandstand, brick detail along west wall, facing south.

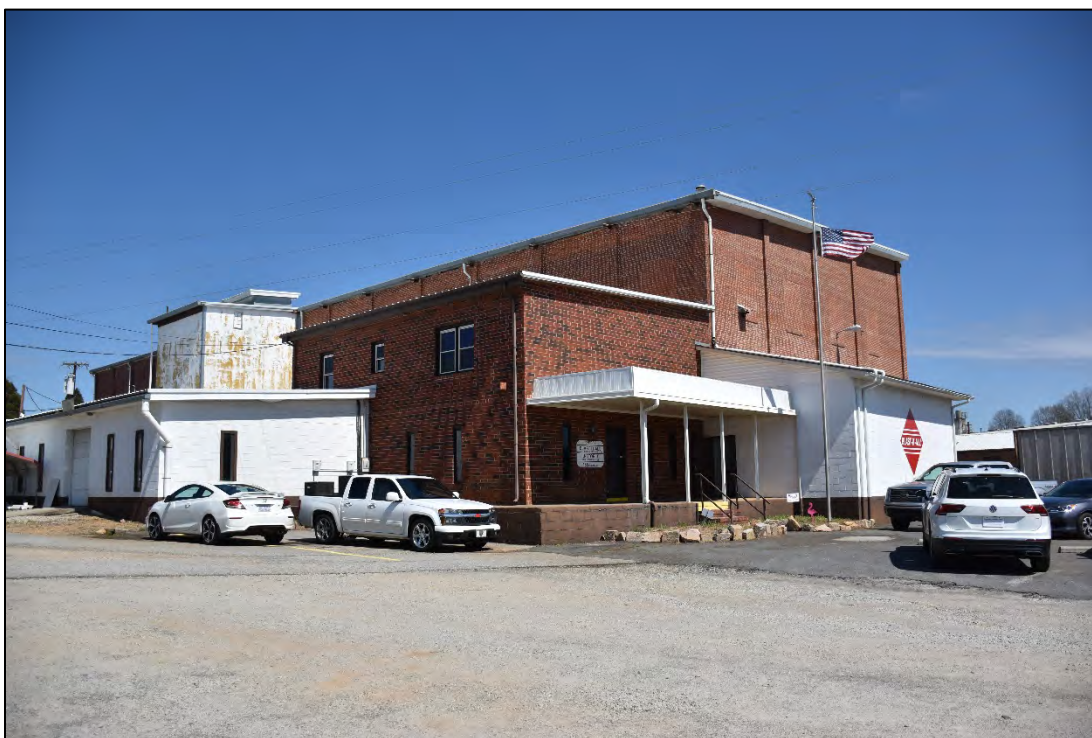
Figure 2.1.5. Salisbury Race Track Grandstand, facing northeast.

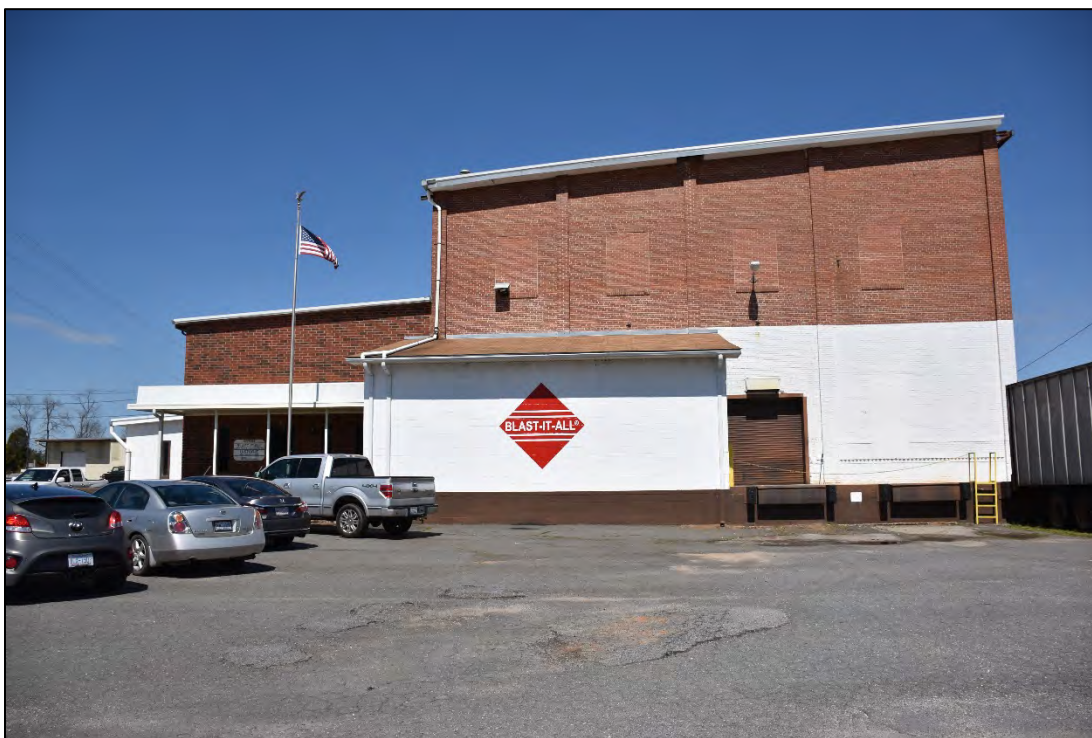
Figure 2.1.6. Salisbury Race Track Grandstand, facing north.

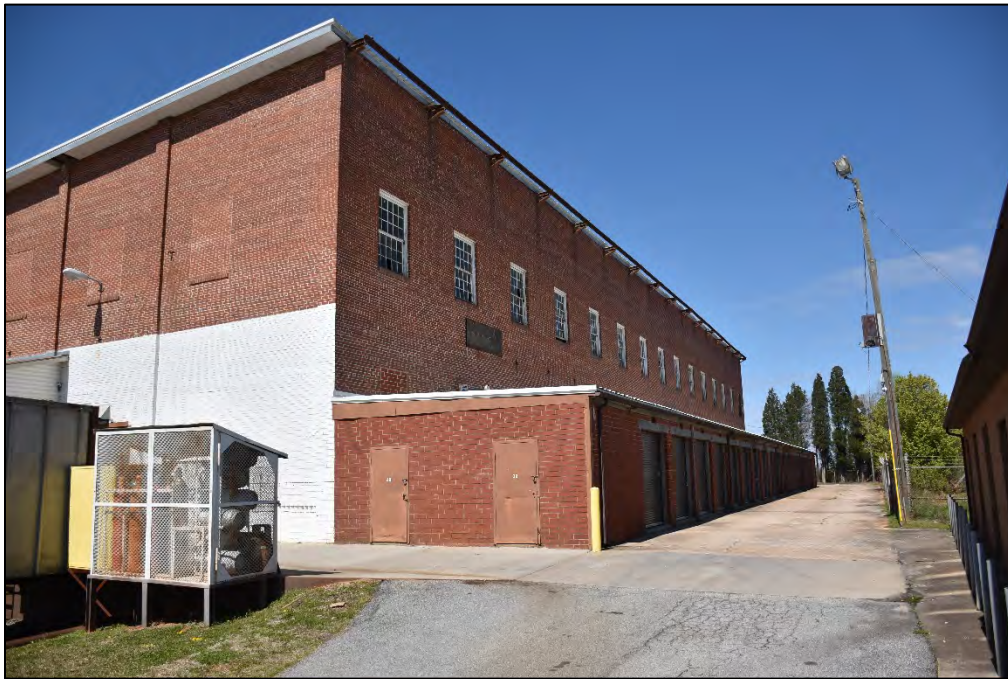
Figure 2.1.7. Salisbury Race Track Grandstand, facing northwest.

The eastern elevation of the building is 15 bays long, with 15-over-15, double-hung, wooden sash windows located in the upper story (Figures 2.1.7 and 2.1.8). The lower story is obscured by a single-story, flat-roofed, brick veneer addition that holds storage units, although bricked-in window openings are visible above this addition on some bays (Figure 2.1.9). An exterior metal beam, supported by metal brackets, runs the length of the eastern elevation just under the roofline. The north elevation is symmetrical to the south elevation, with four bays separated by engaged brick pilasters (Figure 2.1.10). A single story, shed-roofed, metal addition has been appended along this elevation, but the upper story window openings retain the 15-over-15 double-hung, wooden sash windows (Figure 2.1.11). S&ME attempted to gain interior access to the structure but the request was denied.

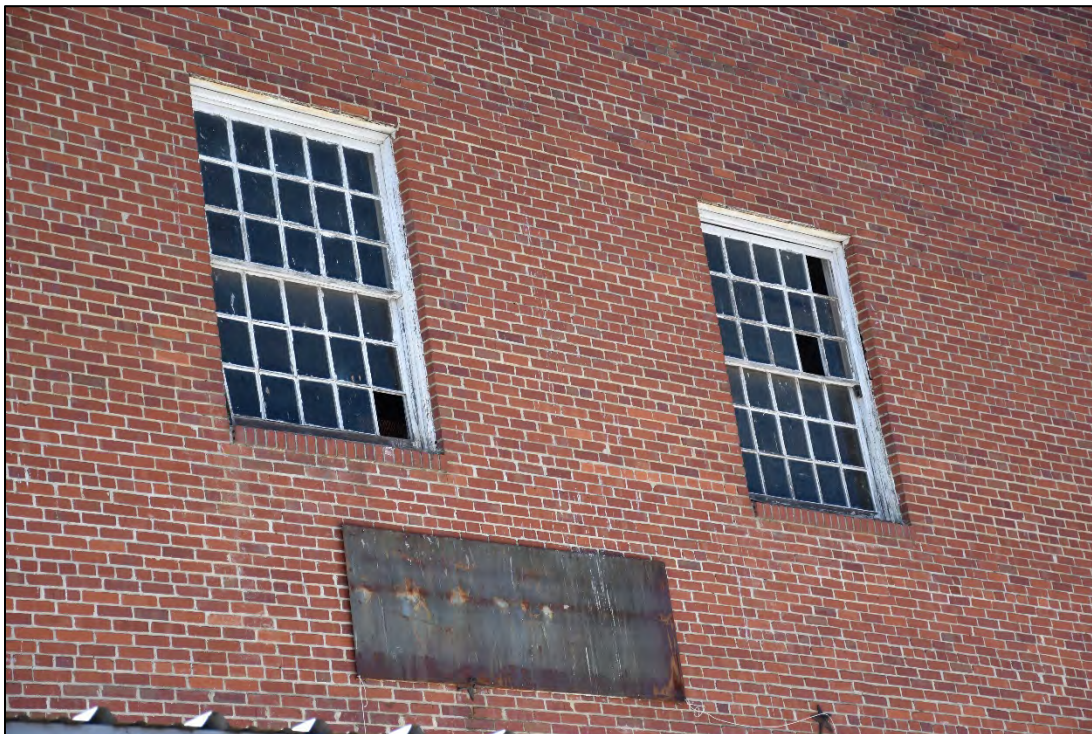
Figure 2.1.8. Salisbury Race Track Grandstand, window detail, facing northwest.

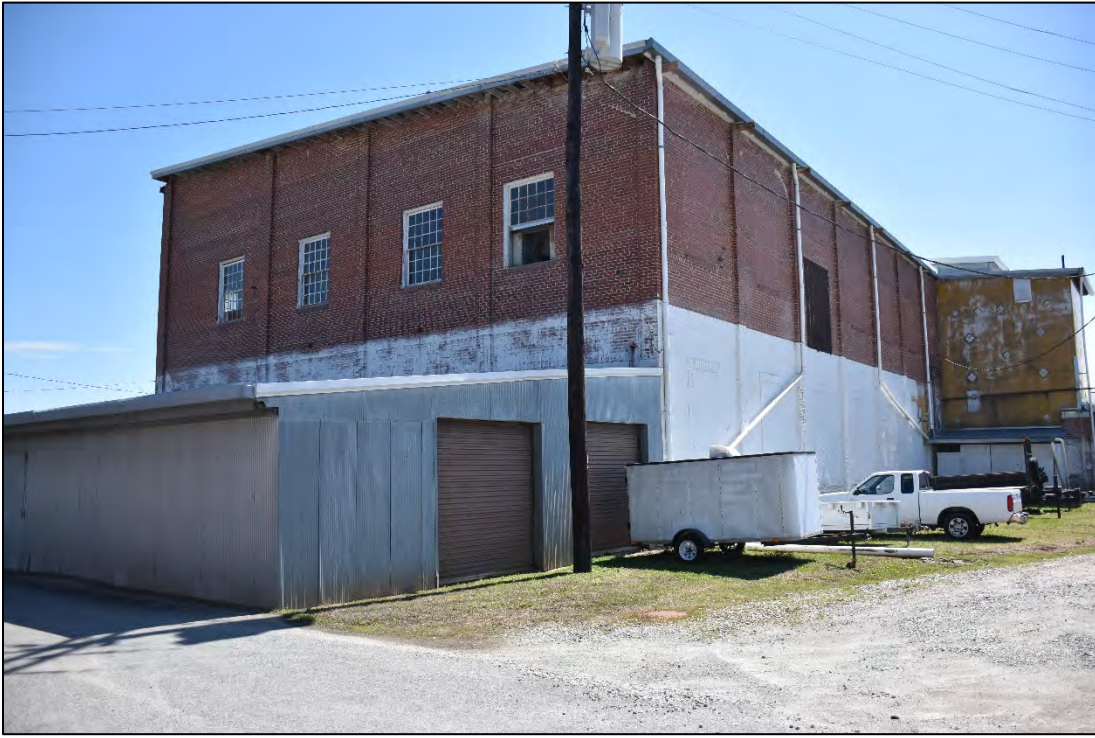
Figure 2.1.11. Salisbury Race Track Grandstand, facing southeast.

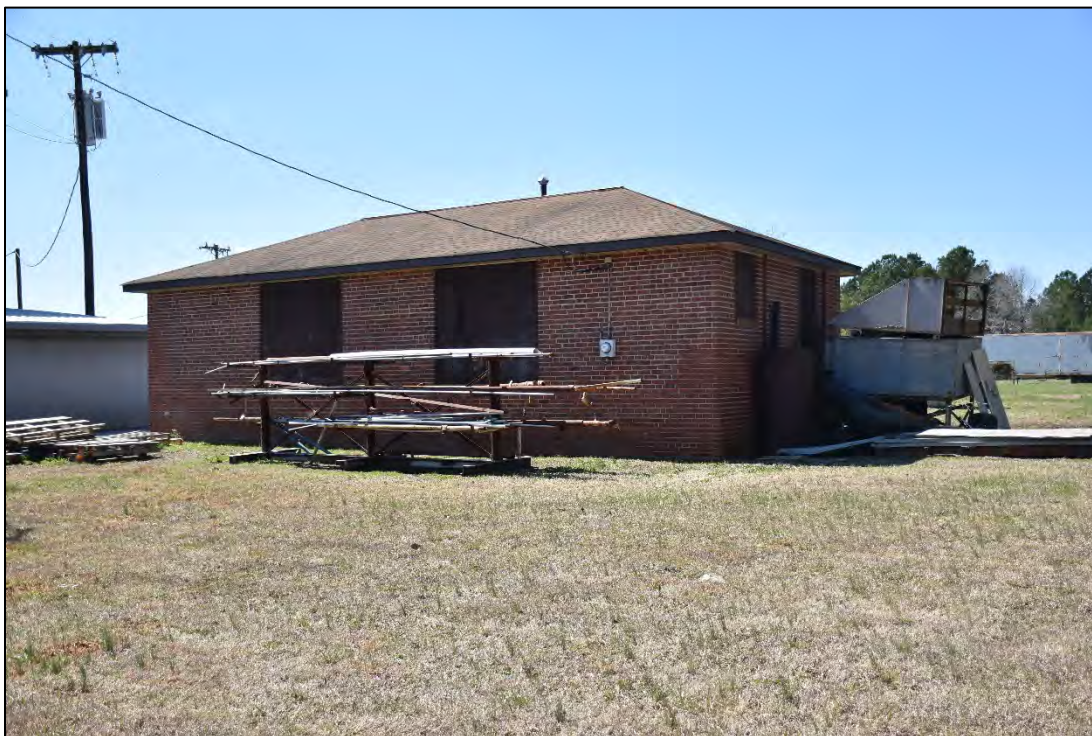
Figure 2.1.12. Salisbury Race Track Grandstand, concession stand, facing southwest.

Three associated buildings are located on the tax parcel along with the Salisbury Race Track Grandstand. To the north is small, single-story structure that appears to have been a concession stand. The building has a rectangular plan and American common bond brick masonry construction; it has a hipped roof that is covered with composition shingles (Figure 2.1.12). The eastern elevation has two window-sized openings, which have been covered over, while the north elevation has a smaller window opening and a doorway that have also been covered. The western elevation of the building has two modern, garage-door style bays (Figure 2.1.13).

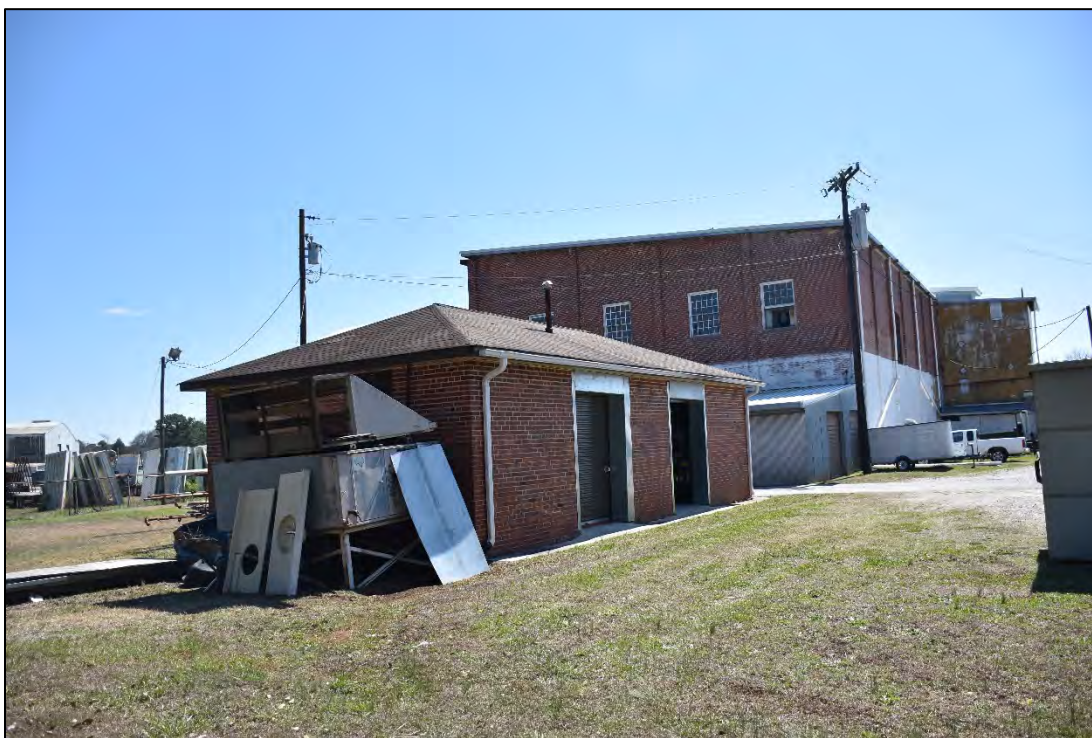
Figure 2.1.13. Salisbury Race Track Grandstand, concession stand, facing southeast.

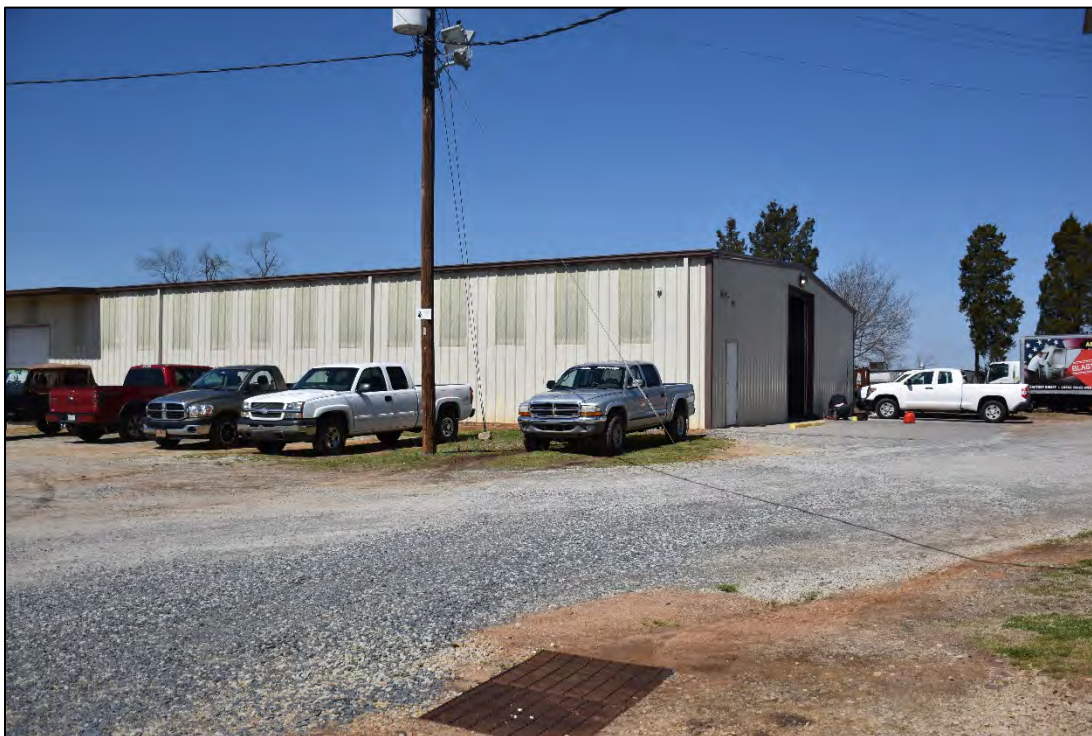
Figure 2.1.14. Salisbury Race Track Grandstand, metal storage building, facing northwest.

Northwest of the Salisbury Race Track Grandstand building is a large, gabled, metal storage building (Figure 2.1.14). Southeast is a single story, brick veneer office structure with a gabled roof (Figure 2.1.15). To the southeast of the Grandstand building are four modern commercial storage buildings (Figure 2.1.16).

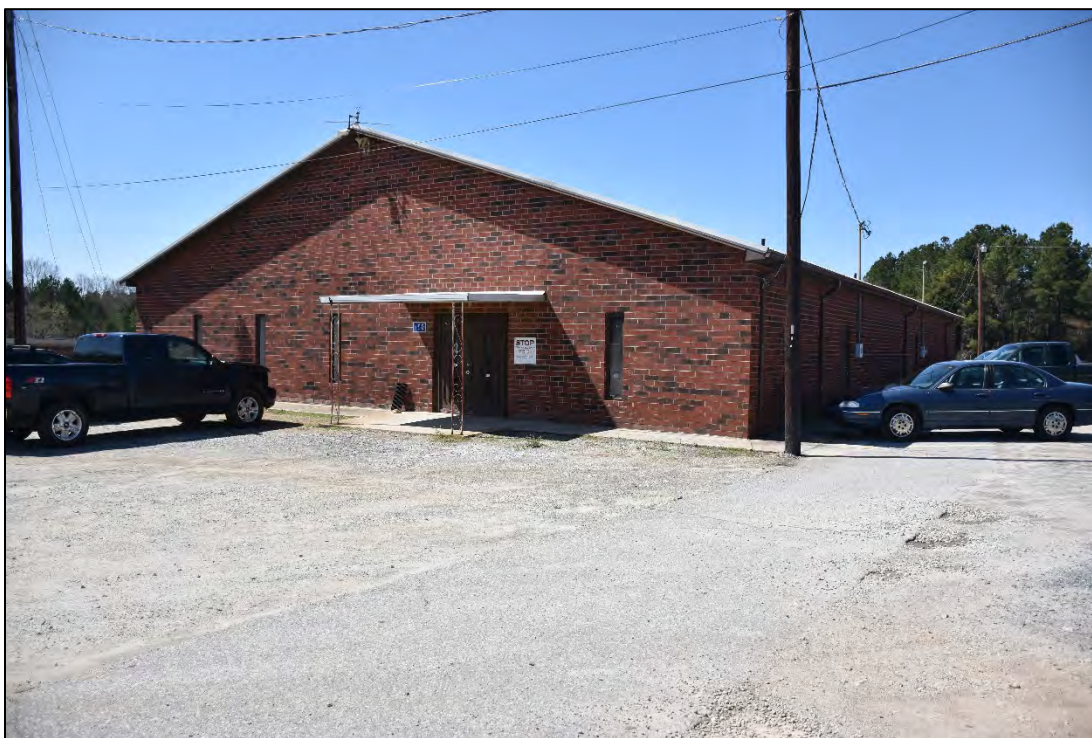
Figure 2.1.15. Salisbury Race Track Grandstand, modern office building, facing west.

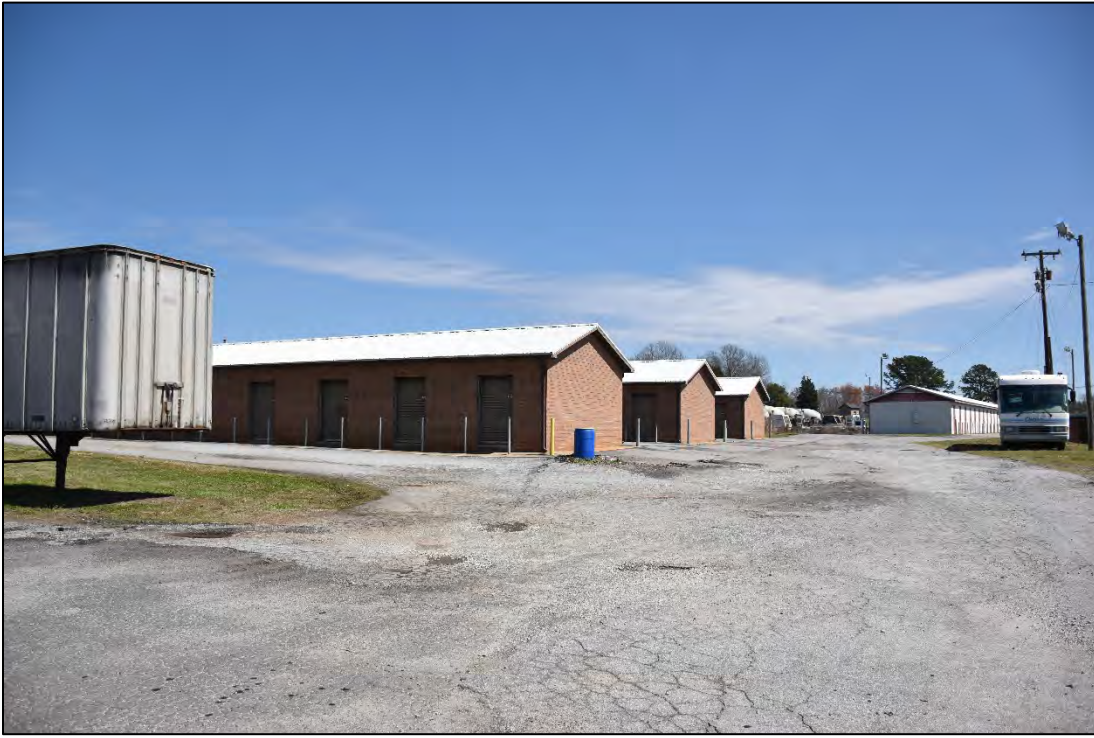
Figure 2.1.16. Salisbury Race Track Grandstand, modern storage buildings, facing east.

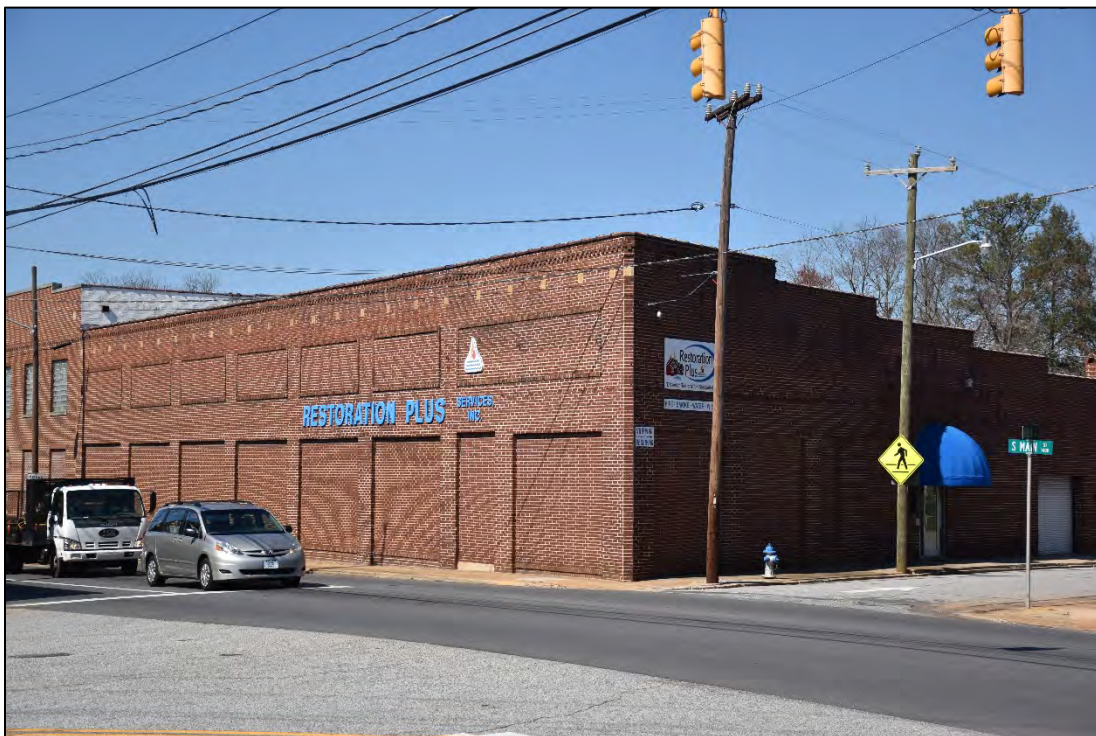
Figure 2.1.34. Stanback Warehouses (RW1465), facing northwest.

The Stanback Warehouses (RW1465) is a large, multi-part, brick industrial structure with a rectangular plan and flat roof (Figures 2.1.24 and 2.1.35). The decorative brick course below the roofline is similar to the brick course along the lower portion of the western wall of the Salisbury Race Track Grandstand and the decorative square blocks are similar to the diamond pattern blocks along the grandstand dower; the window openings are of similar size and construction, although they utilized glass block instead of double-hung windows. The Stanback Warehouses are eligible for the NRHP under Criteria A and B. The Hughes Southeastern building was surveyed as part of a block of South Main Street (RW2103) but was not evaluated for NRHP eligibility. It is also a large brick structure that currently serves as a commercial storefront and warehouse (Figure 2.1.36). The engaged brick piers separating some of the front bays are similar to the piers between bays on the western elevation of the Salisbury Race Track Grandstand and the window openings may have originally held double-hung, wooden sash windows instead of the current, modern, replacements. Although a long, one-story structure with a gabled roof, the Custom Furniture Company (RW1070) is also similar to the Salisbury Race Track Grandstand in that its bays are separated by engaged brick piers, with windows of a similar size as the now enclosed openings of the grandstand structure (Figure 2.1.37). The Custom Furniture Company building is eligible for the NRHP under Criterion C, as an example of Art Deco industrial architecture.

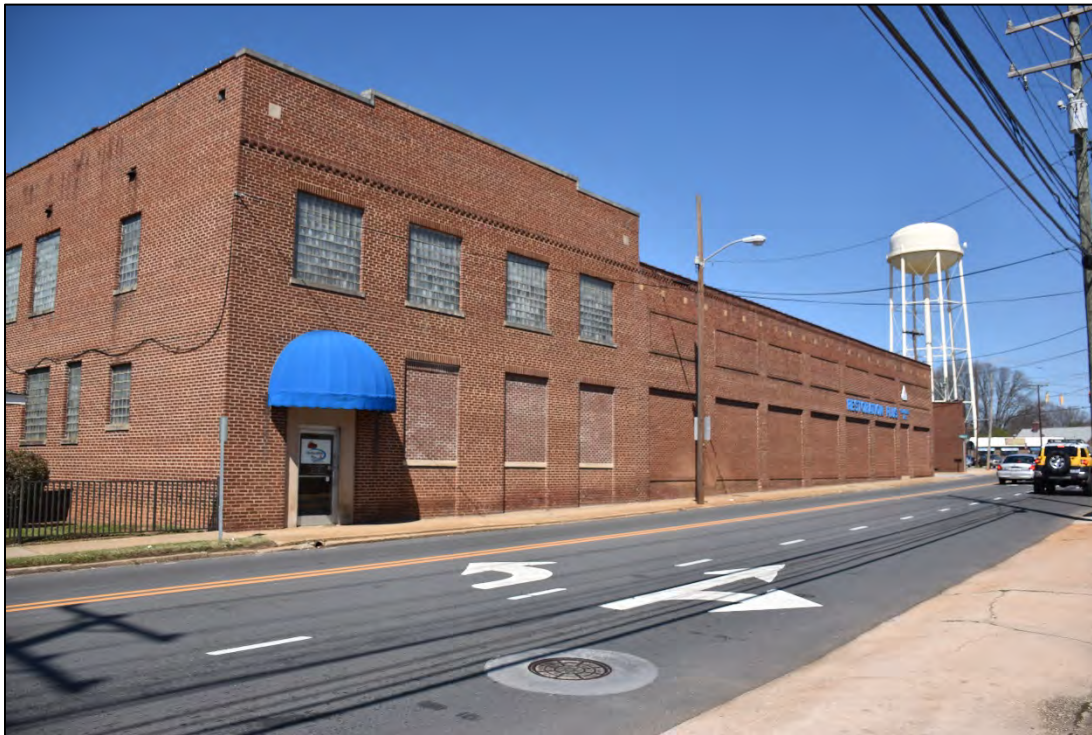
Figure 2.1.35. Stanback Warehouses (RW1465), facing northeast.

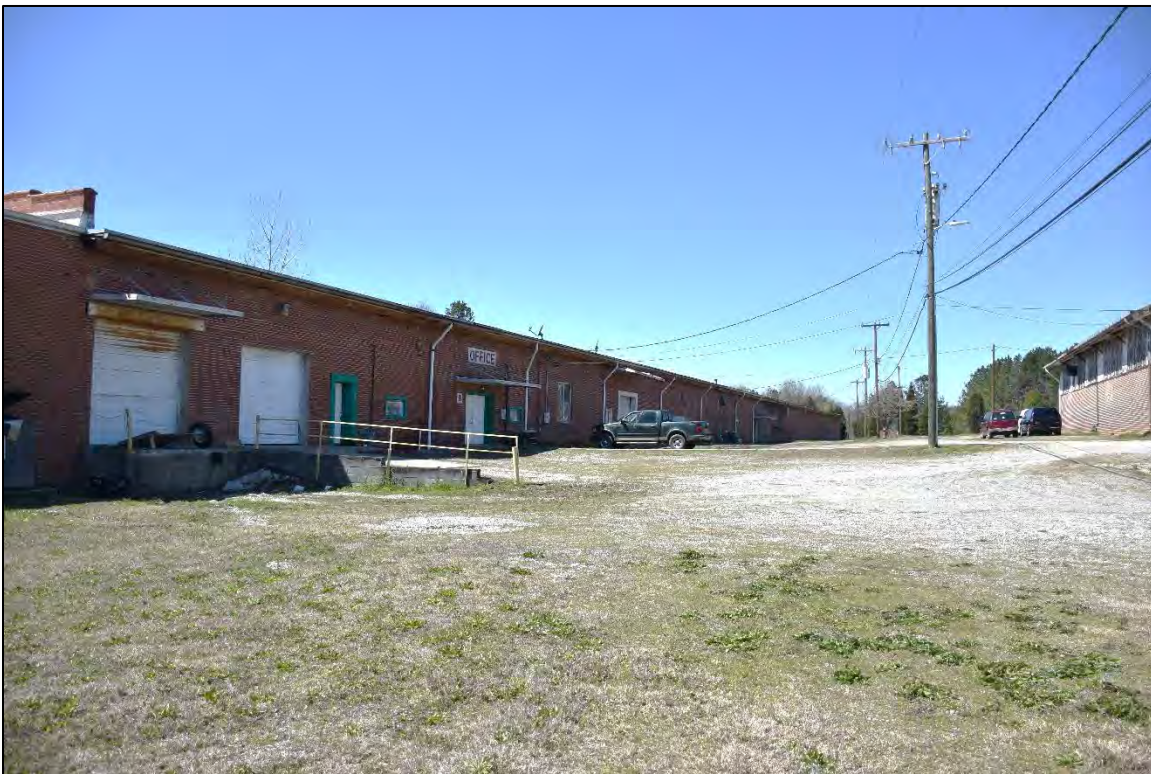
Figure 2.1.38. Salisbury Fairground Buildings (RW2180), facing northwest.

The Salisbury Fairground Buildings are recommended as ineligible for inclusion in the NRHP under Criterion A, as it does not have a significant association with a particular event or broad pattern of history. Although they represent early-to-mid-twentieth-century entertainment in Rowan County and the Salisbury area, there have been

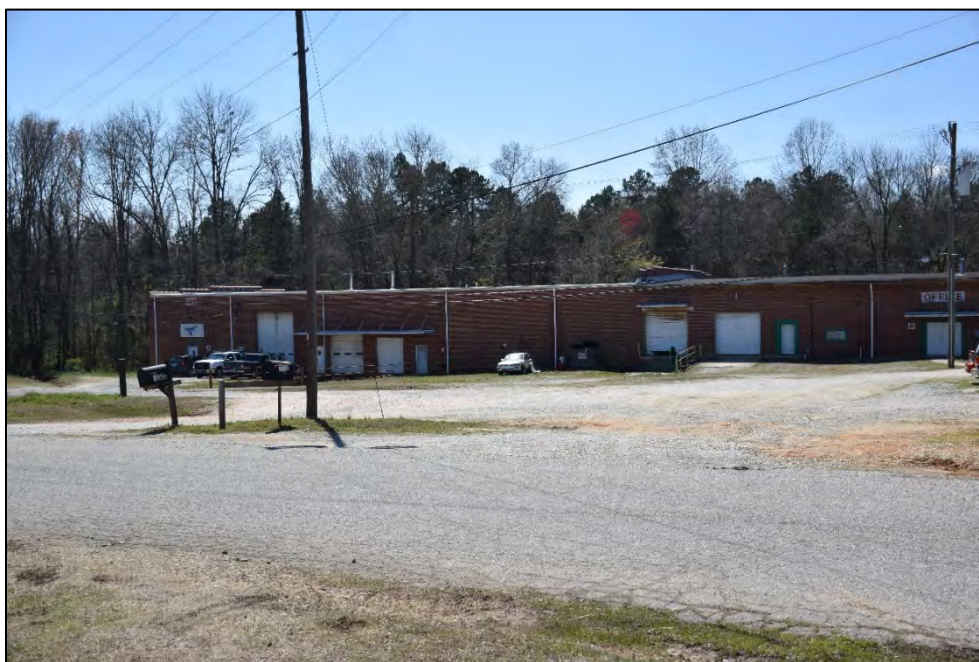
Figure 2.1.39. Salisbury Fairground Buildings, building one, facing west.

at the junction (Figures 2.1.39 and 2.1.40). The northern section of the building is approximately 550 feet in length. Although there are currently three garage bays, four doorways, and two windows penetrating the front wall, these are later additions that were part of the creation of commercial space; there remains evidence of 48 evenly spaced, bricked-over window openings spanning this portion of the front elevation.

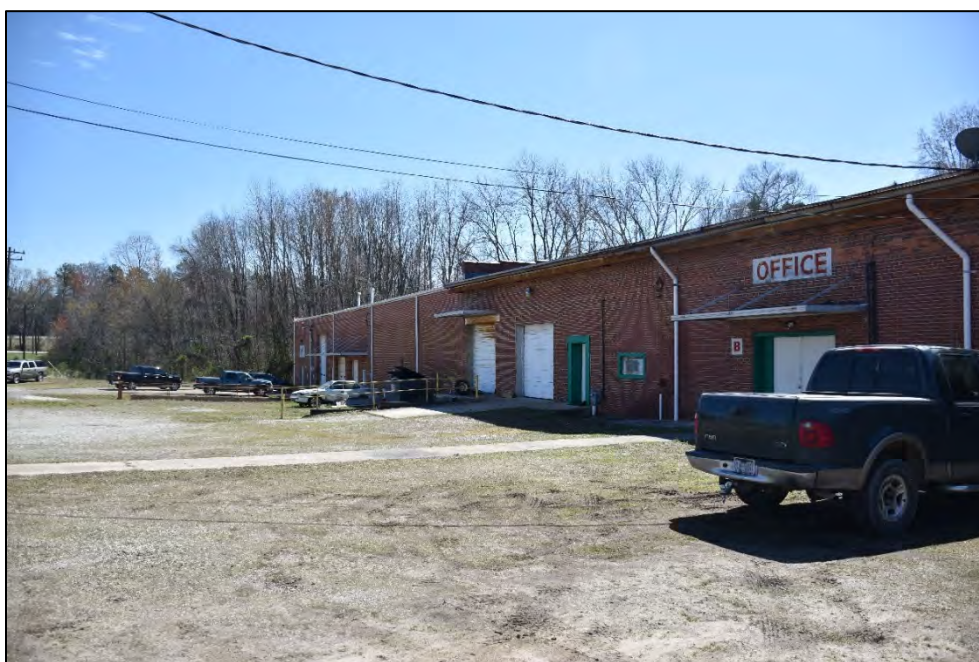
Figure 2.1.40. Salisbury Fairground Buildings, building one, facing south.

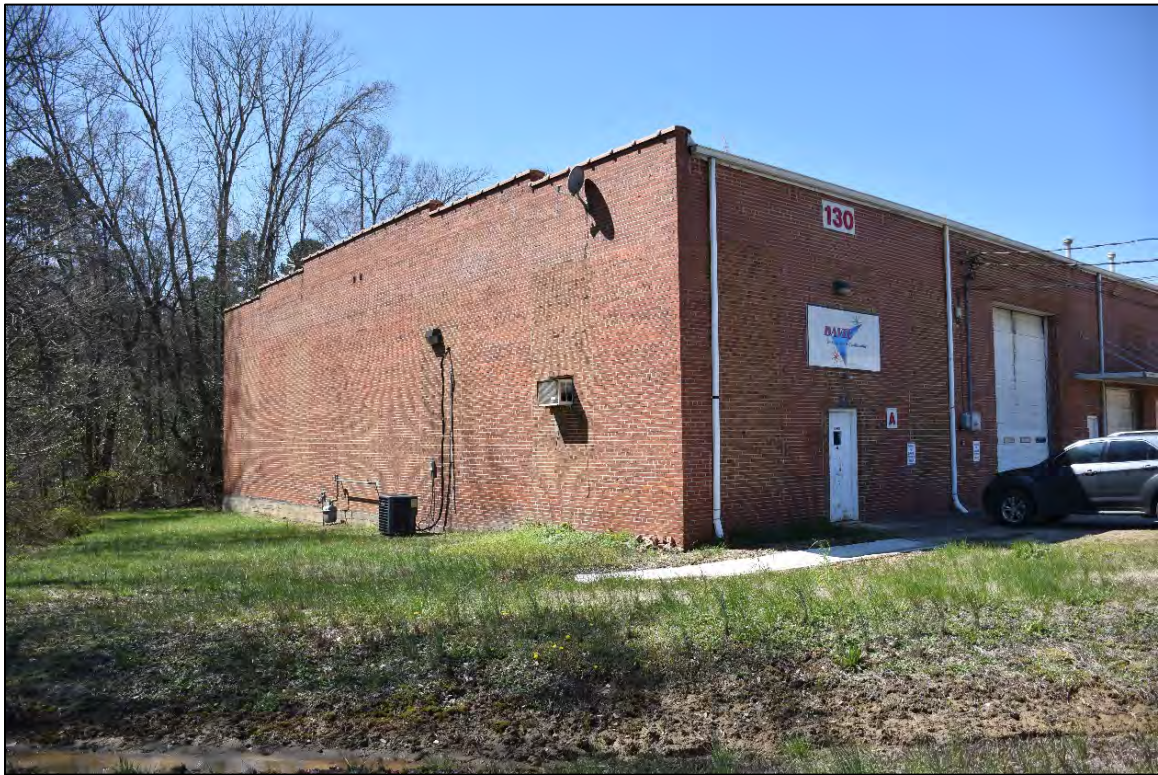
Figure 2.1.45. Salisbury Fairground Buildings, building one, facing west.

The southern elevation of the building reveals the concrete foundation on this section of the structure; it has a stepped parapet roof and five tall, evenly-spaced, bricked-over openings (Figure 2.1.45). The rear elevation of the building is arranged much like the front, with twelve tall openings, enclosed with concrete block, visible on the southern portion of the building (Figure 2.1.46), and 48 smaller window openings, enclosed with either brick or concrete block, evenly spaced along the northern section (Figures 2.1.47–2.1.49). A garage bay and a small covered porch area have been added to the central portion of the northern section (Figure 2.1.48). The north elevation of the structure has a stepped parapet roof and a central garage door opening flanked by three bricked or blocked-over window openings on either side, with an entry door added to the west of the garage; above the garage, a rectangular ghost mark indicates that there may have once been a sign over an open doorway (Figures 2.1.50 and 2.1.51). S&ME attempted to gain interior access to the structure but the request was denied.

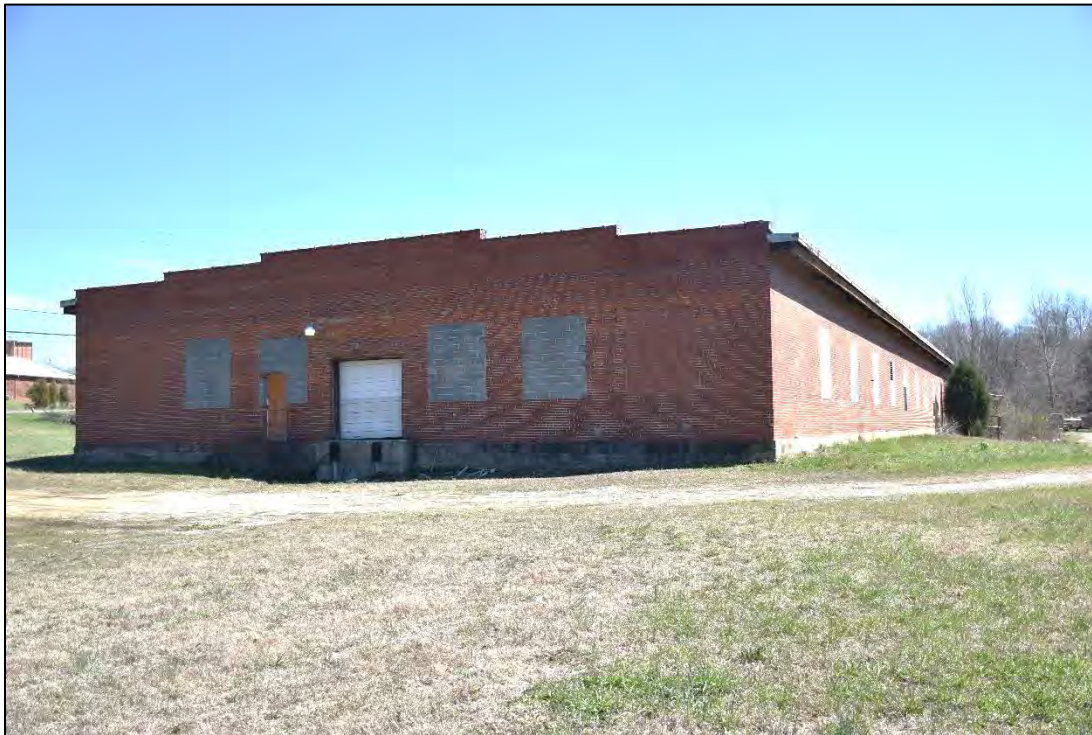
Figure 2.1.50. Salisbury Fairground Buildings, building one, facing east.

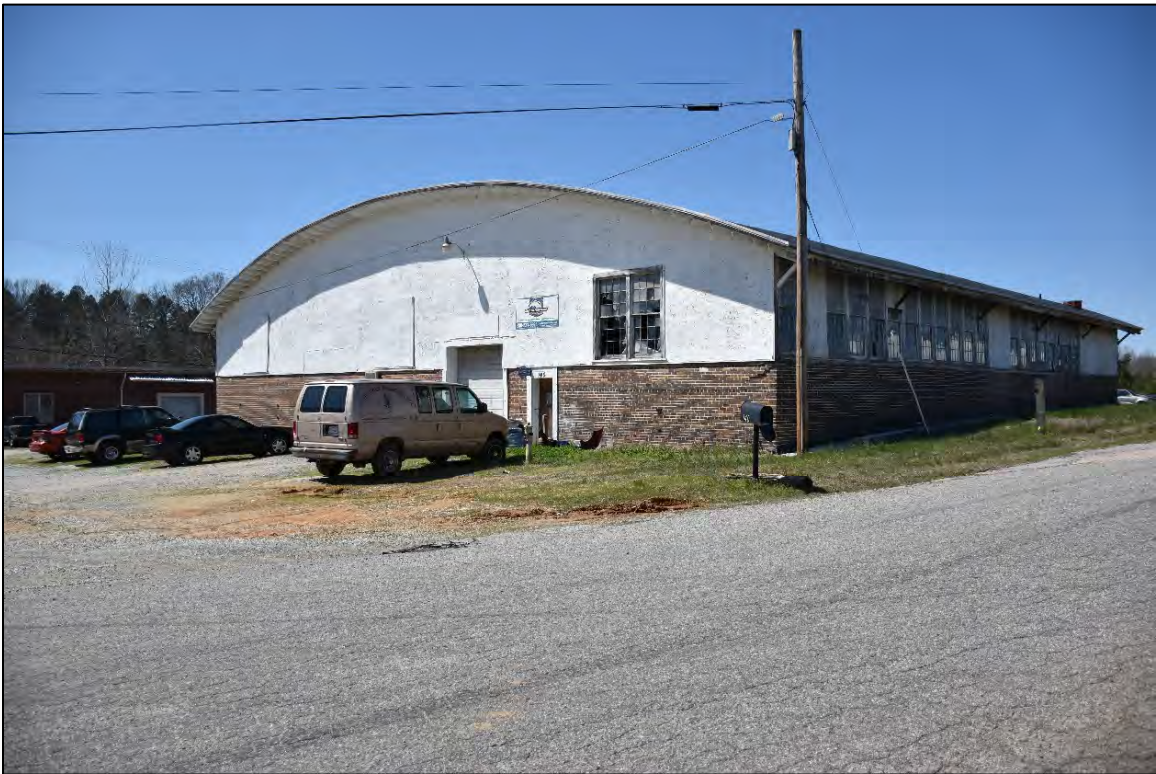
The second Salisbury Fairgrounds Building is a rectangular plan, brick masonry building with an arched roof (Figure 2.1.52). The southeastern elevation of the building is the front elevation and features an off-center garage door and entry door, as well as paired 16-over-16, double-hung, wooden sash windows. The bottom third of this elevation is exposed brick, showing the American common bond masonry construction, while the upper portion has been covered with stucco. There is evidence of another large opening as well as two additional, evenly-spaced, window openings. Along the roof eave, there are decorative brackets. The northeast elevation also has exposed brick on the lower portion, with stucco sections along the upper portion, as well as banks of 16-over-16, double-hung, wooden-frame windows (Figure 2.1.53). There is evidence of two large open areas that have been bricked-in and along the roofline there are metal brackets supporting the roof overhang. The northwest elevation of the structure is almost completely brick, with boarded-over sections along the corner that indicate that the windows, or an open section, may have once wrapped around to this elevation (Figure 2.1.54). A prominent gabled ghost mark is centered within this elevation, showing that another structure was once attached to this building (Figure 2.1.55). Although there is currently a large garage-door bay on this elevation, there is also a bricked-in opening, symmetrically placed from the garage bay, which displays an original arched form; it is likely that an identical arched opening was opened up to create the garage bay (Figure 2.1.55). The southwest elevation of the building is similar to the northeastern section, with a brick masonry lower section and an enclosed upper section, with banks of 16-over-16, double-hung, wooden sash windows, and metal brackets supporting the roof overhang (Figures 2.1.57 and 2.1.58). S&ME attempted to gain interior access to the structure but the request was denied.

Figure 2.1.52. Salisbury Fairground Buildings, building two, facing northwest.

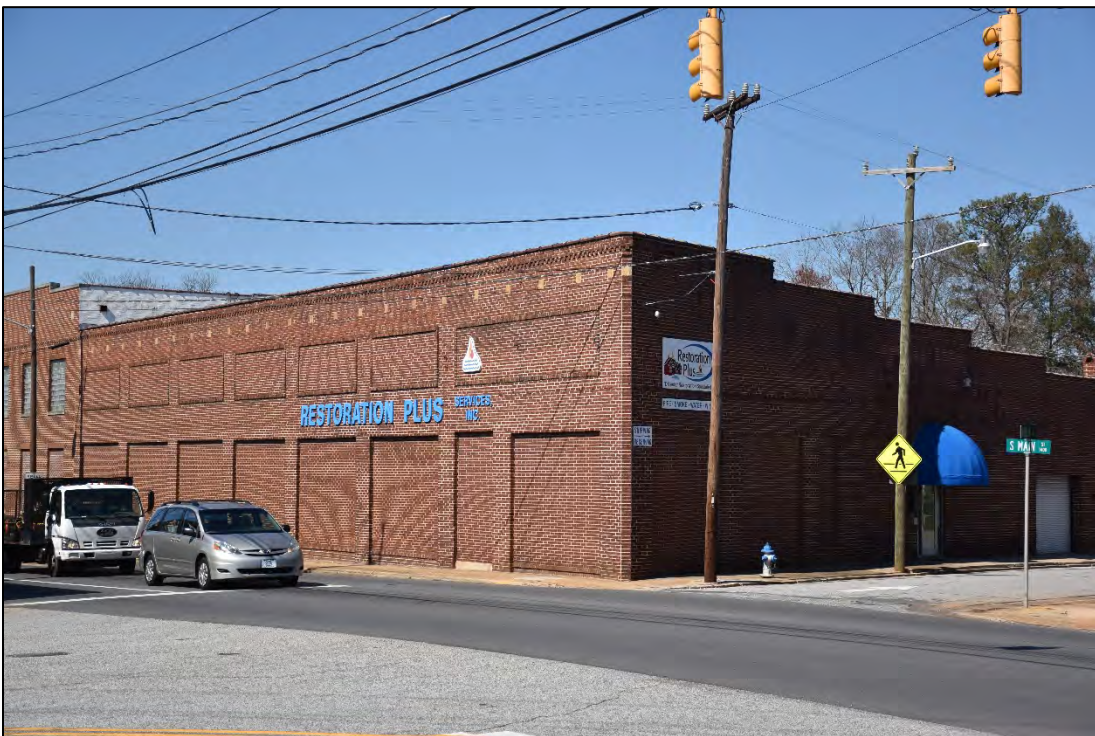
Figure 2.1.68. Stanback Warehouses (RW1465), facing northwest.

Salisbury Fairgrounds Buildings, the Stanback Warehouses (RW1465) feature the same type of evenly spaced openings along its façade; the Stanback Warehouses are eligible for the NRHP under Criteria A and B (Figure 2.1.68).

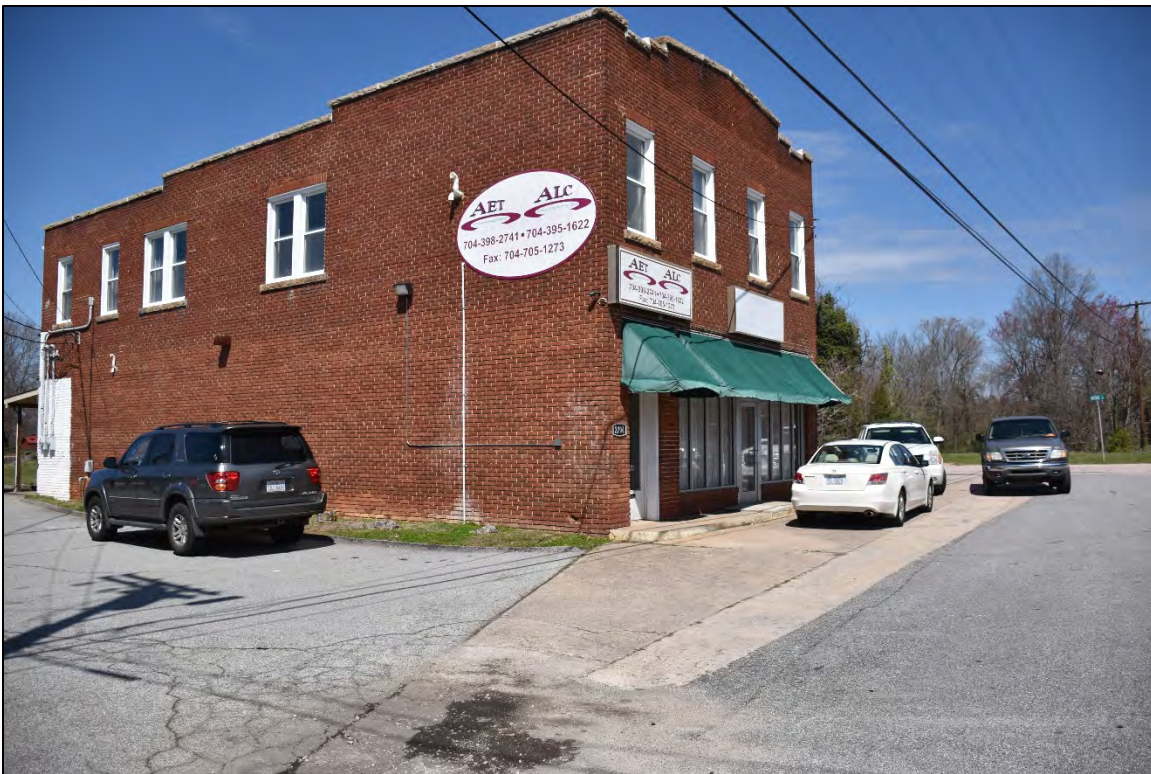
Figure 2.2.3. Rowan Mills Store (RW2181), facing north.

The Rowan Mills Store retains its original framing and brick veneer exterior. However, much of the other exterior material, including the upper story windows, doors, and display windows, has been removed and replaced by modern material. The interior of the store was not accessible; therefore, material integrity of the interior was not assessed.

The Rowan Mills Store is recommended as ineligible for inclusion in the NRHP under Criterion A, as it does not bear a significant association with a particular event or broad pattern of history. While it is a recognizable example of an early-twentieth-century two part block commercial structure, the most significant association of the building
