SUBJECT: Historic Structures Survey Report, Build on New Location, Airport Parkway from
SR1710 to US 70/US 601 to SR 2539 at US 29, U-5901, PA 17-08-0002,
Rowan County, ER 17-2008

The North Carolina Department of Transportation (NCDOT) proposes to build on a new location Airport Parkway. S&ME prepared the attached Eligibility Report and recommends one of the properties surveyed eligible for the National Register of Historic Places, the Plantation Pipeline Pumping Station (RW2185).

On behalf of the NCDOT, S&ME has completed a historic architectural analysis of seven resources located within the project area for the construction on a new location of Airport Parkway, from SR 1710 (Harrison Road) at US 70/US 601 to SR 2539 (Peach Orchard Road) at US 29 in Rowan County (TIP No. U-5901, WBS No. 44705.1.1, PA No. 17-08-0002) (Figures 1.1 and 1.2). Work was conducted in general accordance with the agreed-upon scope, terms, and conditions presented in the Proposal No. 42-1800186, dated February 16, 2018.

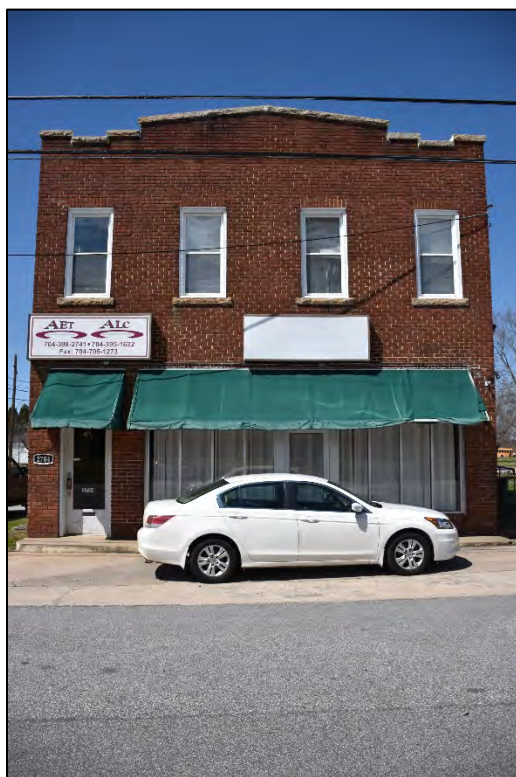
Figure 2.2.4. Rowan Mills Store, facing northwest.

The Rowan Mills Store (RW2181) is located at 2702 Main Street, northwest of US 29, approximately 2.5 miles southwest city center of Salisbury, in Rowan County (Figures 1.2 and 1.4). The Rowan Mills Store was originally surveyed as part of the Rowan Cotton Mill complex (RW0737), in 1980, but no information on the store itself was included in the survey (Survey File 1980:RW0737). The building, which is located close to the road right-of-way is a two-part block commercial style structure, built around 1925 (Figure 2.2.3). The Rowan Mills Store is a two-story building with a brick veneer exterior; it has a rectangular plan, with a flat roof that features a decorative parapet that has stone coping (Figure 2.2.4). The front elevation has two entry doors on the first story, one near the southern corner and one slightly off-center; the central entry is flanked by four large single-pane display windows on either side (Figure 2.2.5). The upper story has four evenly-spaced window openings, each with a single one-over-one, double-hung, vinyl sash window and a stone sill.

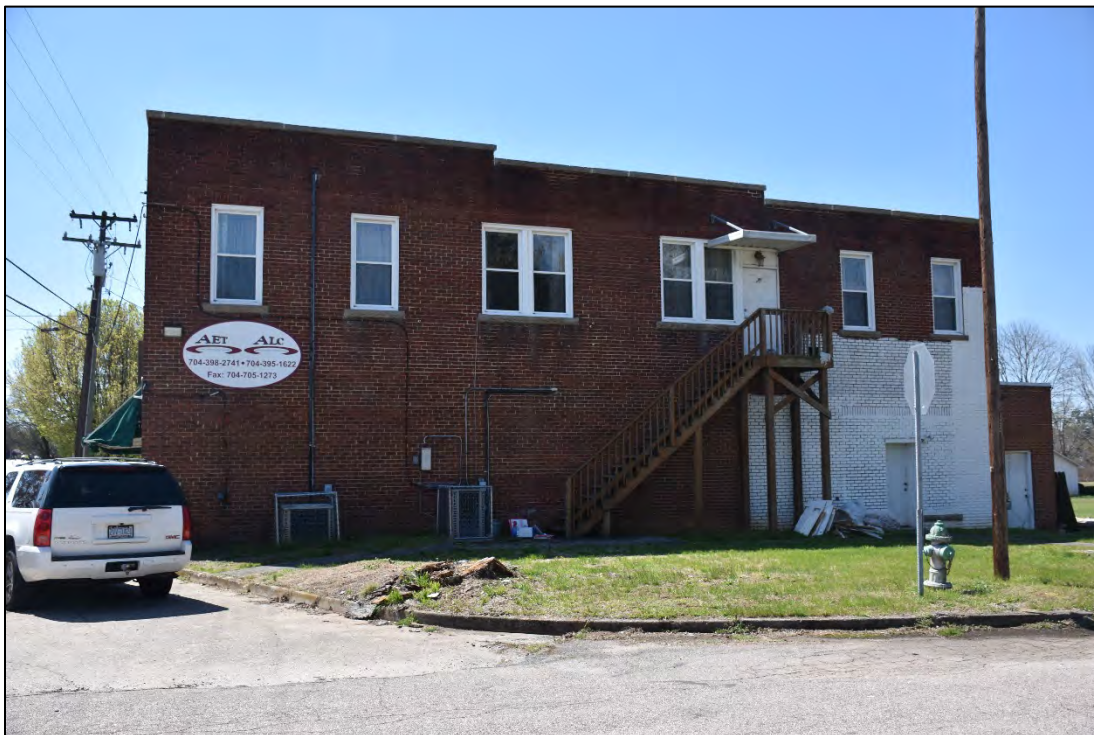
Figure 2.2.6. Rowan Mills Store, facing southwest.

The north elevation of the building steps back in three sections, with the roof parapet dropping slightly on each portion (Figure 2.2.6). There are no window openings on the lower story, but there is a single doorway near the northwest corner of the structure. On the upper story, the front section has two single one-over-one, double-hung, vinyl sash windows; the central section has two paired one-over-one, double-hung, vinyl sash windows and an entry door, reached by a fire escape; and the rear section has two single one-over-one, double-hung, vinyl sash windows (Figure 2.2.7). There is a single story, rear addition that has a doorway on the northern elevation.

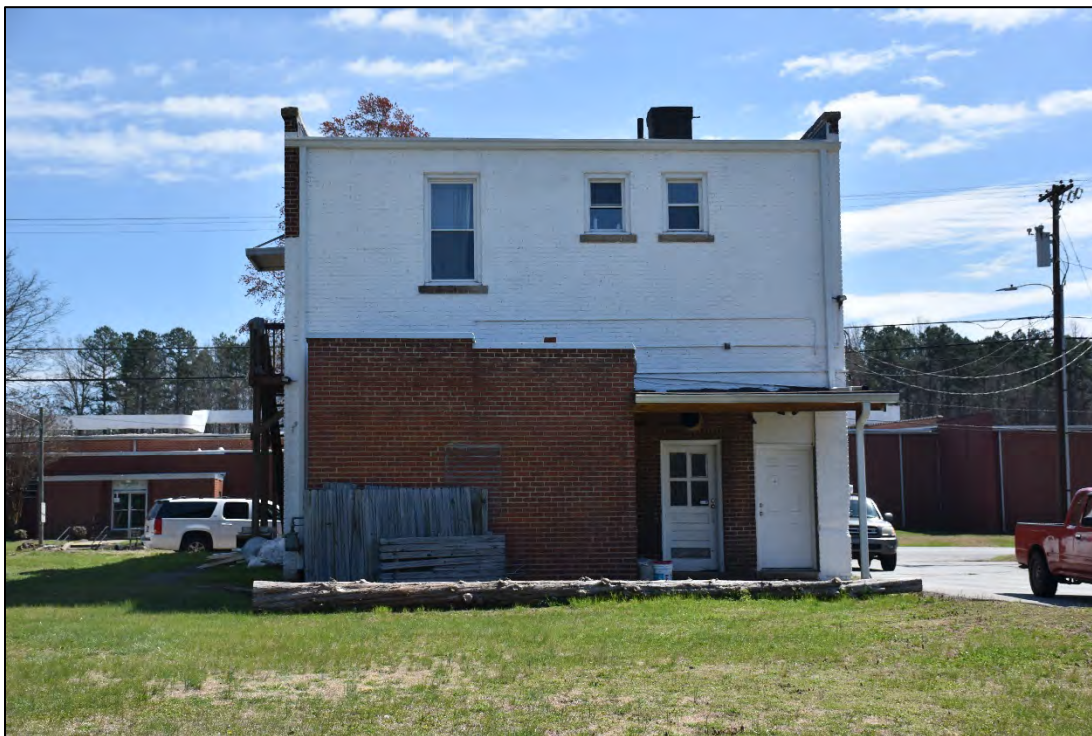
Figure 2.2.8. Rowan Mills Store, facing southeast.

The rear elevation of the building is obscured by the single story addition and the attached roof overhang on the first floor (Figure 2.2.8). The upper story has a single tall one-over-one, double-hung, vinyl sash window as well as two smaller one-over-one, double-hung, vinyl sash windows, which are not evenly spaced along this elevation. The south elevation, like the north elevation, steps back in three sections and has no openings on the lower story (Figure 2.2.9). The front section has no window openings on the upper story, while the central section has two double one-over-one, double-hung, vinyl sash windows and the rear section has two single, one-over-one, double-hung vinyl sash windows. S&ME attempted to gain interior access to the structure but the request was denied.

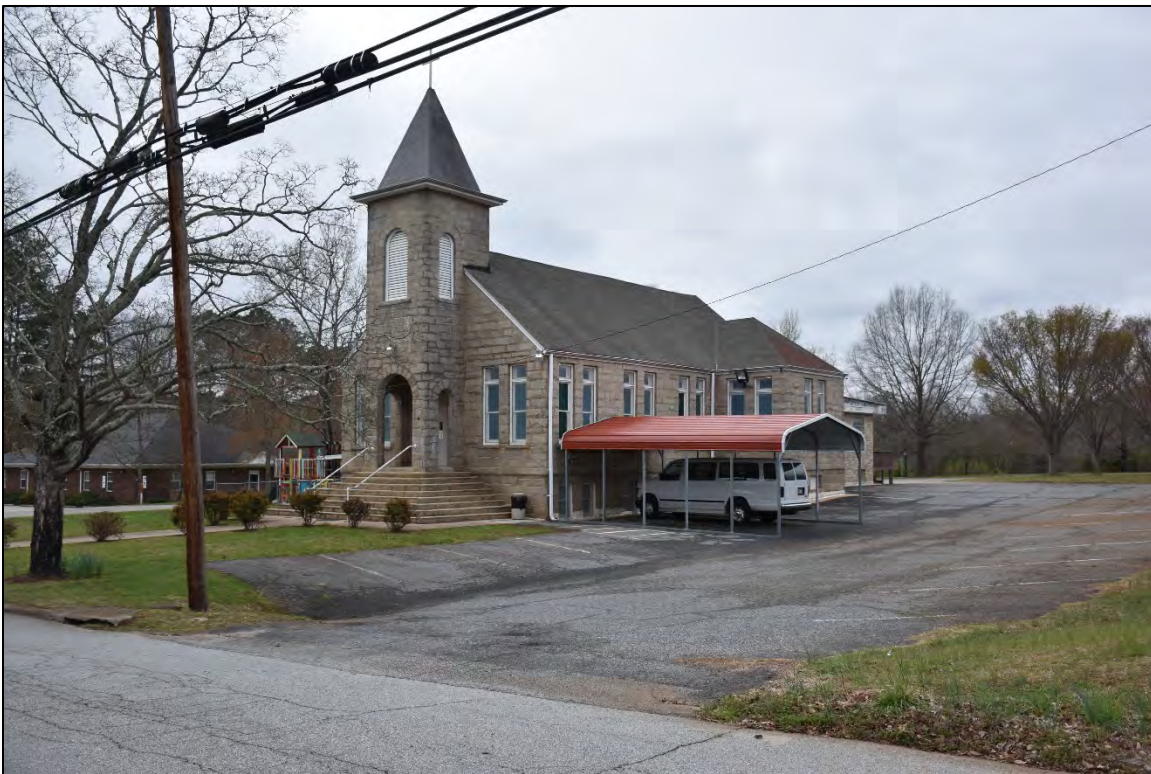
Figure 2.2.14. Rowan Mills Methodist Church (RW2182), facing west.

The Rowan Mills Methodist Church is recommended as ineligible for inclusion in the NRHP under Criterion A, as it does not bear a significant association with a particular event or broad pattern of history. While it is a recognizable example of an early-to-mid-twentieth-century church structure, the most significant association of the building is with the Rowan Cotton Mills village; however, the removal of the housing associated with the village has

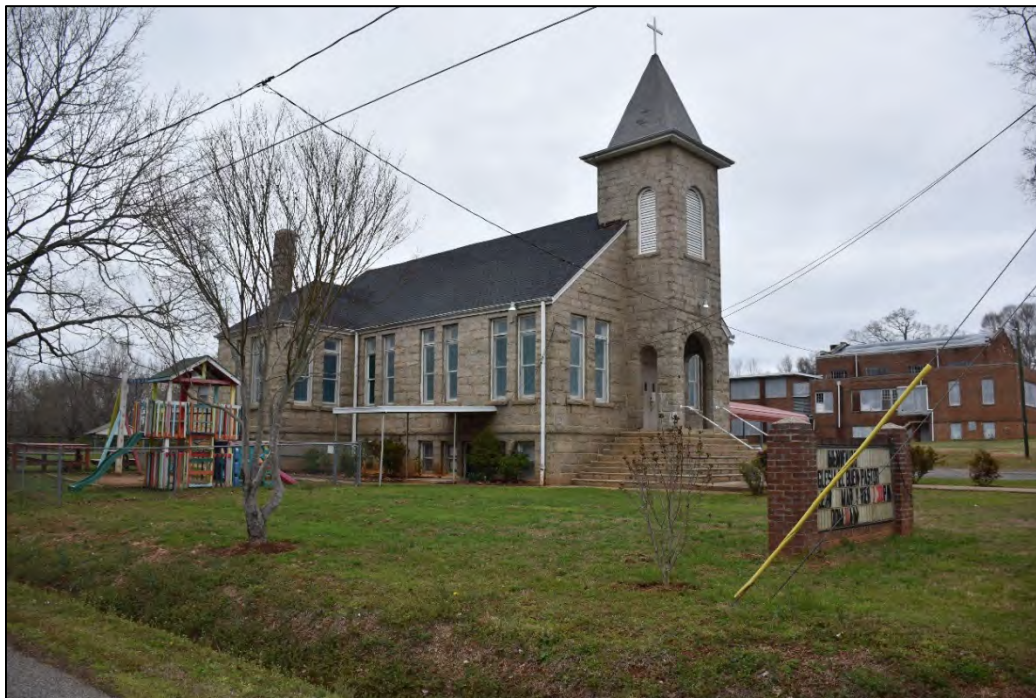
Figure 2.2.16. Rowan Mills Methodist Church, facing north.

The Rowan Mills Methodist Church (RW2182) is located at 2728 Cottage Street, a side street northwest of US 29, approximately 2.5 miles southwest of the city center of Salisbury, in Rowan County (Figures 1.2 and 1.4). The Rowan Mills Methodist Church was originally surveyed as part of the Rowan Cotton Mill complex (RW0737), in 1980, but little information on the church was included in the survey (Survey File 1980:RW0737). The church is a cruciform-shaped, gable-roofed church that is of stone-masonry construction (Figure 2.2.14). The church has a front-gabled façade with a central, rectangular tower topped with a pyramidal roof (Figure 2.2.15). The central double doorway is located beneath the tower and is accessed by an arched opening on each of the three exposed sides; the upper story of the tower has an arched, louvered vent on each of the three exposed sides (Figure 2.2.16). The tower is flanked by two tall windows, consisting of a one-over-one, double-hung, wooden sash window with a single-pane rectangular transom, on either side; the windows are covered with exterior storm windows. The church is four bays deep, with each bay consisting of a pair of one-over-one, double-hung, wooden sash windows with a single-pane rectangular transom (Figures 2.2.16 and 2.2.17). The westernmost bay of both

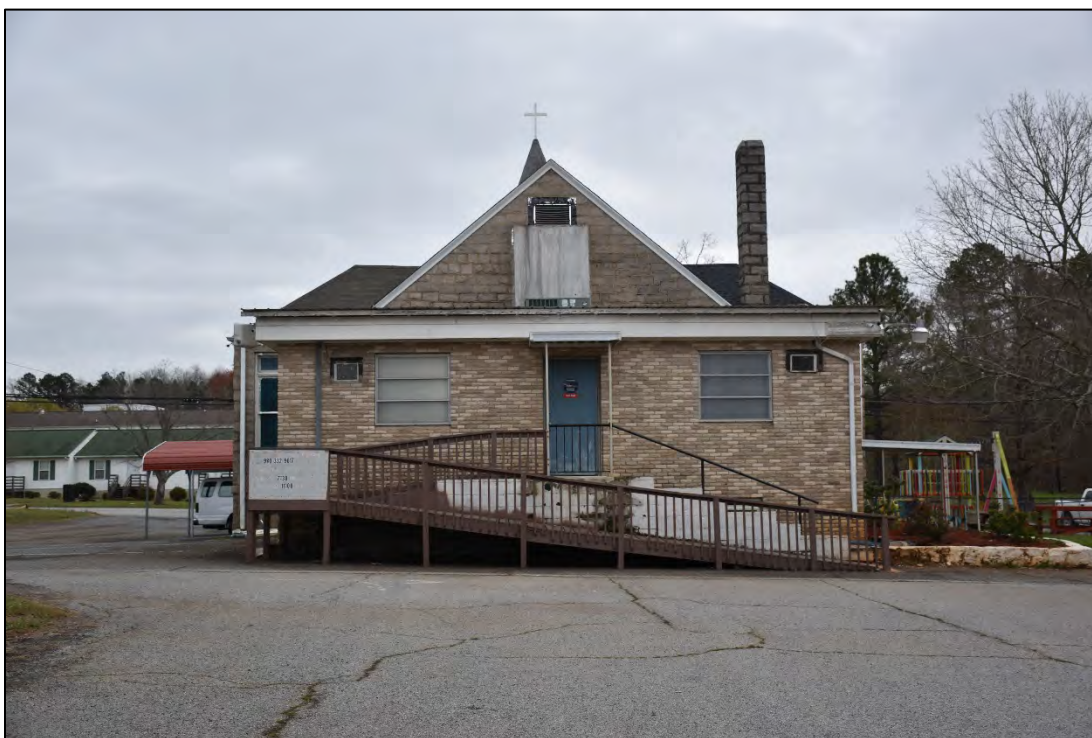
Figure 2.2.18. Rowan Mills Methodist Church, facing southeast.

The western elevation is the rear of the church. The main section of the church has a gabled rear elevation, with a covered-over opening centered within the gable end. There is a single story, pent-roofed, frame and brick-veneer addition that projects from the rear elevation (Figure 2.2.18). This addition has a basement story, which is accessed from a covered stairway on the south elevation. The addition has two metal-frame, horizontal-tilt, casement windows on the south elevation; a central doorway and two metal-frame, horizontal-tilt, casement windows on the west elevation; and three metal-frame, horizontal-tilt, casement windows on the north elevation (Figure 2.2.19). The northern elevation of the church is symmetrical to the southern elevation, with four bays of paired one-over-one, double-hung, wooden sash windows with a single-pane rectangular transom and the rear bay consisting of a hipped-roof extension (Figure 2.2.20). Basement windows are visible along both the north and south elevations of the church and the roof of the church is covered with composition shingles. S&ME attempted to gain interior access to the structure but the request was denied.

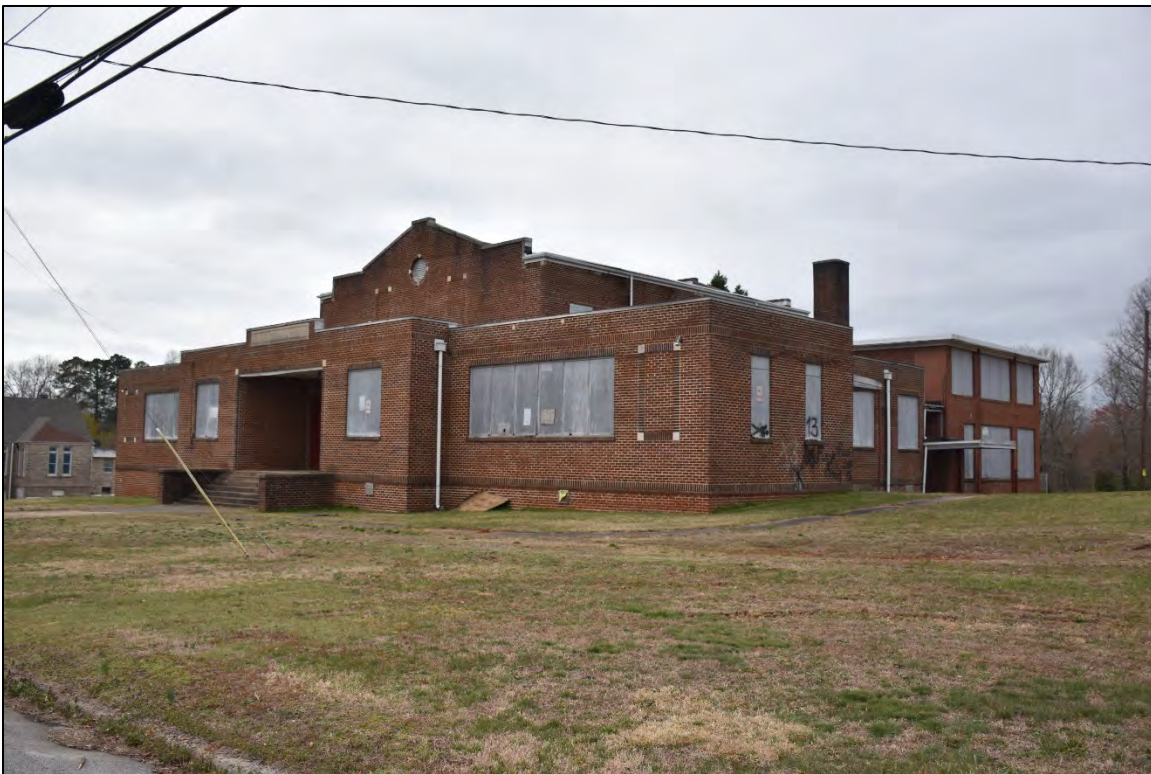
Figure 2.2.26. R. G. Kizer School (RW2183), facing west.

The R. G. Kizer School is recommended as ineligible for inclusion in the NRHP under Criterion A, as it does not bear a significant association with a particular event or broad pattern of history. While it is a recognizable example of an early-twentieth-century school building, the most significant association of the building is with the Rowan Cotton Mills village; however, the removal of the housing associated with the village has compromised the

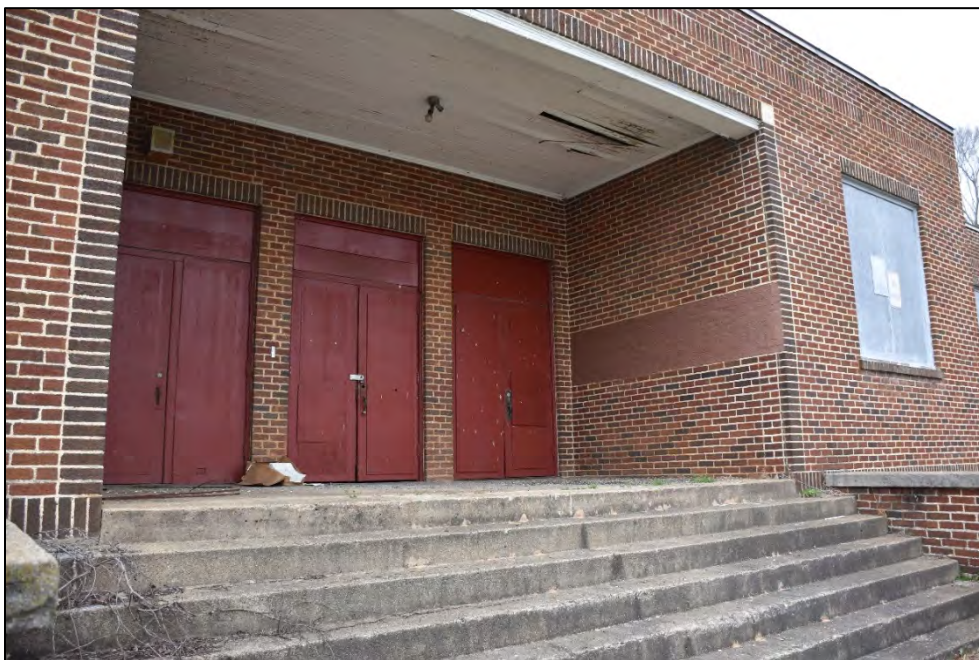
Figure 2.2.28. R. G. Kizer School, entry detail, facing north.

boarded-over, horizontal opening that appears to have been a bank of windows. The brickwork of the front elevation features decorative detailing, including: rectangular false openings with stone corner blocks, on both the one and two-story sections; stone corner blocks along the framing of the recessed entryway; and soldier courses along the foundation line and as a trim band below the roofline.

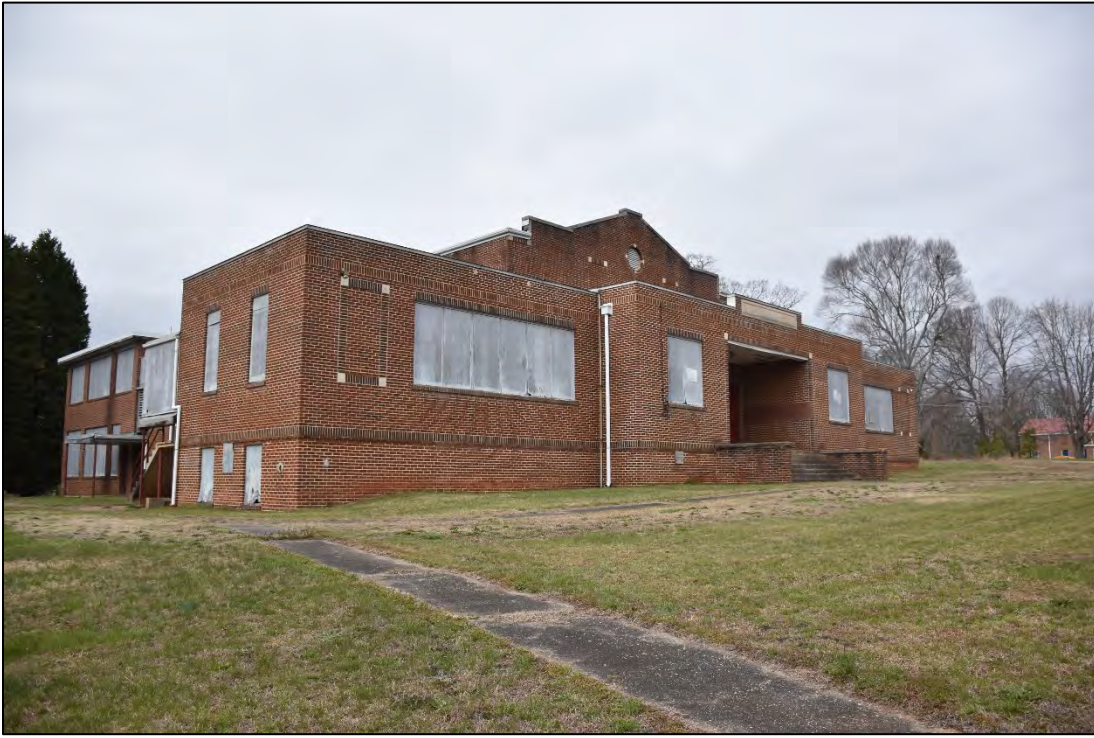
Figure 2.2.29. R. G. Kizer School, facing north.

The R. G. Kizer School (RW2183) is located at 2728 Cottage Street, a side street northwest of US 29, approximately 2.5 miles southwest of the city center of Salisbury, in Rowan County (Figures 1.2 and 1.4). The R. G. Kizer School was originally surveyed as part of the Rowan Cotton Mill complex (RW0737), in 1980, but little information on the school was included in the survey (Survey File 1980:RW0737). The school is of frame construction, with a brick veneer exterior, and has an irregular but symmetrical plan (Figure 2.2.26). The central section of the building is two-stories, with a gabled roof that has a stepped parapet along the front and rear elevations and a central circular, louvered vent (Figure 2.2.27). A single story section wraps around the north, east, and south elevations of the two-story section. The front elevation has a projecting block, with a flat roof and parapet, which holds the nameplate for the school. The recessed entryway has three doors that have been boarded over, but appear to be double doorways with transoms (Figure 2.2.28). Flanking the recessed entry is a single window opening on either side. The projecting block has two L-shaped sections, one to the north and one to the south, which are set back slightly from the façade of the central section (Figure 2.2.29). The eastern elevation of each of these blocks has a

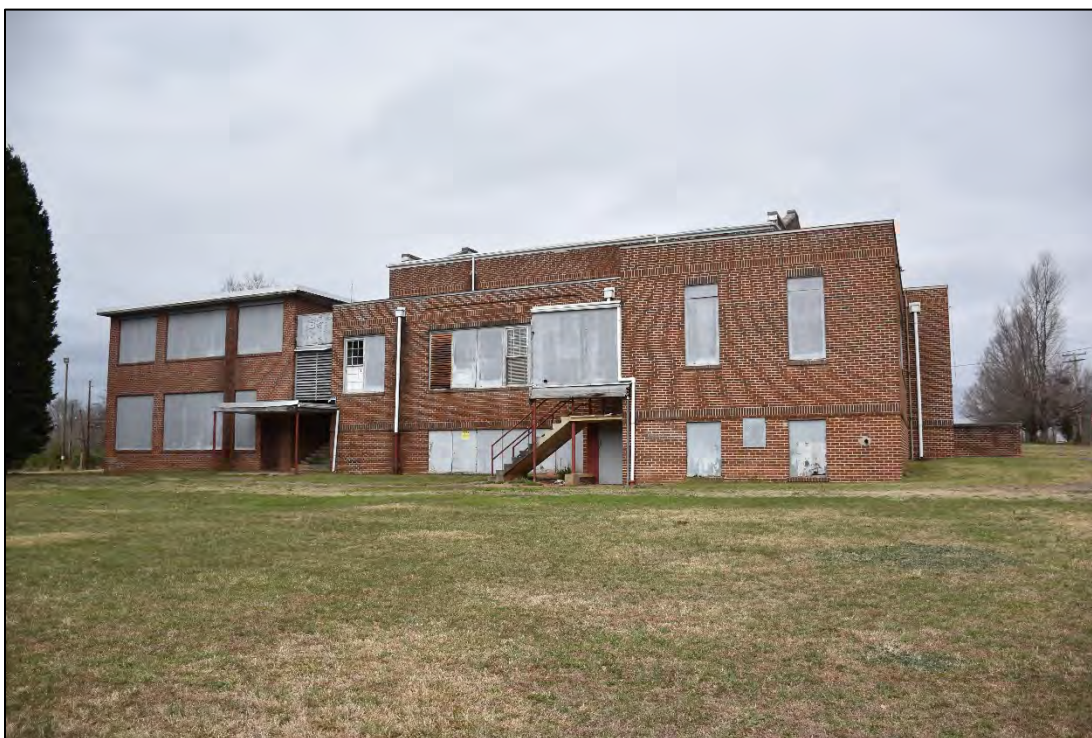
Figure 2.2.30. R. G. Kizer School, facing northeast.

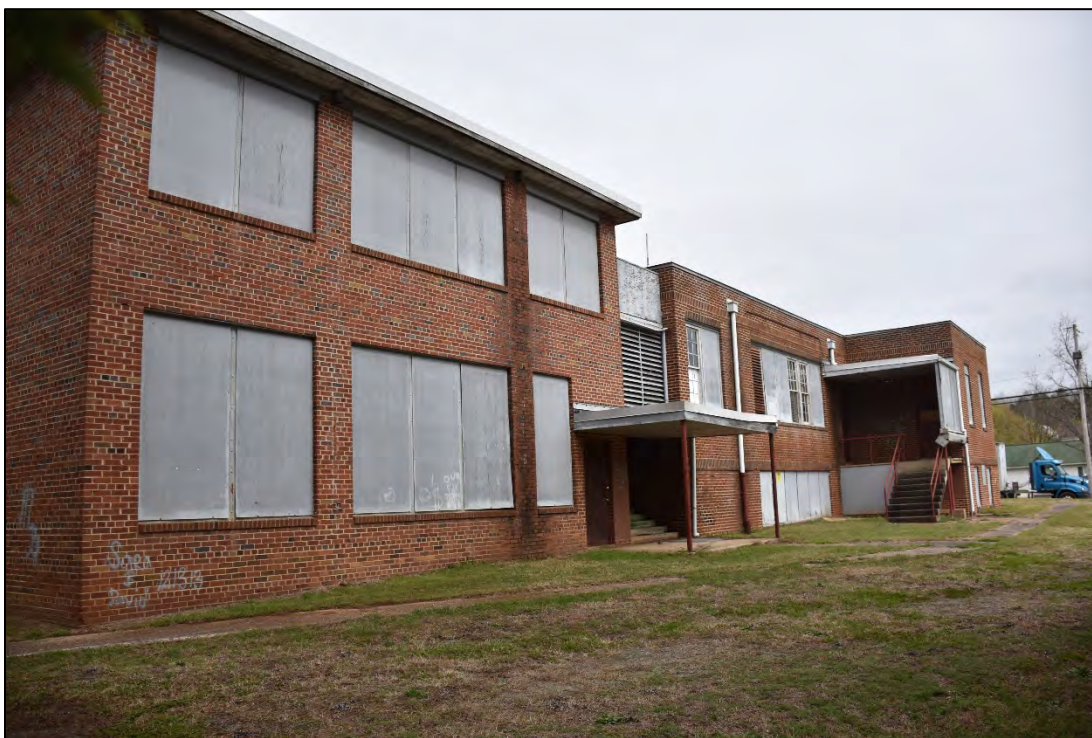
Figure 2.2.31. R. G. Kizer School, facing east.

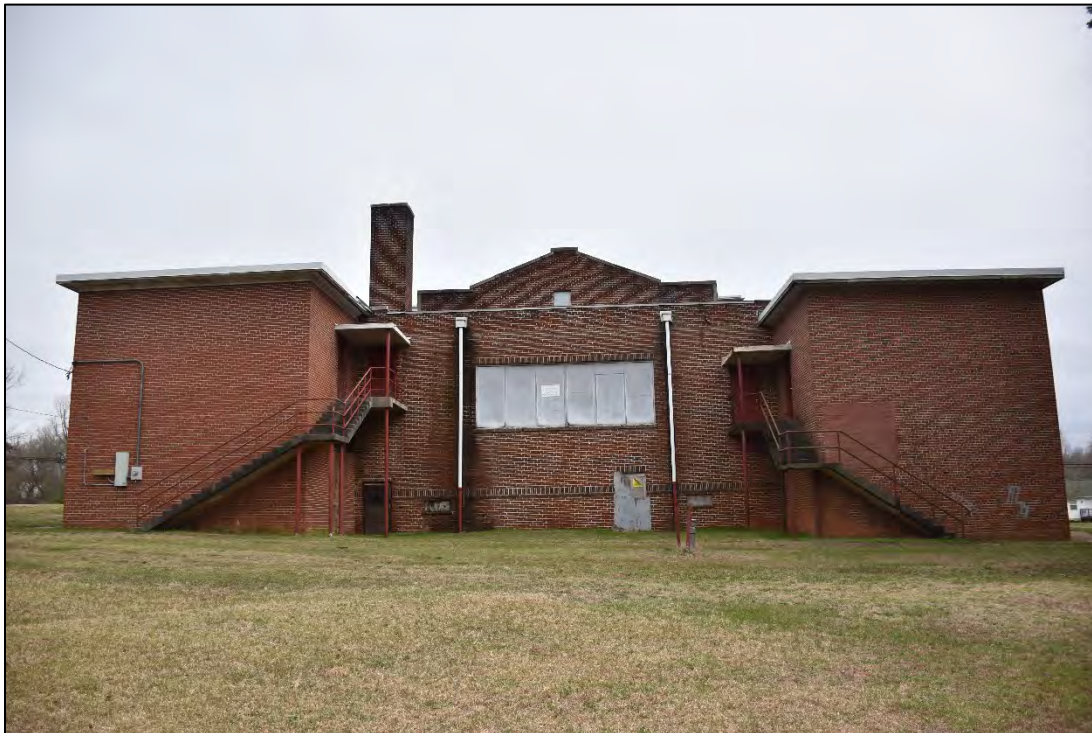
Figure 2.2.32. R. G. Kizer School, facing southeast.

The rear elevation of the school appears symmetrical, with a central one-story section that has a bank of six covered-over windows and the same decorative brickwork along the foundation line as the front sections of the school (Figure 2.2.32). The southwestern addition is mirrored by a two-story, flat-roofed addition at the northwestern corner of the school; both additions are accessed by upper floor doorways that have sets of concrete stairs leading to them. An interior brick chimney rises above the roofline within the single story section. The northwestern addition, like the one on the southwest corner, has a rectangular plan and banks of two and three covered-over windows, as well as a wide roof overhang; however this section of the school was constructed using common bond with Flemish headers (Figure 2.2.33). The north elevation of the school is symmetrical to the south elevation, with the L-shaped section wrapping around from the front elevation and banks of covered-over windows. Above the single story section, on the two-story central portion of the school, there are visible window openings, consisting of multiple-pane, wooden framed windows (Figure 2.2.34). S&ME attempted to gain interior access to the structure but the request was denied.

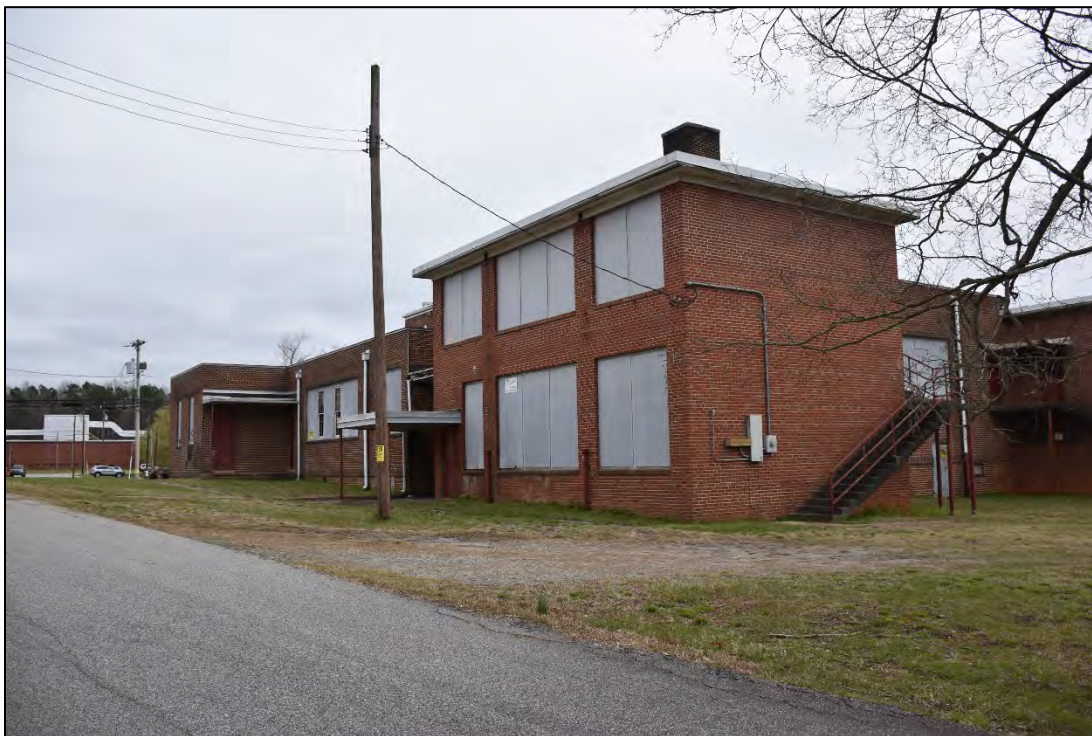
Figure 2.2.33. R. G. Kizer School, facing south.

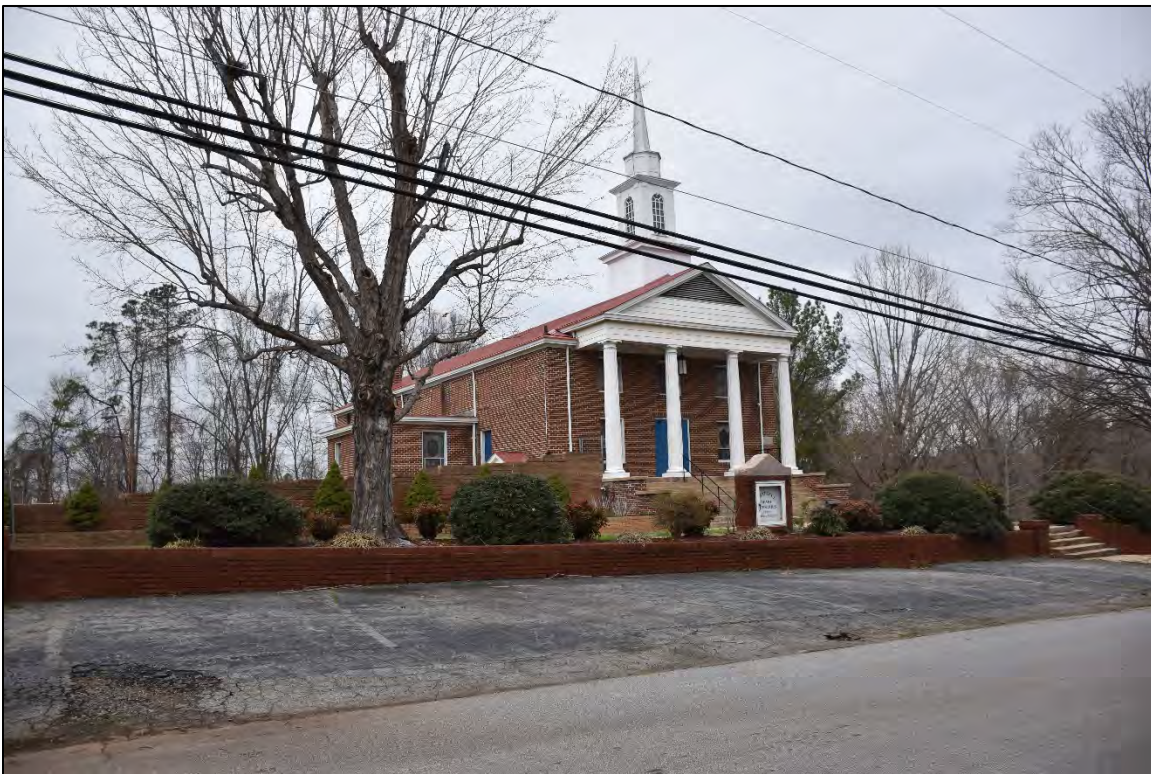
Figure 2.2.48. Rowan Mills Baptist Church (RW2184), facing north.

Rowan Mills Baptist Church (RW2184) is located at 2600 Cottage Street, a side street northwest of US 29, approximately 2.5 miles southwest of the city center of Salisbury, in Rowan County (Figures 1.2 and 1.4). The Rowan Mills Baptist Church was originally surveyed as part of the Rowan Cotton Mill complex (RW0737), in 1980, but little information on the church was included in the survey (Survey File 1980:RW0737). The Rowan Mills Baptist Church is a brick veneer church building with a rectangular plan, set on a raised foundation (Figure 2.2.48). The main block of the church is a two-story, gable-front building that spans three bays wide by eight bays deep. The front gabled façade features a prominent gable-front frame portico, which is supported by four wooden, fluted, Doric columns and is accessed by a set of concrete stairs (Figure 2.2.49). A double doorway is centered in the front elevation, flanked by a single wooden-sash stained glass window on either side; the upper story has three stained glass casement windows. The portico's pediment is sheathed in vinyl siding, as is the frieze above the columns. Centered above the gable is a steeple, set on a square base, of frame construction. The steeple has an octagonal cupola and a spire, along with an arched 19-pane casement window on each side (Figure 2.2.50).

The Rowan Mills Baptist Church is recommended as ineligible for inclusion in the NRHP under Criterion A, as it does not bear a significant association with a particular event or broad pattern of history. While it is a recognizable example of an early-twentieth-century church structure, the most significant association of the building is with the

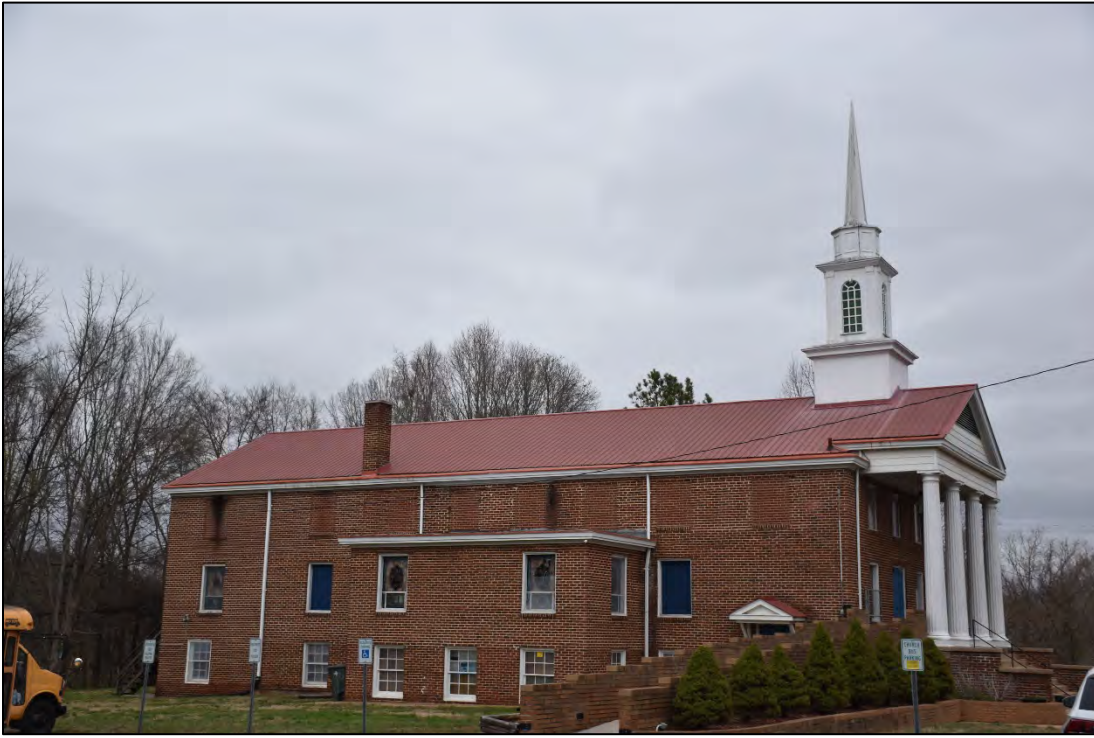
Figure 2.2.54. Rowan Mills Baptist Church, facing northeast.

The north elevation has eight bricked-over window openings on the upper story. The lower story has stained glass windows with wooden frames, although some of them have been covered with wooden panels. The basement story has six-over-six, double-hung, wooden frame windows. There is a single story, three-bay, rectangular addition attached to this elevation; west of the addition, the basement windows have been bricked over (Figure 2.2.51). The rear elevation has a central, six-panel doorway on the basement level, flanked by a single window opening on either side; one has been bricked-over and one has a single six-over-six, double-hung, wooden sash window (Figure 2.2.52). The lower story also has a single six-over-six, double-hung, wooden sash window and a doorway, accessed by a set of wooden stairs. The gable end is covered with vinyl siding. The south elevation of the church is symmetrical to the north elevation, with a three-bay, single story addition, the upper story window openings bricked-over, stained-glass windows on the lower story, and six-over-six, double-hung, wooden sash windows on the basement floor (Figure 2.2.53). The front most bay on the basement story is an entry door, with a pedimented hood supported by brackets (Figure 2.2.54). S&ME attempted to gain interior access to the structure but the request was denied.

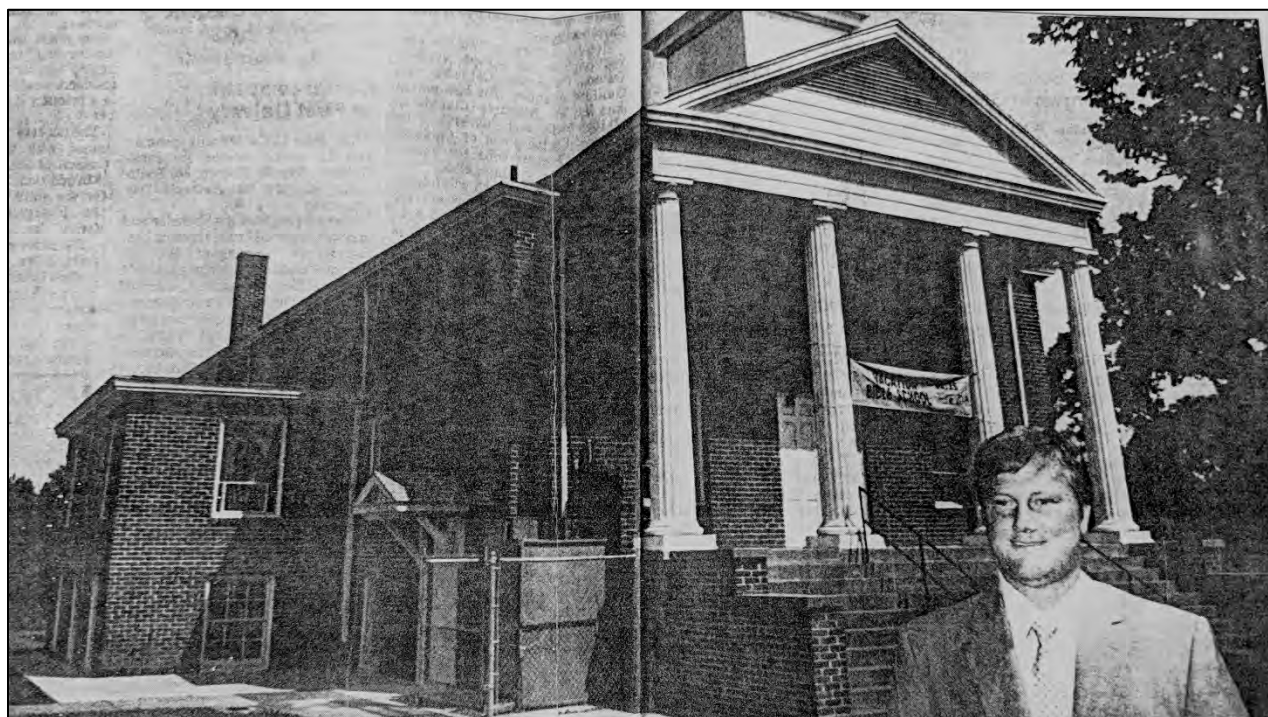
The Rowan Mills Baptist Church (RW2184) was recorded in 1980, as part of the Rowan Cotton Mill complex (RW0737), but little information on the church was included in the survey; the church was depicted on a hand drawn map and a short description noted that “Baptist and Methodist Congregations were organized in the village in 1925” (Survey File 1980:RW0737). The Rowan Mills Baptist Church congregation was organized in 1925, six years after the founding and construction of the mill. Services were originally held in the village school house. The current church building was constructed in 1929, with the first services held there in November of that year (History of the Rowan Mills Baptist Church, 1925–1968, Rowan County Library Files). Aerial photographs from 1948 and 1960 show the location of the church and the surrounding residential structures associated with the mill village (Figures 2.2.55 and 2.2.56). Both the 1948 and 1960 photographs show the Rowan Mills Baptist Church with the same plan as it currently has, including the two side extensions. The basement level of the church was partitioned into rooms for Sunday School between 1957 and 1961 and the interior of the church was completely remodeled, beginning in 1967 (*Salisbury Evening Post* 9 March 1968:3; History of the Rowan Mills Baptist Church, 1925–1968, Rowan County Library Files). The name of the church was changed to Parkdale Baptist Church after the 1950s acquisition of the Rowan Cotton Mill by Parkdale Mills. A 1988 newspaper photograph shows the exterior of the church looking much the same as it currently looks (Figure 2.2.57).

Figure 2.2.57. Photograph (1988) of Rowan Mills Baptist Church.

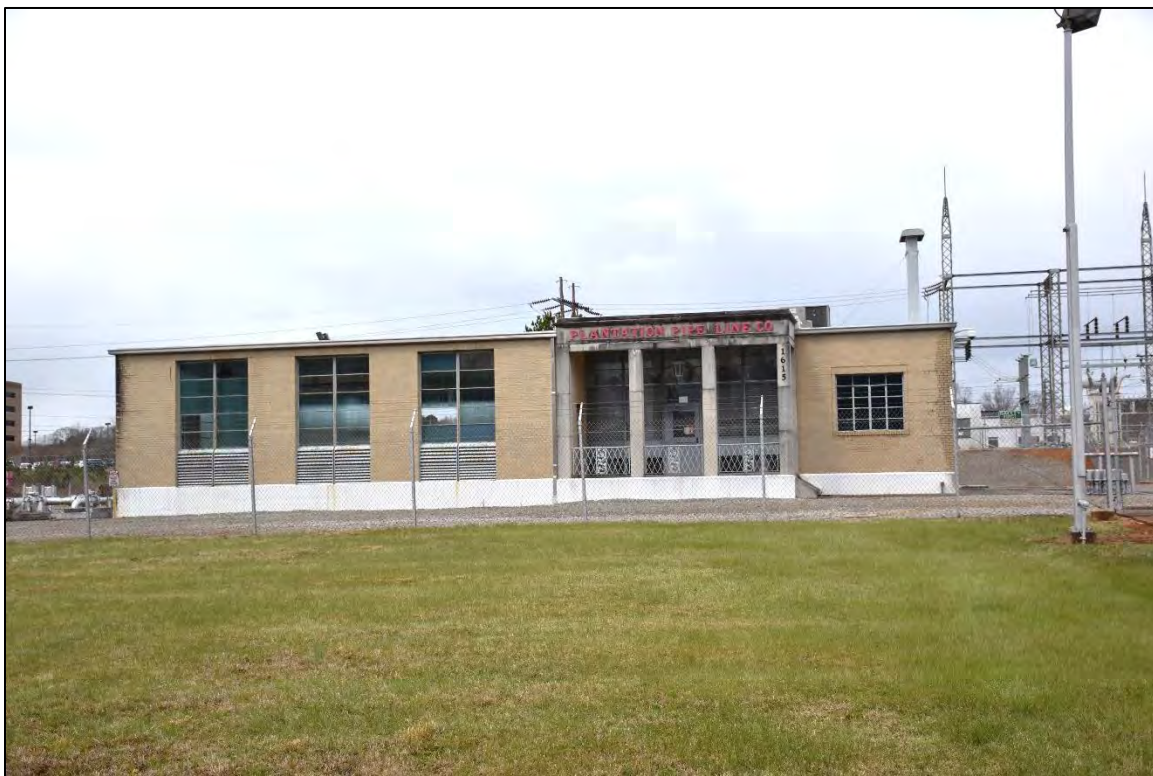
Figure 2.3.1. Plantation Pipe Line Pumping Station (RW2185), facing north.

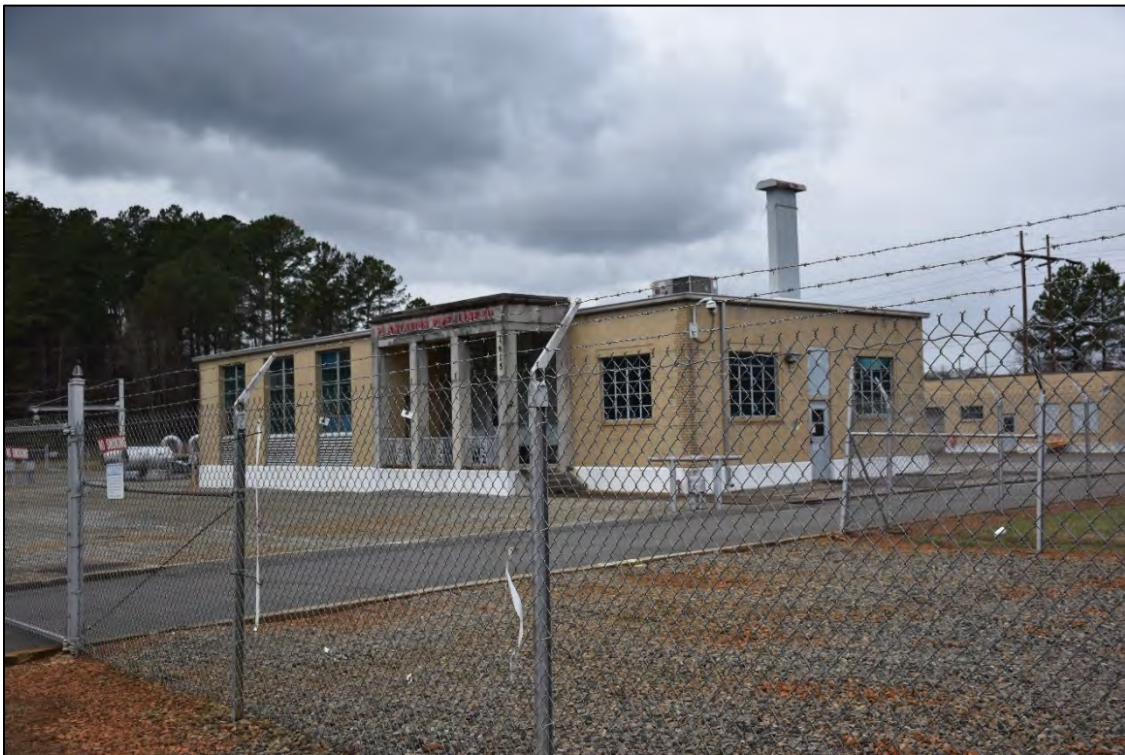
Figure 2.3.2. Plantation Pipe Line Pumping Station, facing northwest.

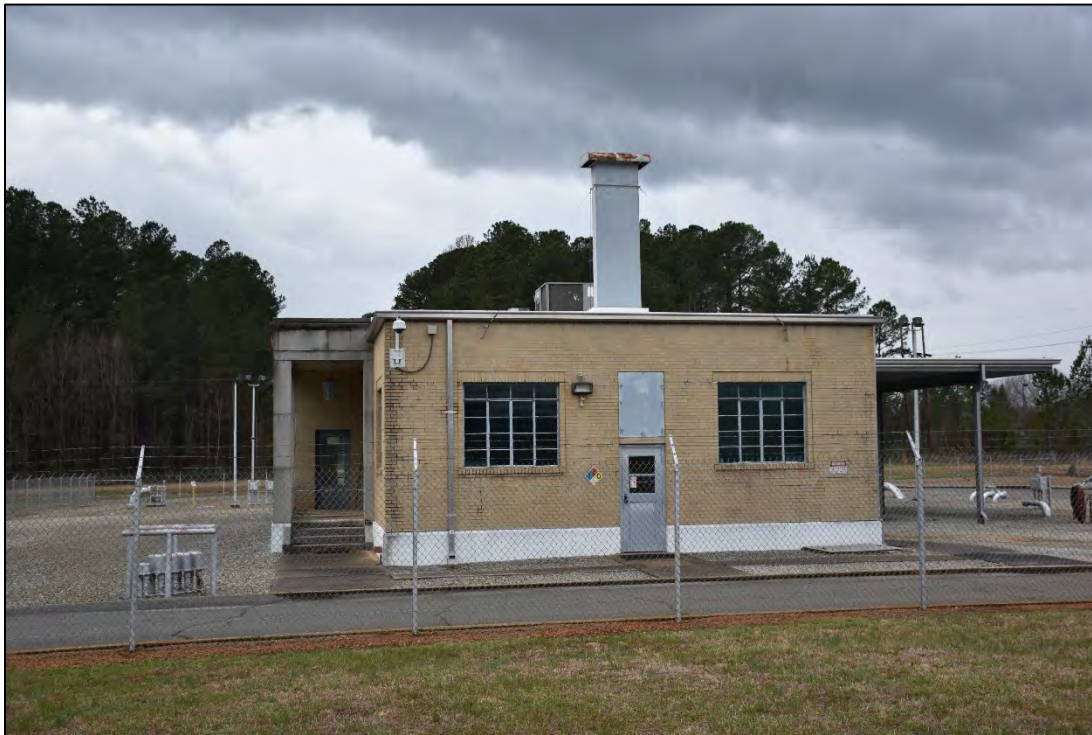
Figure 2.3.3. Plantation Pipe Line Pumping Station, facing west.

The east elevation of the building is symmetrical, with a central doorway, flanked by a twenty-pane metal-frame window on either side (Figure 2.3.3). A large, interior, metal chimney projects above the roofline in the center of this elevation. The rear of the structure has a projection of the roof that creates a covered area off of the northwest corner, which is open to the outside behind a small concrete wall (Figures 2.3.4 and 2.3.5). The eastern portion of the building is enclosed and has three clerestory window openings with a brick sill beneath them; two of the openings have been bricked in, but the remaining window is a four-pane, metal-frame window. A modern, metal, garage-style door has been added to this section of the building. The western elevation of the structure has three, evenly spaced, tall windows, each having fourteen-panes and metal framing (Figures 2.3.6 and 2.3.7). The building is situated on a gravel lot, with visible pumping machinery to the west, and the complex is surrounded by a chain-link and barbed-wire fence (Figure 2.3.8). S&ME attempted to gain interior access to the pumping station but the request was denied.

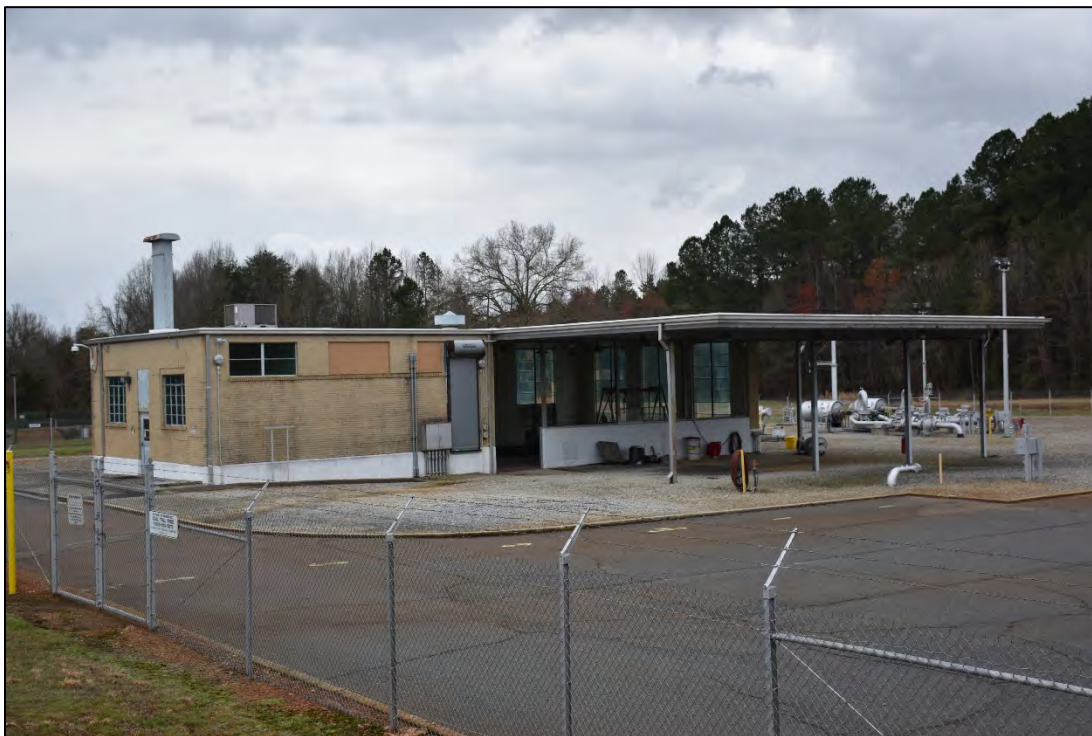
Figure 2.3.4. Plantation Pipe Line Pumping Station, facing southwest.

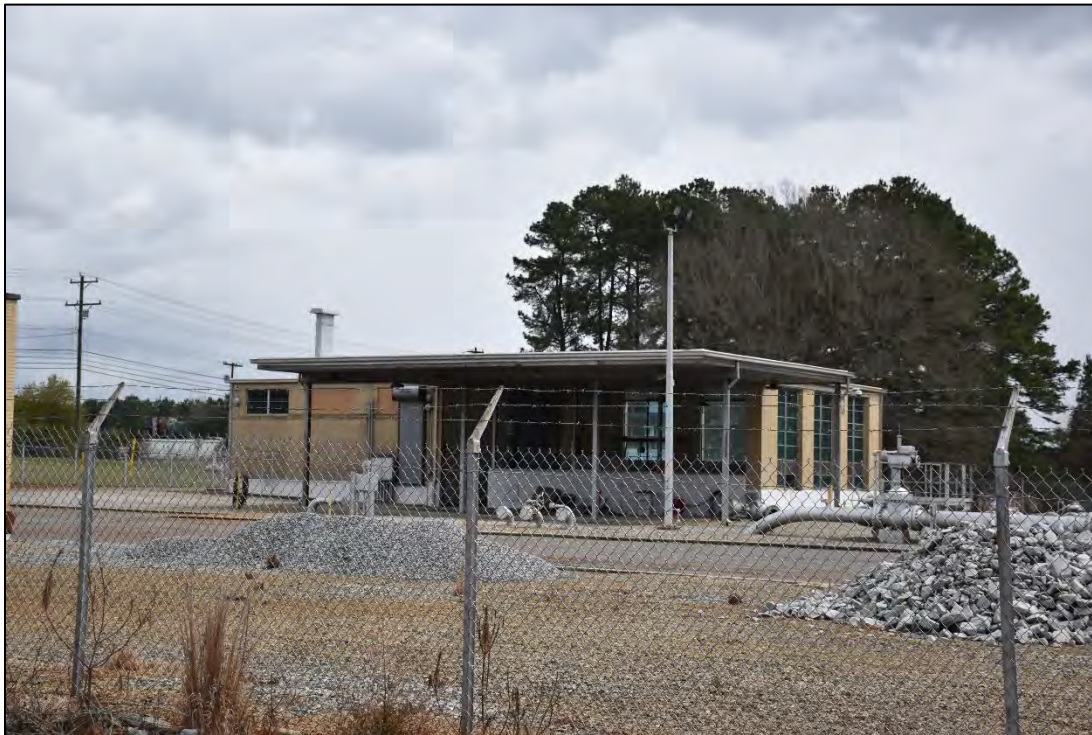
Figure 2.3.5. Plantation Pipe Line Pumping Station, facing south.

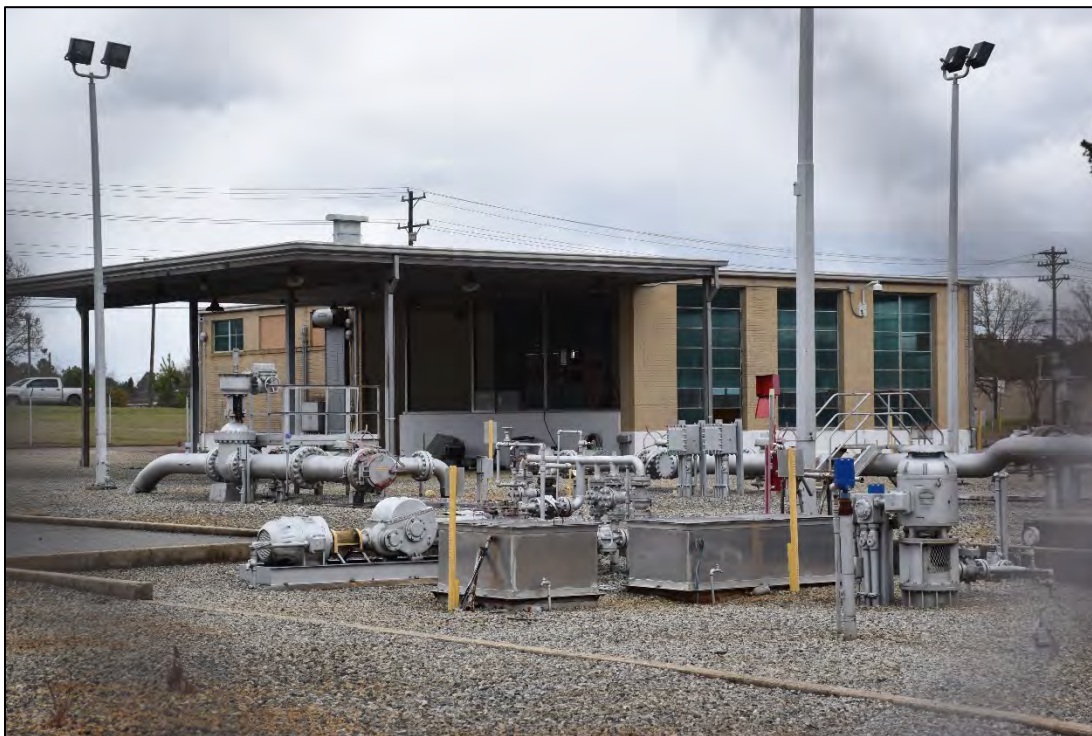
Figure 2.3.6. Plantation Pipe Line Pumping Station, facing southeast.
