SUBJECT: Historic Structures Survey Report, Build on New Location, Airport Parkway from
SR1710 to US 70/US 601 to SR 2539 at US 29, U-5901, PA 17-08-0002,
Rowan County, ER 17-2008

The North Carolina Department of Transportation (NCDOT) proposes to build on a new location Airport Parkway. S&ME prepared the attached Eligibility Report and recommends one of the properties surveyed eligible for the National Register of Historic Places, the Plantation Pipeline Pumping Station (RW2185).

On behalf of the NCDOT, S&ME has completed a historic architectural analysis of seven resources located within the project area for the construction on a new location of Airport Parkway, from SR 1710 (Harrison Road) at US 70/US 601 to SR 2539 (Peach Orchard Road) at US 29 in Rowan County (TIP No. U-5901, WBS No. 44705.1.1, PA No. 17-08-0002) (Figures 1.1 and 1.2). Work was conducted in general accordance with the agreed-upon scope, terms, and conditions presented in the Proposal No. 42-1800186, dated February 16, 2018.

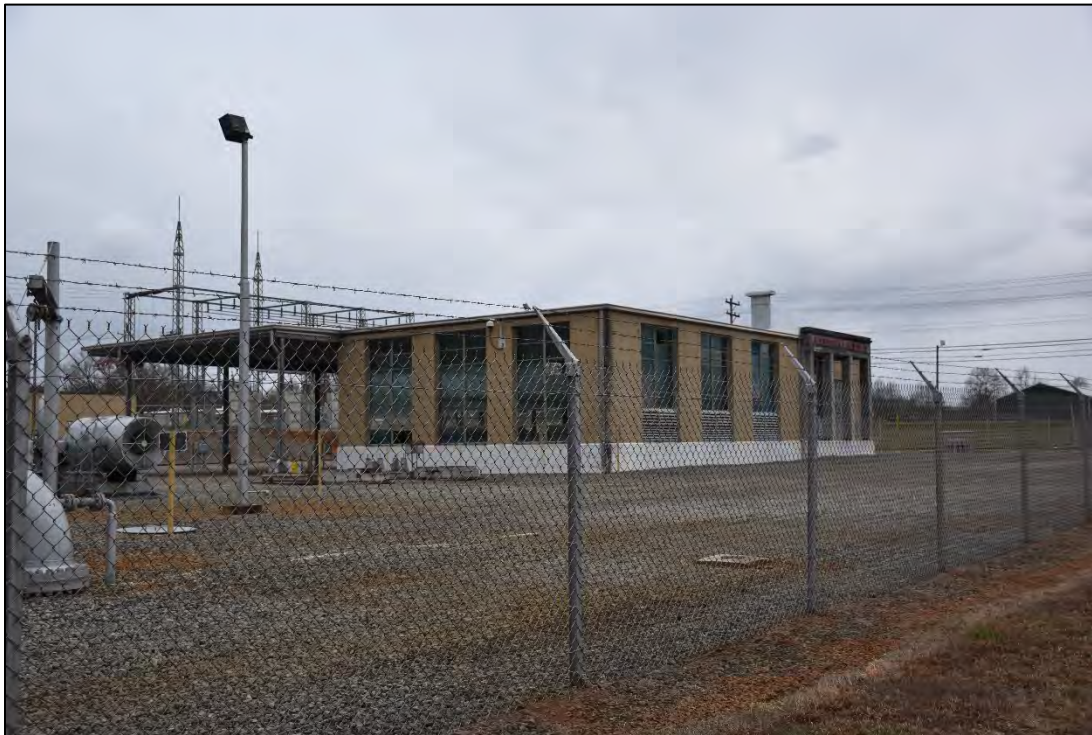
Figure 2.3.7. Plantation Pipe Line Pumping Station, facing northwest.

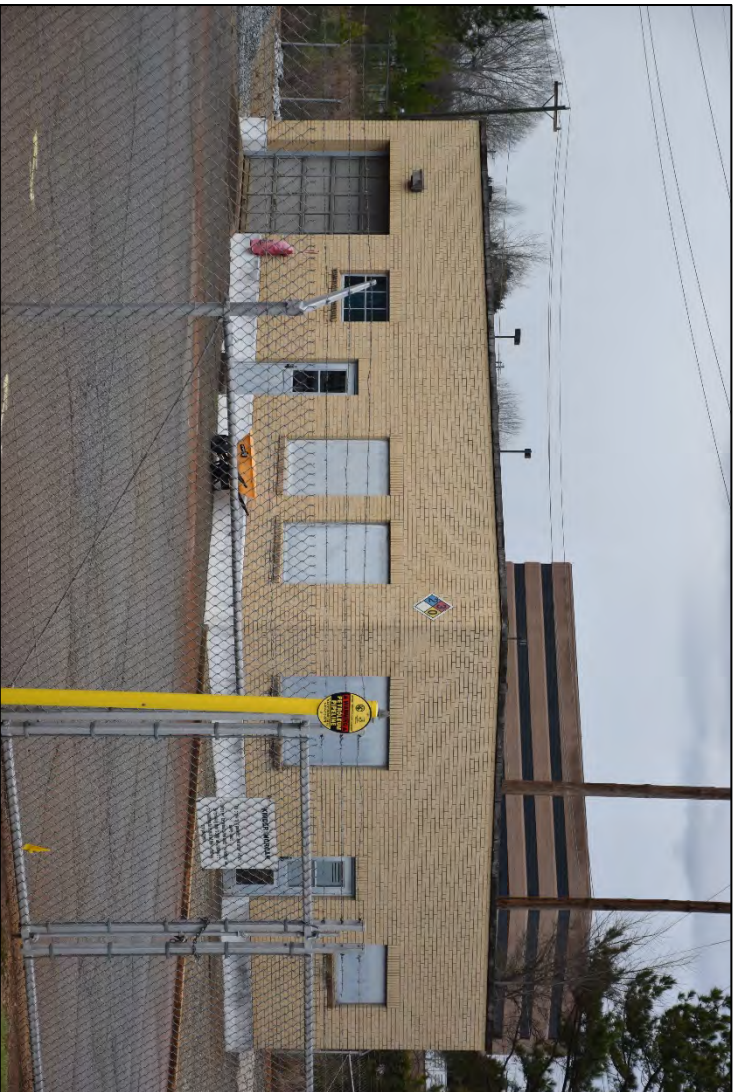
Figure 2.3.9. Plantation Pipe Line Pumping Station, storage building, facing northwest.

North of the main structure, is a single story storage building, constructed in a similar style to the pumping station. It is rectangular in plan, with a flat-roof, buff brick veneer exterior, and contrasting concrete foundation (Figure 2.3.9). The front elevation has a single garage-door bay, a six-pane horizontal metal-frame window, an entry door, and two window openings that have been covered with metal sheeting. The east elevation also has two window openings that have been covered with metal, as well as a metal entry door, while the west elevation has four six-pane horizontal metal-frame windows (Figure 2.3.10).

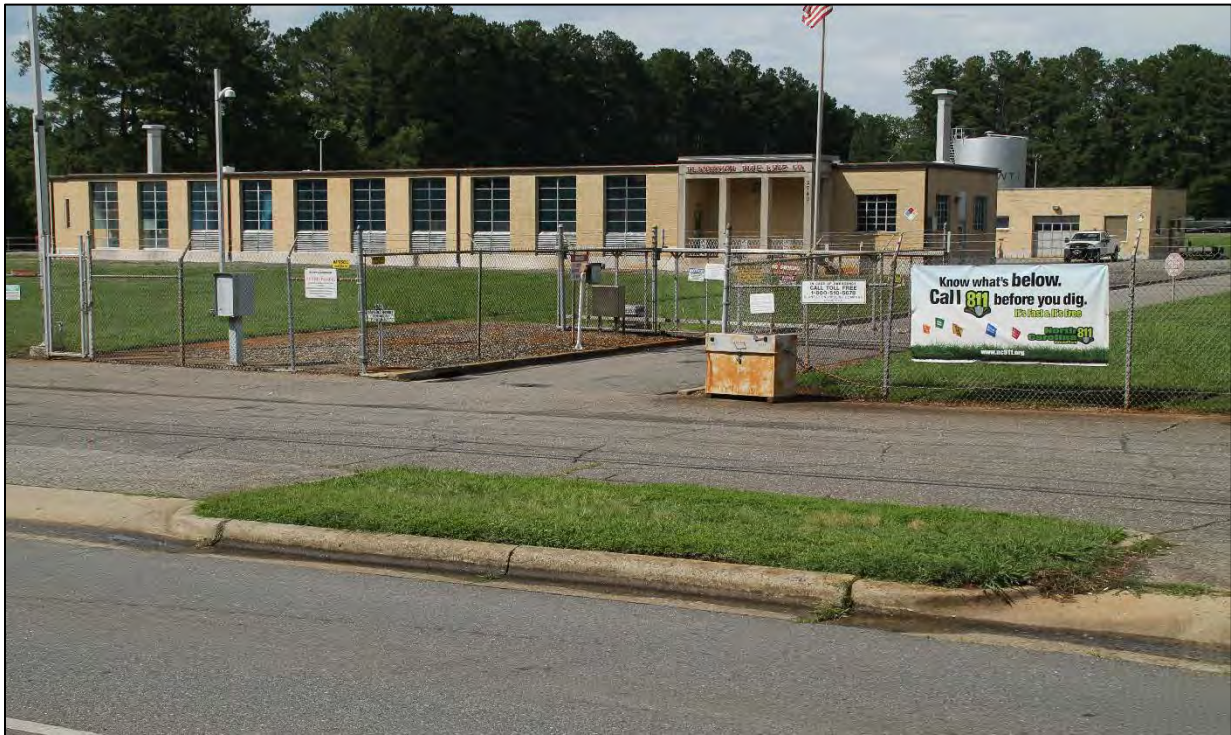
Figure 2.3.15. Plantation Pipe Line Pumping Station in Lowell (NSN), facing northeast.

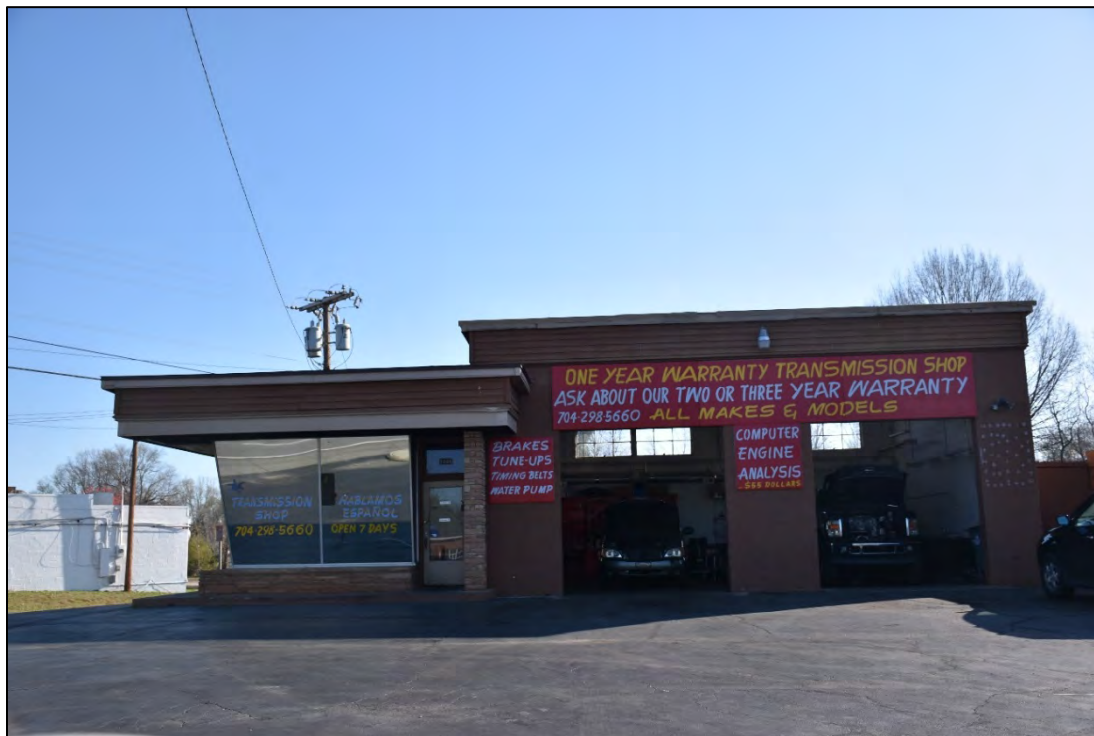
Figure 2.3.16. Gas station (RW1647), facing northeast.

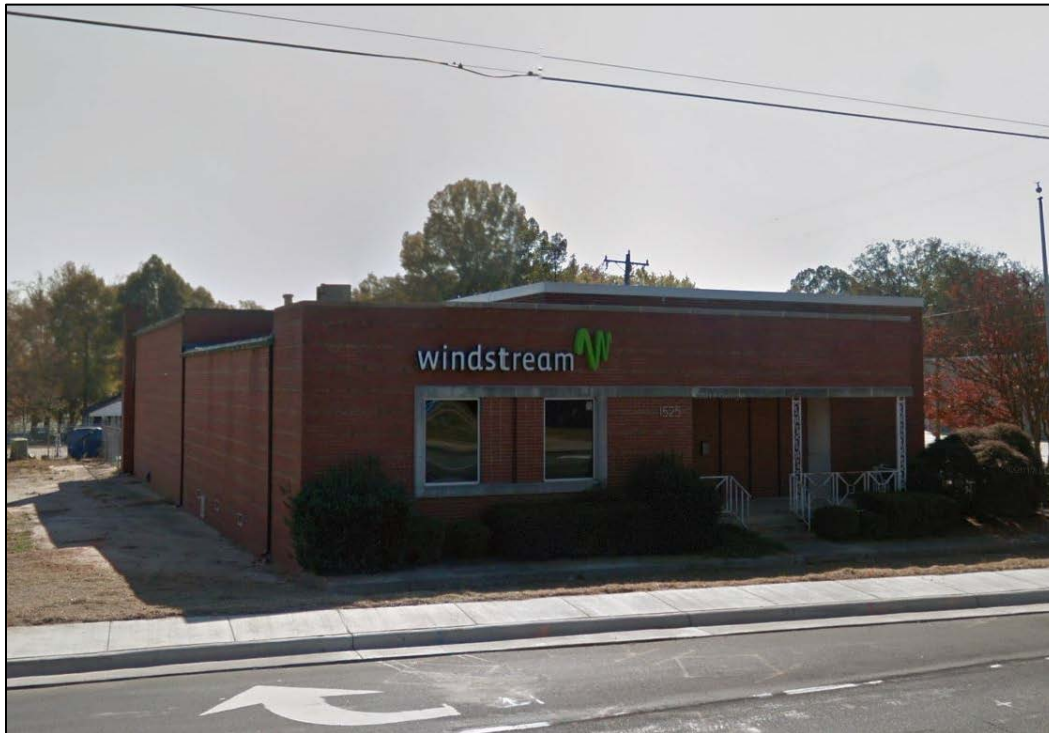
Figure 2.3.17. Concord Telephone Company Building (RW1672), facing north.

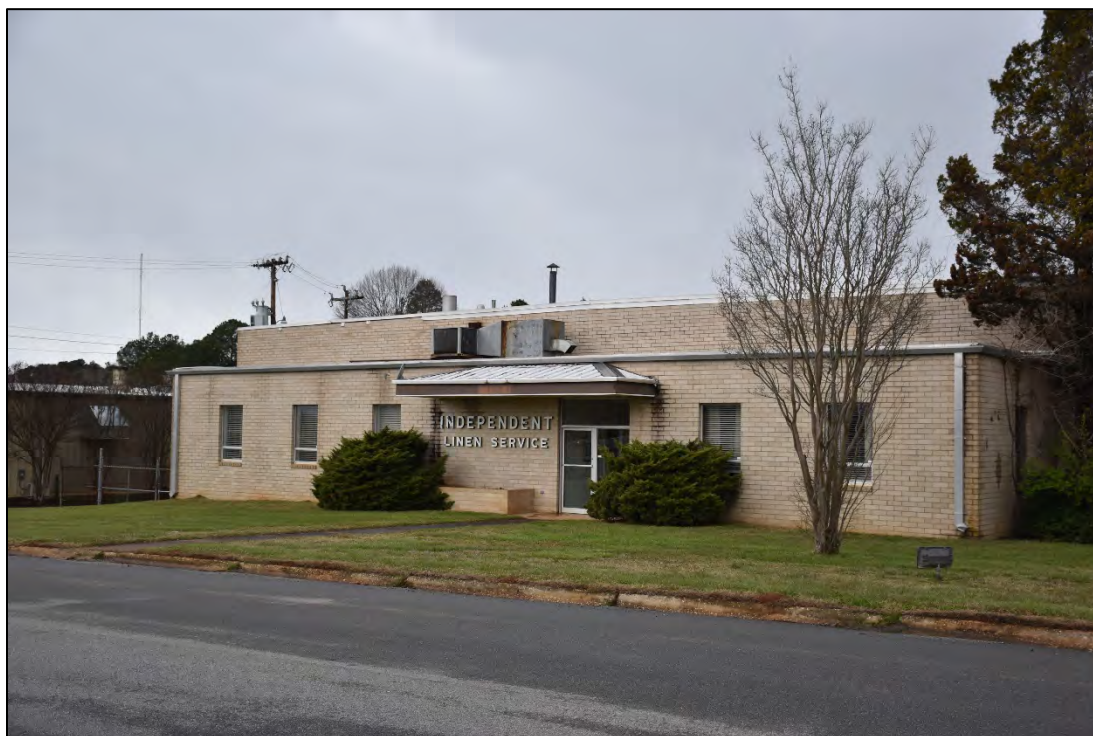
Figure 2.3.18. Independent Linen Service building (NSN), facing north.

A windshield survey of the surrounding area revealed additional structures, which are not recorded in the statewide survey database, that have similar architectural forms and elements as the Plantation Pipe Line Pumping Station. The Independent Linen Service building, located at 640 Industrial Avenue, Salisbury, is constructed of the same buff-brick as the pumping station, with similar horizontal lines, flat-roof, and modernist styling (Figure 2.3.18). However, this commercial structure has less architectural detailing than the pumping station and has modern replacement windows on its front façade. The Salisbury Masonic Temple, at 401 North Fulton Street, is a multi-story structure with a front elevation that has similar modernist elements to the pumping station, including a concrete-framed recessed entryway (Figure 2.3.19). However, the Masonic Lodge is larger, more prominent structure with a vertical component, as well as the horizontal lines that the pumping station exhibits.

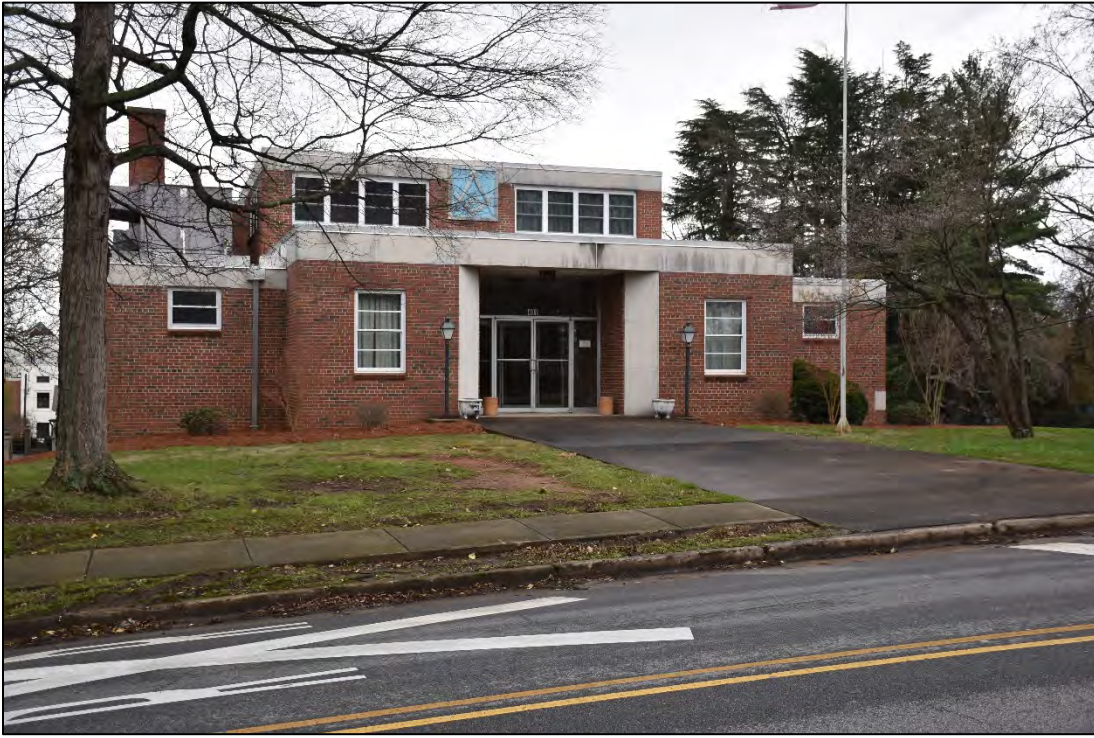
Figure 2.3.19. Salisbury Masonic Temple (NSN), facing northeast.

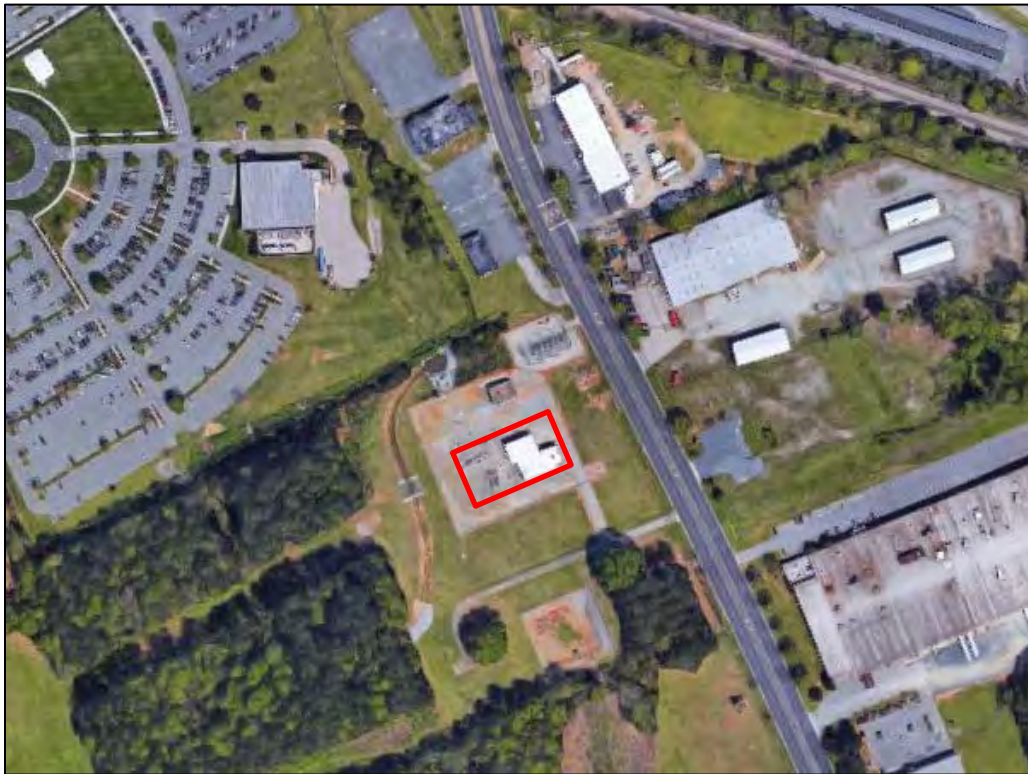
Figure 2.3.20. NRHP boundary for the Plantation Pipe Line Pumping Station.

The National Register boundary for the Plantation Pipe Line Pumping Station includes the structure itself and the associated equipment (Figure 2.3.20). The significance of the Pumping Station is in the architecture of the building and the association of the station with World War II and the domestic war economy; the building and equipment contribute to this significance but the surrounding parcel does not.
