RE: Historic Structures Survey Report for Widening SR 1547 from SR 3106 to
I-85, U-5308, Randolph County, ER 17-2013

Historic Structure Report
TIP No. U-5308, WBS No. 47028.1.2
Widen SR 1547 (Finch Farm Road) from
SR 3106 (Kennedy Road) to I-85
Randolph County, North Carolina
S&ME Project No. 4213-17-245

2.1 Underwood Farm (RD0930)

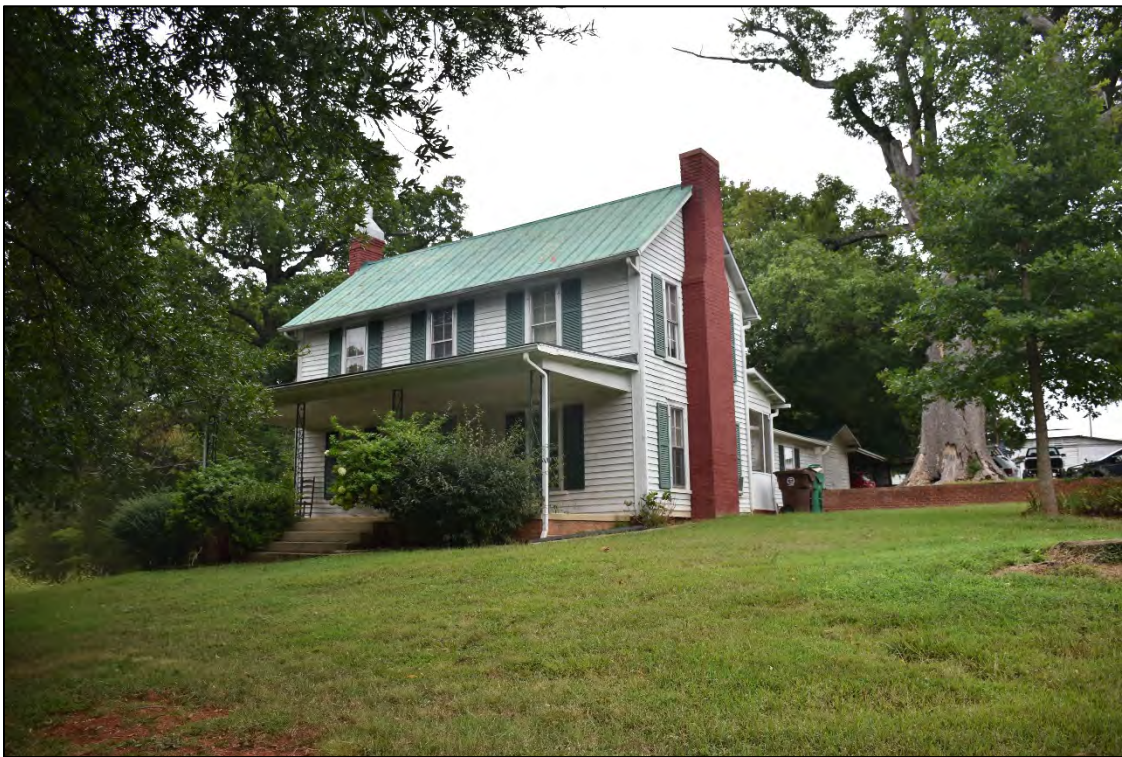
Figure 2.1.1. View of the Underwood Farm, circa-1880 house, facing north.

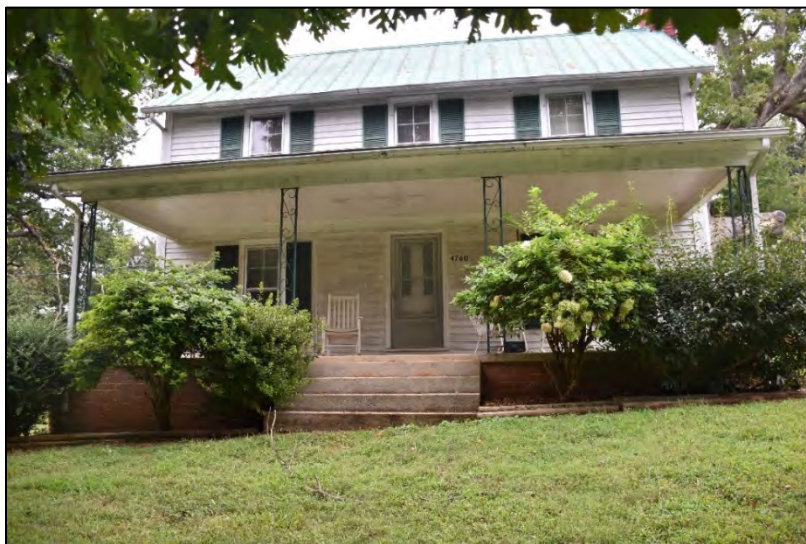
The circa-1880 Underwood House is a two-story, single-pile, frame dwelling, with a two-story rear-ell, as well as later additions. The front elevation is three bays wide and rests on a brick pier foundation that has been infilled (Figure 2.1.1). It has an original central door, with two arched upper window panels and two rectangular lower panels, flanked by a single four-over-four, double-hung wooden sash window with exterior metal storm windows on either side; the upper story has three evenly spaced four-over-four, double-hung wooden sash windows (Figure 2.1.5). The flat-roofed porch, which spans the width of the front elevation, is supported by decorative metal posts that are replacements for original porch supports; the foundation of the porch is newer brick than the house foundation and the floor and stairs are both concrete, suggesting that it is a mid-twentieth-century alteration. Each side elevation of the original I-house has an exterior, brick chimney, between single four-over-four, double-hung wooden sash windows on both the first and second stories (Figures 2.1.6 and 2.1.7). The gable ends have a moderate eave overhang, with an open cornice and decorative exposed roof beams; a simple, wide, raking frieze meets the corner trim of the house.

Figure 2.1.5. Underwood House, circa-1880, front elevation, facing northeast.

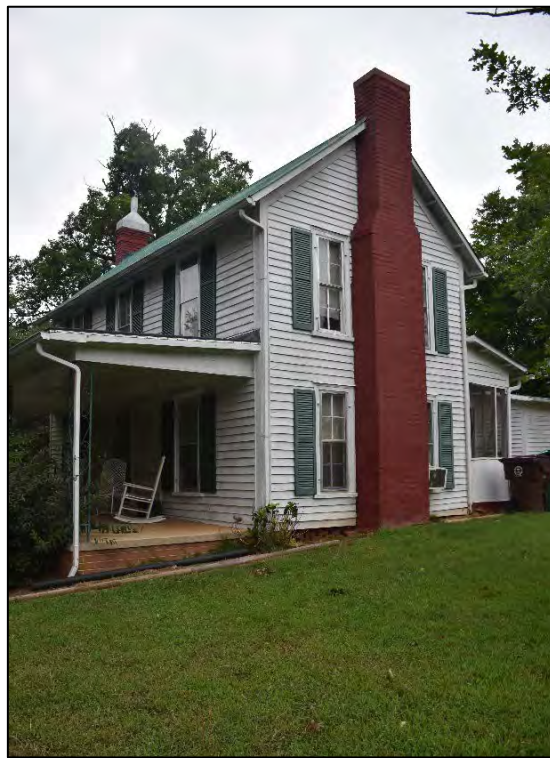
Figure 2.1.6. Underwood House, circa-1880, oblique view, facing north.

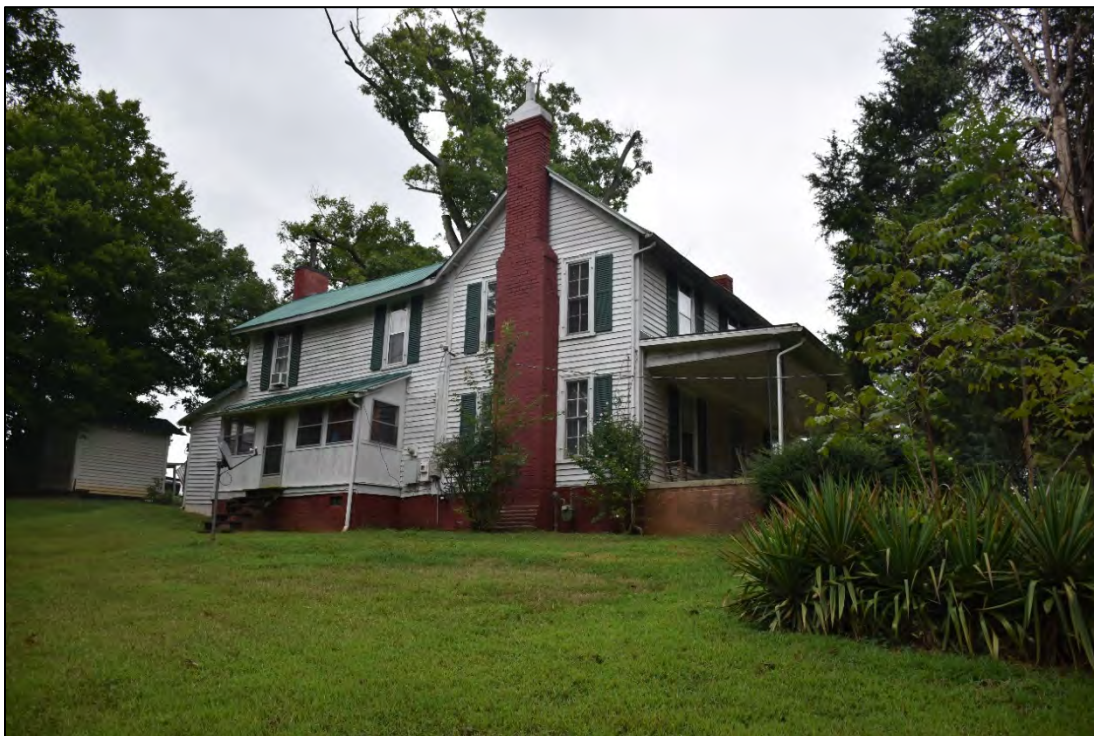
Figure 2.1.7. Underwood House, circa-1880, oblique view, facing southeast.

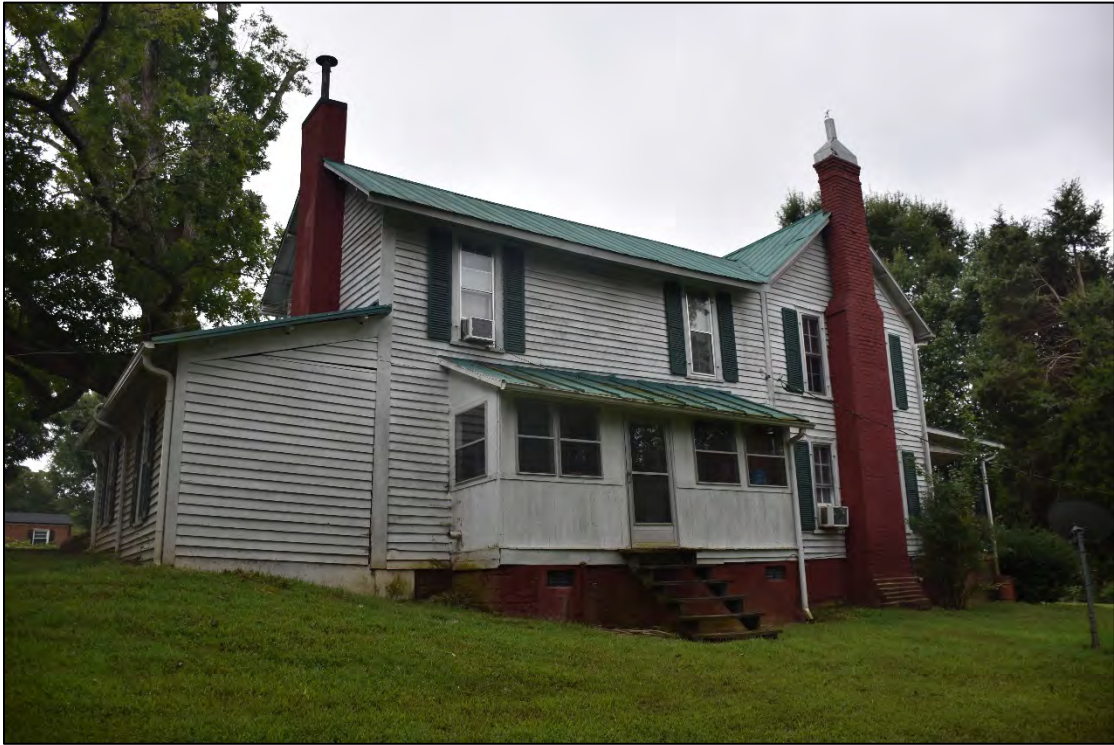
The rear ell portion of the structure is two bays long by two bays deep, with an exterior chimney that has been covered in stucco along the east elevation (Figure 2.1.8). The lower story of the north elevation has a shed-roofed porch structure, which has been enclosed using plywood, beadboard, and one-over-one, double-hung, metal sash windows; the structure sits on an infilled brick pier foundation that appears to date to the same period as the foundation of the rear ell, suggesting that this was an early porch structure that was enclosed during the mid-twentieth century. A single-story, shed-roofed addition has been attached to the east elevation of the rear-ell; it retains the raking frieze, exposed roof beams, and four-over-four, double-hung, wooden sash window of the I-house and rear-ell (Figure 2.1.9). In the early-twentieth century, this shed-roofed addition was continued with a hipped roof section, which wraps around the rear-ell and attaches to the enclosed rear porch on the south elevation; this small addition has a different roof structure than the earlier addition and also has six-over-six, double-hung, wooden sash windows and rests on a concrete foundation (Figure 2.1.10). The south elevation of the house has a shed-roofed porch that is inset between the front section of the house and the rear ell (Figure 2.1.11); the roof structure is similar to the original portion of the house, with exposed beams and raking frieze band, suggesting that it was an early rear porch that was later enclosed, using beadboard and screening.

Figure 2.1.8. Underwood House, circa-1880, north elevation, facing southwest.

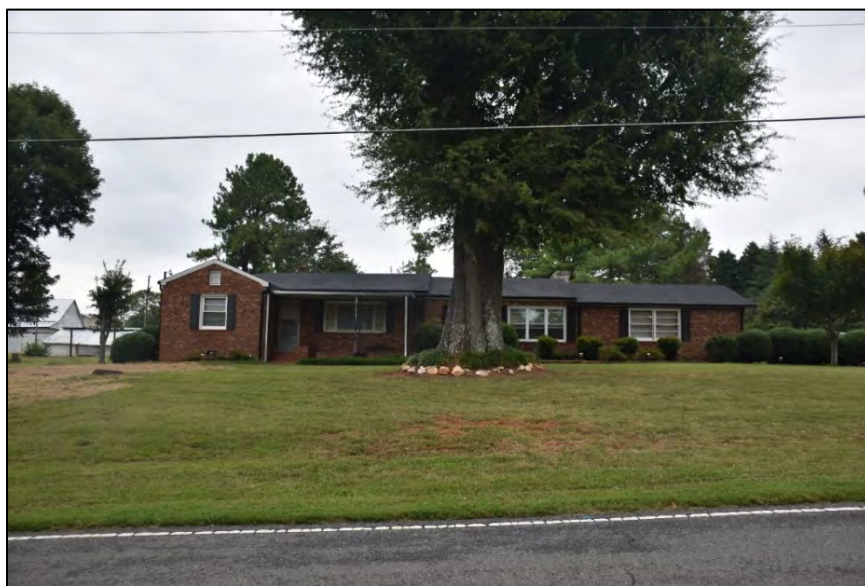
South of the circa-1880 Underwood House, also along Finch Farm Road, is a second residence, the D. S. Underwood House, dating to approximately 1950. This ranch dwelling is a single story, frame residence with a brick veneer exterior and gabled roofline (Figure 2.1.12). The long, low profile of the house, under a laterally gabled roof, with the small cluster of rooms forming a cross-gable at the northern end, along with the integrated side garage, are hallmarks of Ranch-style architecture, which became popular along the east coast in the 1940s through the 1970s. The front entry door is inset within the intersection of the front and side-gabled sections, beneath a flat-roofed porch that is supported by decorative metal posts (Figure 2.1.13). There are multiple window types on the home, including single and paired two-over-two, double-hung, metal sash windows, a triple one-over-one, double-hung, metal sash window, and a tripartite picture window; the windows close to the corner of the rear of the front-gabled section are also common in early Ranch house architecture (Figure 2.1.14). At the rear of the house, a flat-roofed sun porch mirrors the front porch, but includes a brick half-wall and a full windowed upper section (Figure 2.1.15). A small interior chimney is visible at the junction of the side-gabled and front-gabled sections, while a more prominent chimney rises above where the main house meets the garage. A flat-roofed carport has been added to the rear of the structure. The house is set back from the road and integrated into the topography of the land, with the side-gabled roofline stepping down to follow the elevation of the lot; the front yard of the house is open, although a large tree that predates the house remains, and there are foundation plantings along the front elevation which helps tie the house into the landscape. These landscape characteristics are also elements of the mid-twentieth-century Ranch house design.

Figure 2.1.12. D. S. Underwood House, circa-1950, front elevation, facing east.

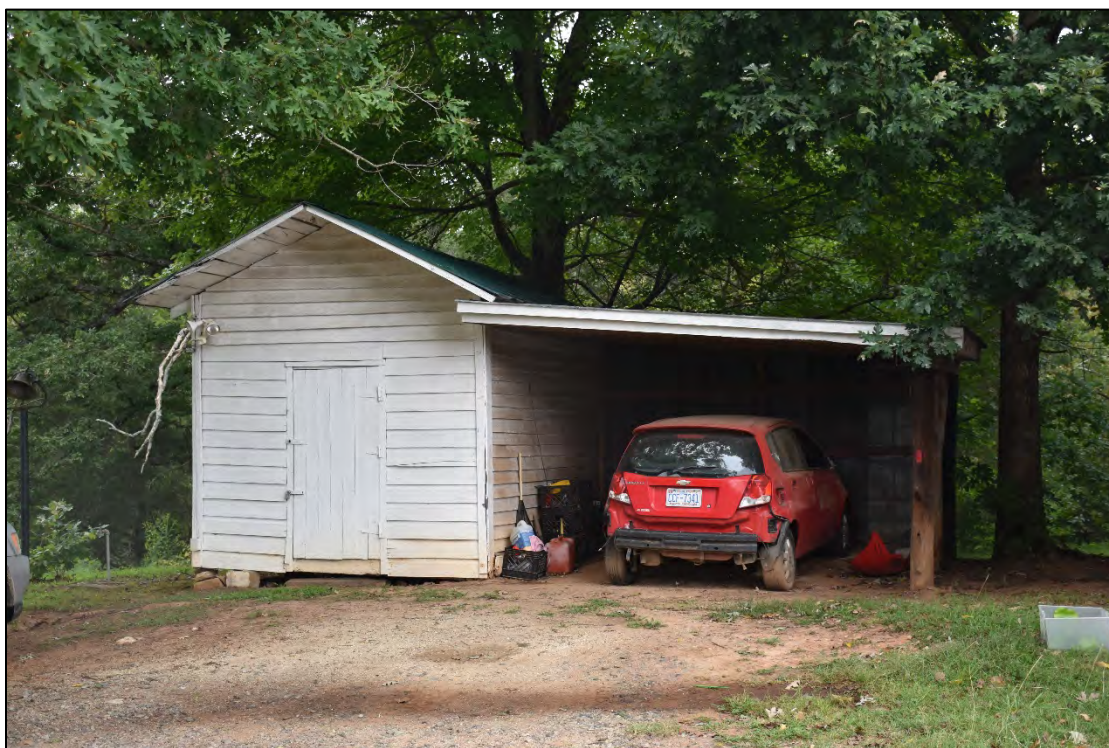
Figure 2.1.16. View of circa-1930 shed, Underwood Farm, facing north.

Along a private, gravel farm road, located between the circa-1880 Underwood House and the circa-1950 D. S. Underwood House, there are multiple domestic and agricultural outbuildings (Figure 2.1.3). North of the farm road, directly behind the circa-1880 Underwood House is a circa-1930 frame shed (Figure 2.1.16). The shed has a front-gabled roof and rests on a stacked stone pier foundation, which has been augmented with concrete block; the exterior of the shed is covered with wooden weatherboard siding and the roof is standing-seam metal. The roof has a wide overhang in the front, where there is a single, central entry door; there are visible rafter tails at the sides of the roof (Figure 2.1.17). To the east, there is a shed-roofed carport addition that is supported by rough-hewn wooden timbers used as posts. East and northeast of the shed are two open storage areas, dating from around the 1930s through the 1950s (Figure 2.1.3). The open storage structure closest to the farm road appears to date from the mid-twentieth century. It has six square wooden posts as supports and a flat roof, covered with standing seam metal (Figure 2.1.18). The northern wall of the structure is enclosed with sheet metal, but the remainder of the structure is open. To the northeast, set back from the farm road, is an older open storage building (Figure 2.1.19). The structure has a flat roof, with visible rafters, which is supported by rough-hewn wooden timbers used as posts; the roof is covered with standing-seam metal. The rear bay of the structure has been partially enclosed, with sheet metal in the front and plywood in the rear. A small, shed-roofed extension off of the rear of the structure appears to be used for firewood storage, while the remainder of the structure stores various mechanical farm equipment.

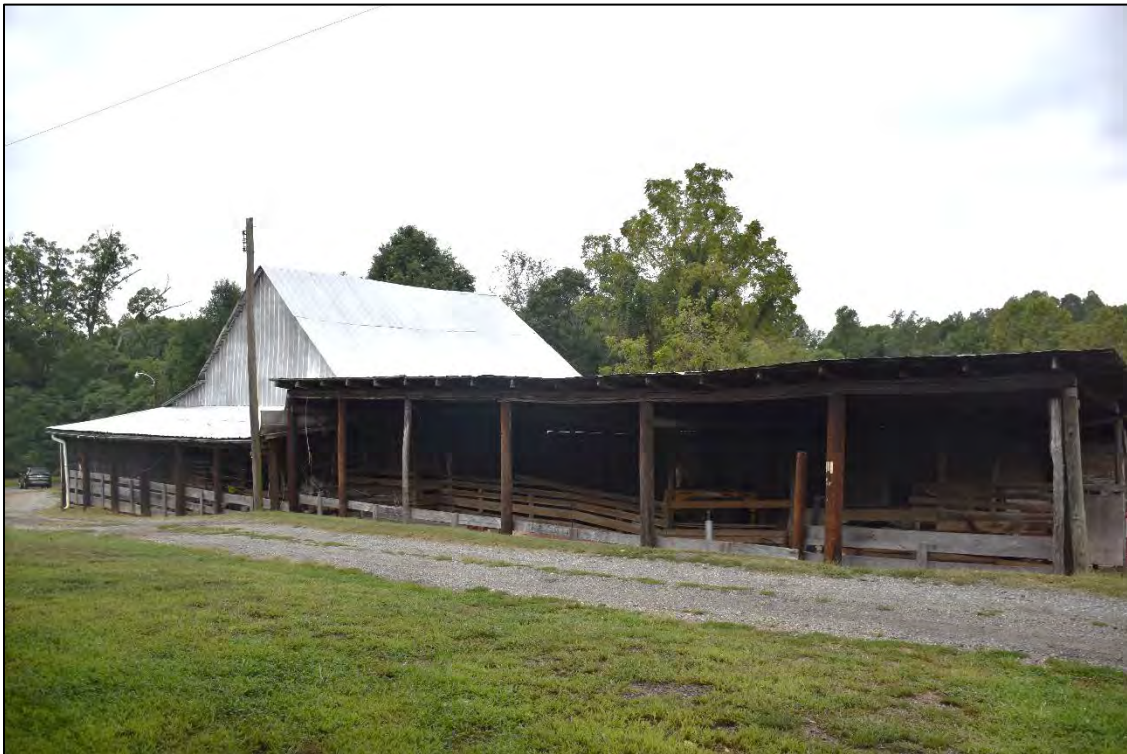
Also north of the gravel farm road is a barn and poultry house complex that has been connected through multiple building periods (Figures 2.1.3 and 2.1.20). The barn comprises the western section of this complex; it is a large, frame, gabled structure that sits on a stacked stone foundation that has been augmented with bricks and concrete block (Figure 2.1.21). The barn appears to be the oldest structure in the complex and dates to around 1900. The tall central gabled section has a shed-roofed extension on either side, creating a three-bay barn (Figure 2.1.22). A shed-roofed front extension, supported by rough-hewn timber posts, spans the front elevation of the barn. The exterior of the barn is covered with sheet metal panels, primarily in the front and on portions of the sides, and horizontal wooden siding, mostly on the back and on the remaining portions of the sides. The roof of the entire structure is covered with standing-seam metal.

Figure 2.1.20. View of early to mid-twentieth-century barn complex, Underwood Farm, facing west.

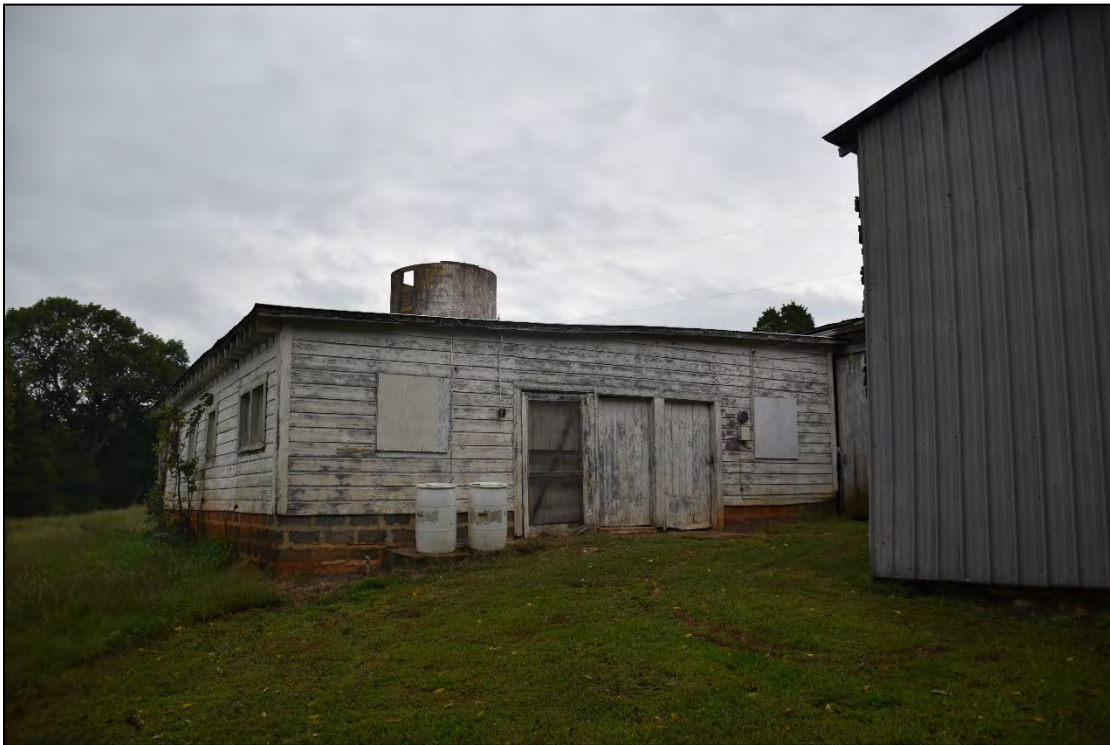
To the northeast of the barn, set slightly back from the farm road, is a flat-roofed, frame poultry house, which rests on a clay block foundation (Figure 2.1.23). This poultry house likely dates to around the 1920s. There are six-pane, wooden sash windows on each elevation of the building (Figure 2.1.24); on the east and west elevations there is a central doorway. The roof of the poultry house has exposed rafter tails and is covered with standing-seam metal. Attached to the front (south) elevation of the poultry house, along the farm road, is an open wooden structure that may have been used as an animal corral (Figure 2.1.25). This structure, which likely dates to the 1950s, has a pent roof that follows the slope of the land to attach to the poultry house, which sits on a lower elevation. The roof, which is standing-seam metal, has exposed rafters and is supported by rough-hewn timber posts. This mid-twentieth-century structure also connects the poultry house to the barn, creating a single complex. East of the poultry house is a circa-1920 tile silo, which was probably built at the same time as the poultry house (Figures 2.1.26 and 2.1.27).

Figure 2.1.23. View of circa-1920 poultry house, Underwood Farm, facing east.

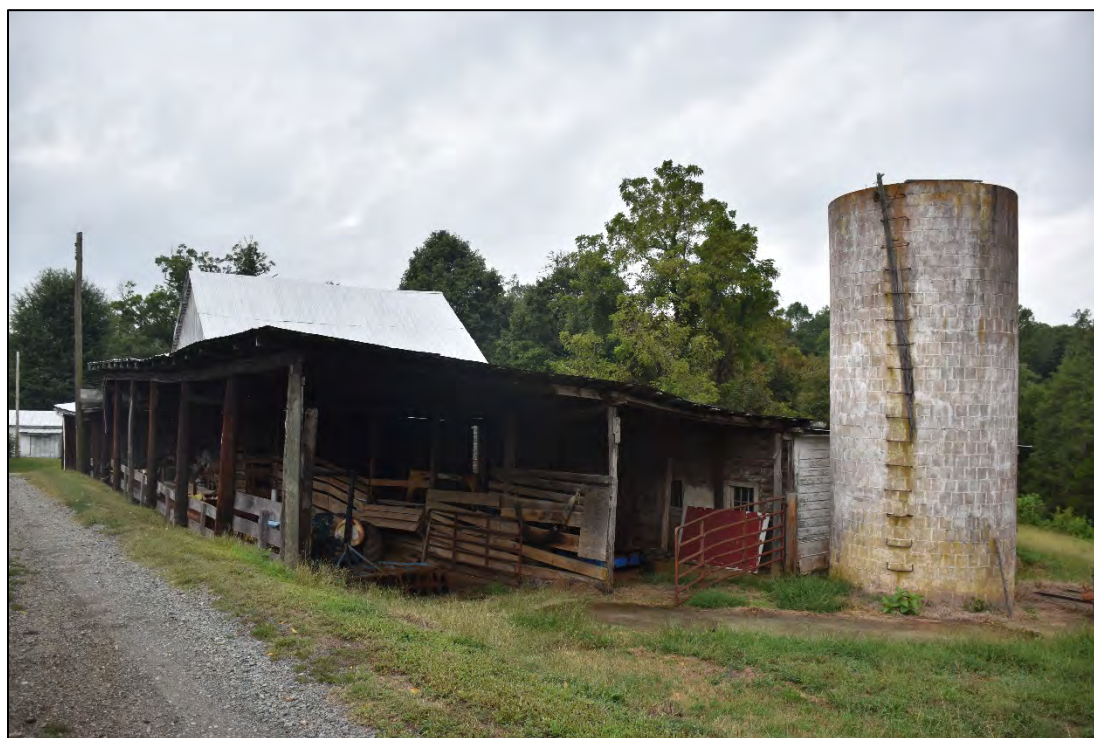
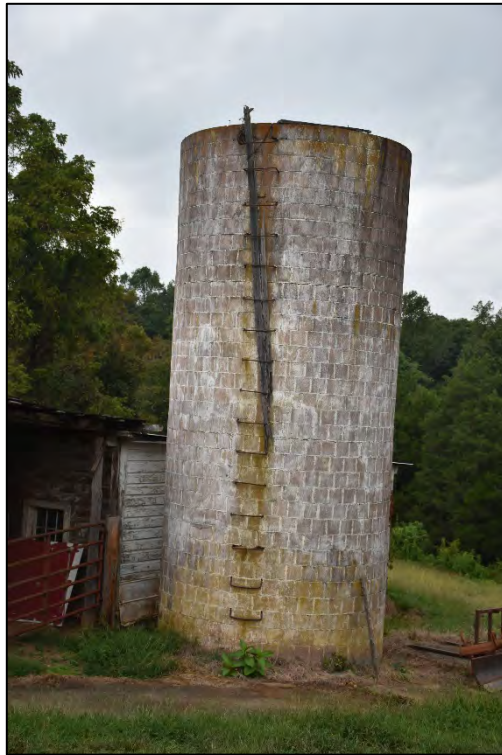
Figure 2.1.26. View of circa-1920 silo, Underwood Farm, facing northwest.

Figure 2.1.27. View of circa-1920 silo, Underwood Farm, facing north.

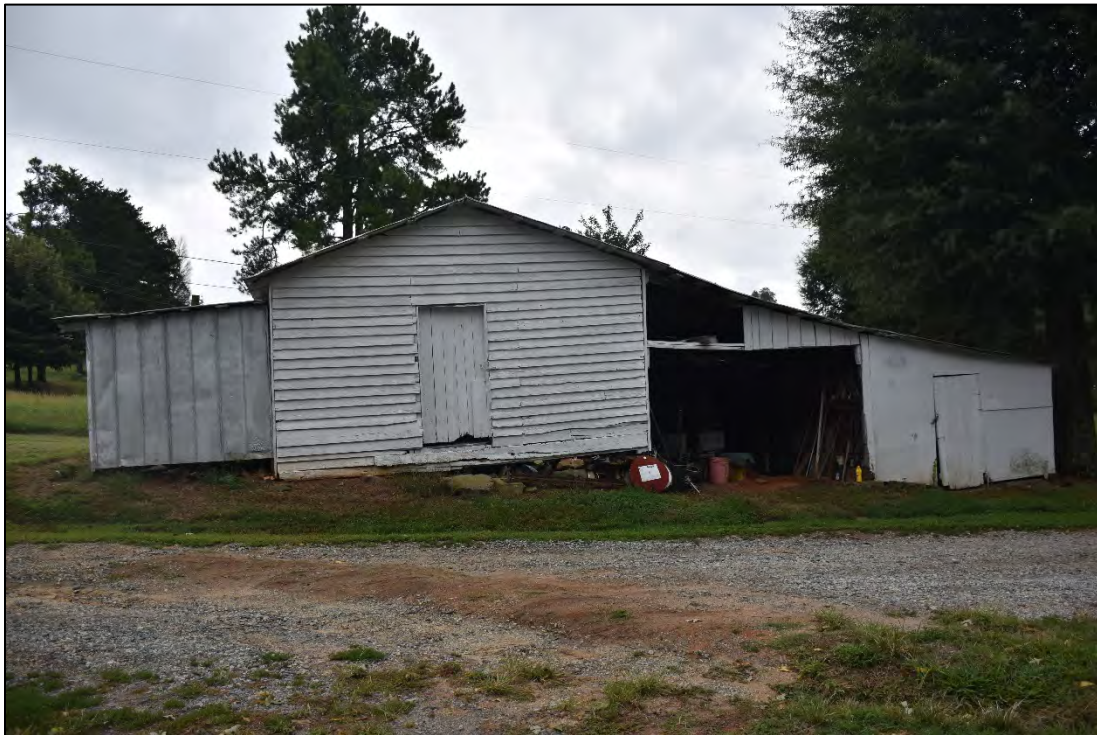
Figure 2.1.28. View of circa-1930 shed, Underwood Farm, facing south.

South of the gravel farm road are two early-to-mid-twentieth-century storage buildings and three late-twentieth-century metal structures (Figure 2.1.3). The westernmost of these structures is a circa-1930 wooden frame shed, which has been added to multiple times (Figure 2.1.28). The central portion is a front-gabled shed, which sits on a mixed material foundation that appears to be primarily piers of stacked stone and brick (Figure 2.1.29). This portion of the shed has horizontal wooden siding and the central doorway may have originally been larger, as there is evidence of patched-in siding to the west of the door. West of the gabled shed portion, there are two shed-roofed projections that were added separately to the original structure, as they are different depths (Figure 2.1.30). The front of the addition connected to the original structure is partially covered with vertical wooden siding, although it is mostly open, while the westernmost addition has a plywood front exterior and a central door; the rear of both additions is covered with plywood siding. Another shed-roofed addition has also been appended to the east of the original shed structure. This addition has a sheet metal exterior covering on its front and side, but an open back (Figure 2.1.31). The shed has visible rafter tails and roof beams on each of its multiple parts and the roof is covered with standing-seam metal.

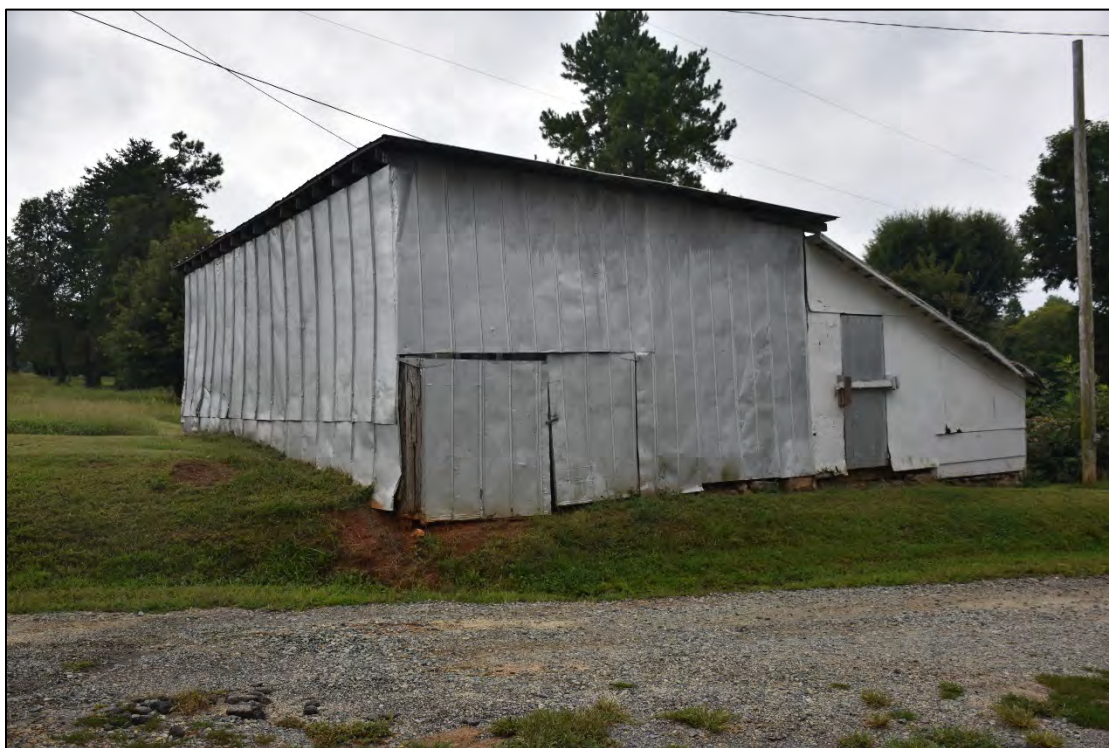
East of the circa-1930 shed building is a circa-1950 storage structure. This building sits on a mixed stone, brick, and concrete foundation and has two distinct parts (Figure 2.1.32). A large, flat-roofed section to the east is covered with sheet metal panels and has visible rafters at its eaves. To the west, a steeply-angled, shed-roofed addition has a barred entry door and is covered with plywood (Figure 2.1.33). Further east, south of the farm road, are three late-twentieth-century metal storage structures, dating from the late 1990s to early 2000s (Figures 2.1.34–2.1.36). Although the construction of the three structures is identical, with metal framing, sheet metal exterior, and a shed-roof with an overhang over the open front, each of the structures is a different height and depth, suggesting that they may not have been built at the same time. The three structures are currently used for equipment and hay storage.

Figure 2.1.32. View of circa-1950 shed, Underwood Farm, facing southwest.

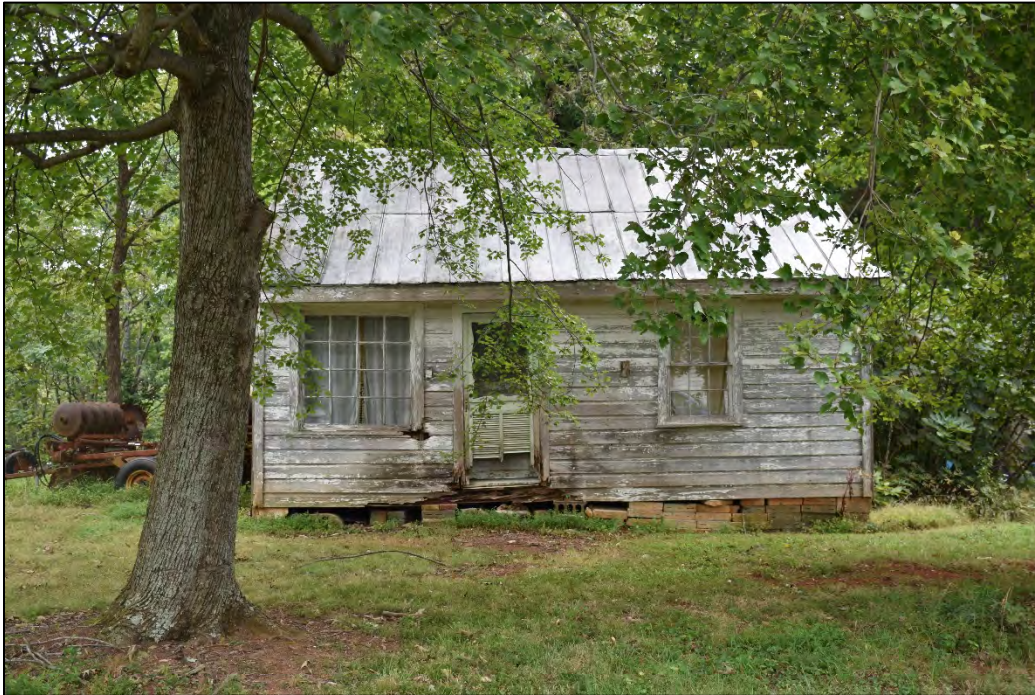
Figure 2.1.41. View of circa-1955 rental house, Underwood Farm, facing north.

At the eastern terminus of the gravel farm road is a circa-1955 rental house, along with other associated structures (Figure 2.1.4). The circa-1955 rental house is a frame structure, with a side-gabled roof, built on a dry-stacked brick and block foundation that has been covered with metal underpinning in some locations (Figure 2.1.41). The front of the house has an off-center door, with a 16-pane picture window to the north and a single six-over-six, double-hung, wooden sash window to the south. There is a small, rectangular attic vent centered in the gable ends, which also have visible roof beams and a narrow band of trim along the raking edge (Figure 2.1.42). A shed-roofed addition, with visible rafter tails, rests on a concrete block foundation at the rear of the structure (Figure 2.1.43). The northern half of this addition appears to be an open porch that may have once been enclosed by screening (Figure 2.1.44). The fenestration on the remainder of the house is the remnants of six-over-six, double-hung, wooden sashes, although many of them are missing panes, stiles, or both. The house is covered with horizontal wooden siding and the roof is sheathed in standing-seam metal; there is an interior, block chimney visible behind the roof ridge on the northern portion of the house.

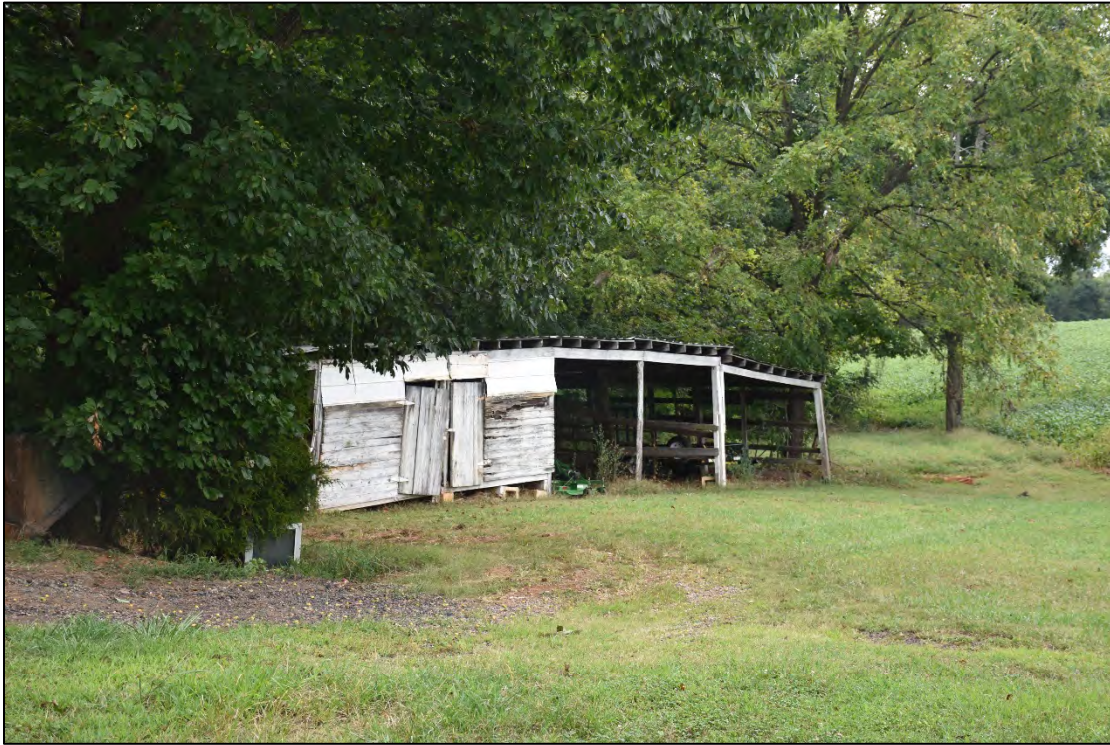
Southeast of the circa-1955 rental house is a wooden storage building that dates to around the same period as the house (Figure 2.1.45). Although the roof may have originally been flat, the building has some structural issues and the roof currently appears bent on one side and bowed on the other (Figure 2.1.46). The building has six sections. The northern section is open, as are the three southern sections; the two sections adjacent to the northernmost section have been enclosed with a combination of horizontal wooden siding and sheet metal. The roof, which has visible rafters, is covered with standing-seam metal, and is supported by rough-hewn timber posts.

Figure 2.1.45. View of circa-1960 shed/storage building, Underwood Farm, facing southeast.

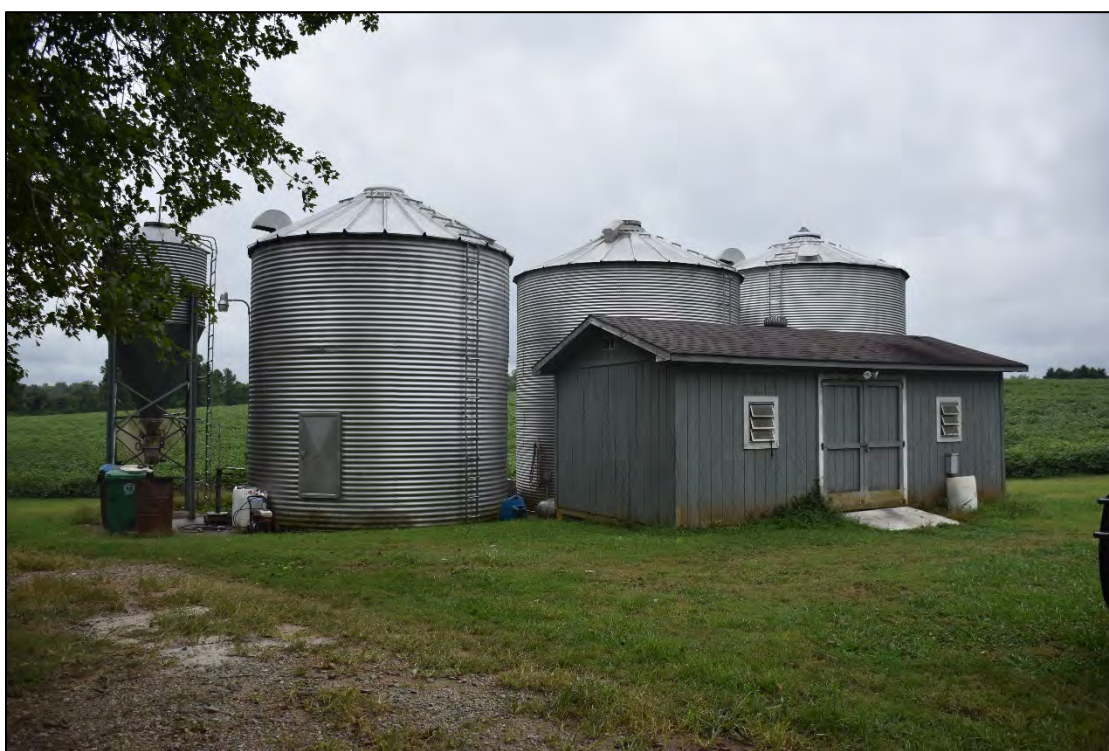
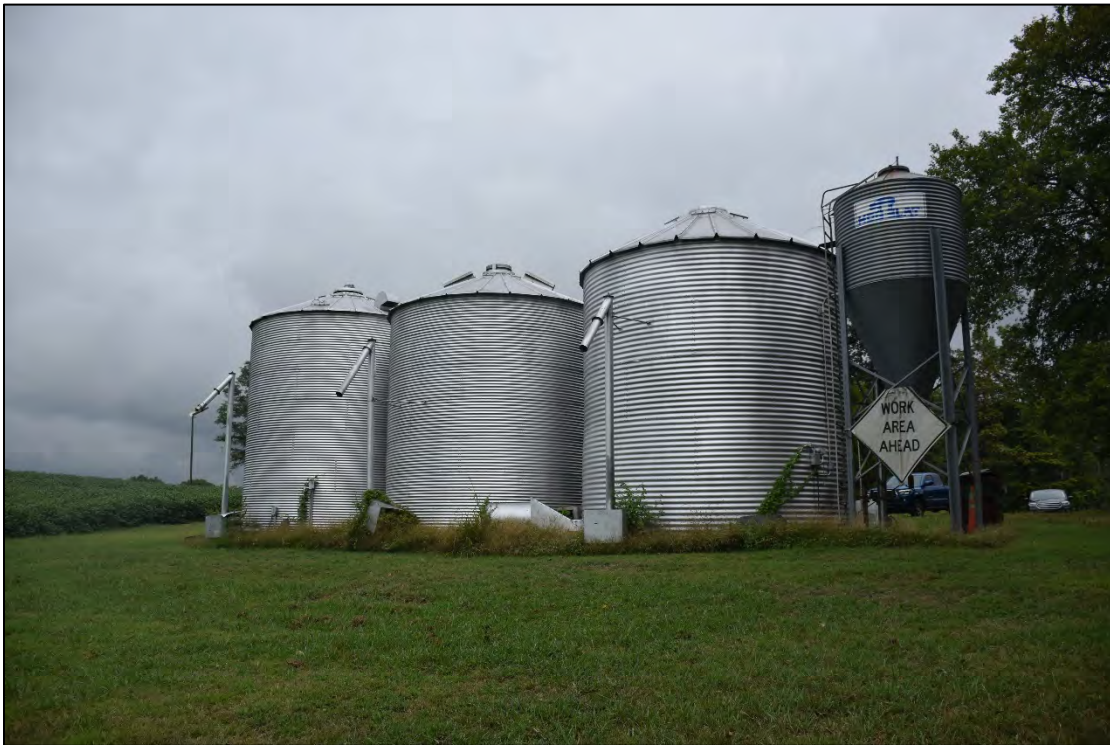
gabled, wooden storage shed (Figure 2.1.48 and 2.1.49). West of the circa-1955 rental house and north of the metal silos is a circa-1990 prefabricated residence (Figure 2.1.50).

Figure 2.1.48. View of circa-2000 silos and storage building, Underwood Farm, facing south.

Figure 2.1.49. View of circa-2000 silos, Underwood Farm, facing northwest.

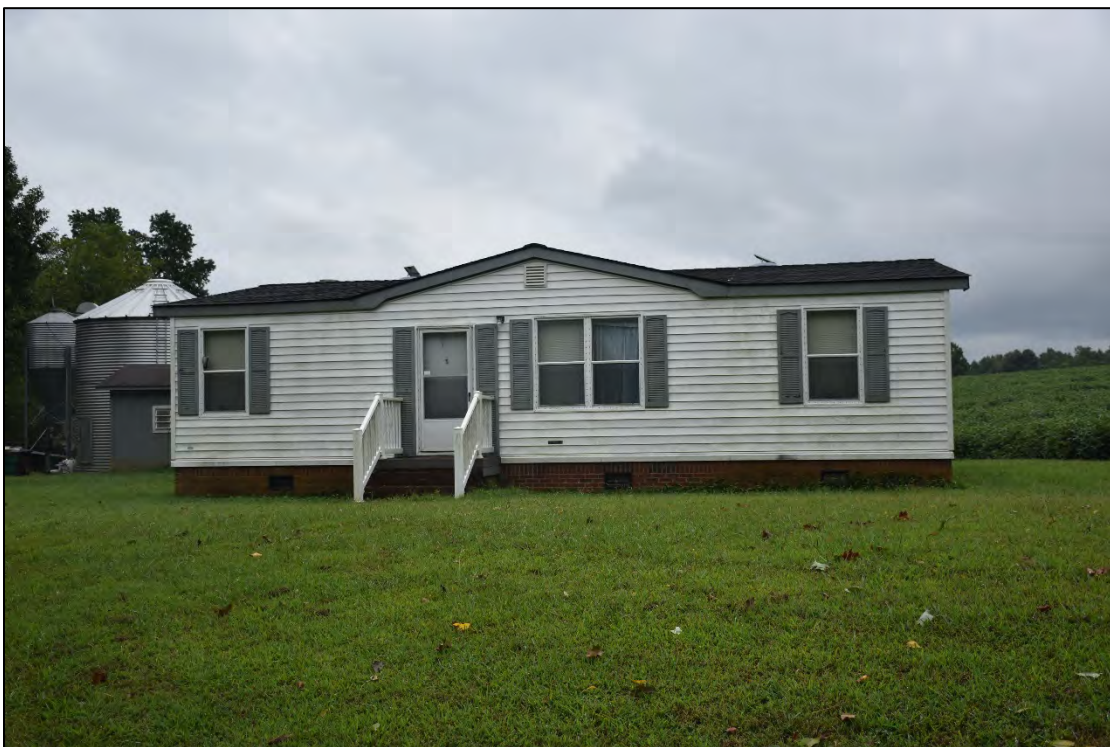
Figure 2.1.50. View of circa-1990 prefabricated home, Underwood Farm, facing south.

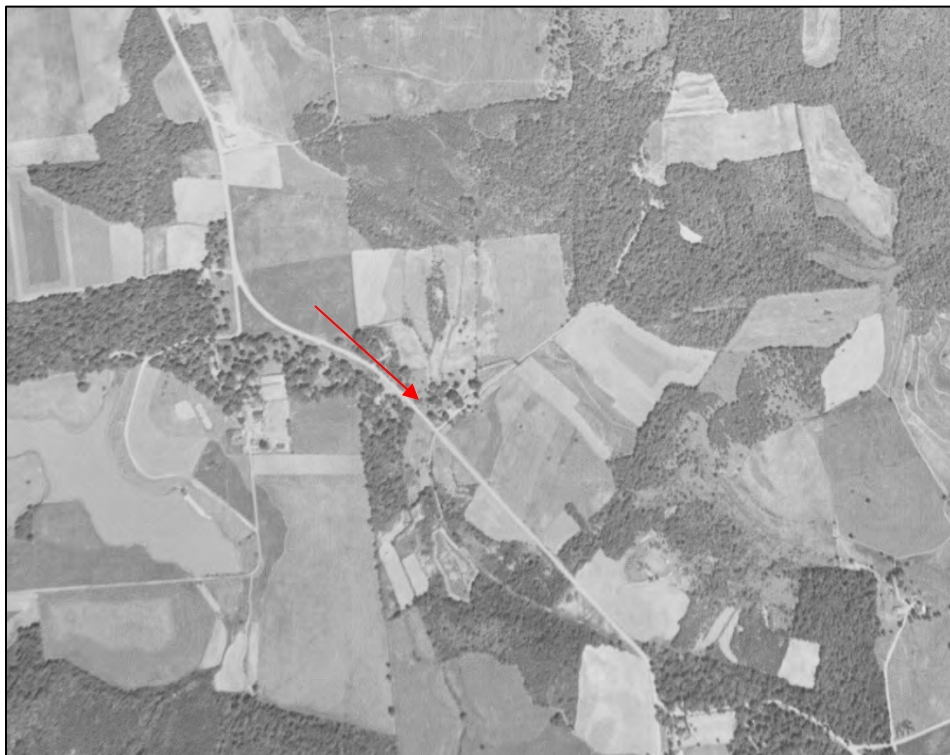
Figure 2.1.53. USGS aerial photograph (1948) showing Underwood Farm property and vicinity.

Historic aerial photographs from the 1940s through the 1960s show the evolution of the farm property during the mid-twentieth century. The 1948 photograph indicates that only the circa-1880 Underwood house, the barn and poultry house, and the circa-1930s sheds were standing on the property, although the private farm road and cultivated fields are clearly visible (Figure 2.1.53). By 1951, the circa-1950 D. S. Underwood House had been constructed, as had the mid-century storage areas (Figure 2.1.54); both houses and an outbuilding are shown on the 1951 USGS topographic quadrangle. By 1964, the rental house at the eastern edge of the property had been constructed (Figure 2.1.55). Aerial imagery from the 1990s and 2000s provides construction dates for the late-twentieth-century structures on the property.

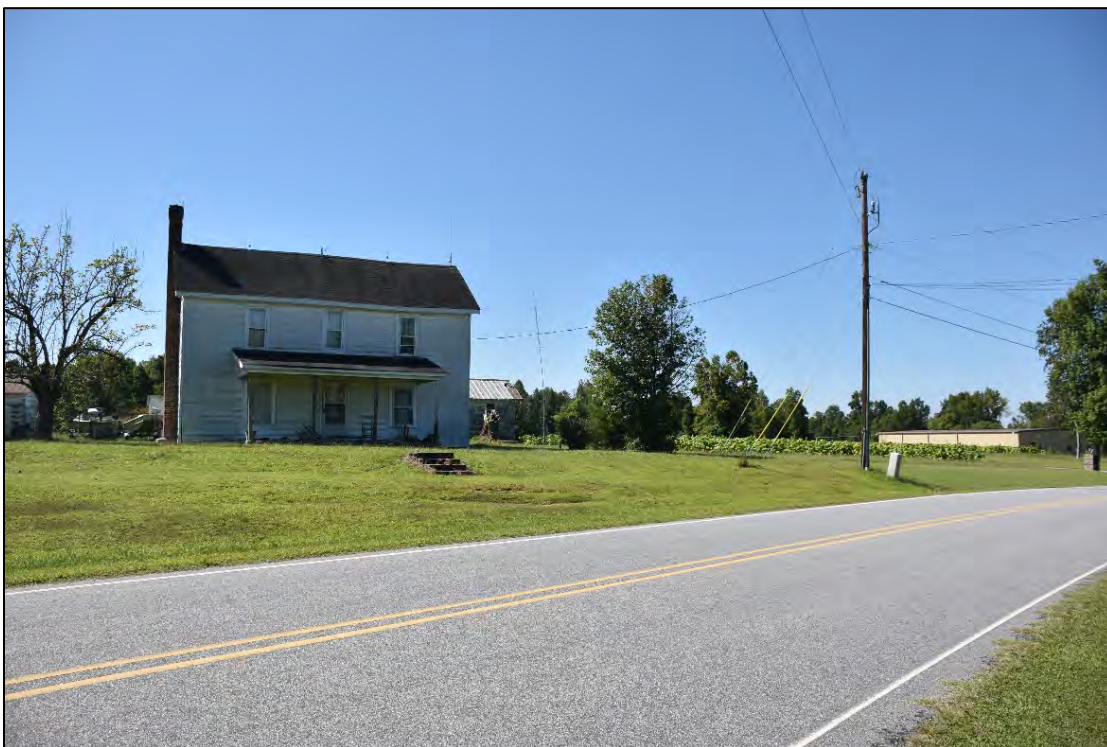
Figure 2.1.58. Welborn House (RD0361), facing south.

The Welborn House, which may date to the mid-nineteenth century, is another I-house (Whatley et al. 1985:64). The height and roof-pitch proportion on the Welborn House is similar to the circa-1880 Underwood House and it has four-over-four windows in its upper story, although the lower story windows are six-over-six (Figure 2.1.58). The Welborn House, however, only has a single exterior chimney, its rear addition is only a single story, it does not have
