SUBJECT: Historic Structures Survey Report, Install Curb, Gutter, and Roundabout on NC 1110,  
U-6055, Haywood County, ER 17-2014

**SUBJECT:** PA No. 17-04-0038: U-6055 Install Curb and gutter, roundabout, and 5' sidewalk on NC 1110 (Pisgah Dr) at Locust Street, Haywood County

HISTORIC STRUCTURES SURVEY REPORT OF THE  
INTERSECTION OF NC 110 (PISGAH DRIVE) AT LOCUST STREET IN CANTON

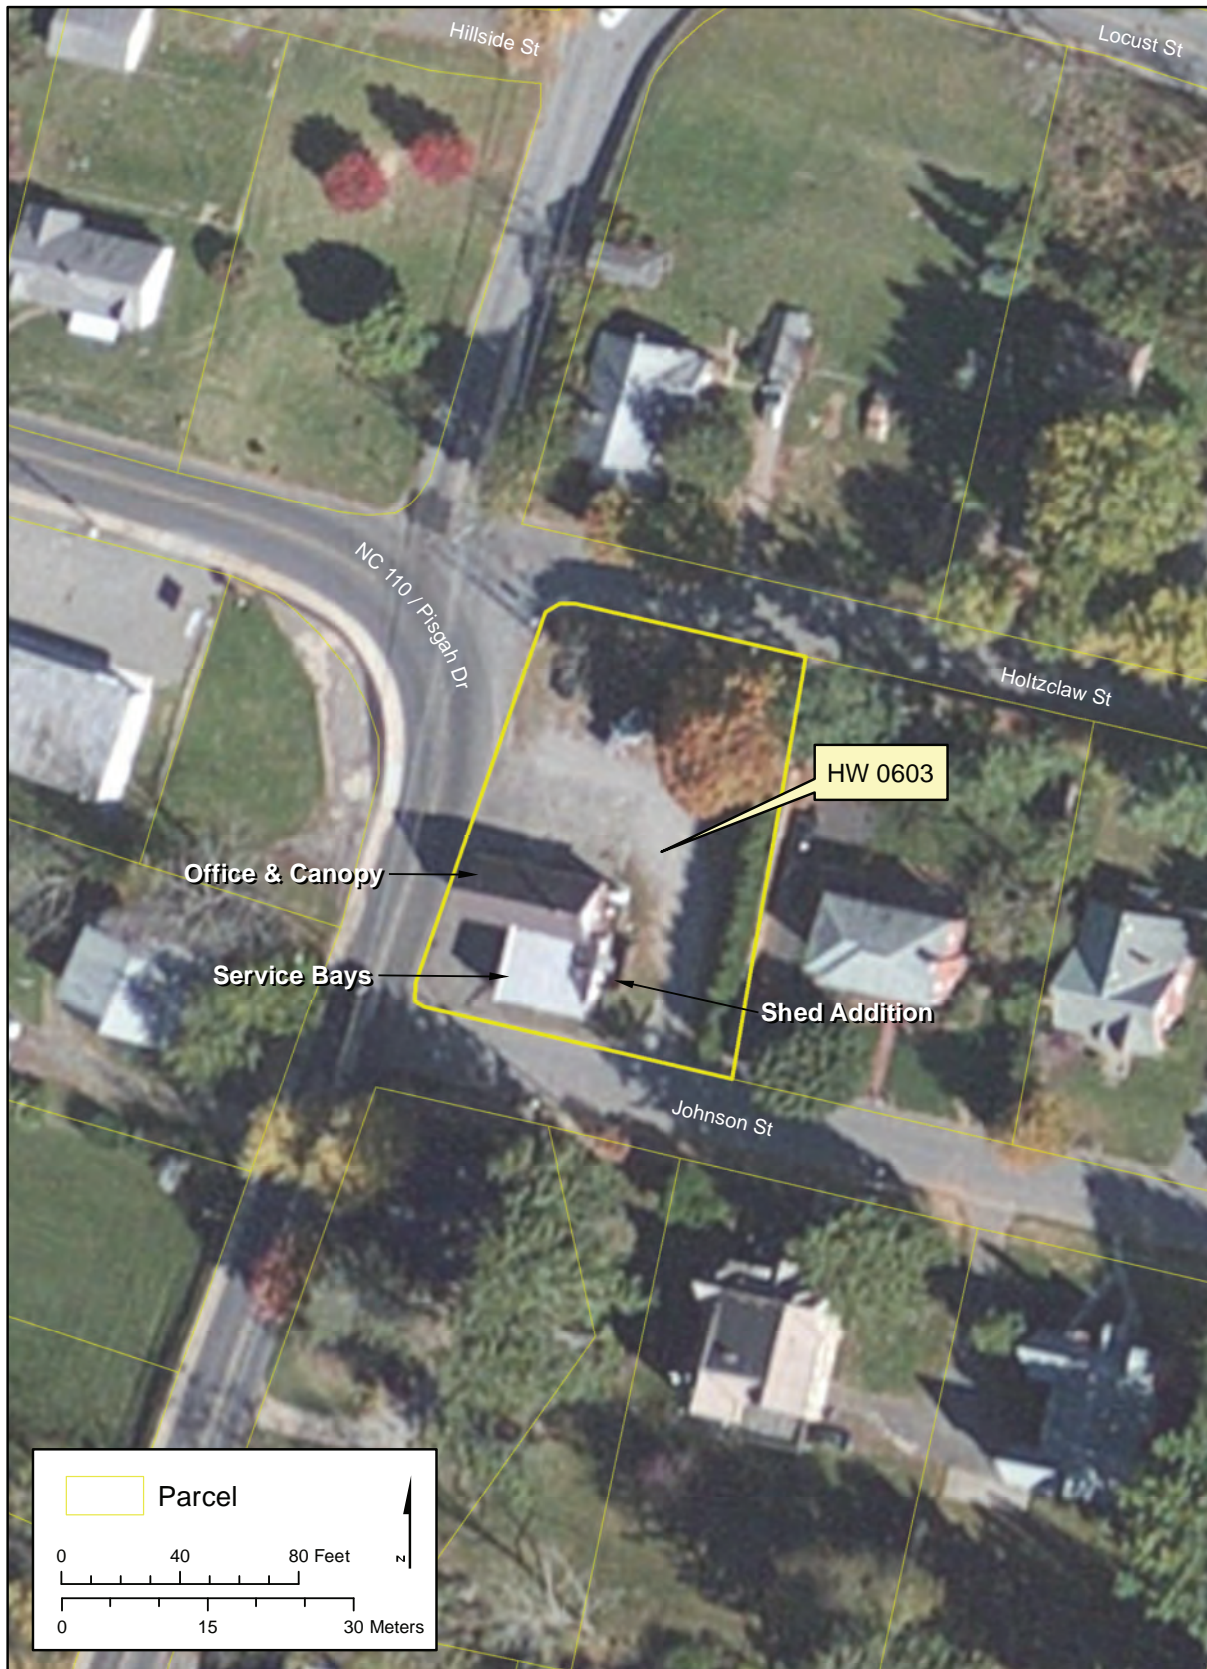
Figure 3.1. Site Plan of Howard Amoco (HW 0603)

Howard Amoco (HW0603) is located within the city limits of Canton, in Haywood County, North Carolina at 119 Pisgah Drive, approximately 0.25 mile south of downtown Canton on the east side of the Pigeon River (Figure 3.1). The property is situated close to the road at the intersection of Pisgah Drive (NC 110), Holtzclaw Road, and Locust Street (Figures 3.2-3.4). During fieldwork, it was observed that the intersection was extremely busy with traffic, including large trucks heading in both directions. The majority of the buildings in the immediate vicinity of Howard Amoco are single-family homes. The Howard Amoco building sits on the south third of a 0.36-acre lot, which is bounded by Johnson Street on the south, Pisgah Drive on the west, Holtzclaw Street on the north, and a residence located at 107 Johnson Street on the east. Automobiles in various states of repair occupy the remaining two-thirds of the parcel.

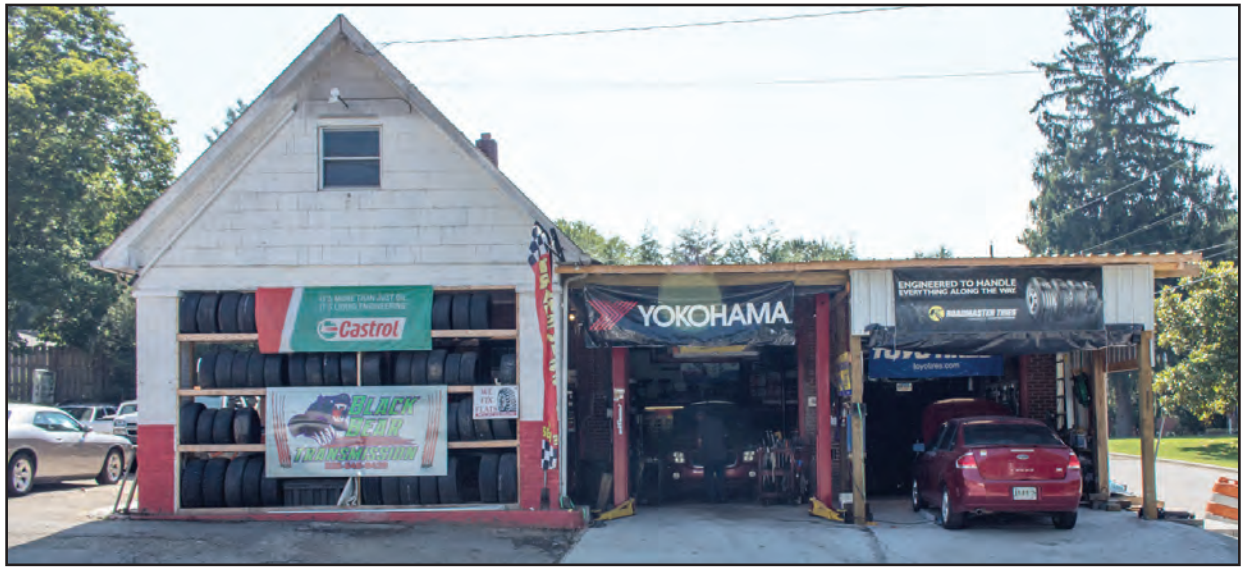
Figure 3.5. Howard Amoco, West Side

Howard Amoco is a small, one-story automotive garage that faces west (Figure 3.5). The main structure is rectangular and consists of a small office and a canopy that served as a refueling area, both contained under a steeply pitched gable-front roof (Figures 3.6 and 3.7). The office section

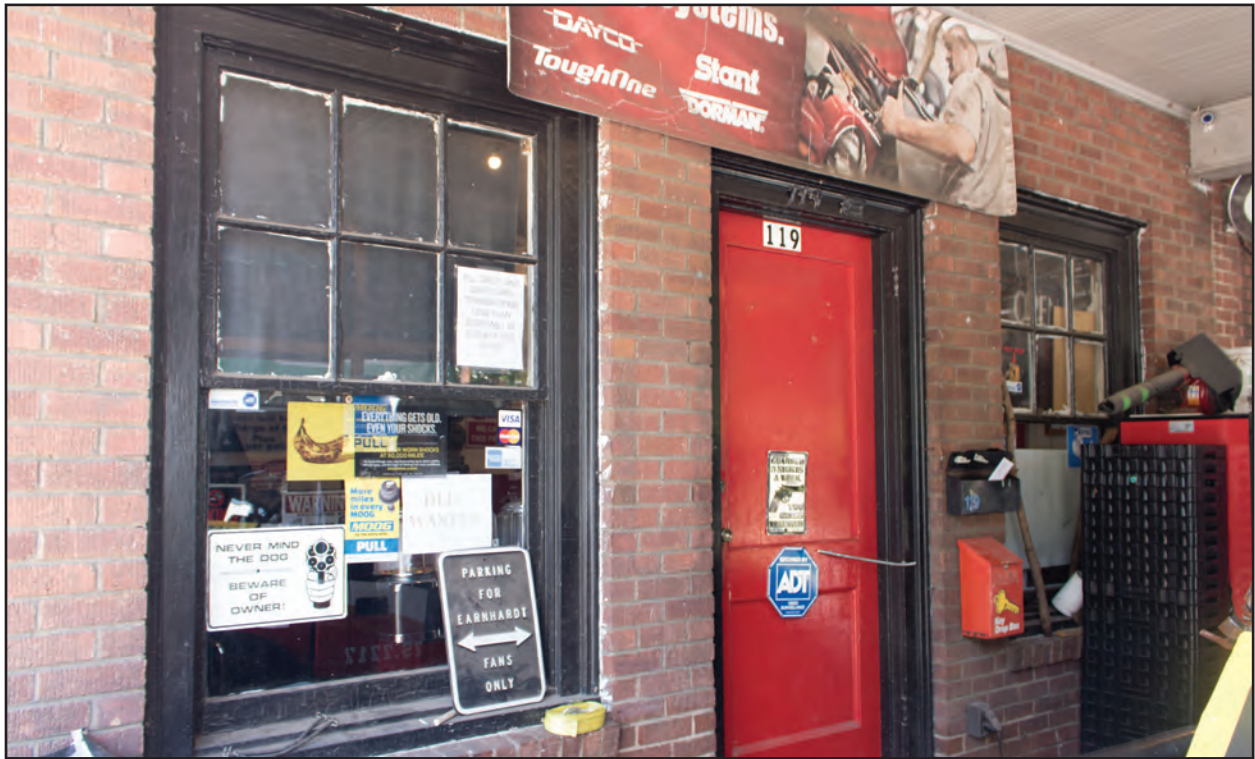
Figure 3.8. Howard Amoco, West Wall of Office

measures approximately 19 feet wide by 24 feet long. It is veneered with textured brick and has three bays on its façade, with entrance door occupying the center bay (Figure 3.8). The door is solid and paneled and is a replacement. The six-over-one double hung windows that flank the door are original to the structure (see Figure 3.8). There are two identical windows on the north elevation (Figure 3.9). The east and south elevations of the original structure are obscured by non-historic additions. There is a small internal chimney located near the back of the building on the composition shingle gable roof.

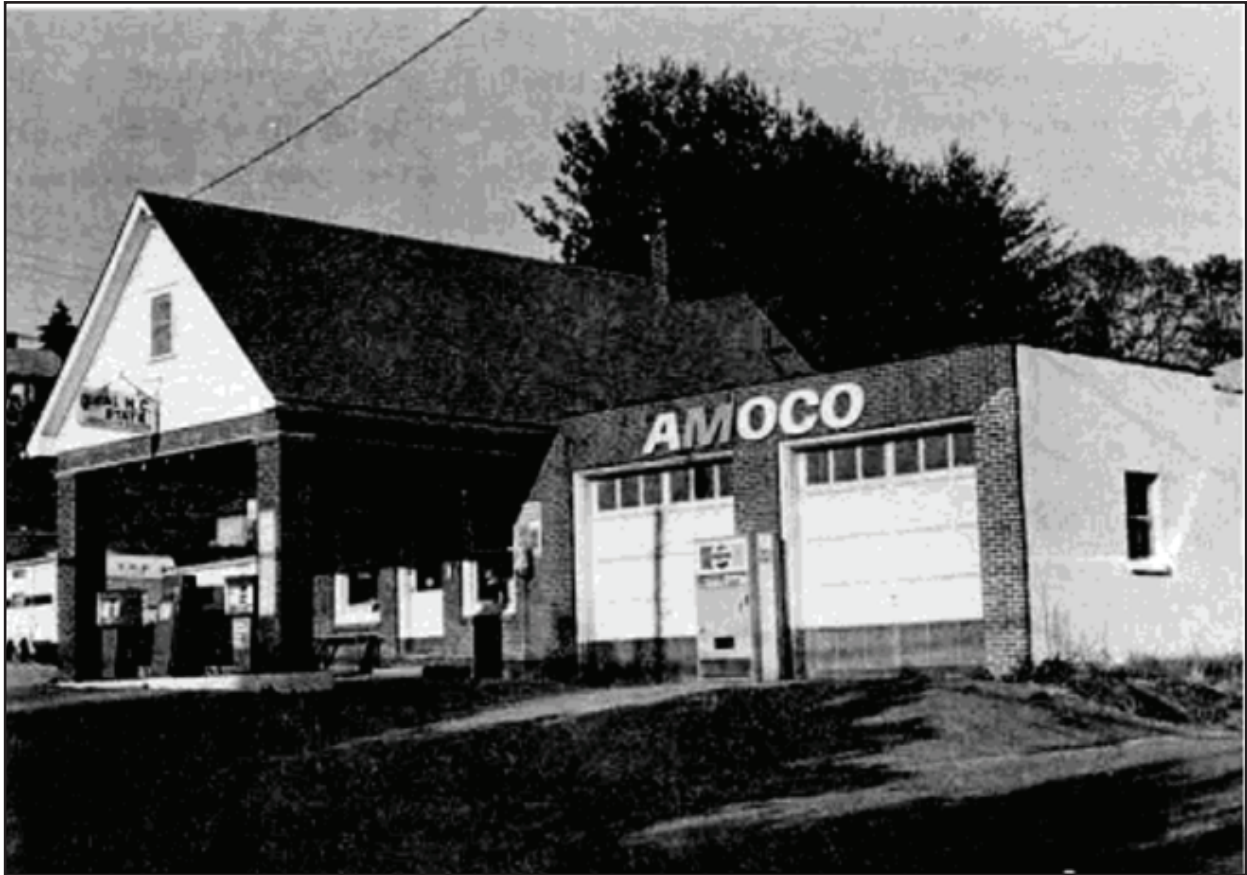
*Figure 3.10. Howard Amoco, Circa 1980*

The refueling canopy projects out from the office approximately 15 feet and is also 19 feet wide (see Figure 3.5). The canopy is supported at the front by two square brick columns at each corner with a low concrete island between them, where at least two fuel pumps were formerly located, as shown by a photograph taken circa 1980 (Figure 3.10). Currently, the space is being used to store tires (see Figure 3.5). The ceiling of the canopy is clad in bead board with a single light fixture in the center. The gable end of the roof, which is facing Pisgah Street, is clad in shingles over the canopy. There is an aluminum-framed window centered in the gabled end.

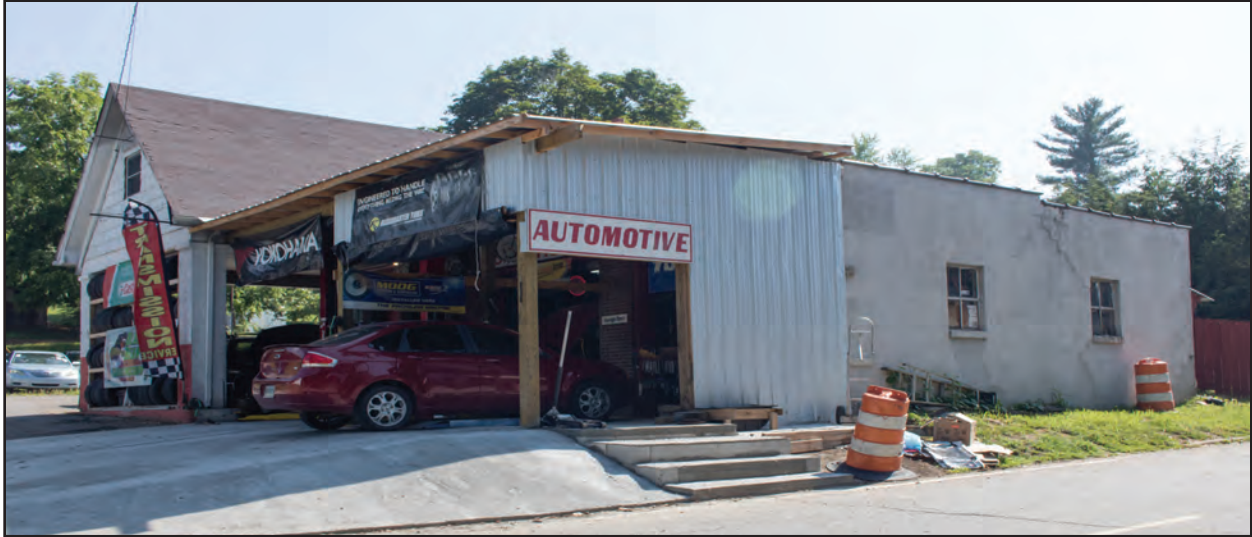
*Figure 3.11. Oblique of West and South Sides*

Attached to the south side of the gable-roof structure is a circa 1950 one-story concrete block structure measuring 28 feet wide by 28 feet long (Figure 3.11), which houses a two-car service bay. It was built on a slab foundation and the roof is flat. The façade is brick veneer with two garage door openings. The south elevation wall is stucco with two two-over-two aluminum frame windows (Figure 3.12). The top of the wall has two steps and is capped with terra cotta coping (Figure 3.13).

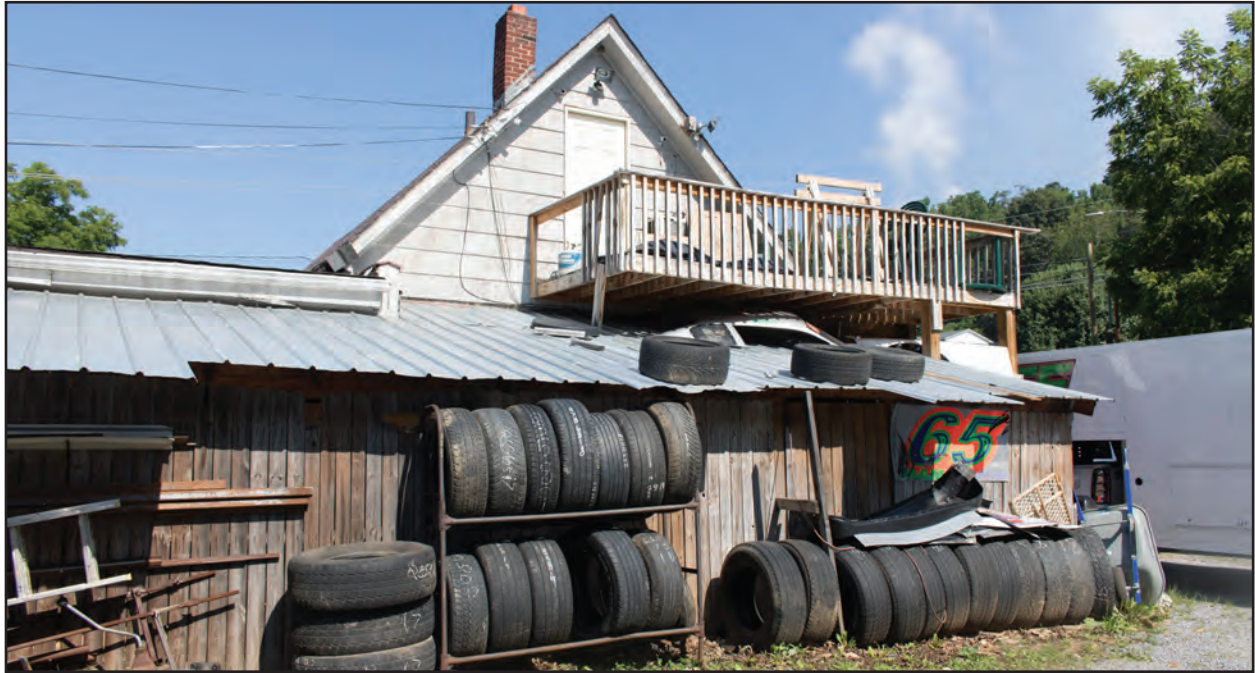
Figure 3.14. *Howard Amoco, East Side*

At the rear of the building is a shed roof addition with a metal roof and vertical board walls, likely used for storage, built around 2010 (Figure 3.14). There is a door centered in the gable end on the rear, with a small deck and stairs that wrap around to the north of the building (Figure 3.15). At the front of the building, a metal roof lean-to was added around 2013 to shade the garage bays (see Figure 3.11).

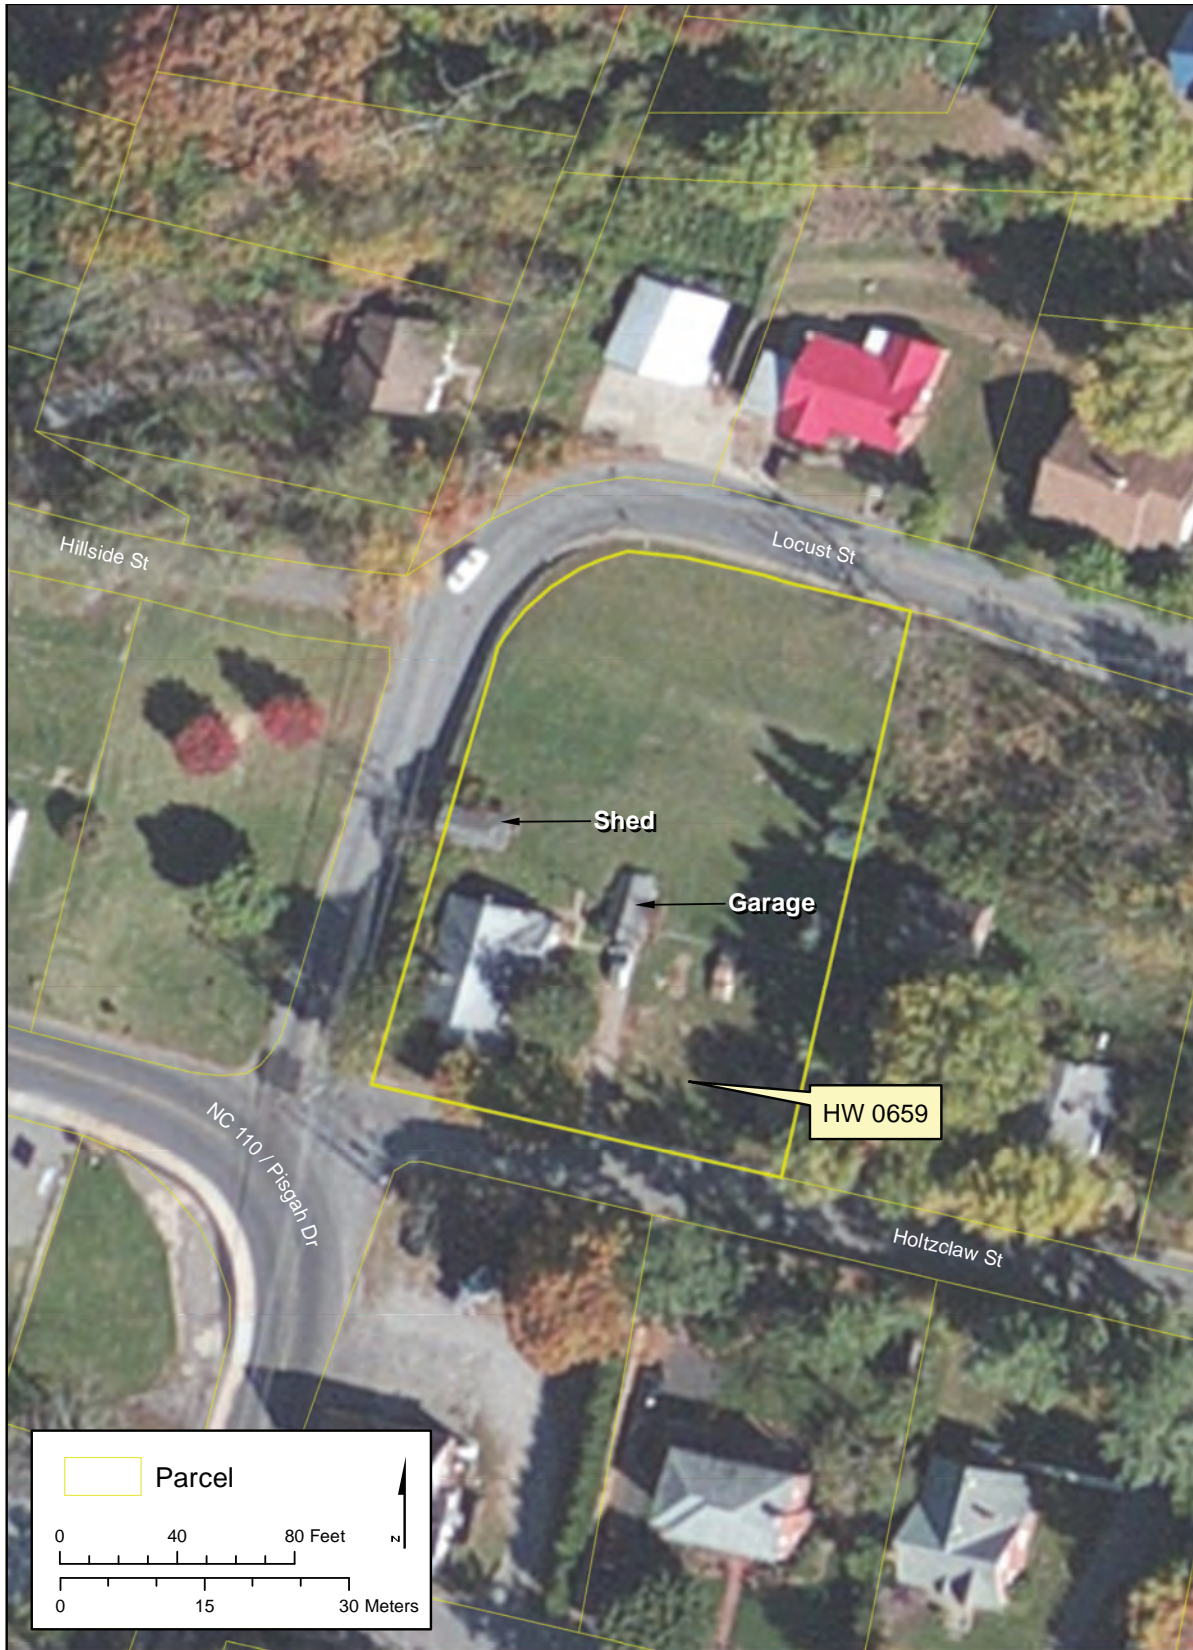
Figure 4.1. 1 Holtzclaw Street, Site Plan

1 Holtzclaw Street (HW0659) is located within the city limits of Canton, in Haywood County, North Carolina, approximately 0.25 mile south of downtown Canton on the east side of the Pigeon River. The house is situated close to the road at the intersection of Pisgah Drive (NC 110), Holtzclaw Road, and Locust Street (Figure 4.1). During fieldwork, it was observed that the intersection was extremely busy with traffic, including large trucks heading in both directions. The majority of the buildings in the immediate vicinity of 1 Holtzclaw Street are single-family homes, although there are two businesses at the intersection of Pisgah Drive within the viewshed of the resource (Figure 4.2). The house is located in the southwest corner of a 0.65-acre parcel of land that is bounded by Holtzclaw Street on the south, Locust Street on the west and north, and another residential parcel on the east. A retaining wall and narrow sidewalk also border the property on the south and west sides, with cuts for steps and a driveway to approach the house from Holtzclaw Street. In addition to the house, there are two outbuildings located on the parcel, a garage and storage shed. Landscaping consists of a large area of grass and some mature trees near house.

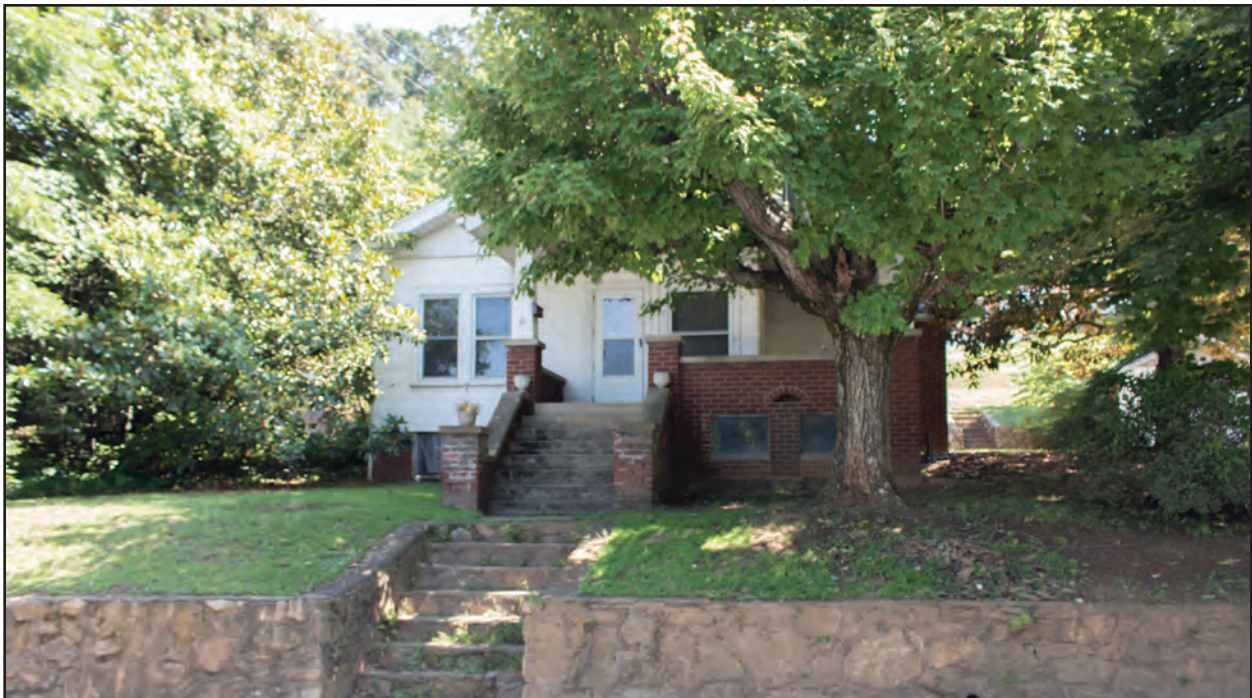
*Figure 4.3. 1 Holtzclaw Street, South Side*

1 Holtzclaw Street is a small, one-story, frame house that possesses elements of the Craftsman architectural style (Figure 4.3). The main block of the house is rectangular and sits on a continuous brick foundation. The low-pitched gable front roof is clad in composition shingles and has projecting eaves that have been boxed in with synthetic siding along with the gable ends (Figure 4.4). The exterior walls of the house are clad in asbestos shingle, for the most part, but red brick is also used for the walls of the porch and a projection on the east wall (Figure 4.5).

design, materials, and workmanship due to the replacement and encasement of some of its historic fabric. The majority of the windows appear to be replacements and at some point, the house was clad in asbestos siding. Additionally, the gable-ends, eaves, and porch ceiling have been clad in synthetic siding.

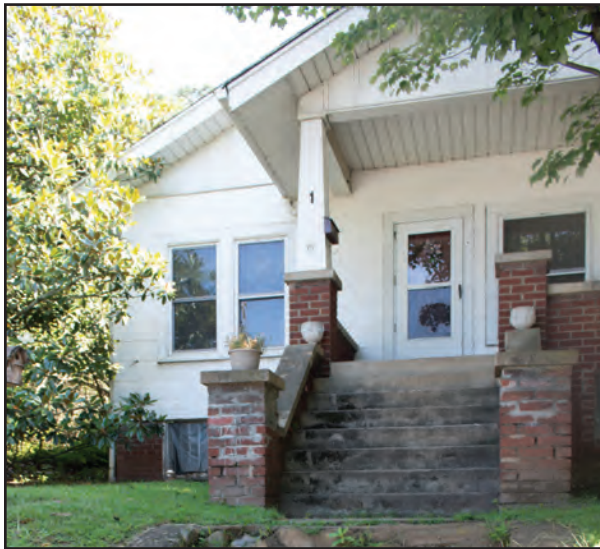
*Figure 4.6. 1 Holtzclaw Street, Eave Detail*

The façade of 1 Holtzclaw Street faces south and has three asymmetrical bays, with the front door occupying the center bay (Figure 4.6-4.7). To the right is a single one-over-one window and to the left is a pair of one-over-one windows. The one-over-one wood sash windows may be

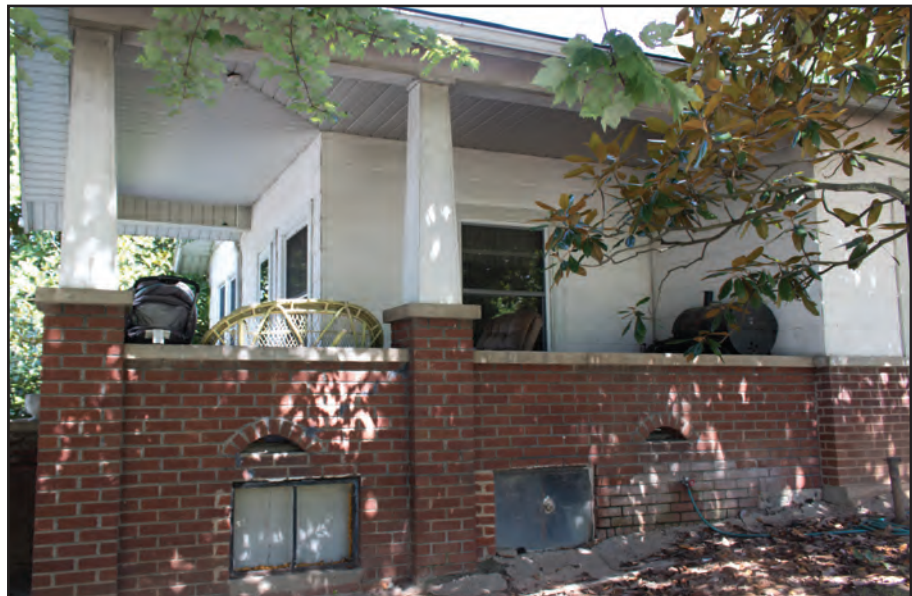
*Figure 4.8. 1 Holtzclaw Street, East Side of Porch*

replacements of the original windows. A partial-width, L-shaped porch projects from the façade and wraps around to the east wall of the house (Figure 4.8-4.9). The walls of the porch are textured red brick arranged in a running bond pattern and are punctuated by small eyebrow arches near the porch floor that were likely placed for ventilation (Figure 4.10). Eight concrete steps leading up from the lawn provide access to the porch, which is supported by three tapered wood columns that sit on square brick piers with concrete caps (see Figures 4.3, 4.6, and 4.9). The porch ceiling is clad in synthetic siding. The house is slightly raised, allowing for daylight windows in the crawlspace/basement, visible on the porch walls under the eyebrow vents.

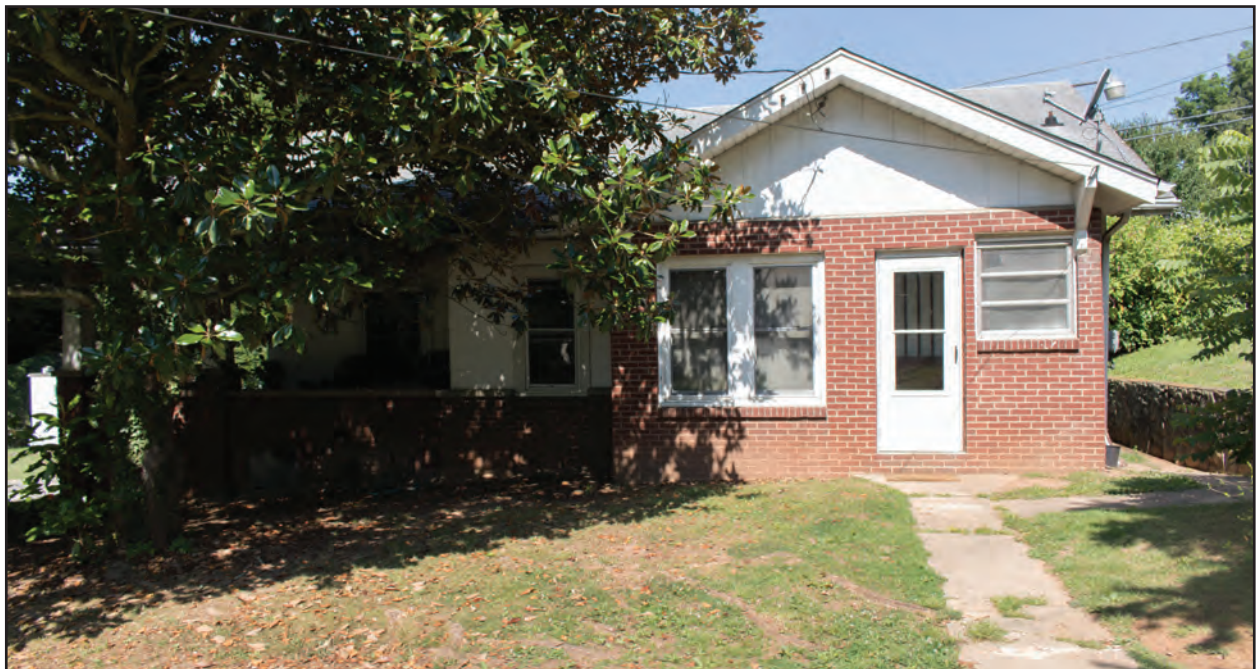
Figure 4.11. 1 Holtzclaw Street, East Side

The east wall of the house has a projecting anteroom with a gable roof that is historic, and likely original to the house, appearing on the 1945 Sanborn Map of Canton (Figures 4.11-4.12). The walls of the anteroom are textured brick, like the porch walls. There is an offset door flanked by a pair of one-over-one windows on the left and a three-light awning window on the right, on the east wall. The rear (north facing) wall of the house is clad in asbestos shingle, with the exception of the anteroom, which has another three-light awning window on this wall (Figure 4.13). There is also a pair of four-over-one historic windows and a single one-over-one historic window. In the center of the wall, the historic window has been replaced with a smaller vinyl window. The west wall of the house is obscured by vegetation and was not documented.

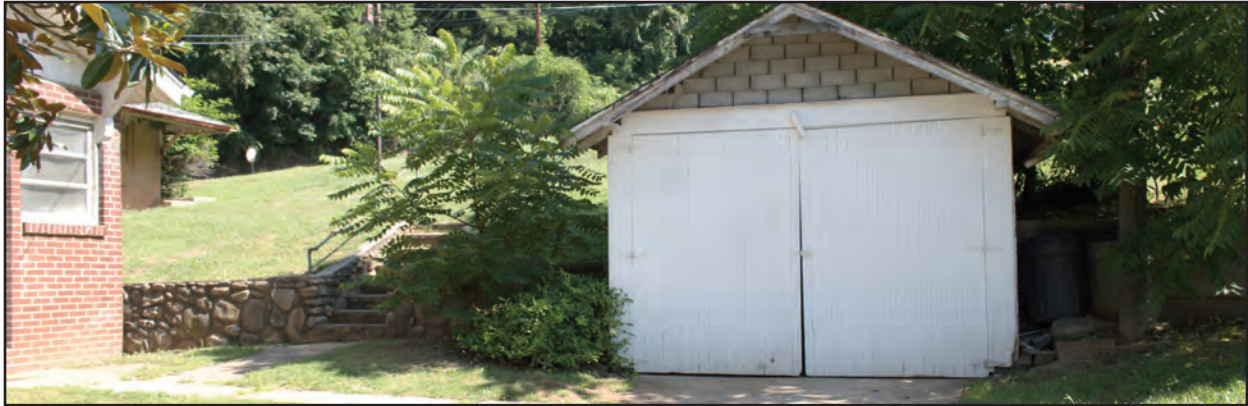
Figure 4.14. 1 Holtzclaw Street, Garage, South Side

To the east of the house is a small cinder block garage with a gable front roof (Figures 4.14-4.15). The south facing garage was built into the side of a hill on the property. Two hinged doors are bead board. The walls of the garage are barely visible from the sides, being built into the earth, but there is some brick near the front of the west wall, as well as exposed rafter tails under the eaves. The garage does appear on the 1945 Sanborn Map of Canton.

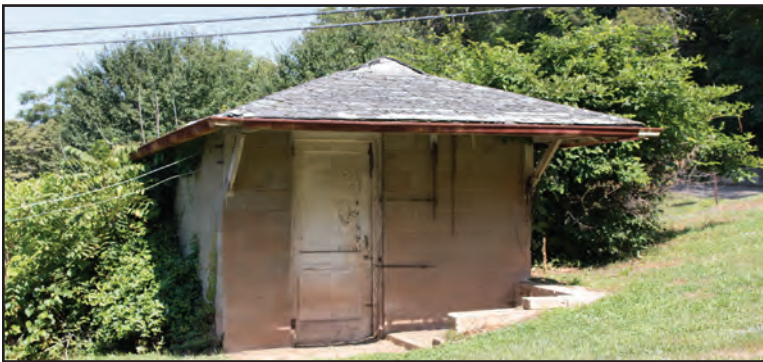
Figure 4.16. 1 Holtzclaw Street, Shed, East Side

A shed located on the hill behind the house does not appear on the 1945 Sanborn Map of Canton. It is a small, windowless rectangular cinder block building with a gable-on-hip roof and deep eaves (Figures 4.16-4.17). Knee braces support the eaves at the front corners of the shed. There is a paneled door on the east wall of the shed. The north and west walls of the shed were inaccessible due to overgrown vegetation.

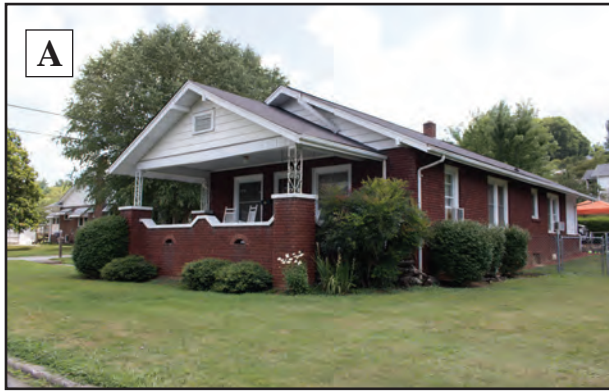
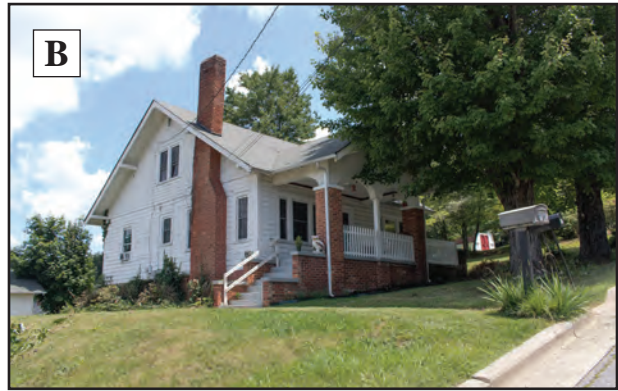
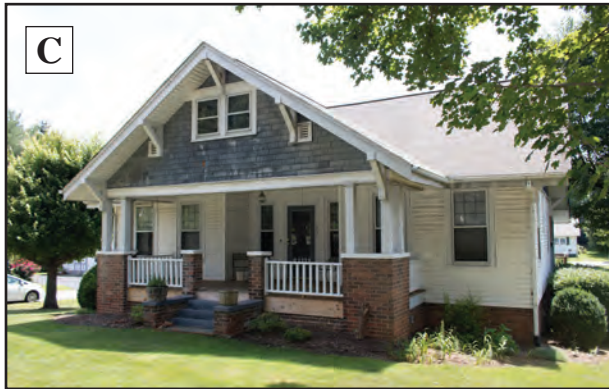
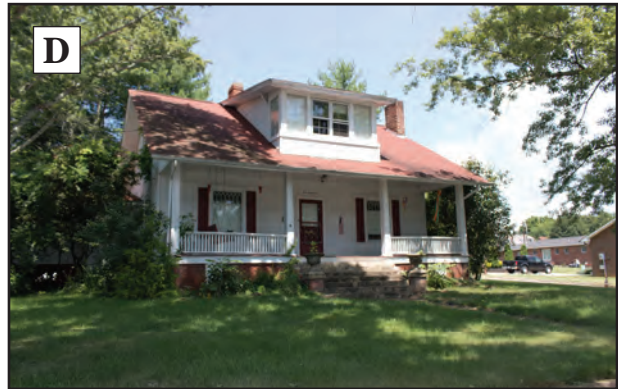
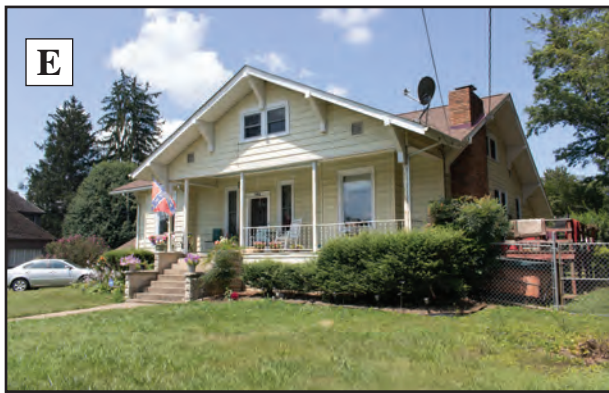
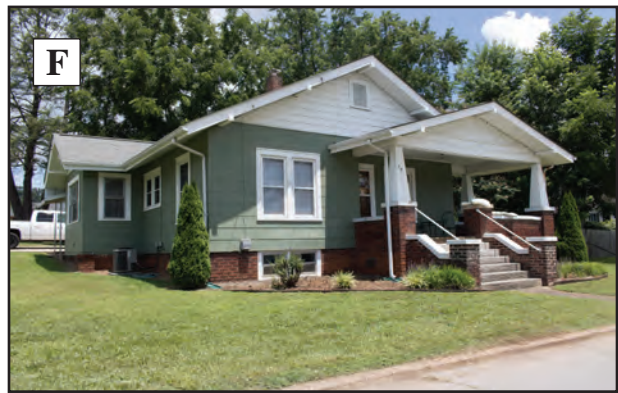
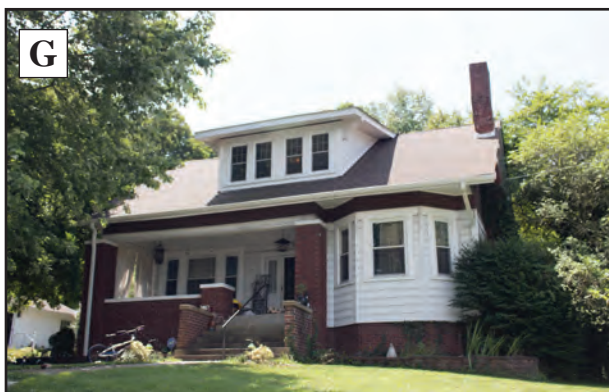
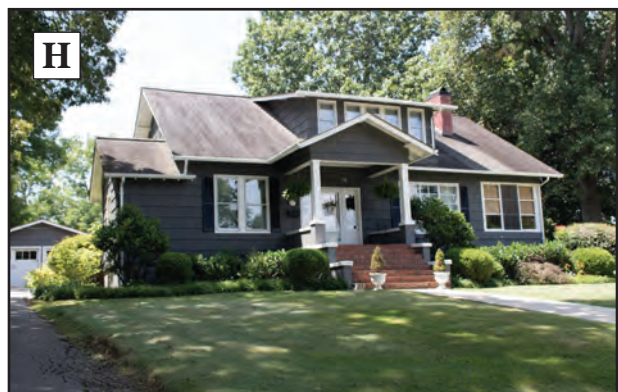
Figure 4.19. Examples of Craftsman Style Homes

Numerous Craftsman-style or influenced houses were built between 1910 and 1940 immediately surrounding the project area. The presence of these houses, here and throughout Canton, attests to the popularity of the style and the need for worker and middle-class housing as the town expanded. Pisgah Drive and its side streets display several examples of houses built in this style. 143 Pisgah Drive was built in 1920 (Figure 4.19C). It is a 1.5-story side gable house that has decorative knee braces and shingles in the gable ends. The front-gabled broad porch is supported by wood columns on brick bases. 144 Pisgah Drive (1927) is also a 1.5-story side gable house (Figure 4.19D). It features battered wood porch columns and a shed-roof dormer. 146 Pisgah Drive (1925) is another 1.5-story home with similar massing, a broad porch, and decorative eave bracing (Figure 4.19E). 39 Poplar Street (1928) is one-story with a gable roof, wrapped porch, and tapered columns with brick piers (Figure 4.19F). Two more examples of obvious Craftsman elements can be found on Wesley Street, south of the project area (Figure 4.19G-H).

A. 29 Pennsylvania Avenue; B. 37 Pennsylvania Avenue; C. 143 Pisgah Drive; D. 144 Pisgah Drive;  
E. 146 Pisgah Drive; F. 39 Poplar Street; G. 57 Wesley Street; H. 62 Wesley Street

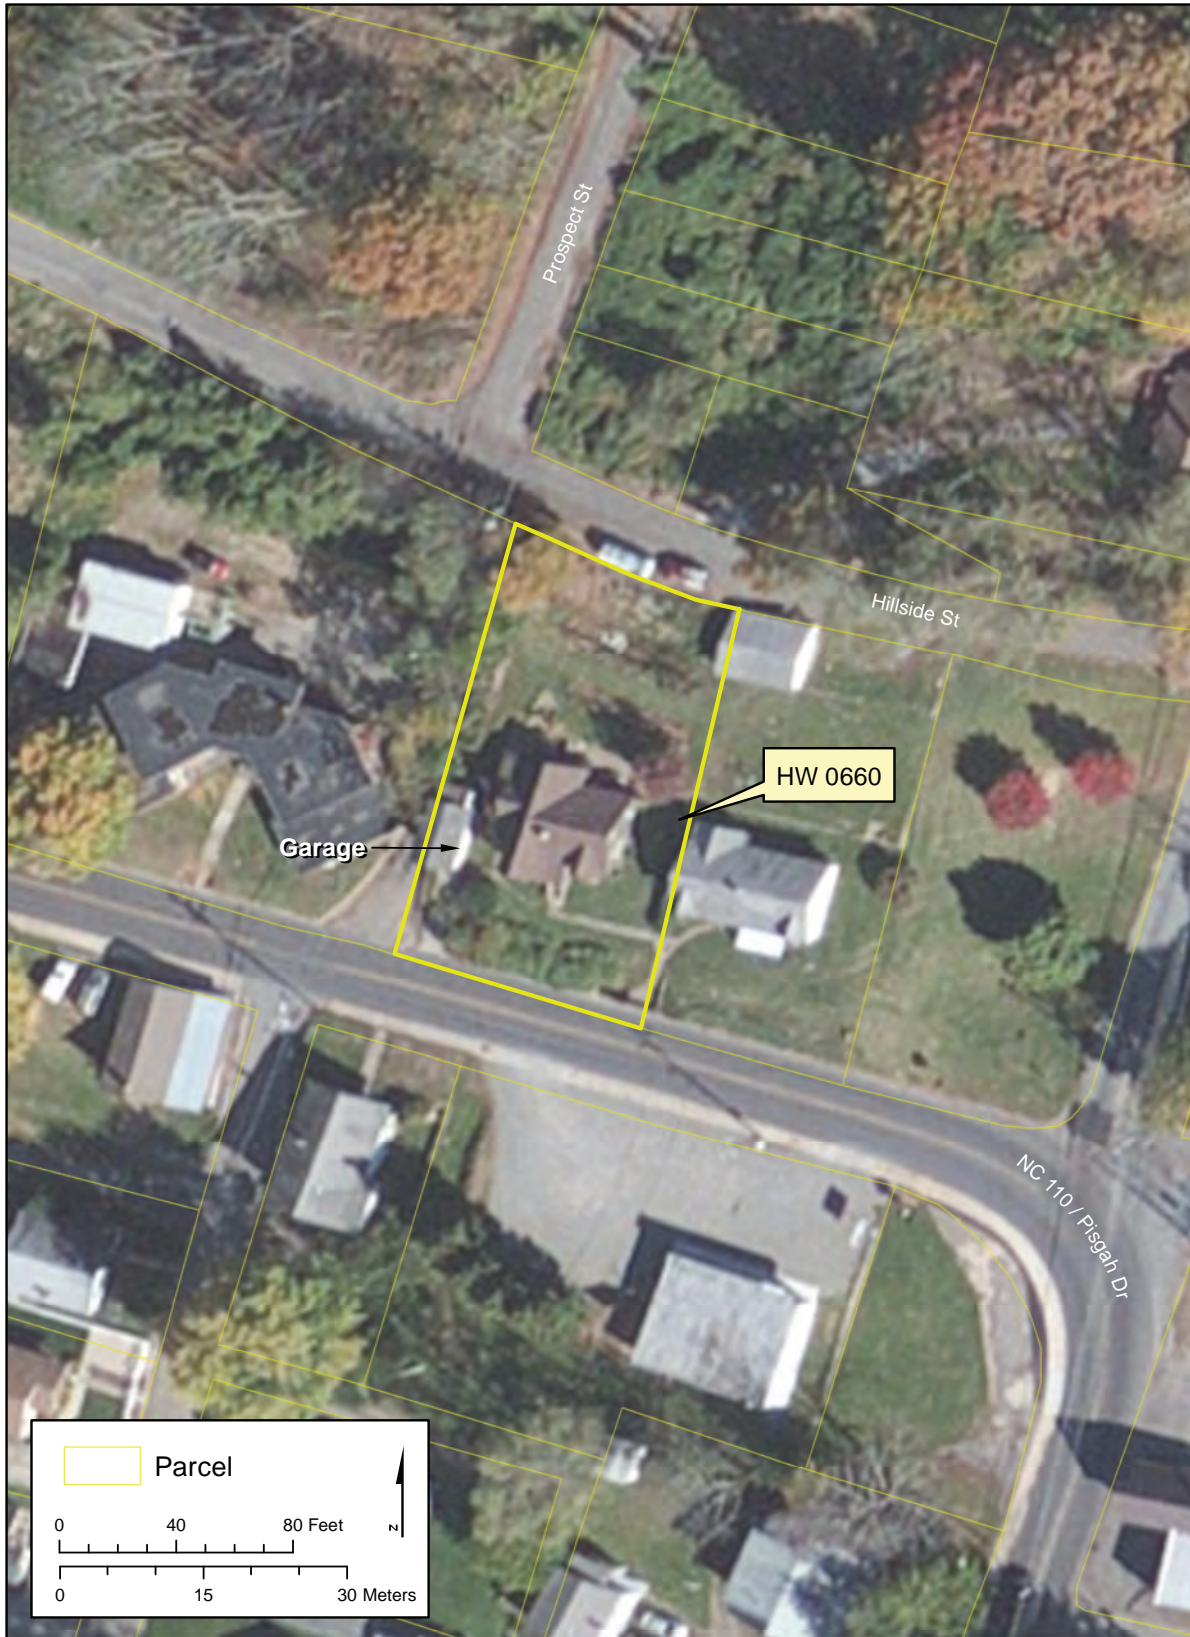
Figure 5.1. 113 Pisgah Drive, Site Plan

113 Pisgah Drive (HW660) is located within the city limits of Canton, in Haywood County, North Carolina, approximately one-quarter mile south of downtown Canton on the east side of the Pigeon River (Figure 5.1). The house is situated on a hill overlooking the intersection of Pisgah Drive (NC 110), Holtzclaw Road, and Locust Street (Figure 5.2). During fieldwork it was observed that the intersection was extremely busy with traffic, including large trucks heading in both directions. The majority of the buildings in the immediate vicinity are single-family homes, although there are two businesses on Pisgah Drive within the viewshed of the resource. The house is located in the middle of a 0.29-acre parcel of land that is bounded by Pisgah Drive on the south, Hillside Street on the north, and residential parcels on the east and west. A substantial stone retaining wall approximately four feet in height borders the property on the south along Pisgah Drive with a cut for steps on the southeast corner of the parcel. In addition to the house, there is a detached two-story garage in the southwest corner of the parcel at the end of a short driveway entered from Pisgah Drive. Landscaping consists mostly of lawn with some foundation plantings.

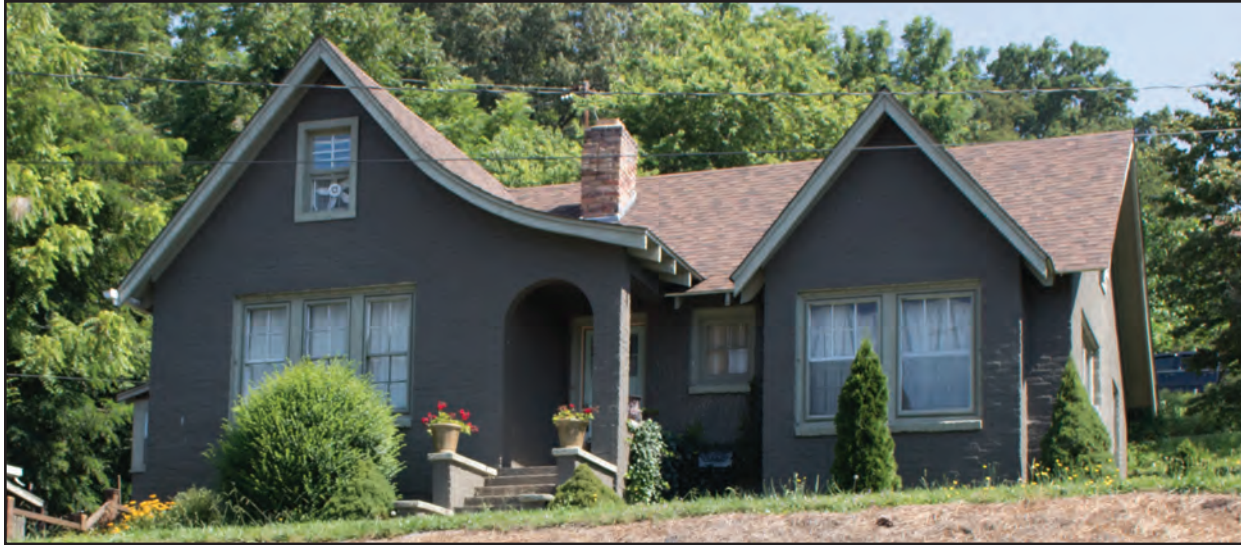
*Figure 5.3 113 Pisgah Drive, South Side*

113 Pisgah Drive is a 1.5-story brick veneered house exhibiting elements of the Period Cottage architectural style, including a steeply pitched roof with projecting gables, sweeping eave and door-width porch. The house has a continuous brick foundation and a cross-gable roof with secondary gable projections clad in composition shingle. The exterior walls are painted brick veneer. There is one internal chimney.

The south-facing façade of the house has a dominant projecting gable on the left with an eave that sweeps toward the façade's center and has exposed rafter tails (Figure 5.3). Under the sweep is a door-width porch containing the front entrance, which is accessed through an arch on the façade's wall (Figure 5.4). The door is rectangular and paneled with six lights near the top. There is a grouping of three four-over-four historic windows centered on the dominant gable, as well as a single window on the upper floor of the gable. A secondary gable is located on the right of the façade (see Figure 5.3). Projecting slightly, the gable contains a pair of six-over-six windows. Between the two gables and adjacent to the front door is a small fixed four-light window.

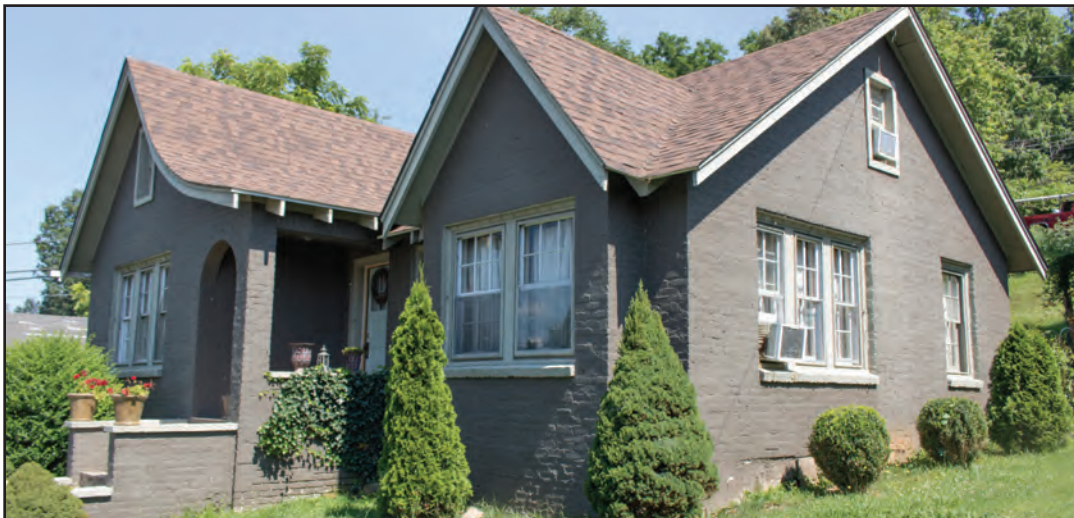
*Figure 5.5. 113 Pisgah Drive, South and East Side Oblique*

The east wall of the house has another grouping of three four-over-four windows, as well as a single four-over-four window and a small window in the upper floor (Figure 5.5). The rear (north) wall of the house has exposed rafter tails in the eave and a variety of historic double hung windows. Stone veneer has been applied to the bottom half of the exterior wall (Figure 5.6). A shed roof addition that appears to be historic was built at the northwest corner of the house (Figure 5.7). The addition is clad in asbestos shingles and has pairs of eight-over-eight windows that wrap around the corners. The original section of the west wall next to the addition houses another grouping of four-over-four windows (Figure 5.8).

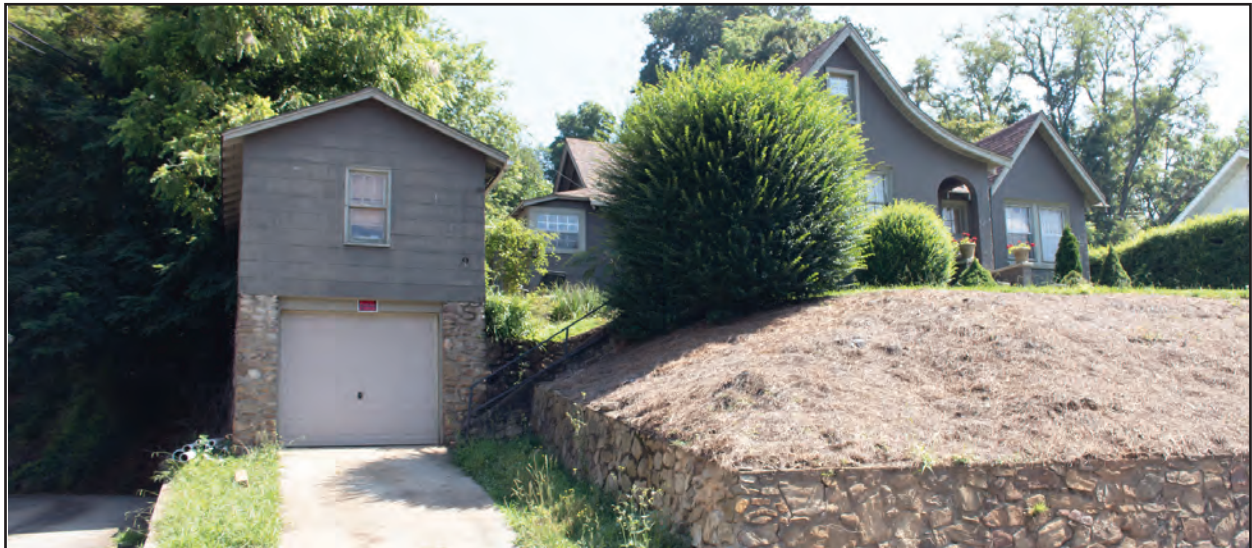
Figure 5.9. *Garage, as Seen from Pisgah Drive*

To the west of the house is a one-car-width two-story garage at the end of a short driveway off Pisgah Drive (Figure 5.9). The bottom half of the garage is clad in fieldstone and the top in asbestos shingle siding (Figures 5.10 and 5.11). It has a low-pitched gable roof with exposed rafter tails in the side eaves. There is a modern metal garage door in the façade's lower level and one three-over-one window in the upper level. The garage's upper floor is level with the house and is accessed by a paneled door on the east wall of the garage (Figures 5.12 and 5.13). The east wall also has two three-over-one windows. There is a small shed-roof addition at the rear of the garage. The garage appears on the 1945 Sanborn Map of Canton.

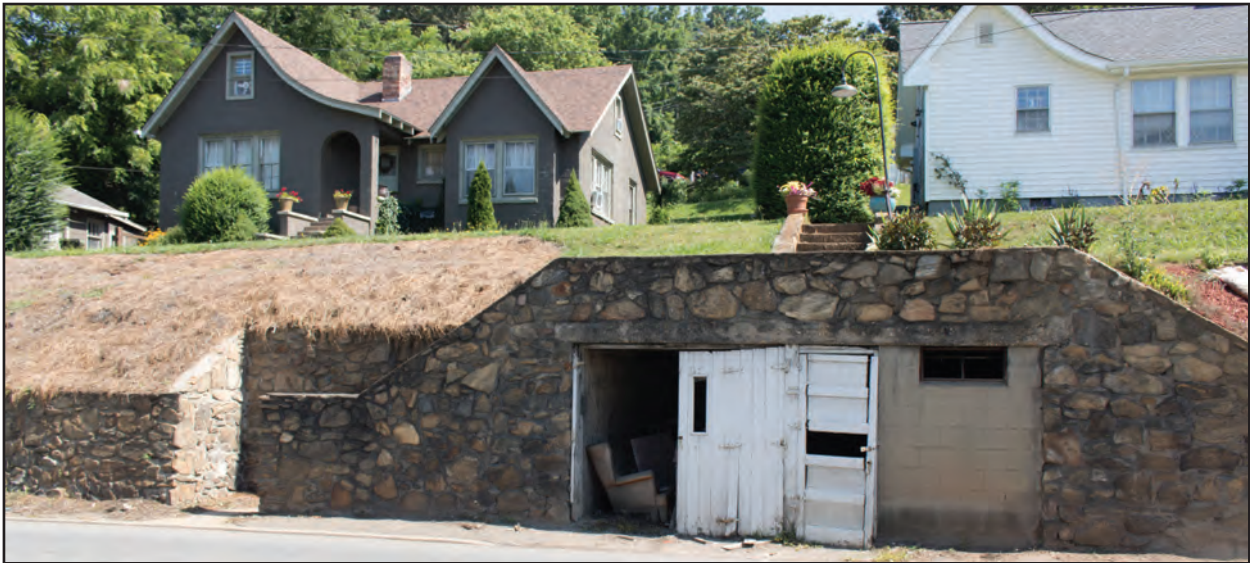
*Figure 5.14. 113 Pisgah Drive, Garage on Pisgah Drive*

An interesting feature of the property is a double garage that was built into the bank and the stone retaining wall in front of 113 and 115 Pisgah Drive (Figure 5.14). There are two garage spaces, one serving each house; neither one is currently being used. The tax parcel maps show that each property owns part of the garage. The space on the left associated with 113 Pisgah Drive is missing half of its door. The homeowner indicated that the door had been blown off by the constant traffic and that it was too dangerous to be down on the road in order to fix it. A set of stairs that approach the houses is located in the retaining wall to the left of the garage (Figure 5.15).
