SUBJECT: Historic Structures Survey Report, Install Curb, Gutter, and Roundabout on NC 1110,  
U-6055, Haywood County, ER 17-2014

**SUBJECT:** PA No. 17-04-0038: U-6055 Install Curb and gutter, roundabout, and 5' sidewalk on NC 1110 (Pisgah Dr) at Locust Street, Haywood County

HISTORIC STRUCTURES SURVEY REPORT OF THE  
INTERSECTION OF NC 110 (PISGAH DRIVE) AT LOCUST STREET IN CANTON

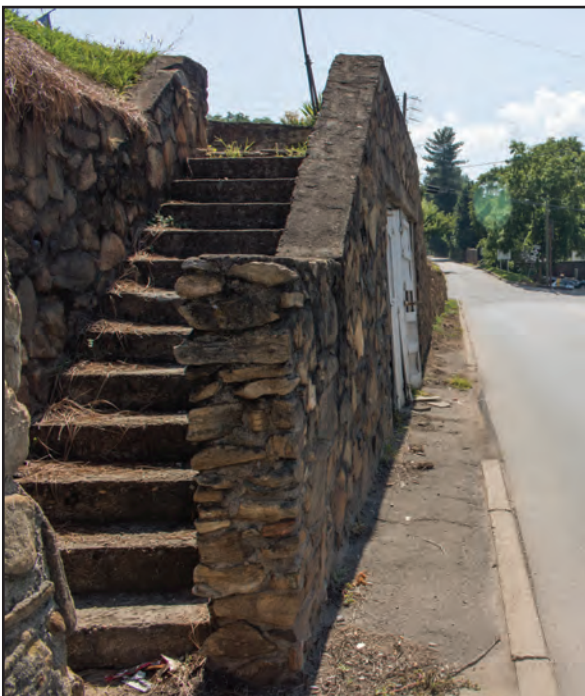
*Figure 5.15. Steps From  
Pisgah Drive to House*

An interesting feature of the property is a double garage that was built into the bank and the stone retaining wall in front of 113 and 115 Pisgah Drive (Figure 5.14). There are two garage spaces, one serving each house; neither one is currently being used. The tax parcel maps show that each property owns part of the garage. The space on the left associated with 113 Pisgah Drive is missing half of its door. The homeowner indicated that the door had been blown off by the constant traffic and that it was too dangerous to be down on the road in order to fix it. A set of stairs that approach the houses is located in the retaining wall to the left of the garage (Figure 5.15).

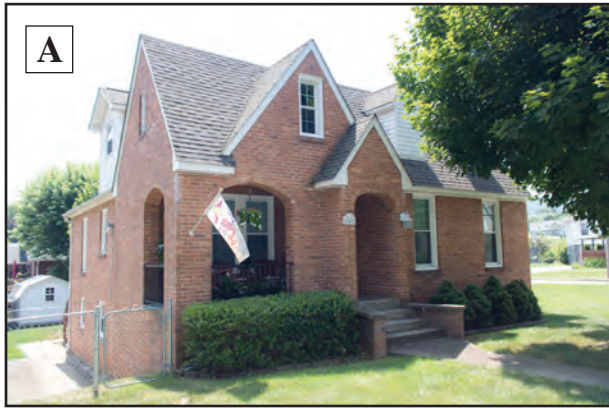
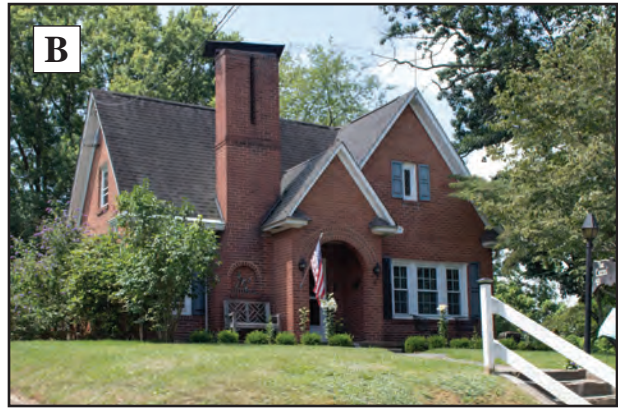
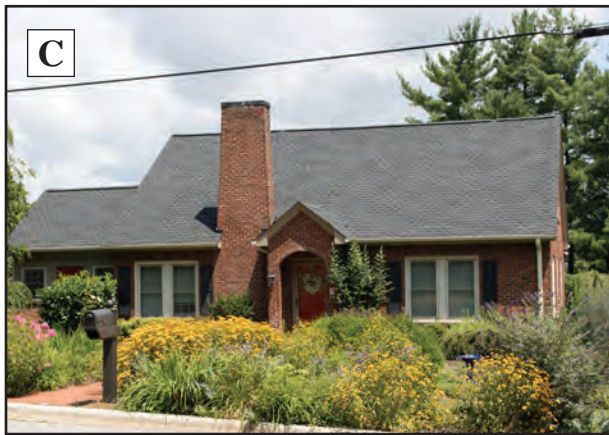
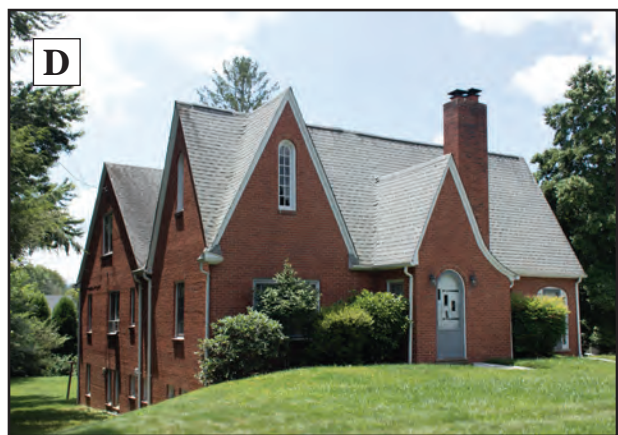
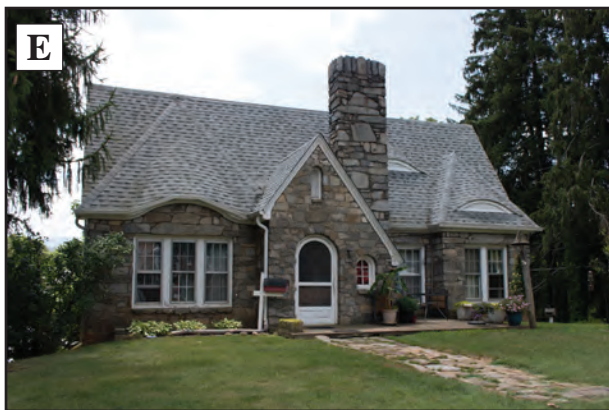
Figure 5.17. Examples of Period Cottage Style Homes

Like the Craftsman style, the Period Cottage was a common architectural style in Canton from the 1910s through the 1930s and examples can be found in many of the town's more affluent neighborhoods. It was not found to be commonly used as worker housing, but local managers and professionals built in this style. The following examples are all brick with side-gabled steeply pitched roofs and forward facing gables. Arched entries are also a common element, as are chimneys positioned on the front façade. 147 Pisgah Drive (1939) is just around the corner from the project area (Figure 5.17A). Examples can also be found at 43 (circa 1930, Wells-Greeley House) and 20 Pennsylvania Avenue (1926) (Figures 5.17B-C). Two more examples close to the project area can be found at 104 (1938) and 108 Johnson Street (Figures 5.17D-E). 104 Johnson Street is the 1938 Hutchins House (HW0569). This interesting example of Period Revival has many of the same elements as the examples already listed, but is built of granite and features eyebrow dormers on its steeply pitched roof.

A. 147 Pisgah Drive; B. 43 Pennsylvania Avenue;  
C. 20 Pennsylvania Avenue; D. 108 Johnson Street;  
E. Hutchins House (HW 0569)

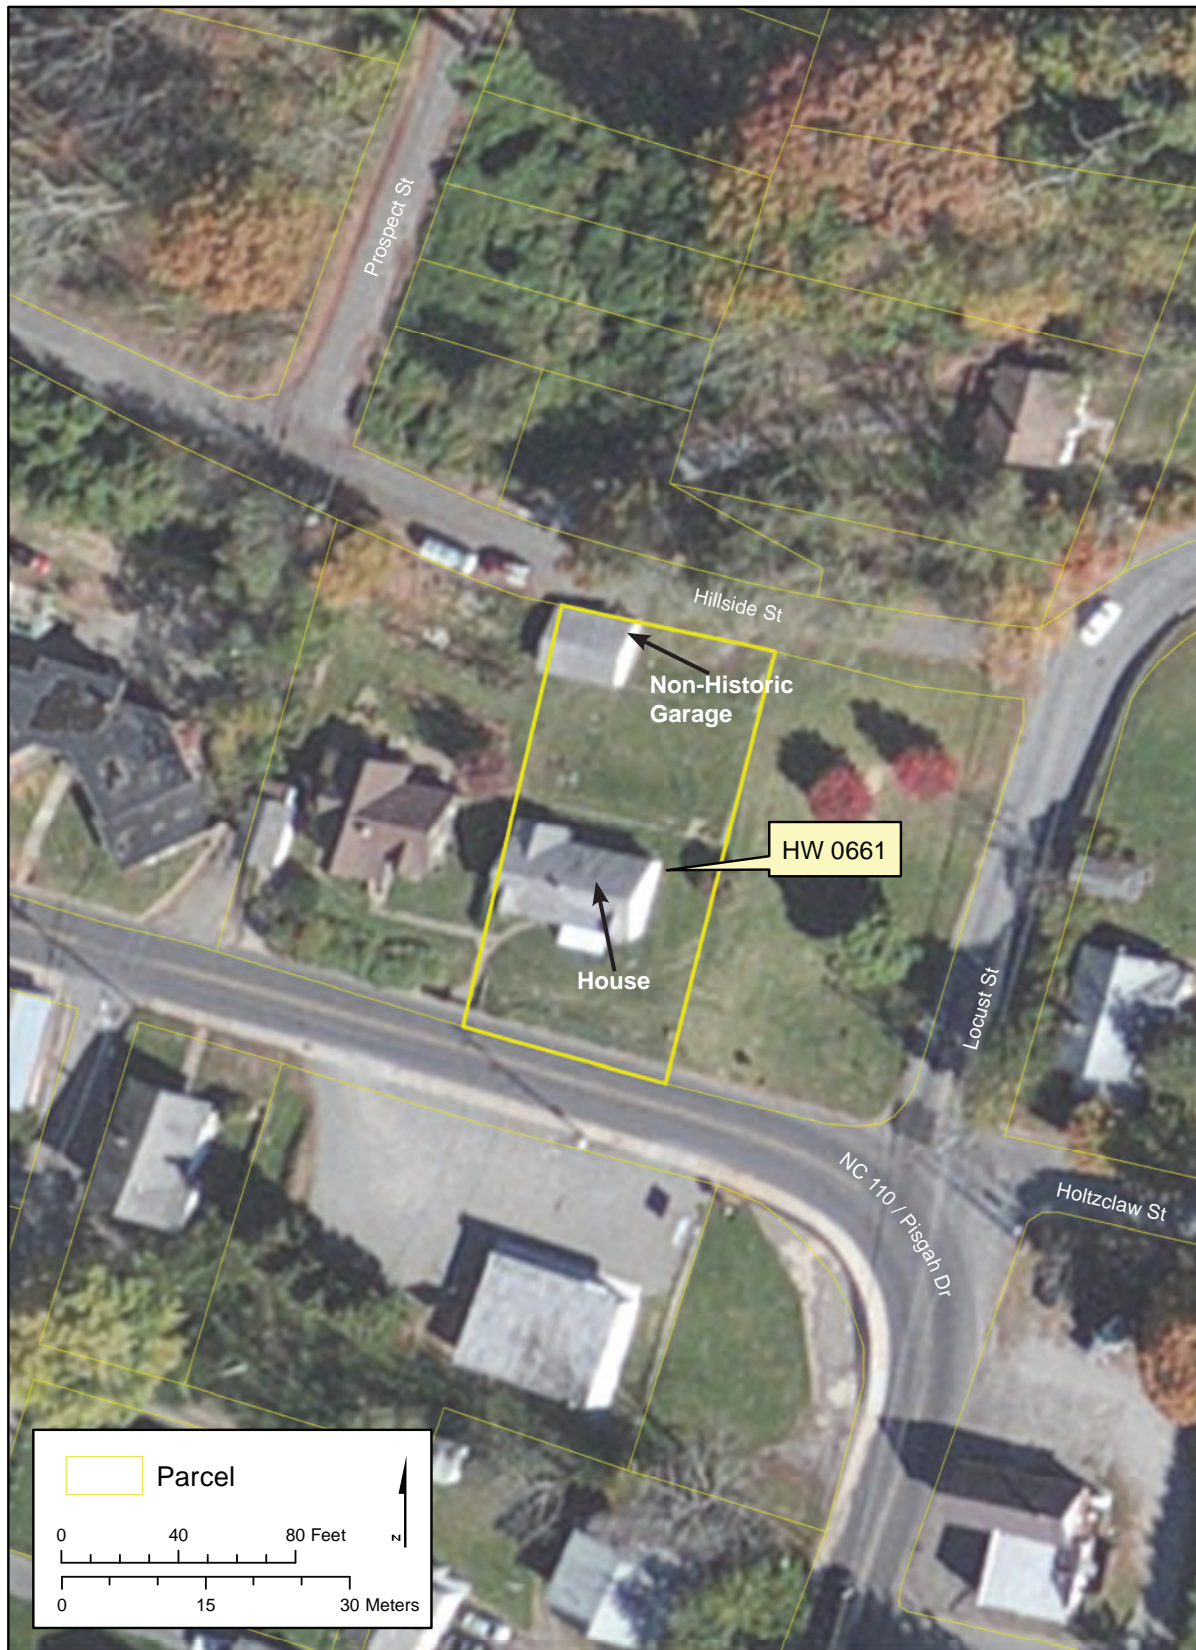
Figure 6.1. 115 Pisgah Drive, Site Plan

115 Pisgah Drive (HW0661) is located within the city limits of Canton, in Haywood County, North Carolina, approximately one-quarter mile south of downtown Canton on the east side of the Pigeon River (Figure 6.1). The house is situated on a hill overlooking the intersection of Pisgah Drive (NC 110), Holtzclaw Road, and Locust Street (Figures 6.2-6.3). During fieldwork it was observed that the intersection was extremely busy with traffic, including large trucks heading in both directions. The majority of the buildings in the immediate vicinity are single-family homes, although there are two businesses on Pisgah Drive within the viewshed of the resource. The house is located near the center of a 0.25-acre parcel of land that is bounded by Pisgah Drive on the south, Hillside Street on the north, and residential parcels on the east and west. A substantial stone retaining wall approximately four feet in height borders the property on the south along Pisgah Drive with a cut for steps on the southwest corner of the parcel. In addition to the house, there is a non-historic garage on the north edge of the parcel accessible by Hillside Street. There is not a driveway on Pisgah Drive. Landscaping consists mostly of lawn.

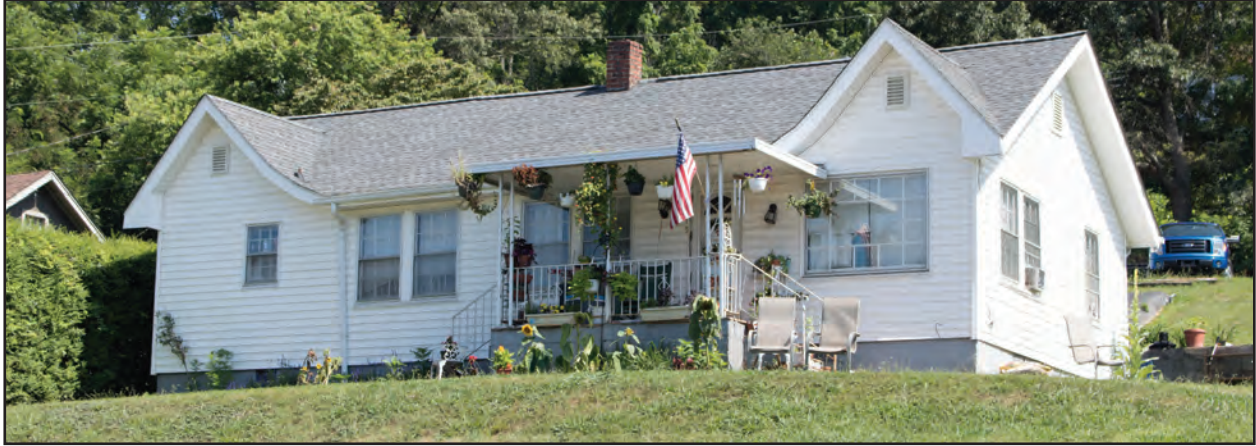
*Figure 6.4. 115 Pisgah Drive, South Side*

115 Pisgah Drive is a one-story rectangular house with a side gable roof clad in composition shingles (Figure 6.4). There is a perpendicular gable at each end of the house on the façade, both with eaves that sweep toward the center. The façade is balanced, but asymmetrical. There is one internal chimney. It has a continuous foundation that has been stuccoed and the exterior walls, soffit, and fascia have all been clad in vinyl siding. The windows are all six-over-six sashes and appear to be original.

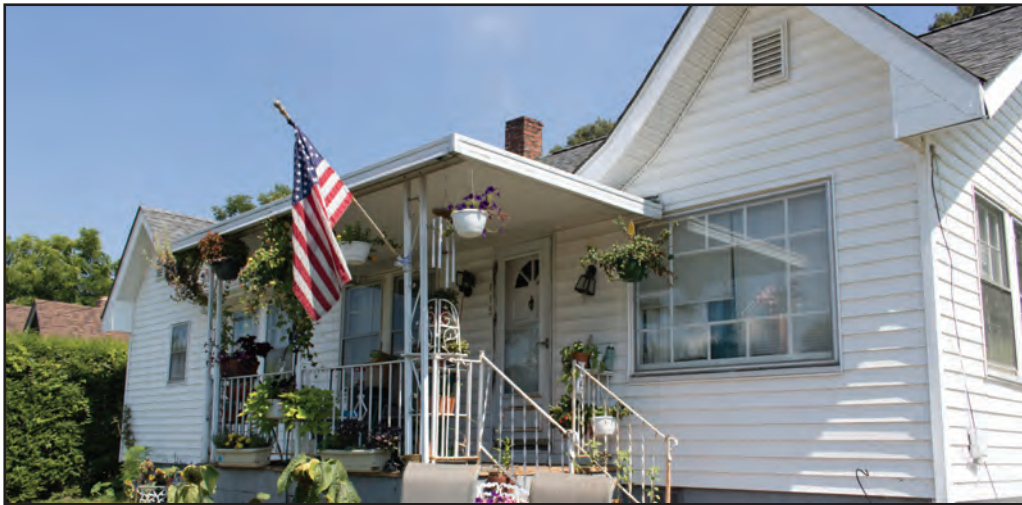
*Figure 6.5. 115  
Pisgah Drive,  
Porch Detail,  
South Side*

The 1945 Sanborn Map indicates that the western third of the house is a post-1945 addition. Under the right gable is a large fixed picture window and under the left gable is a small six-over-six window (Figures 6.5-6.6). To the right of center is a small porch consisting of concrete block foundation, metal posts and a flat metal roof. The single door entry is located on the porch. To

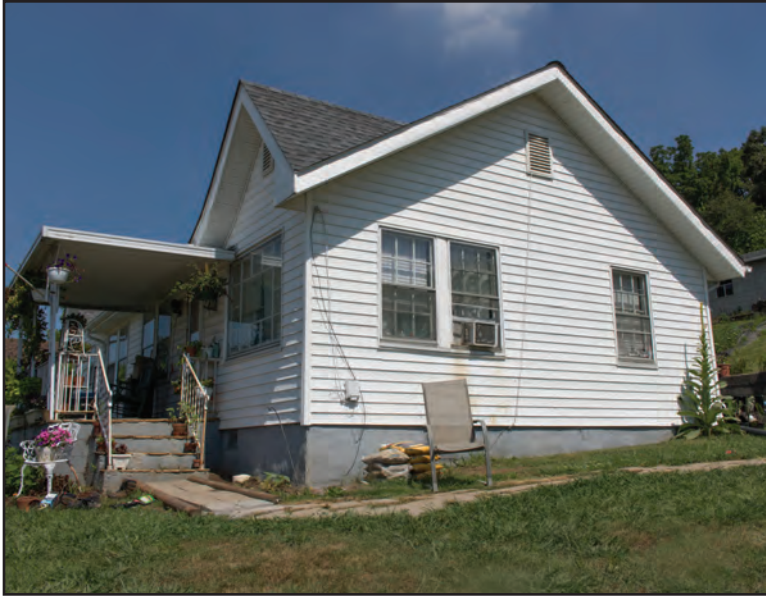
Figure 6.7. 115 Pisgah Drive, East Side

the left are paired windows. The east and west walls are punctuated by paired and single windows (Figure 6.7). The rear (north) wall has a gable projection on the right and five windows openings, two of which are smaller than the six-over-six sashes. (Figure 6.8-6.9). All of the window surrounds have been covered by vinyl siding.

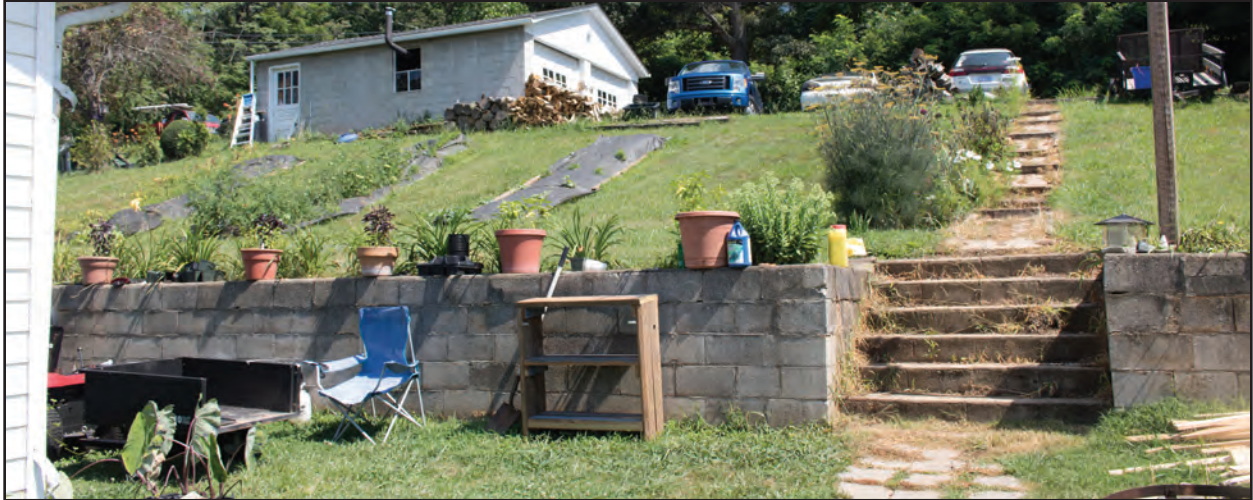
*Figure 6.10. 115 Pisgah Drive, View of Back Yard and Steps to Non-Historic Garage*

The house is located on a relatively steep hill and a concrete block retaining wall was constructed behind the house. Steps were also built to access the north end of the lot, where a two-car concrete block garage was built circa 1980 (Figure 6.10).

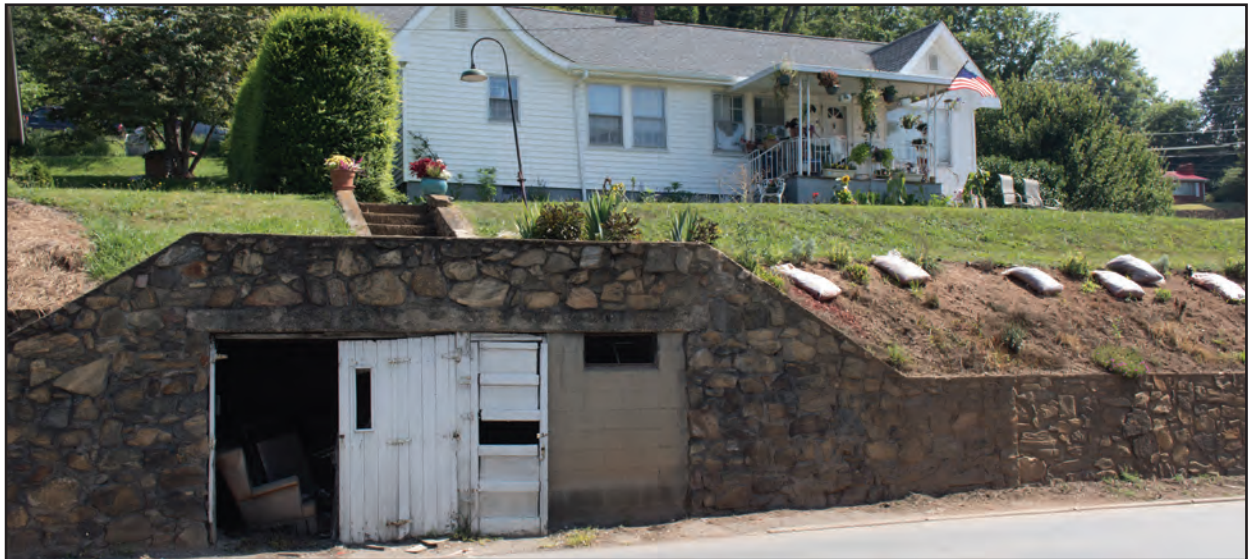
*Figure 6.11. 115 Pisgah Drive, Garage on Pisgah Drive*

An interesting feature of the property is a double garage that was built into the earth and the stone retaining wall shared by 113 and 115 Pisgah Drive (Figure 6.11). There are two garage spaces, one for each house, neither one is currently being used. The tax parcel maps show that each property owns part of the garage. The space on the right associated with 115 Pisgah Drive has been bricked in with concrete block. A set of stairs that approach the houses is located in the retaining wall to the left of the garage.

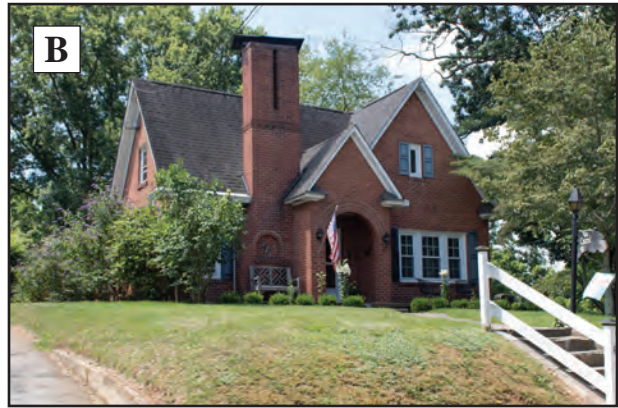
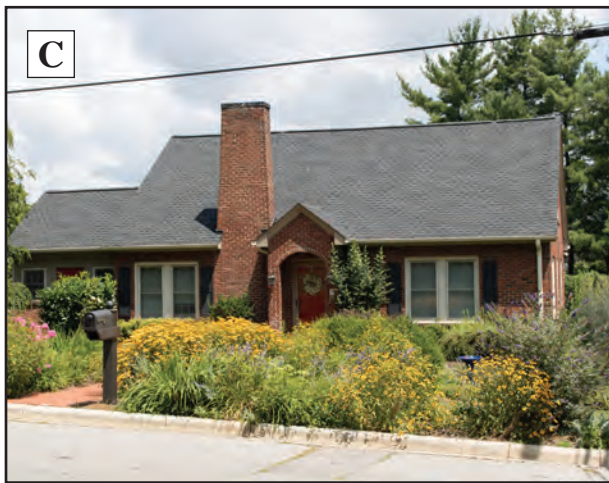
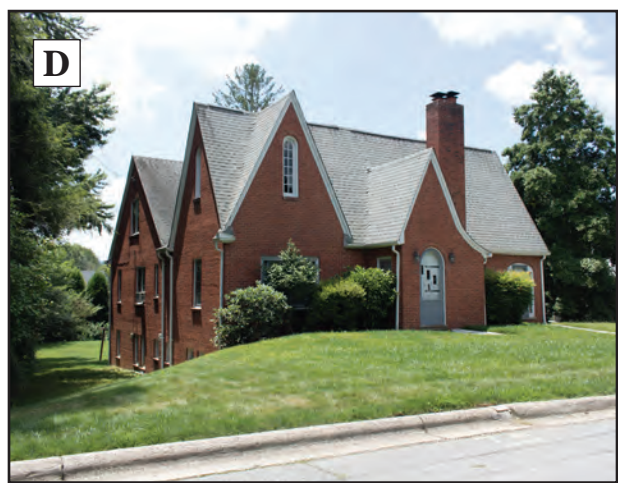
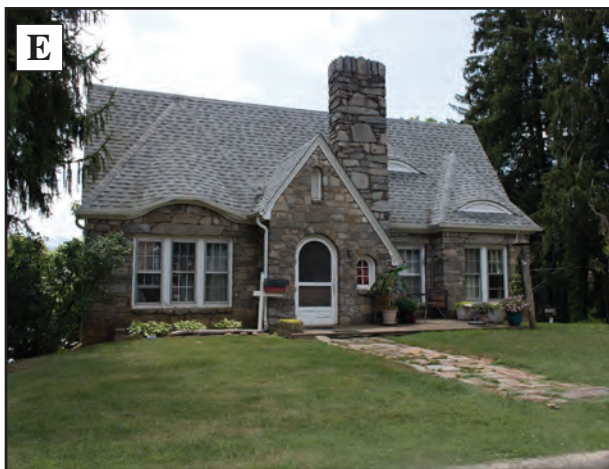
Figure 6.13 Examples of Period Cottage Style Homes

Like the Craftsman style, the Period Cottage was a common architectural style in Canton from the 1910s through the 1930s and examples can be found in many of the town's more affluent neighborhoods. It was not found to be commonly used as worker housing, but local managers and professionals built in this style. The following examples are all brick with side-gabled steeply pitched roofs and forward facing gables. Arched entries are also a common element, as are chimneys positioned on the front façade. 147 Pisgah Drive (1939) is just around the corner from the project area (Figure 6.13A). Examples can also be found at 43 (circa 1930, Wells-Greeley House) and 20 Pennsylvania Avenue (1926) (Figures 6.13B-C). Two more examples close to the project area can be found at 104 (1938) and 108 Johnson Street (Figures 6.13D-E). 104 Johnson Street is the 1938 Hutchins House (HW0569). This interesting example of Period Revival has many of the same elements as the examples already listed, but is built of granite and features eyebrow dormers on its steeply pitched roof.

A. 147 Pisgah Drive; B. 43 Pennsylvania Avenue; C. 20 Pennsylvania Avenue; D. 108 Johnson Street; E. Hutchins House (HW 0569)

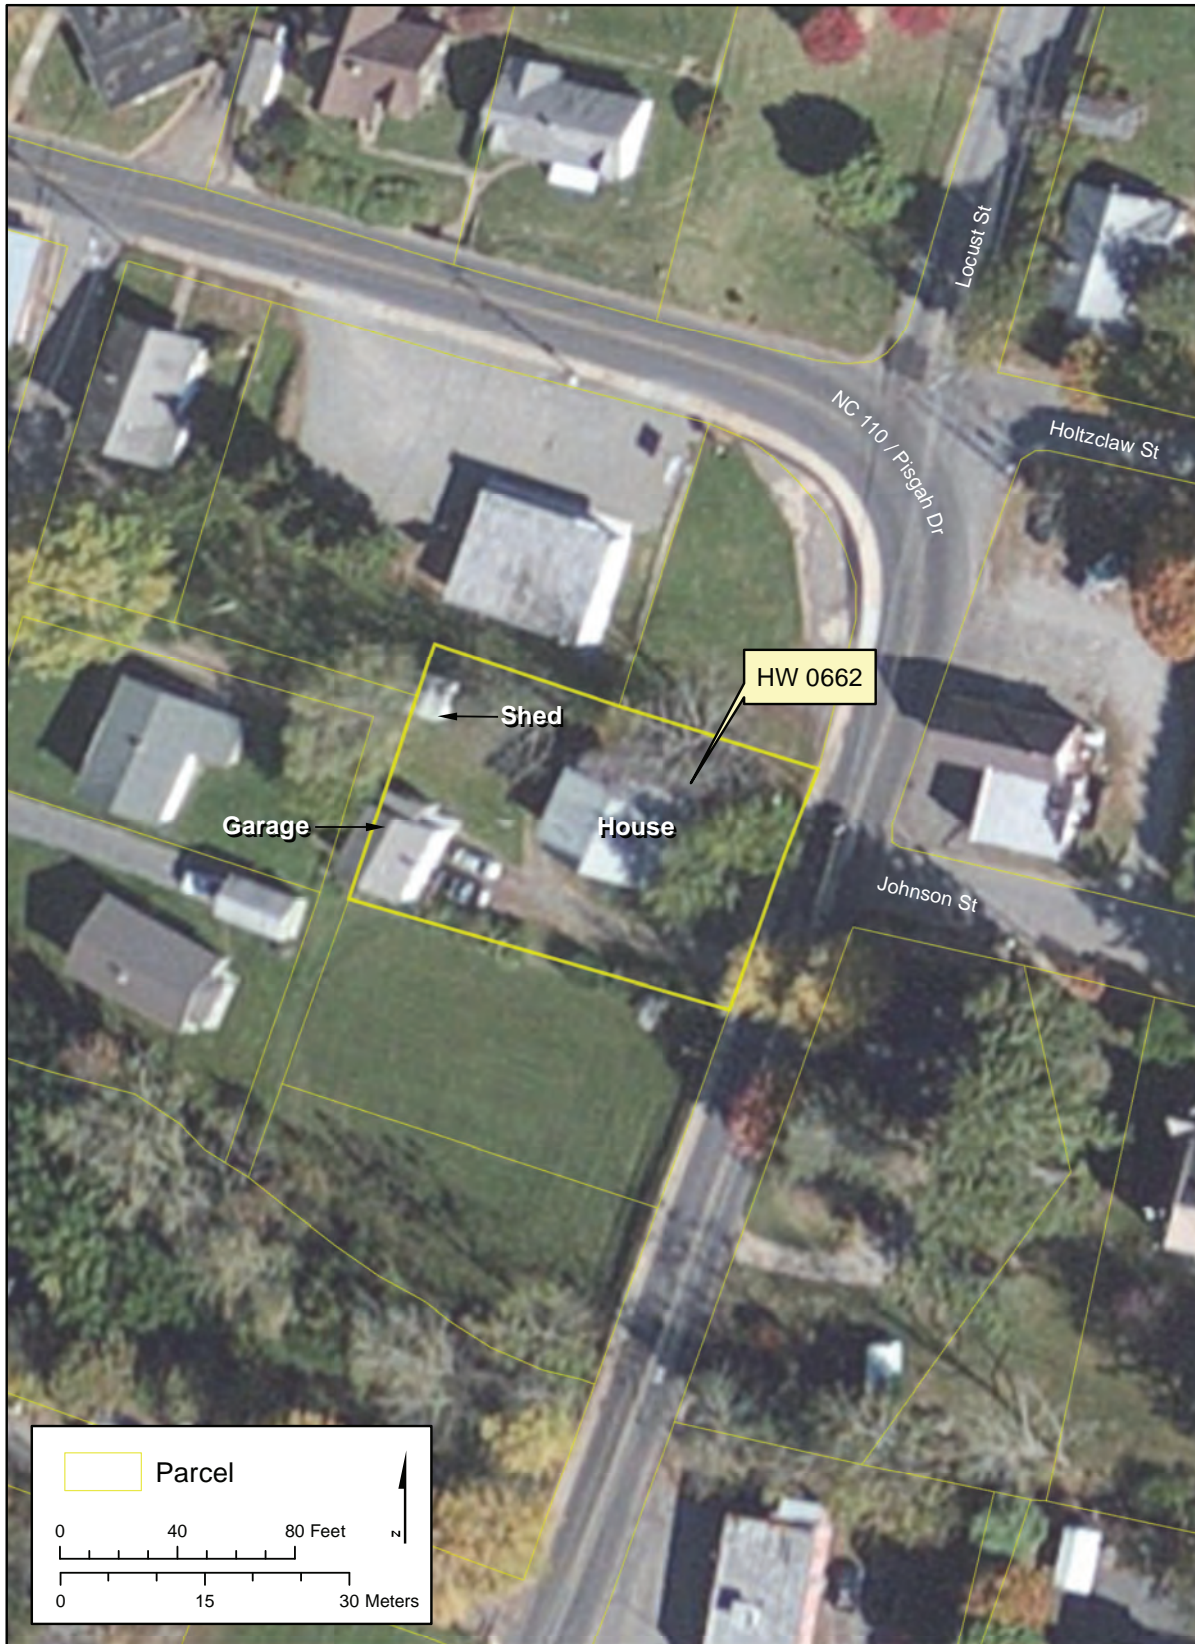
Figure 7.1. 120 Pisgah Drive, Site Plan

120 Pisgah Drive (HW662) is located within the city limits of Canton, in Haywood County, North Carolina, approximately 0.25 mile south of downtown Canton on the east side of the Pigeon River (Figure 7.1). The property is situated on the west side of Pisgah Drive (NC 110) just south of its intersection with Holtzclaw Road, and Locust Street (Figures 7.2-7.3). During fieldwork, it was observed that the intersection was extremely busy with traffic, including large trucks heading in both directions. The majority of the buildings in the immediate vicinity are single-family homes, although Howard Amoco (HW603) is located on Pisgah Drive across the street and within the viewshed of the resource. The house is located near the center of a 0.27-acre parcel of land that is bounded by Pisgah Drive on the east and other residential parcels on the north, south, and west. In addition to the house, there are two historic outbuildings on the property, a two-story garage and a small shed. The gravel driveway is located on the south side of the parcel, entered by Pisgah Drive. Landscaping consists of a small lawn and some mature trees surrounding the house.

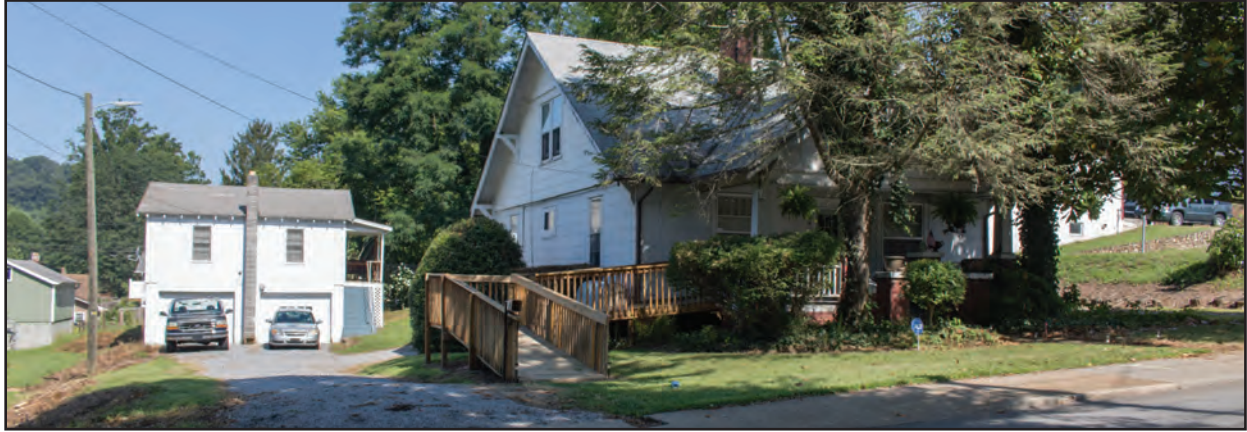
*Figure 7.4. View Across Pisgah Drive of Property*

The east-facing façade of the house features a partial-width porch with a projecting gable roof (Figures 7.4-7.5). The porch is supported at each end by a battered wood column that sits atop a brick base with a concrete cap. There are two brick bases in between without columns. A wood balustrade runs between the bases. A paneled door is centered on the porch and is flanked by a six-over-one windows. A wheelchair ramp has been constructed on the south side of the porch (Figure 7.6).

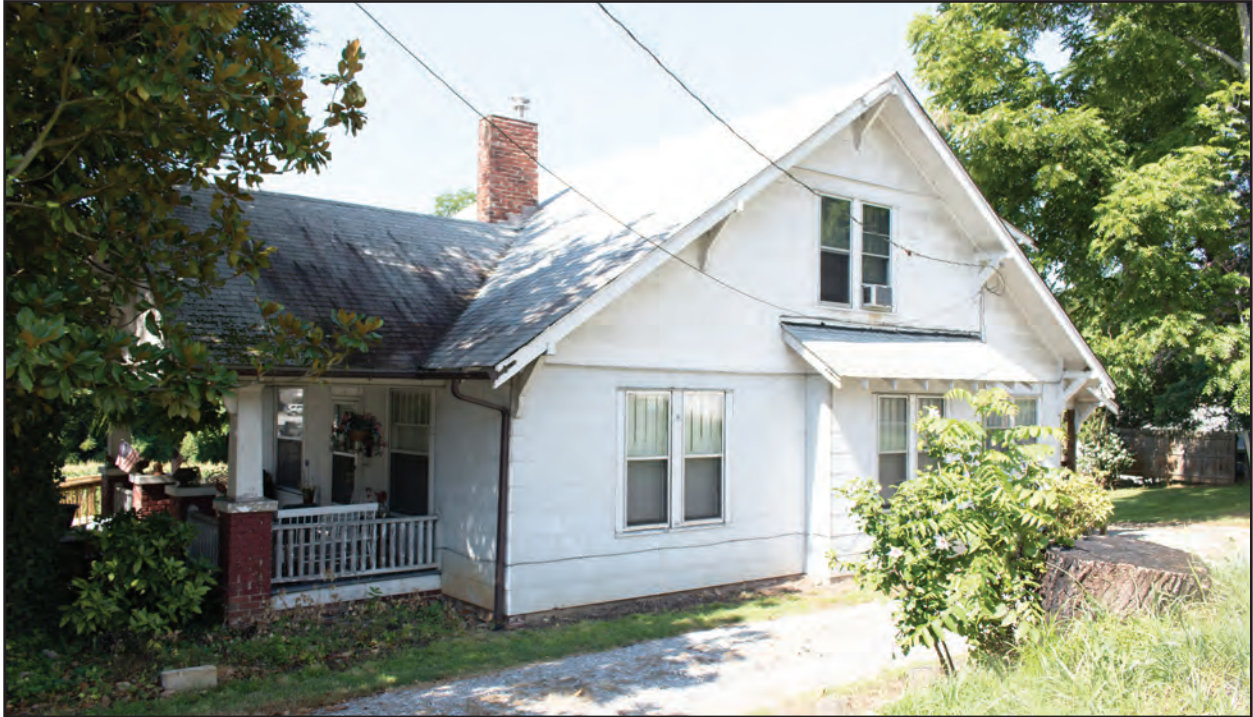
Figure 7.7. 120 Pisgah Drive, North Side

The north elevation is symmetrical with a small shed roof projection with exposed rafter tails in the center of the wall (Figure 7.7). The projection has paired windows and is also flanked by a pair on each side and one above in the upper floor (Figures 7.8 and 7.9). The rear of the house features a large shed-roof dormer with a triple band of windows on the left and a single eight-

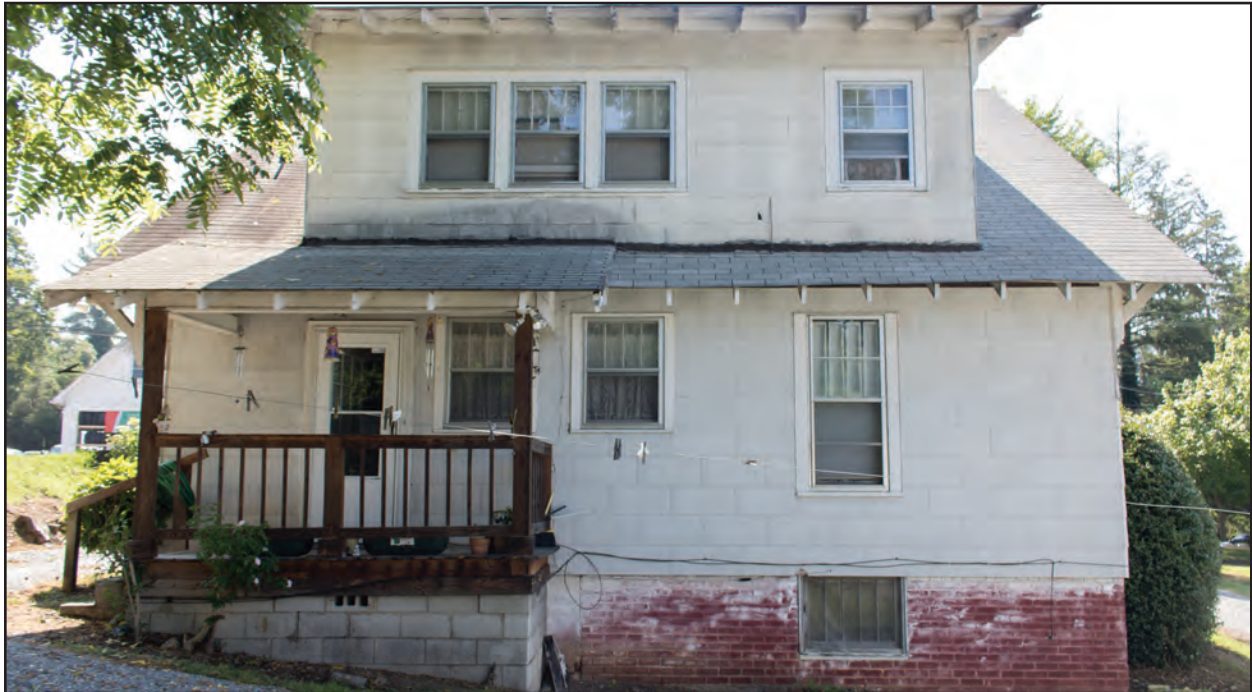
*Figure 7.10. 120 Pisgah Drive, West Side*

over-one window on the right (Figure 7.10). There is a small shed-roof porch at the left end. It has a concrete block foundation, square replacement posts and a replacement balustrade. The porch shelters a partially glazed back door. A rear porch appears on the 1945 Sanborn. There are three windows on the lower rear wall, two smaller ones and one standard size, as well as a fixed five-light window to the basement garage. The south wall contains a roll-up door to the basement garage (Figure 7.11). The wall at the main floor level has a window at each end and a small two-light window in between. The upper floor has paired centered in the gable end.

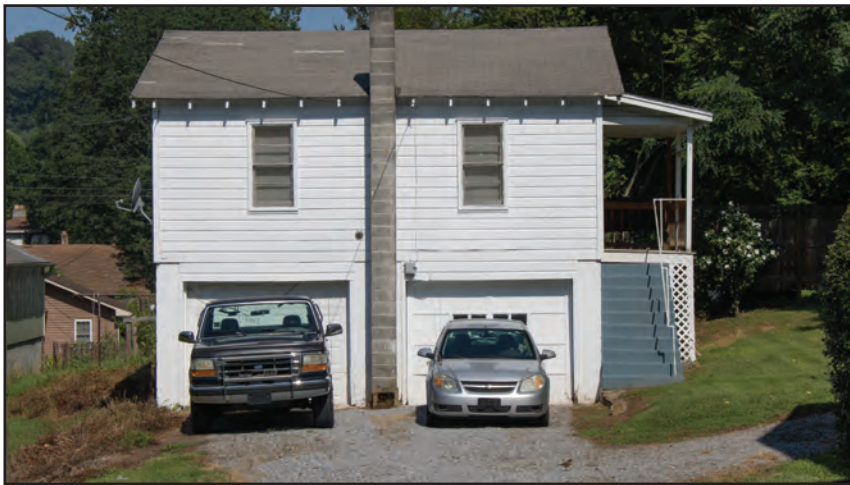
Figure 7.12. 120 Pisgah Drive, Garage

A two-story gabled garage with an apartment above that is located north of the house does not appear on the 1945 Sanborn Map (Figure 7.12). It is concrete block construction with drop siding on the upper floor. Windows are two-over-two horizontal lights and the roof has exposed rafter tails on the east and west elevations. The east wall, which faces Pisgah Drive, has two roll-up garage doors in the lower level and above each garage door on the upper level. A cinder block chimney is centered on the wall, rising several feet above the roof. A shed roof porch with thin, square supports leads to the apartment entrance on the north gable end. The porch is accessed by a set of concrete steps. The single door entrance to the apartment is located on the porch. The south wall has two windows in the upper level. There are also two windows on the north wall.

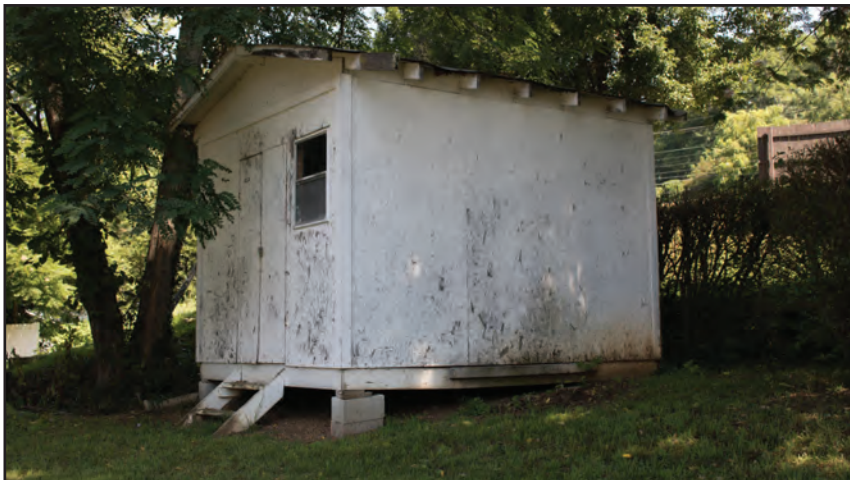
Figure 7.13. 120 Pisgah Drive, Shed

A small, rectangular shed with particle board walls, set on concrete block piers is located in the northwest corner of the lot (Figure 7.13). The shed has a gable roof with exposed rafter tails. A particle board door and a small aluminum frame one-over-one window are located on the south wall.

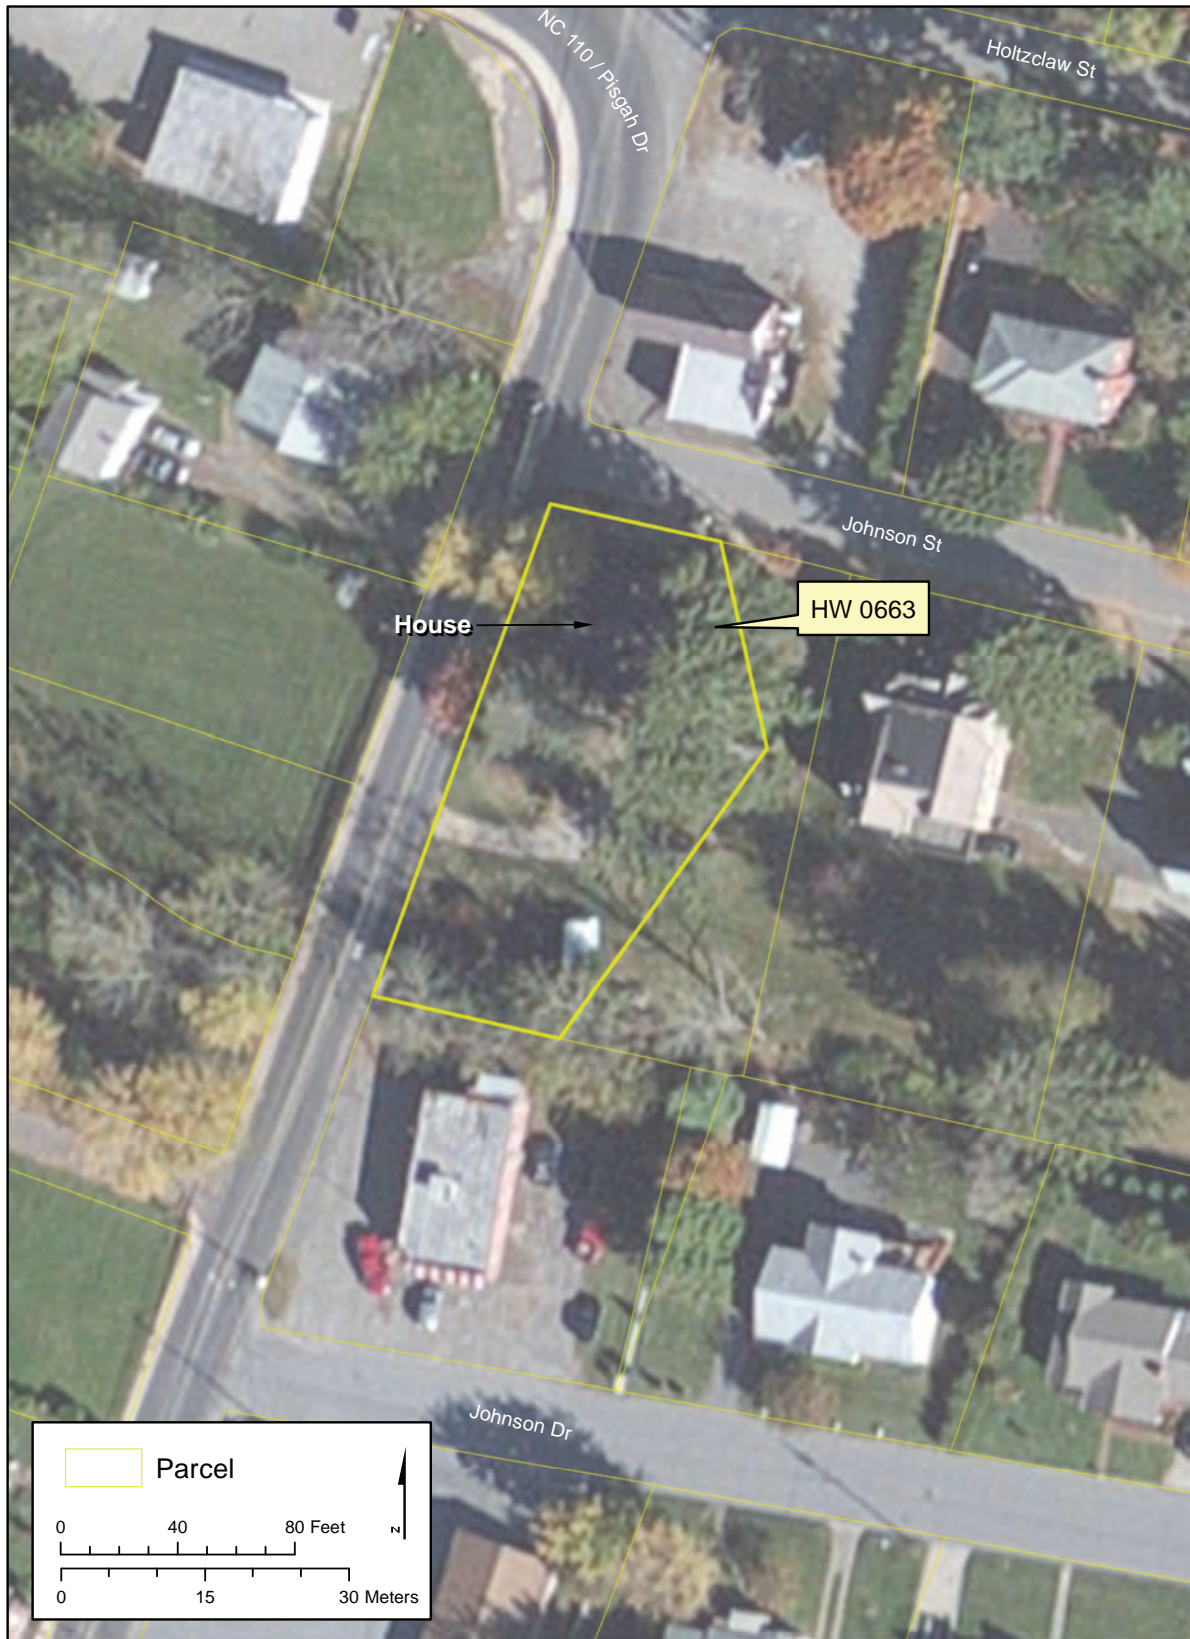
Figure 8.1. 121 Pisgah Drive, Site Plan

121 Pisgah Drive (HW0663) is located within the city limits of Canton, in Haywood County, North Carolina, approximately 0.25 mile south of downtown Canton on the east side of the Pigeon River (Figure 8.1). The house is situated on the east side of Pisgah Drive (NC 110), at its intersection with Johnson Street (Figure 8.2). During fieldwork it was observed that the intersection was extremely busy with traffic, including large trucks heading in both directions. The majority of the buildings in the immediate vicinity are single-family homes, although Howard Amoco (HW603) is located on Pisgah Drive next door and within the viewshed of the resource. The house is located in the northwest corner of a 0.35-acre parcel of land that is bounded by Pisgah Drive on the west, Johnson Street on the north and other residential parcels on the south and east. The gravel driveway is located near the center of the parcel on Pisgah Drive. Landscaping consists of a grass lawn, foundation plantings, and mature trees.

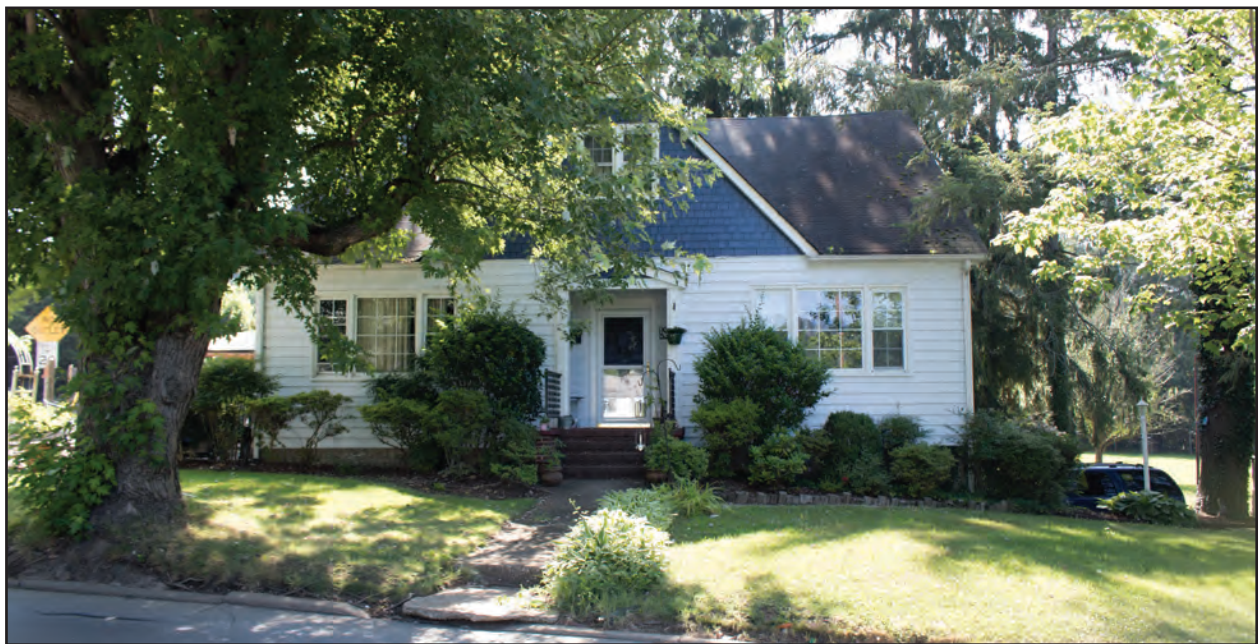
Figure 8.3. 121 Pisgah Drive, West Side

The west-facing façade of the house is symmetrical, with a flush centered gable on the roof (Figure 8.3). A small pedimented recessed entry centered on the façade contains the partially glazed door, and is approached by four brick steps. To each side of the entrance is a tripartite window with a

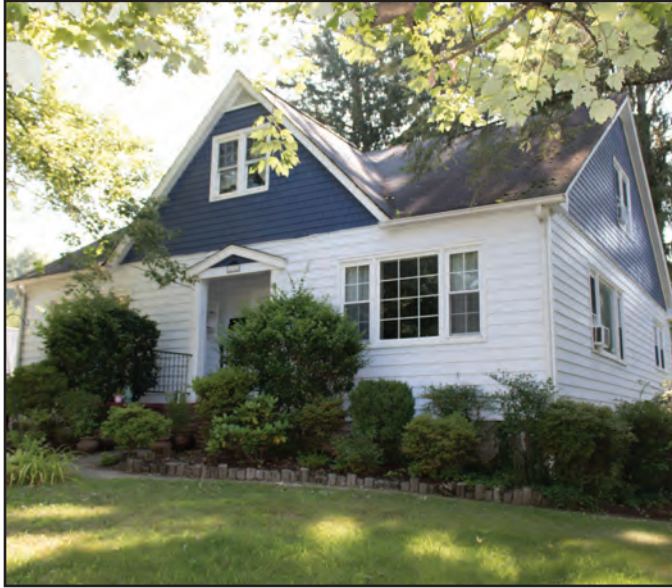
*Figure 8.4. 121 Pisgah Drive, West and South Sides*

large fixed 12-pane window in the center, flanked by double-hung, four-over-four sashes (Figures 8.4-8.5). There is also a pair of four-over-one windows in the front-facing gable. All of the windows are vinyl replacements. The south elevation of the house features a basement level garage door (Figure 8.6). The first floor of the house has another tripartite window toward the

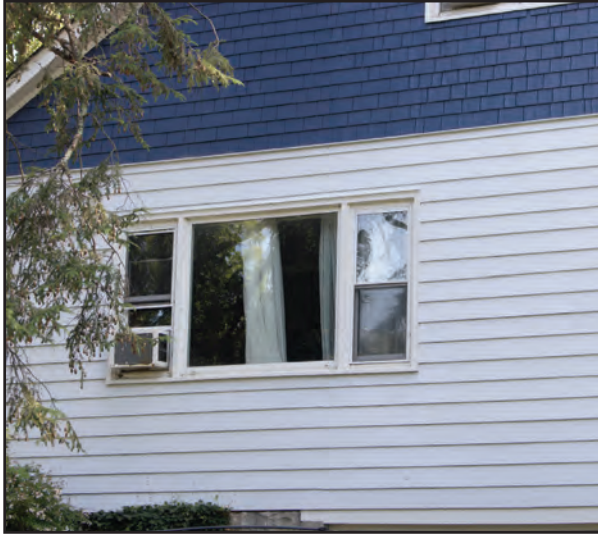
*Figure 8.7. Window Detail South Side*

front of the house and a pair of one-over-one windows at the rear and in the gable end (Figure 8.7). The rear (east) wall has a full-width shed roof dormer. The centered back door is sheltered by a hipped stoop (Figures 8.8-8.9). This elevation was hard to photograph because of the proximity of the trees in the back. The north elevation of the house also has a tripartite window near the center of the wall and a pair of windows at the rear and above in the gable end (Figure 8.10-8.11). There are no outbuildings associated with 121 Pisgah Drive.
