SUBJECT: Historic Structures Survey Report, Replace Bridge 35 on SR 1143 over Tributary  
To Slades Creek, PA 16-08-0034, Hyde County, ER 17-2451

To: Renee Gledhill-Earley, NCHPO  
From: Vanessa E. Patrick, NCDOT  
Date: October 31, 2017  
Subject: *Historic Structures Survey Report - Replace Bridge No. 35 on SR 1143 (Sladesville-Credle Road) over Tributary to Slades Creek, Hyde County, North Carolina. WBS No. 17BP.1.R.83. PA Tracking No. 16-08-0034*

HISTORIC STRUCTURES SURVEY REPORT  
REPLACE BRIDGE NO. 35 ON SR 1143 (SLADESVILLE-CREDLE  
ROAD) OVER TRIBUTARY TO SLADES CREEK  
HYDE COUNTY, NORTH CAROLINA

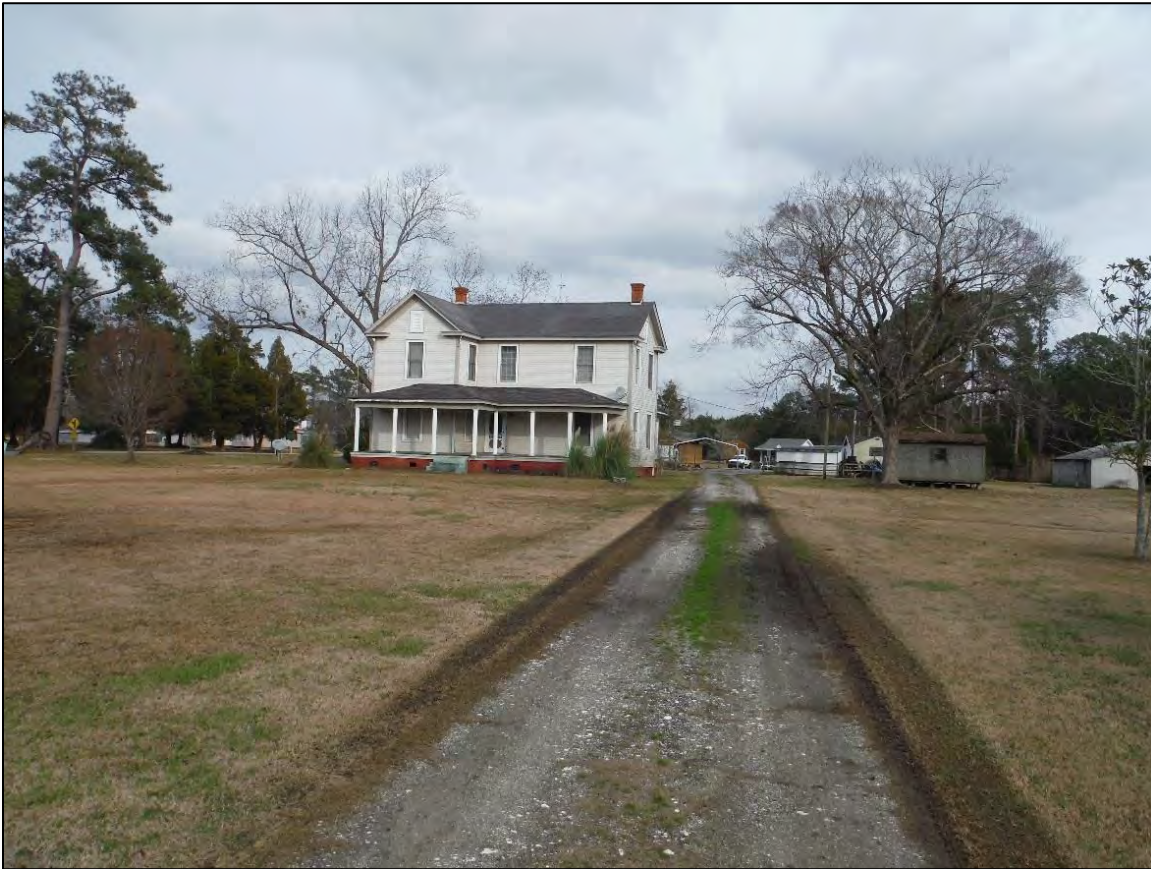
**Figure 3. Gratz Credle House and property, facing east.**

The Gratz Credle House (PIN 7643-73-5076) is located at 5331 Sladesville-Credle Road, southeast of the intersection of SR 1143 (Sladesville-Credle Road) and SR 1142 (Lynnsburg Road), north of a tributary of Slades Creek, in the community of Sladesville, in Hyde County (Figure 2). The structure, which is set back from the road, is a two-story, cross-gabled house, built around 1910 (Figure 3). The parcel on which the house sits, which is approximately 1.2 acres, also contains a late-twentieth-century wooden shed, located south of the house. The house was recorded as part of the Hyde County architectural survey in 1980 (Survey File 1980: HY0190).

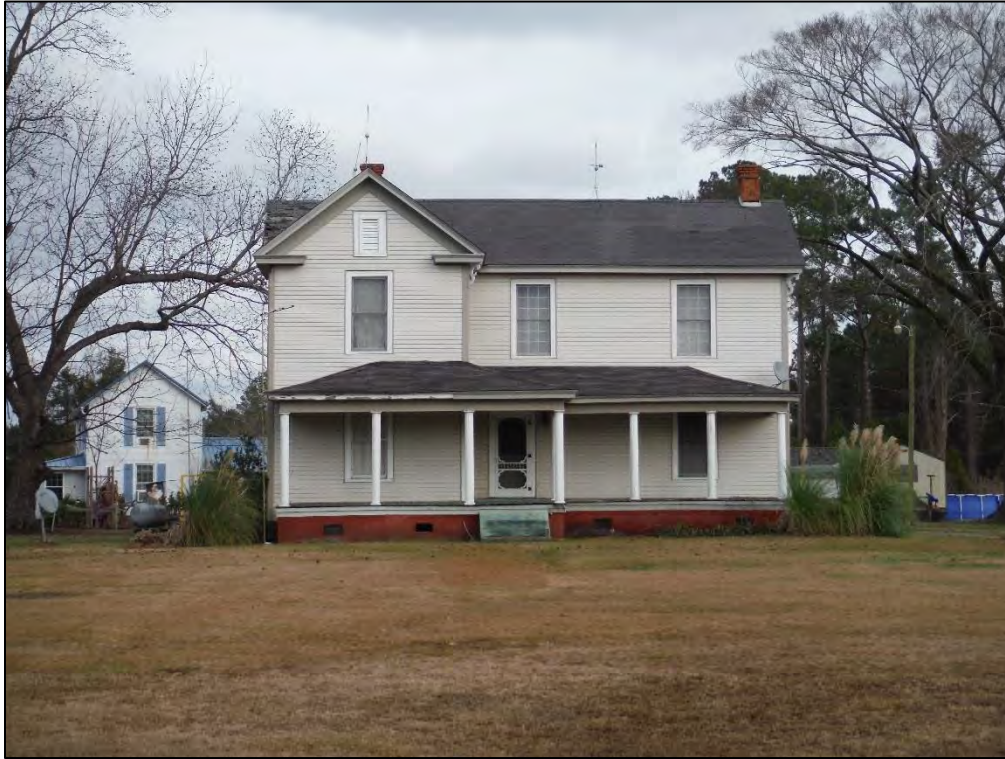
**Figure 4. Gratz Credle House, facing east.**

The Gratz Credle House is a two-story, frame structure with a T-shaped plan (Figure 4). The building rests on a brick pier foundation that has been infilled with brick, leaving vent openings. The front elevation is three bays wide, with the northern bay being the projecting, front-gabled section. The entry door is in the central bay and is located beneath a hipped roof porch, supported by fluted columns and spanning the façade, wrapping around the projecting bay. The bay has cornice returns and a rectangular vent centered in its attic story. Fenestration on both the front and south elevations of the bay consist of one-over-one, double-hung wooden sashes. Where the corners of the gable project from the corners of the walls, there is a single scrollwork bracket, set on the diagonal on the southern side of the gable projection.

The side-gabled portion of the front elevation contains the entry door and a single one-over-one double-hung wooden sash window on the lower story, with two nine-over-nine, double-hung wooden sash windows on the upper story. Two interior brick chimneys, both with corbelled caps, are visible above the roofline (Figure 5). The south elevation of the house is two bays deep, with cornice returns and a rectangular vent centered in the attic story, similar to the front-projecting gable. The upper story fenestration is two nine-over-nine, double-hung wooden sash windows, while the lower story has one-over-one, double-hung wooden sash windows (Figure 6). The same scrollwork bracket as on the front-projecting elevation is visible on both corners of the south gable end.

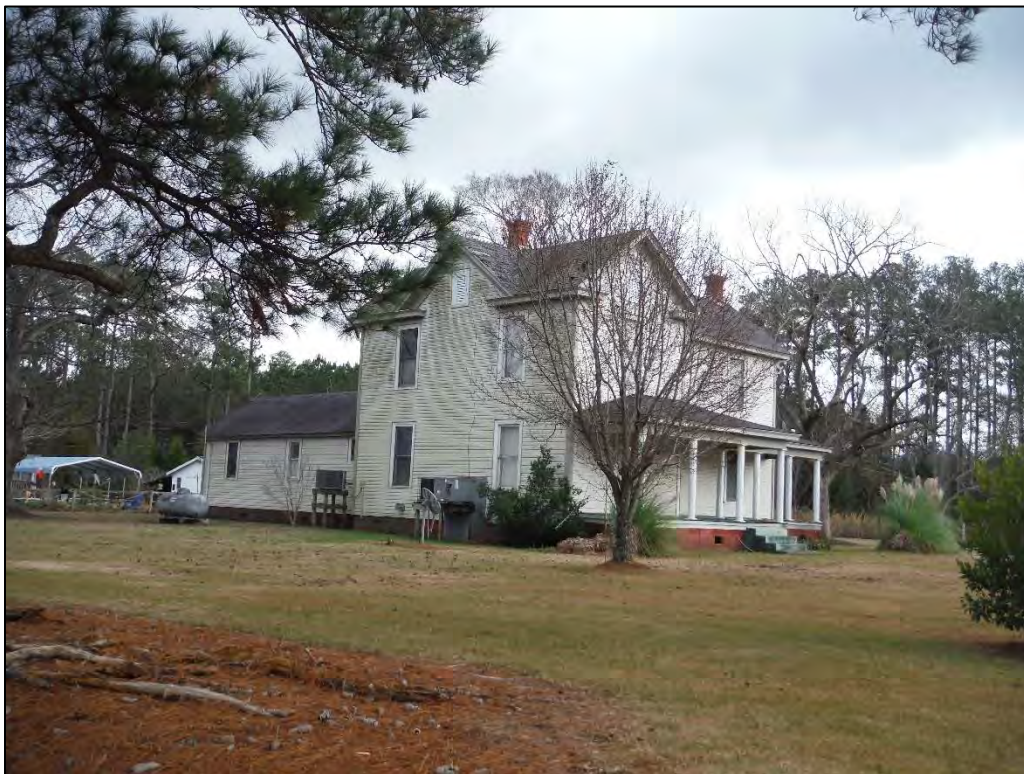
**Figure 7. Gratz Credle House, facing southeast.**

Since it was surveyed in 1980, the Gratz Credle House has undergone some alterations. Original survey photographs show that in 1980 the brick pier foundation had yet to be infilled and a portion of the rear single-gable addition was a screened in porch. At the time, the portion of the front porch along the side-gabled section of the house was enclosed by screens and the rectangular attic vents were small windows. The type of fenestration on the house is difficult to decipher in the photographs, as are the details of the columns, but it appears there have been some window replacements and that the porch support columns have been changed to new, metal, fluted versions. The corner scrollwork brackets are not visible in the 1980s photographs, and the wooden weatherboard siding has been covered or replaced with vinyl siding.

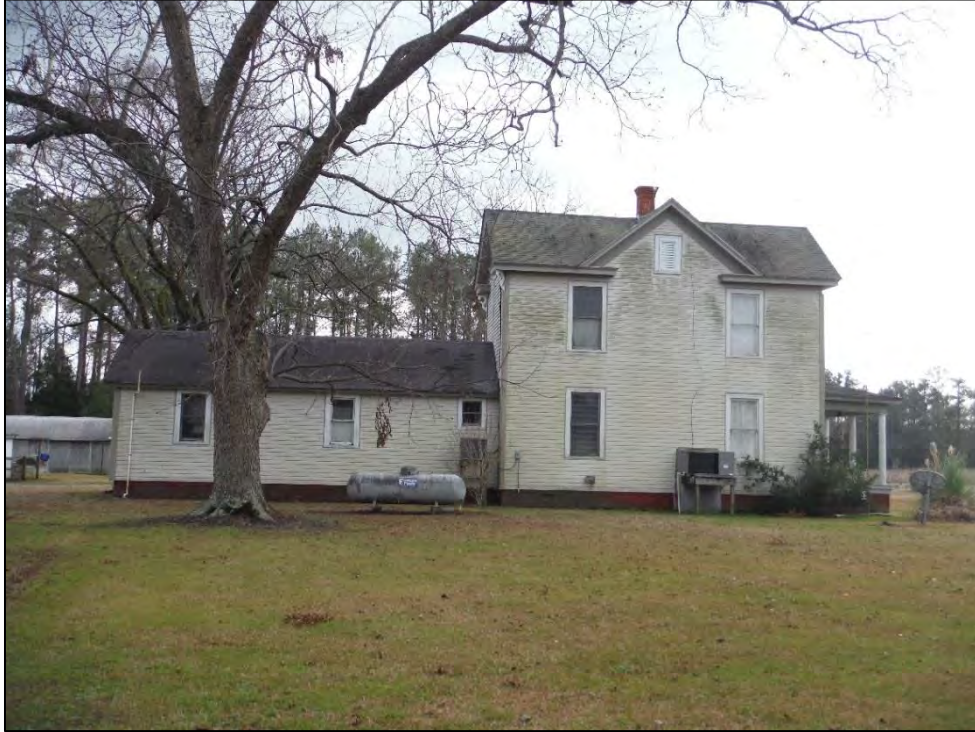
**Figure 8. Gratz Credle House, facing south.**

The north elevation of the house has two bays, with a central gable with cornice returns projecting above the eaves (Figures 7 and 8). This section of the house projects rearward, past the side-gabled portion of the house, creating a T-shape. The rear-facing gable has no windows, but has cornice returns, a rectangular vent in the attic story, and the decorative corner scrollwork brackets that are evident on the front and side gables. A single story, gabled rear addition projects from the rear gable at the northeastern corner of the house; its north elevation has three small, one-over-one, aluminum sash windows, while its south elevation is a recently enclosed porch with plywood and modern four-over-four, vinyl sash windows. A second porch, hipped roof and supported by fluted columns, spans the portion of the house's rear elevation that is south of the rear-projecting gable (Figure 6). The house is covered with vinyl siding and the roofing is composition shingle. Although it has undergone alterations since its construction, the house retains an early-twentieth-century vernacular form with classical influences that were popular during the period. Interior access to the structure was not possible, as attempts to contact the owners went without response.

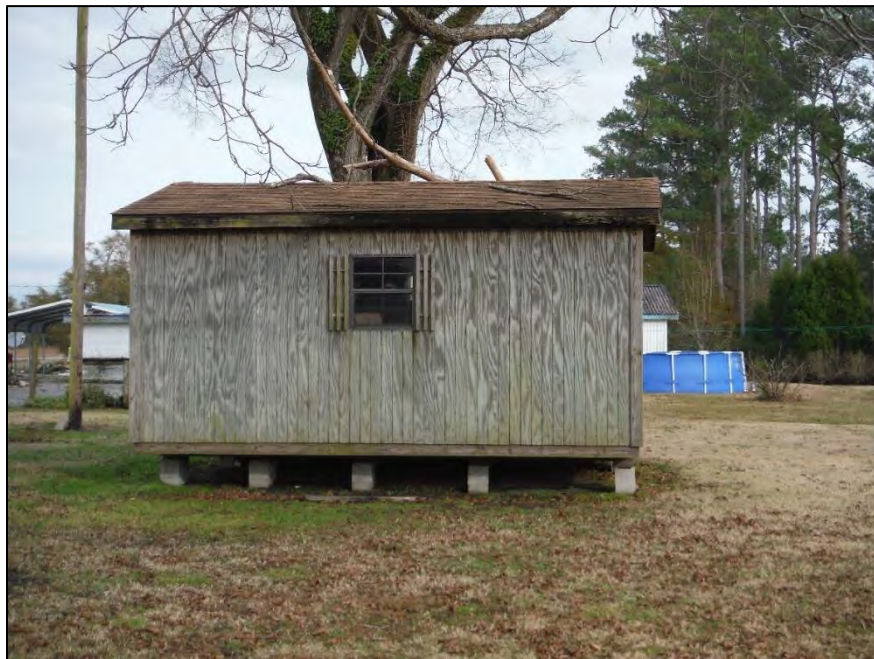
Located south of the Gratz Credle house is a single story, gabled, wooden storage shed that dates to the late-twentieth century. It is set on concrete blocks and has vertical wooden beadboard siding and a composition shingle roof (Figure 9). Other outbuildings photographed during the 1980 survey are no longer extant.

**Figure 9. Twentieth century storage building at the Gratz Credle House, facing east.**

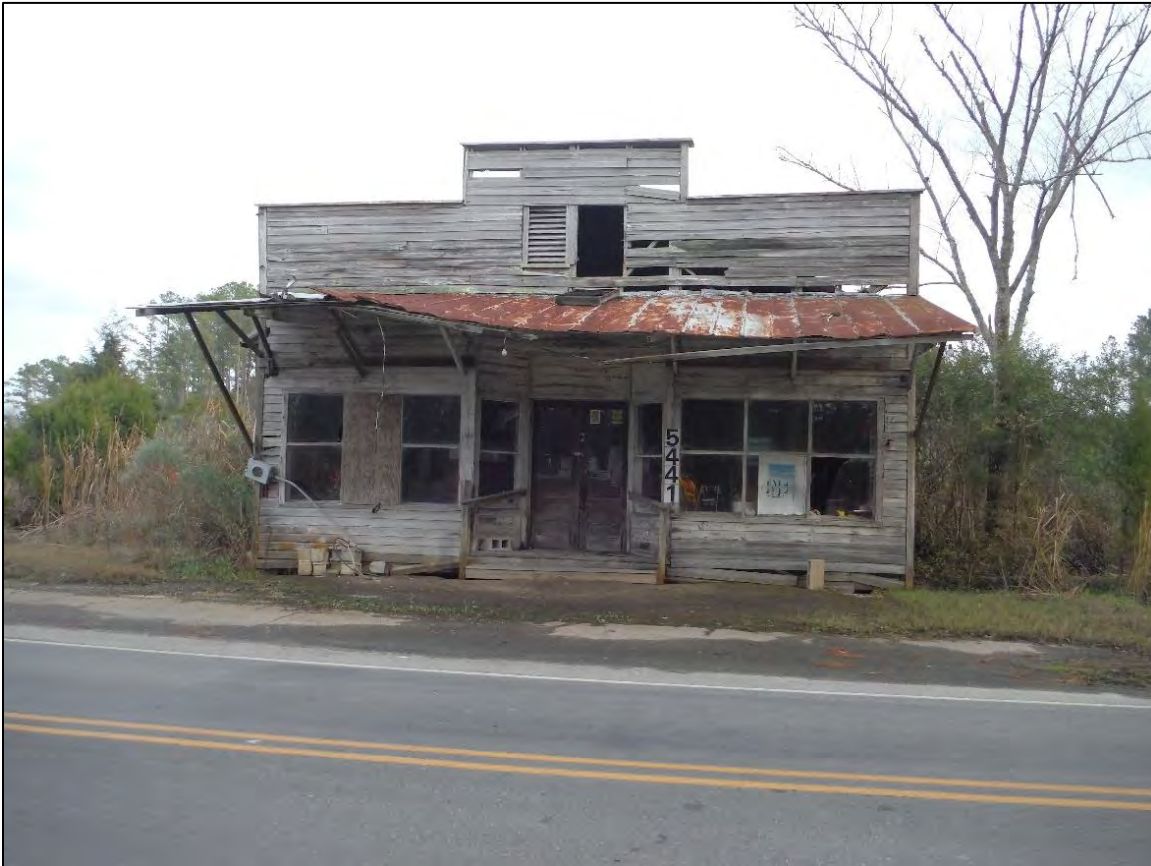
**Figure 21. Napoleon Sears Store, facing east.**

The Napoleon Sears Store (PIN 7643-72-2538) is located at 5441 Sladesville-Credle Road, east of SR 1143 (Sladesville-Credle Road) and south of a tributary to Slades Creek, in the community of Sladesville in Hyde County. The structure, which is set close to the road, is a single-story, gable-roofed commercial building with a façade parapet, built around 1937 (Figure 21). The 0.25-acre parcel on which the store sits is a triangular piece of land, situated at a bend in the nearby creek, and consisting of mostly marshland, outside of the store. The store was recorded as part of the Hyde County architectural survey in 1980 (Survey File 1980:HY0194).

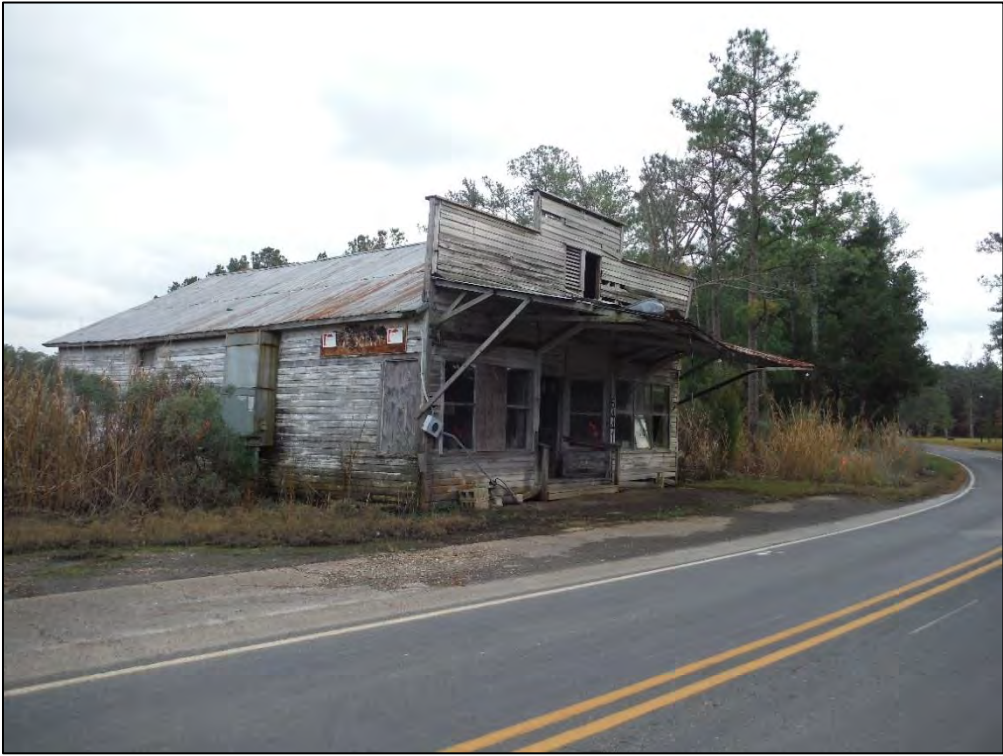
Figure 22. Napolean Sears Store, facing southeast.

The Napoleon Sears Store is a wooden framed building, with a rectangular plan and gabled roofline, although a false, stepped parapet front obscures the primary roofline from the façade (Figure 22). The structure is covered with horizontal wooden weatherboard and the roof is covered with corrugated metal (Figure 23). The north elevation has a small window, near the roof-wall juncture, toward the back of the

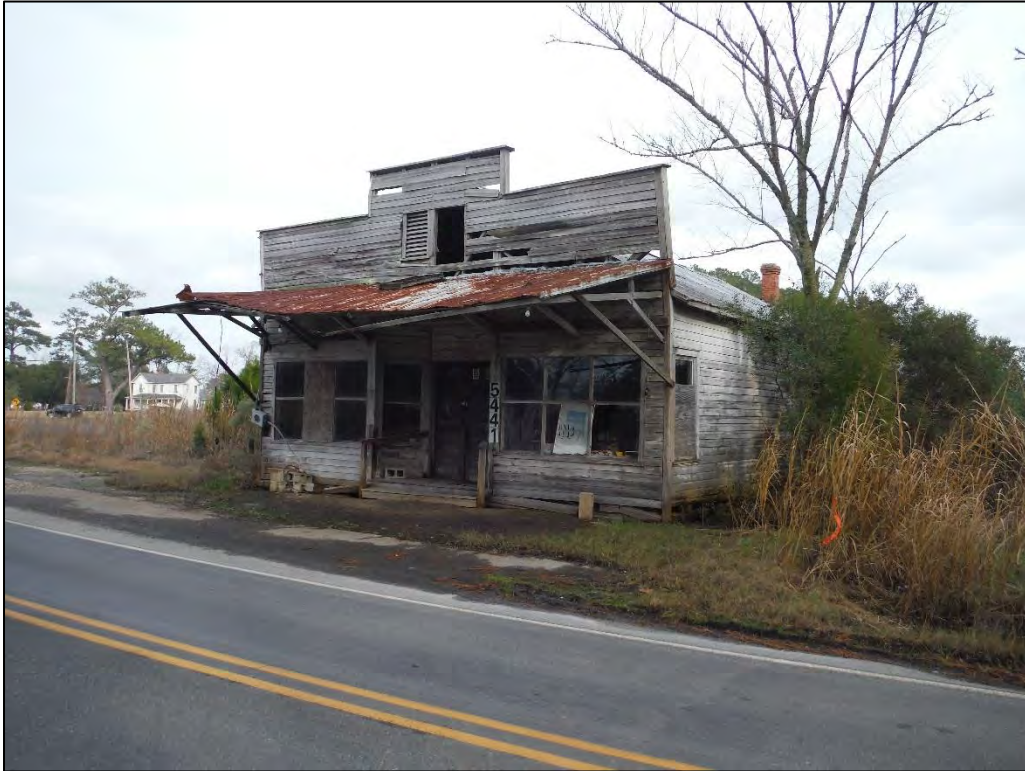
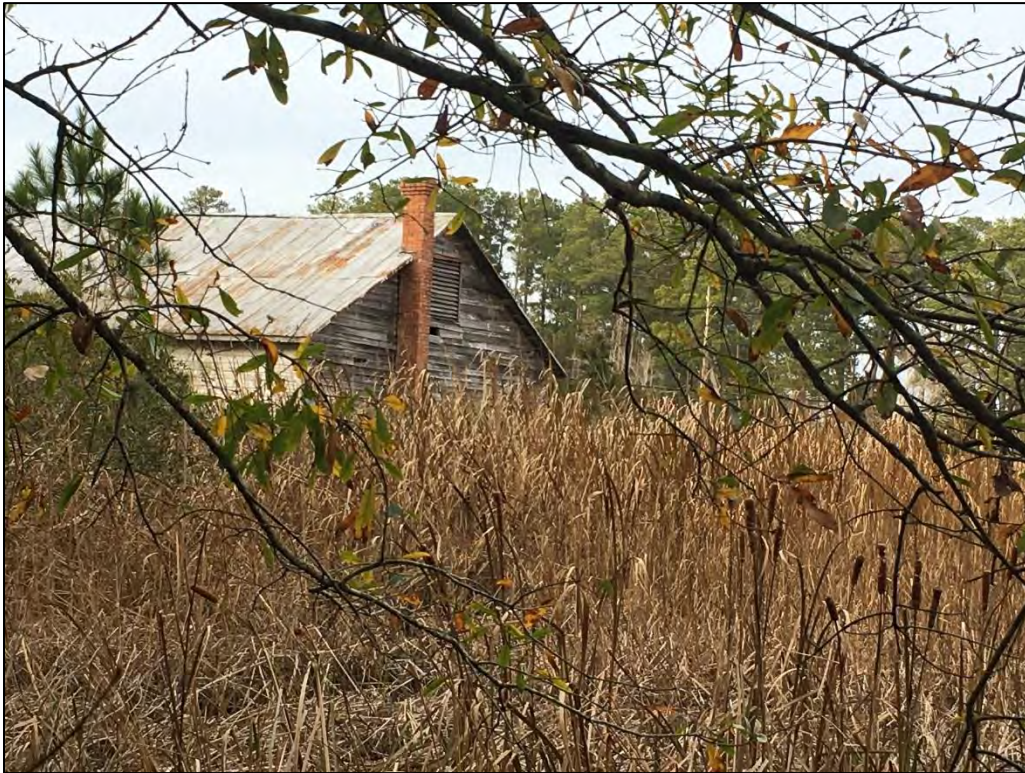
store and a vintage "Grocery" sign with Pepsi logos near the front of the building. There is an exterior, end chimney with a corbeled cap at the rear of the structure (Figures 24 and 25).

Figure 24. Napolean Sears Store, facing northeast.

Figure 25. Napolean Sears Store, facing northwest.

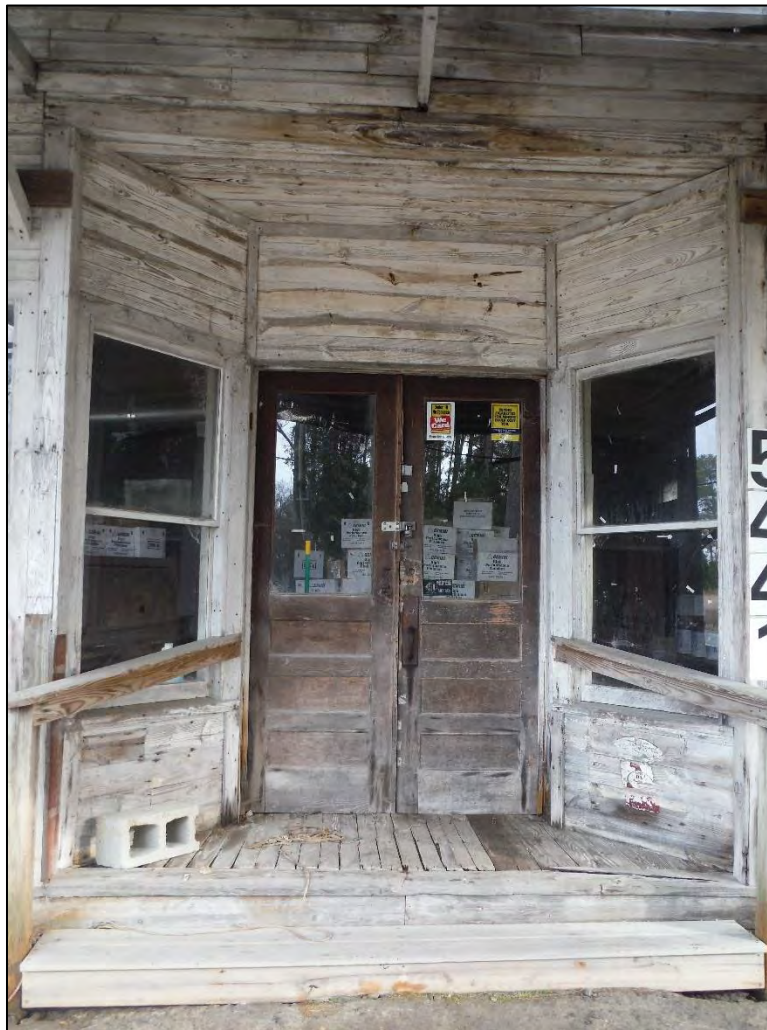
**Figure 26. Detail of entryway of the Napoleon Sears Store, facing east.**

The front of the store building has a commercial-style display arrangement, with a recessed central entryway (Figure 26). The front display windows each contain six square panes of glass arranged in a three-over-three rectangle, along with a set of two square panes at the north and south corners of the building, creating a large, glass, wraparound display. The display area chamfers inward at the entryway, creating a small, trapezoidal vestibule in front of the door, which is flanked by another set of two square panes; the double entry doors feature three lower panels and tall glass windows in the upper half. The entire storefront is shaded beneath a standing-seam metal awning, which is supported by simple triangular bracing. Directly above the awning, in the central step of the parapet, are two rectangular attic vents. Interior access to the structure was not possible, as attempts to contact the owners went without response. However, the view through the windows revealed that the interior of the store retains shelves to hold merchandise.

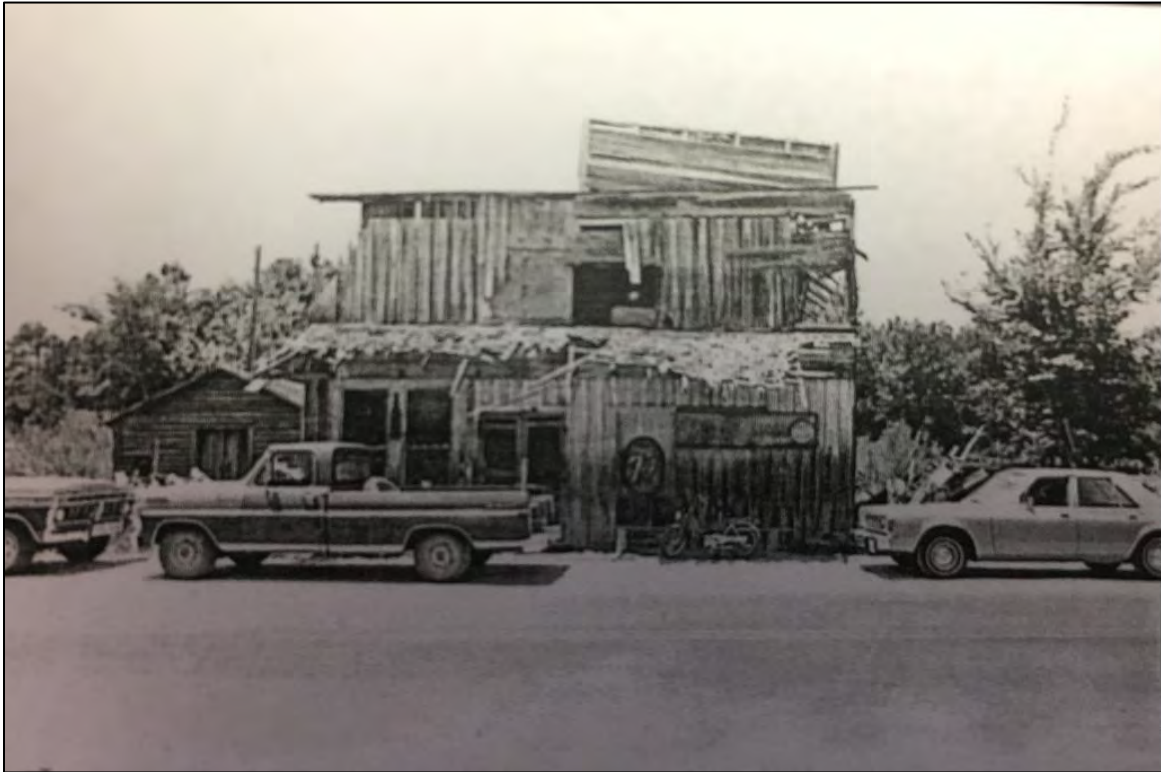
**Figure 27. Survey photograph of Napolean Sears Store, 1980 survey of Hyde County.**

Since it was surveyed in 1980, the Napoleon Sears Store has undergone some significant alterations. Original survey photographs show that in 1980 the store was divided into two sections, with much of the front elevation enclosed and the entry door off center (Figure 27). The façade at that time was much more dilapidated than its current appearance, with the stepped parapet only visible on the southern portion. At some point in the past 36 years, the façade has been rebuilt and the store restructured to its current single entry appearance.

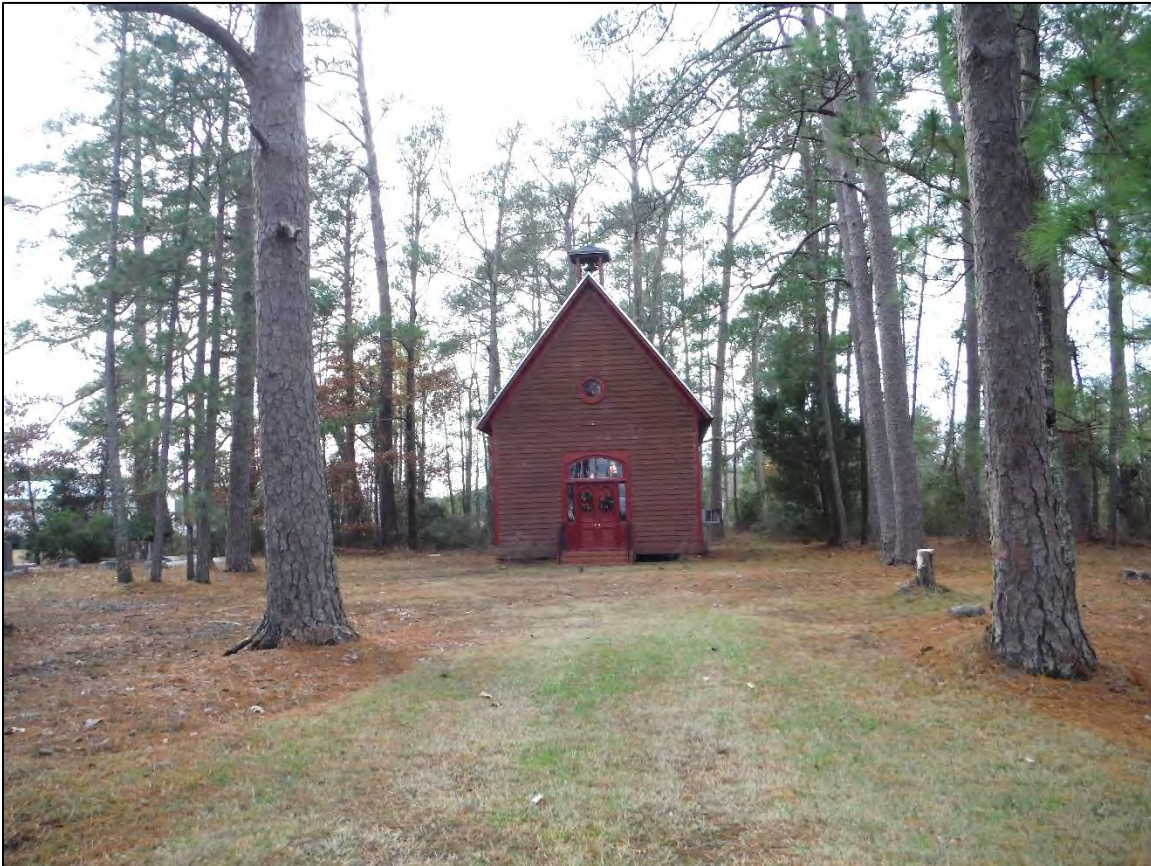
**Figure 35. St. John's Episcopal Church, facing west.**

St. John's Episcopal Church (PIN 7643-72-0425) is located at 5454 Sladesville-Credle Road, west of SR 1143 (Sladesville-Credle Road) and south of a tributary to Slades Creek, in the community of Sladesville. The church is a small, framed, Gothic Revival style structure that is set back from the road among a grove of trees; there is a small cemetery to the south of the church (Figure 35). The church building was recorded as part of the Hyde County architectural survey in 1980 and was placed on the North Carolina Study List (Survey File 1980:HY0195).

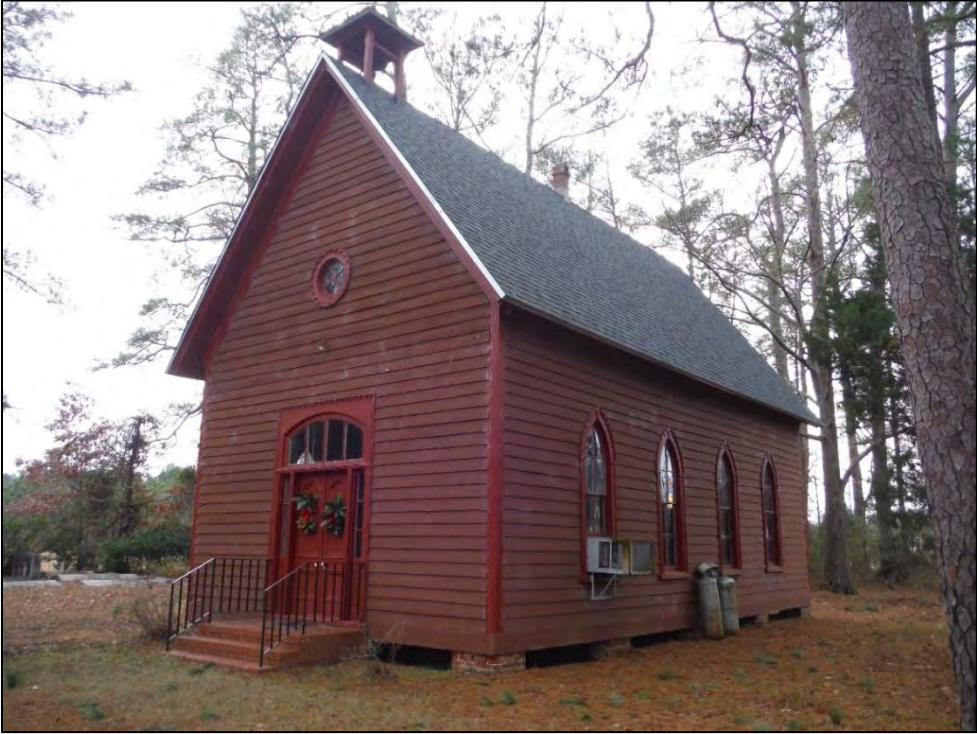
Figure 36. St. John's Episcopal Church, facing southwest.

The church building is a wooden framed structure, with a steep, front-gabled roof resting on a brick pier foundation (Figure 36). The front elevation features a central entryway, with a single, circular window of four panes and a dentiled surround centered above it. The entry is served by a set of double doors, with square lower panels and arched upper panels (Figure 37). The doors are flanked by three-pane sidelights and are topped with a four-pane, segmental-arch transom. The surround for the door has dentiled detail on its

upper molding. Above the front gable is a small, open belfry with a pyramidal roof, which protects the church bell.

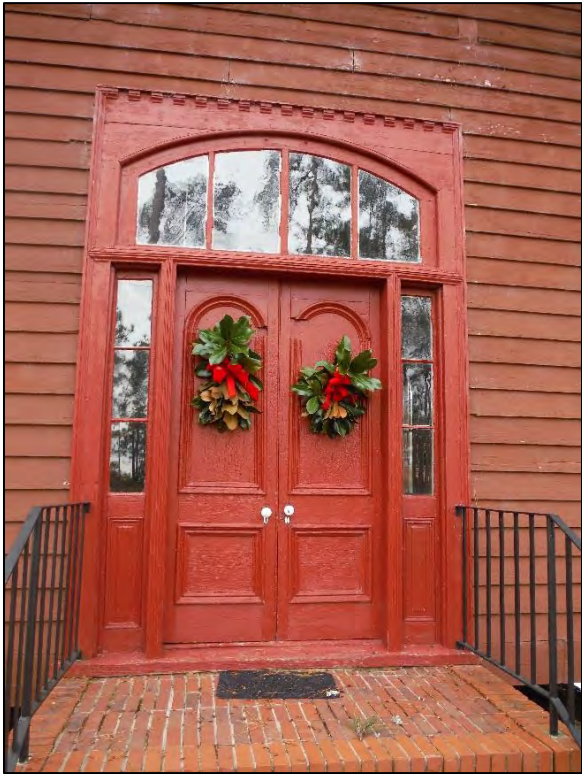
Figure 37. Detail view of front entry doors, St. John's Episcopal Church, facing west.

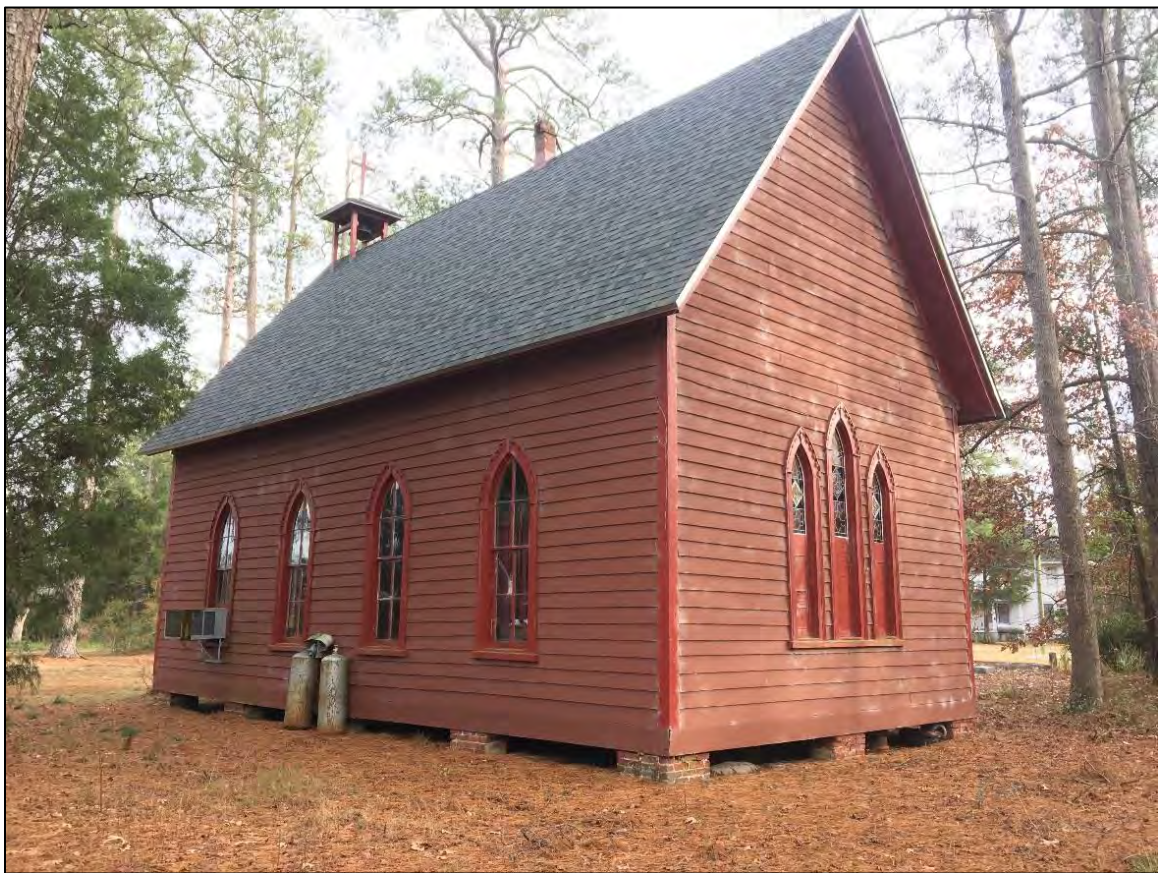
**Figure 38. St. John's Episcopal Church, facing southeast.**

The church building is four bays deep, and the north elevation features four lancet wooden windows, with four-over-four pane configuration, surrounded by heavy wooden molding, with dentil detailing in the lancet arch (Figures 38 and 39). The rear elevation of the building has a group of three, stepped lancet windows; the upper portion of the windows is stained glass, while the lower portion is covered with metal that has been salvaged from soda advertisement signs (Figure 40); based on the design of the signs, the metal has been part of the windows since the first half of the twentieth century. The south elevation of the church has three windows, identical to the windows on the northern elevation, as its first four bays (Figure 41). The rear bay contains a single, recessed entry door, with arched upper panels and square lower panels, set into a shallow pediment surround. This entry door leads to a preparation room on the south side of the church's altar.

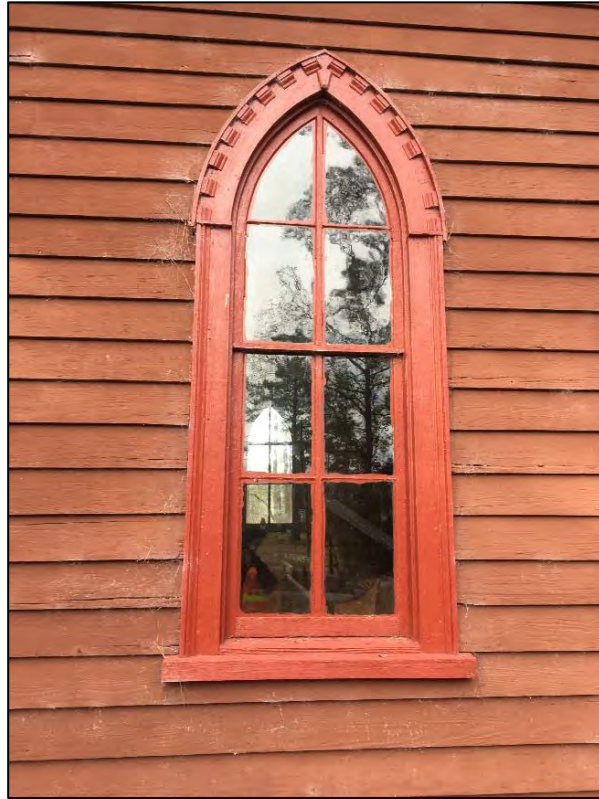
Figure 39. Detail view of north elevation window, St. John's Episcopal Church, facing south.

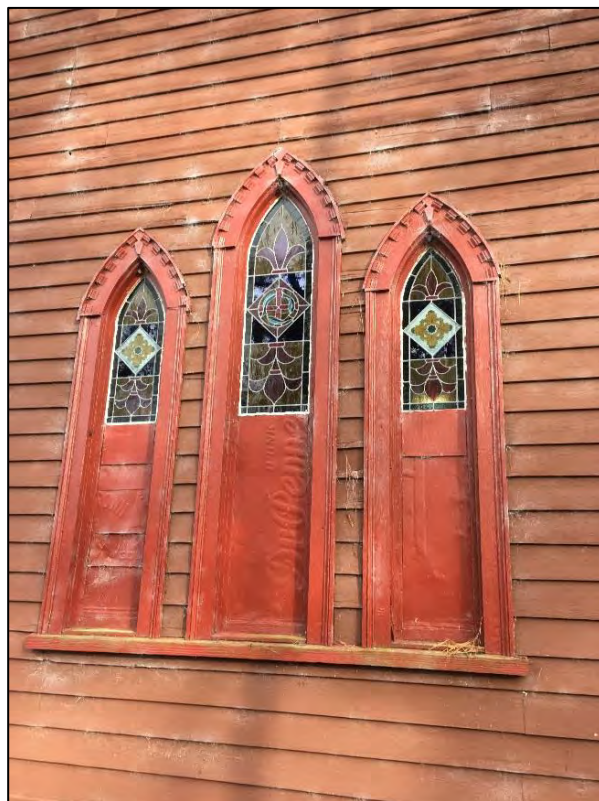
Figure 40. Detail view of west elevation window, St. John's Episcopal Church, facing east.

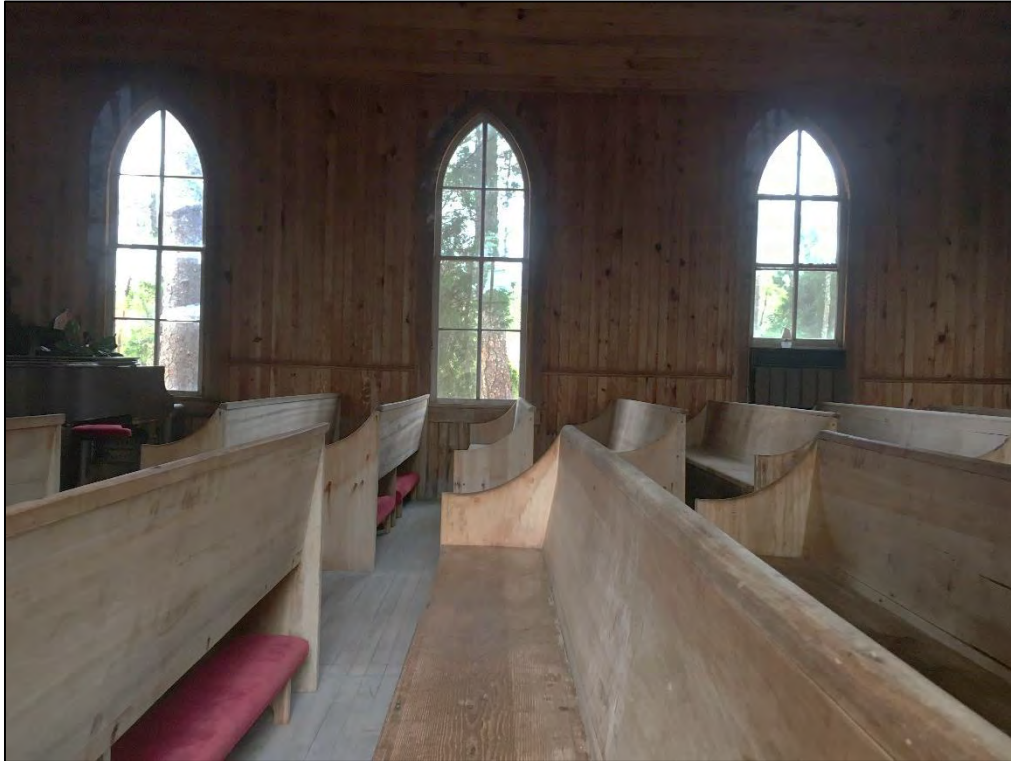
Figure 42. Interior view of St. John's Episcopal Church, facing north.

Since it was surveyed in 1980, St. John's Episcopal Church has undergone few alterations. The 1980 survey information indicates that the church originally had a wooden shingled, roof. Sometime before 2007, when the church was photographed for the *Landmarks of Hyde County* book, the wooden shingles had been replaced with a new composition-shingle roof. When the original survey photographs were taken, there was scaffolding on the south side of the church building, probably placed there to complete roof repairs. A large pine tree was removed from the northeast corner of the church between 1980 and 2007. Otherwise, little has been changed on either the interior or exterior of the church for over more than three decades.

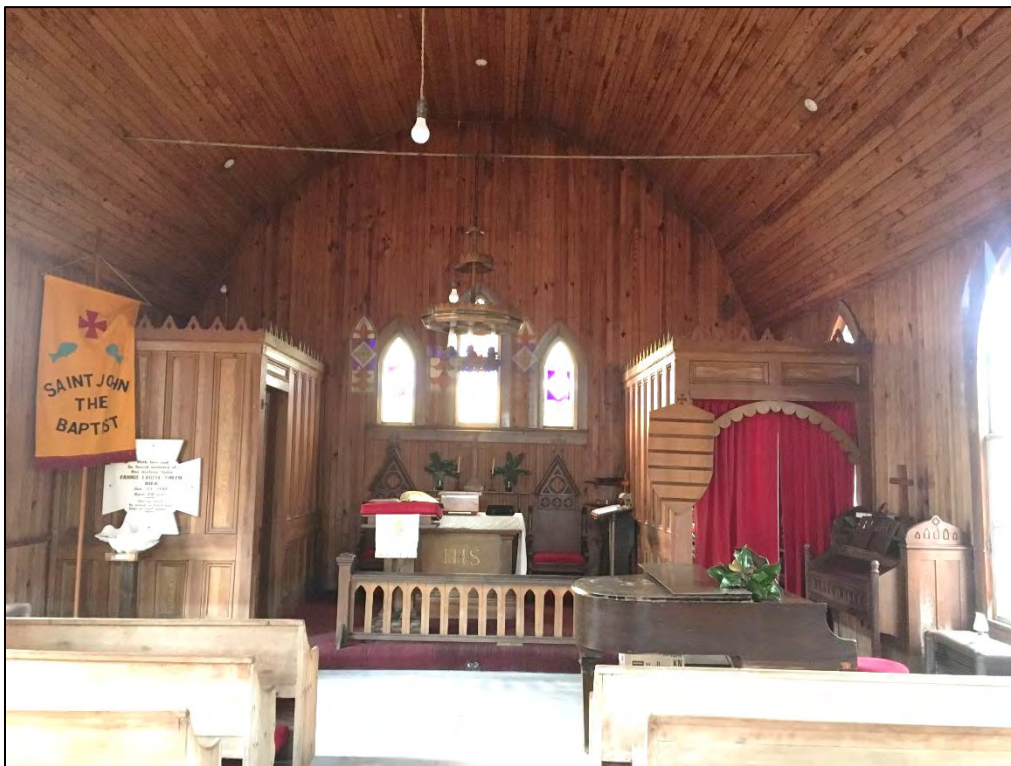
The interior of the church is one large room, with a central altar on the rear wall, flanked by two small open vestries. The church has a barrel-vaulted ceiling and both the ceiling and the walls are sheathed with tongue-and-groove pine. Although the pews in the church are simple, wooden seating, they have subtle elements of decorative carving on their aisle-end pieces (Figure 42). The altar, which is raised slightly from the church floor, has decorative carved seating on the rear wall and a low partition at the front, featuring carved lancet arches. The vestries, which flank the altar, are enclosed with wooden paneling and have carved detailing above the walls; the one to the north of the altar also features a carved archway entrance (Figure 43).

Figure 43. Interior view of St. John's Episcopal Church, altar, facing west.

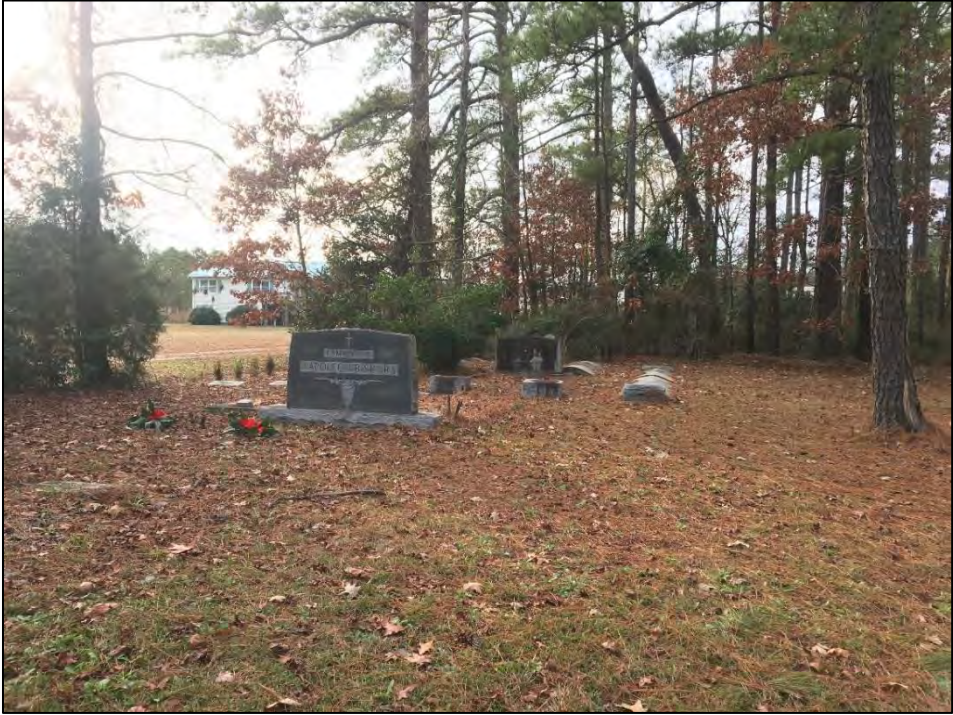
**Figure 44. St. John’s Episcopal Church cemetery, facing southwest.**

North of the church building is a small cemetery (Figure 44). The two main burial plots belong to the Sears and Lupton families, which were both prominent families in the Sladesville area; the majority of the stones from these burials date from the early-to-mid-twentieth century. Because of the high water table of the area, some of the graves are enclosed with concrete vaults that extend above the ground (Figure 45).

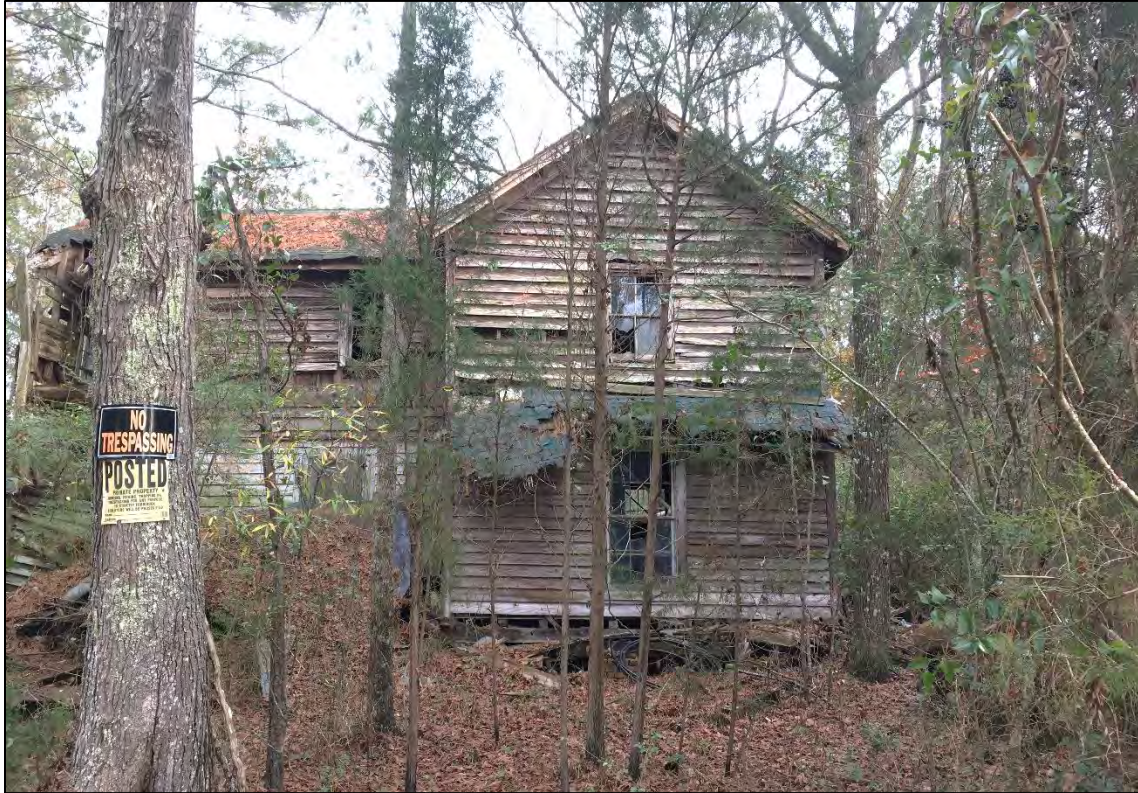
**Figure 56. Jarvis-Elixson House, facing east.**

The Jarvis-Elixson House (PIN 7643-72-7090), which has the same legal address (5441 Sladesville-Credle Road) as the Napoleon Sears Store, is located east of SR 1143 (Sladesville-Credle Road), south of a tributary of Slades Creek, in the community of Sladesville. The house is a two-story, frame structure with a cross-gabled roof that has been vacant for a number of years and has begun to deteriorate (Figure 56). The house was recorded as part of the Hyde County architectural survey in 1980 (Survey File 1980:HY0196).

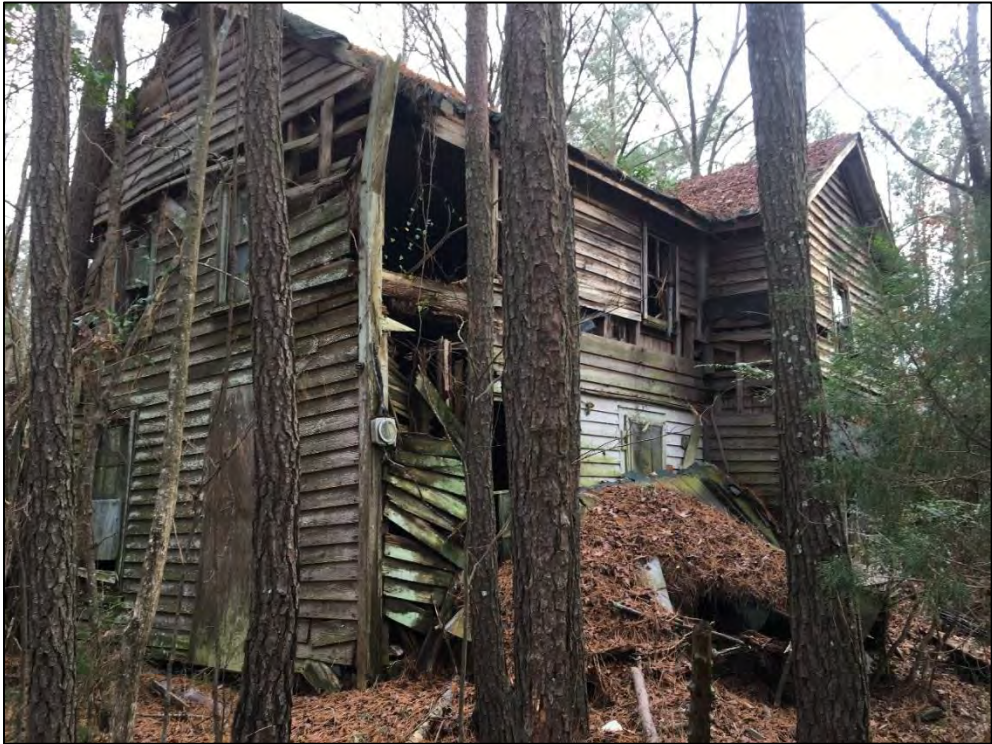
Figure 57. Jarvis-Elixson House, facing southeast.

The front elevation of the house is three bays wide, with a side-gabled section and a projecting front-gabled section. The front-gabled section is a single bay, with a two-over-two, double-hung, wooden sash window on the upper story and the remains of a six-over-six, double-hung, wooden sash window on the lower story. The two bay wide side-gabled section has the remains of a two-over-two, double-hung, wooden sash window on the upper story and an entry door below it, close to the front-gabled section; the northern portion of the front elevation has caved in, leaving a large hole on the upper story and crumbling siding on the lower story (Figure 57). The south elevation shows the intersection of the cross-gables, with two two-over-two, double hung, wooden sash windows unevenly spaced in the gable end. The lower story is beginning to collapse, but shows the remains of a six-over-six, wooden sash window and a door (Figures

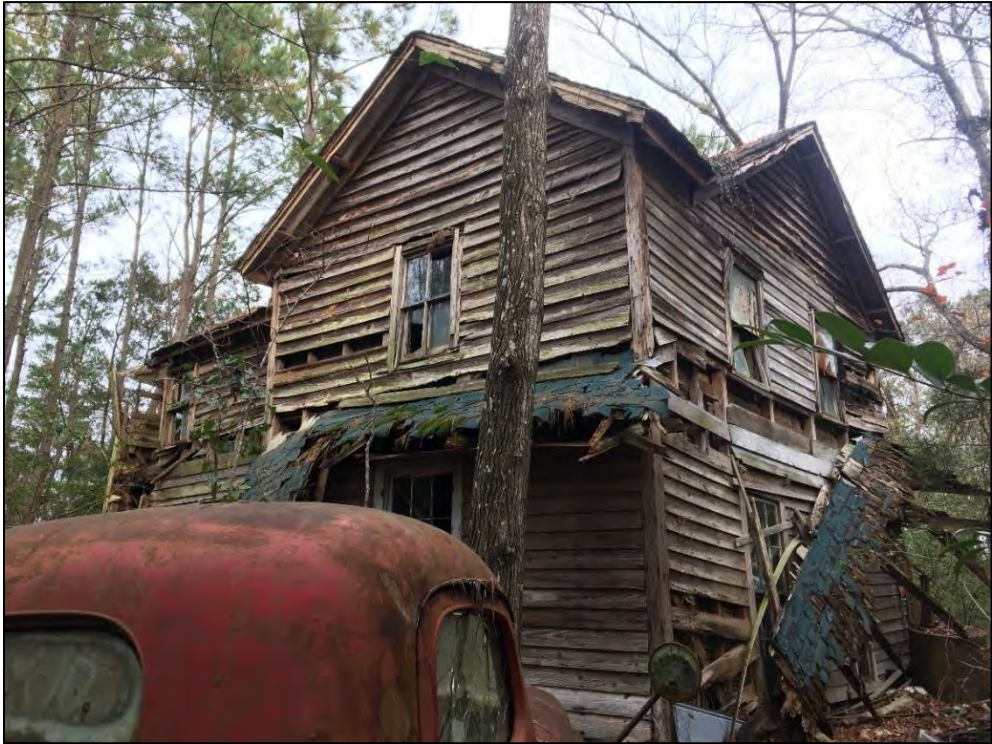
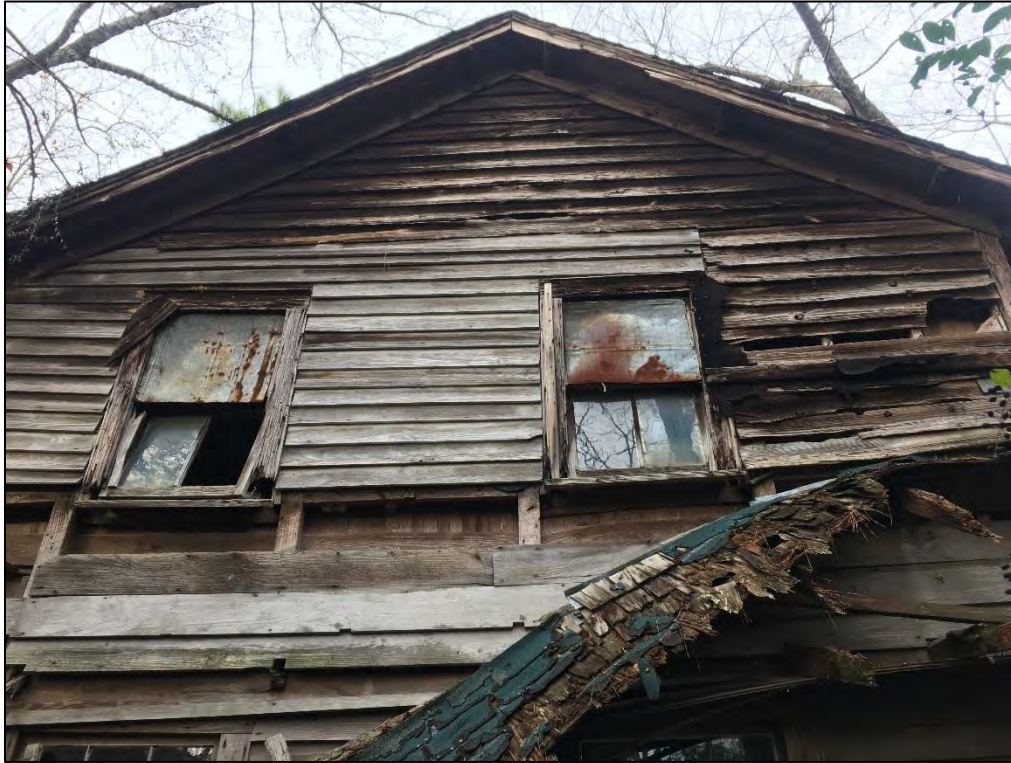
58 and 59). Originally, a shed-roofed porch wrapped around the front and south elevations, and the remains of the roof and the plate that attached it to the house are visible on both.

Figure 58. Jarvis-Elixson House, facing northeast.

**Figure 59. Jarvis-Elixon House, facing north.**
