SUBJECT: Historic Structures Survey Report, Replace Bridge 35 on SR 1143 over Tributary  
To Slades Creek, PA 16-08-0034, Hyde County, ER 17-2451

To: Renee Gledhill-Earley, NCHPO  
From: Vanessa E. Patrick, NCDOT  
Date: October 31, 2017  
Subject: *Historic Structures Survey Report - Replace Bridge No. 35 on SR 1143 (Sladesville-Credle Road) over Tributary to Slades Creek, Hyde County, North Carolina. WBS No. 17BP.1.R.83. PA Tracking No. 16-08-0034*

HISTORIC STRUCTURES SURVEY REPORT  
REPLACE BRIDGE NO. 35 ON SR 1143 (SLADESVILLE-CREDLE  
ROAD) OVER TRIBUTARY TO SLADES CREEK  
HYDE COUNTY, NORTH CAROLINA

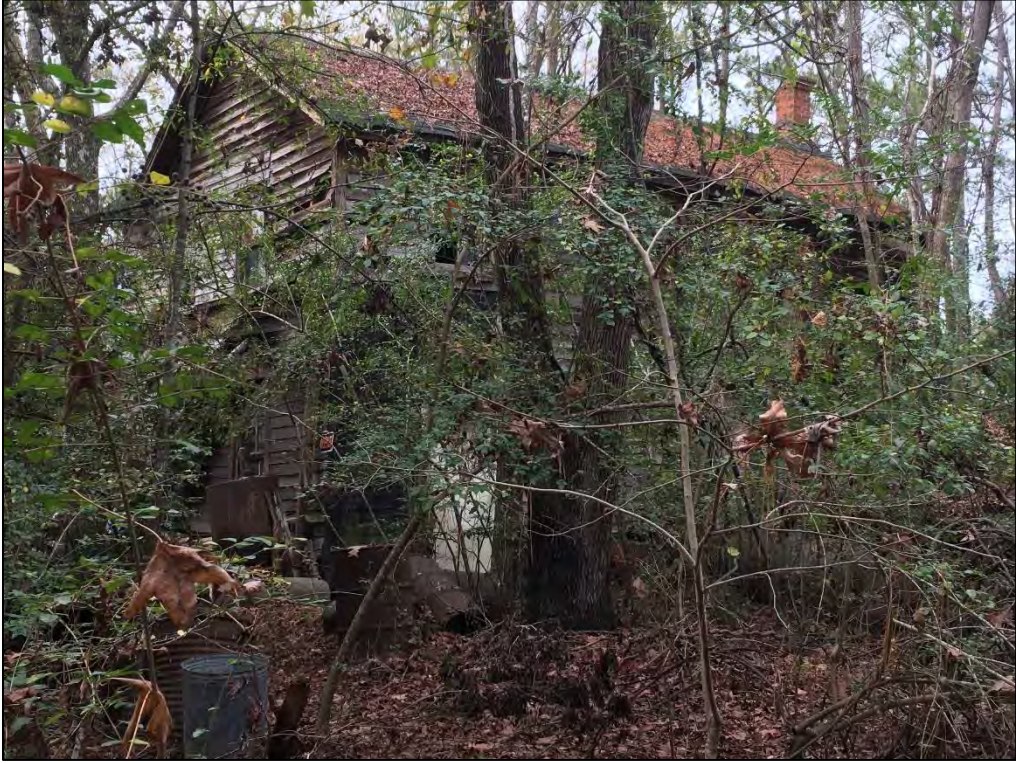
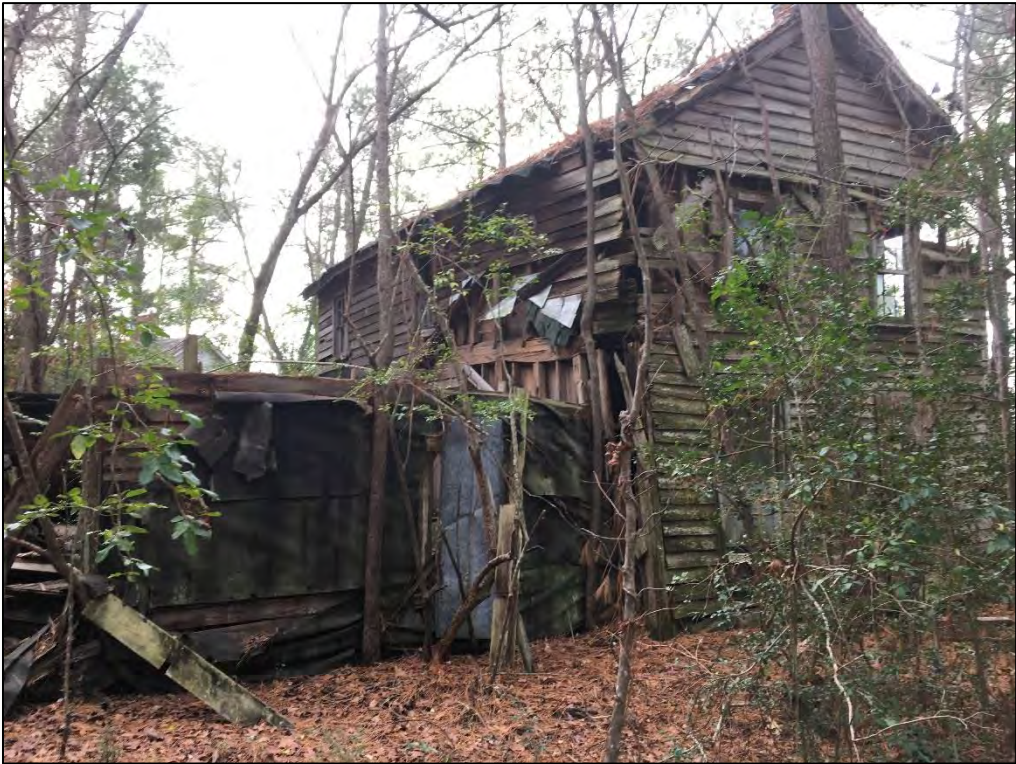
The rear elevation of the house is virtually inaccessible due to tree and brush growth, and much of the northern portion of the rear wall has started to cave in (Figures 60 and 61). The two visible windows on the back side of the house are two-over-two, double-hung, wooden sashes. At the northeast corner of the house, a small, single story addition, which is currently missing a roof, has been joined to the house. The gabled north elevation has six-over-six, double-hung, wooden sash windows on the upper and lower stories, with the western bay on the lower story boarded over (Figure 62). An interior end chimney, with a corbelled cap, is visible above the roofline. The house is covered with horizontal wooden weatherboard and the roof is sheathed in composition shingles. The roof has a wide eave overhang and may have once had decorative brackets along the cornice. Interior access to the structure was not possible, as attempts to contact the owners went without response.

Figure 60. Jarvis-Elixson House, facing northwest.

Figure 61. Jarvis-Elixson House, facing southwest.

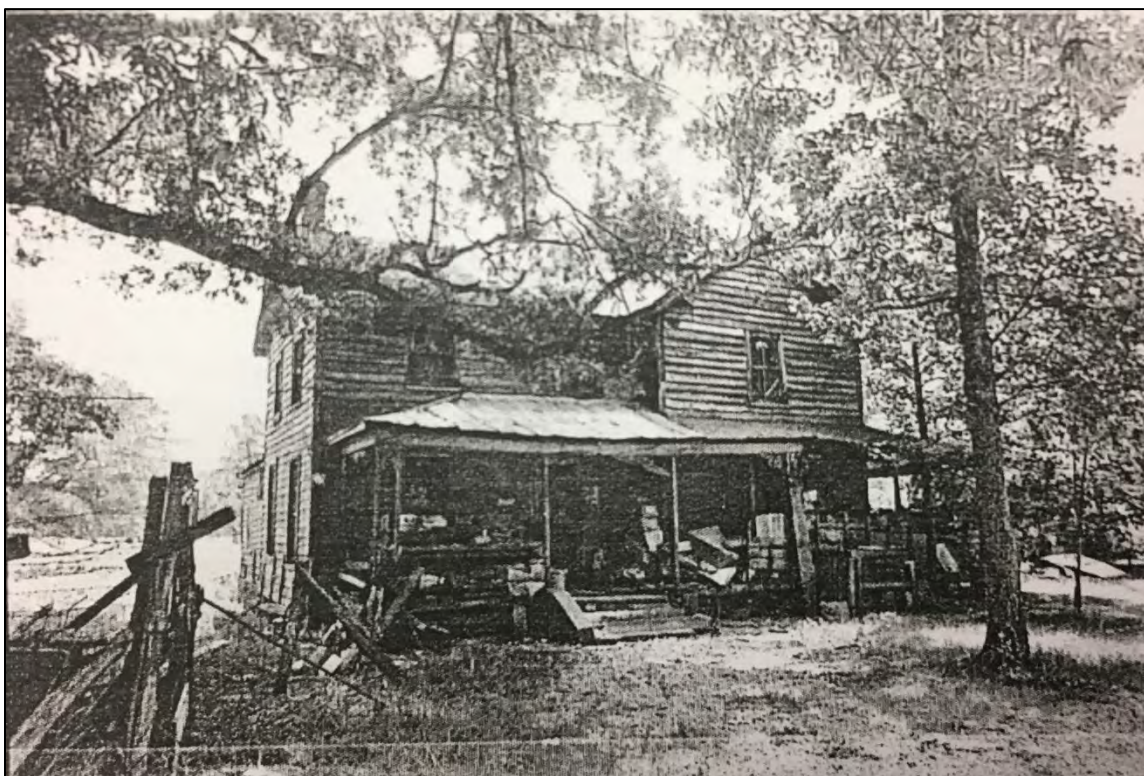
Figure 63. Survey photograph of Jarvis-Elixon House, 1980 survey of Hyde County.

Since it was surveyed in 1980, the Jarvis-Elixon House has undergone significant deterioration. When it was originally surveyed, the condition was recorded as "deteriorated", but survey photographs show that the walls of the house were intact and the porch remained attached to the house (Figures 63 and 64). One of the details noted in the original survey was the scrollwork brackets that remained visible on the porch supports; these have either been removed or have been buried under the collapsed porch remains.

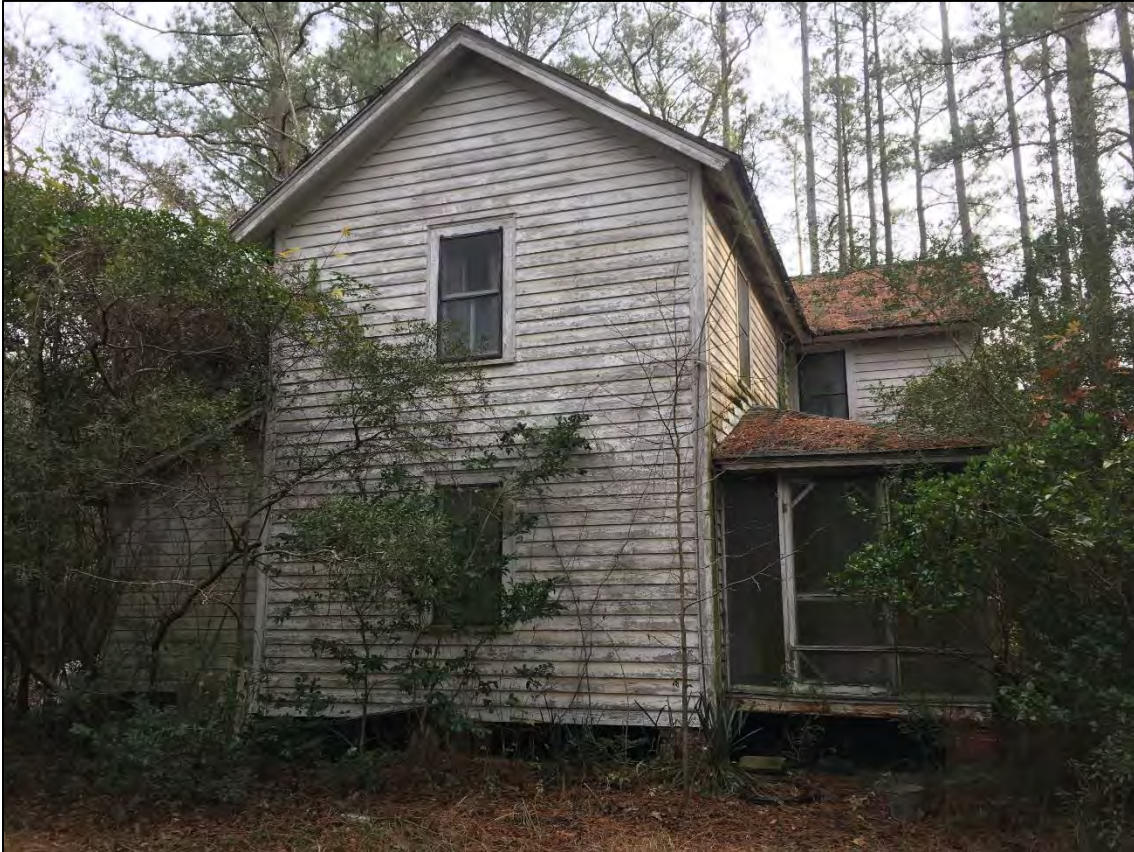
**Figure 71. Jarvis-Sears House, facing southeast.**

The Jarvis-Sears House (PIN 7643-72-3145) is located at 5505 Sladesville-Credle Road, east of SR 1143 (Sladesville-Credle Road), south of a tributary of Slades Creek, in the community of Sladesville. The house is a two-story, frame structure with a cross-gabled roof that has been vacant for a number of years and has begun to deteriorate (Figure 71). The house was recorded as part of the Hyde County architectural survey in 1980 (Survey File 1980:HY0197).

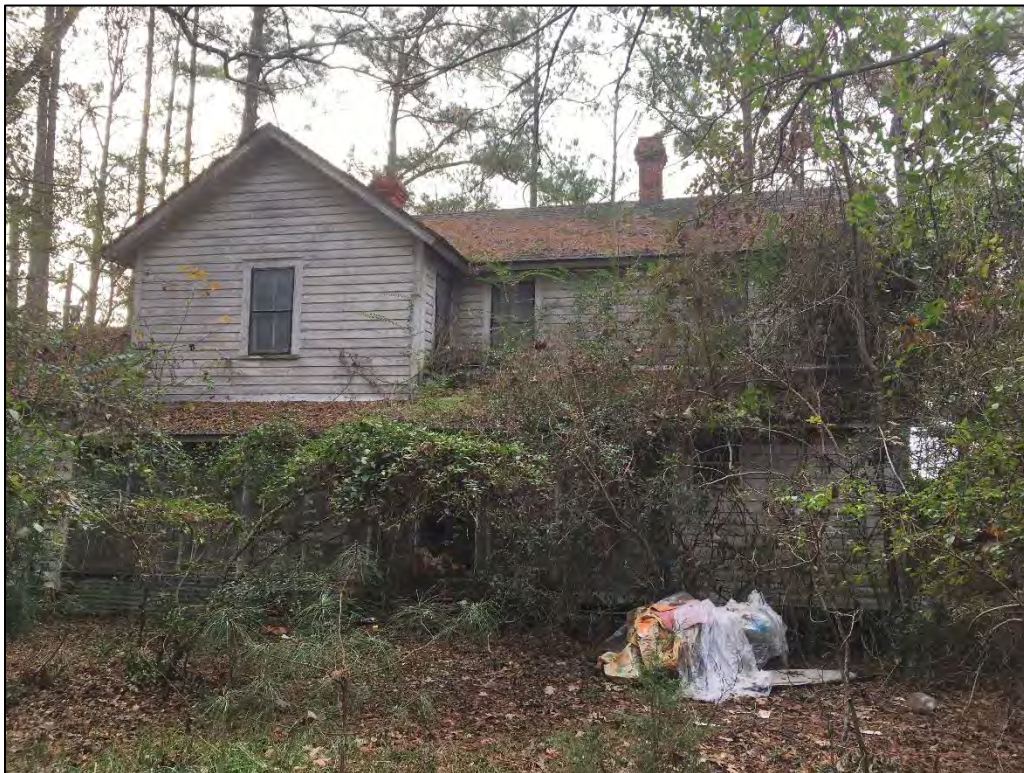
**Figure 72. Jarvis-Sears House, facing west.**

The rear elevation is a mirror image of the front elevation, with a single-bay, gabled section projecting from a two-bay, side-gabled section (Figure 72). The visible windows on the upper story are two-over-two, double hung, wooden sashes. The lower story has a shed-roofed porch, which wraps around the rear ell created by the two gabled sections, and the northern one-third of this porch has been enclosed with walls and siding, while the rest of the porch is screened. A single-story, gabled addition with an interior chimney has been attached to the southeast corner of the house (Figures 73 and 74). The north elevation of the house has one two-over-two, double hung, wooden sash window in each story, centered under the gable.

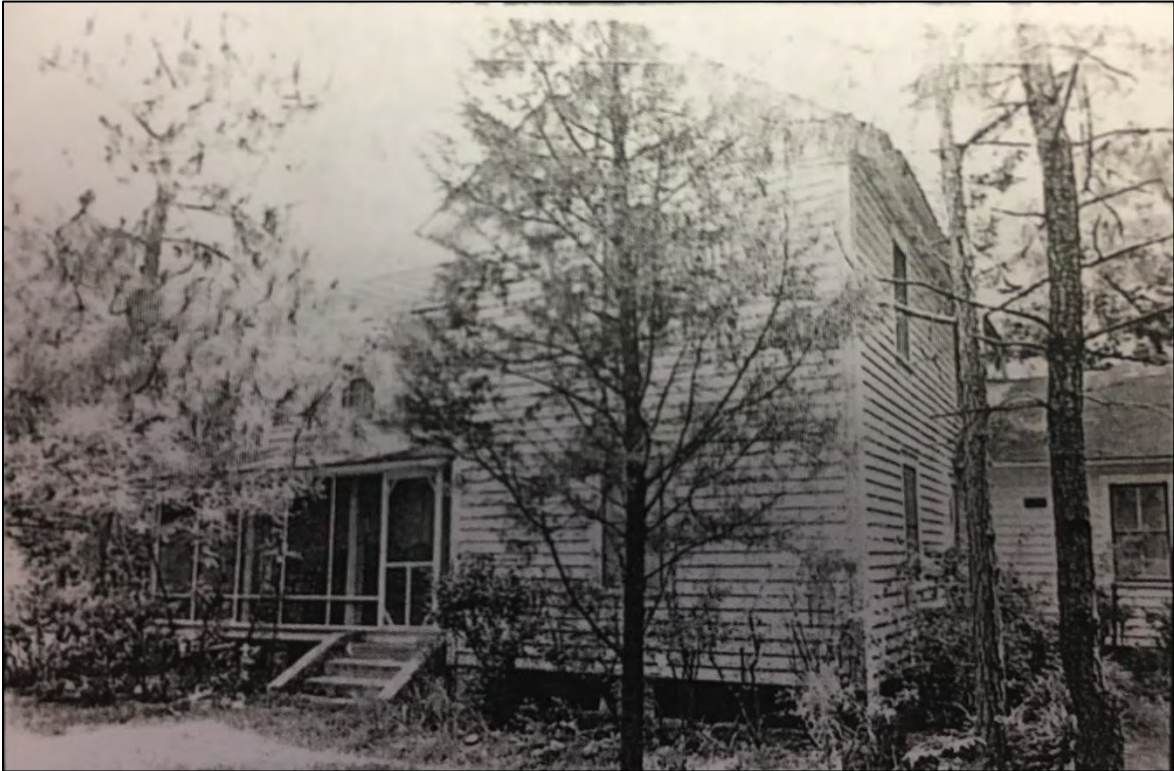
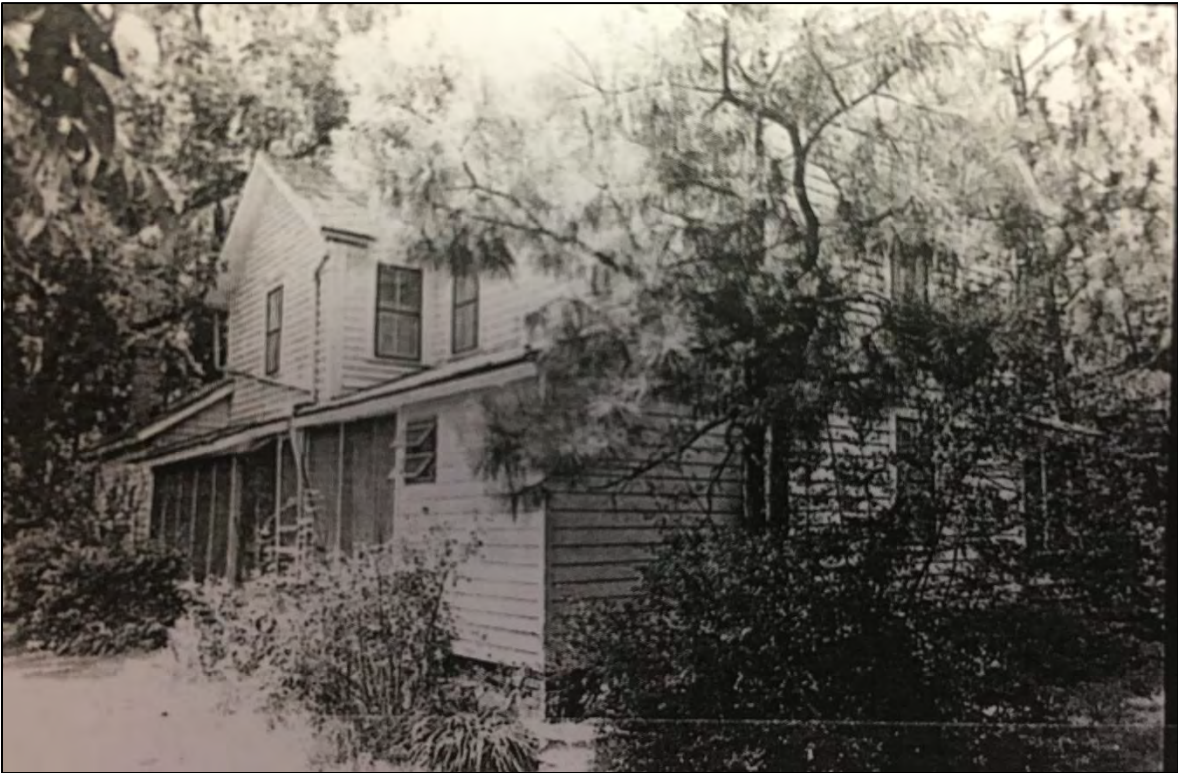
Since it was surveyed in 1980, the Jarvis-Sears House has been vacant for a number of years and has undergone some deterioration. When it was originally surveyed, the condition was recorded as "fair". Survey photographs show that the vegetation around the house was thick, but maintained; currently the vegetation obscures much of the first story of the house and is beginning to damage the roof on the porch (Figures 75 and 76).

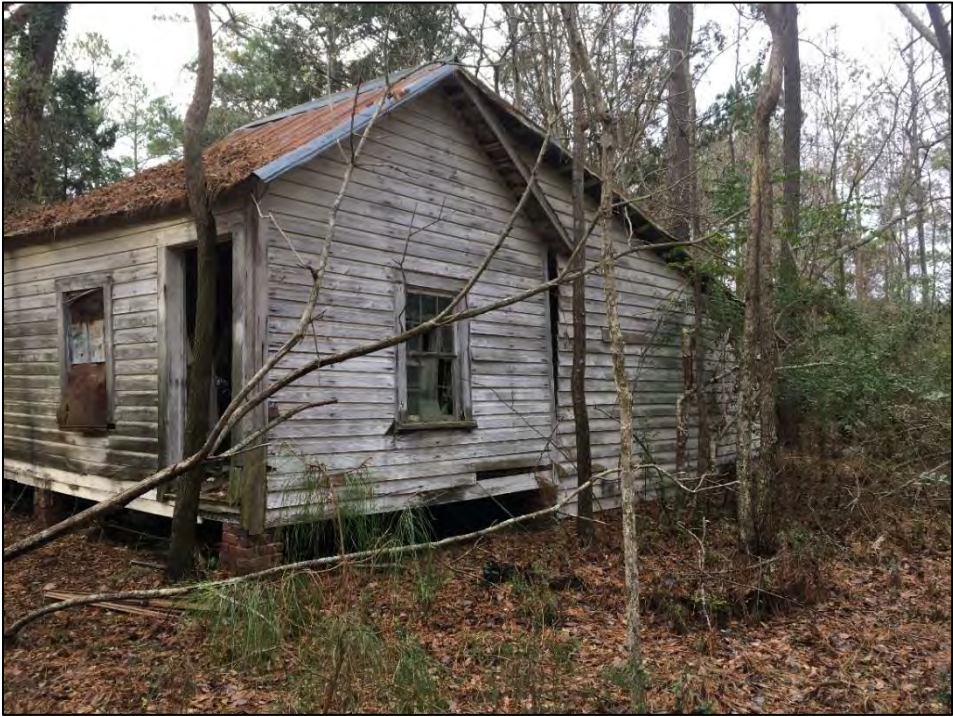
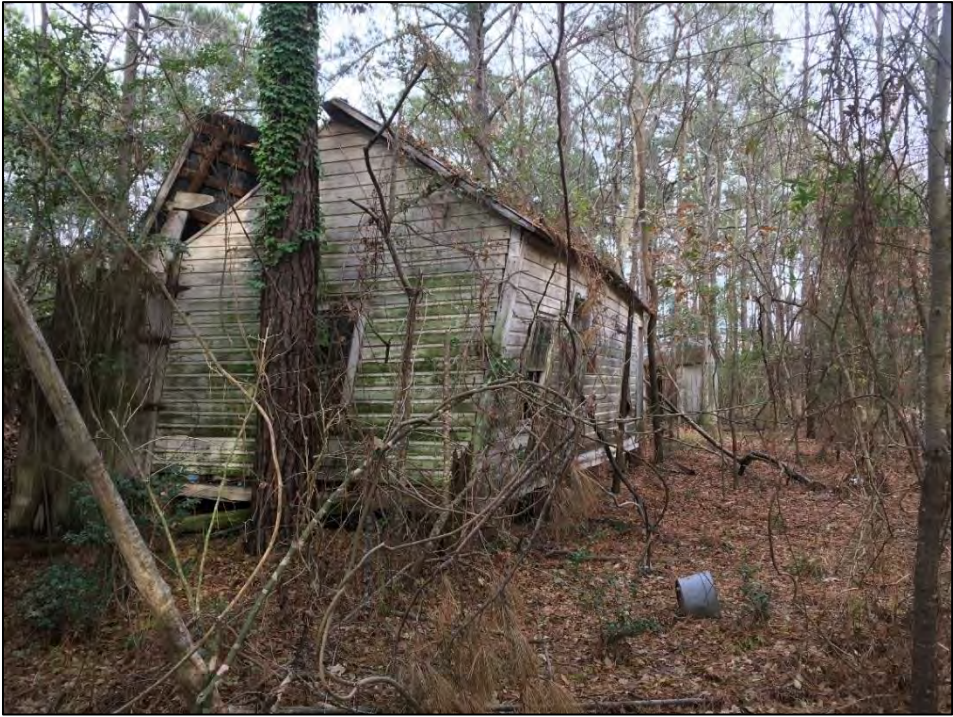
Located east of the Jarvis-Sears House is a single-story, gabled, wooden storage building with a shed roofed addition (Figures 77 and 78). The structure, which rests on a brick pier foundation, has six-over-six, double hung, wooden sash windows and a standing seam metal roof. There are also a small, wooden storage building, privy, and a brick well on the property (Figures 79–81).

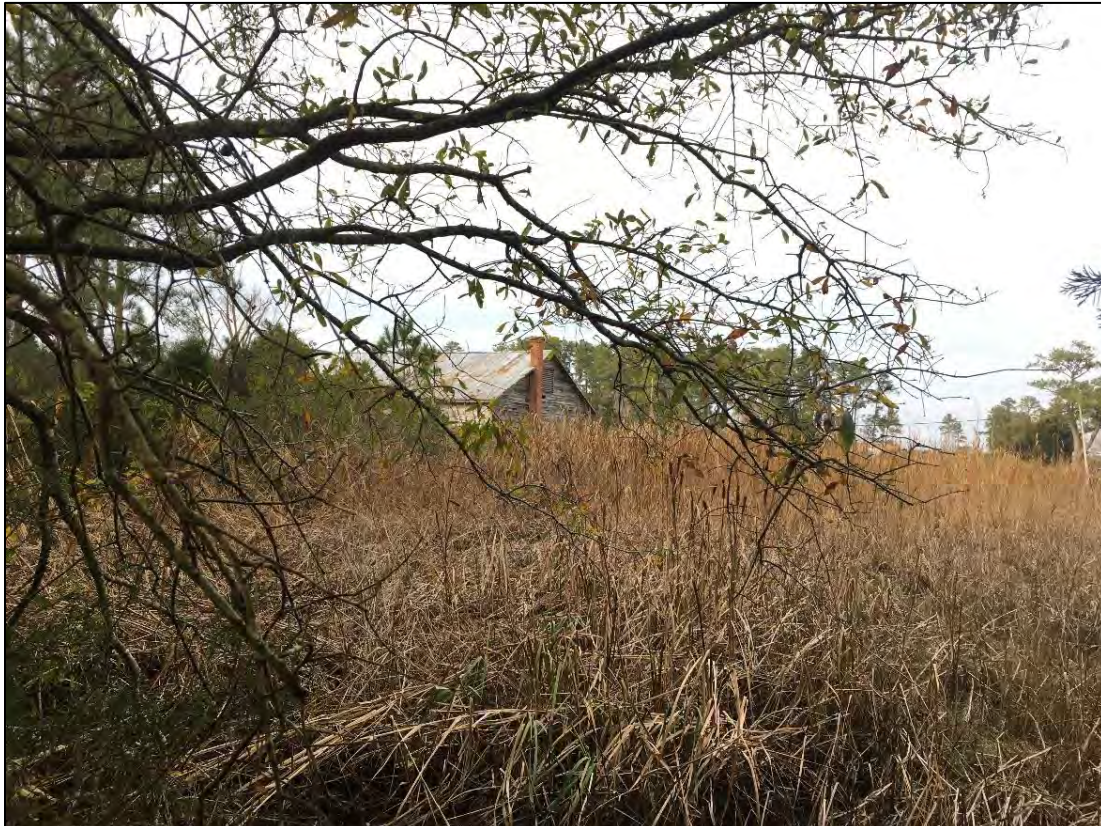
**Figure 89. Unnamed House property, facing northeast from HY0196, with HY0194 visible in the background.**

The unnamed House property (PIN 7643-72-2469) is located on the east side Sladesville-Credle Road, between the Napoleon Sears Store (HY0194) and the Jarvis-Elixson House (HY0196), south of a Slade Creek tributary, in the community of Sladesville, in Hyde County (Figure 2). The property is owned by Joseph M. Hollowell; the approximately 0.3-acre property was purchased by Venetia Hollowell from A. B. and Nannie (Nancy) Lupton in 1955 and deeded by Venetia Hollowell to Joseph Hollowell in 1978 (Hyde County Register of Deeds 1955 Deed Book 68:384; 1978 Deed Book 96:837). The parcel had been owned by John M. Credle, who sold it to Minnie Hamilton in 1916. Three years later, Minnie Hamilton and her husband sold the property to Statz Credle, who sold it to A. B. and Nannie (Nancy) Lupton in 1923 (Hyde County Register of Deeds 1916 Deed Book 38:334; 1919 Deed Book 43:283; 1923 Deed Book 46:504). None of the deeds mention a structure on the property. Hyde County tax records note an “old dwelling” on the property and classifies it as a “building site”, but does not give information or list a value for the building. No standing structure was evident during field investigations, although bricks that may have been part of a home foundation were visible on the ground (Figures 89 and 90).

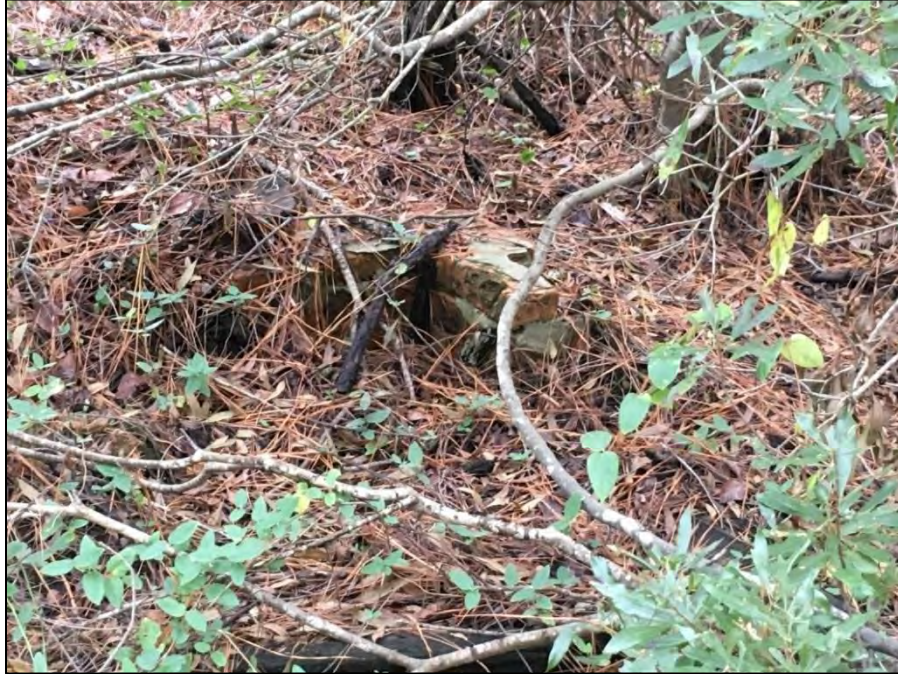
**Figure 90. Brick foundation on unnamed House property, facing east.**

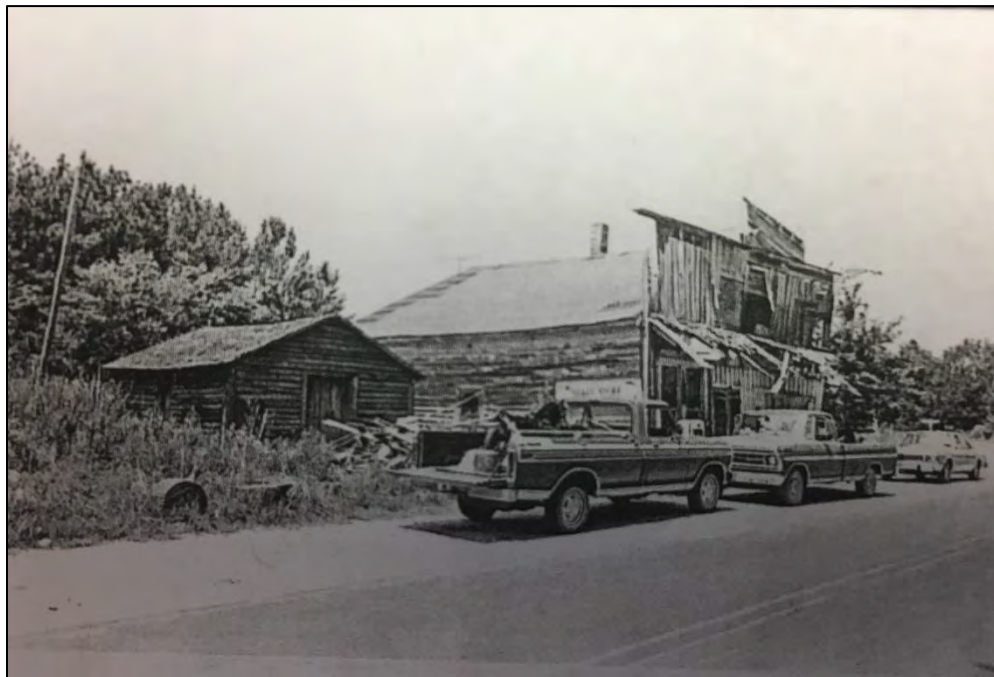
**Figure 91. Survey photograph, 1980, showing the Napoleon Sears Store and the former blacksmith shop to the north, but no standing structure to the south.**

A composite map of structures in the Sladesville community does not show a house located between the Napoleon Sears Store (HY0194) and the Jarvis-Elixson House (HY0196) (Figure 10), nor do photos taken when the area was surveyed in 1980 (Figure 91). However, aerial photos from 1964 and 1971 do show a structure at the location (Figure 92 and 93). Based on the field investigations, S&ME concluded that the unnamed structure that may have formerly been on the property is no longer extant.

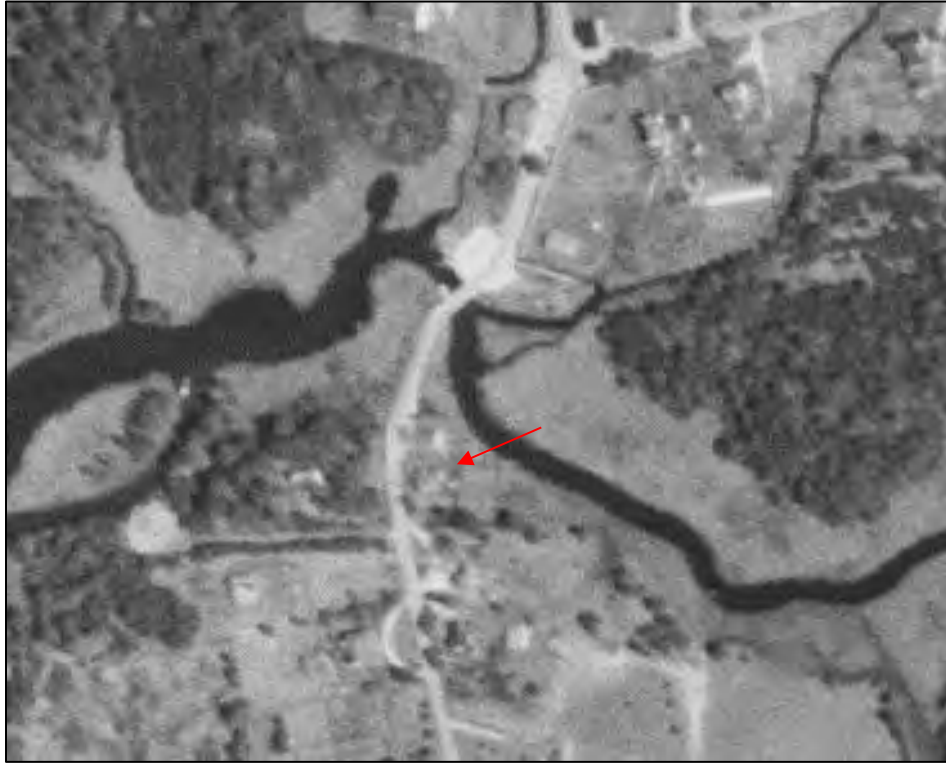
**Figure 92. Aerial photograph, 1964, showing Sladesville area and house property (USGS 1964).**

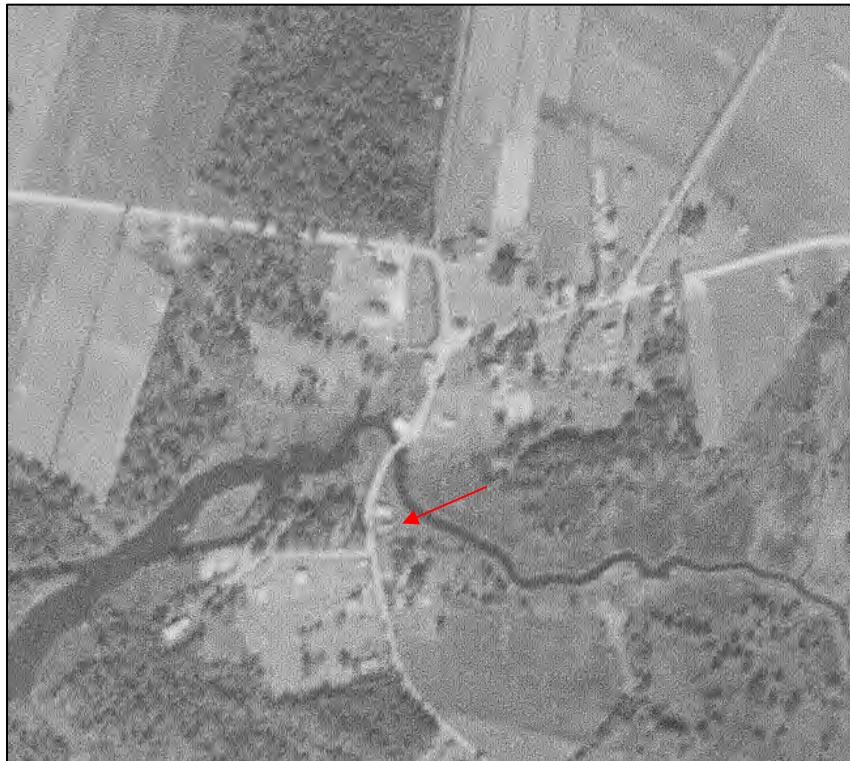
**Figure 93. Aerial photograph, 1971, showing Sladesville area and house property (USGS 1971).**
