SUBJECT: Replace Bridge 12 on SR1122 (Dobbins Mill Road) over Snow Creek, PA 17-06-0004,
Surry County, ER 17-2874

HISTORIC STRUCTURES SURVEY REPORT

Replace Bridge 12 on SR 1122 (Dobbins Mill Road) over Snow Creek
Surry County
WBS# 17BP.11.R.144

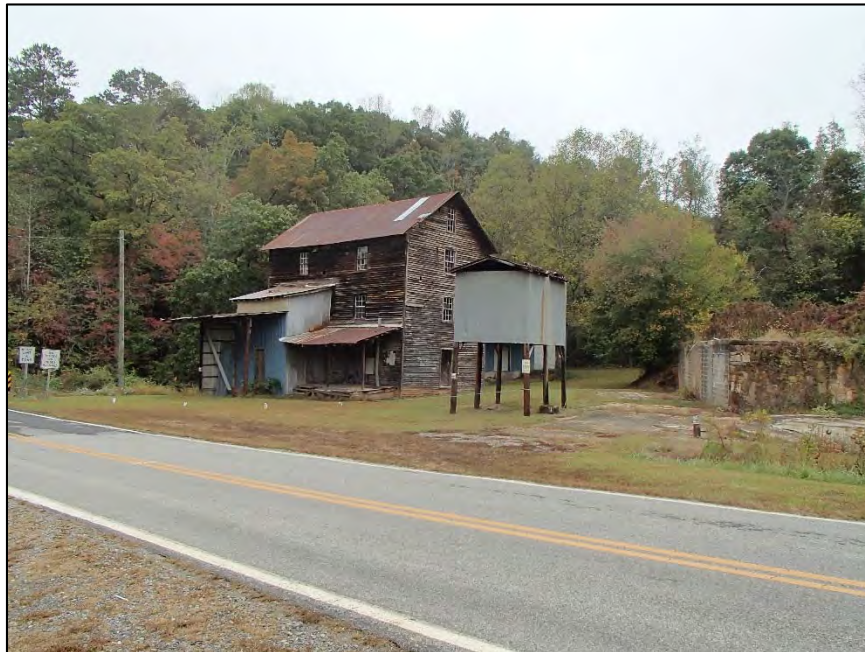
Figure 5: Dobbins Mill, southeast corner

At the Dobbins Mill Historic District, the approach to the site, the mill (figure 5), the two houses (figures 6 and 7), and the location of the bridge (figure 8) are all characteristic of the county's archetypal mill sites. From both the east and the west, Dobbins Mill Road drops through several curves toward Snow Creek, the bridge, and the mill. To the south of the mill is the Charlie Dobbins House, which is a traditional two-story I-house built by the brother and uncle of the Dobbins family members that constructed the existing mill building. This house is situated immediately downstream from the mill and is also downhill from the mill. To the northeast of the mill is an early twentieth-century house built by Cleveland Dobbins. This house is on a hillside, well above the mill, and was originally approached from the mill via a slope that was cut to create a steep embankment between the house and the mill. Bridge No. 12 crosses Snow Creek in front of the mill.

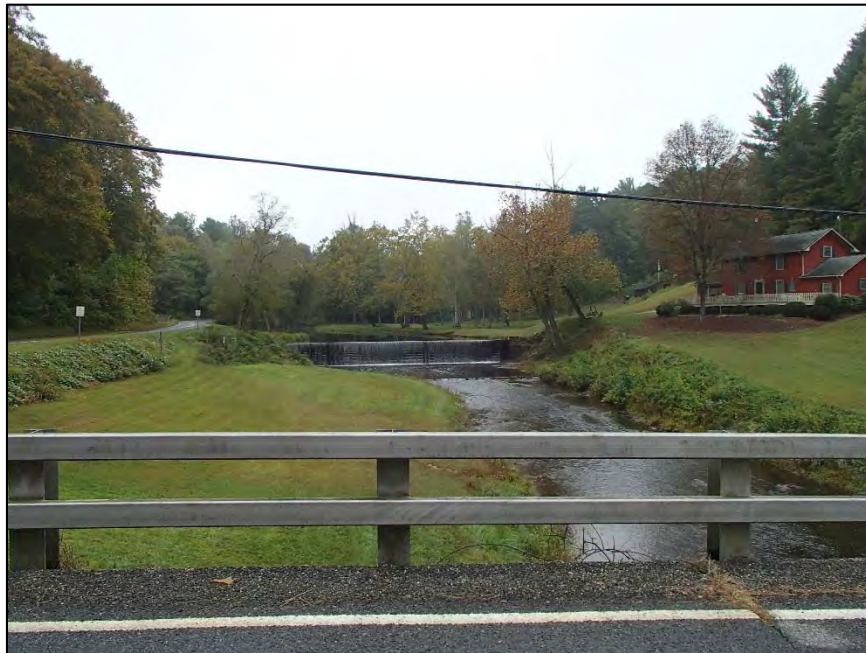
Figure 11: Dam at Kapp's Mill. The house in the image is a heavily remodeled store. This view is facing north toward the mill dam. Kapp's Mill is located to the east, just out of the frame. The bungalow is located to the west, and the miller's house to the south.

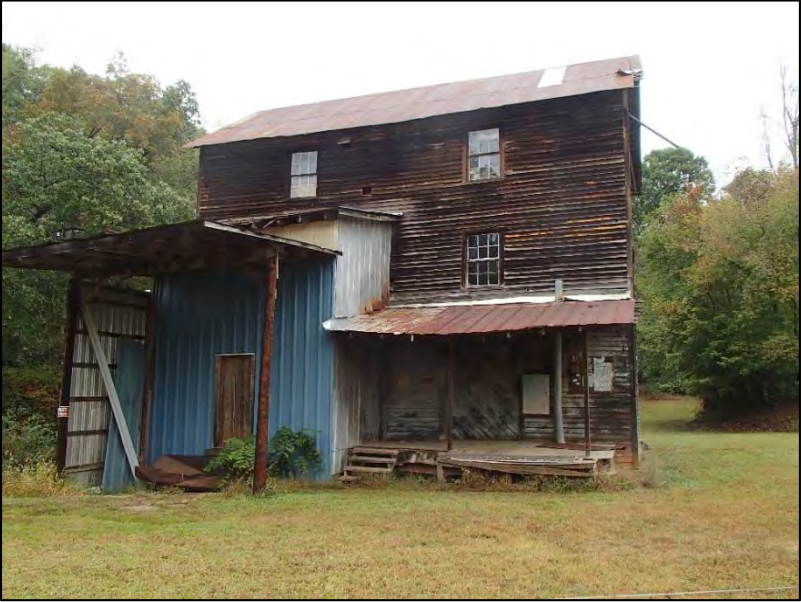
Figure 13: Dobbins Mill, south elevation

square posts, a wooden floor, and wooden steps. The porch shelters a wide front door constructed from diagonally-laid boards. The second floor of the south elevation contains one six-over-six sash window while the metal, shed-roof addition conceals the other window. The third floor retains two six-over-six sash windows. A side-gable roof with five-v crimp metal roofing and deep eaves shelters the building.

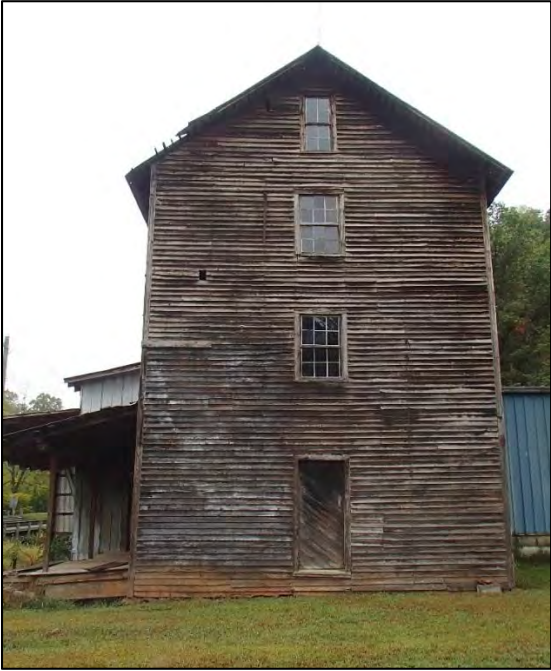
Figure 14: Dobbins Mill, east elevation

On the east elevation (figure 14), a narrower board-and-batten door with diagonal boards occupies the first floor and is centered on the elevation. Above the door, six-over-six sash windows pierce the elevation at each level. A four-over-four window lights the attic. .

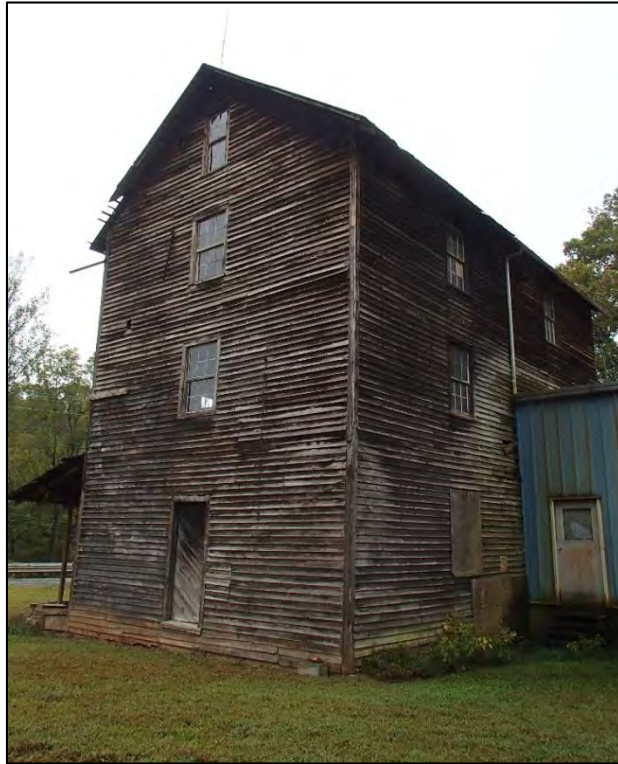
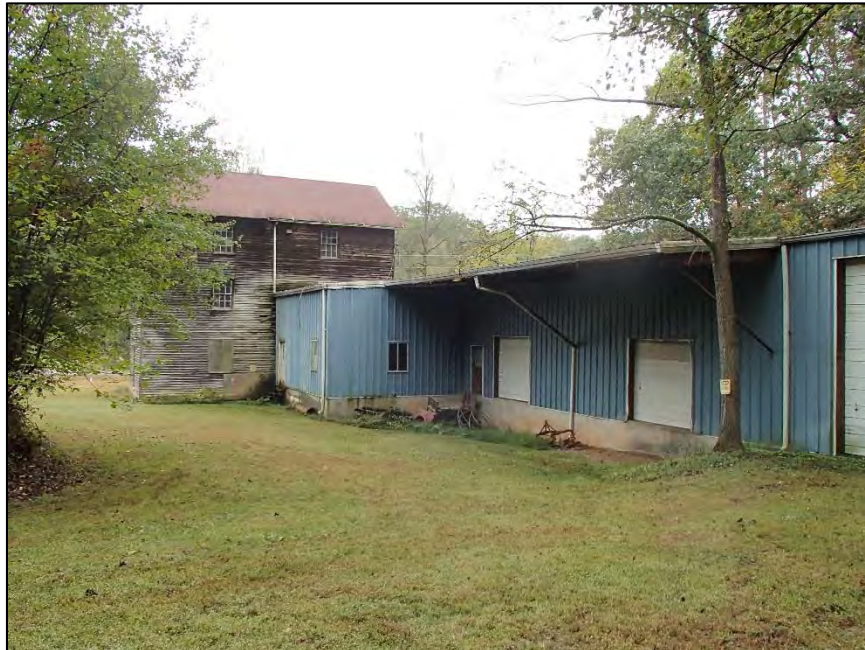
The north or rear elevation (figures 15 and 16) repeats the façade: a two-bay elevation retains six-over-six sash windows with the first floor east window boarded over and the first floor west window obscured by a large addition.

Figure 15: Dobbins Mill, northeast corner

Figure 16: Dobbins Mill, north elevation and addition

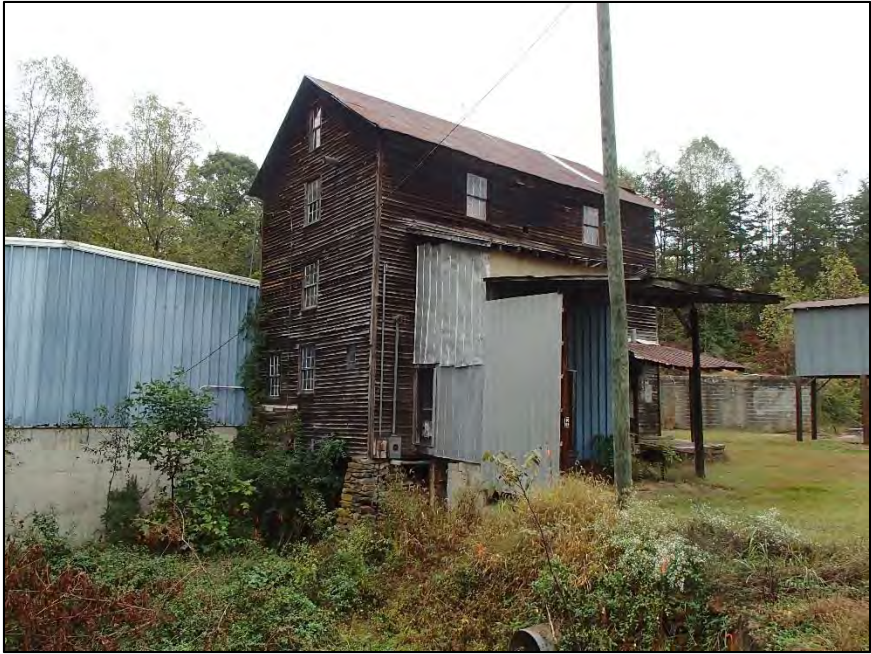
Figure 17: Dobbins Mill, southwest corner

On the west elevation (figure 17), the gable end features a single six-over-six sash window centered on the elevation. At the first floor level, an off-center six-over-six sash window has been added to the composition.

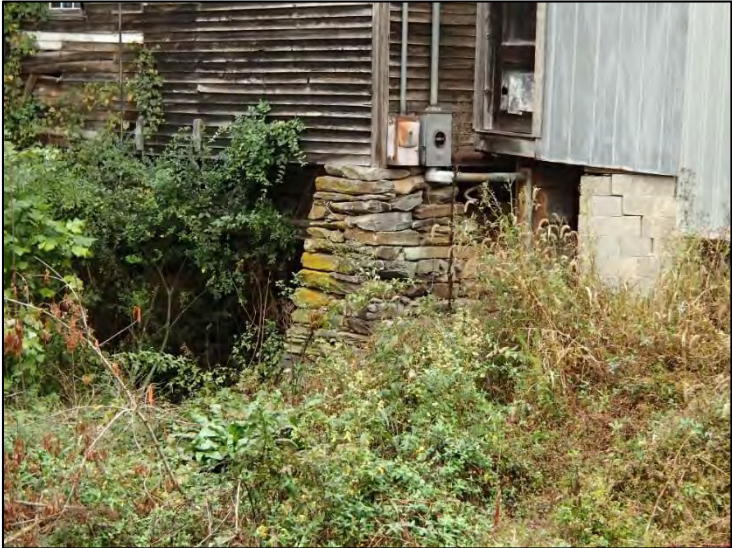
Figure 18: Dobbins Mill, stone foundation pier

A truncated pyramidal foundation pier of dry-laid stone supports the building’s southwest corner (figure 18). Another matching pier is probably located at the northwest corner, but existing, dense vegetation prevents confirmation. The rest of the building’s foundation is nearly invisible because the building’s weatherboards extend nearly to the ground. Where the foundation can be seen on the south, east, and north elevations, it appears to be a continuous foundation created from stone, concrete block, and some brick.

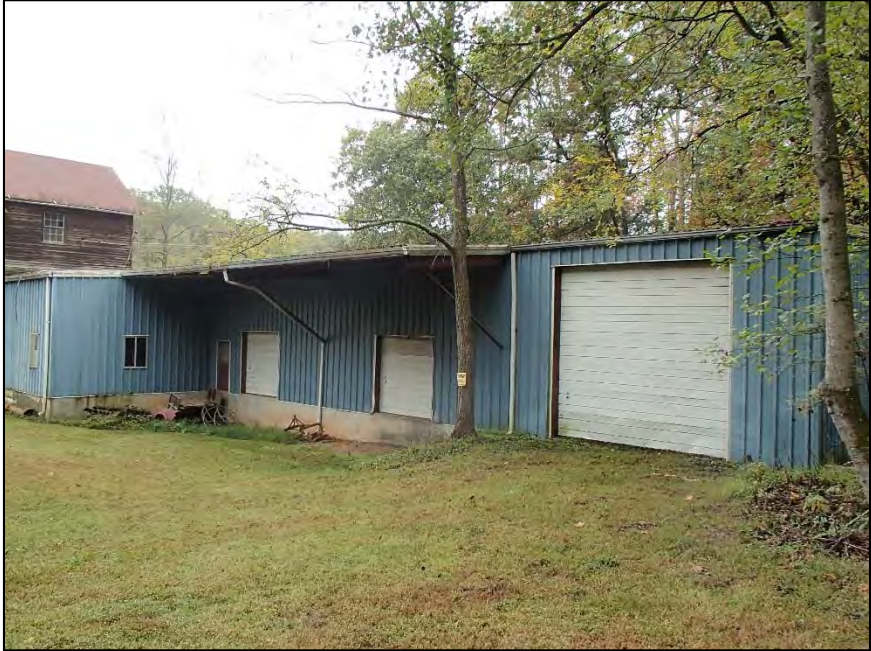
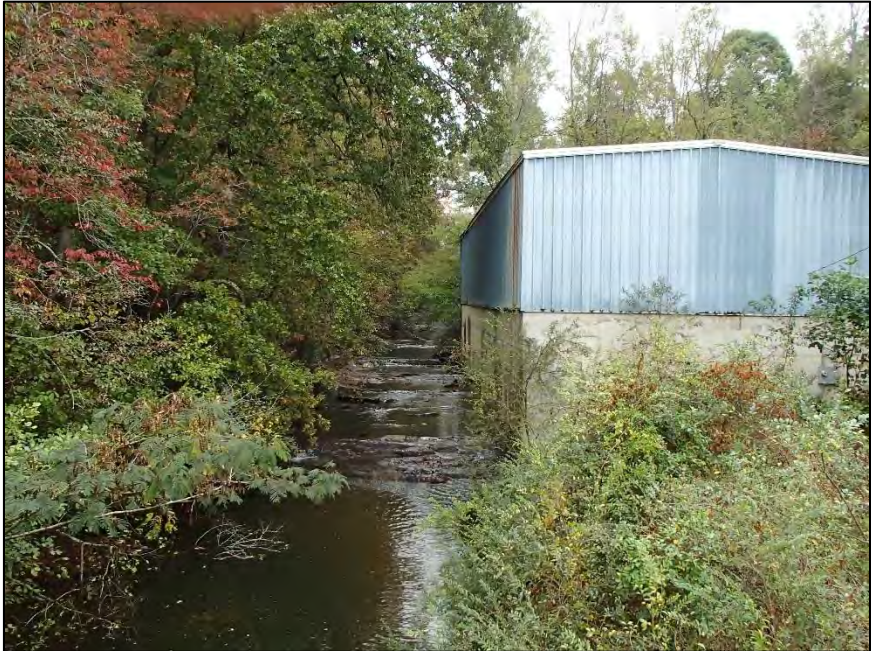
On the building's north elevation, a long, one-story, steel-framed, metal-clad addition extends along the edge of the creek (figures 19 and 20). On the creek side, the building features a tall cast concrete foundation. On the east side, it has small sliding windows and garage bays sheltered by a shed roof overhang.

Figure 19: Dobbins Mill, east elevation of rear addition

Figure 20: Snow Creek, looking north with mill addition on the east side of the creek

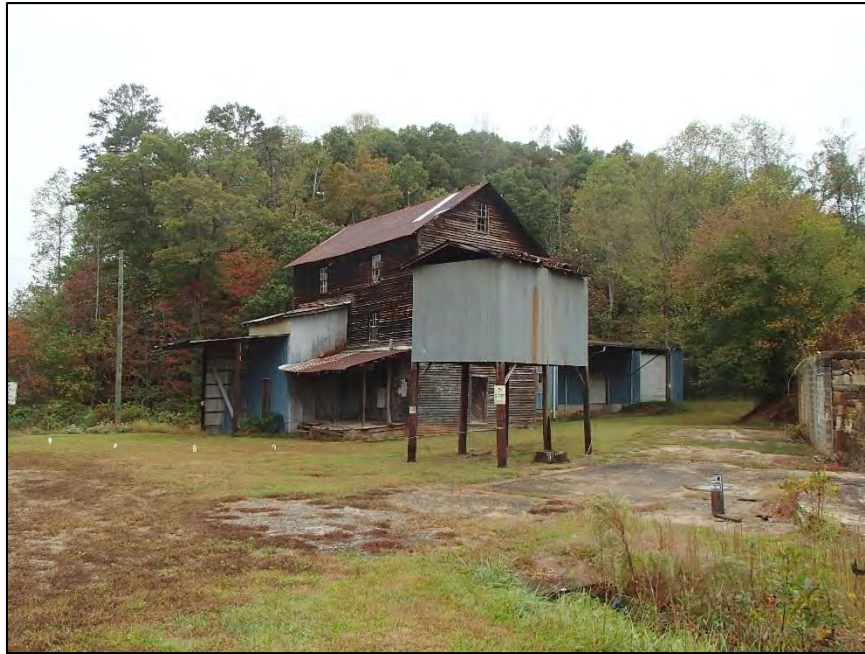
Figure 21: Dobbins Mill, loading dock and in-ground scales

To the east of the main mill building is a small, metal-clad, gable-roof building on tall stilts (figure 21). This was part of a loading system for transferring ground products (flour, corn meal, and feed) to trucks. A ninety-five-foot-tall elevator was also part of this structure originally. An in-ground scale for weighing trucks is located adjacent to this structure.

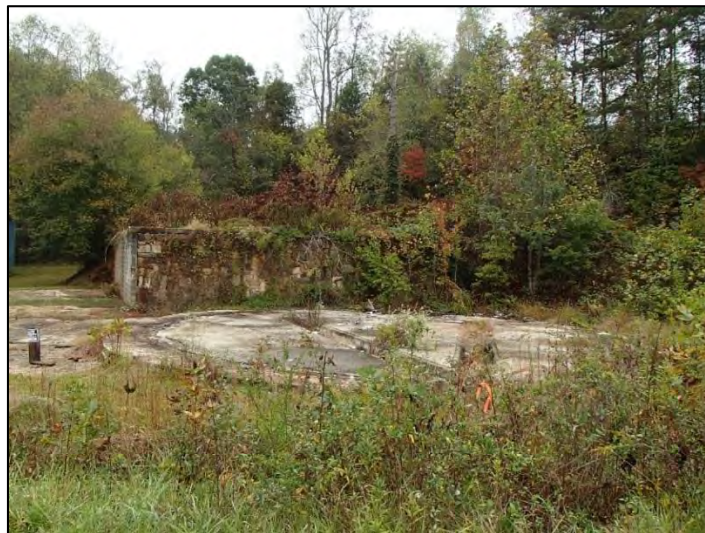
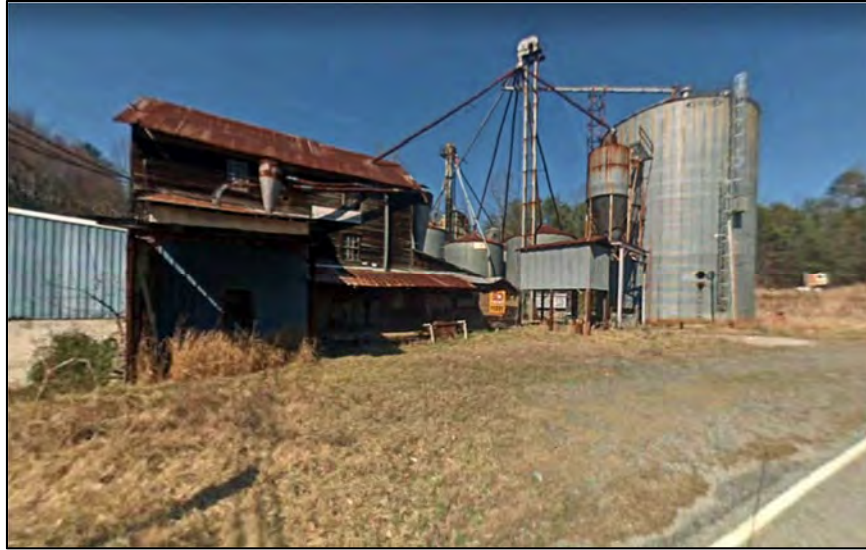
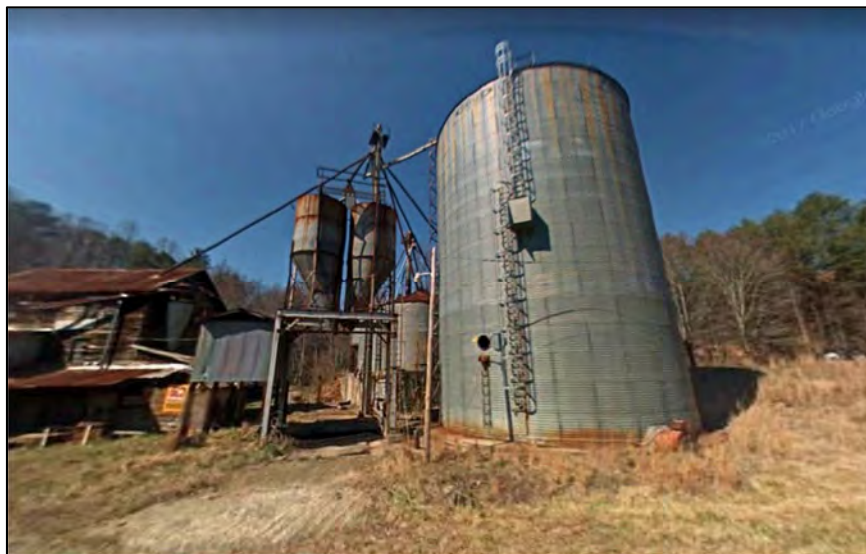
To the east of the loading structure is a round concrete foundation where a 73,000-bushel storage bin once stood (figures 22-24).

Figure 22: Dobbins Mill, grain bin foundation with retaining wall in background

Figure 23: Google Streetview image from 2008 showing grain elevator and storage bins

Figure 24: Google Streetview image from 2008 showing grain storage

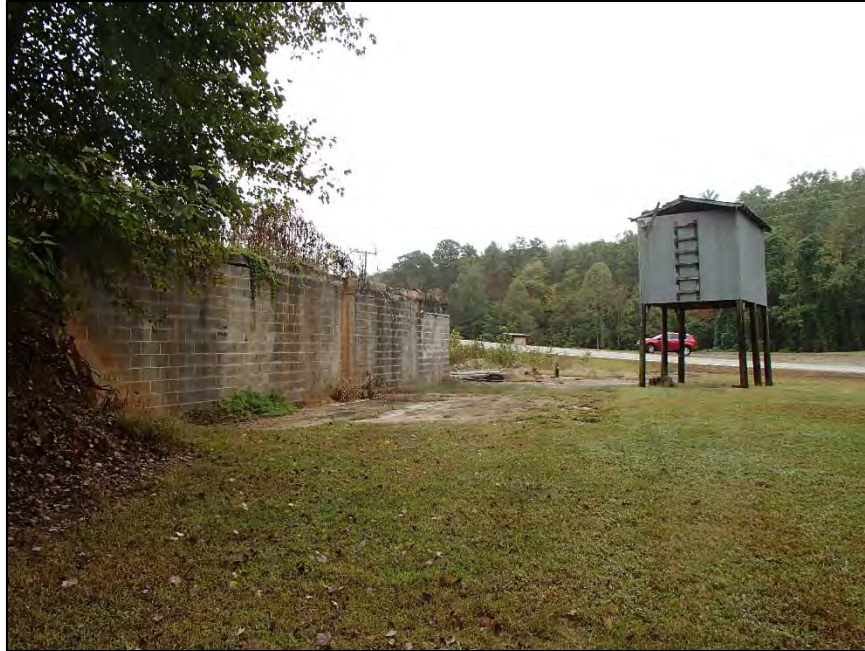
Figure 25: Dobbins Mill, facing southeast toward loading dock and retaining wall

Immediately east of the storage bin foundation is a concrete block and stone retaining wall, on top of which is a level plateau where smaller storage bins stood (figure 25).

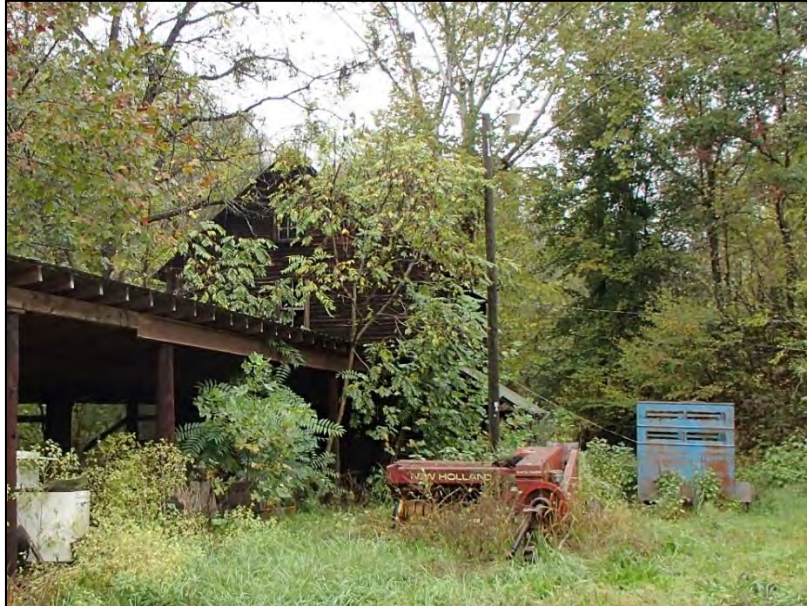
Figure 28: Joe Layne Mill

The Joe Layne Mill (figure 28, SR 549) dates from the late 1800s, and Joe Layne also operated a sawmill and blacksmith shop here. It ceased operations in the mid-1900s after a flood destroyed the dam. The mill stands on Snow Creek near the intersection of Beach Road and Joe Layne Mill Road.

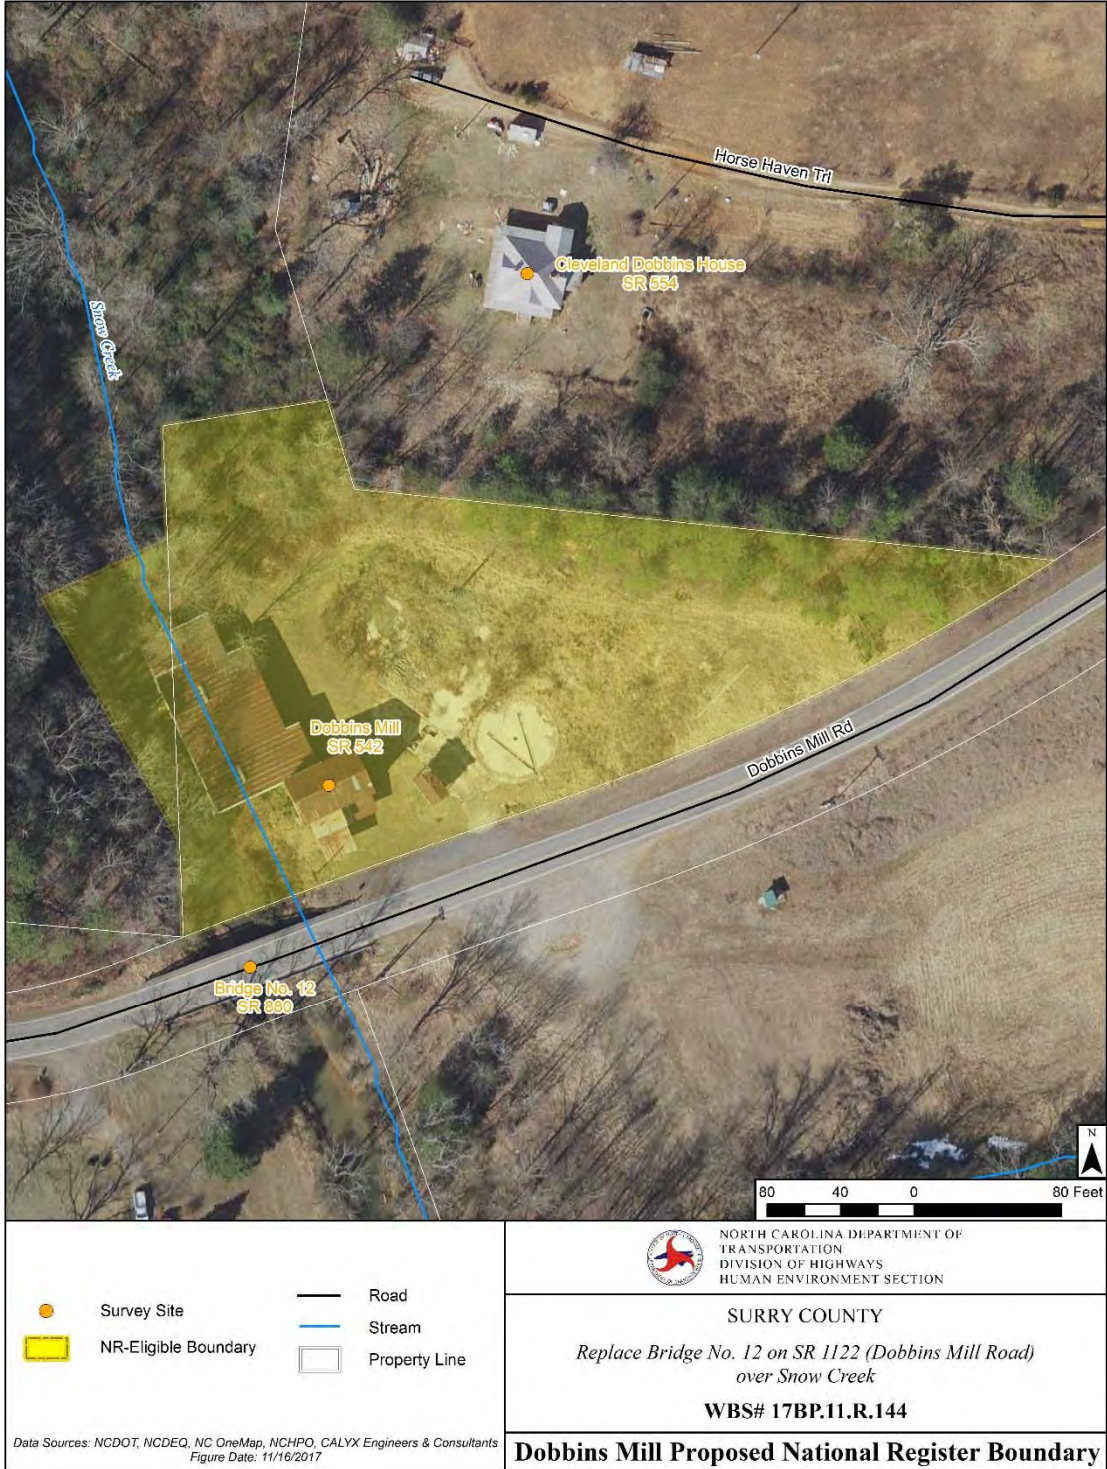
Figure 30: Dobbins Mill Proposed National Register Boundary

The proposed Dobbins Mill National Register Boundary follows the Surry County parcel lot line associated with the tract identified by PIN 497400838979 except along the lot line's western edge where the boundary jogs into the adjacent lot to capture the full footprint of the mill building. This boundary encompasses the land historically associated with the mill and sufficiently conveys the building's historical association with milling and rural industry.

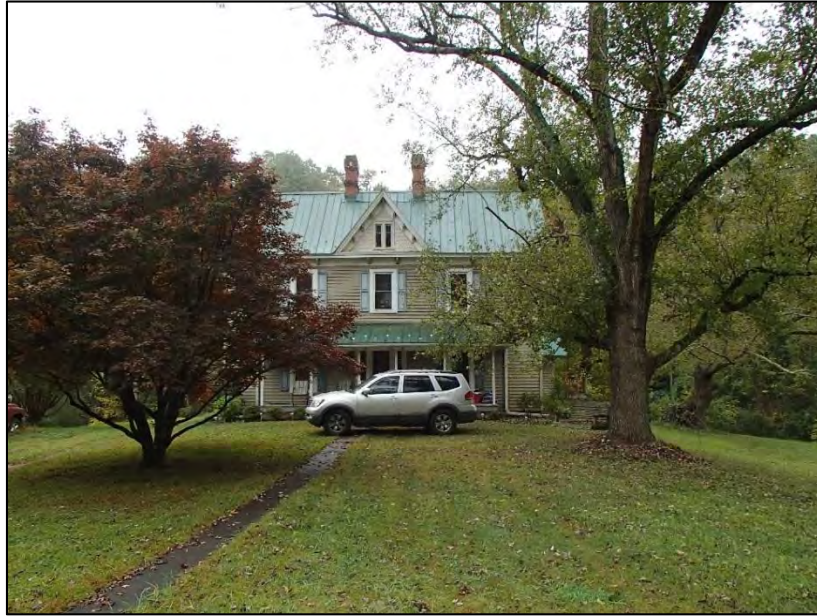
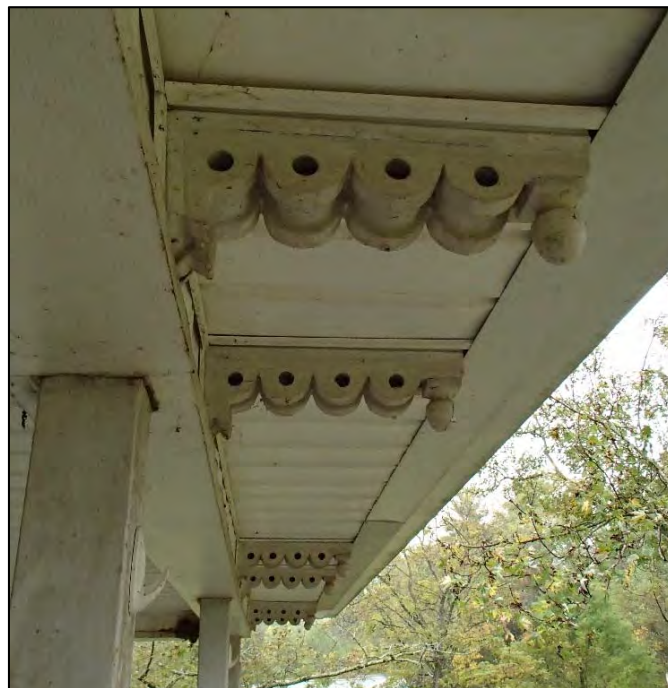
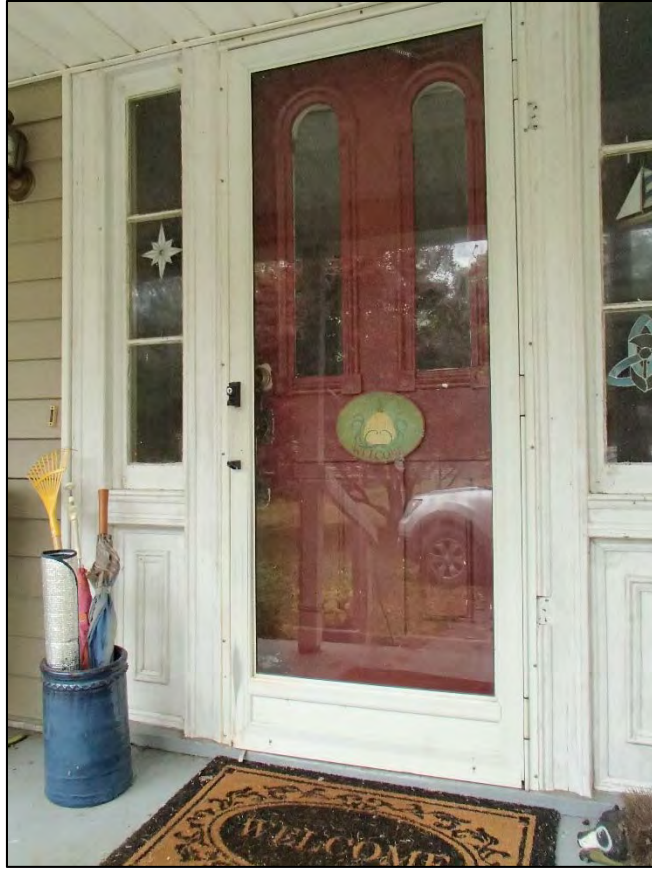
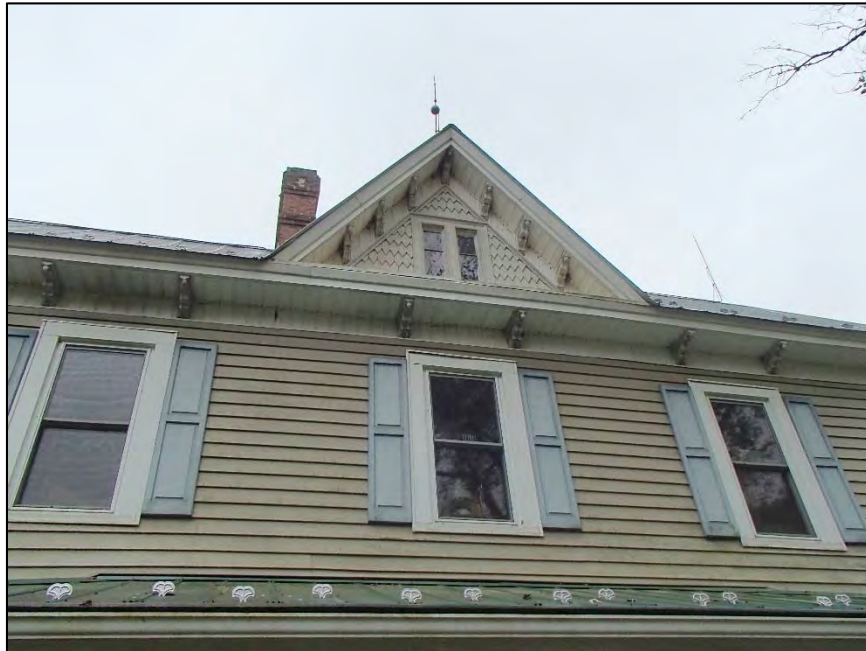
The house is a two-story, traditional I-house with vernacular Italianate ornamentation (figures 32-35). The house has been covered in vinyl siding and the original windows, which appear to be two-over-two sash, based on photos in the SHPO survey site file, have been replaced. A single leaf door with two arched, glazed panels above vertical panels and three-light sidelights above molded panels compose the front entrance. A full-width, hip-roof porch retains paired, scalloped brackets along the eaves, but the porch posts, which were turned and featured rich sawnwork brackets, have been replaced with plain, square posts.

Figure 32: Charlie Dobbins House, north elevation

Figure 33: Charlie Dobbins House, porch eave detail

Figure 34: Charlie Dobbins House, front door

Figure 35: Charlie Dobbins House, roof gable and eave

The Charlie Dobbins House retains integrity of location, setting, feeling, and association as a rural farm house associated with a milling operation. However, the introduction of vinyl siding, the replacement of original windows, and the replacement of the porch posts and loss of porch brackets detracts significantly from the house's integrity of workmanship, materials, and design. Particularly, removing the porch post brackets has eliminated the delicate framing around the openings between the porch posts that contributed significantly to the house's original romantic, Italianate feel.

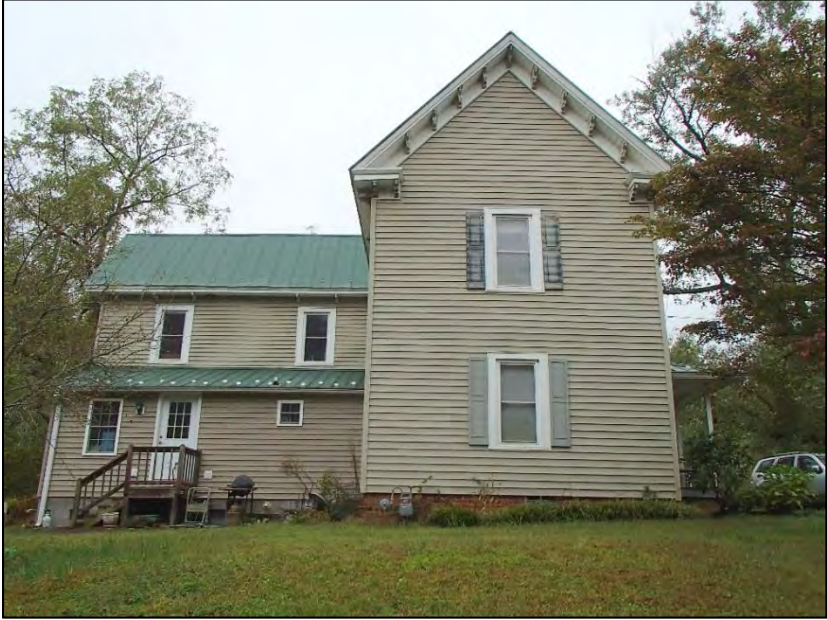
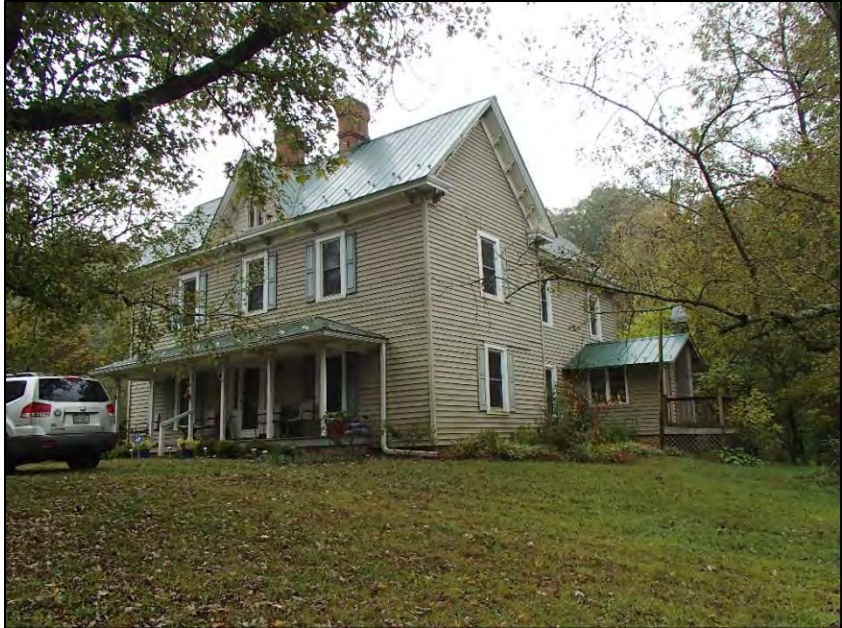
On the main block's gable ends, a single window is centered on each floor (figures 36 and 37).

Figure 36: Charlie Dobbins House, east elevation

Figure 37: Charlie Dobbins House, northwest corner

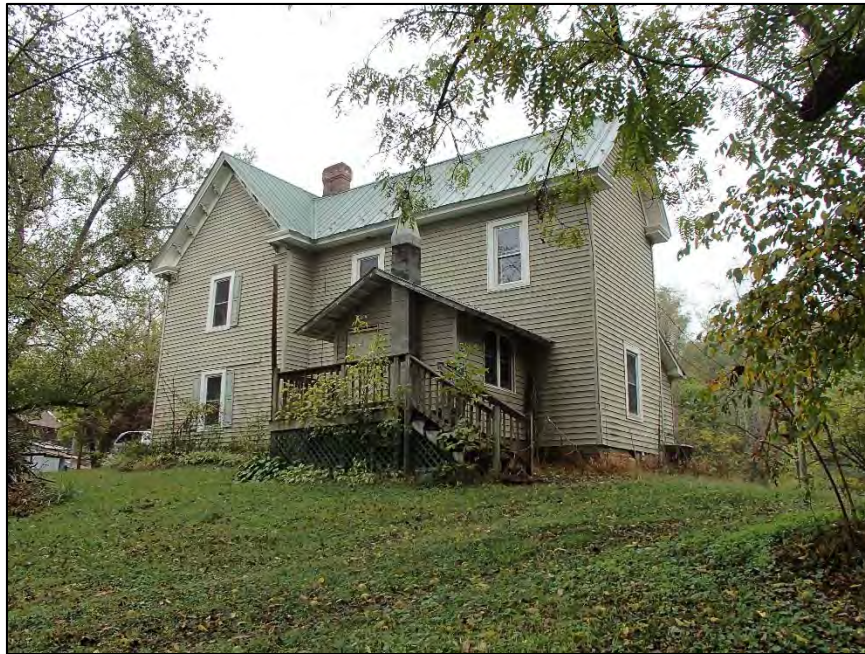
Figure 38: Charlie Dobbins House, west elevation

A two-story ell extends to the rear (figure 38). A one-story gabled addition is attached to the ell's west elevation; this addition was built before the 1981 architectural survey. A shed-roofed, enclosed porch extends along the ell's east elevation.

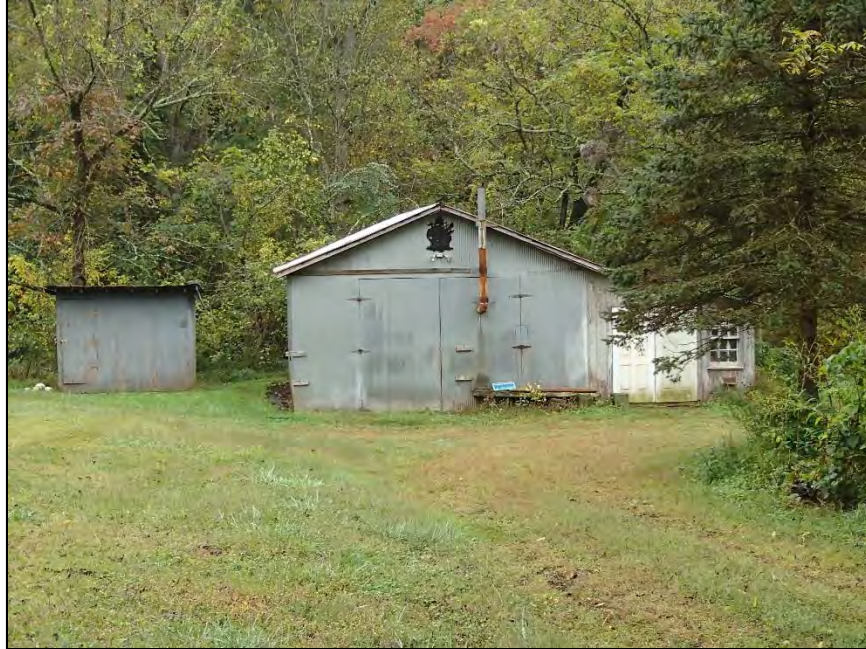
Figure 39: Charlie Dobbins House, shed and tinsmithing shop

The site includes four outbuildings. To the west of the house, and slightly downhill is a small metal-clad shed with a single door and exposed rafter tails (figure 39). Next to this is a larger, gable-front, metal-clad building with double-doors in the gable end and a shed addition along the west elevation (figure 39). A metal flu extends out of the building through one leaf of the double door. According to the owner of the mill building across the road, this building serves as a workshop for the owner, who is a tinsmith.

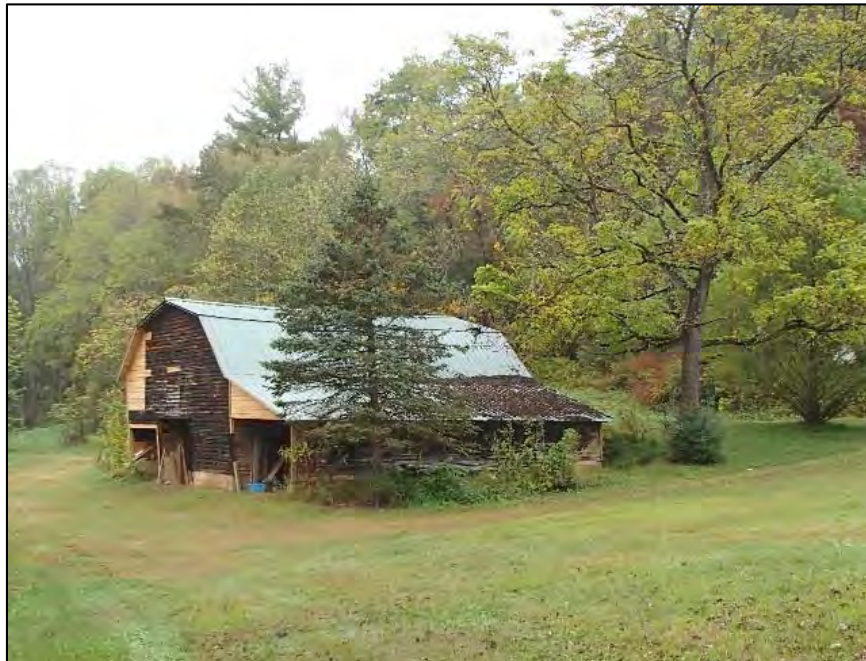
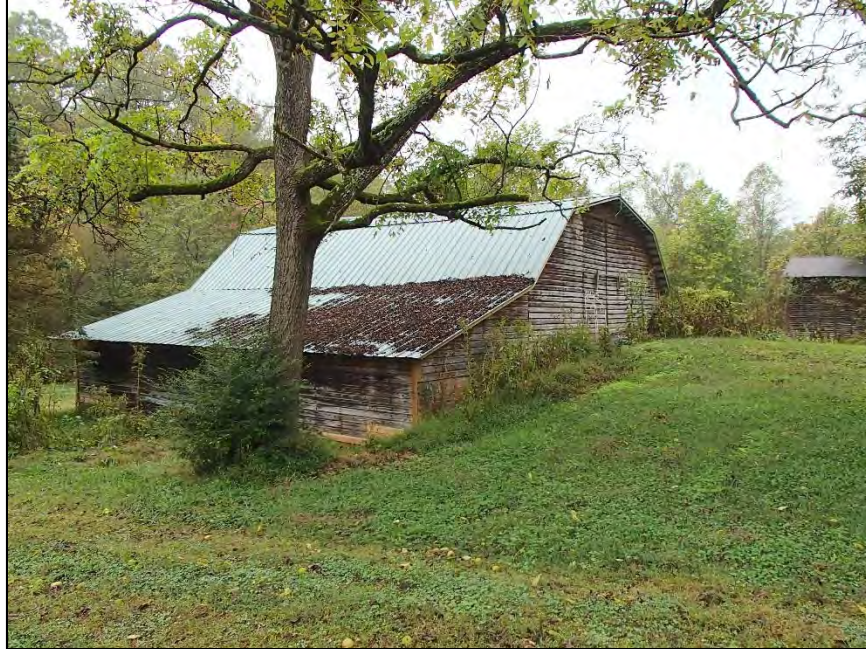
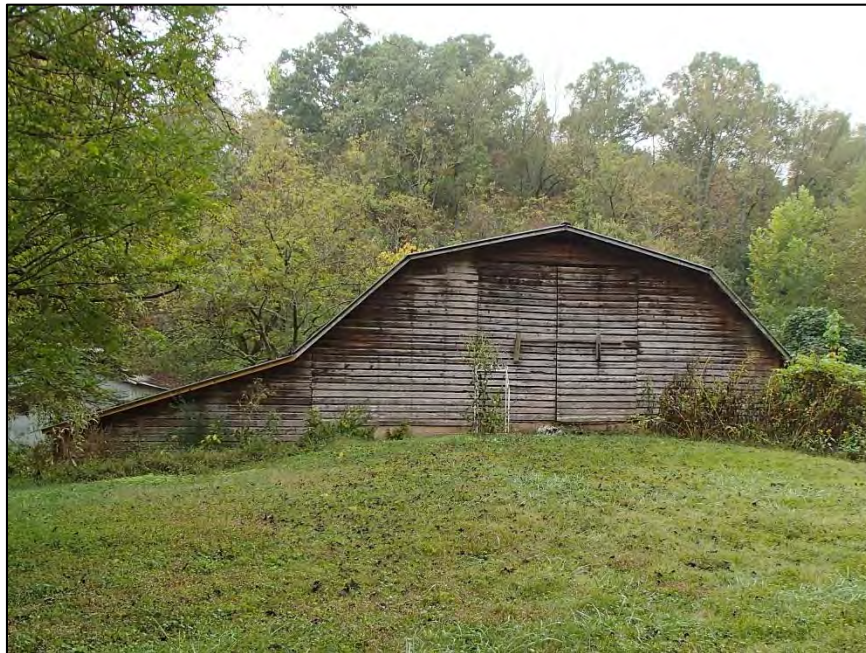
Farther west is a gambrel-roof barn with a shed wing on the east elevation (figures 40-42). The barn is full-height on its south elevation with a wide doorway centered on the elevation. On the north elevation, it is approached by a bank and less than half its height extends above the grade. Weatherboards cover the barn.

Figure 40: Charlie Dobbins House, barn, southeast corner

Figure 41: Charlie Dobbins House, barn, northeast corner

Figure 42: Charlie Dobbins House, barn, north elevation

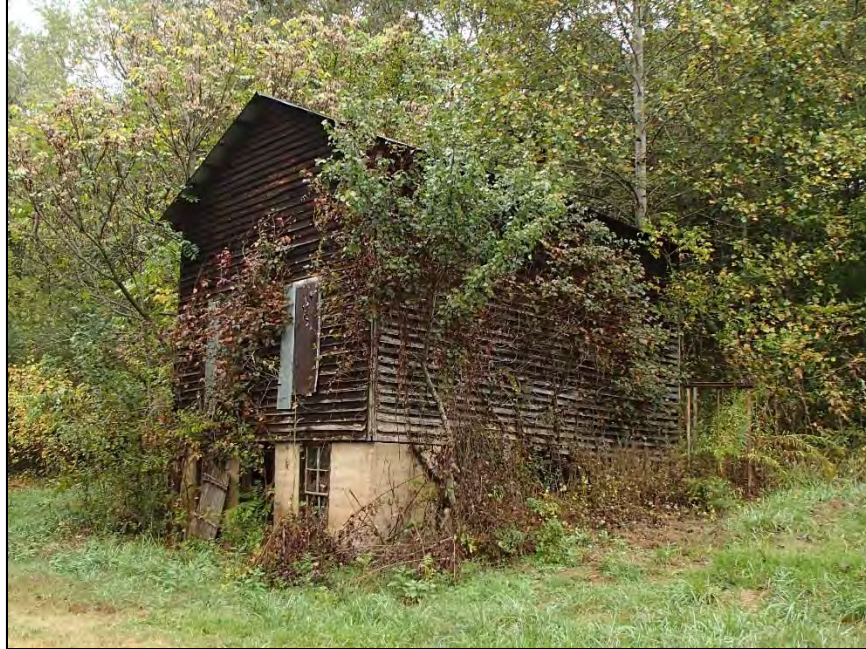
Figure 43: Charlie Dobbins House, tobacco packhouse, southeast corner

To the west of the barn is a tobacco pack house with a concrete foundation and weatherboard siding (figure 43). One four-over-four sash window is located in the foundation on the south elevation.

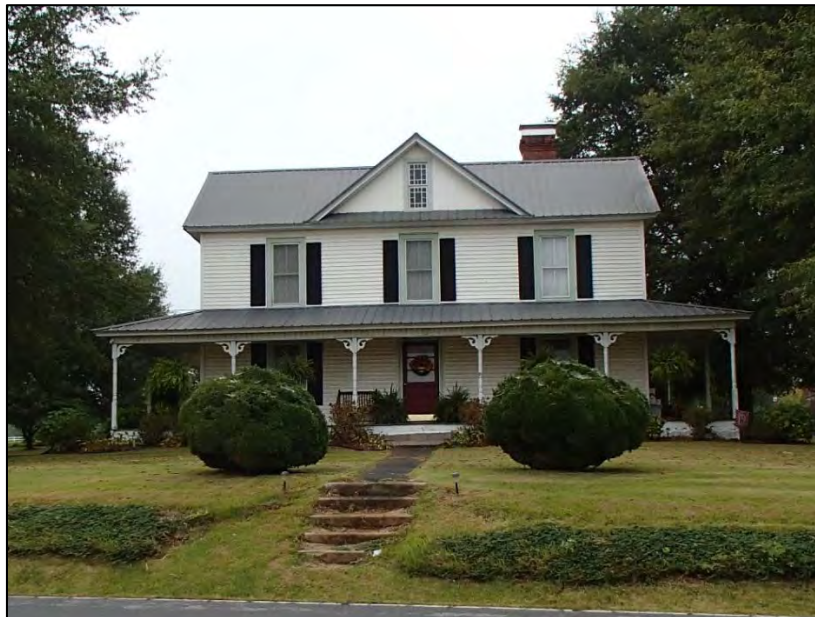
Figure 47: Abraham Phillips House, SR 244, at 8802 N.C. Highway 268

The Abraham Phillips House (figure 47, SR 244) is covered with vinyl siding, but retains original windows and porch materials.

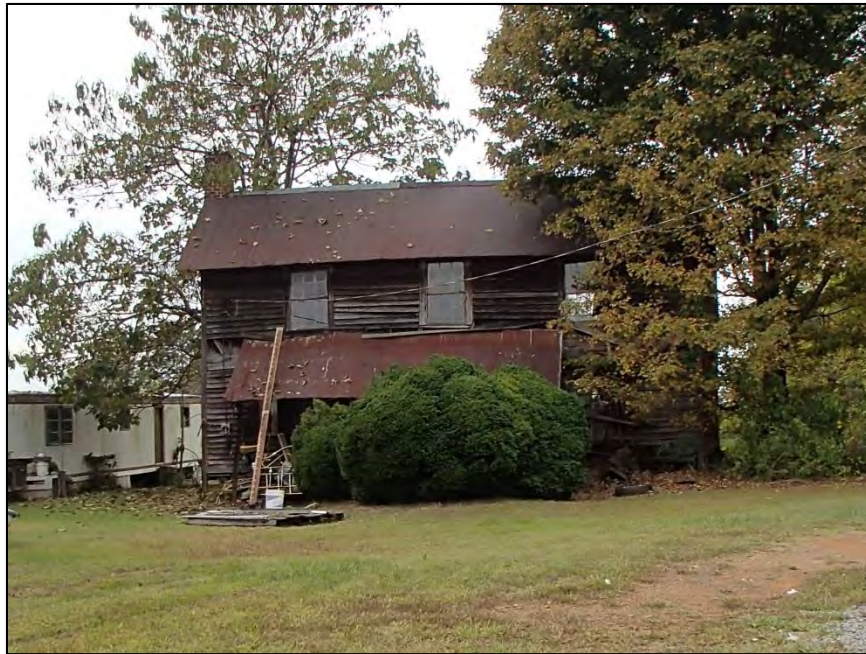
Figure 48: Perry Scott House, SR 116, Shoals Road

Deteriorated I-houses, such as the Perry Scott House (figure 48, SR 116), are also common. Although the porch is collapsing, the house retains original windows, siding, and gable-end chimneys. It is a good example of a very plainly finished I-house.

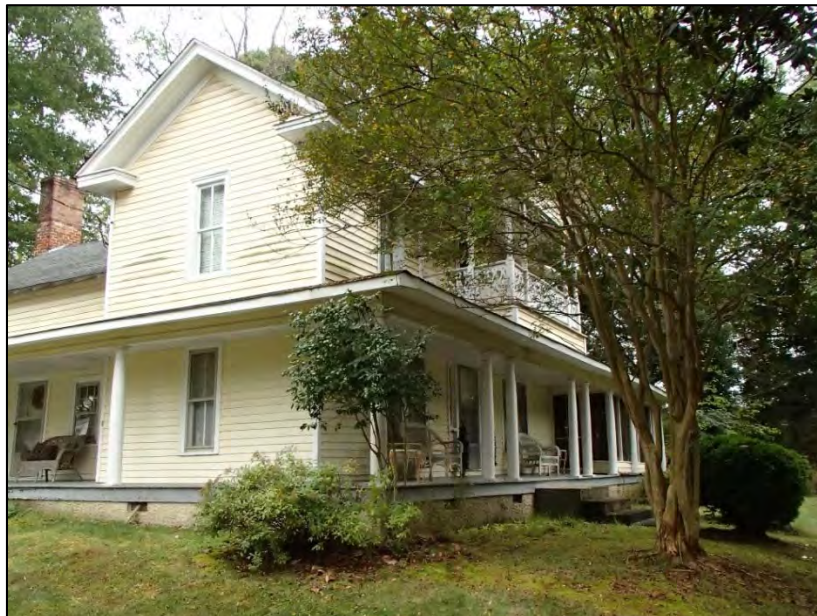
Figure 49: Robert Trulove House (SR 123) at the corner of Shoals and Hauser roads

At the Robert Trulove House (figure 49, SR 123) classical columns are probably a later addition, but the house retains a sawnwork balustrade and turned posts on the upper porch. This house is an excellent example of its type.

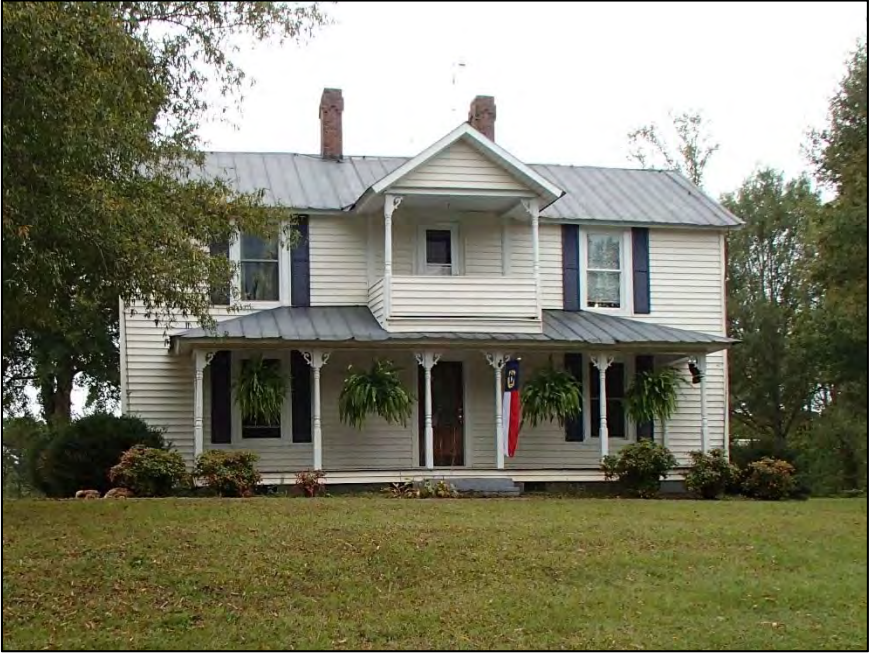
Figure 50: Unsurveyed House at 1416 Hauser Road

Vinyl siding and replacement windows are common, but many owners still retained porch posts and brackets. An unsurveyed example at 1416 Hauser Road features heavily corbeled chimneys (figure 50).

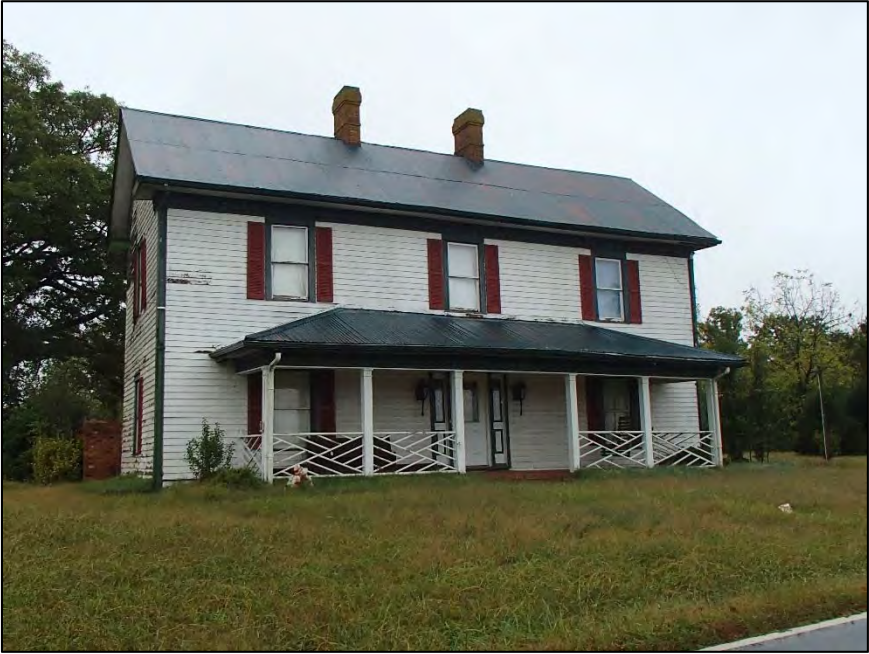
Figure 51: George Washington Bowman House

The George Washington Bowman House (figure 51, SR 253, Siloam Road) has undergone extensive alterations, including vinyl siding, replacement windows, and modern porch materials.

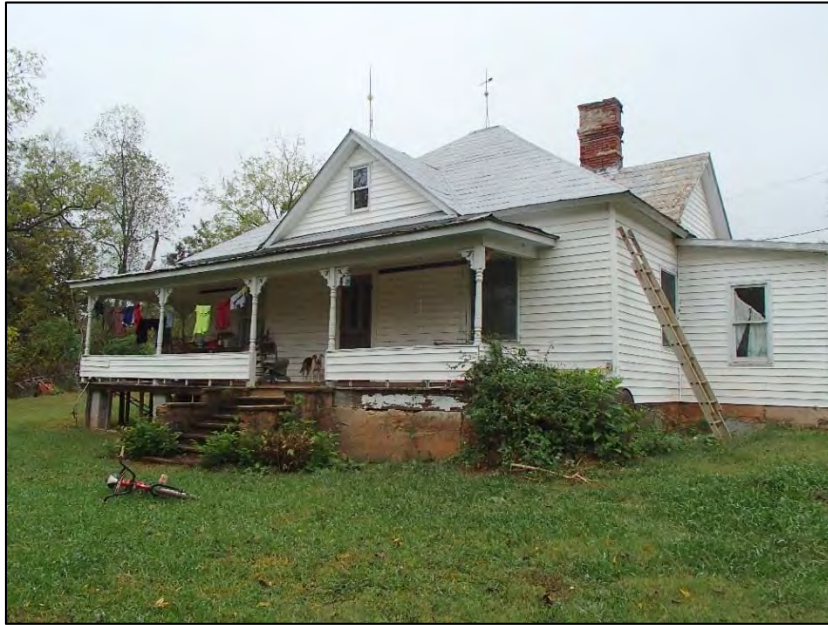
Figure 53: Cleveland Dobbins House, south elevation

The house is a one-story, pyramidal-roof cottage with roof gables on the front and side roof slopes and a small gabled-ell extending from the rear elevation (figure 53). Vinyl siding covers the exterior, and the windows are one-over-one and simulated-light, six-over-six vinyl replacement units.

The Cleveland Dobbins House is not eligible for the National Register of Historic Places under Criterion C. Changes to the house, including vinyl siding, replacement windows, and significant interior alterations, have made the house ineligible for the National Register as a good example of an early-twentieth-century house.

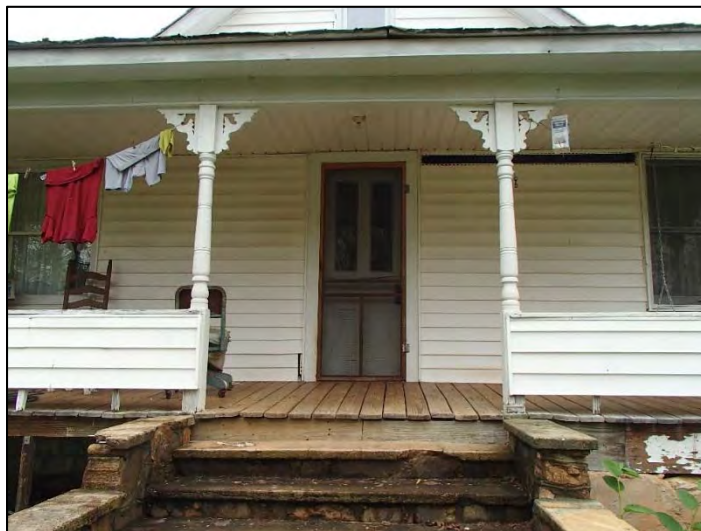
Figure 54: Cleveland Dobbins House, south elevation detail

The front (south) elevation is three-bays wide with a single-leaf front door occupying the middle bay. This door is original and has two arched, glazed panels above molded panels (figure 54). The porch steps feature stone cheek walls.
