SUBJECT: Replace Bridge 12 on SR1122 (Dobbins Mill Road) over Snow Creek, PA 17-06-0004,
Surry County, ER 17-2874

HISTORIC STRUCTURES SURVEY REPORT

Replace Bridge 12 on SR 1122 (Dobbins Mill Road) over Snow Creek
Surry County
WBS# 17BP.11.R.144

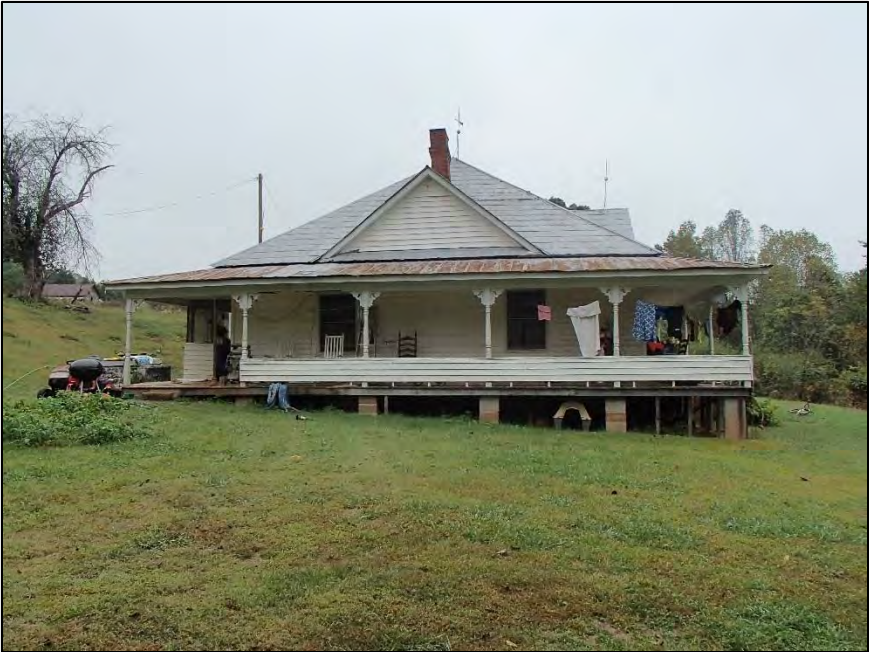
Figure 55: Cleveland Dobbins House, west elevation

The west elevation has two symmetrical bays (figure 55). The east elevation includes a shed-roof bathroom addition (figure 56). The north elevation is occupied by the rear ell, and a back door that opens onto the wrap-around porch (figure 57).

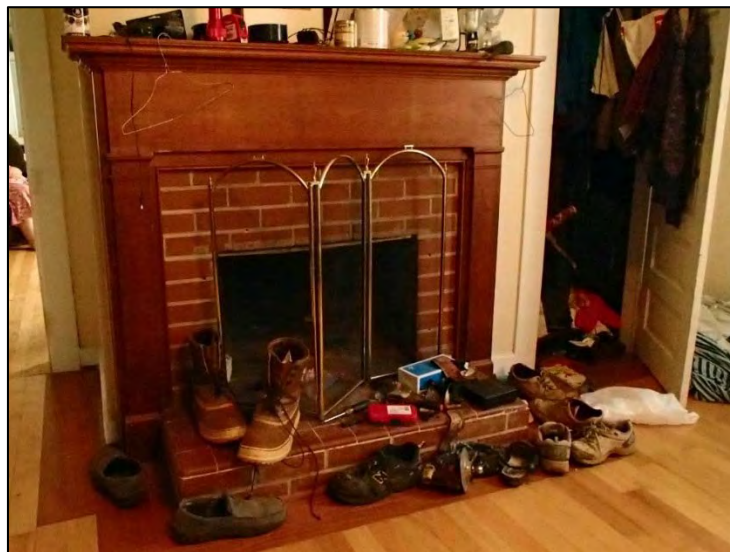
Figure 58: Cleveland Dobbins House, mantelpiece

Inside, the house retains a single original mantelpiece (figure 58), which is a simple but well-executed and finely finished post-and-lintel configuration. The other mantelpieces have been removed, and two of the four fireplaces have been walled-over. A wall between the kitchen and the rest of the house has been removed, as has a portion of the wall in the center hall toward the rear of the house. The front half of the hallway has been altered by the enclosure of the staircase with a wall and door. Interior walls have been covered with sheetrock.

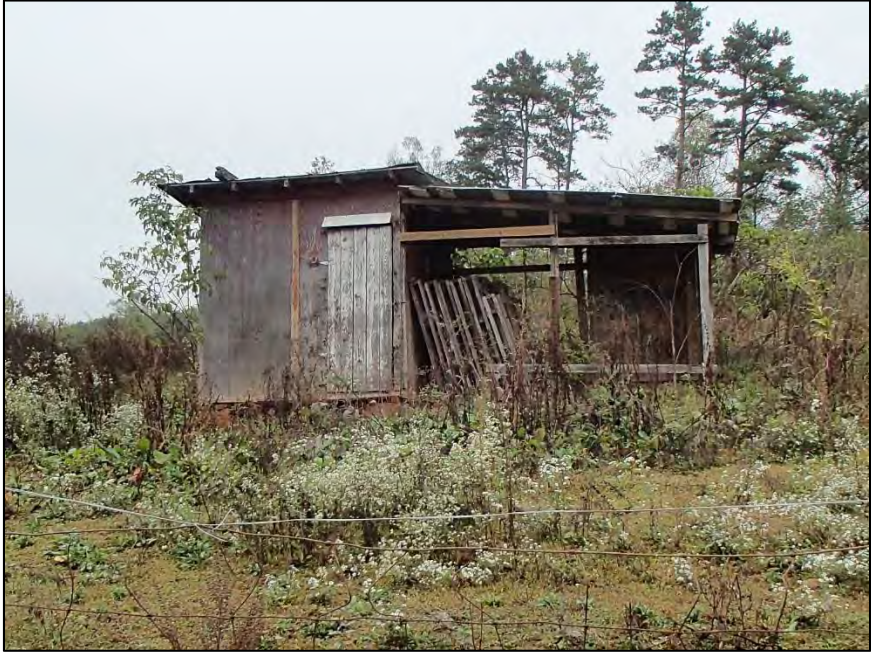
Figure 59: Cleveland Dobbins House, plywood shed

Uphill, north of and behind the house, is a small, plywood shed (figure 59). Farther west is a gable-roof barn with vertical wood siding and shed wings (figure 60). Another small, open-sided shed is located to the west of the house along the drive way (figure 61).

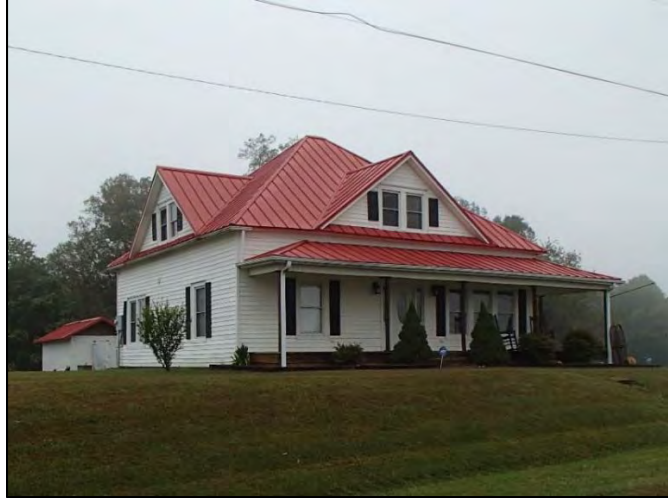
Figure 62: Unsurveyed house at 241 Judsville School Road, with vinyl siding, replacement windows, new porch and roof materials, missing chimneys

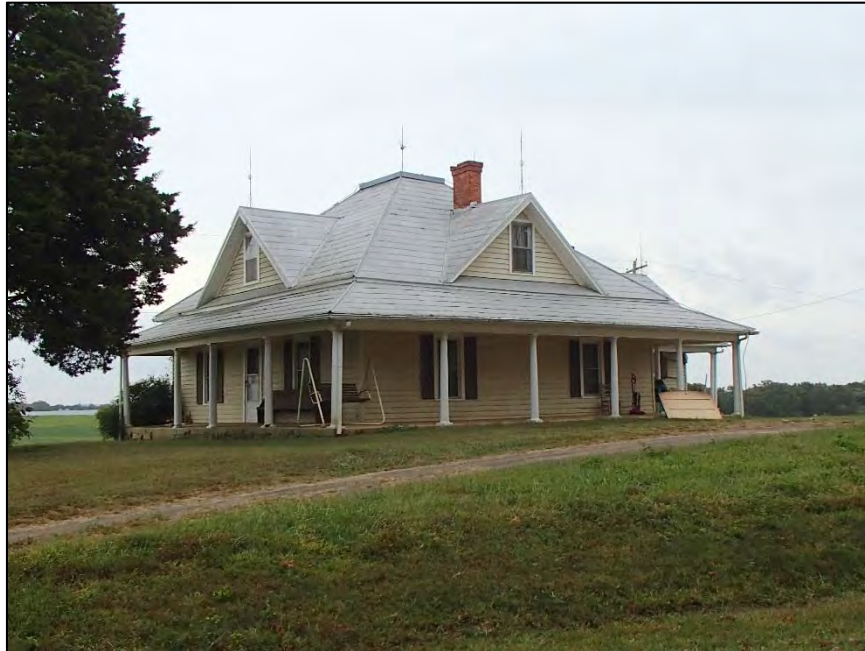
Figure 63: Unsurveyed House at approximately 182 Miller Gap Road, close to Music Lane, with vinyl siding, original windows, and original shingles

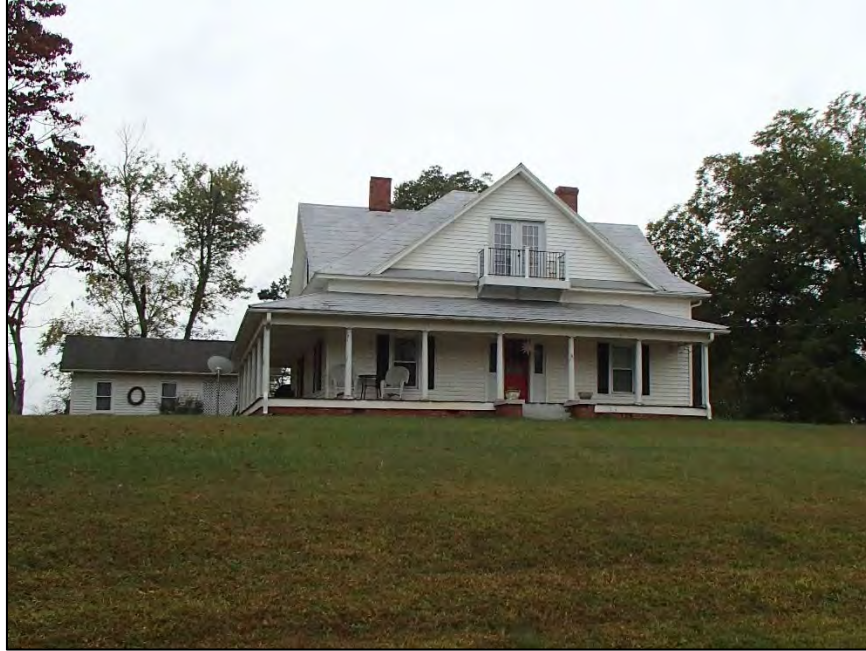
Figure 64: Riley Faulk House (SR 179) at 1218 Quaker Church Road, with vinyl siding, added balcony, and replacement windows
