**HISTORIC ARCHITECTURE
ELIGIBILITY EVALUATION REPORT**

**Widen NC 150 (Mooresville Road) from SR 1514 (Airport Road) to
West of Grants Creek, Rowan County**

**TIP # U-5900
WBS # 44690.1.1
PA # 17-06-0012**

**AECOM Technical Services of North Carolina, Inc.
701 Corporate Center Drive
Raleigh, NC 27607**

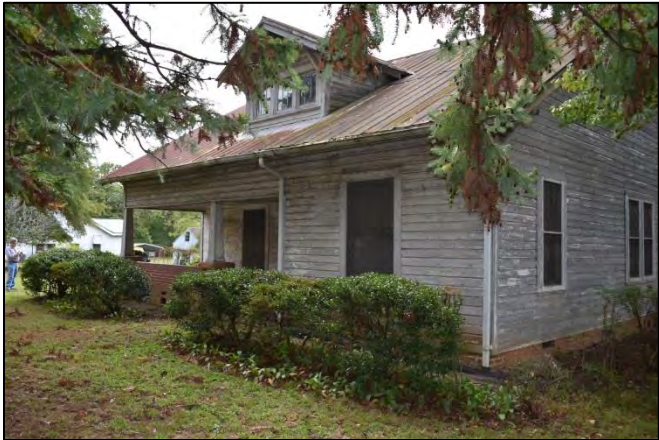
Resource Name	Ludwig House
	HPO Survey Site #	RW2176
	Location	1813 Mooresville Road, Salisbury
	PIN	460 018
	Date of Construction	Ca. 1925
	Recommendation	Recommended not eligible for NRHP Listing

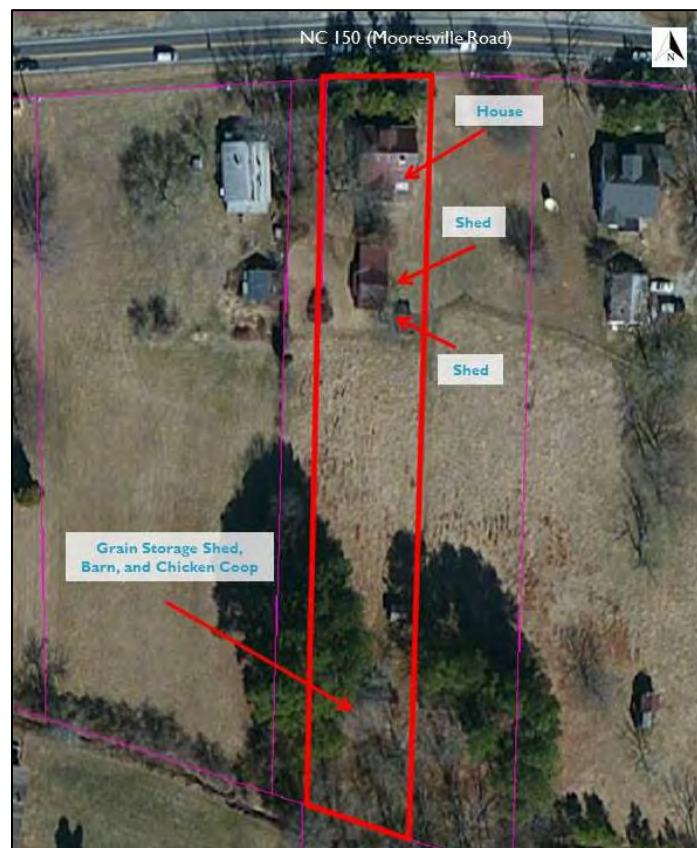
Figure 3: Site plan of Ludwig House.

The Ludwig House (RW2176) sits at the edge of a narrow, one-acre, rectangular lot approximately three miles west of downtown Salisbury. It is located less than 50 feet from NC 150 (Mooresville Road), which bounds it on the north. Although close to the road, the house is screened from it by a row of mature trees. Otherwise, the parcel is mostly open. A gravel drive once ran to the west of the dwelling, but it has since disappeared from lack of use. The house is bounded on its eastern side by a gravel company, and its western side by a residential parcel (Figure 3).

Five surviving outbuildings accompany the Ludwig House, all located to its rear (south). These buildings are two sheds, a chicken coop, a grain storage shed, and a barn. All five appear to date to the early/mid-twentieth century.

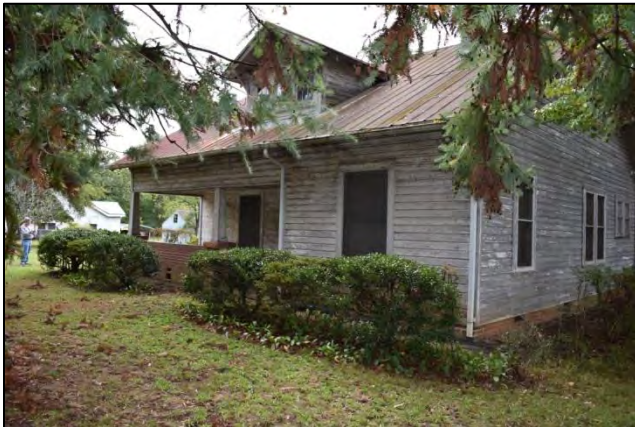
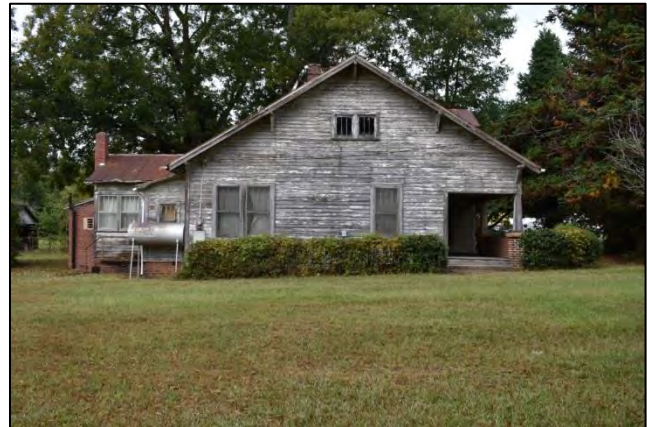
Figure 4: Left, north front and west side elevations; right, east side elevation.

The Ludwig House is a one-and-a-half-story, frame, Craftsman-style bungalow. It has a three-bay-wide, two-pile-deep front block with an original, centered, one-story rear ell (Figure 4). Two enclosed, early or original, shed-roofed appendages extend from the rear elevation of the main block, framing the ell (Figure 5). The house is clad in German siding and edged by wooden cornerboards. It rests on a brick-piered foundation that was later filled in with brick. A small, mid-twentieth-century, masonry, shed-roofed room—the house’s only modern addition—extends across the rear of the ell.

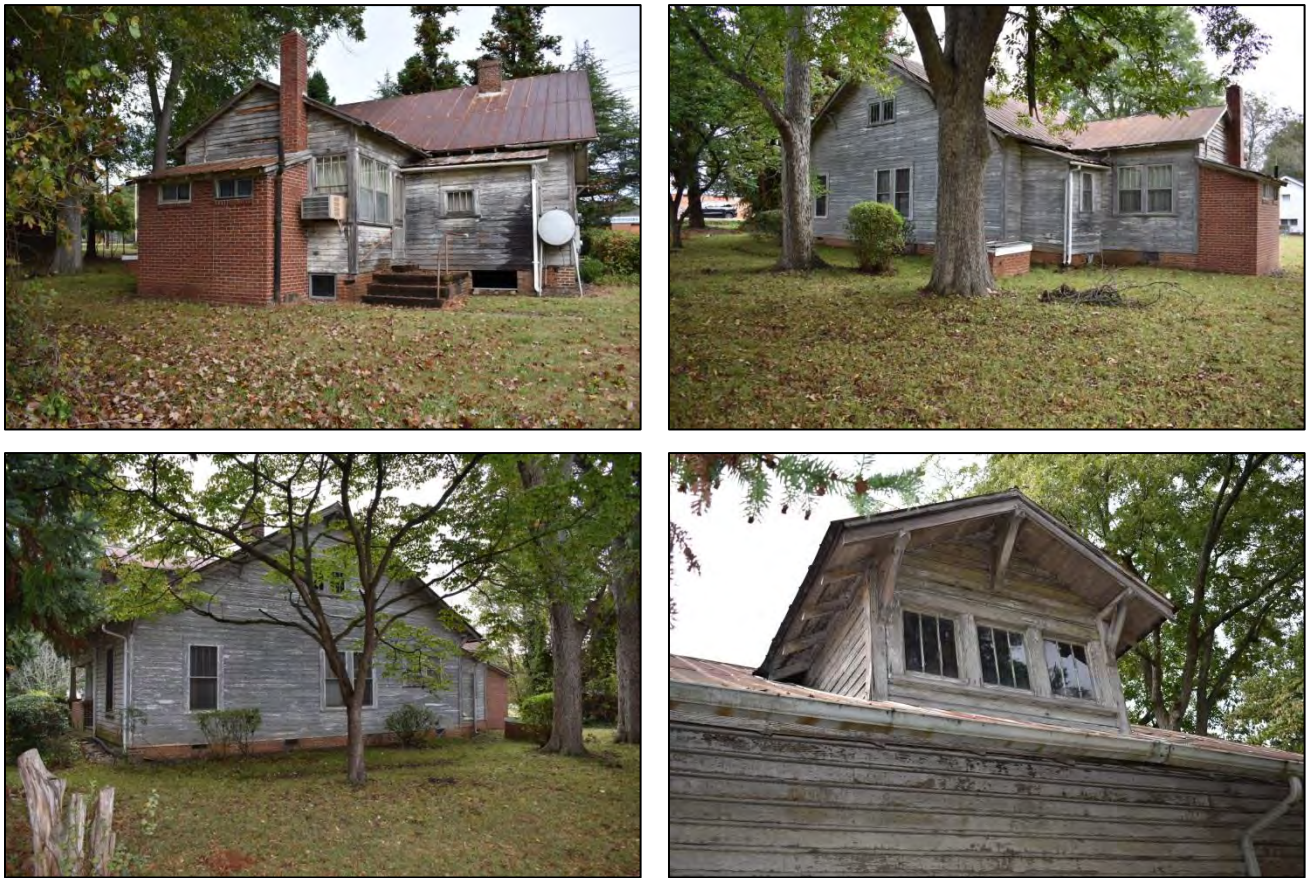
Figure 5: Left, rear (southeast) elevation; right, southwest corner; bottom left, side (western) elevation; bottom right, detail view of dormer found on primary elevation.

A low-pitched side-gabled roof capped with standing seam metal tops the house. Craftsman-style triangular knee braces and exposed rafter ends adorn the roof’s deep eaves. A front-gabled dormer centered on the building’s front elevation is also ornamented with triangular kneebraces. The dormer retains three small, original, fixed windows, each comprised of three long rectangular lights. A pair of similar windows is additionally found in either gable of the main block. A slightly off-center interior-end chimney projects from the roof’s southern slope. Much of its corbelling has fallen away. A secondary, exterior-end, brick chimney stack rises off-center on the southern gable end of the rear ell.

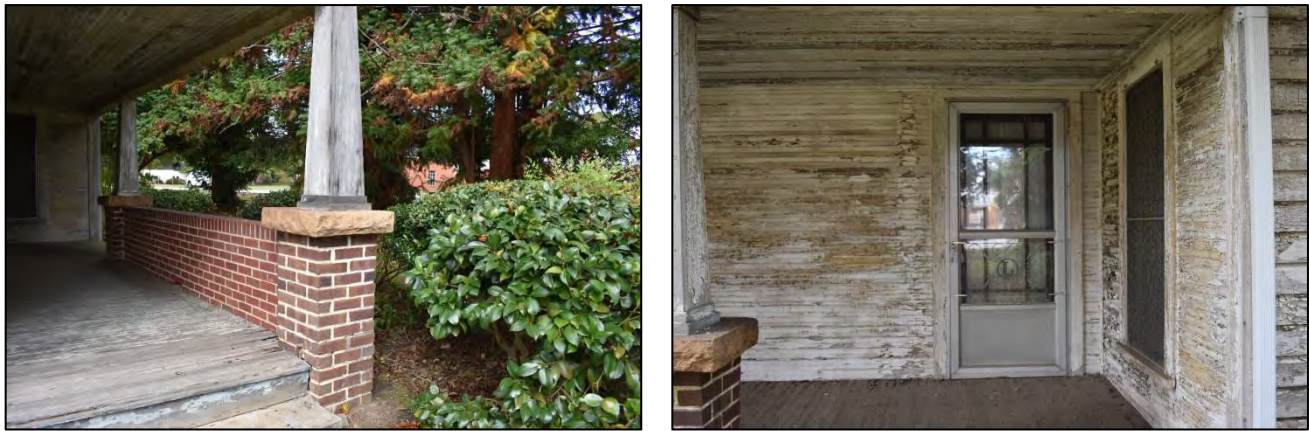
Figure 6: Details of the front porch.

An engaged, recessed, front porch crosses the eastern section of the house’s front elevation. It is supported by two battered wooden posts resting on brick piers and granite plinths. A later-added, solid brick balustrade connects the two piers. An engaged front room fills the front elevation’s western section. The ceiling and walls of the porch are covered with flushboard siding. The bays at either side of the façade hold two large six-over-one windows (Figure 6). The façade’s central bay—the house’s principal entry—retains a large, original, wood-and-glass paneled door. A metal screen door featuring an “L” inscription (for Ludwig) shades the entry. A secondary entrance on the eastern side of the ell features an original paneled door with four long, rectangular lights. The remaining elevations of both the main block and the rear ell feature original four-over-one light sash of the same style as those of the front elevation, dormer, and gable peaks.

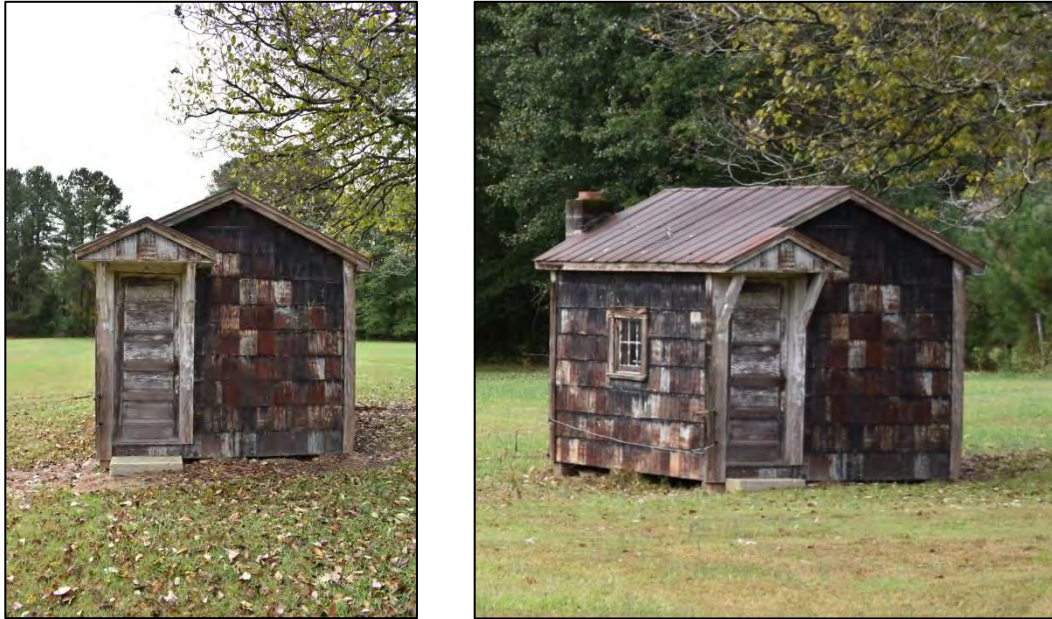
Figure 8: Left, view of front (northern) elevation; right; view of northeast corner.

Located just southeast of the garage, the small, frame, front-gabled shed rests on a piers foundation and is clad in tin shingles. Oriented to the north, a pedimented doorway supported by triangular brackets is placed on the eastern side of the building's front elevation. A wooden four-paneled door rests above a concrete stoop. A concrete-masonry-unit (CMU) block chimney is placed off-center on the building's southern gable end. Small six-light sash windows are centrally placed on the building's

eastern and western elevations. Constructed during the early/mid-twentieth century, the building was likely used as an office or workshop (Figure 8).

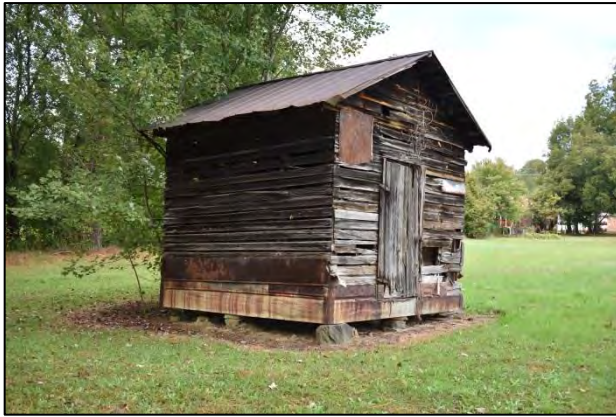
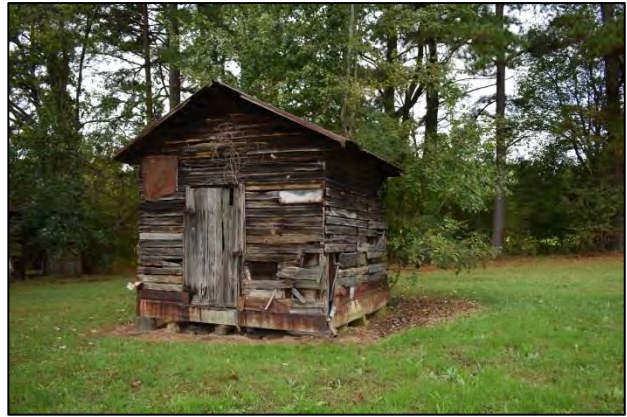
Figure 9: Left, view of southeast corner; right, view of front (eastern) elevation.

The small front-gabled frame building, which is oriented to the west, is situated a few hundred feet to the south of the house, in a cluster of trees toward the back of the lot. Resting on a stone and CMU-block piered foundation, the building is clad primarily with horizontal wood siding, with replacement metal sheathing applied to the bottom of each side. A door comprised of vertical wooden battens is centrally placed on the building's front elevation. Limited views of its interior through gaps in the siding suggest that it may have been used for grain/crop storage. The shed likely dates from the early/mid-twentieth century (Figure 9).

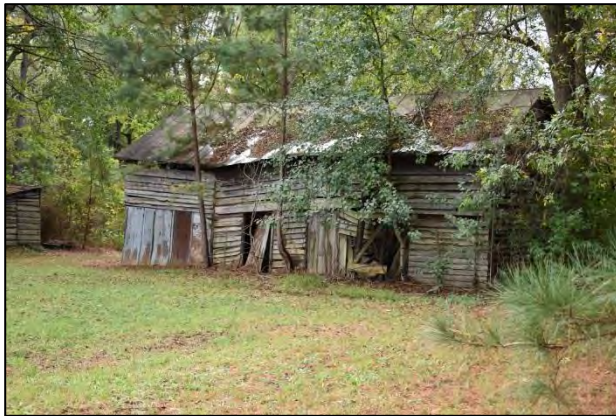
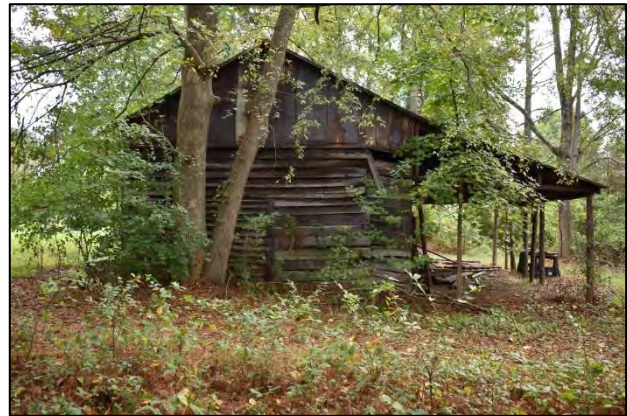
Figure 10: Left, view of rear (northern) elevation; top right, view of side (western) elevation;

Located to the south of the grain storage shed, the early/mid-twentieth-century side-gabled barn is oriented to the south. The one-bay main block is rectangular in form, and is fronted by a five-bay recessed lean-to supported by rough-cut wooden posts. The building is clad primarily with weatherboard siding, although metal sheathing covers the top third of either gable end. The roof is capped with standing-seam metal and displays exposed rafter ends. Two doorways with roughly assembled vertical wood-batten doors are found in the two westernmost bays on the barn's southern side. Limited views of the interior revealed multiple stalls, with a loft above, suggesting the barn was used to house livestock and hay (Figure 10 and Figure 11).

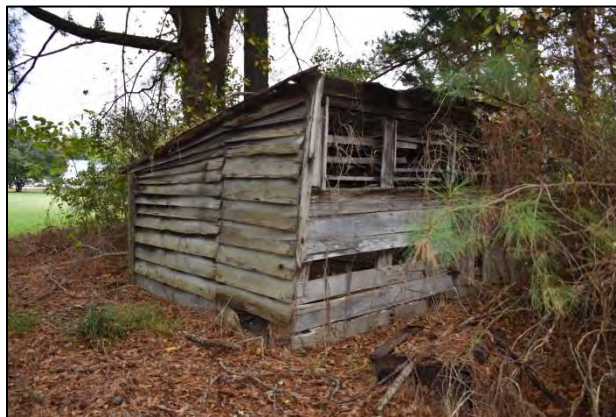
Figure 12: View of the front (southern) elevation of the chicken coop.

Situated just to the east of the barn is a shed-roofed, horizontal-board-sided chicken coop. The south side of the building, which was once open, has been partially covered with horizontal boards. The building likely dates from the mid-twentieth century (Figure 12).

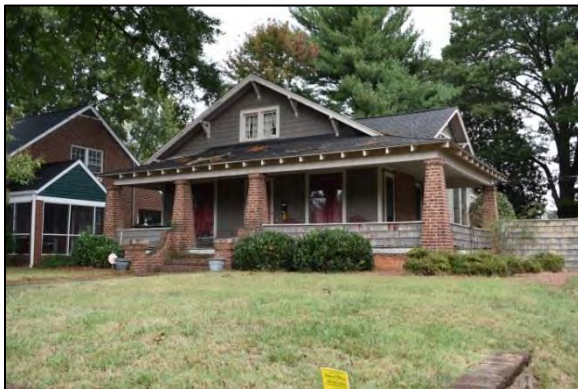
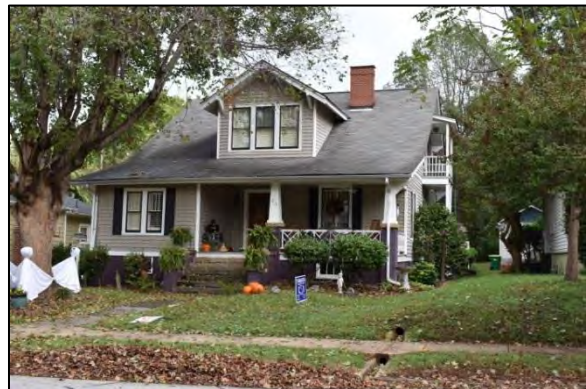
Figure 17: Left, M.L. Davis House at 202 Maupin Avenue, Salisbury; right, J.W. Taylor House at 214 Maupin Avenue, Salisbury.

The M.L. Davis House at 202 Maupin Avenue (Figure 17, left), which contributes to the Fulton Heights Historic District, personifies the bungalow form and Craftsman-style characteristics. The house’s one-and-a-half story, cross-gabled, frame form displays an engaged wraparound porch supported by battered brick columns, gabled dormers with original paired six-light windows, knee-braces, and exposed rafter ends. Constructed between 1911 and 1921 the bungalow, retains a large amount of original material including its overall form, windows, shingle cladding, and decorative brackets/trim.

Another contributing bungalow to the Fulton Heights Historic District, the J.W. Taylor House at 214 Maupin Avenue (Figure 17, right), was built ca. 1925 and displays a very similar design to the Ludwig House. The Fulton Heights National Register nomination describes it as a “One-and-a-half-story side-gable frame bungalow with engaged shed-roofed porch with porch room, battered posts on brick piers, front-gable dormer, side upper-story balcony with shed-roof” (Graybeal 1998:44). Like the Ludwig House, the house retains its original four-over-one sash, half porch, and front room; however its original weatherboard siding, decorative trim, and knee braces have been replaced with vinyl.

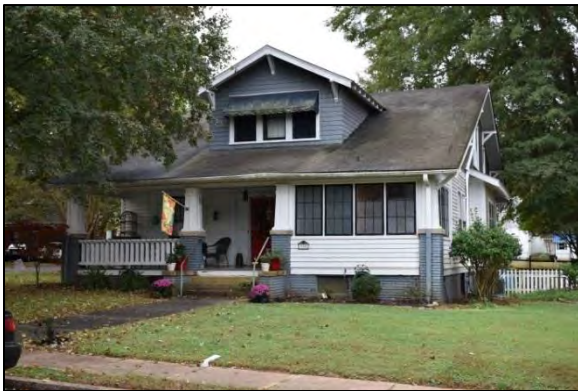
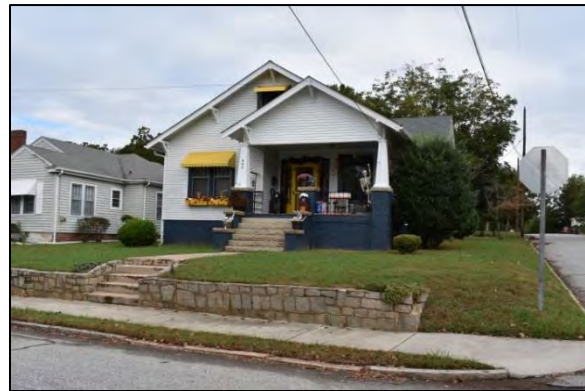
Figure 18: Left, “E.W. Wagoner House” 305 Mitchell Avenue, Salisbury; right, 400 Heilig Avenue, Salisbury.

The E.W. Wagoner House (Figure 18, left) located on Mitchell Avenue in Salisbury was constructed between 1911 and 1921 and is listed as a contributing resource to the Fulton Heights Historic District. The nomination describes it as a “One-and-one-half-story side-gabled frame bungalow with a large central gable dormer over porch, bracketed gables and eaves show exposed rafters; full-façade porch

partially enclosed and supported by heavy square columns on brick piers” (Graybeal 1998:32). It retains a significant amount of original material including original windows, weatherboard and shingle siding, supporting porch columns, and decorative brackets.

Constructed around 1925, according to tax records, the house at 400 Heilig Avenue (Figure 18, right) is one of the many bungalows found throughout Salisbury outside of the Fulton Heights Historic District. The frame house features stacked gables on its primary façade, with a recessed front porch supported by battered posts on brick columns. Its other original features include triangular knee-braces, paired four-over-one light windows, and original door; however, its original weatherboard siding has been replaced with vinyl.

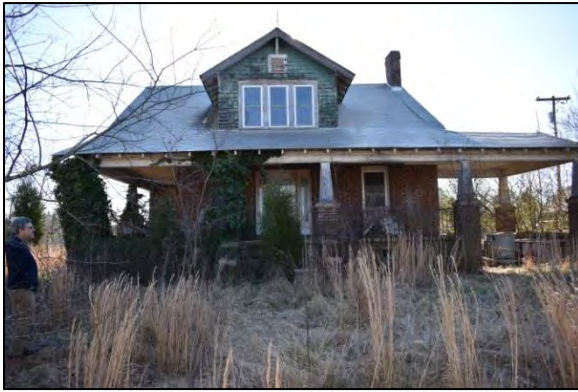
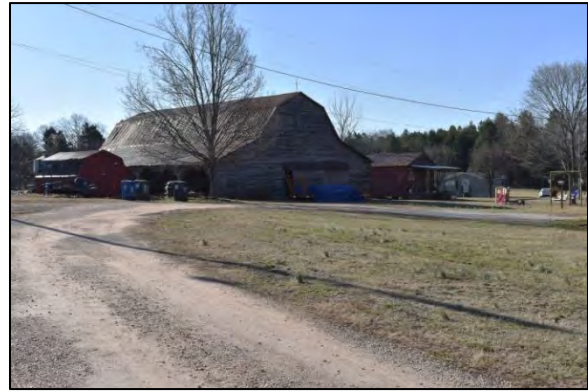
Figure 19: Reid Farm (RWI741) located at 141 Reid Farm Road, Salisbury.

The Reid Farm (RW1741) (Figure 19, left) built ca. 1920 sits six miles south of Salisbury, on the south side of the US 29 corridor. Like the Ludwig House, a one-and-a-half story Craftsman/Bungalow serves as the farm’s seat. The building’s masonry construction features a decorative header-stretcher brick bond. Deep overhanging eaves compose a large front porch and carport and are supported by original tapered wooden and brick columns. The house retains its original front door, sidelights, and front-gabled dormer clad in original wood shingles. Supporting the house is a collection of early/mid-twentieth century farm buildings, including: a large gambrel roof barn, two frame corncribs, a concrete block slaughterhouse, and several other later twentieth century frame buildings (Reid Farm (RW1741), North Carolina SHPO) (Figure 19, right).

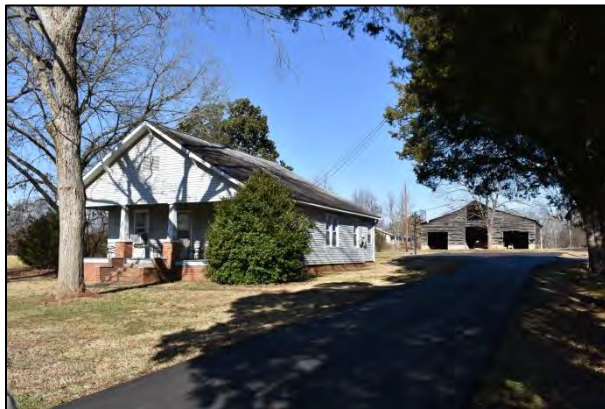
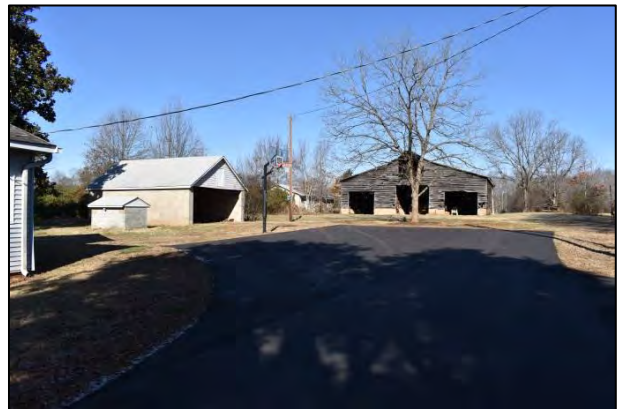
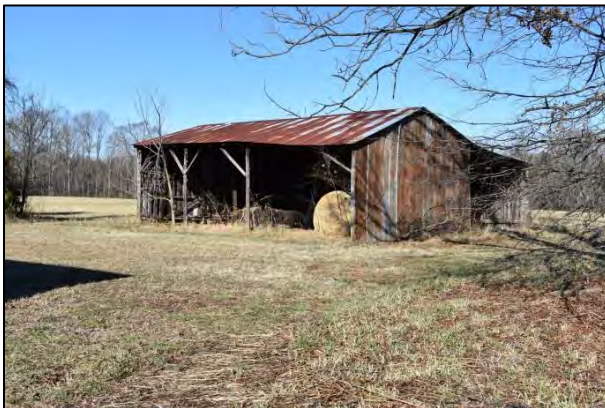
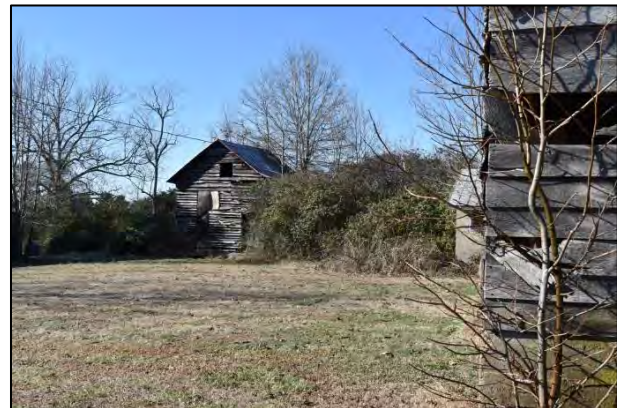
Figure 20: 4712 Mooresville Road, Salisbury.

The house at 4712 Mooresville Road (Figure 20) is located to the west of Salisbury and was constructed ca. 1922 according to tax records. The single-story, frame Craftsman-style building is clad in vinyl siding and its openings house replacement windows and doors. Two original tapered wooden columns remain on the building’s primary elevation and support a deeply set recessed front porch. To the rear of the house are found numerous early/mid-twentieth century farm buildings, including a large three-bay, front-gabled barn clad in original weatherboards; a front-gabled shed/workshop and three-bay machine shed also featuring original claddings; and a handful of slightly later mid/late-twentieth century buildings.

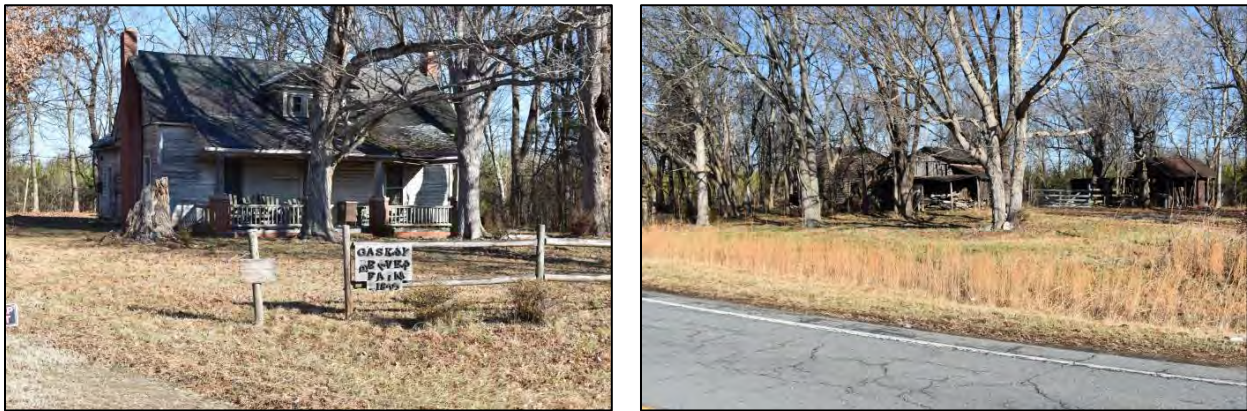
Figure 21: "Gaskay Beaver Farm" 1875 Peach Orchard Lane, Salisbury.

Located five miles south of Salisbury, at 1875 Peachtree Lane, the Gaskay Beaver Farm (Figure 25) was constructed ca. 1910 according to tax records. The one-and-a-half story Craftsman-style house sits just over 100 yards east of the Interstate 85 corridor. Clad in original weatherboards, the building additionally retains its original four-over-four sash and paneled doors. The house is accompanied by an assembly of early/mid-twentieth century farm buildings, including multiple barns and sheds, all of which appear to retain much of their original materials and building forms. Despite the farm's close proximity to the road, its building collection creates a very complete picture of a small early/mid-twentieth century farmstead.

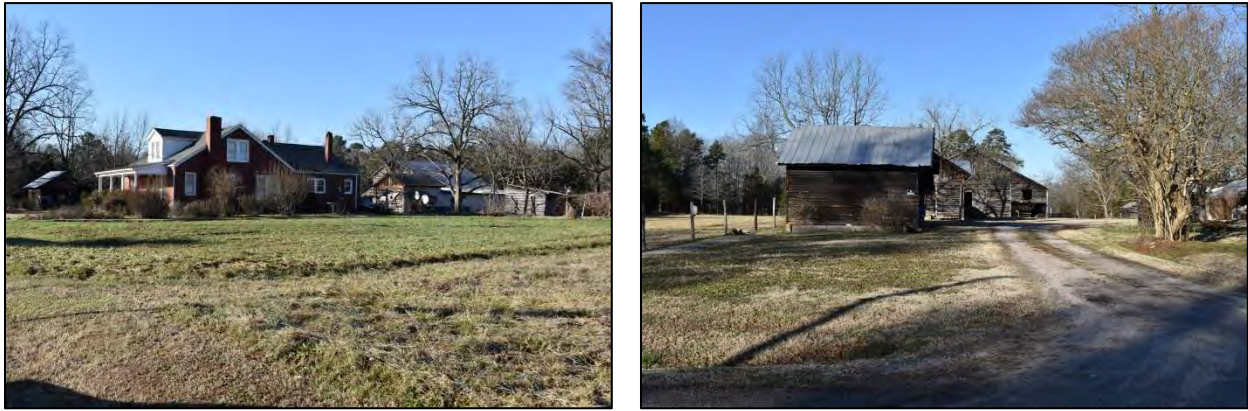
Figure 22: Yost-Weddington Farm (RW0773) located at 3175 Lentz Road, China Grove.

Built ca. 1949 according to tax records, the Yost-Weddington Farm (RW0773) (Figure 22) lies 13 miles south of Salisbury, just south of the small town of China Grove. The farm was recommended eligible for NRHP listing under Criterion A (agriculture) in 2014 and retains a large collection of intact early/mid-twentieth century farm buildings as discussed below (Yost-Weddington Farm (RW0773, North Carolina SHPO):

A large and orderly collection of farm outbuildings are located adjacent to the farmhouse. Frame constructed, they are largely in good condition and appear to date primarily from the early twentieth century. Many rest of foundations of heavy fieldstones.

The collection of outbuildings includes: a livestock and hay barn (ca. 1925), two machine sheds (ca. 1950), a corncrib (ca. 1925), an original 1880s kitchen which was converted to a wash house, a granary and wood shed (1925), a wash house (1925), and two chicken houses (1925).

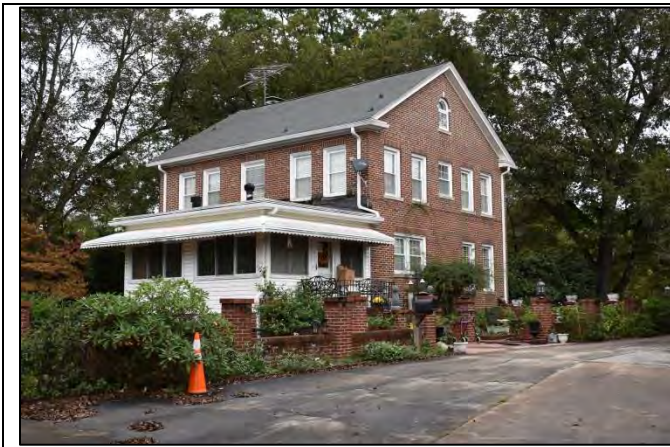
Resource Name	ZumBrunnen House
HPO Survey Site #	RW2175
Location	3511 Mooresville Road, Salisbury vicinity
PIN	463 009
Date of Construction	Ca. 1932
Recommendation	Recommended not eligible for NRHP Listing

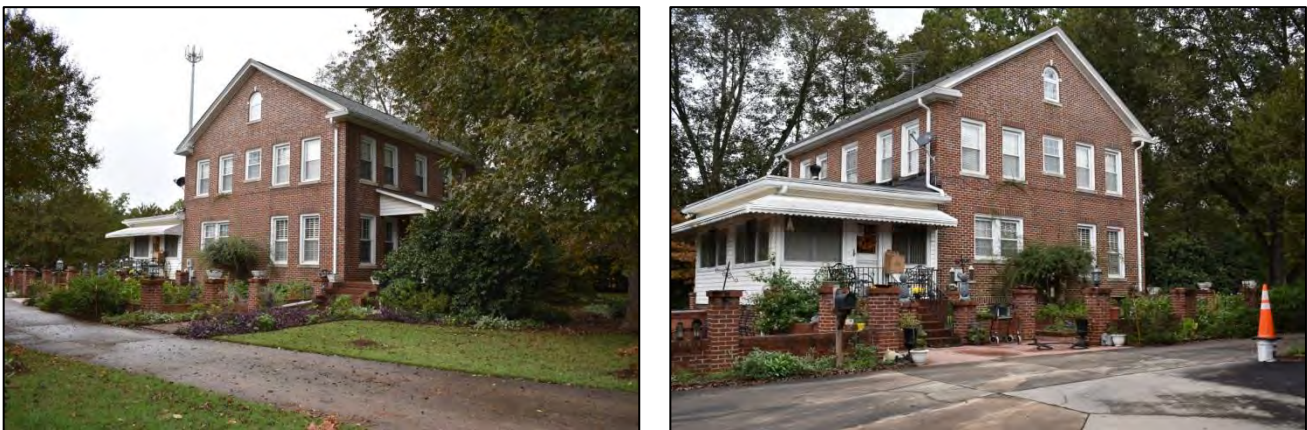
Figure 24: Left, view of northeast corner of the ZumBrunnen House; right, view of side (eastern) and rear elevations.

The two-pile Colonial Revival-style ZumBrunnen House is rectangular in plan, stands two-stories tall, and features a partially exposed basement. Built ca. 1932, the five-bay-wide masonry building is topped by a side-gable roof with aluminum cornice returns and asphalt shingles. Clad in brick running-bond veneer, the house features vinyl six-over-six replacement windows with aluminum surrounds that sit on what appear to be original concrete sills. Lunette windows top with decorative brick arches and concrete keystones are found in either of the building's gable ends (Figure 24). An exterior-end brick-shouldered chimney sits off-center at the building's western gable end.

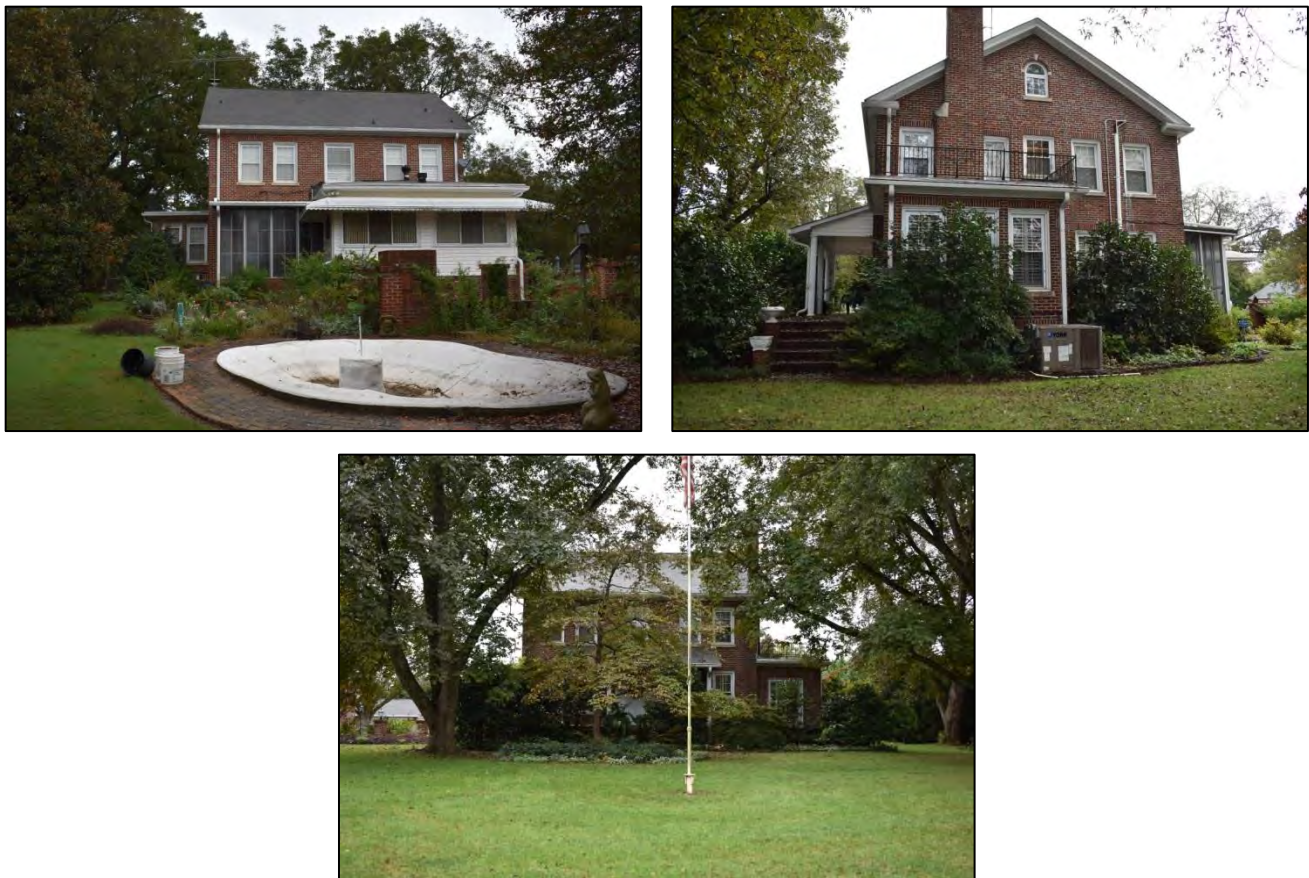
Figure 25: Left, rear (southern) elevation of house; right, view of side (western) elevation; center, front (northern) elevation.

A three-bay shed roof porch embraces the front (northern) elevation of the ZumBrunnen house. The porch is supported by replacement fluted aluminum columns.

An interview with the Comers suggests that much of the interior remains intact. The couple stated that upon their purchase of the house in 1976, they refinished the building’s original hardwood floors, removed wallpaper, and painted the walls. They did not describe any other major renovations. Interior access to the house was not offered by the homeowners.

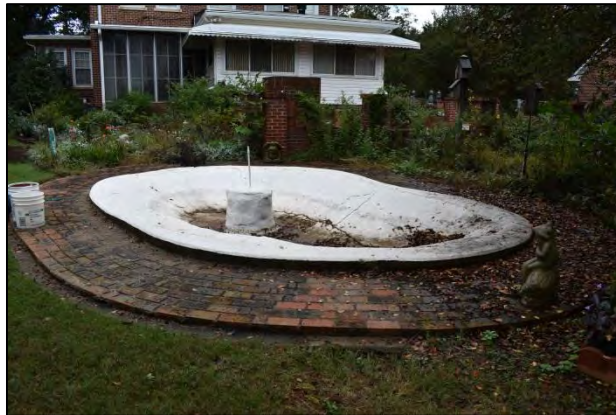
Figure 26: View of original fish pond, looking north toward the rear of the house

Located directly to the south of the ZumBrunnen House, the fish pond is a shallow ovular concrete basin with a centrally placed water pump that is contemporary with the house (according to the Comers). The pond is surrounded by an original brick walkway. According to the Comers, the pond currently has a leak and is unable to retain water (Figure 26).

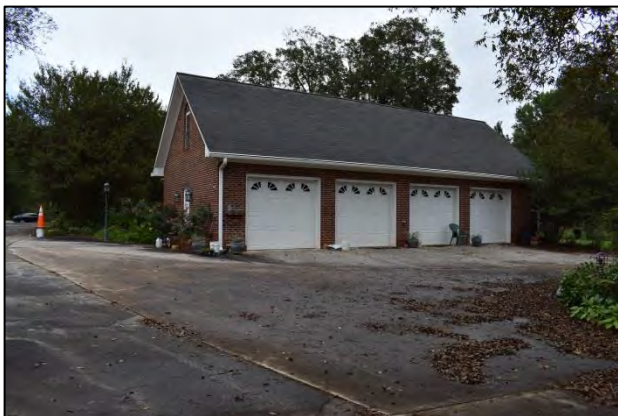
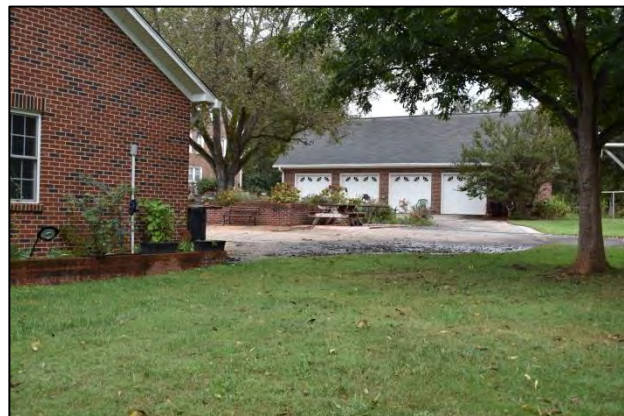
Figure 27: Left, rear (southern) elevation of northern garage; right, northern elevation of southern garage.

Constructed by the Comers in 2011, the two nearly identical four-bay masonry buildings are located to the east of the house and are clad in brick veneer. The garages are situated on either side of a patio-courtyard (the remnants of the original garage associated with the house) with their primary elevations oriented toward one another. Both buildings feature side-gabled roofs clad in asphalt shingles. Each building features four garage doors on their courtyard side, six-over-six vinyl windows on their eastern gable ends, and four-paneled vinyl doors on their western gable ends. The north-facing elevation of the garage nearest to the road has a projecting gable front section that gives it the appearance of a house from the road (Figure 27).

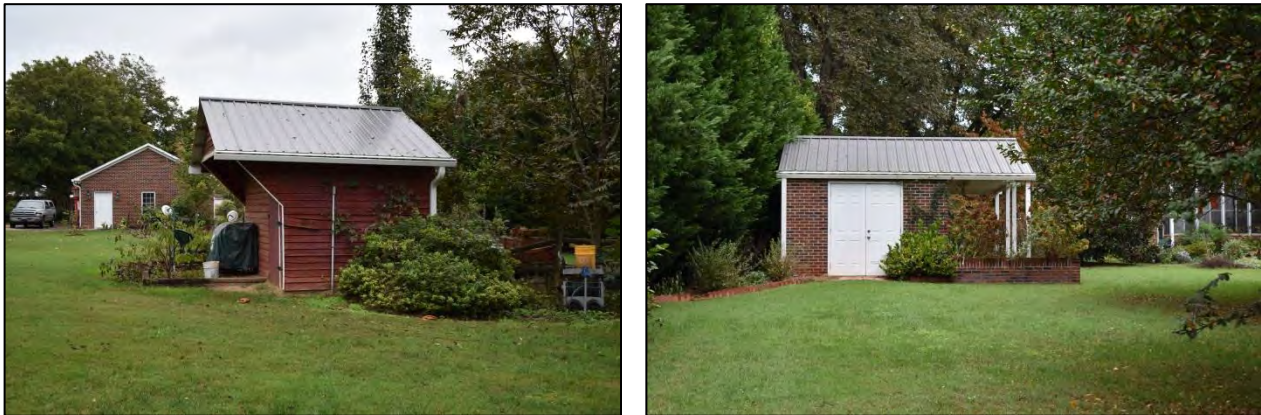
Figure 28: Left, side (eastern) elevation west shed; right, side (western) elevation of east shed.

According to the Comers, the front-gabled west shed dates to the ZumBrunnen period of ownership. The building is clad in weatherboard siding and features a widely overhanging roof at its north-gable end, in addition to a wood-batten door. The roof is clad with replacement metal sheathing (Figure 28, at left).

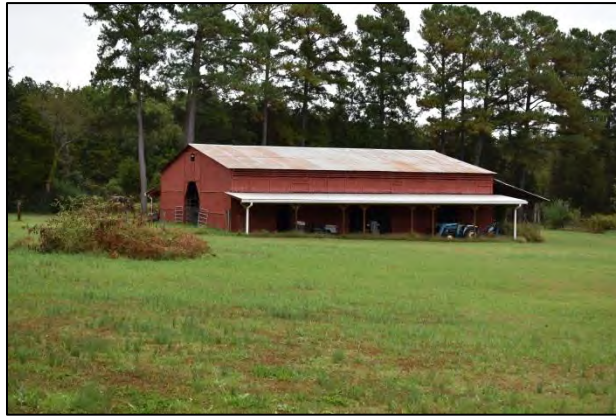
Figure 29: Side (eastern) elevation of barn.

Located in the middle of the 15-acre parcel, to the south of the house, beyond a line of mature trees, the front-gabled frame barn likely dates to the mid-twentieth century. Clad in original vertical wood siding, the barn features a centrally located entrance on its north gable end, with a small loft door above. The building's roof is clad in standing-seam metal. A seven-bay shed-roof lean-to supported by wooden posts and horizontal bracing extends off of the building's eastern elevation. Views inside suggest that much of the building is divided into stalls and was likely used to house livestock (Figure 29).

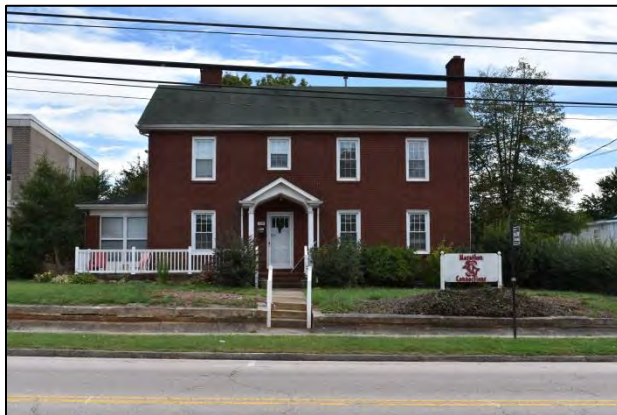
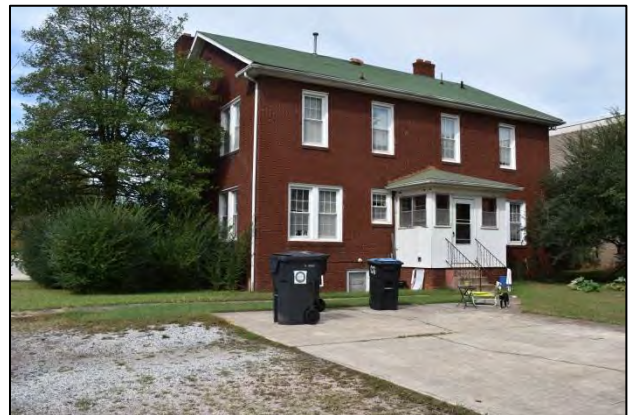
Figure 32: 316 N. Main Street China Grove (RW1700).

All of the two-story, double-pile, masonry houses identified in Rowan County as comparable to the ZumBrunnen House were located in built-up environments. (It is not surprising that ZumBrunnen chose a “town”-type house, as he spent his adult life living and working in large towns and small cities.) A comparable Colonial Revival-style masonry house (RW1700) located at 316 North Main Street in China Grove stands two-stories tall with a basement, two-bays deep, and four-bays wide. It is clad in brick and features an exterior-end chimney on its western gable end and rear southeastern corner. Replacement windows are framed by aluminum window surrounds, and a single-bay front-gabled portico on its front elevation (Figure 32). The house was constructed between ca.1920 (survey date) and 1936 (tax record date).

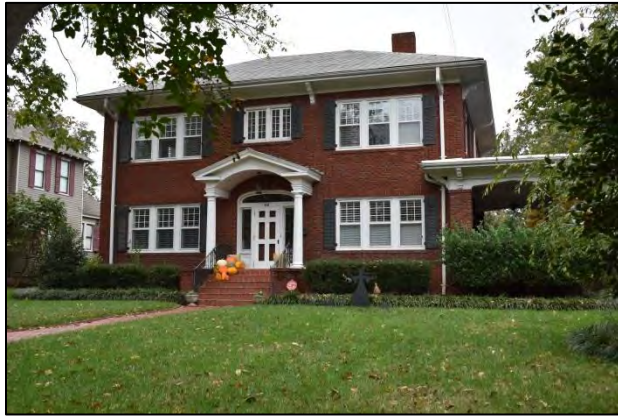
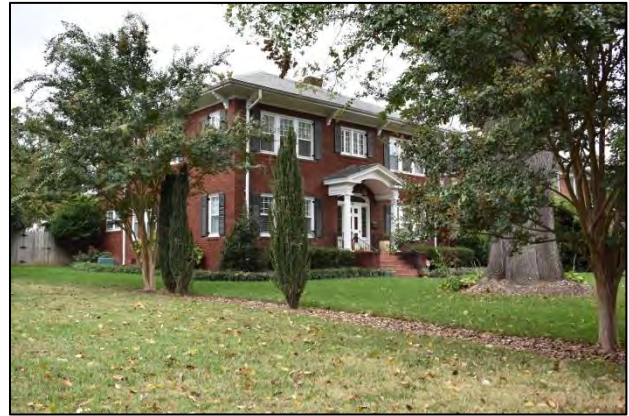
Figure 33: 418 S. Fulton Street, Salisbury.

A comparable two-story, double-pile, masonry house at 418 S. Fulton Street in Salisbury features a hipped-roof with an interior brick chimney. The Colonial Revival-style house is three bays wide. A one-story pedimented portico frames a tripartite doorway with a sunburst transom above. All of the house's banded six-over-one windows appear to be replacements (Figure 33). The brackets at its widely overhanging eaves appear to be original.

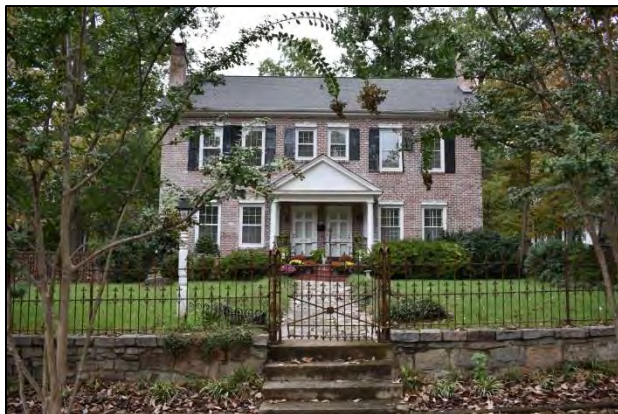
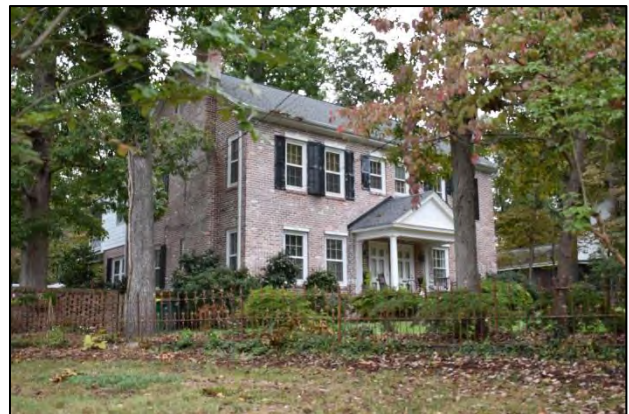
Figure 34: 708 Mitchell Avenue, Salisbury.

The comparable house at 708 Mitchell Avenue in Salisbury—a contributing resource to the Fulton Heights Historic District—was constructed as a duplex in 1934 for two sisters by the Waggoner Construction Company (Graybeal 1998). The two-story, double-pile, Colonial Revival-style residence features off-center shouldered-end chimneys on either of its gable ends. A pedimented portico frames the two centrally located doors, which comprise two of the building's six bays. The replacement six-over-six windows are framed with aluminum window surrounds and capped with aluminum keystones (Figure 34).
