North Carolina Department of Natural and Cultural Resources
State Historic Preservation Office

MEMORANDUM

SUBJECT: Historic Structures Survey Report for the proposed widening of SR 1005 (Startown Road) from U.S. 70 to N.C. 10, R-5113, Hickory, PA 17-05-0034, Catawba County
ER 17-3030

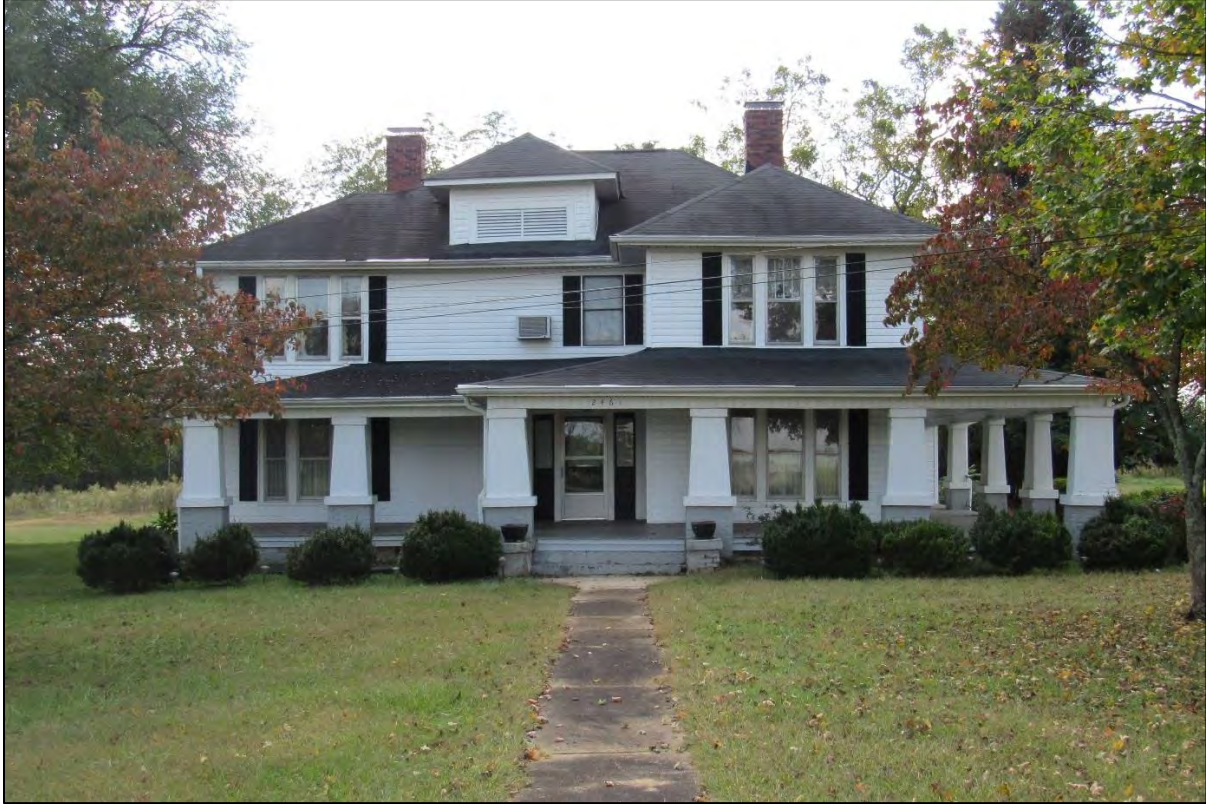
The primary resource is a two-and-a-half-story, three-bay, single-family dwelling constructed around 1910 in the American Foursquare form with Craftsman-style attributes (Photo 1, p. 8). The continuous brick foundation supports the vinyl-clad structural system. It is covered by a complex, hipped roof with a front and rear hipped projection sheathed in asphalt shingles. A hipped-roof dormer pierces the northeast roof slope and features a louvered vent. Two interior-end brick chimneys flank the resource on the northwest and southeast slopes (Photo 2, p. 8).

Photo 1: Northeast Elevation of the House at the W.R. Lutz Farmsite.

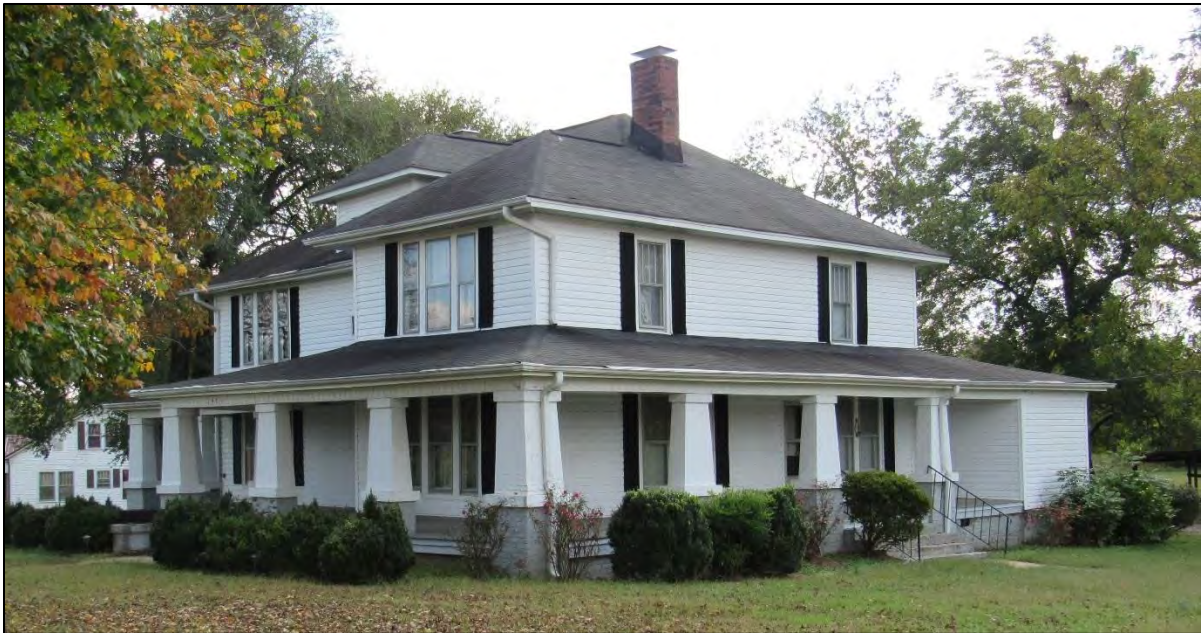
Photo 2: North Oblique of the House.

Centered on the northeast elevation, the primary entrance is filled with a single-leaf, half-glazed, wooden door covered by a metal-and-glass storm door within a paneled surround with single-light side lights. A one-story, wrap-around porch spans from the northeast elevation around to the western elevation. Set on a solid, brick foundation, the porch is accessed by a set of concrete steps on the northeast side. Tapered wooden posts set on brick plinths support the hipped roof sheathed in asphalt shingles. The primary elevation features tripartite windows that are composed of a four-over-one, double-hung sash, wood-framed window flanked by one-over-one, double-hung sash, wood-framed windows as well as a one-over-one, double-hung sash, wood-framed window centered on the second story, all of which are flanked by fixed, vinyl louvered shutters. Other fenestration includes single and paired, four-over-one, double-hung sash, wood-framed windows. Most of the windows are flanked by fixed, vinyl louvered shutters.

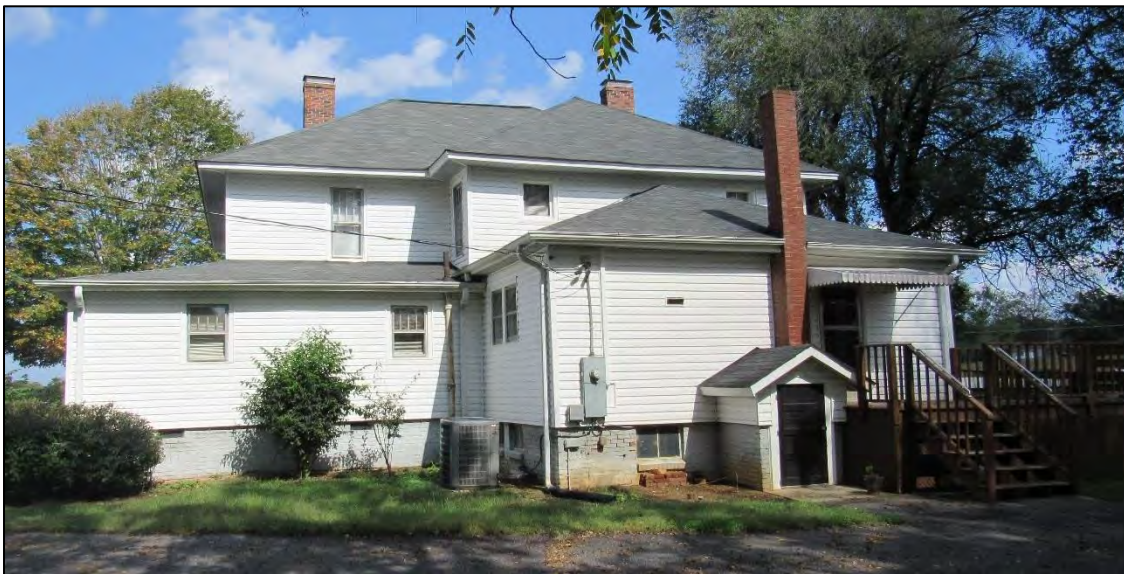
This resource features two additions that were likely constructed around the mid-twentieth century. The first is a one-story addition that extends from the west corner of the resource and is composed of the same materials as the main core (Photo 3). It is covered by a hipped roof and features small, four-over-one, double-hung sash, wood-framed windows. The other is a one-story, hipped-roof, rear addition that extends southwest from the rear projection (Photo 4, p. 10). It is composed of the same materials as the main block and features a front-gabled cellar entrance filled with a single-leaf, paneled wood door. Other fenestration includes sliding metal windows along the foundation as well as single and paired, four-over-one, double-hung sash, wood-framed windows. A secondary entrance is located on the southwest elevation and is filled with a single-leaf door covered by a metal-and-glass storm door. The entrance is covered by a metal awning and accessed by a set of wood steps with wood railing. An exterior-end brick chimney is located directly east of the entrance.

Photo 3: Addition Detail on the House, Looking Northeast.

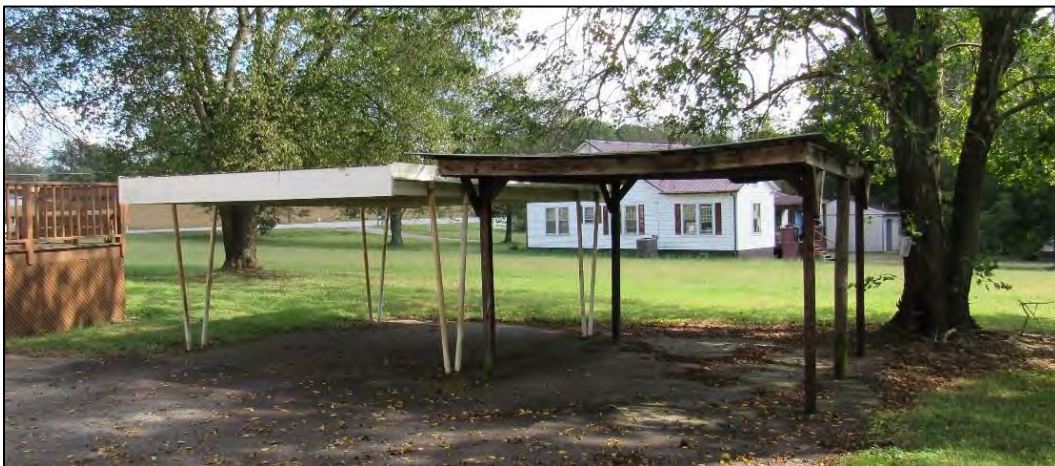
Photo 5: View of Carports Looking East.

Two carports are situated immediately southwest of the house. One is a circa-1970, one-story, metal-framed structure with a flat metal roof and the other a circa-1980, one-story, frame structure with a very low-pitched shed roof sheathed in v-crimp metal (Photo 5). Further southwest of the house is another open-air shed, this one also likely dates from the 1980s and may have been enclosed at one point. It is made of pole-type construction and is covered by a low-pitched shed roof that appears to be sheathed in corrugated metal (Photo 6, p. 11).

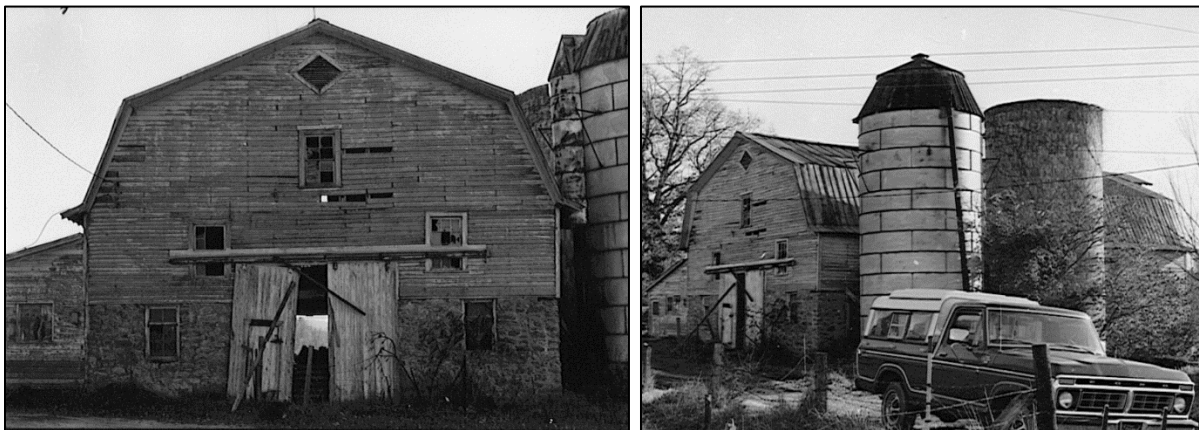
Photo 7: Barn and Two Silos as Photographed in the Mid 1970s.⁸

During the mid-1970s survey of this property, the surveyor documented a large two-and-a-half-story, stone-and-frame barn with two adjacent silos: one hollow-tile-block silo, likely constructed in the first half of the twentieth century, and the second was a circa-1960 metal-panel silo (Photo 7). This cluster of buildings was historically part of the larger dairy complex, as run by W.R. Lutz. Today, all that survives is the metal-panel silo that is topped with a metal conical roof (Photo 8, p. 12). The barn and an older hollow-tile-block silo that were formerly connected to this structure are no longer extant.

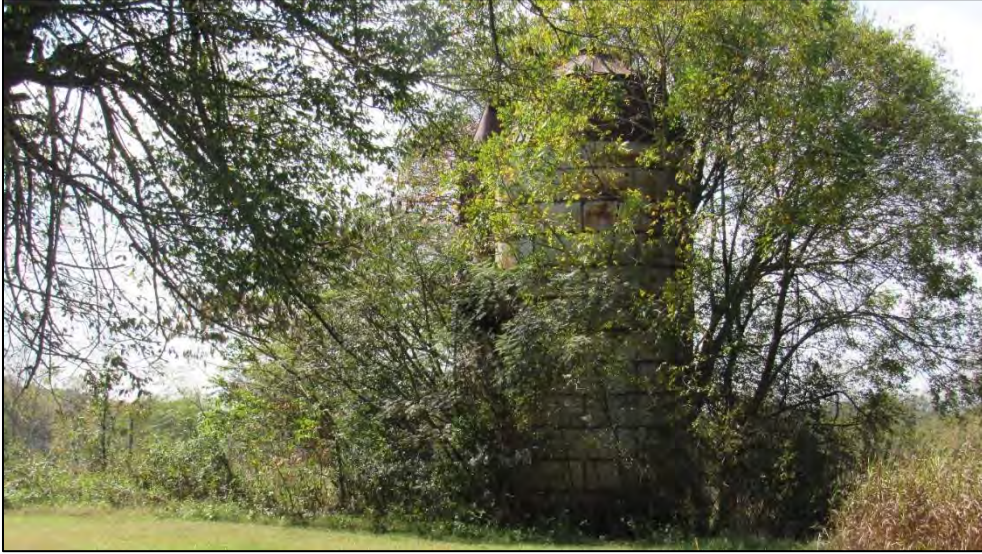
Photo 8: View of Silo Looking West.

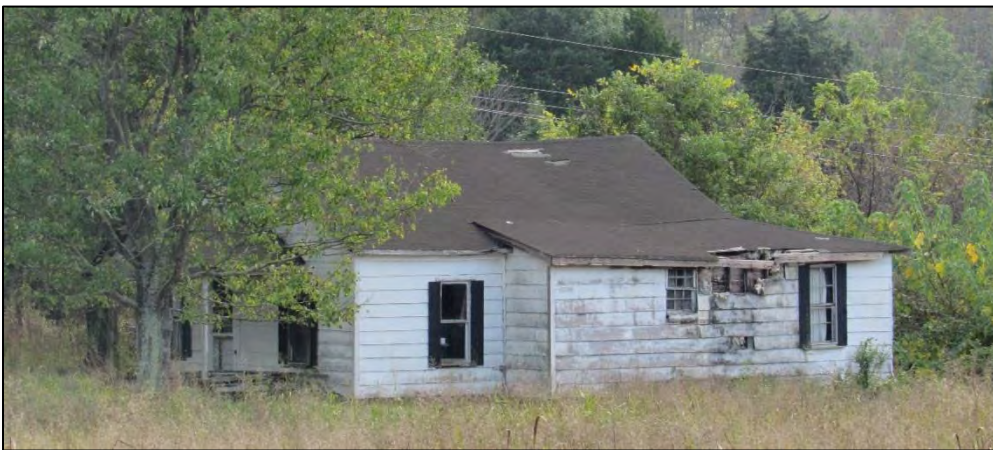
A circa-1935, one-story, three-bay, tenant house or secondary dwelling is also located on the property, northwest of the main house (Photo 9 and Photo 10, p. 12). This dwelling is vacant but appears to have been occupied into the late-twentieth century as additions and alterations were made at that time. The foundation of the house is continuous concrete block and the frame structural system is clad in Masonite or asbestos siding that sought to imitate weatherboard. The original portion of the house is covered by a front-gabled roof sheathed in asphalt shingles with an area on the northern slope covering an old opening for a chimney that is no longer extant. The main entrance is situated in the center of the northeast elevation under a small gabled porch and is filled by a half-glazed wood door. Windows throughout the house are a mix of four-over-one, one-over-one, and six-over-six, wood-framed, double-hung sashes. A lean-to addition extends from the northwest elevation and appears to be constructed of the same materials as the main massing of the house.

Photo 9: North Oblique of Tenant House.

- Please provide photos of the second barn and additional photos of the tenant house with an explanation of what has changed since the period of significance.
- The discussion of comparative properties is limited to Craftsman style or foursquare-type houses. If evaluating as a farm site, we recommend the consultant include comparative dairy farm resources in the area.
- The additional information will enable us to conclude whether we agree with the determination of eligibility.

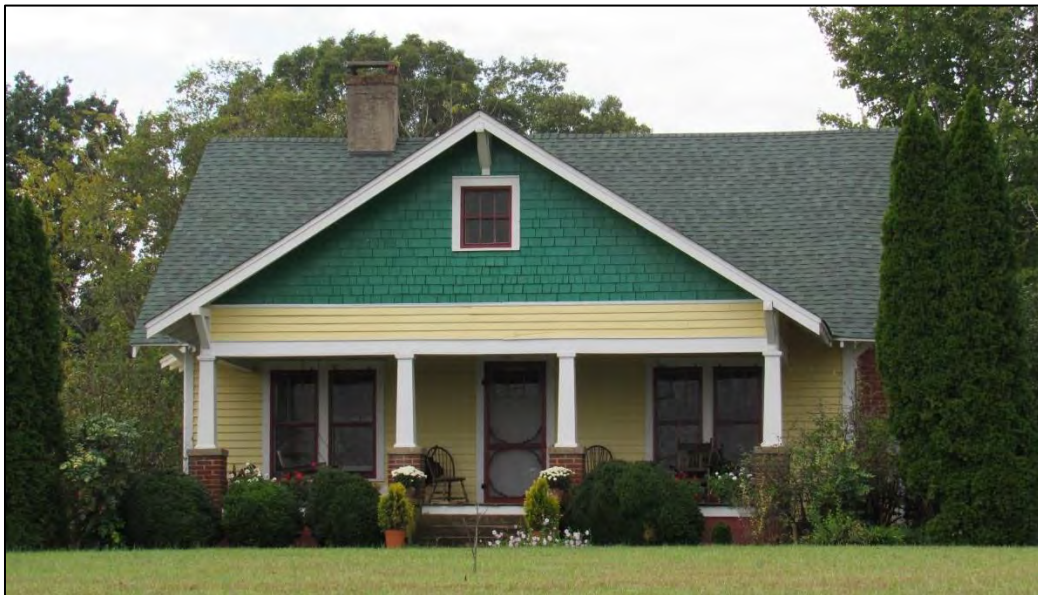
Photo 11: Primary (East) Elevation of the Caleb Rudisill House (CT0590).

The two-and-a-half-story house associated with the W.R. Lutz Farmsite appears to be one of the few early-twentieth-century dwellings of that size and form in this region of rural Catawba County. This house was constructed near the height of the Dutch Dairy Farm success and reflects this prosperity and as a result, it stands out on the landscape. Many of the buildings reflective of the Craftsman style this region of the county tend to be modest one- to one-and-a-half story dwellings. Examples include the Caleb Rudisill House, a one-and-a-half-story, three-bay Craftsman-inspired bungalow located at 6907 Old Shelby Road (CT0590) in Vale, Catawba County. Constructed around 1922, the dwelling retains its original siding, including the wooden shingles in the front-gabled roof above the porch, windows, and overall form and design (Photo 11, p. 18). NC-HPO placed this property on the North Carolina study list in 1981.

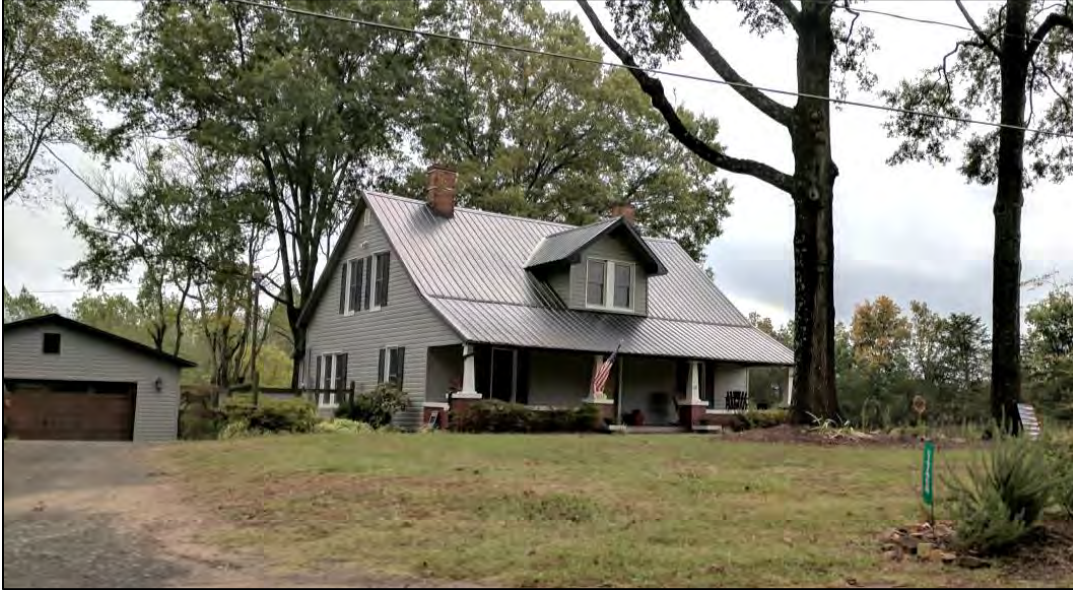
Photo 12: Northwest Oblique of the House at 1724 Old Conover-Startown Road.

Another example of the Craftsman style in rural Catawba County is the one-and-a-half-story house at 1724 Old Conover Startown Road. Previously unrecorded with the NC-HPO, this house, which likely dates to the second or third decade of the twentieth century, has replacement siding and windows, but does possess its character-defining elements, including the double interior chimneys, tapered, wooden posts set on brick plinths, and design, with the exception of a small addition to the rear (Photo 12).

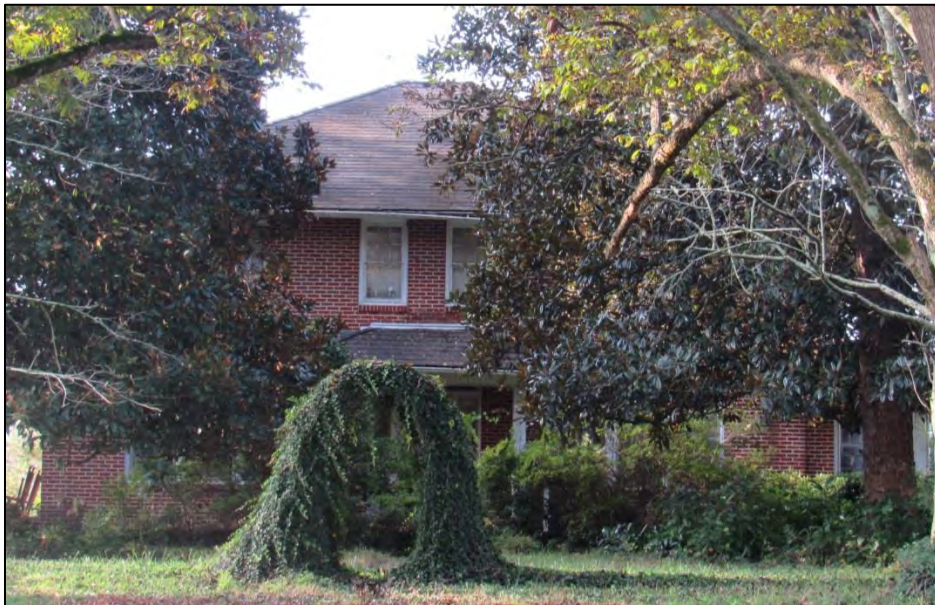
Photo 13: North Elevation of the Clyde H. Bost House (CT0483).

Although it does not appear to be an example of the Craftsman style, the Clyde H. Bost House (CT0483) is similar in size and form to the dwelling at the W.R. Lutz Farmsite. Located 2 miles to the east of the subject property, at 1783 Radio Station Road, this two-story brick house is covered by a hipped roof with six-over-six, double-hung sash windows and likely dates to the late-first or early-second quarter of the twentieth century (Photo 13 and Photo 14). NC-HPO has not yet evaluated this property for its NRHP eligibility.

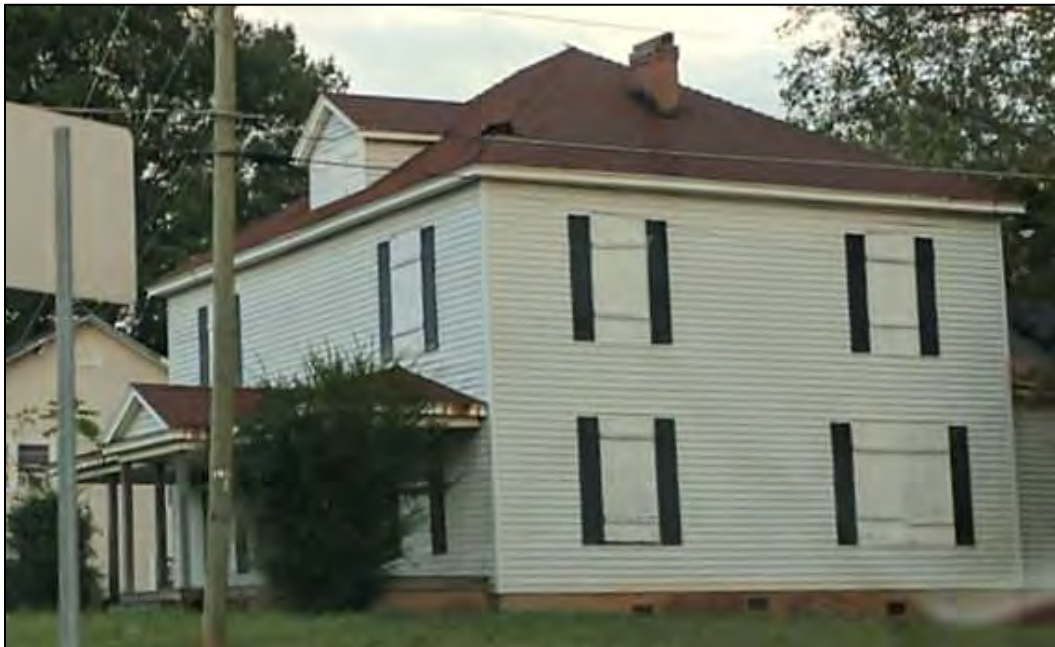
Photo 15: Northwest Oblique of the House at 773 Second Avenue SW.

In the more developed areas of Catawba County, such as Hickory, larger, two-and-a-half-story dwellings are more common. The house at 773 Second Avenue SW in Hickory is currently reflective of the Colonial Revival style, as evidenced by the columns on the front porch (Photo 15). This vinyl-clad, square-shaped building sits on a continuous brick foundation and is capped by a hipped roof. Currently vacant, all windows and doors are boarded over. The resource is previously unrecorded with the NC-HPO.

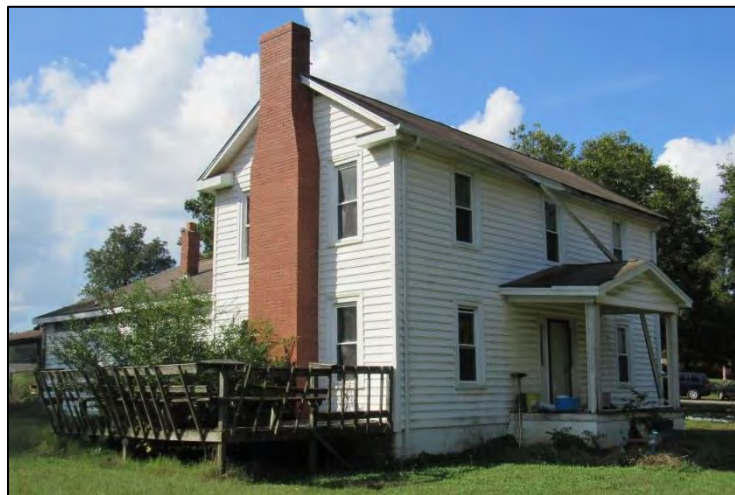
The primary resource is a two-story, three-bay, single-family dwelling constructed around 1890 with an I-house form. The continuous concrete-block foundation supports the structural system that is clad in vinyl siding. Covering the building is a moderately pitched, side-gabled roof sheathed in asphalt shingles with eve returns. An exterior-end, brick chimney is located on the north elevation of the resource.

Photo 16: Southeast Oblique of J.B. Lutz House.

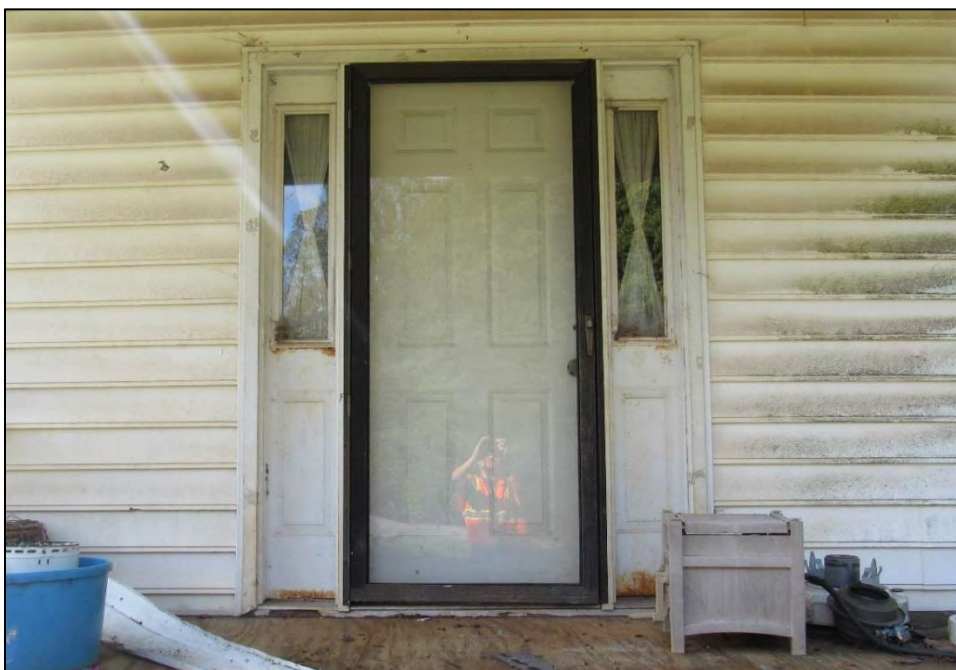
The primary entrance, centered on the east elevation, is filled with a single-leaf, six-paneled, vinyl replacement door flanked by a wooden door surround featuring single-light side lights (Photo 17). Surrounding this door is a one-story, one-bay entry porch, which is covered by a front-gabled, asphalt-sheathed roof supported by square wooden posts. Raised on a concrete-block foundation, the porch is accessed by a set of poured-concrete steps on the east elevation. Fenestration throughout the entire building includes one-over-one, double-hung sash, vinyl windows located within vinyl surrounds. A secondary entrance, filled with a half-glazed, paneled wood door covered by a screen storm door, pierces the south elevation just west of the chimney and is accessed from a full-width, wooden deck with wood railings.

Photo 17: Primary Entrance Detail of J.B. Lutz House, Looking West.

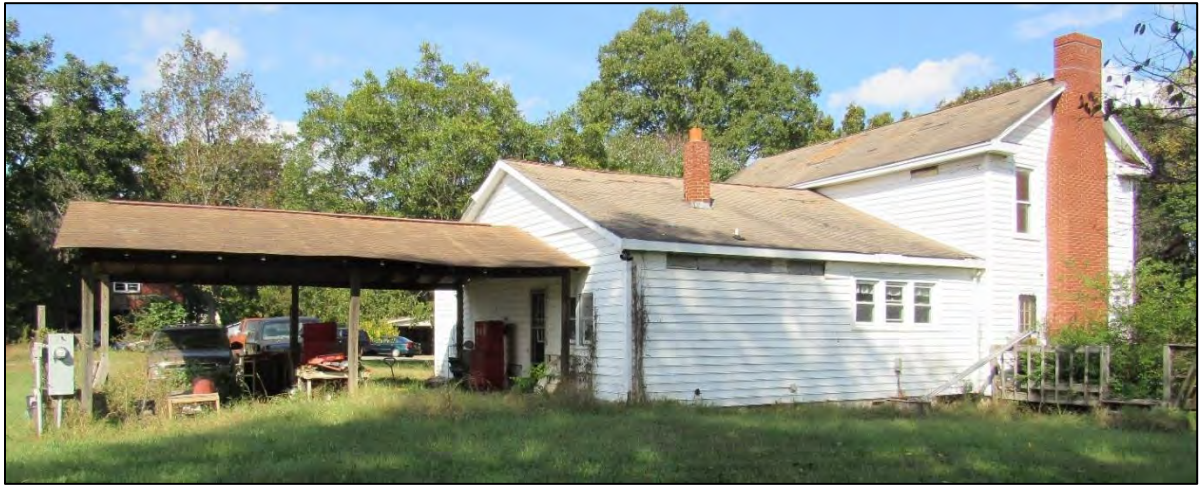
A large, pre-1950, rear addition extends from the west elevation of the resource (Photo 18, p. 27).³⁶ It is situated on a continuous concrete-block foundation and clad in faux-beadboard vinyl siding. The resource is covered by a moderately pitched, front-gabled roof sheathed in asphalt with an interior chimney located on the southern slope. A ribbon of one-over-one, double-hung sash, vinyl windows lines the south elevation and single, one-over-one, double-hung sash, vinyl windows pierce the north and west elevations. A single-leaf, half-glazed, paneled wood door is located on the west elevation to allow access into the addition from outside. A circa-1970 covered carport addition supported by square-wood posts extends west from the pre-1950 addition. It is covered by a low-pitched, front-gabled roof sheathed in asphalt shingles with exposed rafter tails (Photo 19, p. 27).

Photo 18: Rear Addition Detail of J.B. Lutz House, Southwest Oblique.

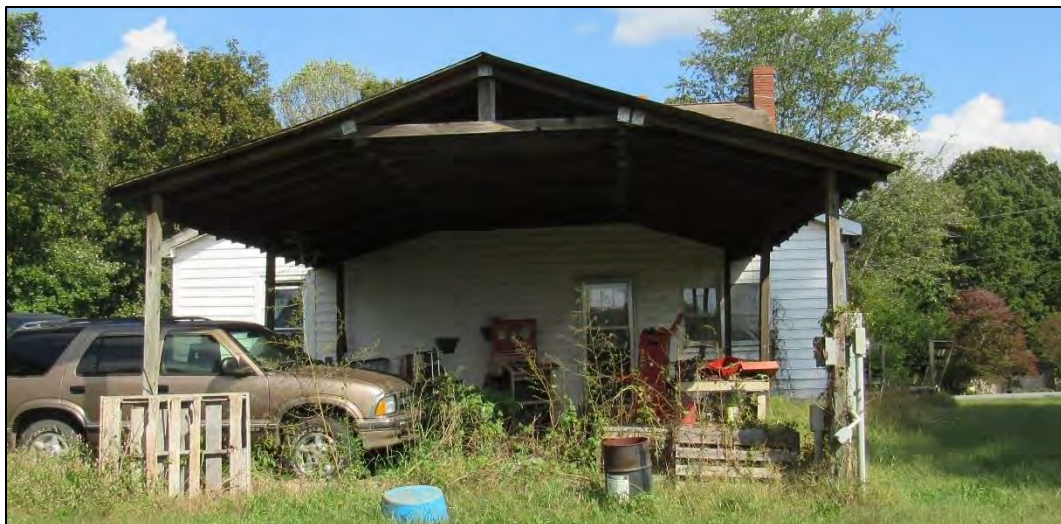
Photo 19: West Elevation of J.B. Lutz House.

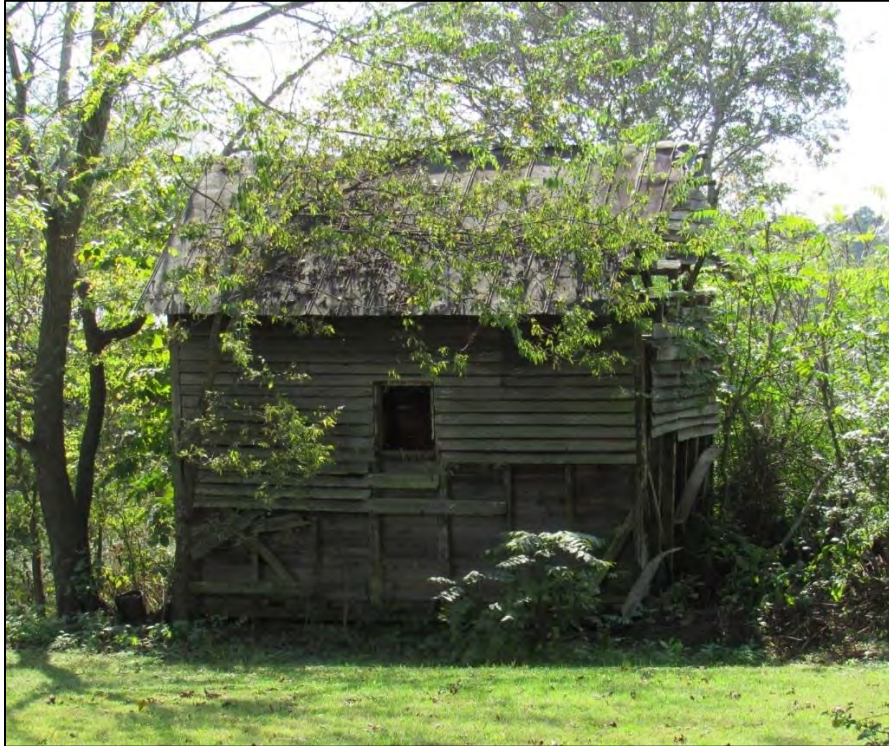
Situated to the northeast, east, and southwest of the house are a number of domestic and agricultural outbuildings associated with the J.B. Lutz House, most of which appear to date from the mid-twentieth century. Two of these resources are located east of the dwelling: a circa-1940 domestic outbuilding and a circa-1970 storage shed that has been heavily altered (Photo 20–Photo 21, p. 28). The foundations of these resources were not visible as both were partially covered in overgrown vegetation. The framing of the circa-1940 domestic outbuilding is exposed as some weatherboards have been removed, thereby showing several re-used members. It is covered by a front-gabled roof sheathed in v-crimp metal sheets. A single window opening is visible on the north wall, but a significant portion of the building was obscured by vegetation. The one-story, two-bay, circa-1970 shed also has a frame structural system clad in weatherboard siding. It is covered by a shed roof sheathed in v-crimp metal sheets. A circa-1990, one-story, one-bay, pre-fabricated storage shed has been added to the

Photo 20: View of Domestic Outbuilding Looking South.

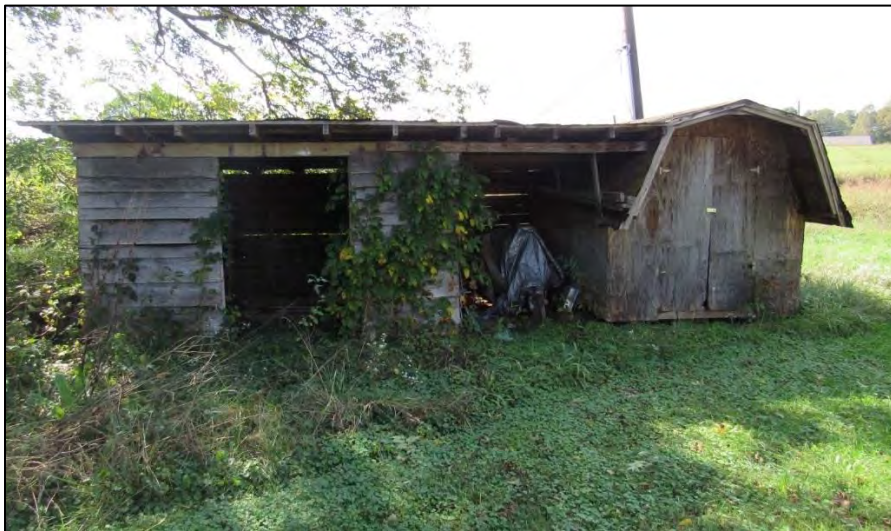
north end of this building and is included under a portion of its roof. This addition is clad in plywood siding and covered by a gambrel, asphalt-shingled roof.

Photo 21: East Elevation of Storage Shed. The circa-1970 shed section is on the left and the circa-1990 section is on the right.

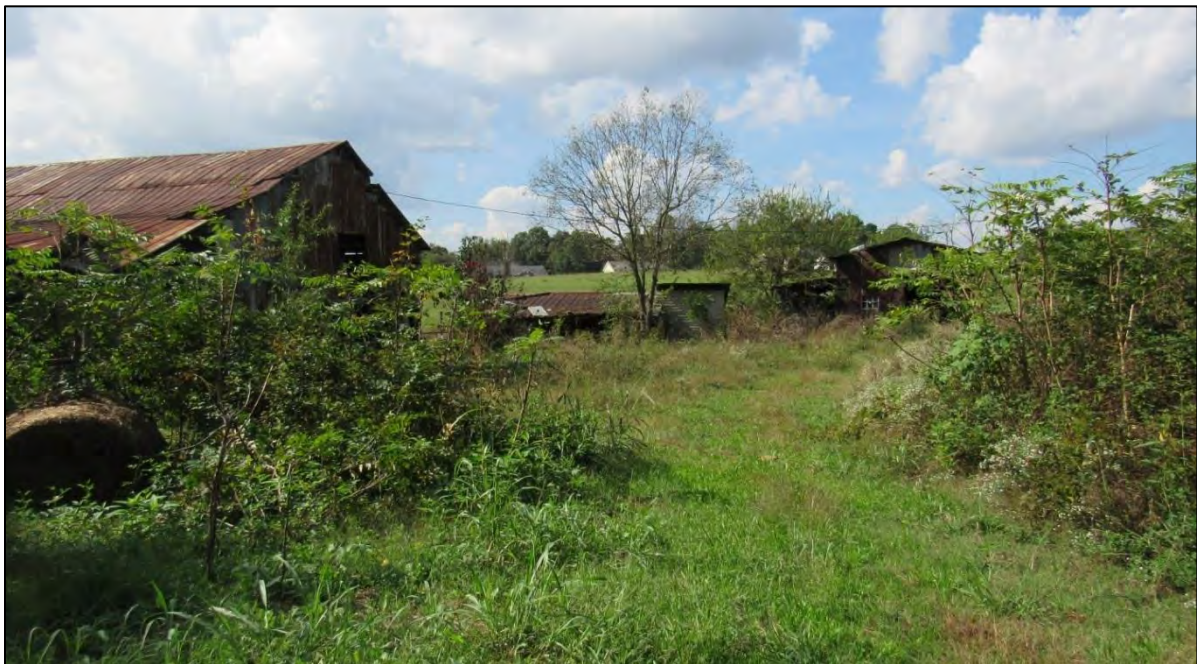
There are five agricultural buildings clustered southwest of the dwelling (Photo 22). Four of the five standing agricultural buildings in this area appear to date from the mid-twentieth century and include a workshop, possible milking area, barn, hay shed, and a one-bay shed that is likely a re-purposed garage. The fifth building in this cluster dates from around 1970. All of these buildings have either a post-in-ground foundation or have framing members resting directly on the ground. The one-story, two-bay, circa-1950 workshop was originally clad in weatherboard siding, much of which is now covered in re-purposed corrugated metal sheeting (Photo 23, p. 30). This building is covered by a front-gabled roof sheathed in corrugated metal and features a lean-to addition along both side walls. At the southwest side, the addition is clad in weatherboard on all three sides, while the northeast addition is open to the elements. The southeast elevation of the workshop is marked by an open garage bay at the east end and a single, fixed, six-light, wood window at the west.

Photo 22: View of Southwestern Cluster of Agricultural Buildings Looking West.

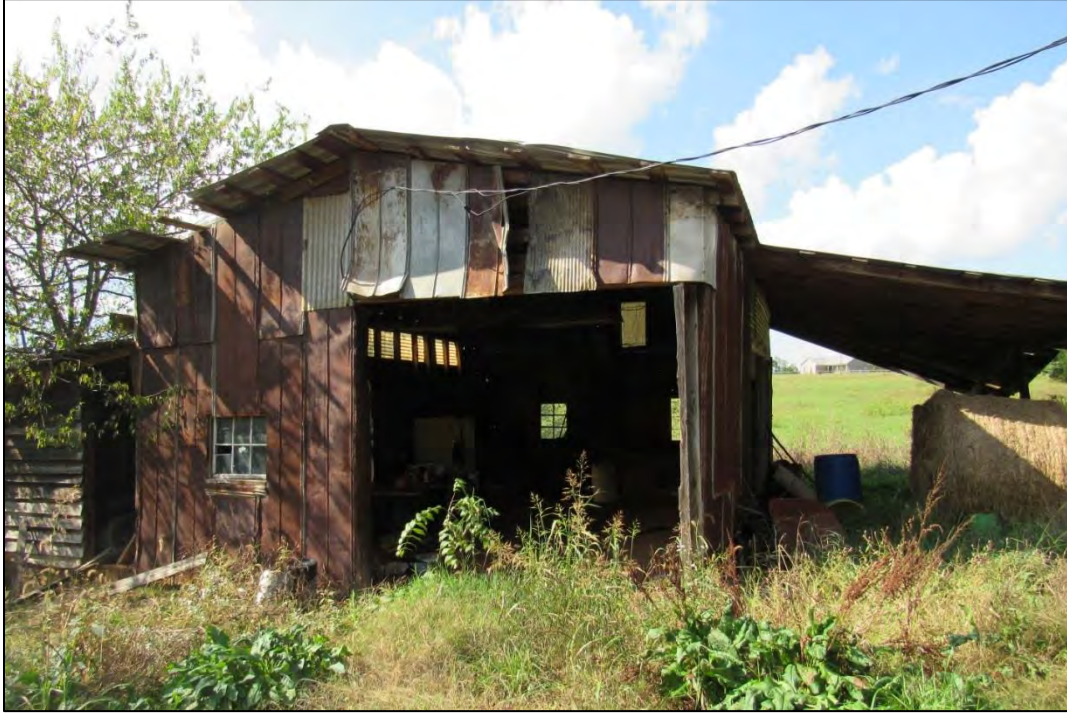
Photo 23: View of Southeast Elevation of Workshop with Lean-to Additions at Either Side

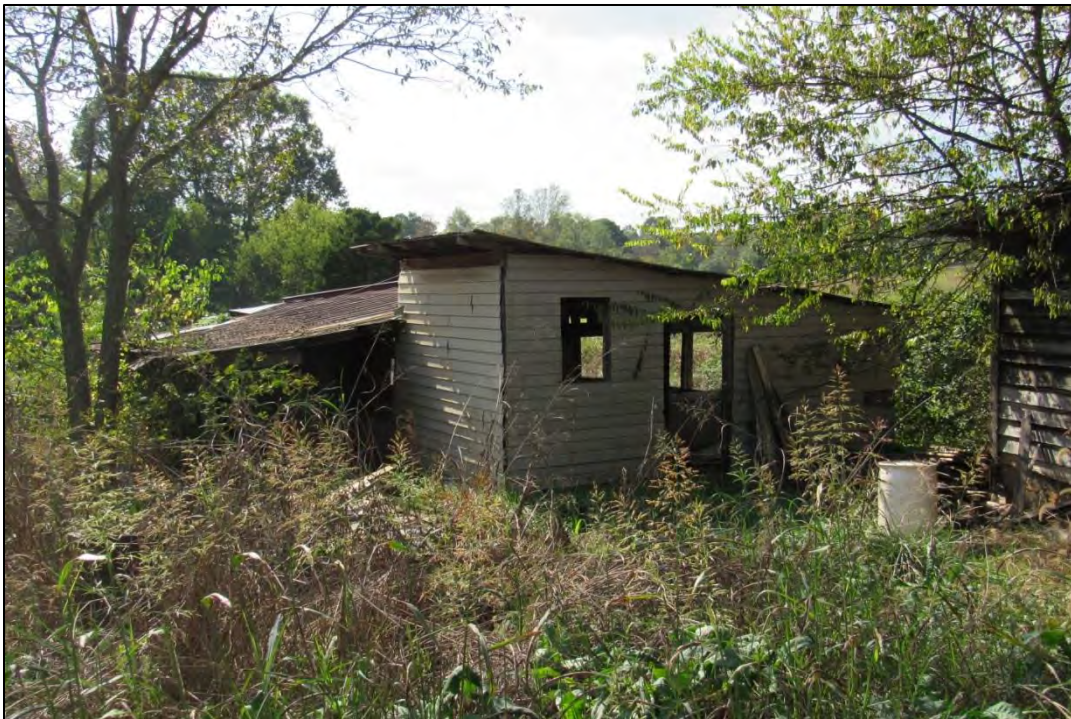
Just south of the workshop is a one-story, circa-1950 farm building. It is built low to the ground and possibly extends below ground level, which suggests that may have been used as a milking area or parlor (Photo 24, p. 30). This frame building is in poor condition is partially clad in vinyl siding. It is topped by a shed roof at the north end, perhaps a space where milk was stored or tested, while a gabled roof sheathed in v-crimp metal covers the larger portion of the building and is open to the elements. A portion of this open area may have been used as a loafing shed.

Photo 24: View of Possible Milking Parlor with Loafing Shed Looking Southwest.

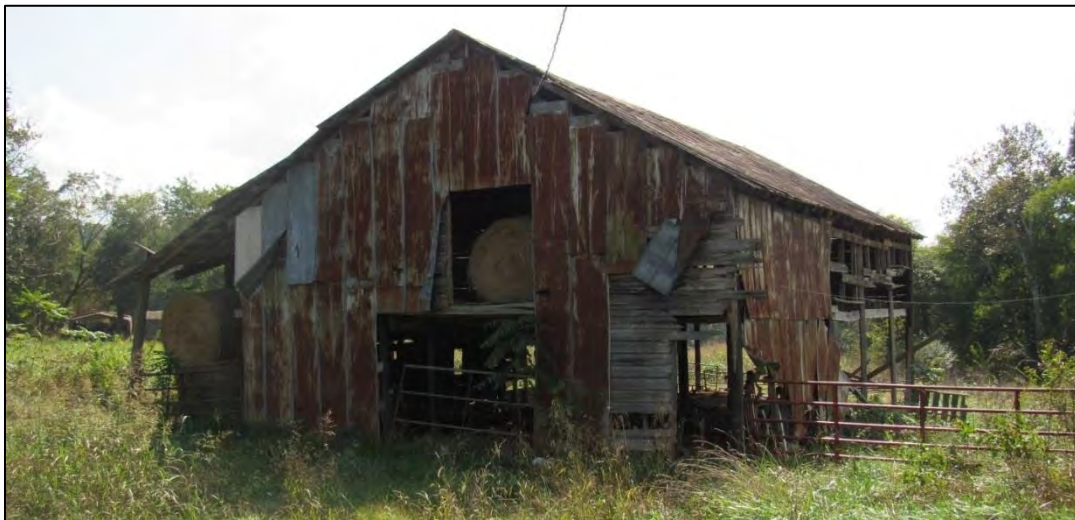
Photo 25: Northeast Elevation of Pole Barn.

A circa-1960 pole barn now used for hay storage is situated at the southwestern corner of this cluster of buildings, facing northeast. This barn was originally clad in weatherboard siding that is now predominantly covered in corrugated metal sheeting. Though it has been modified over time, this barn features a central aisle covered by a hay loft above and a lean-to addition along the southeast elevation (Photo 25).

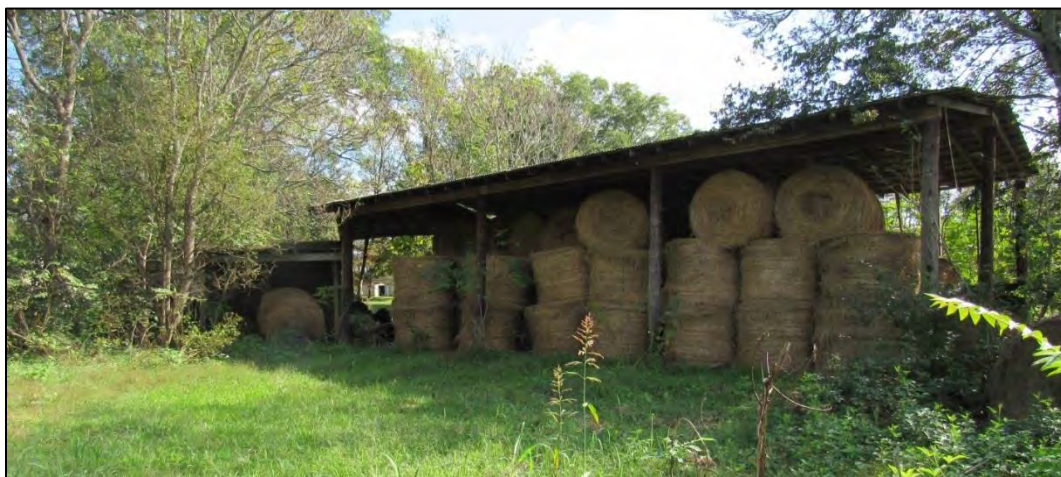
Photo 26: View of Hay Shed (Right) and Former Garage (Left) Looking East.

Situated further east of the large barn is a circa-1980 hay shed of pole-type construction. It is open on all sides and covered by a low-pitched, side-gabled roof covered in corrugated metal sheeting (Photo 26). Near the eastern end of this building is a small one-story, one-bay building that is likely an older garage which may have been relocated its present location. A portion of this circa-1950 garage may have been used as a corn crib or tool shed, but is now clad in shiplapped siding and has a wooden floor. The entire garage building is covered by a shed roof sheathed in v-crimp metal (Photo 26).

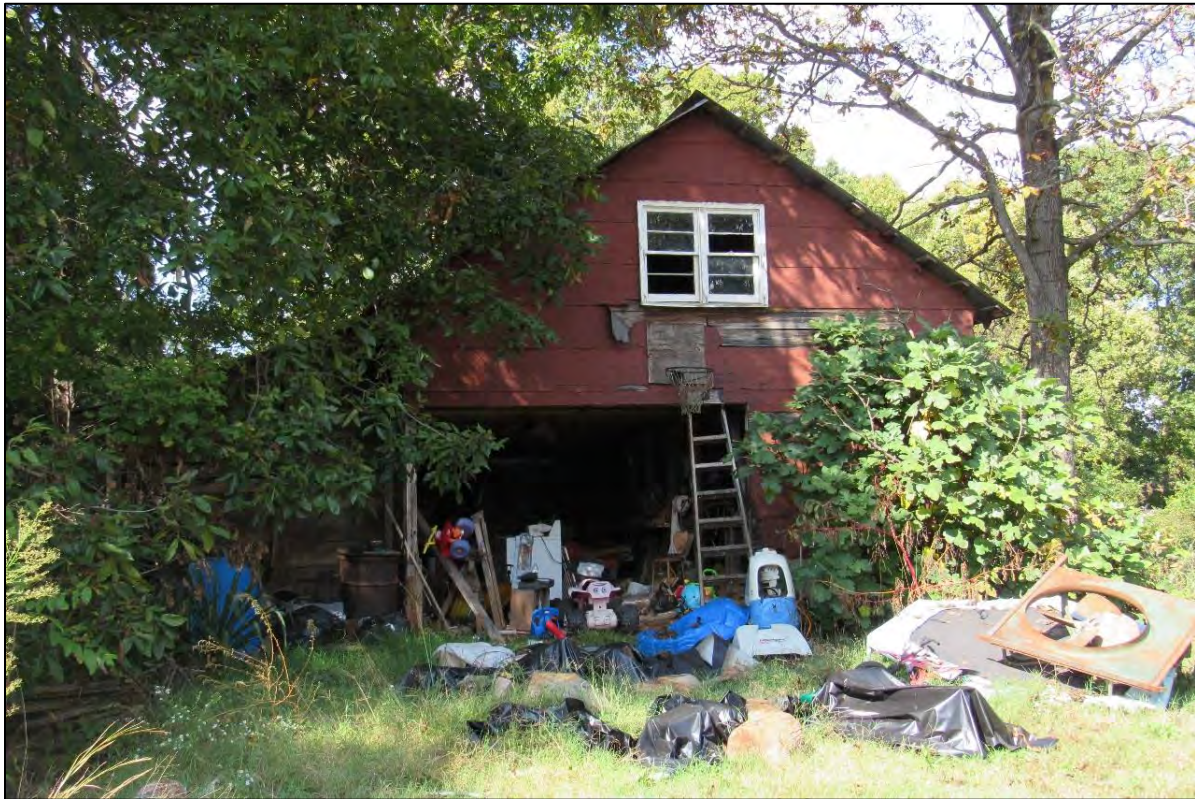
The one-and-half-story, two-bay, garage/ workshop is situated just north of the main house in its current location (Photo 27). This building likely dates circa 1960 and may have functioned as a multi-purpose barn initially. Its foundation was not visible, but it has a frame structural system that is clad in weatherboard siding covered by asphalt tar paper. It is topped by a front-gabled roof sheathed in v-crimp metal. The south elevation is marked by a large open bay and features a paired, two-over-two (horizontal muntins), wood window at the upper level.

Photo 27: Southeast Elevation of Garage/ Workshop.

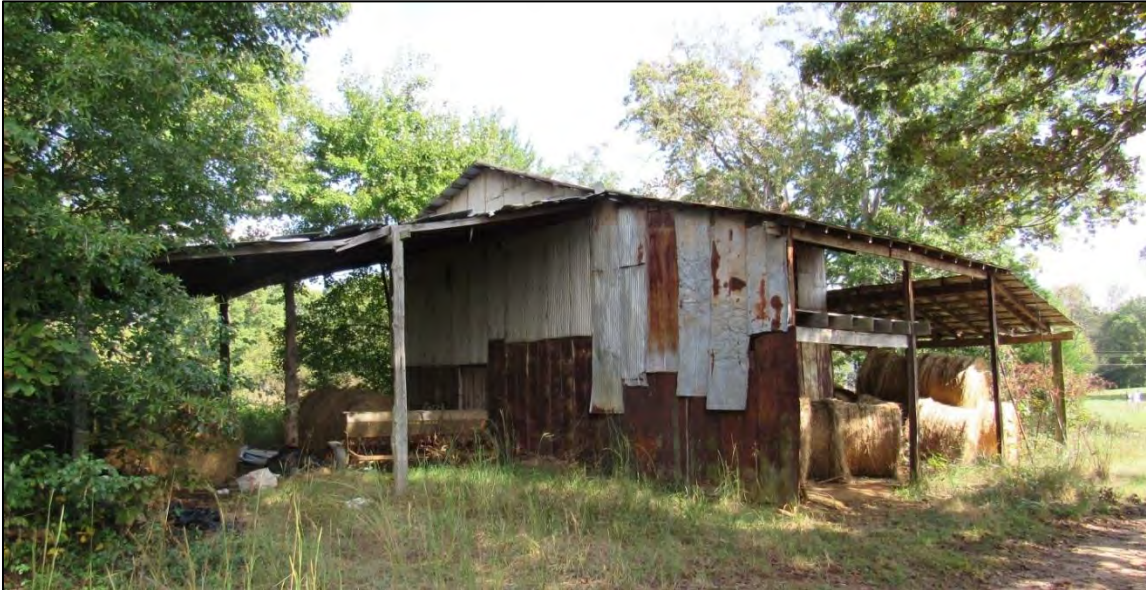
Situated northwest of this garage is a small, circa-1960 barn topped by a gable roof that is clad in re-purposed corrugated metal siding. The interior of this structure was inaccessible, but three, post-in-ground, open air shed additions extend across its northwest, southwest, and southeast elevations. These areas currently function for hay storage (Photo 28 and Photo 29).

Photo 28: Northwest Oblique of Small Barn with Shed Additions Now Used for Hay Storage.

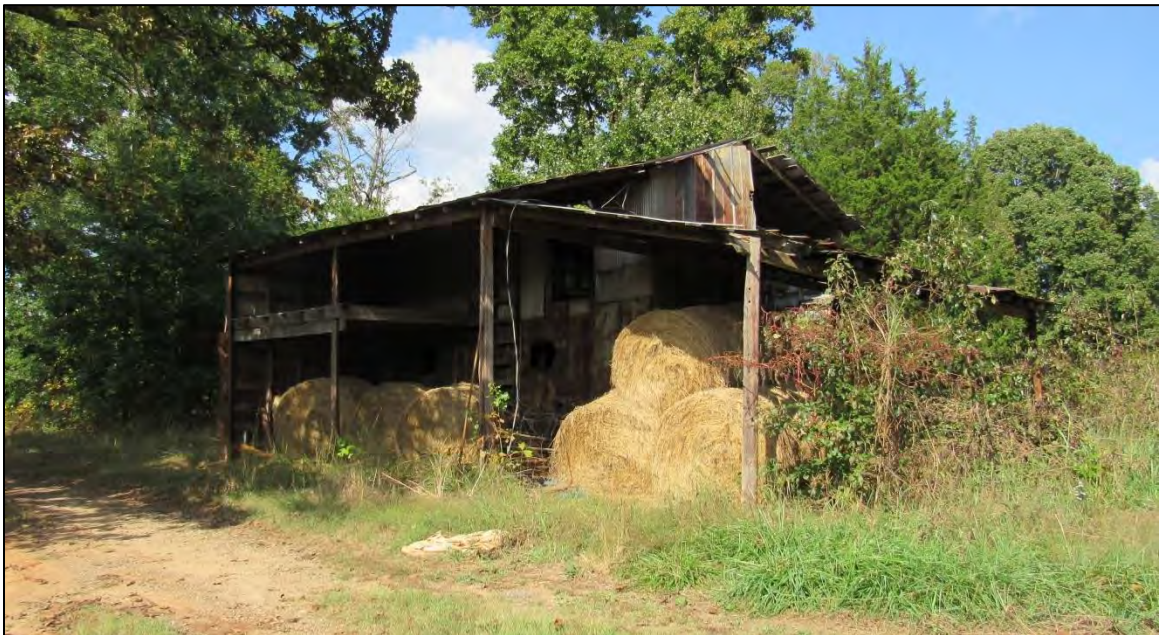
Photo 29: Southwest Oblique of Small Barn in Use for Hay Storage in Northwest Cluster of Farm Buildings.

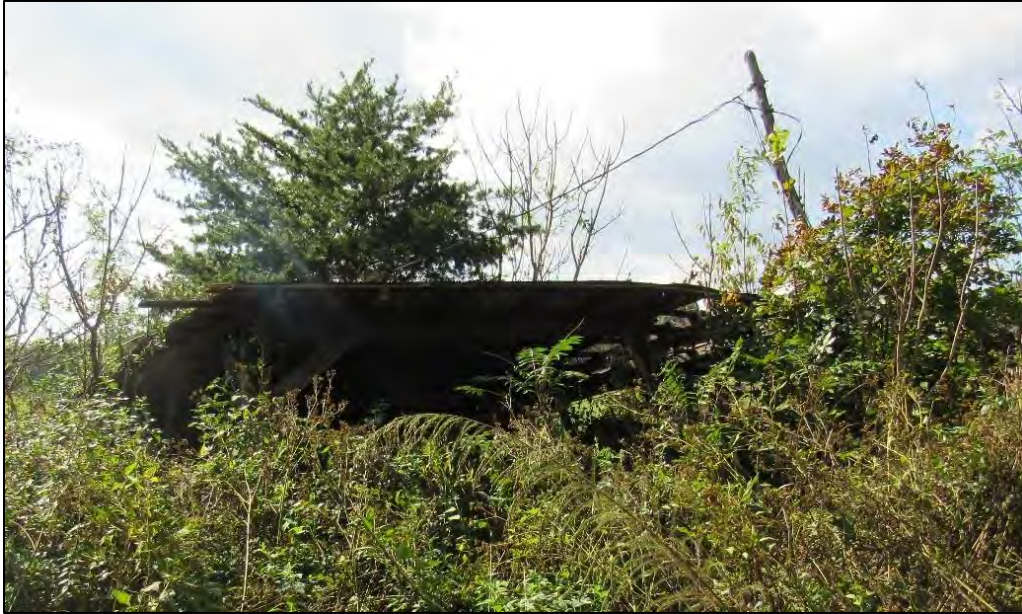
Photo 30: View of Shed Looking West.

Immediately southwest of this resource, on the west side of a long dirt driveway that passes north-south through the east side of farm property, is a circa-1960 shed. This resource was not accessible due to overgrown vegetation, but has a frame structural system and is topped by a shed roof sheathed in corrugated metal (Photo 30). On the east side of the dirt driveway is a ruin of what may have been a late-twentieth century machine shed. Today, just four posts and two flat metal trusses remain extant (Photo 31).

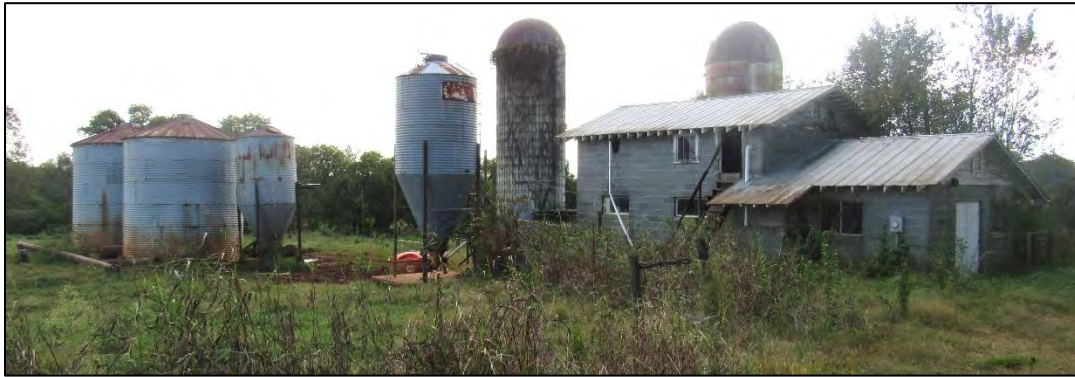
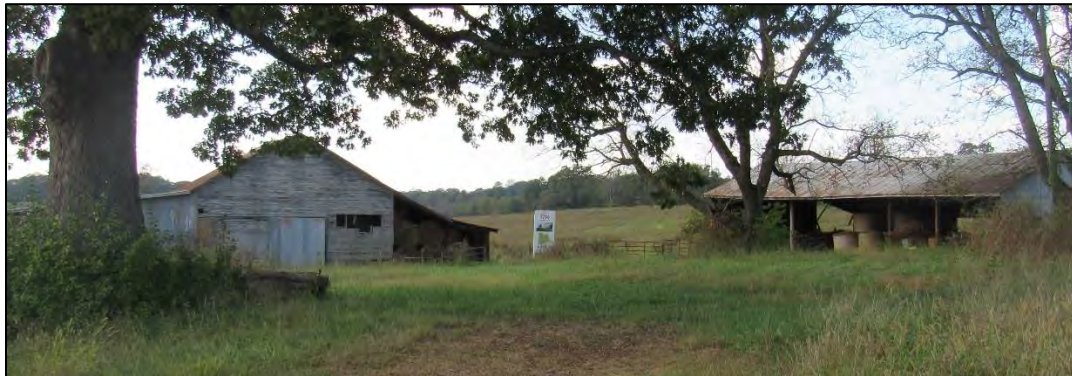
Photo 32: Agricultural Outbuildings located at 2355–2369 Startown Road, Looking Southwest.

Just north of the W.R. Lutz Farmsite at 2355–2369 Startown Road is a cluster of outbuildings likely once associated with dairying. If a historic dwelling was ever associated with this property, it is no longer extant; however, a late-twentieth century house was constructed just north of the outbuildings. This resource, not previously recorded with the NC-HPO, comprises two silos, several circa-1970s grain and corn bins, a shed currently used for hay storage, a 1940s frame central-aisle cow house with additions, and a circa-1960 concrete-block building likely used for feed storage (Photo 32, p. 37).
