North Carolina Department of Natural and Cultural Resources
State Historic Preservation Office

MEMORANDUM

SUBJECT: Historic Structures Survey Report for the proposed widening of SR 1005 (Startown Road) from U.S. 70 to N.C. 10, R-5113, Hickory, PA 17-05-0034, Catawba County
ER 17-3030

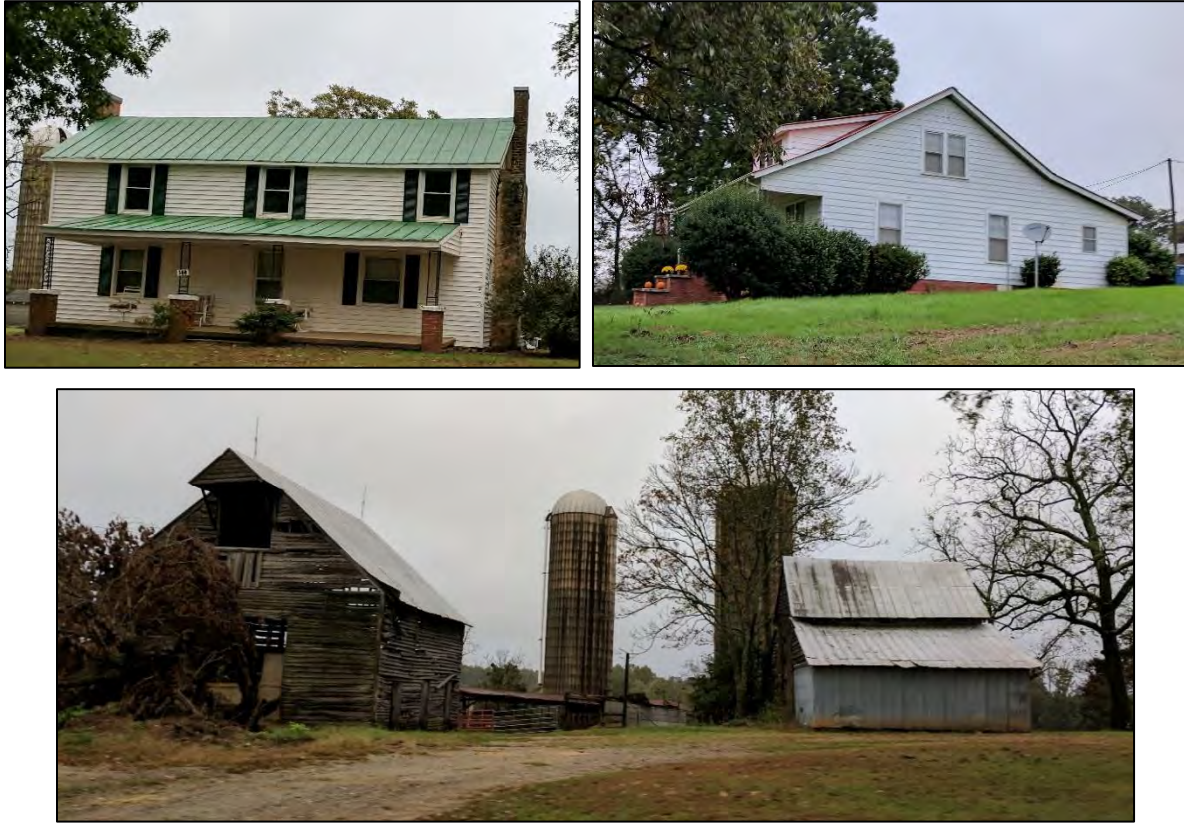
Photo 33: Circa-1904 Dwelling (Top Left), Circa-1935 Dwelling (Top Right), and Dairy Barn, Silos, and Barn (Bottom) of the Wright Dairy Farm (RK1340).

During the windshield survey completed as a part of this project and a review of previously recorded resources on the NC-HPO's HPOWEB program, no Catawba County historic dairy farms still in use today could be identified. However, an excellent example of a dairying complex that retains many of its original and historic features and is still in operation is the Wright Dairy Farm (RK1340) near Reidsville in Rockingham County, North Carolina. According to information on file and obtained during the background review, this property was purchased by George Wright in 1880 and he constructed a two-story, side-gabled I-house around 1904 and started his dairy farm business. The resource comprises three dwellings and many outbuildings that reflect changes in farming technology from the turn of the twentieth century to present day. As of a survey completed in 2002, grandchildren of George Wright continue to operate the dairy farm today. The complex as a whole retains a high level of historic integrity and architectural significance. It was placed on the Study List in 2003 (Photo 33, p. 38).

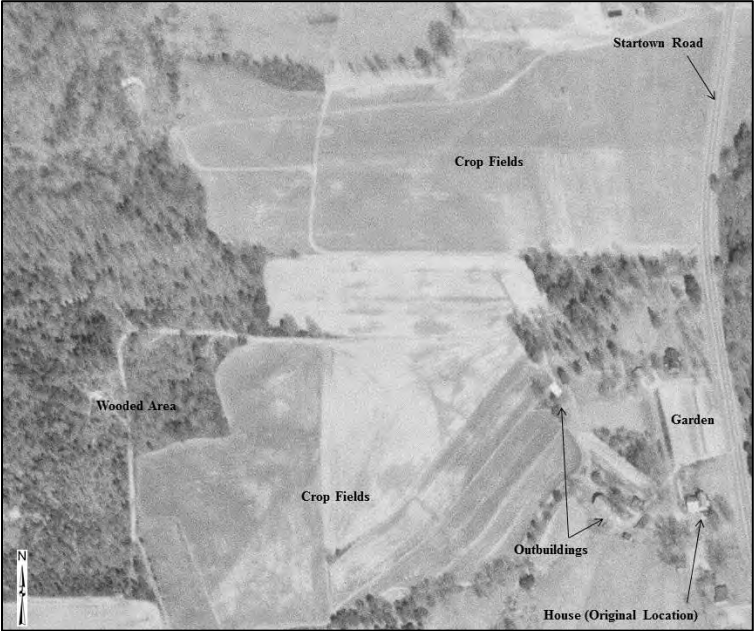
Figure 11: 1966 Aerial Showing the J.B. Lutz House Property.⁵² Note the large surrounding crop fields. Not to scale.

The J.B. Lutz House property is directly associated with the Dutch Dairy Farms, a series of farms that played a significant role in dairy farming throughout Catawba County. Their products, both livestock and dairy-related such as cheese, milk, and butter, were consumed throughout the community. As previously mentioned in the W.R. Lutz Farmsite evaluation, historic rural landscapes eligible for the NRHP under Criterion A for agriculture must “have served or resulted from an important event, activity, or theme in agricultural development as recognized by the historic contexts for the area [...] have had a direct involvement in the significant events or activities by contributing to the area's economy, productivity, or identity as an agricultural community,” and “cogently reflect the period of time in which the important events took place.”⁵⁰ In a 1915 article about the Dutch Dairy Farms, it was stated that each of the six farms had the following: silos, at least one cow barn, large fields for crops such as soy beans and sweet potatoes, potato house, an orchard, tenant house.⁵¹ During the field survey, it did not appear that any of these outbuildings once considered a character-defining feature of the Dutch Dairy Farms survive today, with the exception of the fields; however, these fields have been drastically reduced in size (Figure 11 and Figure 12, p. 39).

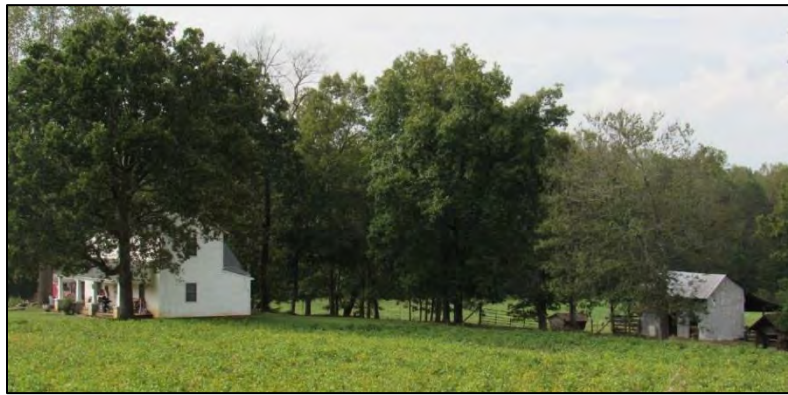
Photo 34: Southeast Oblique of the Dwelling at the Heffner Farm (CT1574).

The I-House form that the J.B. Lutz House represents was common throughout rural Catawba County in the late-nineteenth and early-twentieth centuries. A similar example is the circa-1910 Heffner Farm (CT1574) at 1503 Rock Barn Road, NE in Conover, Catawba County. This resource comprises a two-story, three-bay, I-house and several associated agricultural outbuildings including a livestock and hay barn and a hog barn (Photo 34 and Photo 35). In addition to lacking association with a significant event or individual, the removal of original materials and replacement with vinyl windows and siding resulted in the NC-HPO determining that this resource is not eligible for listing in the NRHP.

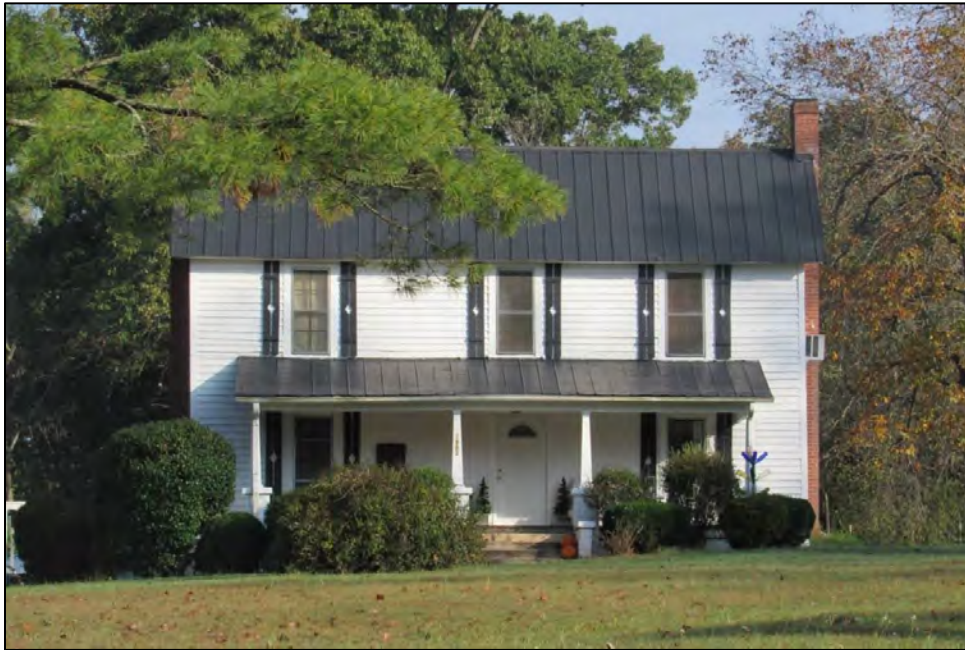
Photo 36: South Elevation of the House at 1882 Settlemyre Bridge Road (CT0564).

Located approximately 2 miles east of the J.B. Lutz House is the House at 1882 Settlemyre Bridge Road (CT0584). Surveyed in 1977, this two-story, three-bay house has exterior-end chimneys at either gable end. From the public right-of-way, Dovetail could not determine if vinyl siding covers the building, but two-over-two, wood-framed windows could be seen. A narrow two-story, rear-ell addition extends from the north elevation (Photo 36). Aerial images also show a few surviving outbuildings, including a larger gabled resource that is likely a barn, suggesting that this property once functioned as a farm.⁶³ The building appears to retain a moderate to high level of historic integrity, although its NRHP eligibility it has not yet been evaluated by NC-HPO staff.

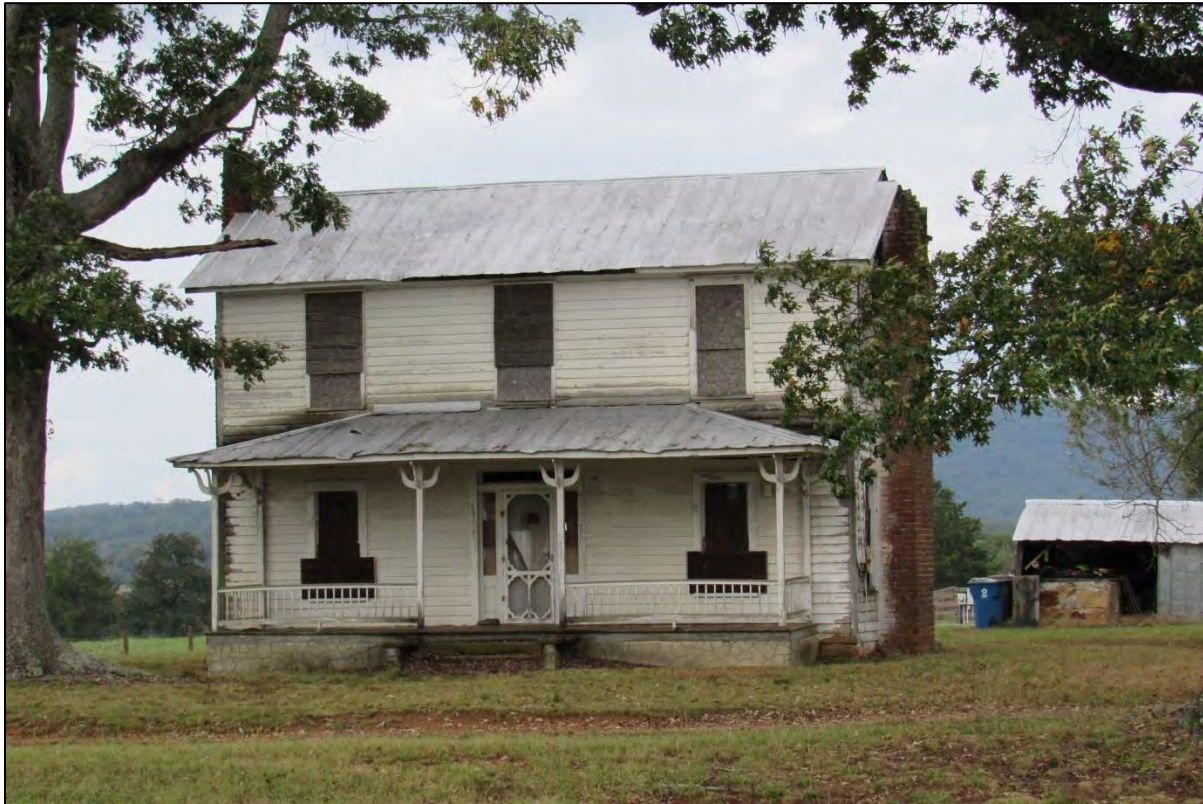
Photo 37: South Elevation of the D.P. Shuford House (CT0988).

Another example of a near-by two-story I-House is the D.P. Shuford House (CT0988) on N.C. 10. According to the 1977 survey of the property, the side-gabled, three-bay dwelling dates to around 1875. Although the house has sat vacant for a number of years, it still retains many of its character defining features, including original siding, unique porch posts, and wooden screen door (Photo 37). Effects of the vacancy can be seen in the exterior-end chimneys where the tops have crumbled. The windows are boarded over; however, in the 1977 survey, they openings were filled with four-over-four, wood-framed windows and it is possible that they are still in place below the boards. There are two surviving historic outbuildings, both seen from the public right-of-way, and modern aerial images show a possible cemetery located just north of the dwelling.⁶⁴ This building has not been evaluated for NRHP eligibility.

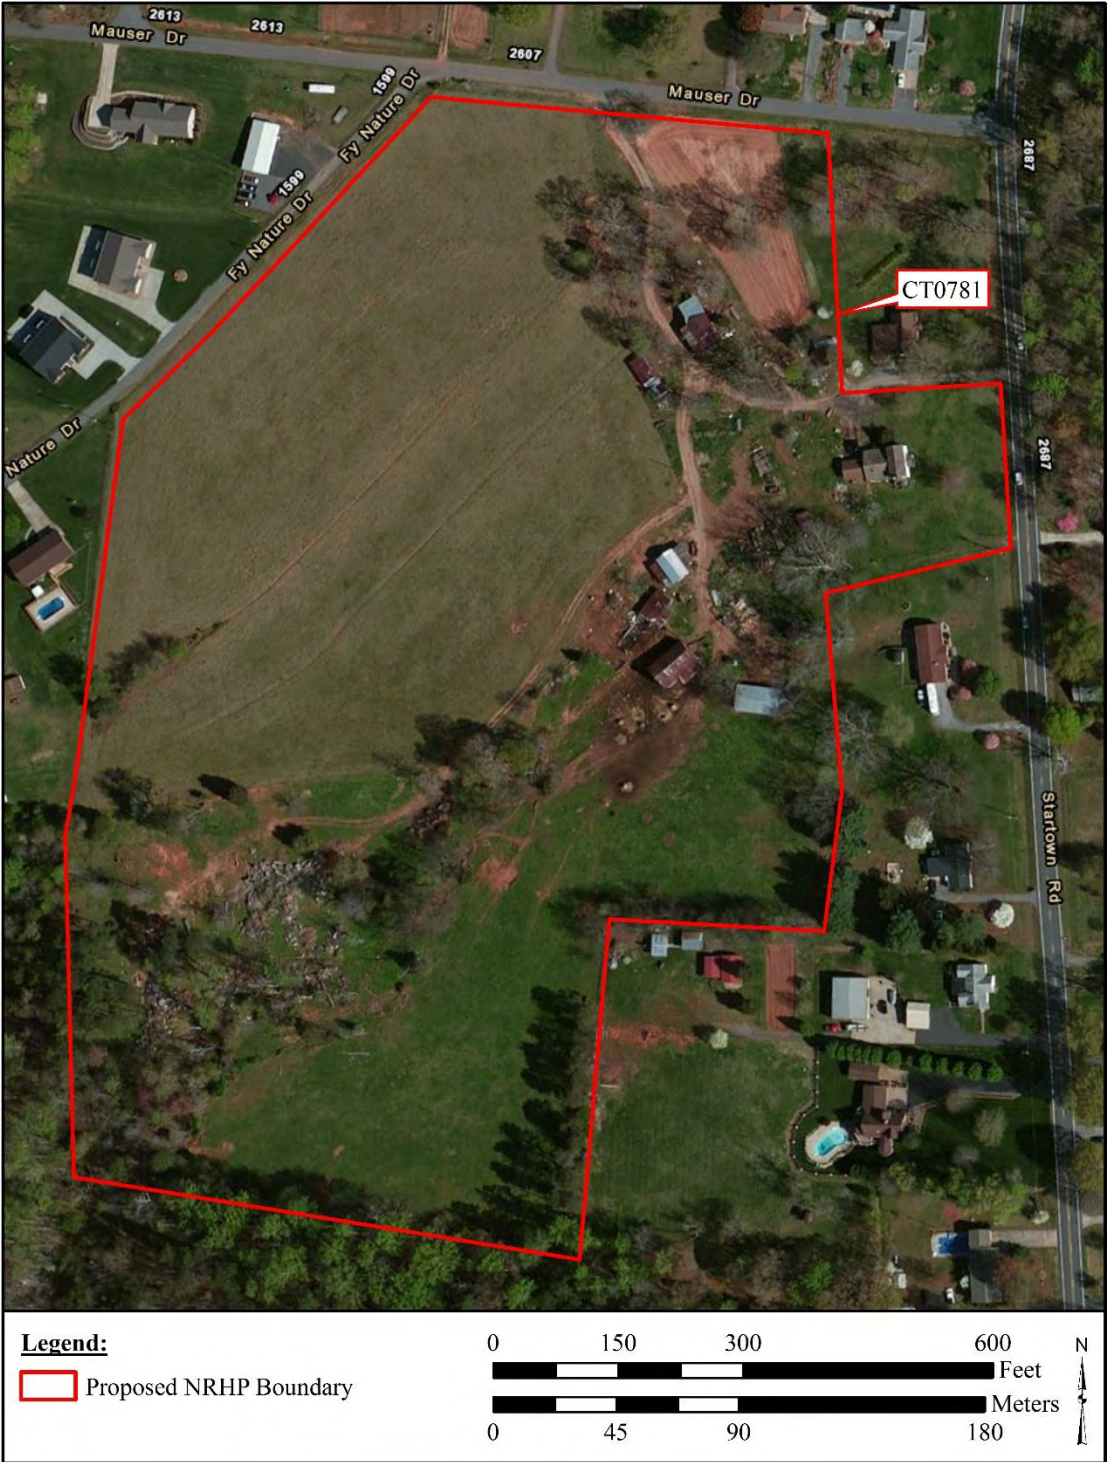
Figure 13: Proposed NRHP Boundary for the J.B. Lutz House (CT0781).⁷⁰

The proposed period of significance for this resource is the period during which the dairy farm operated under the ownership of J.B. Lutz, circa 1890–1914. The proposed NRHP boundary for the J.B. Lutz House comprises two parcels in their entirety: Parcel ID 372006486085 and Parcel ID 372006471856. It also includes the western half of another parcel immediately to the north of the dwelling (Parcel ID 372006486320) to incorporate a mid-twentieth century outbuilding historically associated with the farm (Figure 13, p. 46).⁶⁹ The boundaries include the dwelling, domestic outbuilding, possible milking area, two barns, hay shed, shed (former garage), garage, shed, and ruins. Only the dwelling was constructed during the resource’s period of significance and contribute to the property’s eligibility.

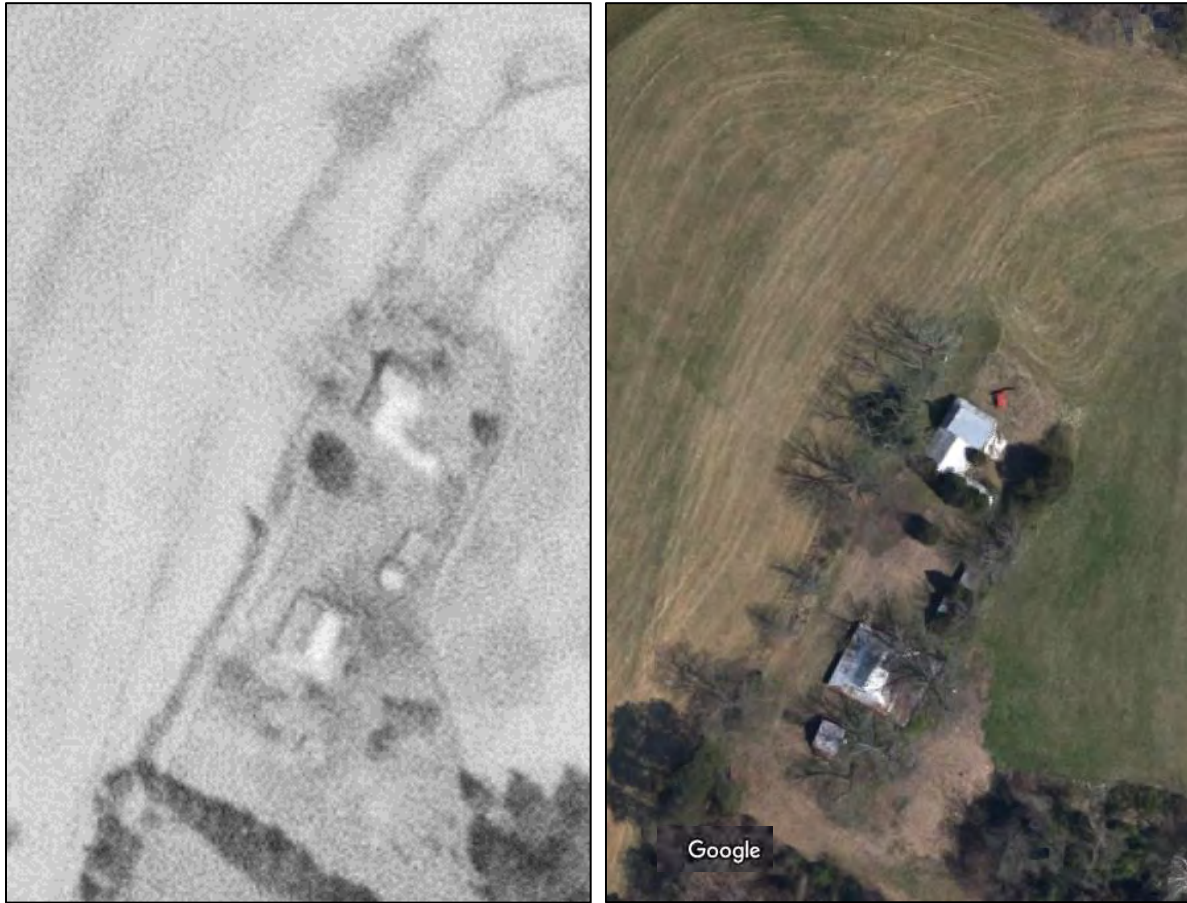
Figure 16: 1966 (Left) and 2017 (Right) Aerial Comparison of the C.F. Bolick House.⁷³

According to the previous survey conducted in the mid 1970s, this resource consists of a single-family dwelling (the C.F. Bolick House), cow barn, well house, pig pen, log granary, and several small agricultural outbuildings (Figure 15–Figure 16, pp. 49–50).⁷¹ Access to the property, including the interior of the buildings, was not granted during this survey, as such, an assessment of the current condition of the property was limited to a glimpse of a roof line and a comparison of current and historic aerial photography. Through these methods, Dovetail surmised that it is likely that the C.F. Bolick House, cow barn, granary, and either the well house or one of the frame outbuildings are still standing, though their integrity and materials could not be evaluated at this time (Photo 38, p. 51).

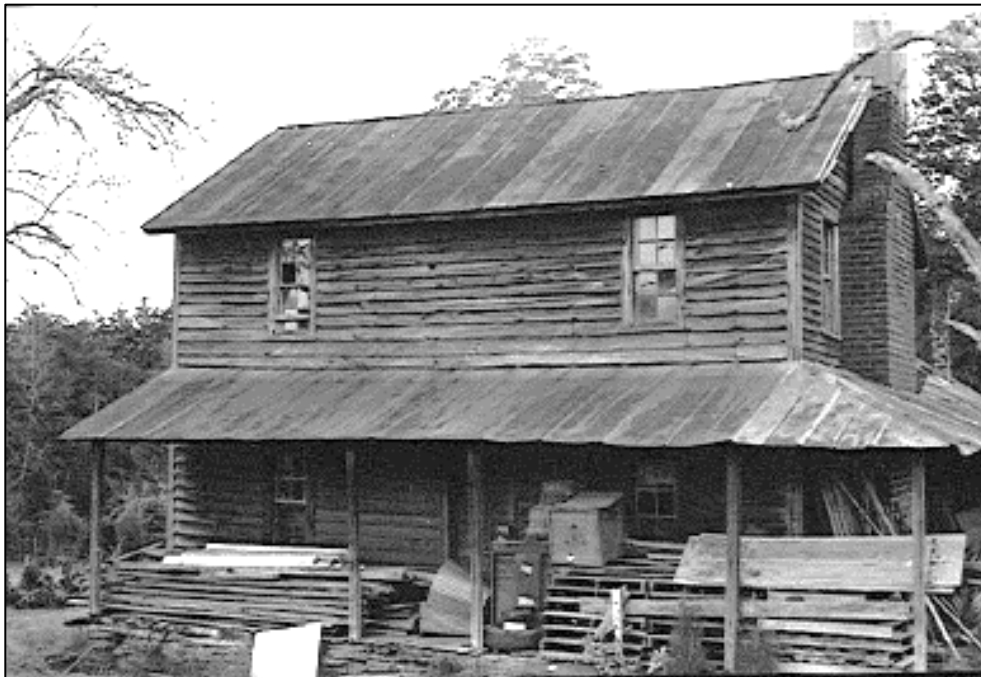
The previous survey documented the C.F. Bolick House as a two-story, three-bay, single-pile farmhouse with an exterior-end brick chimney and a wrap-around, hipped-roof metal porch (Photo 39, p. 51). The surveyor noted that the original portion of the house was actually the rear, gabled wing which is timber-framed and clad in board-and-batten siding with a dry-laid stone chimney (Photo 40, p. 52). Though the materials cannot be confirmed, both of those sections of the C.F. Bolick House, as well as the porch, appear to still be standing today.

Photo 39: Photo of C.F. Bolick House from Previous Survey, North Oblique.⁷⁴

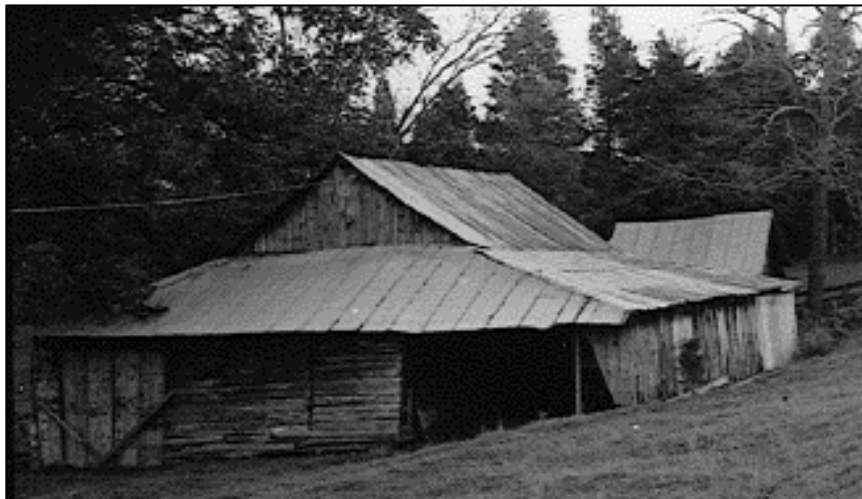
Photo 41: Photo of the Cow Barn from Previous Survey.

The cow barn also appears to still be extant. The previous survey notes it as being a front-gabled, frame, two-pen cow barn with a hipped skirt (Photo 41). The log granary, which appears in aerials as a side-gabled building south of the cow barn, is likely still extant as well but was not photographed in the previous survey and no additional information is known about this resource.

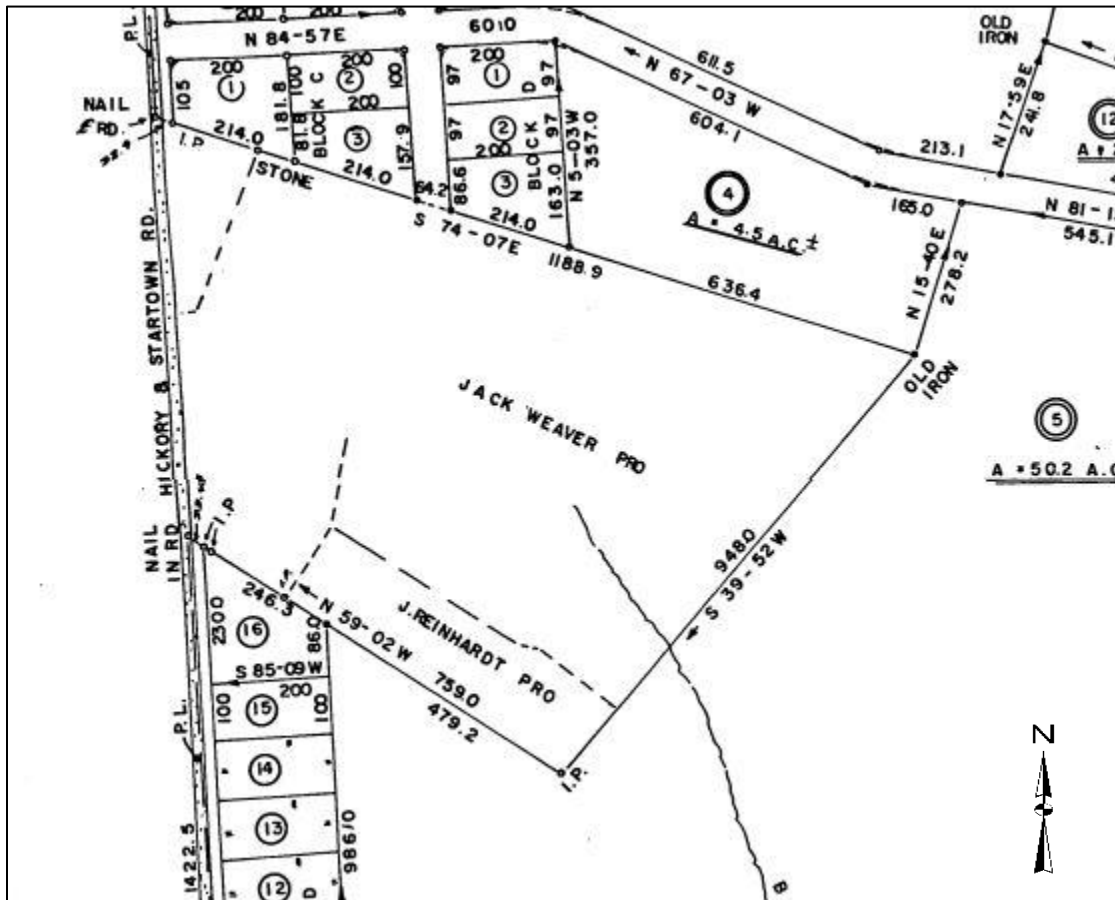
Figure 17: 1959–1960 Plat Map Showing the Jack Weaver Property (CT0780) East of Startown Road.⁸⁷ Not to Scale.

Jack David Weaver was born on June 17, 1919 to Autus Marvin and Lula M. Weaver, who lived in the Hickory Township of Catawba County.⁸⁴ As a young adult, he worked as a salesman for George H. Harris, a distributor of Millers High Life Beer in Hickory.⁸⁵ On April 18, 1946, Jack married Gladys I. Cline, also of Catawba County, and land records suggest that the first property Jack purchased in the county was from Essie Hawn on the east of Startown Road containing the dwelling and all of its associated outbuildings (Figure 17).⁸⁶

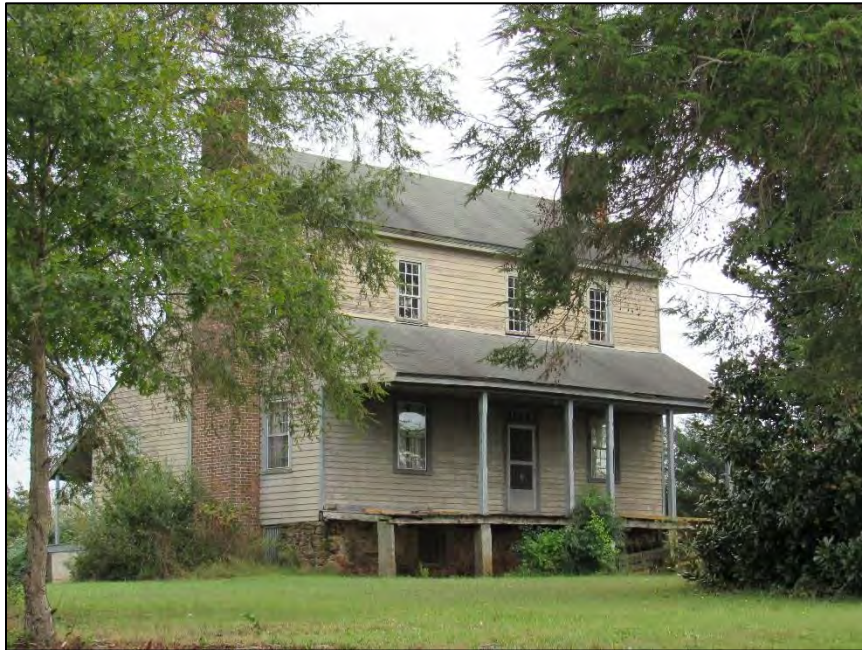
Photo 42: Rudisill-Wilson House (CT0006).

Although little is known about the current condition of the property, it is possible to understand certain aspects of the C.F. Bolick House property's significance, including the rarity of similar buildings on the current Catawba County landscape. It seems that there are several surviving early- to mid-nineteenth century dwellings that serve as good comparisons for the C.F. Bolick House. The Rudisill-Wilson House (CT0006), located 2 miles south of Startown, is a two-story, three-bay frame dwelling constructed around 1821. It retains many of its original features, such as a stone foundation, chimneys laid in a Flemish bond, nine-over-nine and six-over-six, wood-framed windows (Photo 42). It was listed in the NRHP under Criterion C in 1973.

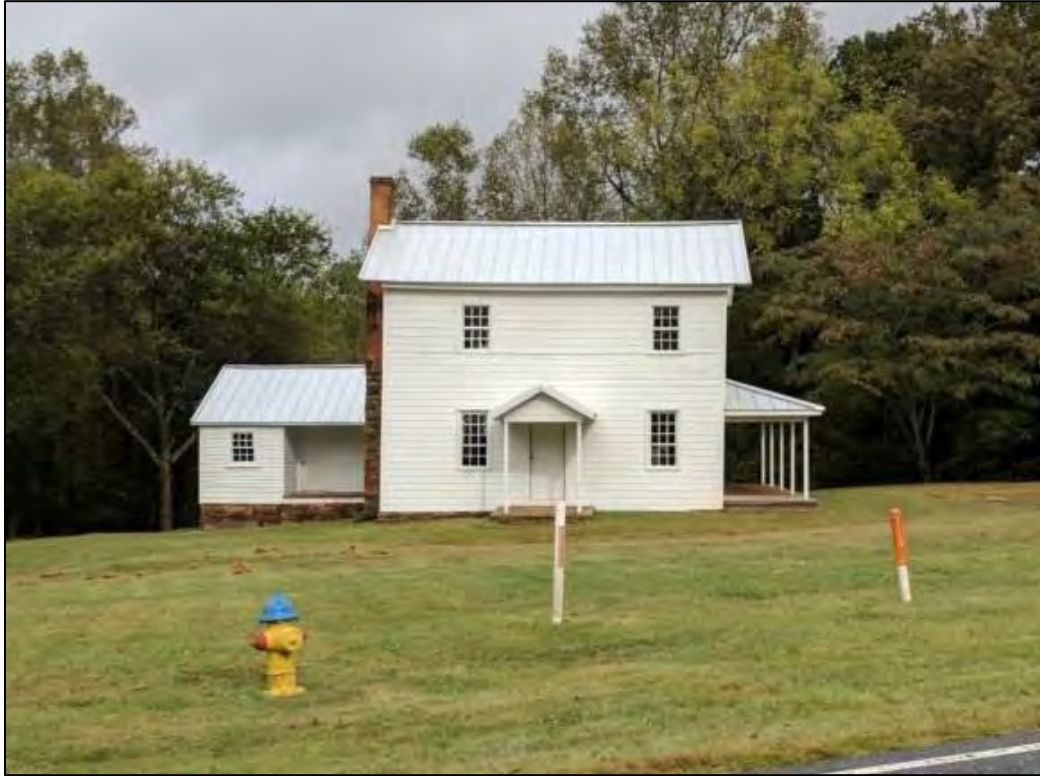
Photo 43: Bost-Burris House (CT0409).

The Bost-Burris House (CT0409), located on Conover-Startown Road just west of Newton, is another frame, two-story dwelling (Photo 43, p. 57). Like the C.F. Bolick House, the house associated with this resource was constructed in several phases, the earliest of which dates to around 1810 and the two later additions were added around 1870 and the late 1890s. When this farmhouse was listed in the NRHP in 1990, it was in very good condition and retained a high level of historic integrity. The property was found to be significant under Criterion C as a “representative of the property type ‘Houses of Catawba County: Antebellum (1800–1864),’ and under Criterion A as a representative of the historic context ‘Exploration and Settlement of Catawba County, 1747–1820.’”⁹⁰

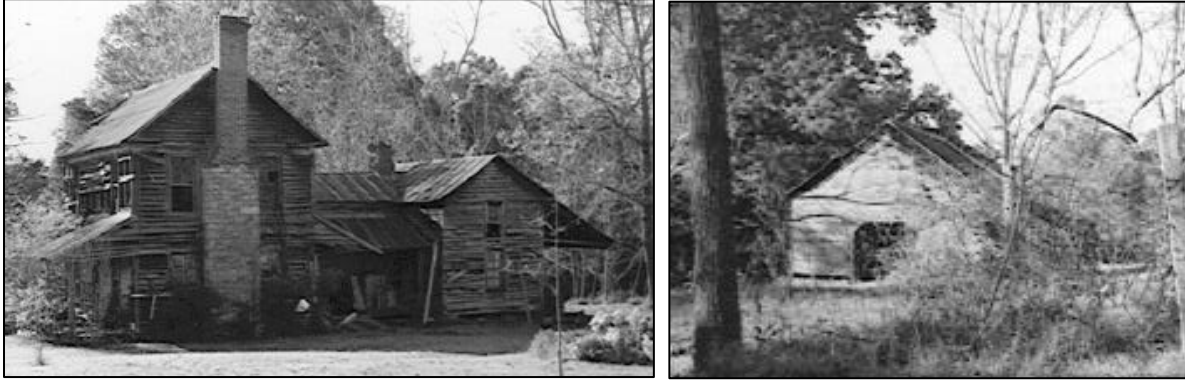
Photo 44: Photos from the Mid-1970s Survey Showing the Cicero Cline House on the Left and Corn Crib on the Right.⁹⁵

The Cicero Cline House, as previously recorded in the mid 1970s, was a two-story, timber-framed, single-family dwelling with large stone chimneys and several frame addition (Photo 44, p. 62) According to historic aerials and topographic maps, the resource appears to have been demolished by the early 1990s (Photo 45, p. 62).⁹³ According to the previous survey, a corn crib, now demolished, was also located on the property (Photo 44, p. 62).

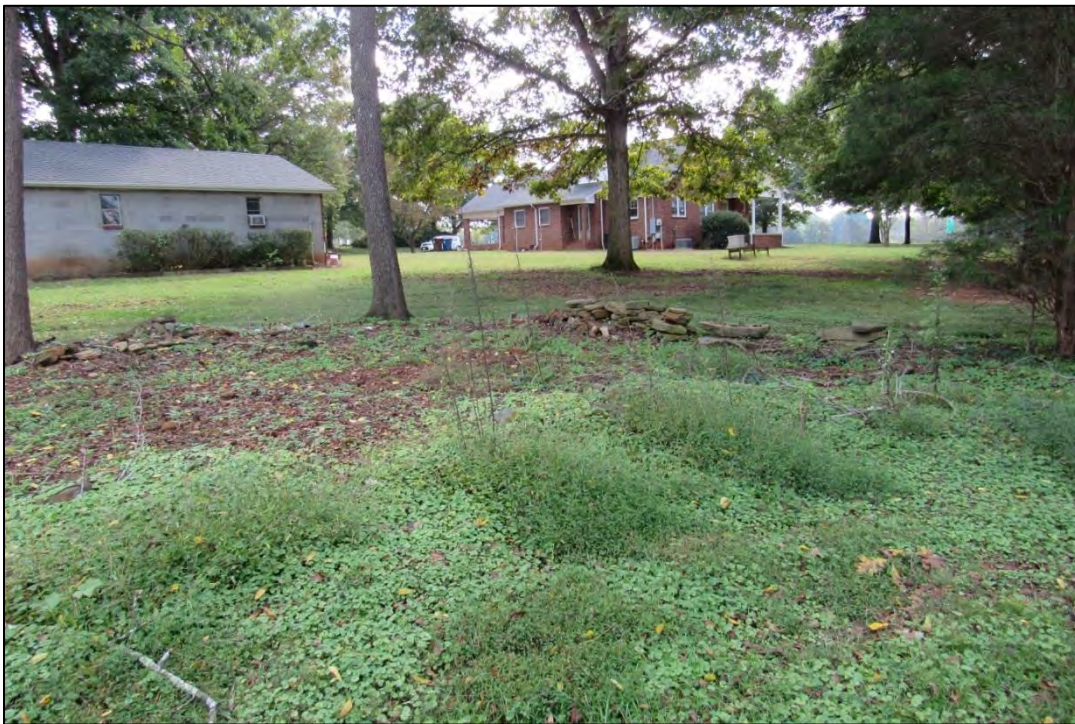
Photo 45: Site of the Former Cicero Cline House, Looking Southeast.

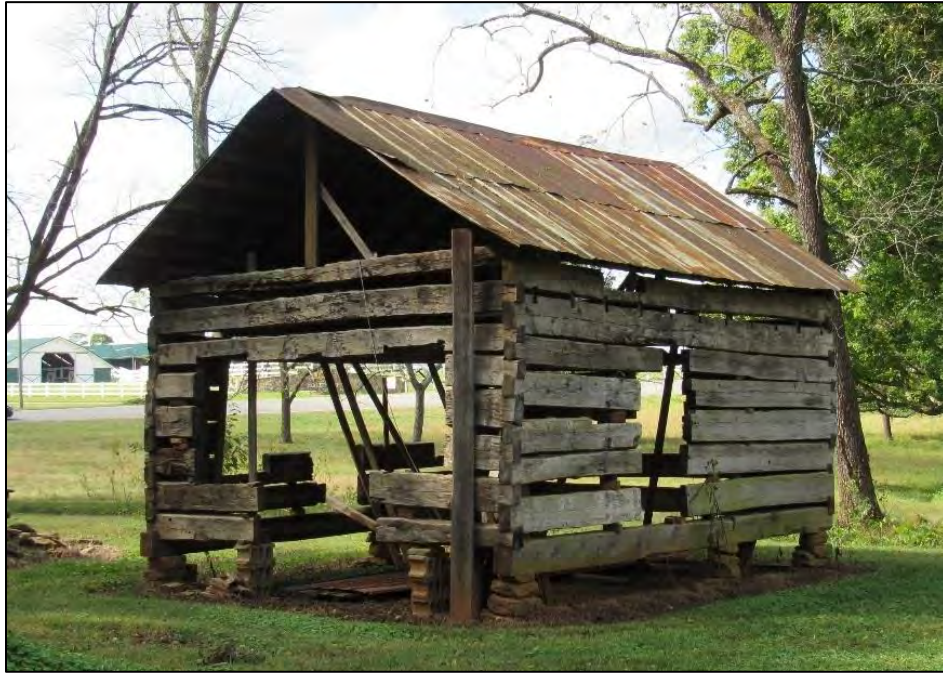
previous survey, this resource once had a dry-laid stone chimney.⁹⁶ All fenestration on the resource are open bays. The open bay on the east elevation was likely the primary entrance, and the remaining elevations feature open bays that likely held windows. The silo foundation is located about 150 feet north of the log kitchen (Photo 47). It is cylindrical in shape and composed of poured concrete with an aggregate of stone.

Photo 46: Log Kitchen, Northeast Oblique.

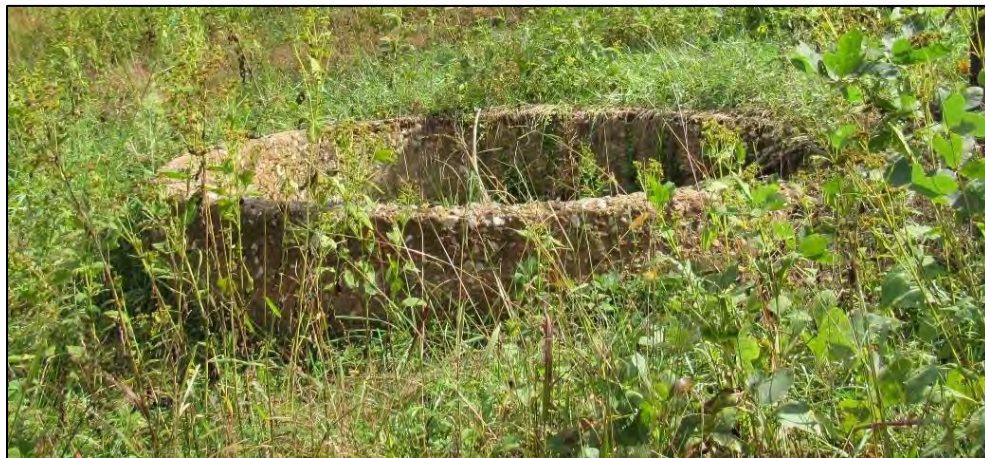
Photo 47: Silo Foundation, Looking North.

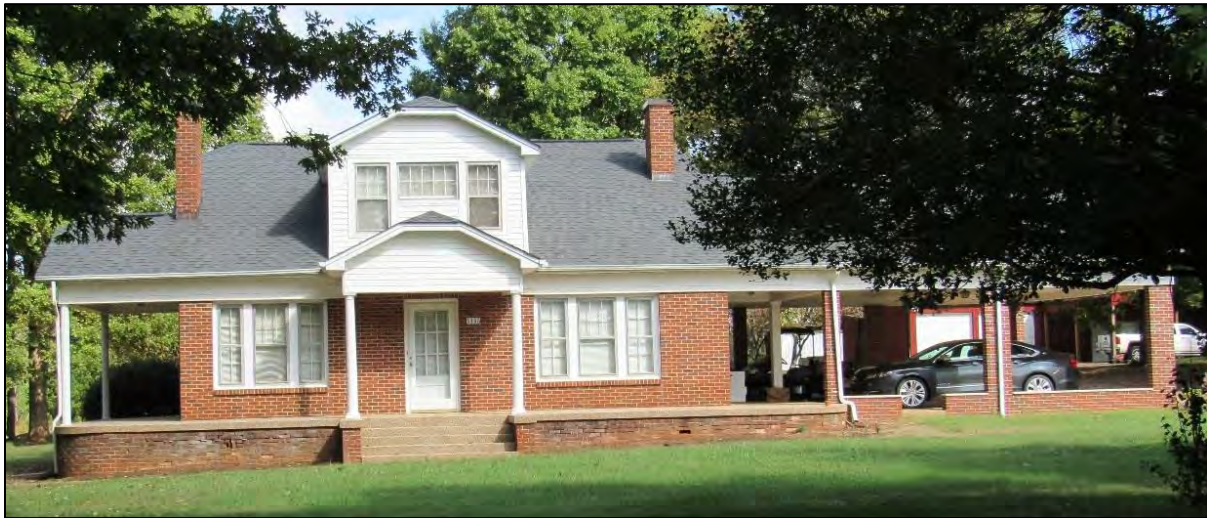
The remaining resources all date post 1930. These include the single-family dwelling, workshop, machine shed, garage, and well cap. The circa-1935, one-and-a-half-story, three-bay, single-family dwelling constructed in the Minimal Traditional style is located at the end of the poured-concrete driveway, about 150 feet north of Startown Road (Photo 48). The foundation and structural system are both clad in a running-bond brick veneer. The resource is covered by a moderately pitched, clipped side-gabled roof. A clipped-gable dormer is centered on the south elevation and a shed-roof dormer is centered on the north elevation. Both dormers are clad in vinyl siding and feature wood-framed windows. Two brick chimneys pierce the north slope of the roof. The first is an exterior-end chimney located on the west elevation and the other is an interior chimney located near the east elevation.

Photo 48: Single-Family Dwelling, South Elevation.

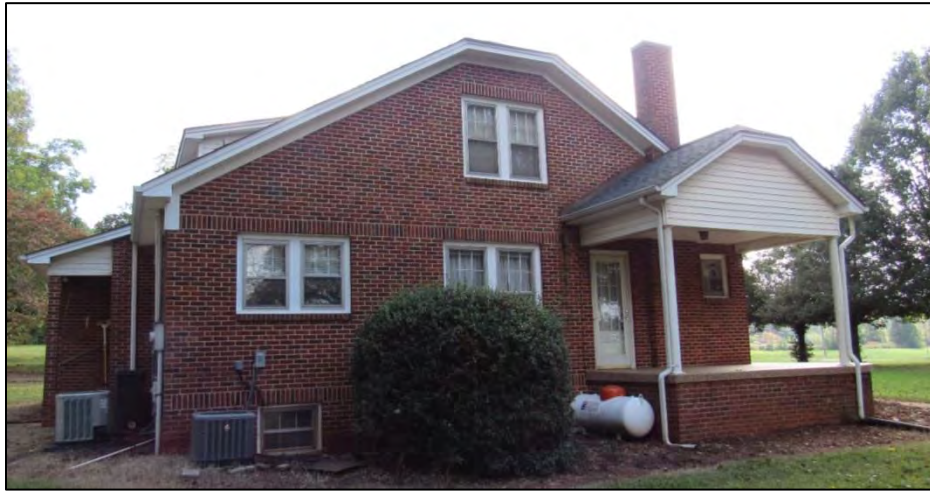
Photo 49: Single-Family Dwelling, West Elevation and Porch Detail.

A one-story, two-bay, side porch addition extends from the west elevation (Photo 49, p. 65). The porch is set upon the wraparound deck, is supported by square-wood posts, and is covered by a clipped-gabled roof sheathed in asphalt shingles with vinyl in the gable end. This porch covers a secondary entrance that is filled with a single-leaf paneled wood door with nine fixed lights covered by a metal-and-glass storm door.

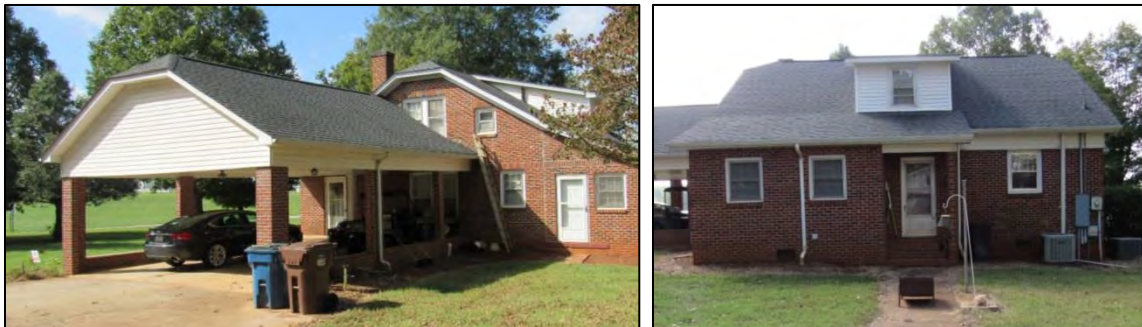
Photo 50: Single-Family Dwelling, East Elevation and Carport Detail (Left) and North Elevation and Addition Detail (Right).

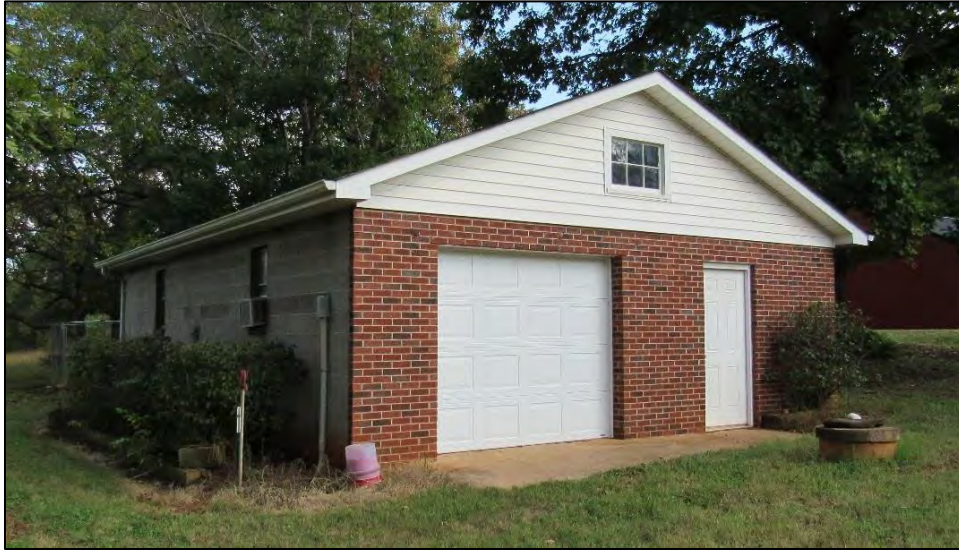
Photo 51: View of Garage and Well Cap, Looking Northeast.

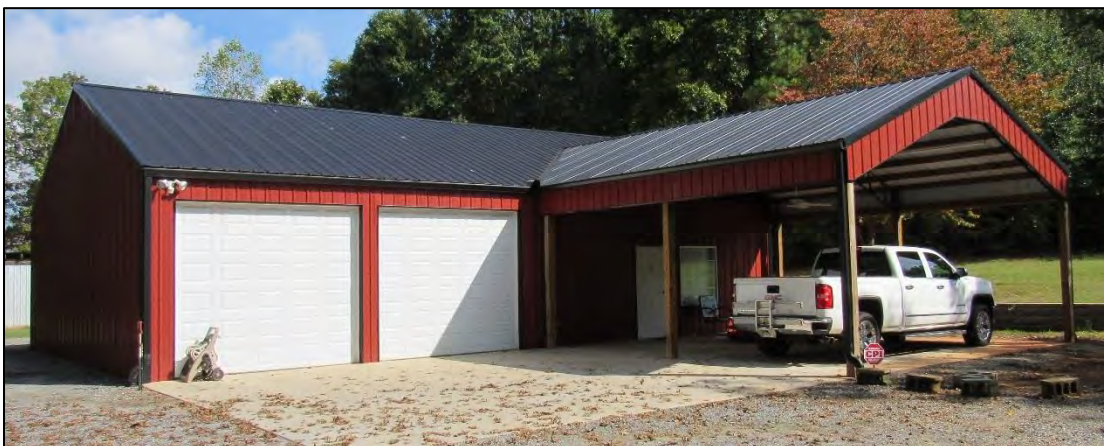
Photo 52: Workshop, Southwest Oblique.

A one-story, three-bay, circa-2015 workshop is located about 50 feet east of the garage. The resource is clad in corrugated metal and covered by a side-gabled roof sheathed in corrugated metal. Two vinyl garage doors are located to the west in the primary (south) elevation and a single-leaf vinyl door is located to the west. The single-leaf door is covered by a large, front-gabled vehicular portico supported by square-wood posts (Photo 52).

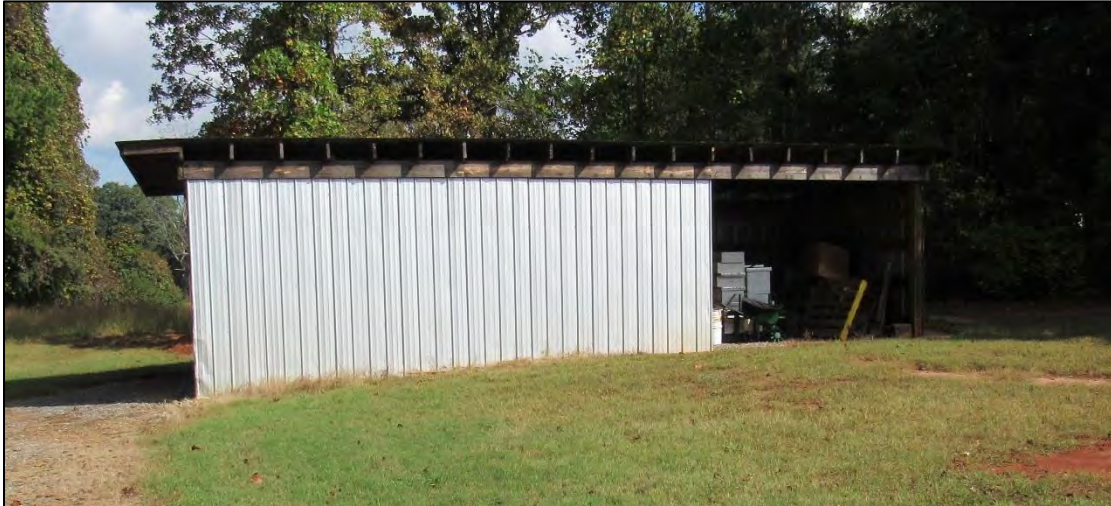
Photo 53: Machine Shed, South Elevation.

A circa-2010 machine shed is located about 50 feet north of the workshop. The wood-frame structural system is clad in corrugated metal and covered by a shed-roof sheathed in corrugated metal with exposed rafter tails. A large open bay is located to the east of the primary (south) elevation (Photo 53).

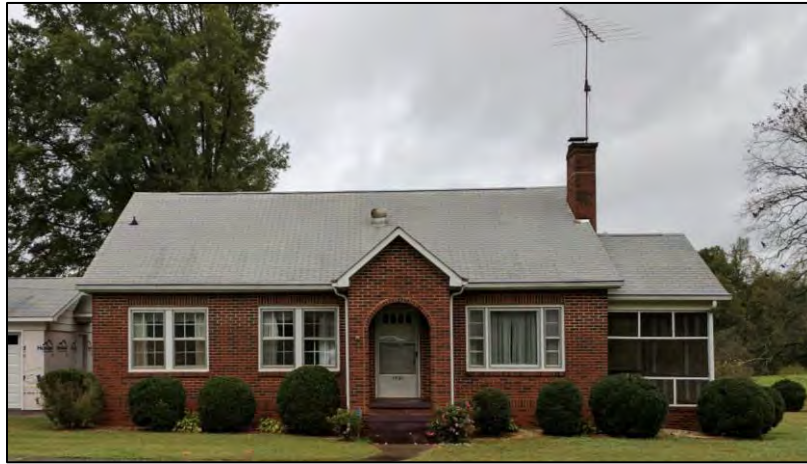
Photo 54: House at 1901 Old Conover-Startown Road, East Elevation.

Conover-Startown Road (Photo 54). A moderately pitched, side-gabled roof covers the dwelling and an exterior-end, brick chimney stands at its north elevation. Constructed in the mid-twentieth century, this house appears to retain its original form and shape, as well as the wooden six-over-six, double-hung sash window and a tripartite window comprising a fixed window flanked by wooden two-over-two windows. This resource has not yet been surveyed or evaluated for the NRHP.

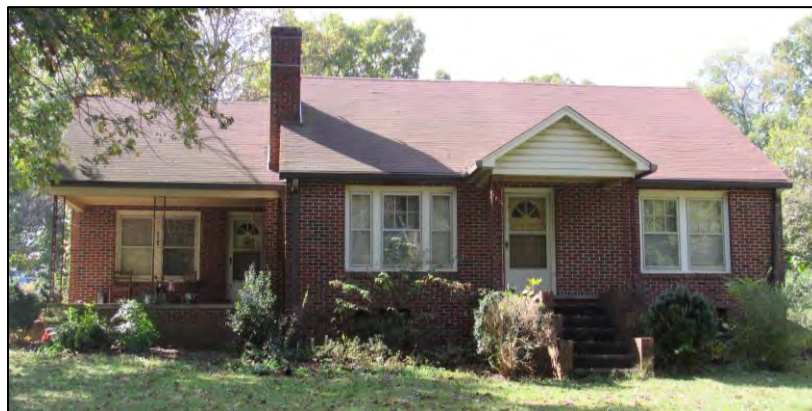
Photo 55: House at 2733 Startown Road, East Elevation.

Located approximately 1.25 miles north of the circa-1935 dwelling at the Cicero Cline House is a one-story, three-bay house constructed in the 1940s at 2733 Startown Road (Photo 55). A moderately pitched, side-gabled roof covers the brick-clad building. Fenestration includes original paired six-over-six, double-hung sash, wood-framed windows and a six-over-six window set between two four-over-four windows. Slightly off-centered on the east elevation is the primary entrance filled with a wooden door and metal storm door. A side-gabled, brick addition, likely built around the building's date of construction, extends from the south elevation. This house has not been surveyed or evaluated for NRHP eligibility by HPO staff.

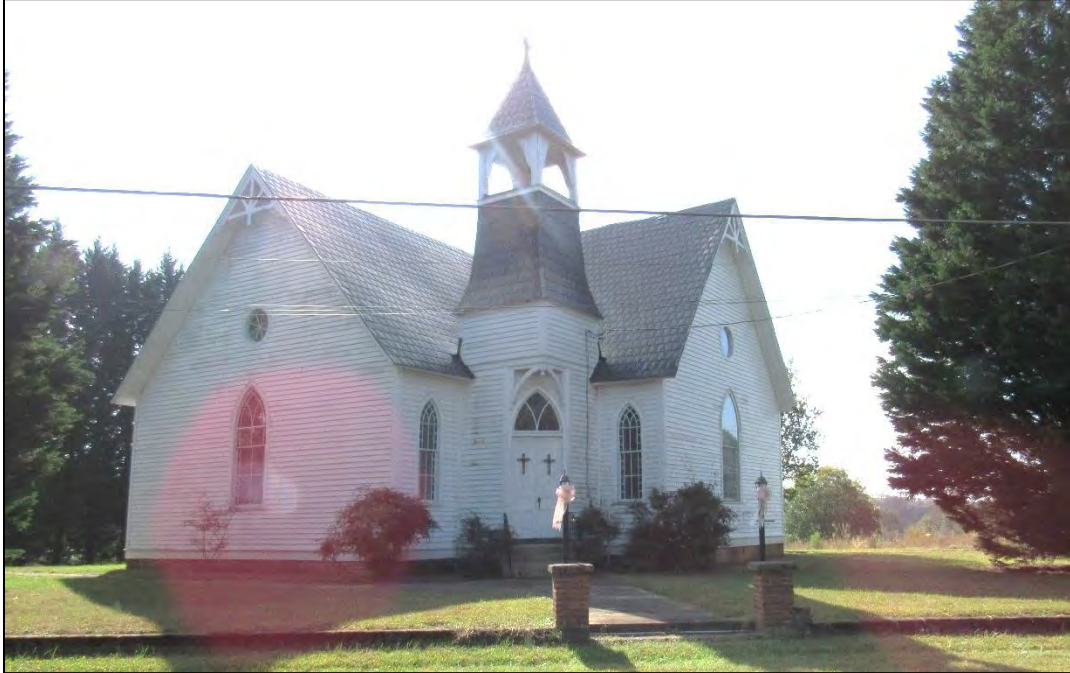
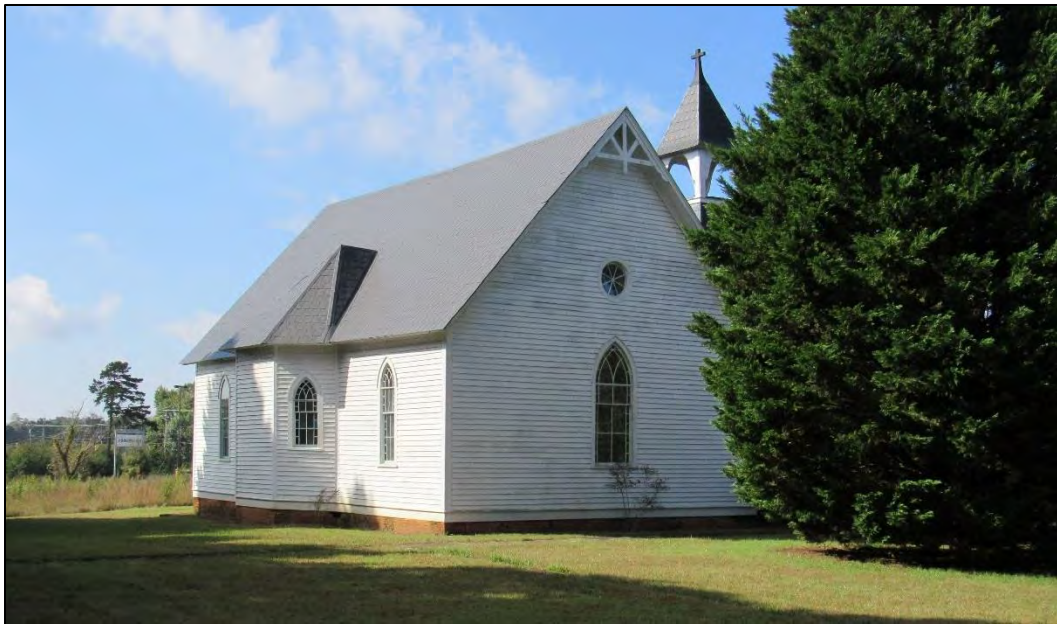
The primary resource is a one-and-a-half-story, three-bay church built in 1904 in the Gothic Revival style (Photo 56–Photo 57, p. 75). The church rests on a brick pier foundation with brick infill that features small, cross-shaped vents. The frame structural system, clad in weatherboard with wood corner boards, is covered by a side-gabled roof with a front-gabled projection extending west and a rear, hipped apse extending east, all sheathed in tin shingles. Decorative wood trusses are located in the gable ends. A two-story bell tower which features the primary entrance is located on the northwest corner of the resource. The bell tower features a steep, tin-clad skirt beneath the open belfry which is topped by a pyramidal roof sheathed in tin shingles with a small, slim, wood cross at the pinnacle.

Photo 56: St. Paul's Reformed Church (CT0403), Northwest Oblique.

Photo 57: St. Paul's Reformed Church (CT0403), Northeast Oblique

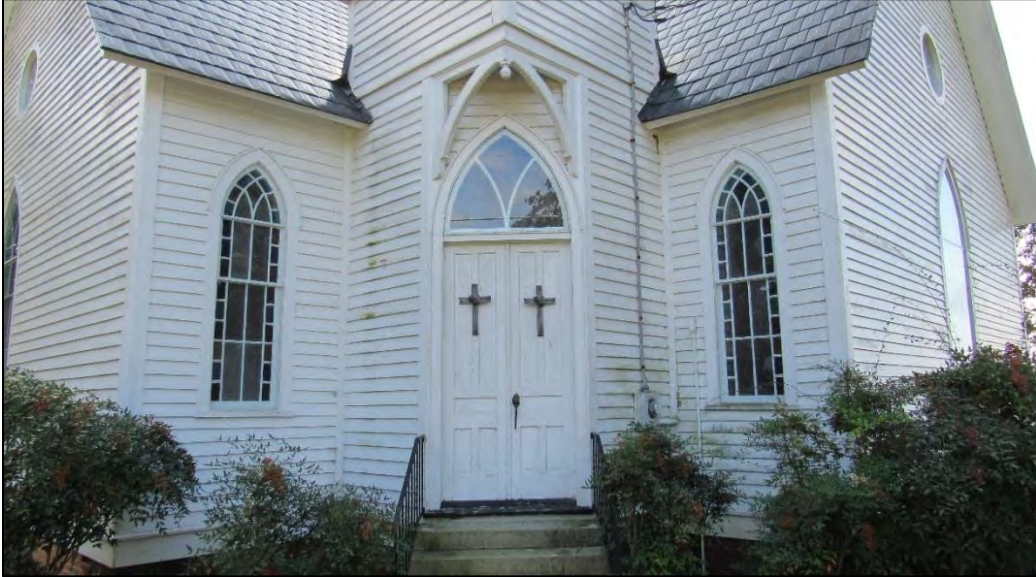
Photo 58: St. Paul's Reformed Church (CT0403), Primary Entrance Detail.

The primary entrance, which faces northwest, is centered in the corner bell tower and is filled with a double-leaf, paneled wood door topped by a three-light, wood-framed lancet transom that is located beneath a roof overhang with decorative wood brackets (Photo 58, p. 76). A set of poured-concrete stairs with metal railing leads to the door. Other fenestration includes fixed and one-over-one, double-hung sash, wood-framed, stained-glass, lancet windows, some of which are covered by metal-framed storm windows. The gable ends of the resource also feature fixed, multi-light, wood-framed, stained-glass, roundel windows.
