North Carolina Department of Natural and Cultural Resources
State Historic Preservation Office

MEMORANDUM

SUBJECT: Historic Structures Survey Report for the proposed widening of SR 1005 (Startown Road) from U.S. 70 to N.C. 10, R-5113, Hickory, PA 17-05-0034, Catawba County
ER 17-3030

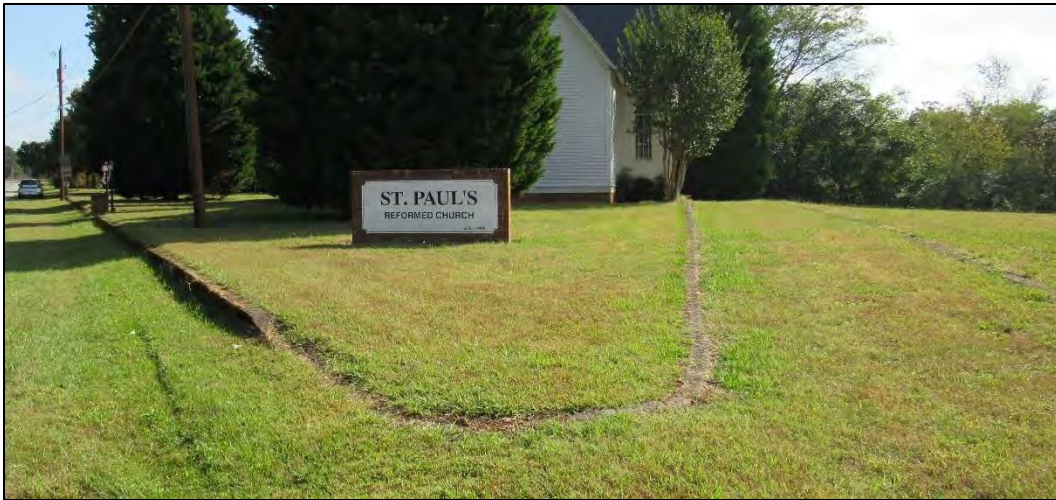
Photo 59: View of Sign and Low Concrete Border Wall, Looking East.

A circa-1980 sign is located west of the resource, facing Dove Street (Photo 59, p. 76). It is made of brick and features a metal plaque that reads “St. Paul's Reformed Church Built 1904.”

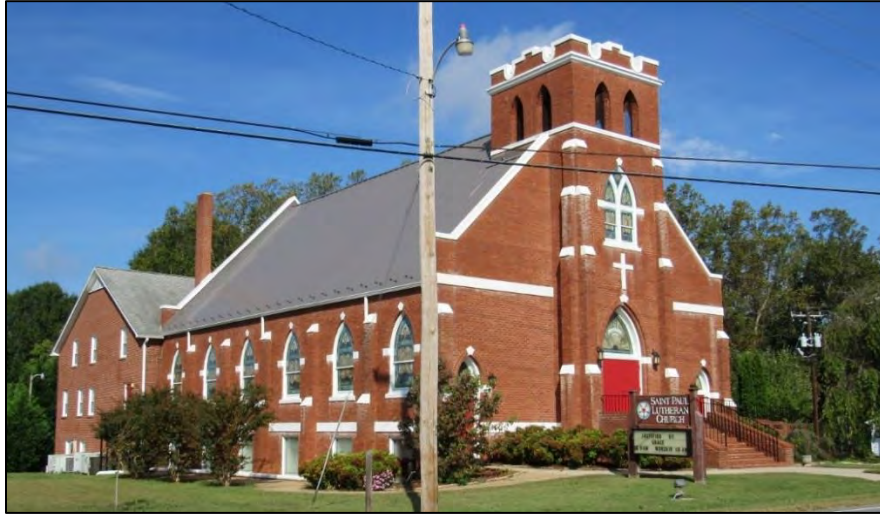
The primary resource is a one-and-a-half-story, three-bay church built in 1924 in the Gothic Revival style on a linear plan (Photo 60, p. 82). The raised basement and structural system are both clad in running-bond brick veneer with poured concrete decorative banding dividing each story. The raised basement features single-light, fixed, metal windows on the south elevation. Decorative buttresses line the building, flanking each window on the north and south elevations. The building is topped by a front-gabled roof sheathed in standing seam metal with a large brick bell tower piercing the east edge of the ridgeline and slightly projecting from the east elevation. The bell tower features faux buttresses, lancet openings, and decorative battlements. An exterior-end brick chimney is located on the rear (west) elevation of the church where it joins a large addition.

Photo 60: St. Paul Lutheran Church (CT1576), Southeast Elevation.

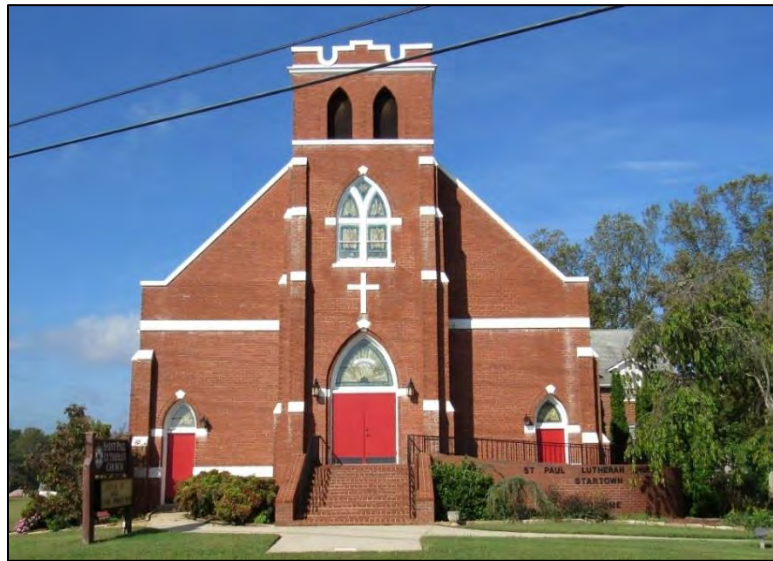
The primary elevation is centered on the east elevation, located within the projecting bell tower, and is filled with a double-leaf, flush wood door (Photo 61). The door is topped by a stained-glass fan light, and both are located within a lancet-shaped, brick surround. Above the door and fan light is a small wood cross that is topped by a multi-light, stained-glass, wood-framed, fixed, double-lancet window. The door is accessed by a set of brick stairs with metal railing that extends west from Startown Road as well as a brick and poured-concrete ramp that extends from the north elevation of the resource. Additional fenestration on the north and south elevations include one-over-one, double-hung sash, stained-glass, wood-framed, lancet windows with brick lancet arches topped by a concrete keystone and set on concrete sills.

Photo 61: St. Paul Lutheran Church (CT1576), East Elevation.

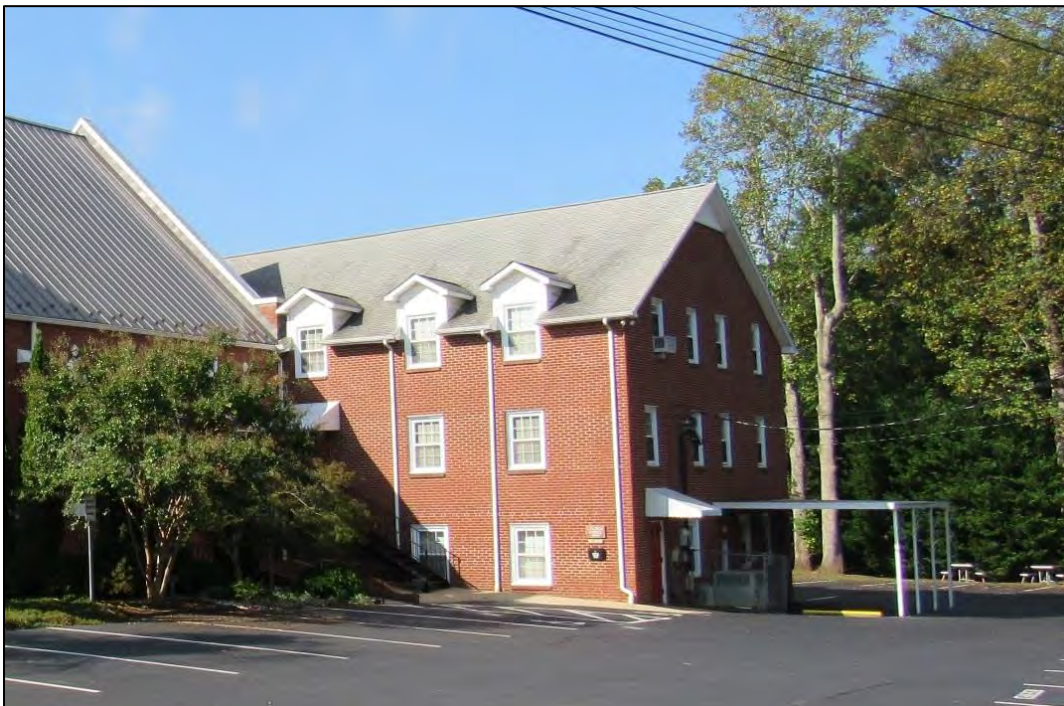
Photo 62: St. Paul Lutheran Church (CT1576), Addition Detail, Looking Southwest.

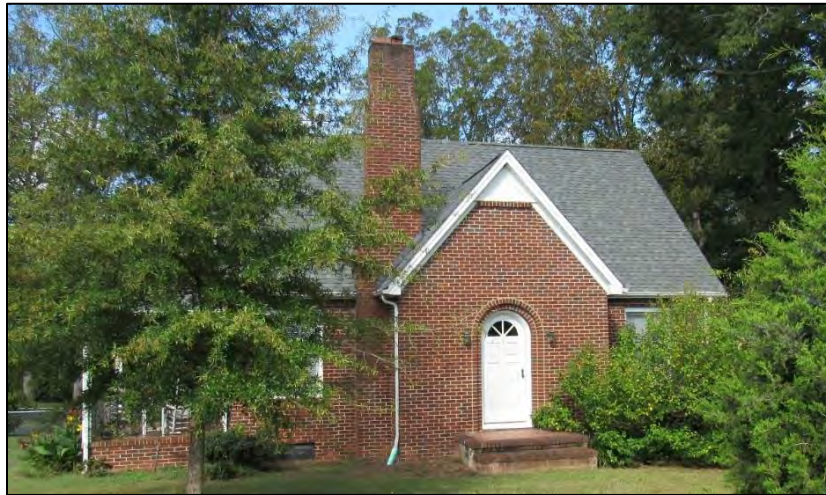
A one-story, three-bay, single-family dwelling constructed around 1947 in the Minimal Traditional style with Tudor Revival elements is located about 125 feet north of the church (Photo 63, p. 84). This resource had historically been used as a parsonage and is referred to as such on the site plan. The foundation and structural system, though not visible, are clad in a running-bond brick veneer and covered by a cross-gabled roof sheathed in asphalt shingles with a front-gabled projecting bay centered on the primary (east) elevation. An exterior-end brick chimney is also located on the primary elevation, adjacent to the projecting bay. Another exterior-end brick chimney is located on the west elevation.

The primary entrance is centered within the projecting bay and is filled with a rounded, paneled vinyl door with a four-light fan at the top, located within a rounded brick door surround. A brick-veneer stoop leads to the door. Other fenestration includes paired and single, one-over-one, double-hung sash, vinyl windows.

Photo 63: Parsonage, East Elevation.

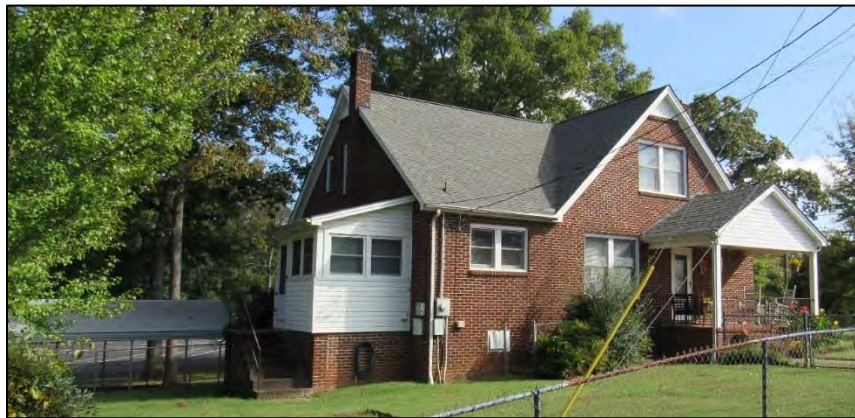
Photo 64: Addition Details on the Parsonage. Note the carport on the bottom left corner of the photograph.

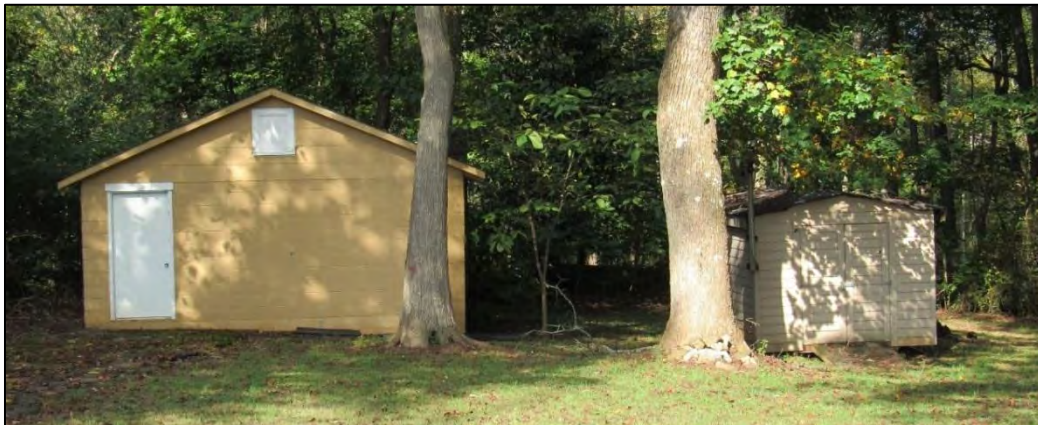
A circa-1970, one-and-a-half-story, one-bay storage shed is located about 200 feet northwest of the primary resource. The continuous concrete-block foundation and structural system is covered by a front-gabled roof sheathed in asphalt shingles with asbestos shingles in the gable end. The primary (east) elevation features a single-leaf flush wood door and a window opening covered in wood (Photo 65).

A circa-1990, one-story, one-bay, storage shed is located about 200 feet northwest of the primary resource and adjacent to the circa-1970 storage shed. The structural system is clad in vinyl siding and covered by a front-gabled roof sheathed in asphalt shingles. A double-leaf door clad in vinyl siding with a wood ramp leading to it is located on the primary (east) elevation (Photo 65).

Photo 65: Storage Sheds, Looking West.

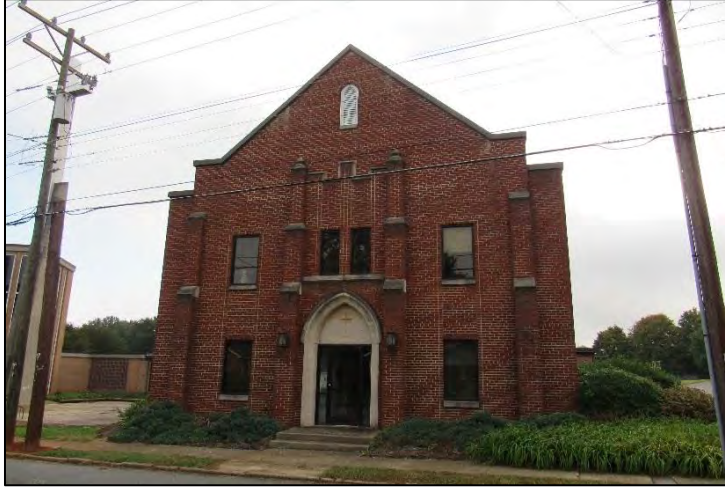
A windshield survey and review of NC-HPO property files suggests that several congregations constructed new brick churches between the 1920 and 1950 reflecting the Gothic Revival style in this area. The Bethany Lutheran Church (CT0495), located on Main Avenue Drive, NW in Hickory, was constructed in 1929; however, it was demolished in 1987 and a new church building replaced it. Currently, the oldest surviving building on the property is the 1949, Gothic Revival-inspired education building (Photo 67, p. 88). Although previously surveyed in 1979 and 2015, this resource has not received a formal eligibility evaluation by NC-HPO.

Photo 67: Education Building Associated with the Bethany Lutheran Church (CT0495)

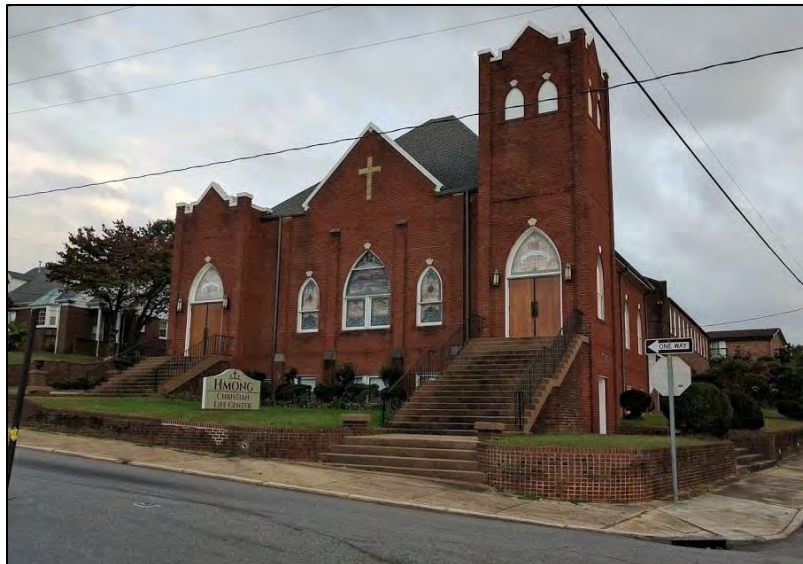
Another example is St. Paul's Lutheran Church (CT1366) at 629 2nd Avenue SW in Hickory, North Carolina. This brick, 1927 Gothic Revival Church features an asymmetrical façade, with a slightly projecting entrance on the eastern corner and a second entrance located on a square tower at the western corner (Photo 68). The original core appears to retain a high level integrity and retains many of its character defining features. A two-story, T-shaped secondary building, possibly used for classrooms or offices, is located immediately south of the church. Although it is an entirely separate building, it is attached to the church by a one-story, covered entrance. Situated on the same parcel just east of the church is a one-and-a-half story, brick dwelling, possibly once used as a parsonage. The NRHP eligibility of this resource has not yet been evaluated.

Photo 68: Northwest Oblique of the St. Paul's Lutheran Church (CT1366).

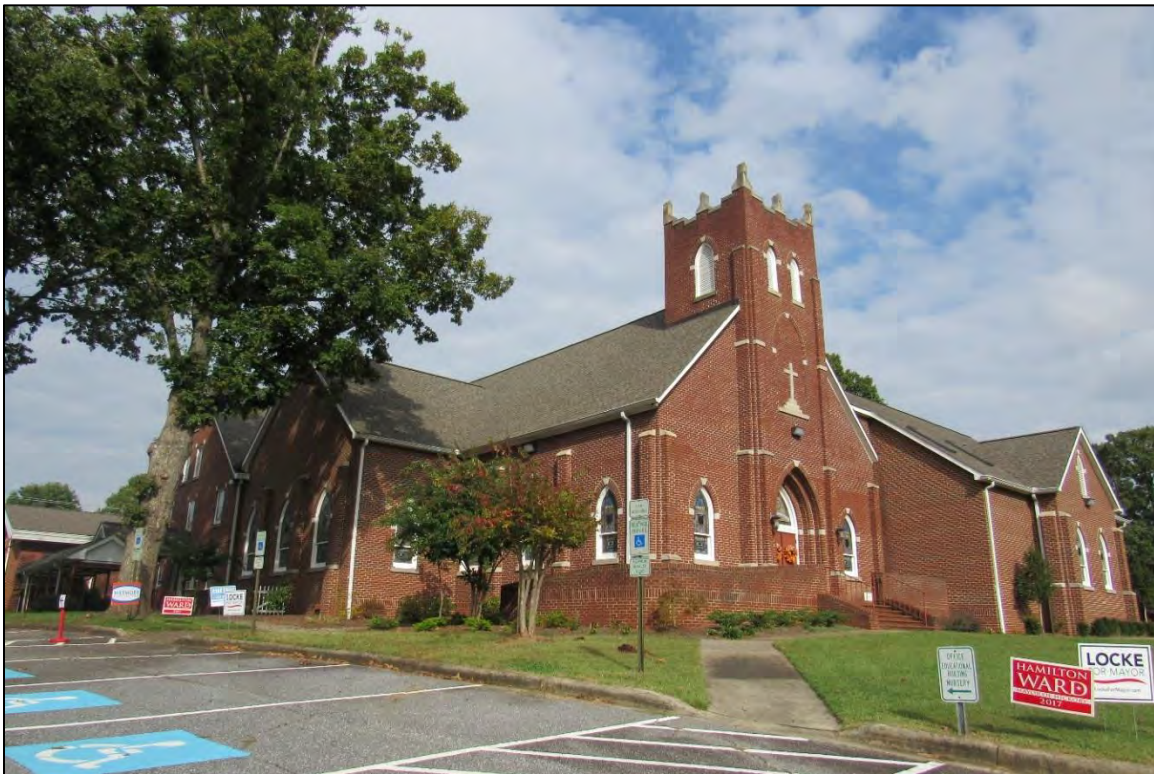
Another example is the New Jerusalem Lutheran Church (CT1573) at 2120 Startown Road. This one-and-a-half story, brick, Gothic Revival church was constructed in 1948. Like St. Paul Lutheran (CT1576) and St. Paul's Lutheran Church (CT1366), this building features a brick, castellated tower, lancet windows, arched doorways, and buttresses (Photo 69). In the late 1960s, the building was altered through the construction of a large education wing on the building's rear elevation. Also associated with this building is a two-story, brick dwelling once used as a parsonage (1949), cemetery (1908), recreational fields (1983), and Boy Scout hut (1983). In 2016, NC-HPO determined that this resource is not eligible for listing in the NRHP due to large additions to the church.

Photo 69: Southwest Oblique of the New Jerusalem Lutheran Church (CT1573).
