SUBJECT: Historic Structures Survey Report, , Intersection Improvements at US 64, US 276 and NC 20 near Brevard, R-5799, PA 17-05-0033, Transylvania County, ER 18-0081

Historic Structures Survey Report for the Intersection Improvements at US 64, US 276, and NC 20 near Brevard

Transylvania County, North Carolina

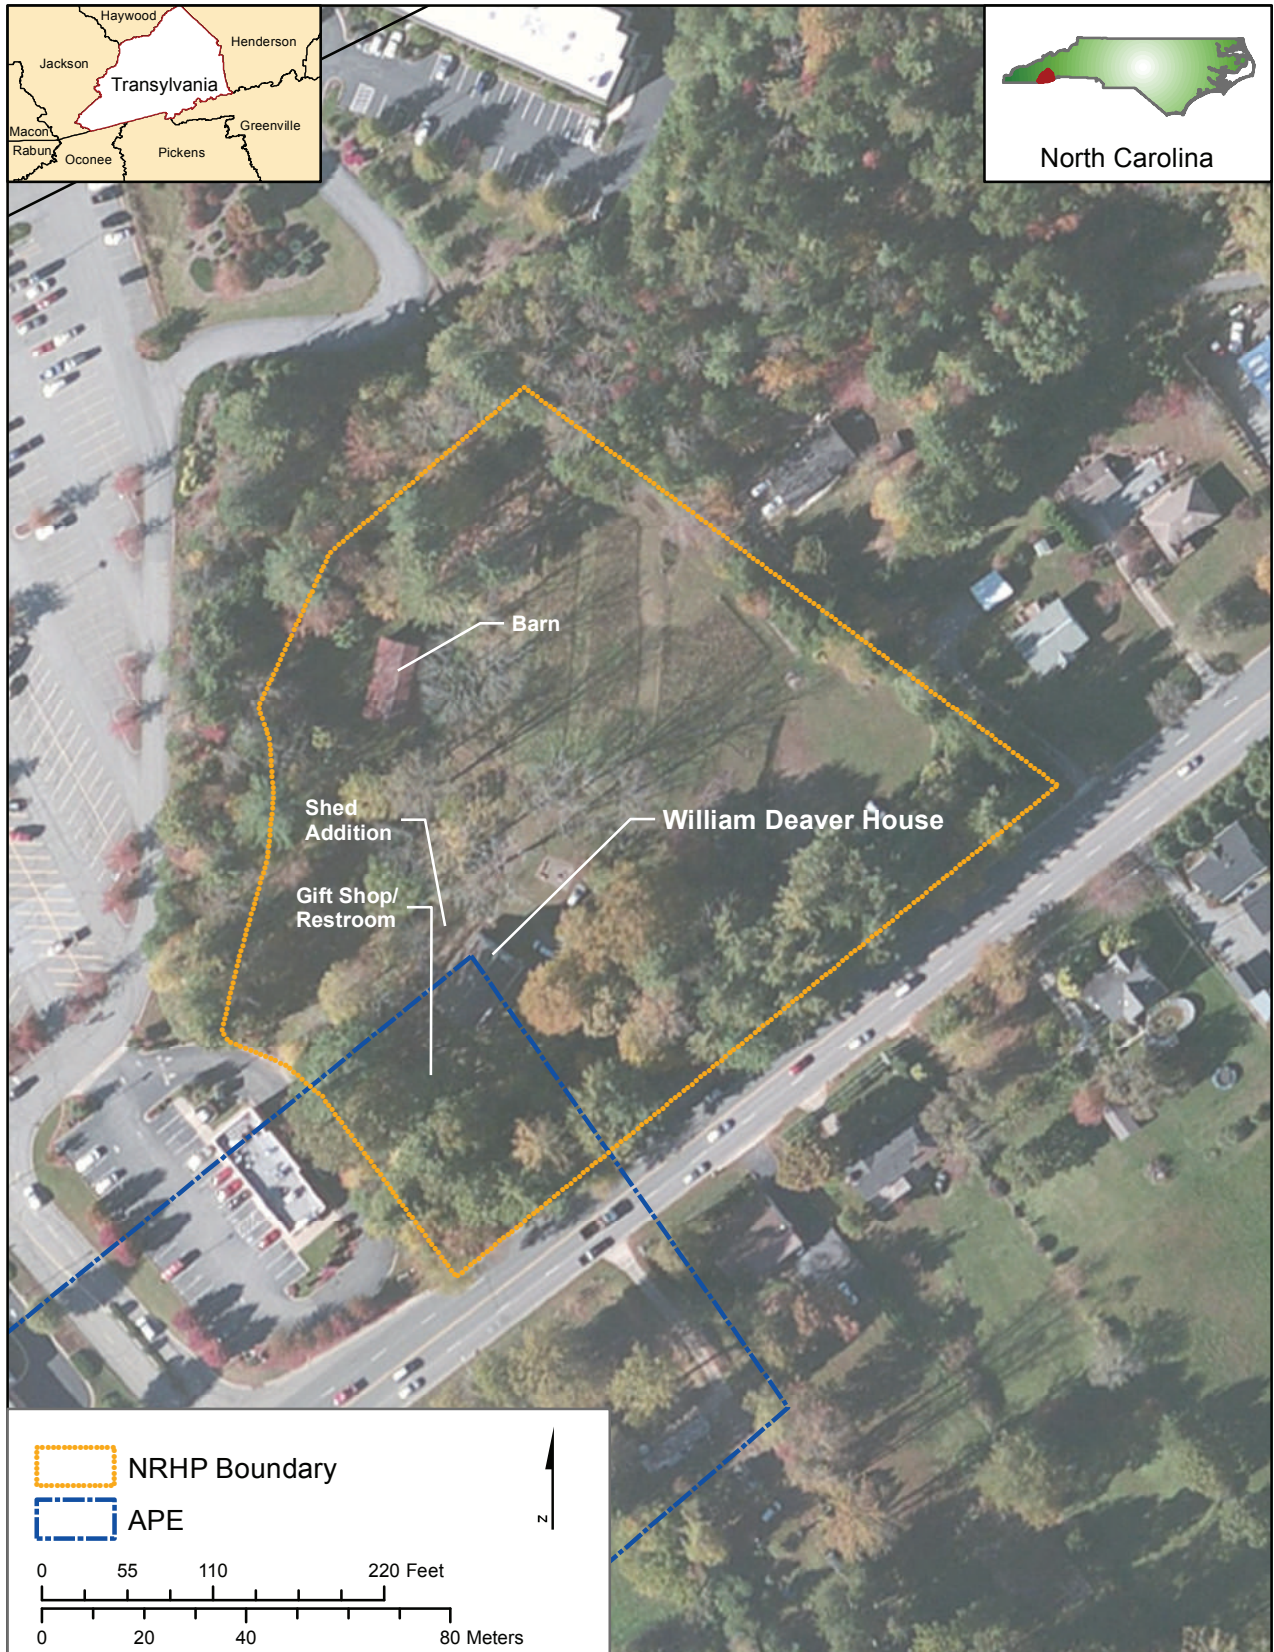
Figure 3.1. William Deaver House, Site Plan

The William Deaver House faces southeast on the northwest side of four-lane NC Highway 280, northeast of the intersection of NC Highway 280 and US Highway 64/276 in the unincorporated community of Pisgah Forest in Transylvania County (Figure 3.1). Mature trees partially shield the roadway from the resource, which sits atop a hill at the end of a gravel drive located northeast of the house. The house sits on a nearly four-acre lot, with its immediate surroundings consisting of a mowed grass lawn and its acreage dotted by additional mature trees. North of the house is a historic barn, and southwest of the house is a non-historic gift shop/restroom building.

The 2.3-acre NRHP boundary sits within the 3.79-acre tax parcel PIN 8597-56-4170-000. The hand-drawn boundary map included in the NRHP nomination appears to be narrower than the current parcel boundary (Figure 3.7, see Figure 3.1). Since the house was listed on the NRHP, the property has gained a gift shop/restroom building. Though only recently added around 2013, the non-historic building has a modest design and siting that is sympathetic to the listed property. The interior of the building was inaccessible during the field visit; however, nothing indicates that the interior has undergone significant changes. Finally, the loss of the garden, which likely does not date to the period of significance (1800-1899) for the listed property, does not diminish the overall historic integrity of the property due to the high level of preservation of the historic house.

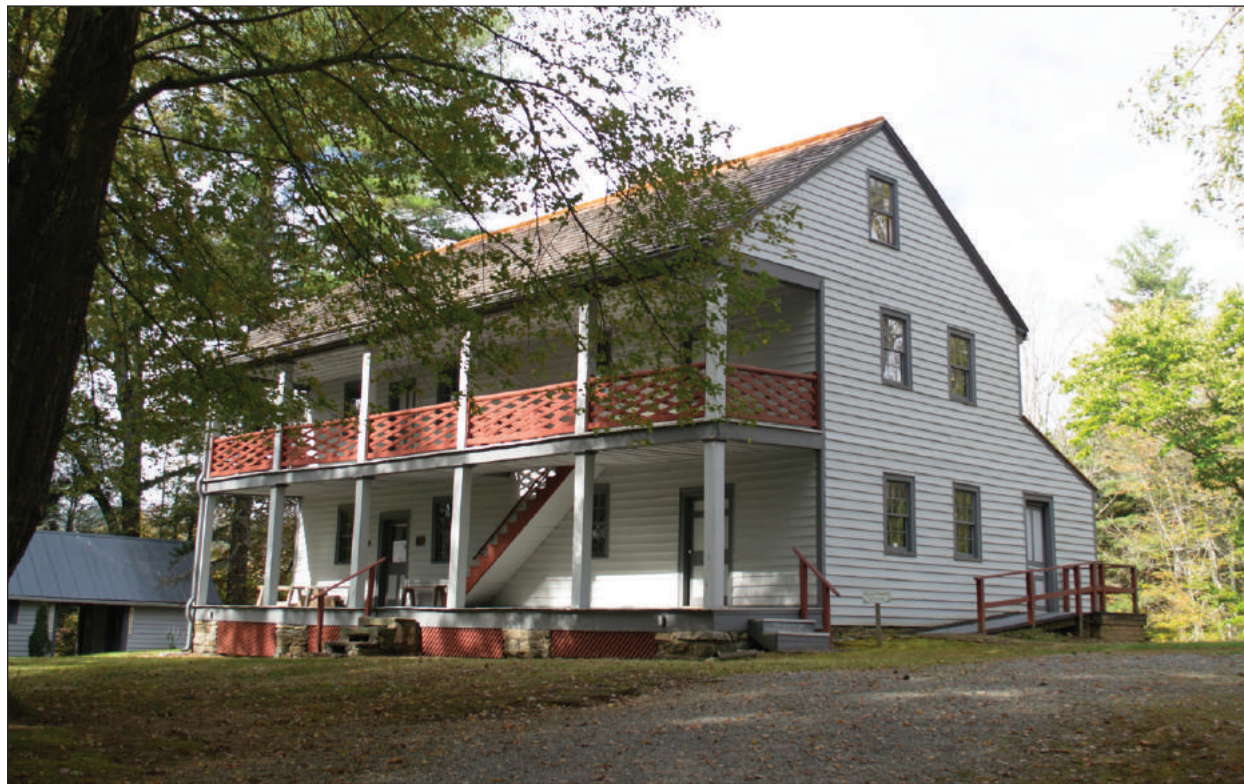
Figure 3.2. William Deaver House, Looking West

The circa-1815, two-story, side-gabled house was listed on the NRHP in 1979 and is a local landmark. It has a wood frame construction clad in weatherboard (Figure 3.2). The wood shingle-covered gabled roof includes a slightly offset brick chimney rising from the rear roof surface. The house sits atop a fieldstone pier foundation.

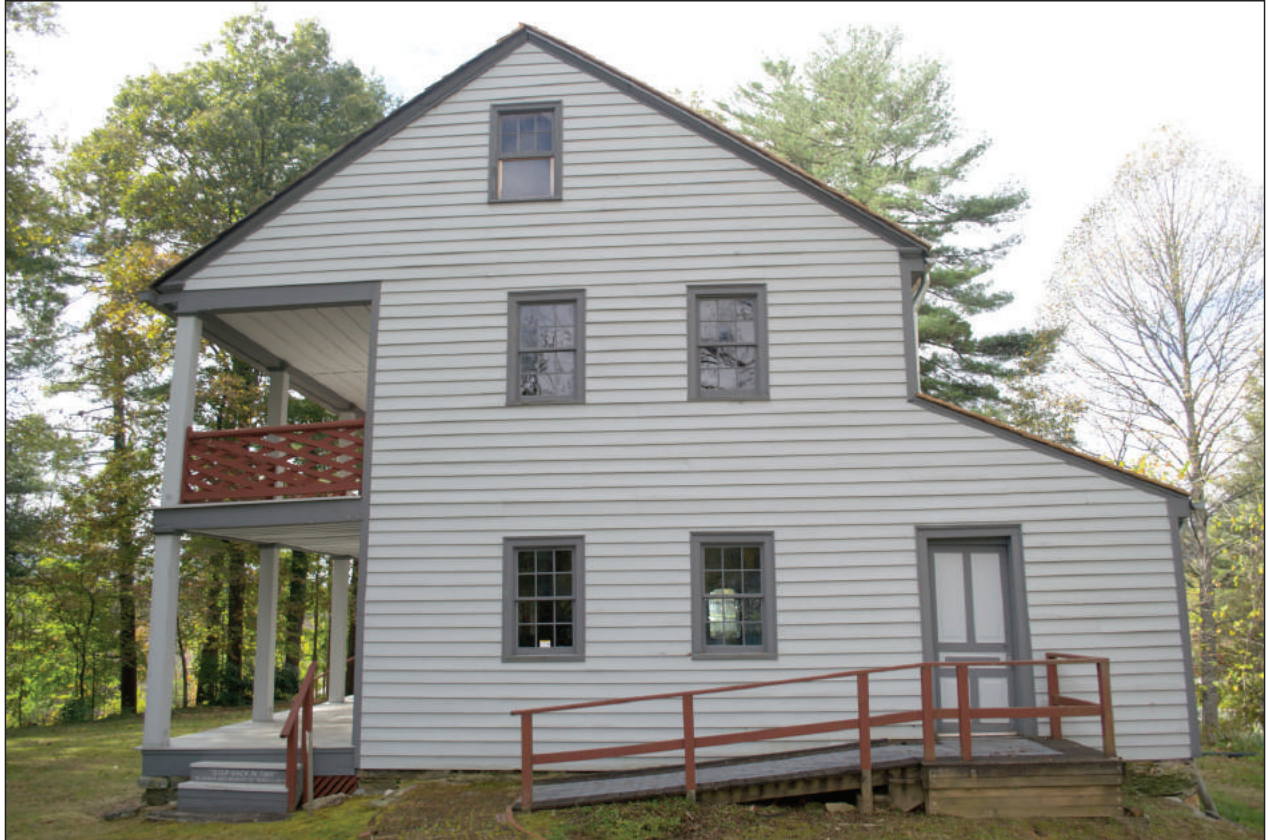
Figure 3.3. Northeast Elevation, Looking Southwest

Along the building's rear is a one-story shed addition that spans the full elevation and includes an engaged porch with a wood-paneled door and a non-historic metal railing (Figure 3.4). A non-historic, wood ADA ramp has been installed along the first story of the northeast elevation and leads to another wood-paneled door in the shed addition (see Figure 3.3).

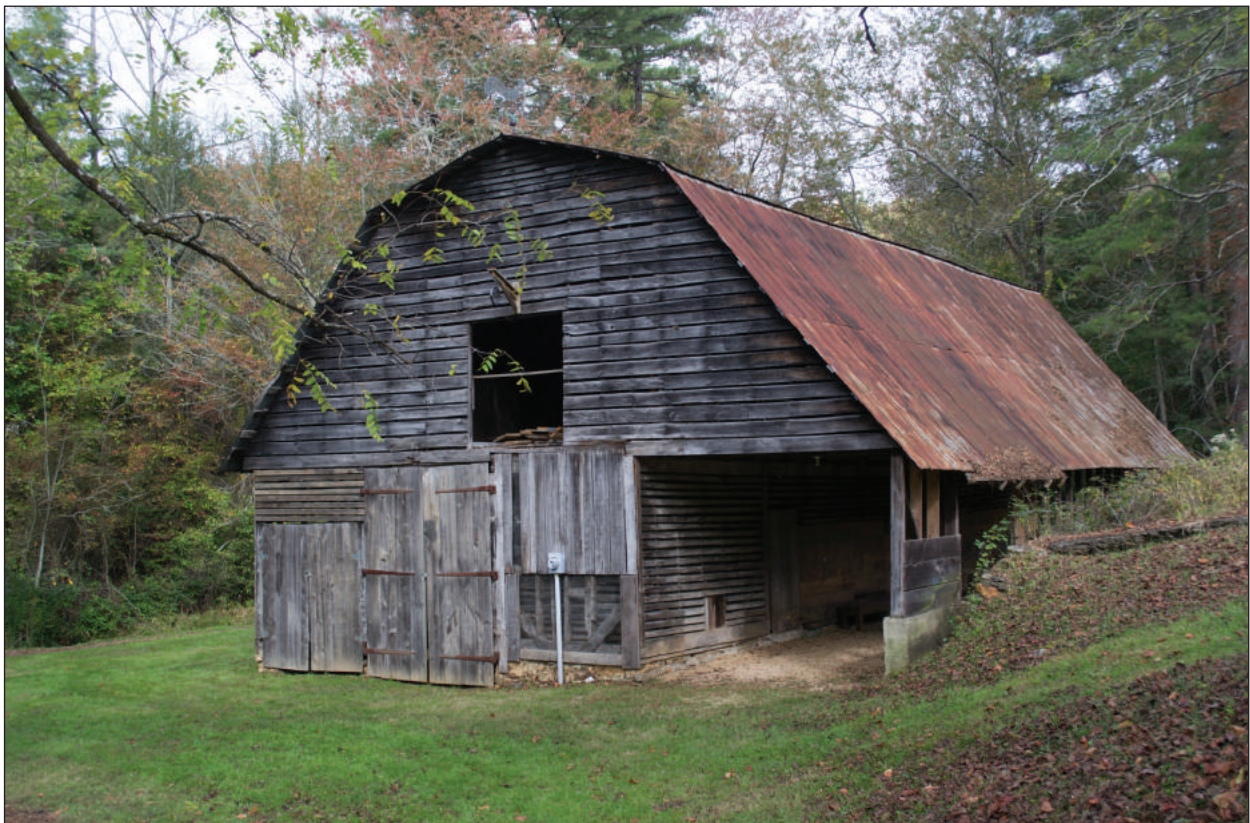
Figure 3.5. Barn, Looking North

A circa-1900 gambrel-roof wood barn sits north of the house (Figure 3.5). Wood shiplap siding covers the side-drive crib barn. A vertical wood board double door and a second-level hayloft are accessible in the gable end. The gambrel roof is clad in standing-seam metal.

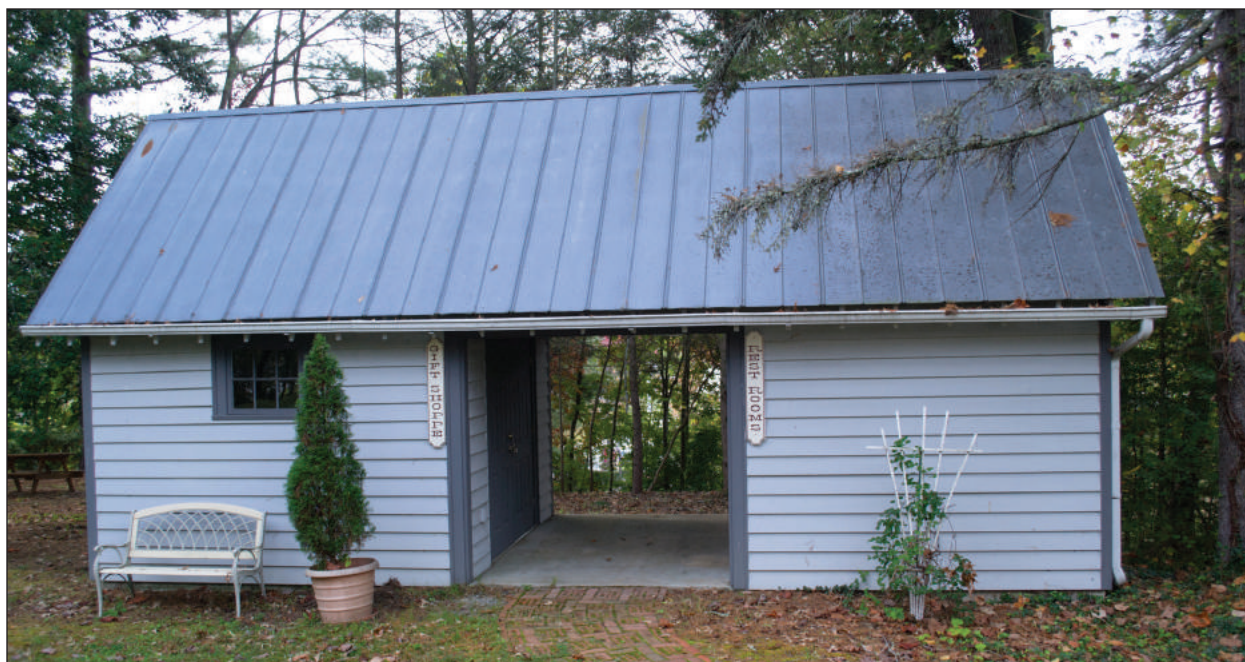
Figure 3.6. Gift Shop/Restroom, Looking Southwest

Southwest of the house is a small, circa-2013 gift shop/restroom building (Figure 3.6). Constructed in a dogtrot form, the building features a central open, paved breezeway dividing the gift shop from the restrooms. Synthetic siding mimicking wood weatherboard covers the building, and windows are six-paned wood sash. Standing-seam metal covers the side-gabled roof, and eaves are lined by exposed rafter tails.

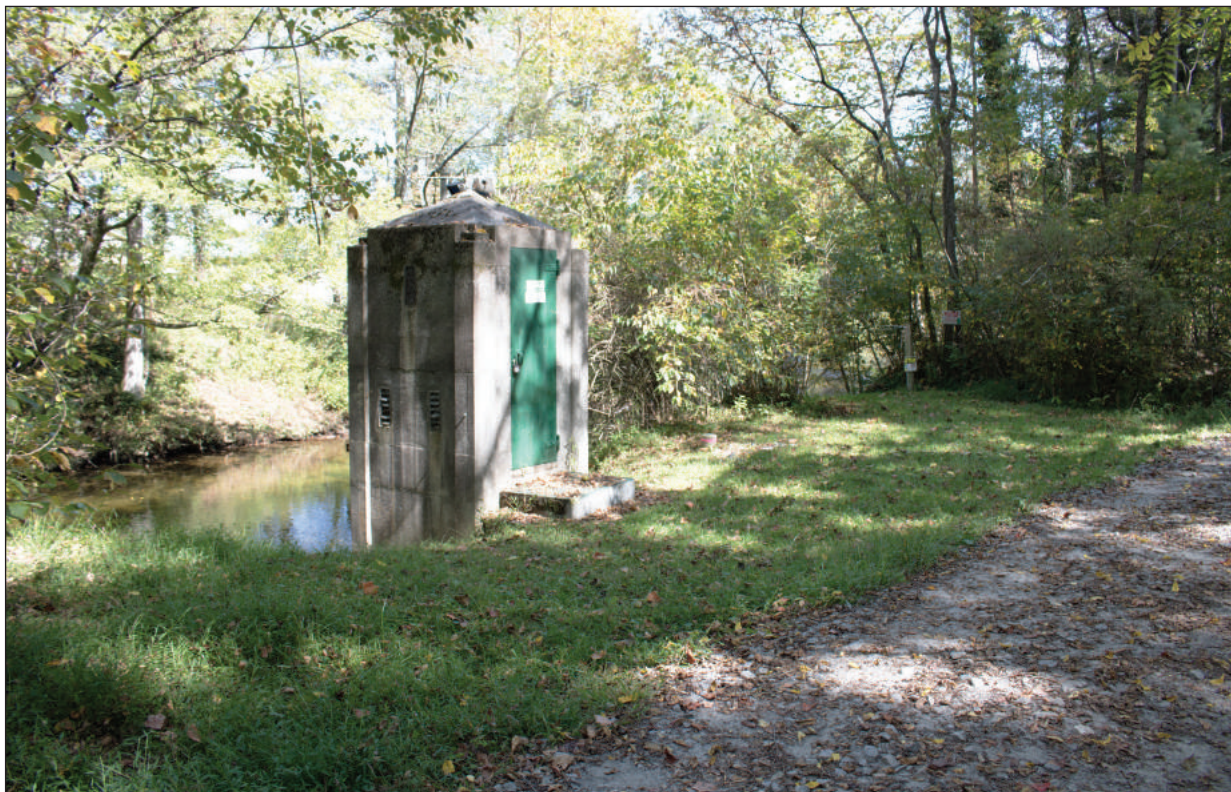
Figure 4.2. Davidson River Gaging Station, Looking East

The Davidson River Gaging Station consists of a small, poured concrete gage house standing roughly eight to 10 feet in height above a sloping grade, a low concrete retaining wall, a concrete piling, and a circular concrete cylinder (Figures 4.2).

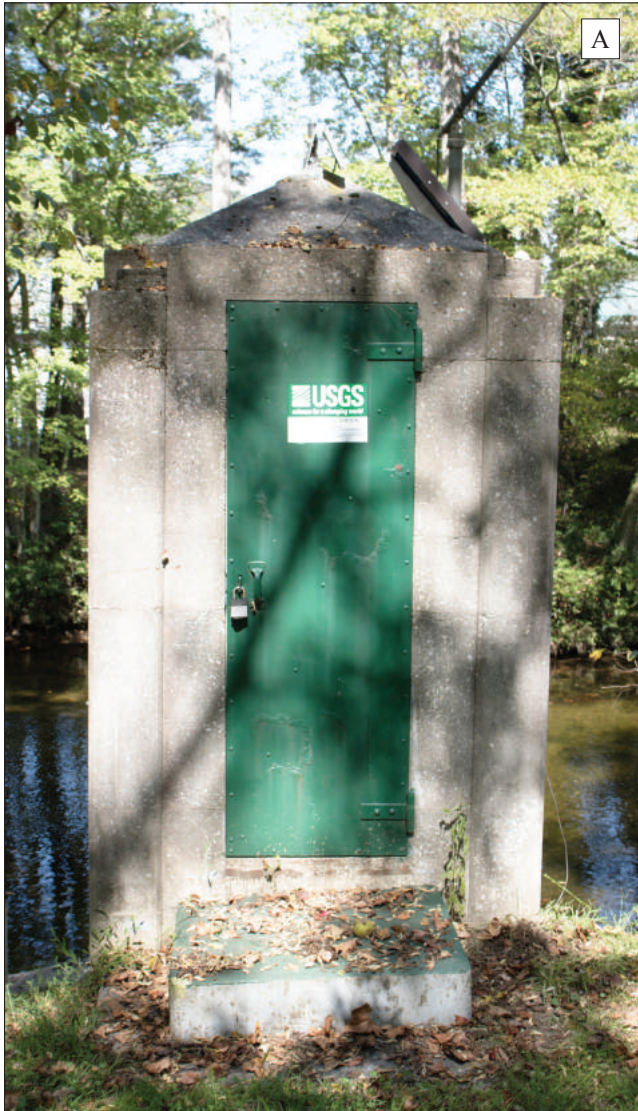
Figure 4.3. Gage House

With its square footprint, the gage house measures approximately three feet wide on each elevation (Figure 4.3a). The structure has elements of the Art Deco style, including a shallow pyramidal roof, stepped corners, and a tall, narrow, tower-like design that emphasizes verticality. On its southwest elevation, the resource has a painted metal door accessed by a low, square, concrete step. Each side elevation holds three current or former rectangular, metal-louvered vents (Figure 4.3b). The uppermost east elevation has been converted as an access point for wires leading from rooftop-installed solar panels to interior equipment. The northeast elevation includes a low, locked, small metal panel door and a metal panel near the roofline with a drilled hole for additional solar panel wires (Figure 4.3c). A metal pipe pole is installed on the north elevation near the northeast corner of the building and holds a small metal antenna.

- A. Southwest Elevation
- B. South Oblique
- C. East Oblique

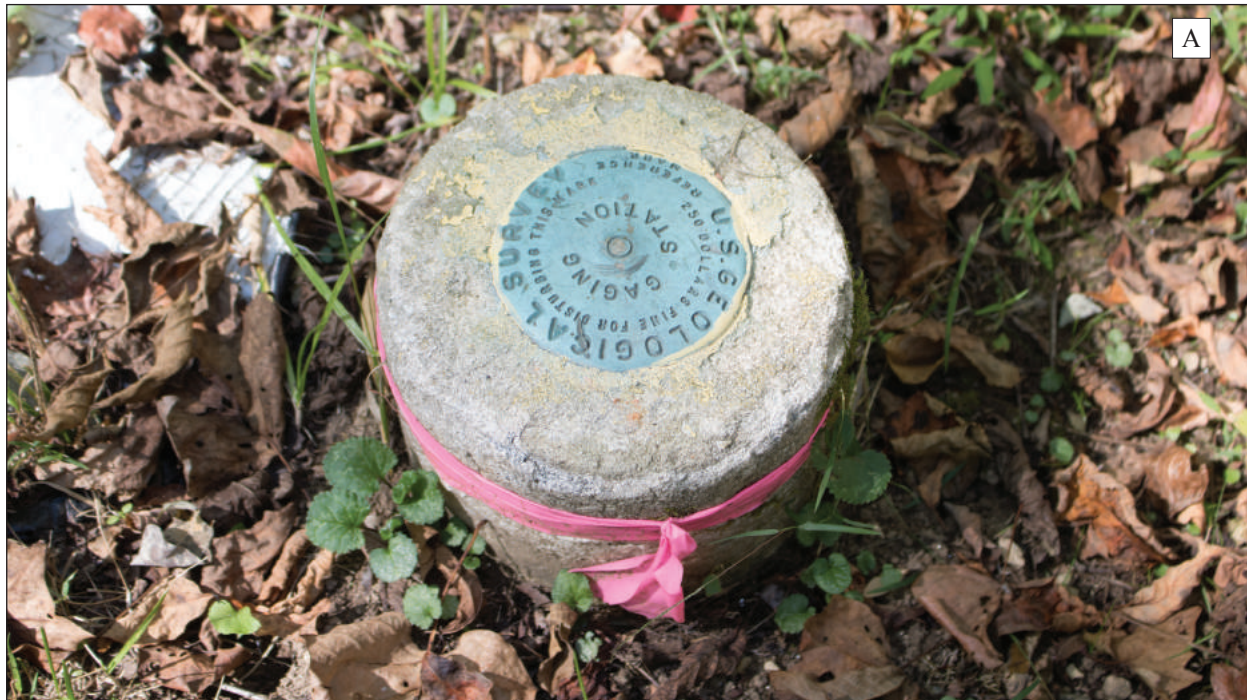
Figure 4.4. Gaging Station

A few feet east of the gage house is a small, circular concrete cylinder holding a US Geological Survey Reference Mark (Figure 4.4a). Inscriptions on the marker indicate the use of the resource as a gaging station and note a fine amount for disturbing the mark. A low concrete retaining wall and a small, concrete, overturned piling are located alongside the riverbank just northeast of the gage house (Figure 4.4b). Atop the overturned piling is another reference mark that is identical to the one atop the concrete cylinder (Figure 4.4c). The door to the gaging station was padlocked and inaccessible during the site visit.

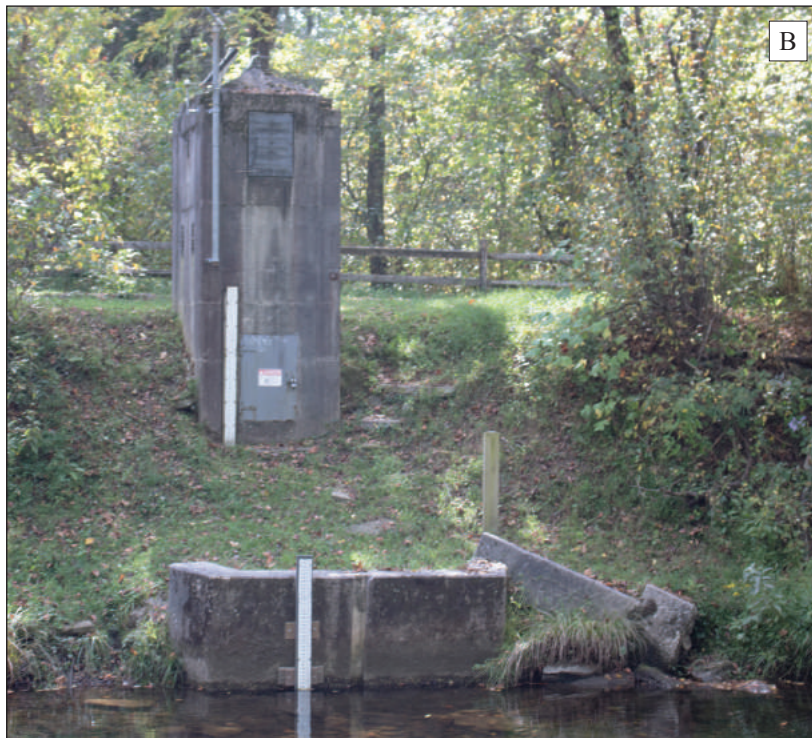
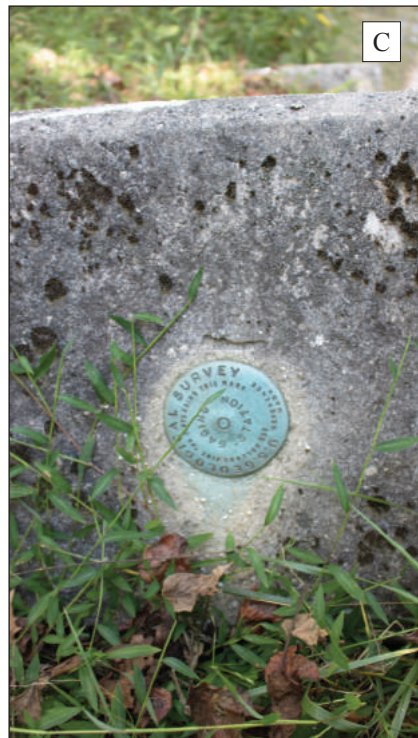
- A. Concrete Cylinder, Looking West
- B. Concrete Retaining Wall and Overturned Concrete Piling, Looking Southwest
- C. Detail, Overturned Concrete Piling

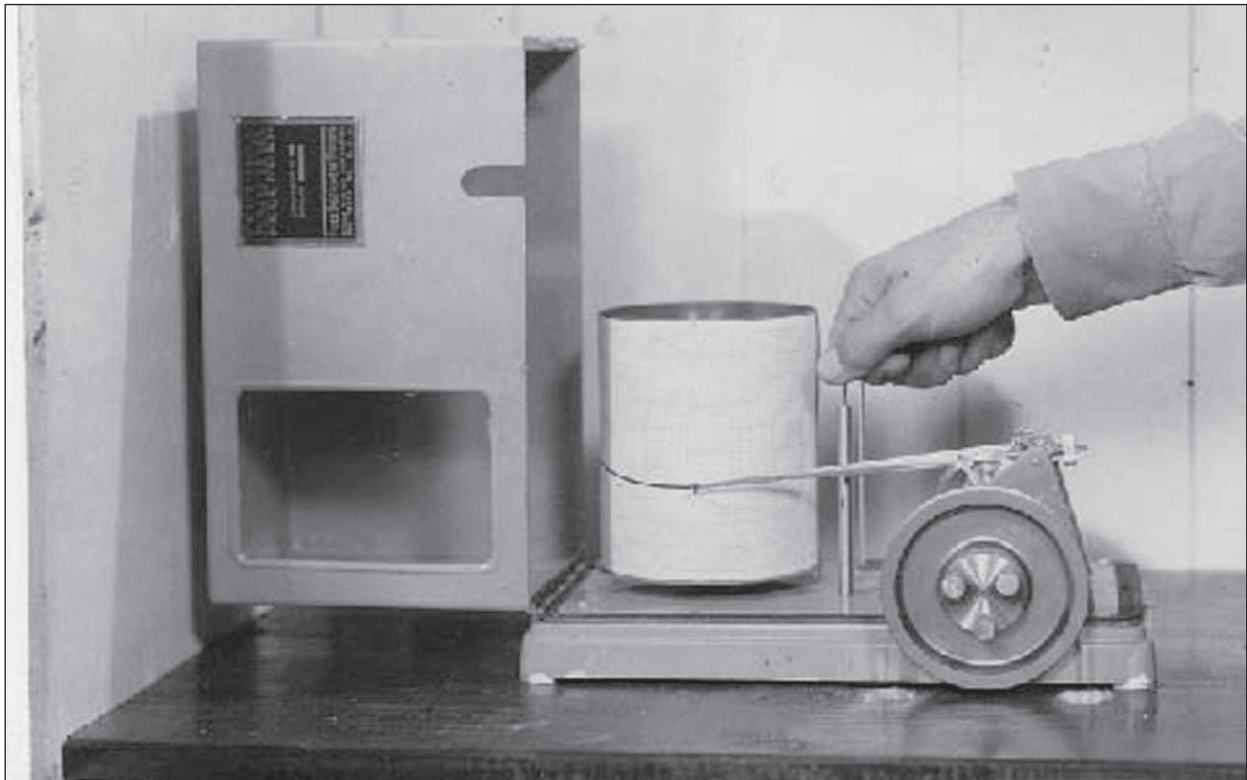
Figure 4.5. Example of a Gage House Recording Instrument

Gaging stations are located on banks and consist of a well connected to the stream by intake pipes. The stations were positioned upstream from a shoal or other constricted point to provide a relatively stable surface. A water stage recorder was then placed in the gage house over the well. The instrument was in contact with the well by a float that moved up and down with fluctuations in water level. Continuous measurements were then recorded by pencil on graph paper (Figure 4.5).

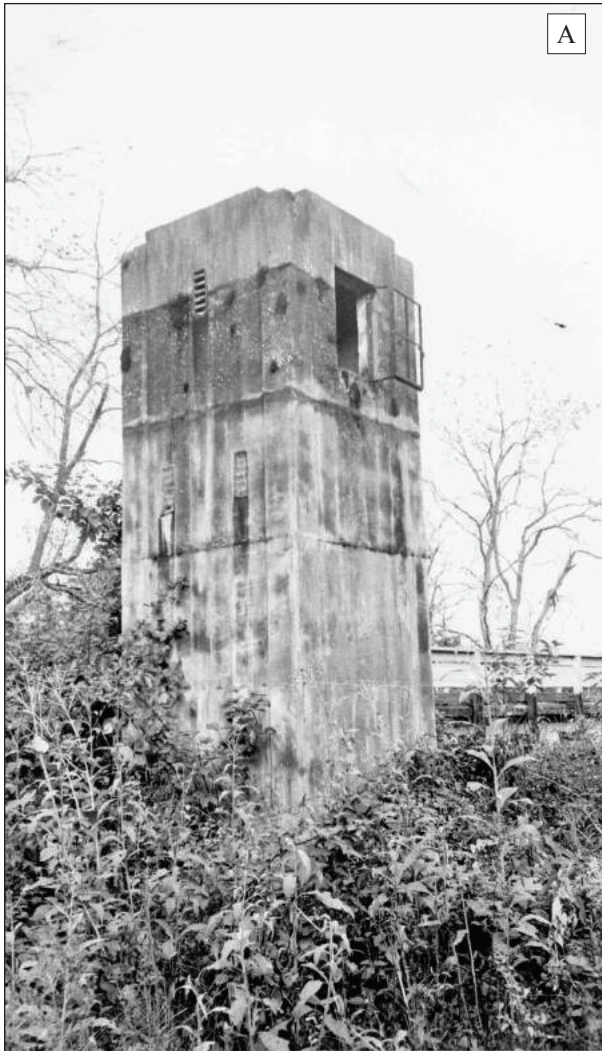
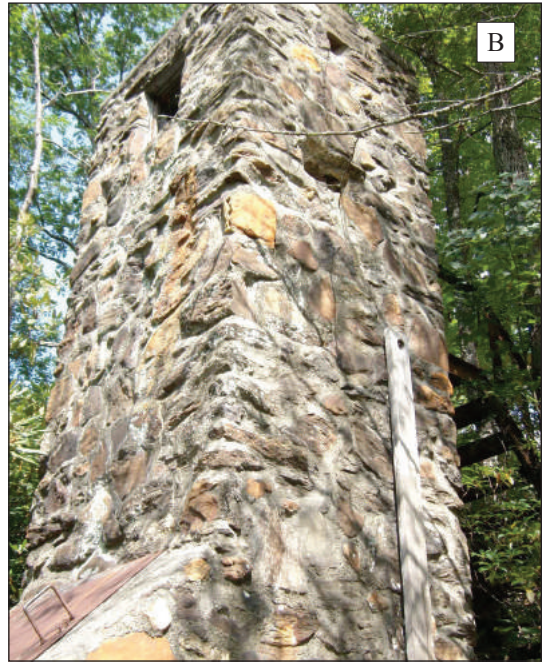
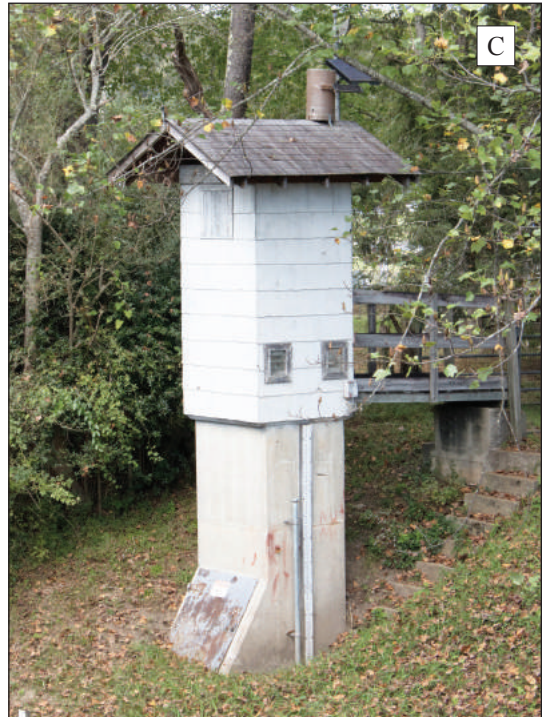
The South Mills River Gaging Station (Determination of Eligibility [DOE] 2011) has a slightly larger gage house that measures approximately 9 feet tall and 4½ feet wide (Figure 4.6b). Originally constructed in 1924, the gage house was reconstructed by the CCC in 1935 using native rocks from local stream gravels. This gage house has the Rustic Style of most CCC-built structures and includes a splayed triangular base with a metal trap door and a wood staircase leading to its door. This gaging station has been study listed.

The gage house at the Rosman Gaging Station (Study Listed [SL] 1992) has a tall, rectangular form common to all of the gage houses (Figure 4.6c). Though built just a year after the Davidson River and Calvert stations, the gage house has a frame construction below an asphalt-covered gabled roof with wide overhanging eaves and exposed wood rafter tails. The exterior walls are covered in asbestos shingle siding and a short, wood walkway accesses the gage house. Like the South Mills River Gaging Station, this gage house foundation also has a splayed triangular base with a metal trap door. This gaging station has been study listed.

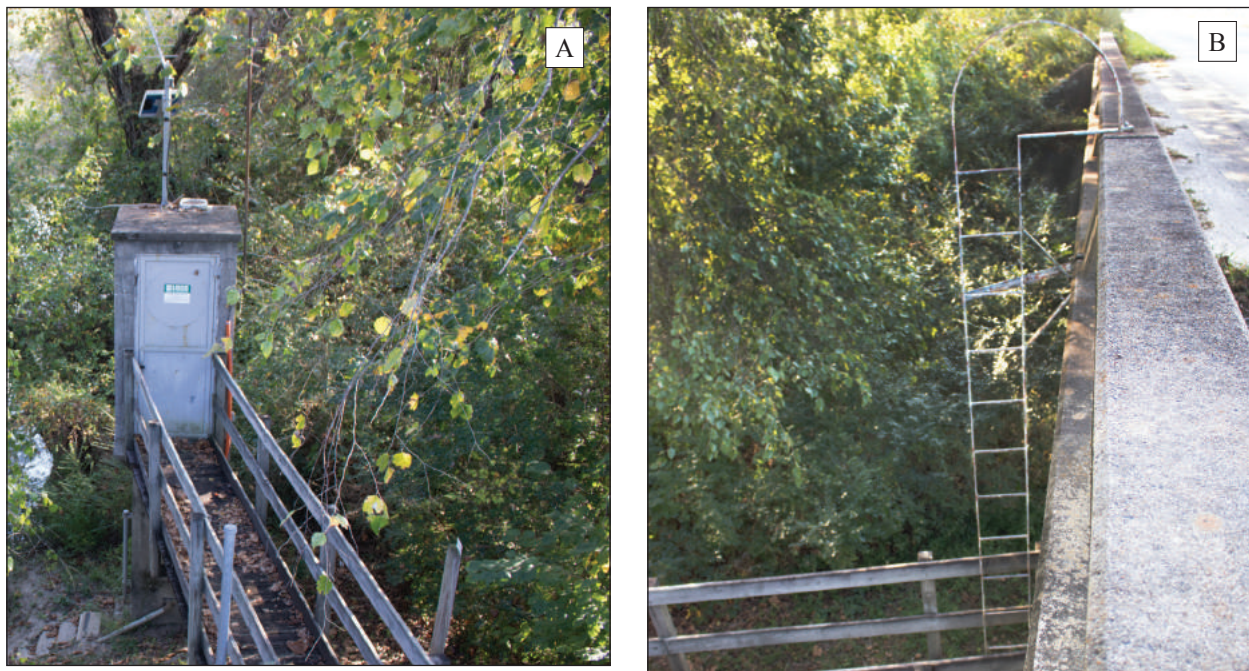
Figure 4.7. Blantyre Gaging Station

Blantyre Gaging Station, (surveyed only [SO]), constructed in the mid-1950s, includes a gage house that is similar in size to that at Davidson River Gaging Station (Figure 4.7a). This station is constructed of concrete block and, while it shares an overall similar appearance to the other stations, a metal ladder leading from a highway bridge to a wood-and-metal suspension bridge accesses the station gage house (Figure 4.7b). This gaging station has not been study listed.

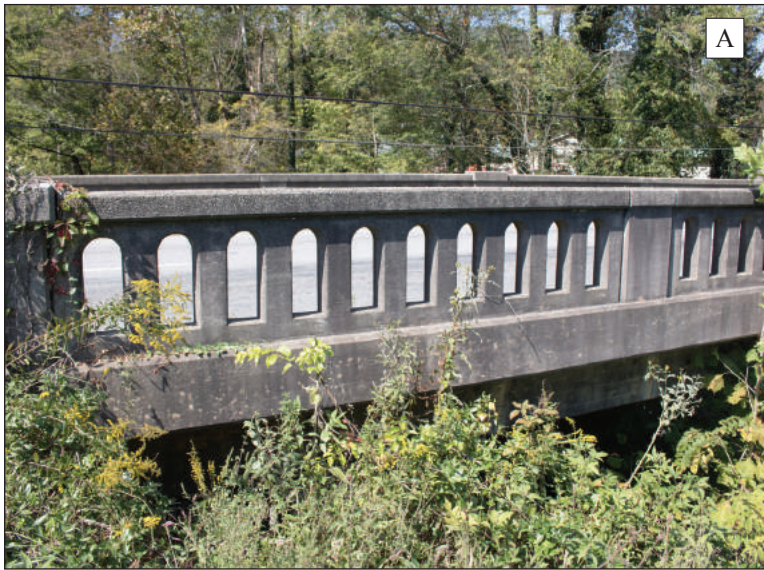
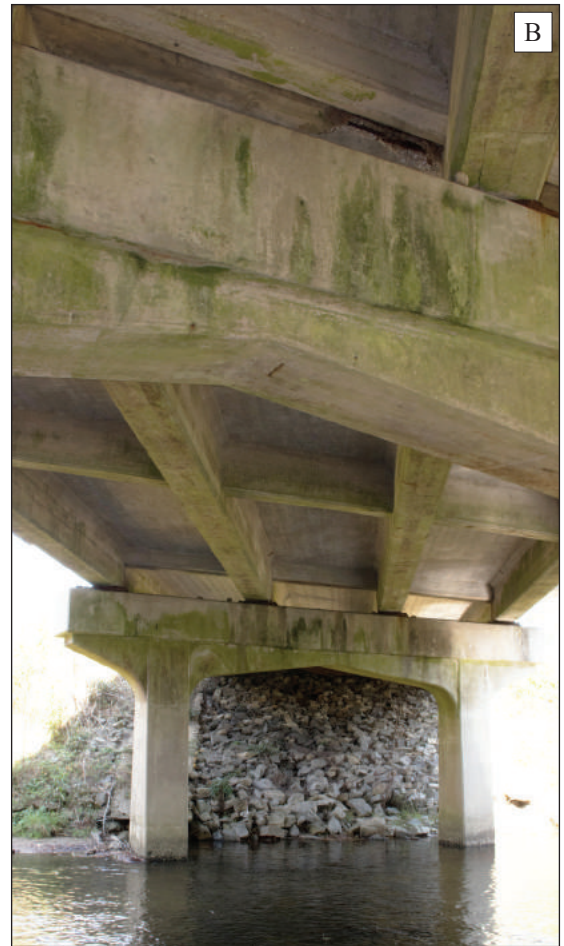
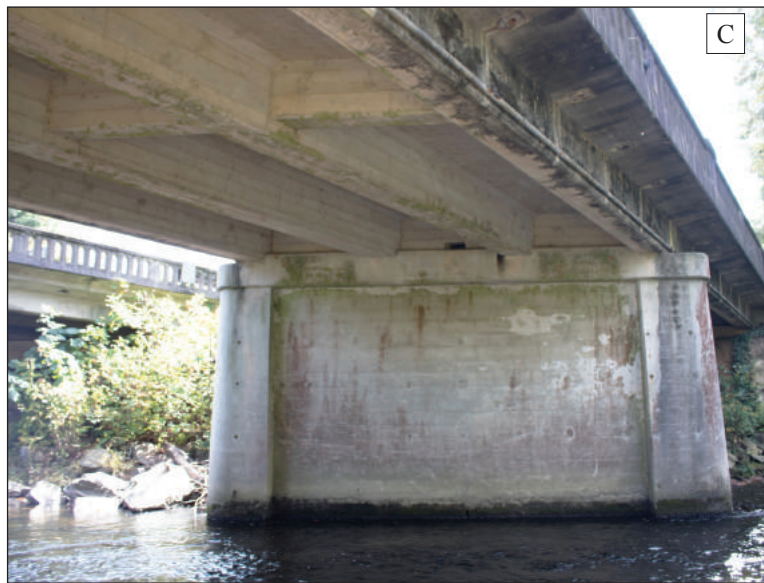
Figure 5.4. Guard Wall and Piers

Both bridges have a similar design with arcaded concrete guard walls flanking the roadway (Figure 5.4a). There are subtle differences, such as the depth of the curbing and the height of the columns at the expansion joints. Additionally, the 1934 bridge is supported by solid wall piers, while the 1956 bridge has a columned pier with a cap (Figures 5.4b and 5.4c).

- A. 1934 Section, Looking West
- B. 1956 Section, Looking North
- C. 1934 Section, Looking Northeast

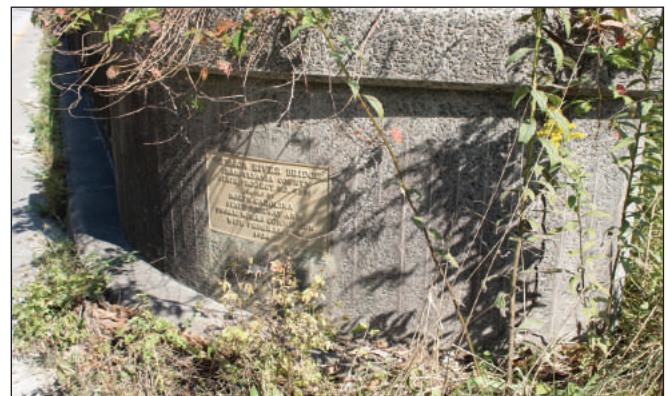
Figure 5.5. 1934 Bridge Plaque

Davidson River Bridge
Transylvania County
State Project No. 9891
Built by
North Carolina
State Highway and
Public Works Commission
With Federal Aid
1934

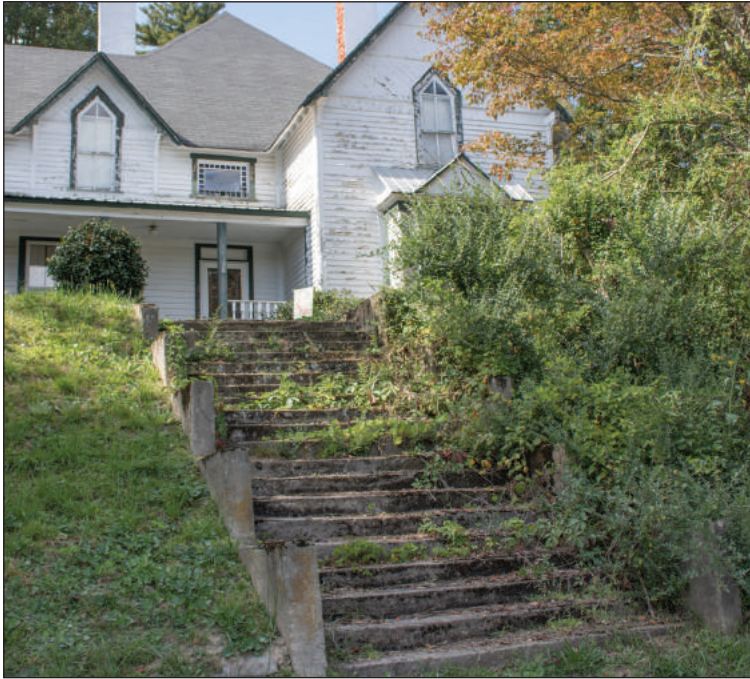
The house is the only historic building on the 2.04-acre property. The house sits in the center of the driveway loop. The north side is grassy with a large oak tree in middle, while to the south of the house, the lawn has been covered with gravel. The house can also be accessed by a set of concrete stairs that climb the hill directly in front of the house (Figure 6.2). Mature trees and vegetation on the hill partially shield the house from the intersection. The large oak tree in the side yard to the north of the house sits atop a high knoll (Figure 6.3). It was noted on the 1992 survey form that the rest of the yard was excavated in 1938 when the road into Pisgah National Forest (US 276) was being graded. The portion of the property outside of the driveway loop is forested.

Figure 6.2. Robert E. Patton House, Concrete Stairs, Looking Northwest

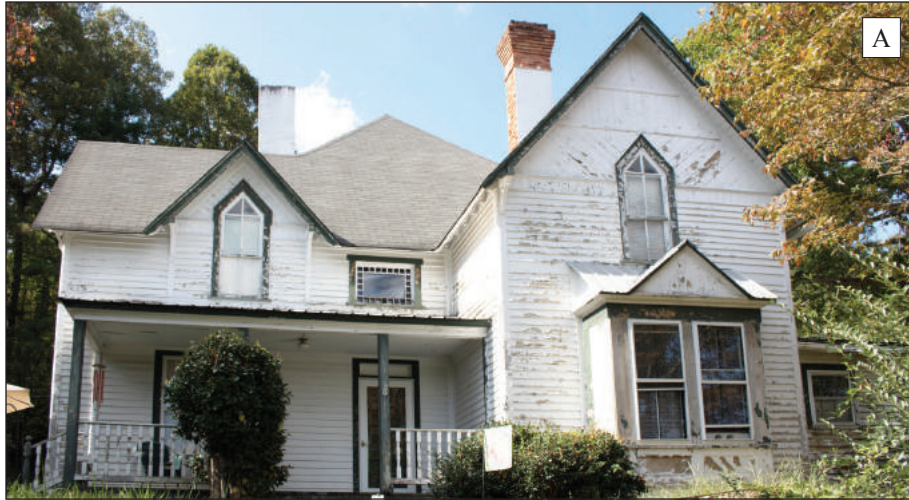
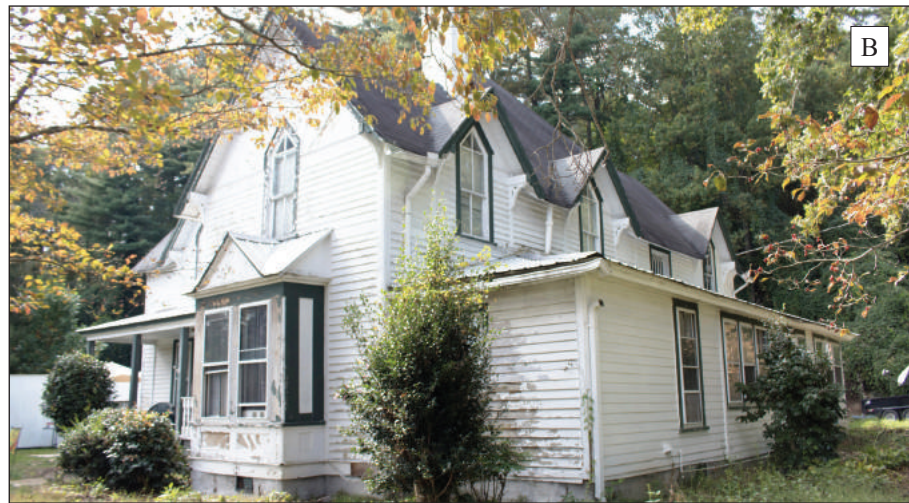
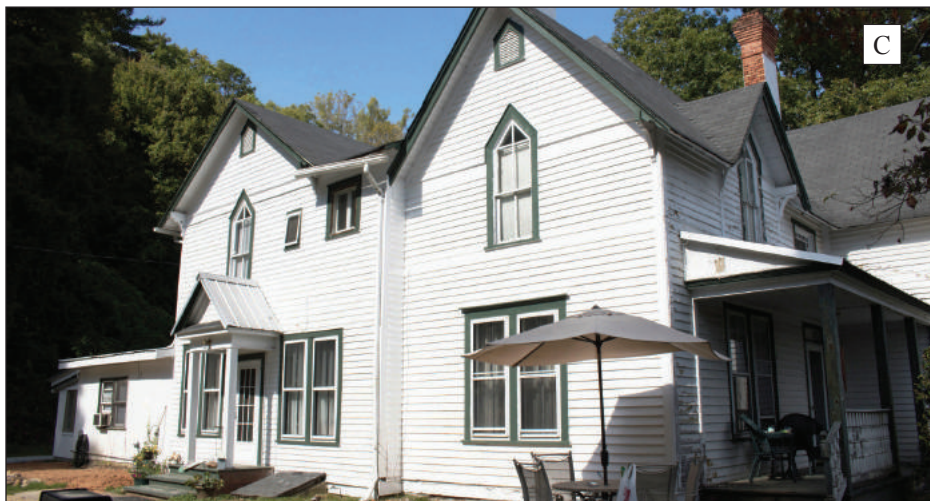
Figure 6.4. Robert E. Patton Exterior Details

The Robert E. Patton house is a large two-story Victorian house that was influenced by the Gothic Revival architectural style. The house features a high, hipped roof with four steeply pitched lower cross gables. Two tall brick chimneys pierce the roof, one of which retains its corbeled top (Figure 6.4a). The foundation is fieldstone piers with brick infill that was stuccoed sometime after the property was surveyed in 1991. The exterior walls are weatherboard and have gabled wall dormers (Figure 6.4b). Each of the gabled wall dormers contains a double-hung sash window with a pointed arch surround on the second story. The house's windows are all historic, but storm windows have been installed over those on the ground floor. Two decorative band boards run horizontally around the southeast and northeast walls of the house, one at the bottom of the upper story windows and another where the wall meets the eaves of the roof, which overhang the wall slightly and display decorative brackets (Figure 6.4c).

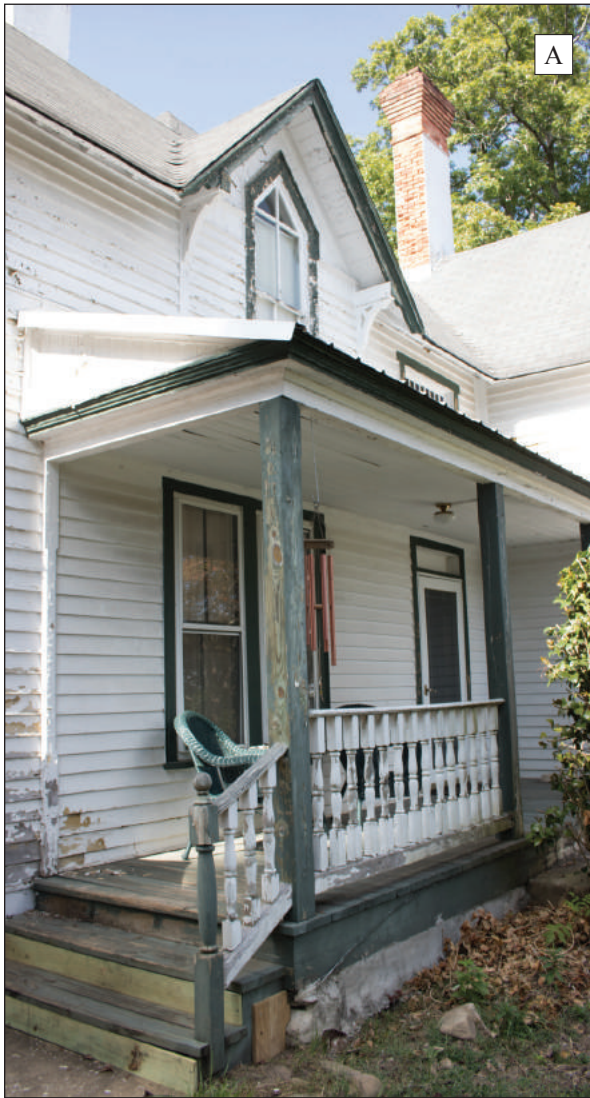
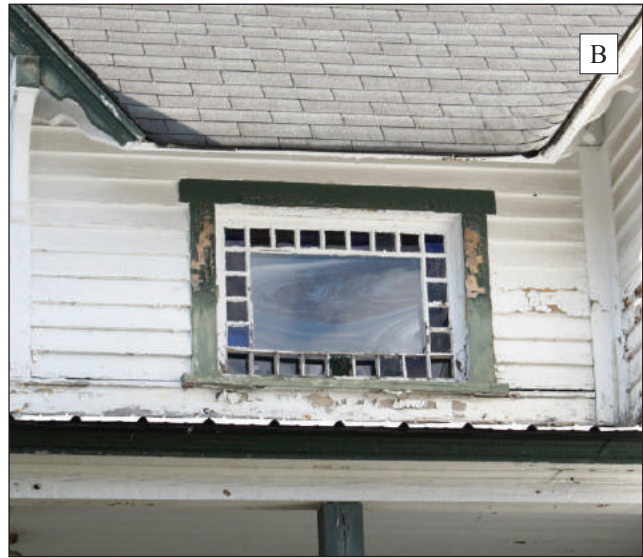
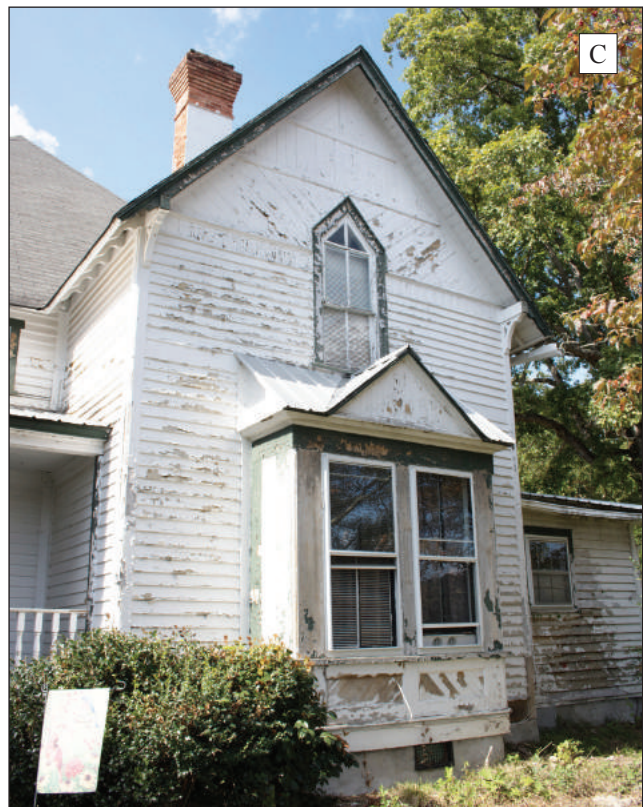
Figure 6.5. Robert E. Patton House Details

The southeast-facing façade has a narrow, one-story, shed-roof porch on the side ell section that shelters the East-Lake style front door and a pair of two-over-two windows (Figure 6.5a). The porch has been rebuilt with new supports, floor, an additional set of stairs at the end, and a turned balustrade. Directly above the front door on the second story is a rectangular stained glass window (Figure 6.5b). The front facing ell has a projecting bay, with a shed roof and gable detail, that houses another pair of two-over-two windows. The decorative diagonal stick work in the gable end is one of the house's most distinctive features (Figure 6.5c).

- A. Porch, Looking Northeast
- B. Stained Glass Window
- C. Decorative Diagonal Stick Work

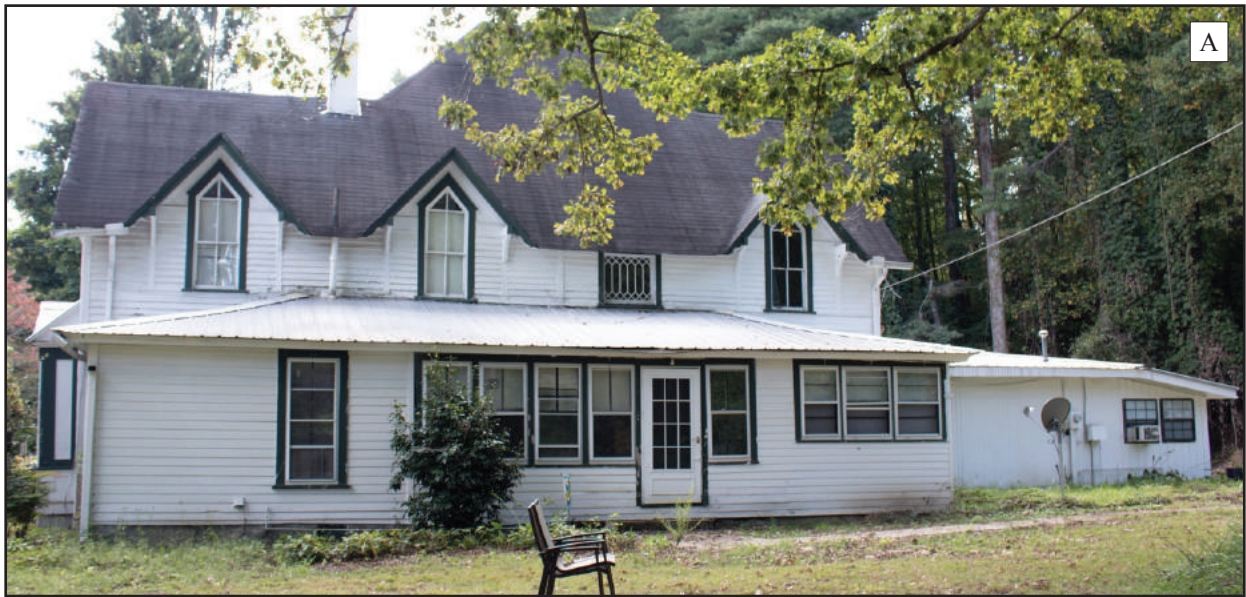
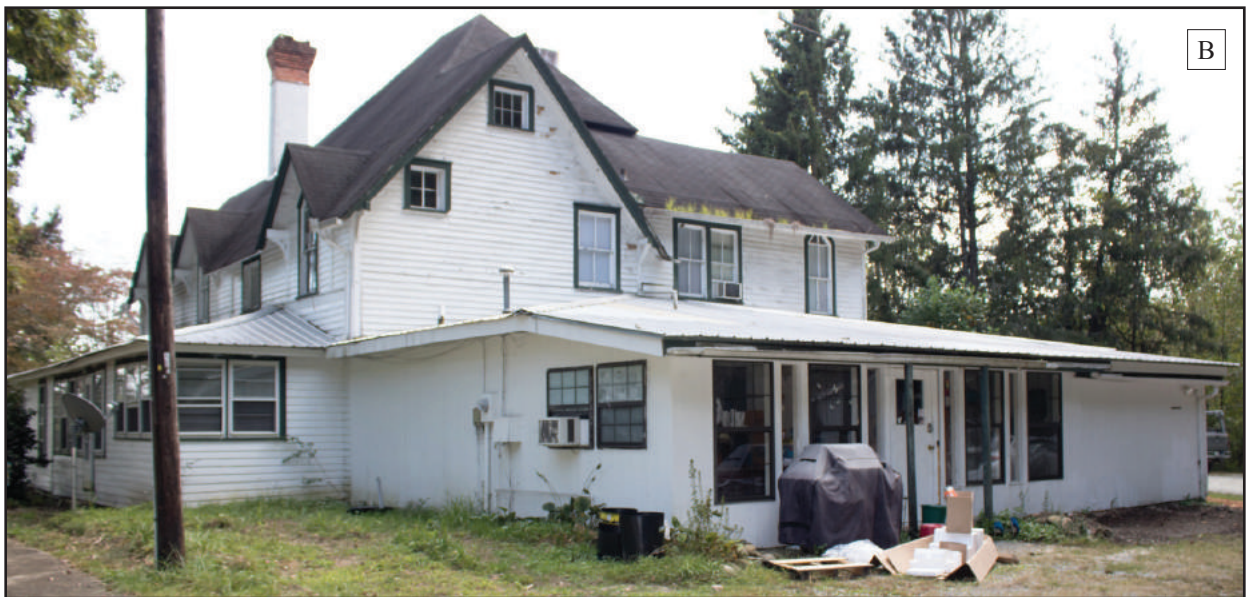
Figure 6.6. Robert E. Patton House Additions

On the northeast side of the house, there is a full-width, one-story, hipped-roof addition or, possibly, what is an enclosed porch (Figure 6.6a). There is another large addition on the northwest (rear) side, which was built in two sections, as indicated by the different widths of vertical siding used on the walls of each (Figure 6.6b). This was reportedly built as a living quarters and kitchen when the house was converted to a bed and breakfast circa 1985. The southwest side of the house has three pairs of two-over-two windows on the first floor and two pointed-arch windows on the second floor. There is a small pedimented stoop that shelters the single door entrance on this side (Figure 6.7). Access to the interior of the house was not granted.

B. Addition on the Northwest Side, Looking South
