SUBJECT: Historic Structures Survey Report, , Intersection Improvements at US 64, US 276 and NC 20 near Brevard, R-5799, PA 17-05-0033, Transylvania County, ER 18-0081

Historic Structures Survey Report for the Intersection Improvements at US 64, US 276, and NC 20 near Brevard

Transylvania County, North Carolina

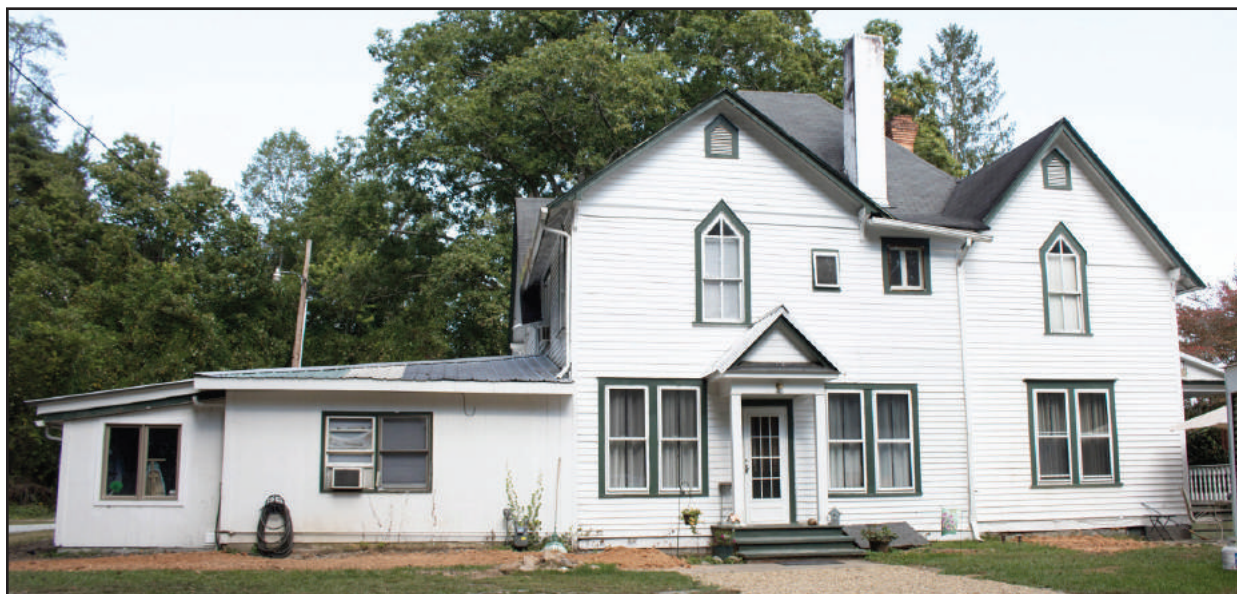
On the northeast side of the house, there is a full-width, one-story, hipped-roof addition or, possibly, what is an enclosed porch (Figure 6.6a). There is another large addition on the northwest (rear) side, which was built in two sections, as indicated by the different widths of vertical siding used on the walls of each (Figure 6.6b). This was reportedly built as a living quarters and kitchen when the house was converted to a bed and breakfast circa 1985. The southwest side of the house has three pairs of two-over-two windows on the first floor and two pointed-arch windows on the second floor. There is a small pedimented stoop that shelters the single door entrance on this side (Figure 6.7). Access to the interior of the house was not granted.

Figure 6.7. Southwest Side, Looking Northeast

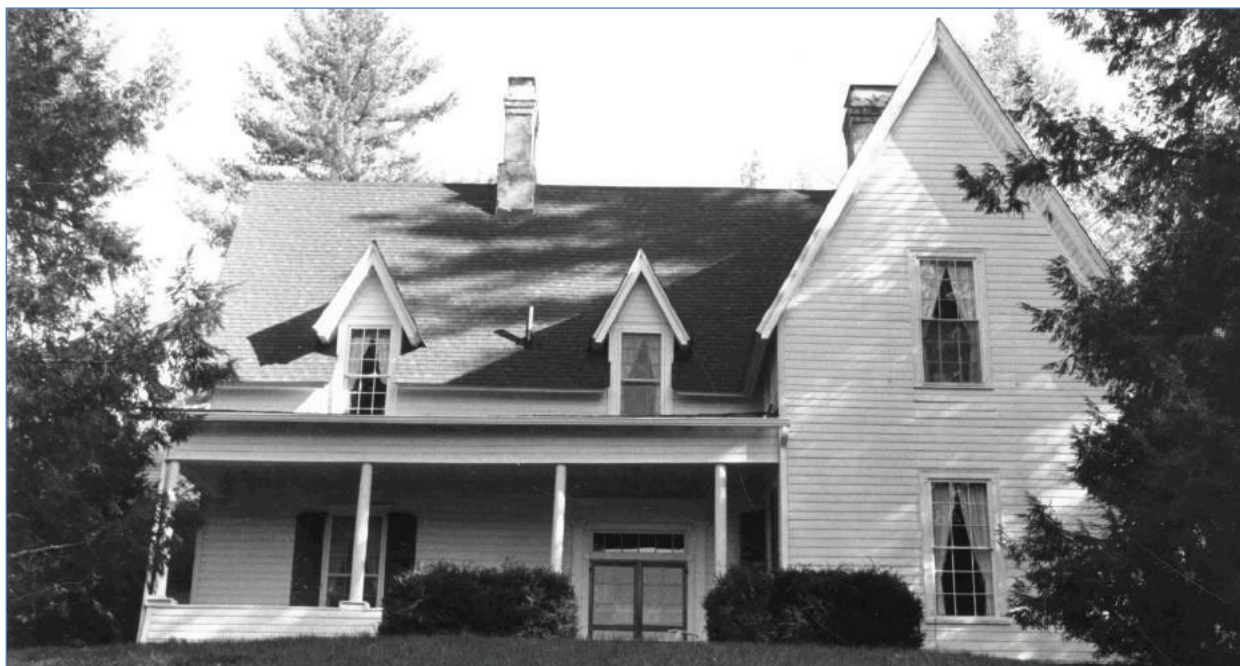
Figure 6.8. Montclove

of both the Gothic and Greek Revival styles (Figure 6.8). Like the Robert E. Patton House, it is a two-story frame house with weatherboard walls, steeply pitched roof, gabled wall dormers, corbeled interior chimneys, and a one-story porch on the side ell.

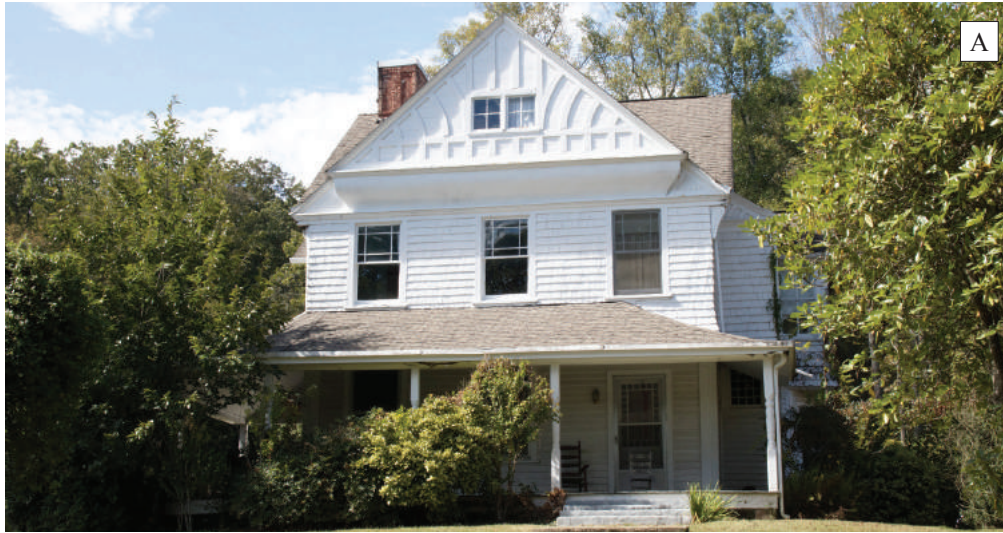
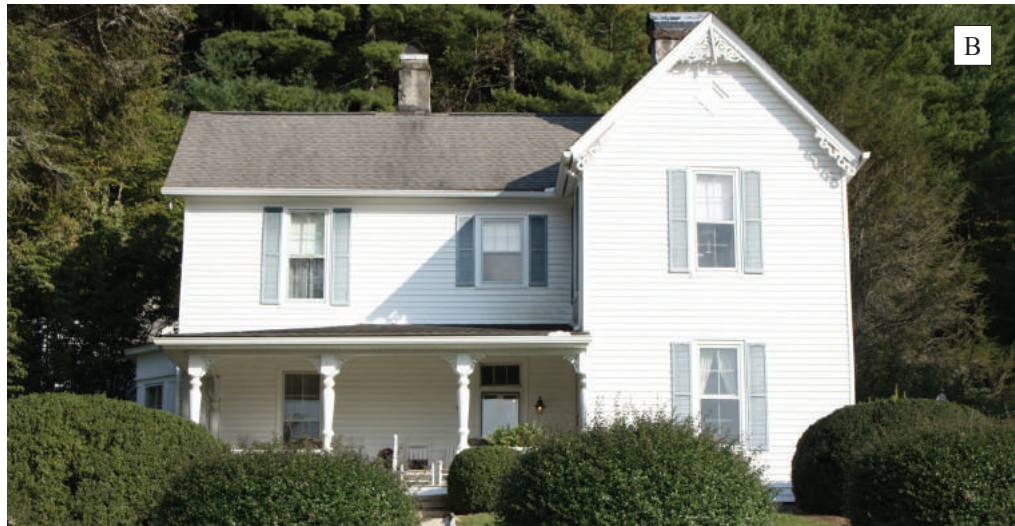
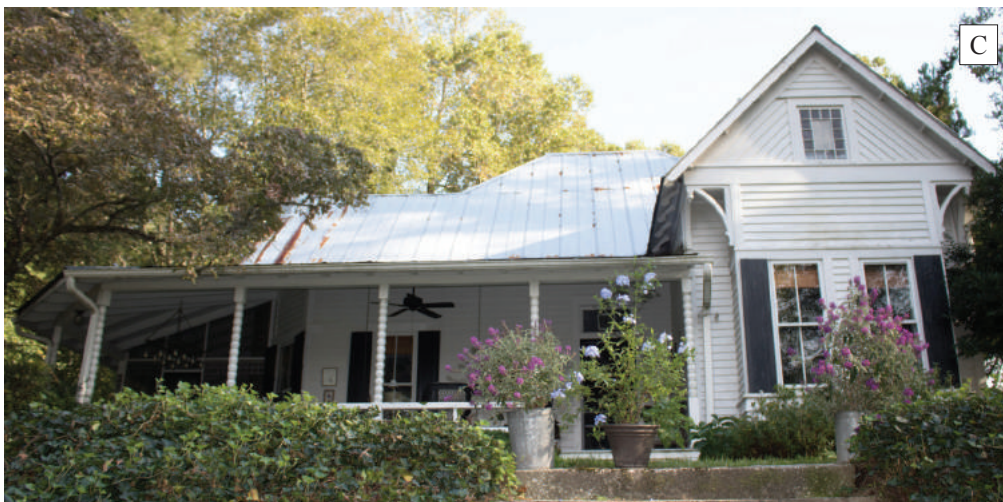
Figure 6.9. Examples of Gothic Revival Style Houses

Though the Gothic Revival style was not widespread in Transylvania County, there are many houses in the county dating from the end of the century that demonstrate an enhanced attention to architectural design, several of which were built for members of the Patton family. The closest of these houses is the Fitzgerald Patton House (TV0424, SO), located just up the hill from the Robert E. Patton House (Figure 6.9a). The Fitzgerald House, built circa 1895, is an example of the Queen Anne style. Credited to Joe Williams, who was a local builder, the house is a two-story, frame construction with a weatherboard first story and a shingled second story and a multi-gabled roof. The projecting front and side gable ends feature half-timbering.

One-and-one-half miles to the east, the Charles and Mary Mills Patton House (TV0376, SL 1983) began as a small two-room house, which later became the rear ell of a large front section (Figure 6.9b). Sometime after the Civil War, the two-story front section was added. The L-shaped house has weatherboard siding, with a steeply pitched roof and decorative sawn work detailing in the gable ends. Like the Robert E. Patton House, it also has a one-story shed roof porch on the side-facing ell. The house is located down a long driveway and backs up to a mountain, on

- A. Fitzgerald Patton House (TV0424)
- B. Charles and Mary Mills Patton House (TV0376)
- C. Partridge Hill (TV0623)

which Partridge Hill (TV0623, SO) is located (Figure 6.9c). Partridge Hill was built around 1900 and is attributed to John S. Patton, who sold it to W. S. Patton in 1901. Partridge Hill shares stylistic similarities with both the Robert E. and Fitzgerald Patton houses. The one-and-one-half story house is asymmetrical with weatherboard walls, corbeled chimneys, a rounded porch, and decorative stick work in the gable ends.

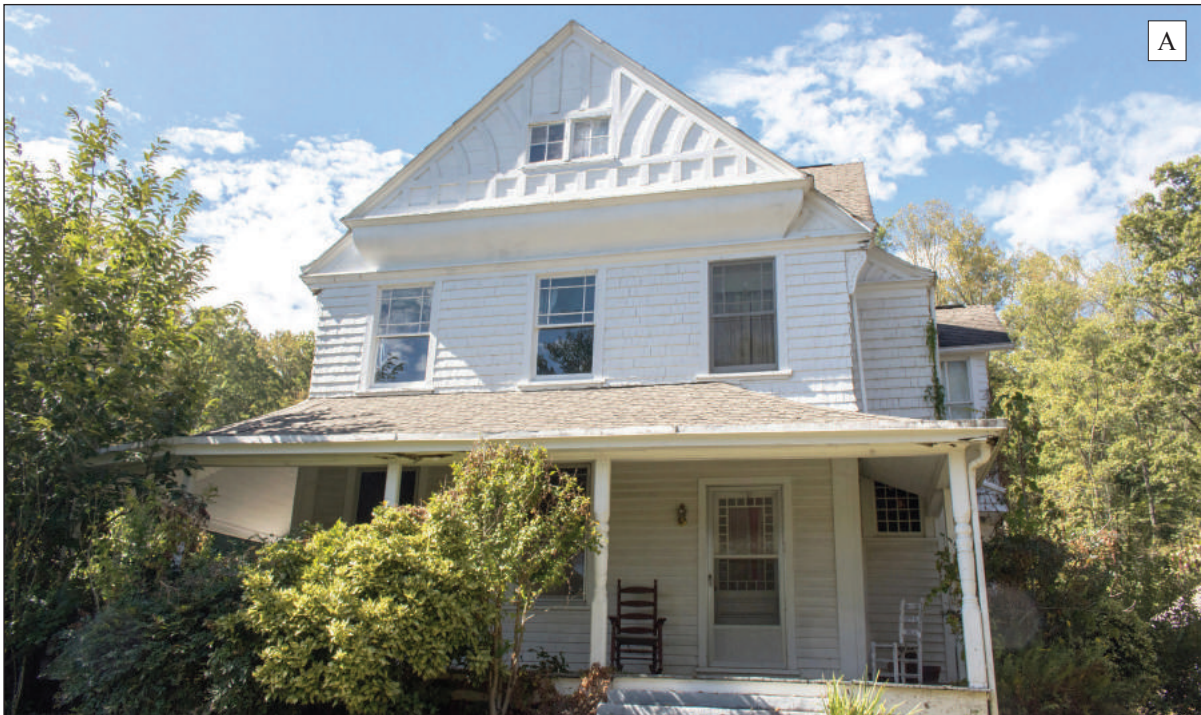
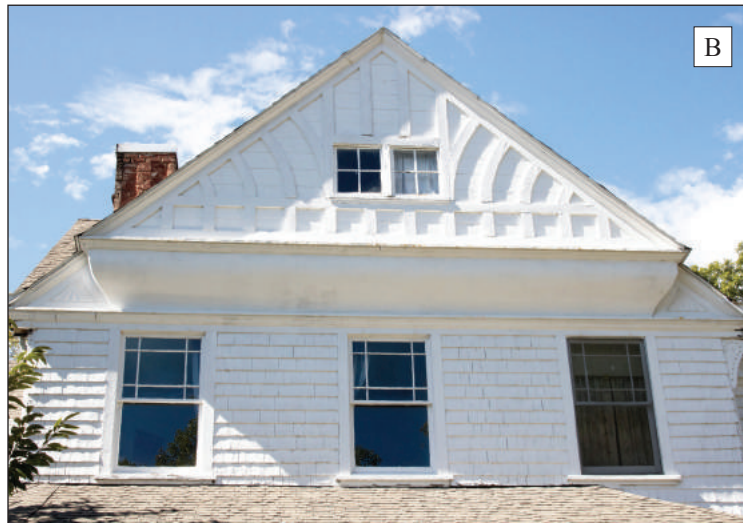
Figure 7.2. Fitzgerald Patton House

The Fitzgerald Patton House is a fine example of the Queen Anne architectural style (Figure 7.2a). It is a large two-and-one-half-story frame house with a multi-gable roof and a cut stone foundation. The house has one interior brick chimney. The exterior walls are weatherboard on the first story and shingle on the second story and above. The windows all appear to be historic and there are a number of different window configurations exhibited, the majority of which are double-hung sash, with the most notable being the nine-over-one windows on the second floor (Figure 7.2b). The lights on the upper sash are unequally divided, creating more architectural interest, of which there is abundance on this house.

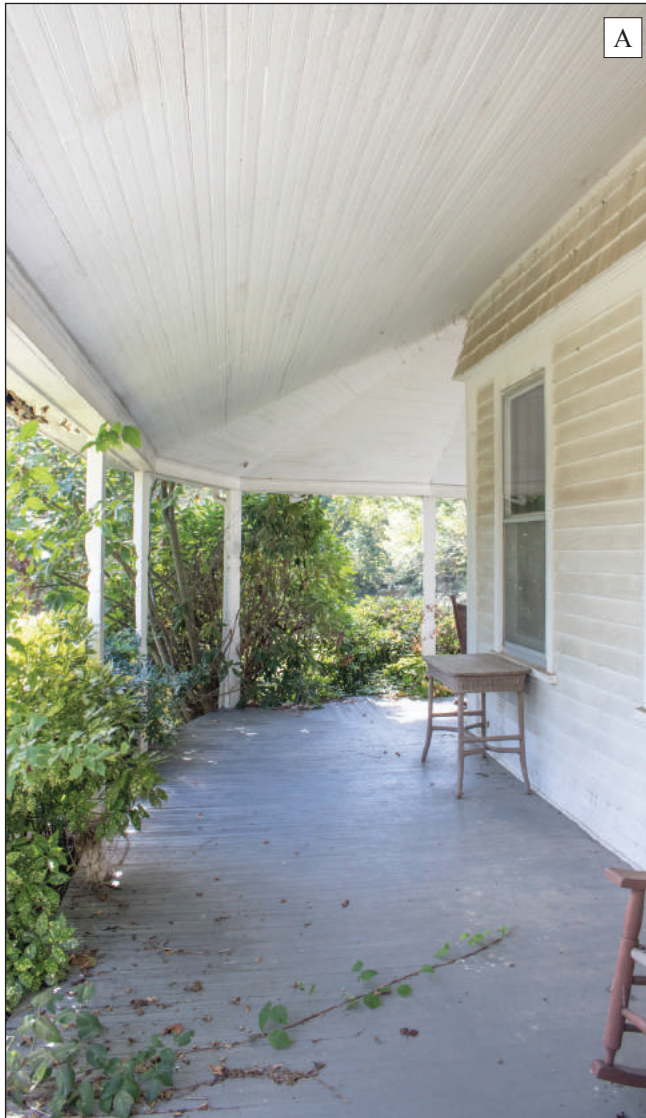
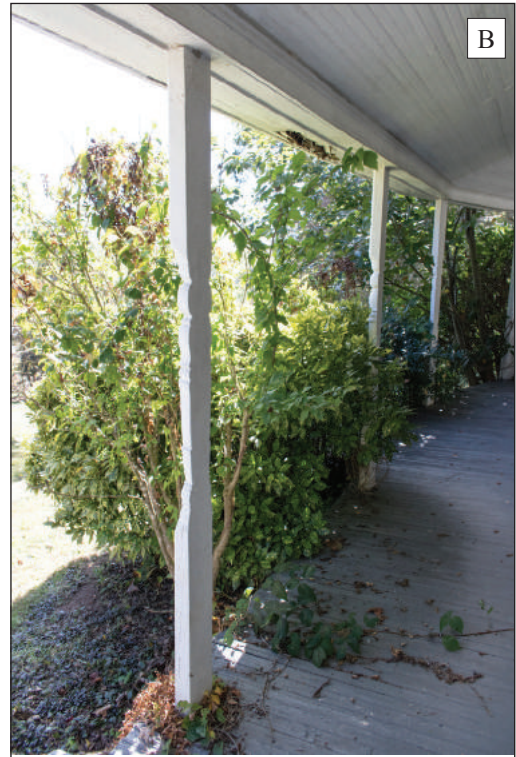
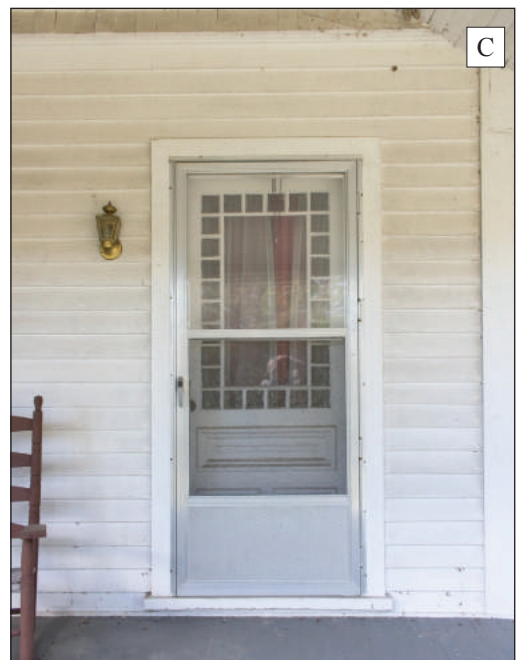
Figure 7.3. Porch Details

The east-facing façade features a full-width, one-story, hipped-roof, wraparound porch with a rounded corner (Figure 7.3a). The porch supports are unique in that they are half circles in plan, which are turned in front and flat in back, as if they were originally to be used as pilasters (Figure 7.3b). The single front door is located at the north end of the porch. It has a segmented stained glass light in the top half of the door and panels below (Figure 7.3c). Two historic one-over-one windows are also located on the porch and have been outfitted with storm windows. Above are three nine-over-one windows mentioned earlier. The slightly projecting gable end rests on a

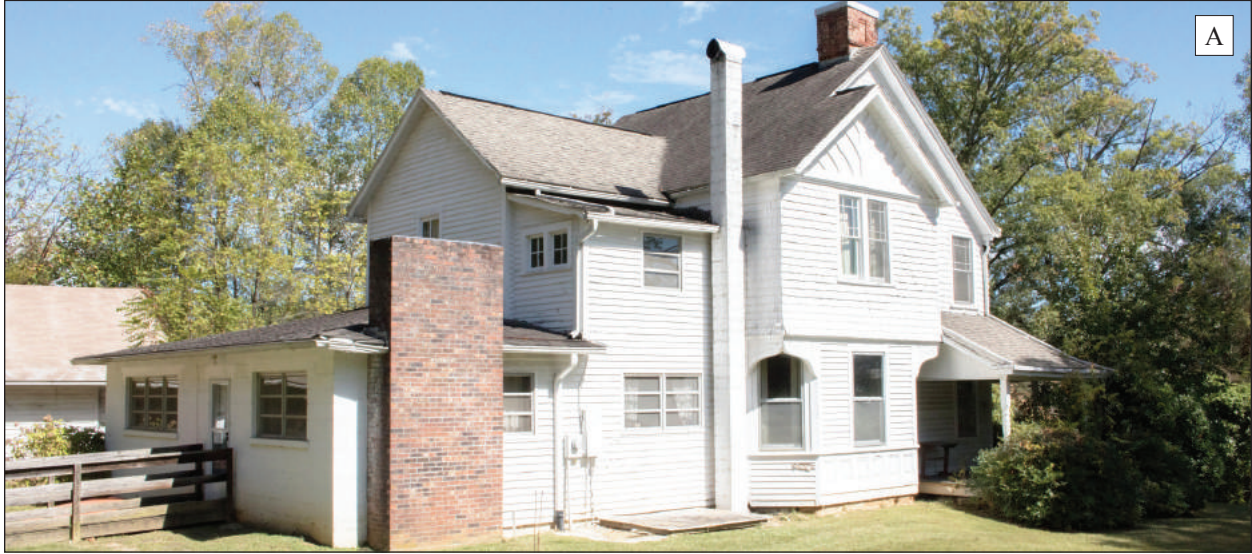
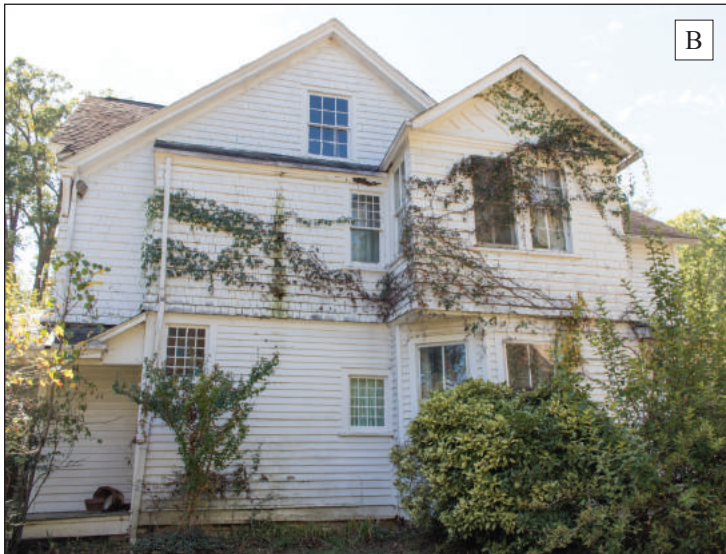
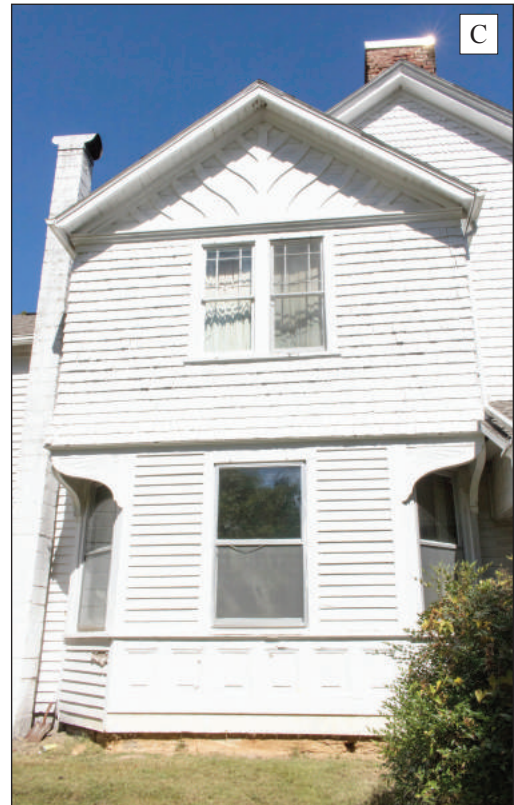
Figure 7.4. Gable Details

curved plaster base and features decorative, curved half-timbering (see Figure 7.2b). It is flanked by carved detailing in the corners of the primary gable, which is supported under the architrave with perforated braces. Similar detailing is found on the projecting secondary gable ends on the north and south sides (Figures 7.4a and b). The south secondary gable is quite ornamental with a polygonal bay on the first floor with paneled dado and carved sunburst brackets that support the overhanging second floor (Figure 7.4c). The primary gable end on the south side features scalloped shingling.

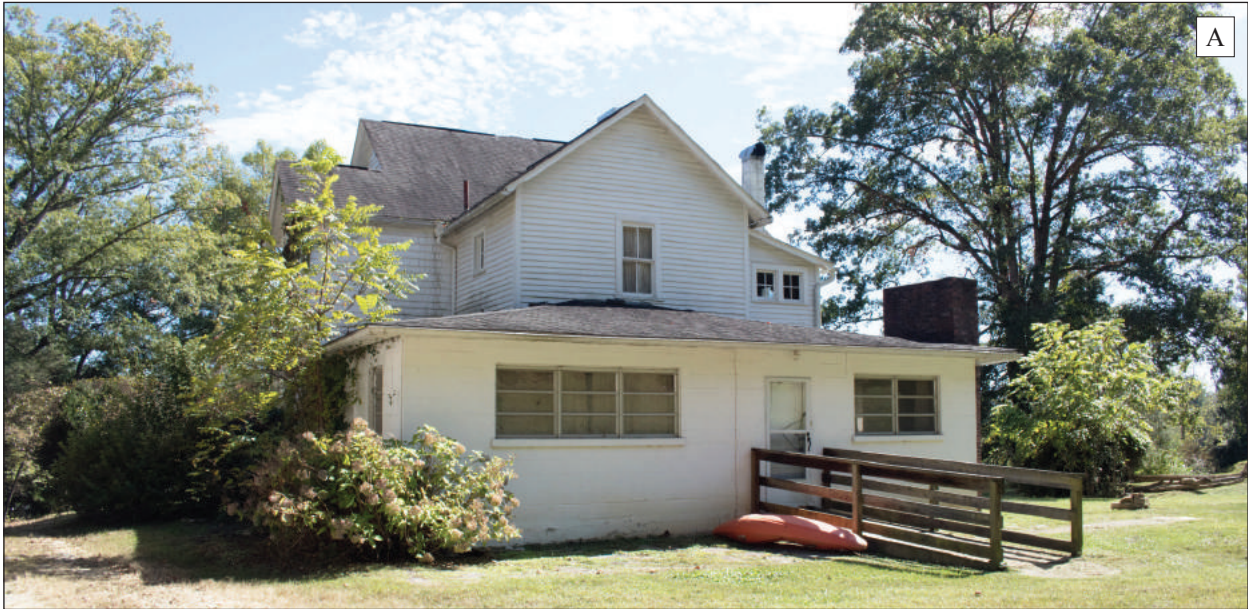
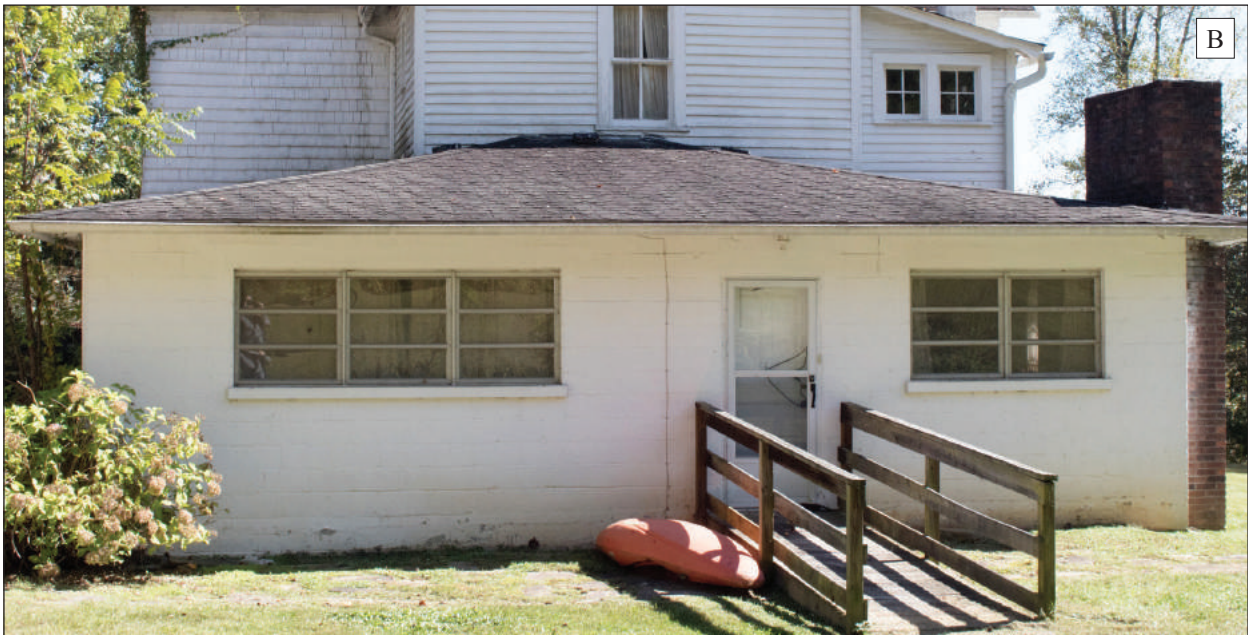
Figure 7.5. Rear of the House

The west-facing rear of the house is plain in comparison, clad in weatherboard with no decorative embellishment (Figure 7.5a). There is a small, two-story, shed-roof addition attached to the south side of the rear gable (see Figure 7.4a). It has horizontal three-light windows. There is also a one-story, hipped-roof, concrete block addition at the rear of the house, which was built in the 1950s to replace a two-room ell that contained a kitchen and bathroom and was connected to the main house by a breezeway (Figure 7.5b). This concrete block addition also has horizontal light windows and a wide brick chimney. The house is currently vacant and the interior was inaccessible.

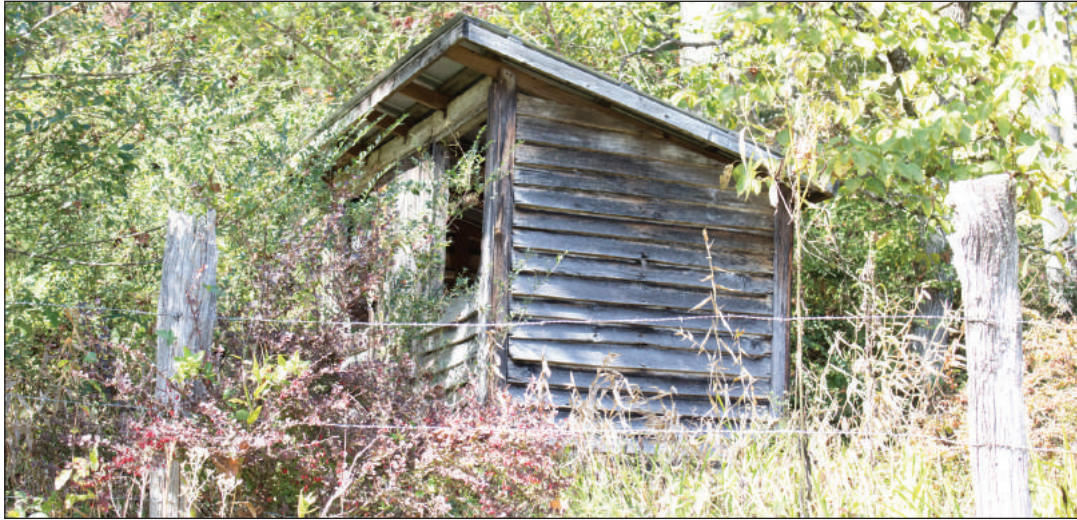
Situated to the northwest of the house is a small chicken house that sits atop a low rise next to the driveway (Figure 7.6). It has weatherboard walls and a metal-clad shed roof, which looks as if it has recently been rebuilt. Access to the chicken house is overgrown with vegetation, and it does not appear to have been used for some time.

Figure 7.6. Chicken House, Looking North

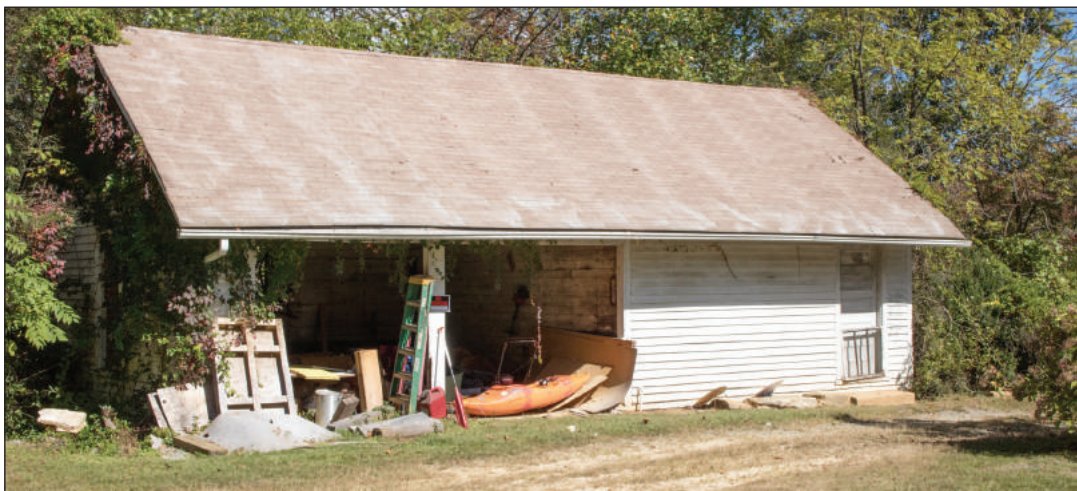
To the immediate north, across the driveway from the house, is the rectangular one-story garage that was also used as a workshop and root cellar at one time (Figure 7.7). It is currently being used for storage. The building has a gable-end roof with weatherboard walls. Two open garage bays are located at the north end of the south wall. The rest of the wall is solid and has a single paneled door at the south end. Vegetation has grown around the building obscuring the other walls.

Figure 7.7. Garage, Looking East

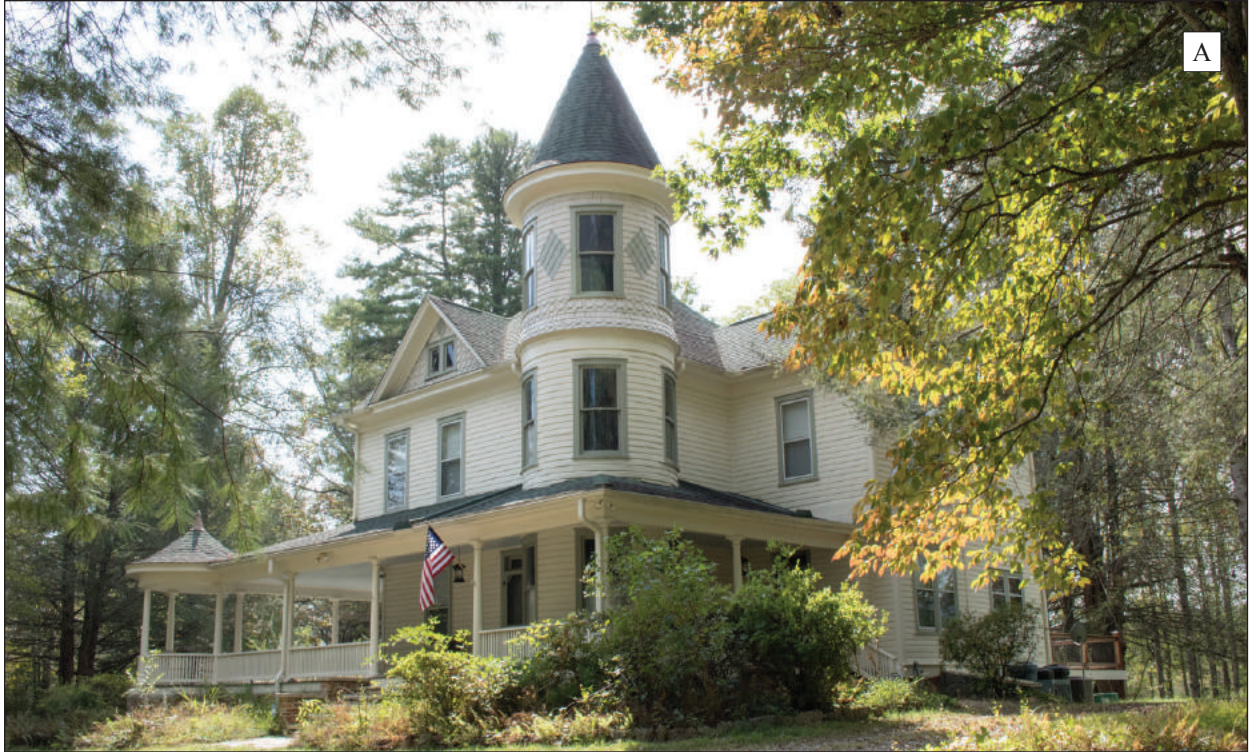
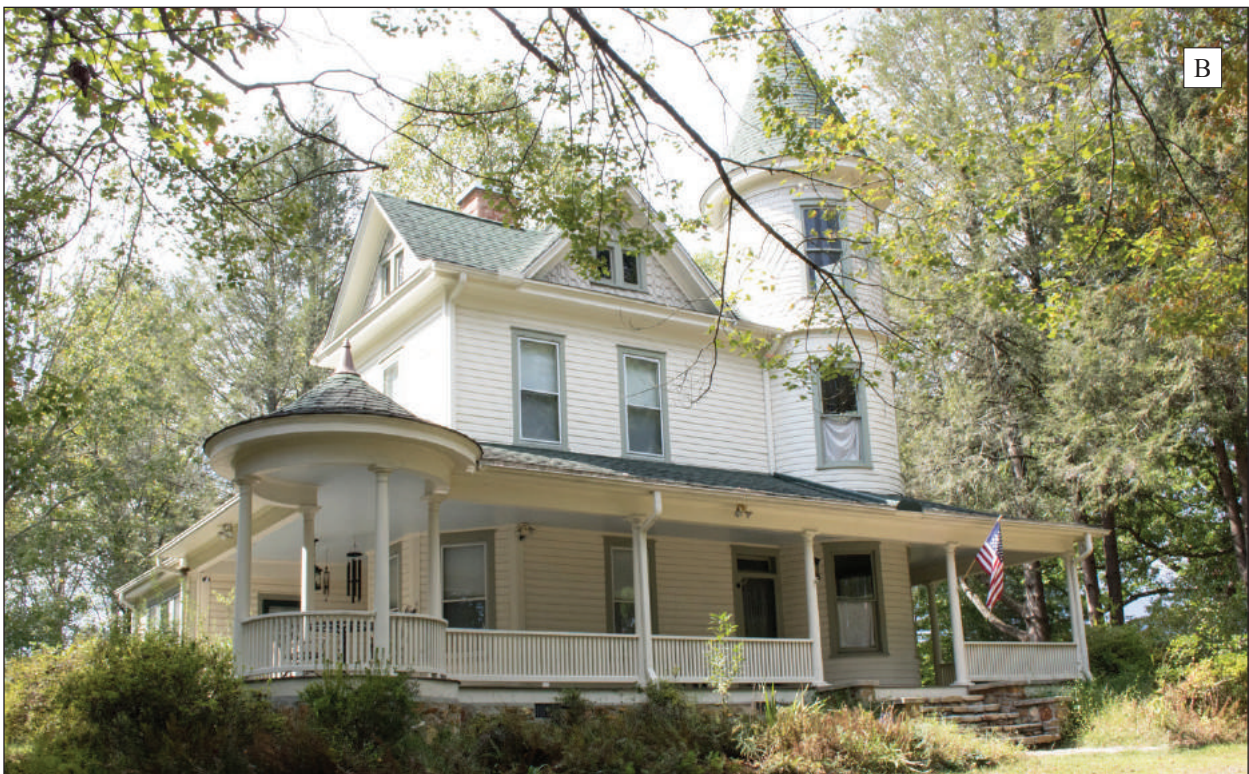
Figure 7.8. John Duckworth House

Several examples of the Queen Anne style survive in Transylvania County, the John Duckworth House (TV0342, SL 1992, DOE 2011) being one of the most notable (Figures 7.8a and b). The large two-story house has an irregular plan with a complex roof and varying wall textures and patterns. The wrap-around porch boasts a projecting gazebo with a conical roof, which is reflected in the three-story rounded tower at the northeast corner of the house. The first two stories are clad in German siding, while shingles adorn the gable ends and tower. An additional example of the Queen Anne style can be found at Partridge Hill (TV0623, SO), another house that was constructed by a member of the Patton family (Figures 7.9a and b). Located on a forested hill off Everett Farm Road, the circa 1900 one-and-one-half story house echoes features of both the Fitzgerald Patton and Robert E. Patton houses. The house has an irregular plan with a multi-gabled

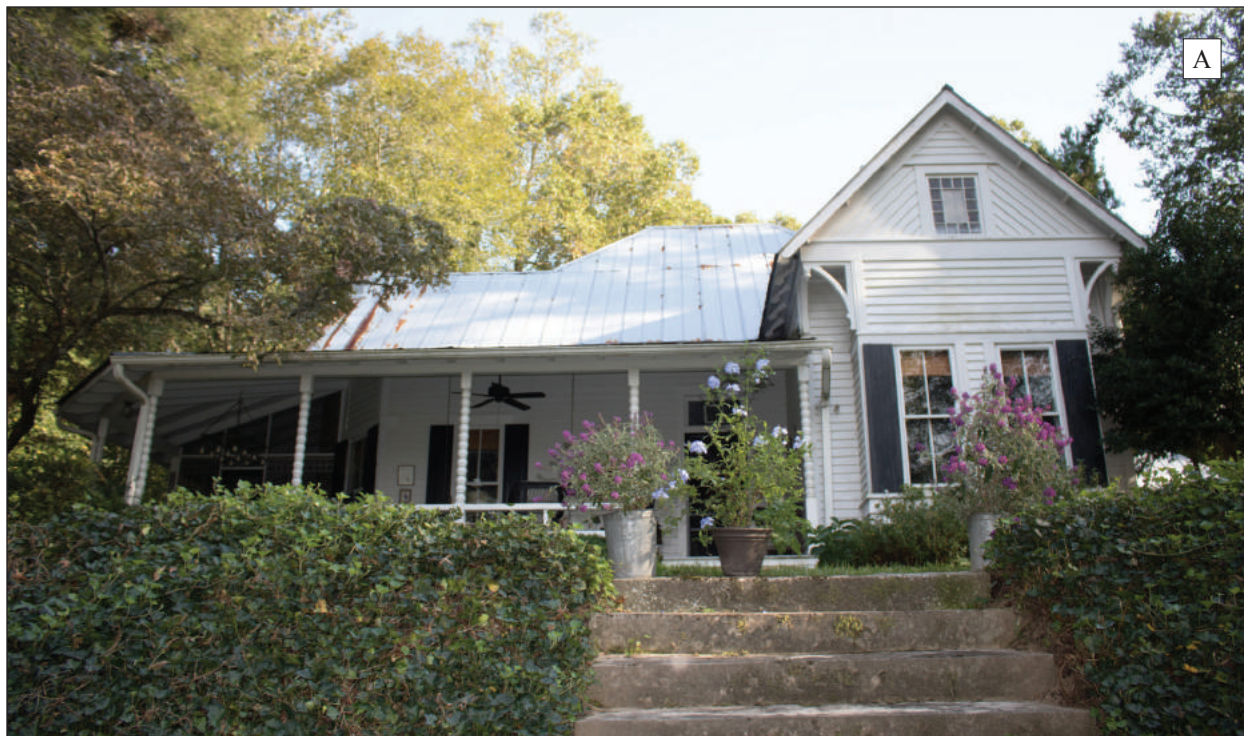
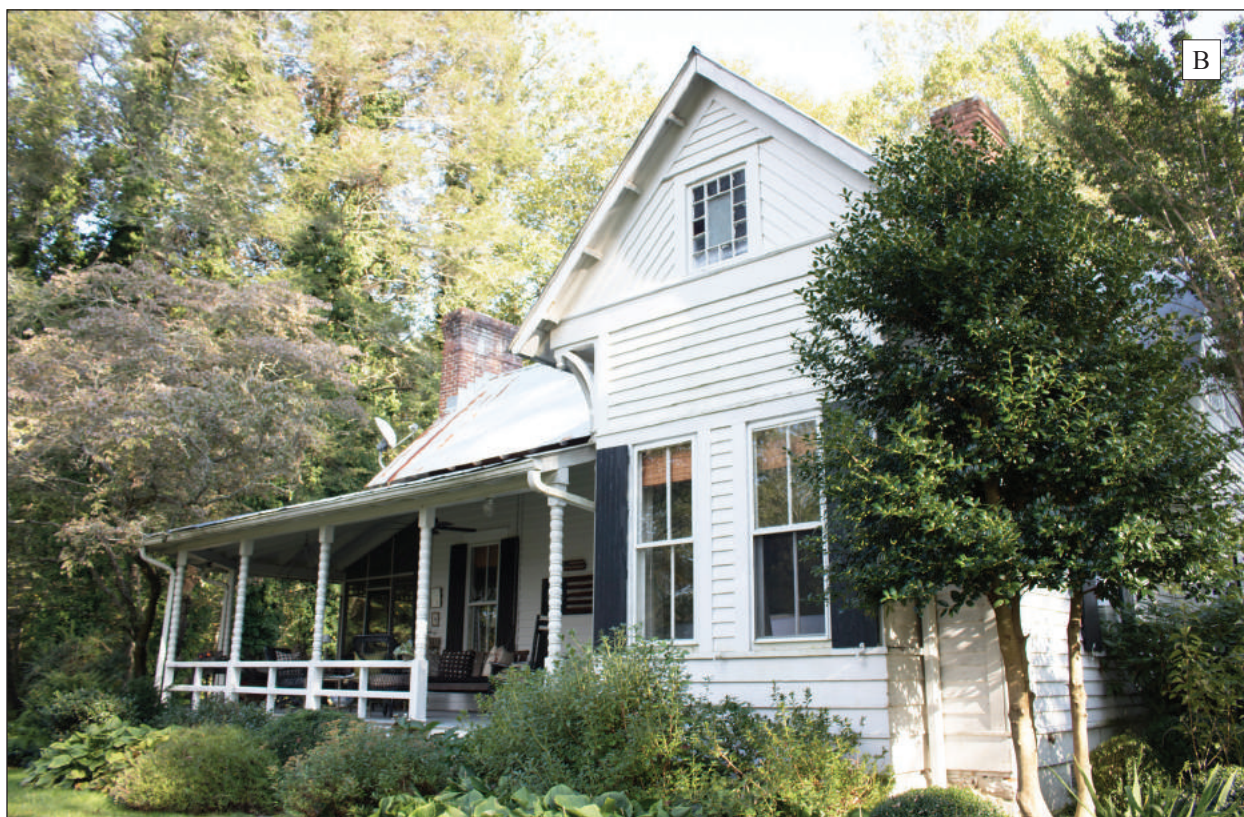
- A. Looking Northwest
- B. Looking Northeast

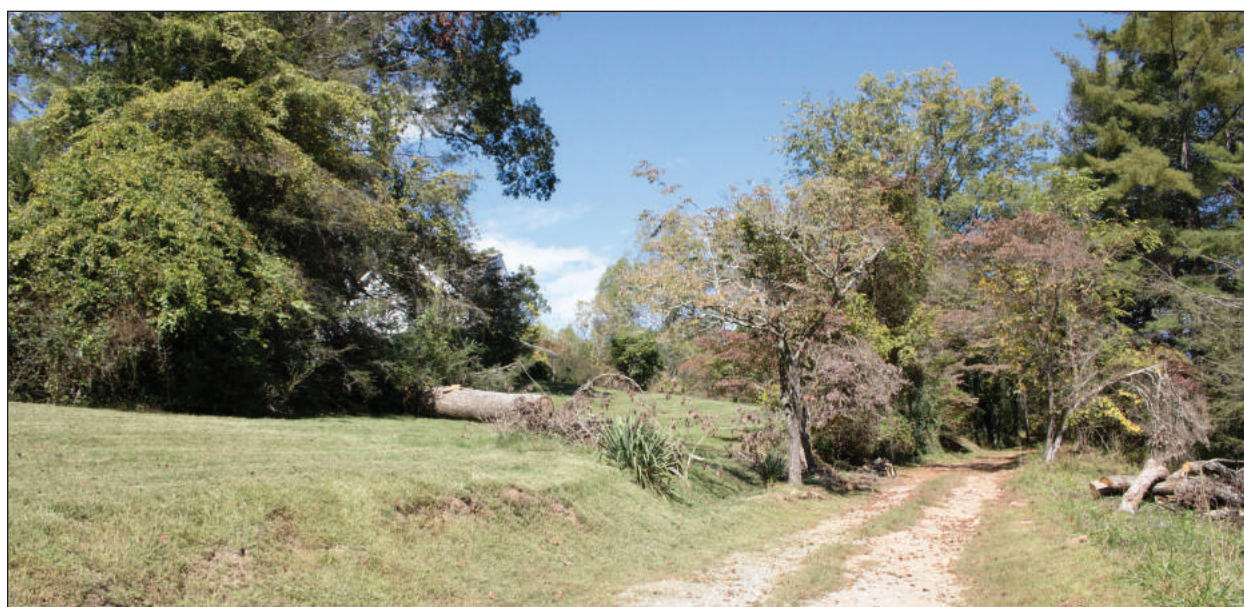
Figure 7.10. View of Driveway, House Located Behind Trees at Left, Looking Northeast

In order to be eligible for the NRHP, a property must possess several, usually the majority, of the seven aspects of integrity: location, setting, design, materials, workmanship, feeling, and association. The Fitzgerald Patton House remains in its original location, but the setting of the house has changed dramatically over the years. When it was constructed, the location of the Fitzgerald Patton House would have been considered remote. Although the Robert E. Patton House was nearby, other neighboring houses would have been located some distance away. Today, the area is home to a busy intersection surrounded by modern commercial buildings; however, the trees on the property help to obscure view of the development (Figure 7.10). The immediate setting of the house on the property itself is also altered. A variety of changes have taken place within the last year, so recently that they do not appear on the most recent aerial of the property. Two historic outbuildings, the 1916 gambrel roof barn and smokehouse, have been demolished. In the terraced fields to the west of the house, a large amount of dirt was dumped and hills or moguls formed for what appears to be recreational purposes (Figure 7.11a and b). Although integrity of design, materials, and workmanship is largely intact as far as the house is concerned, it is showing signs of neglect with areas of rotten wood evident and overgrown vegetation. Taking into account the altered setting and the loss of the outbuildings, the property no longer conveys the feeling of a rural farmhouse, and though its association as such extended well into this century, the sale of the property in 2015 and subsequent development signified the end of that association.

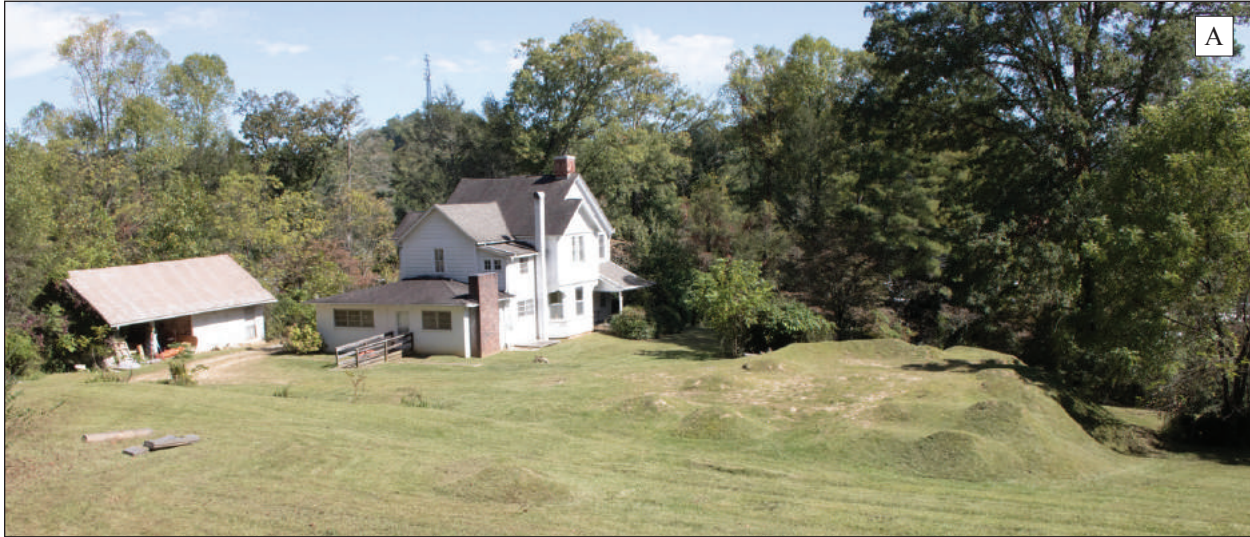
Figure 7.11. Former Terraced Fields

has lost integrity in the physical characteristics that would have conveyed its significance as an agricultural property. The terraced fields have been altered and are no longer being farmed. The two most significant outbuildings on the property, a gambrel roof barn and smokehouse that were documented in a 1991 survey of the property, have been recently demolished. The house no longer conveys the feeling of a turn-of-the-century rural agricultural property. *Therefore, the Robert E. Patton House is recommended not eligible for listing under Criterion A.*

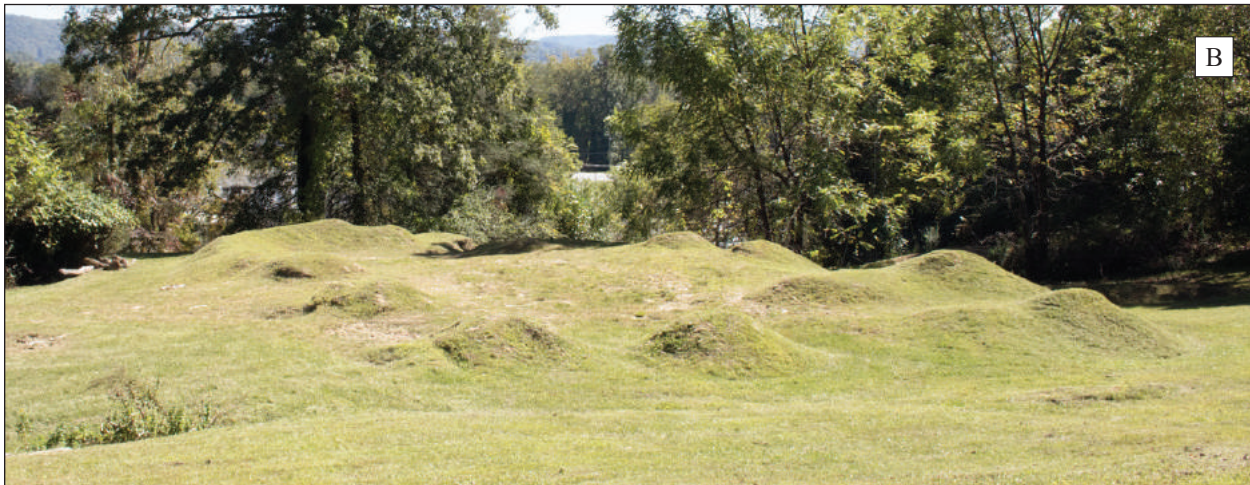
- A. View of House and Former Terraced Fields From the Location of the Barn (demolished), Looking East
- B. Detail of Dirt Deposited on Former Terraced Fields

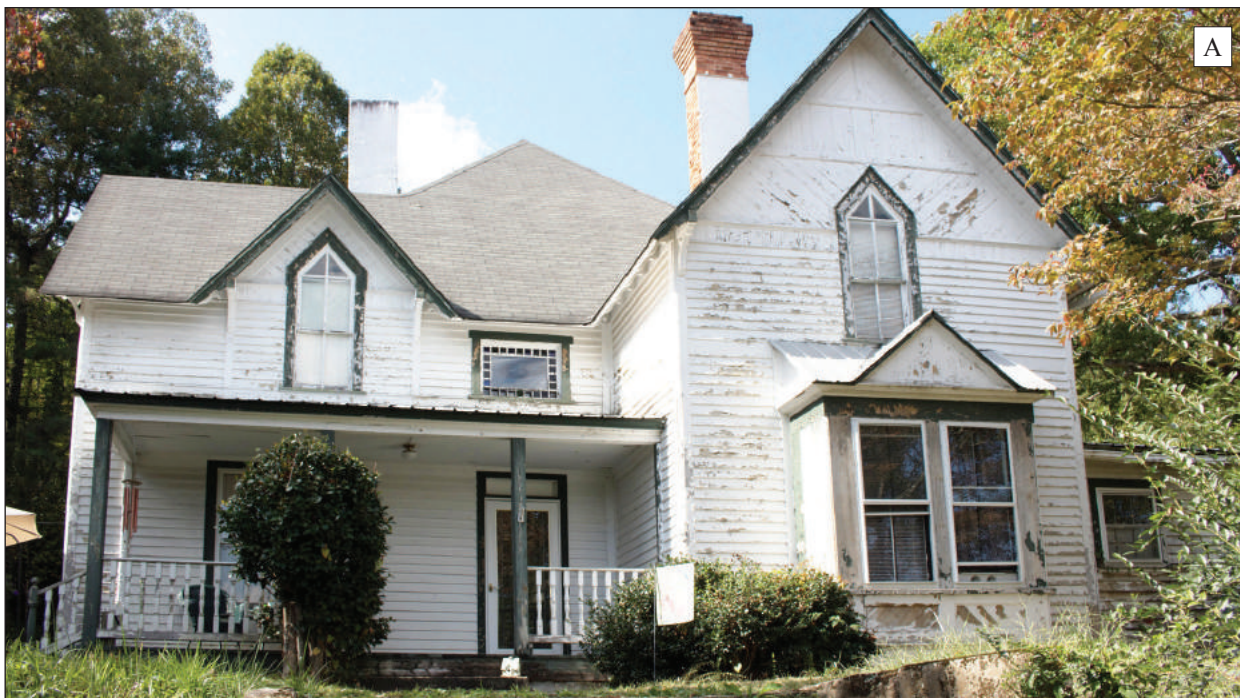
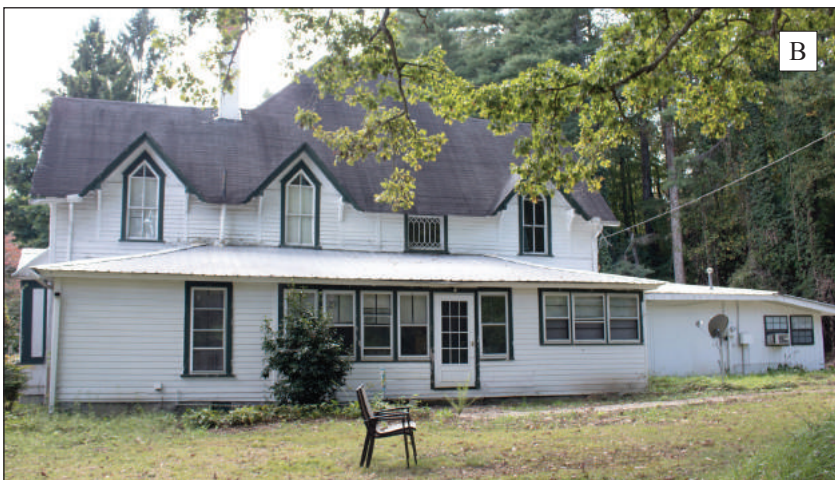
Figure 8.2. Robert E. Patton House

A. Façade, Looking Northwest
B. Northeast Side, Looking Southwest

The Robert E. Patton House is located on parcel A, just off US 276 West. Robert E. Patton, farmer and part owner in a Brevard jewelry store, built his house in this location in 1890 (Phillips and Thompson 1998). The house is a two-story frame house with a multi-gabled roof and gabled wall dormers (Figures 8.2a and b). Under each of the gables and dormers is a pointed arch window influenced by the Gothic Revival architectural style. The house also has sawn eave brackets and decorative braces supporting the primary gables. The house has multiple additions, both historic and non-historic, and the porch structure has been rebuilt. There are no other historic buildings on this parcel.

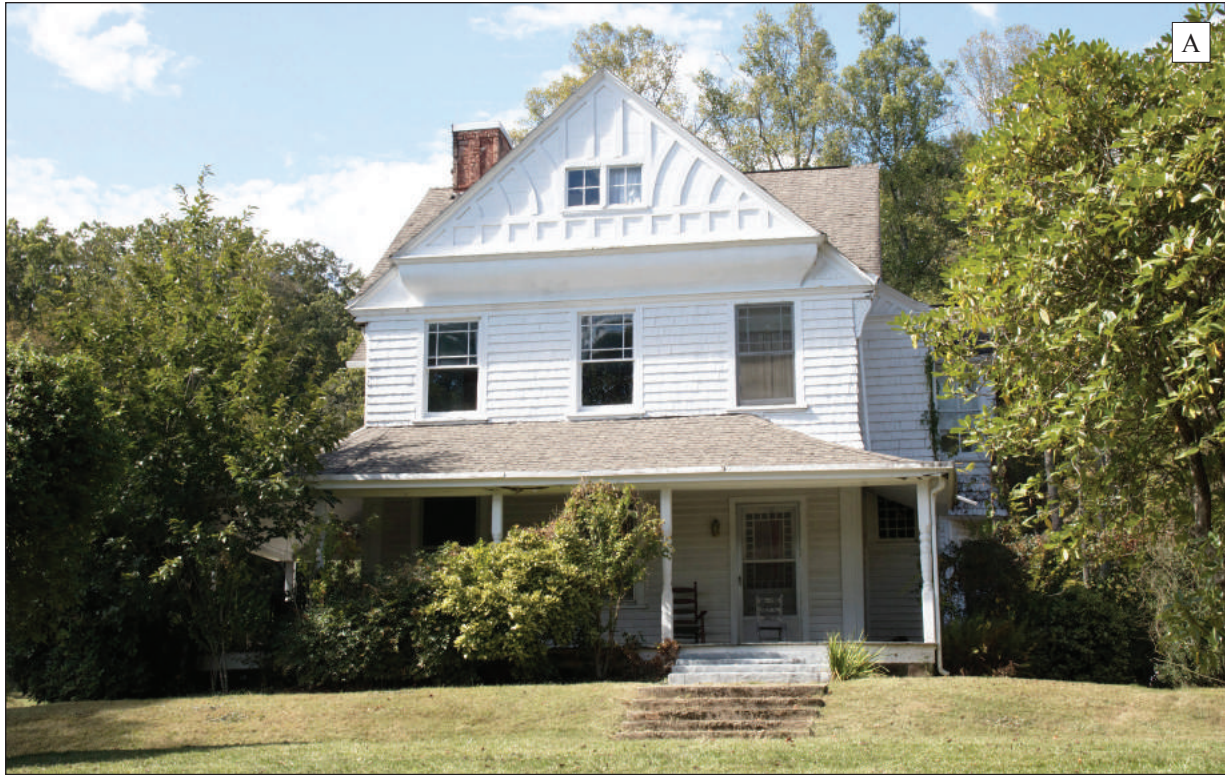
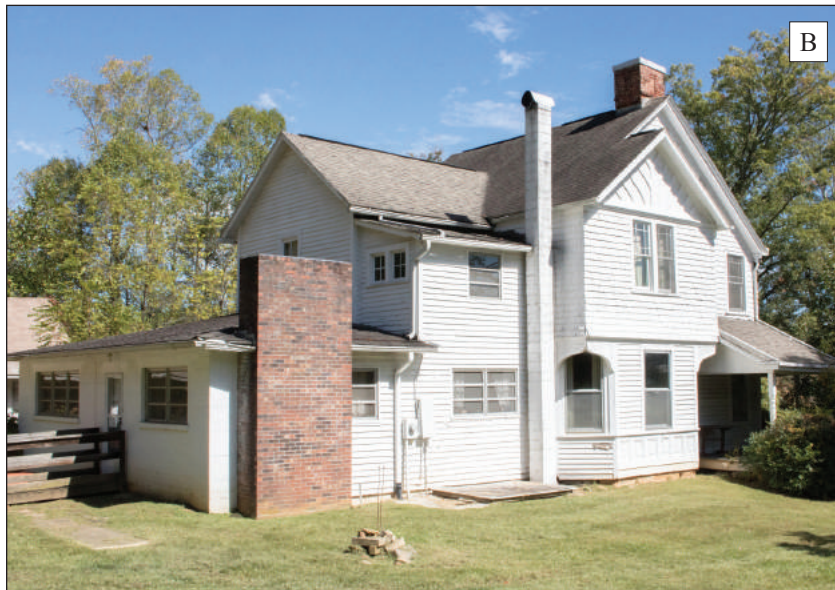
Figure 8.3. Fitzgerald Patton House

- A. Façade, Looking Northwest
- B. Southwest Side, Looking East

The Fitzgerald Patton House is located on parcel B, on the hill to the north and adjacent to the Robert E. Patton House. Robert E. Patton also built this house, which he gave to his three unmarried sisters where they would care for his infant son, Fitzgerald, after Robert's wife passed away (Phillips and Thompson 1998). The Fitzgerald Patton House is a fine example of the Queen Anne architectural style and possesses many of the style's identifying features, including a steeply pitched roof with multiple gables, wrap-a-round porch, patterned shingles, cutaway bay windows, decorative gable detailing, and carved brackets and eave braces (Figures 8.3a and b). Two outbuildings are associated with the house, a garage/workshop and a chicken coop. A gambrel roof barn and smokehouse that were on the property have recently been demolished.

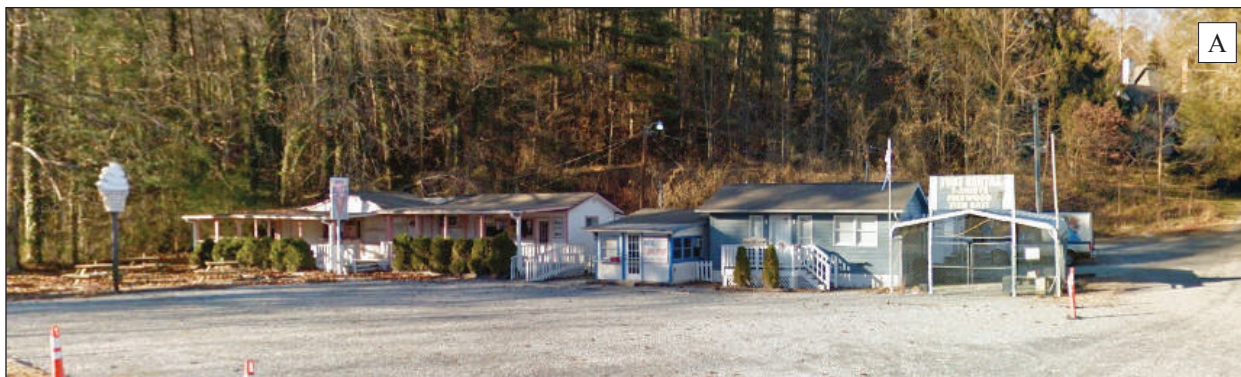
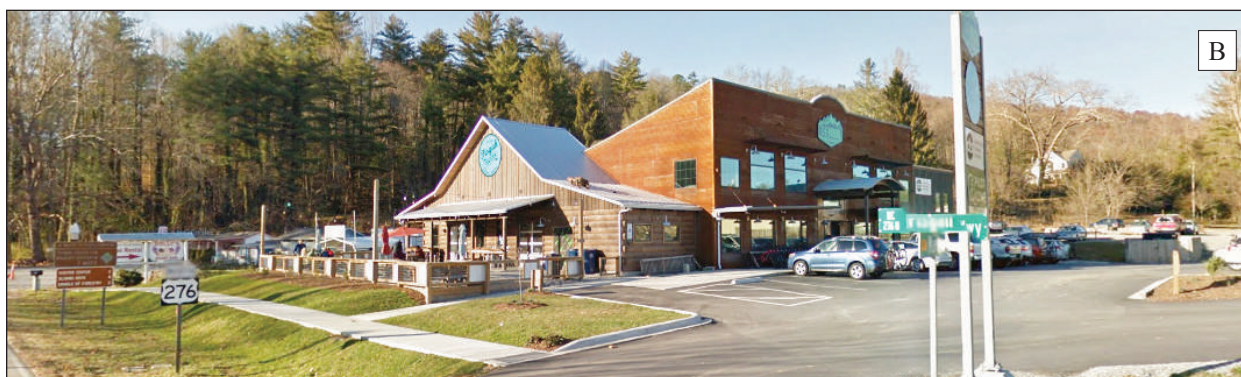
Figure 8.4. Parcels C and D

- A. Parcel D, Dolly's Dairy Barn
- B. Parcel C, The Hub and Pisgah Tavern

Parcels C and D are located at the front of the Patton House Historic District. Dolly’s Dairy Barn was built on parcel D in the mid-1960s. Parcel C was in use as an agricultural field as late as 2013, but The Hub and Pisgah Tavern, a large metal commercial structure, was built on the parcel in 2015 (Figures 8.4a and b).
