November 9, 2018

MEMORANDUM

SUBJECT: Historic Structures Survey Report, Merrimon Avenue & WT Weaver Boulevard Intersection Improvements. U-5781, U-5782, PA 17-04-0023, Buncombe County, ER 18-0102

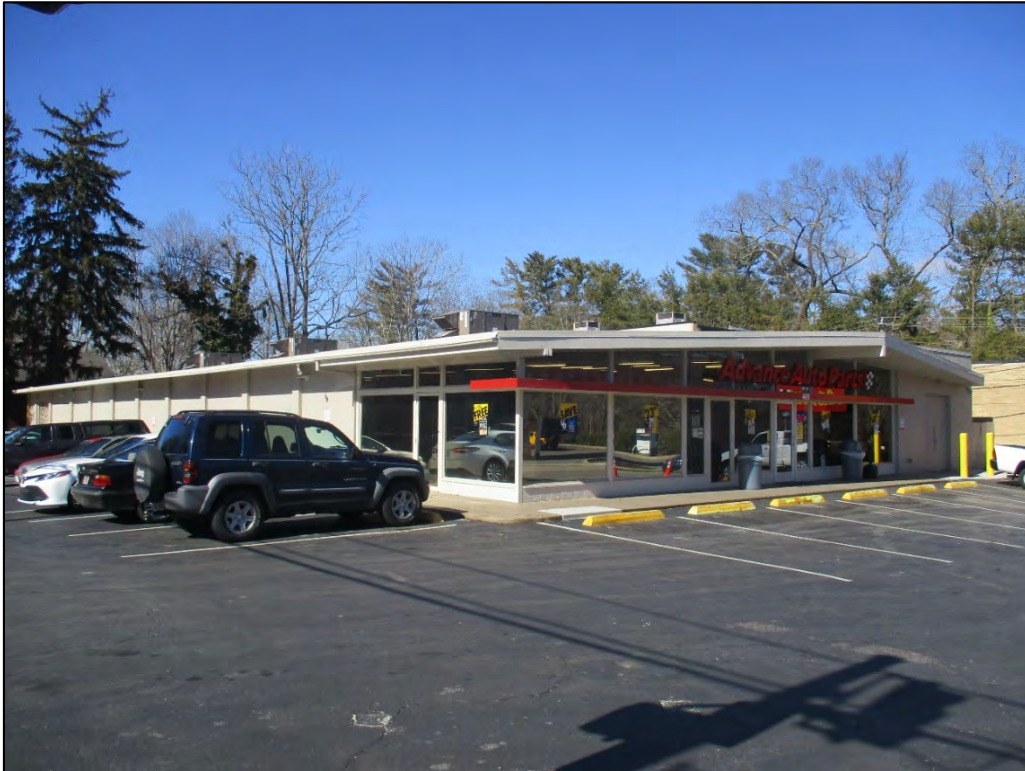
Former Glidden Drive-In Paint Center façade, view to the northeast from the Coleman Avenue corner

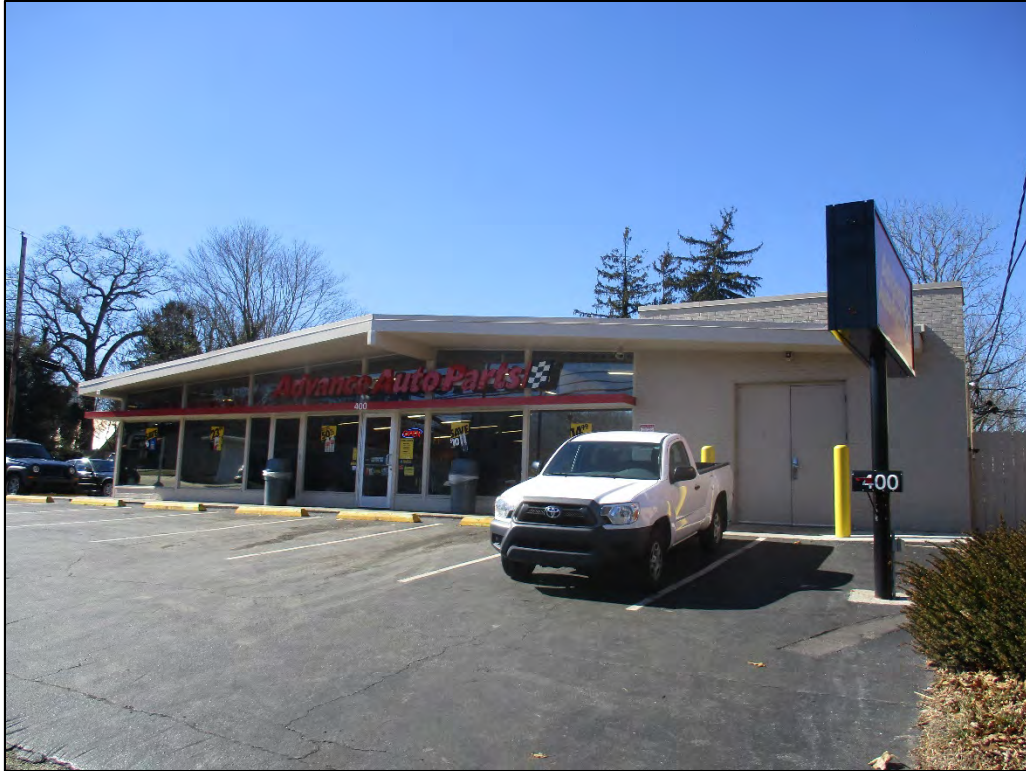
The façade has a low-profile, front-gable roof with wide eaves that extends to a peak at a central exposed ridge beam. Three quarters of the façade is glass storefront and the remaining quarter has a prominent brick-clad wall that protrudes through the roofline. The brick wall north of the glass storefront includes a modern double security door. The glass on the façade below the metal clad canopy is tinted and the glass above the canopy is clear. One of the two metal-framed glass doors is operable on the façade. The current owner, Advanced Auto Parts has affixed their sign above the canopy. A free-standing sign of unknown age is also present in the northeast corner of the parcel.

Former Glidden Drive-In Paint Center façade, view to the southwest

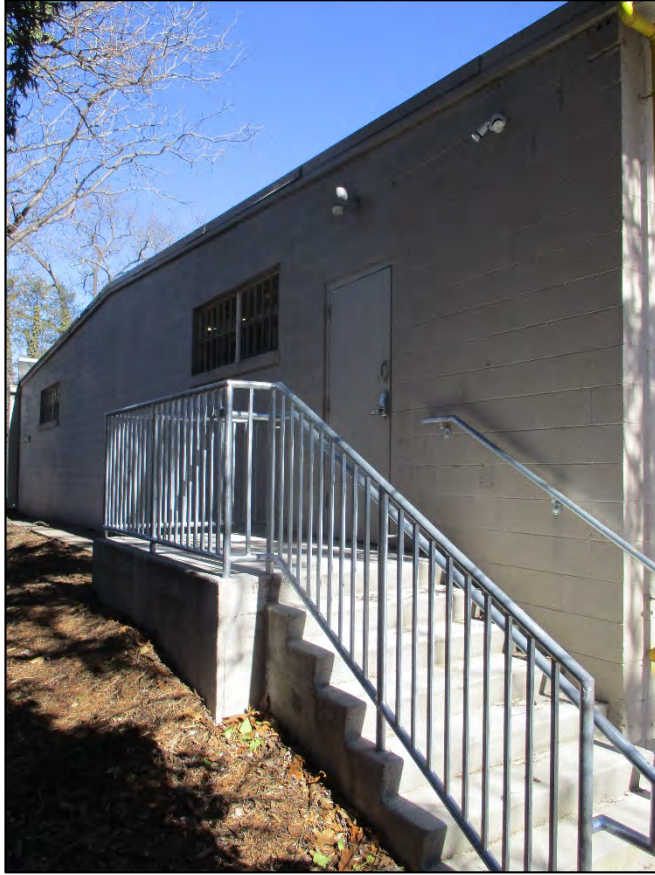
The west elevation (rear) roofline reveals the gable roof form, though no eaves are present. Two paired twelve-light steel casement windows are set above concrete sills. These opening dimensions closely match those observed in the south elevation that are infilled. A small window infilled with concrete block above a concrete sill is evident near the northwest corner of the building. A non-historic metal security door is located near the southwest corner of the building, and accessed by a poured concrete stairway and porch with steel tube bannister all of which is less than fifty years old, based on materials and condition. The north elevation is also concrete block with simple pilasters and includes no openings. The roofline is concealed by a parapet wall with aluminum cap.

Former Glidden Drive-In Paint Center rear elevation, view to the northeast

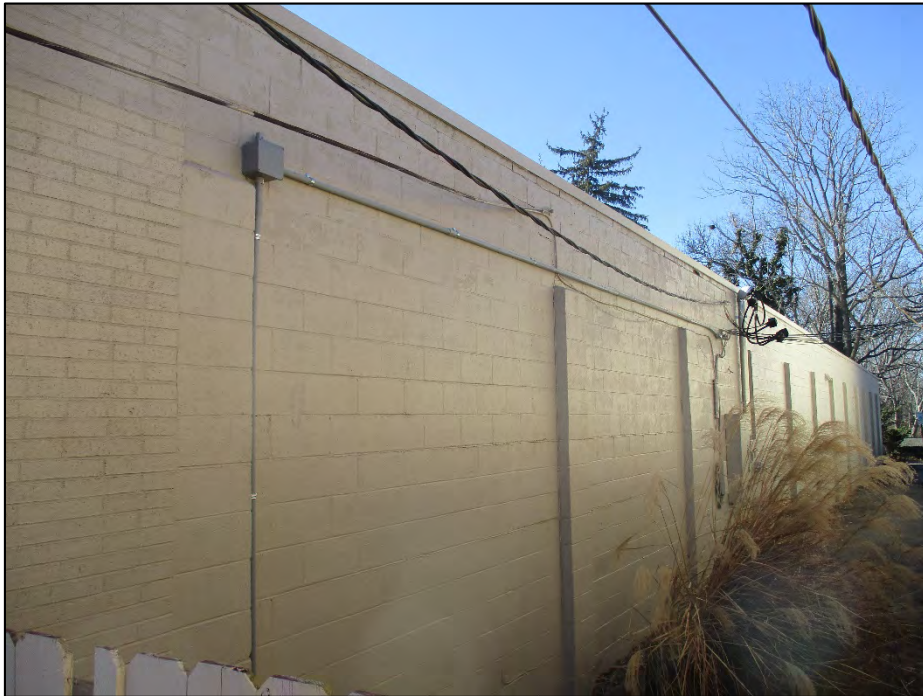
Former Glidden Drive-In Paint Center north elevation, view to the southwest

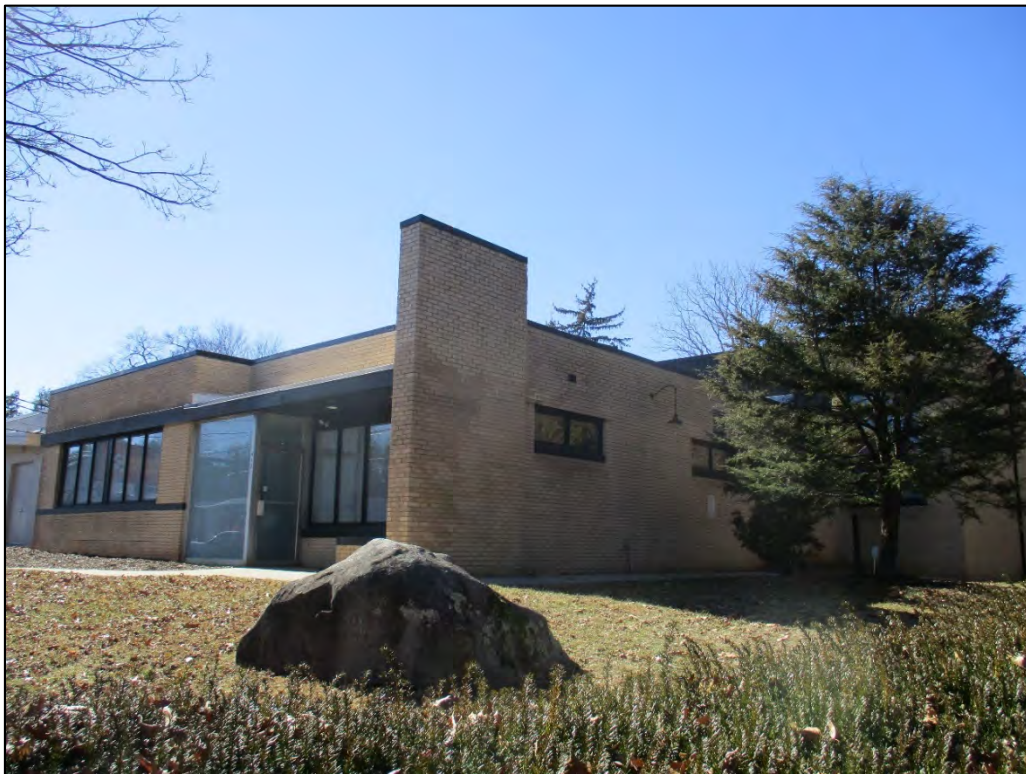
Former Western and Southern Life Insurance Company façade, view to the southwest from the King Street corner

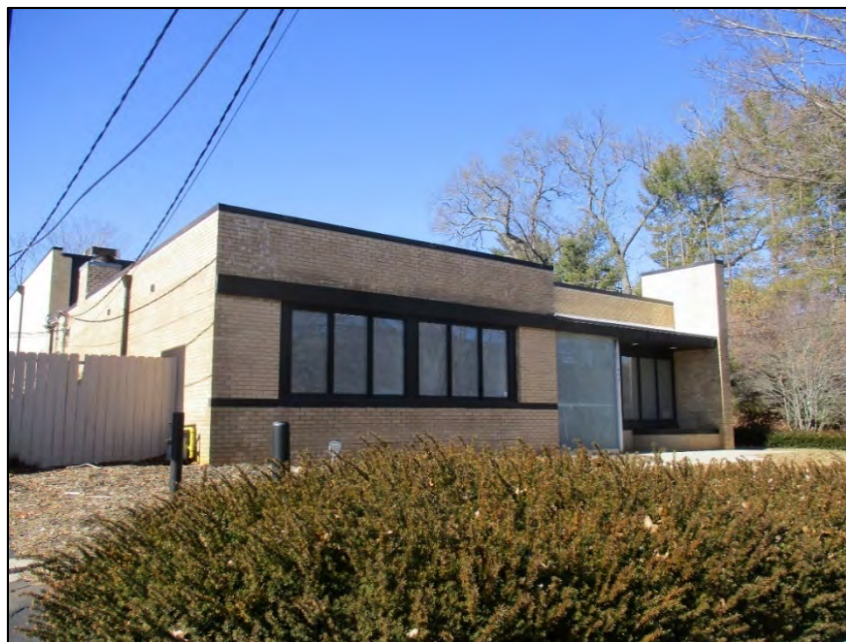
Former Western and Southern Life Insurance Company façade, view to the northwest

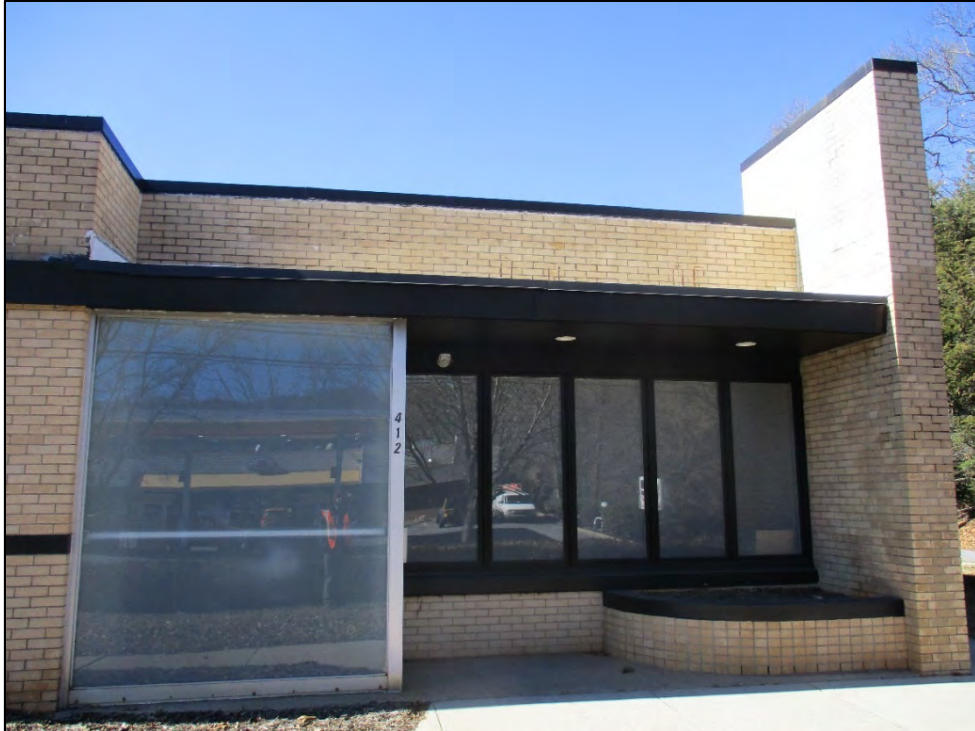
Former Western and Southern Life Insurance Company façade detail of the integrated canopy and altered entry, view to the west

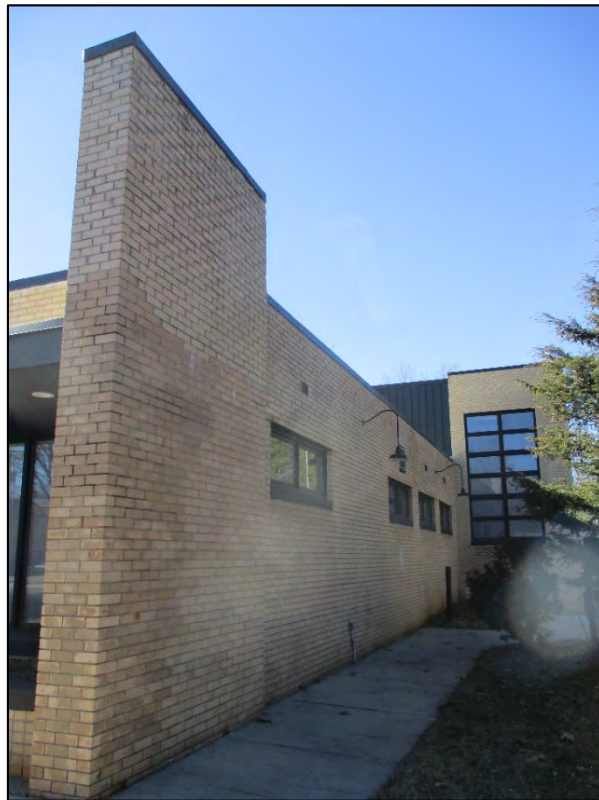
The north elevation faces King Street and includes paired aluminum awning windows over concrete sills. The ca. 2000 two-story addition extends beyond the northern plane of the historic office building. Though undertaken sympathetically in materials and style, the seam between the two is evident in the north elevation where two types of brick cladding are evident. The east facing elevation on the ca. 2000 addition includes a vertical set of six paired awning windows over a concrete sill. The rear (west) elevation of the addition is clad in brick and stucco panels and includes an aluminum service bay door and metal door with fixed light accessible via a poured concrete ramp under an aluminum framed canvas awning.

Former Western and Southern Life Insurance Company north elevation, view to the west

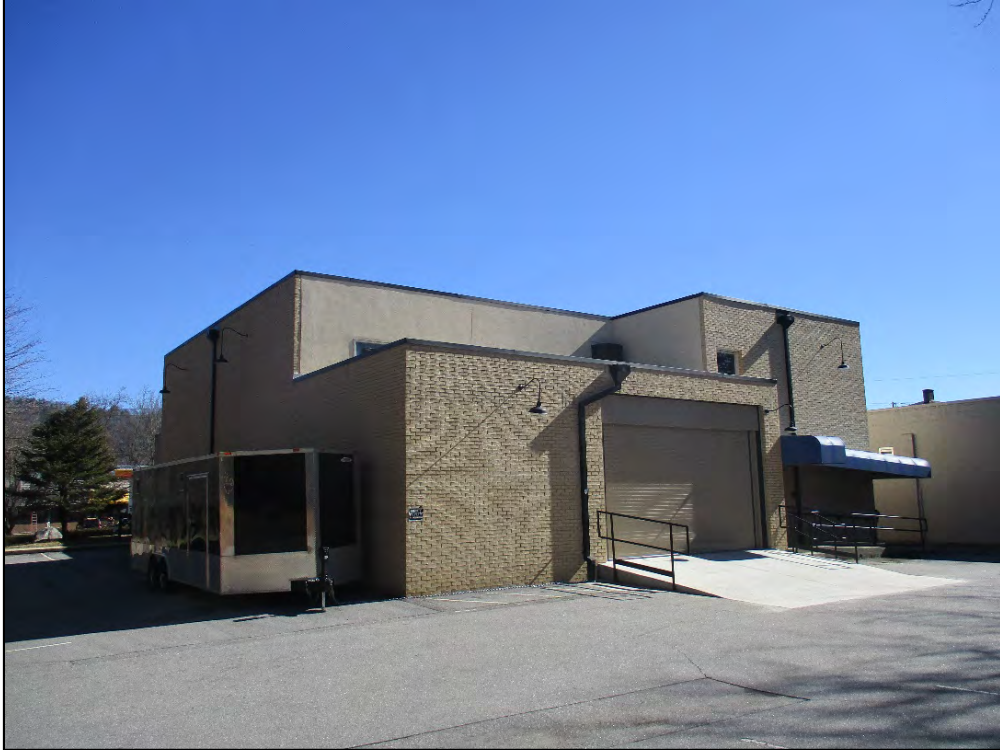
Former Western and Southern Life Insurance Company oblique view of rear (west) and north elevations, view to the southeast

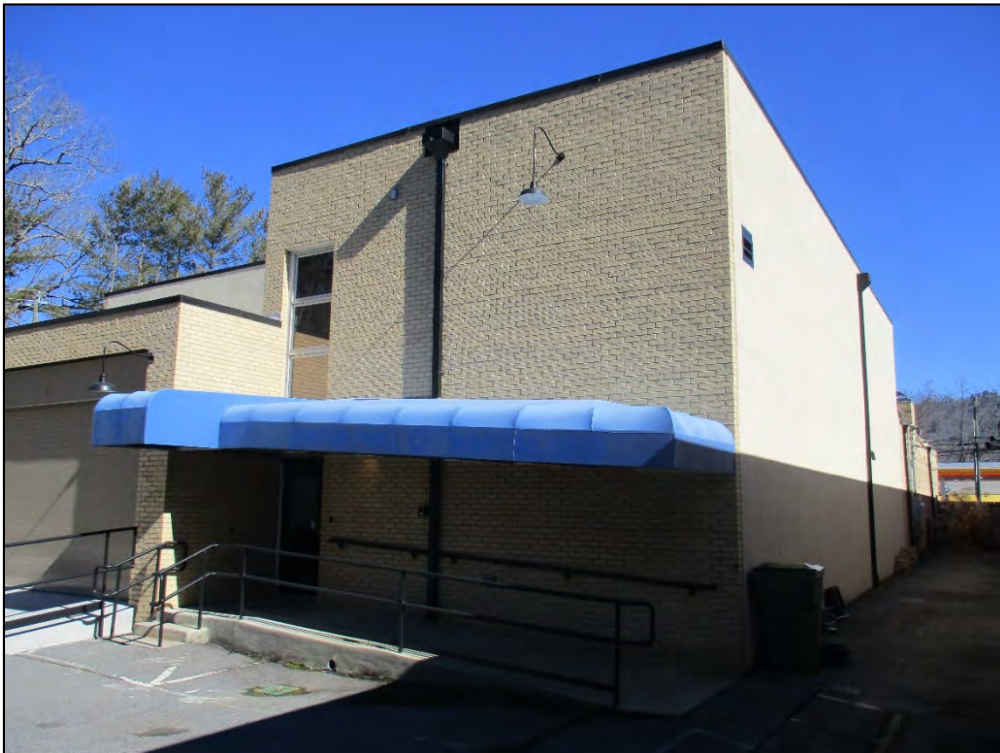
The south elevation also reveals the union of the two-story addition to the one-story historic office building. Stucco panels clad the two-story addition above a concrete block foundation and masonry veneer resumes at the one-story section of the building. An engaged brick veneer chimney is present in the historic building. Multiple small window openings original to the office building have been infilled with brick that resembles the brick cladding on the two-story addition.

Former Western and Southern Life Insurance Company oblique view of the rear (west) and south elevations, view to the east

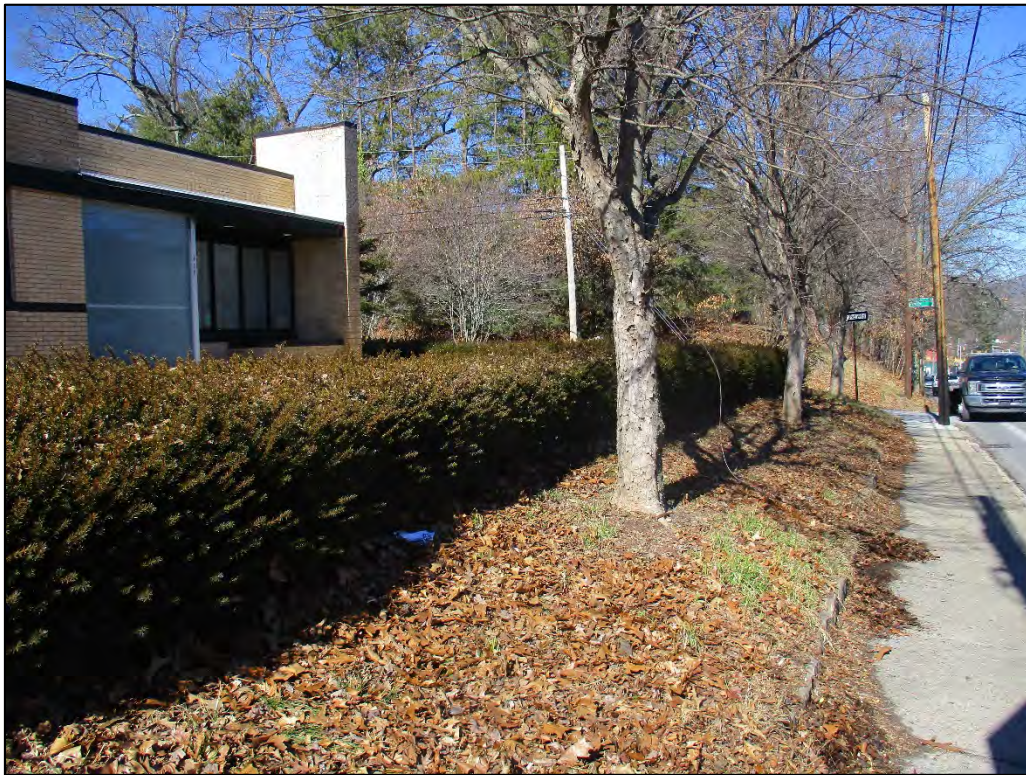
View to the north along the Merrimon Avenue curb. Note the granite curbing at the back of the sidewalk. The former Western and Southern Life Insurance Company visible at left.

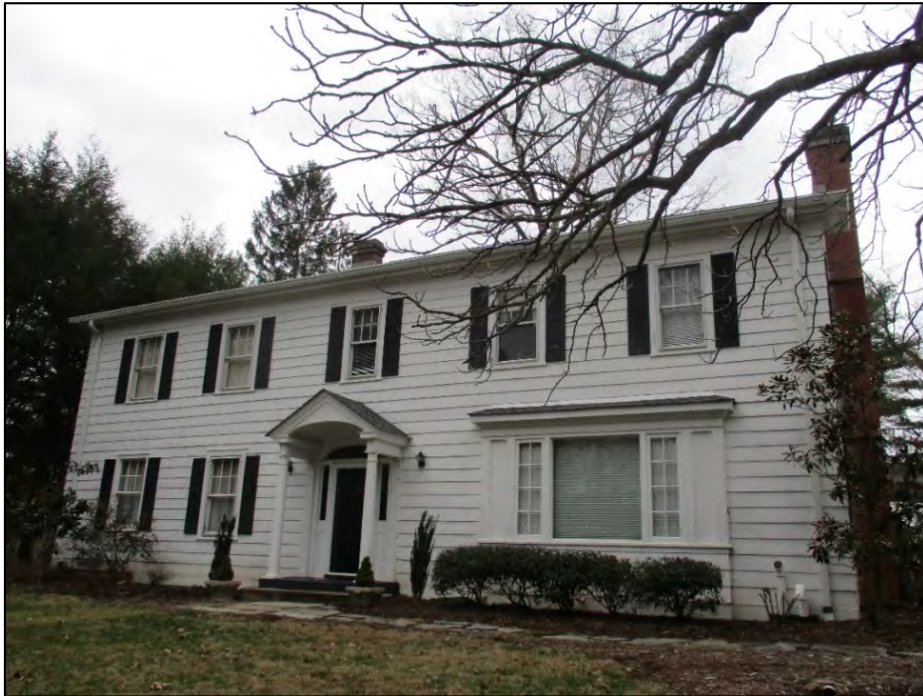
The east-facing façade has a small pediment portico supported by classical wooden columns. The front door is protected by a storm door and features sidelights and a fan light between pilasters. All of the windows except for one are six-over-one wooden sash. To the right (north) of the front door is a tripartite picture window with one large single pane and eight-light panes on either side. This window appears to be the result of a historic addition. Under the boxed eave is dentil molding, which is replicated under a small overhang above the picture window.

Rhoades House façade, view to the west

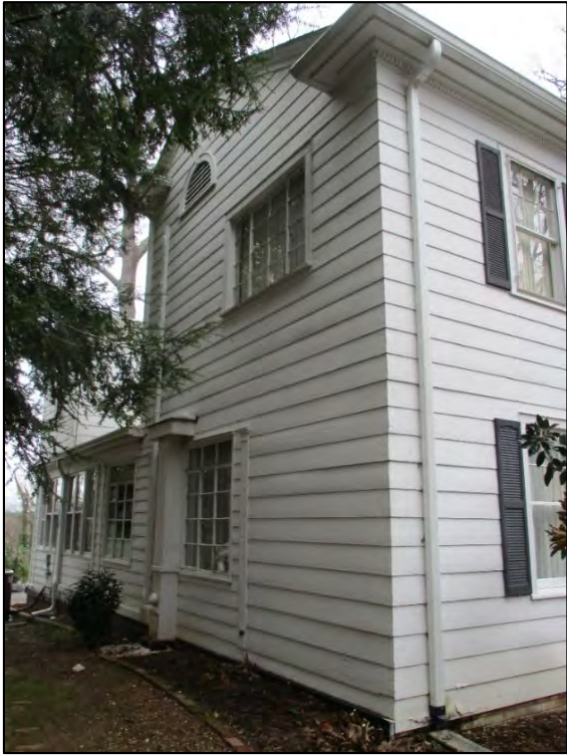
The south elevation of the house features two pairs of pilasters on the first level towards the rear (east) of the house with a fifteen-light steel casement window between. The remainder of the elevation includes a variety of windows among a series of additions to the first and second stories. The first-story windows include fifteen-light casement, one-over-one sash, and Craftsman-style cottage windows. The second story windows include a sixteen-light casement, a three-paned rectangular window, and a six-over-one sash. Dentil molding is repeated under the boxed eaves of both the first and second story levels and a half-round vent is located in the gable-end. Multiple projections are visible from this angle, and it appears that the original house was extended to the west (rear) with first and second story

Rhoades House south elevation, view to the northwest

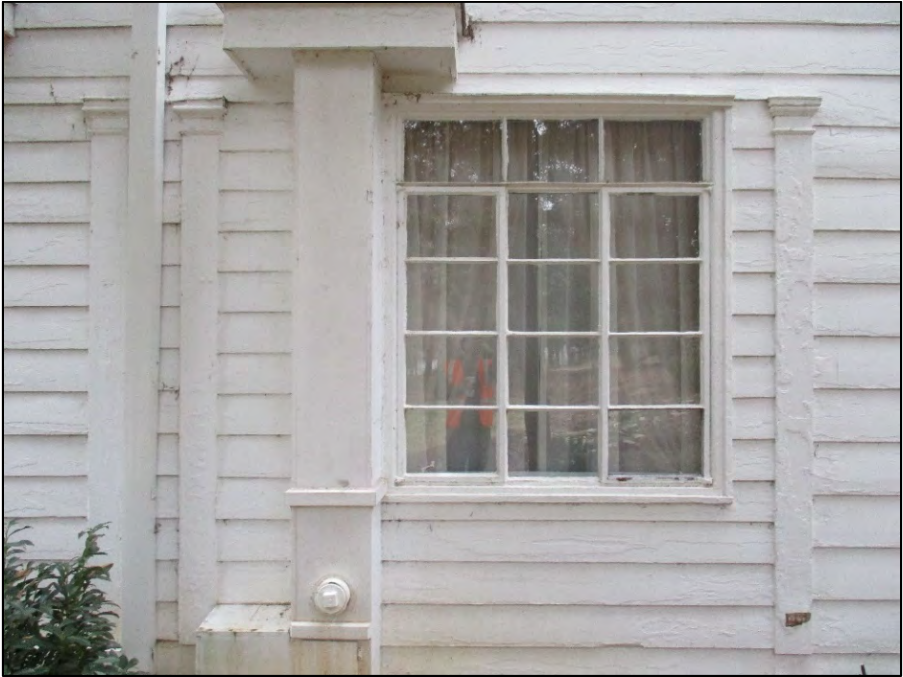
Rhoades House south elevation window detail. Also note pilasters in first story.

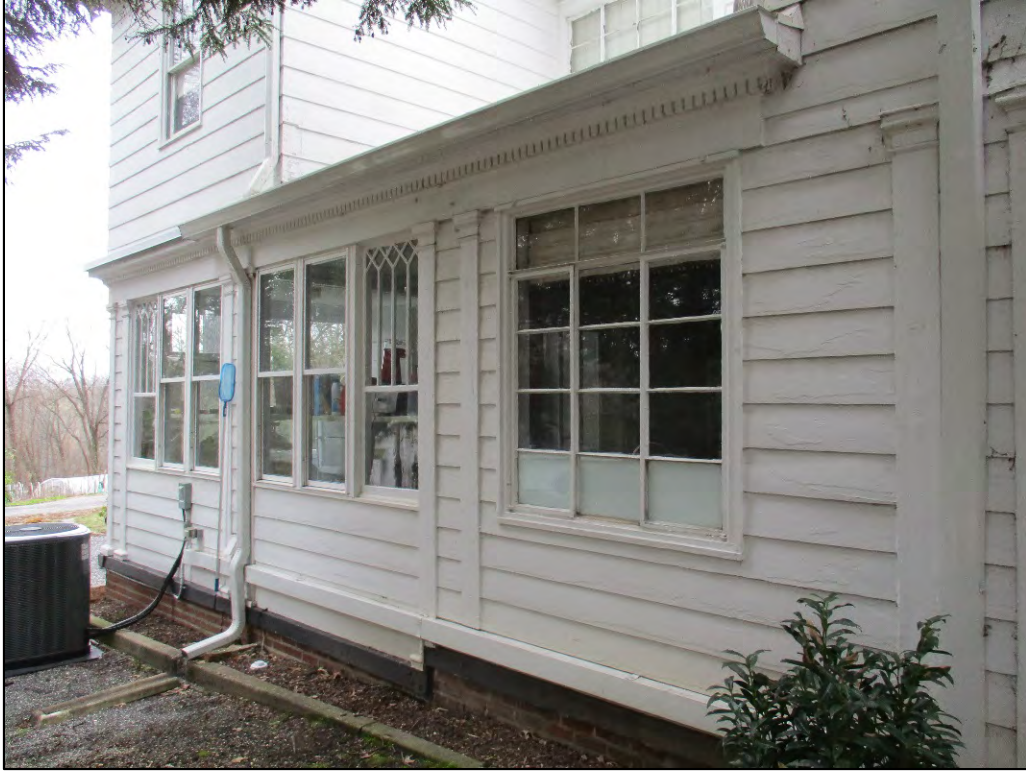
Rhoades House south elevation window detail, view to the northwest

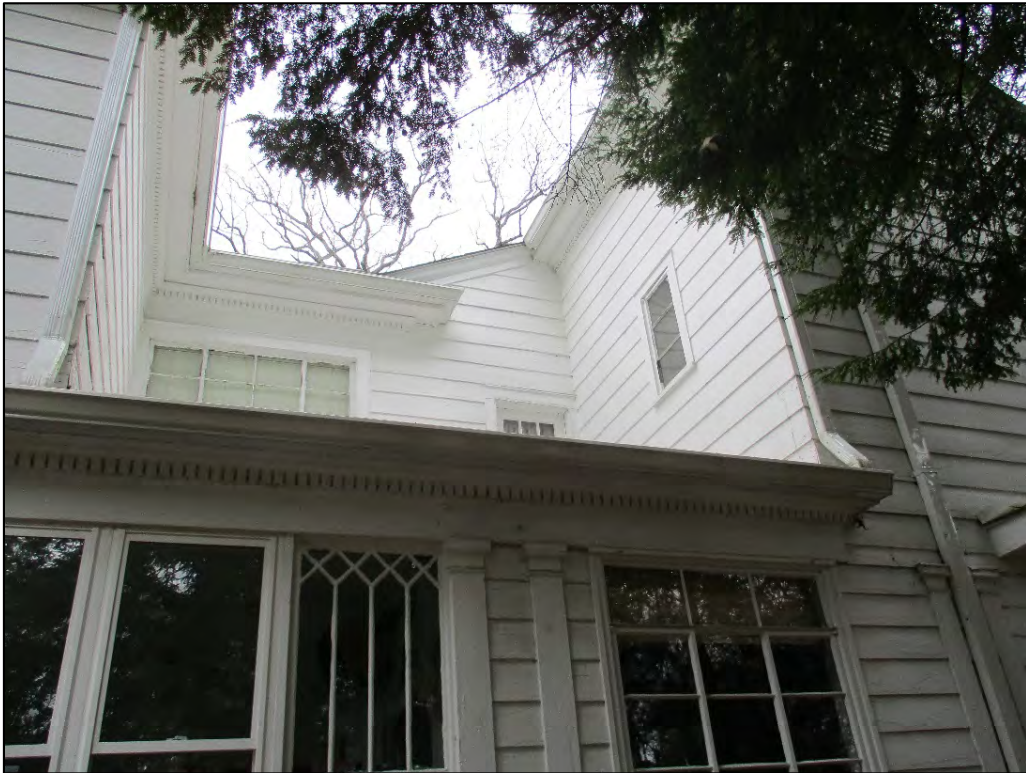
additions after 1954, as they do not appear on the 1954 Sanborn maps. A porch was enclosed on the first-story and several multi-gable additions are present in the second story. One addition included a French door with access to the first-story roof.

Rhoades House south elevation, second-story detail

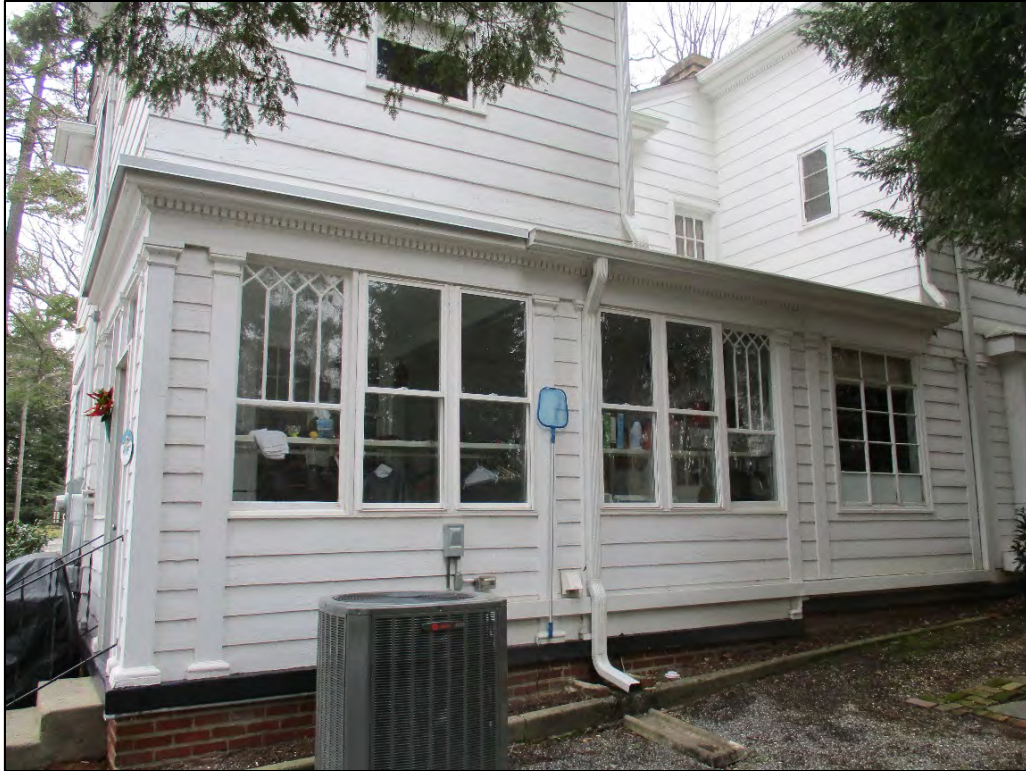
Rhoades House south elevation view to the northeast

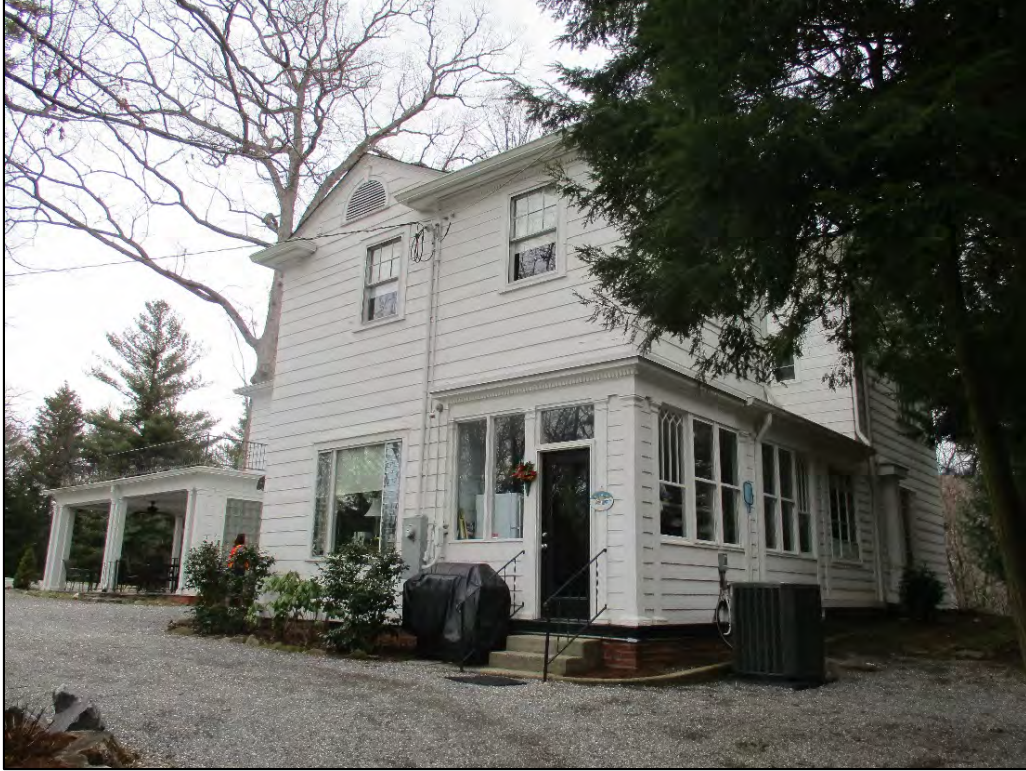
The rear (west elevation) contains the enclosed porch addition, a hipped roof addition above the enclosed porch, and a two-story gable ell addition north of the porch. The boxed eaves and cornice returns in the two-story gable ell addition feature dentil molding, consistent with the façade. A non-historic wood and glass door with transom window provides entry to the enclosed porch and serves as the primary entrance to the house. A second non-historic door with metal awning is present on the north side of the addition. The windows on the first story of this elevation include single pane rectangular windows, six-over-one wood sash, one-over-one sash, six and nine paned casements, and two picture windows. The tri-partite picture window in the gable ell addition contains a large, fixed center pane with louvered sidelights. The second picture window is just south of the rear patio and has a single fixed-pane, transom, and multi-pane sidelights. The second-story windows include six-over-one wood sash, one-over-one sash, and nine-, three-, and four-paned casements.

Rhodes House rear (west) elevation, view to the northeast

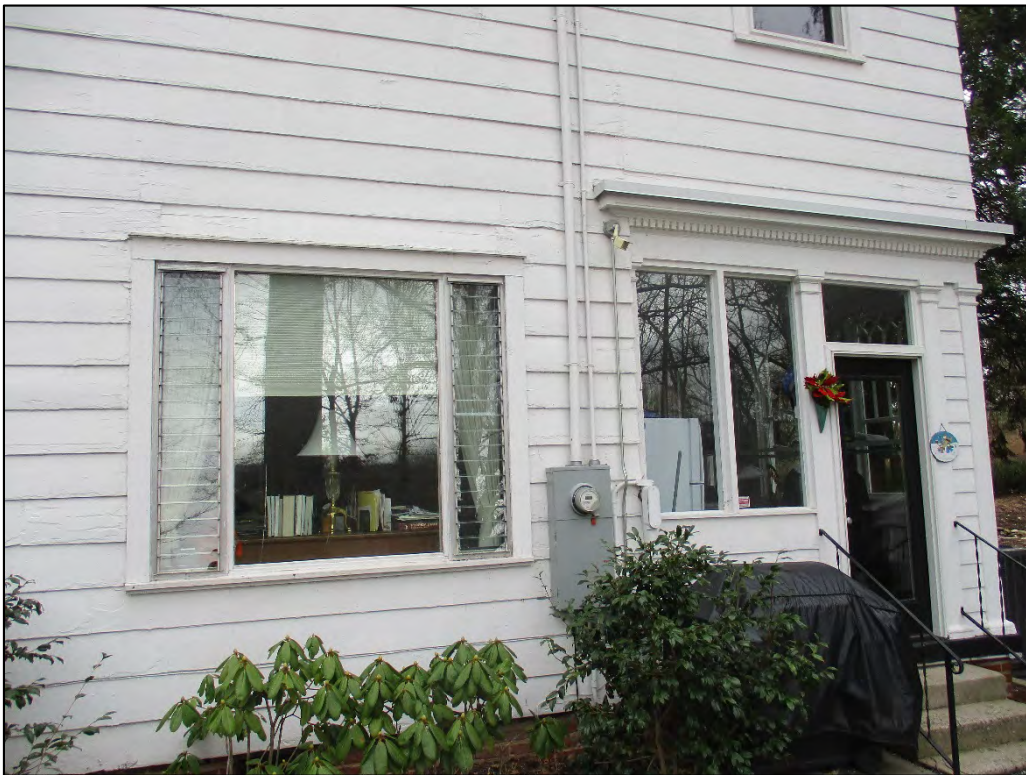
Rhodes House rear (west) elevation picture window and enclosed porch (at right), looking southwest

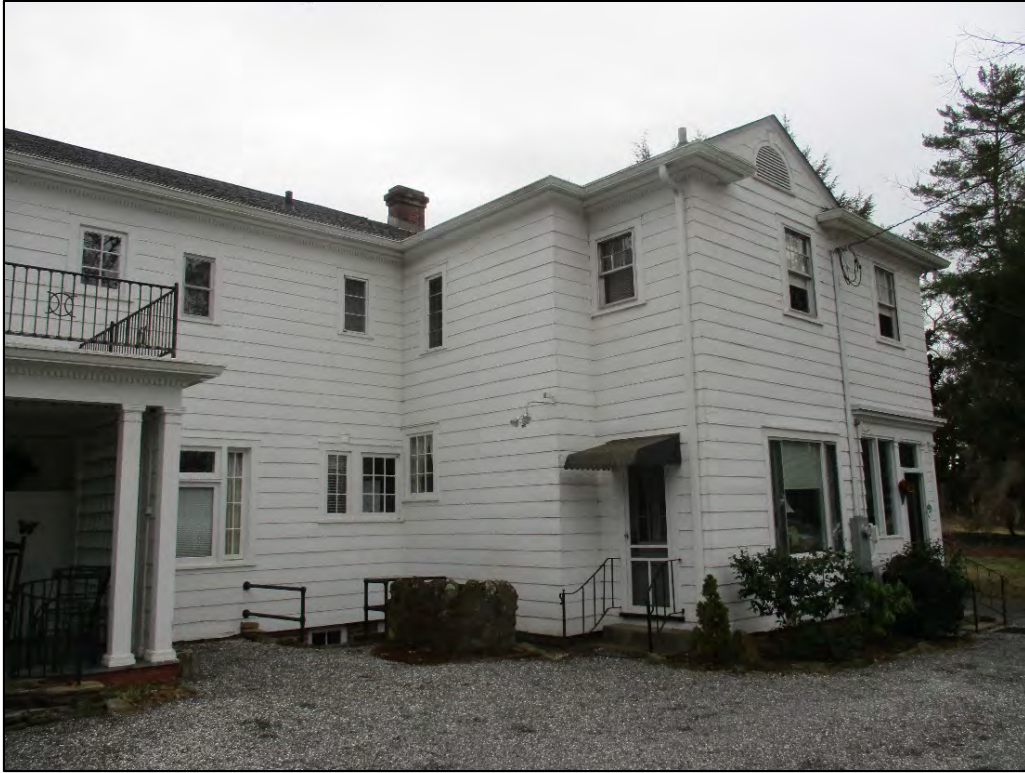
The historic wood and glass basement door is located towards the center of the rear elevation and is accessed by a brick-lined stairwell and concrete steps with metal pipe railing. A single four-paned wood casement window is adjacent to the basement door.

Rhodes House rear (west) elevation, view to the southeast

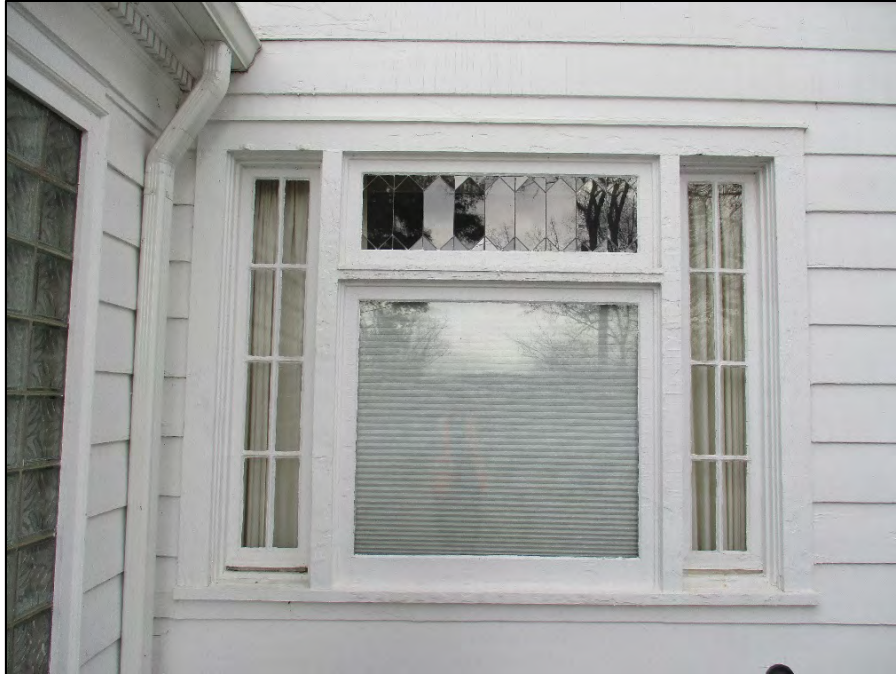
Rhoades House rear (west) elevation picture window detail

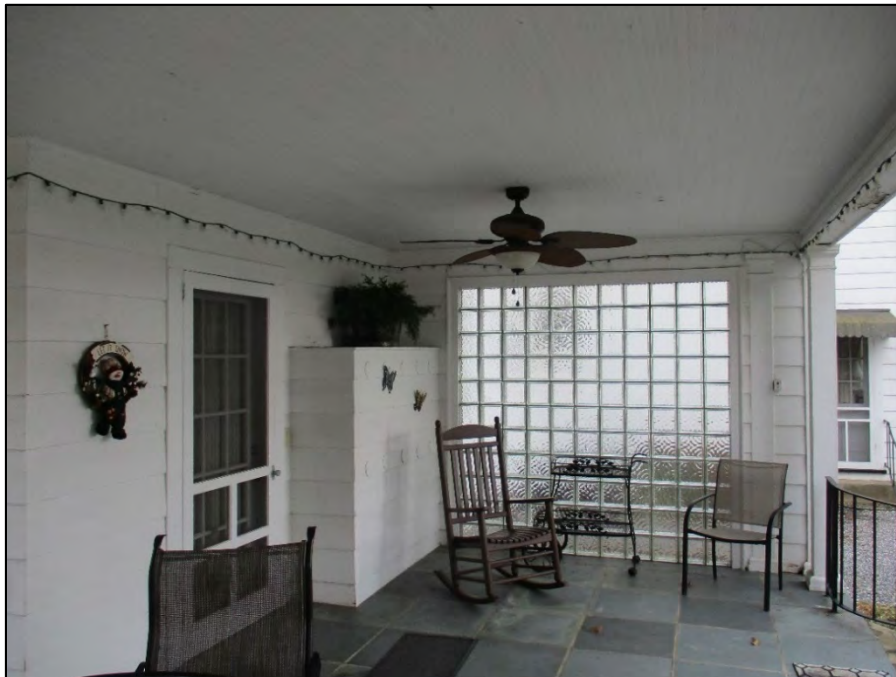
A covered patio on paired classical wood columns is attached to the northwest corner of the house with a French door connecting the two. The patio is approached by stone steps with curved iron railings and the floor is tiled. On the south side of the patio is a glass block wall. Above the patio is a balcony with wrought iron baluster that is accessible via a second-story door. Based on the 1954 Sanborn maps, it appears this patio was a later addition to the house.

Rhoades House rear (west) elevation porch detail, view to the south

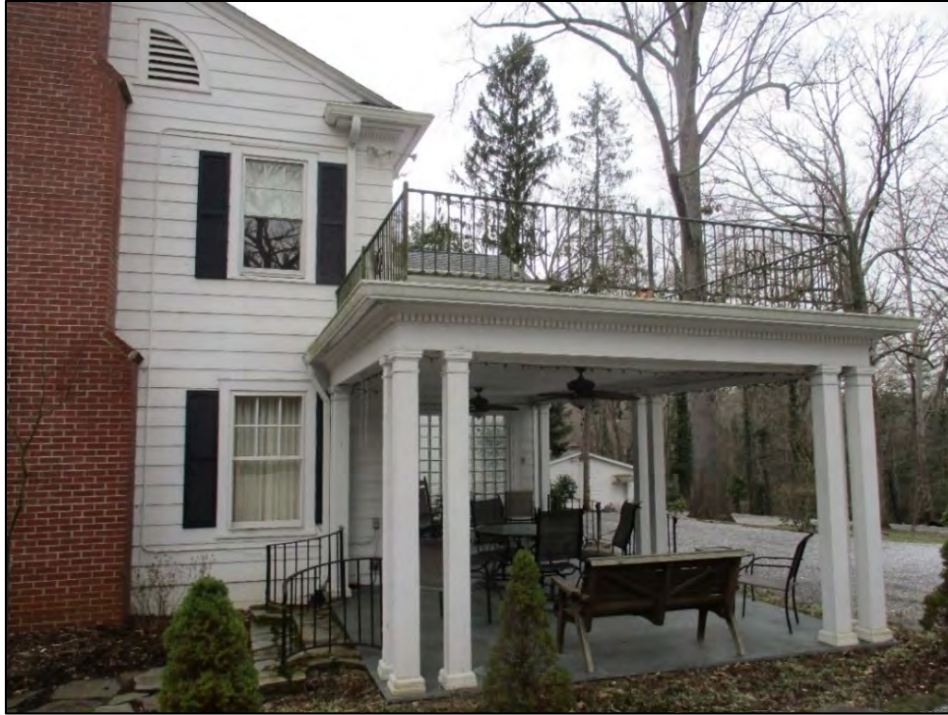
Rhoades House rear (west) elevation porch, view to the southwest

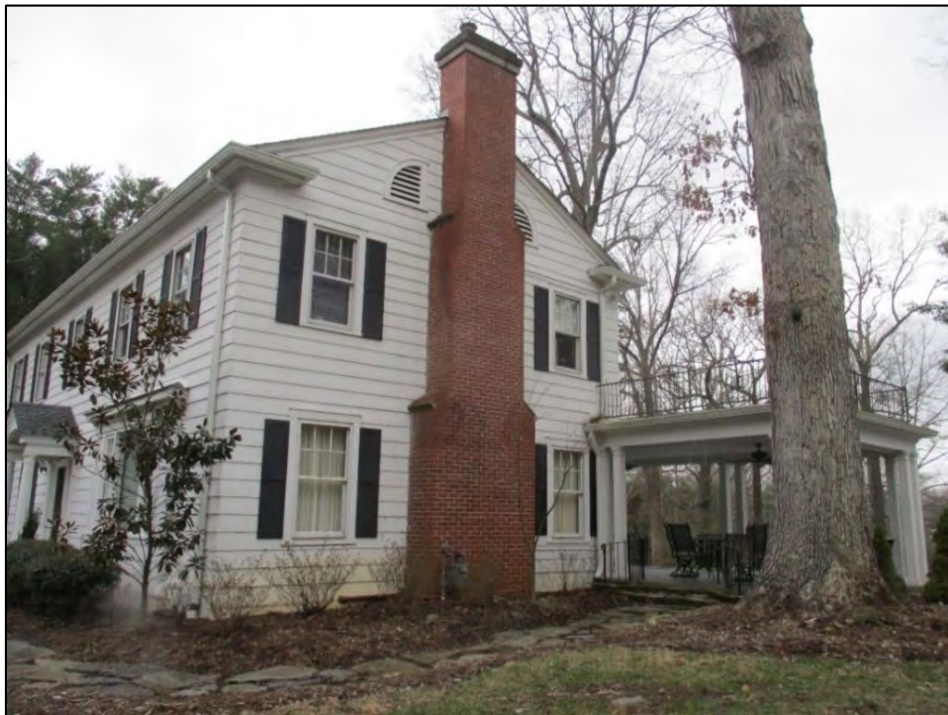
The north elevation of the house contains a large, double shoulder external brick chimney with concrete cap in the gable end. Two quarter-circular gable vents are located on either side of the chimney. The windows on this elevation are six-over-one sash. Dentil molding is present under the cornice returns.

Rhoades House north elevation, view to the southwest

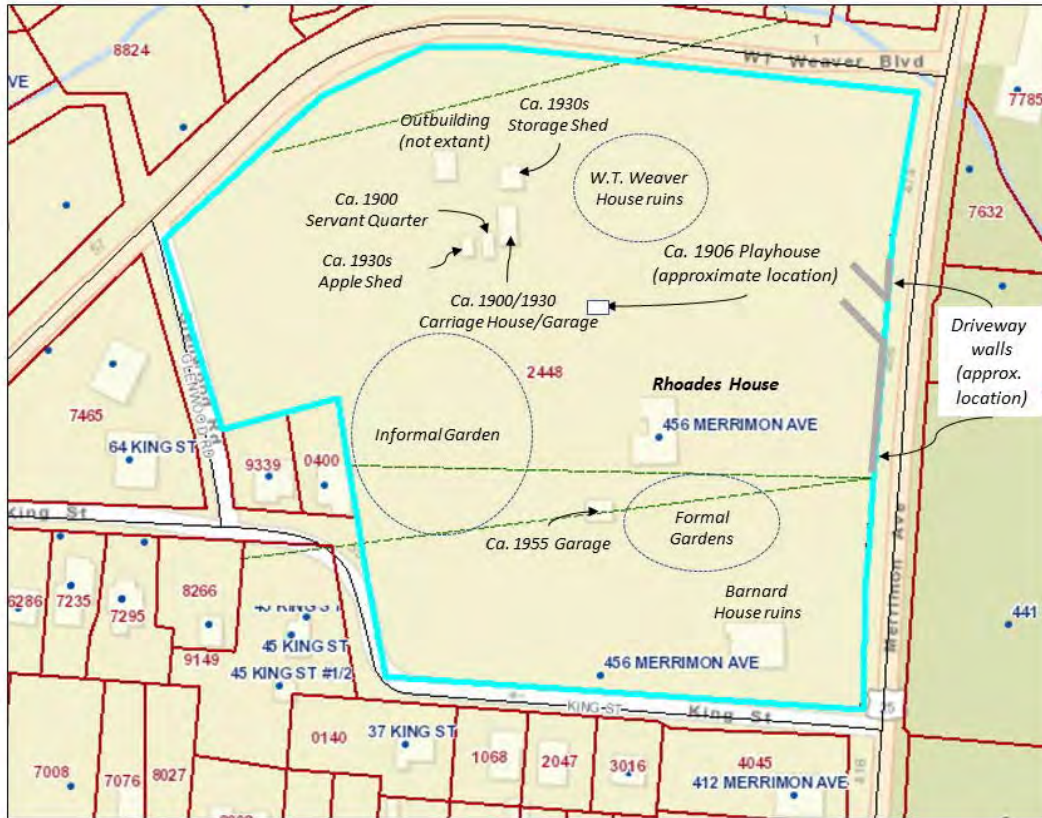
Multiple outbuildings are located on the grounds, including a ca. 1955 garage; a ca. 1906 children’s log cabin playhouse which belonged to Dorothea Rhoades when she was a child; a ca. 1900 carriage house with a later garage addition; ca. 1900 servant’s quarters; and two ca. 1930s storage sheds. The servant’s quarters, log cabin playhouse, and carriage house are located northwest of the Rhoades House and were historically associated with the W.T. Weaver House. The ca. 1955 garage is located to the southwest of the Rhoades House.

Rhoades House Site Plan (basemap courtesy of Buncombe County GIS)

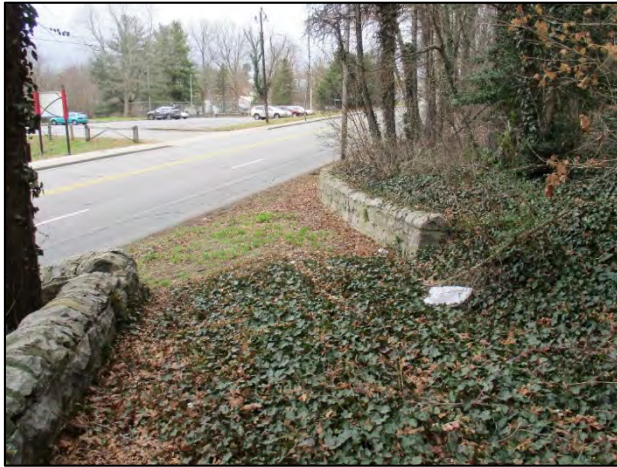
Rhoades House historic driveway alignment to Merrimon Avenue; view to the southeast

Historic aerials reveal the evolution of access to the property (Exhibit 15). In 1951, two entries to Merrimon Avenue were in place with the driveway approaching the house in a loop; the northern entry corresponds to the stone walls and the southern entry may have entered south of the stone wall, though no evidence (e.g., grading) was observed of this entry. A distinct hedgerow paralleled the south side of the southern driveway. At this time, a driveway also accessed King Street to the south with access to the Barnard House and a drive continuing to the north to tie into the Rhoades House at the center of the property and the W.T. Weaver House to the north. This is consistent with Mrs. Purdue's and Mrs. Fox's recollections of the property. The driveway to W.T. Weaver Boulevard is clearly depicted in the 1975 aerial, and may predate that. (Note: W.T. Weaver Boulevard was not completed until the early 1960s).

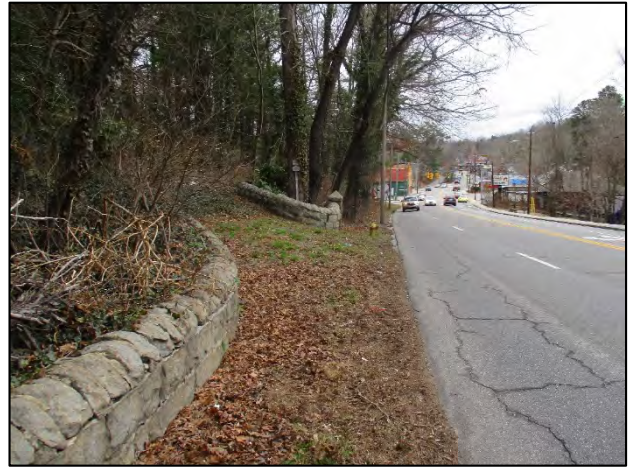
Rhoades House historic driveway entrance from Merrimon Ave; view to the north

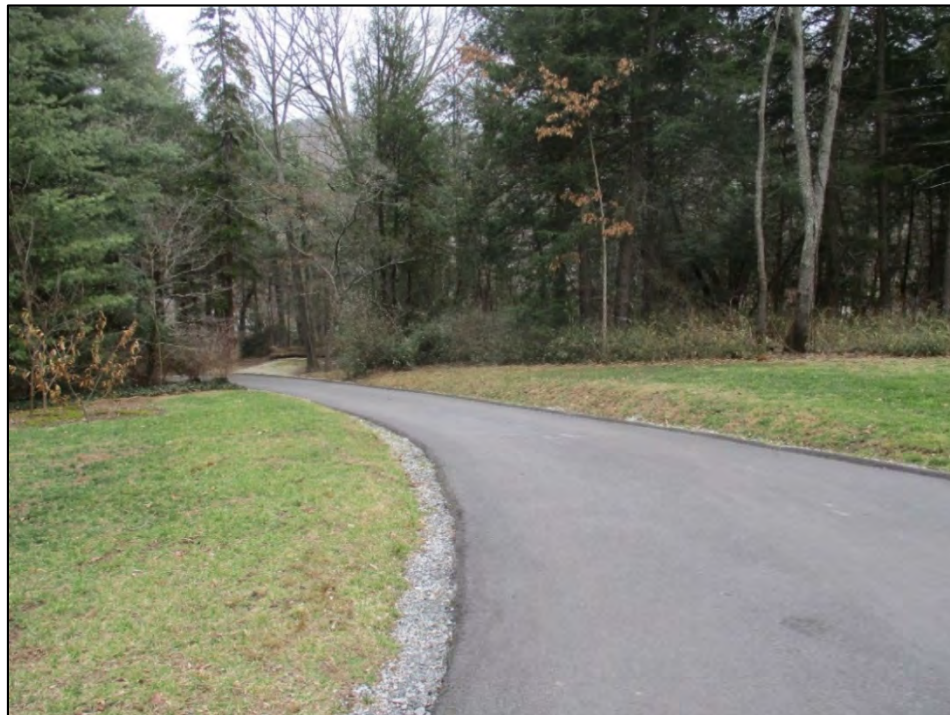
Rhoades House current driveway for public access to/from W.T. Weaver Boulevard, view to the northeast

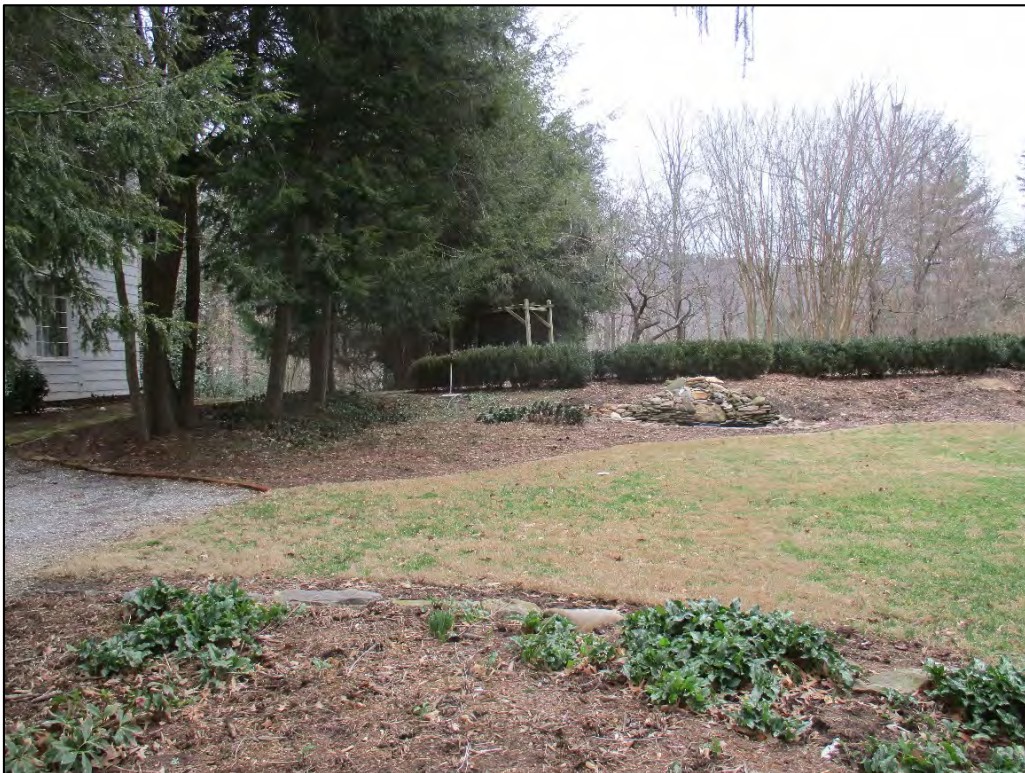
Rhoades House formal gardens and stone fish pond, view to the east. A Greek Key hedgerow traverses the height of land directly east of the fish pond.

The 2011 survey attaches a 1950s date to the formal garden southeast of the Rhoades House and described a hedge of boxwoods in a Greek Key pattern which was surrounded by herbs and flowers. Below the hedges was a small rock garden that gave way to a waterfall and fish pool. However, based on interviews and a review of historic aerials (see Exhibit 15), this episode could not correspond with the current formal garden southeast of the Rhoades House as the area was crisscrossed by driveways into the mid-1970s. It is possible the garden described in 2011 was established elsewhere on the property in the 1950s; however, these features were not observed elsewhere on the property. It seems likely the garden referenced in the 2011 survey corresponds to a later date, in agreement with interviews. Mrs. Fox attributes the formal garden with her sister Sally’s residence, resulting in a mid-1970 establishment, at which time a tennis court was removed or covered by the grassed lawn and surrounded by native flowers, the stone barbeque, and the small fish pond; the Greek Key hedgerow was also installed at this time. Mrs. Purdue recollects the tennis court at this location in the late 1940s, and also stated that it was removed after Verne Jr. moved in. A rose garden was mentioned by Mrs. Fox and Ms. Symmes somewhat separated from the house, south of the formal garden; no evidence of a rose garden was observed during survey (in February 2018).
