November 9, 2018

MEMORANDUM

SUBJECT: Historic Structures Survey Report, Merrimon Avenue & WT Weaver Boulevard Intersection Improvements. U-5781, U-5782, PA 17-04-0023, Buncombe County, ER 18-0102

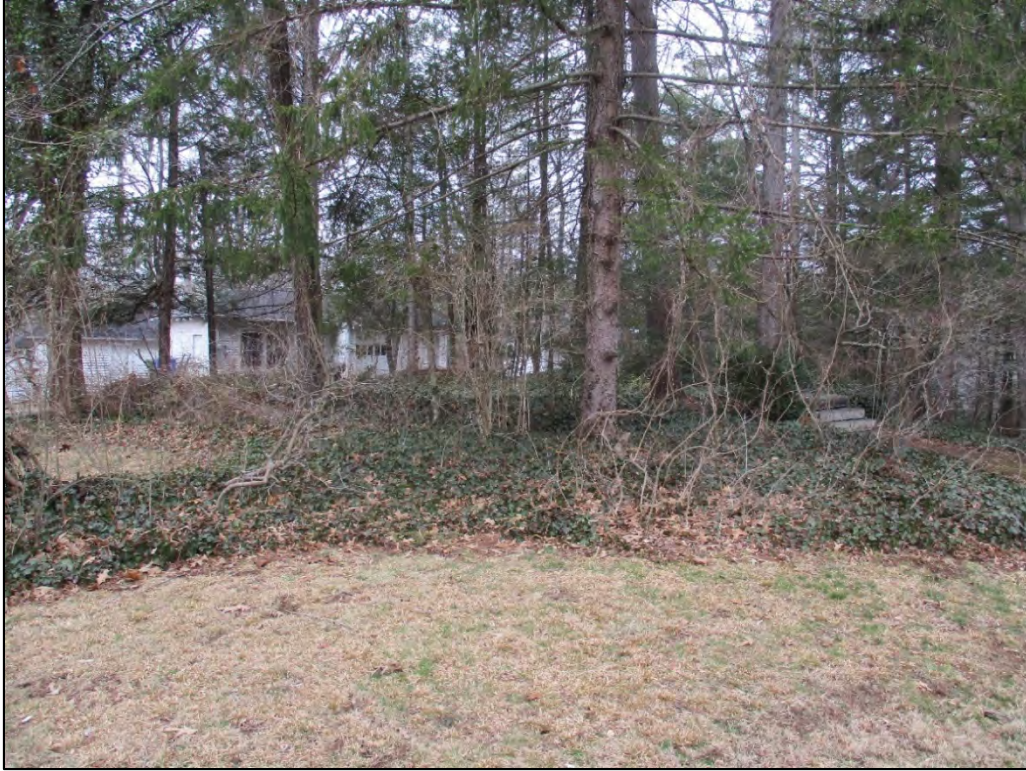
Rhoades House, W.T. Weaver House foundation on north end of the property, view to northwest

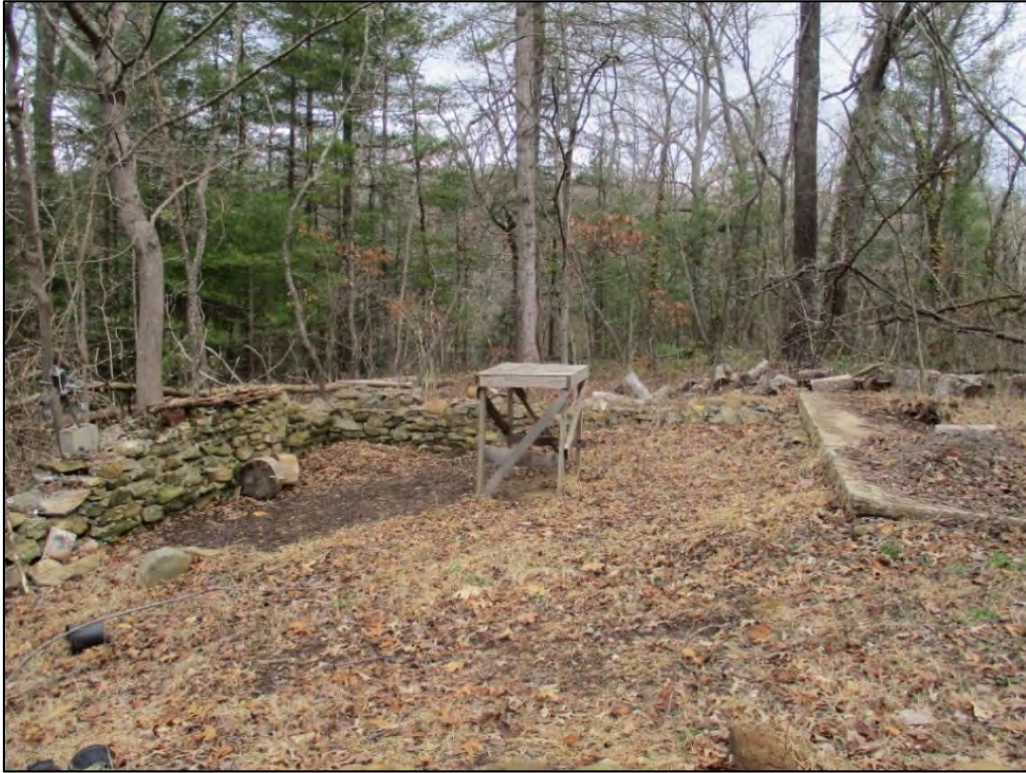
Rhoades House, likely barn ruins on northwest part of property, view to the north

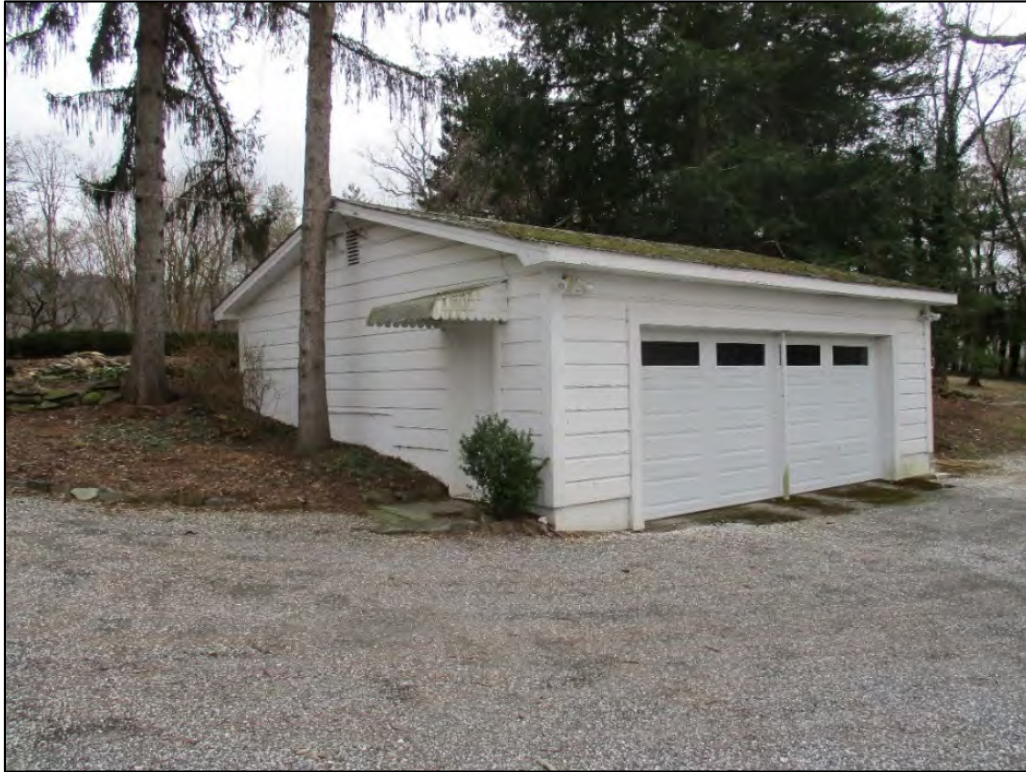
The two-car garage located to the southwest of the Rhoades House features a side gable roof with asphalt shingles, German siding, and a concrete block foundation. The two garage doors are non-historic vinyl and have two horizontal windows on each door. A door covered by a metal awning is present on the north elevation. The garage structure does not appear on the 1954 Sanborn maps and based on materials was given a construction date ca. 1955.

Rhoades House garage, view to the southeast

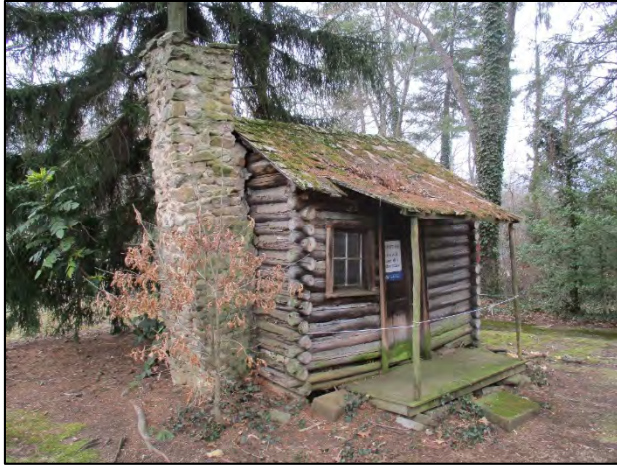
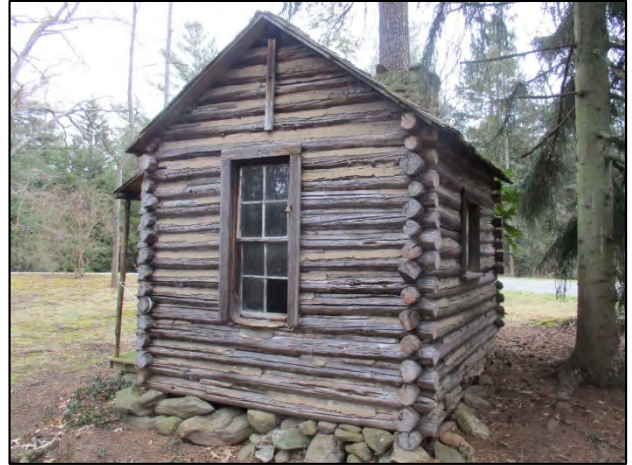
The log cabin playhouse is a small one-room structure with stone chimney, stone foundation, and side gable wood shingle roof. According to a 1971 newspaper article, the cabin was built by W.T. Weaver for his daughter, Dorothea as a Christmas gift around 1906.¹⁶ In the front of the cabin is a small shed porch supported by thin, wood columns. A wood door is located off the porch with a four-pane window immediately adjacent. A wood four-over-over sash is located on the west and south elevations, and the external stone chimney is located on the east elevation of the cabin.

Rhoades House log cabin playhouse, view to the southwest

Rhoades House log cabin playhouse view to the northeast

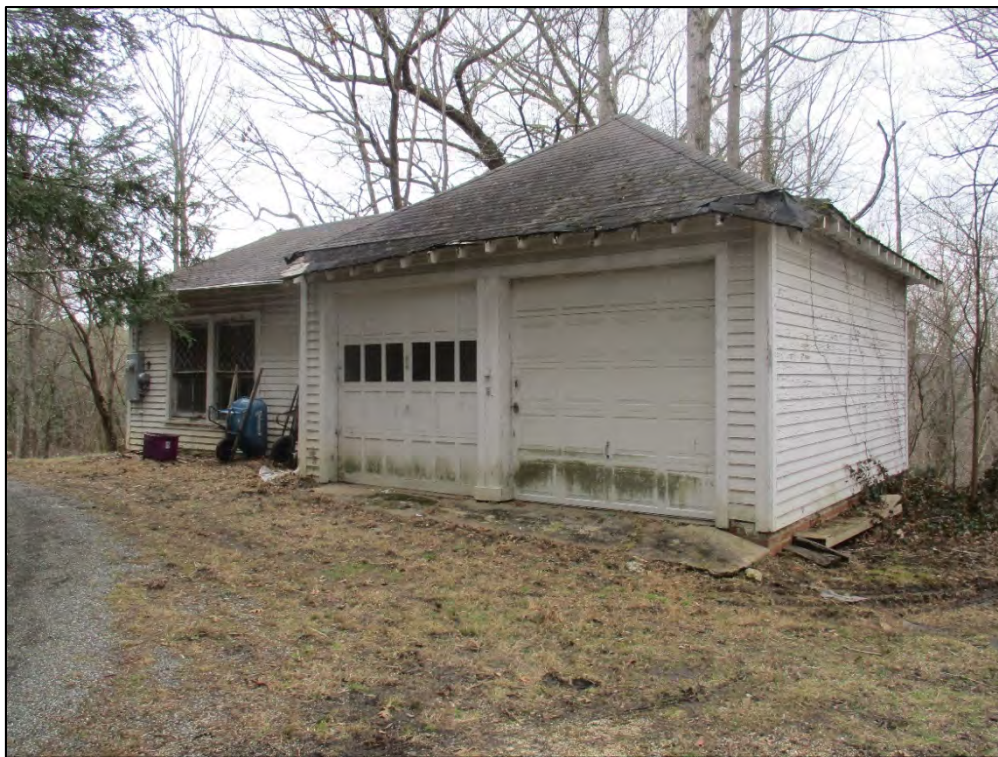
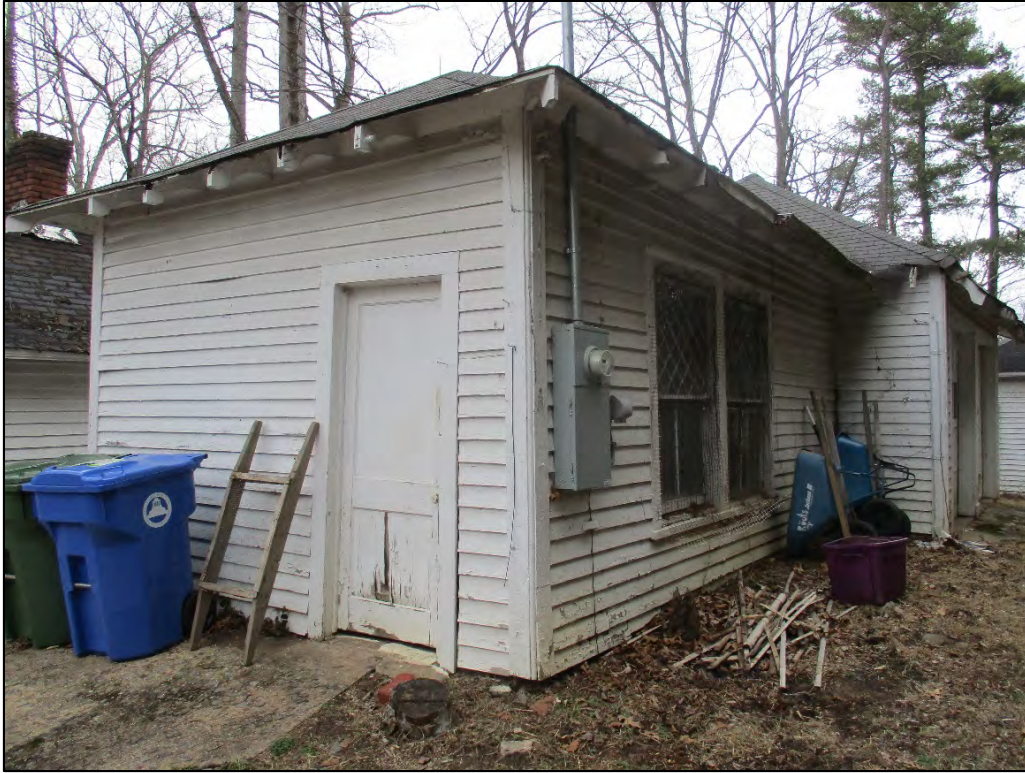
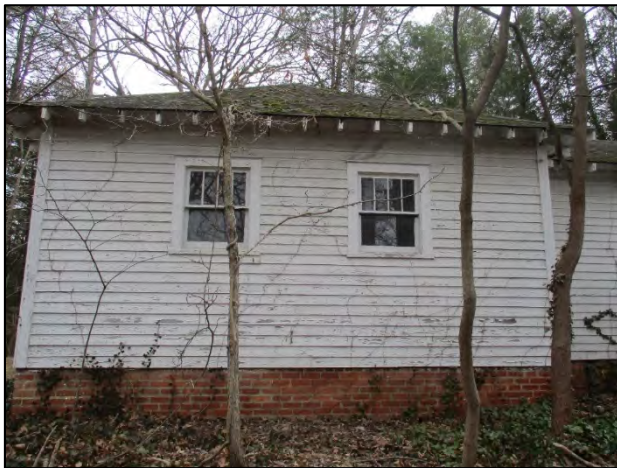
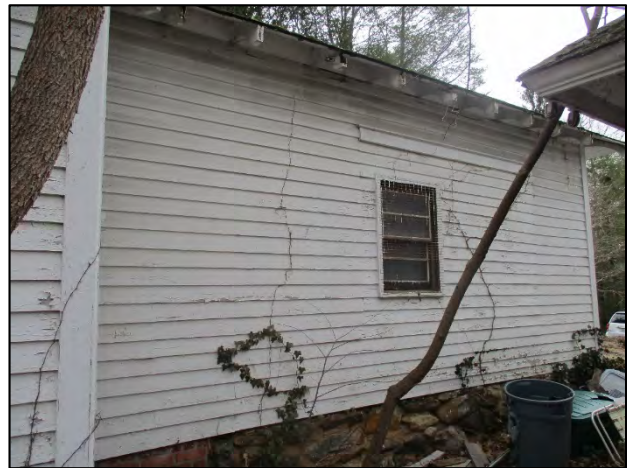
The carriage house is a hipped-roof structure with a pyramidal-roofed garage addition to the north. Both the original part of the building and the addition feature exposed rafters, corner boards, and weatherboard siding. The original structure is set on a stone foundation and features two cottage-style sash windows, wood panel door. The rear (west) of the carriage house features two horizontal sash replacement windows, which appear to have been an attempt to enclose a former, larger opening. The garage addition features a continuous brick foundation and two garage doors—one appearing to be historic, the other a replacement. The rear (west elevation) of the garage addition features two four-over-one Craftsman-style windows.

Rhoades House carriage house east elevation, view to the west

Rhoades House carriage house east elevation, view to the northwest

Rhoades House carriage house west elevation, view to the east

Rhoades House carriage house west elevation, view to the southeast

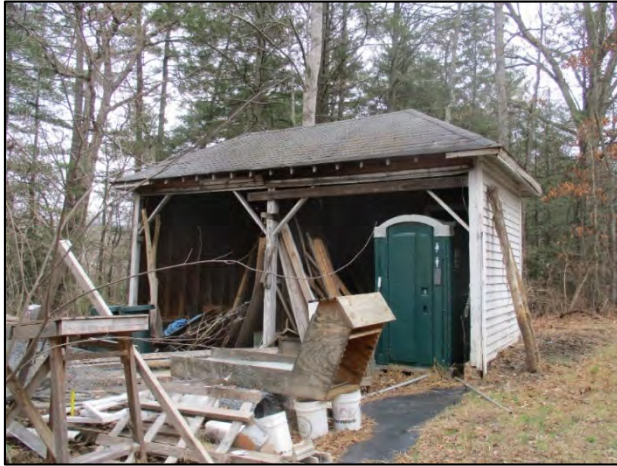
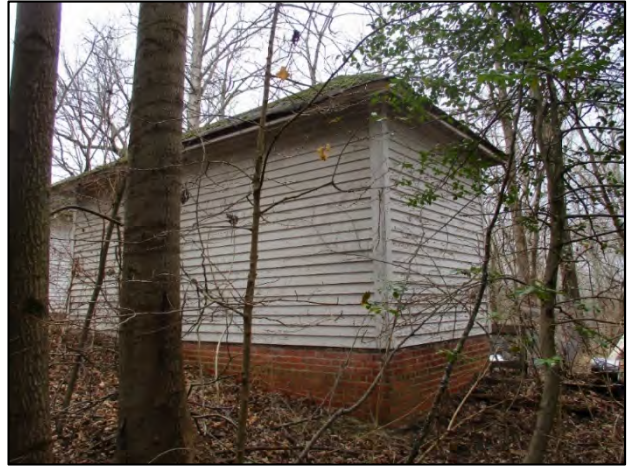
A hipped-roof storage shed is located to the north of the carriage house. The shed features weatherboard siding, corner boards, a continuous brick foundation, and exposed rafters. The western side of the shed is open and has a wooden “Y” shaped support in the center. This building was not present on the 1925 Sanborn maps and, based on interviews, materials and similarities to the garage

Rhoades House storage shed west elevation, view to the east

Rhoades House storage shed oblique view of north and east elevations, view to the southwest

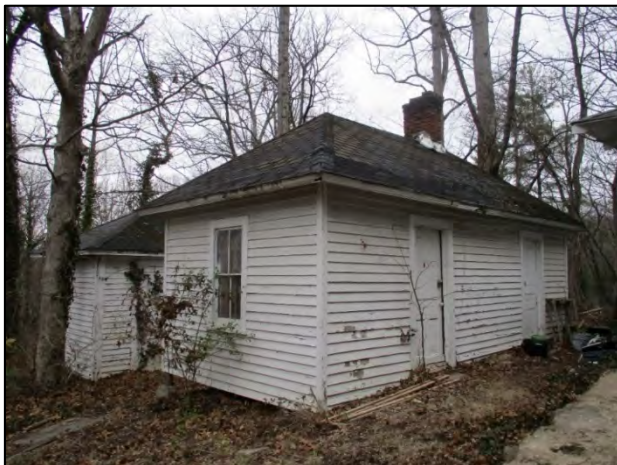
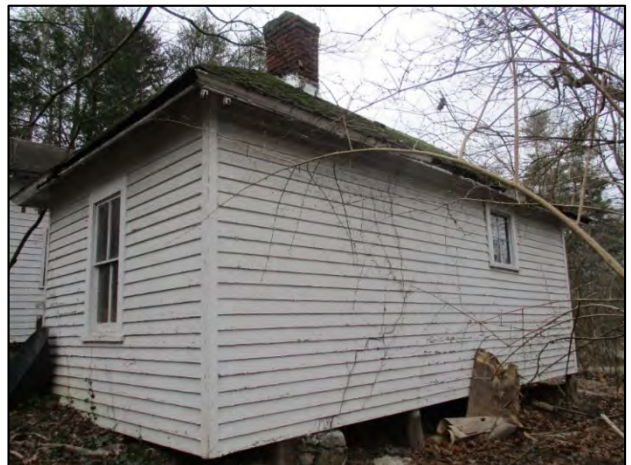
A small hipped-roof building with weatherboard siding and corner boards on stone piers is located directly west of the carriage house. The east elevation has two wood panel doors and an internal brick chimney is located in the ridgeline of the roof. The windows on the north and south elevations are two-over-two sash; in the rear of the building (west elevation) there is a small four-paned window. This building appears on the 1925 Sanborn maps with “D”, indicating a dwelling (refer to Exhibit 8). Landon Fox indicated that the building housed a gardener by the name of Seemster in the late 1940s and early 1950s. Based on materials and association with the late nineteenth century W.T. Weaver House (no longer extant), the servant quarters was given an approximate construction date of ca. 1900.

Rhoades House oblique view of servant quarters south and east elevations, view to the northwest

Rhoades House oblique view of servant quarters north and west elevation, view to the southeast

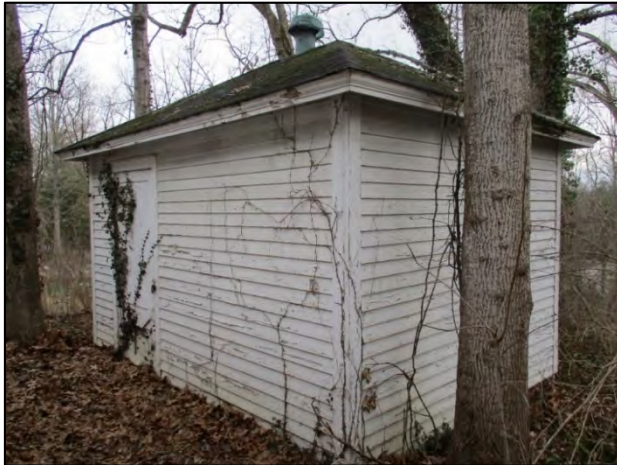
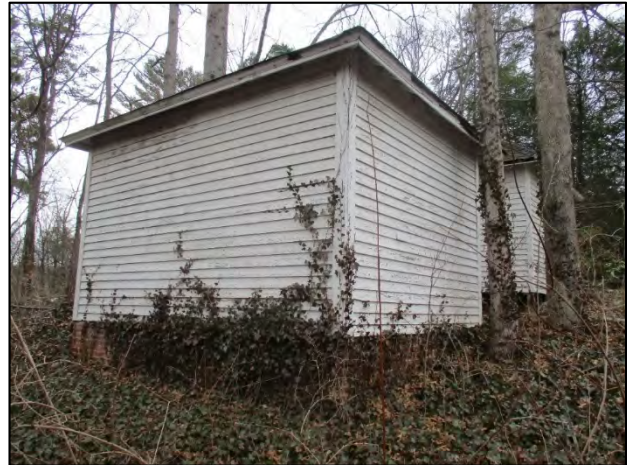
A second storage building is located behind (west of) the servant quarters and has no windows and a small copper chimney pipe in the roof. The building has a hipped-roof and a continuous brick foundation. A wood panel door is located on the east elevation. This building does not appear on 1925 Sanborn maps and based on interviews and materials was given a construction date of ca. 1930. Based on interviews with Carter Eagle and Mrs. Purdue, this building was known as the apple shed, used for the canning and storage of apples. Interviews did not conclusively indicate apples were cultivated on site, and the field survey did not identify apple trees on the property.

Rhoades House oblique view of Apple Shed north and east elevations, view to the southwest

Rhoades House oblique view of Apple Shed south and west elevations, view to the northeast

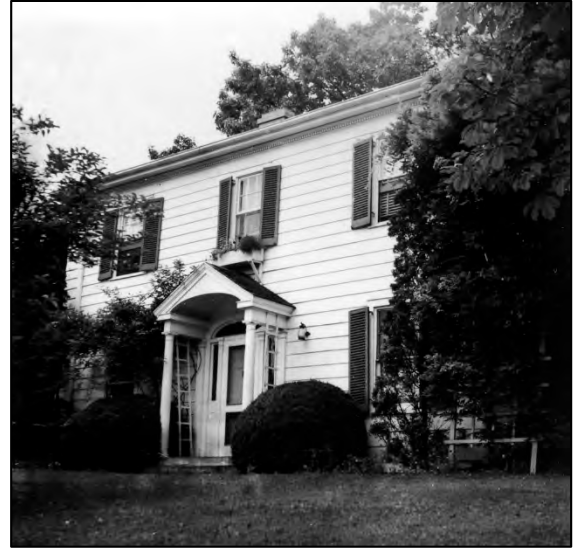
Exhibit 14. Rhoades House ca.1940. Courtesy of UNCA. Though partially obstructed by the tree, note the absence of the picture window with overhang.

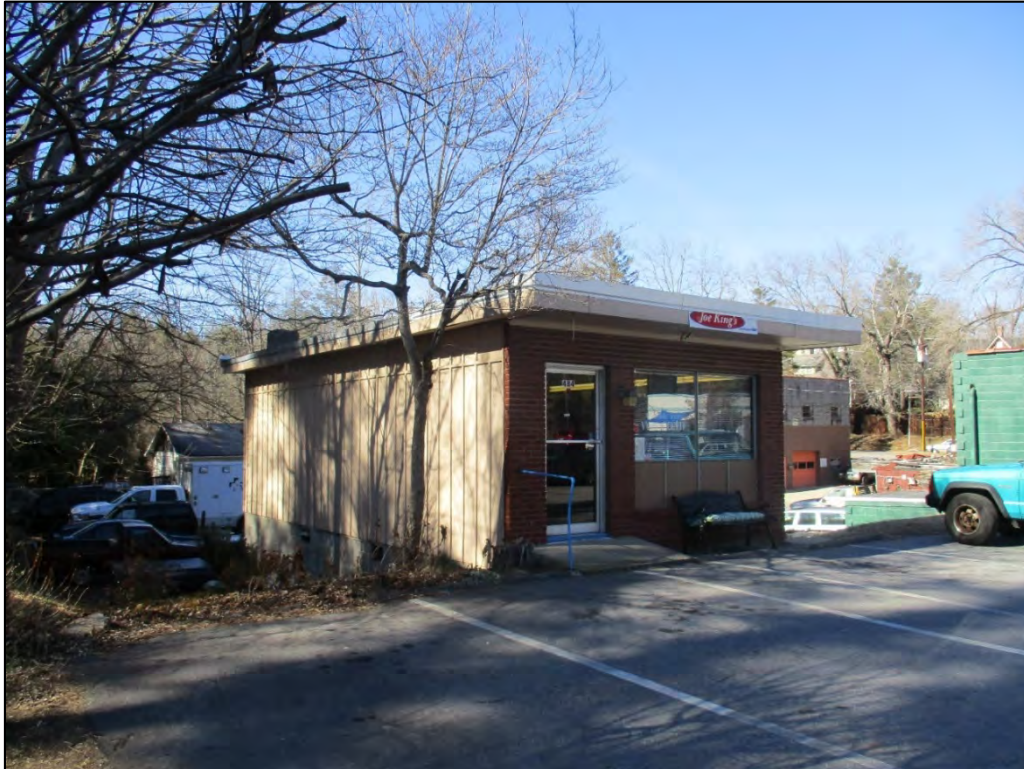
King's Barber Shop oblique view of the façade and south elevation, looking northwest

The resource is a simple, 16 x 36-foot, rectilinear plan commercial building. The building employs balloon construction on a concrete block basement, and is clad with plywood and batten siding under a flat roof. The façade (east facing storefront) is clad in a brick veneer and consists of a glass door and paired aluminum-framed single-pane, plate glass windows with the lower portion of the windows filled with wood. The flat roof projects over the façade forming a full-length canopy. The eaves are enclosed with plywood, and the roof is framed with aluminum.

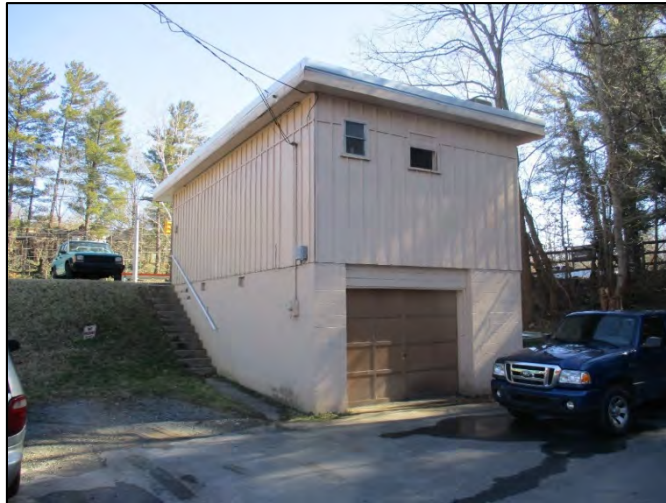
A poured concrete stairway traverses the north elevation to allow access to the rear of the building via a concrete sidewalk. Aside from four vents in the concrete block basement, there are no openings on the north or south elevation. A non-historic PVC handrail is affixed to the north elevation along the stairway. The rear elevation consists of a wood garage door in the basement, accessible via an alley from Chatham Road. Two small windows are present on the main floor, including a two-light aluminum awning and a fixed-pane window partially covered with plywood.

King's Barber Shop oblique view of the rear (west) and north elevations, looking southeast

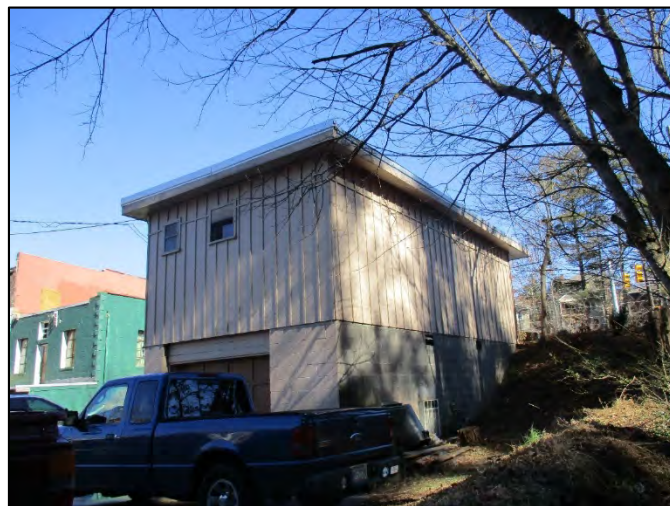
This property is setback from Merrimon Avenue by approximately 40 feet and parking is available along the façade. Undeveloped lots to the north are also utilized for parking by the property. Some landscaping is present at the south extent of the parking lot. The terrain is steeply sloping to the west so that the full-length basement is nearly completely exposed on all but the façade. The slope between this property and Keith's Super-Cleaners is grassed. Reed Creek borders the parcel to the south, and the stream banks are vegetated with some grass between the stream and the south elevation. The alley traverses the west side of the commercial block and terminates behind the property, before the creek.

King's Barber Shop oblique view of the rear (west) and south elevations, looking northeast

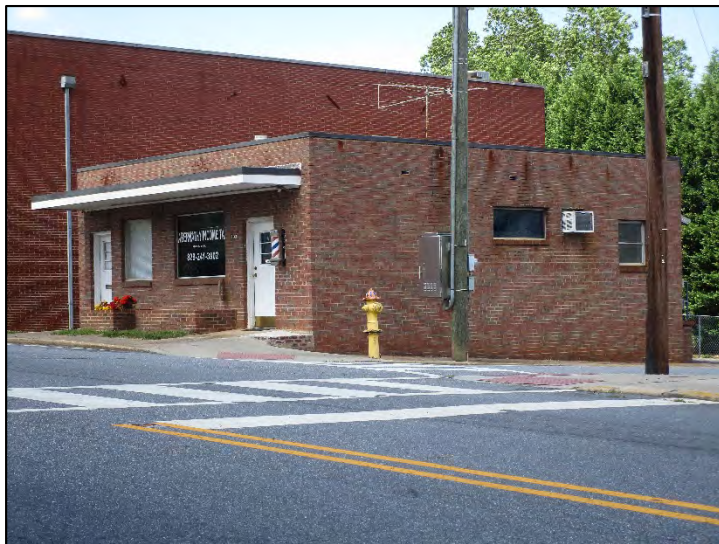
Exhibit 20. Grady’s Barber Shop, 100 N. Main Street, Catawba

The two-bay, flat-roof asymmetrical ca. 1962 Grady’s Barber Shop (CT0226) at 100 N. Main Street in Catawba, Catawba County is a plain brick-clad 27 x 32-foot building (Exhibit 20). Two flush wood doors with three horizontal glass panes are located near either side of the façade with two fixed pane windows between. Brick planters are incorporated in the design and located directly below the windows. A flat canopy extends from the roofline on the façade covering all openings. The rear elevation includes two doors located on either side of the elevation and accessed by a continuous brick and concrete porch that is covered by an attached shed canopy.

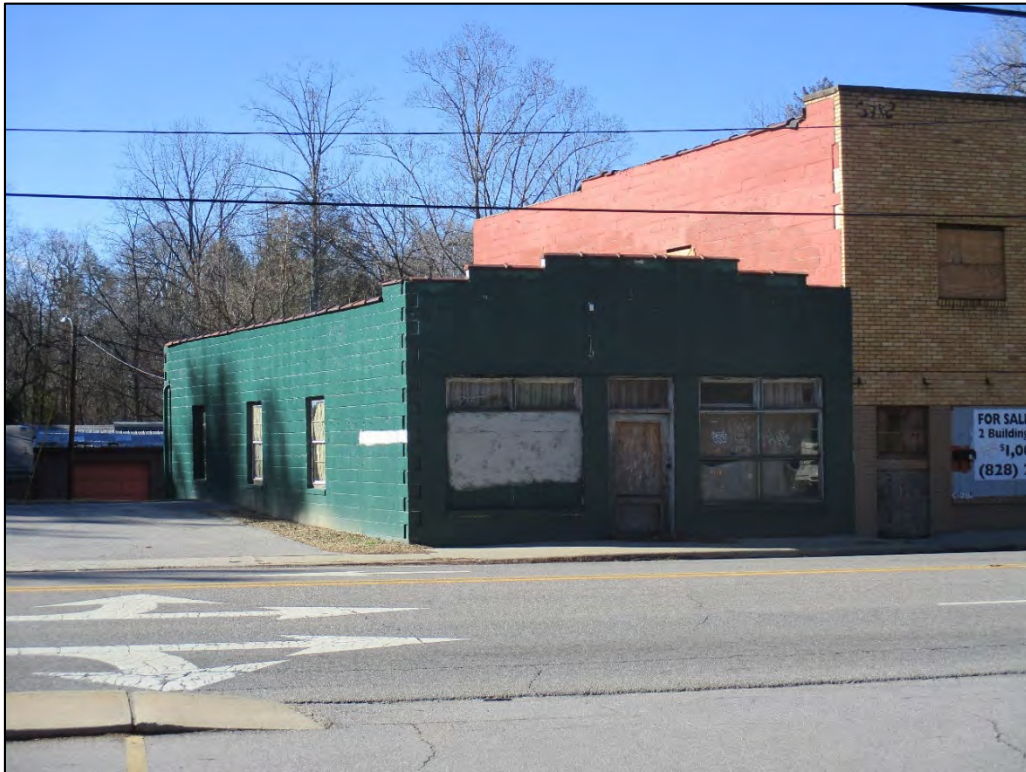
Former Keith’s Super-Cleaners oblique view of façade and south elevation, looking northwest

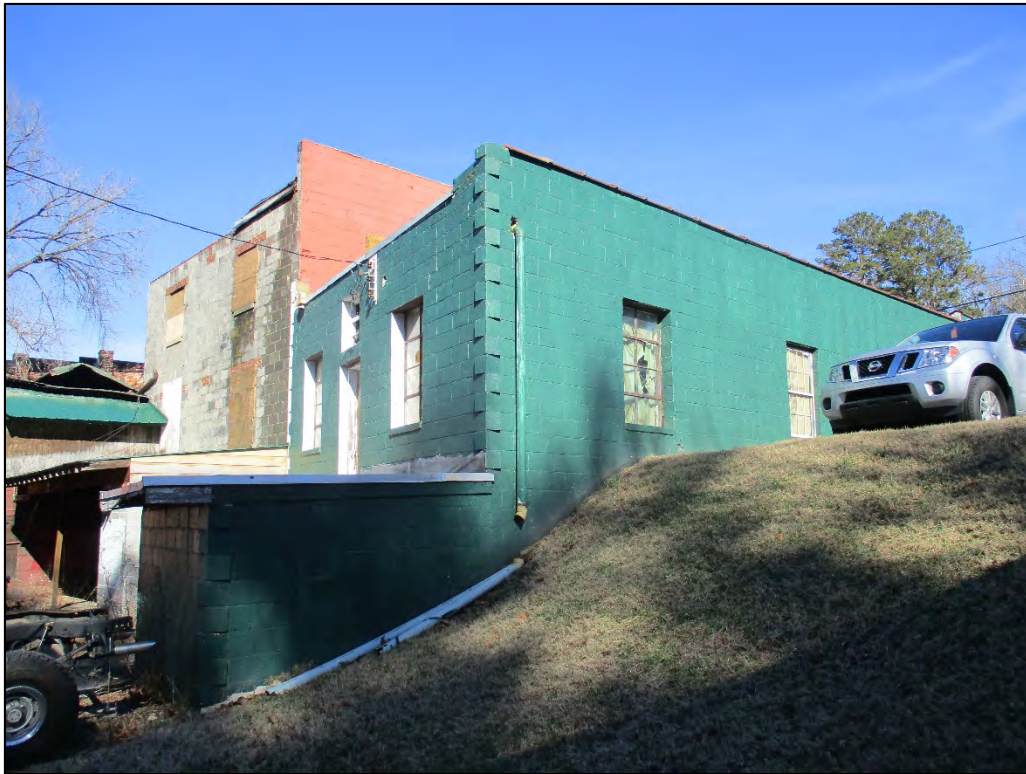
The south elevation contains three openings, including two vinyl replacements and one eight-light steel casement window towards the rear (west). Terracotta tile also cap the parapet wall on this exposed elevation. The north elevation shares a party wall with the former Moser Plumbing Building. The west elevation exposes the basement level. The first floor includes an off-center doorway (wood door) and an eight-light steel casement window on each side. A small void is present above the door, and may have housed a window or vent, but is currently enclosed with plywood. The basement level includes an aluminum garage door at the base of a short driveway that slopes towards the building. The alley forms the rear property line. A one-story, half-width wing extends from the south side of the basement level. The concrete block shed roof wing includes a plywood door (non-standard size) on its northern elevation.

Former Keith's Super-Cleaners oblique view of the rear (west) and south elevations, looking northeast

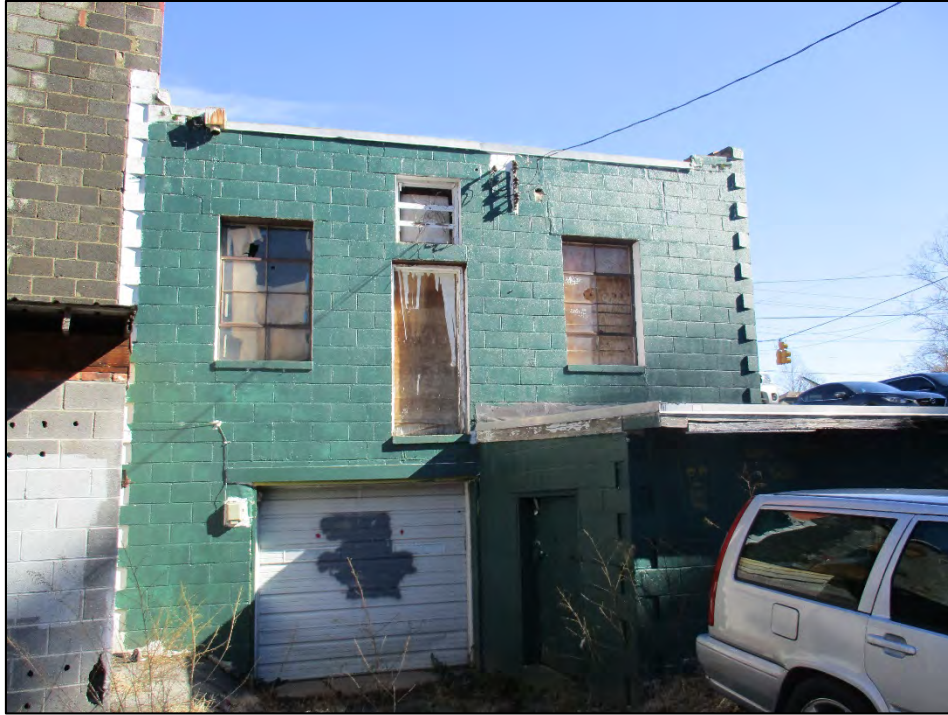
Former Keith's Super-Cleaners rear (west) elevation, view to the west. The former Moser Plumbing Building is visible at left.

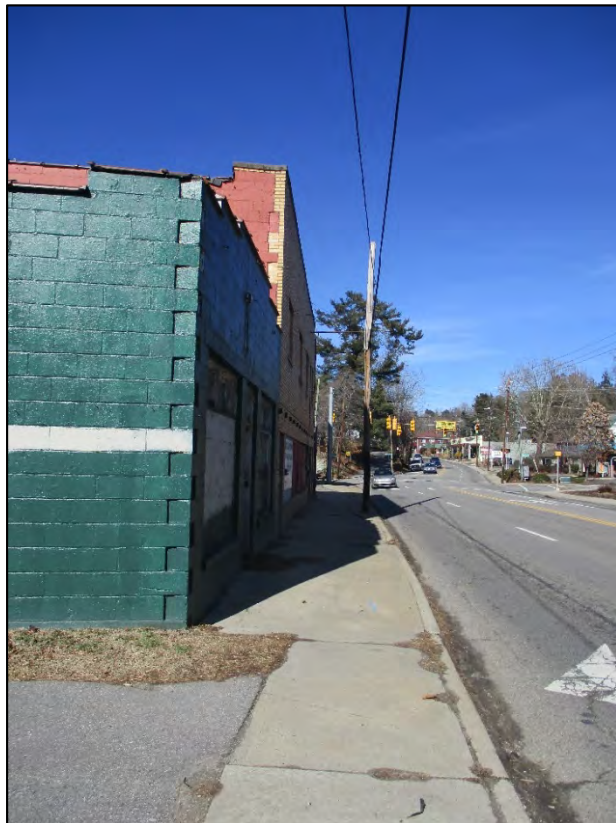
Former Keith's Super-Cleaners, view to the north along Merrimon Avenue showing sidewalk along facade

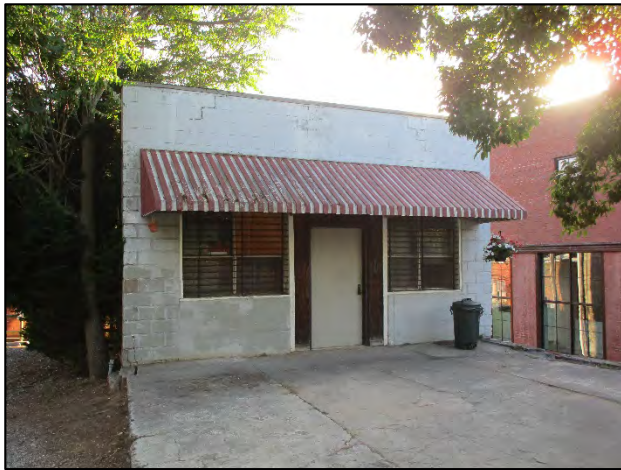
Exhibit 22. 99 Broadway Avenue (BN5142) (1923) in the Downtown Asheville Historic District (BN0003)

Buncombe County land records attribute a 1923 construction date to the concrete block structure at 99 Broadway (Exhibit 22). The storefront appears to be the result of a renovation of possibly a garage. The central flush door is surrounded by wood and flanked by paired vinyl windows behind security bars. A concrete skim coat or stucco application beneath the flanking windows suggests a larger void may have been converted to the current three-bay form. An aluminum, attached awning spans the openings, and a parapet extends above the flat roof. The concrete block structure at 821 Haywood Avenue dates to the 1970s and has a front gable roof (Exhibit 23). The storefront is asymmetrical and the gable end filled with weatherboard siding. Located at the corner of Oakwood Street, the southwest corner of the building is not square.

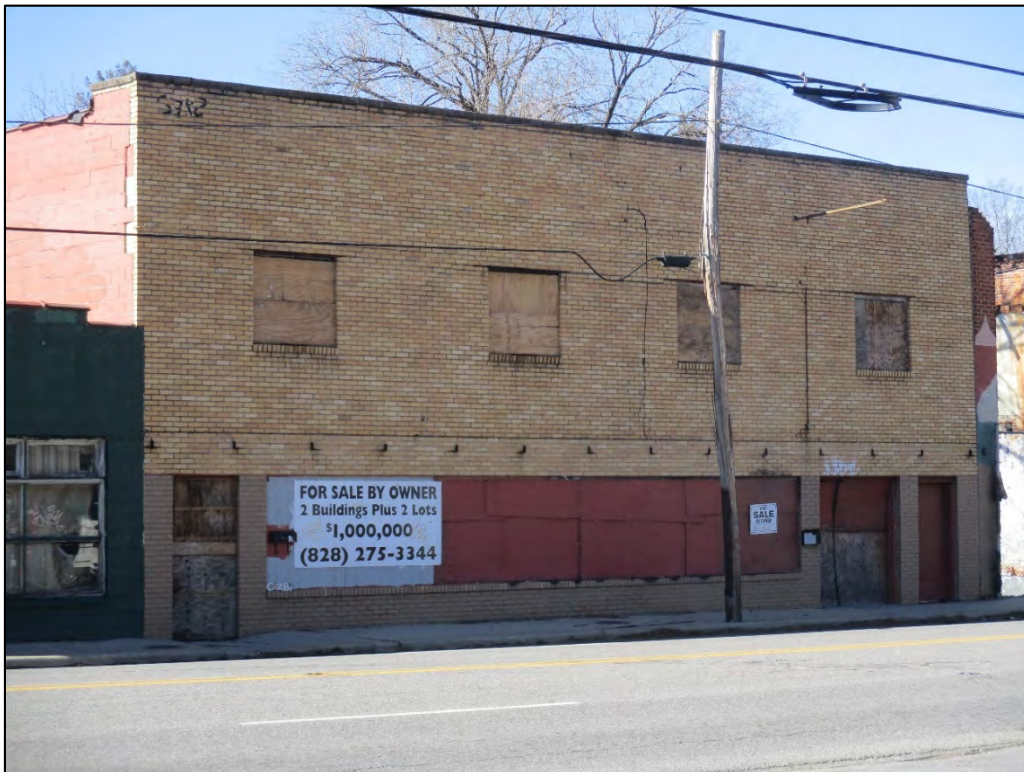
Former Moser Plumbing Building façade, view to the northwest

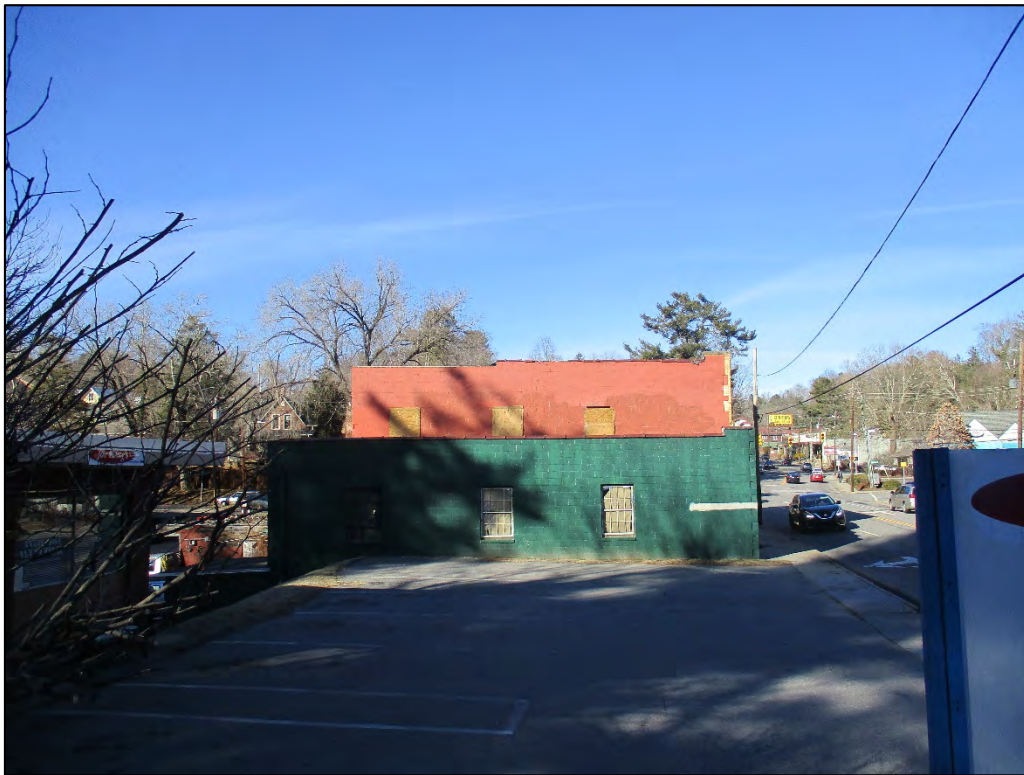
The exposed south elevation, above the neighboring one-story concrete block Keith's Super-Cleaners reveals concrete block construction. Three windows are located in this elevation, though all are covered with plywood. The parapet wall on the south elevation steps down to the west, and some terracotta caps remain in place. The north elevation is mostly obscured by the remnant brick wall from the demolished Allison's Grocery. As viewed through remnant window openings in the brick wall, this portion is wood framed with weatherboard siding. The fire (occurring approximately five years ago) severely damaged this portion of the structure; the roof is almost completely destroyed. An interior brick chimney is visible through the wreckage.

Former Moser Plumbing Building south elevation, view to the north. Keith's Super-Cleaners is in foreground.

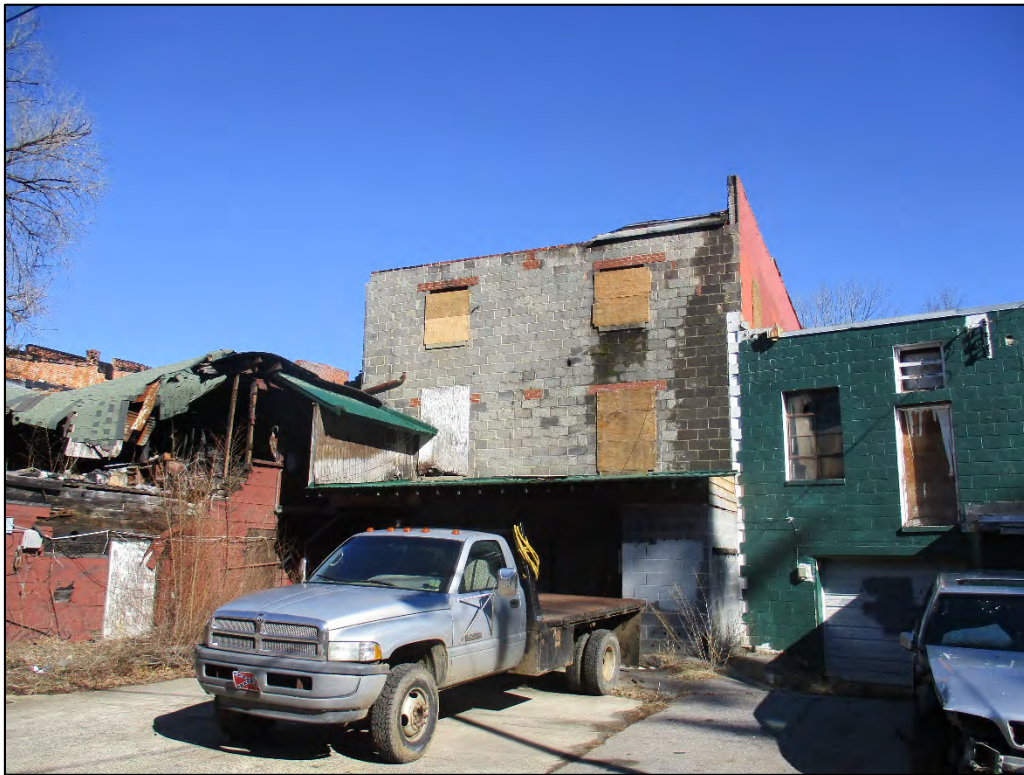
fire compromised a section of this roof as well. The rear elevation includes two windows in the second story with brick lintel and concrete sills; the openings are covered with wood. The first floor includes two openings with brick lintels and concrete sills – also covered with plywood – that may have been doors, or tall windows. A wood frame shed roof extends from the basement level with a raised seam metal roof. A small one-story concrete block wing with metal security door extends from the southwest corner of the building under the shed roof. Two windows and a double door are present in the basement level under the shed roof, though also covered with plywood.

Former Moser Plumbing Building rear (west) elevation, view to the northeast. Keith’s Super-Cleaners is at right.

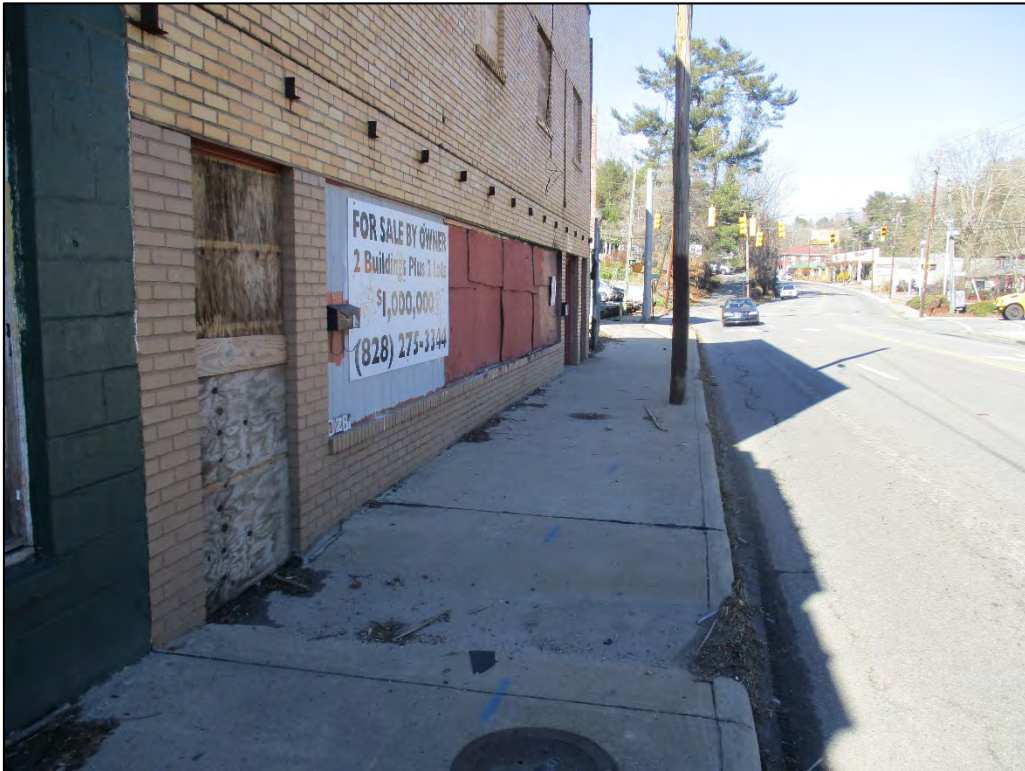
Former Moser Plumbing Building, view to the north along Merrimon Avenue along façade and sidewalk

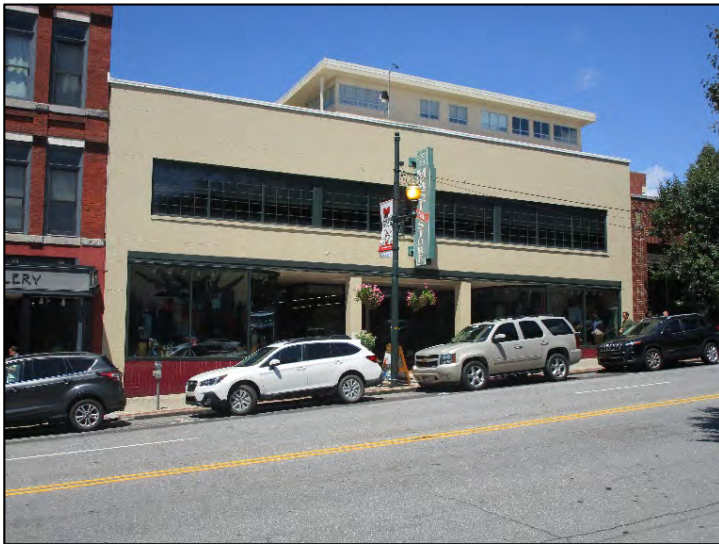
Exhibit 27. Fain's Thrift Store (BN5155) (1946), 15 Biltmore Avenue in Downtown Asheville Historic District

The ca. 1946 Fain's Thrift Store (BN5155) at 15 Biltmore Avenue in downtown Asheville stands as a good and intact modernist commercial building with elements of the Moderne style (Exhibit 27). Fain's Thrift Store utilizes a recessed entry – opposed to the cantilevered canopies employed on Merrimon Avenue examples – on an urban street to maximize storefront exposure. The curved display windows are set above red tiles which, coupled with the flat expanse of wall space, draws the eye to the storefront display. A continuous span of windows, flush to the wall surface, traverses the second story and the building is capped with a flat parapet.

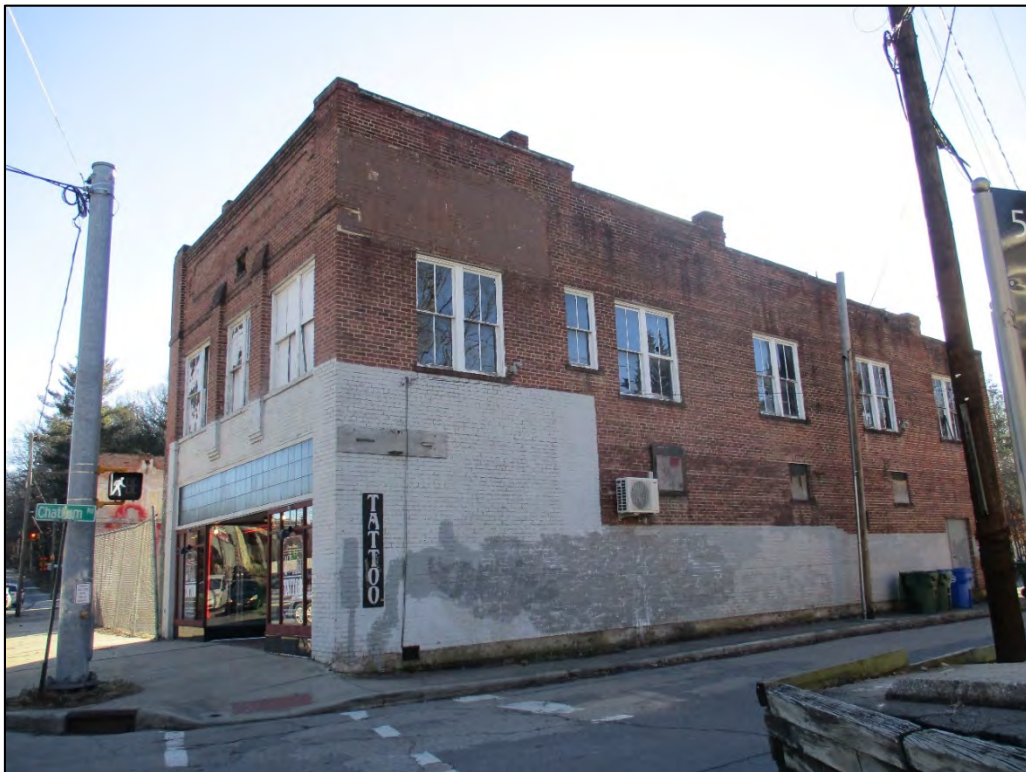
Allison's Grocery oblique view of the façade (east facing) and north elevation, looking to the southwest

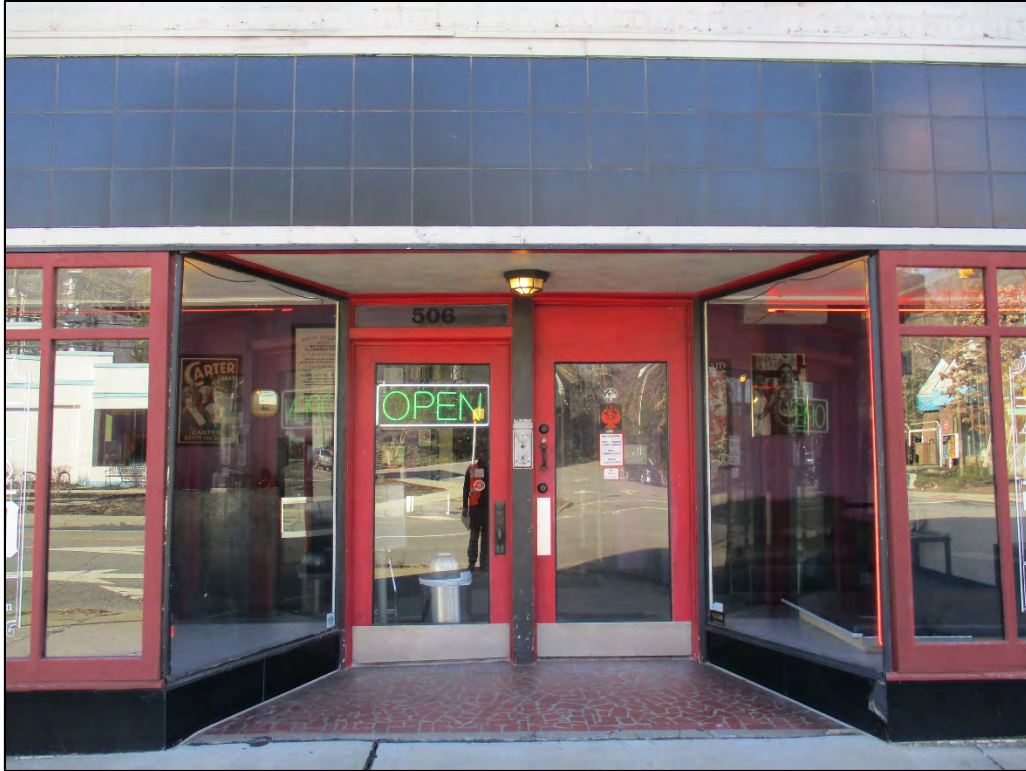
The east-facing façade features a recessed canted entry centrally within three bays. The double glass doors are framed with wood rails and stiles and a narrow, fixed transom is present above the left (south) door; the transom on the other door is infilled with wood. The storefront is framed with wood. The display windows consist of six large single pane lights within a wood frame and fill the recessed entry. Black structural glass is attached beneath the enclosed show windows. The ceiling within the recessed entry is covered in plywood, and the floor is broken tile. Above the storefront is a band of blue-tinted structural glass application or architectural tiles in a simple wood frame.

Allison's Grocery façade entry detail, facing west

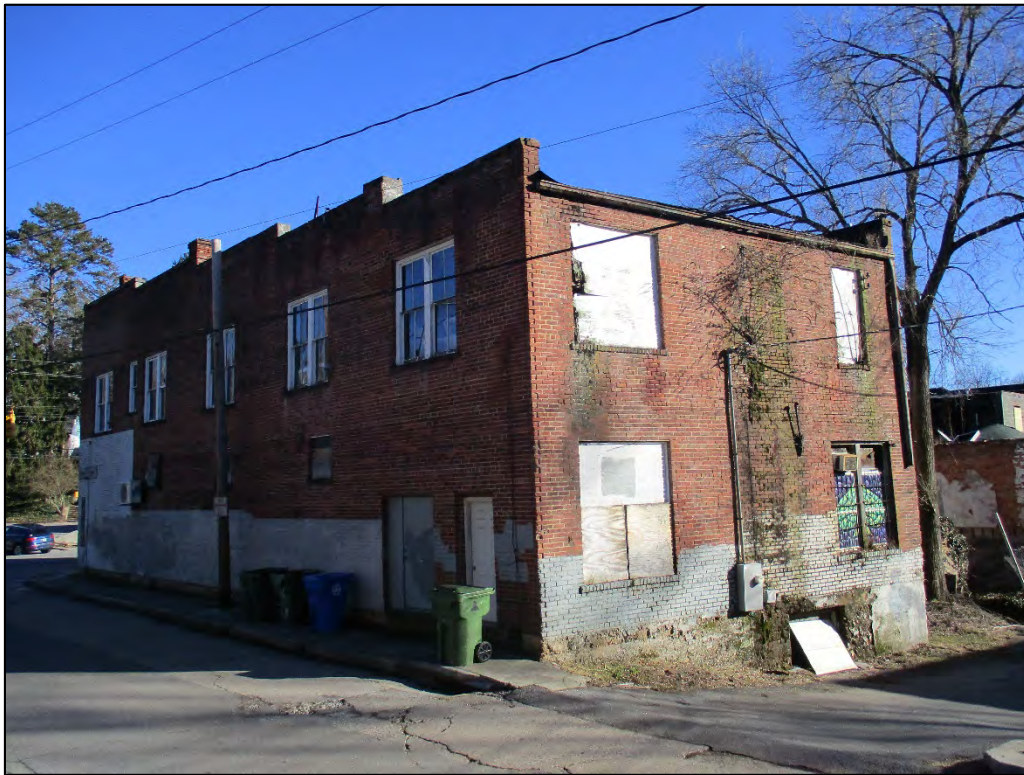
is infilled with wood. Two pairs of windows are present on the first floor with slanted brick sills and steel lintels. The pair at left (north) are infilled with plywood, and the pair at the south end are aluminum replacements with plywood infill above. The second story includes a paired window opening at the left (north) that is infilled with plywood and a single window infilled with plywood. The rear roofline is exposed (no parapet) and a steel gutter is attached with an incomplete downspout in the southwest corner. Multiple holes in the gutter are apparent and correspond to staining and mortar degradation on this elevation.

Allison's Grocery oblique view to the southeast of the rear (west) and north elevations
