November 9, 2018

MEMORANDUM

SUBJECT: Historic Structures Survey Report, Merrimon Avenue & WT Weaver Boulevard Intersection Improvements. U-5781, U-5782, PA 17-04-0023, Buncombe County, ER 18-0102

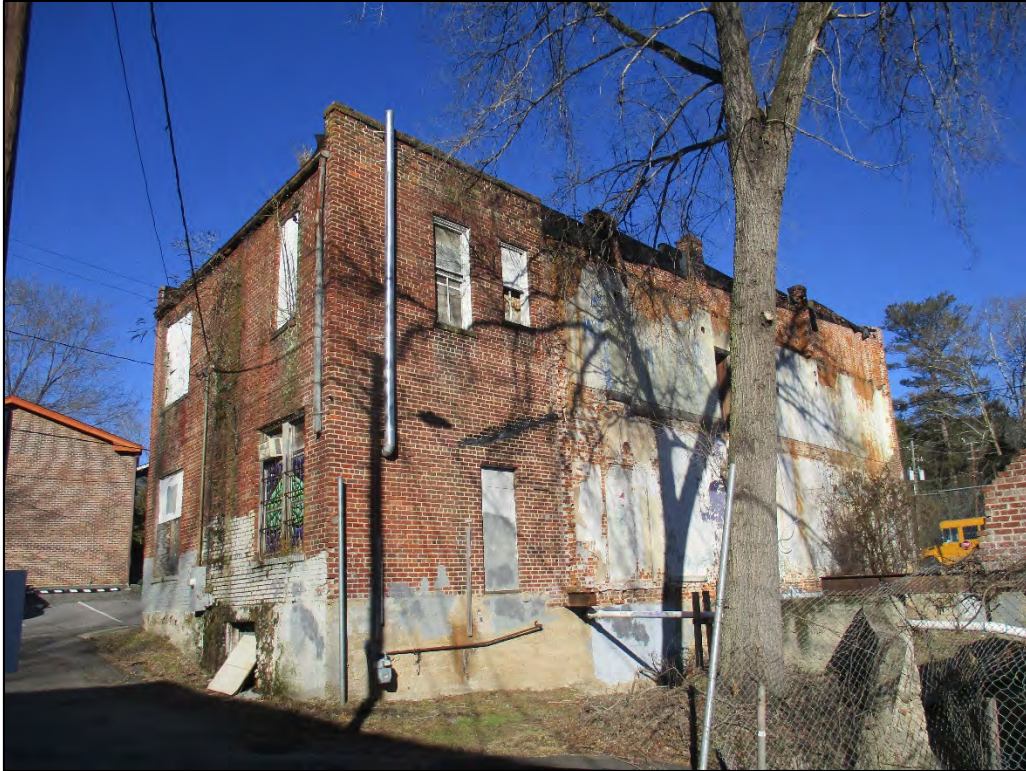
The south elevation is exposed due to the loss of the adjacent building by collapse and subsequent demolition resulting from a car accident. The western quarter of the elevation was not previously covered by the adjacent building, as evident in the I-beam and remnant brick wall. This portion of the elevation includes a door opening in the first floor which has been infilled with plywood and two two-over-two wood sash windows in the second story. Remnants of interior spaces are visible on the south elevation, including a plaster-like covering along the first and second stories. A single six-panel interior wood door is present on the second story, indicating some measure of connection between the adjoining buildings historically. Three engaged brick chimneys are apparent on this elevation: the central chimney originating in the first story, and the other two in the second story. The presence of circular cut-outs for flues indicate the use of these features, and informed the conclusion for those present on the north elevation. Similar to the north elevation, the parapet steps down to the west (rear) of the building. This elevation reveals a slanted (east to west) tar line that likely corresponded to the former adjacent building's slanted roofline.

Allison's Grocery oblique view to the northeast of the south and rear (west) elevations

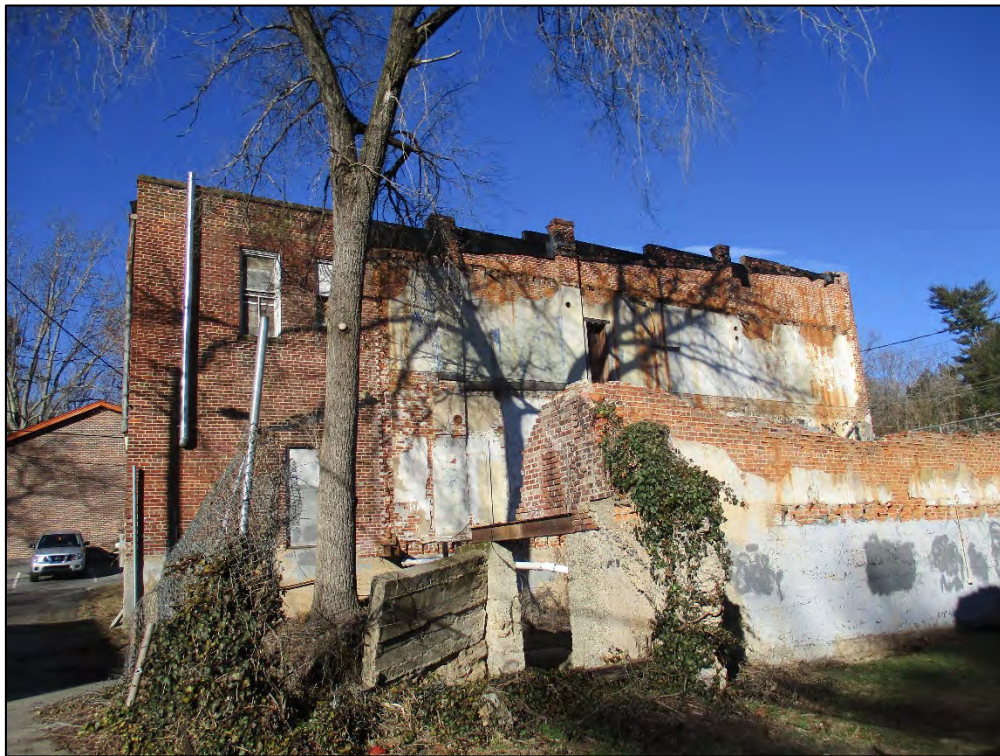
Allison's Grocery, view of exposed south elevation from the alley, looking northeast. The party wall ruins in the foreground are remnants from the three-part building once filling this area.

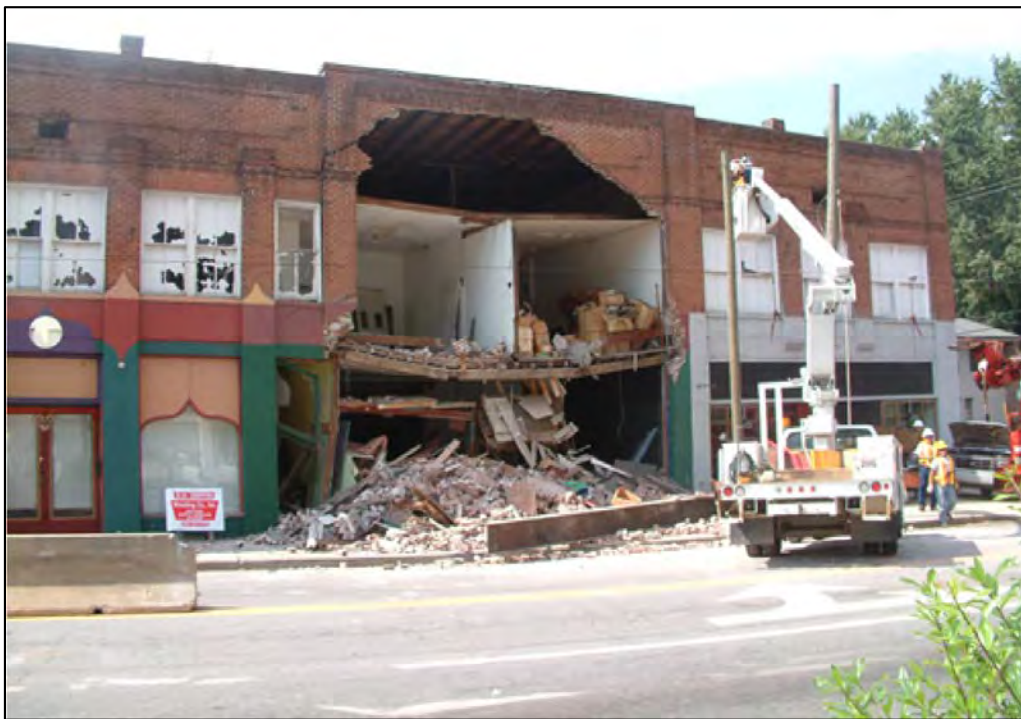
In 2005, a vehicle struck the resource (assumed 502 Merrimon Avenue) and resulted in the subsequent partial demolition due to the extent of structural damage. Photographs of the damage posted by Asheville.com show that the resource was originally constructed as a three-unit commercial building (Exhibit 29). Based on the early 1920s advertisements, the entire ground floor was initially occupied as a grocer, and over the years the three units assumed independent use. At the time of its construction, this would have been the earliest purpose-built, and most substantial, commercial building in the Woolsey area north of Asheville.

Exhibit 29. 500-502-504 Merrimon Avenue in 2005, following a vehicle collision with the central unit (502 Merrimon Avenue) and the collapse of the façade. This photograph reveals the full extent of the historic construction, a three-unit brick-front with slightly projecting, dominant central mass. Only 504 Merrimon Avenue (BN5742) (at right) remains. Source: Asheville.com (www.asheville.com/news/merrimon0905.html).

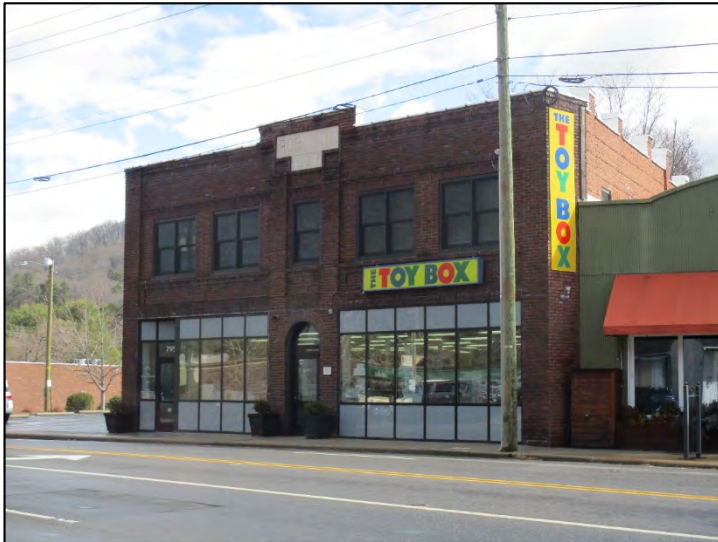
Exhibit 30. Robinson Building (BN5749) (1927), 793 Merrimon Avenue

Approximately one mile to the north at 793 Merrimon Avenue is the Robinson Building (BN5749) in the northeast corner of the Gracelyn Road/Colonial Place intersection in an area of Asheville historically known as Grace. The Robinson Building was constructed as a stand-alone, brick-front, three-bay commercial building in 1927 (Exhibit 30). The symmetrical, two-story brick-front with corbelled cornice building features a central arched entry and stepped gable. Similar to Allison's Grocery, the west-facing façade of the Robinson Building is framed with brick pilasters, and a narrow central bay is delineated with two-story

brick pilasters. Though replacement windows, doors and a redesigned storefront compromise its integrity, the Robinson Building is a good example of the brick-front commercial building type.

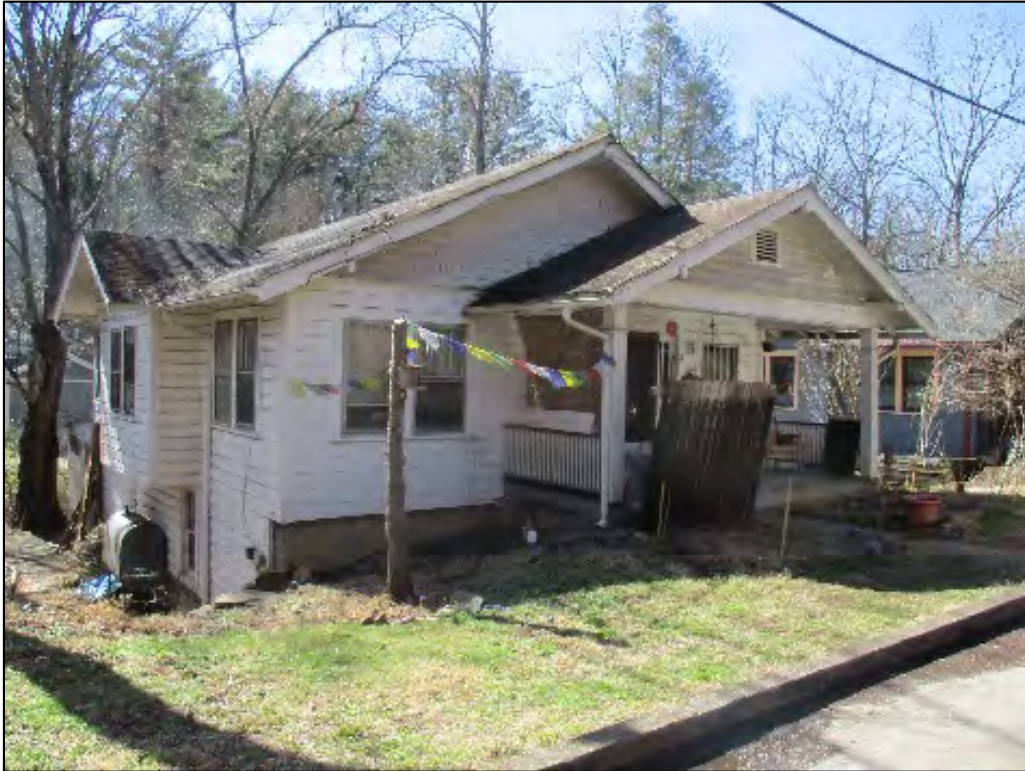
Atkins House elevation view to the southwest

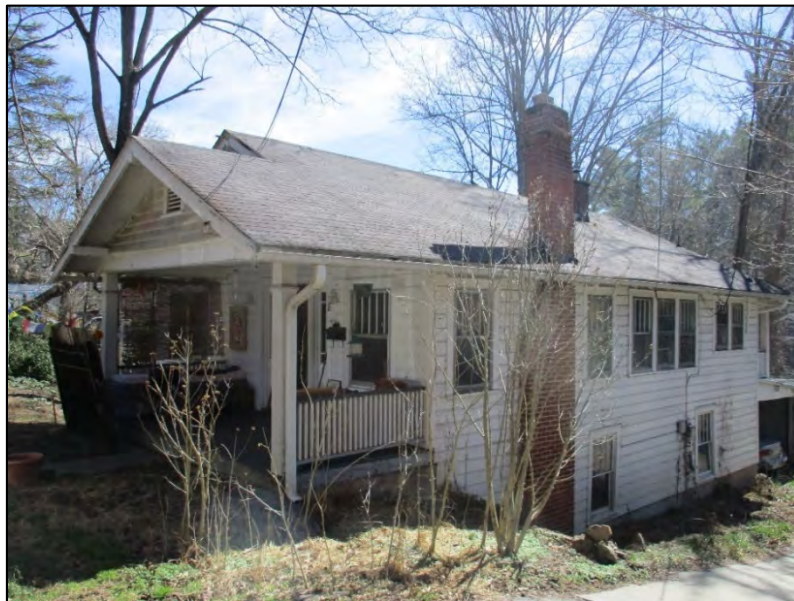
The east and west elevation reveal a full-length basement level with a foundation covered in stucco. On both the east and west elevations the basement level contains two-single four-over-one sash windows. There is an external entrance to the basement located in the rear (south elevation) beneath an attached shed roof garage. The east elevation has a small gabled projection with paired four-over-one sash windows. On either side of the projection are additional paired four-over-one sash windows. The west elevation contains an external brick chimney, two-single four-over-one sash windows, one set of paired four-over-one sash windows, and one triple set of four-over-one sash windows. The roof is asphalt shingle and there is an internal brick chimney on the west slope of the roof near the rear of the house.

Atkins House west elevation, view to the southeast

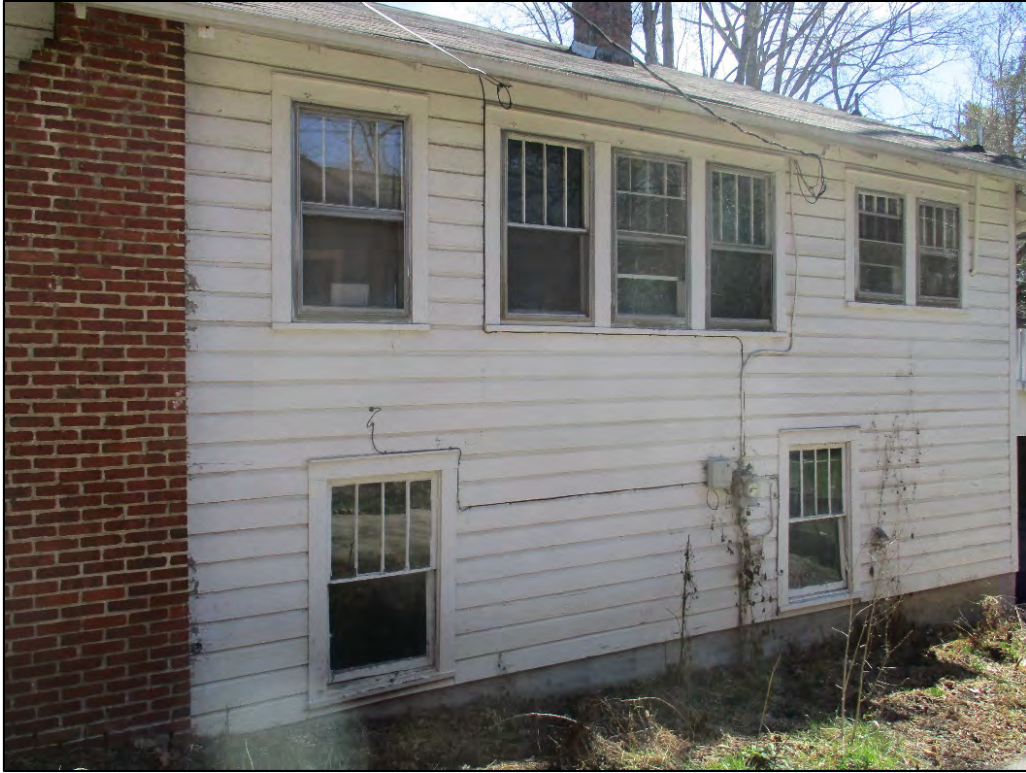
Atkins House west elevation, view to the southeast

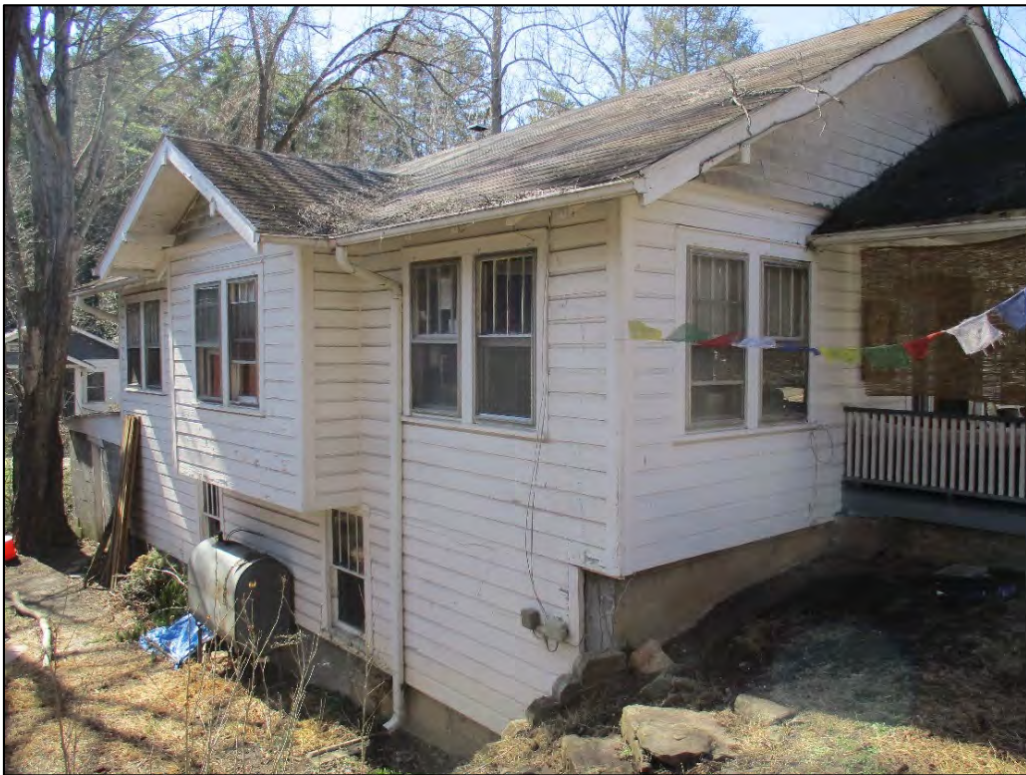
Atkins House east elevation, view to the southwest

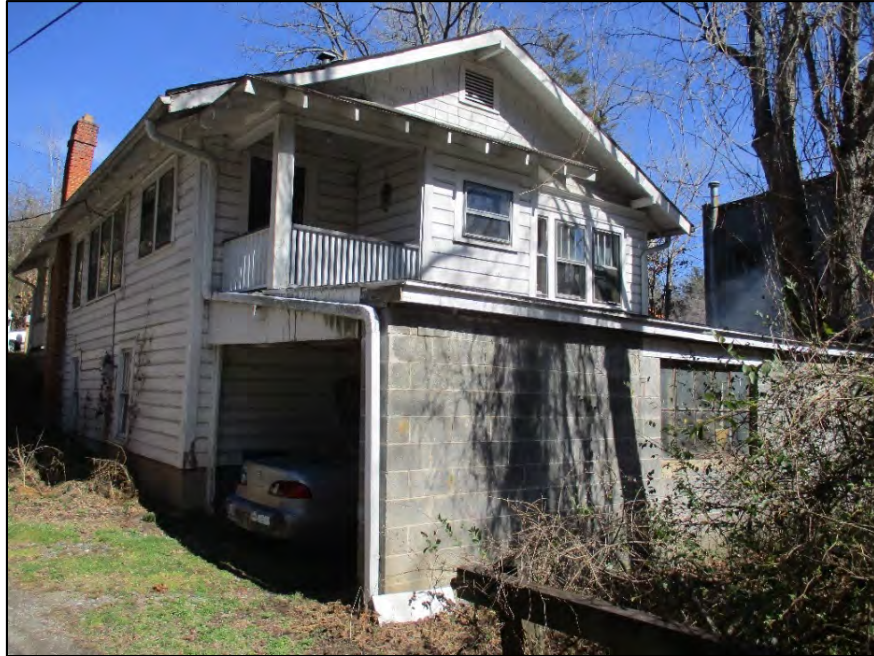
A small, hipped roof porch is attached to the rear (south elevation) that features a one-over-one horizontal pane window and a door. There is also a triple set of four-over-one sash windows to the east of the porch. The concrete block shed-roof garage extends from beneath the first-floor porch and contains a door providing access to the basement. The south elevation of the garage features one fixed pane window with ten lights. The west side of the garage is open and a door is present in the east elevation.

Atkins House south elevation, view to the northeast

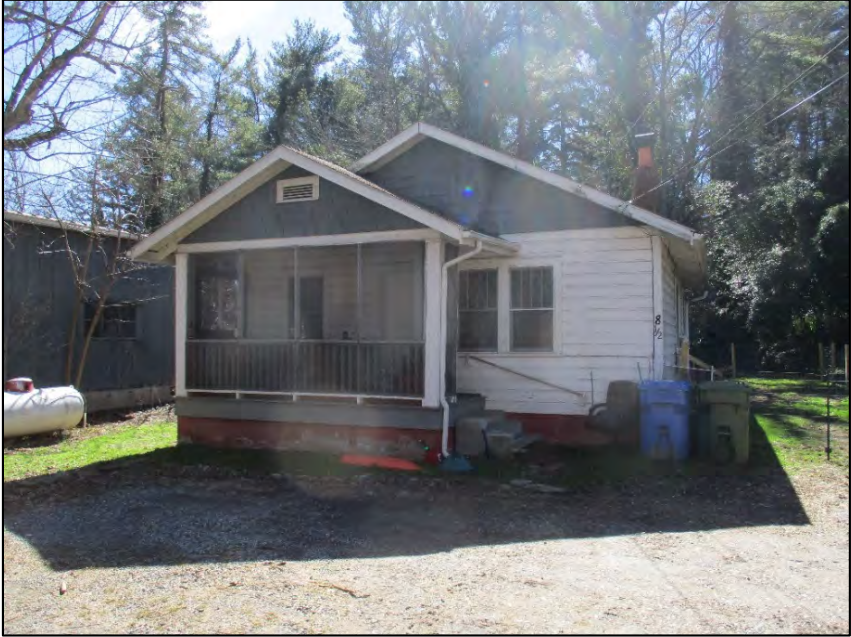
The large outbuilding located south of the house is currently a residence and the number “8 ½” is affixed to the façade (north elevation). The building is a one-story, front gabled structure with German siding and four-over-one sash windows. The façade features a screened front gable porch with a concrete floor, wood supports, and simple square railing. Wood shingles are present in gable ends. The foundation is concrete block and no basement is apparent. The roof is asphalt shingle and the structure has one visible internal brick chimney on the west elevation. A small wooden deck extends from the south (rear) elevation that leads to an informal, grassed backyard.

Atkins House outbuilding façade, view to the south

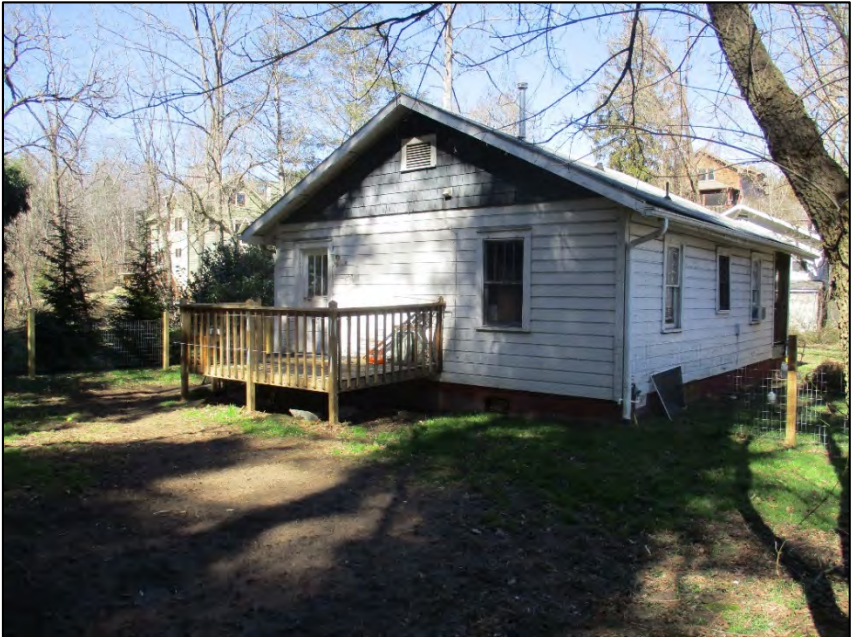
Atkins House oblique view of outbuilding south and east elevations, view to the northwest

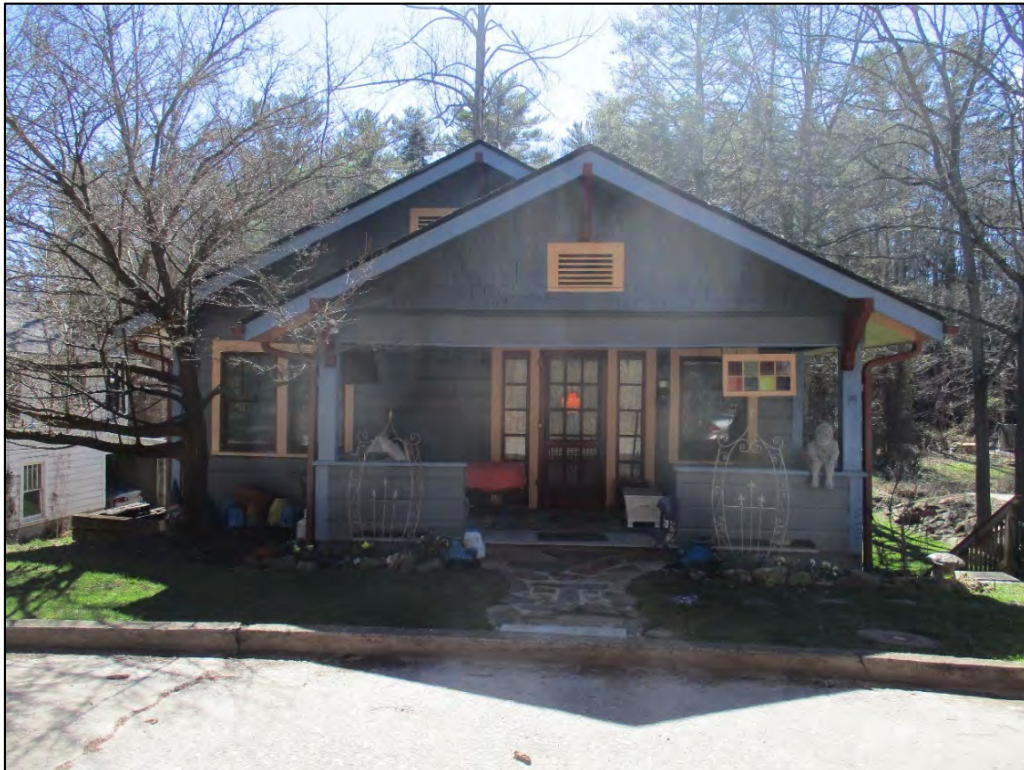
Williams House façade, view to the south

The north-facing facade is asymmetrical with three bays under a front gable roof and an attached front gable porch in which a replacement French door with sidelights is present. The front porch features wood support columns and a partially closed rail, with decorative half-moon cutouts at the porch floor. On the left (west) side of the door are paired three-over-one sash replacement windows; to the right (east), is a single three-over-one sash replacement window. The roof gables are clad with wood shingles and contain gable vents. The wide, overhanging eaves are open with exposed plank sheathing and knee braces. The house features German siding on all elevations. The roof is asphalt shingle and there is an

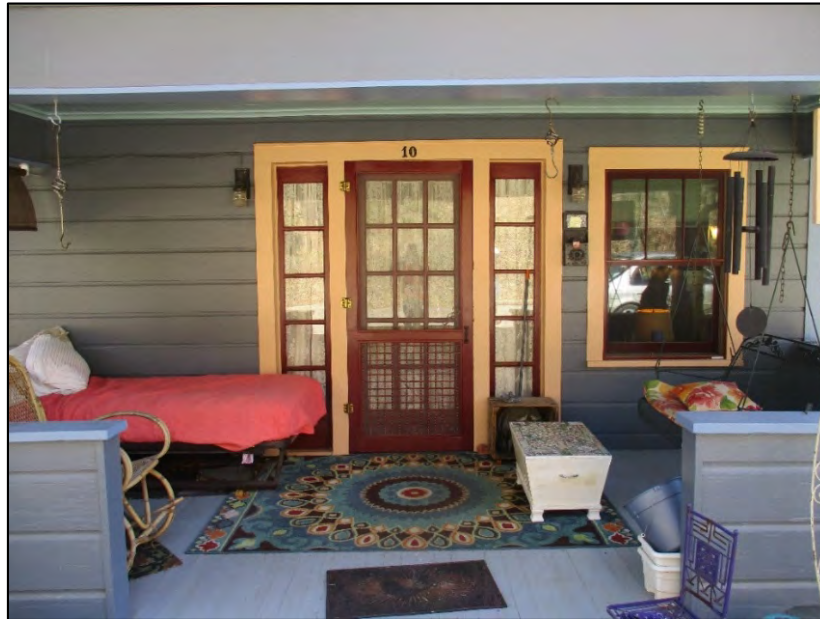
Williams House façade porch detail, view to the south

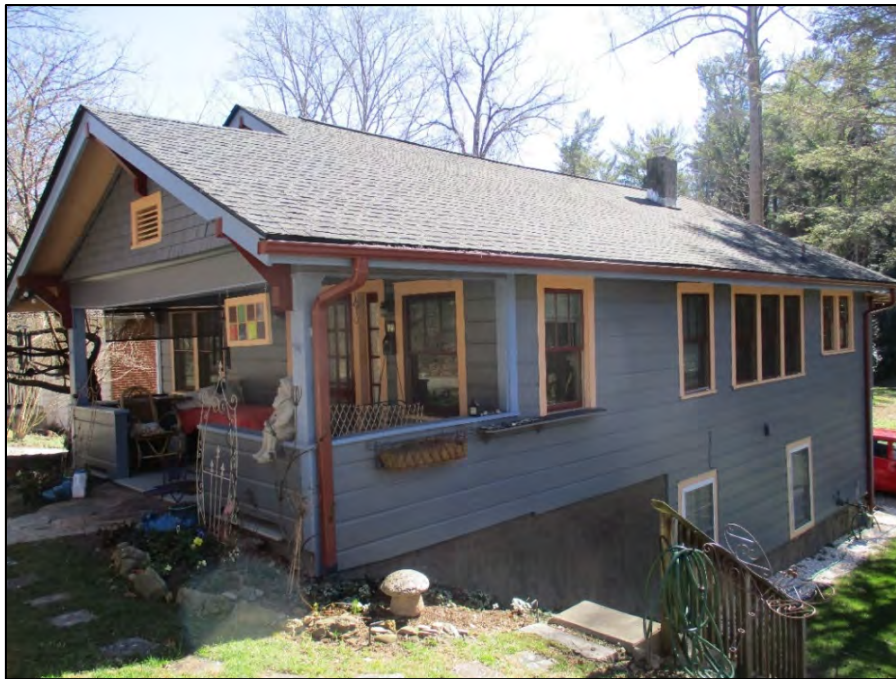
Williams House oblique view of façade and west elevation, view to the southeast

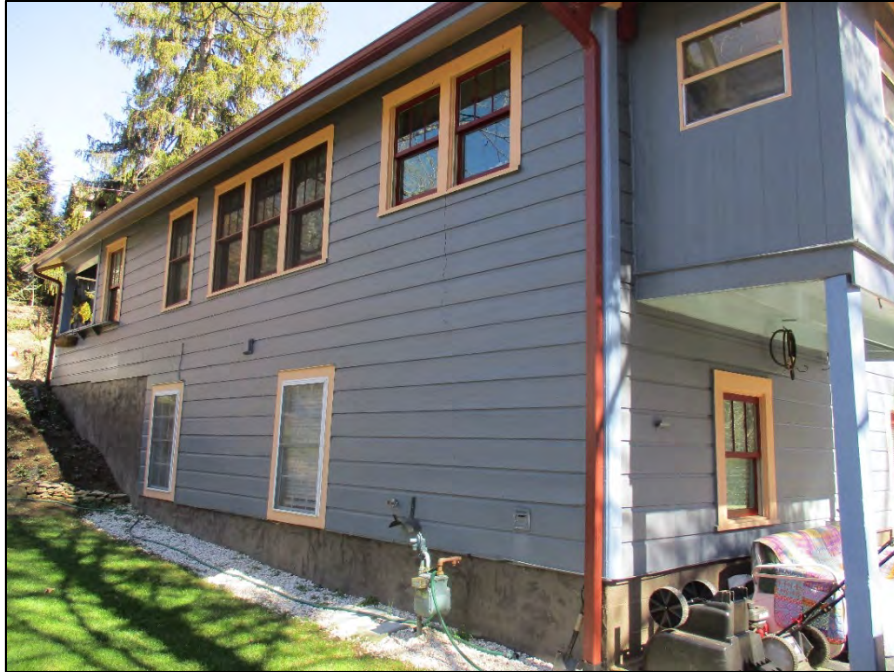
Williams House west elevation, view to the northeast

The east elevation of the house has a small gabled projection with paired three-over-one sash replacement windows and decorative knee braces. On either side of the projection are additional paired three-over-one sash replacement windows. The west elevation contains two single three-over-one sash replacement windows, one paired three-over-one sash replacement windows, and one triple set of three-over-one sash replacement windows.

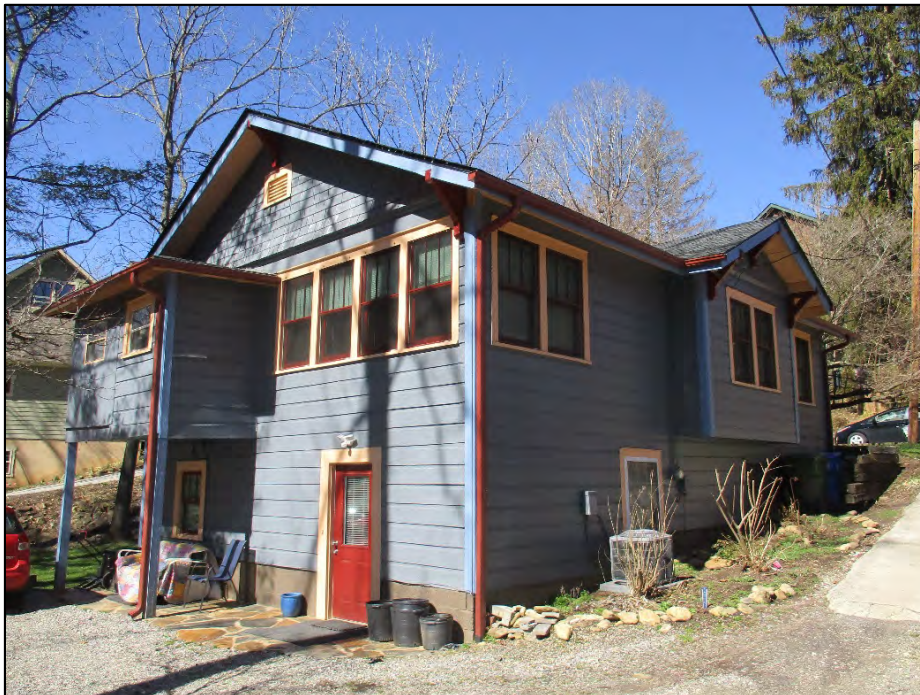
Williams House oblique view of south and east elevations, view to the northwest

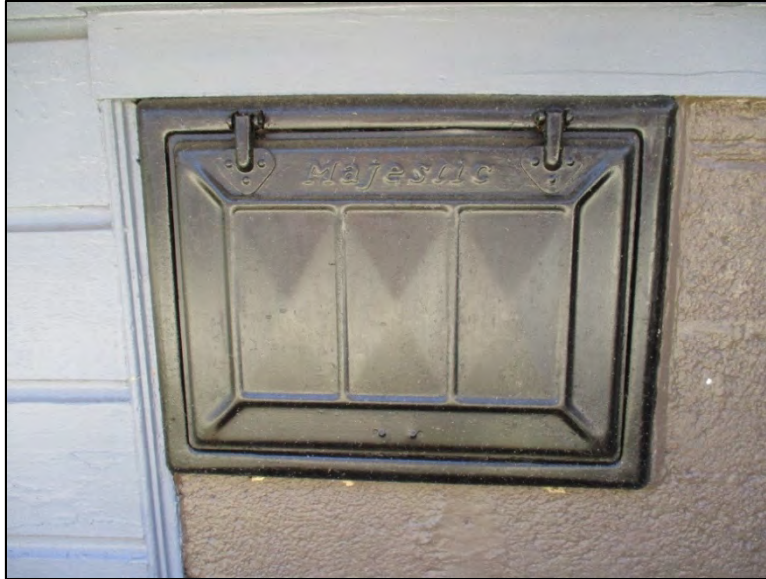
The east and west elevations reveal a full-length basement which contain single six-over-six sash vinyl windows; a historic coal chute was noted in the east elevation. The entrance to the basement level is at the rear (south) of the house and features a replacement door with a single window. The original foundation material is unknown, as it has been covered in a stucco application.

Williams House east elevation, coal chute detail

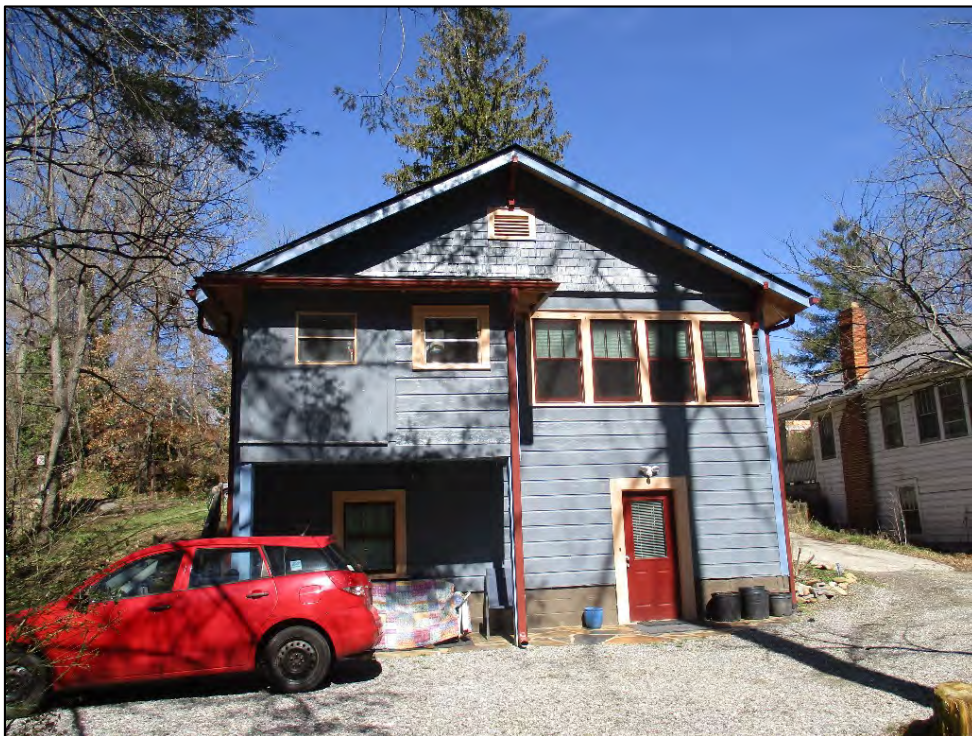
There is a small, shed porch projecting from the rear (south) elevation on slender support posts that has been enclosed on the first story and is open below. The porch features two one-over-one horizontal pane windows. There is also a row of three-over-one sash windows to the east of the porch. The south elevation gable contains wood shingles, a small rectangular vent, and decorative knee braces. As described above, the rear elevation also contains a non-historic basement door and a small three-over-one double hung sash replacement window with a small stone patio under the enclosed porch.

Williams House south elevation, view to the north

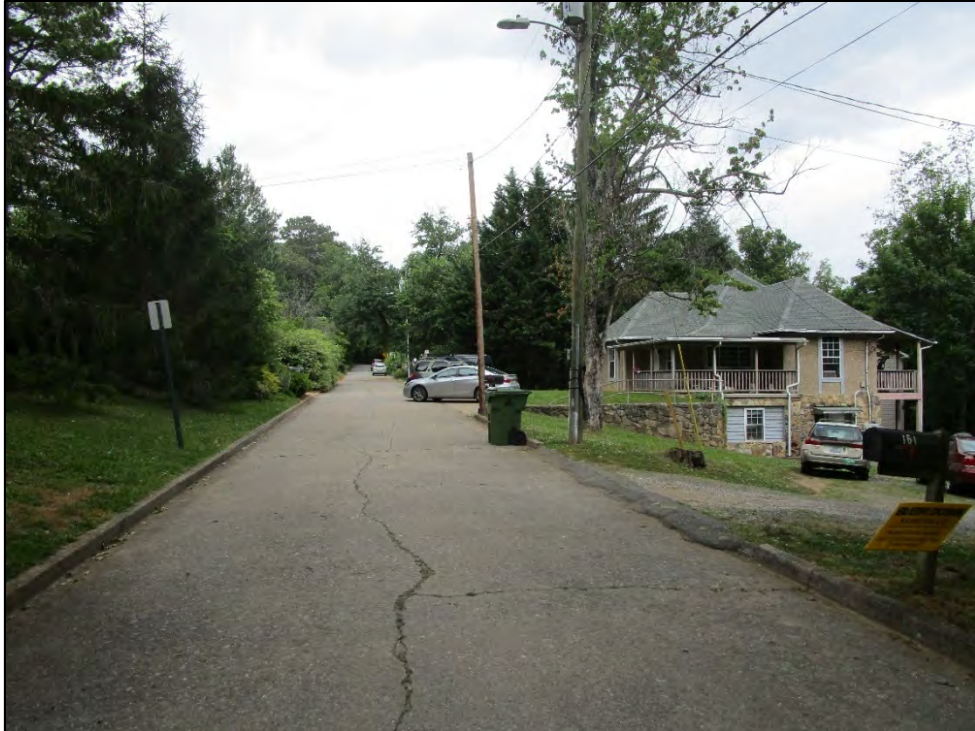
View north along Chatham Road from the Salem Avenue intersection. The 1916 Queen Anne cottage at right (163 Chatham Road) includes replacement doors and windows and a textured stucco application.

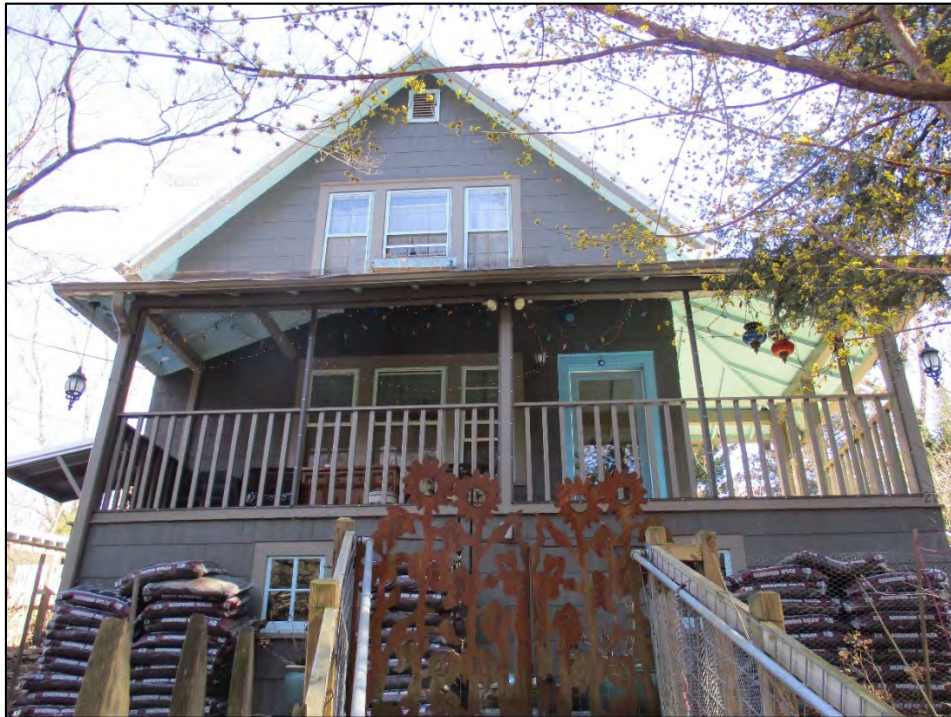
Weaver House façade, view to the east

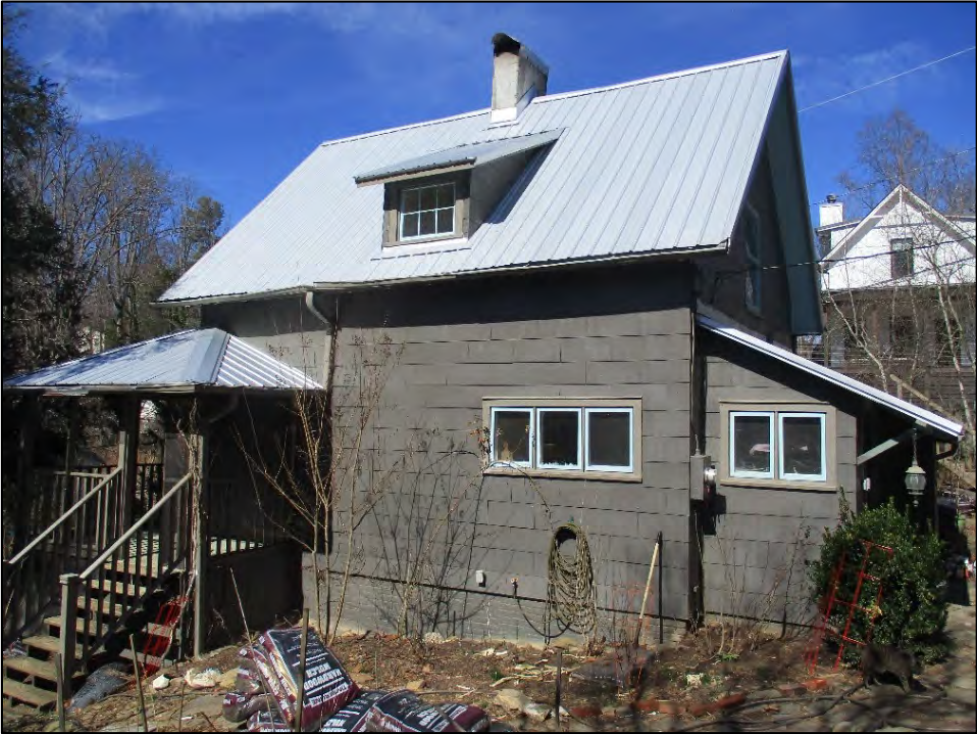
The south elevation features a wooden staircase leading to the wrap-around front porch. A ribbon of three fixed windows is visible to the right (east) of the stairs. The foundation is continuous painted brick, but shows evidence of ghost brick piers. The steeply pitched roof is covered in standing seam metal and

Weaver House south elevation, view to the north

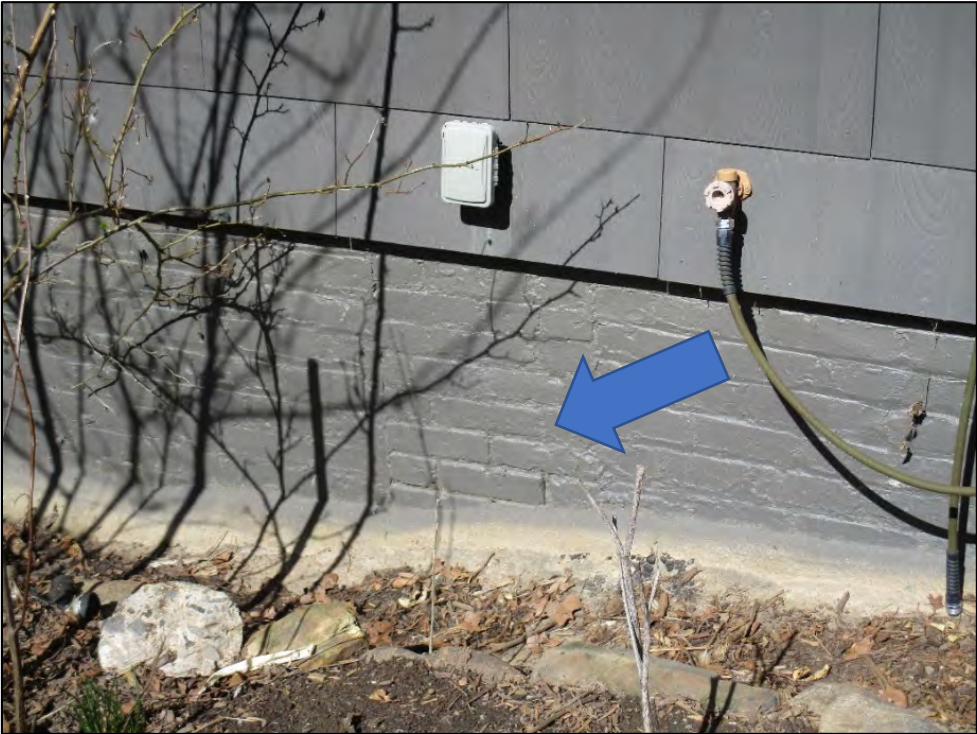
Weaver House south elevation foundation detail with ghost pier

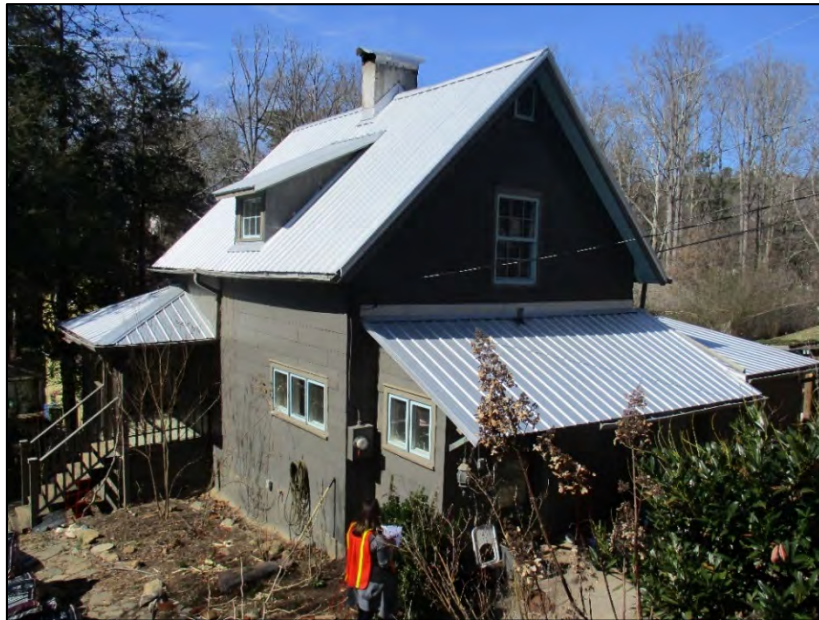
The rear (east) elevation of the house has a first-story shed addition which contains two single pane windows and a wood and glass door. A single six-over-six sash window and rectangular vent are located in the gable end.

Weaver House east elevation, view to the northwest

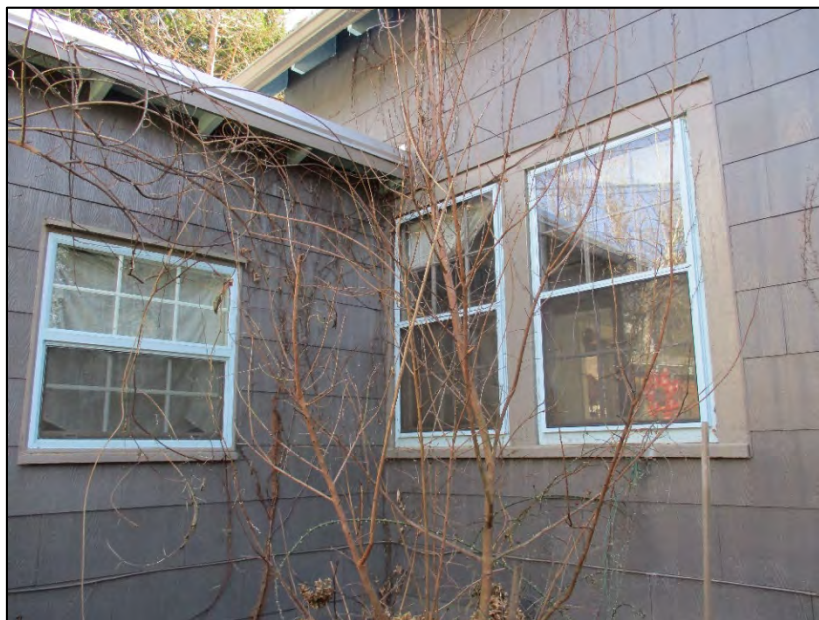
The north elevation of the house features a small shed addition that appears to extend from the rear shed addition and includes two six-over-six sash windows. Original six-over-six sash windows and six-paned casement windows remain in the north elevation and a small central shed dormer includes a six-pane window, the same as the south elevation.

Weaver House north elevation windows, view to the southeast

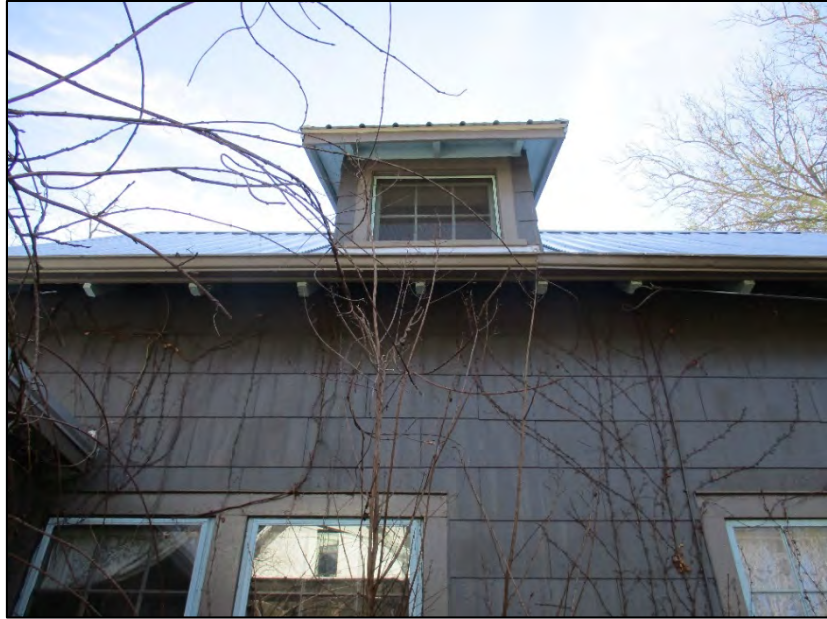
Weaver House north elevation shed dormer, view to the south

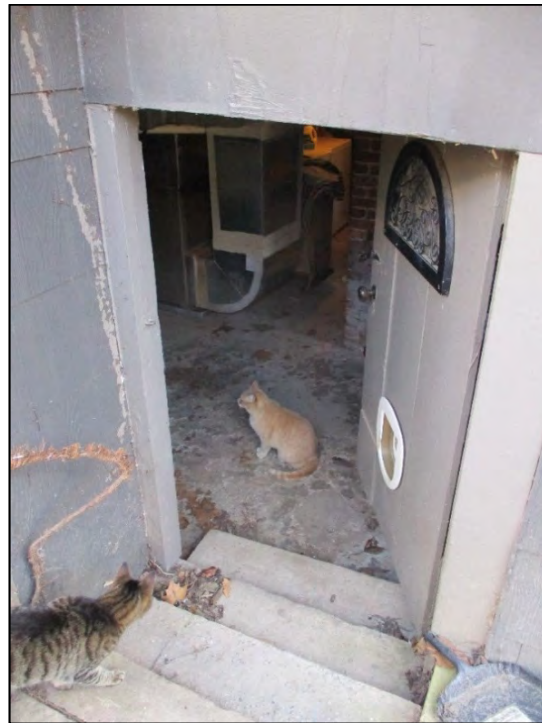
Weaver House north elevation basement entrance

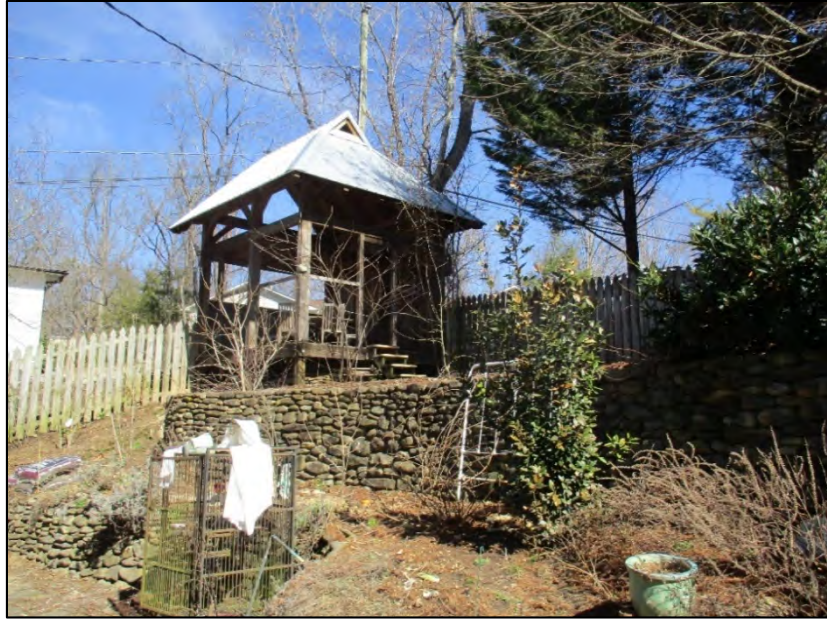
The property contains two outbuildings that appear to be less than fifty years of age: a gazebo in the northeastern corner of the property and a wood chicken coop with an attached shed north of the house. The rest of the yard features informal plantings, intermittent stone terracing, and stone pathways with steps leading to different areas of the yard. As mentioned, the site slopes steeply to the west and a concrete staircase with wood railing permits access to the house from Chatham Road.

Weaver House gazebo (outbuilding), view to the northeast

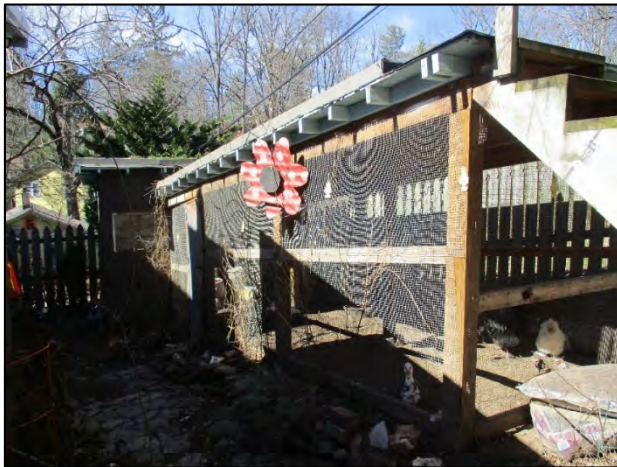
Weaver House chicken coop and shed (outbuilding), view to the west

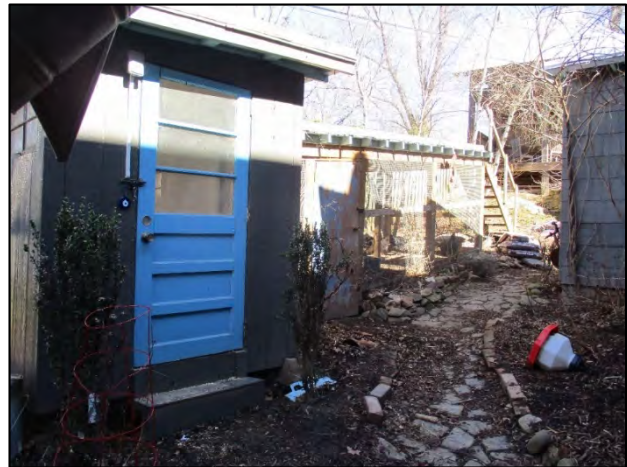
Weaver House shed attached to chicken coop (outbuilding), view to the northeast

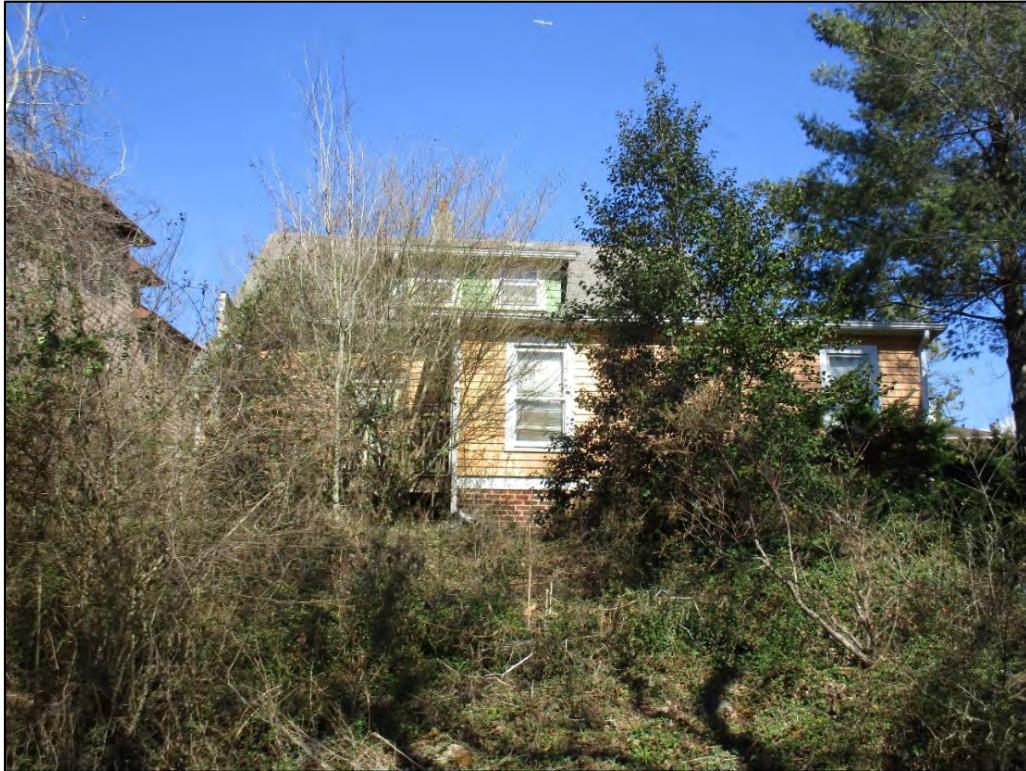
Guischarde House façade, view to the north

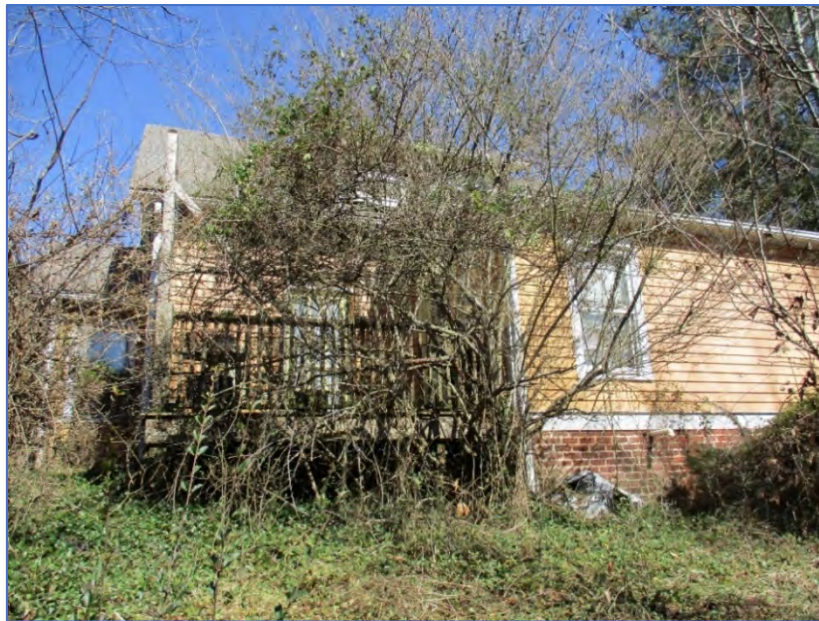
Guischarde House façade, view to the north of deck addition

While the house maintains its location, setting, and some of its original materials, certain alterations detract from the resource’s overall integrity. Evidence of the front porch enclosure is confirmed in photographs from a 1998 survey (Exhibit 50). These photos also indicate that the area with the wooden deck (to the west of the front porch) on the façade of the house used to be enclosed. The introduction of new materials for the front porch enclosure, window replacements, and the French door replacements in the rear and front of the house represent an overall loss of historic material integrity. As a result,

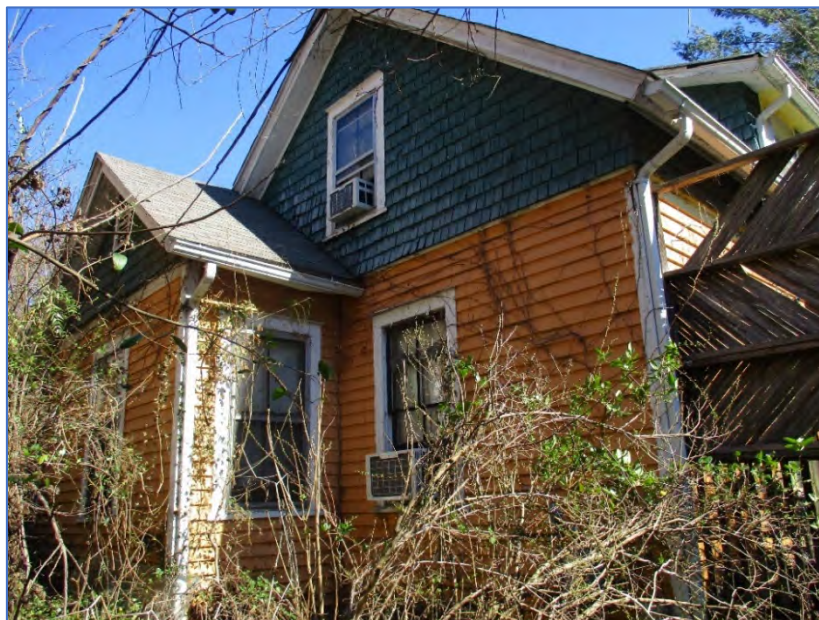
The west elevation features a diminutive wing projection at the rear of the first story with two-over-two sash windows; a single two-over-two sash window is located in the second story gable. Due to overgrowth and a fence, this side was difficult to access and photograph in detail, but all windows and siding appear to be original.

Guischarde House west elevation, view to the north

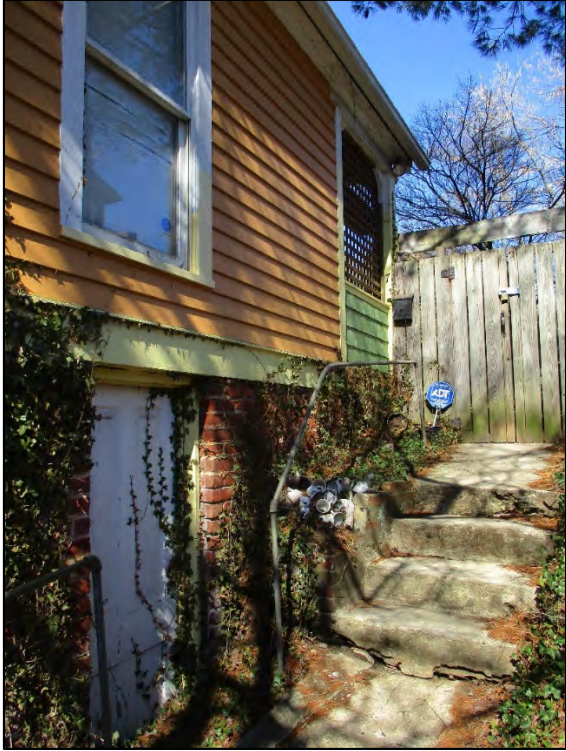
The east elevation of the house has a wood panel door that leads to a partial basement. There are concrete steps that lead up to a locked gate that provides access to the rear of the house. A small porch with a shed roof is visible by the gate. Similar to the west elevation, the windows on the east elevation are two-over-two double hung sash and the gable features wooden shingles.

Guischard House east elevation, view to the north
