November 9, 2018

MEMORANDUM

SUBJECT: Historic Structures Survey Report, Merrimon Avenue & WT Weaver Boulevard Intersection Improvements. U-5781, U-5782, PA 17-04-0023, Buncombe County, ER 18-0102

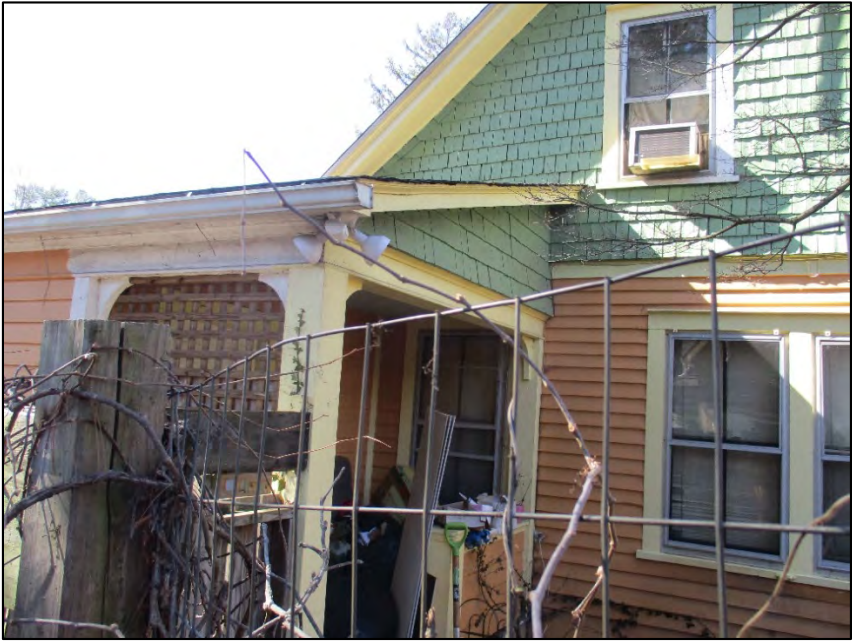
Guischard House east elevation, view to the west

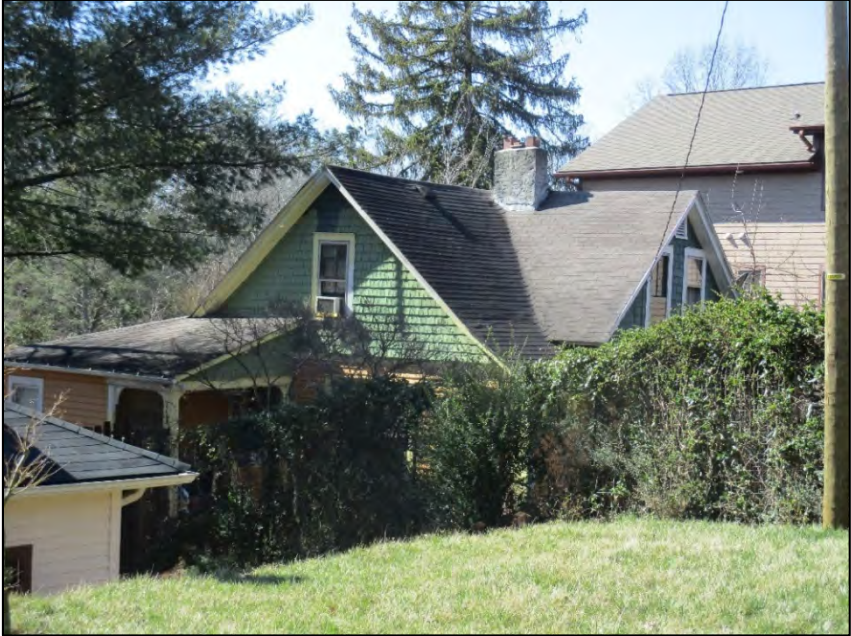
Because the gate to the rear of the house was locked, photos and descriptions for this elevation are limited. A view from the alley behind the house (accessible via Clearview Terrace) provided some detail. From this vantage, a rear gable is visible with two-over-two double hung sash windows and wood shingles.

Guischard House east and rear (north) elevations, view to the southwest

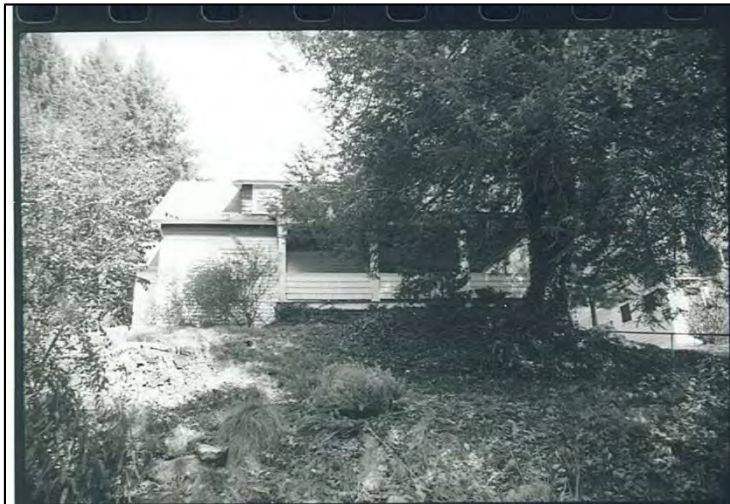
Exhibit 50. 7 Chatham, 1998 photograph from the BN3372 Historic Property Survey Summary

While the house maintains its location, setting, and some of its original materials, certain alterations detract from the resource’s overall integrity. Evidence of the front porch enclosure is confirmed in photographs from a 1998 survey (Exhibit 50). These photos also indicate that the area with the wooden deck (to the west of the front porch) on the façade of the house used to be enclosed. The introduction of new materials for the front porch enclosure, window replacements, and the French door replacements in the rear and front of the house represent an overall loss of historic material integrity. As a result,

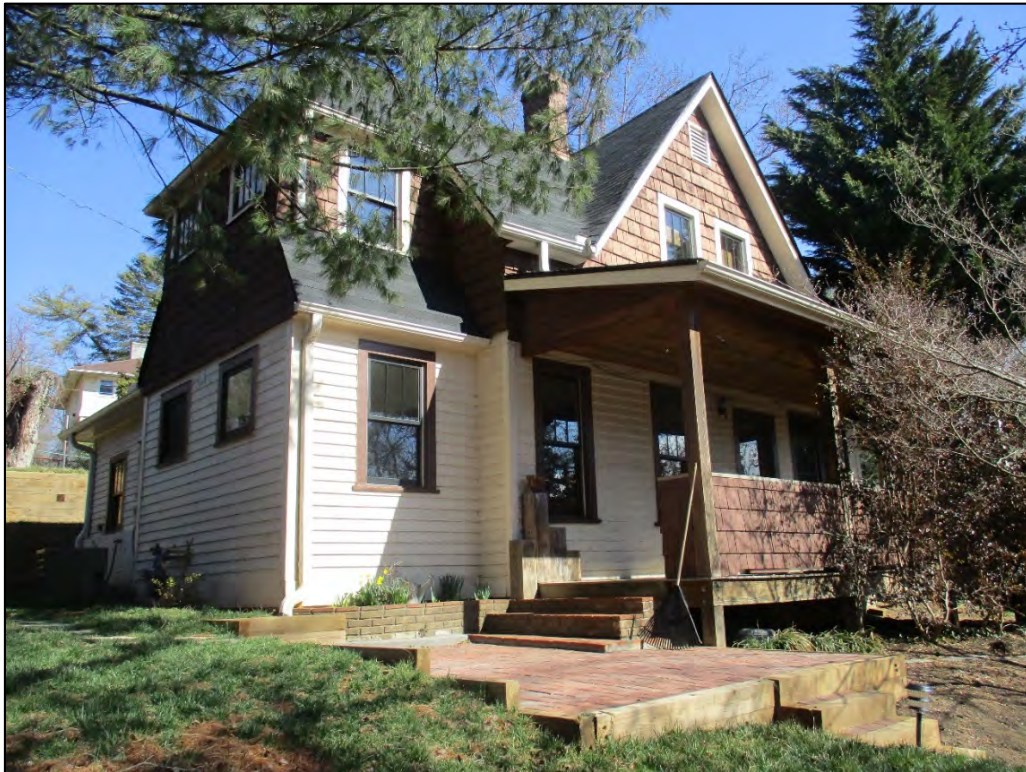
Martha Sayre House oblique view of the façade and west elevation, view to the northeast

The south-facing façade is asymmetrical with a cross gable roof featuring a large centered front gable clad in decorative wood shingles. The house is two stories with a partial shed roof porch. The windows on both levels of the house are three-over-one sash vinyl windows, and the front door is historic wood and glass. The front porch is updated with new wooden support columns and a new floor; the railing is closed and clad in wood shingles. Two brick steps on the west side of the porch provide access to the centered front door. The entire house is clad in a combination of weatherboard siding and wood shingles. The cross-gable roof includes steeply pitched simple gables on the south and north elevations, and clipped gables on the east and west elevations. The roof is covered with asphalt shingle and has an internal central brick chimney that has been covered in stucco.

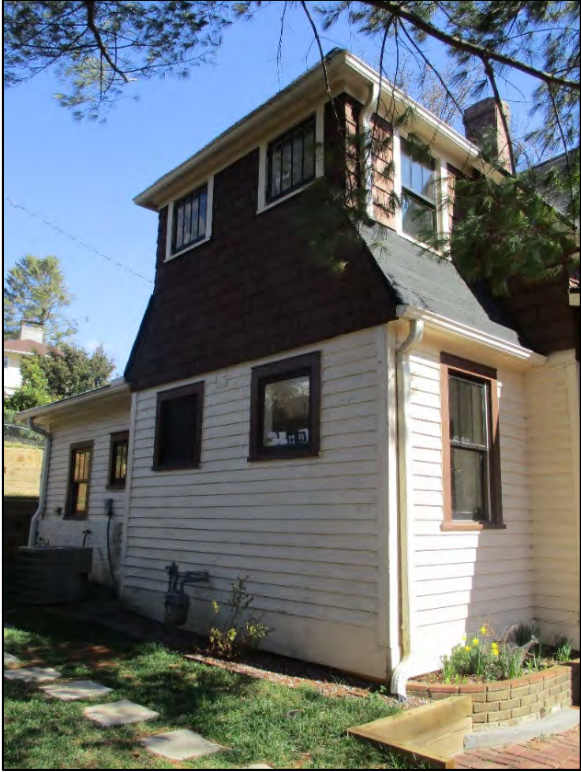
The west elevation features a single three-over-one sash replacement window, two single pane square windows, three casement windows with four vertical panes (second level), and one small casement window with three vertical panes (first level). The foundation of the house is visible from this elevation and consists of continuous brick with portions covered by stucco.

Martha Sayre House west elevation, view to the northeast

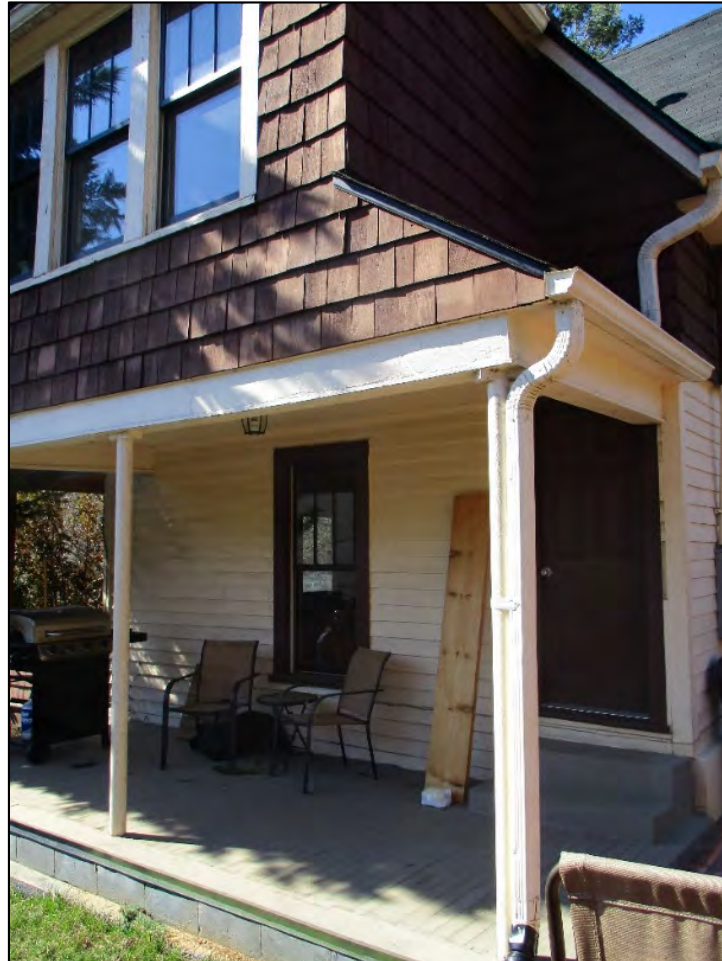
The east elevation of the house has a small engaged porch on the first level with a concrete block foundation. The second-story projects above the porch and includes a ribbon of three-over-one sash windows. The second level is supported by metal posts in the porch. Two concrete steps lead to a replacement door that provides access to the porch. To the south of the door is a three-over-one replacement sash window.

Martha Sayre House east elevation engaged porch detail

While the house maintains its location, setting, and a high degree of historic materials, a few alterations were noted. Multiple windows have been replaced, and both the front porch and east elevation engaged porch have been updated with new materials. These alterations represent a loss of historic material and workmanship. However, based on historic Sanborn maps from 1925 and 1954 the house footprint does not appear changed, although they do indicate that a two-story garage used to exist in the northwest corner of the property (see Exhibit 52); therefore, the historic design integrity is considered intact.

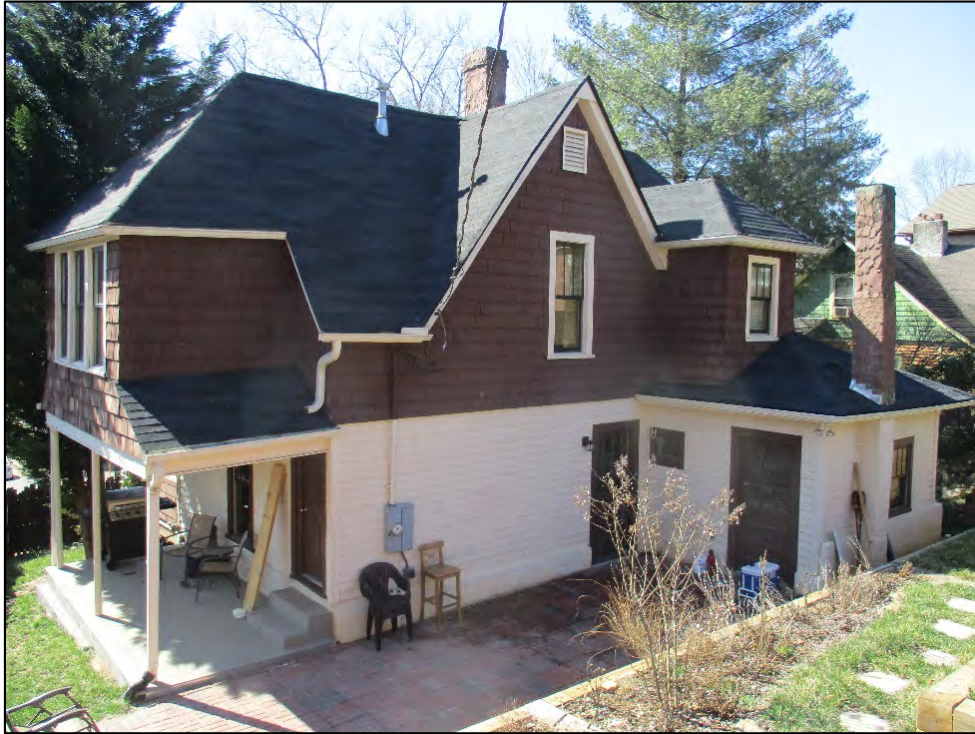
The rear of the house (north elevation) features two historic wood panel doors with six lights above three panels that lead onto a brick patio. One of these doors is located in the east elevation of a one-story ell that projects from the west side of house. The rear ell has an external brick chimney that is partially covered with stucco and includes three-over-one double windows as well as a small, decorative stained-glass window to the left of the door. The second story of the rear elevation features a gable with a three over-one sash window, as well as a small hipped roof projection above the rear ell that also includes a three-over-one sash window.

Martha Sayre House rear (north) elevation, view to the southwest

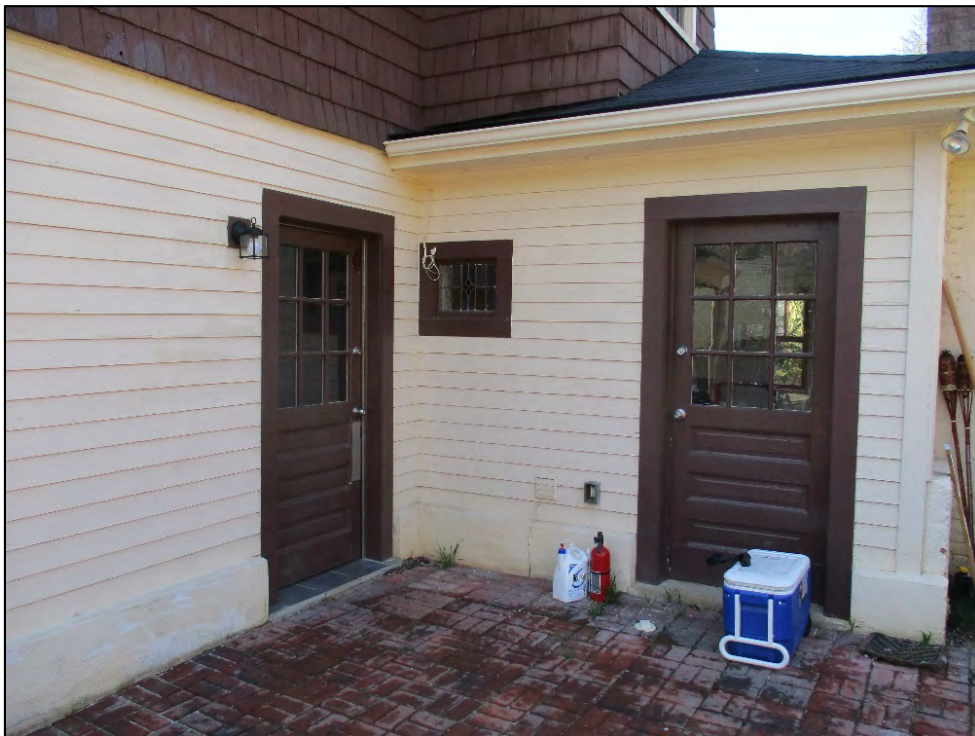
Martha Sayre House rear (north) elevation patio door and window detail

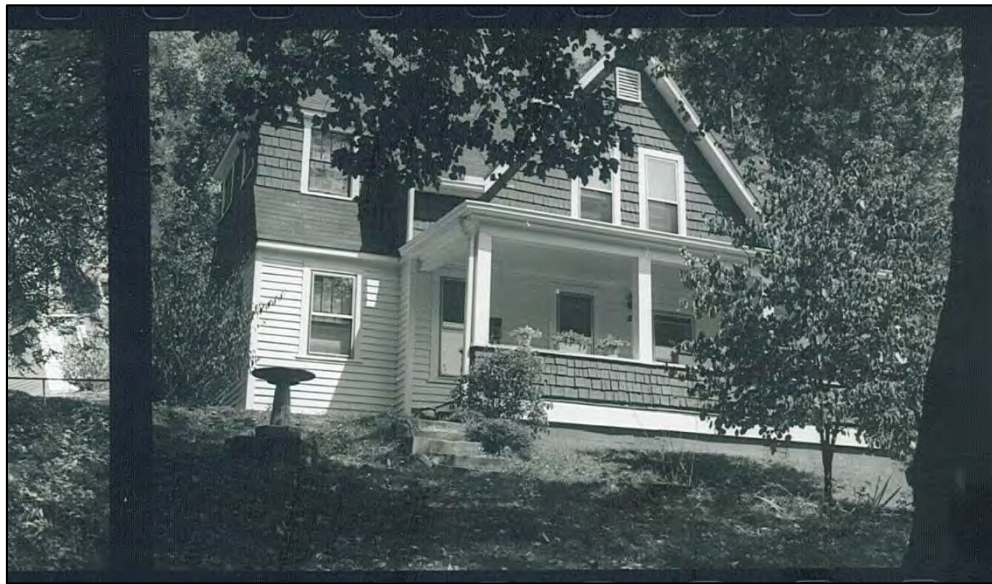
Exhibit 54. Chatham, 1998 photograph from the Historic Property Survey Summary

The Shingle style was popular from 1880-1910 and its distinguishing feature was wall cladding consisting primarily of shingles.⁵⁸ In addition to the shingle siding, the Martha Sayre House features other elements of the Shingle style, including an asymmetrical façade with an irregular steeply pitched roofline, rooflines with intersecting cross gables and multi-level eaves, and an extensive porch. Though the house appears to have more common characteristics with other Shingle style examples in the Asheville area, shingle siding was also a common material found on Craftsman style homes in Asheville. The use of shingles in addition to the three-over-one windows suggest a Craftsman influence, as well. However, many of the windows are replacements, though they appear to match those present in 1998 (see Exhibit 54 on next page).

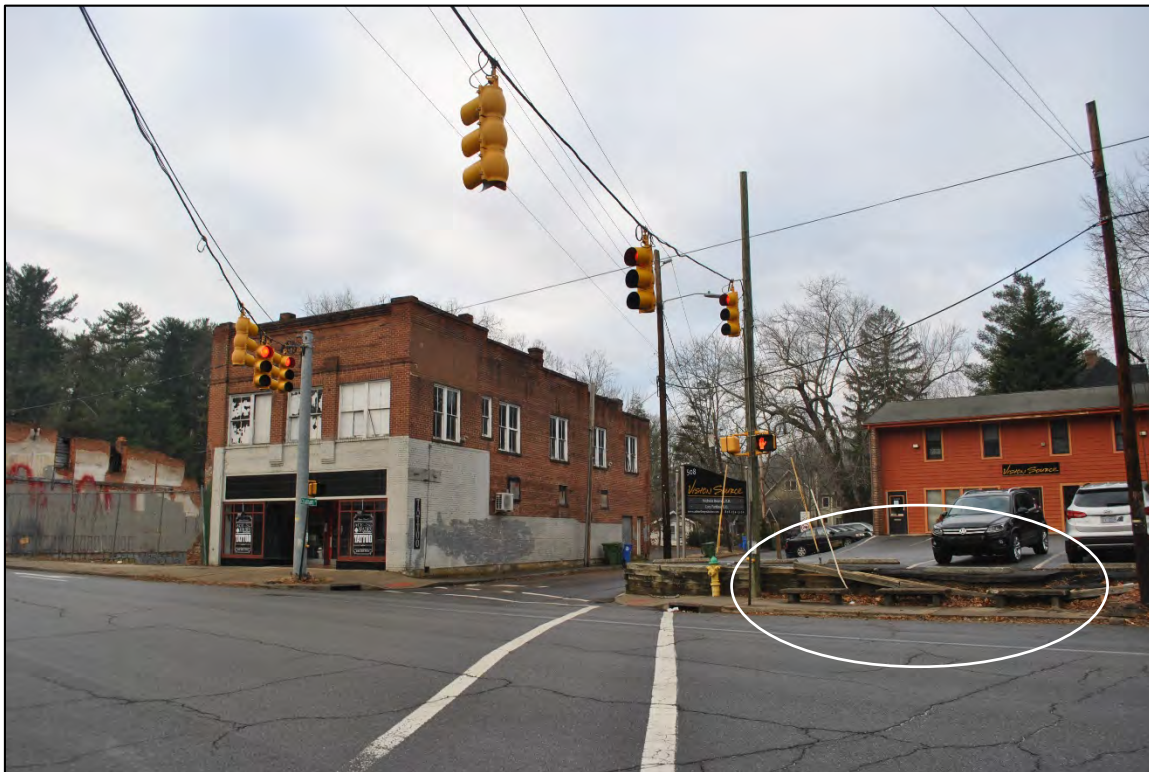
Merrimon Avenue Transit Benches on the north side of the Chatham Road intersection, view to the west.

These three concrete with pebble aggregate, flat benches are located in the sidewalk on the west side of Merrimon Avenue, north of Chatham Road, in the wedge formed by Clearview Terrace's acute intersection with Merrimon Avenue. The benches consist of simple concrete supports and a slab bench with an "M" or "W" emblazoned centrally on each bench, possibly dyed. There is no evidence in the concrete sidewalk to suggest the benches corresponded to any other above-surface feature, e.g., a canopy or shelter. However, the placement of the feature suggests an association with transportation history. Overall, the benches are in good condition, though the northernmost bench is chipped and degrading.

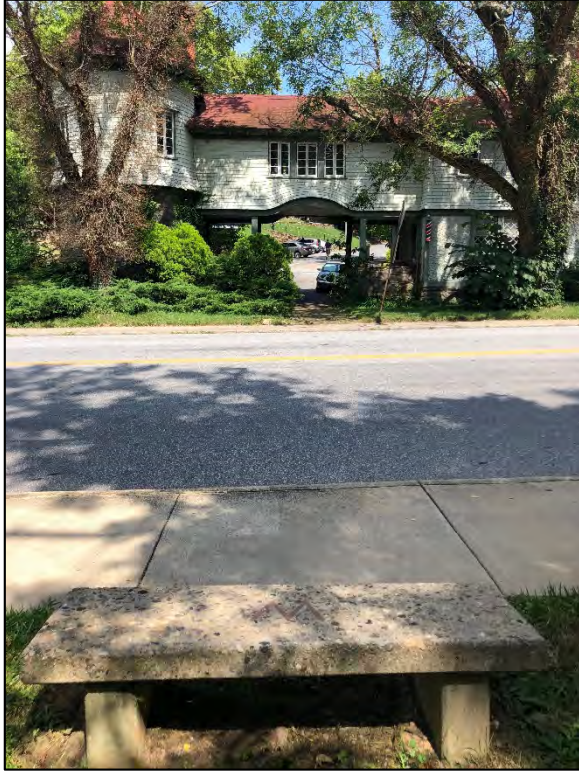
Exhibit 56. Charlotte Street transit bench, located in the southwest corner of Charlotte Street and Edwin Place. Photo courtesy of Jack Thomson.

Charlotte Street historically supported a trolley line. However, additional information regarding the features provenance is unknown. The “M” or “W” located in this example weakens a theory that the letter on the Merrimon Avenue Transit Benches may have been a locational designation, though remains possible.

In addition to the comparable bench on Charlotte Street, which is essentially a replication of the Merrimon Avenue Transit Benches (or vice-a-versa), the elaborate, rusticated stone canopies at Grove Park along Charlotte Street were examined as a possible comparable property (Exhibits 58–59). Though a streetcar traversed Charlotte Street, the Grove Park neighborhood was designed for residents who could afford to own an automobile. As such, that the referenced structures were constructed as a waiting stop for the streetcar seems unlikely, though not impossible. These structures are not specifically mentioned in the 1989 NR Nomination Form.

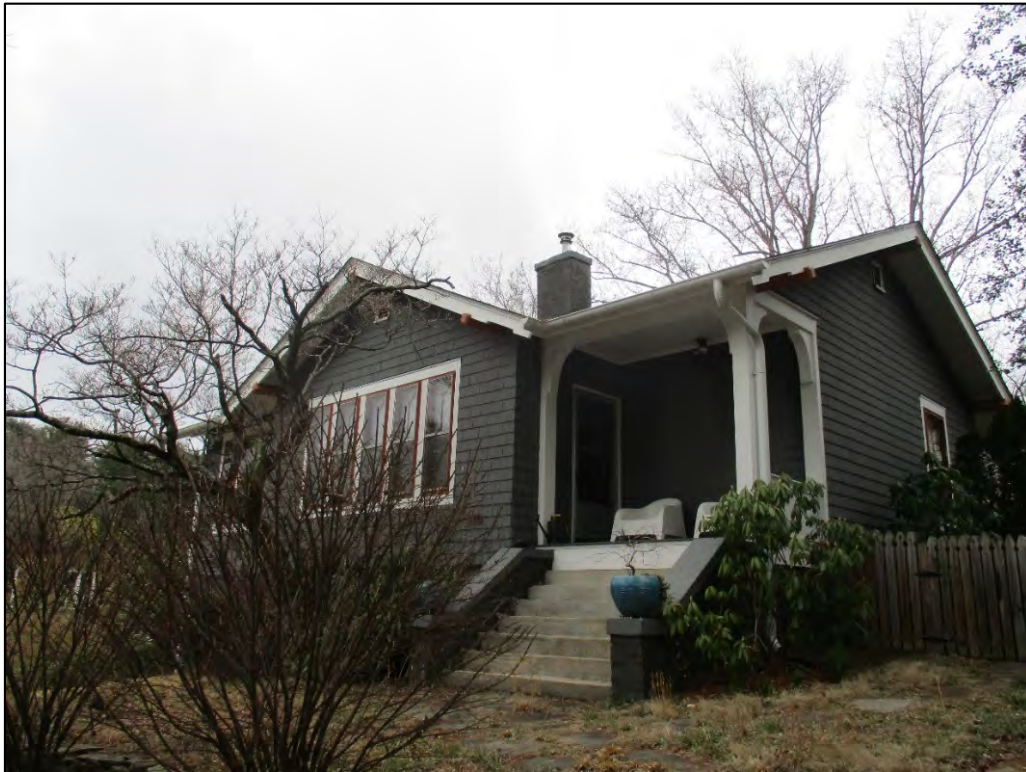
Façade, view to the southwest

The east-facing façade is asymmetrical under a side-gabled roof with a central projecting front gable. The house is one story and sits on a full basement. There is a partial, engaged front porch in the northeast corner of the house that permits access to the house via an original side-entry wood panel door with a half-height latticed window door. An open rail, wood baluster is present in the north porch exposure. The porch columns are wood and feature decorative knee braces in the corners. There are six concrete steps that provide access to the porch and front door. A ribbon window featuring five sash

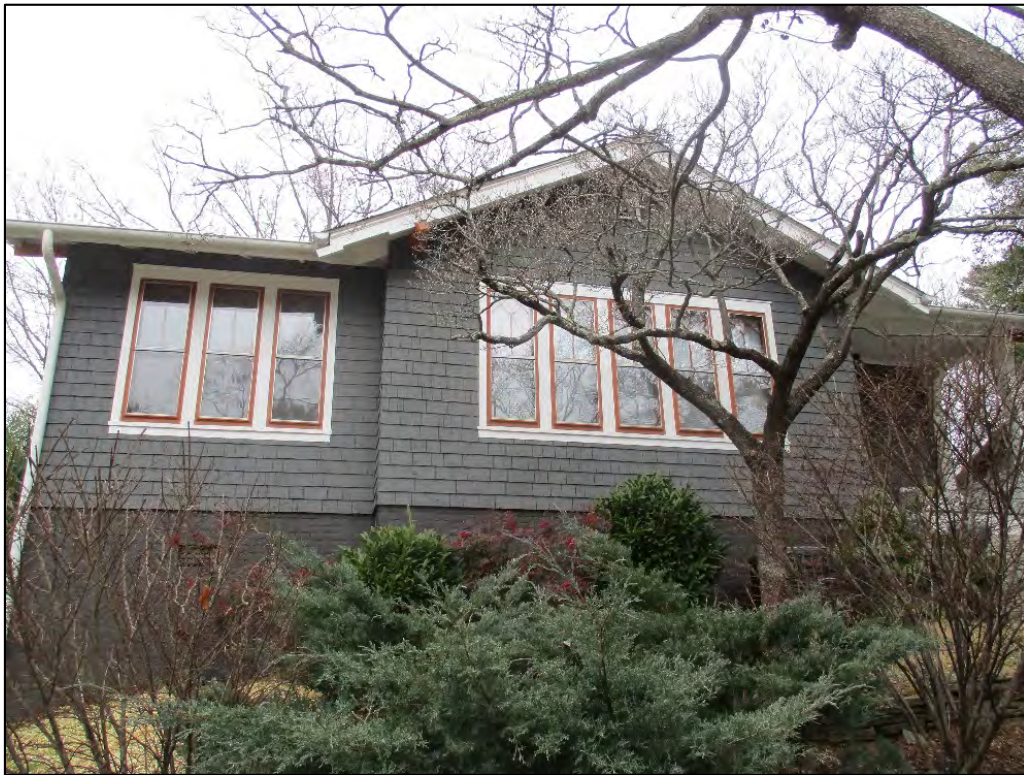
windows with a lattice pattern in the top sash is centered under the front projecting gable, and triple sash windows the same lattice pattern are located immediately to the left. Aluminum storm windows are present over the windows. The foundation of the house is continuous brick and the siding on all elevations is wood shingle. The wide eaves expose plank wood sheathing and rafter tails with exposed beams in the gable ends. Rectangular wood-slat gable vents are also present. The roof is covered with asphalt shingles. There are two internal brick chimneys which have been clad with stucco: one is located centrally on the ridgeline and the second on the rear (west) roof slope.

Façade, view to the west

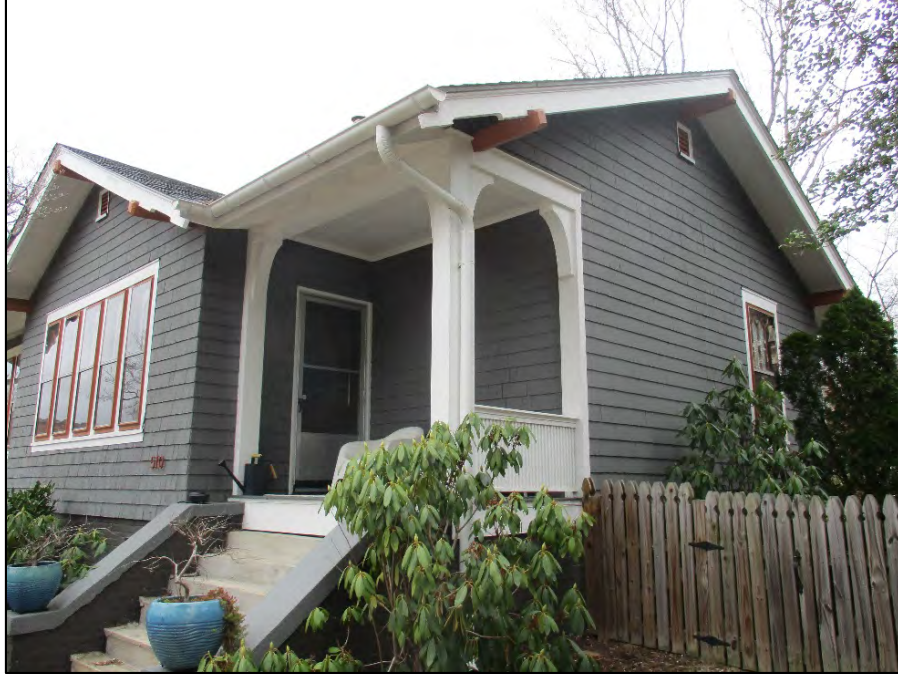
Oblique view of the façade and north elevation, view to the southwest

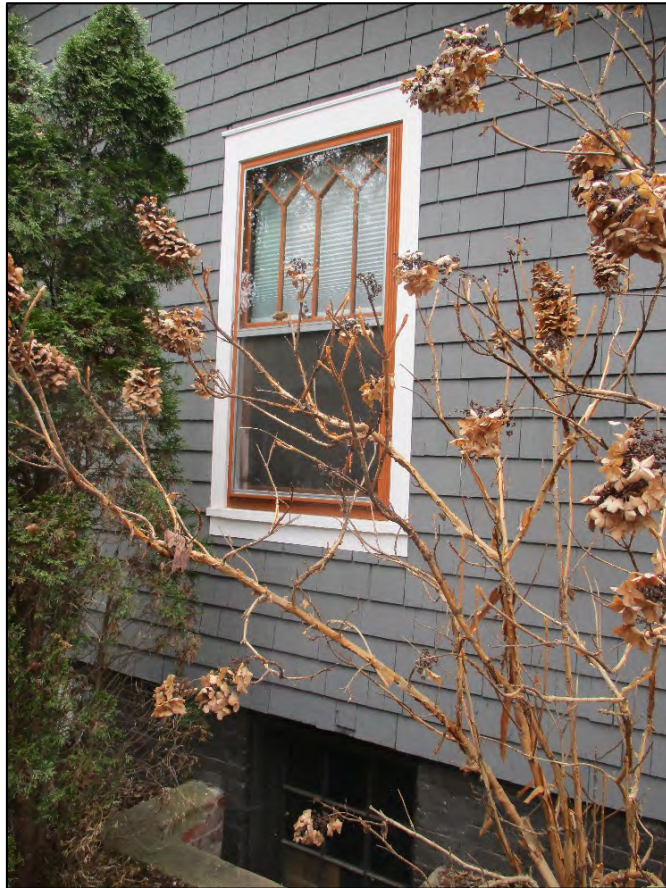
The north elevation of the house features a single sash window with a lattice pattern and a portion of the integrated front porch. A fixed window with twelve panes is also visible in the basement level. The south elevation has triple sash windows and two single sash windows with a lattice pattern in the top sash.

North elevation window detail

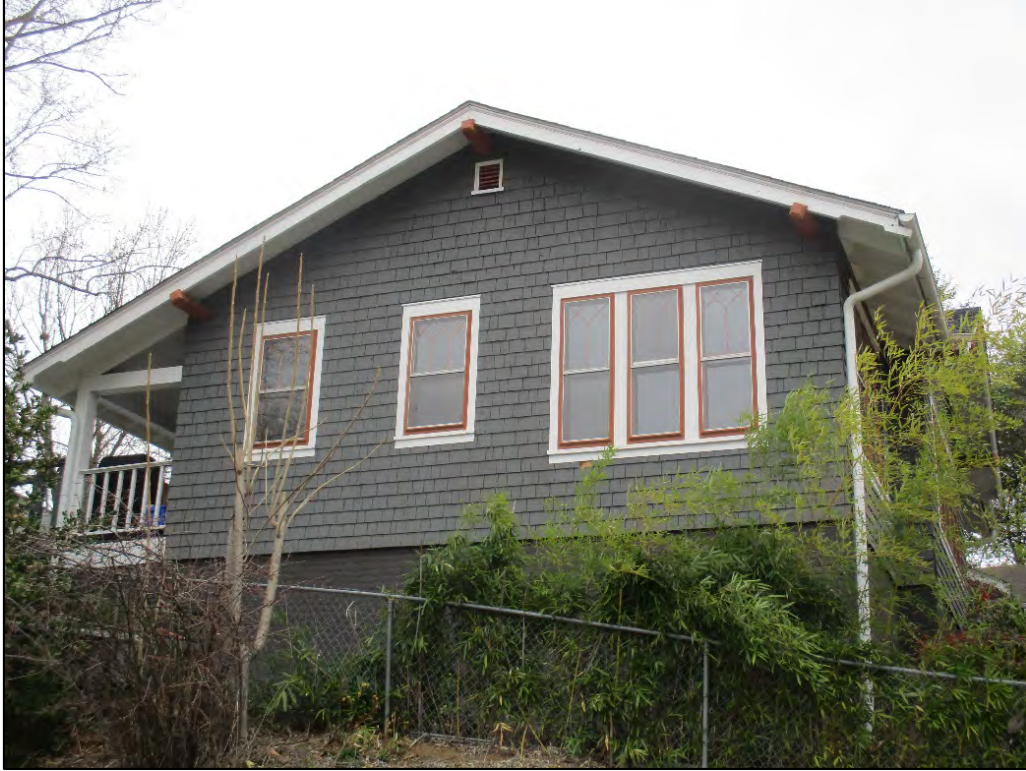
South elevation, view to the north

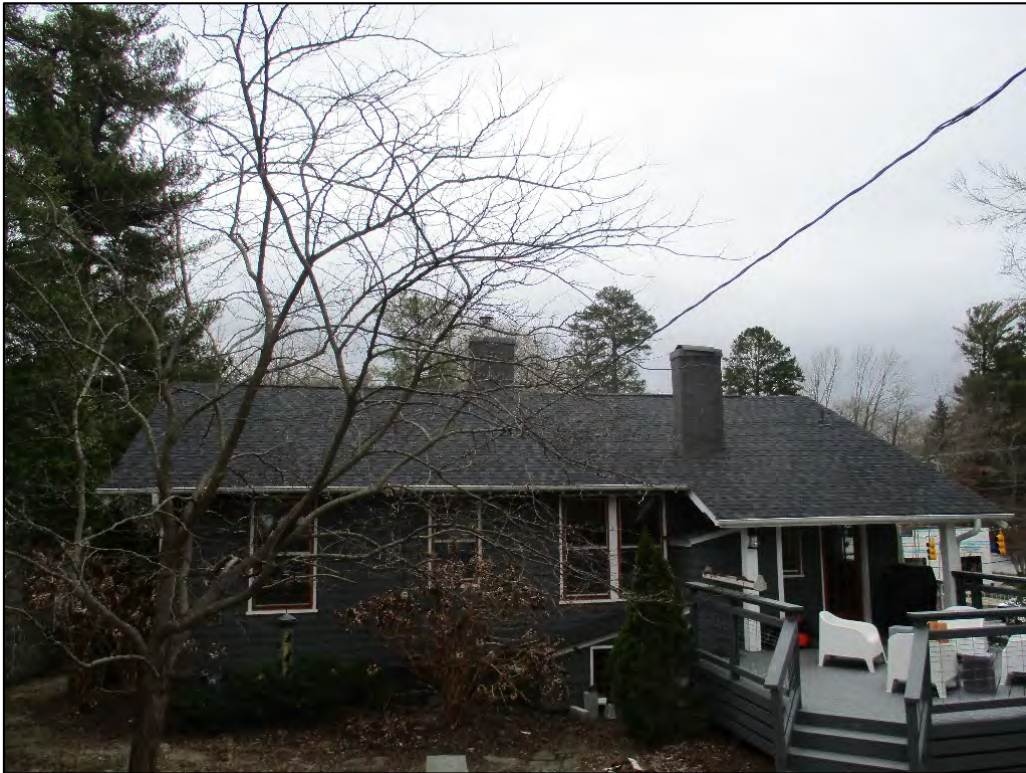
There is a small, extended shed porch on the rear (west) of the house supported by two square posts. A deck addition extends from the southwest portion of the house. The window styles are consistent with the rest of the house with three single windows and one pair. A small enclosed projection under the shed porch contains a doorway, a fixed pane 16-light window, and stairs that lead to the basement level of the house. A fixed window with twelve panes is visible in the brick foundation that provides light to the basement.

West elevation, view to the east

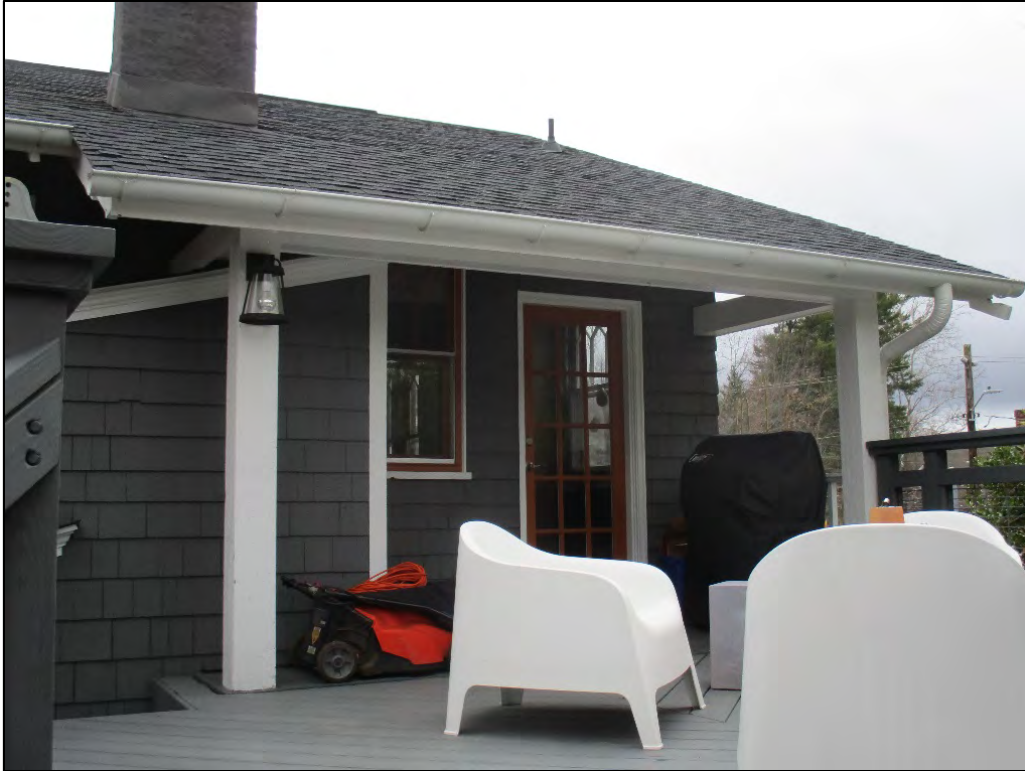
West elevation porch detail

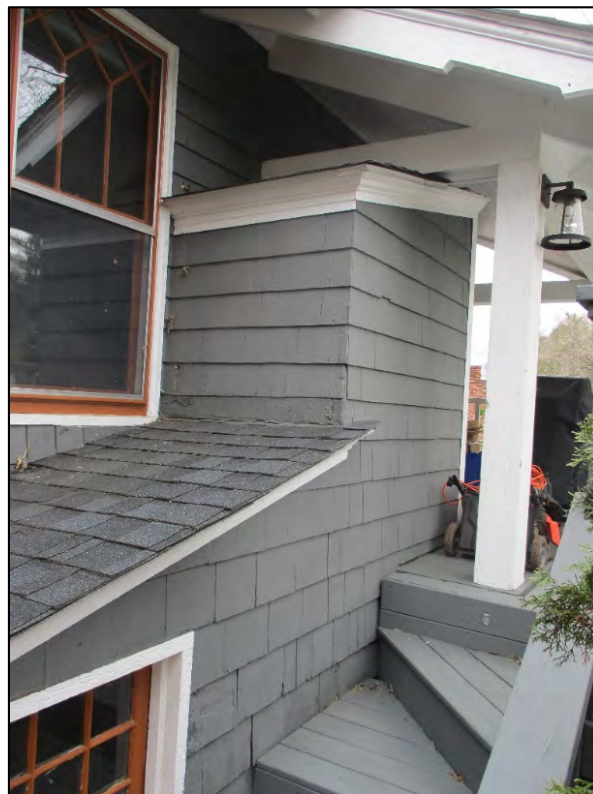
West elevation, enclosed basement entry and stairs detail

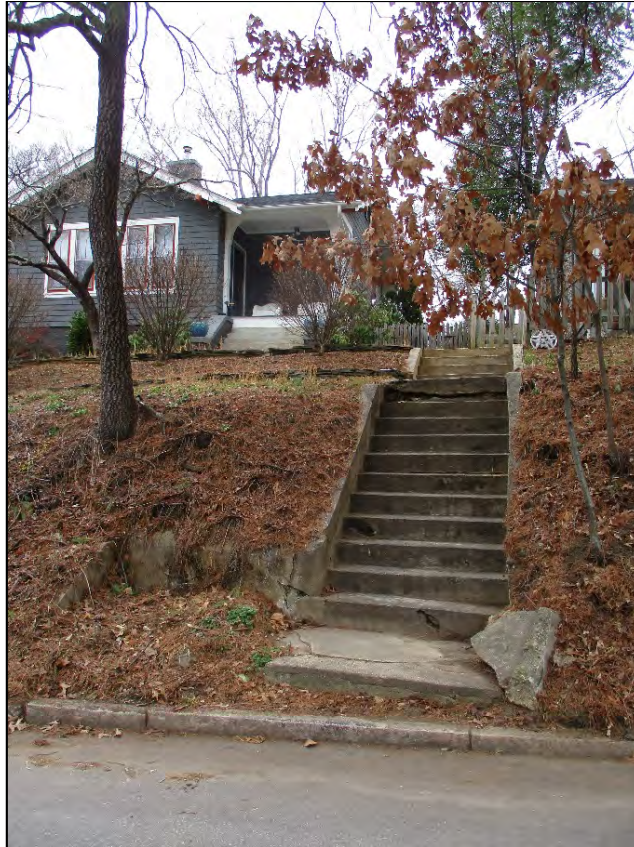
House approach from Clearview Terrace. Note granite curbing on Clearview Terrace. View to the west.

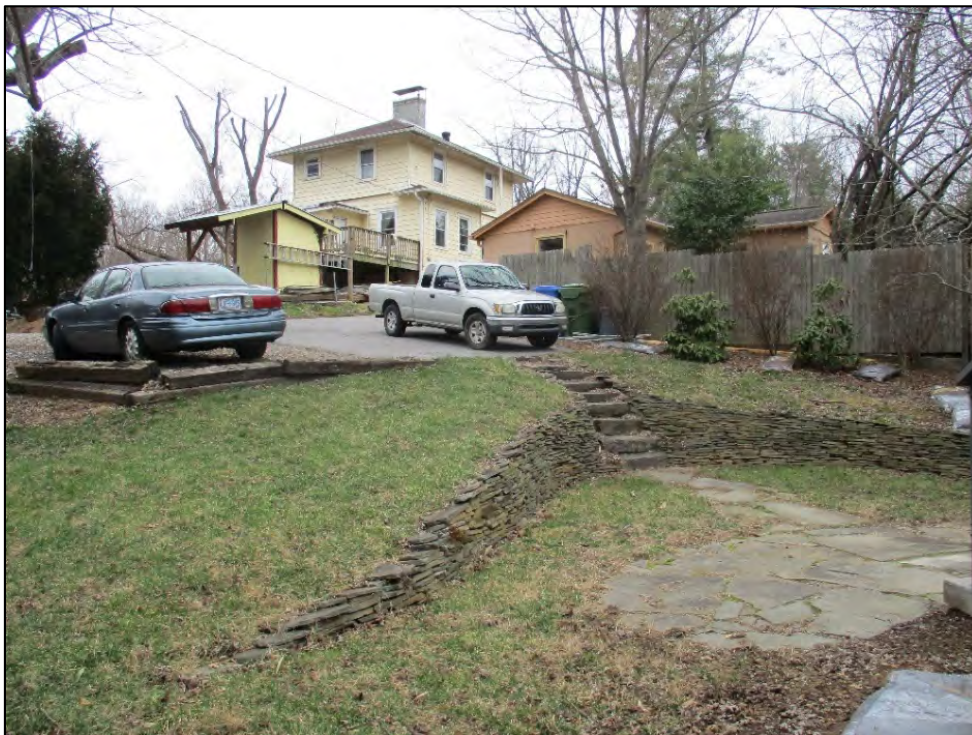
Backyard and parking area, view to the northwest

The yard is grassed with informal plantings. The property has a wooden gate that leads from the front of the house to the backyard which contains a low stone wall, a small stone patio, and concrete steps that lead up to a partially paved parking area accessible via Clearview Terrace.

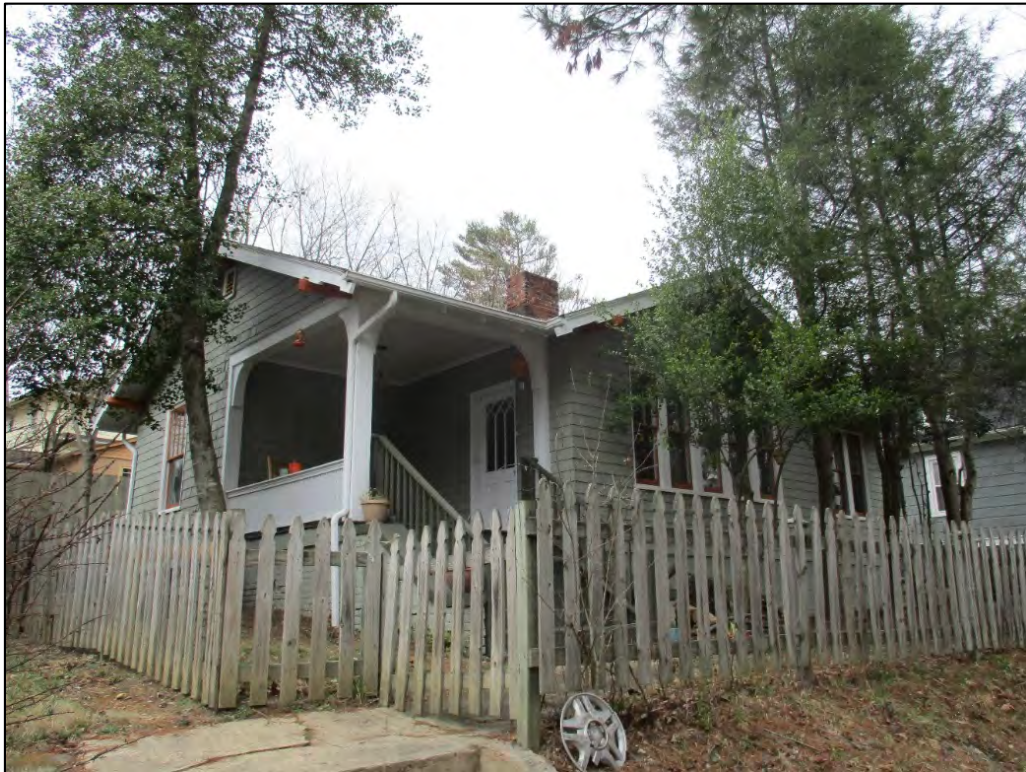
Lauerhass House façade, view to the northwest

The east-facing façade is asymmetrical with a side gable roof and central front gable projection. The house is one story and sits on a full basement. There is a partial, engaged front porch in the southeast corner of the house with a side entry door. The front door is wood panel with glass and features the same decorative glazing pattern (i.e., latticed) as the windows of the house. The porch columns are

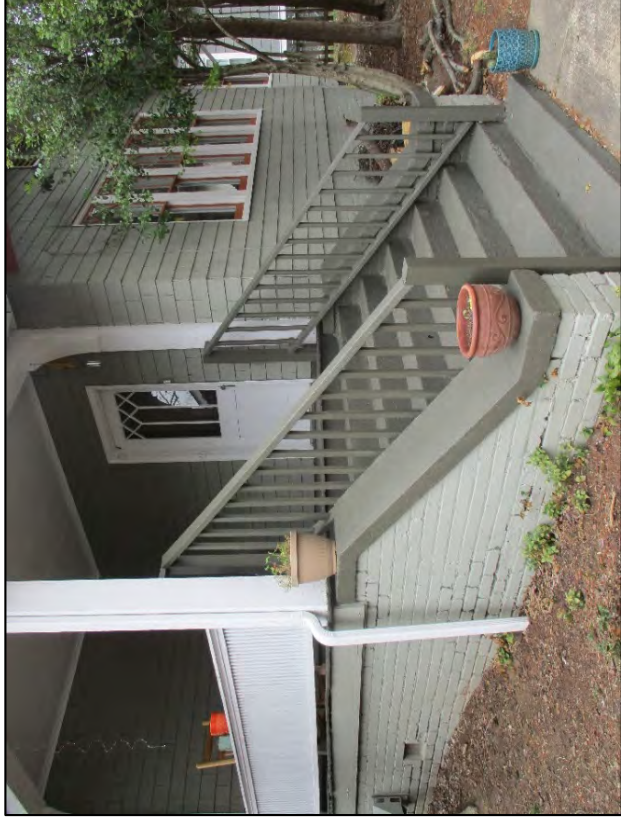
wood and feature decorative knee braces at the roof junction. There are seven concrete steps with a replacement wood bannister within the porch wing walls that provides access to the porch. A ribbon window featuring five windows with a lattice pattern in the top sash is centered under the front projecting gable, and triple sash windows with the same lattice pattern are located immediately to the north (right). The foundation of the house is continuous brick and the siding on all elevations is wood shingle. The roof has wide eaves with exposed rafters and decorative braces, and is covered with asphalt shingles. There are two internal brick chimneys: one is located centrally within the house, the other towards the rear of the house.

Lauerhass House front porch detail, view to the northwest

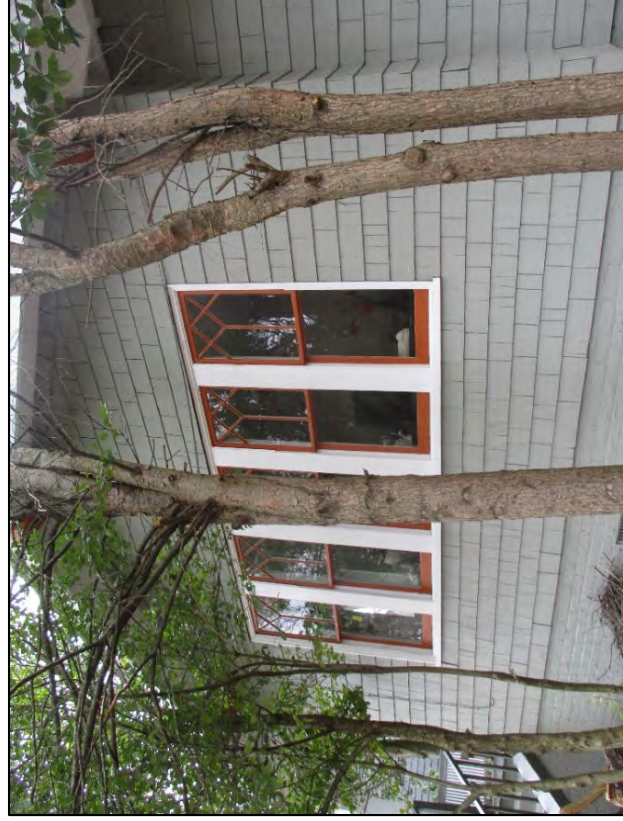
Lauerhass House façade, latticed window detail

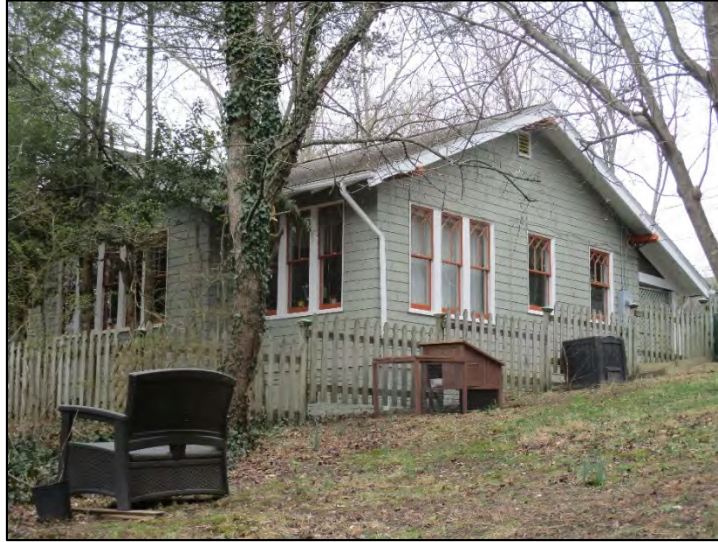
The south elevation of the house features a single four-over-one sash window, the only such window noted in the house. A fixed window with nine panes is also visible in the basement level. The north elevation has triple double hung sash windows and two single double-hung sash windows with the same lattice pattern featured on the windows on the façade. There are small square wood vents in the gable ends.

Lauerhass House north elevation view to the southwest

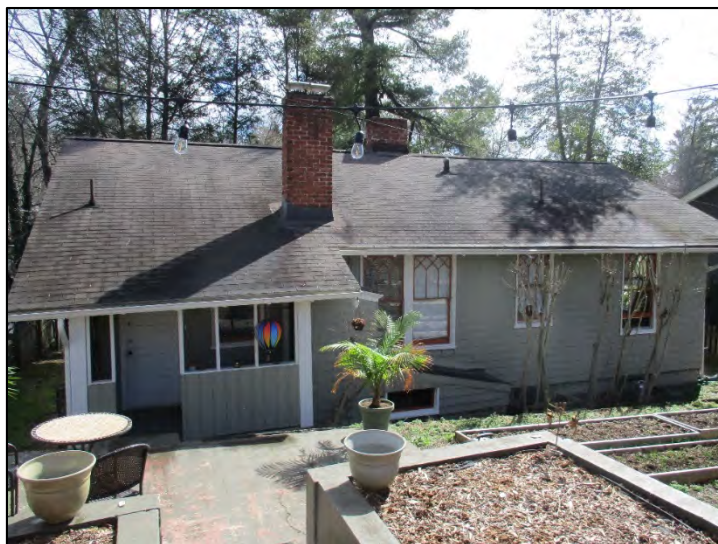
There is a small, extended shed porch on the rear of the house (west elevation) that has been partially enclosed. The windows on this elevation are the same style as the rest of the house, with three single windows and one paired window. A small enclosed projection underneath the shed porch contains a doorway, a fixed pane window with two lights, and stairs that lead to the basement level of the house. Two fixed windows with nine panes each are visible in the brick foundation that provides light to the basement.

Lauerhass House west elevation view to the east

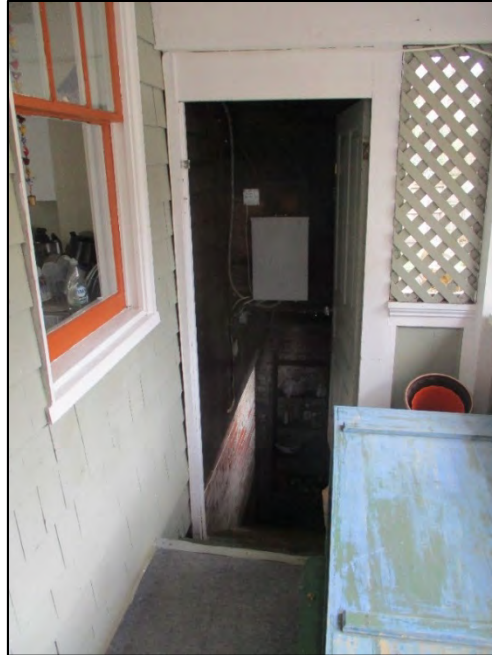
Lauerhass House rear porch detail and view into basement

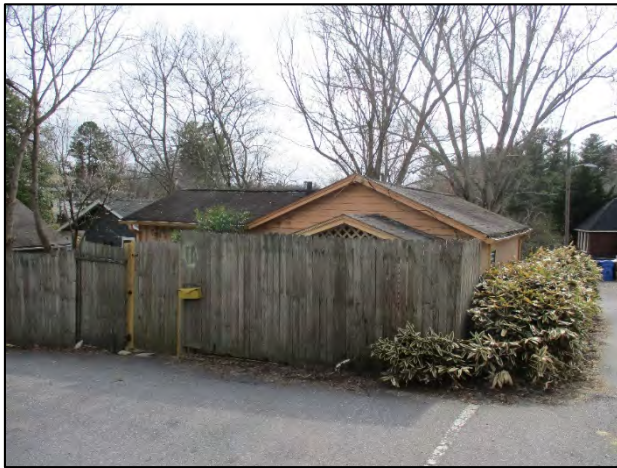
Adjacent to the parking area is a one-story outbuilding. The building has the address 512 ½ and is currently being used as a residence, though no one was present at the time of the survey. A privacy fence extends from the west elevation of the building and encloses the building and small associated yard. The building is constructed of concrete block and has an asphalt shingled, cross-gable roof. The north elevation contains one-over-one sash windows and a small covered front gable portico. Both the east and west elevations contain six-over-six sash windows with a picture window on the south elevation. A concrete patio is present to the rear of the building with a Craftsman-style wood panel and glass door providing access to the house. Based on tax assessor data, this building was constructed in 1948, however, it does not appear on the 1954 Sanborn maps. One outbuilding is associated with the house on the 1954 Sanborn (Exhibit 63) but it is a frame garage and is in the wrong location to be the building described above. Therefore, it is likely that this current structure was built after 1954.

Lauerhass House outbuilding façade from alley, view to the south

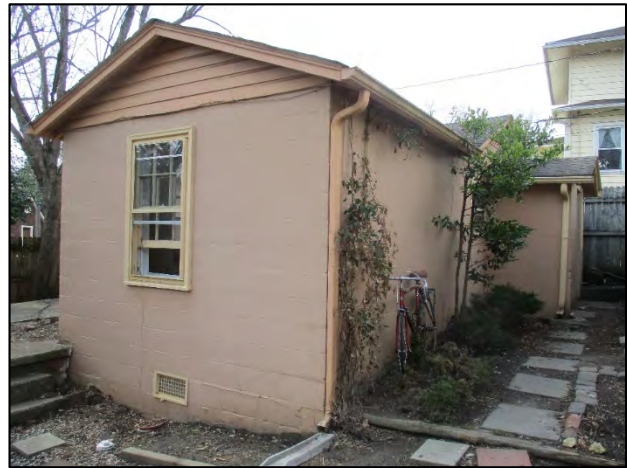
Lauerhass House outbuilding east and north elevation, view to the west

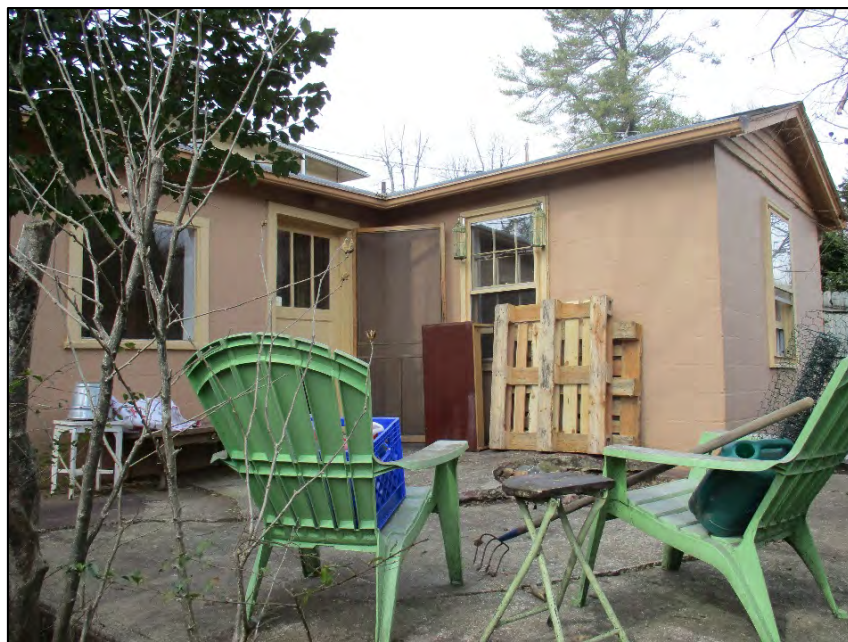
Lauerhass House outbuilding rear elevation view to the northwest

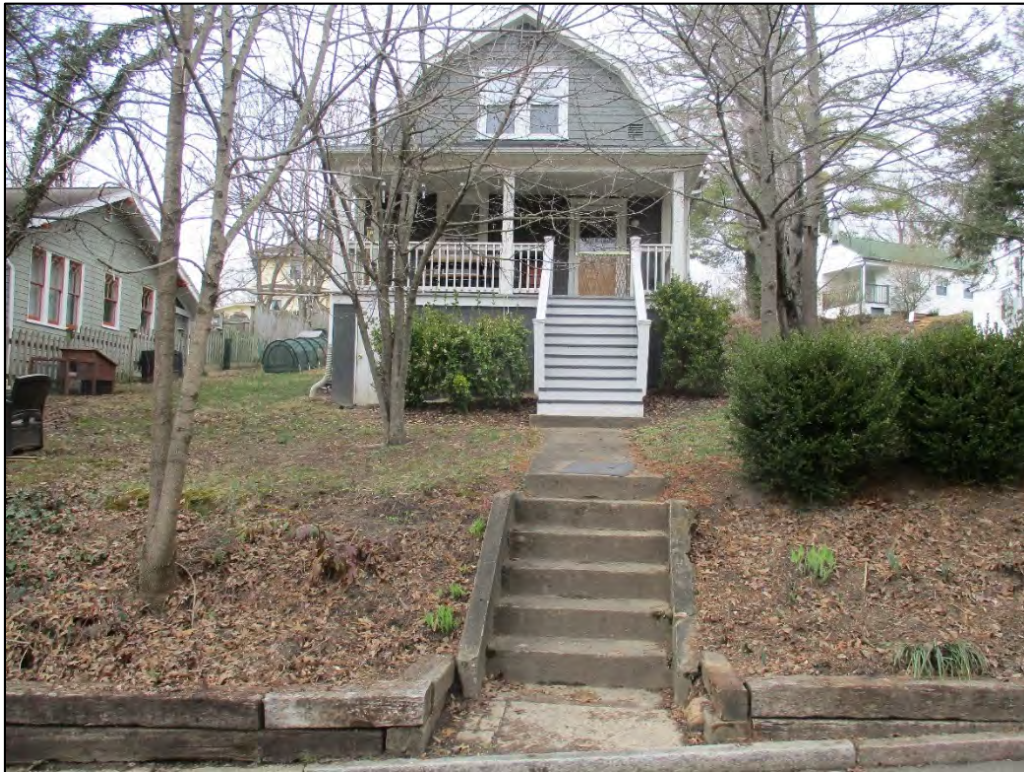
Joseph Lewis House façade, view to the west

The east-facing façade is asymmetrical with a front facing gambrel roof covered by asphalt shingles. The house is two stories and has paired one-over-one sash windows located in the gambrel end. A full one-story porch spans the façade and is supported by simple square columns and a square balustrade and railing with 11 wood steps accessing to the porch and front door. The front door is wood panel with two vertical glass lights and appears to be original to the house. A single one-over-one sash window is located to the left (south) of the front door. The house has German siding on all elevations, although the width of the siding varies. The foundation under the front porch is concrete block while the rest of the

While the house maintains its location and some of its original materials, certain alterations detract from the overall integrity. The windows have all been replaced with non-historic vinyl windows and the porch has been expanded and updated with several new materials. Additionally, a suspected second story was added to the house after 1954. The introduction of these new materials and the second story addition represent a loss of historic materials, workmanship, and design, and detract from the overall integrity of the house.
