November 9, 2018

MEMORANDUM

SUBJECT: Historic Structures Survey Report, Merrimon Avenue & WT Weaver Boulevard Intersection Improvements. U-5781, U-5782, PA 17-04-0023, Buncombe County, ER 18-0102

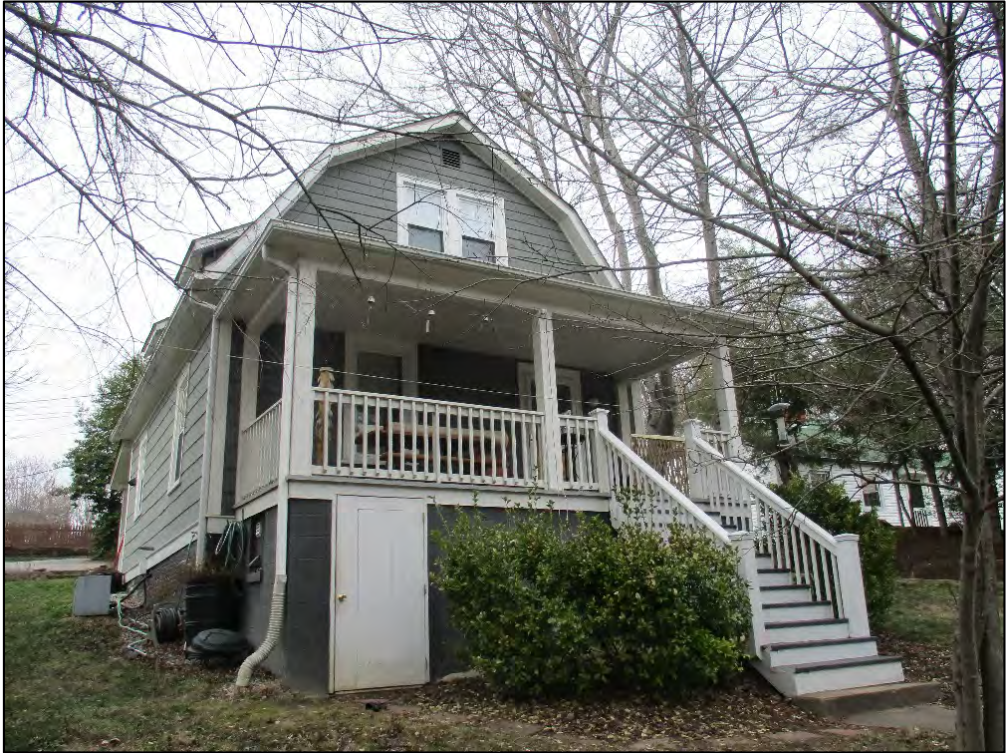
Joseph Lewis House oblique view of façade and south elevation, view to the northwest

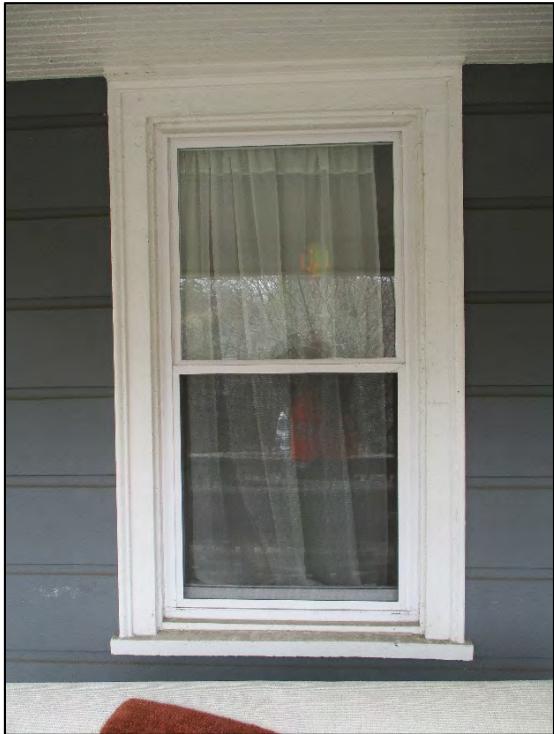
Joseph Lewis House front porch window detail

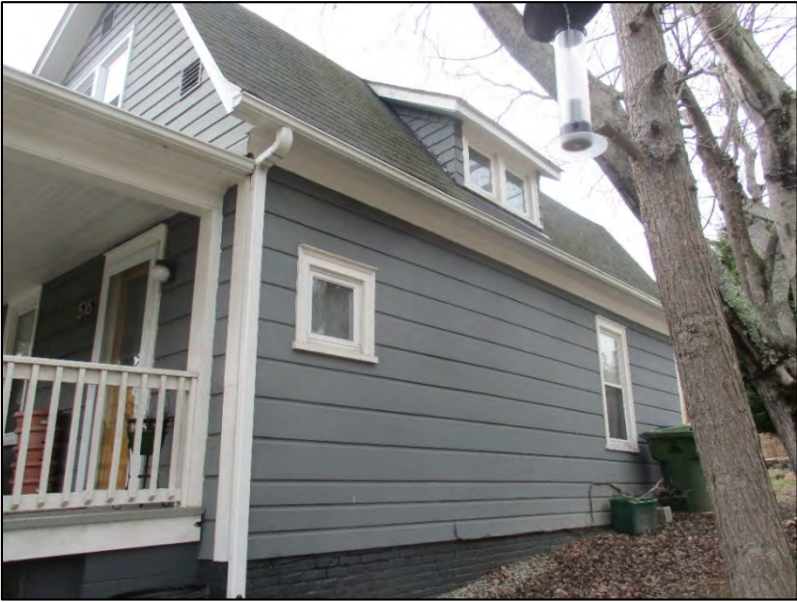
The north elevation of the house includes one small, square fixed pane window and a single one-over-one sash window. A small, wood shingle-clad shed dormer with two fixed paned windows is visible in the second story.

Joseph Lewis House north elevation, view to the southwest

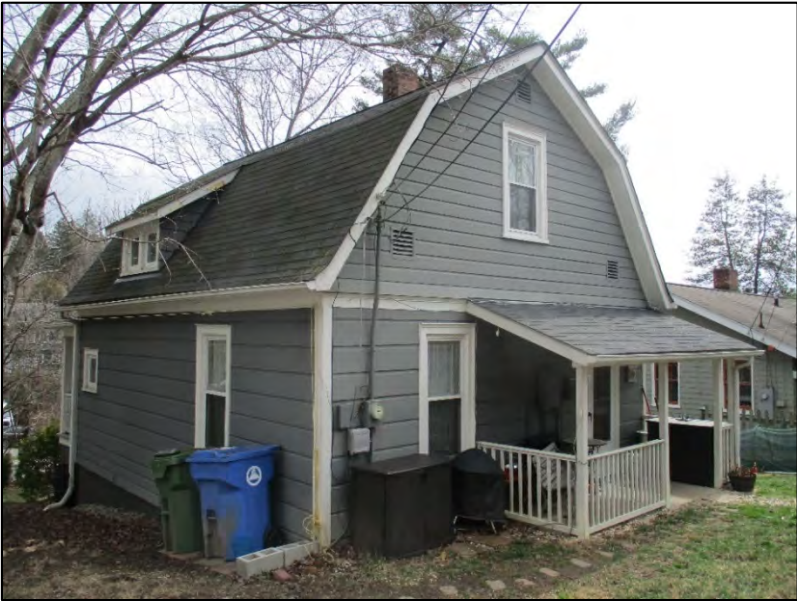
The rear of the house (west elevation) has a small, attached shed porch with a concrete floor, square columns, and square balustrade and railing. The rear door matches the front door and also appears to be original to the house. There is a single one-over-one sash window on the first story and a single one-over-one window in the second story.

Joseph Lewis House west elevation, view to the southeast. Note the different German siding width in first and second stories.

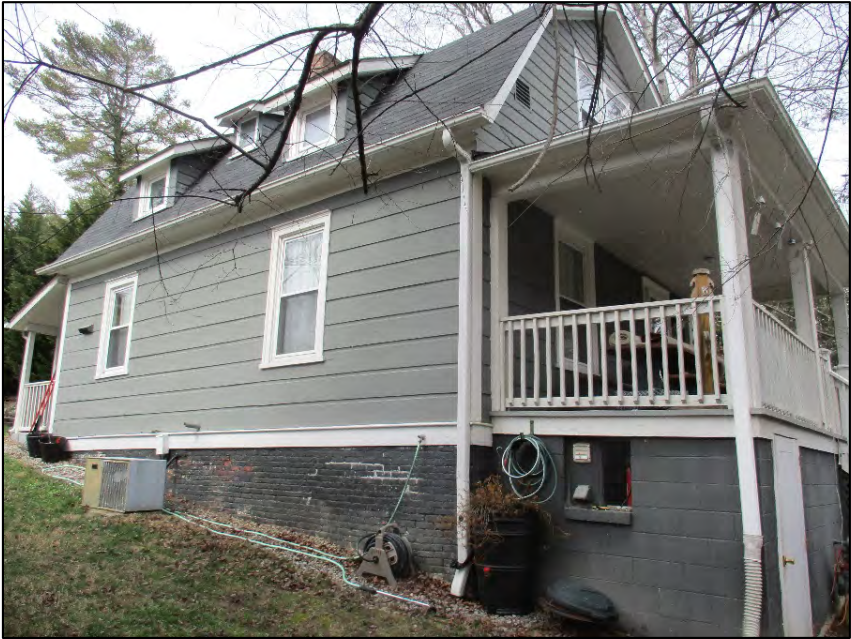
The south elevation of the house has two single one-over-one sash windows on the first story with three shed dormers in the second story with a single fixed pane window in each. The center dormer is slightly higher than the other two; all are clad in German siding.

Joseph Lewis House south elevation, view to the north

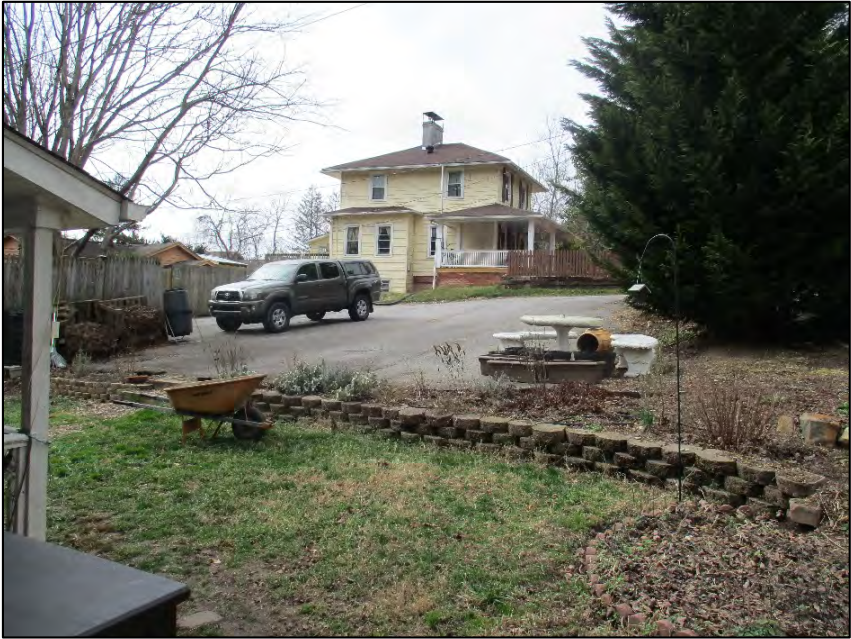
The yard surrounding the house is grassed with informal plantings. The back yard features a low stone retaining wall and two concrete steps that lead up to a paved parking area which is accessed via Clearview Terrace.

Joseph Lewis House backyard and parking area view to the west (BN6354 is visible in background)

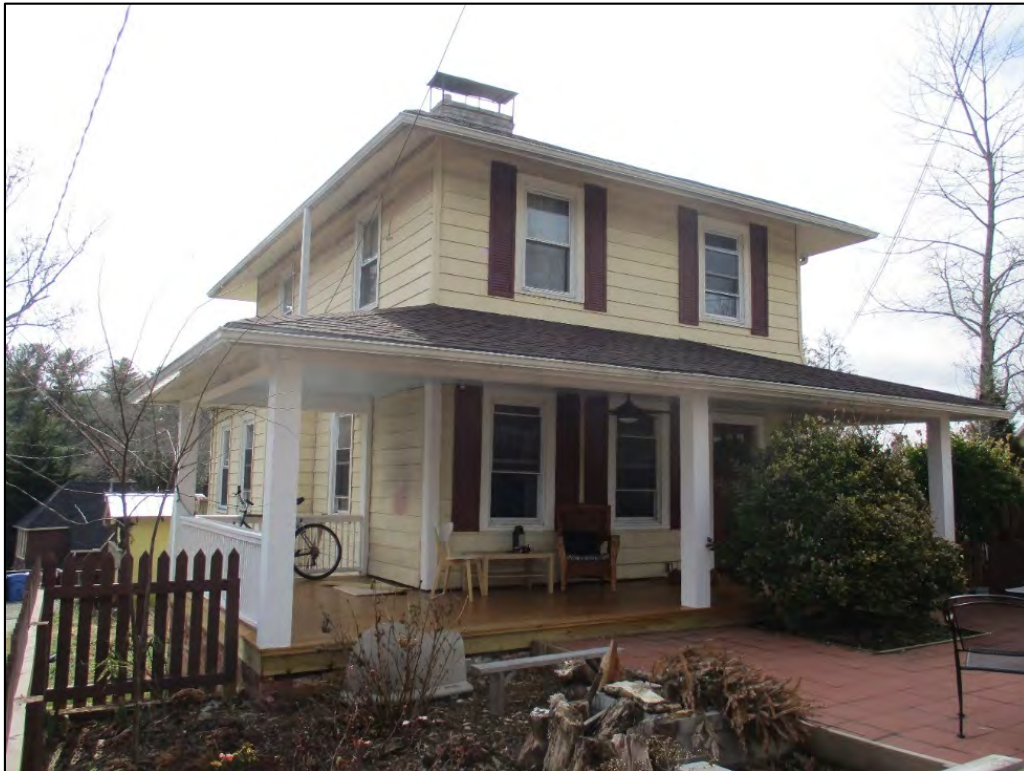
Oblique view of façade and east elevation, view to the southwest

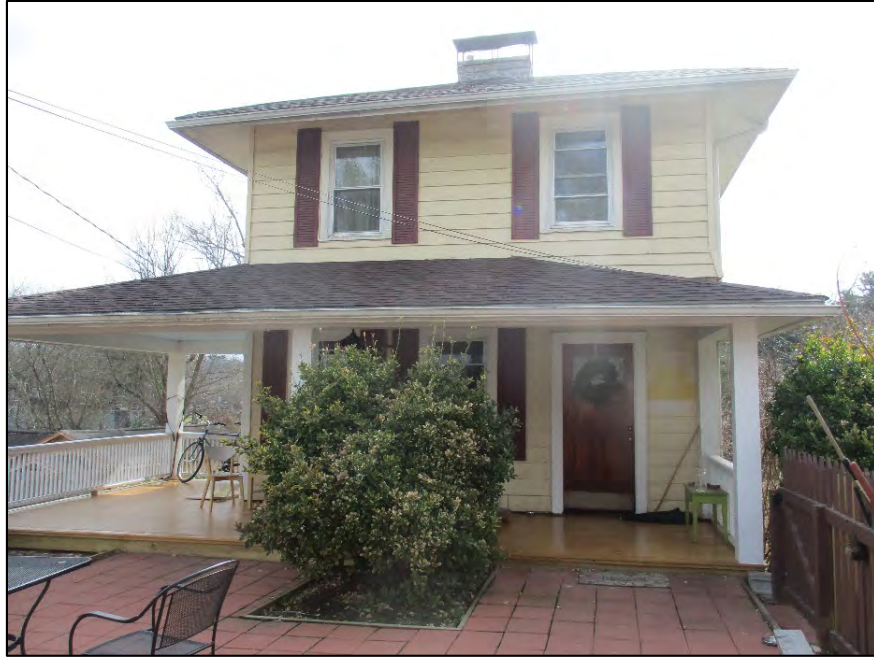
The north-facing façade is asymmetrical with a hipped roof covered by asphalt shingles and wide, enclosed eaves. The house is two stories and has a wraparound hipped roof porch extending the full width of the façade and a portion of the east elevation. The porch features replacement wood columns and flooring with new balustrade and railings on the east and south sides. The main entry is a non-historic wood panel with glass door. Two one-over-one sash replacement windows with decorative shutters are located on the first and second levels. The house has aluminum siding and one internal central brick chimney.

Façade, view to the south

The current owner stated that the porch flooring, railing, and supports were recently replaced. Access to the interior of the house was not permitted for privacy reasons. According to tax assessor records, the property has been under current ownership for seven years.

While the house maintains its location and setting, certain alterations detract from the overall integrity. Per the current property owner, the house's porch footprint was maintained when the columns, floor, and railings were replaced with new materials. Many of the windows are vinyl replacements and the siding has been replaced or covered with aluminum. Additionally, the wing addition on the rear (south) elevation appears to represent an alteration of the original design. As a result of these alterations, the resource's integrity of design, materials, and workmanship are compromised.

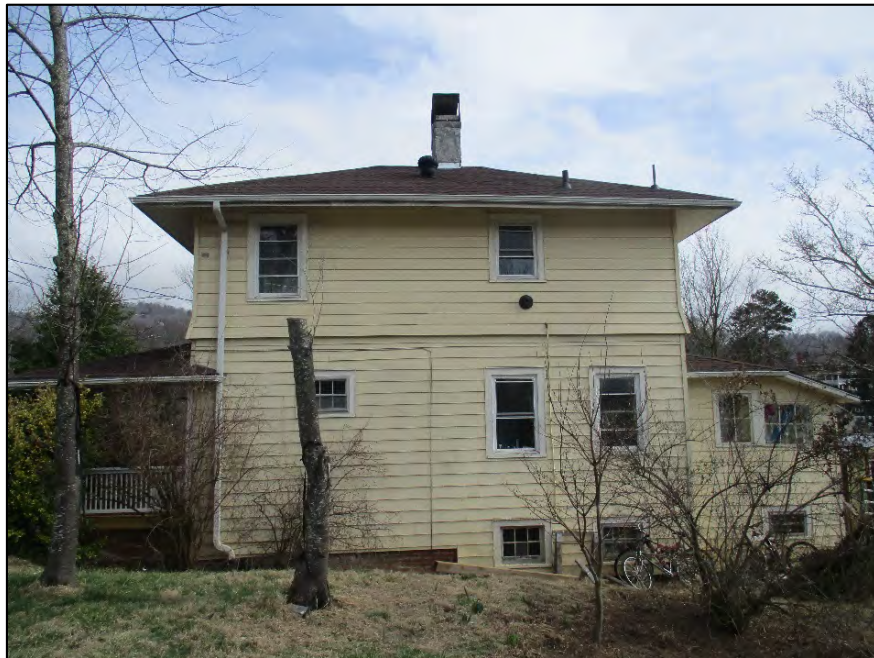
The west elevation of the house has one-over-one sash windows of varying sizes and a single six-light fixed window. From this elevation, a basement level is visible. The foundation is continuous brick and includes two six-paned fixed windows. The east elevation features a small hipped roof projection at the rear (south elevation) of the house with two windows on the first story and two windows on the basement level. The windows on this side of the house are one-over-one sash in the first and second stories with two six paned fixed windows in the basement level.

West elevation, view to the east

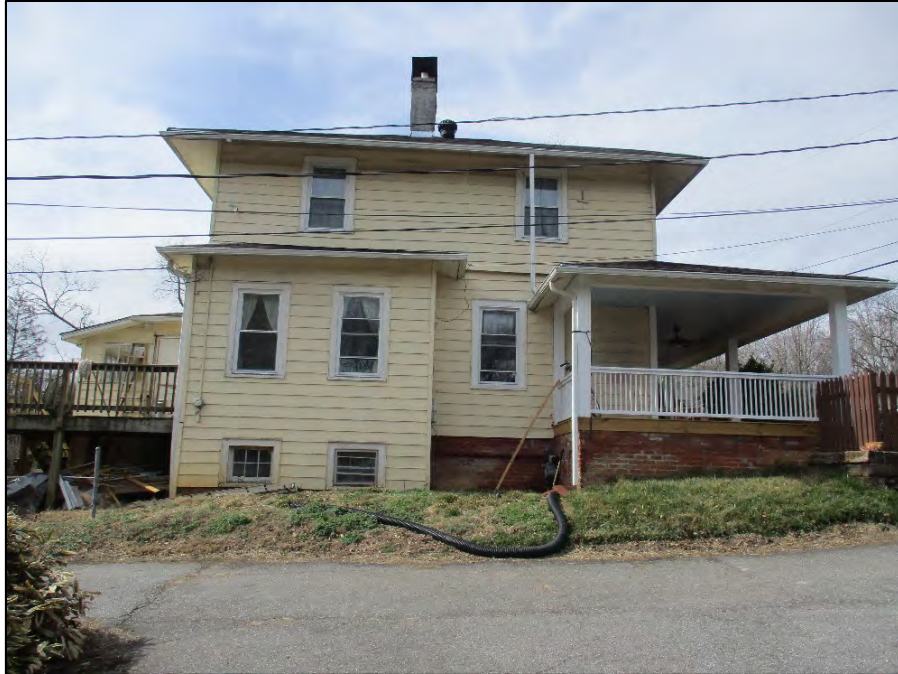
East elevation view to east

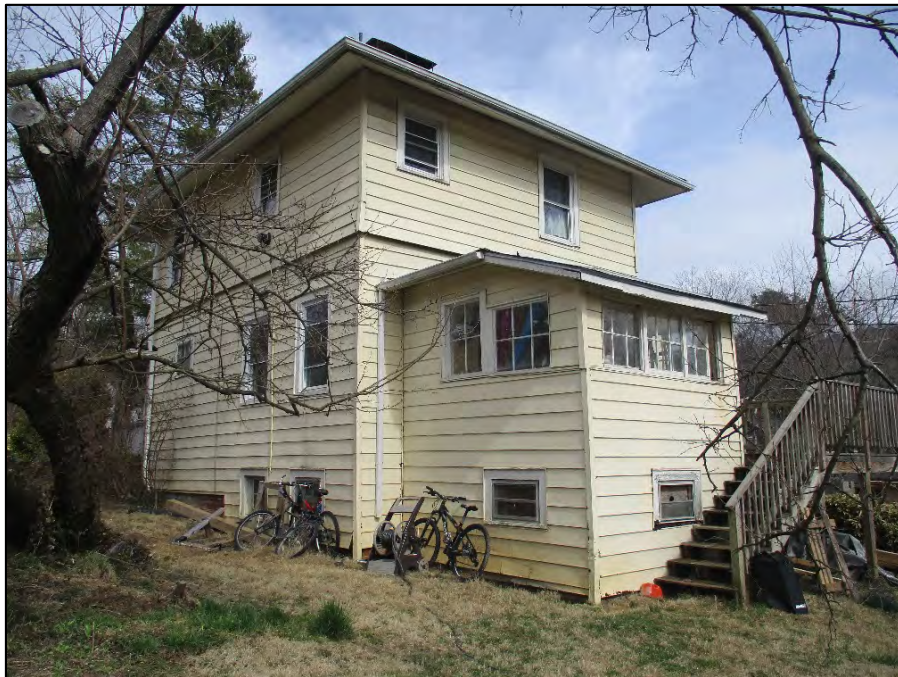
The rear of the house (south elevation) has a one-story wing that extends roughly two-thirds the width of the elevation. The windows on the basement level of the wing are one-over-one sash, while the windows on the first story are six-light casement windows. A wooden deck was added off of the first story addition with stairs leading to the backyard. A wood door is located on the east side of the addition that provides access to the deck.

South elevation addition view to northeast

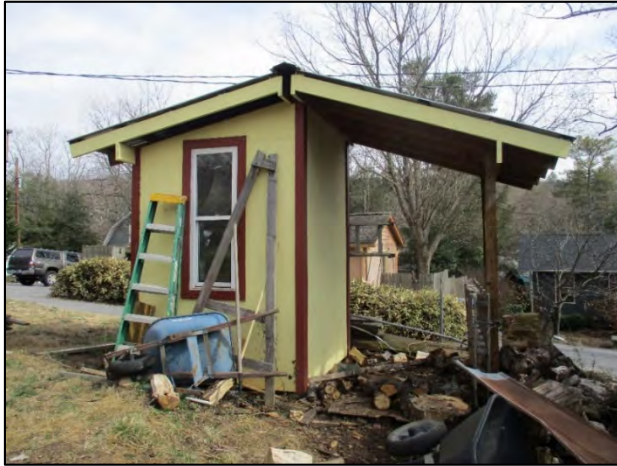
Shed outbuilding located in backyard along the alley on the east side of the house, view to the east

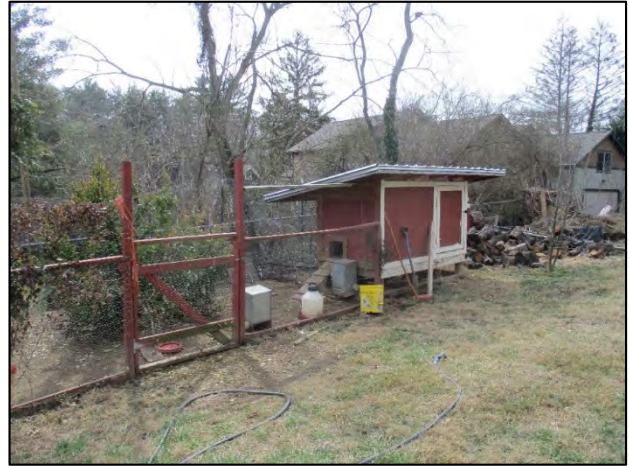
Chicken coop along the south edge of the backyard, view to southwest

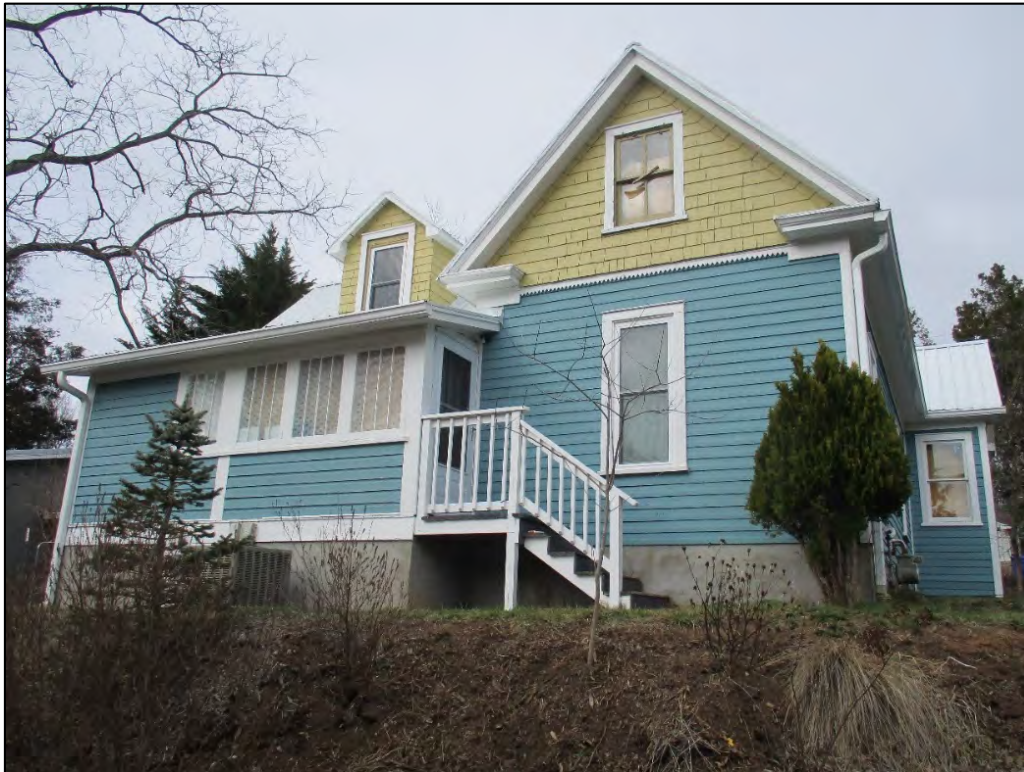
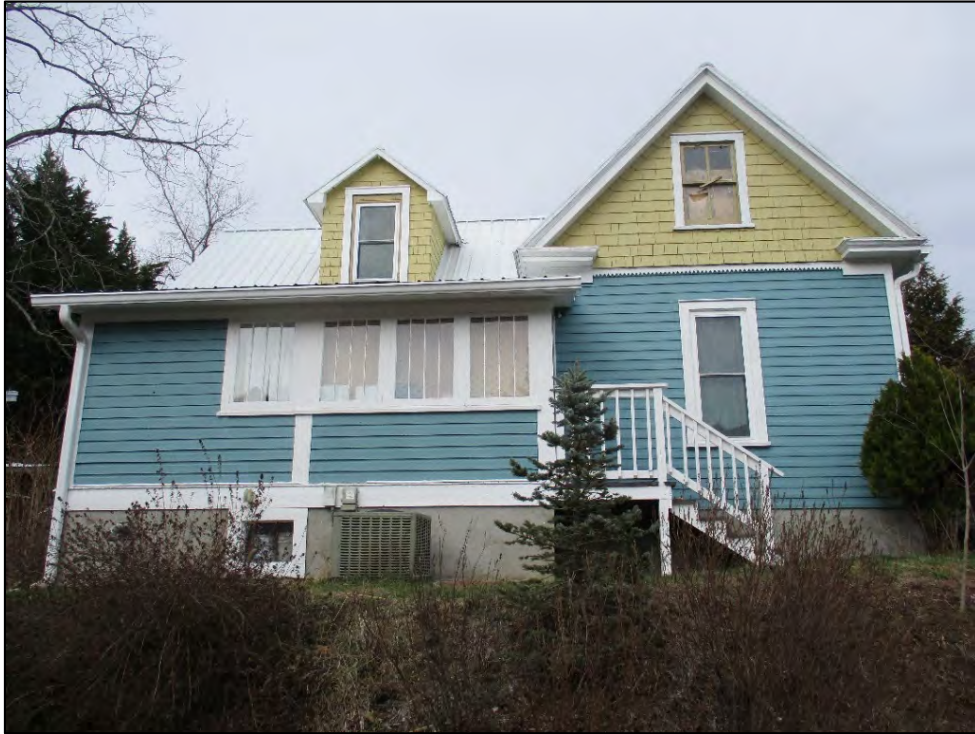
Barber House façade, view to north

The south-facing façade is asymmetrical with a cross gabled roof covered with standing seam metal. The house is one-and-a-half stories with German siding and corner boards on the first story and wood shingles in the gable ends. The wood and four vertical pane glass Craftsman-style porch door is oriented to the east and provides access to the enclosed partial façade shed roof front porch. Wooden steps with a simple wood railing approach the porch entry. The porch enclosure features a ribbon of four casement windows with four vertical panes. To the east of the front porch is a one-over-one sash window. The wood-shingled front gable features a two-over-two sash window, gable returns, and sawtooth

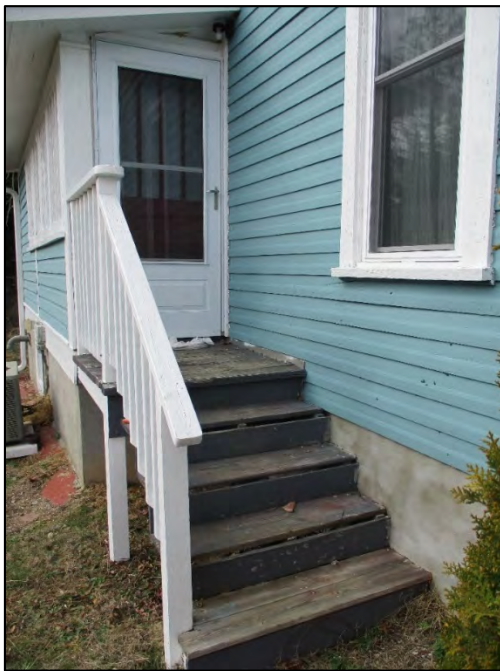
Barber House former front door on south elevation, view to northwest

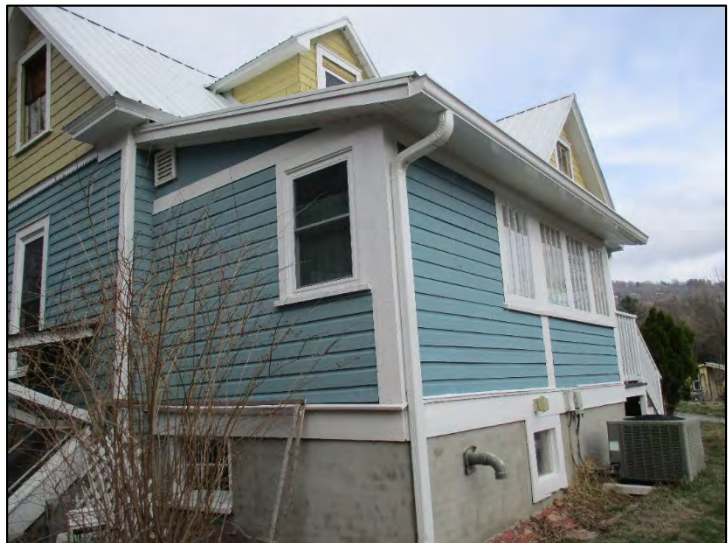
Barber House oblique view of façade, enclosed porch, and west elevation, view to northeast

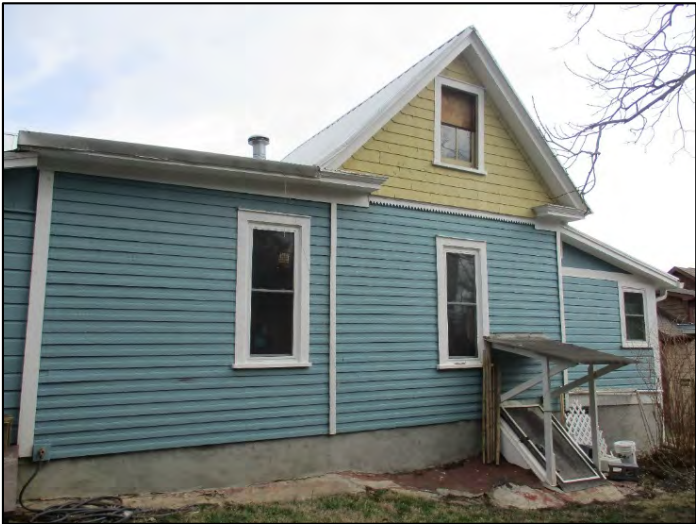
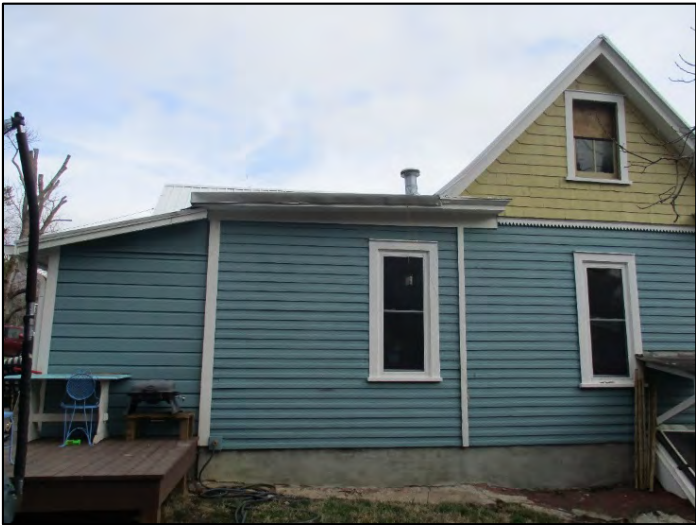
From the west elevation, the front porch enclosure, a rear porch enclosure, and a shed addition that extend off the back of the house are visible. The windows on this side of the house are one-over-one sash on the first level, and a two-over-two sash in the gable end. Similar to the front gable, the side gable features wood shingles, gable returns, and sawtooth decorative trim at the base of the gable. A raised and slightly angled hatch door accesses the basement and is protected by a simple shed roof. There is one fixed, six-pane window located in the basement level south of the hatch door.

Barber House west elevation, view to southeast

Barber House west elevation, view to east

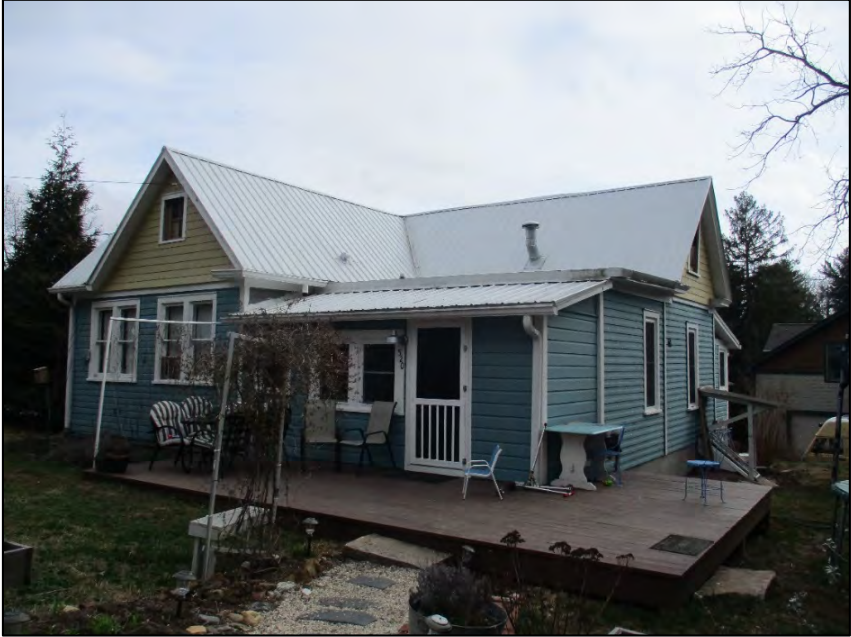
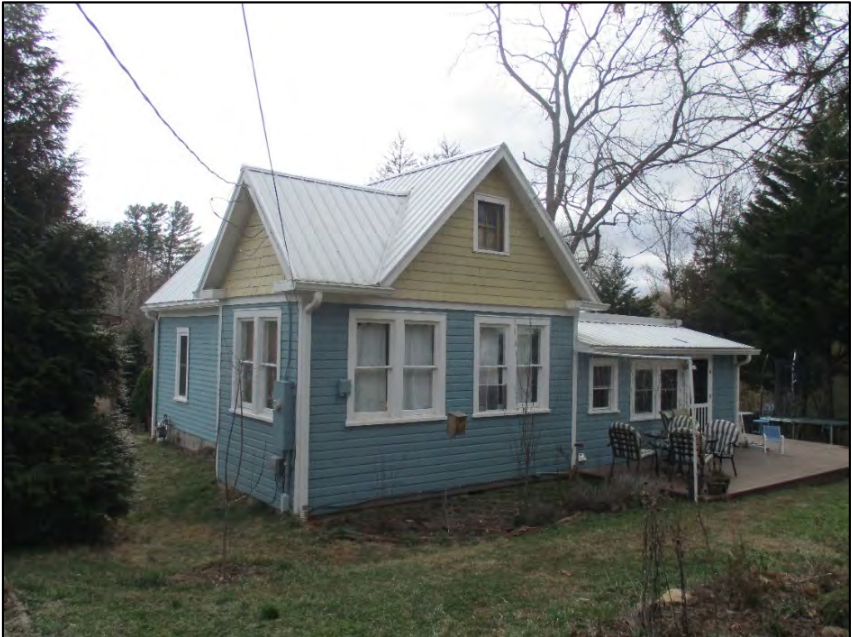
The rear of the house (north elevation) functions as the primary entry. Two shed porch enclosures fill the gabled wing, squaring the house’s footprint. The enclosed rear shed addition features a door leading to a wooden deck and three one-over-one sash windows. To the east of the shed addition, within the historic extent of the house, are two paired one-over-one sash windows. Similar to other gable exposures, the north-facing gable end is clad in wood shingles and features a small four-paned casement window and gable returns; however, the sawtooth detail is not present. A stove pipe chimney is located towards the northern edge of the gabled wing roof.

Barber House north elevation, view to southeast

Barber House north elevation, view to southwest

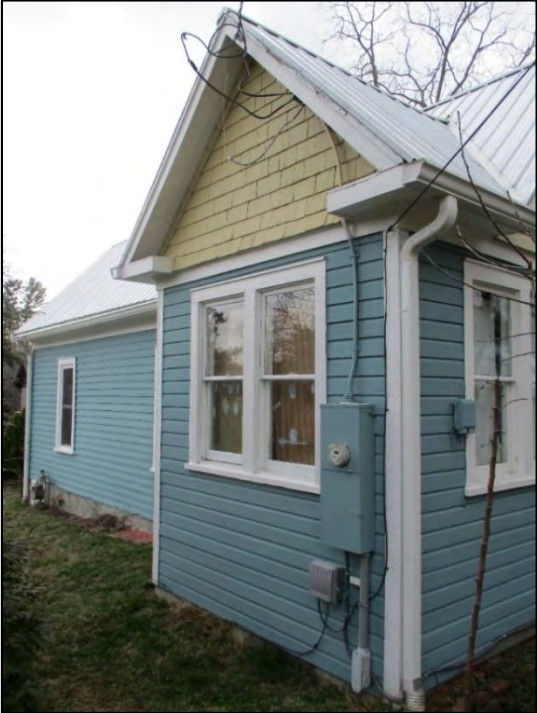
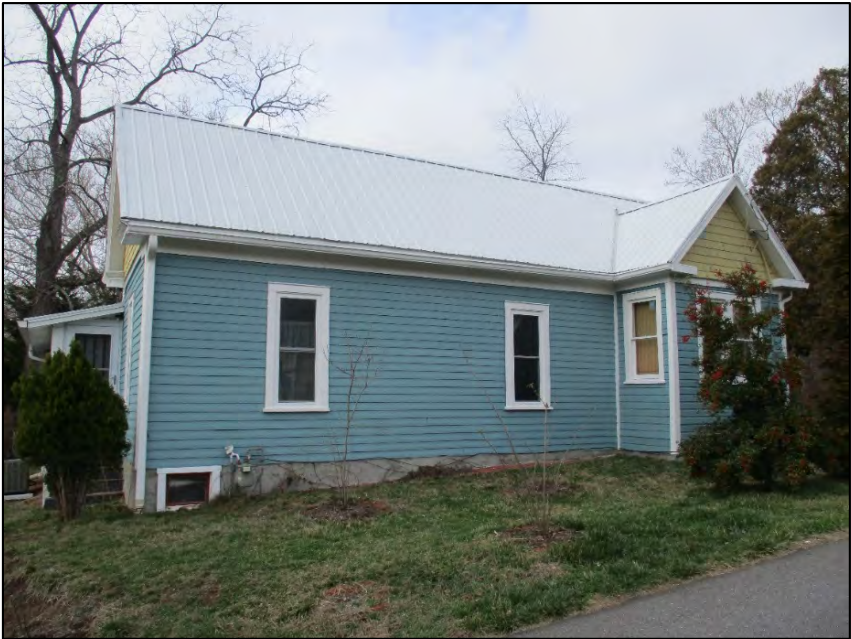
The east elevation of the house features a diminutive gable ell projection at the rear (north) of the house with paired one-over-one windows. The gable end does not include a window or the sawtooth detail seen in other exposures, but is clad with wood shingles and features gable returns. The remaining windows on this elevation are one-over-one sash, and there is a fixed pane rectangular window visible in the basement level.

Barber House east elevation, view to southwest

Barber House east elevation, view to northwest

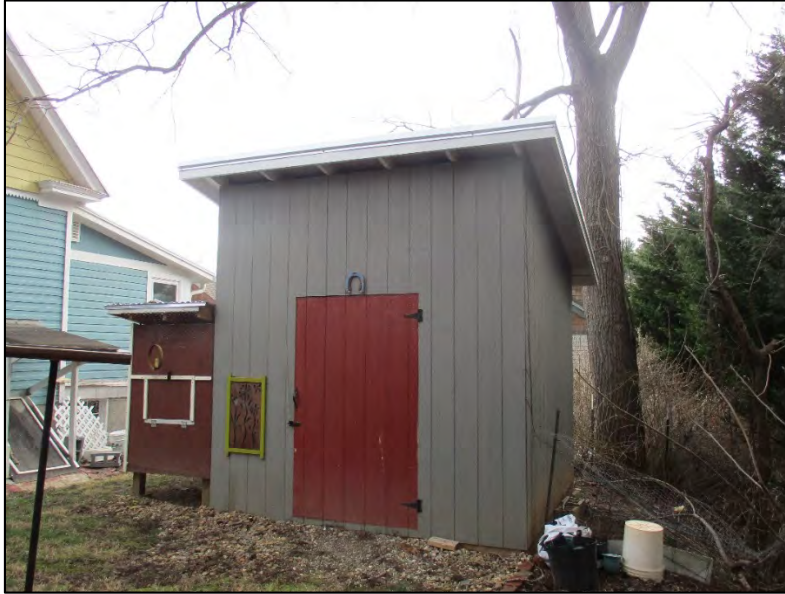
The yard surrounding the Barber House is grassed with some informal plantings. There is one outbuilding located on the western side of the property, a small frame shed with T1-11 siding and shed roof. A chicken coop is attached to the east side of the shed. Based on materials, the outbuilding does not appear to be historic. A short, paved driveway enters the northwest portion of the property, terminating at the wooden deck that extends from the back entry.

Barber House outbuilding with attached chicken coop, view to the southeast

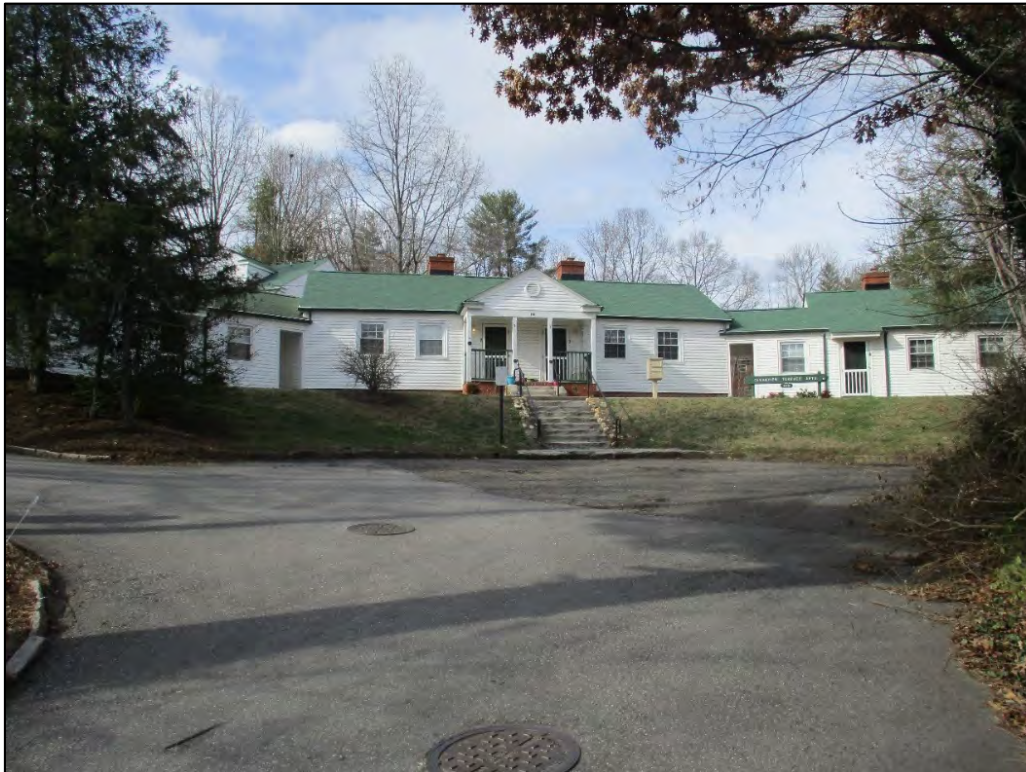
Clearview Terrace Apartments Building A façade, view to north

The Clearview Terrace Apartments are located at 518 Clearview Terrace and were newly identified by this survey. There are two buildings that comprise the complex: Building A contains Units 1 through 4 and is located in a cul-de-sac facing southeast onto Clearview Terrace; and Building B contains Units 5 through 8 and is located directly to the west of Building A on a slight hill. In general, the buildings have been updated with vinyl siding and replacement six-over-six sash or four-over-four sash windows. Additionally, both buildings are side gabled with asphalt shingles and have continuous brick foundations.

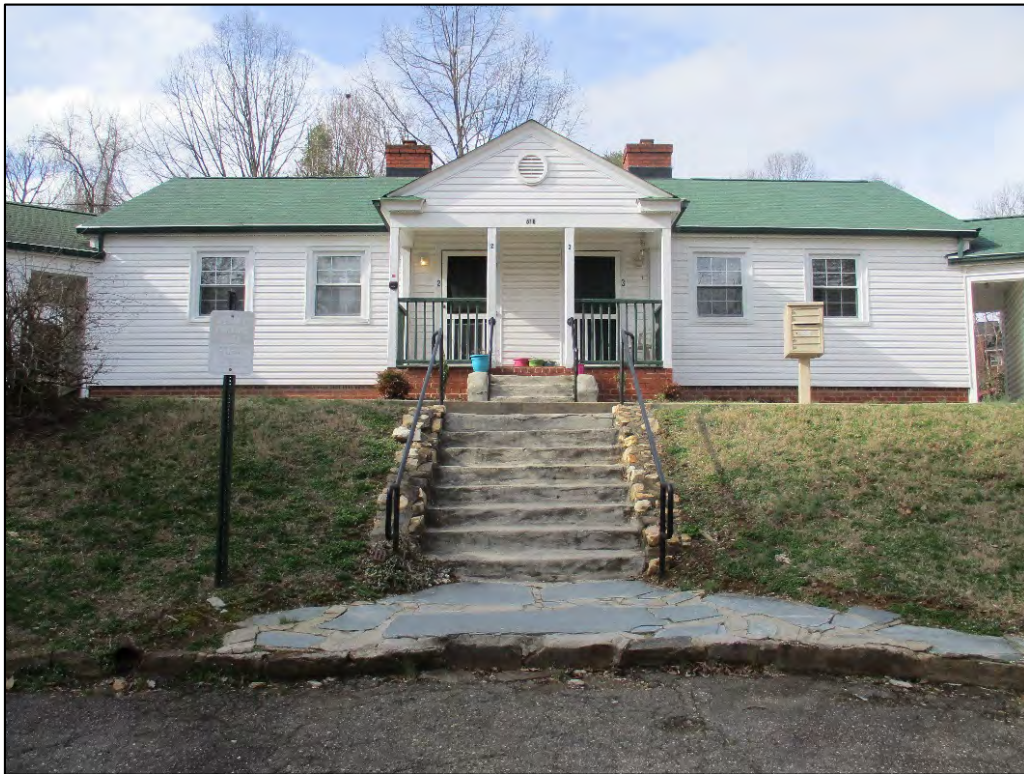
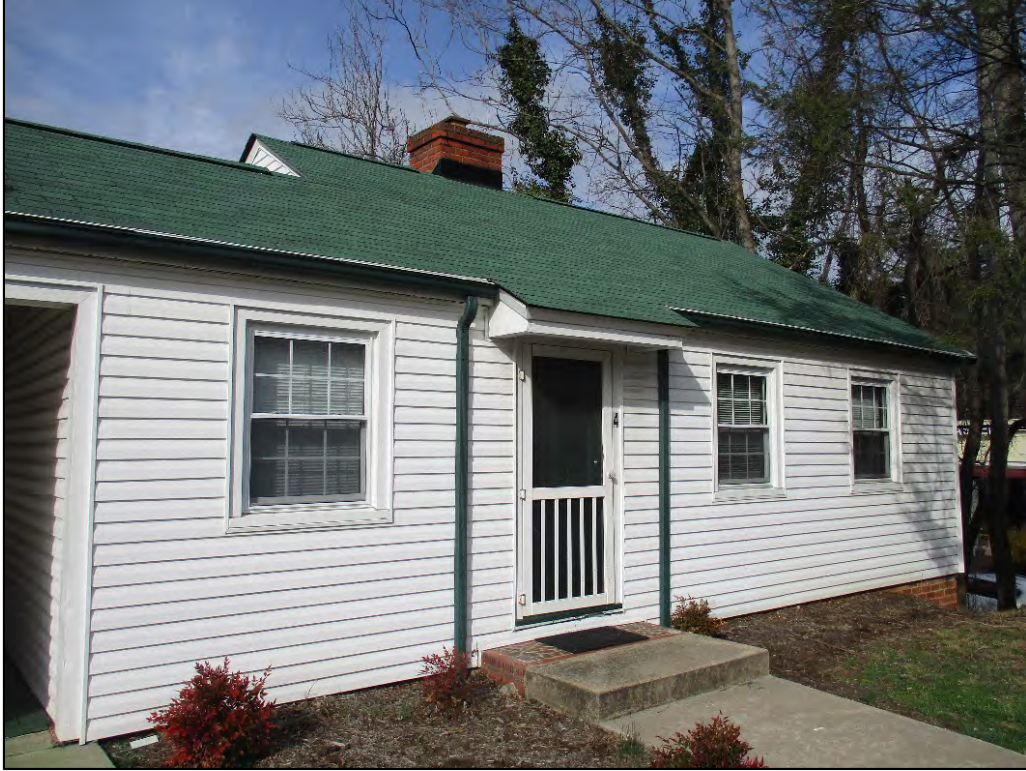
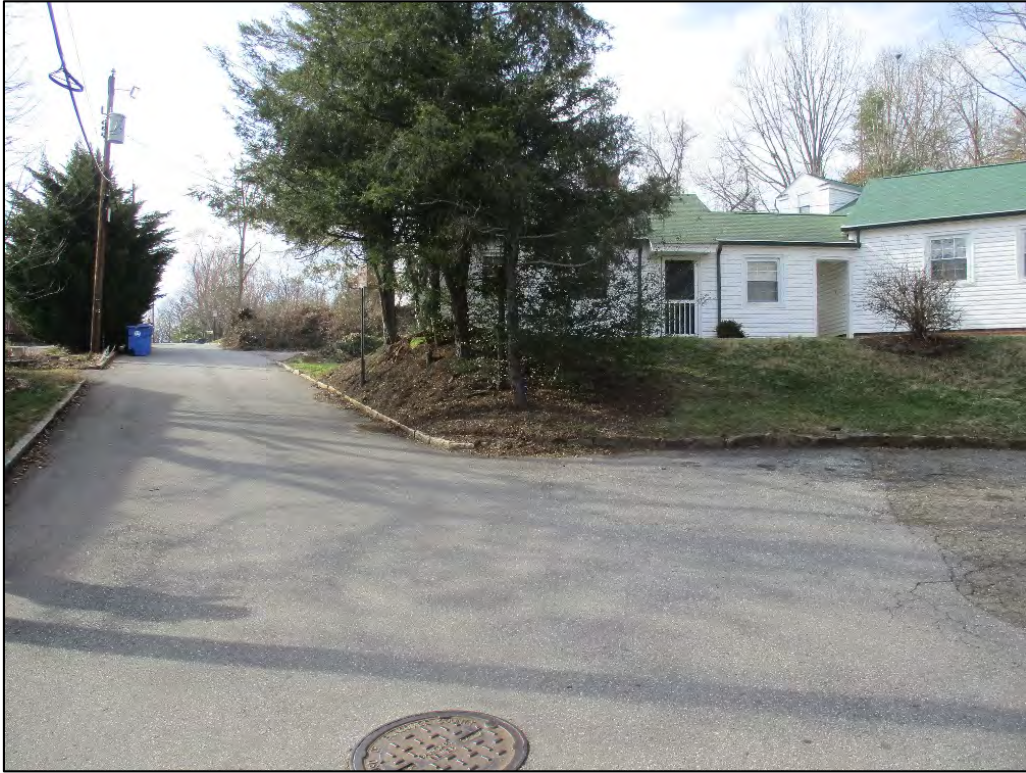
Units 1 and 4 are connected to Units 2 and 3 by small open breezeways, comprising Building A. A single internal brick chimney is visible centrally within each unit (four in total). Units 2 and 3 feature entries under a partial façade temple front gable porch with gable returns and a circular vent in the gable end, which is supported by simple wood posts with a simple railing and balustrade. The porch also has a brick foundation and stone steps. All of the units in Building A feature vinyl replacement front doors with wood screen doors.

Clearview Terrace Apartments Building A, Units 2 and 3 façade, view to north

Clearview Terrace Apartments Building A, Unit 4 façade, view to northeast

Clearview Terrace Apartments Building A, Unit 1 façade, view to west along Clearview Terrace

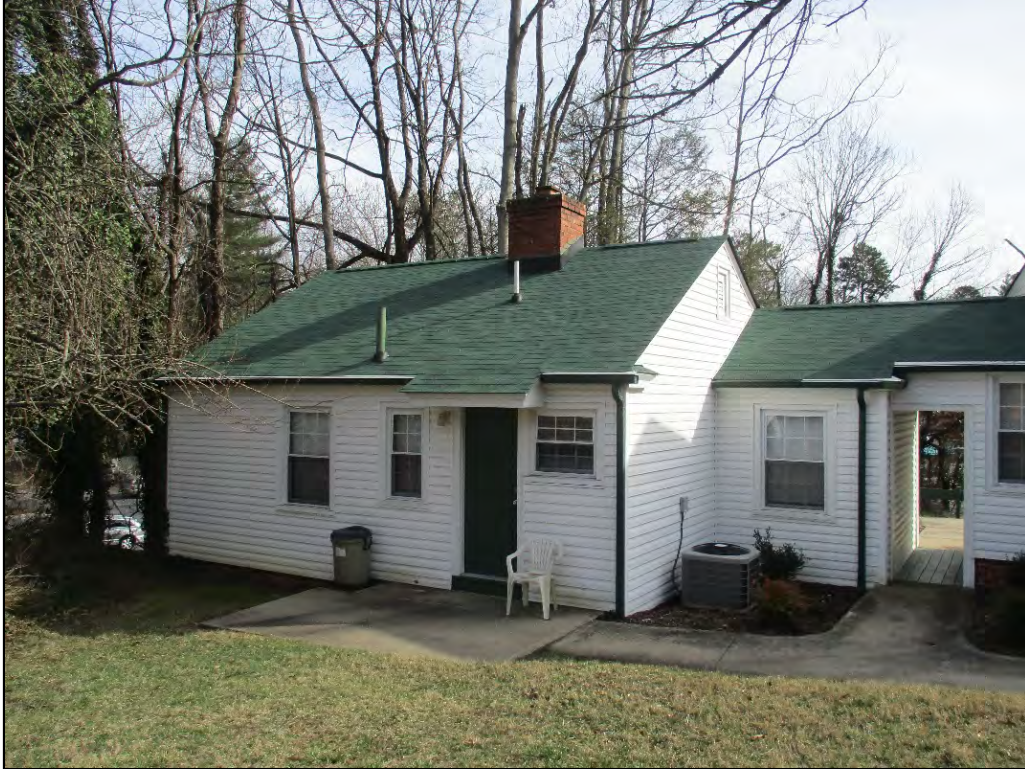
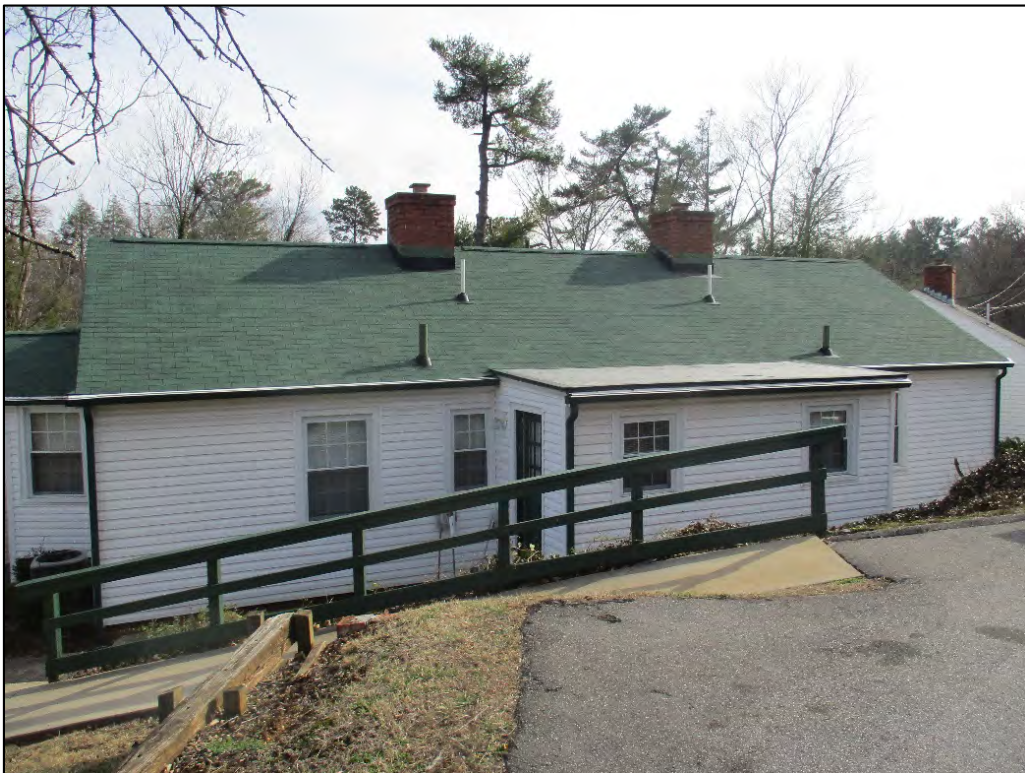
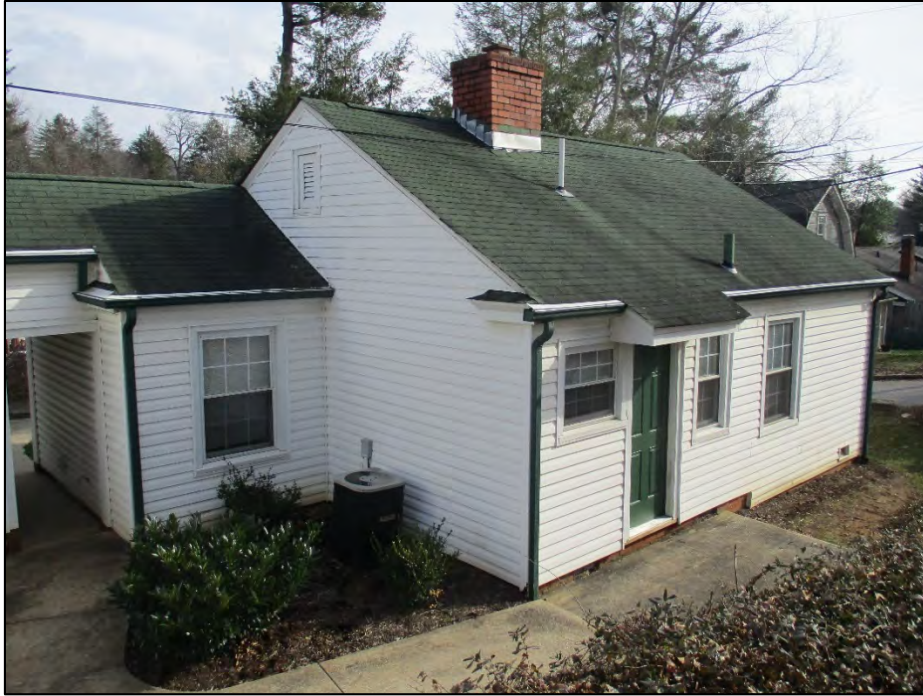
Clearview Terrace Apartments Building A, Unit 4 rear (north) elevation, view to southeast

Clearview Terrace Apartments Building A, Units 2 and 3 rear (north) elevation, view to southeast

Clearview Terrace Apartments Building A, Unit 1 rear (northwest) elevation, view to southeast
