November 9, 2018

MEMORANDUM

SUBJECT: Historic Structures Survey Report, Merrimon Avenue & WT Weaver Boulevard Intersection Improvements. U-5781, U-5782, PA 17-04-0023, Buncombe County, ER 18-0102

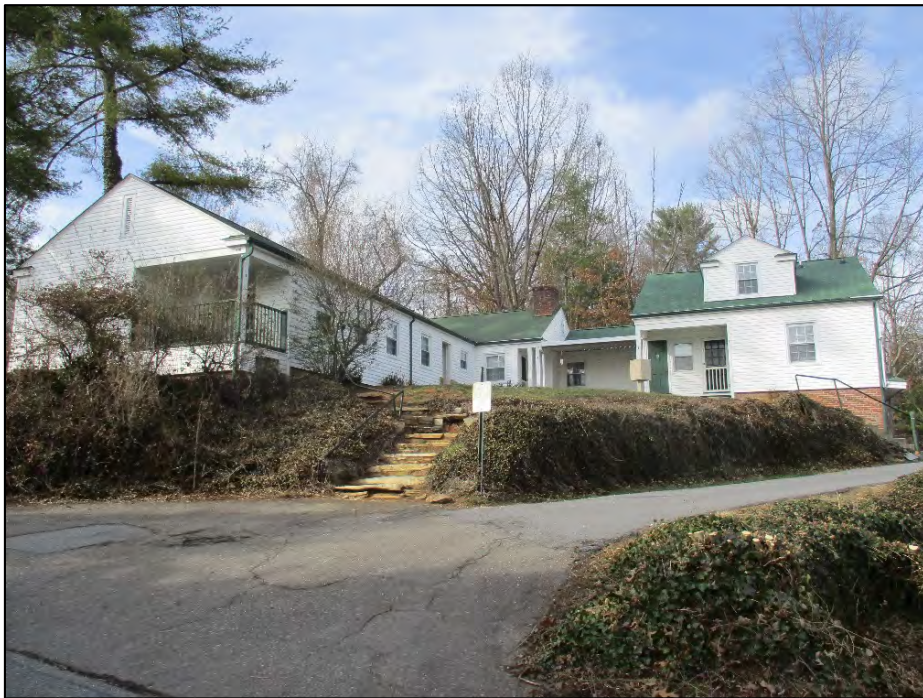
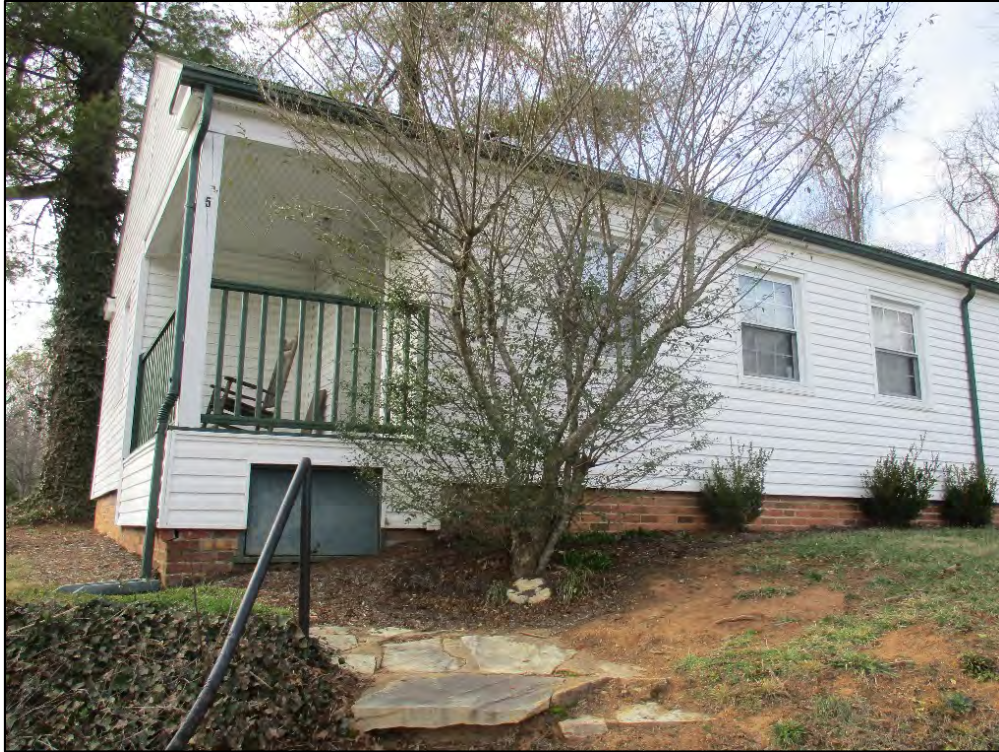
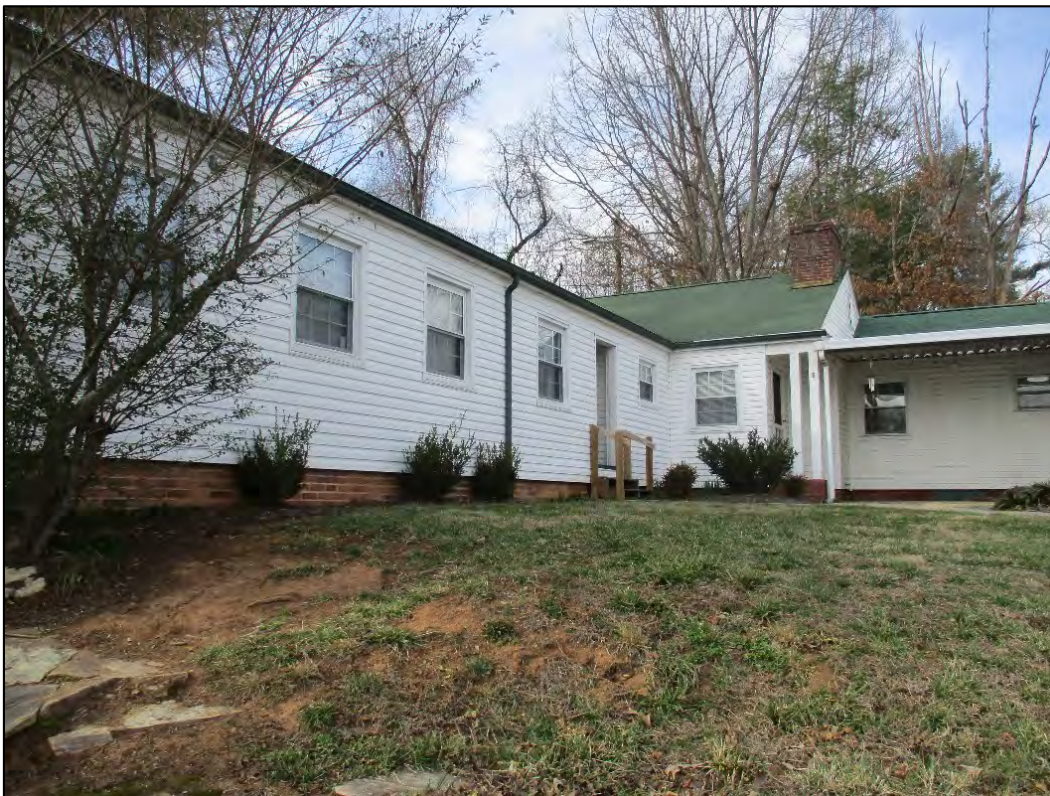
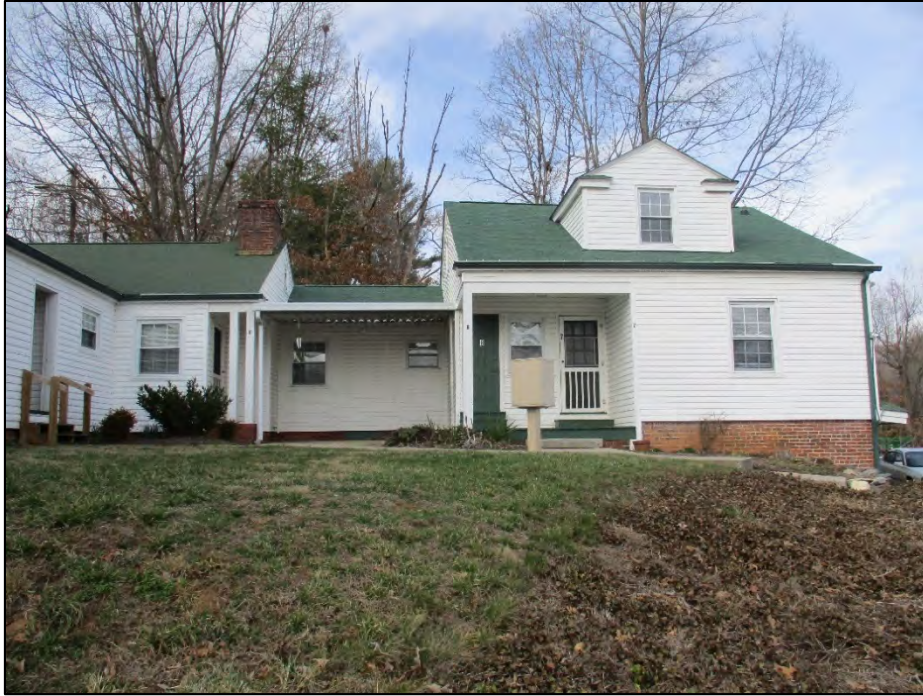
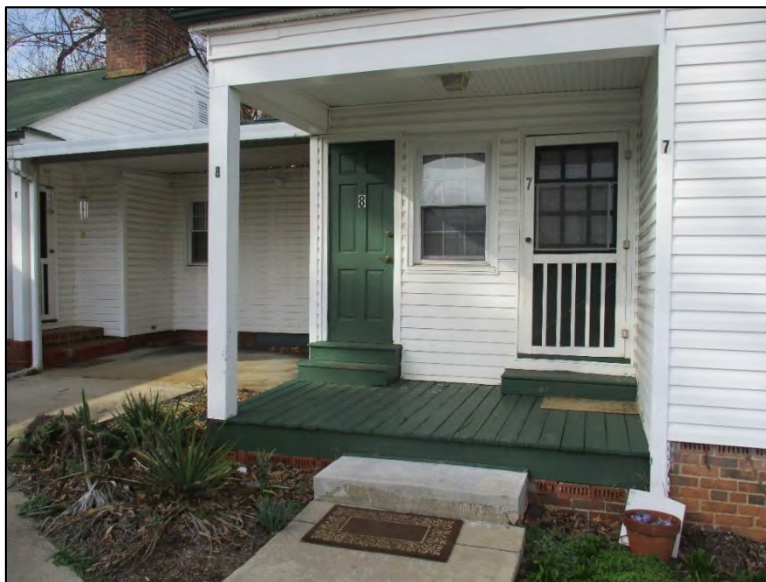
Units 5 through 8 comprise Building B, which is located slightly uphill, to the west of Building A. In general, the building is L-shaped and features a side-gable roofline with asphalt shingles. The portion of the building that contains Units 7 and 8 features a front gable dormer with cornice returns. One internal brick chimney is visible above Unit 6.

Clearview Terrace Apartments Building B façade, view to north from Clearview Terrace

Clearview Terrace Apartments Building B, Unit 5 façade, view to northwest

Clearview Terrace Apartments Building B, Unit 6 façade, view to north

Clearview Terrace Apartments Building B, Units 6, 7, and 8 facade, view to north

Clearview Terrace Apartments Building B, Unit 7 and 8 façade, porch detail

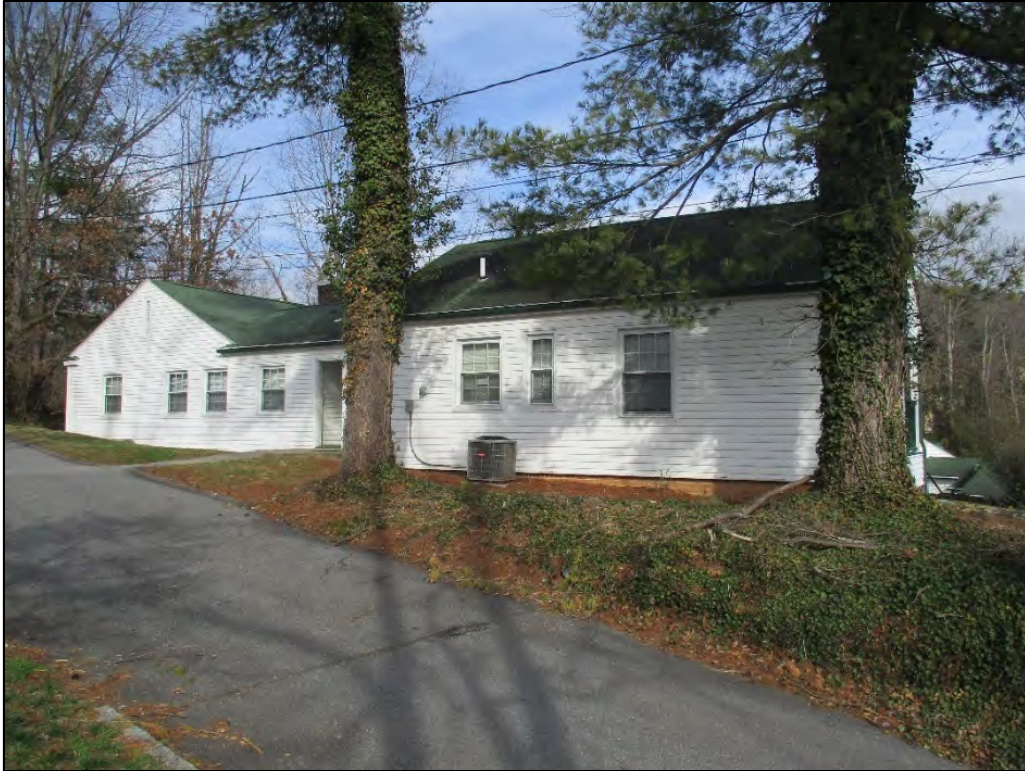
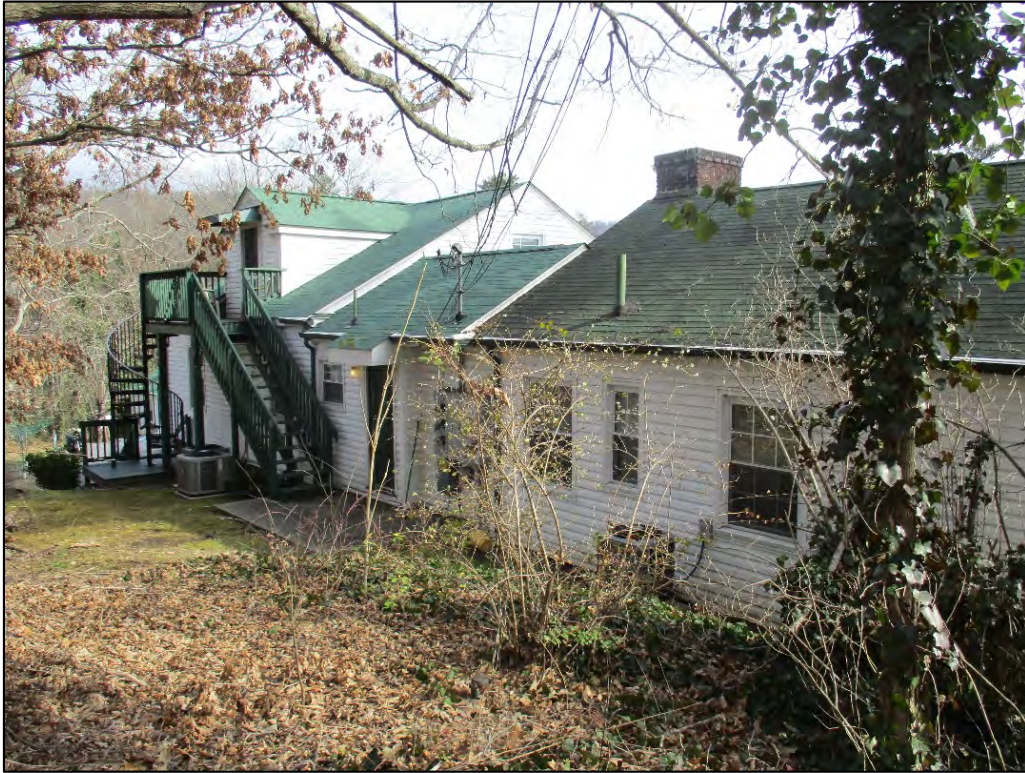
Each unit in Building B is slightly different. The portion of the building containing Units 7 and 8 is one and one-half stories tall, with an open garage/carport below the first floor and accessible via a driveway that traverses between Buildings A and B. Presumably, Unit 7 is the multi-story unit but it is difficult to discern from the exterior. Units 7 and 8 share a small, engaged porch with simple wood columns and wood flooring. The rear elevation of Units 7 and 8 contain a gabled dormer, also with cornice returns, with a door leading onto a small wooden deck. The deck has stairs on either side – one wood, the other metal spiral – that lead to a lower wooden deck.

Clearview Terrace Apartments Building B, Units 5 and 6 rear (west) elevation, view to northeast

Clearview Terrace Apartments Building B, Units 6, 7, and 8 rear (north) elevation, view to southeast

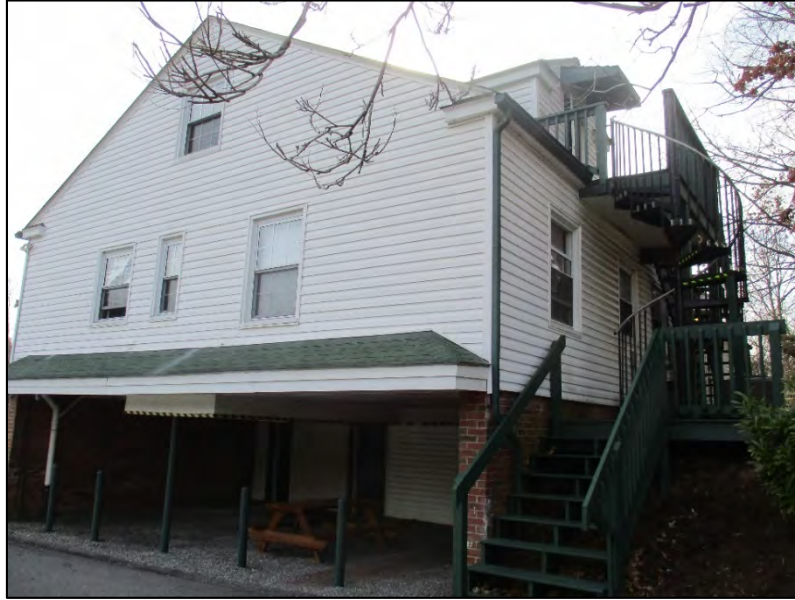
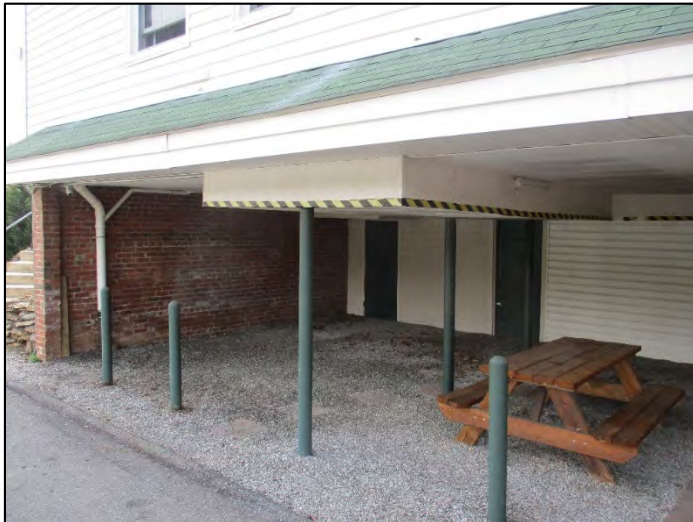
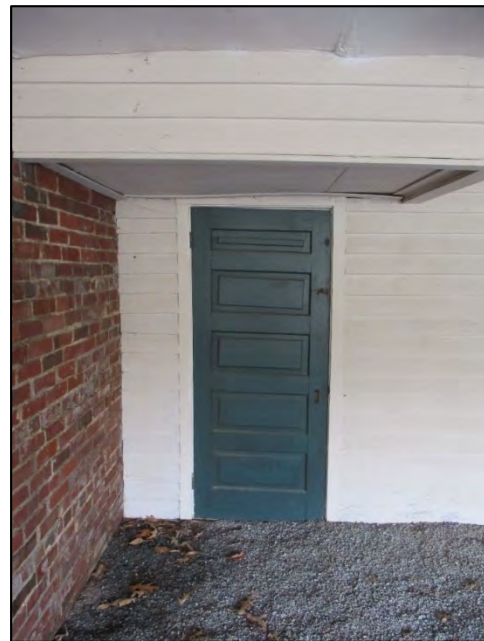
The carport/garage under Units 7 and 8 is no longer used as such (bollards have been installed to prevent parking), but now contains a picnic table and may serve as a public space. A hipped pent roof with asphalt shingles extends the length of the carport/garage. The floor is graveled and includes three doors with access to a basement level. Two of these doors appear to be original wood panel doors, with presumably original wood weatherboard siding visible between them.

Clearview Terrace Apartments Building B, Units 7 and 8 east elevation over converted carport/garage, view to southwest

Clearview Terrace Apartments Building B east elevation converted carport/garage detail, view to southwest

Clearview Terrace Apartments Building B east elevation, converted carport/garage detail, presumed original door and siding, view to west

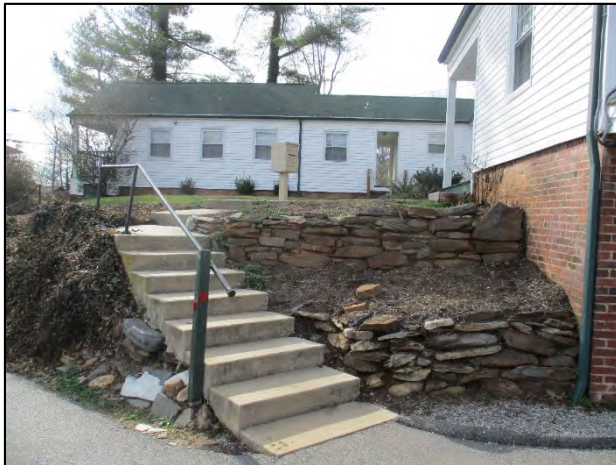
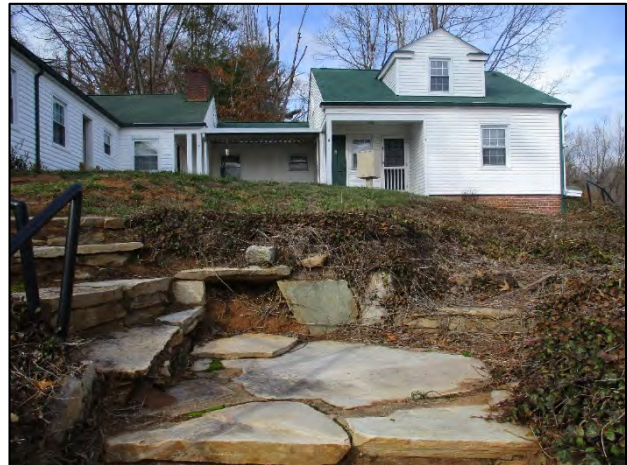
The approach to Clearview Terrace Apartments via Clearview Terrace includes a “cul-de-sac” area south of Building A (the road does not terminate here, though there is a bulb-out in the roadway as it makes a ninety-degree turn to the west). The cul-de-sac is lined with stone curbing, opposed to the granite curb found elsewhere on Clearview Terrace. A set of stone stairs leads to Building A from the cul-de-sac and a free-standing sign is present in the sloping grassed lawn. The terrain drops precipitously to the north and east (to Merrimon Avenue) surrounding the apartment complex. Stone terracing is utilized throughout the complex providing graded surfaces for driveways and pathways; stone or concrete steps and concrete sidewalks are found throughout the complex to provide access to individual units. There are also informal plantings around the exterior of both buildings, including some foundation plantings.

Clearview Terrace Apartments Building B landscaping detail, view to west

Clearview Terrace Apartments Building B landscape detail, view to north

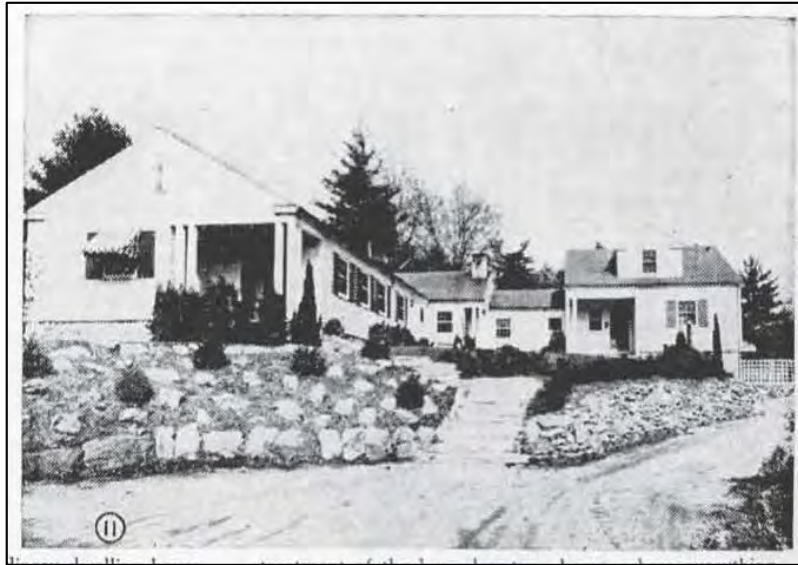
Exhibit 77. Historic photograph of building B. Source: Advertisement, Asheville Citizen-Times, 2/18/1940.

When the Clearview Terrace Apartments were first constructed they were designed to have a cottage-like feel. The apartments were planned to accommodate the hilly terrain and were set back from the road. Early photographs show a landscape that included numerous plantings and terracing to create a natural garden-like setting (Exhibit 77).

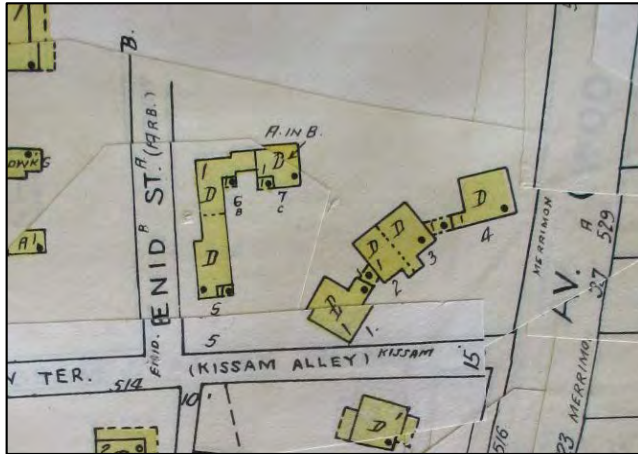
Exhibit 81. Portion of the 1954 Sanborn map (Sheet 60) depicting the Clearview Terrace Apartments. Note: 3 Units in Building B; "A in B" refers to garage in basement.

While the apartments maintain their location and setting, the replacement vinyl windows, doors and siding have greatly compromised the resource's integrity of materials and workmanship. Additionally, there have been changes to the physical form of both buildings which is evident when reviewing the 1954 Sanborn map (Exhibit 81). In Building A, there is a rear shed addition on Units 2 and 3. In Building B, the Sanborn map shows three Units while presently there are four; indicating that at some point after 1954 Unit 7 was carved into two units, presumably an upstairs and downstairs apartment. This alteration may have corresponded with the addition of the rear entry

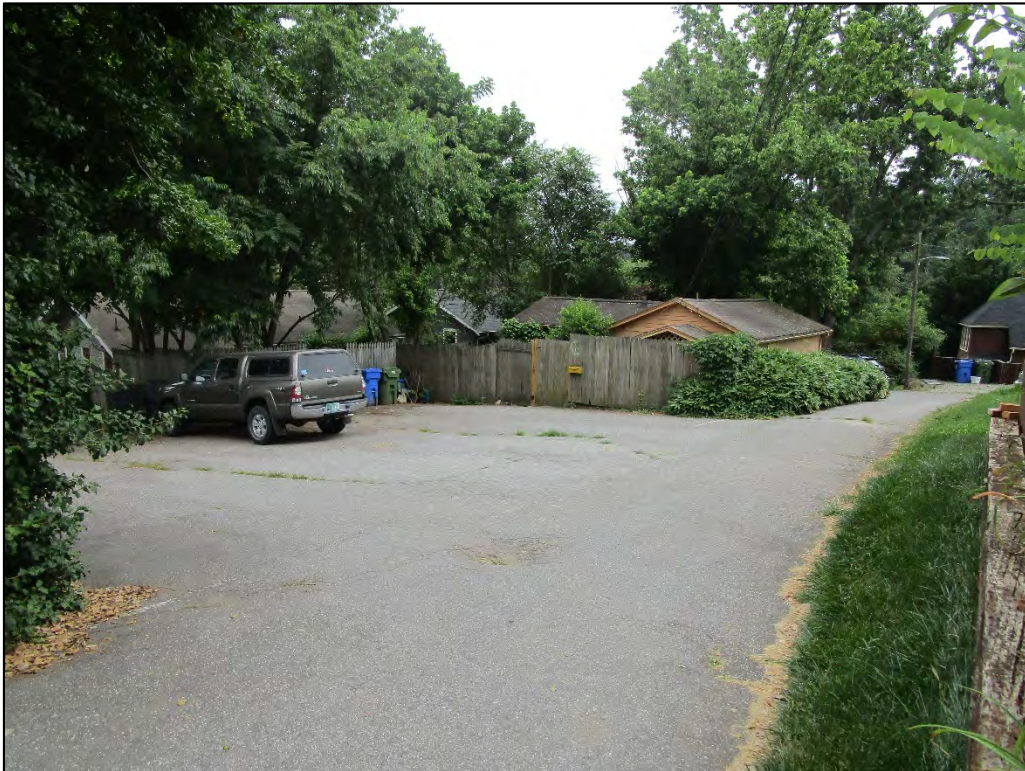
Clearview Terrace Historic District, ten-foot alley terminating at the Martha Sayre House, view to south

Three short alleys intersect Clearview Terrace; all appear in historic mapping of the district and correspond with right of way depicted in the accompanying site map. Two ten-foot alleys extend approximately 100 feet south of Clearview Terrace, the eastern alley providing access to parking pads behind 510–512 Merrimon Avenue and 518 Clearview Terrace. The eastern alley terminates at a gravel parking pad associated with the Martha Sayre House (6 Chatham Road) and the western alley has been repurposed for a driveway to access infill residences fronting Chatham Road (622 and 624 Chatham Road). An unnamed, remnant road (historically Enid Street) intersects Clearview Terrace west of the Clearview Terrace Apartments and continues to the north for approximately 100 feet until it becomes overgrown. This road is approximately 15 feet wide with granite curbing, consistent with Clearview Terrace, and may have extended further north in the past (as indicated by historic mapping and current right of way data).

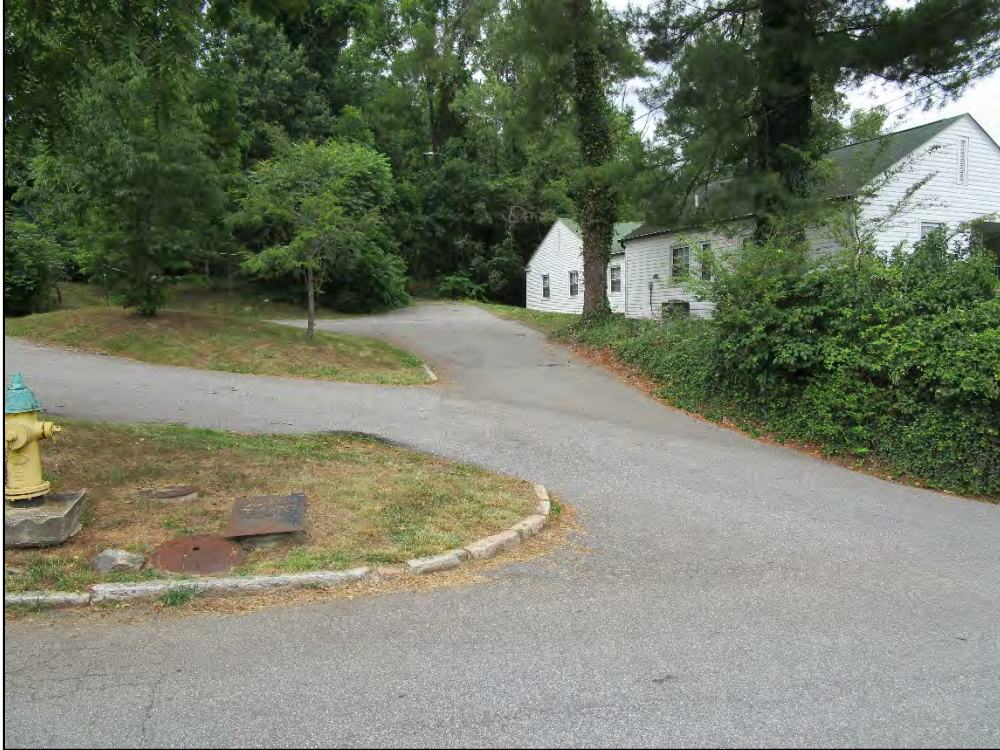
Clearview Terrace Historic District, 15-foot former Enid Street, view to north. Clearview Terrace Apartments visible at right.

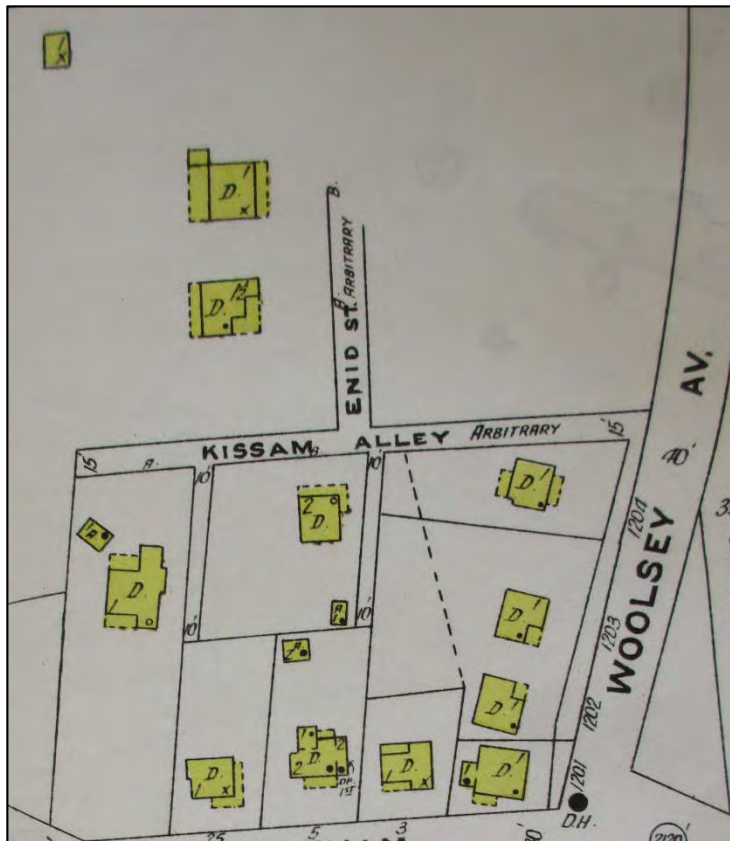
Exhibit 82. Portion of 1925 Sanborn map (Sheet 60) depicting the Clearview Terrace Historic District

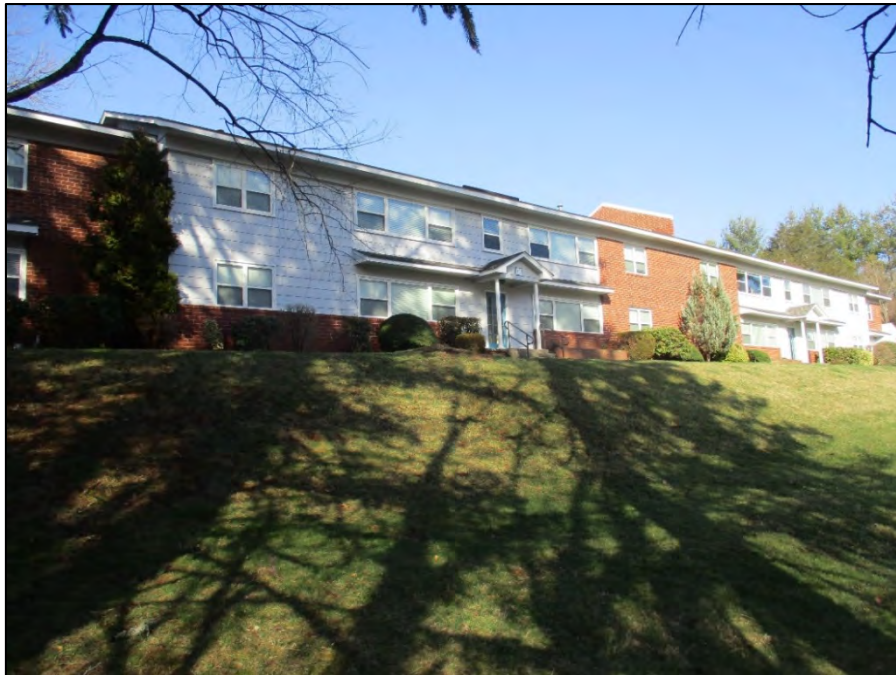
Edgewood Knoll Apartments Building 11 façade, view to northwest

Building Type 1 contains ten apartment units: a two-story townhome located on either end of the building with two groups of four garden apartments (two on each floor) in between (total of eight one-story garden apartments). There are three buildings in the complex that are representative of this type, Buildings 5, 16, and 11. The facades contain a combination of brick and composite board siding. The garden apartment units feature picture windows and one-over-one double hung sash windows. A front gable portico supported by columns and flanking pent roof is centered on the two clusters of garden apartments; a French door providing access to interior stairs and hallways connects the garden apartment units. Stone steps and metal pipe railings provide access to these entrances. Individual entrances to the townhome units are on the ends of the buildings and typically feature an attached shed roof porch. The front doors on the townhomes across the property are a unique wood panel.

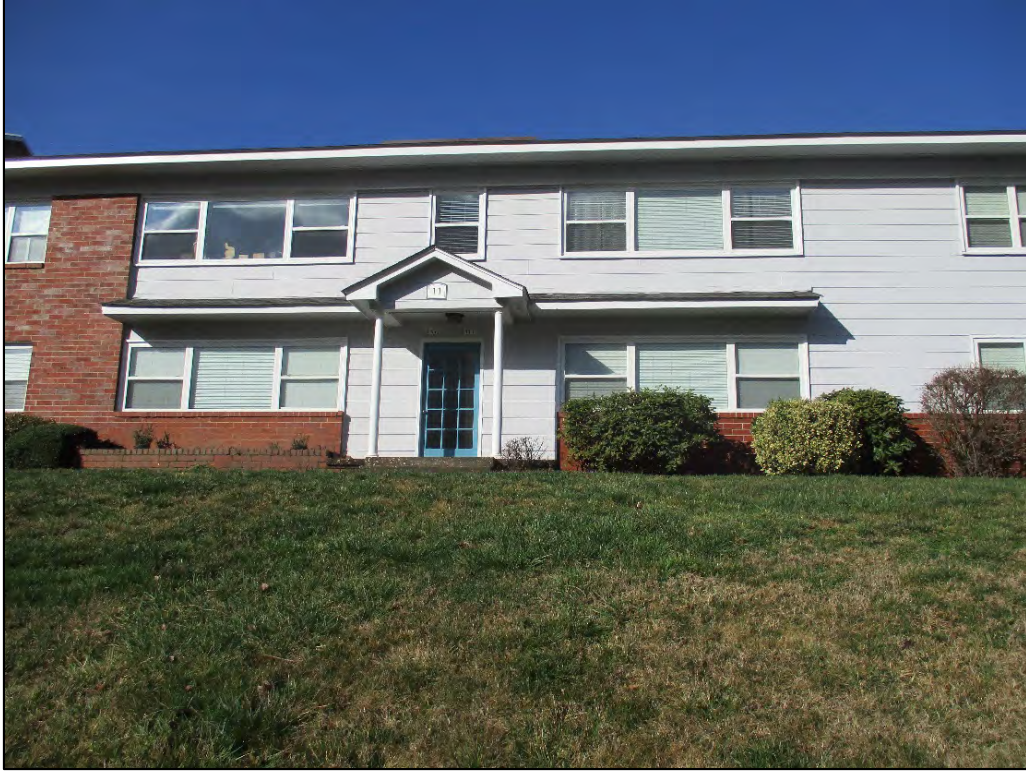
Edgewood Knoll Apartments Building 11 facade detail, front entry to garden apartments, view to west

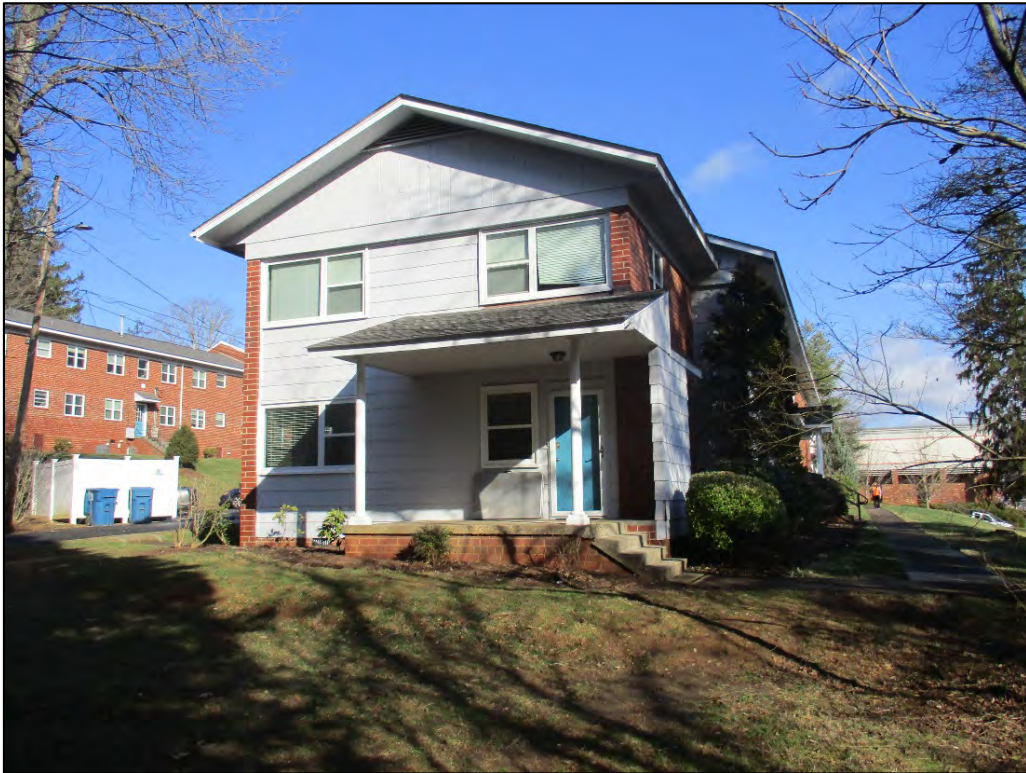
Edgewood Knoll Apartments Building 11 south elevation townhome porch entry detail, view to north

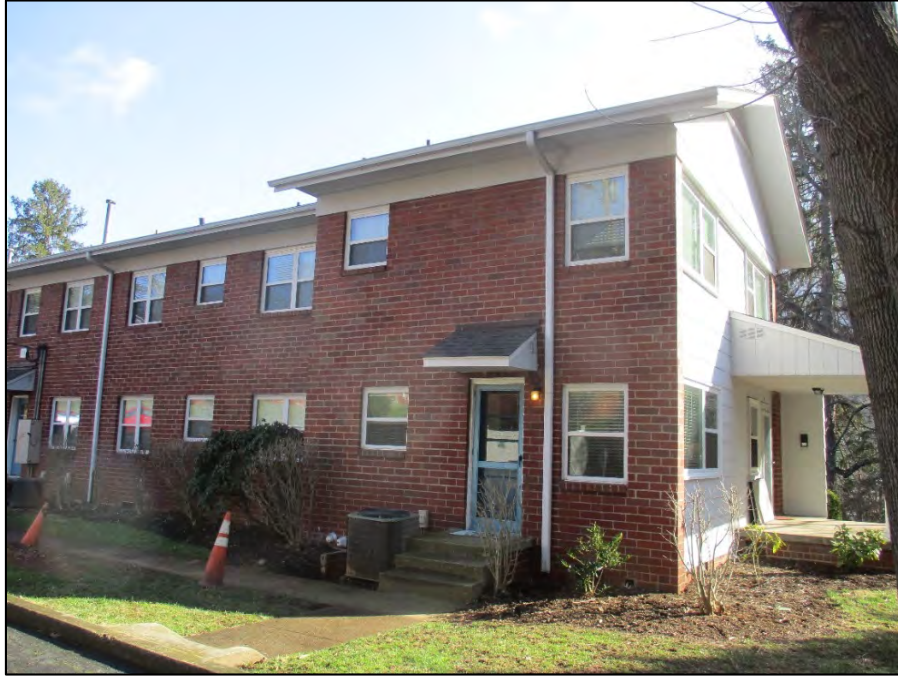
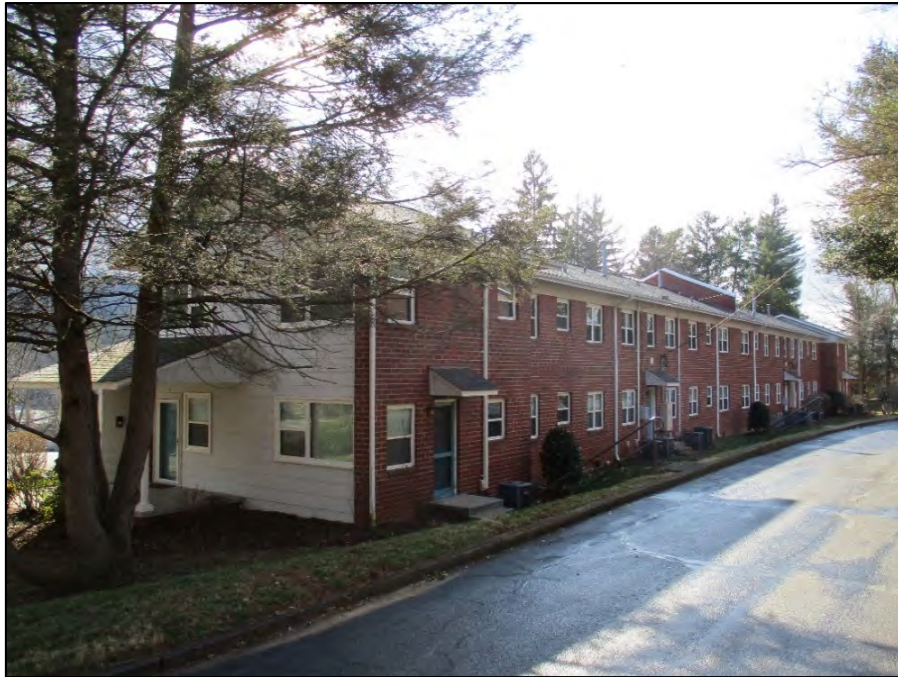
Edgewood Knoll Apartments Building 11 rear (west) elevation, view to east

Edgewood Knoll Apartments Building 11 rear (west) elevation, view to southeast

The rear elevation of the Building Type 1 feature four entrances onto concrete stoops that are covered by a small shed roof hood. The doors are typically wood panel and glass – which appear to be historic – with a screen door (several historic examples remain). The door arrangement is similar to those on the façade with each townhome including an individual back door, and each cluster of four garden apartments sharing a single door. The windows on this elevation are vinyl one-over-one sash.

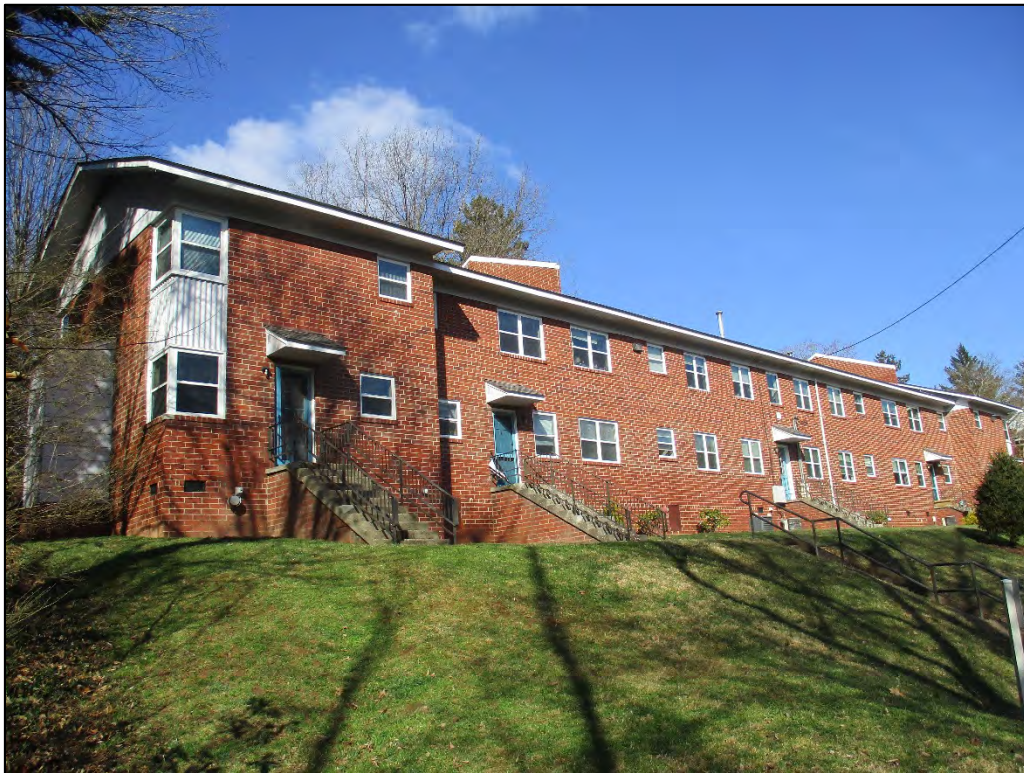
Edgewood Knoll Apartments Building 9 rear (east) elevation, view to southeast

The rear elevation of Building Type 2 feature five entrances that are covered by a small shed roof hood. The doors are typically wood panel and glass – which appear to be historic – with a screen door (several historic examples remain). Each townhome has its own back door while the other door is shared by the four central garden apartment units. The windows on this elevation are vinyl one-over-one sash.

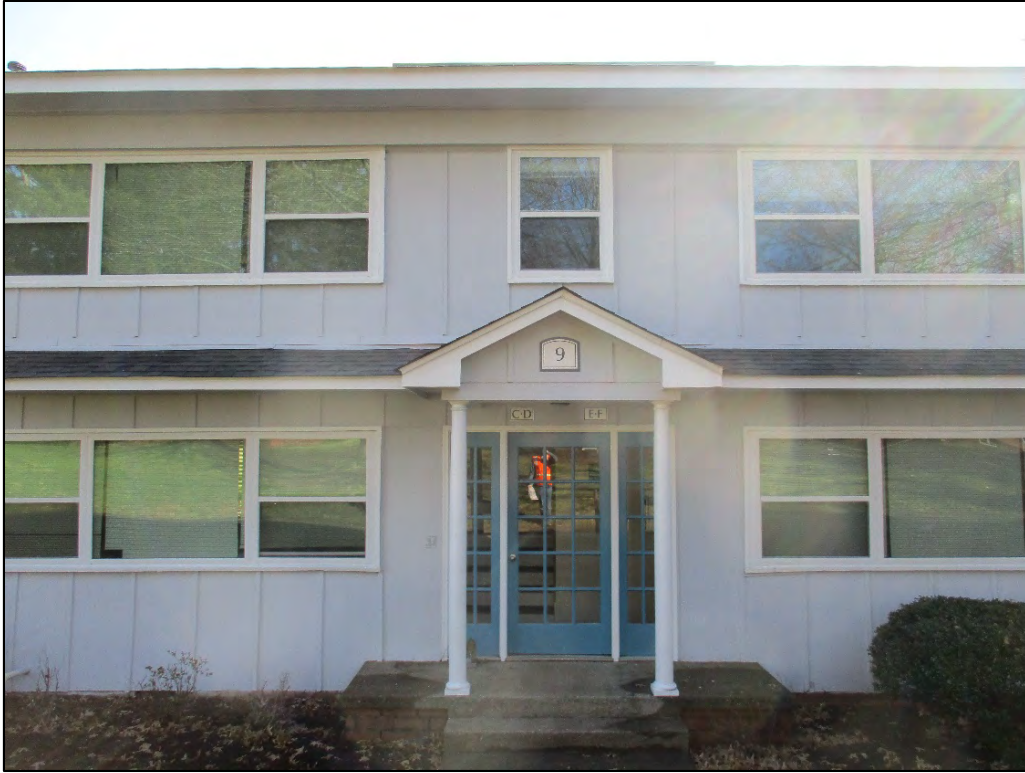
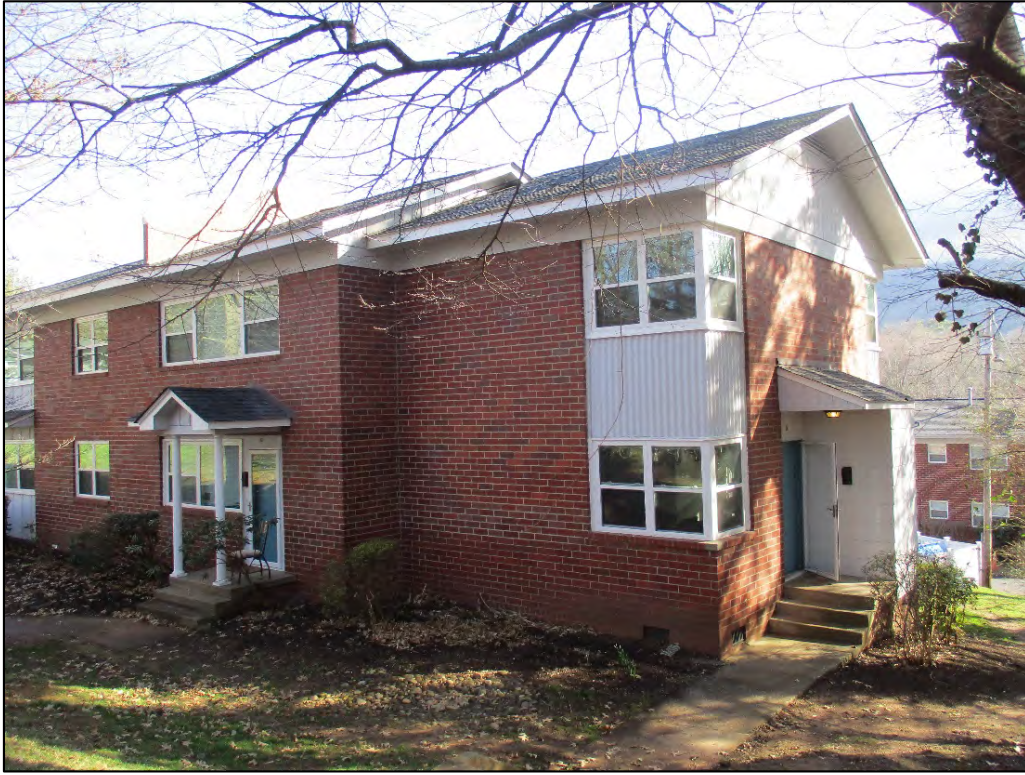
Edgewood Knoll Apartments Building 9 façade garden apartment entry detail, view to west

Edgewood Knoll Apartments Building 9 façade and north elevation, townhome entrances, view to southwest

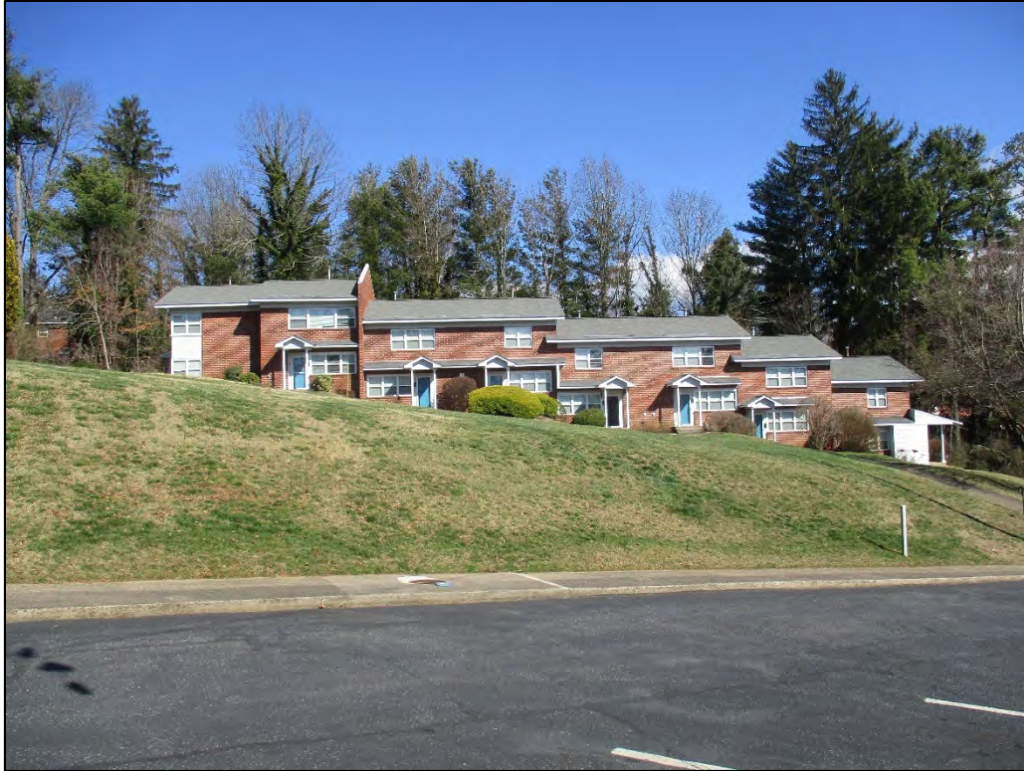
Edgewood Knoll Apartments Building 2 façade, view to north

One notable exception to this building type is Building 2, located at the south end of the complex along Edgewood Knoll Road, which is comprised of eight townhome units. The two townhome units on the ends have entrances located on the sides of the building with small shed roof porches supported by columns. The six remaining entrances feature small gabled porticos. Building 2 features a variety of windows, including corner windows, picture windows, and paired one-over-one sash.

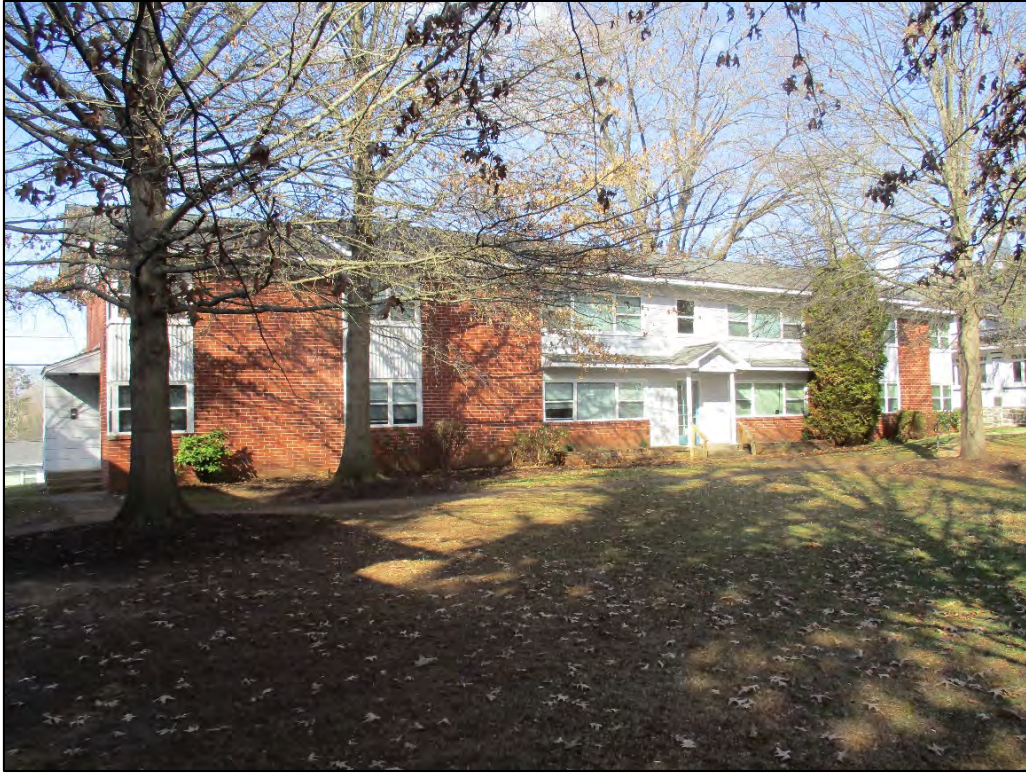
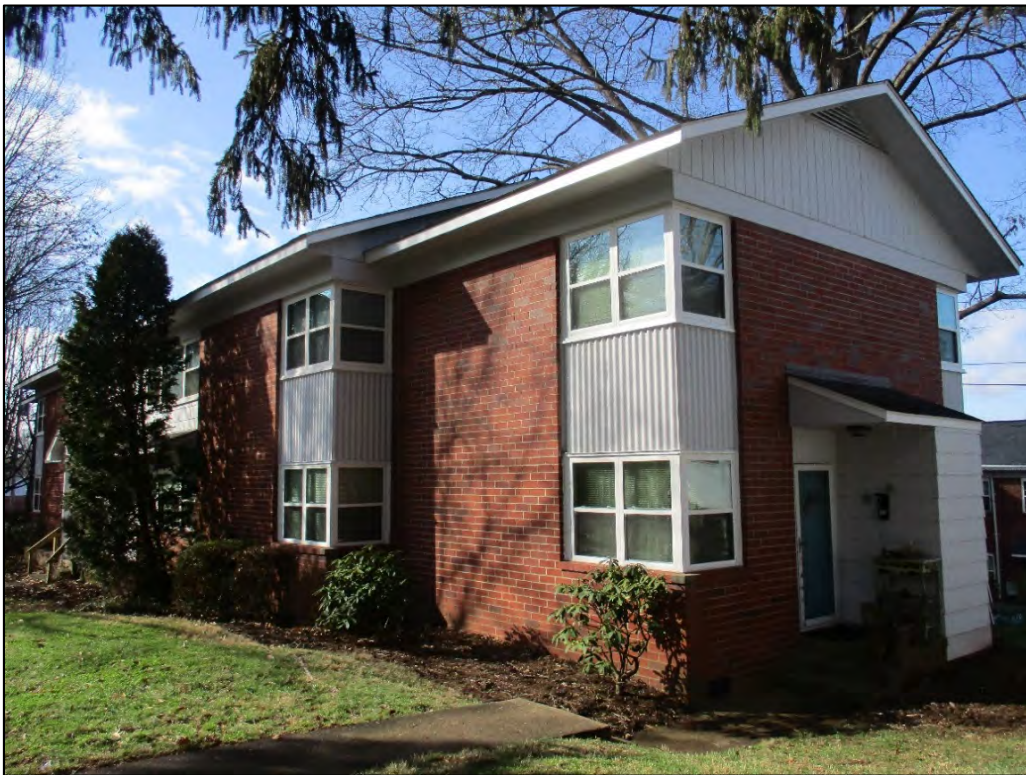
Edgewood Knoll Apartments Building 7 façade, view to northwest

Edgewood Knoll Apartments Building 7 façade and north elevation, townhome entrance, view to southwest

Building Type 3 is the most common, with ten buildings that represent this type. These buildings feature a townhome on either end and four garden apartments in between. The townhomes have a small shed portico entry supported by columns on the sides of the building and feature corner windows on both the first and second stories. The entry for the garden apartments is located in the center of the primary elevation and, like the other building types, has a centered gabled entry portico and flanking pent roof over a French door that provides access to the four units. The garden apartments each have a large picture window on the primary elevation. The exterior of these buildings are a combination of brick veneer, vertical and horizontal composite board, and ribbed aluminum.

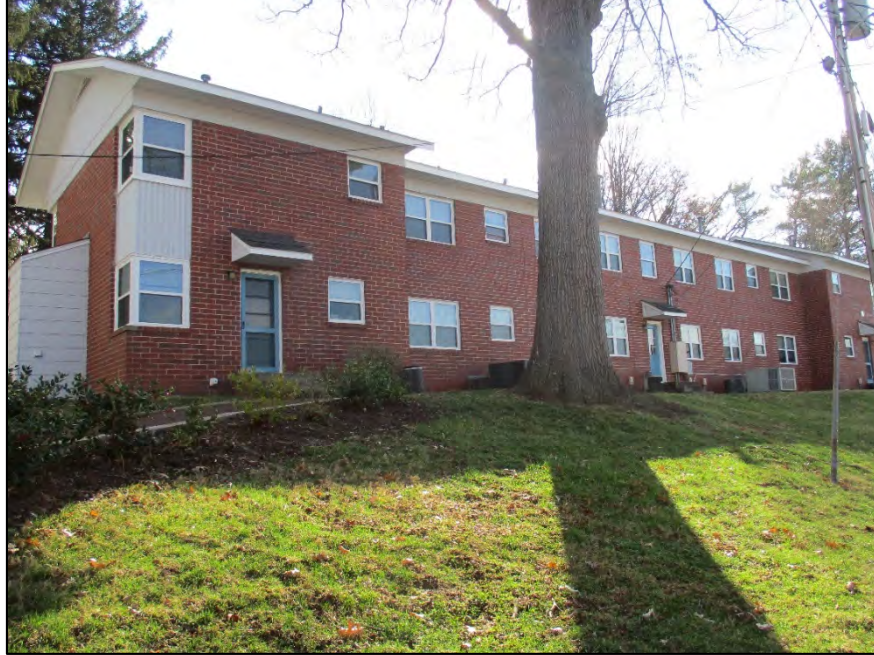
Edgewood Knoll Apartments Building 7 rear elevation, view to southeast

The rear elevation of Building Type 3 feature doors covered by small shed roof hoods. The doors are typically wood panel and glass – which appear to be historic – with a screen door (several historic examples remain). Each townhome has its own back door and the center door is shared by the four garden apartment units. The windows on this elevation are one-over-one sash with corner windows on each of the townhome units.

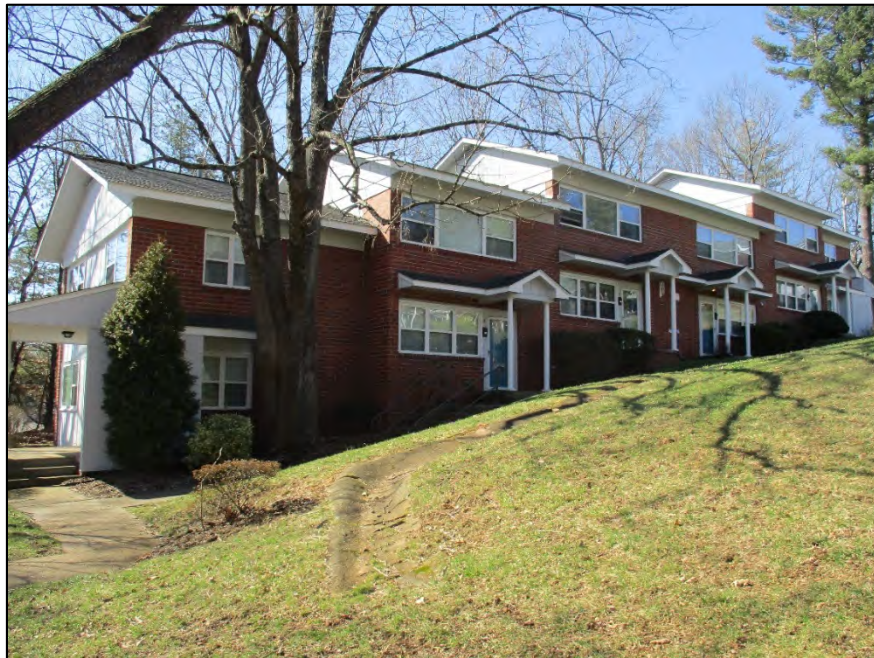
Edgewood Knoll Apartments Building 3 primary elevation, view to southwest

Two exceptions for the Building Type 3 were noted: Building 1 and Building 3, which are comprised of only townhome units. These exceptions are located near Building 2 (Building Type 2 exception) at the south end of the complex along Edgewood Knoll Road. The two townhome units on the ends have entrances located on the sides of the building with small shed roof porches. The four remaining entrances each have small gabled porticos. Building 3 features a variety of windows including picture windows and paired one-over-one sash.

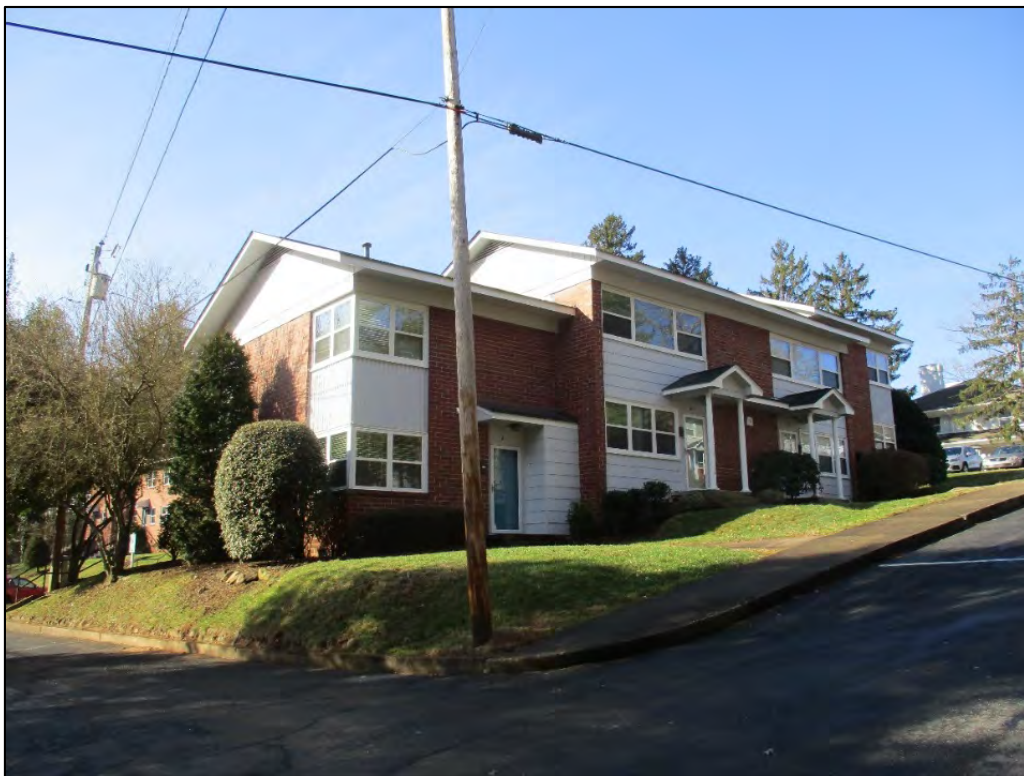
Edgewood Knoll Apartments Building 10 façade, view to the southwest

Building Type 4 is comprised of four townhome units. There are five buildings that represent this type. The townhome units on either end have entrances located on the front of the building and feature small shed roof stoops. The two interior units also have entrances on the front of the building but feature small gabled porticos with a pent roof connecting the two gables. On the facades, the end units have corner windows while the interior units have picture windows. The exterior materials are comprised of brick veneer, horizontal composite board, and ribbed aluminum siding.
