November 9, 2018

MEMORANDUM

SUBJECT: Historic Structures Survey Report, Merrimon Avenue & WT Weaver Boulevard Intersection Improvements. U-5781, U-5782, PA 17-04-0023, Buncombe County, ER 18-0102

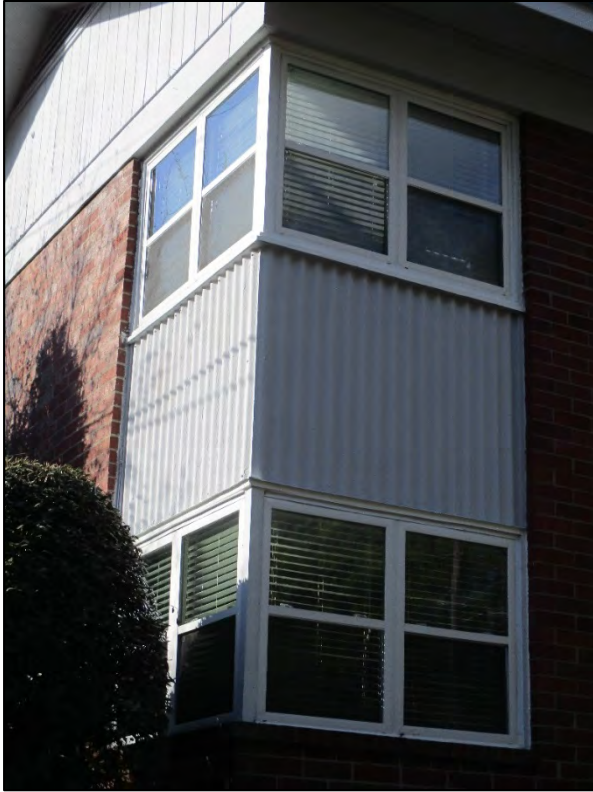
Edgewood Knoll Apartments Building 10 corner window detail, view to southwest

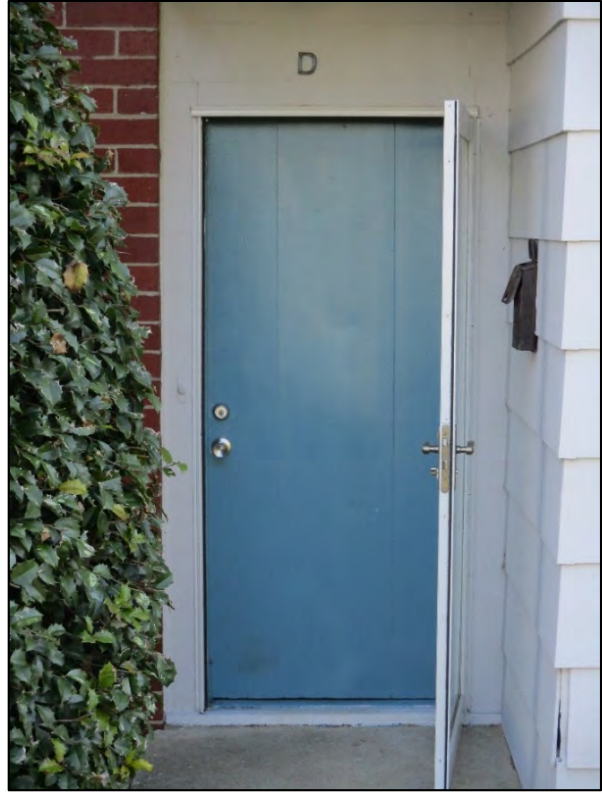
Edgewood Knoll Apartments wood panel front door detail (typical for all units)

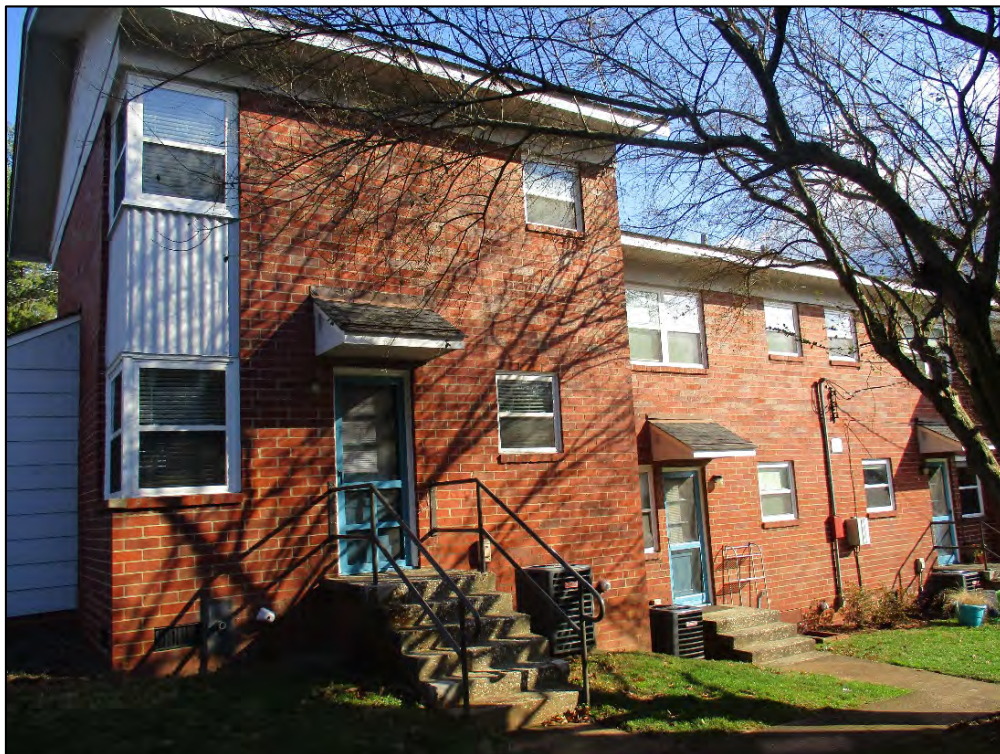
Edgewood Knoll Apartments Building 10 rear (south) elevation, view to northeast

The rear elevation of Building Type 4 includes four entrances, each corresponding to a townhome unit, that are each covered by a small shed roof hood. The back doors are typically wood panel with three horizontal glass panes – which appear to be historic – with a screen door (several historic examples remain). The windows on this elevation are one-over-one sash with corner windows on either end unit.

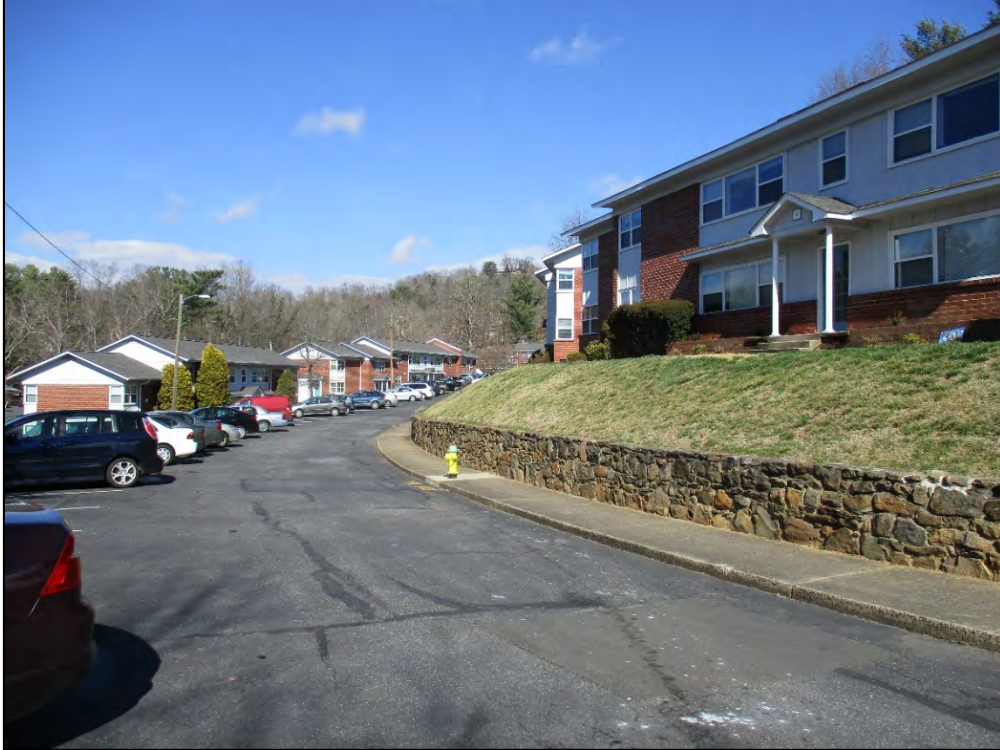
Edgewood Knoll Apartments, view to north of Edgewood Knoll Road streetscape, with stone retaining walls and sidewalks

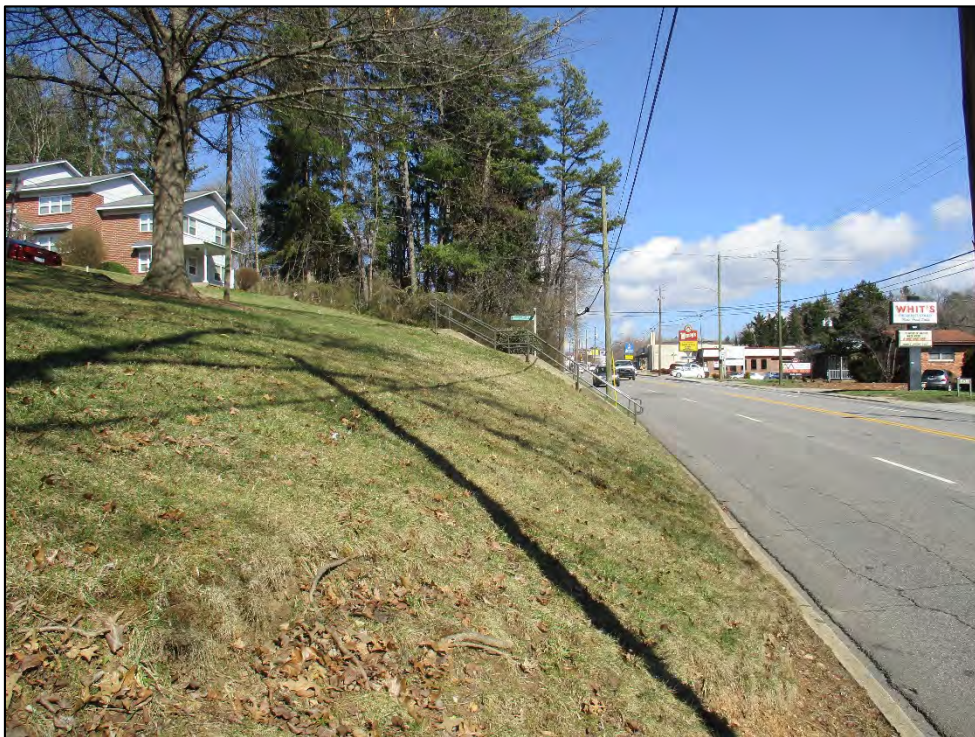
Concrete sidewalks are located along the interior road network. Stone and concrete retaining walls are utilized across the site to manage the terrain. Three concrete stairs provide access directly to Merrimon Avenue (there is no sidewalk along Merrimon Avenue), two near the Edgewood Knoll Road intersection and one near the Durwood Road intersection. Some of the buildings have brick planters near the entry to the garden apartments, while others include foundation plantings. The leasing office (located at the top of the hill near the center of the complex) has its own parking lot and more formal landscaping, including foundation plantings, and is surrounded by large hardwood shade trees. The rest of the property is grassed, with on-street angled parking and off-street parking lots for residents.

Edgewood Knoll Apartments, view north along Merrimon Avenue from near the southern property boundary. Note stairs leading to Merrimon Avenue.

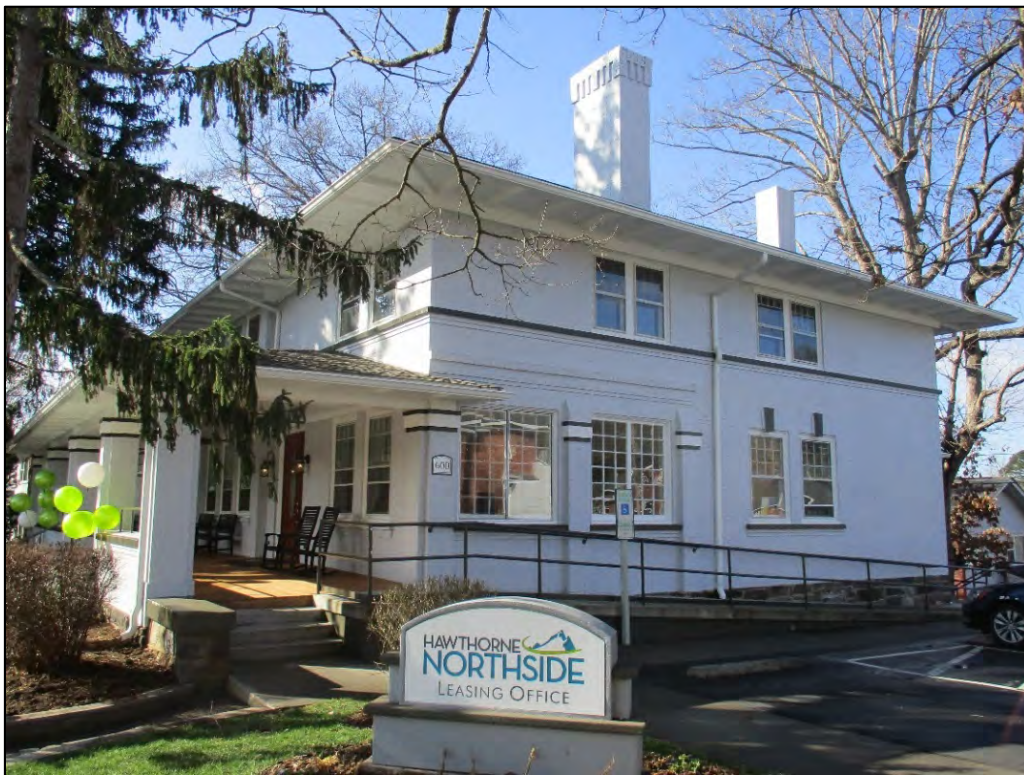
The east-facing façade features a front porch with a half-hipped roof. The porch is supported by brick columns that feature fluted corners and corbelling at the base and cap. Between the porch columns is a closed rail of brick, which also features brick corbelling at base and cap, with a header course brick rail that has been capped by a rounded concrete application and a metal railing attached above. Concrete stairs pass between stone wing walls with concrete cap and metal rails to access the primary entry. The porch floor is comprised of historic hardwood and the ceiling is beadboard. The front door is a replacement (non-historic) wood panel door with an ellipse pane of glass in the center and features a single wood panel and glass sidelight. A sunroom is connected to the south side of the porch which wraps around the south elevation and is currently used as a small gym for residents. The windows on the facade are vinyl twelve-over-one sash, and the windows on the sunroom are cottage-style ribbon casement windows which feature decorative brick pilasters between every five windows.

Edgewood Knoll Apartments leasing office, oblique view to southwest

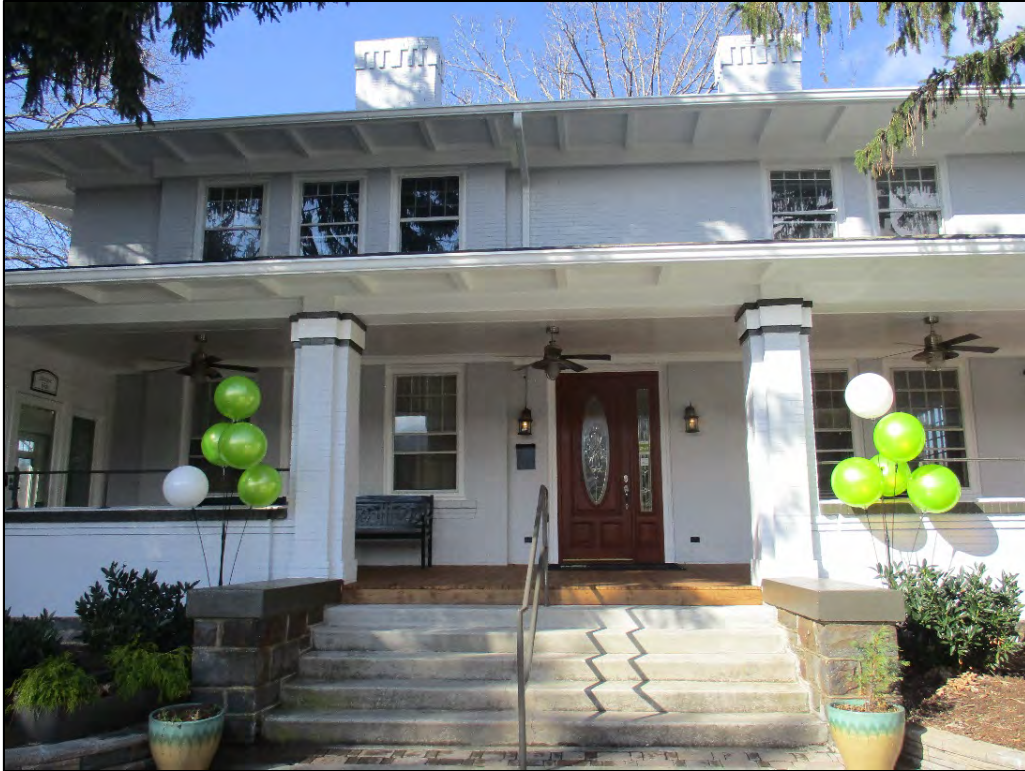
Edgewood Knoll Apartments leasing office front porch detail, view to west

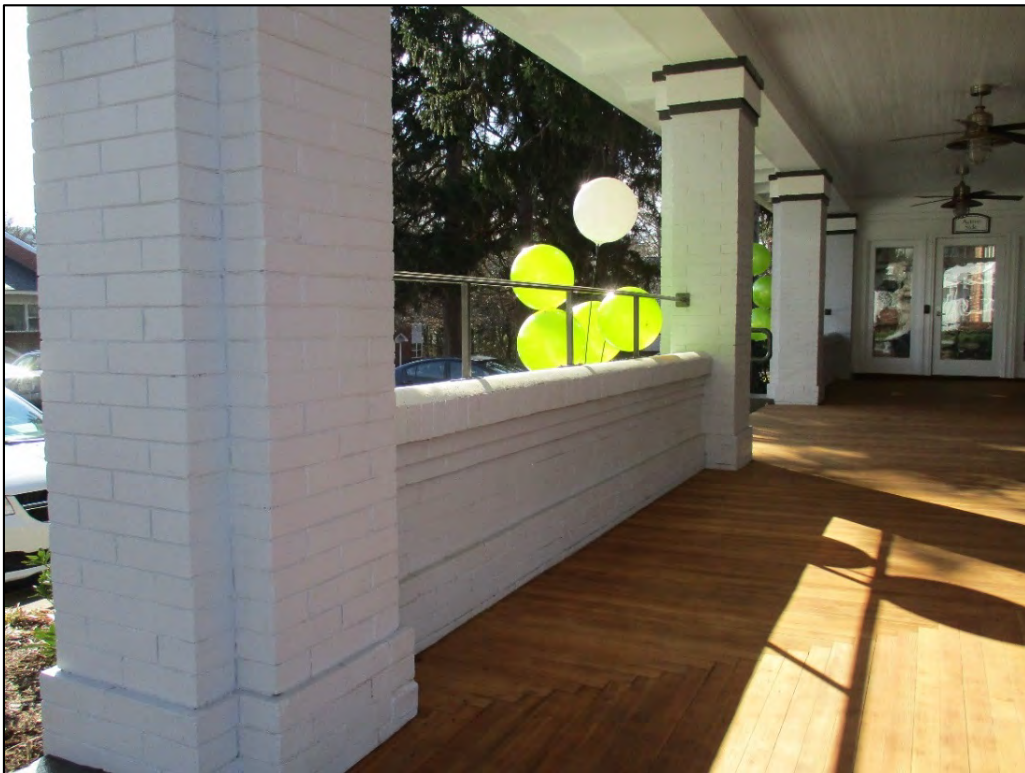
Edgewood Knoll Apartments leasing office front porch detail, view to south. Sunroom is visible at end of porch.

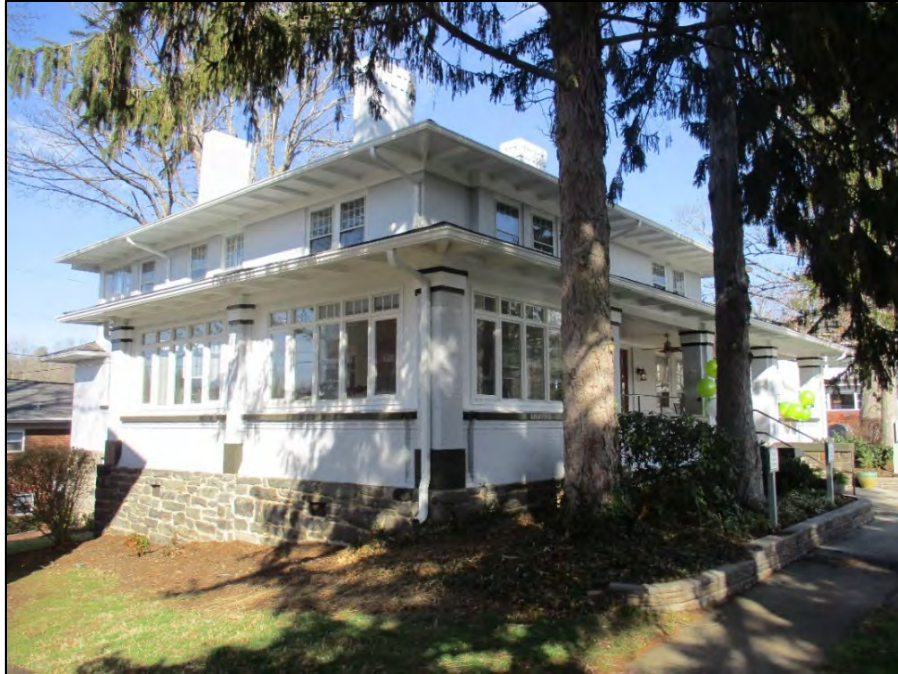
Edgewood Knoll Apartments leasing office, oblique view of façade and south elevation, view to northwest

The south elevation of the house features a variety of historic wood windows, including twelve-over-one sash, fifteen-over-one sash, and multi- and single-pane casements. The windows on the first story have decorative gauged brick lintels in a fan design with exaggerated brick keystones. Decorative brick header bonds form the sills for the windows on the first story. The basement level of the house is visible on this elevation and contains a non-historic, six-over-six sash vinyl window.

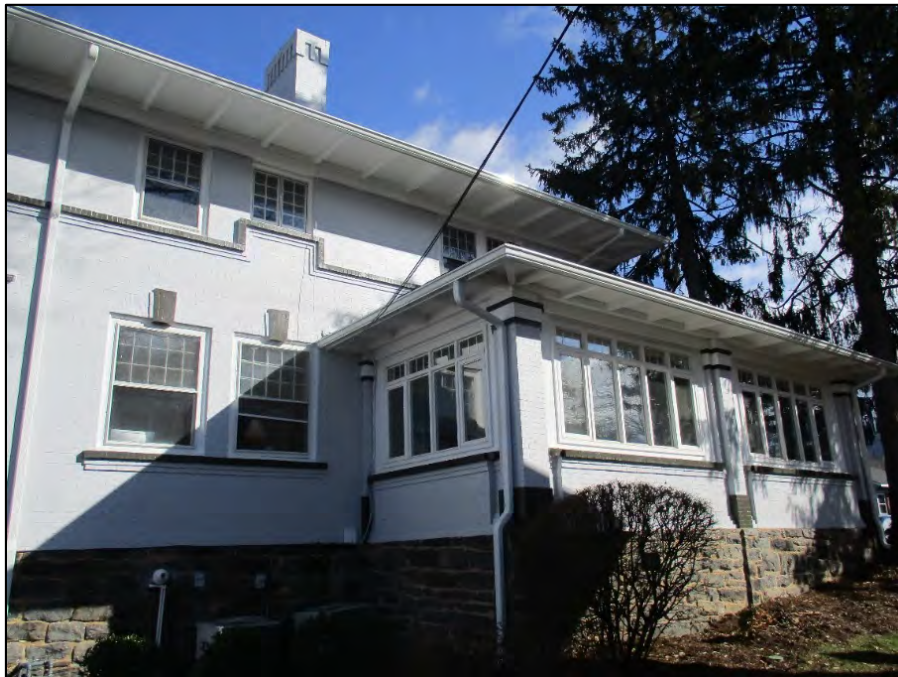
Edgewood Knoll Apartments leasing office portion of south elevation, view to northeast

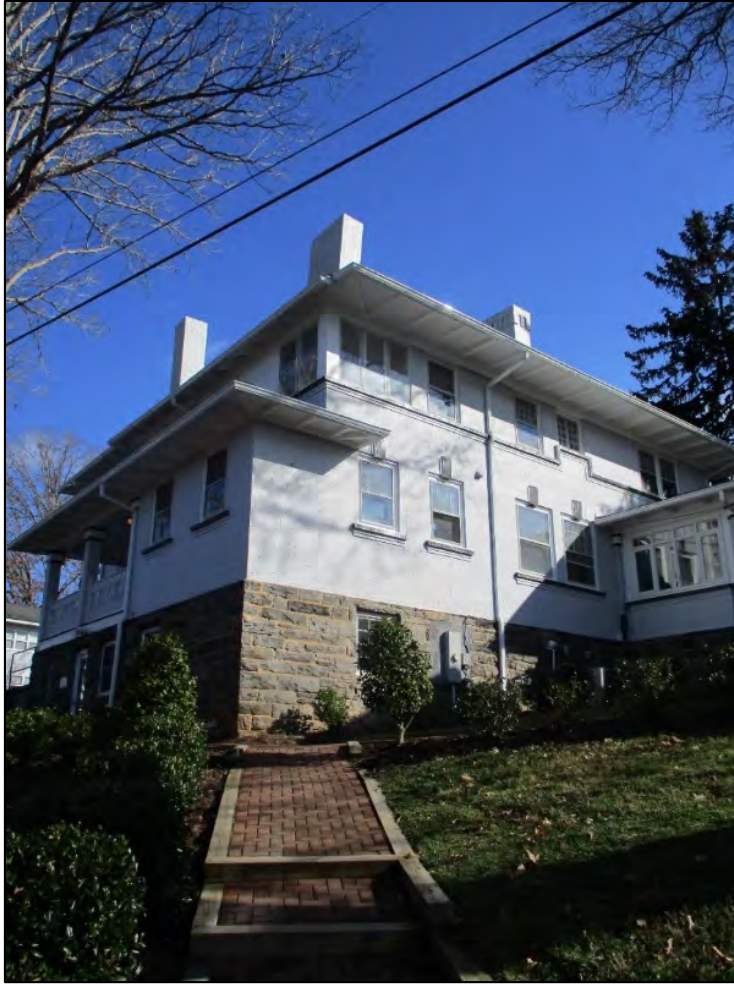
Edgewood Knoll Apartments leasing office, oblique view of south and west elevations, view to northeast

The rear of the structure (west elevation) has a partial, half-hipped roof porch supported by brick columns with corbelled caps and a bead board ceiling. A set of concrete stairs with metal pipe railing leads from the basement level to a concrete walk, providing access to a second set of stairs to the porch. The porch floor and stairs have been reconstructed with wood decking; the turned baluster on the stairs and porch are also replacements. There are two non-historic French doors located off the porch that provide access to the interior of the house: one is located in the center of the porch and features sidelights and a multi-light transom; the second is located at the south side of the porch. A variety of historic wood windows remain on this elevation and include: twelve-over-one sash, four-over-one sash, nine-over-one sash, and multi-light casement windows. There is a wood-shingled hipped dormer with two twelve-light windows in the center of the roof. Based on materials and design, the dormer appears to be an addition to the house of unknown date. The internal brick chimneys located at the rear of the house (and visible from this elevation) are plain in their treatment, lacking corbelled brick caps. Also on this elevation is a door leading to the basement level of the house. The basement level features non-historic four-over-four and six-over-six sash vinyl windows.

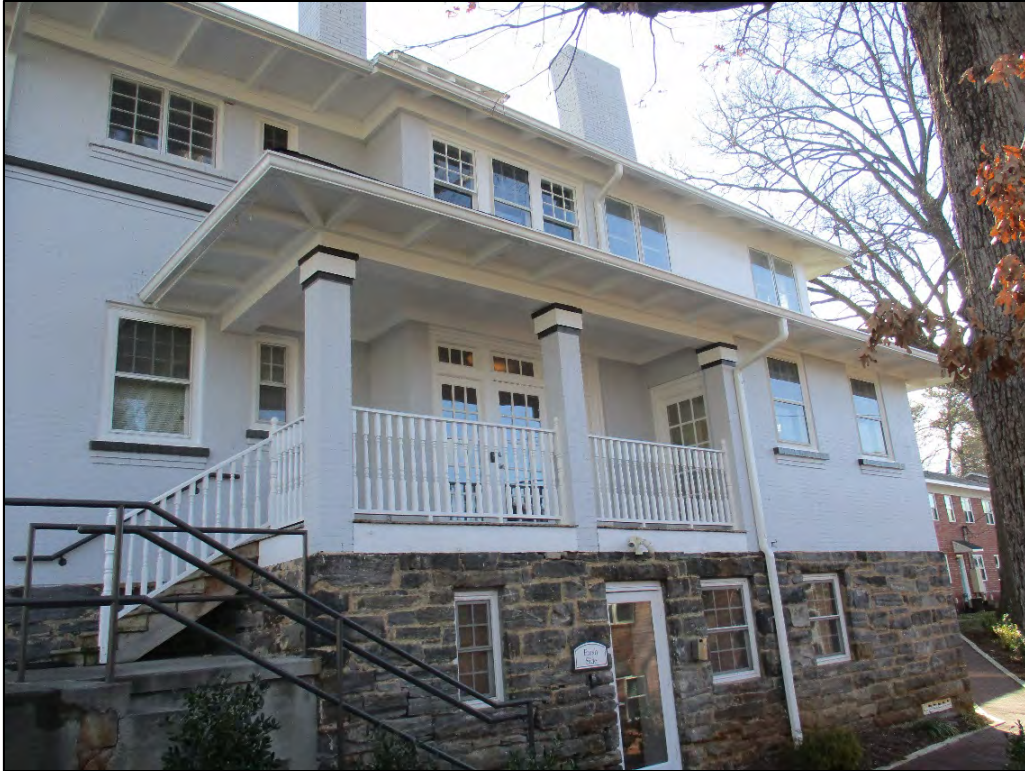
Edgewood Knoll Apartments leasing office west elevation, view to southeast

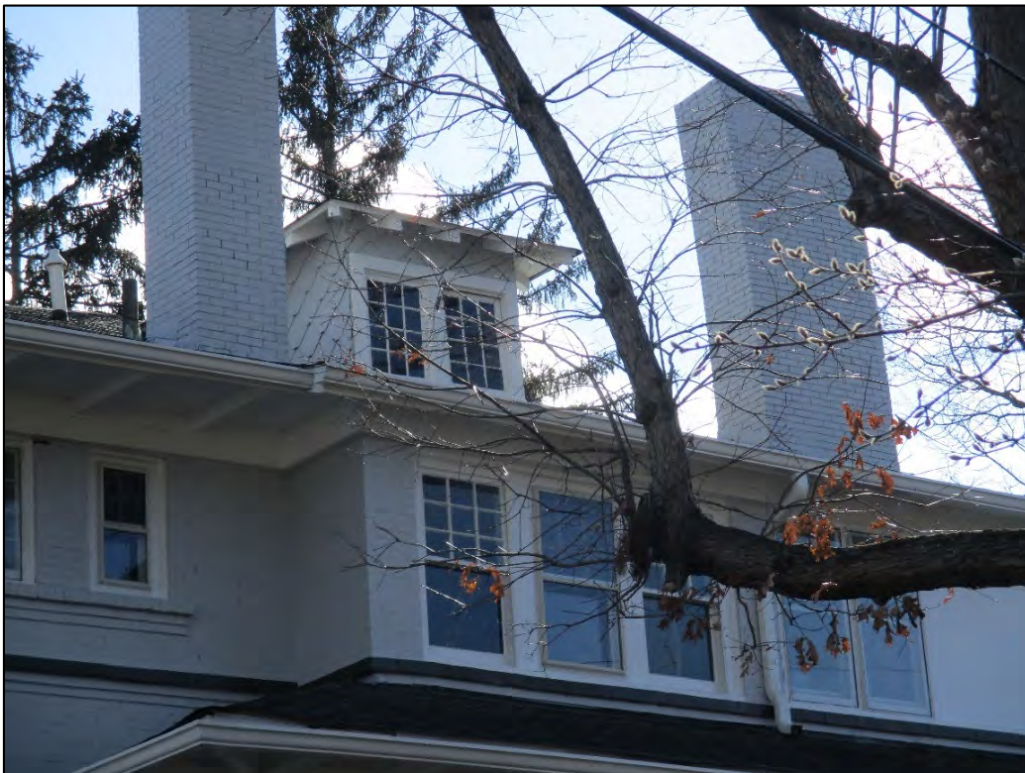
Edgewood Knoll Apartments leasing office west elevation window and dormer detail, view to southeast

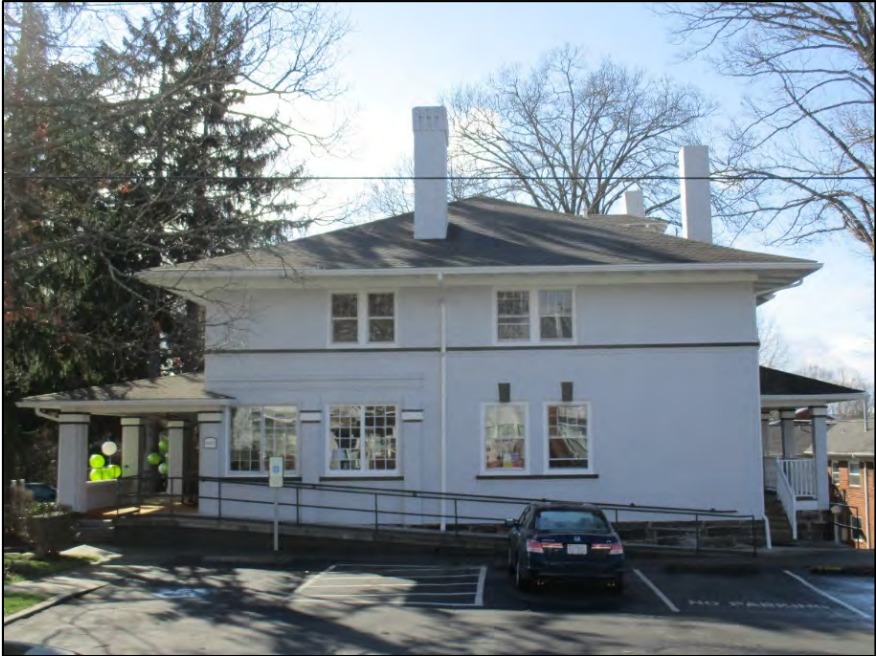
A concrete handicap ramp with metal rails traverses the length of the north elevation of the house and leads to the front porch. The historic wood windows on this elevation consist of twelve-over-one sash, nine-over-one sash, and large multi-light casements. The windows on the lower level of the house feature the same decorative gauged brick lintel with exaggerated brick keystone design and corbelled brick header bond sills as the east elevation. The large casement windows are bounded with three corbelled brick pilasters.

Edgewood Knoll Apartments leasing office north elevation, view to south

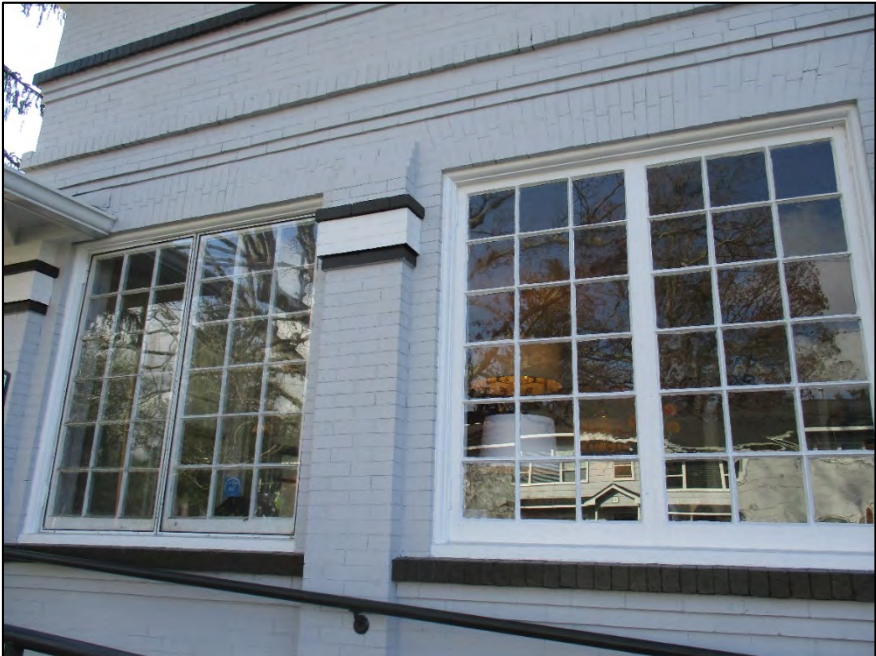
Edgewood Knoll Apartments leasing office north elevation window detail

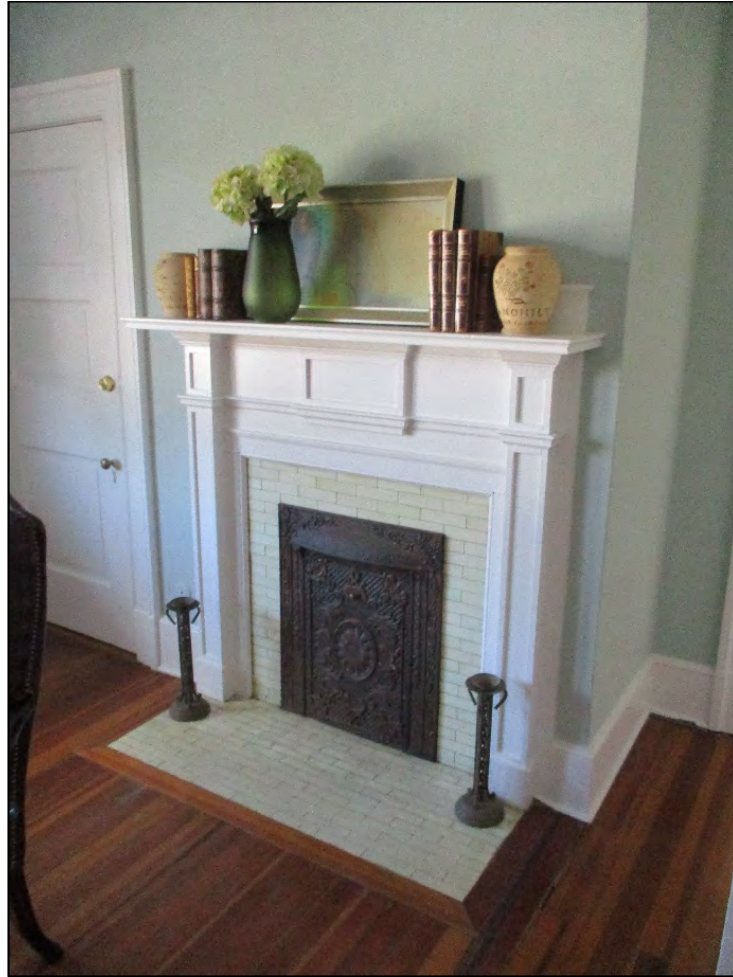
The interior of the house contains many historic elements including original fireplaces and tiled fireplace surrounds, original hardwood flooring, wood molding, window and door surrounds, historic doors, and intricate wood banisters. Internal arrangements appear to be relatively intact, as the rooms in the house are mainly used for offices, meeting spaces for the leasing office staff, and recreational/common spaces for apartment residents. Though a kitchen was not observed, it likely occupied the space in the southwest corner of the house, which was locked and entry denied. Bathroom updates were noted.

Edgewood Knoll Apartments leasing office interior fireplace and door detail

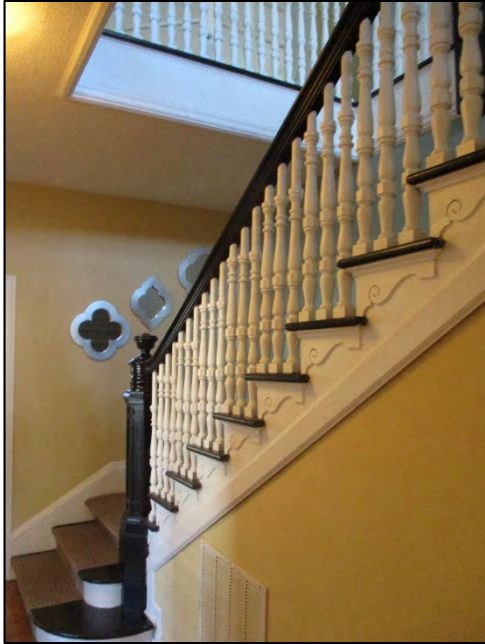
Edgewood Knoll Apartments leasing office interior stair detail

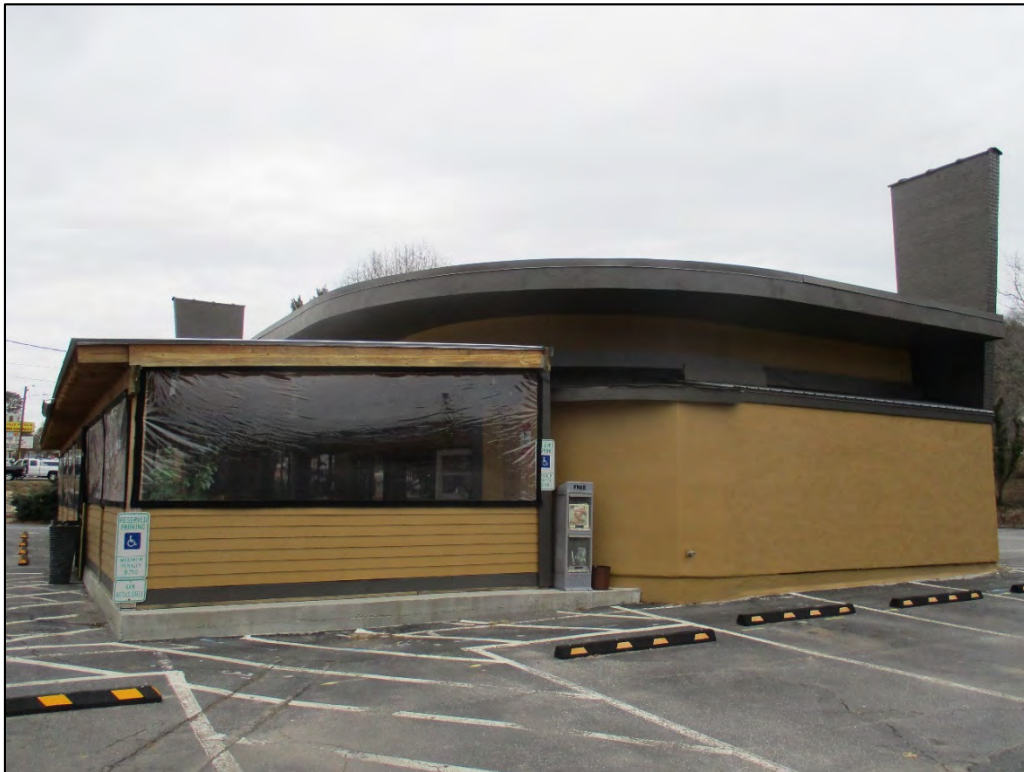
Former Athens Restaurant south elevation, view to north

The resource was constructed in the late 1950s as an automobile service station and then converted to a restaurant in the late 1960s. It has been a restaurant since. A few remnants of the historic construction remain visible, though additions to all elevations obscure the original construction. The original extent of the building appears to correspond to the two exaggerated, raking (wider at top than at bottom) brick walls (referred to as vertical elements throughout this evaluation) with terracotta caps that bound the original building’s public façade (consisting of the south and west elevations). The roofline extends between these exaggerated vertical elements and features a rounded southwest corner.

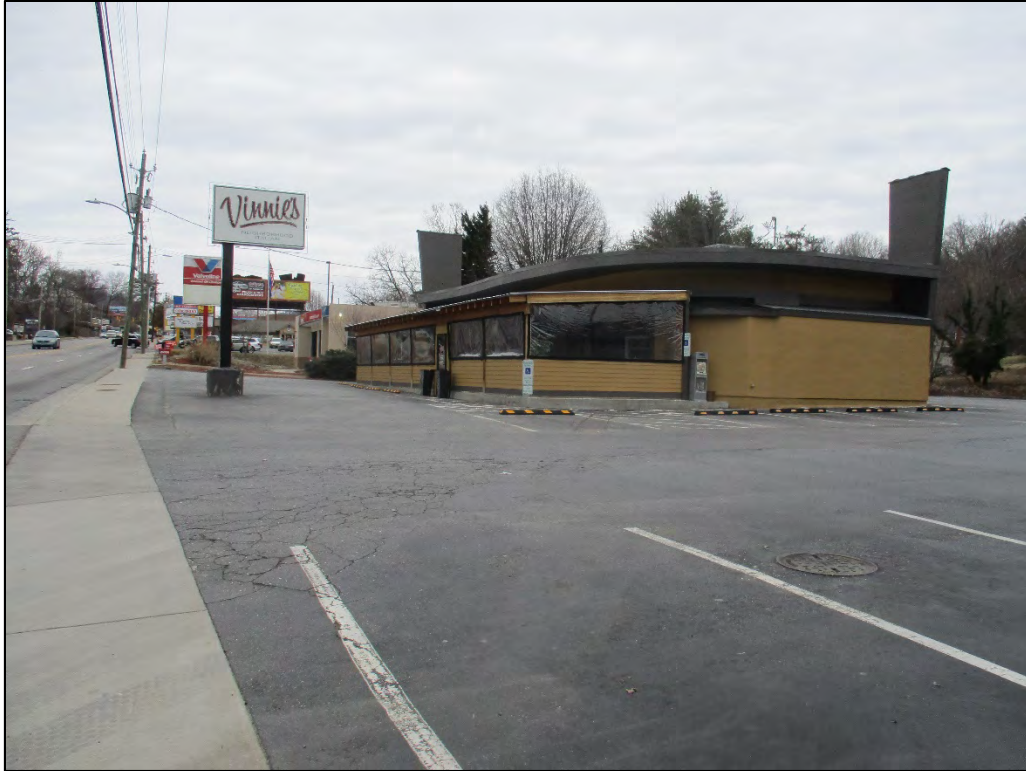
Former Athens Restaurant public façade, consisting of south and west elevation, view to northeast

The façade (west facing) includes a near full-length wood-framed shed attachment on a concrete pad that serves as convertible indoor/outdoor seating. Within the shed enclosure appear three ghost bay doors, separated by brick columns. One service bay door is entirely in-filled with concrete masonry units and the two others consist of a span of four fixed-lights over a brick skirt wall. Also noted within the shed addition are a replacement French door and a plate glass window and vinyl sash window with plywood infill above, presumably the location of the automobile service station's office. (An intermediate, curved canopy above the presumed office mirrors the roofline's curve – though recessed slightly from the roofline – and is partially exposed along the south elevation). An addition to the north elevation extends beyond the brick vertical element on the façade. This addition is clad in patterned projecting brick along the façade; this same pattern was noted in the brick skirt walls used to partially infill two service bay doors and may correspond to a renovation episode that converted the service station to a restaurant in the late 1960s. A vinyl replacement door is included on the northern addition's façade wall.

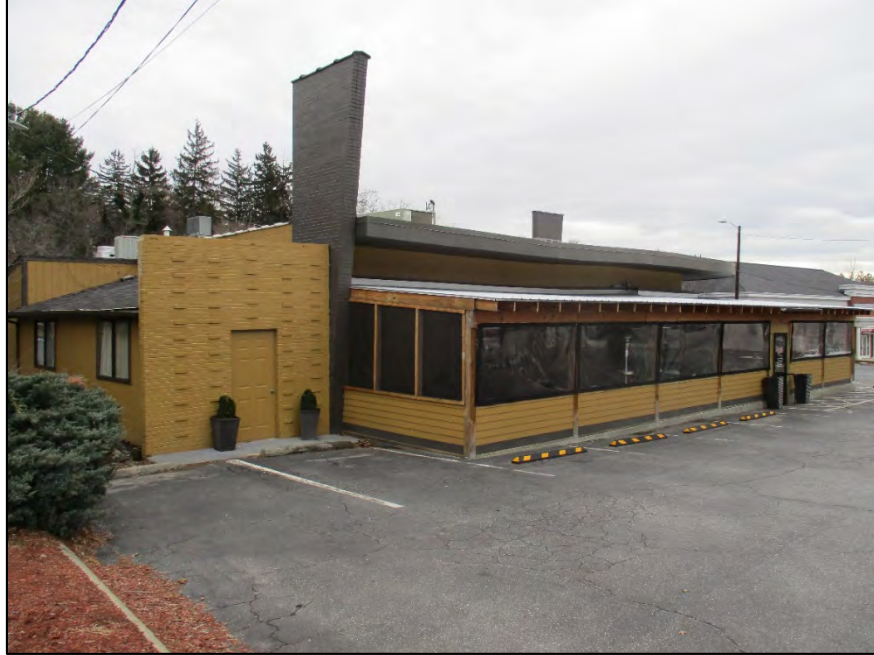
The south elevation has a small shed addition which projects beyond the plane of the curving roofline above and the bounding brick vertical element. This addition corresponds to an interior hallway connecting the dining room to the bathrooms. The shed addition is clad in a stucco application with a raised seam metal roof. The eaves in the original curved, projecting roof are boxed with plywood, and the fascia also appears to be a thin plywood application with an aluminum drip edge.

Former Athens Restaurant west elevation, looking southeast

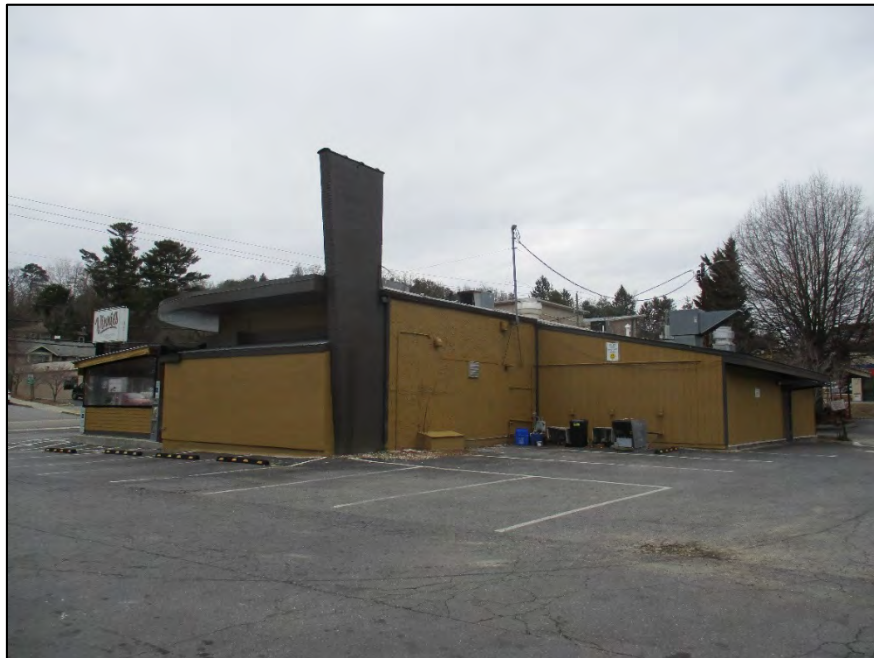
The rear (east) elevation is partially clad in a textured stucco application. A large shed addition extends from the remainder of the elevation, and continues to the north of the original building's extent to adjoin the wall of the northern lean-to addition (described below). The kitchen is contained within the rear addition. The rear shed addition is set on a concrete masonry unit foundation and is clad in T1-11 siding with an asphalt shingle roof. There is a single metal security door in the shed addition under a wood-framed hood.

Former Athens Restaurant oblique view of south and rear (east) elevations, view to northwest

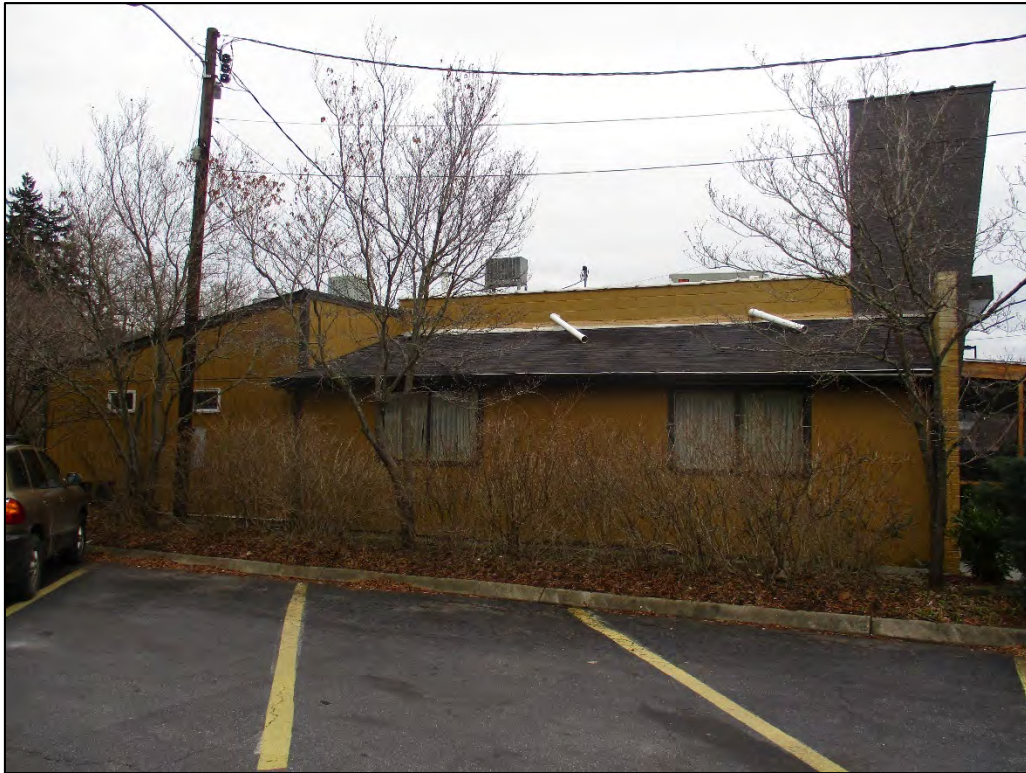
The north elevation is comprised of the exposures of the rear shed addition and the previously mentioned lean-to addition. The rear shed addition includes two vinyl awning windows in its northern elevation. Above the lean-to addition, the concrete masonry unit wall of the original construction is visible, delineating the historic extent of the automobile service station. Terracotta caps the parapet visible on this exposure. The lean-to addition is clad in T1-11 siding and includes two vinyl sliding windows; the roof has asphalt shingles.

Former Athens Restaurant north elevation, looking south

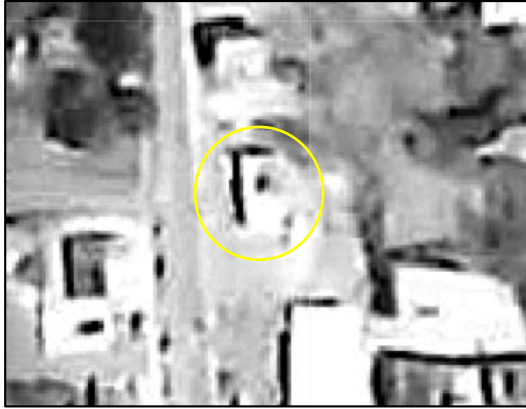
Exhibit 95. 1975 aerial imagery showing the former Athens Restaurant. Source: Asheville Through Time.

While attention-grabbing architecture would have served the purpose of a roadside restaurant, the internal arrangement of an automobile service station would not. The building was first converted by the Athens Restaurant; the earliest alterations and additions correspond with the patterned brick applications on the northern lean-to addition and the service bay door infill. The patterned brick application is a common treatment from this period, utilized in contemporary residential and commercial construction. The bathroom hallway is also suspected to date to this initial conversion and dulled the curved corner, formerly associated with the service station's office, as seen in the 1975 aerial image.

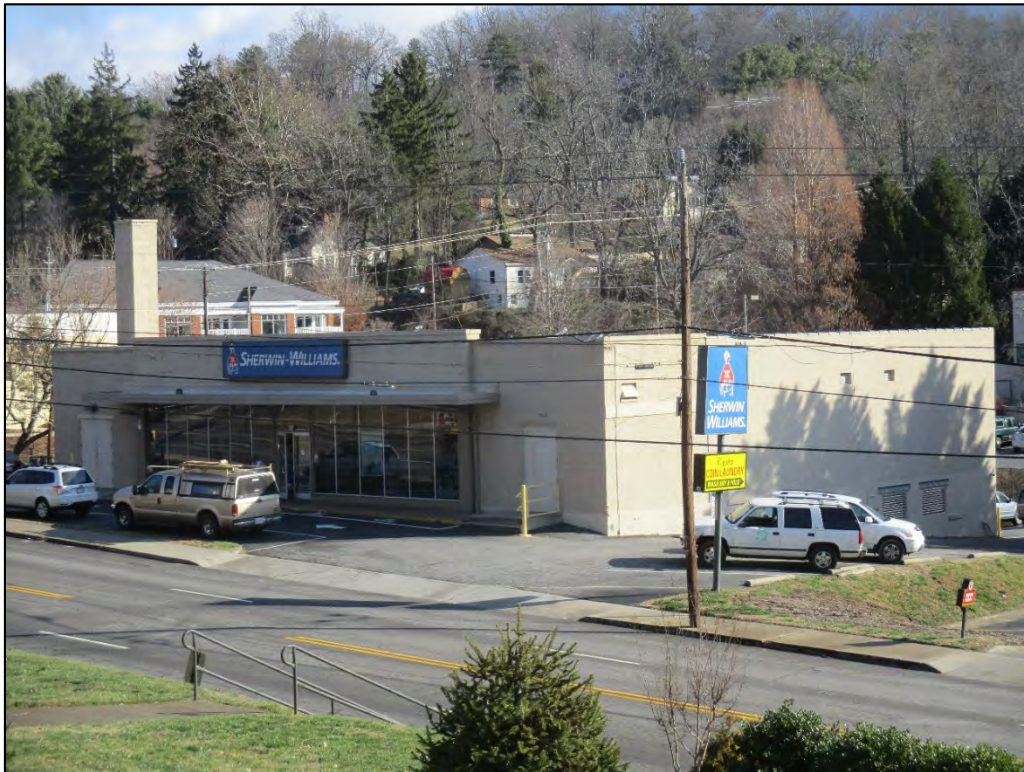
Burton and Son Furniture Store oblique view of façade and south elevation, looking northeast

The west-facing façade features a slightly projecting, emphasized storefront with central glass double-doors and fixed-transom. The entry is wood framed. Six single-pane display windows are present on both sides of the entry in aluminum frames and on a slanted concrete sill. The glass storefront is protected by a shallow, cantilevered canopy which appears to be clad in vinyl, with an aluminum drip edge. Above the canopy, the emphasized storefront mass is clad in stucco (or concrete) with concrete caps on the stepped parapet. The Sherwin-Williams sign is affixed to the wall above the canopy. On both

sides of the emphasized storefront are a bay clad in six-course American bond striated brick that has been painted. The northern brick bay includes a metal security double-door in a metal frame; the southern brick bay includes a single metal security door with a sidelight that has been infilled. The southern door is accessible by two concrete stairs with a metal tube railing. The foundation is partially exposed at the southwest corner of the façade and is also clad in stucco.

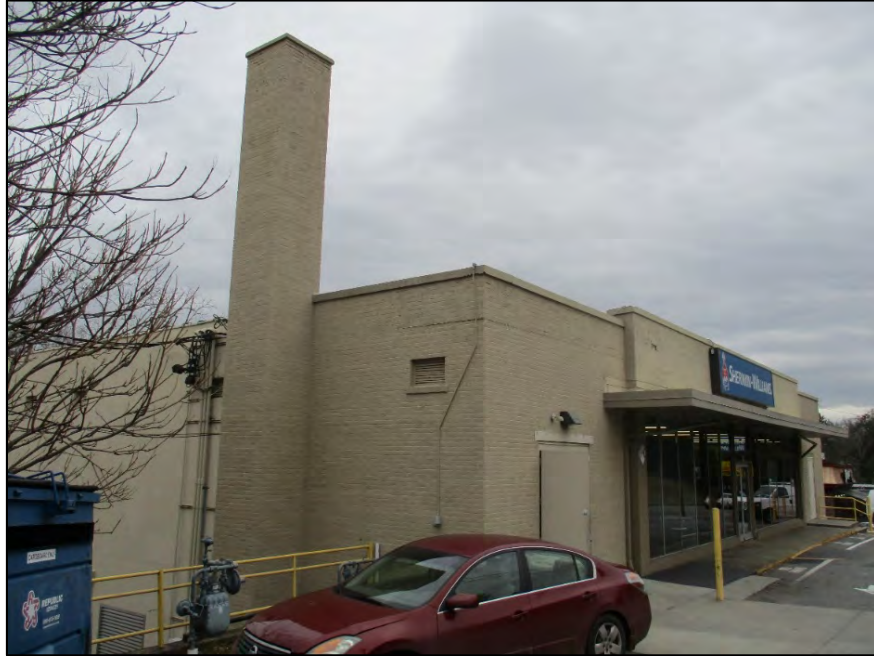
Burton and Son Furniture Store oblique view of portion of north elevation and façade, looking southeast

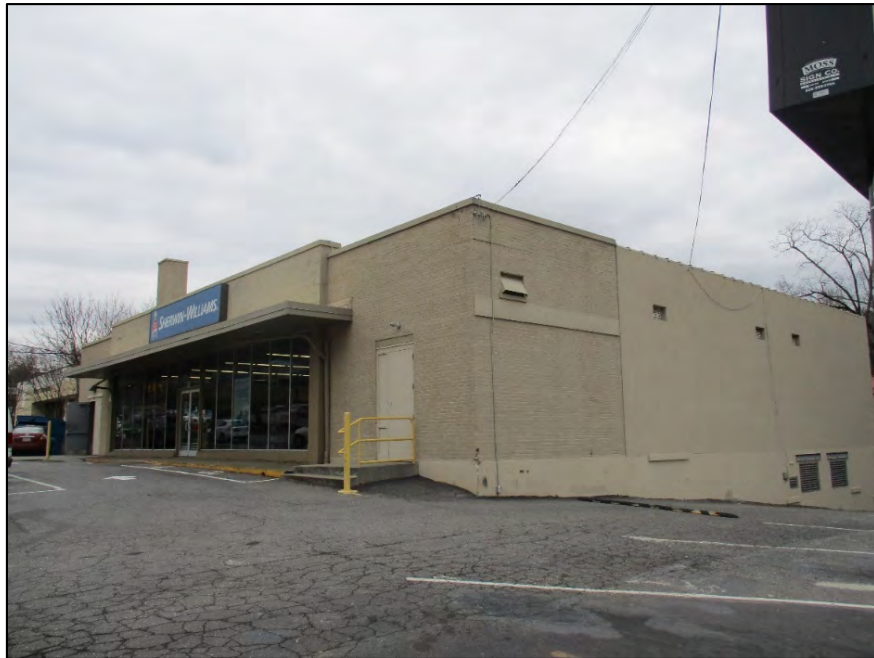
Burton and Son Furniture Store of north elevation and façade, looking northeast

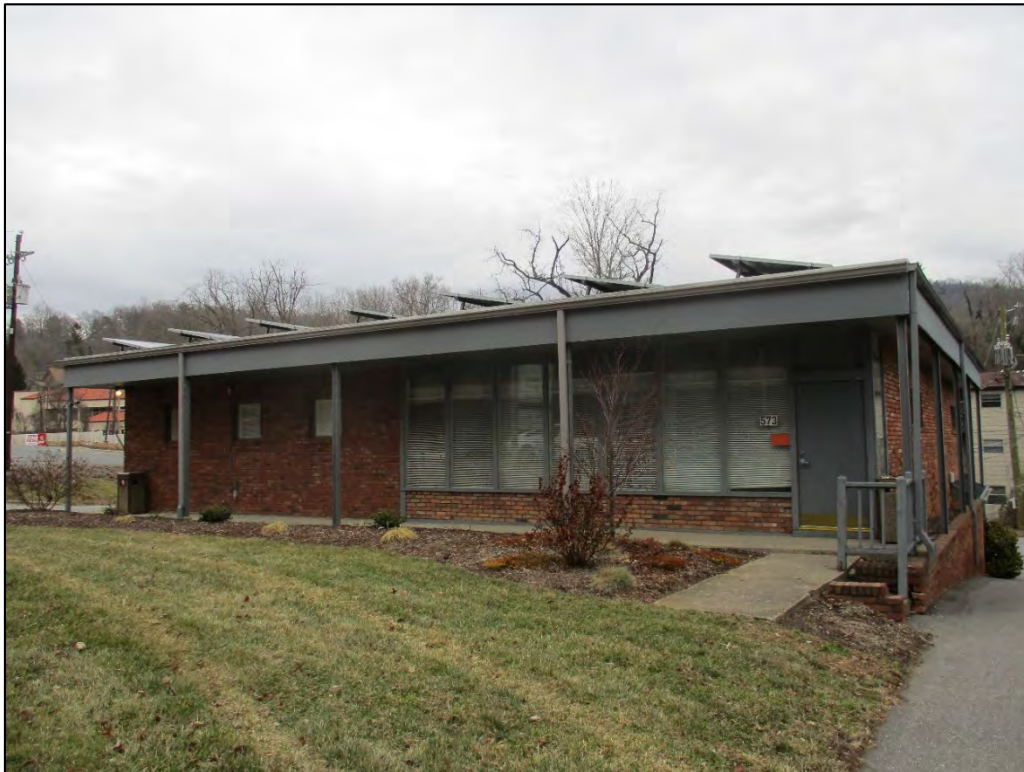
Thompson Building façade, view to the northeast

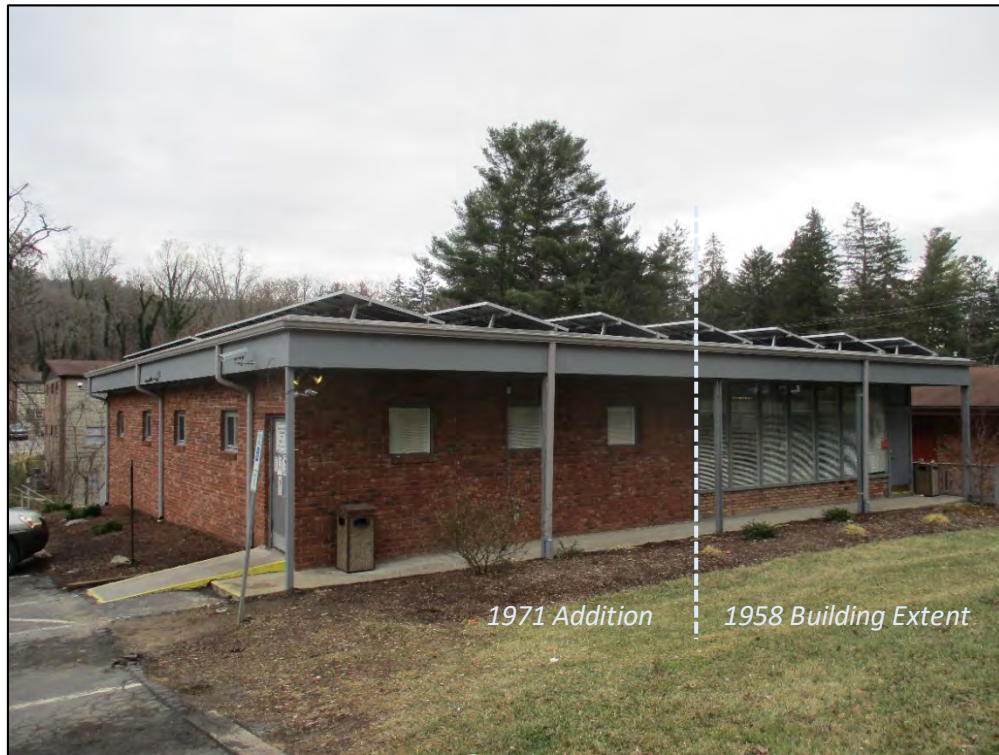
The north elevation fronts Westall Drive. A metal security door is present at the west end of the elevation and is accessible via a concrete ramp. Four aluminum sliding windows are symmetrically placed along the elevation over slanted brick sills and with steel lintels. The flat roof projects in a narrow, boxed eave. Gutters and downspouts are present along this elevation.

Thompson Building oblique view of the façade and north elevation, view to the southeast
