November 9, 2018

MEMORANDUM

SUBJECT: Historic Structures Survey Report, Merrimon Avenue & WT Weaver Boulevard Intersection Improvements. U-5781, U-5782, PA 17-04-0023, Buncombe County, ER 18-0102

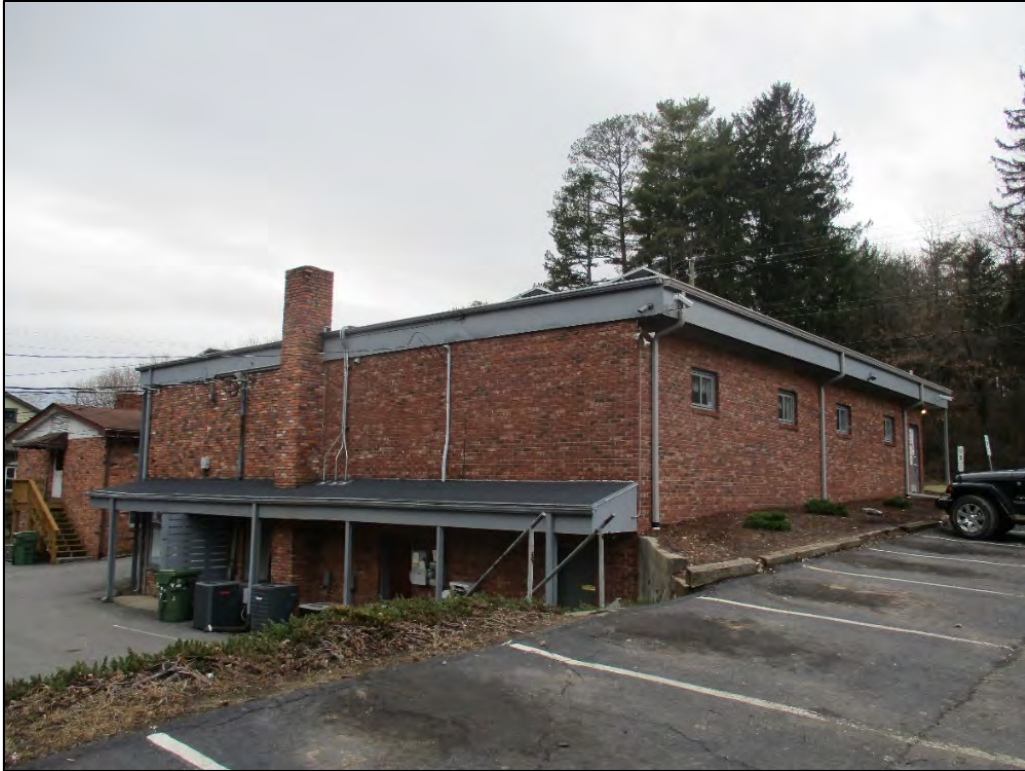
Because the terrain slopes to the east, the full basement is exposed on the rear (east) elevation. The rear elevation also reveals the seam between the original 1958 construction and the later 1971 addition, split at the centrally positioned external brick chimney (which appears to belong to the original construction based on materials). The roofline is flush with the wall on this elevation, and gutters and a single downspout are present. The first floor has no window openings. The basement level includes four doors protected by a full-length, wood frame lean-to porch addition. The porch addition has plywood ceiling, includes gutter and downspouts, and has a rolled asphalt roof. From right to left, the doors to the basement are: solid wood door in wood frame; an interior hollow wood door in wood frame; wood door with wood slats in wood frame; wood door with a diamond light in wood frame with transom light above. The southern entry is accompanied by fixed-pane windows, two at right (north) and one at left (south) framed with wood. These features appear to be historic and likely correspond to an entry for a separate office, a secondary “storefront”.

Thompson Building oblique view of the rear (east) and north elevations, looking southwest

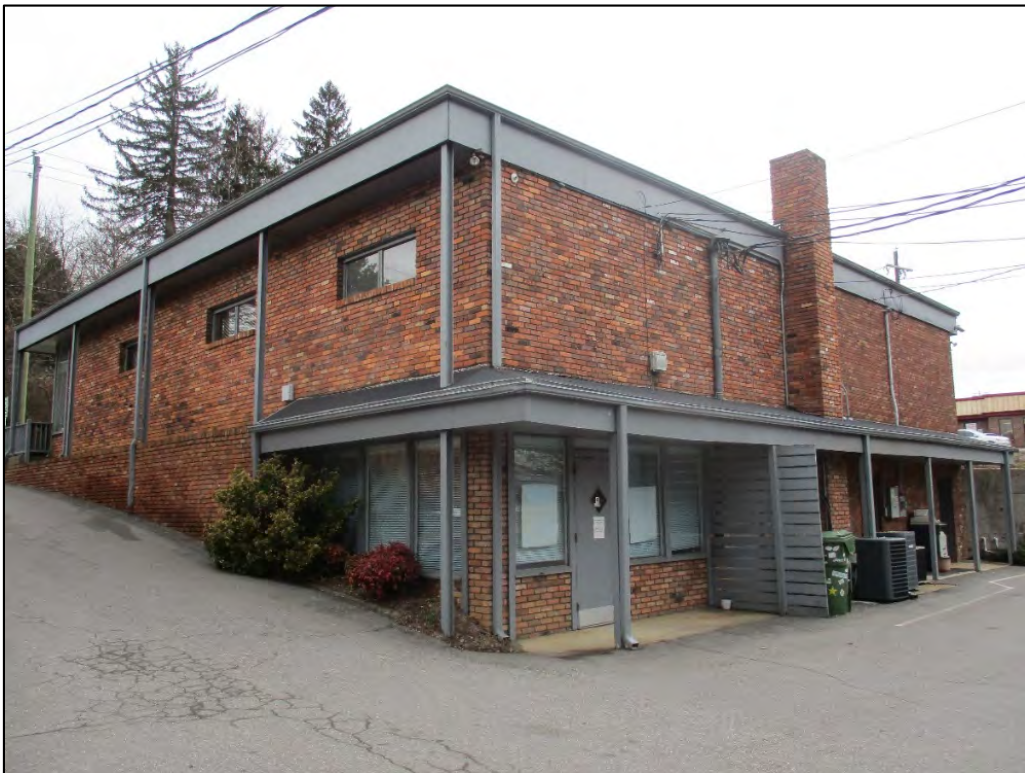
Thompson Building oblique view of the rear (east) and south elevations, looking northwest

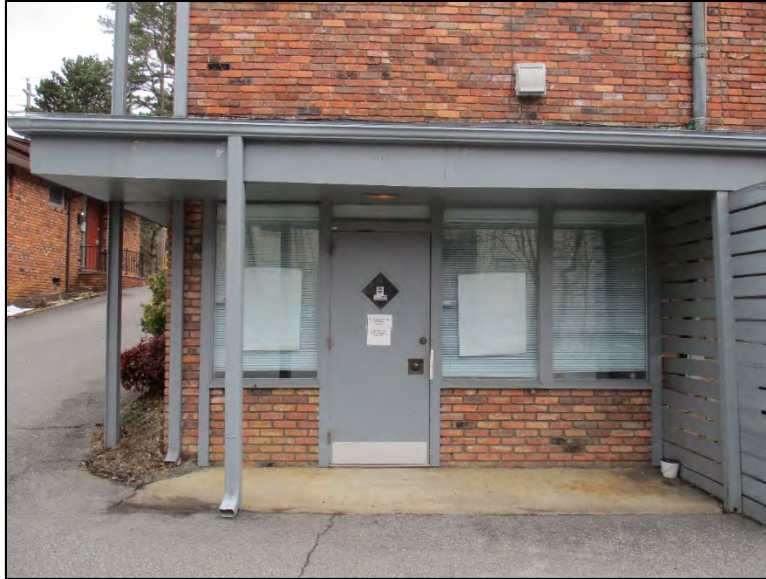
Thompson Building rear (east) elevation entry detail, looking west

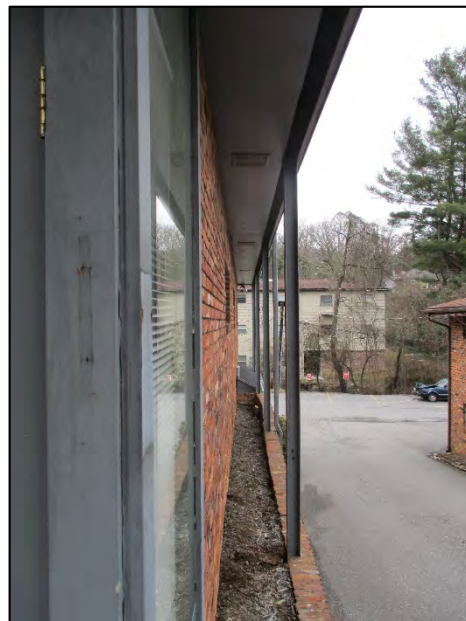
The south elevation belongs to the original 1958 construction. The wood frame lean-to porch addition continues around the southeast corner to cover three windows in the basement level, exposed in the east corner of the south elevation. These fixed-pane windows are treated similarly to those on the rear elevation. The lean-to roof terminates at the integrated brick planter that traverses the remainder of the south elevation. The flat roof extends in a narrow, boxed eave and features I-beam supports, the same as the façade, three of which terminate in the brick planter wall. Gutters and a single downspout are present. Three paired wood framed awning windows over brick sills and with steel lintels are symmetrically placed along the first floor. A single fixed-pane window is present in the west corner of the elevation, forming a “glass” corner, a continuation of the façade treatment.

Thompson Building south elevation, view to the east from the southwest corner

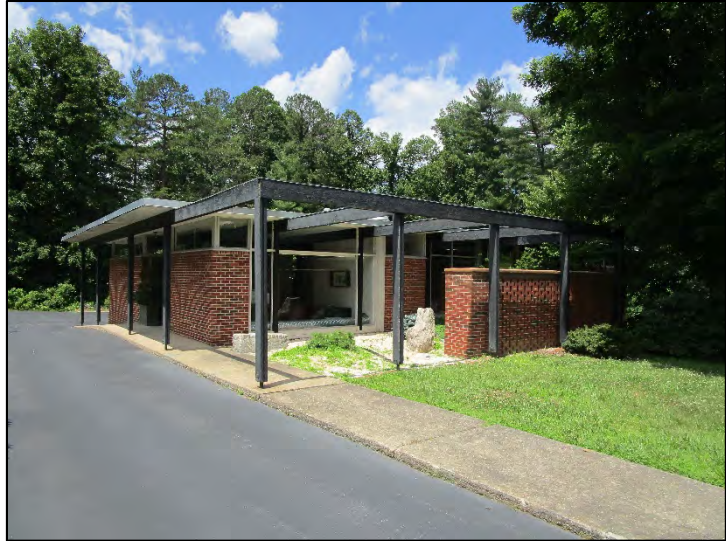
Exhibit 103. 1087 Hendersonville Road

The 1961 Modernist office building (currently a dentists’ office) at 1087 Hendersonville Road utilizes the exposed structural construction technique to striking effect (Exhibit 103). The rectilinear wood-frame and brick veneer building shows its structural composition and suggests interior uses. A band of fixed-pane windows sit atop brick walls at the roof junction, giving the impression of a flat, floating roof. A large fixed-pane, floor-to-ceiling window is located in the façade, permitting views to the partially screened garden framed under an open-air structural projection intended to blur the interior and exterior spaces. The entry is hidden, recessed along the north elevation. The office building is in good condition and stands as an excellent early-1960s Modernist building.

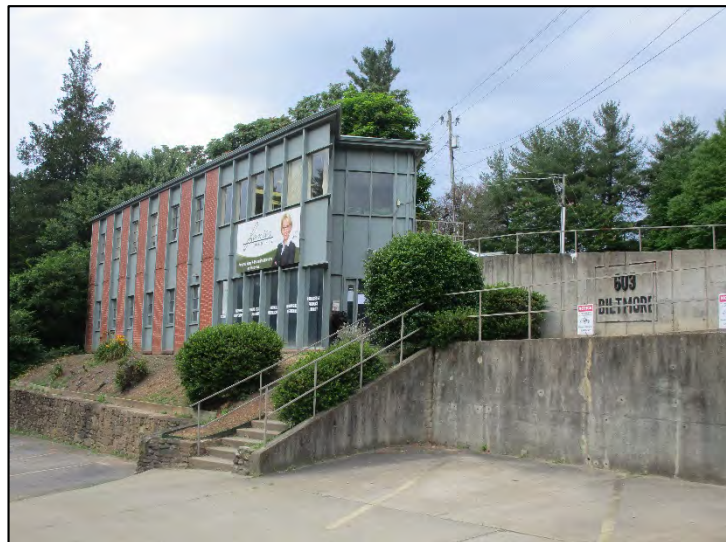
Exhibit 104. 603 Biltmore Avenue

The two-story office building at 603 Biltmore Avenue was completed in the mid- to late 1960s in a triangular corner parcel with a severe southeasterly slope (Exhibit 104). The triangular building with flat roof was fit within the parcel, with two stories facing Biltmore Avenue. As a result, the structural composition is amplified across two floors, consisting of several slender bays between columns alternating between flush brick panels and recessed three-pane wood windows.

The entry/lobby, located in the north V-notched elevation, features sharp glass corners with a series of the slender recessed bays filled with fixed-pane windows. No significant alterations were observed at the property, and it also stands as a good example of modernist design.

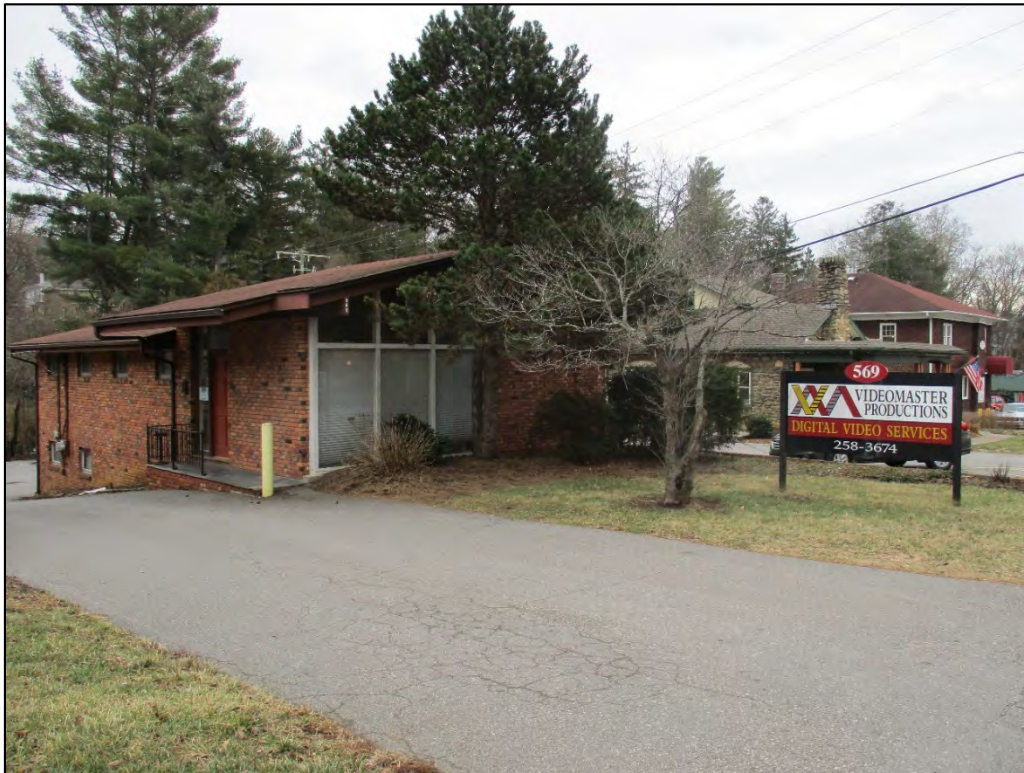
Ray Dental Office oblique view of the façade and north elevation, looking southeast

The west-facing façade occurs in two parts with the low-pitched front gable peak dividing the two. Six fixed pane windows fill the gable with three wood-framed fixed glass windows that continue to the ground at left (north) and a brick wall at right (south). The deep eaves are open, with exposed roof

beams and plank wood sheathing. The front portion of the building (reception area) is larger than the rear of the building in plan and profile.

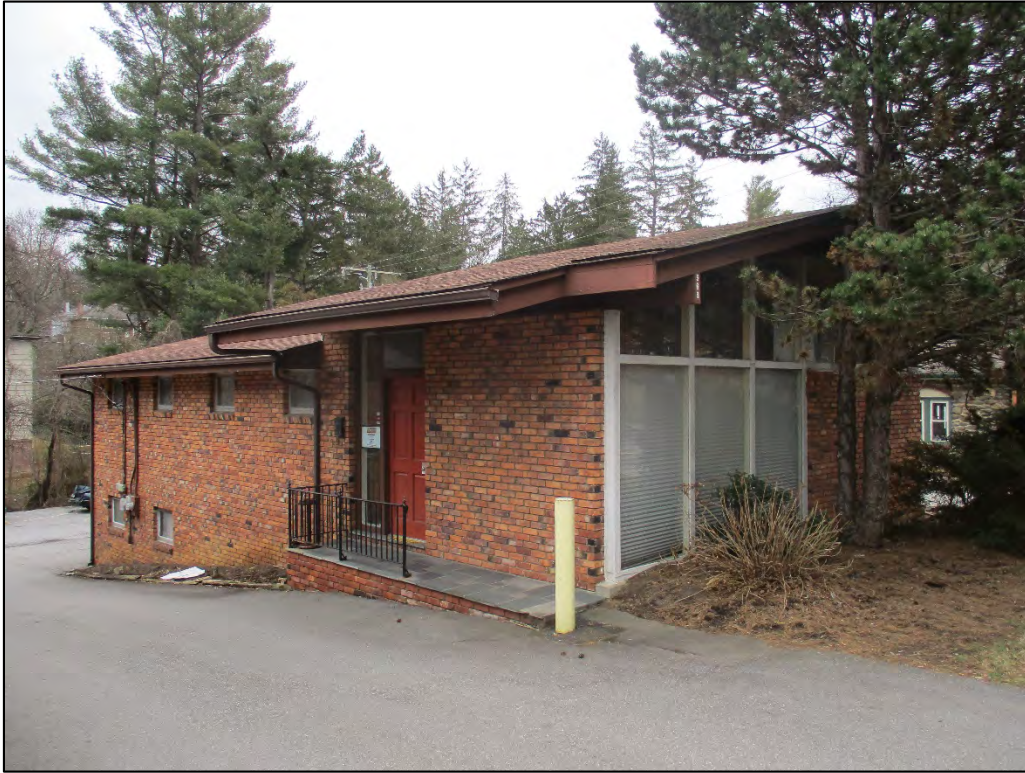
Ray Dental Office oblique view of façade and north elevation, looking southeast

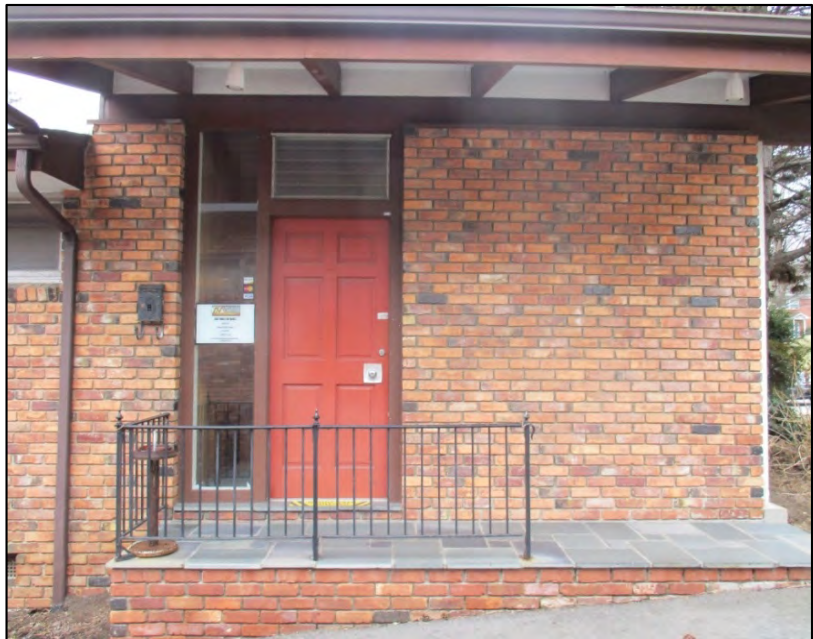
The main entry is placed on the north elevation and is accessible via the shared asphalt driveway traversing this elevation. A tile patio with wrought iron railing is covered by the wide overhanging, open eave with exposed rafters and plank wood sheathing. A fascia board encloses the rafter tails and a gutter is attached. The entry features a wood-framed six panel wood door, louvered glass transom, and full height sidelight. As mentioned, the roof line steps down east of the entry. Four aluminum awning windows above slanted brick sills and terminating at the top of the wall/roofline are symmetrically placed along the building behind the reception

Ray Dental Office north elevation primary entry detail, view to the south

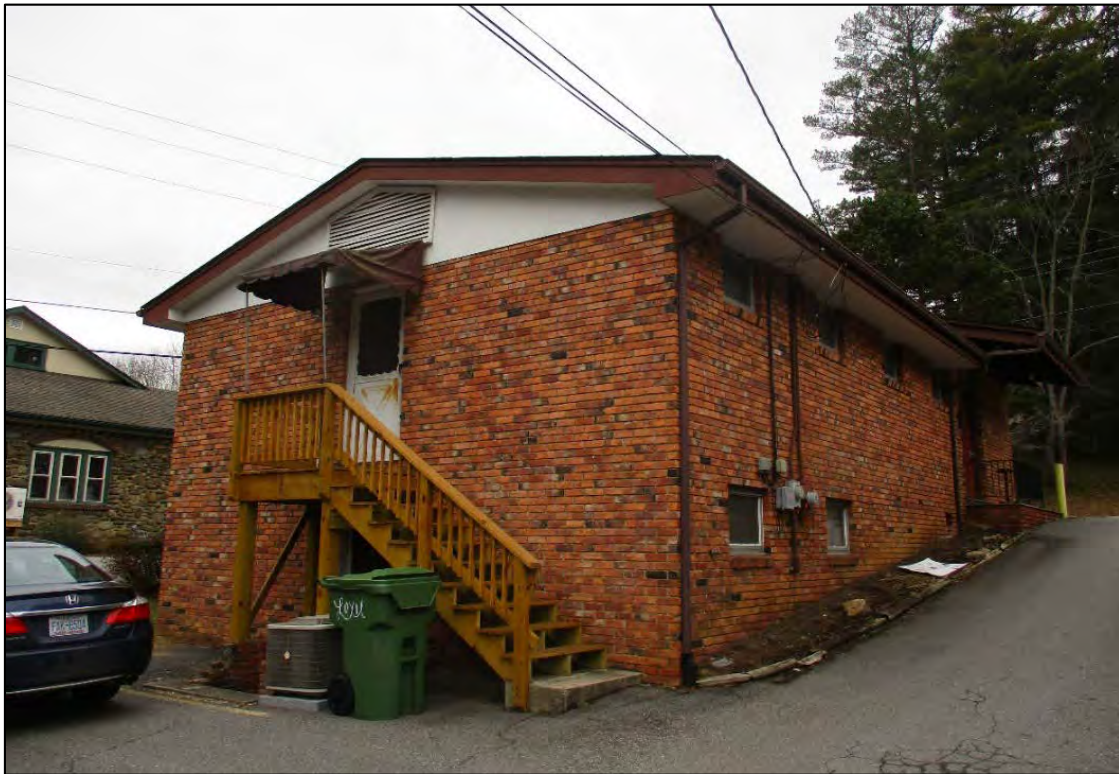
The rear (east) elevation includes two two-horizontal light wood doors, one in the first story accessible via a replacement wood stairway, and one into the basement. The first-floor door is covered with a canvas awning supported by aluminum pipes and has an aluminum screen door. The owner reported that the awning was removed, then replaced following the replacement of the wood stairs. Three concrete stairs descend to the basement door. The gable end is clad in plywood with a large barn-shaped vent, with wood slats.

Ray Dental Office oblique view of rear (east) and north elevations, looking southwest

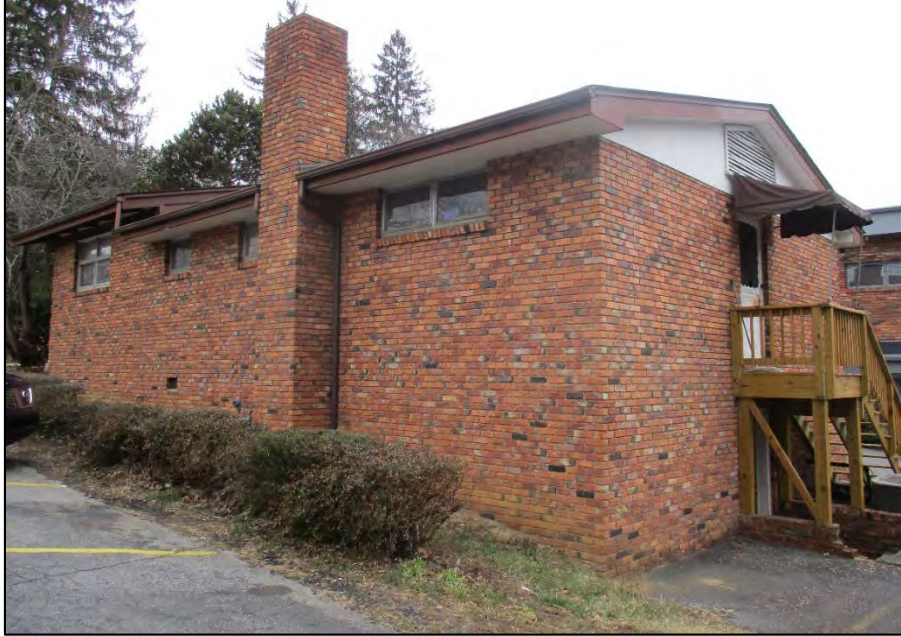
The fenestration on the south elevation is irregular due to the arrangement of interior space and the presence of the external brick-clad chimney. East (right) of the chimney is a pair of aluminum awning windows over slanted brick sills; west (left) of the chimney are two aluminum awning windows. The overhanging eaves are boxed in with plywood and a vinyl gutter is attached to the fascia board. The roof line steps down, same as the north elevation. In the exaggerated front portion of the building are a pair of aluminum awning windows with transoms. The rafters and sheathing are exposed here as well.

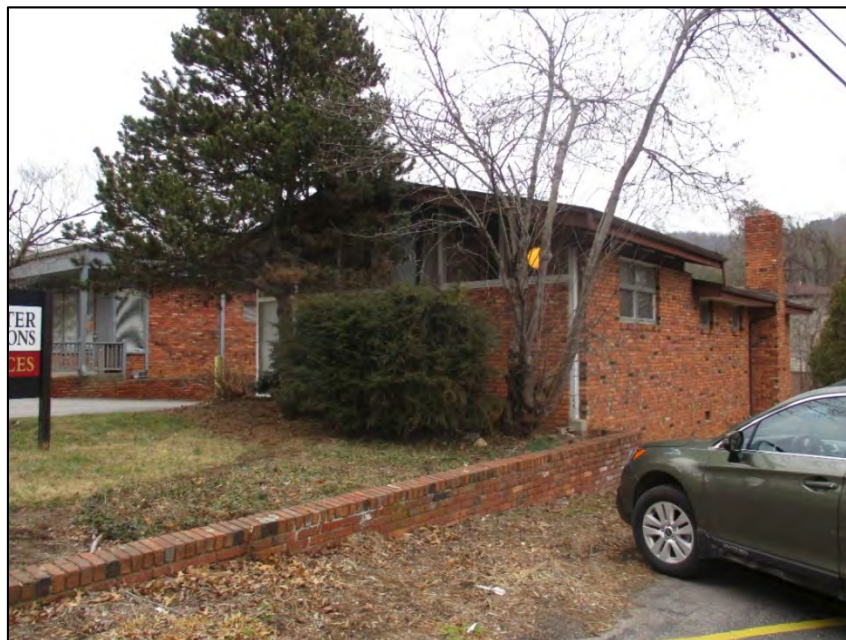
Ray Dental Office oblique view of south and rear (east) elevations, looking northwest

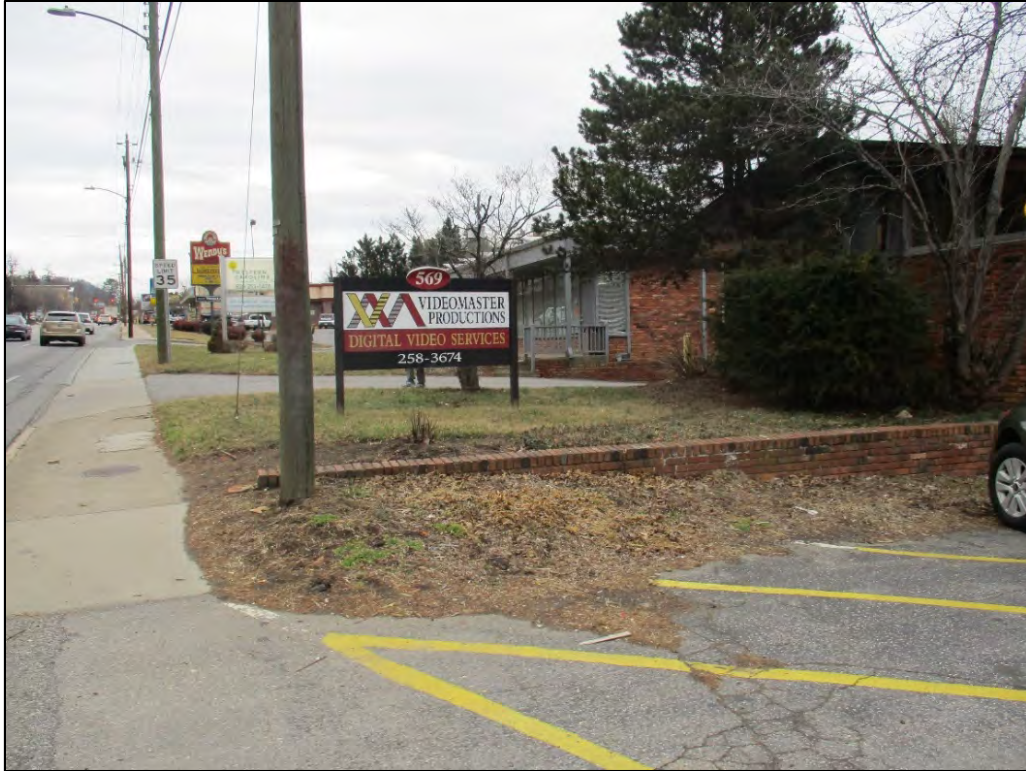
Ray Dental Office oblique view of façade and south elevation, looking northeast

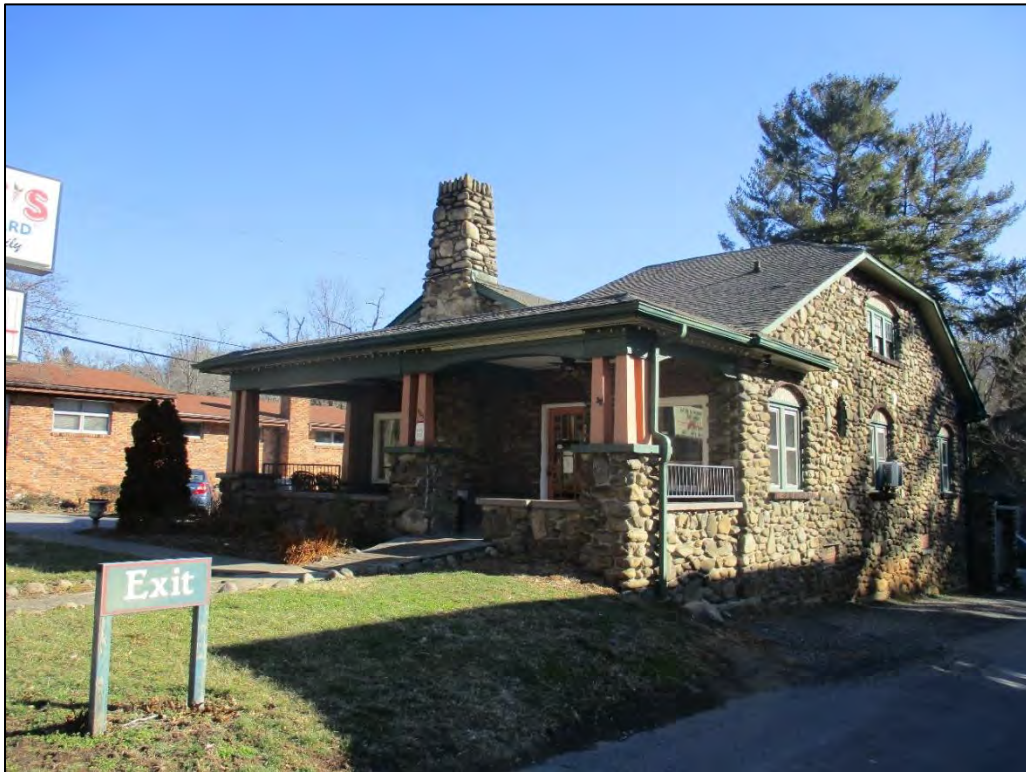
Former Belva L. Saunders House oblique view of façade and south elevation, looking northeast

The west-facing façade features a full length flat roof (with a faux hip) porch supported by half piers and triple and double wood columns with closed porch railing. The porch is accessible via a wood ramp and has a poured concrete floor. Metal bannisters are present above the closed porch railing at the north and south end of the porch. The porch ceiling contains bead board above the main entry and a textured/molded plywood sheet in the northern half. The main entry wood door consists of

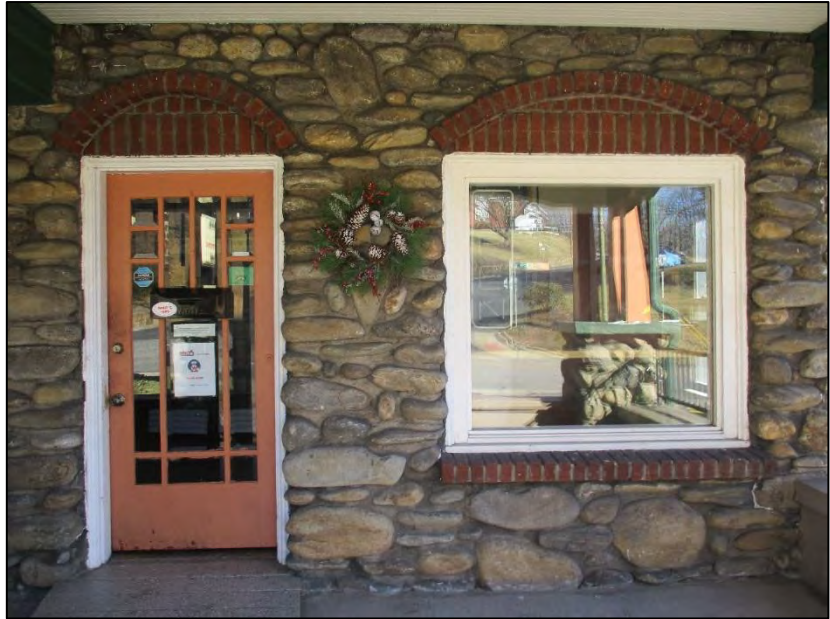
twelve-lights (beveled glass) in a geometric pattern.¹¹⁵ Two wood framed, fixed-pane windows over brick sills are present in the façade. The openings in the façade feature brick arches above that are filled with soldier brick course (false fanlights). A battered, exterior rock veneer chimney capped with vertical stones is present north of the entry and breaks the front gable peak.

Former Belva L. Saunders House façade entry detail, looking east

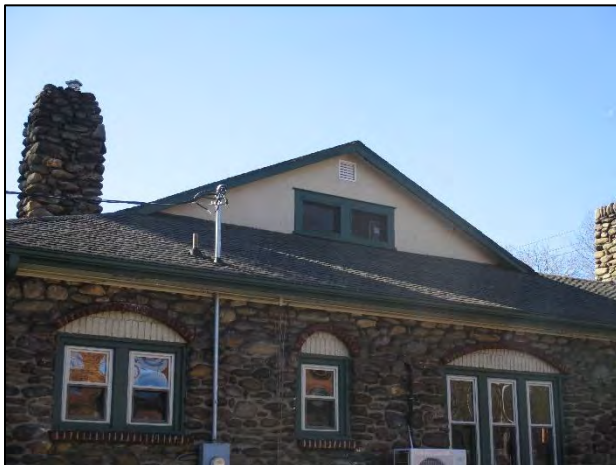
arch above the windows, consistent with the façade treatments, though materials vary. The arches over windows in the north and south elevations are brick and filled with soldier brick courses. The arches in the rear (east) elevation are stone and filled with stone. Windows are most commonly paired, with one triple example on the north elevation, and few single examples in the north and rear elevations. An oval fixed pane in a wood frame is present centrally within the south elevation. The half-story exposure includes historic window, including: a pair of wood awning windows set in the north elevation's stuccoed gable exposure; and a triple six-over-one window in the south elevation's clipped gable, which includes brick sill and arch above filled with soldier brick courses.

Former Belva L. Saunders House north elevation gable detail, facing southwest

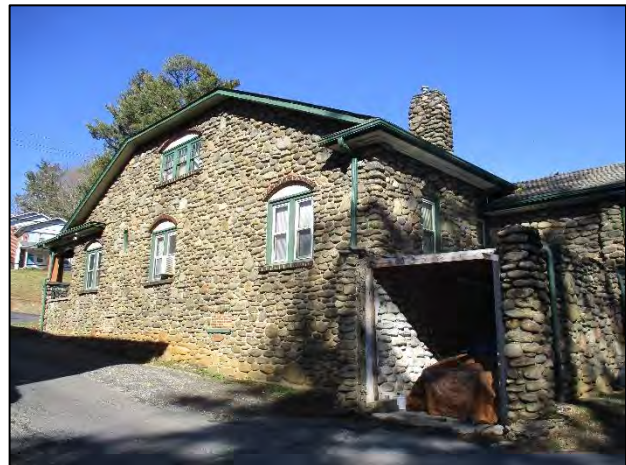
Former Belva L. Saunders House south elevation, view to the northwest

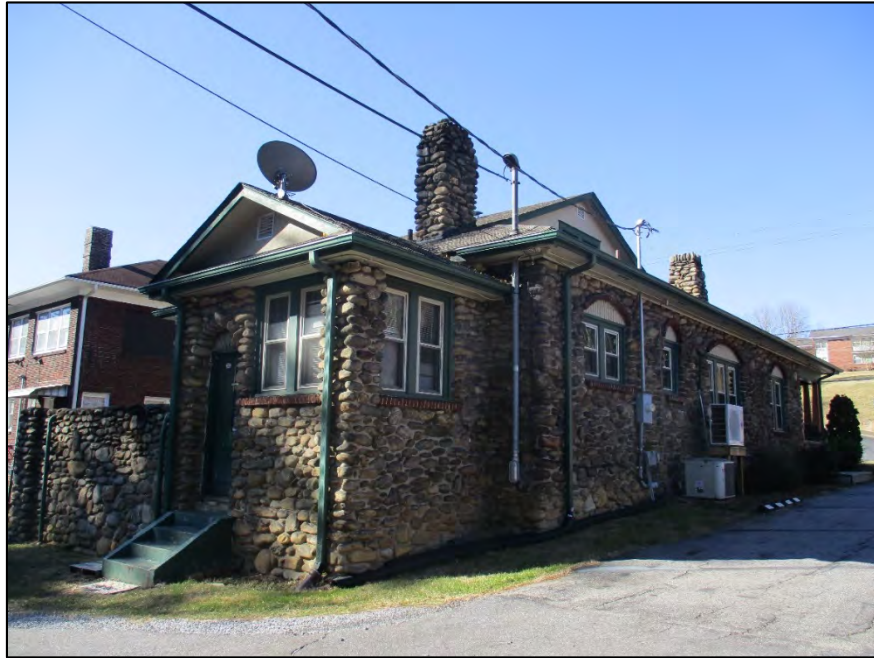
A rear projecting wing includes a six-light wood panel historic door in wood frame accessed by four concrete stairs under a closed, stuccoed gable. An interior rock veneer chimney is also present in the rear of the house. A rock garage with parapeted flat roof is attached to the southeast corner of the house, south of the rear entry. The garage roof is currently raised seam metal; no door is present. Brick infilled basement vents were observed in the north and south elevations.

Former Belva L. Saunders House oblique view of north and east (rear) elevations, looking southwest

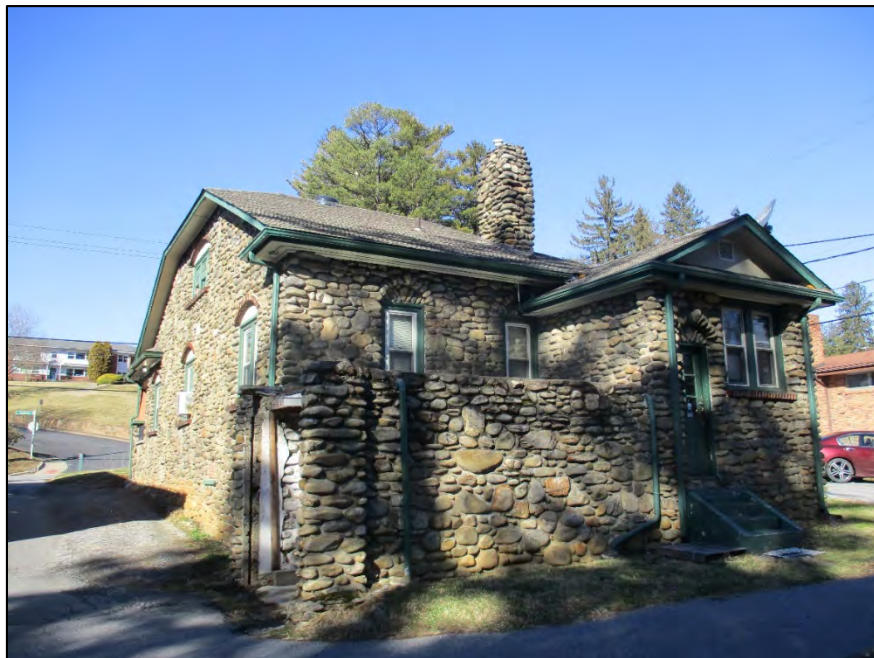
Former Belva L. Saunders House oblique view of east (rear) and south elevations, facing northwest. The garage is in foreground; the Ray Dental Office Building is visible at right.

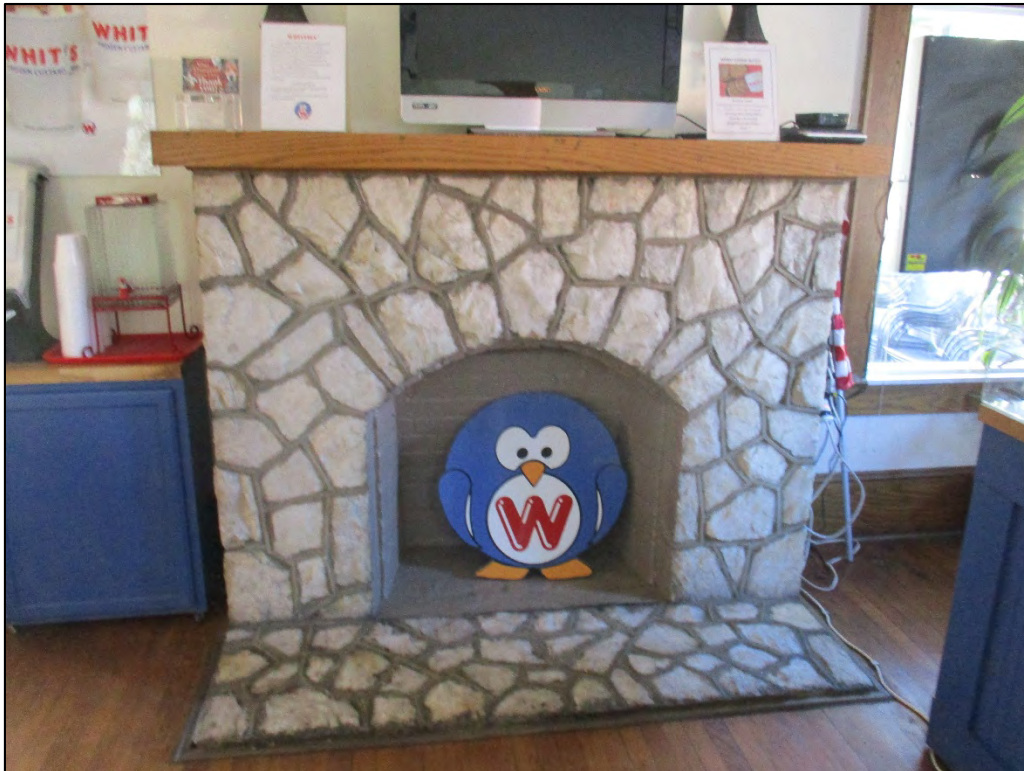
Former Belva L. Saunders House interior detail of fireplace at front of house, facing west

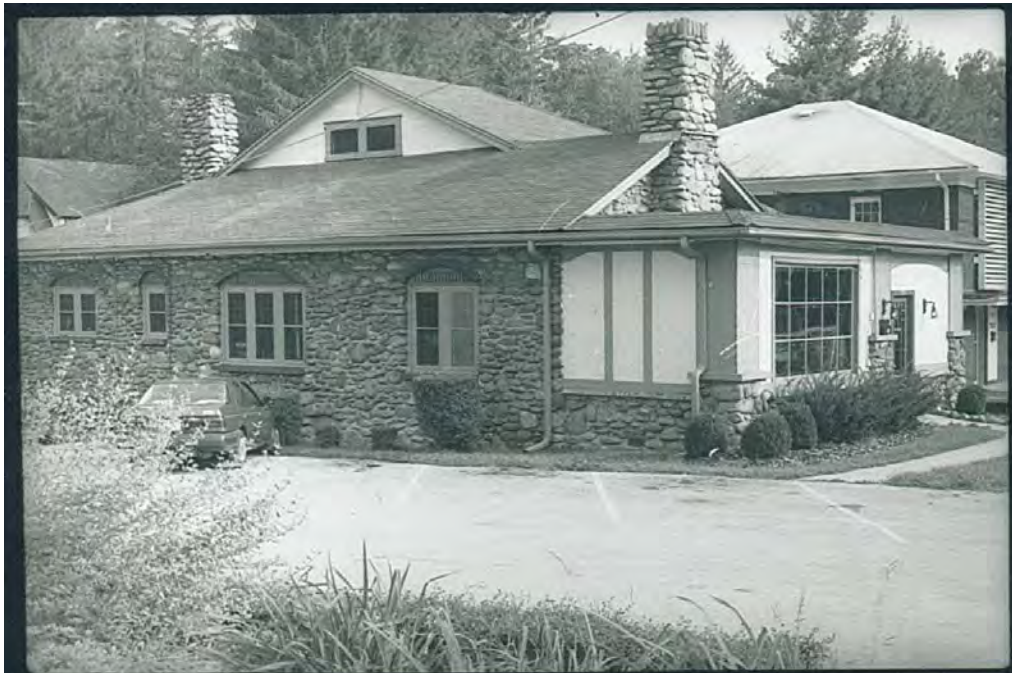
Exhibit 109. The (former) Belva L. Saunders House at the time of the 1989 survey. Note the six-over-one windows in the north elevation. Credit: Mary Hooper, 1989.

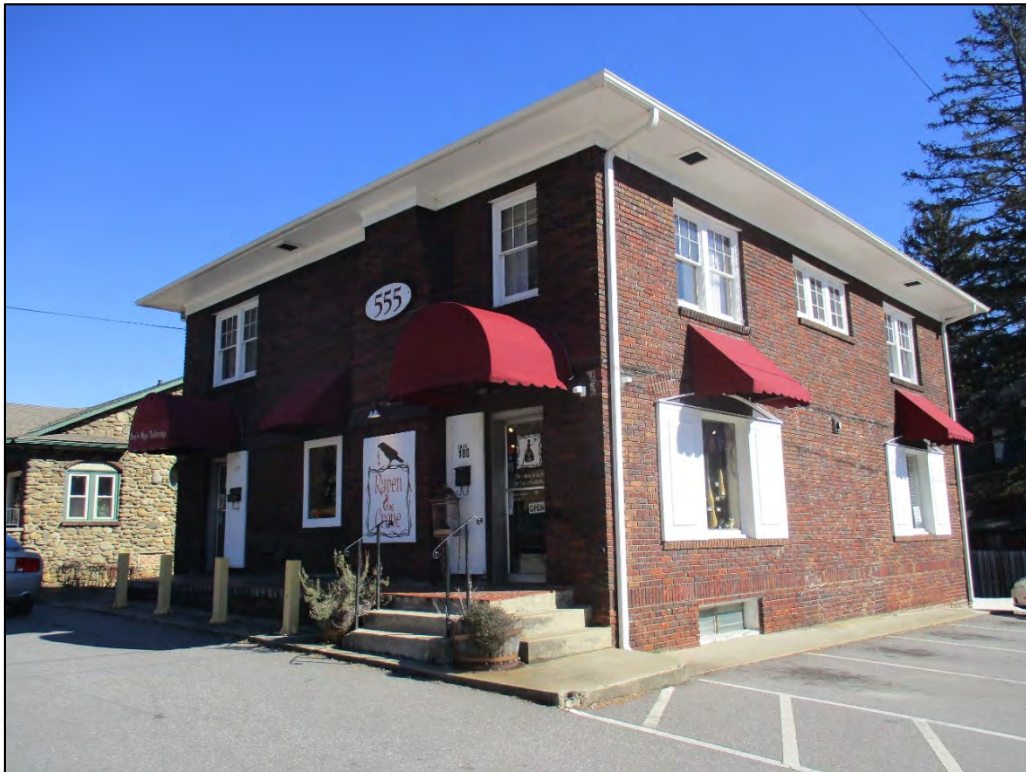
Oblique view of façade and south elevation, view to the northeast

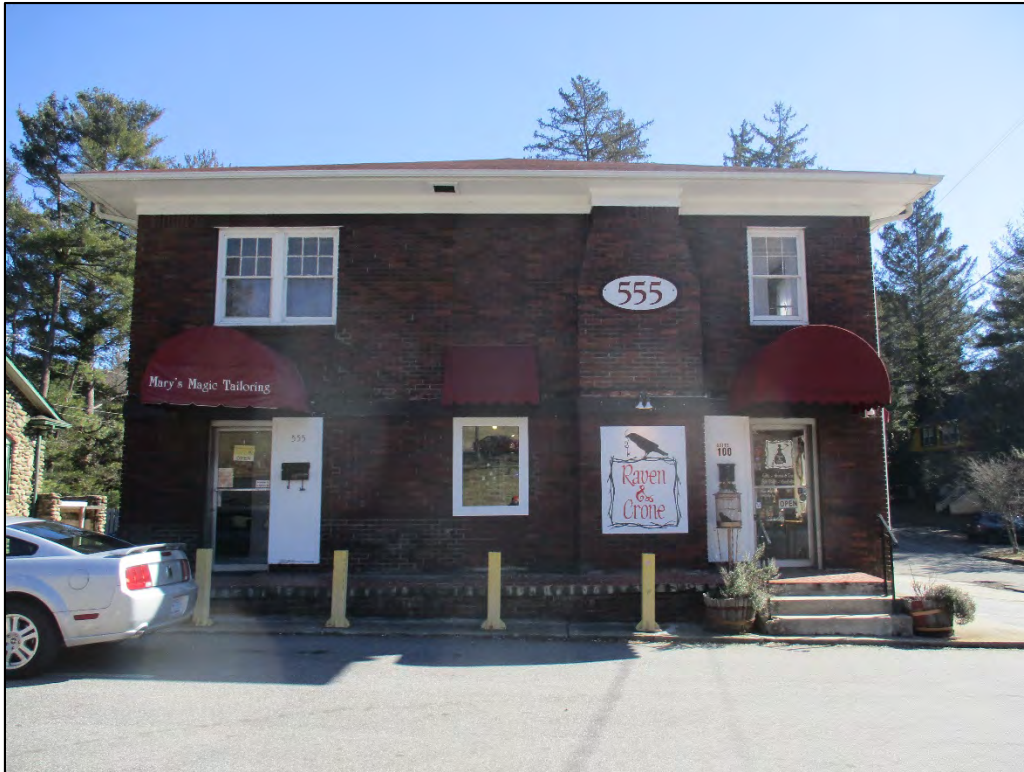
The west-facing façade is asymmetrical with an engaged brick chimney located towards the south extent, adjacent to one of the entries. The chimney is truncated at the roof line. One glass door is located at each side (north and south) of the façade. The door at left (north) leads to a stairway to the second floor; the door at right (south) provides access to the specialty shop. Each entry is covered by an

awning and includes an adjacent wood panel affixed to the brick wall – possibly to post advertisements at some point, but is currently the location of the mailboxes. A horizontal wood element is applied above the entries and continues across the façade. A fixed-pane window is present in the first floor in a wood frame, also covered by an awning. A broken tile, concrete patio traverses the length of the façade and is accessible by concrete stairs at both ends. The second floor includes a pair of six-over-one wood windows and a single six-over-one wood window with slanted brick sills. The low-pitched pyramid roof includes wide overhanging, closed eaves (with plywood), with a wood frieze and crown molding. A brick soldier course defines the top of the second story, below the applied frieze. Gutters surround the building with two downspouts on the north and south elevations.

Present façade, facing east

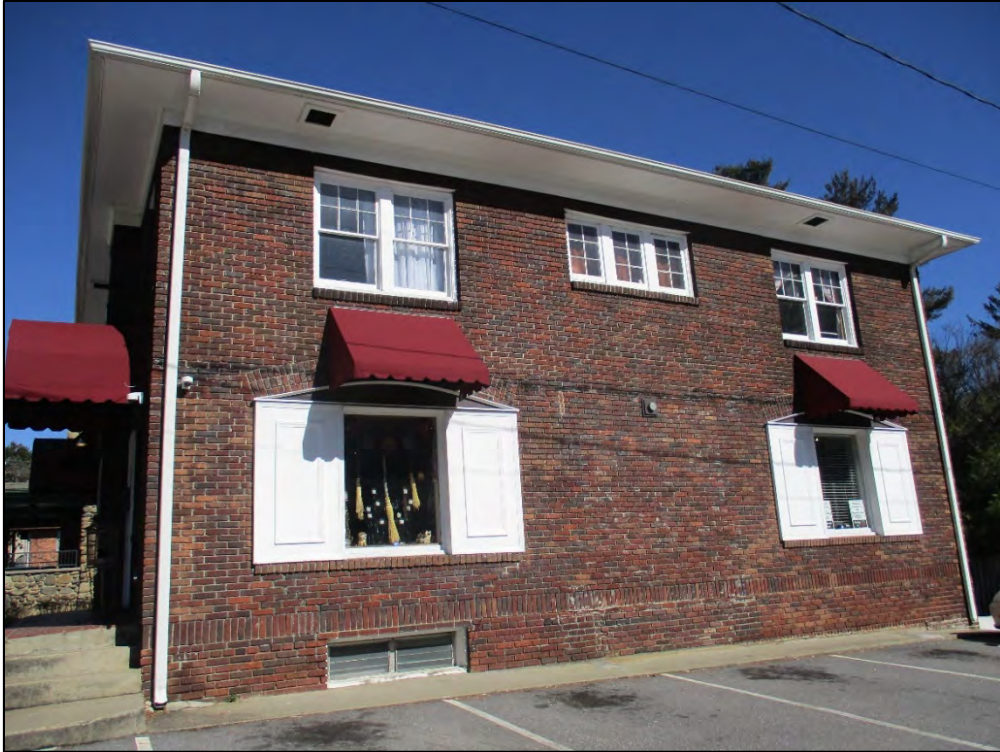
South elevation, facing northeast. Previous survey and current field investigations suggest this elevation originally served as the façade, with a centered entry between the triple windows (see detail below).

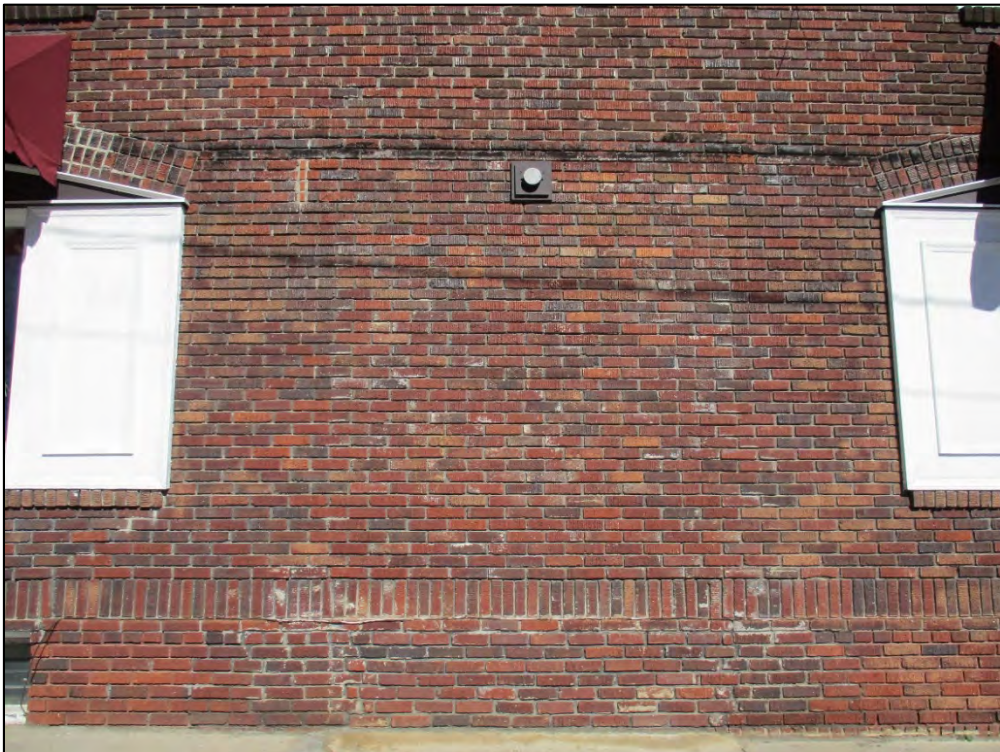
The south elevation fronts Farrwood Avenue. Prior documentation suggests this historically served as the primary entry and formal façade. The basement level is partially exposed along this elevation with a paired louvred window in a wood frame at the west end. A brick soldier course is present above the foundation. Two large composition windows are located in the first floor under segmental brick arches with awnings attached above; however, the windows have been altered. The brick arches correspond to the slanted brick sills, and the arch is filled with wood. A fixed-pane window is located at the center with a wood panel on each side to fill the void. Variations in brick and mortar suggest a third opening was historically located centrally in the first floor, but has since been infilled (possibly a main entry with stair approach). The second floor includes two pairs of six-over-one wood windows and triple wood casement windows between (the casements correspond to a large upstairs bathroom).

South elevation detail, location of suspected historic entry discernible by mortar treatments and tar line

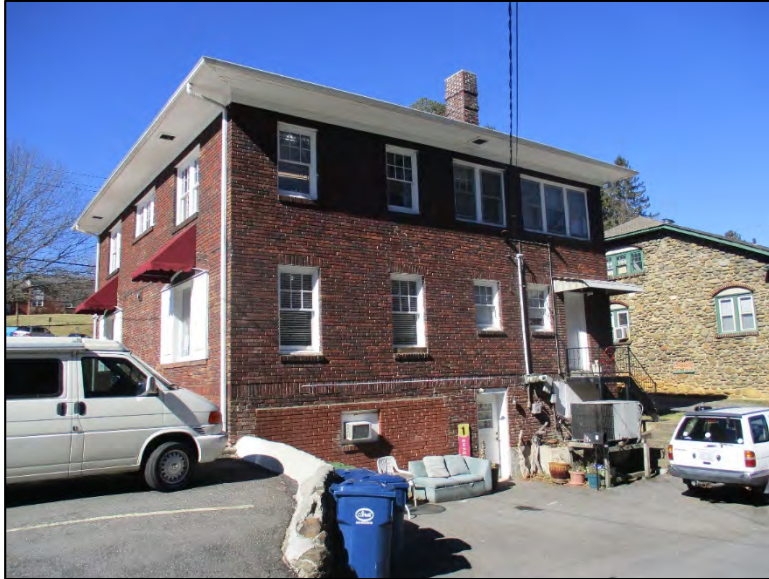
Rear (east) elevation, view to the northwest

The basement is fully exposed on the east elevation. A large void is infilled with brick at the south end, which includes a window air conditioning unit. A wood door with three horizontal lights permits access to the basement. A second void with slanted brick sill is infilled with wood at the north end of the basement under the metal staircase. The windows on this elevation are consistent with the six-over-one wood windows elsewhere on the building, and include single, paired, and triple arrangements. The slanted brick sills are coupled with a soldier brick course above steel lintels. A wood panel door is accessible via half flight concrete stairs and half flight of metal stairs at the north end of the first floor. This entry includes an aluminum awning. The closed eaves retain wood planks (as opposed to plywood) on this elevation.

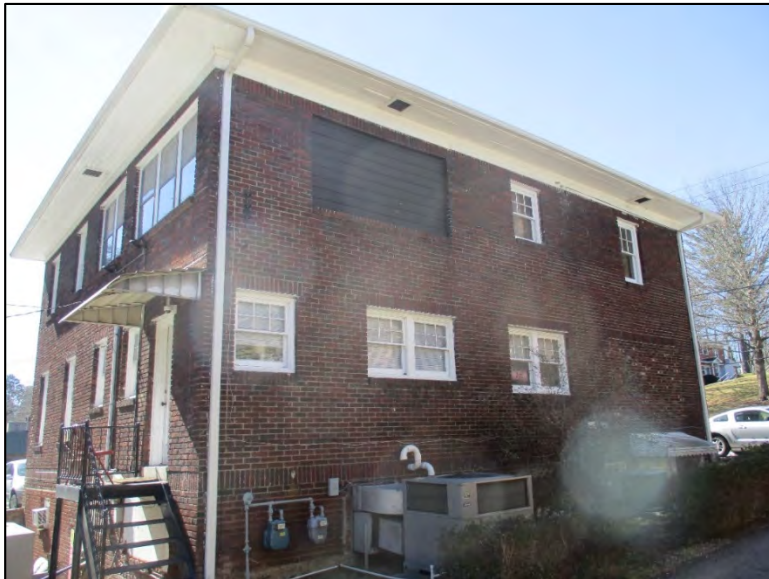
North elevation, view to the southwest

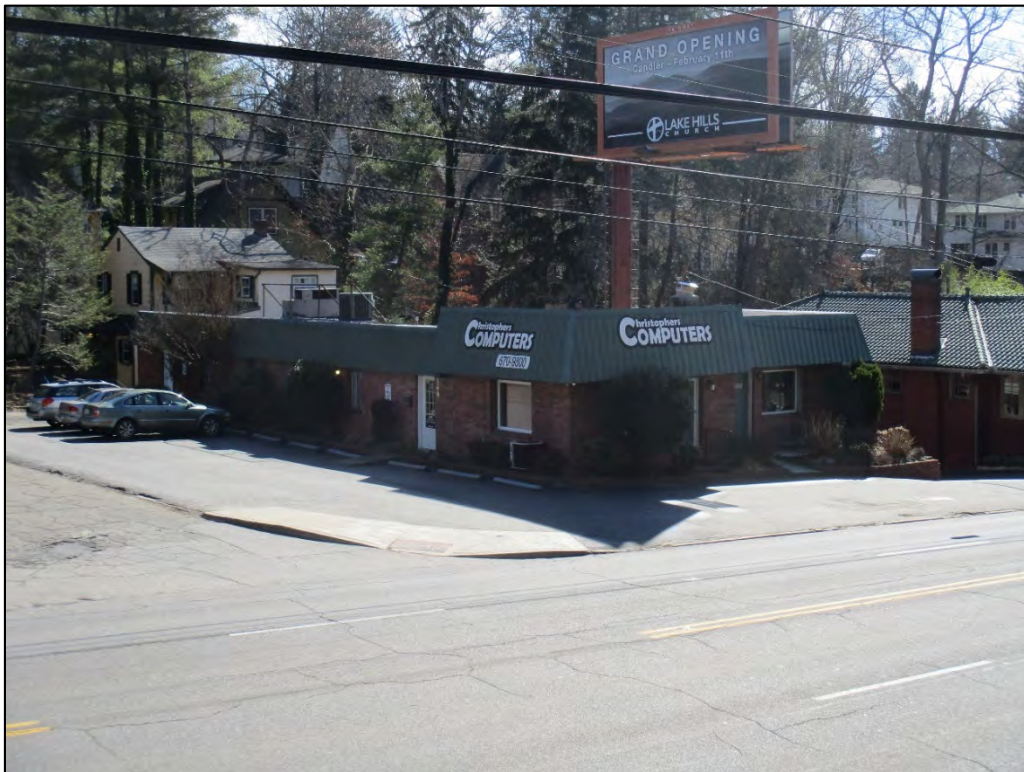
Farrwood Tourist Court oblique view of north and west elevations, looking southeast

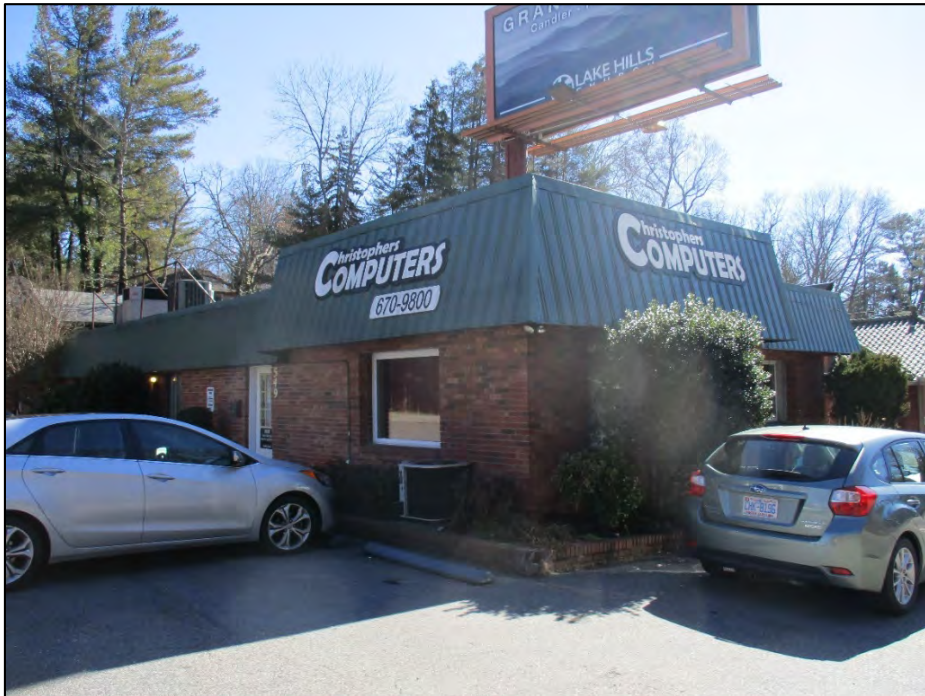
The Farrwood Tourist Court is an L-plan motel with the long axis paralleling Farrwood Avenue. The corner of the building slightly projects from the wall planes, and likely corresponds to the historic motel office. The basement level is accessible via a shared driveway south of the building. The majority of the first floor is currently occupied by Christopher's Computers which has two vinyl replacement doors on

the north elevation. Four aluminum framed sliding windows are present between the replacement doors, and a fixed-pane vinyl window is present at the west extent of the north elevation. An aluminum clad “false” mansard roof (i.e., mansard only on public-facing elevations) is attached to the roof.

Farrwood Tourist Court oblique view of northwest corner – likely motel office – view to the southeast

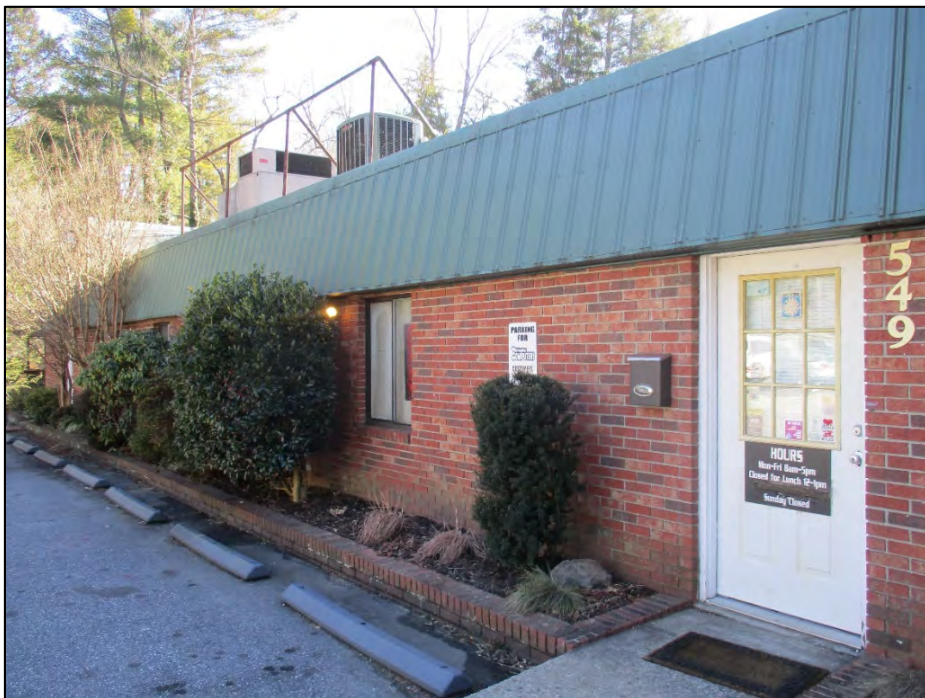
Farrwood Tourist Court portion of the north elevation, view to the southeast
