November 9, 2018

MEMORANDUM

SUBJECT: Historic Structures Survey Report, Merrimon Avenue & WT Weaver Boulevard Intersection Improvements. U-5781, U-5782, PA 17-04-0023, Buncombe County, ER 18-0102

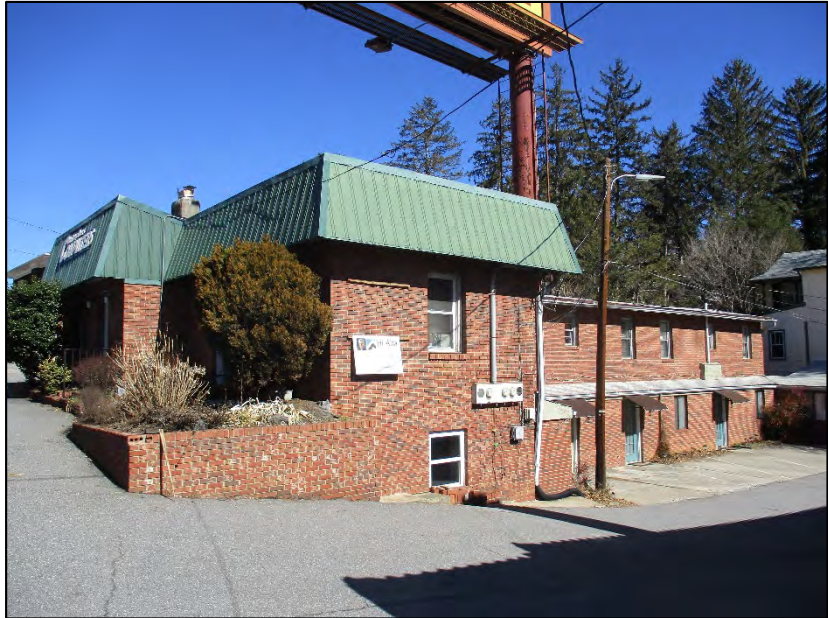
The west elevation includes two replacement vinyl doors accessed by brick stairs and two fixed-pane vinyl windows on the short axis of the L plan. One door and window is located in the slightly projecting mass at the corner of the building (likely historic office) and one door and window to the south. An interior brick chimney is located near the inside corner of the likely historic office. The door at the south end of the elevation permits entrance to a single-chair salon (549 Salon). The owner of the salon has rented this space for 17 years.

The terrain slopes to the south and east, exposing the basement along the south elevation. A narrow, brick clad lean-to addition is attached to the basement level with shingle roof, gutter and downspouts. The lean-to addition includes aluminum sliding windows and replacement vinyl doors with canvas awnings. The first floor includes a couple vinyl replacement windows, as well as multiple historic four-light wood windows with slanted brick sills and steel lintels. The roof eave is boxed and vented. Gutters and downspouts are attached.

Farrwood Tourist Court oblique view of west and south elevations, view to the northeast

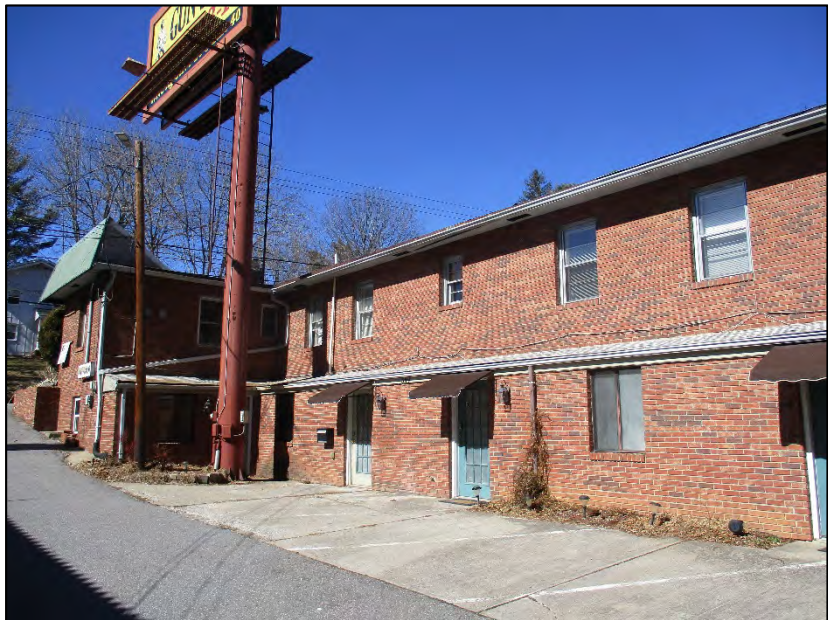
Farrwood Tourist Court south elevation, view to the northwest

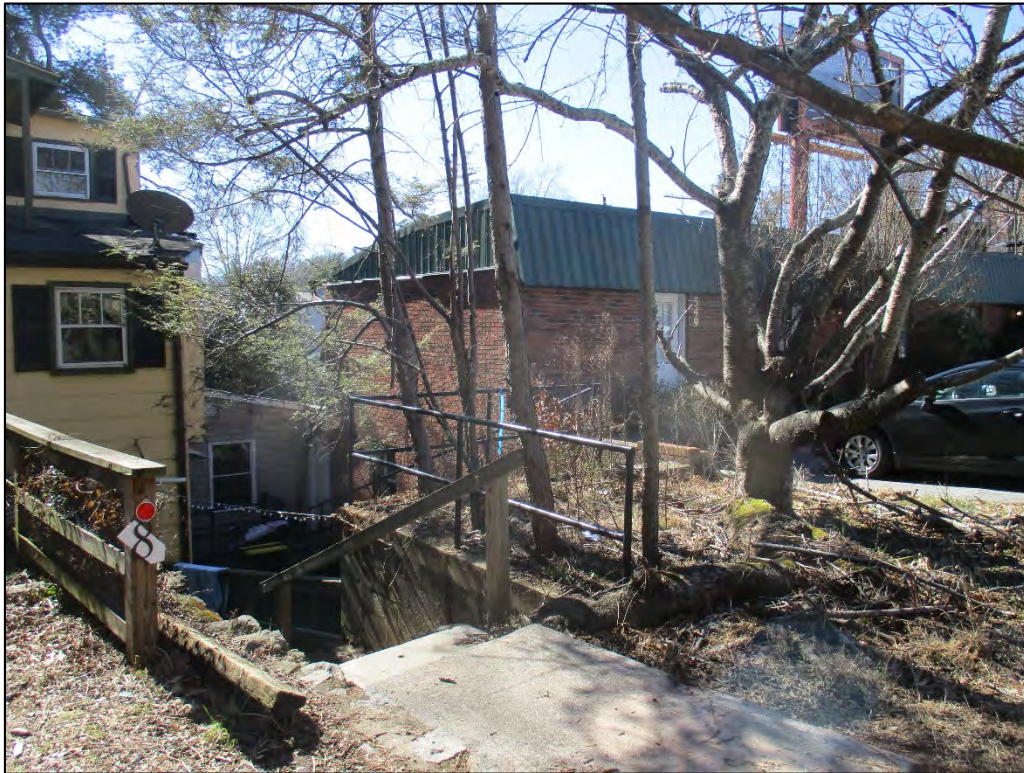
Farrwood Tourist Court view towards the east elevation from 4½ Farrwood Avenue, looking to the southwest. The resource’s east elevation bounds a creek. The one-story vinyl shed roof structure that spans the creek is visible. Also, note the resource’s roof profile.

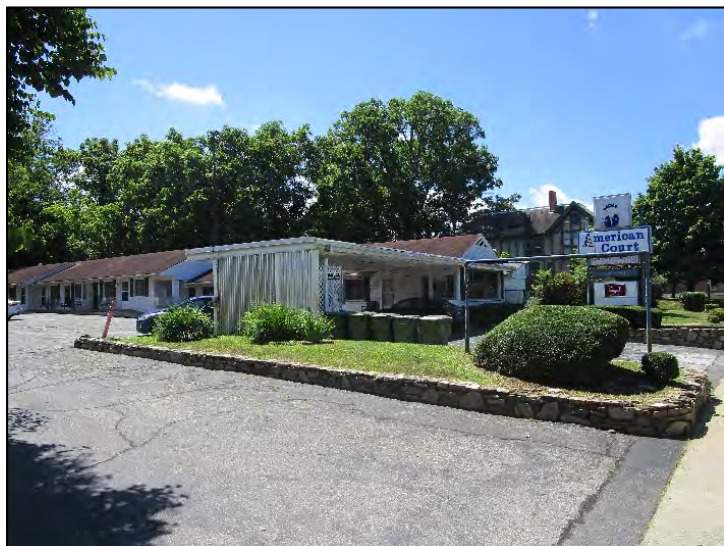
Exhibit 114. Former Rhododendron Court (BN5704) (1953), 85 Merrimon Avenue; currently in use as apartments

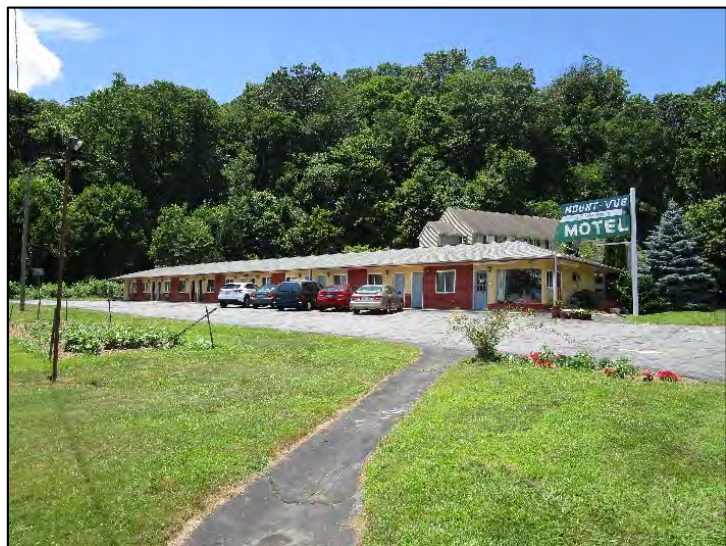
Completed in 1956, the 11-unit Mount-Vue Motel at 15 Tunnel Road features a low-pitched hipped-roof on a single linear building (Exhibit 115). Wide, closed eaves cover entries and painted random broken coursed ashlar alternates with smooth stuccoed surfaces that accentuate individual units. The corner office features a large picture window with two wrought iron columns supporting the northern roof overhang, borrowing from contemporary residential architecture. A neon sign is located adjacent to the office, a common feature to motels from the postwar era. The Mount-Vue Motel is in overall good condition and, despite some material updates represents a good example of the building type from its period of construction.

Exhibit 115. Mount-Vue Motel (1956), 15 Tunnel Road

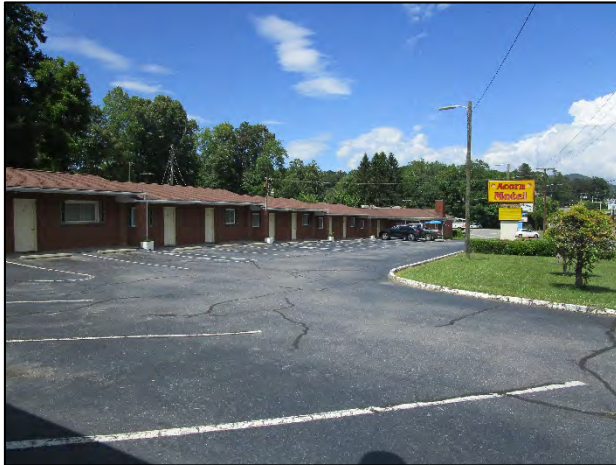
Two neighboring motels on US 70 (W. State Street) just west of Black Mountain employ more stripped-down, utilitarian design. The Acorn Motel was completed in 1950 at 600 W. State Street and consists of a long and low side-gabled, brick clad building in a modified U-plan (Exhibit 116). The linear plan consists of two-unit modules, each sharing party walls, that step up with the terrain and wide; closed eaves

cover individual room entries. The office is located in the diminutive, hipped-roof west leg of the U-plan. The Acorn Motel is stark in its appearance, consisting of a uniform brick-cladding with no embellishment. Some material updates, in the fixed-pane windows and flush wood doors, compromise the materials integrity of the motel; however, the Acorn Motel remains in its original use and maintains its form and design.

Exhibit 116. Acorn Motel (1950), 600 W. State Street, Black Mountain

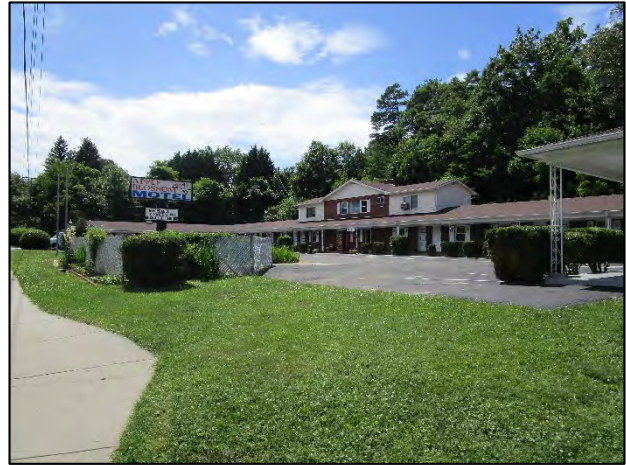
Exhibit 117. Apple Blossom Motel (1958), 602 W. State Street, Black Mountain

At 602 W. State Street stands the brick clad Apple Blossom Motel, constructed in 1958. It is a transitional court motel including both single-story and two-story massings in a U-plan (Exhibit 117). At the center of the building is the two-story, cross-gable massing clad in brick veneer and vinyl siding. The one-story U-plan consists of the string of individual rooms, each featuring an original three horizontal raised panels door and one-over-one windows with false shutters, and covered by the low-pitched side-gable roof which is supported by wrought iron columns. Though considerably larger than the Farrwood Motor Court, the Apple Blossom Motel retains several original materials, notable the doors and wrought iron columns. Further, its continued use as a motel strengthens its association with mid-twentieth-century roadside motels.

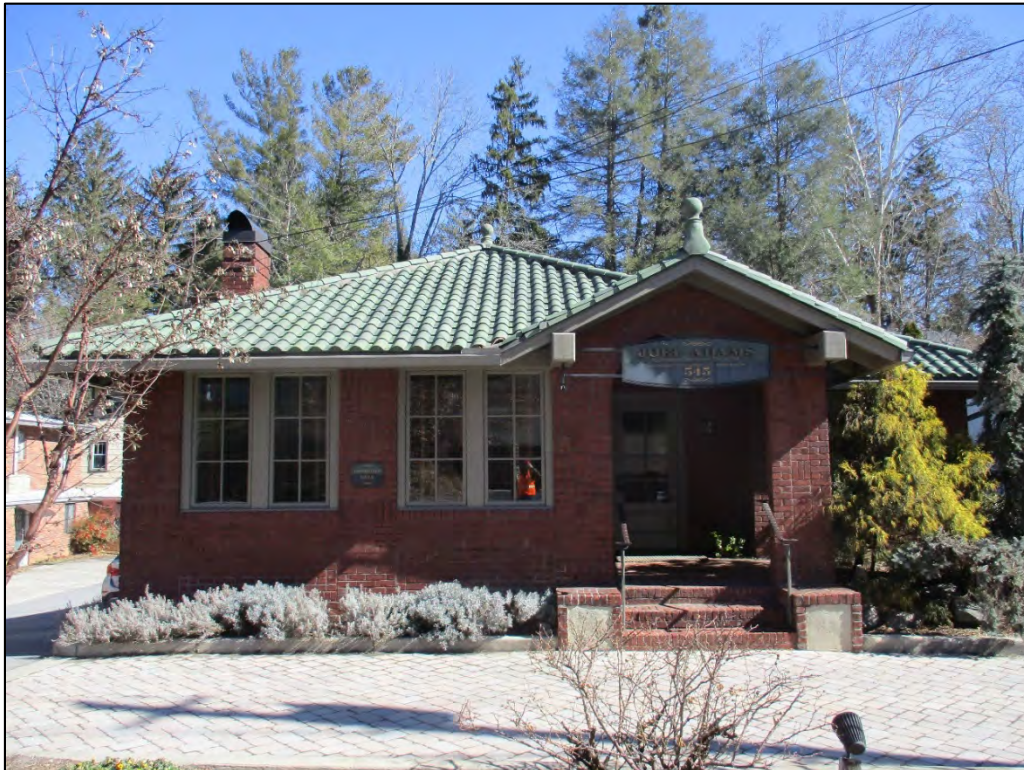
Chester W. Israel House façade, facing east

The west-facing façade features an integrated porch under a front gable. The porch entry is via three brick stairs with replacement cast iron railings and through a brick arch supported by two full-height

brick columns. The porch roof is supported by exposed beams that project slightly beyond the roof plane. The porch ceiling is bead board and rafter tails are exposed. The integrated porch floor is tiled and includes the wood framed eight-light wood panel door on a tiled threshold with a soldier brick course above. To the right (south) of the main entry is a replacement double French door which, according to previous documentation, accessed a tiled terrace¹³⁷; however, this area is currently landscaped.

The Chester W. Israel House is not individually eligible for the NR under Criterion C. The apparent alteration of the front porch from an open frame porch to the current brick clad, partially enclosed porch contributes to the resource's loss of design, material, and workmanship integrity. The origin of the decorative pattern brickwork in the porch is of unknown vintage. Though several aspects of the ca. 2002 renovation were completed sensitively with compatible replacement materials, particularly with the wood six-over-one windows, the overall effect is detrimental to the material integrity of the house. Though a rare example of the hipped roof variation, it is not the only example in Asheville, and the extent of the material and design changes prevent the Chester W. Israel House from representing a good example of the type and style. For these reasons, the resource appears to not be significant under Criterion C for its architecture.

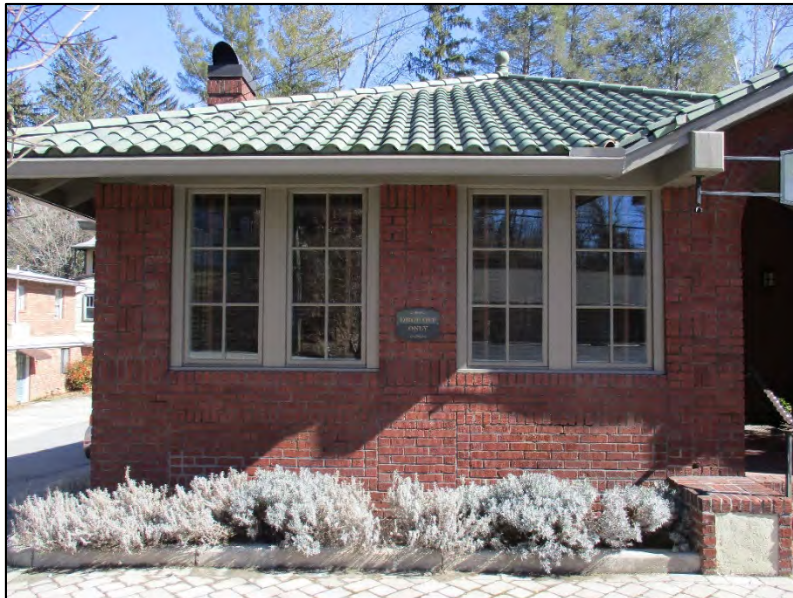
Chester W. Israel House façade enclosed porch detail, view to the east

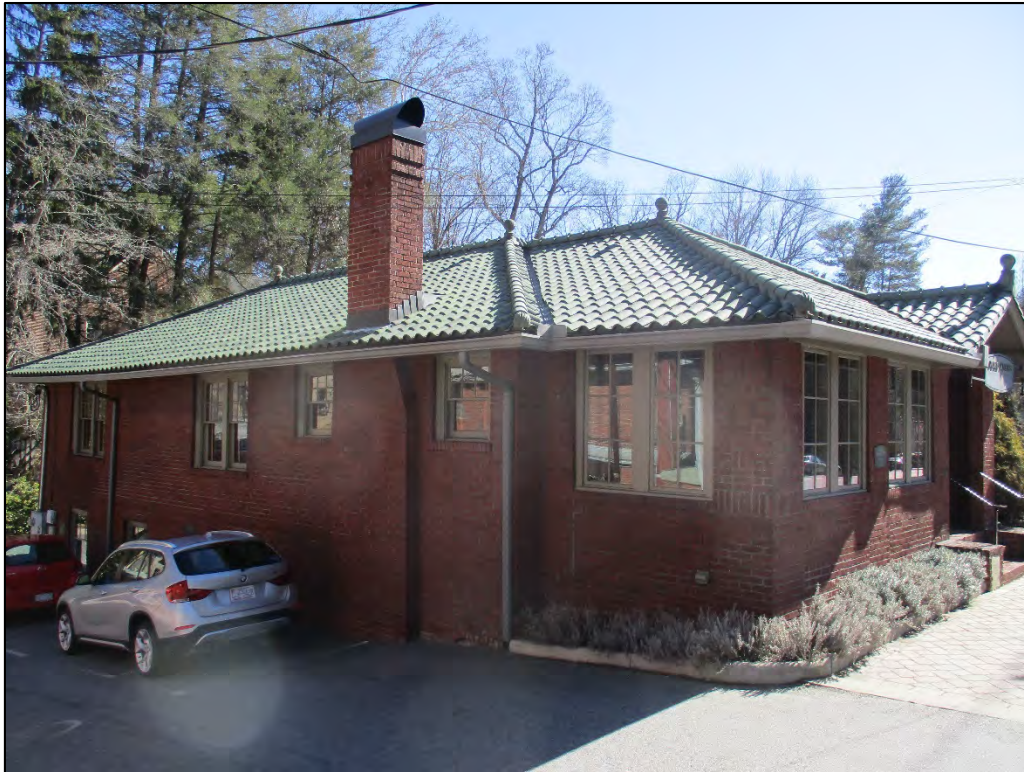
The terrain slopes to the east, gradually exposing the basement level towards the rear of the house. The basement level is delineated with a soldier course. Replacement wood windows on this elevation are six-over-one and include single and double windows. First story windows terminate at a soldier brick course under the roof line. Three windows are exposed in the basement level; the basement windows terminate at the top of the soldier brick course that delineates the extent of the foundation. The windows are wood framed and have a header course brick sills. A single shouldered, engaged brick chimney is present towards the front (west) of the home and features corbelling at its crest. The overhanging eaves are open, exposing roof sheathing. A fascia is attached to the end of the rafters and supports a gutter and downspouts.

Chester W. Israel House north elevation, view to the southeast

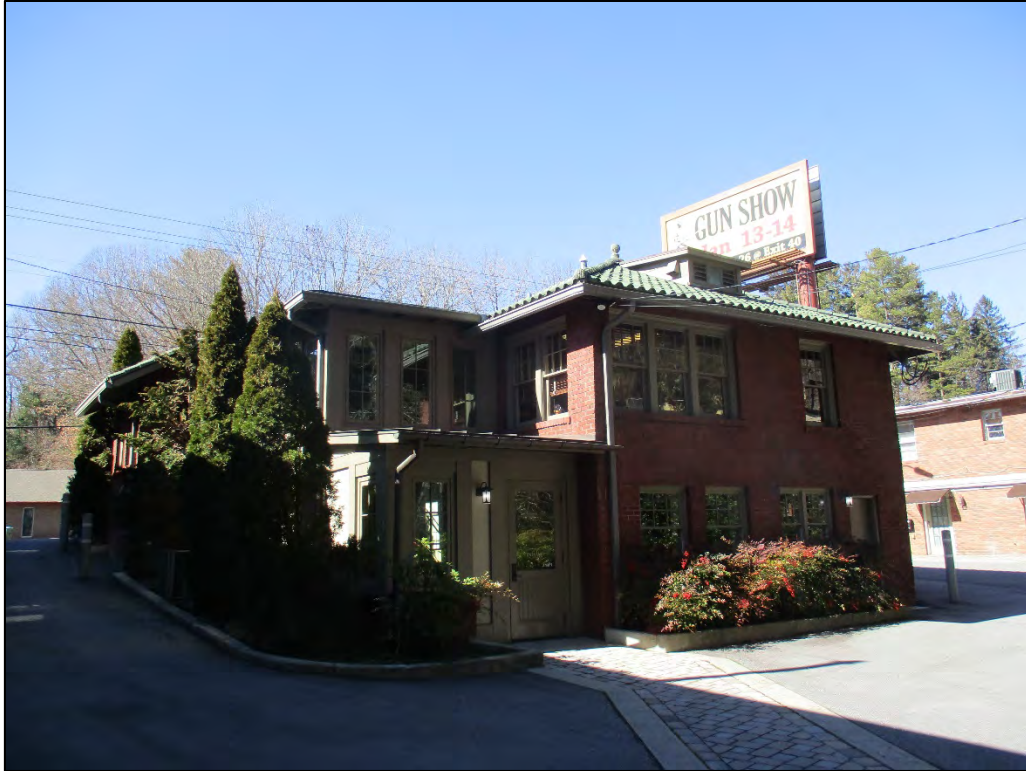
Chester W. Israel House rear (east) elevation, view to the northwest. Note non-historic addition in southeast corner of the house.

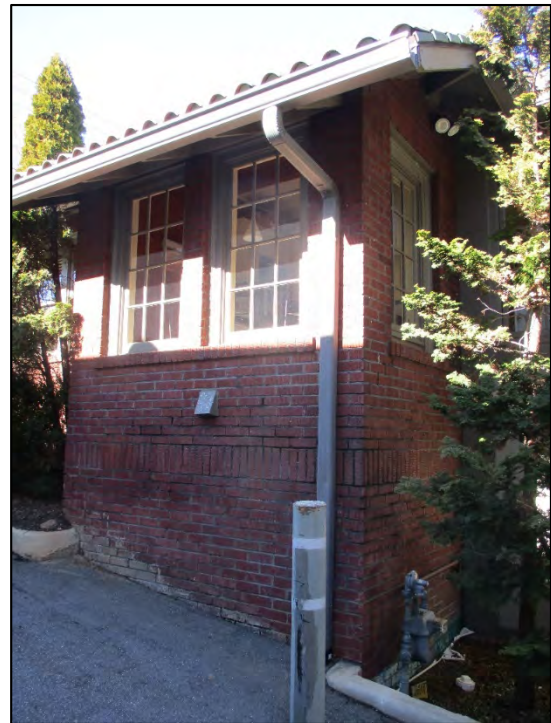
The south elevation includes a wing projection under a shed roof, also with overhanging, open eaves. The projection features three twelve-light fixed windows, two in the south elevation and one in the east. A concrete curb circles the house on the façade, and rear and south elevations which enclose foundation plantings. A stone block driveway traverses the façade with a landscaped island between the drive and the back of the concrete sidewalk. The house is setback from Merrimon Avenue by about 25 feet. A shared asphalt drive traverses the north elevation, with parallel parking spots along the elevation. The rear of the building has additional parking, and another asphalt drive traverses the south elevation.

Chester W. Israel House south elevation shed wing detail, view to northwest

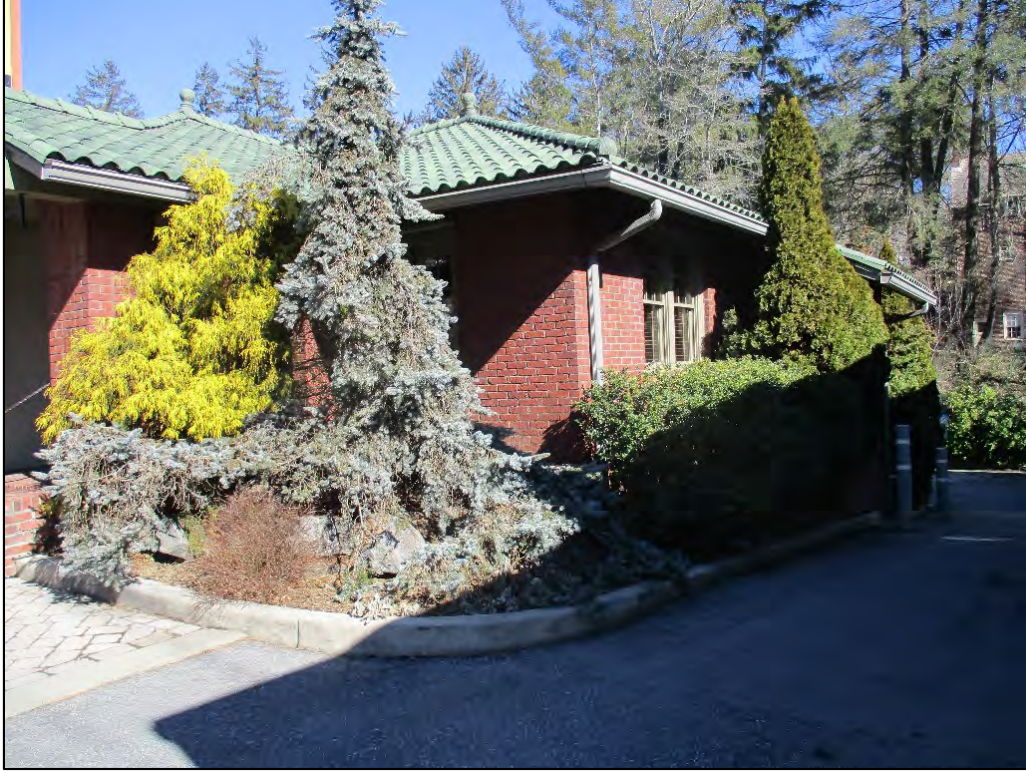
Chester W. Israel House south elevation, view to northeast

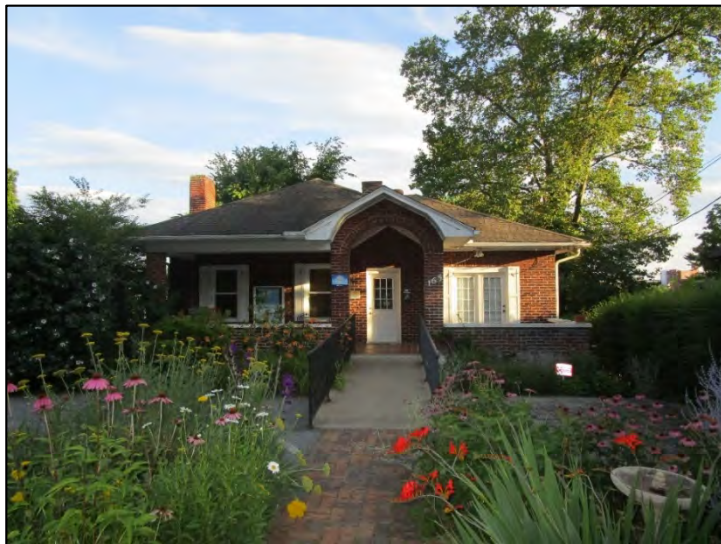
Exhibit 119. House (BN4330) (1924), 165 Chestnut Street in the Chestnut Hill Historic District

Windshield survey identified a nearly identical hipped-roof, brick veneer example at 165 Chestnut Street (BN4330) in the Chestnut Hill Historic District (BN0140), constructed in 1924 (Exhibit 119). Though the massing is slightly different – a wing extension on a secondary elevation was not observed – the asymmetrical façade closely resembles the Chester W. Israel House and may more closely represent its historic configuration. An off-center, slightly projecting gable entry with brick archway is flanked by an open porch at left and a patio, enclosed by a brick skirt wall with concrete cap, accessible via French doors to the right. A concrete ramp with railing approaches the entry and wing walls are not present. Despite suspected window

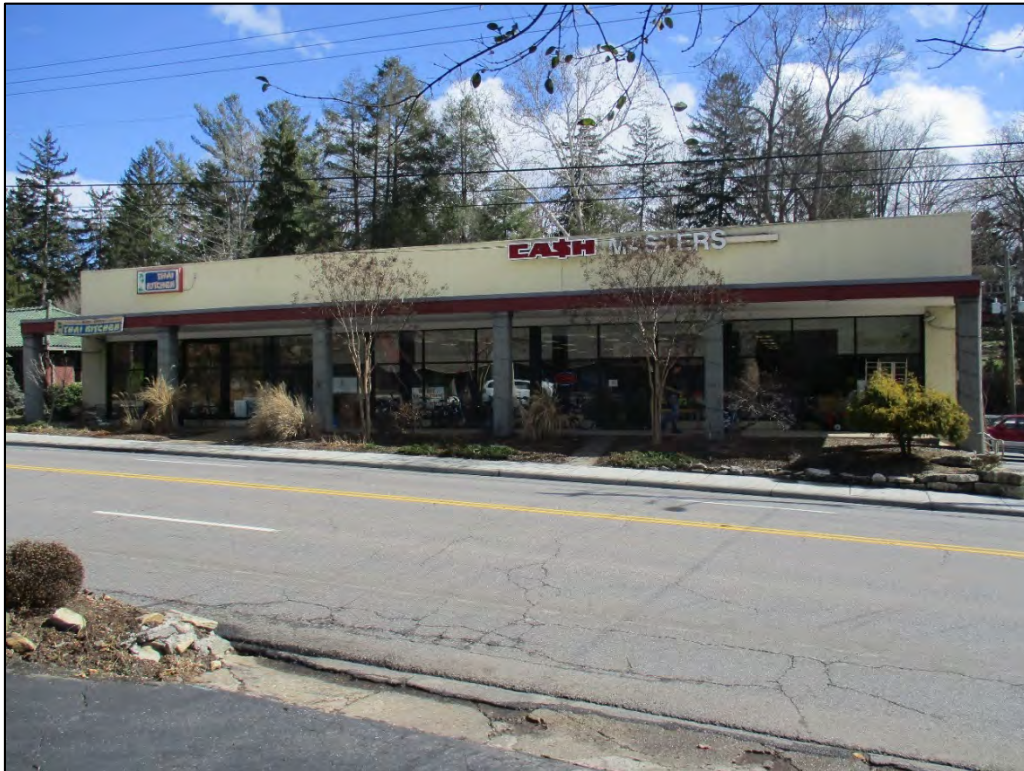
Former Morrison’s Furniture Store façade, view to northeast

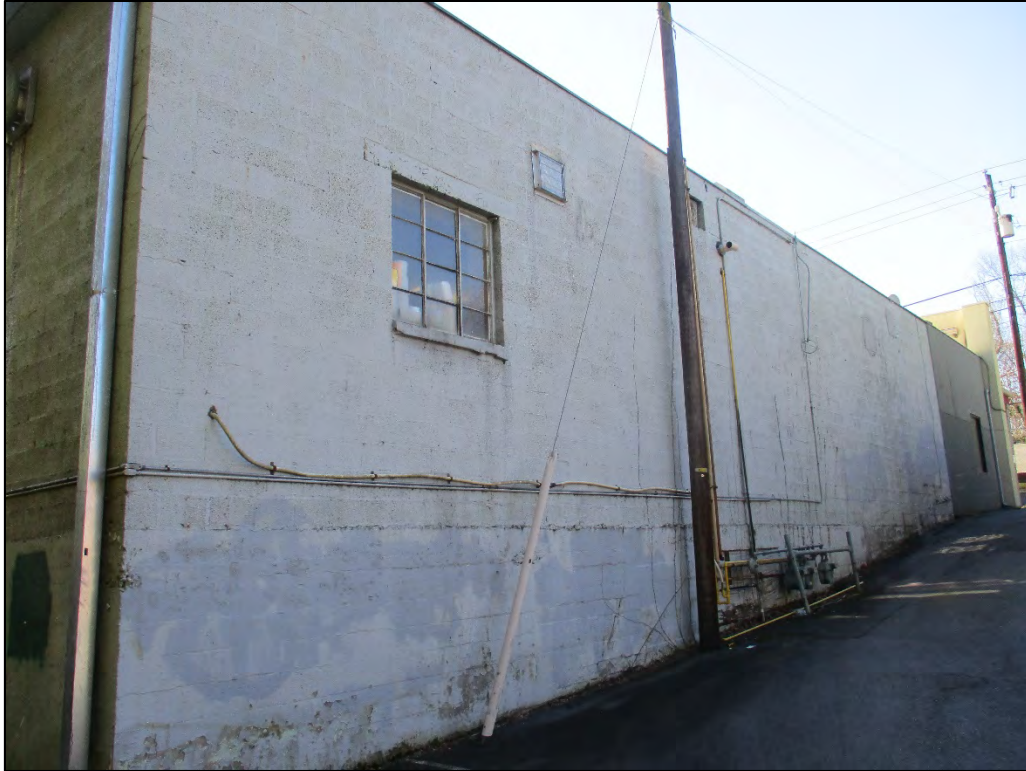
A fixed-pane aluminum framed window is present in the north and south elevation near the façade. The concrete block construction is exposed on the north elevation, while the south elevation is clad in stucco panels. At the rear (east) of the north elevation is a historic steel casement window with concrete sill and lintel. The rear elevation is exposed concrete block with a metal security door accessing the basement level at the north end of the building basement. Plywood infills a window opening north of the basement door. Steel casement windows are regularly placed along the first floor of the east elevation. A large, concrete block lean-to addition on a concrete foundation extends roughly three-quarters of the rear elevation, terminating at a parapet wall on the south elevation. The addition has a wood framed shed roof with exposed rafters and plank sheathing. Steel casement windows are symmetrically placed at the top of the walls along the rear (east) of the lean-to addition.

Former Morrison's Furniture Store north elevation, view to southwest

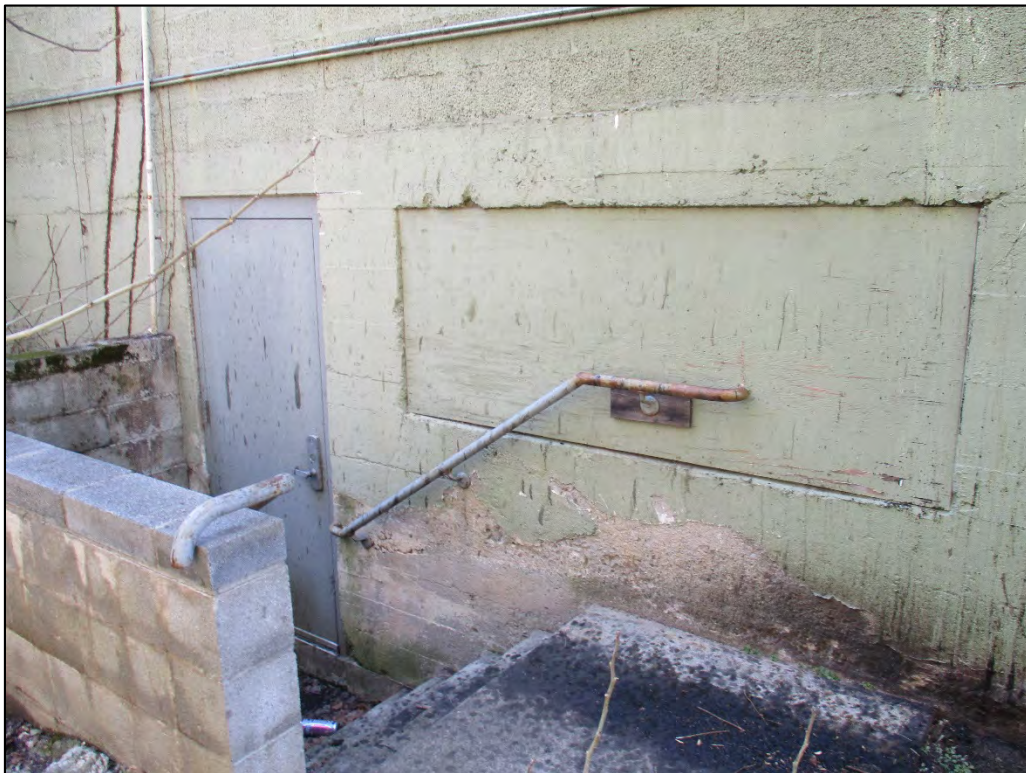
Former Morrison's Furniture Store rear (east) elevation basement door detail, located in the north side of, looking southwest

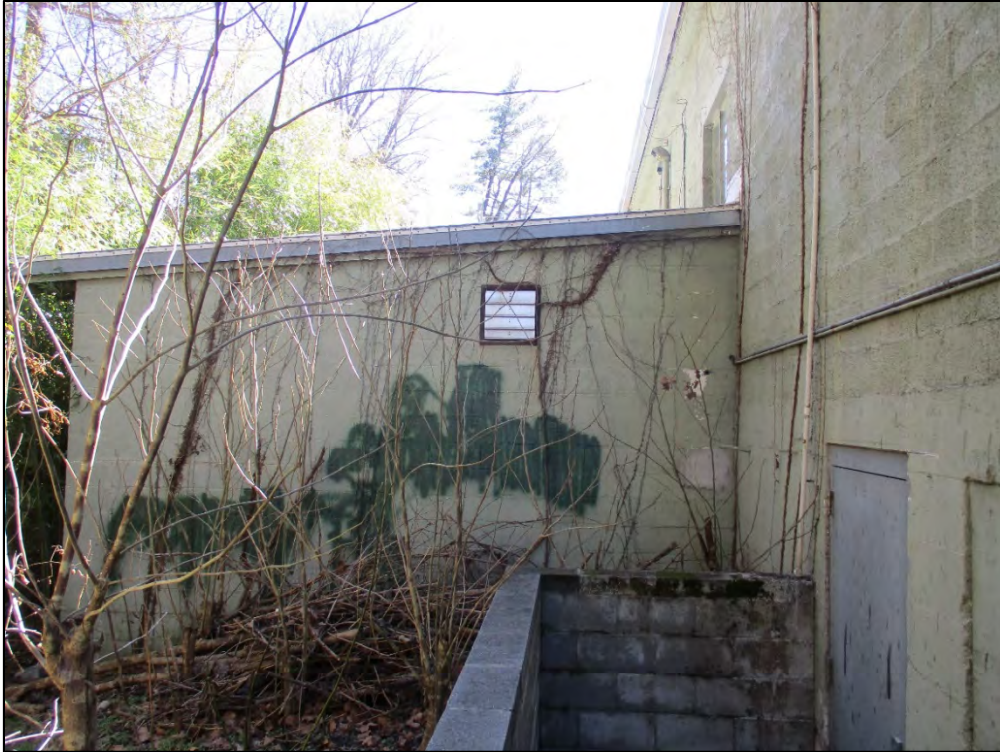
Former Morrison's Furniture Store rear (east) elevation and historic lean-to addition, view to south. Dense bamboo and proximity to the creek along this elevation constrained photography.

The Buncombe County Property Card attributes a 1957/1958 date to the rear lean-to addition, canopy, and basement level (Exhibit 120). Other research avenues do not dispute these dates. The materials observed in the rear lean-to addition (e.g., concrete block, steel casement windows, exposed rafters and roof sheathing) roughly agree with this date.

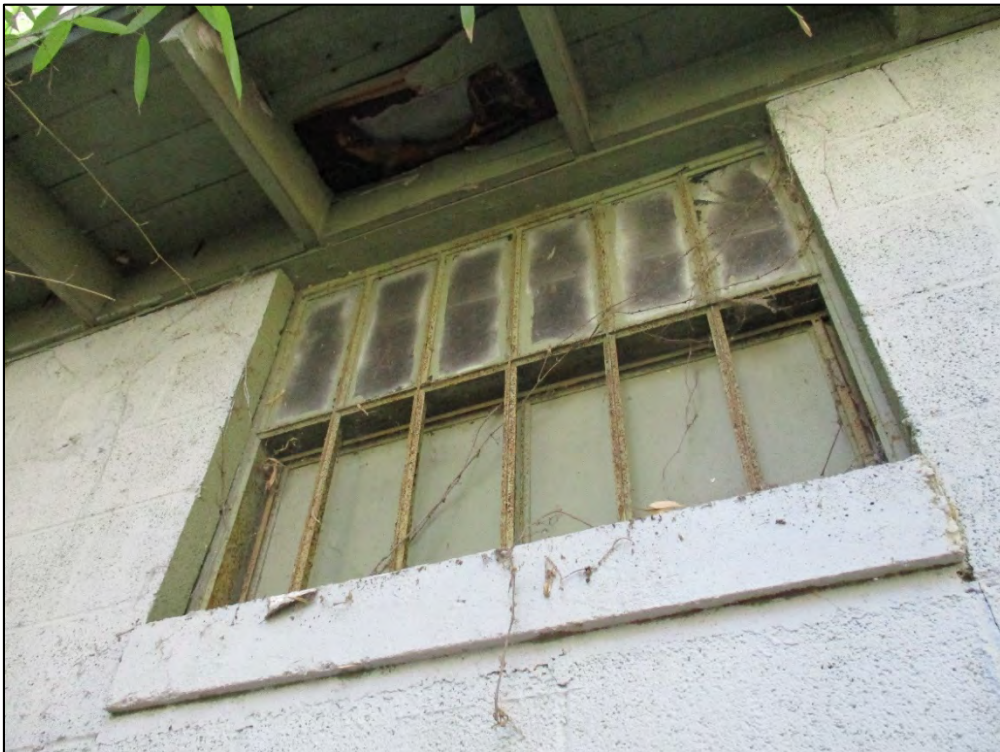
Former Morrison's Furniture Store rear (east) elevation detail of steel casement windows in the rear lean-to addition

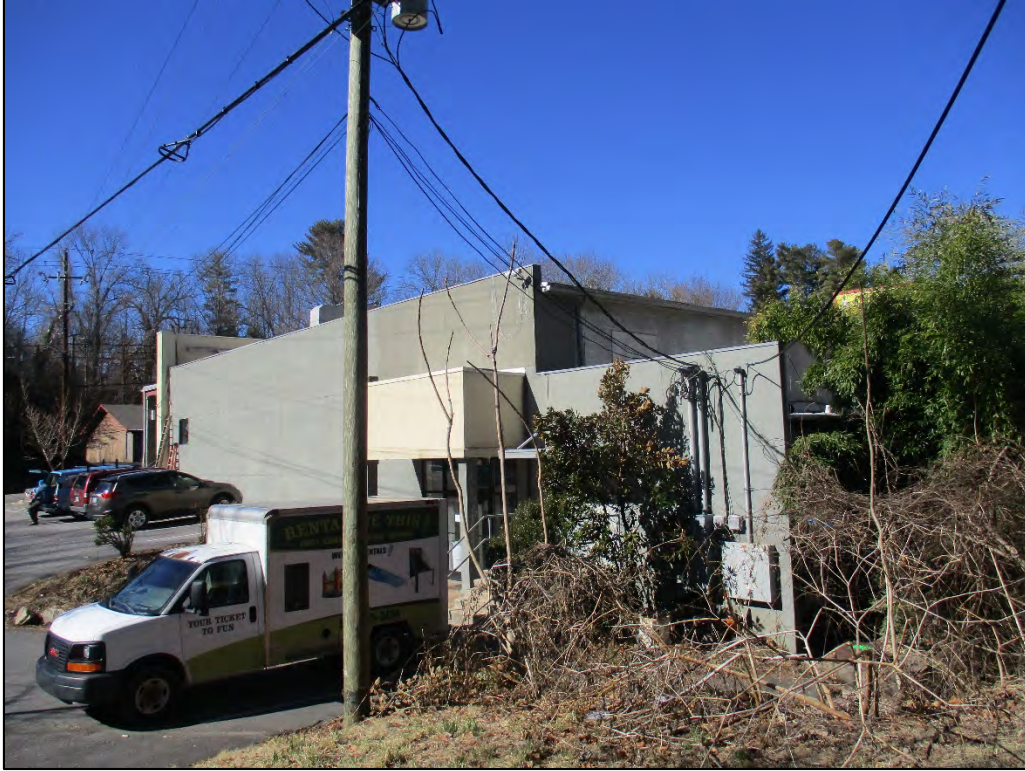
The south elevation includes a second entry at the east extent of the elevation. The double glass doors are flanked by fixed pane display windows with transoms above. The secondary entry is covered with a flat roof extension supported by two columns, clad in stucco. A wide concrete stairwell with metal pipe railing accesses a metal security door leading into the rear lean-to addition.

Former Morrison's Furniture Store south elevation, view to northwest

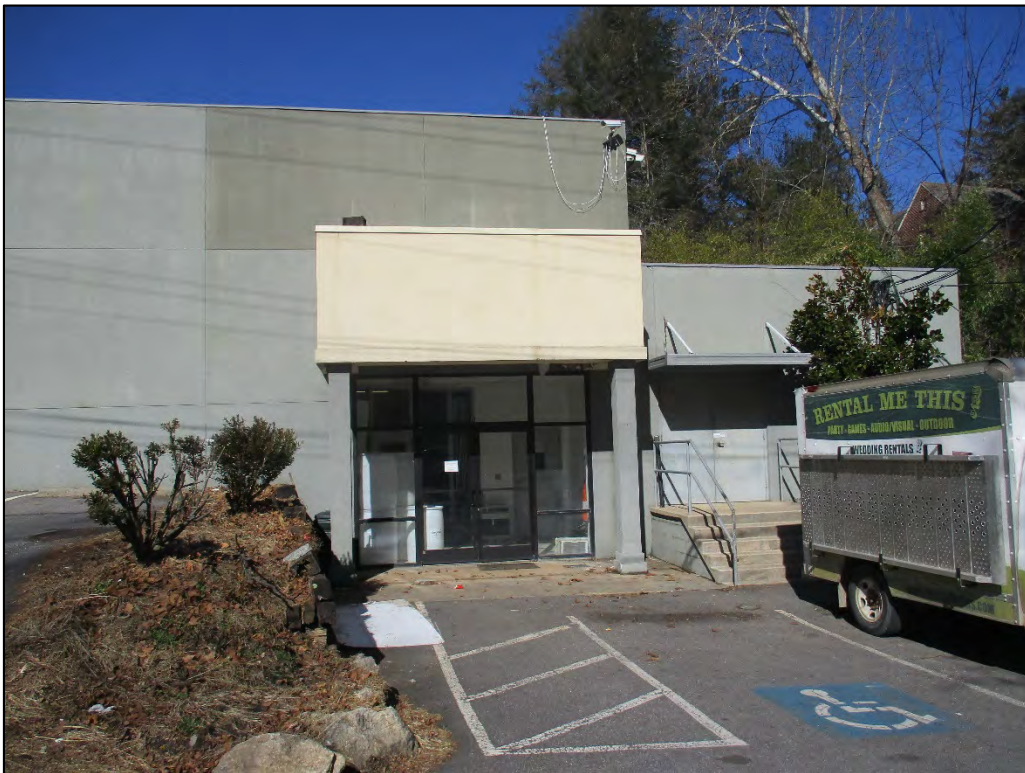
Former Morrison's Furniture Store south elevation secondary entrance detail, located in rear (east) of building, view to the north

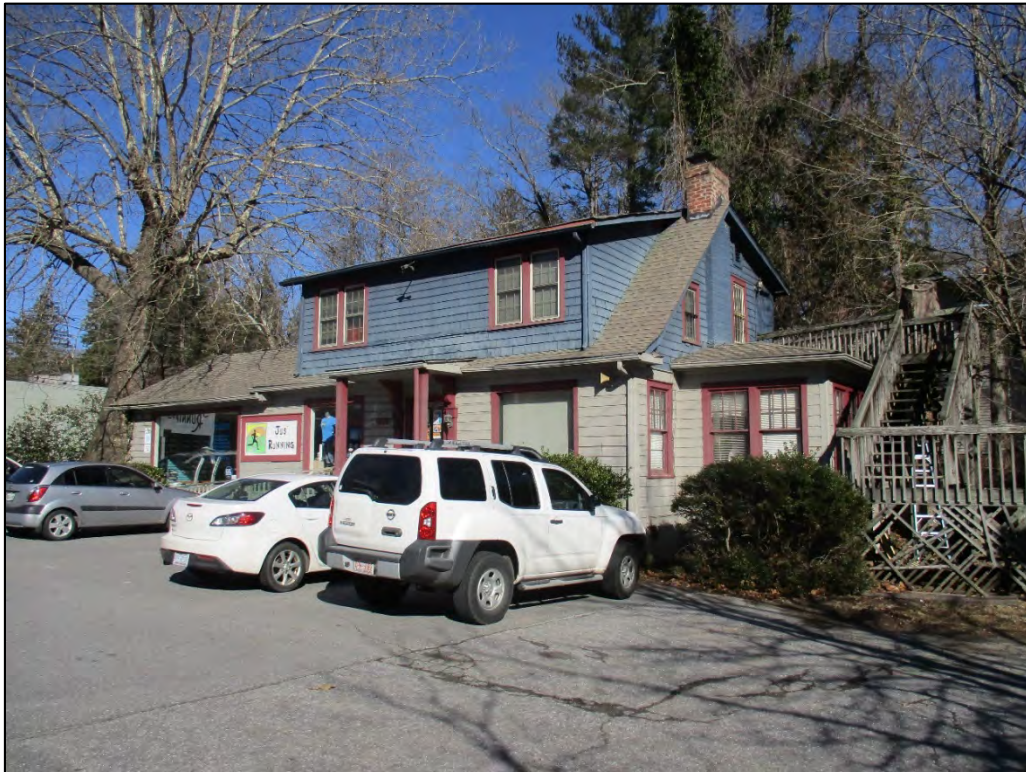
Façade, view to northeast

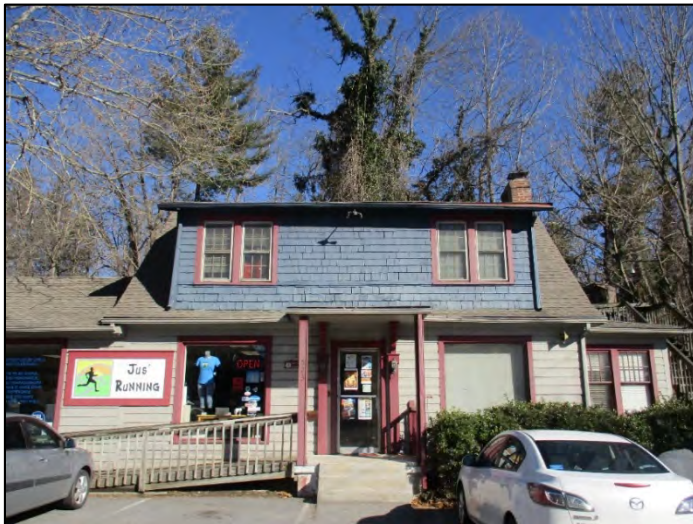
Several historic, wood-framed, single-pane six-over-one wood sash windows on wood sills remain in the house occurring as single and double units. A ribbon of four historic wood windows is present in the south elevation of the (original) diminutive hipped wing attached to the south elevation of the house. A single two-light wood awning window was observed on the east elevation. Renovations for conversion of the second story to a separate upstairs apartment included the replacement of windows with vinyl sashes, in addition to the previously mentioned vinyl door and wood deck structure. Windows in the original house have also been replaced on the first floor of the façade with large fixed-pane display windows. A wood ADA ramp provides access to the replacement glass door on the façade. The porch is concrete.

Façade, focused on the of the original house mass, view to east

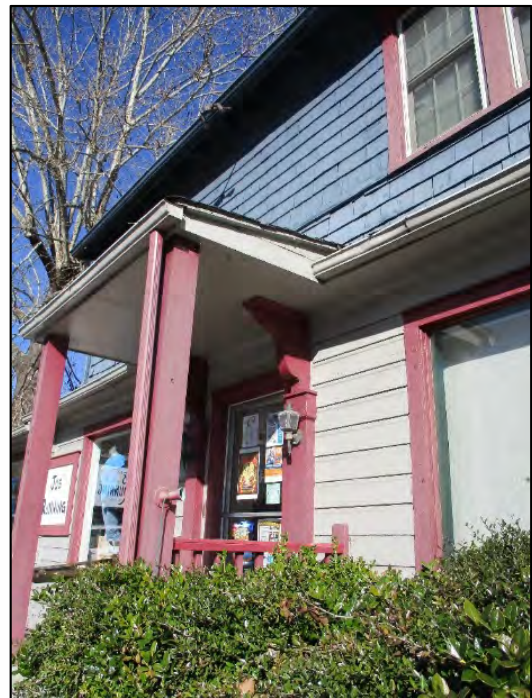
**Façade shed portico detail, view to northeast.
Note the pilasters and brackets.**

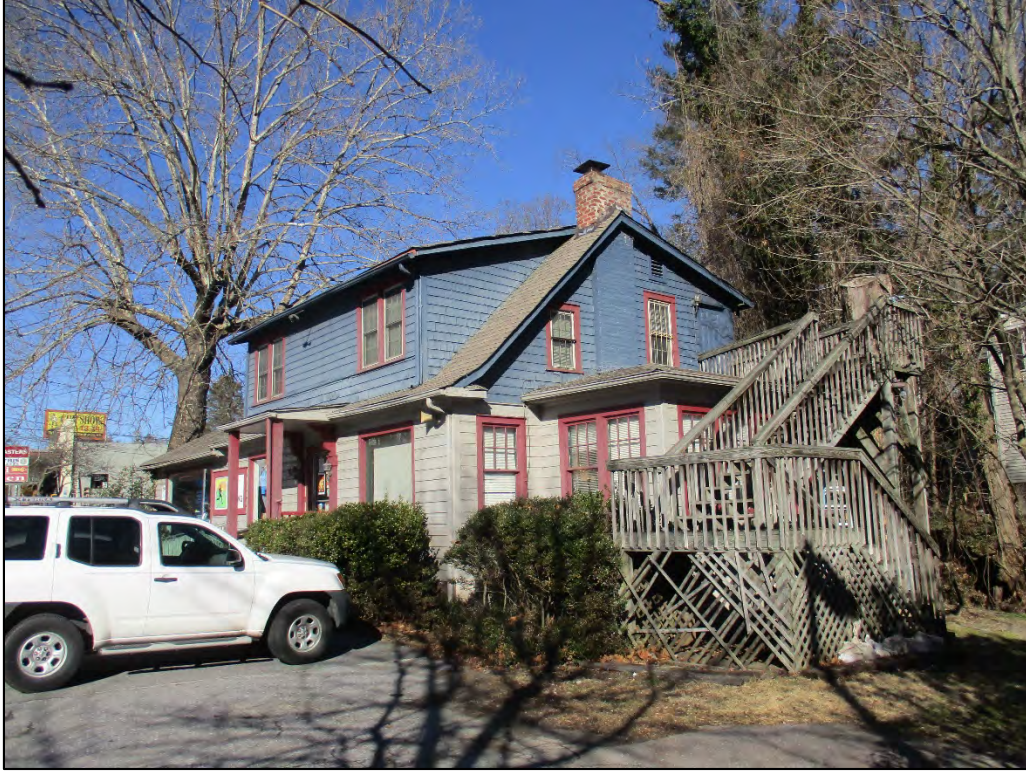
Oblique view of façade and south elevation, looking to the northeast

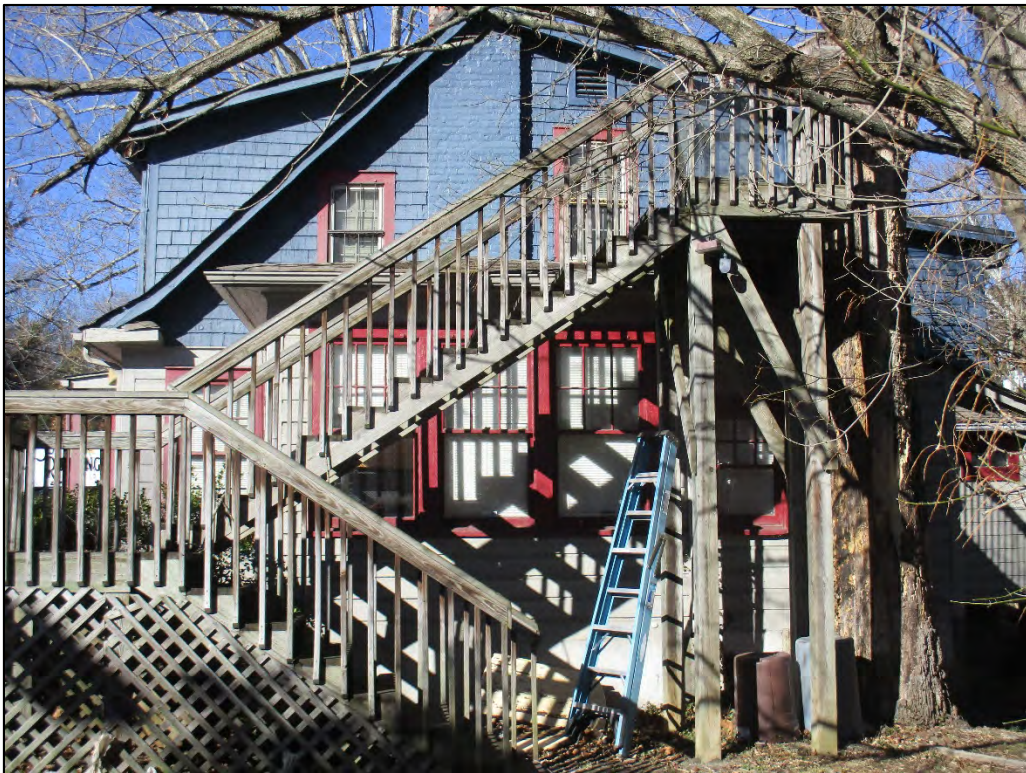
South elevation, view to north. The ribbon of four windows in the hipped roof wing is partially obscured by deck structure.

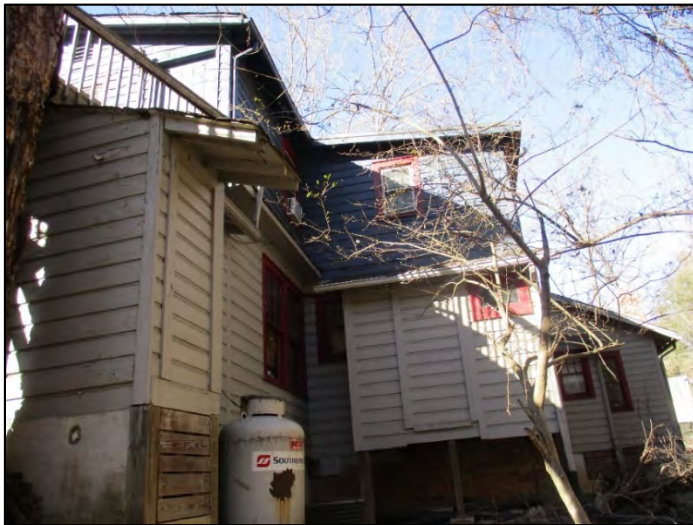
The resource was operated as a guest house beginning in the 1930s and expanded to suit the purpose. Additions to the rear elevation, and one addition to the north elevation appear to date from this period. A two-story shed addition extends from the north end of the house's rear (east) elevation and overlaps some window trim on the original house. Historic six-over-one wood windows are present in the first floor of this addition and vinyl replacements in the second story, consistent with the general description above. Brick piers are visible in the south-facing exposure of the foundation, though infilled with brick, and the east-facing foundation exposure clad in stucco. Three lean-to additions extend from the original house and the two-story addition. These are set on wood piers in concrete footers. Each has a small center door, which are infilled with German siding, and a small window. These additions are clad in German siding and have open eaves, exposed rafter tails and sheathing.

Rear (east) elevation, view to north. Note that the detail photograph below is taken at the two-story junction mid-frame.

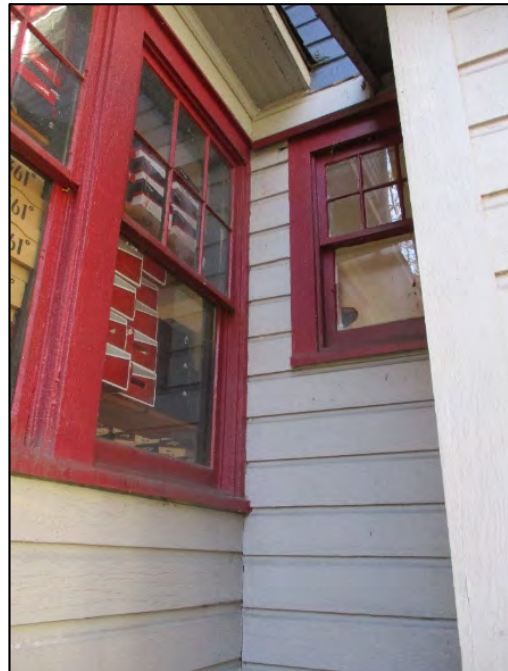
Rear (east) elevation detail of the two-story addition junction, view to north. Note the two-story addition (to the right) partially covers window surrounds (at left) and the boxed eave above.

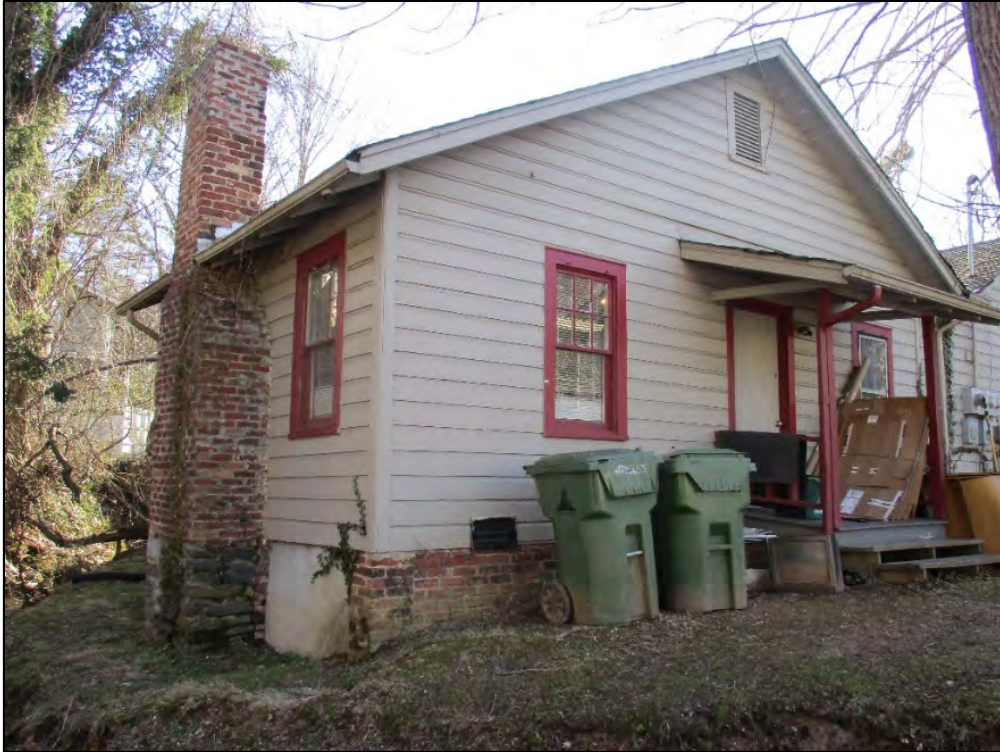
Oblique view of gable addition at northeast corner of house, view to southwest. This addition appears to date to the same period as the additions to the rear of BN5736.

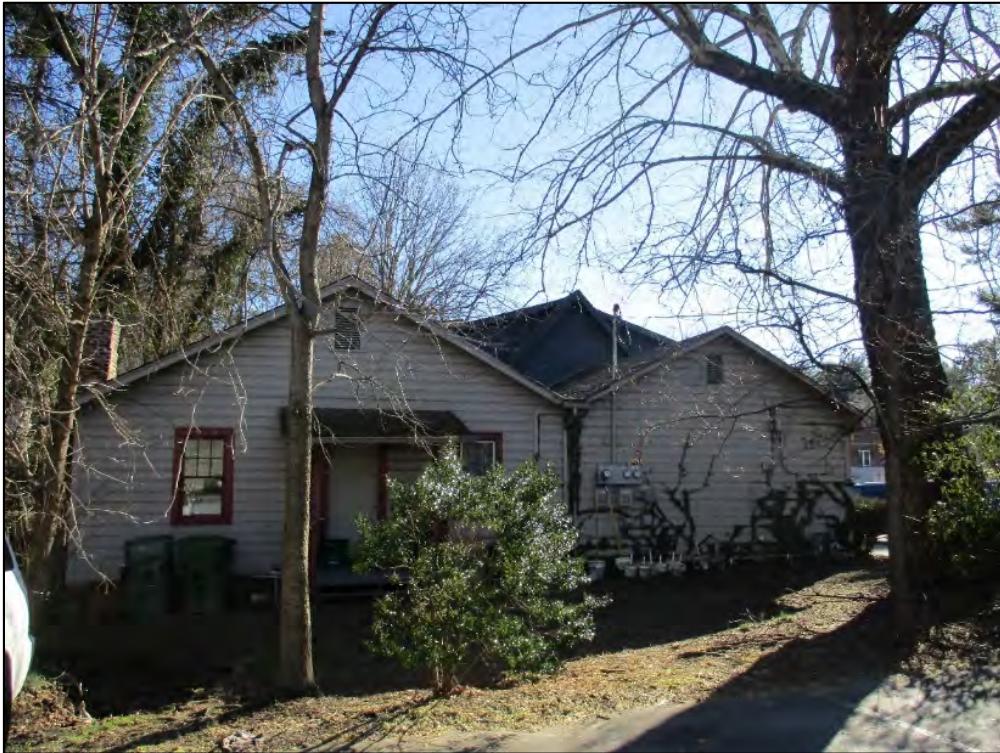
Two one-story gable additions are attached to the north elevation of the house, the gabled roofs meet to form a valley. Based on materials consistent with those described on the rear additions, and the stone and brick, single stepped exterior chimney, the rear (east) addition appears to predate the other gable addition which is flush with the house's façade and contains the large fixed pane display window. Brick piers are visible in the rear gable addition foundation, though have been infilled with brick and partially clad in stucco. This addition also includes a centered entry with a replacement flush, wood door in the gable end under a shed roof porch supported by simple wood posts. The porch floor is wood and accessible via wood stairs. The eaves are open, consistent with those described on the rear additions, and a wood slat gable vent is present. The north elevation of the adjacent addition is blank except for a wood slat gable vent.

North elevation, view to south
