November 9, 2018

MEMORANDUM

SUBJECT: Historic Structures Survey Report, Merrimon Avenue & WT Weaver Boulevard Intersection Improvements. U-5781, U-5782, PA 17-04-0023, Buncombe County, ER 18-0102

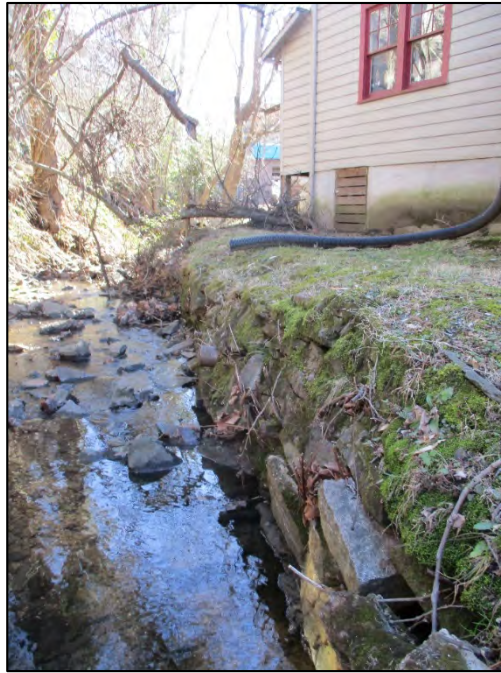
A large asphalt parking lot fills the area between the house and the back of the sidewalk on Merrimon Avenue. The property is grassed on the other elevations and a small unnamed creek traverses the back of the property, in very close proximity to the house in some places.¹⁴⁷ The creek bank bordering the resource has been reinforced with a dry-laid stone wall in places. A couple mature hardwoods remain on the property and foundation plantings are present on the façade.

View along unnamed creek at east parcel boundary. Note laid stone embankment and proximity of house at right.

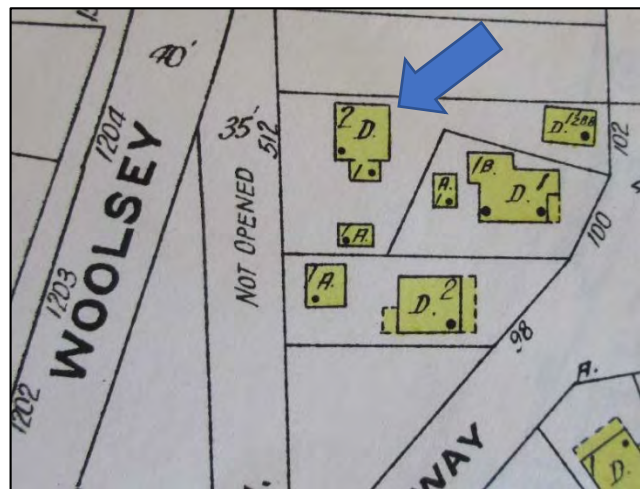
Exhibit 123. Portion of the 1925 Sanborn map (Sheet 60) showing the resource at 512 Merrimon Avenue

Despite the irregularities in the parcel, the house footprint described in the 1925 Sanborn appears to represent the house’s original form: a one-story wing extending from the rectilinear, two-story frame

Early deeds for the property indicate the parcel fronted to Lynndon Road, an extension of Murdock Avenue north of the city limits. City directories indicate, though, the resource had a Merrimon Avenue address. The 1925 Sanborn map shows the resource at 512 Merrimon Avenue with the Lynndon Road right of way (35 feet, “not opened”) between the house and Woolsey Avenue (current Merrimon Avenue) (Exhibit 123). It is suspected the “not opened” right of way may have been used as a driveway to access the resource historically. The 1925 Sanborn describes an odd parcel boundary, with 100 Midway Road (east of resource) cutting into the southeast corner of the parcel at a jagged angle and with a one and one-half story frame dwelling with basement at 102 Midway Road on the same parcel as the resource.

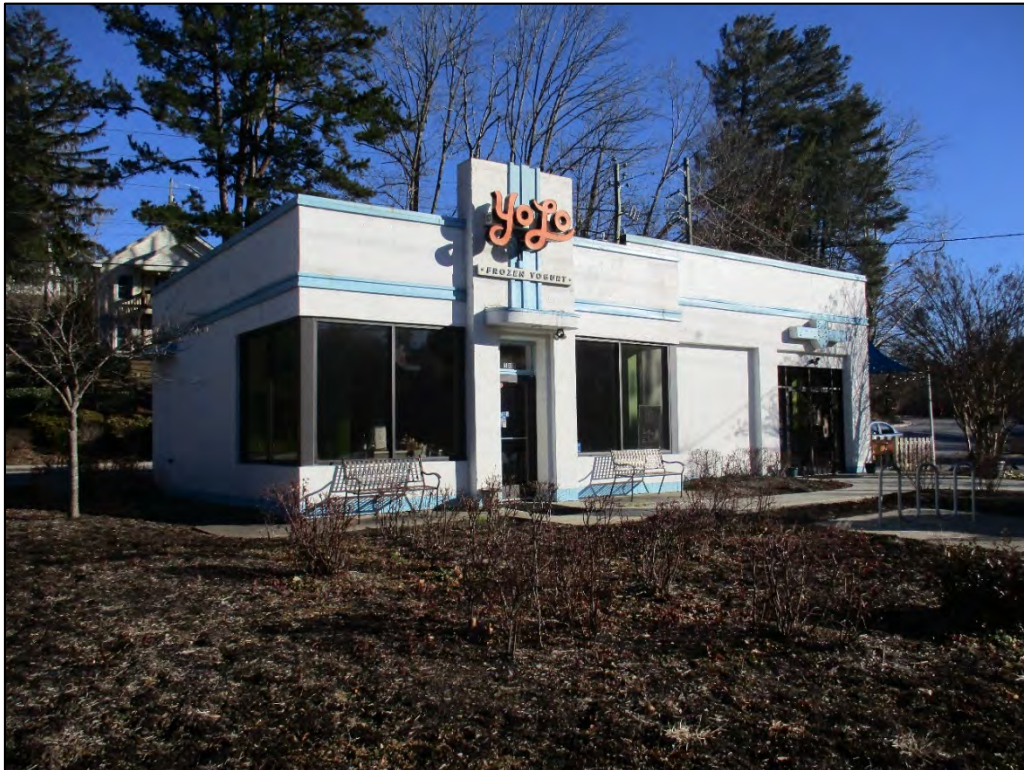
Former Woolsey Dip Amoco Station façade, view southeast

This 52-foot by 29-foot masonry filling station is constructed in two parts, including the slightly projecting corner office at the north end of the building and two service bays to the south. The elevations of these spaces differ slightly based on internal use, with the office elevation being slightly lower than that of the service bays. The office features a centered wood-framed replacement glass door with fixed transom and stucco clad hood within a vertical accent that slightly projects from the wall

plane and extends above the parapet roof. Double fixed pane, tinted display windows are present on either side of the door with windows continuing around both corners. The vertical accent includes applied (wood) decorative elements. The “Yolo Frozen Yogurt” sign (current occupant) is attached above the door. One service bay door (closest to office) is infilled completely and clad in stucco. The second service bay door is also infilled, but includes a double glass door entry with sidelights and transom. The remnants of a neon light (attributable to previous occupant, The Hop) remains affixed to the wall above this entry, though the tube lettering is mostly removed. The steel lintels above the service bays remain evident.

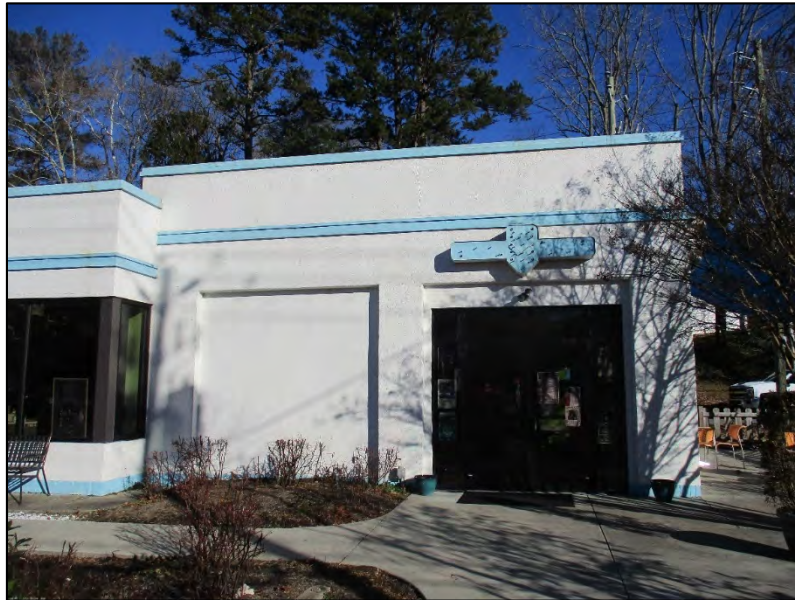
Former Woolsey Dip Amoco Station façade service bay detail, view to east. One service bay door is infilled at left, the other converted to a secondary entry.

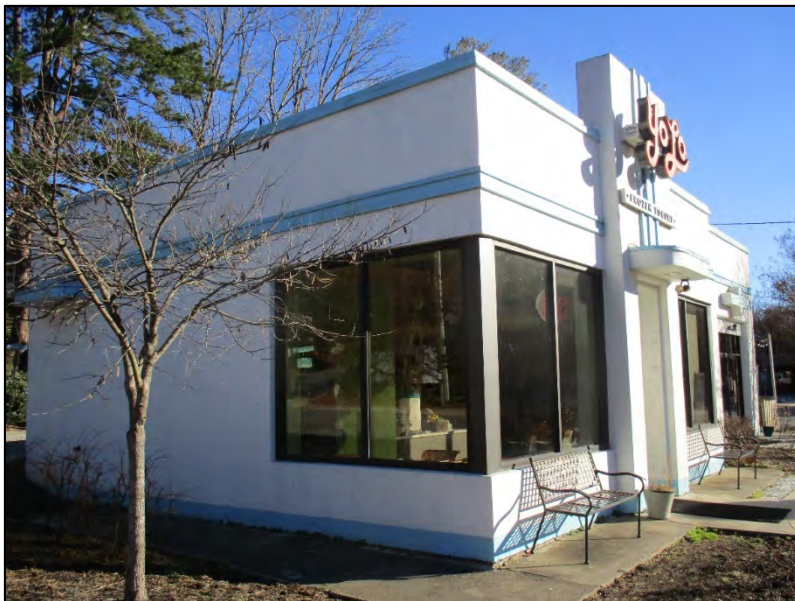
Former Woolsey Dip Amoco Station oblique view of the corner office and north elevation, view to the southeast

Decorative trimming elements – i.e., soldier brick course at the foundation and concrete block coping on parapet – are present on the façade (west facing) and north and south elevations. An intermediate applied wood horizontal element traverses these elevations at the roof line, below the parapet. The parapet treatment corresponds with the foundation treatment, with a concrete cap on the façade and north elevation. These treatments turn the corner on the south elevation, but then end. The parapet on the north elevation is wood.

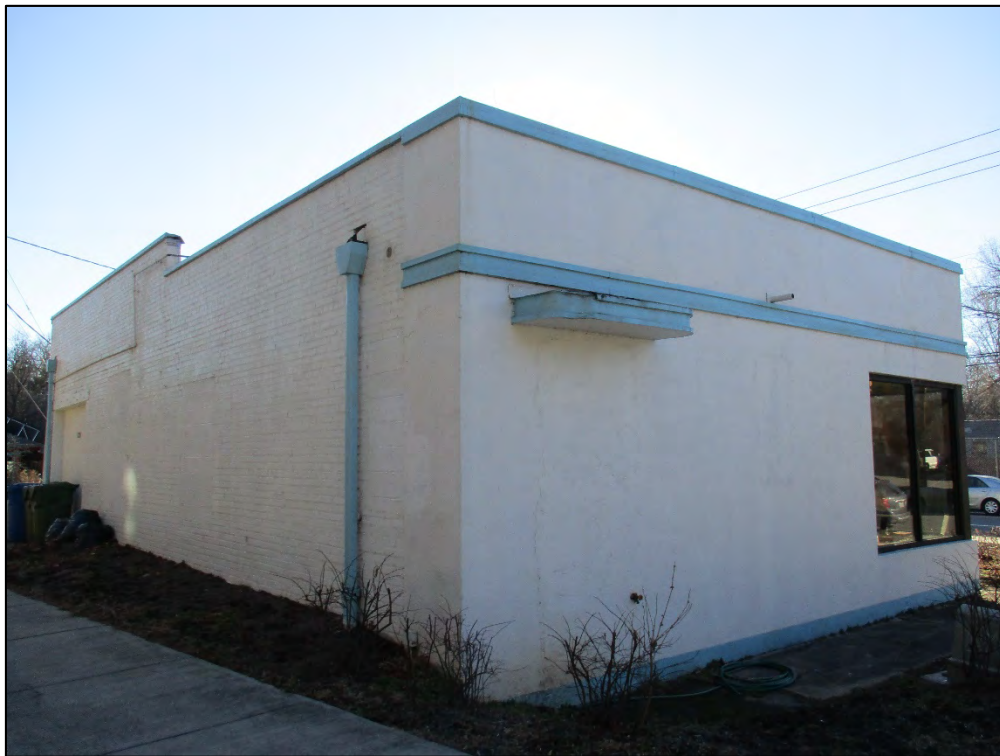
**Former Woolsey Dip Amoco Station oblique view of the north and rear (east) elevations, view to the southwest.
Note hood above the infilled bathroom door in rear of north elevation.**

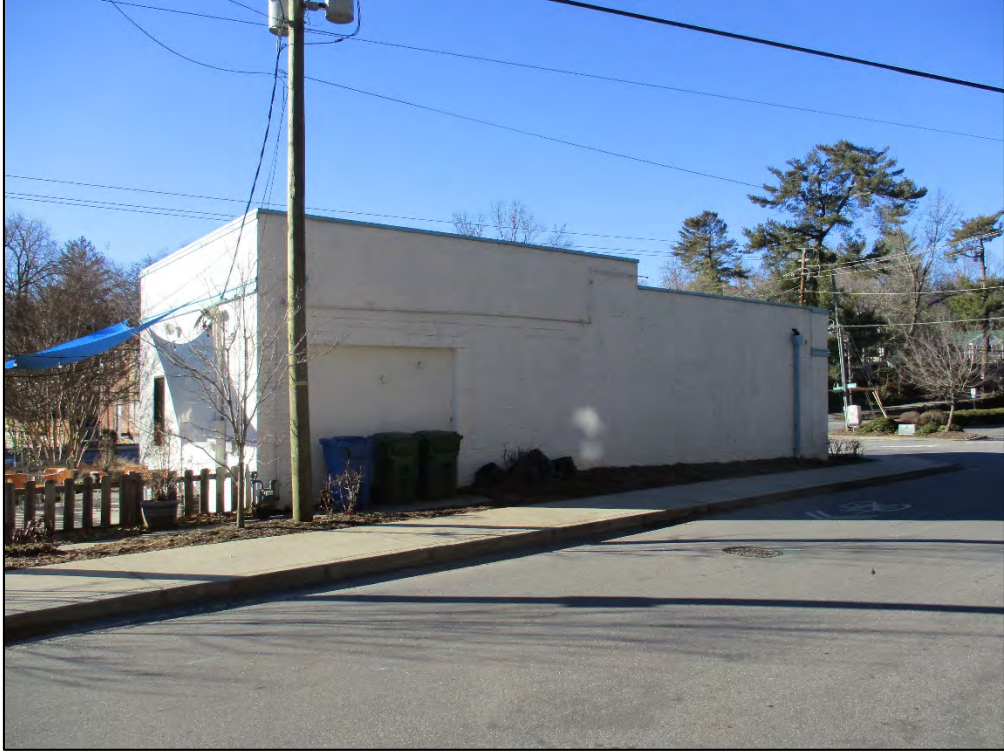
Former Woolsey Dip Amoco Station rear (east) elevation, view to the northwest. Murdock Avenue in foreground.

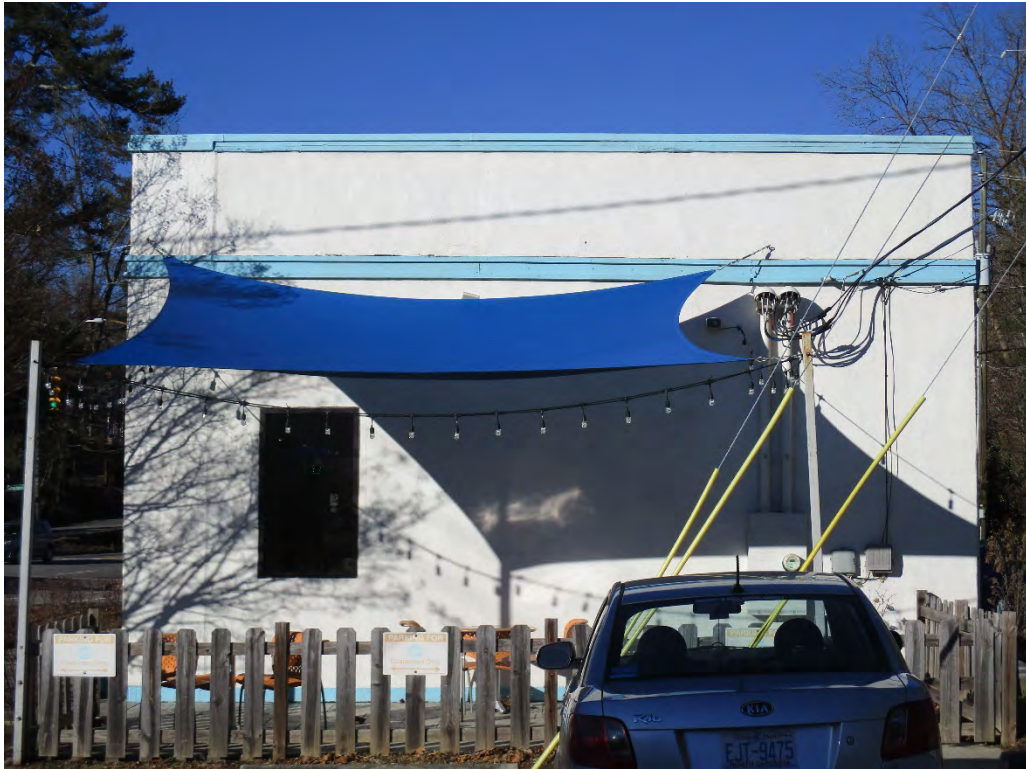
Former Woolsey Dip Amoco Stationsouth elevation, view to north

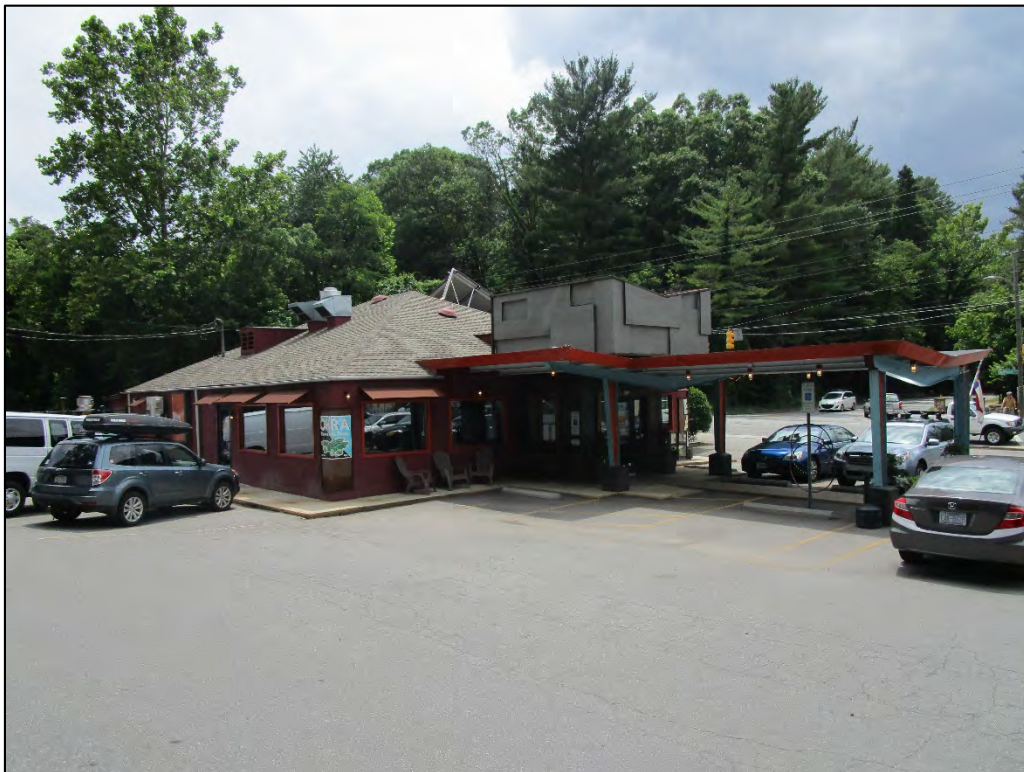
Former A&W Drive-In, oblique view of façade and east elevation, view to southwest

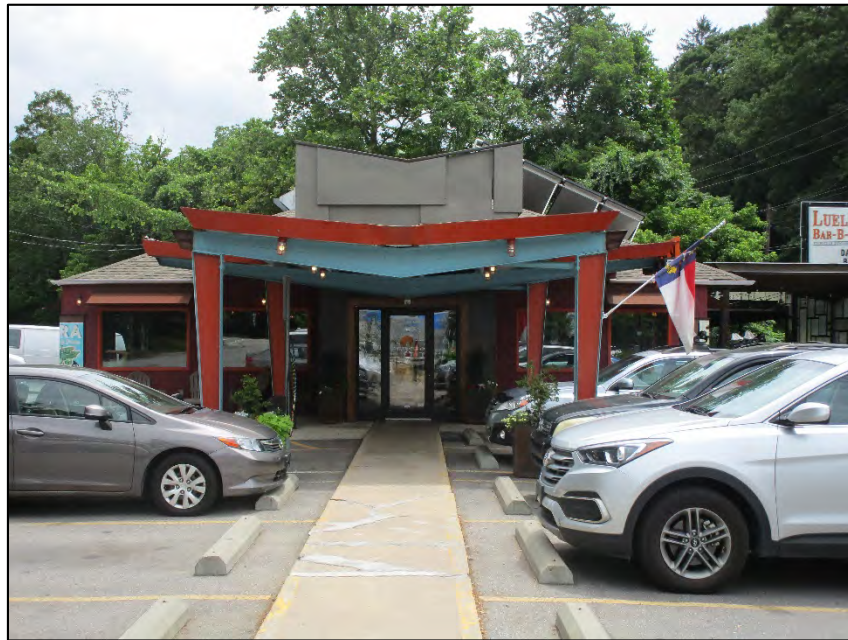
Former A&W Drive-In façade, view to south

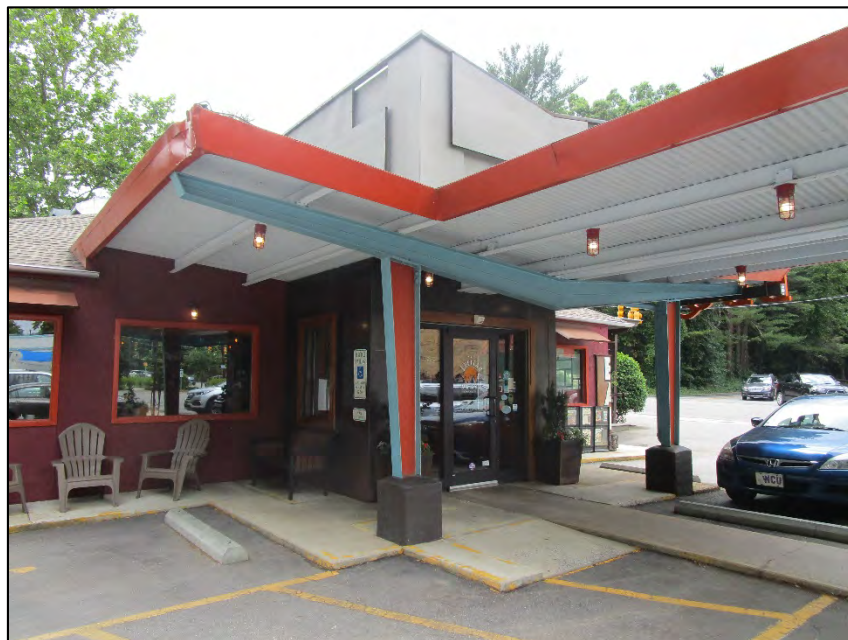
Former A&W Drive-In façade, canopy detail, view to southwest

The interior features an open dining area at the north end of the building with a bar dividing the public space from the kitchen and office. Interior finishes are updated, including tiled floors and walls. The valley of the canopy butterfly roof extends to the interior of the restaurant, terminating at the break between the dining room and kitchen. The surrounding ceiling consists of a tile drop ceiling.

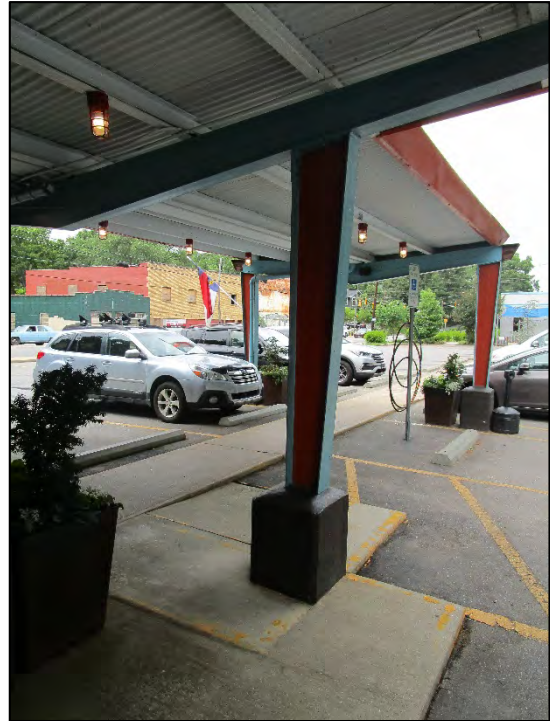
Former A&W Drive-In, canopy detail, view to northwest

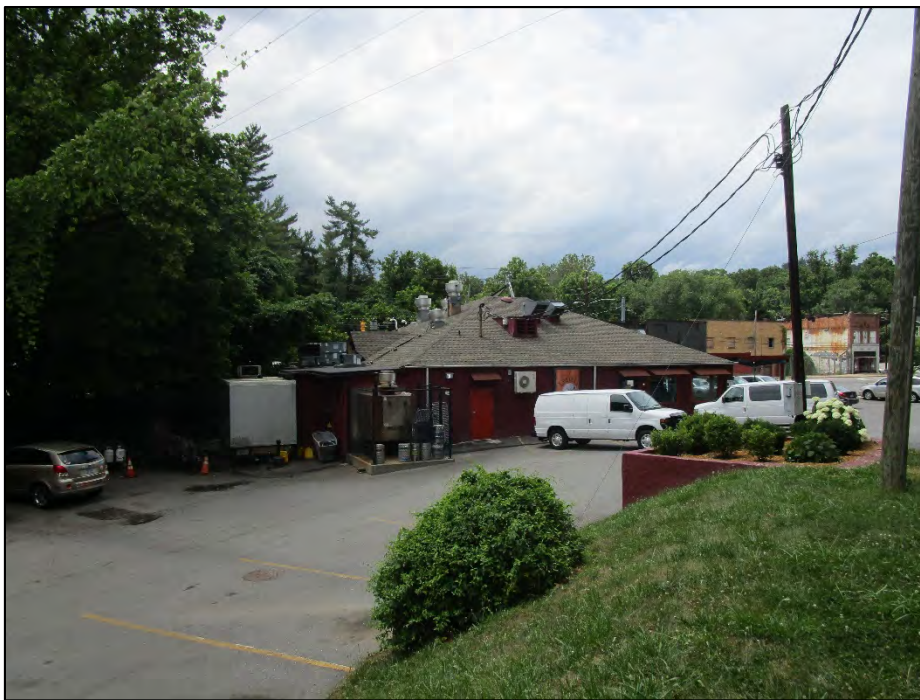
To the rear (south) are three shed additions on concrete block foundations and clad in T1-11 siding. Brick veneer was noted on short exposures of the building's south elevation between the lean-to additions. The concrete patio is located on the west elevation between the restaurant and the sidewalk on Merrimon Avenue and is bound by a stucco clad skirt wall. A metal shed roof on steel posts covers the patio.

Former A&W Drive-In, oblique view of east and south (rear) elevations

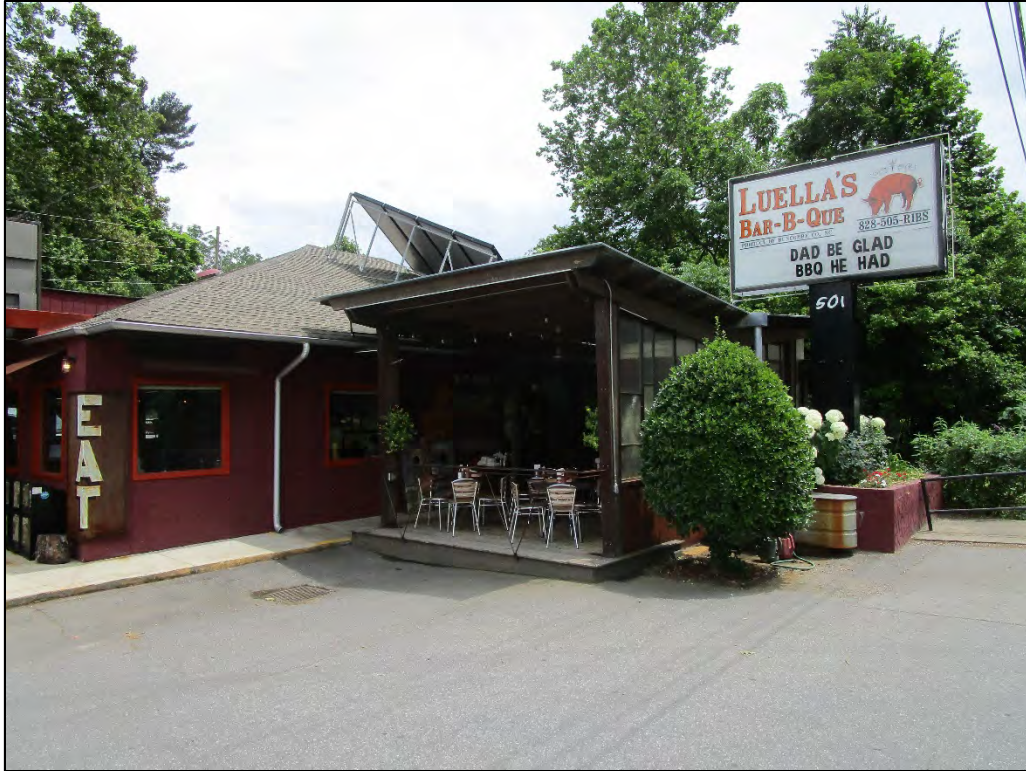
Former A&W Drive-In west elevation with covered patio and sign

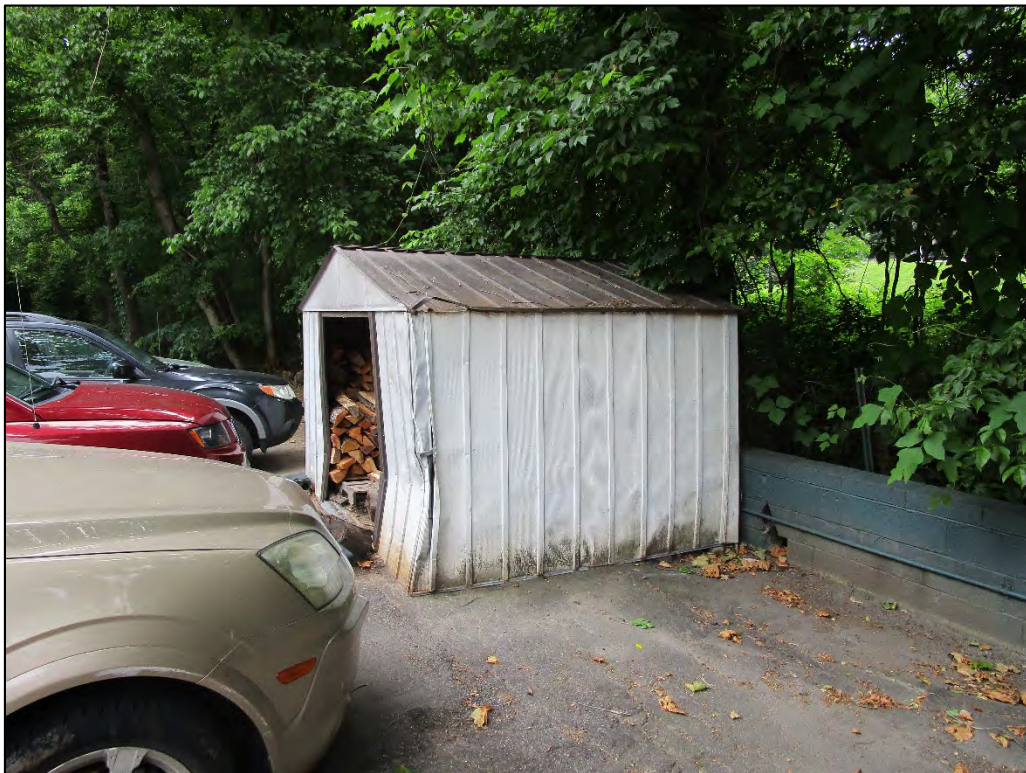
The building is placed centrally within an irregular parcel bound by Reed Creek and Merrimon Avenue along its west extent (the proximity of both made photography of the southwest corner difficult). Concrete block retaining walls are present in places along the creek. Most of the parking is located north of the building, between the former Woolsey Dip Amoco Station, Merrimon Avenue, and Murdock

Former A&W Drive-In, aluminum wood shed south of the building. Concrete block walls are utilized in places adjacent to Reed Creek; the incised creek bank is located directly behind this wall.
