SUBJECT: Historic Structures Survey Report, Upgrade of Existing NC 127 from SR 1400
to SR 1156, R-3603A, PA 16-10-0022, Alexander and Catawba Counties, ER 18-0268

The report considers eight resources: five houses, two churches, and an agricultural complex. The study recommends all but one as not eligible for listing in the National Register of Historic Places. The House at 93 Telephone Exchange Road (AX0069) is recommended as eligible under Criterion C. Initial screening of the R-3603A project area by NCDOT Historic Architecture identified which resources warranted additional study.

As a result of this investigation, one resource is recommended as eligible for the NRHP, a one-story, Contemporary-style dwelling constructed in 1966. The house at 93 Telephone Exchange Road (AX0069) **is recommended eligible for the NRHP under Criterion C for its association with the post-World War II housing boom in Alexander County and as a unique example of the Contemporary style's application in a rural setting.**

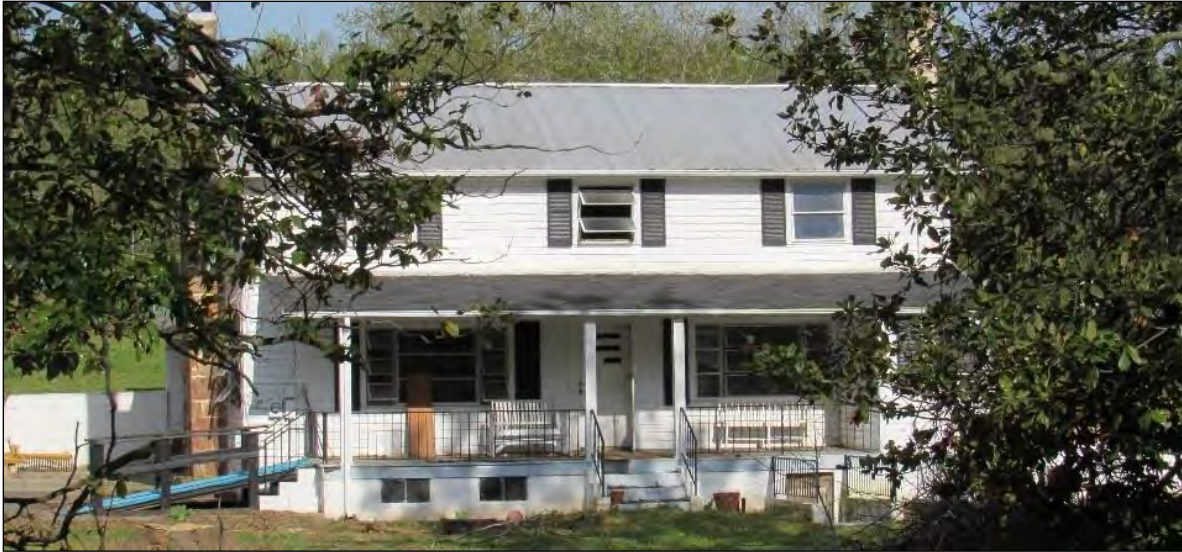
Photo 1: House at 7031 N.C. Highway 127, West Elevation.

The resource is a two-story, three-bay, single-family dwelling built around 1884 (Photo 1, p. 10). The resource does not have a discernable style, but instead is built in a common, two-story, central-passage, double-pile form. Constructed on a continuous, concrete-block foundation, the house's structural system is likely frame and clad in aluminum siding. A side-gabled roof with overhanging eaves sheathed in v-crimp metal, tops the dwelling. Two exterior-end, uncoursed, stone chimneys flank the resource to the north and south. The northern chimney features what appears to be the original cut stone up to the second floor hearth and parged brick at the top of the stack where it is covered by a metal cap.

The primary entrance is centered on the west elevation and is filled with a single-leaf, flush, wooden door with three horizontal, rectangular lights. The door's design is typical of mid-twentieth-century Ranch and Contemporary styles and was likely replaced sometime between 1950 and 1970.⁸ A one-story, full-width porch spans the west elevation. Built atop a continuous concrete-block foundation, the porch features a wood-plank deck and metal railings. The shed roof sheathed in asphalt shingles is supported by square-wood posts. A set of concrete-block steps are centered on the west elevation with a matching set of steps at the north end of the porch. The porch's foundation is raised and may shelter a cellar as a set of poured-concrete stairs descends about 5 feet down at the southern end of the west elevation, leading to a single-leaf vinyl door. Two two-light, fixed, metal windows also sit on the northern end of the foundation's west elevation. Additional fenestration on the primary (west) elevation includes metal picture windows at the first story as well as two- and three-light, replacement, metal-framed awning windows at the second story. Two and three light, metal awning windows are present on the secondary elevations as well. Fixed, louvered, aluminum shutters flank the windows on the north and west elevations.

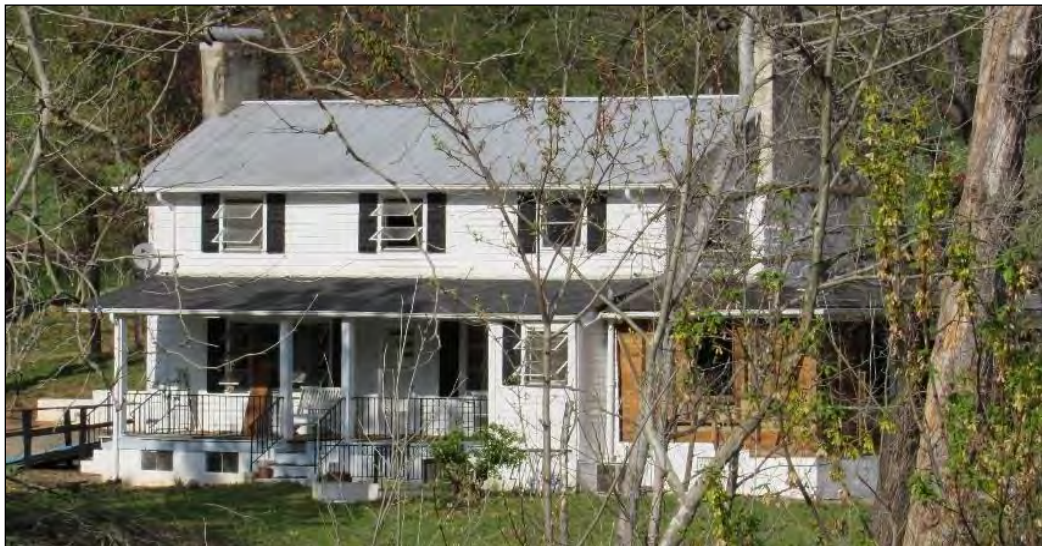
Photo 3: House at 7031 N.C. Highway 127, Addition Detail, Southwest Oblique.

A one-story, one-bay addition extends from the south elevation of the resource (Photo 3). Built atop a continuous concrete-block foundation, the addition's frame structural system is partially covered by weatherboard. Given the addition's appearance compared to the rest of the dwelling, it is possible that its exterior cladding was being replaced at the time of survey. It is topped by a hipped roof sheathed in asphalt shingles.

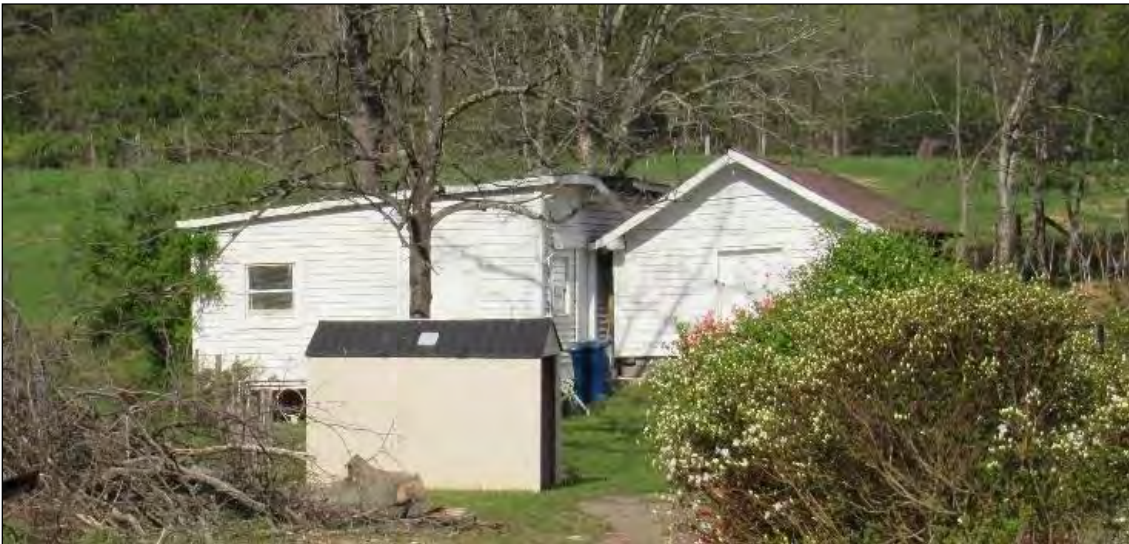
Photo 4: Circa-2015 Shed (Front), Circa-1960 Outbuilding (Rear Left), and Circa-1970 Outbuilding (Rear Right), Looking North.

A one-story, two-bay, circa-1960 outbuilding sits north of the primary resource (Photo 4). Built on a pier-type foundation, the weatherboard-clad outbuilding is covered by a shed roof that slopes to the north. A single-leaf, flush, wood door opens on the southern end of the west elevation while a one-over-one, double-hung-sash, wood windows occupies the northern bay. A single-leaf replacement door opens on the south elevation but is partially obscured by a circa-1970 outbuilding. The remaining secondary resource situated north of the dwelling is a one-story, one-bay outbuilding constructed around 1970 that almost abuts the circa-1960 outbuilding's south elevation (Photo 4). Built atop a continuous concrete-block foundation, the outbuilding is covered in weatherboard. The front-gabled roof, sheathed in v-crimp metal, tops the building. A single-leaf wooden door opens on the west elevation.

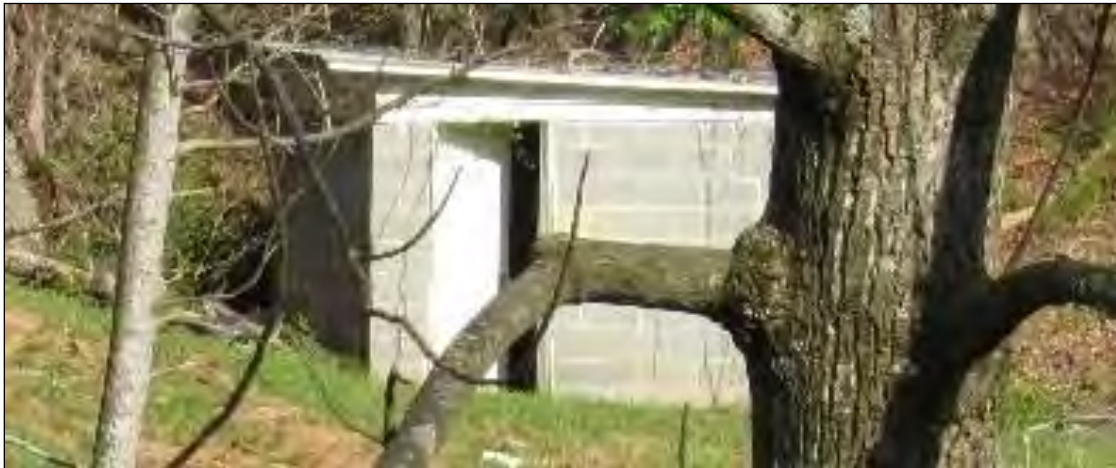
Photo 5: Circa-1960 Shed, Northwest Oblique.

A one-story, one-bay, circa-1960 shed sits to the south of the primary resource (Photo 5). The concrete-block building is covered by a standing-seam-metal-clad, shed roof that slopes to the south. A single-leaf, six-panel replacement door opens on the northern end of the building's west elevation.

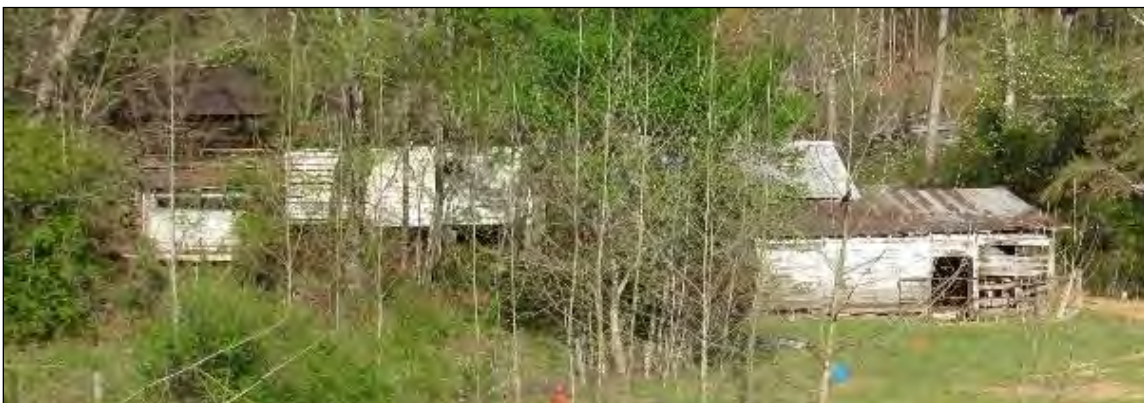
Photo 6: The Circa-1945 Barn (Left) and Circa-1940 Outbuilding (Right), Looking East.

Although not clearly observed during survey due to tree growth there are two additional resources located south of the dwelling. The southernmost building is a one-story, wood-framed outbuilding constructed around 1940 clad in weatherboard and covered by a front-gabled roof sheathed in metal. A one-story, two-bay addition extends from the outbuilding's southeast elevation and is covered by a front-gabled roof with exposed rafter tails. The northernmost of these two outbuildings is a one-story, wood-framed, circa-1945 barn built on a pier-type foundation and clad in weatherboard siding (Photo 6). A front-gabled roof, sheathed in v-crimp metal, tops the building. A one-story gabled addition extends from the barn's northeast elevation and is constructed from the same materials as the main barn.

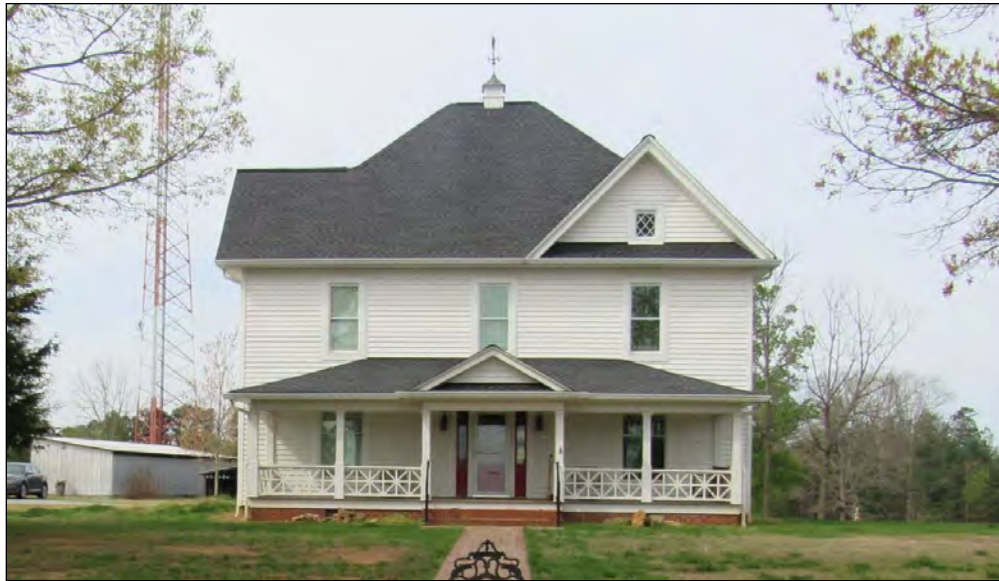
Photo 10: House at 225 Richey Road, Northeast Elevation.

The primary entrance, located on the northeast elevation, contains a single-leaf, half-glazed, single-paneled wood door within a wood surround composed of two half-glazed, single-paneled, wood sidelights and features a storm door. Additional fenestration includes one-over-one, double-hung-sash, vinyl replacement windows and a vinyl bay window set on the northwest elevation. The windows on the first story of the primary (northeast) elevation feature vinyl, false muntins on the upper sash laid in cathedral-and-diamond-pane pattern; this same pattern using the vinyl false muntins is also present on the central light in the bay window. A one-story, full-width porch spans the house's northeast elevation (Photo 11, p. 24). Built atop a brick-veneer-clad foundation, the porch features a Hardie-board deck and a hipped roof sheathed in asphalt shingles with a centered, front-gabled projection. Square, wood columns support the porch's roof and are linked by a decorative wood railing. Matching square, wood pilasters provide visual balance to the porch. Two brick steps lined with metal rails connect the porch to the brick path that runs to the main road.

A one-and-a-half-story, four-bay addition was appended to the house's southwest elevation in the late-twentieth century and connects to the main house by way of a narrow one-and-a-half-story, side-gabled hyphen (Photo 12, p. 24). This hyphen features a front-gabled dormer on the roof's southeastern slope and single-leaf door within a recessed entry on the southeast elevation. This recessed entry is accessed by a set of brick steps lined with a metal rail.

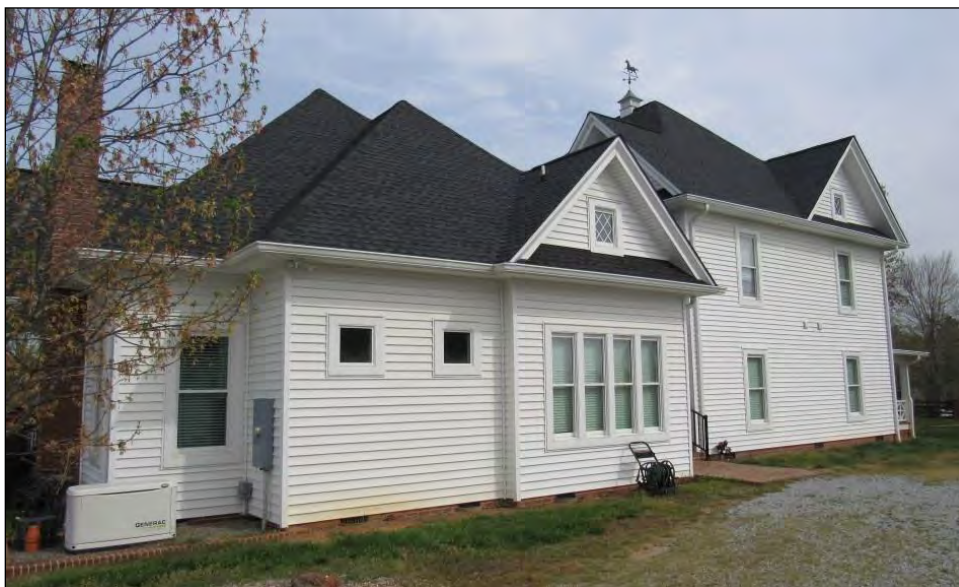
Photo 12: House, Addition Detail, Southeast Elevation.

The addition was designed to aesthetically echo the original core, including the vinyl siding and hipped roof. An exterior-end brick chimney abuts the southwest elevation. Additional fenestration in the addition includes one-over-one, double-hung-sash, vinyl, replacement windows, single-light, fixed, vinyl windows, and two secondary entrances filled with single-leaf doors—one on the southwest elevation and one on the northwest elevation. Most of the window openings are filled with a single double-hung-sash window, but one window bay on

the southeast elevation is filled with four vinyl, replacement, one-over-one windows and one on the northwest is filled with three. A one-story, two-bay, front-gabled porch extends from the addition's southwest elevation. Built on a brick-veneer-clad foundation, the porch's steeply pitched, front-gabled roof is supported by square wooden posts with metal railings (Photo 13, p. 25). A set of brick steps leads from the southwest side of the porch to a brick pathway that connects to the driveway.

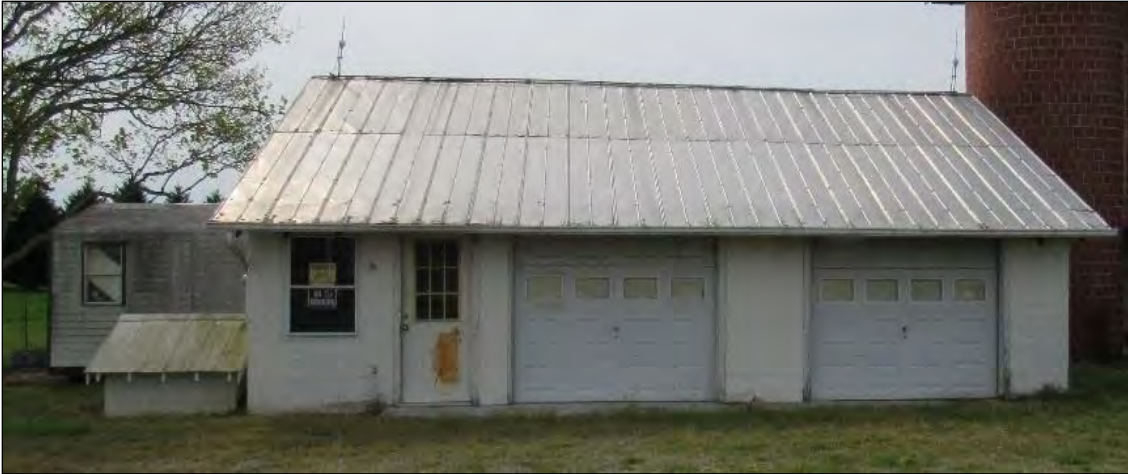
Photo 14: Garage, Northwest Elevation.

A one-story, four-bay, circa-1940 garage sits to the south of the primary resource (Photo 14, p. 26). Covered by a side-gabled roof sheathed in v-crimp metal with weatherboard in the gable ends, the concrete-block structure features two overhead, metal garage doors and a single-leaf, half-glazed door on the northwest elevation. Other fenestration includes one-over-one, double-hung-sash, vinyl windows. A one-story, two-bay, prefabricated shed has been appended to the garage's northeast elevation. Built on a continuous, concrete foundation, the shed addition is topped by a front-gabled roof and is completely covered in aluminum siding. Two one-over-one, double-hung-sash, metal windows sit on the northwest elevation of the addition. A circa-1950 cistern is located immediately adjacent to the garage's northeast elevation. The surrounding structure is made of concrete blocks and covered by a shed roof sheathed in standing-seam metal with exposed rafter tails on the northwest and southeast (Photo 15, p. 26). A small opening is centered on the northeast elevation.

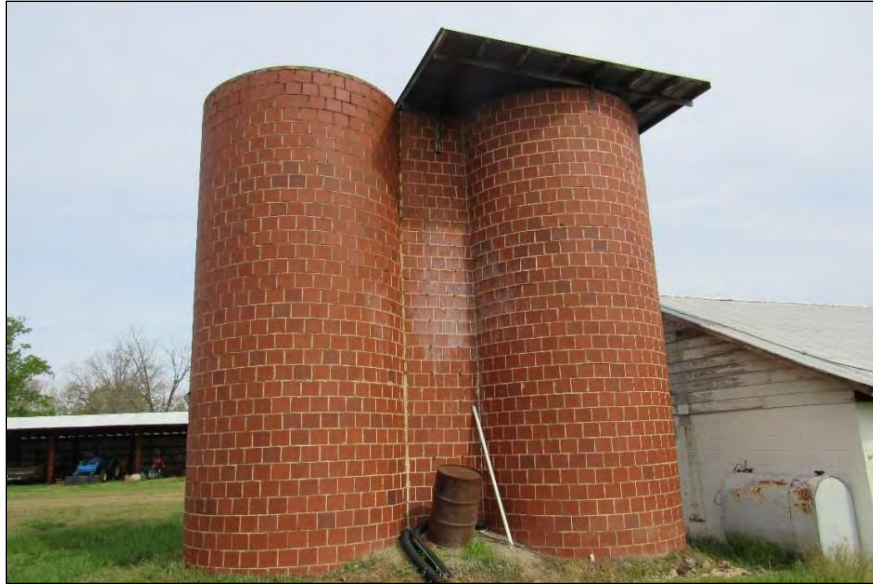
Photo 16: Silo Structure, Looking Northwest.

A pair of circa-1905 silos sit to the south of the primary resource (Photo 16, p. 27). The two cylindrical silos, approximately 15 feet high, are connected by a central rectangular shaft with a built-in ladder to access the interior. Both silos are composed of structural terra cotta lined on the inside with poured-concrete, and feature poured-concrete floors. The southwestern silo is empty and does not have a roof. An open bay is located on the northwest elevation. The northeastern silo has been converted into a small bathroom with a toilet and sink and is topped by a square, flat metal roof. A single-leaf, replacement door opens on the northwest elevation.

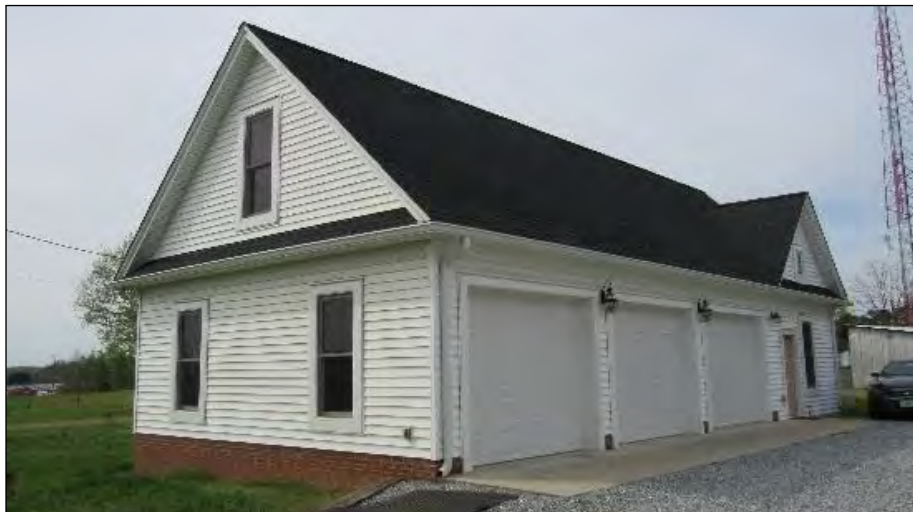
Photo 17: Garage, North Oblique.

A one-and-a-half-story, five-bay, circa-2000 garage sits to the southeast of the primary resource (Photo 17). Built on a continuous foundation clad in brick veneer, the garage's frame structural system is covered in vinyl siding. A side-gabled roof with two front-gabled peaks sheathed in asphalt shingles covers the garage. Three overhead, metal garage doors are located in the three northern bays on the northwest (primary) elevation, while a single-leaf, six-panel door fills the second-most-western bay. Additional fenestration includes one-over-one, double-hung-sash, vinyl windows and single-leaf, fixed, vinyl windows with false muntins that give the appearance of diamond panes in the peaks.

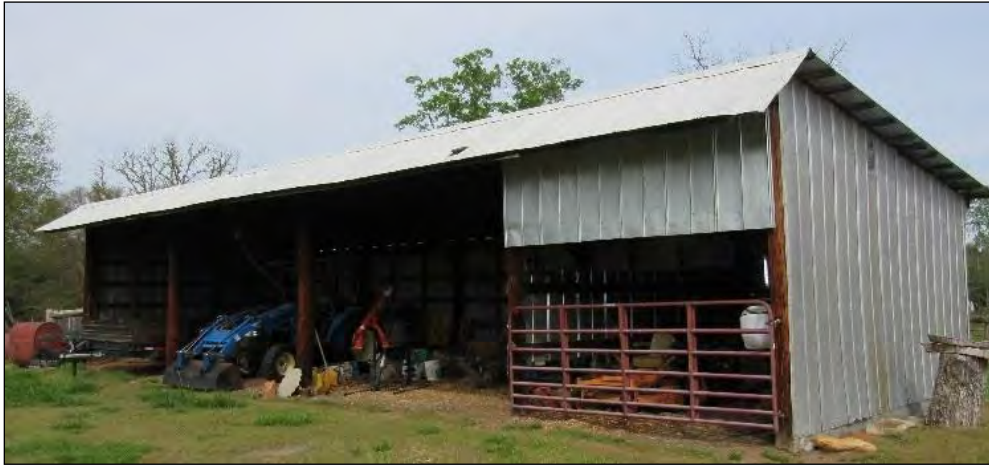
Photo 18: Machine Shed, East Oblique.

Southwest of the dwelling is a one-story, four-bay machine shed constructed around 1960 (Photo 18). Capped by a corrugated-metal, shed roof with a small pentice lining the southeast elevation, the frame building is clad in v-crimp metal on the northwest, southwest, and northeast elevations. The eastern-most bay on the southeast elevation is partially enclosed by a sheet of v-crimp metal across the top of the bay while a metal-pole gate covers the bottom of the bay, while the remaining three bays are open.

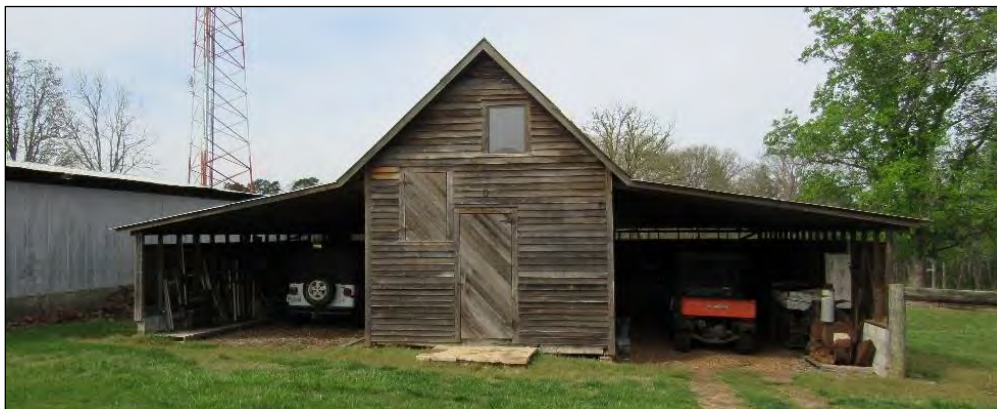
Photo 19: Granary, Northeast Elevation.

A one-and-a-half-story, one-bay, circa-1905 corn crib sits to the southwest of the primary resource (Photo 19). The wood-frame building is clad in weatherboard siding and is topped by a steeply-pitched, front-gabled roof sheathed in v-crimp metal. A single-leaf wood door is centered on the northeast elevation. A single-light wood window sits in the gable end of the half story. A one-story, U-shaped, lean-to addition encloses the entire resource except northeast elevation. Featuring the same materials as the granary, the addition creates two open bays that flank the main core providing space for machine storage.

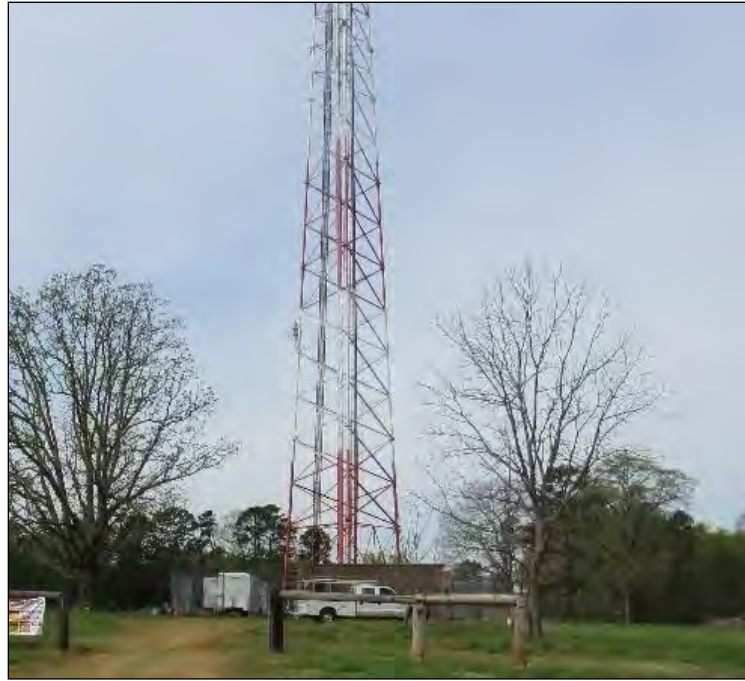
Photo 20: Cell Tower, Looking Southwest.

A circa-2000 cell tower sits to the southwest of the primary resource (Photo 20). Built on a poured-concrete pad, the tower is set at the end of a gravel driveway that extends from the poured-concrete driveway and loops in front of the primary resource. It is separated from the primary resource and all of the other outbuildings by a wood-and-barbed-wire fence that is marked “no trespassing.”

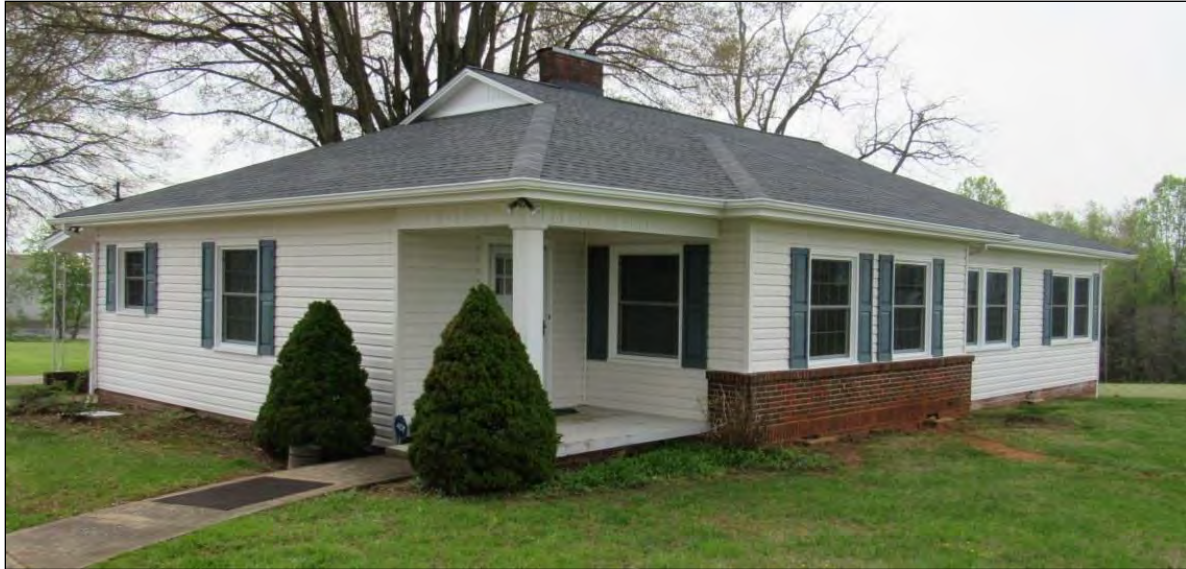
Photo 22: House at 7625 N.C. Highway 127, Northwest Oblique.

The house is a one-story, five-bay, single family dwelling constructed around 1951 with Ranch-style attributes (Photo 22, p. 40). Interior access was not granted during the current survey. The continuous concrete-block foundation is clad in a running-bond brick veneer on all elevations except the east elevation. Though the structural system was not visible at the time of this survey, the age and massing of the house suggest that it is also concrete block. The resource is clad in replacement vinyl siding and covered by a low-pitched, hipped-on-gable roof sheathed in asphalt shingles. The roof features vinyl siding in the north gable end and weatherboard in the south gable end. A hipped projection extends from the south of the west elevation. A central-interior brick chimney pierces the ridgeline.

The primary entrance—a single-leaf, two-paneled wood door with six fixed lights at the top and covered by a metal-and-glass storm door—is located to the south of the west elevation under an entry porch. The entrance is recessed and faces west. All elevation of the resource feature paired and single, one-over-one, double-hung-sash, vinyl windows with false muntins. All of the windows have vinyl surrounds and sills. The windows on the north and west elevations are flanked by paneled vinyl shutters. The resource is built on a slight hill, therefore the basement is visible on the rear (east) elevation (Photo 23, p. 40). The basement features four-light, fixed, wood-framed windows as well as a secondary entrance which is filled with a single-leaf, two-paneled, wood door with six fixed lights at the top.

The 7625 N.C. 127 Highway parcel's circa-1951 home appears to be in generally good condition. It retains adequate integrity of location, but aspects of design, materials, workmanship, feeling and association are all impacted by several factors, including the installation of vinyl siding and vinyl windows, the demolition of two formerly associated

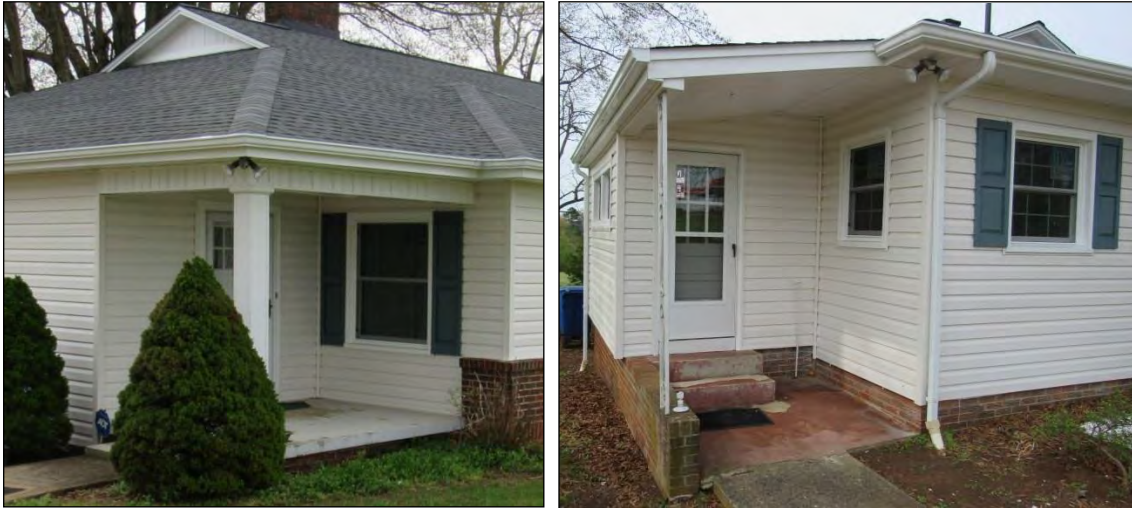
Photo 24: House at 7625 N.C. Highway 127, Northwest Oblique Porch Detail (Left) and Northeast Oblique Porch Detail (Right).

A one-story, one-bay, recessed entry porch is located on the northwest corner of the house (Photo 24, p. 41). It is set on a continuous foundation clad in brick veneer and supported by a square Tuscan column. It is covered by a hipped roof sheathed in asphalt shingles. A secondary entrance is located at the northeast corner of the resource (Photo 24, p. 41). It is set on a continuous foundation clad in brick veneer which supports the structural system that is clad in vinyl siding. It is covered by a shed roof sheathed in asphalt shingles. This addition features a recessed porch supported by a decorative metal post that covers the secondary entrance. The secondary entrance—filled with a single-leaf, three-paneled wood door with six

fixed lights at the top and covered by a metal-and-glass storm door—faces north. Other fenestration on this addition includes paired, single-light vinyl windows with false muntins and a one-over-one, double-hung-sash, vinyl window.

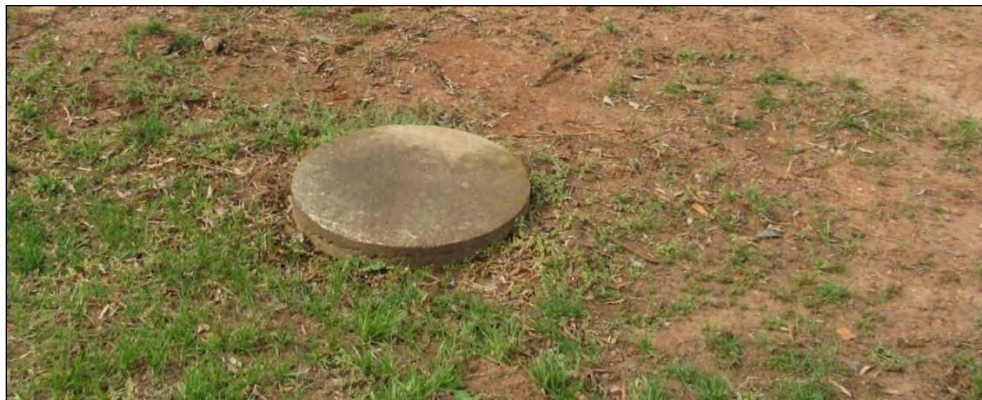
Photo 25: Well Cap, Looking South.

Associated with this primary resource are one well and three foundations. The circa-1950 well cap is located to the north of the primary resource (Photo 25). It is round in shape and made of poured concrete. A circa-1965 poured-concrete foundation is located to the north of the primary resource (Photo 26, p. 42). According to recent aerial photography, the resource was still standing until about 2015. A circa-1980 poured-concrete foundation is located to the north of both the primary resource and the circa-1965 foundation (Photo 26, p. 42). A circa-1970 poured-concrete foundation is located to the southeast of the primary resource (Photo 26, p. 42). According to recent aerial photography, the resource was also still standing until about 2015.

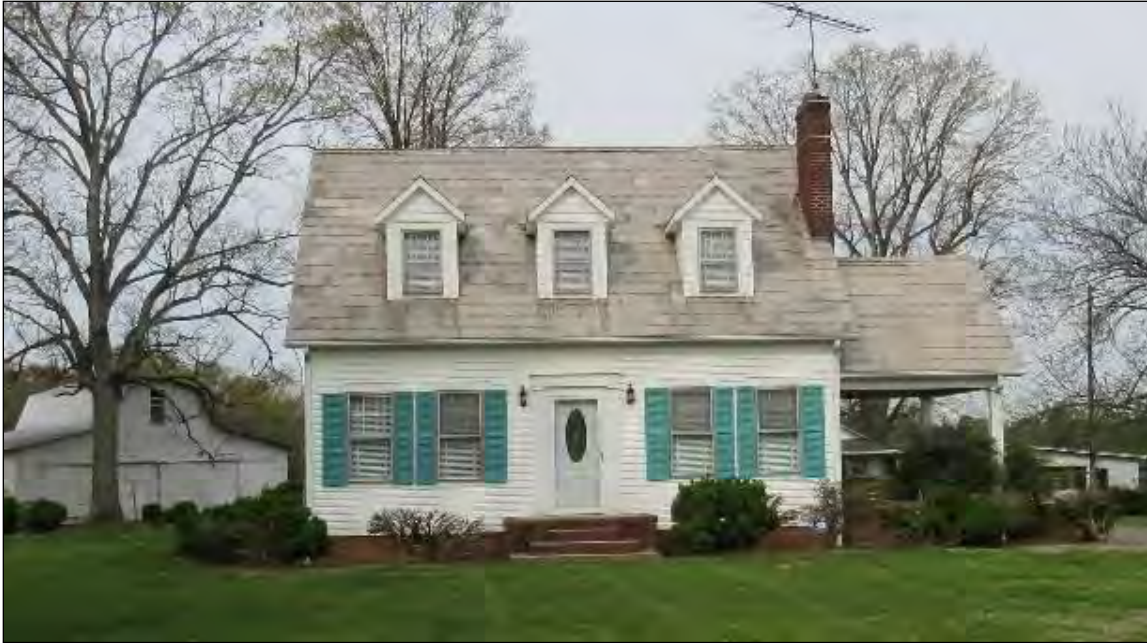
Photo 29: House, East Elevation.

The house at 8290 N.C. Highway 127 is a one-and-a-half-story, three-bay, single-family dwelling built around 1945 in the Colonial Revival style with a Cape Cod form (Photo 29, p. 53). Interior access was not granted during the current survey. Built atop a foundation clad in a running-bond brick veneer, the house's nonvisible structural system is covered in replacement vinyl siding. A side-gabled roof sheathed in slate shingles tops the house and features three front-gabled dormers on the east roof slope. These dormers feature six-over-one, double-hung sash, wood-framed windows. An exterior-end, coursed-brick chimney sits on the eastern slope of the house's north elevation.

The primary entrance, centered on the east elevation, is filled with a single-leaf, vinyl replacement door with a large, decorative, oval light and a storm door. The door is set within a plain, classically-inspired surround with wooden pilasters. Two brass sconces flank the door. A poured-concrete stoop clad in brick veneer with three poured-concrete steps leads to the door. Additional fenestration on the primary (east) elevation includes paired, one-over-one, double-hung-sash, vinyl windows with false muntins and six-over-one, double-hung-sash, wood-framed windows. All are flanked by fixed louvered shutters. A one-story, one-bay porch is located on the house's north elevation (Photo 30, p. 53). Built on a foundation clad in brick veneer, the porch's side-gabled roof is sheathed in slate shingles and supported by square wood posts. A set of four steps are located at the eastern end of the north elevation leading to the porch and connects directly to the driveway.

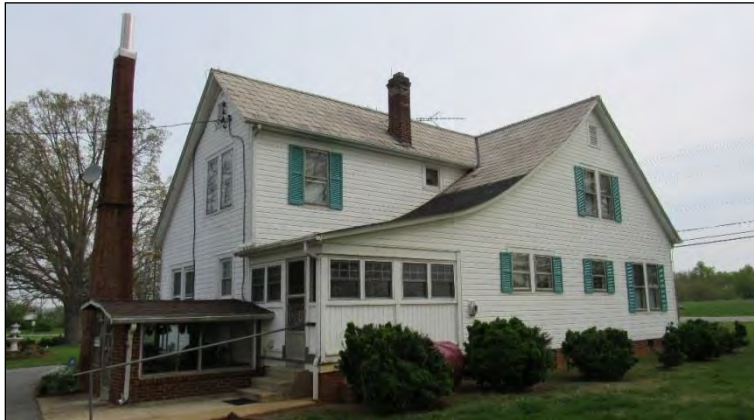
Photo 31: House, Addition Detail, Southwest Oblique.

A one-story, one-bay, enclosed-porch addition is located on the southwest corner of the resource (Photo 31). Likely dating from the late-twentieth century, the addition is clad in vinyl siding and is topped by a shed roof sheathed in asphalt shingles that slopes to the west. A metal storm door opens on the west elevation. A set of three poured-concrete steps leads to a storm door on the west elevation and connects to a poured-concrete pad and then the driveway. Additional fenestration includes three sets of paired one-over-one, double-hung-sash, vinyl windows with false muntins that give the appearance of six-over-one windows.

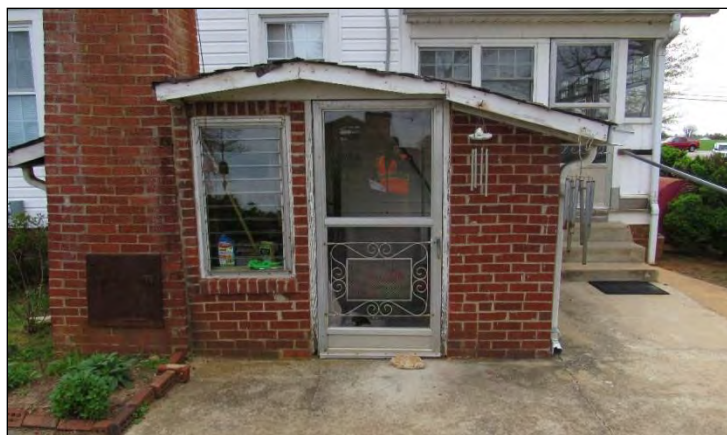
Photo 32: House, Addition Detail, West Elevation.

A one-story, two-bay, basement-entry addition extends from the west elevation, directly north of the enclosed porch (Photo 32). Clad in stretcher-bond brick veneer, the addition is topped by a low-pitched, front-gabled roof that is sheathed in asphalt shingles. A single-leaf storm door sits in the southern bay of the west elevation and leads down a set of steps to single-leaf, wood basement door. A large exterior-end, brick chimney sits on the northern end of the addition's west elevation. Additional fenestration includes single-light, fixed, wood windows and a metal jalousie window.

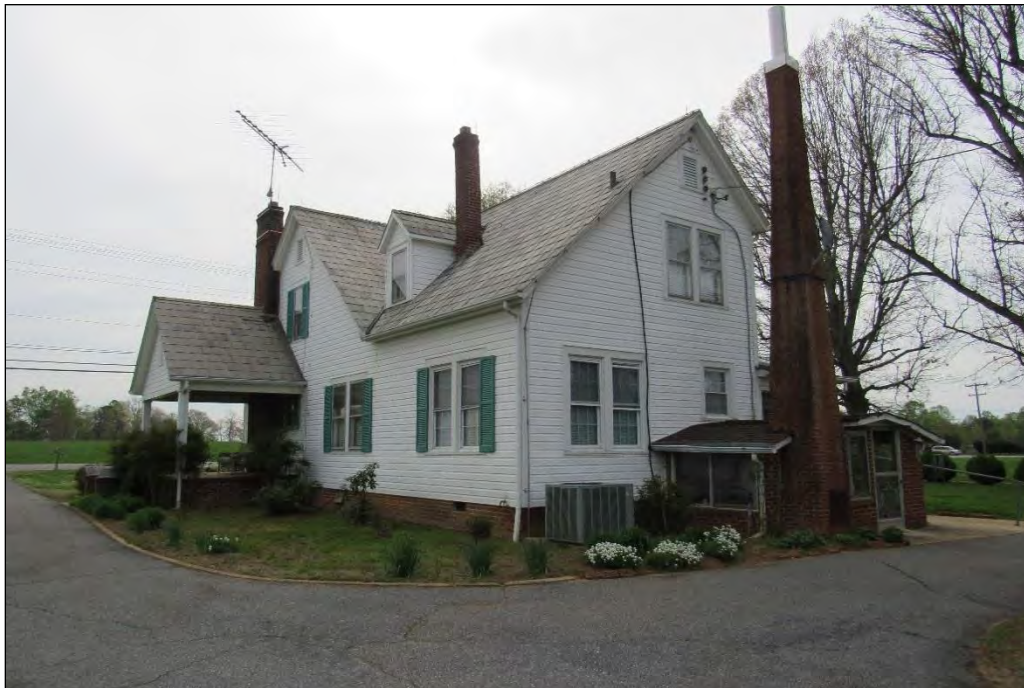
Photo 33: House, Northwest Oblique.

A one-and-a-half-story, two-bay addition extends from the northwest corner of the resource (Photo 33). Featuring the same materials as the main block, the addition is topped by an asymmetrical gabled roof. Two interior-sloped, coursed, brick chimneys with corbeled caps pierce the roofline, one on each slope. A front-gabled dormer also sits on the northern slope and features a one-over-one, double-hung sash, vinyl window. Additional fenestration includes one-over-one, double-hung-sash, vinyl windows; the windows on the north and south elevations are flanked by vinyl, fixed, louvered shutters while the windows on the west elevation are not.

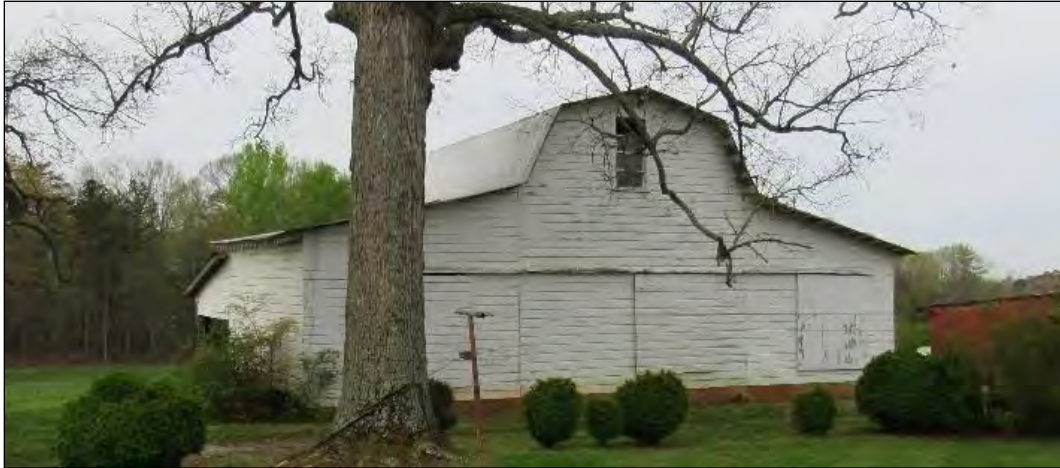
Photo 34: Barn, East Oblique.

Eight secondary resources are associated with the dwelling, all of which are concentrated near the northwest corner of the lot. A circa-1945, one-and-a-half-story, one-bay, barn is located to the southwest of the primary resource (Photo 34, p. 56). The first of these resources, a circa-1945 barn, is clad in weatherboard and is topped gambrel roof sheathed in v-crimp metal. This resource features wood windows; most of which have either damaged or missing sashes, making it difficult to determine how they were originally hung. The window in the gable end appears to have originally been a four-light, awning window. Large sliding doors are located on the primary (northeast) elevation. Two lean-to additions line the barn's southeast and northwest elevations. Built atop concrete-block-pier foundations, the additions are clad in weatherboard and topped by shed roofs sheathed in v-crimp metal with exposed rafter tails. A third lean-to addition spans the southwest elevation and is supported by round wooden posts but it has partially collapsed.

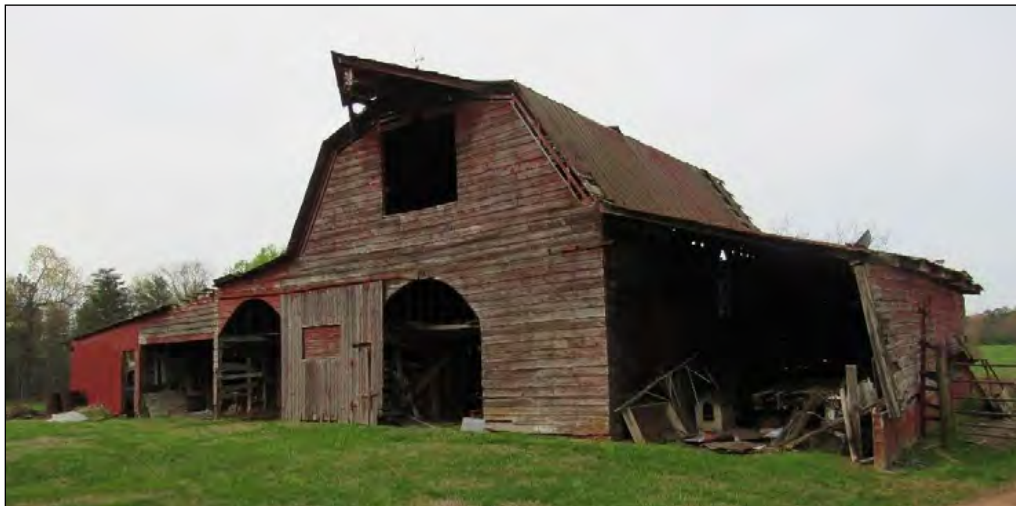
Photo 35: Barn, Northeast Oblique.

A second barn, situated slightly northwest of the previously described barn, is a circa-1945, one-and-a-half-story structure constructed around 1945 (Photo 35). The frame building is clad in weatherboard and is topped by gambrel roof sheathed in v-crimp that features a hay-hood on the east elevation. A central aisle is covered by a sliding wood door on the primary (east) elevation. Two lean-to additions line the north and south elevations. The addition on the north features on large open bay while the addition to the south features three smaller bays. Both additions are composed of the same materials as the barn. A full-width addition spans the rear (west) elevation. Featuring the same materials as the barn, this addition is topped by a shed roof that is pierced by a large, cylindrical silo composed of structural terra-cotta blocks.

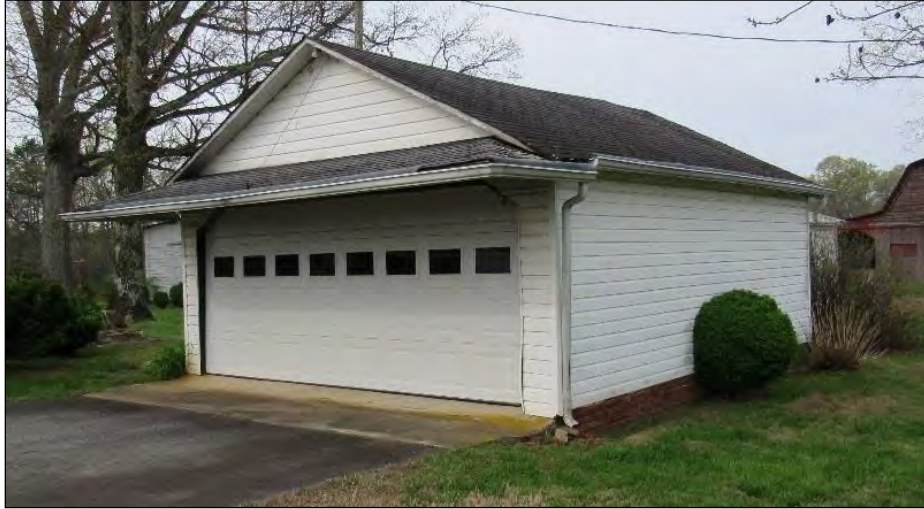
Photo 36: Garage, Northeast Oblique.

A circa-1945, one-story, one-bay, garage is located to the west of the primary resource (Photo 36). Built on a foundation clad in brick veneer, the garage is clad in vinyl siding. A front-gabled roof sheathed in asphalt shingles covers the resource and features a hipped-pent roof on the east elevation. An overhead, metal garage door opens on the primary (east) elevation beneath the pent roof. A single-leaf door opening is located on the southern elevation; however, it has been boarded over with a single sheet of plywood.

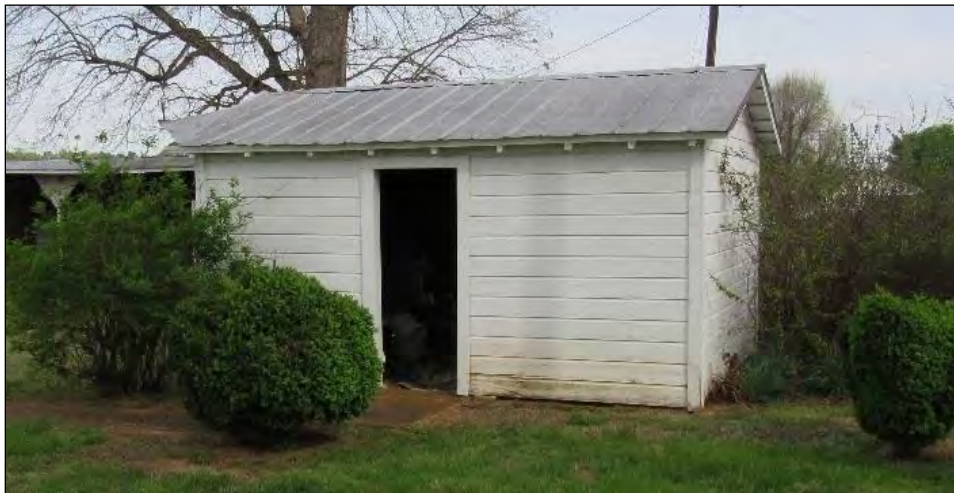
Photo 37: Shed, Southeast Oblique.

A circa-1935, one-story, one-bay, shed sits to the west of the primary resource immediately to the west of the garage (Photo 37). Clad in weatherboard siding, the shed is topped by a side-gabled roof with exposed rafter tails; the roof is sheathed in v-crimp metal. An open bay is located on the primary (south) elevation. A small poured-concrete pad leads to the bay.

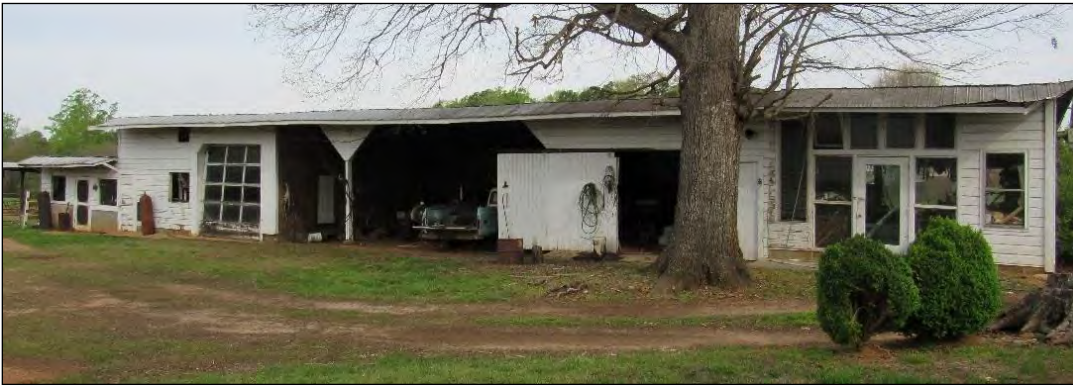
Photo 38: Machine Shed, South Elevation.

A circa-1945, one-story, five-bay, machine shed sits to the northwest of the primary resource (Photo 38). The wood-framed building is clad in weatherboard siding and topped by shed roof sheathed in v-crimp metal. The two eastern-most bays and the western-most bay on the primary (southern) elevation are enclosed, while the two central bays are open. The western-most bay is accessed through a canopy-style, wood-and-glass garage door, while the two eastern enclosed bays are accessed through a wood-and-glass, single-leaf door and a single-leaf, solid, wood door. A three-bay addition extends from the shed's west elevation. Featuring the same materials as the main shed, it features a saltbox roof and a single-leaf door centered on the southern elevation.

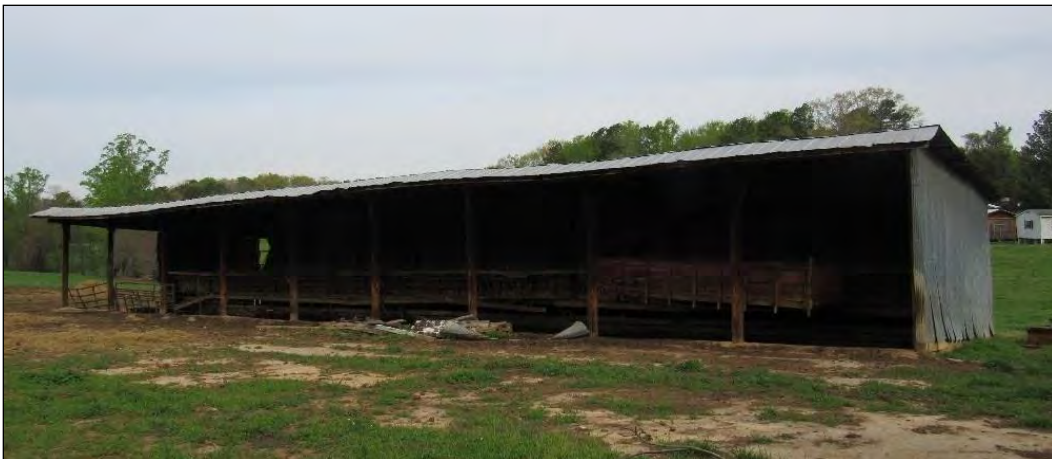
Photo 39: Loafing Shed, Southeast Oblique.

A circa-1950, one-story, nine-bay, loafing shed (a barn or shed in a pasture or paddock that provides shelter for free-ranging horses or cattle) sits to the northwest of the primary resource (Photo 39). The wood-framed building is clad in corrugated metal siding and topped by a shed roof sheathed in v-crimp metal. All of the bays on the primary (southern) elevation are open.

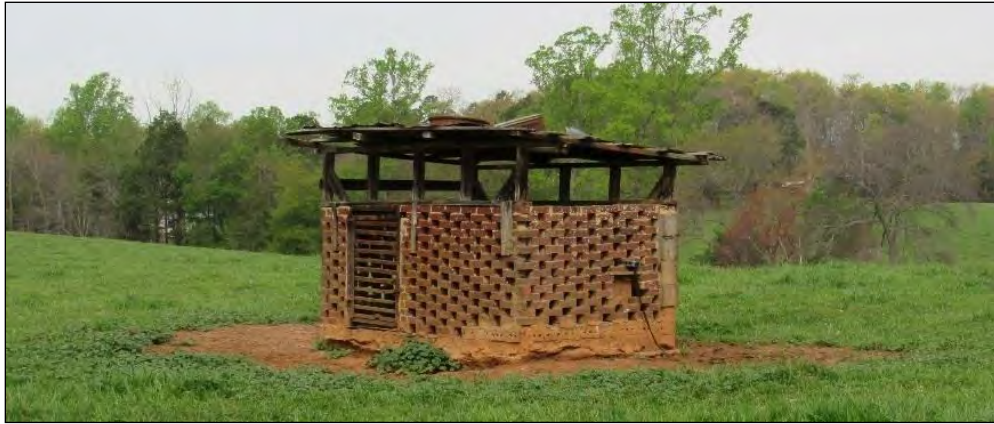
Photo 40: Outbuilding, Southeast Oblique.

A circa-1950, one-story, one-bay, outbuilding sits to the west of the primary resource (Photo 40). The lower two-thirds of the building is composed of a ventilated brick wall. The remaining one-third of the building is exposed, leaving the square, wood framing visible. A shed roof tops the building sheathed in v-crimp metal. A metal gate opens in the primary (south) elevation.

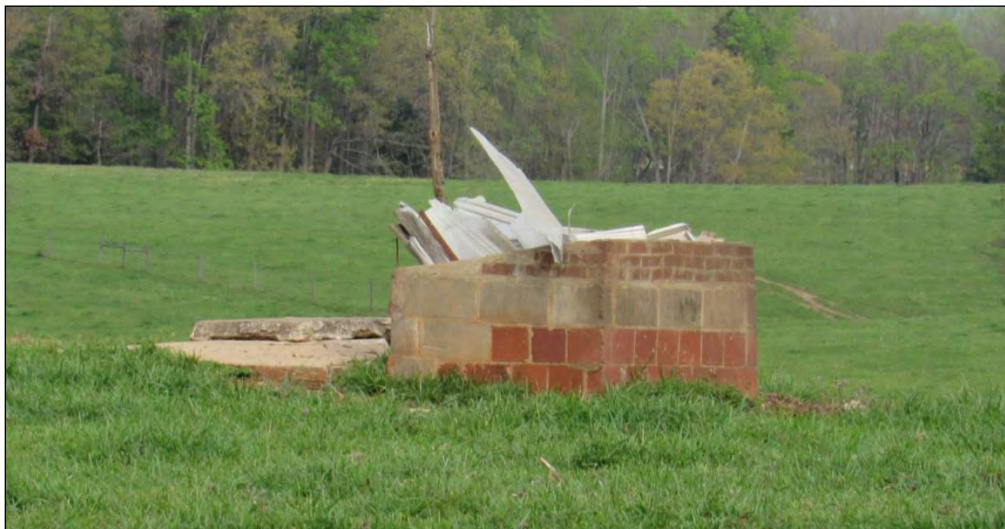
Photo 41: Foundation Remains, Looking North.

The foundation remains of a demolished outbuilding sit to the west of the primary resource. The outbuilding, which appears on 2014 aerial images, was a rectangular building about the same size as the loafing shed. However, the 2014 images showed it to be in ruinous condition with large sections of its roof cladding missing and was demolished between 2014 and 2015 (Photo 41).
