SUBJECT: Historic Structures Survey Report, Upgrade of Existing NC 127 from SR 1400
to SR 1156, R-3603A, PA 16-10-0022, Alexander and Catawba Counties, ER 18-0268

The report considers eight resources: five houses, two churches, and an agricultural complex. The study recommends all but one as not eligible for listing in the National Register of Historic Places. The House at 93 Telephone Exchange Road (AX0069) is recommended as eligible under Criterion C. Initial screening of the R-3603A project area by NCDOT Historic Architecture identified which resources warranted additional study.

As a result of this investigation, one resource is recommended as eligible for the NRHP, a one-story, Contemporary-style dwelling constructed in 1966. The house at 93 Telephone Exchange Road (AX0069) **is recommended eligible for the NRHP under Criterion C for its association with the post-World War II housing boom in Alexander County and as a unique example of the Contemporary style's application in a rural setting.**

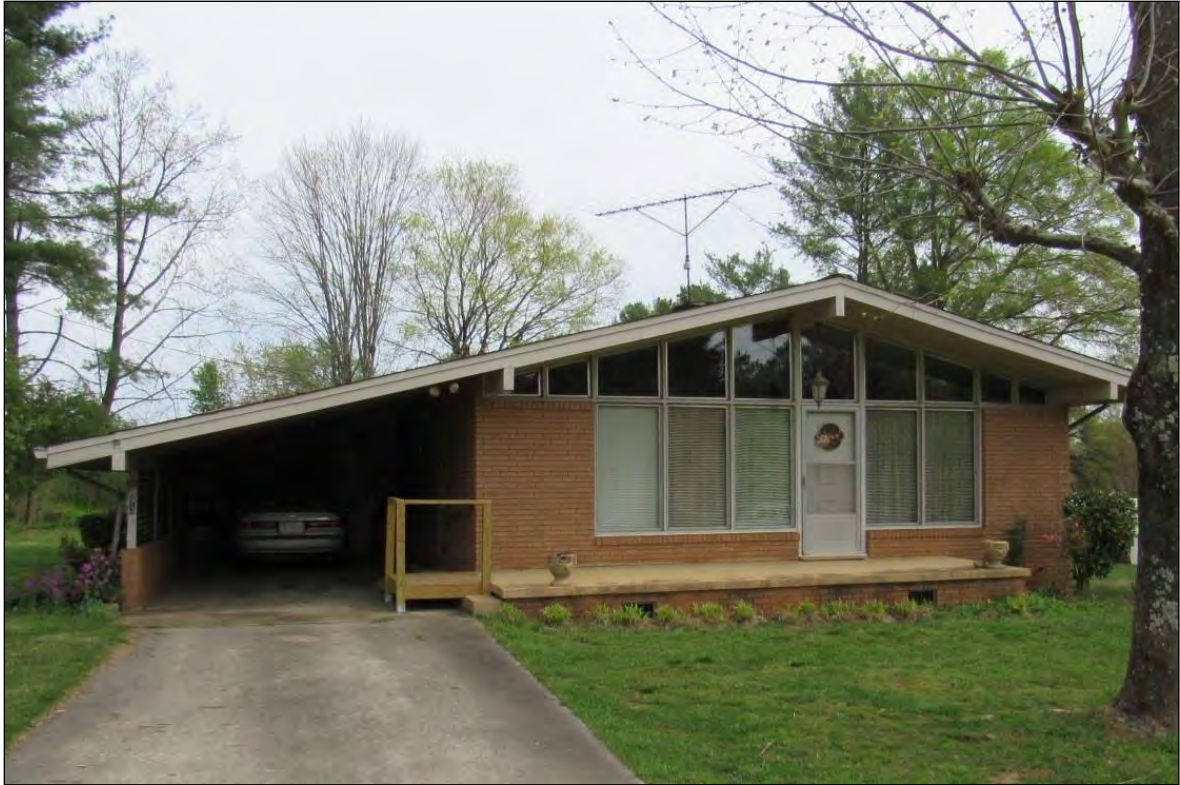
Photo 44: House, South Elevation.

The House at 93 Telephone Exchange Road is a one-story, one-bay, single-family dwelling built around 1965 in the Contemporary style (Photo 44, p. 67).⁶³ Constructed on a continuous foundation that is likely a concrete slab, the house's structural system was not visible, but is clad in a stretcher-bond brick veneer. A low-pitched, front-gabled roof with deep-overhanging eaves, sheathed in asphalt shingles, tops the dwelling. It features large exposed rafters and board-and-batten soffits. The roof is pierced by a broad and low, interior-slope, brick chimney on the eastern side of the ridgeline. The western side of the roof continues to slope beyond its connection with the house and extends over the poured-concrete driveway to form an attached carport (Photo 45, p. 67). The western edge of the carport is supported by square, wooden posts filled with wooden lattice and set on a brick-veneer-clad wall.

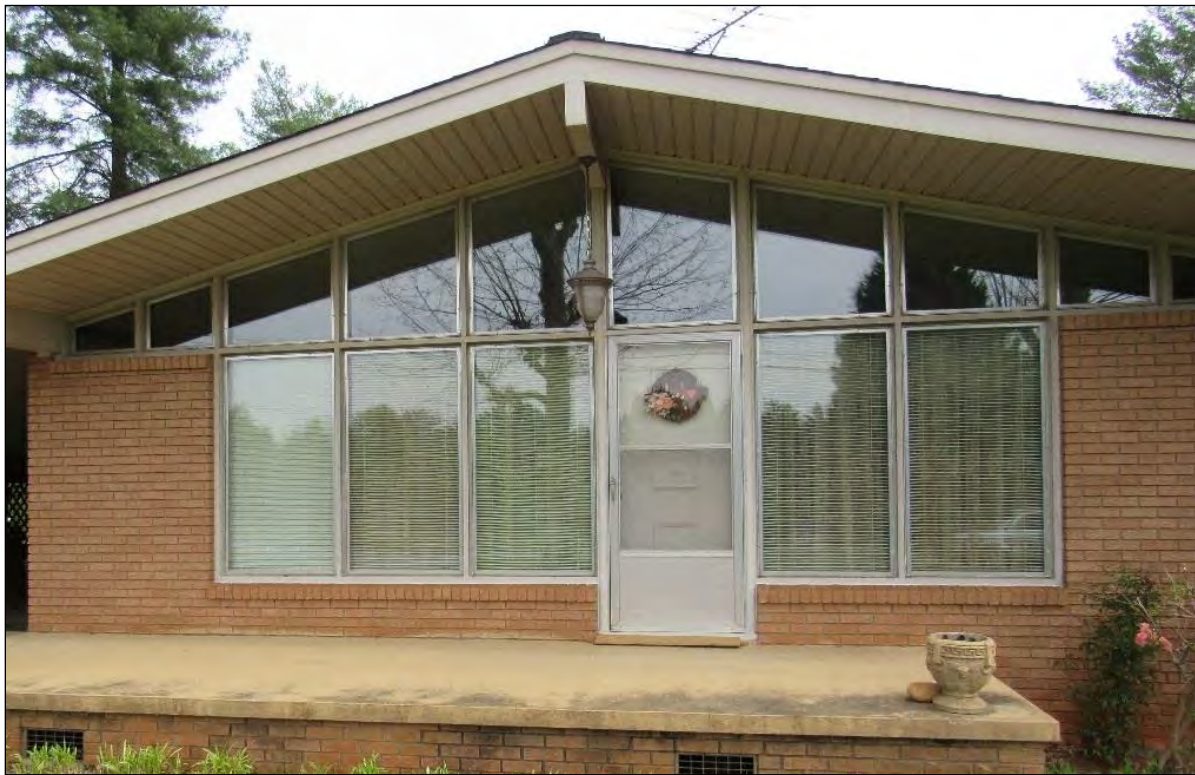
Photo 46: House, Window Detail, South Elevation.

The primary entrance—a single-leaf, wooden door with three vertically-stacked, paneled, square rosette details and a storm door—is centered on the south elevation (Photo 46). The primary entrance is set in a large-single bay composed of the door and five large, fixed-light, metal windows with two to the east of the door and three to the west. Ten additional single-light, fixed-metal, trapezoidal windows sit atop the door and other windows, spanning the entire southern gable end. A stoop clad in a stretcher-bond veneer with a poured-concrete deck sits in front of the western half of the southern elevation. One poured-concrete step leads from the driveway to the stoop but a wood ramp has been constructed over the step and runs along the house’s west elevation beneath the carport.

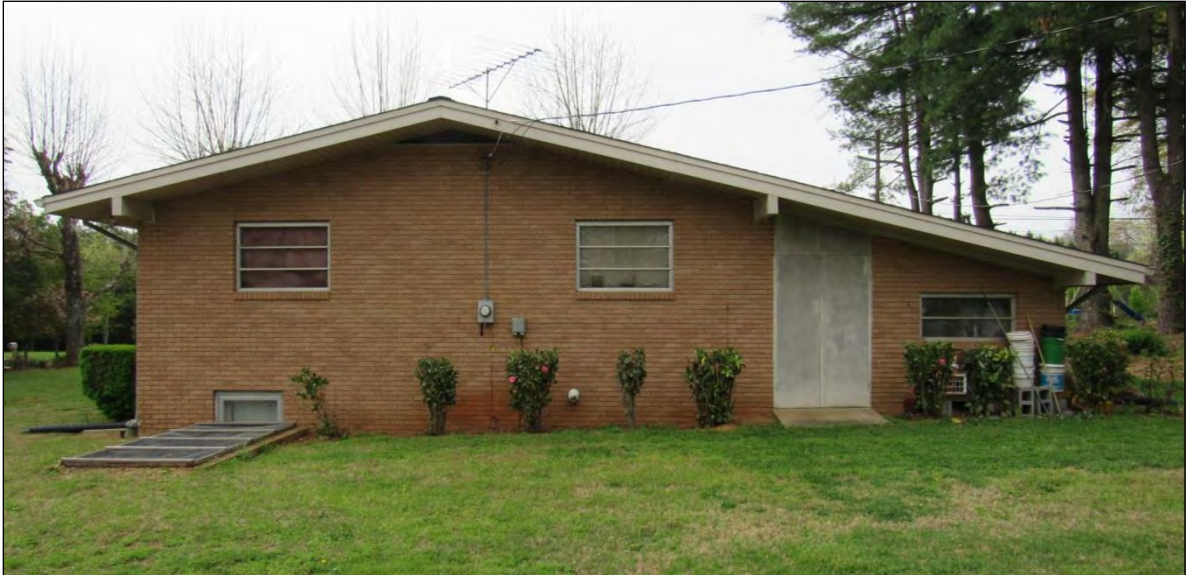
Photo 47: House, North Elevation.

Additional fenestration on the remaining elevations of the house includes two-and-three-light, metal-framed, awning windows. A secondary entrance, located to the west on the rear (north) elevation of the resource, is filled with a double-leaf, flush, metal door (Photo 47, p. 69). An entry to the basement is also located on the north elevation. A set of poured concrete stairs lead down approximately five feet to the single-leaf, wood door topped by three fixed lights.

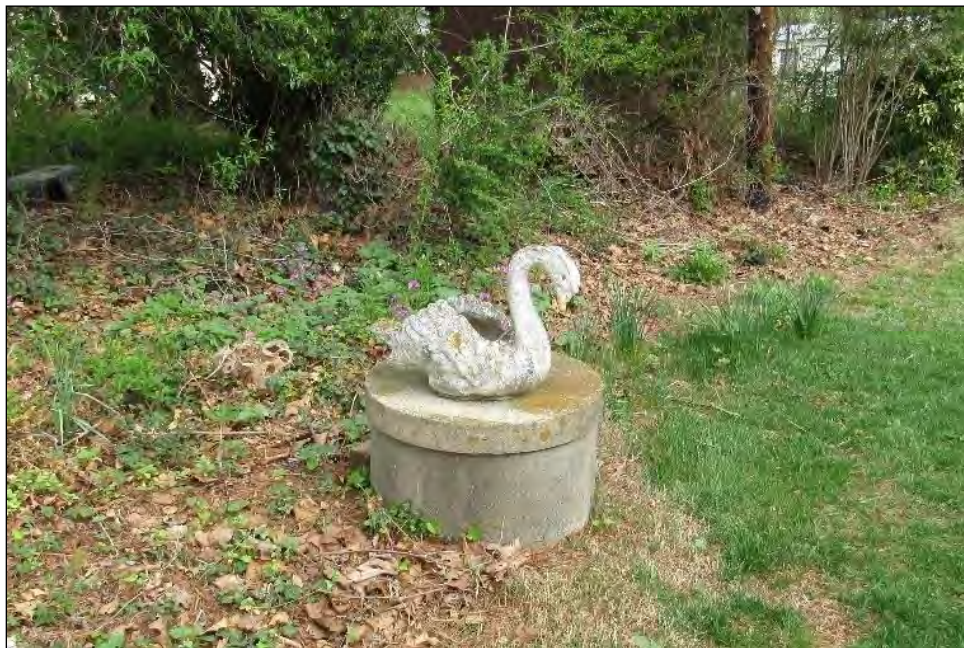
Photo 48: Well Cap, Looking North.

There is only one secondary resource located at 93 Telegraph Exchange Road: a circa-1965 well cap located west of the dwelling (Photo 48, p. 69). It is cylindrical in shape and constructed of poured concrete. This well is the only secondary resource associated with the resource and is set where the edge of the manicured grass lawn meets with a band of landscaped shrubbery.

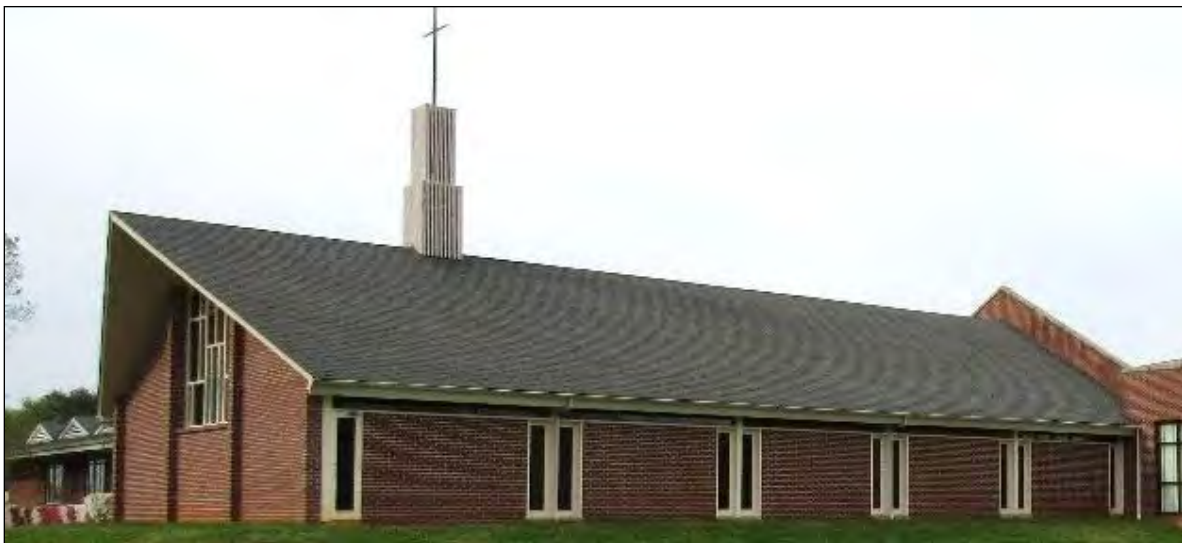
Photo 53: Mount Bethel United Methodist Church, Northeast Oblique.

The church is a one-story, one-bay building built around 1962 with Contemporary-style attributes (Photo 53). Both the church's foundation and structural system are clad in a stretcher-bond, brick veneer. A front-gabled roof with deep-overhanging eaves and boxed soffit, sheathed in asphalt shingles, tops the church. A small, rectangular, fluted-concrete steeple sits on the ridgeline near the eastern end of the building and is topped by a slim metal cross. A gabled brick parapet is located on the west elevation and separates the main core of the church from the additions.

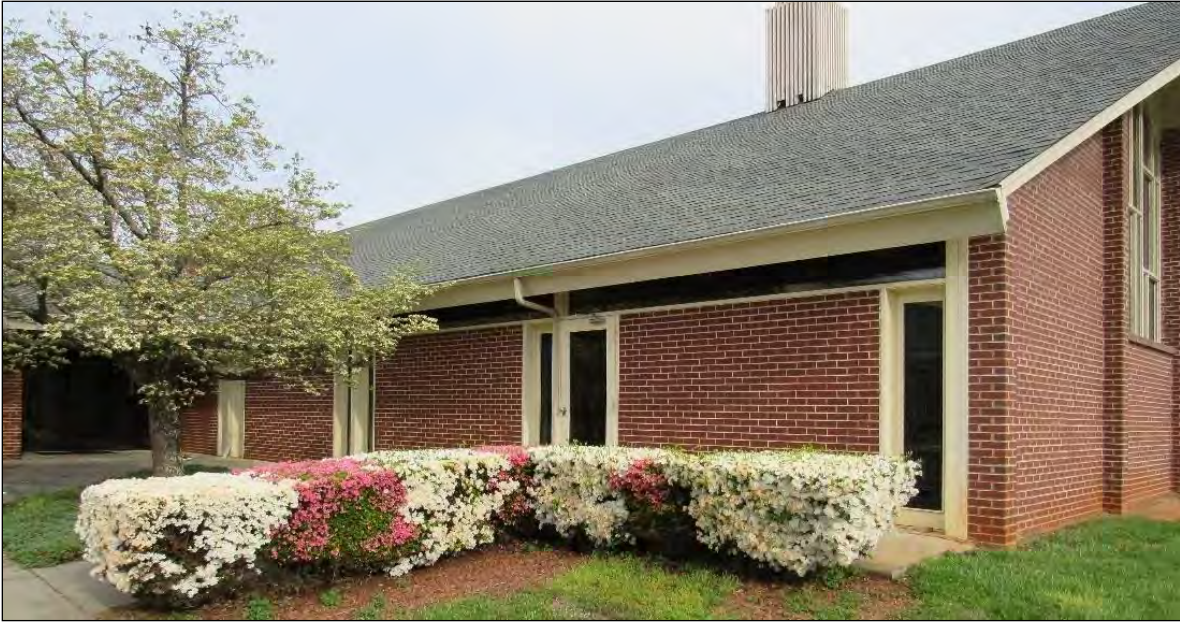
Photo 54: Church, View of South Elevation.

On the eastern elevation, which faces the road, the church features a large multi-light, fixed, wooden, stained-glass window (Photo 54, p. 82). On the other elevations fenestration includes multi-light, fixed, wooden windows; and single-light, fixed, wooden, stained-glass windows. Although they are not the church's primary entrance, several single-light, wood-and-stained-glass doors open on the north and south elevations.

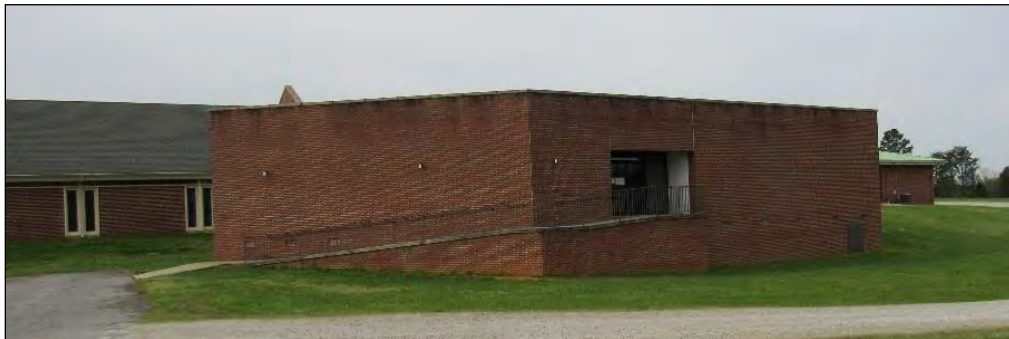
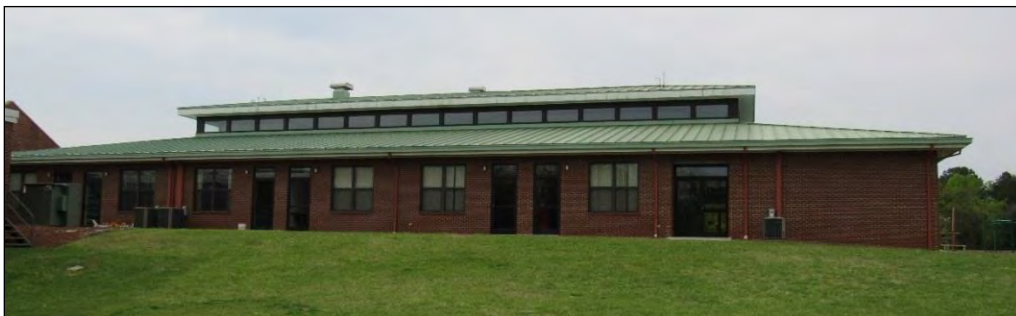
Photo 57: Hyphen for the Circa-2000 Addition, Northeast Oblique.

Around 2000, a one-story, five-bay building was constructed west of the church and connected to the original building with a one-story, irregularly shaped, flat-roofed hyphen (Photo 57 and Photo 58). Clad in brick-veneer, the addition is topped by a hipped roof sheathed in standing-seam metal. A hipped-roof clerestory is centered roof ridgeline and features 16 fixed, metal-framed windows running the full length. Two square metal vents with metal caps pierce the roofline in the clerestory. Other fenestration includes paired one-over-one, fixed, metal windows and single- and double-leaf, metal-and-glass, commercial style doors.

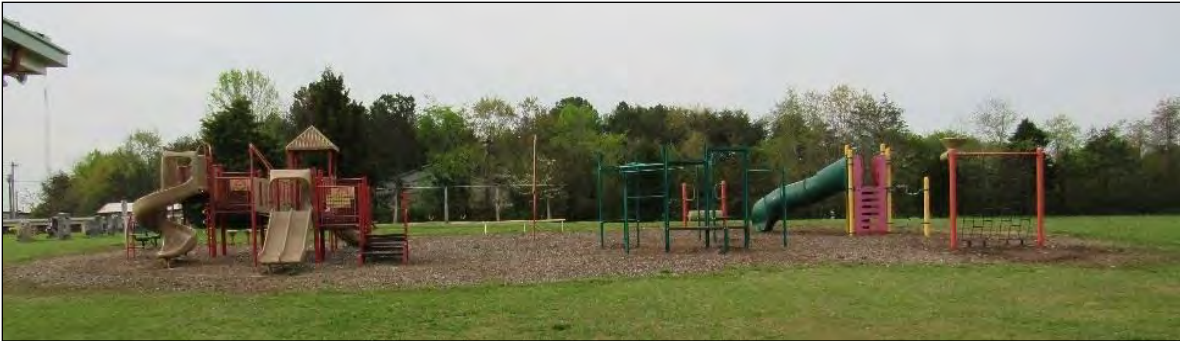
Photo 59: Playground, Looking West.

There are three secondary resources associated with the Mount Bethel United Methodist Church: a playground, a sign, and a cemetery. The circa-2000 playground sits to the southwest of the most recent addition (Photo 59). It is composed of a wood-framed swing set, a metal-and-plastic funnel ball set, several sets of monkey bars, a free-standing plastic tube slide, and a large tower featuring a flat slide, spiral slide, and several metal climbing elements.

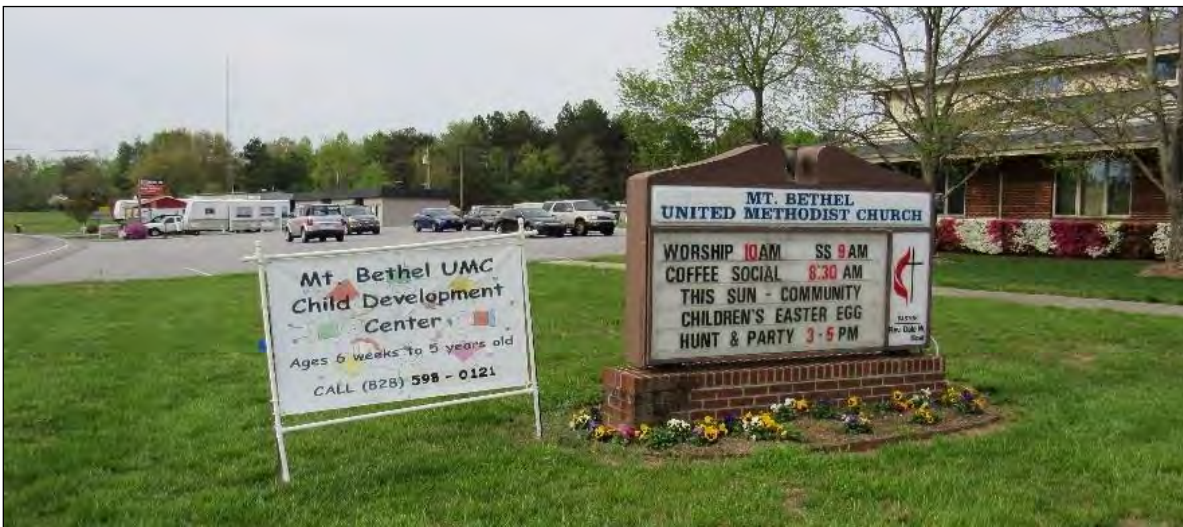
Photo 60: Sign, Looking South.

A circa-1990 sign sits to the west of the primary resource (Photo 60). Built on a brick foundation, the metal-framed sign features a backlit plastic board with shallow plastic trays that hold letters printed on plastic sheet.

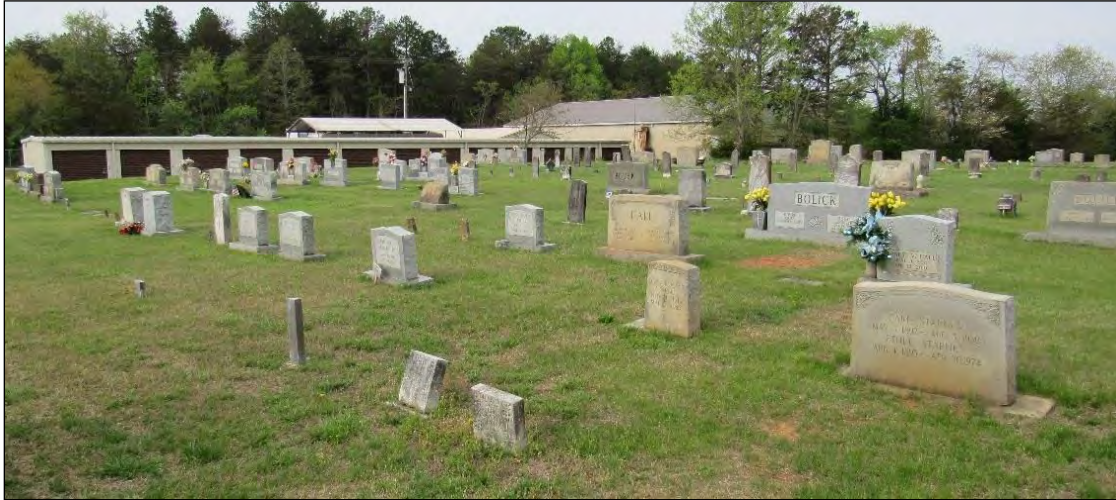
Photo 61: Cemetery, Looking Southwest.

A cemetery affiliated with the church sits to the southwest of the primary resource (Photo 61, p. 85). The cemetery has approximately 100 interments which are laid out in a grid pattern. The cemetery's earliest interment dates to 1885, with the majority of the burials date from the 1950s and 1960s. The cemetery appears to still be in active use by the church, with the most recent interments dating to 2015. A majority of the stones are made of granite or marble, some of which

feature footstones as well. The cemetery grounds are covered by manicured grass and do not currently feature any fences or boundaries.

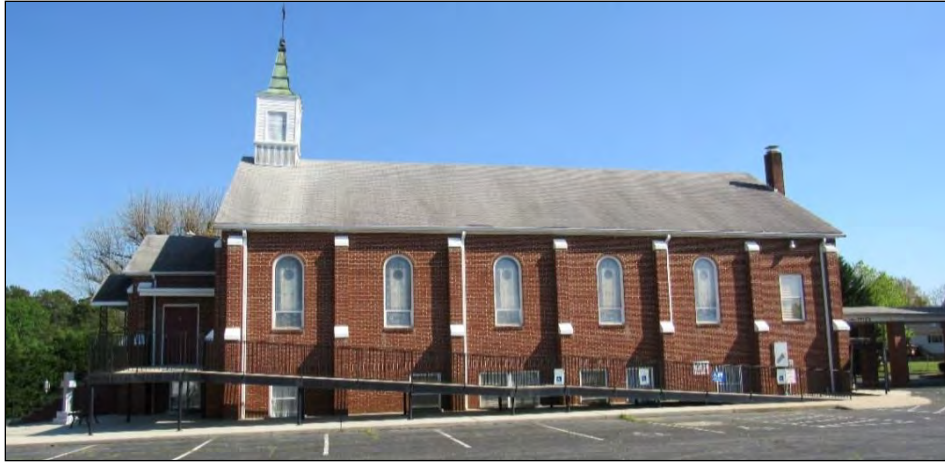
Photo 65: Shiloh Lutheran Church, Northwest Elevation.

The primary resource is a one-and-a-half-story, three-bay church constructed in 1951 in the Colonial Revival style on a linear plan (Photo 65, p. 95). Constructed atop an English basement clad in brick veneer, the church's structural system is covered by a stretcher-bond brick veneer. The veneer features a decorative course between the English basement and the rest of the building known as a soldier row. Decorative buttresses line the building, flanking each window on the southeast and northwest elevations as well as the porch on the primary (northeast) elevation. A front-gabled roof sheathed in asphalt shingles tops the church. A rectangular steeple clad in vinyl siding rises from the northeast ridgeline of the roof and features a copper pyramidal roof with a slim cross at its apex. An exterior-end, brick chimney sits on the church's southwest elevation.

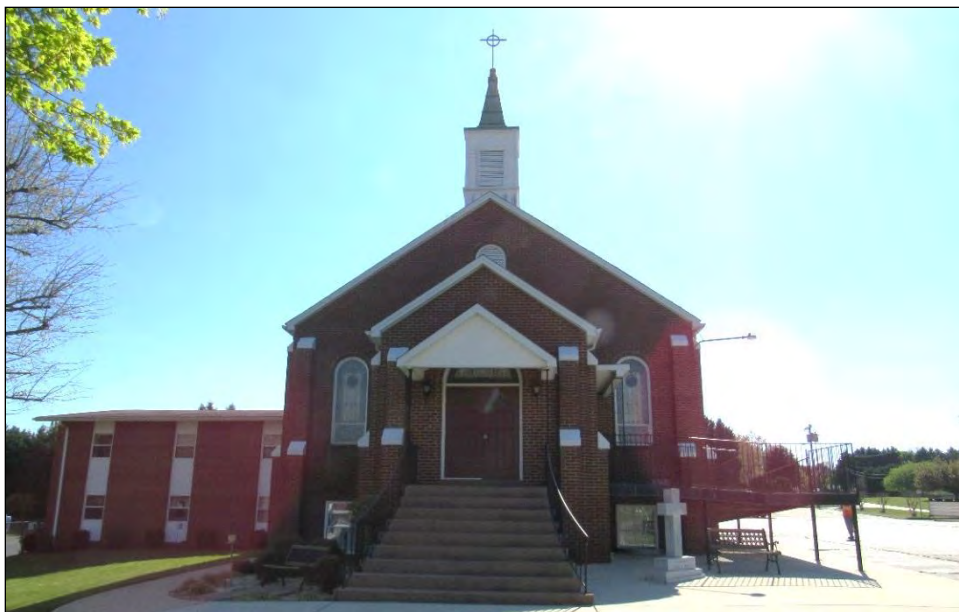
Photo 66: Church, Northeast (Primary) Elevation.

The primary entrance is centered on the northeast elevation and is filled with a double-leaf, four-paneled, wood door (Photo 66, p. 95). Each leaf features a four-light fanlight, and the entire door is set beneath a large stained-glass fanlight bearing the inscription "Shiloh Lutheran Church Welcome." Brass sconces flank the door.

The church's narthex extends from the primary (northeast) elevation and features the same materials as the main core of the church (Photo 66). Two fixed, arched, wooden stained-glass windows flank the narthex. A one-story, one-bay, entry porch extends from the narthex. Built atop a brick-veneer-clad stoop, the porch's front-gabled roof is covered in asphalt shingles and is supported by decorative metal posts. A small shed-roof porch extends off the narthex's northwest elevation and covers the end of an elevated metal wheelchair ramp that runs along the church's northwest elevation. Additional fenestration on the southeast and northwest elevation includes one-over-one, double-hung-sash, vinyl windows on the basement level with fixed, arched, wooden, stained-glass windows above.

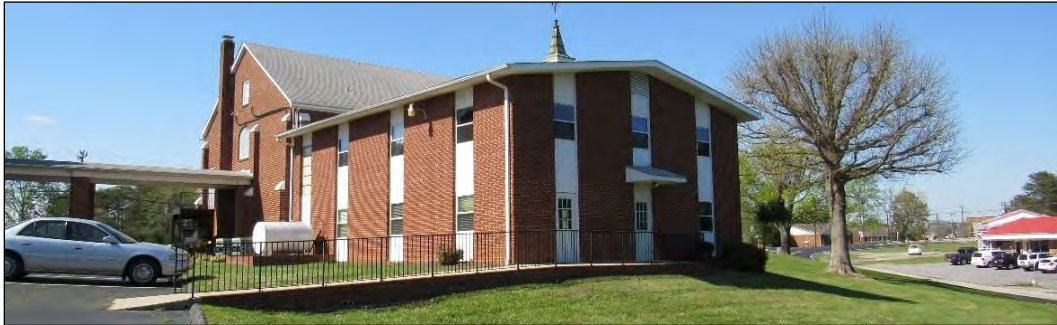
Photo 67: Church Addition South Oblique.

A two-story, four-bay, circa-1965 addition extends off the southern end of the church's southeast elevation (Photo 67). Featuring the same materials as the main church, the addition's brick veneer is laid in a five-to-one common bond. A low-pitched, side-gabled roof tops the addition. A single-leaf, half-glazed, wood door opens in the northern-most bay on the northeast elevation and is covered by a pent roof. Another single-leaf, half-glazed, wood door is centered on the southeast elevation and is also topped by a pent roof.

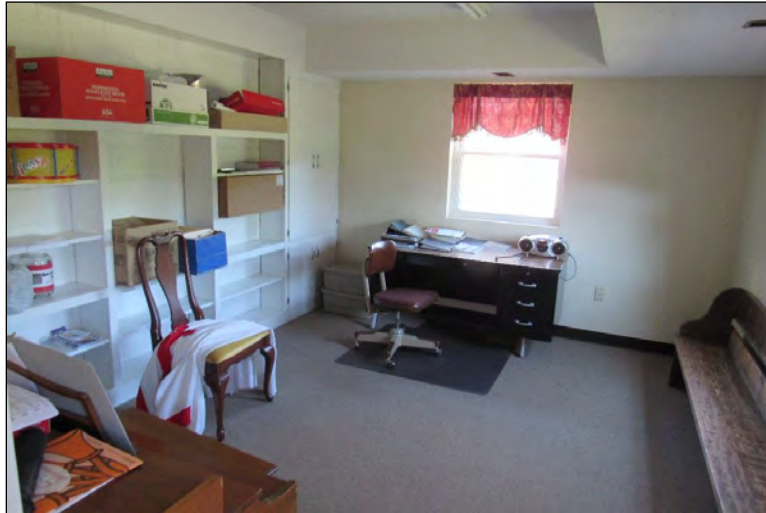
Photo 69: Interior Detail of Shiloh Lutheran Church, View of the Sacristy.

Within the altar's recessed archway, a door on the northwest wall leads into the sacristy (Photo 69). The basement area directly beneath the altar features several of the church's classrooms, as well as the choir room, and two restrooms. What had previously been used as the church hall before the construction of the separate building for that use, is located in the basement beneath the main body of the church. Other classrooms, offices, and the church's library are set beneath the narthex and on the first floor of the circa-1965 addition.

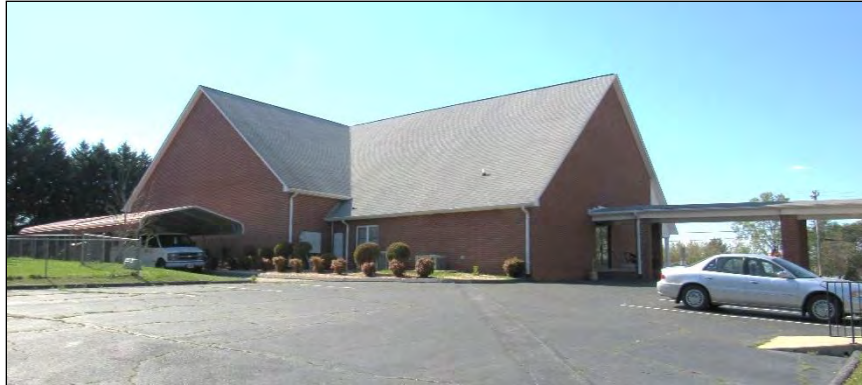
Photo 70: Church Hall, East Oblique.

Throughout much of the second half of the twentieth century the addition on the back of the church building served the church as a space for meetings, classrooms, and storage. However, in the mid-1990s, the congregation was in need of additional space and they constructed a new hall (Photo 70, p. 99).. The building's continuous foundation and structural system are clad in a stretcher-bond brick veneer. A cross-gabled roof sheathed in asphalt shingles tops the building. The primary entrance is centered on the northeast elevation and is filled with a double-leaf, metal-and-glass, commercial-style door. Two secondary entrances sit on the northwest elevation: a single-leaf, six-panel door opens directly on the northwest elevation while a double-leaf, six-panel door opens on the northeast elevation of the projecting cross gable. Additional fenestration includes one-over-one, double-hung-sash, vinyl windows and arched, fixed, metal-framed, stained-glass windows. A one-story, three-bay, recessed porch covers the three northern bays on the northwest elevation. The porch's roof is supported by Tuscan columns and features a Tuscan pilaster on the northern end of the building. A covered walkway connects the church hall with the main church. Topped by a low-pitched, gabled roof, the covered walkway is supported by four, square, brick posts.

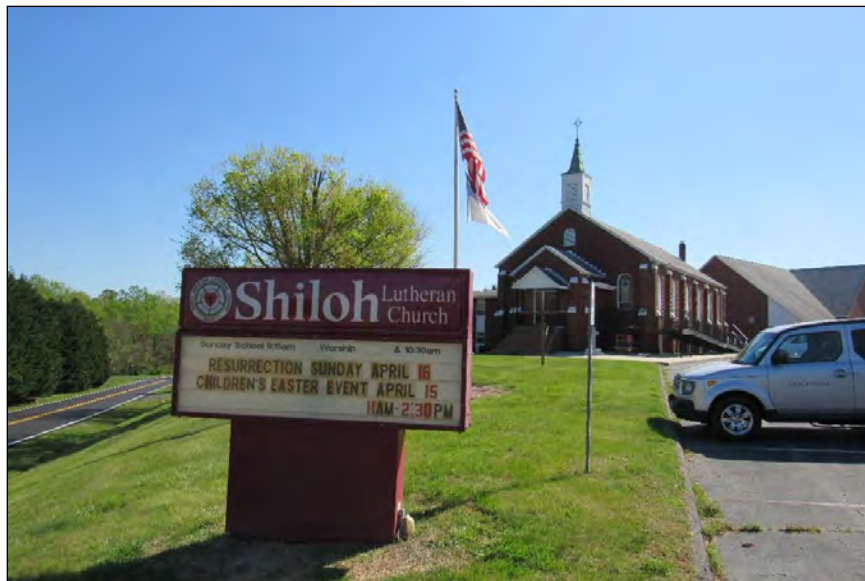
Photo 71: Sign, Looking South.

A circa-1995 sign sits to the northeast of the primary resource (Photo 71). The metal-frame sign is supported by a rectangular metal post and features a back-lit plastic board. The board features the church's worship schedule as well as three rows of plastic trays that can hold plastic letters for customized messages.

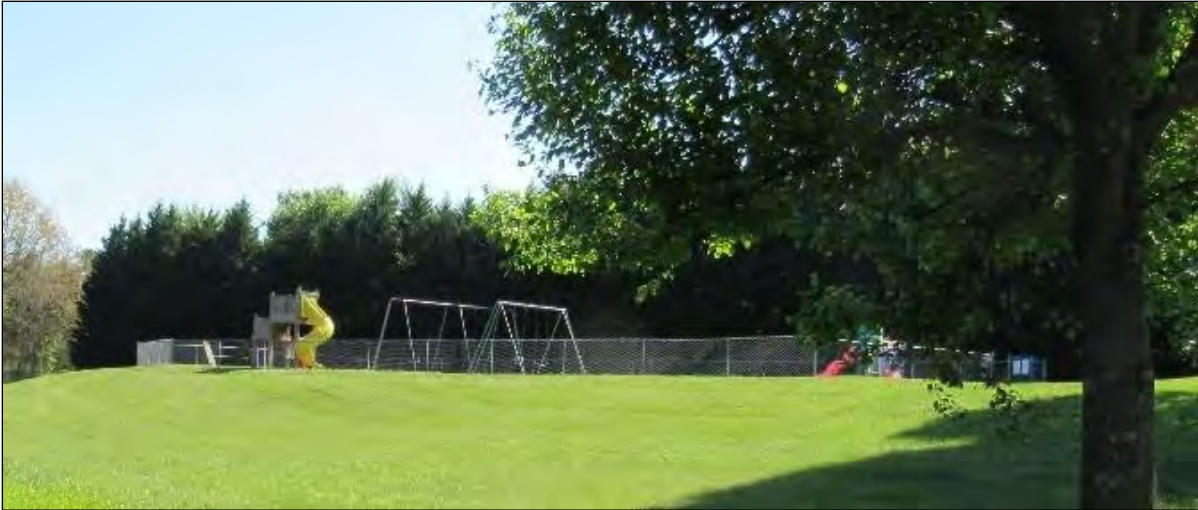
Photo 72: Playground, Looking South.

A circa-1995 playground sits to the south of the primary resource (Photo 72). Enclosed by a metal chain-link fence, the playground is composed on two metal-framed swing sets and a wood climbing tower with a plastic tube slide.

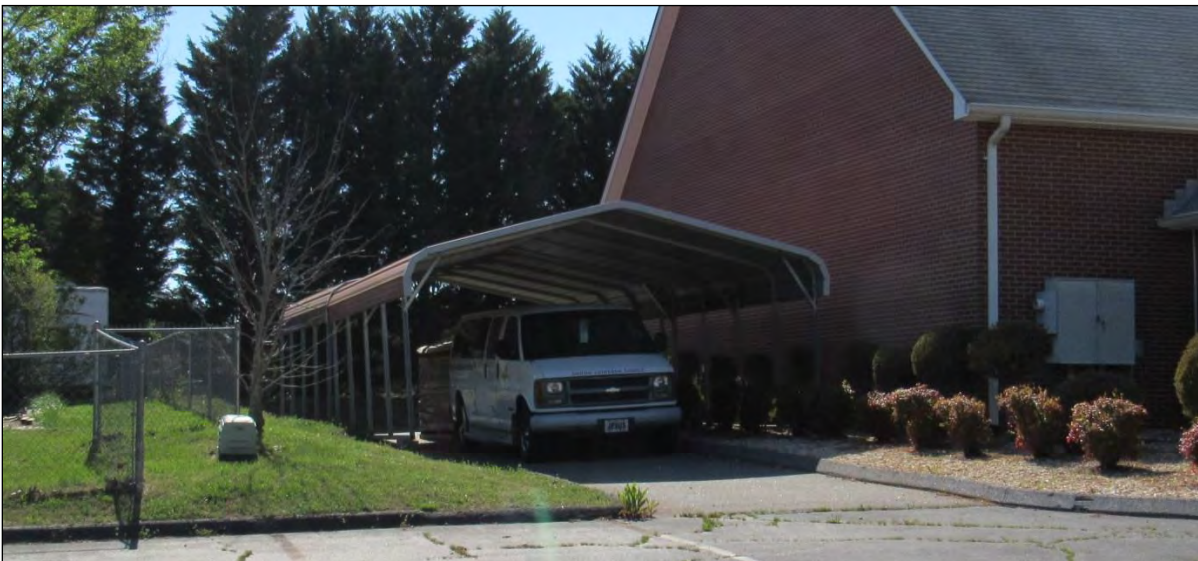
Photo 73: Carport, East Oblique.

A one-bay, circa-2000 carport sits immediately to the southeast of the church hall (Photo 73). The metal-frame structure is topped by a low-pitched, front-gabled roof sheathed in corrugated metal.

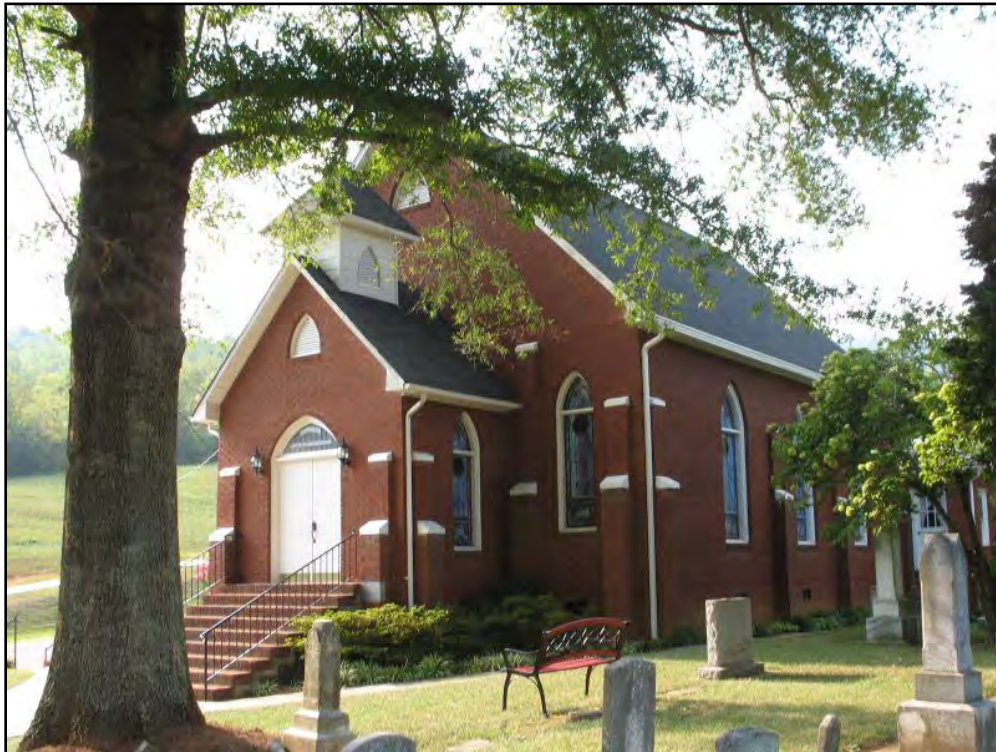
Photo 74: Mt. Olive Baptist Church, 210 Mt. Olive Church Road, Taylorsville, North Carolina.

A number of Colonial Revival-styled churches can be found in the general area. The two pictured below are just a couple of examples (Photo 74–Photo 75, p. 104). The first, Mt. Olive Baptist Church in Taylorsville, was constructed in 1957. This building’s form and massing resembles that of Shiloh Lutheran Church and features a similar gabled entry and decorative buttresses as well. The second, Friendship Baptist Church (CT1291), was built in southwest Hickory in 1958.

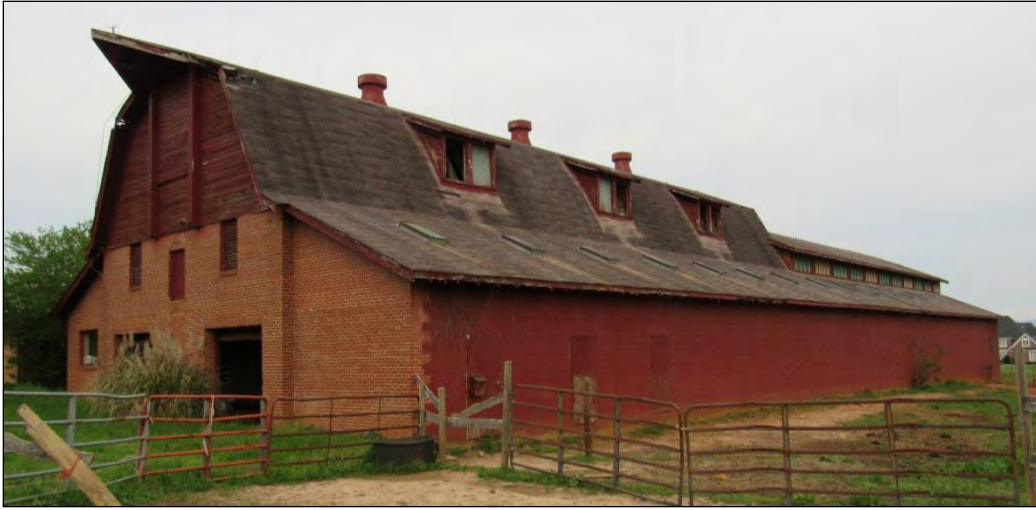
Photo 76: Horse Barn, East Oblique.

A circa-1950, one-and-a-half-story, two-bay, horse barn is located on the east side of the building cluster (Photo 76, p. 110). The foundation and structural system for the first floor have a brick veneer laid in a five-to-one-common bond with a decorative course about halfway up the building. This is topped by the half story that appears to be wood framed and clad in weatherboard. It is covered by a gambrel roof with exposed rafter tails and sheathed in asphalt shingles. The front gable features a large hay hood. Three shed dormers line both the northeast and southwest roof slopes. These dormers feature two-light, fixed, wood-frame windows. Three large metal flues pierce the ridgeline of the roof.

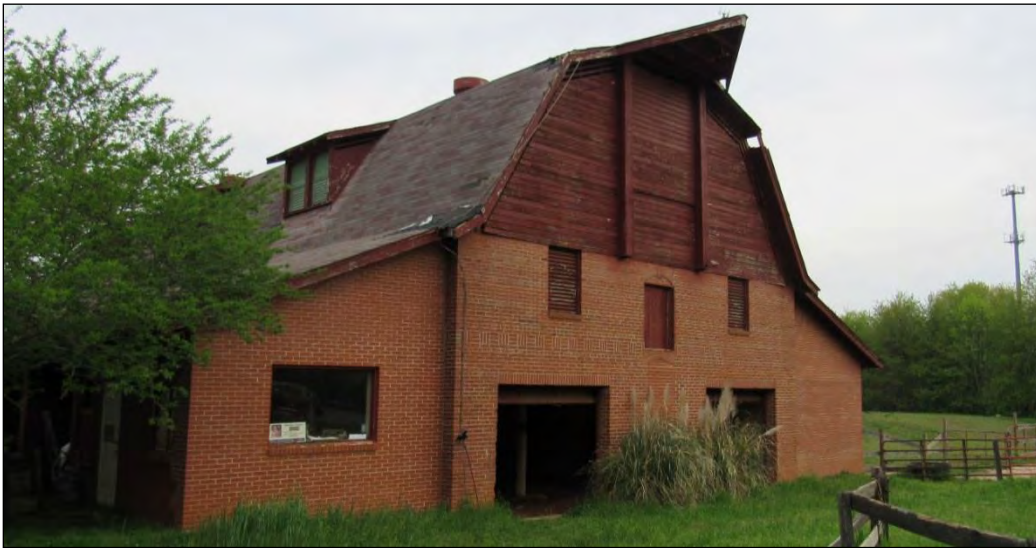
Photo 77: Horse Barn, Southeast Elevation.

The primary entrance, located on the southeast elevation and facing the road, features two large open bays (Photo 77, p. 110). A louvered vent is located above each open bay. Additional fenestration on the primary elevation includes a centered window opening topped by a segmental arch that has been boarded up. Another segmental arch is located directly under the boarded up window opening, suggesting that there had been another window located there. The barn is flanked by one-story, one-bay, full length additions. These additions are composed of concrete block with brick veneer on the primary (southeast) elevation and are covered by shed roofs sheathed in asphalt shingles. These additions feature multiple single-leaf, flush wood doors as well as skylights along the roof slope.

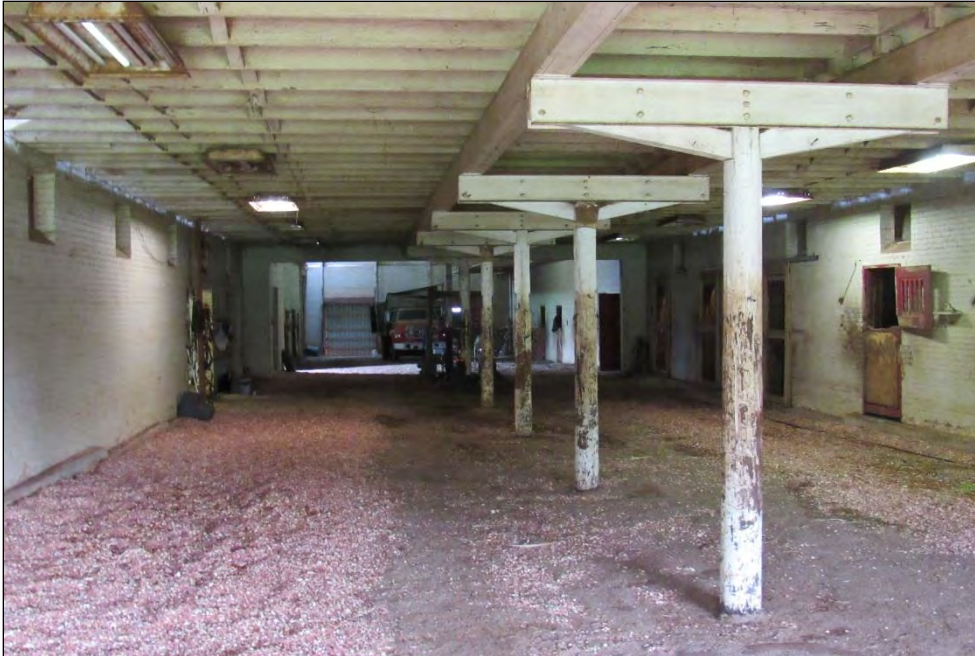
Photo 78: Interior of the Horse Barn, Looking Northwest.

Access was obtained to the first floor of this barn. The barn is built on an open linear plan with a poured-concrete aisle running down the center (Figure 49, p. 111; Photo 78, p. 112). Large wood posts line the aisle, supporting the exposed ceiling joists. The walls are composed of brick laid in a five-to-one common bond. Upon first entering the barn, a single-leaf, three-paneled, wood door with six-fixed lights at the top is located directly to the southwest and leads to an office. The northeast side of the barn is lined with horse stalls, most of which feature a single-leaf, Dutch-style, wood door. Both the northeast and southwest sides of the barn have three-light, fixed, metal-framed windows. A set of stairs are located on the northwest end of the barn and lead to the loft or half story above.

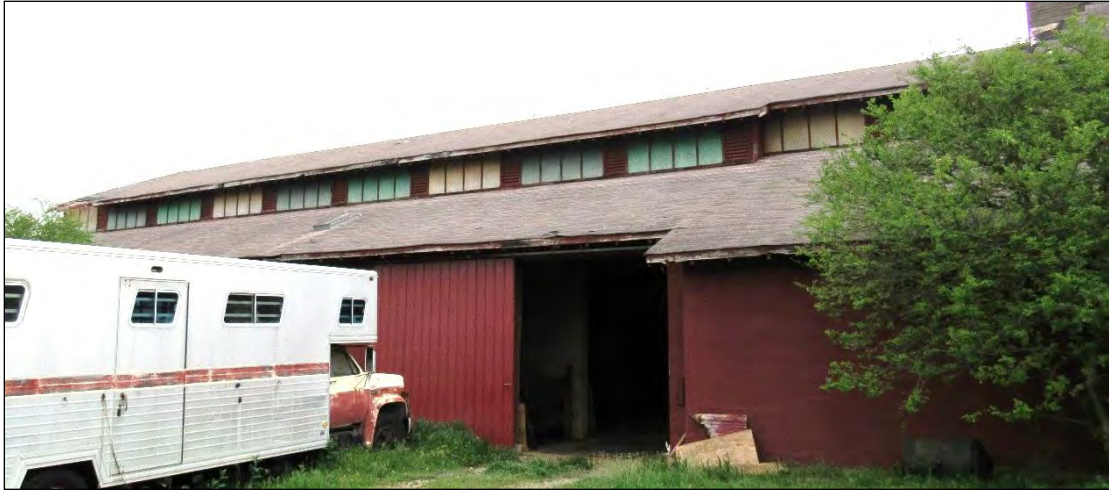
Photo 79: The Horsebarn LLC, Addition Detail, Southwest Elevation.

A circa-1970 addition extends from the northwest elevation of the horse barn (Photo 79, p. 113). It is equal in size and massing to the original core. The foundation and structural system are composed of concrete block and are covered by a front-gabled roof with exposed rafter tails sheathed in asphalt shingles. A gabled clearstory extends the entire ridgeline of the roof and features four-light, fixed, wood-frame windows separated by louvered vents. All of the windows have been boarded up. A large, sliding metal door is located on the southwest elevation.

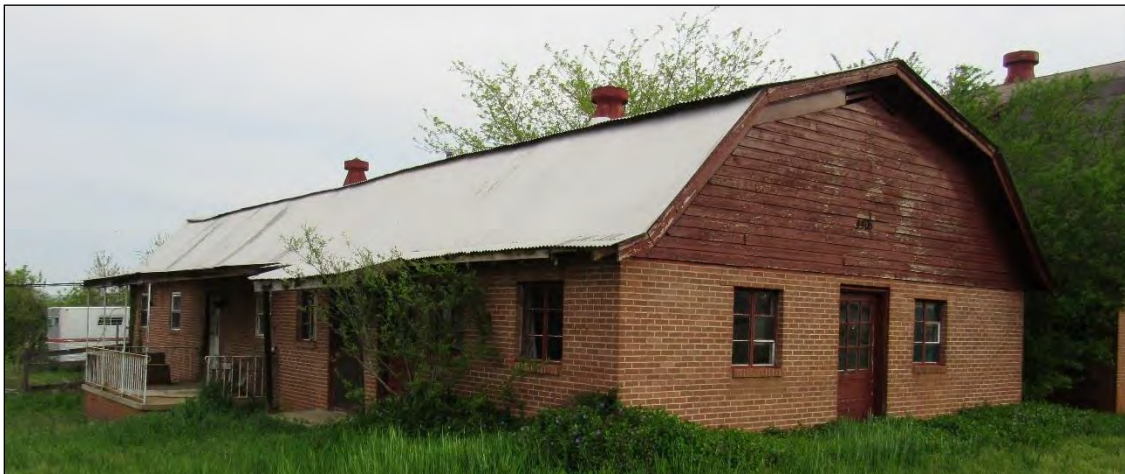
Photo 80: Office, South Oblique.

A circa-1950, one-story, three-bay, office is located west of the horse barn (Photo 80, p. 113). The foundation and structural system are not visible and are clad in a running-bond brick veneer. The attic and roof space is wood framed and clad in weatherboard. The resource is covered by a gambrel roof with flared eaves and exposed rafter tails that is sheathed in corrugated metal. Two larger metal flues pierce the ridgeline of the roof. The primary entrance is centered on the southeast elevation and is filled with a single-leaf, two-paneled, wood door topped by seven fixed lights. The door is flanked by three-light, metal casement windows on brick sills. Additional fenestration on the other elevations includes three-light, metal casement windows on brick sills as well as one-over-one, double-hung sash vinyl windows. Two secondary entrances are located on the southwest elevation (Photo 81, p. 113). The southernmost features two, single-leaf, wood doors. They are covered in a shed-roofed awning supported by metal poles on a poured-concrete foundation. The other secondary entrance is filled with a single-leaf vinyl door with two fixed lights. This entrance is located within a two-bay porch, set on a brick-veneer foundation, supported by metal poles, and covered by a shed-roof sheathed in corrugated metal.

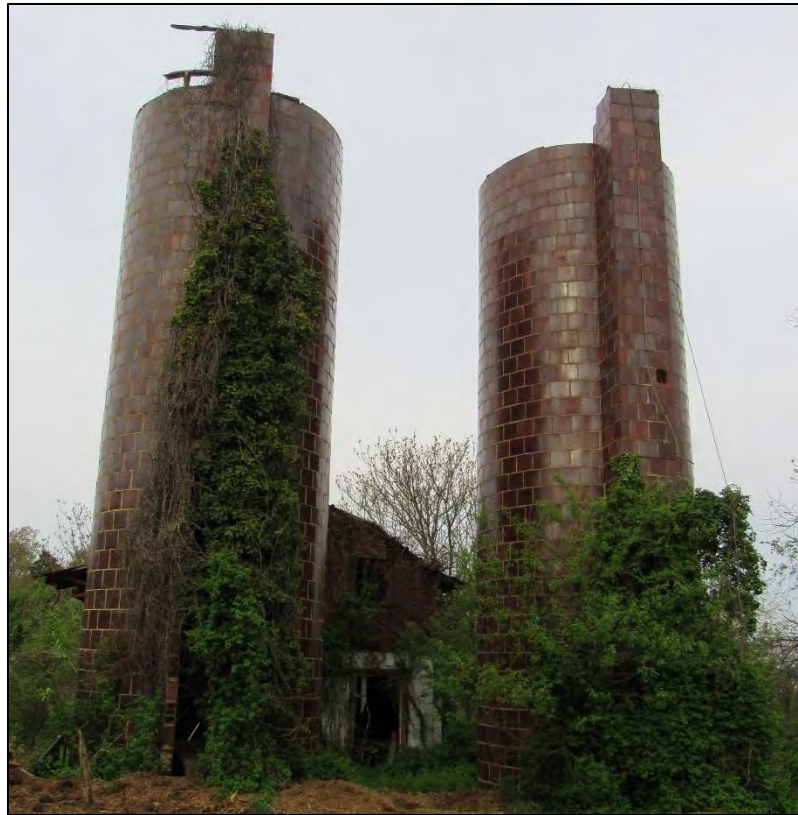
Photo 82: Silos, Looking West.

Two circa-1945 silos are located west of the horse barn and office (Photo 82). These two terra-cotta, cylindrical structures stand approximately 30 feet tall. A chute covering and unloading door entry are located on the east elevation of both silos and are also composed of structural terra cotta. These silos were most likely capped by metal dome roofs, but they are no longer present.

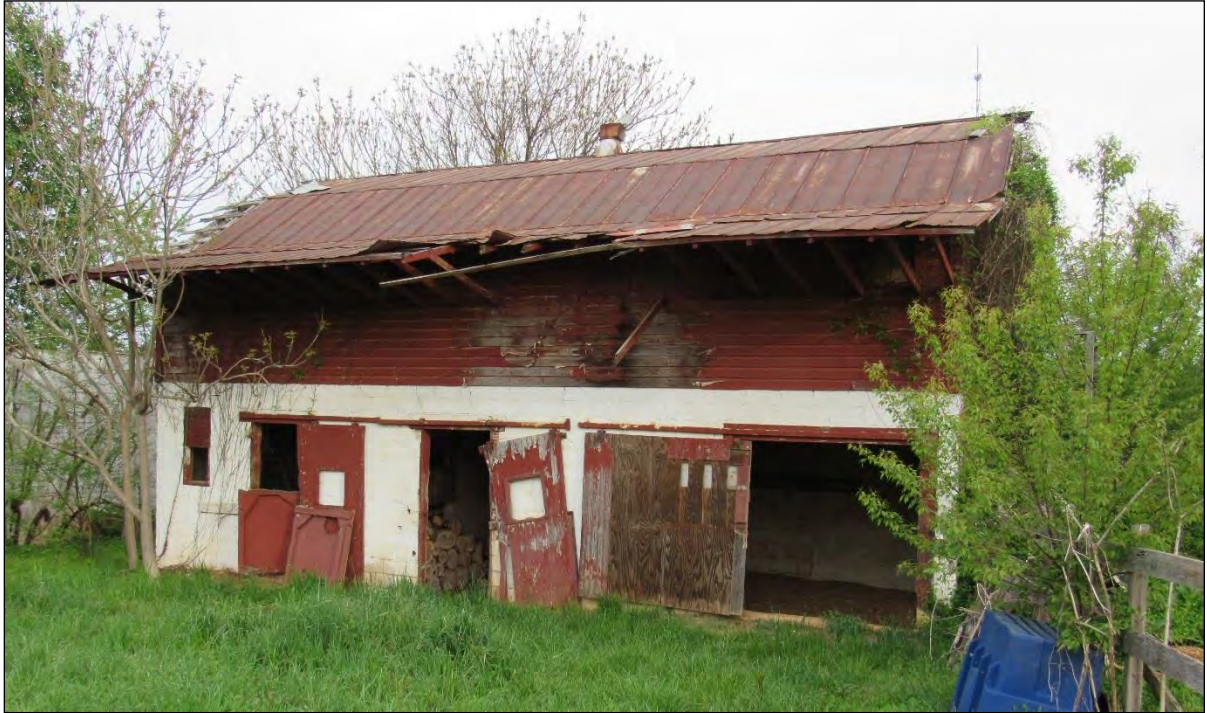
Photo 83: Barn, East Elevation.

A circa-1945, one-and-a-half-story, four-bay barn is located west of the silos. The concrete-block foundation and structural system is topped by the half story that appears to be wood framed and clad in weatherboard (Photo 83). It is covered by a gambrel roof with exposed rafter tails that is clad in v-crimp metal. The roofline extends on the southeast elevation and creates an awning clad in v-crimp and supported by wood brackets. A metal flue pierces the ridgeline.

The primary (southeast) elevation features three entrances: the southernmost is filled with a larger single-leaf, sliding, wood door and the other two entrances have single-leaf, sliding, wood doors with a single light in the middle. All the doors slide on metal tracks with metal casters. The remaining bay on the primary elevation is filled by a single-light fixed window with a wood sill. Other fenestration includes large open bays and four-light, fixed, wood

windows on the other elevations as well as a secondary entrance to the half-story which is filled with a single-leaf, paneled, wood door which is accessed by a wood staircase.

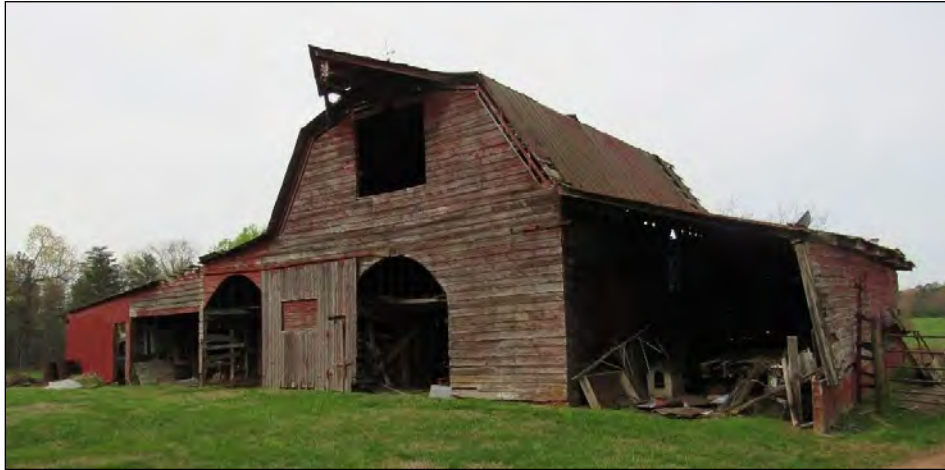
Photo 84: Barn at 8290 N.C. 127 Highway, Northeast Oblique.

A review of mid-twentieth-century aerial photographs of the property indicated that the Whisnant home and several outbuildings were extant prior to 1950, but the present-day horse barn was not constructed until at least 1951 when it appears on aerial images. The Whisnant Farm property’s horse barn exhibits some interesting design and stylistic features, but it is not a particularly unique or a standout example. Wood frame barns of varying size, shape and function can be found in the rural areas to the north, in Alexander County (see Photo 85 and Photo 84, p. 120 for examples), but are disappearing along the northern edges of Catawba
