SUBJECT: Historic Structures Survey Report, Widening of US 258 from SR 1101 (Browntown Road) to SR 2010 (C.F. Harvey Parkway), R-5814, PA 17-09-0026, Greene and Lenoir Counties, ER 18-0280

HISTORIC STRUCTURES SURVEY REPORT

**Widen US 258 from SR 1101 (Browntown Road) in Greene County to
SR 2010 (C.F. Harvey Parkway) in Lenoir County**

**TIP # R-5814
WBS # 46985.1.1
PA # 17-09-0026**

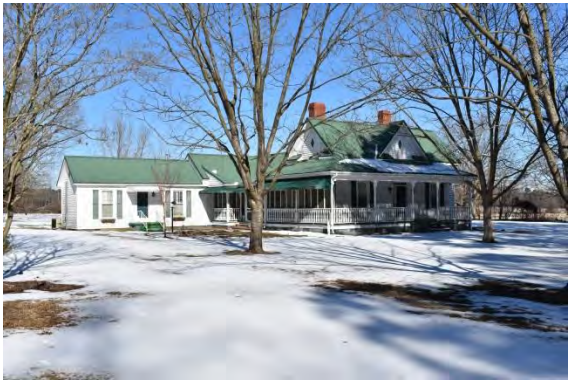
Resource Name	Jesse H. Jones House
	HPO Survey Site #	GR0341
	Location	3292 Grays Mill Road, Institute vicinity
	PIN	359700967582
	Date of Construction	Ca. 1880s
	Recommendation	Recommended not eligible for NRHP listing

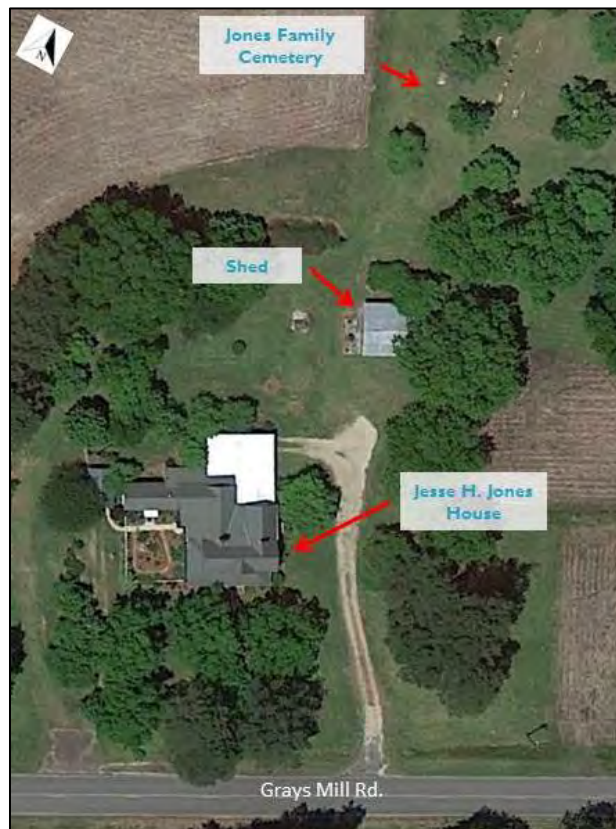
Figure 3: Site plan of the Jesse H. Jones House (base image courtesy of GoogleMaps).

The Jesse H. Jones House (GR0341) sits on a 22.5-acre parcel fronting Grays Mill Road in rural Greene County, approximately ten miles northwest of Kinston. The house sits back from the road approximately 100 feet, and is screened from view by a line of mature trees. The parcel is bounded on its northern and eastern edges by a line of trees, to the south by Grays Mill Road, and to the west by US 258. A gravel driveway runs from Grays Mill Road to the northeast of the house, and forks upon reaching the building's rear. The western fork leads to the house's modern carport, and the eastern fork leads to the Jones Family Cemetery. Tax maps reveal that the cemetery has become an independent parcel from the house and surrounding property. Tax records also show the cemetery is owned by the Jones family. Only one outbuilding—a twentieth-century shed—accompanies the house.

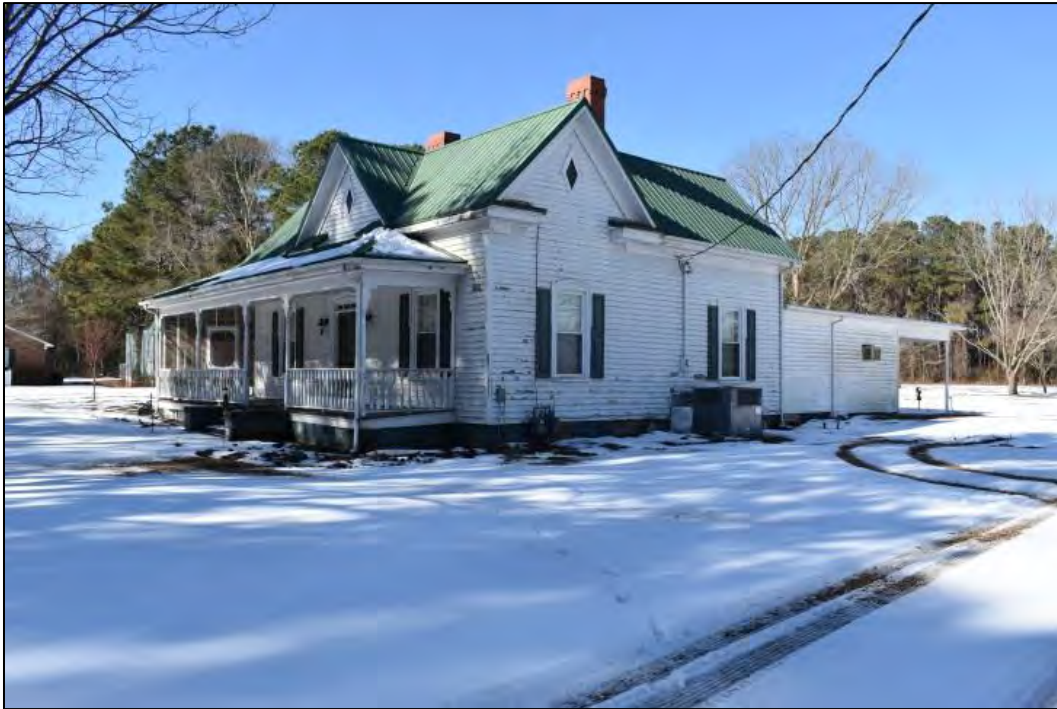
Multiple other twentieth century additions have been made to the building, altering its footprint considerably. On the northern (rear) side of the house, attached to the rear ell, a single-story, single-pile flat roof block has been added. Additionally, a modern single-bay carport has been added to the northern side of this rear ell addition. Two noticeable additions have been made to the western side of the house, extending from the original detached kitchen ell. A two-bay, single-story mass extends from the western end of the kitchen, and a single-story, single-pile shed roof addition projects to the northern side of the kitchen (Figure 5 through Figure 7). All of these alterations to the building's footprint are easily visible from the street when approaching the house from either the east or west.

Figure 4: View, southeast corner of house.

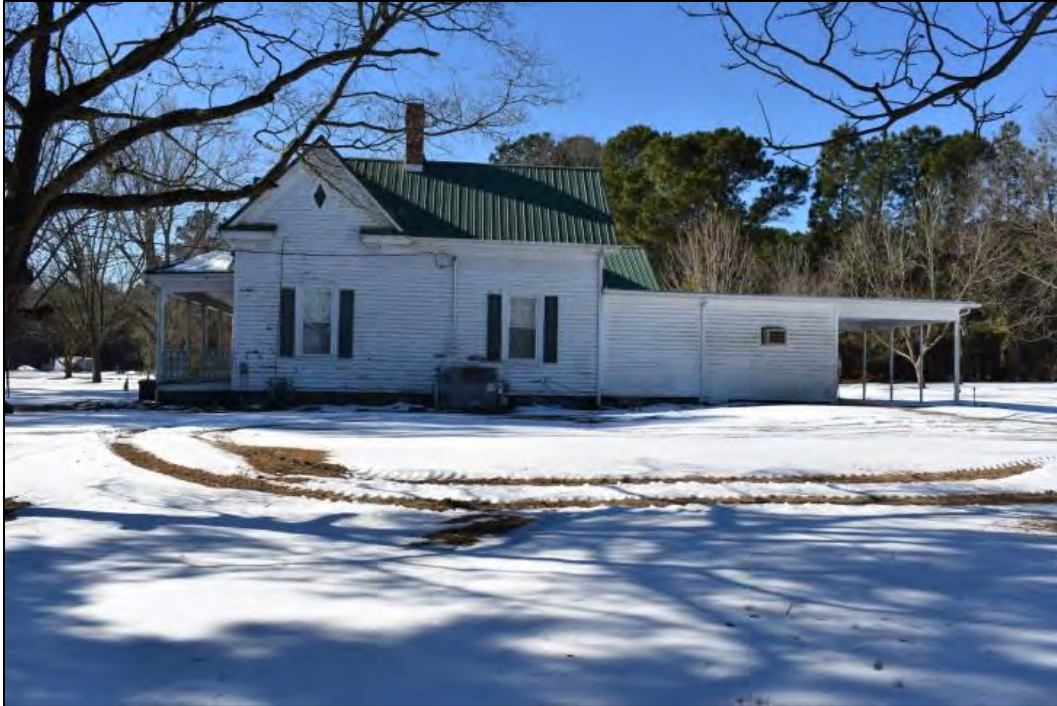
Figure 5: View of right, side (northeastern) elevation.

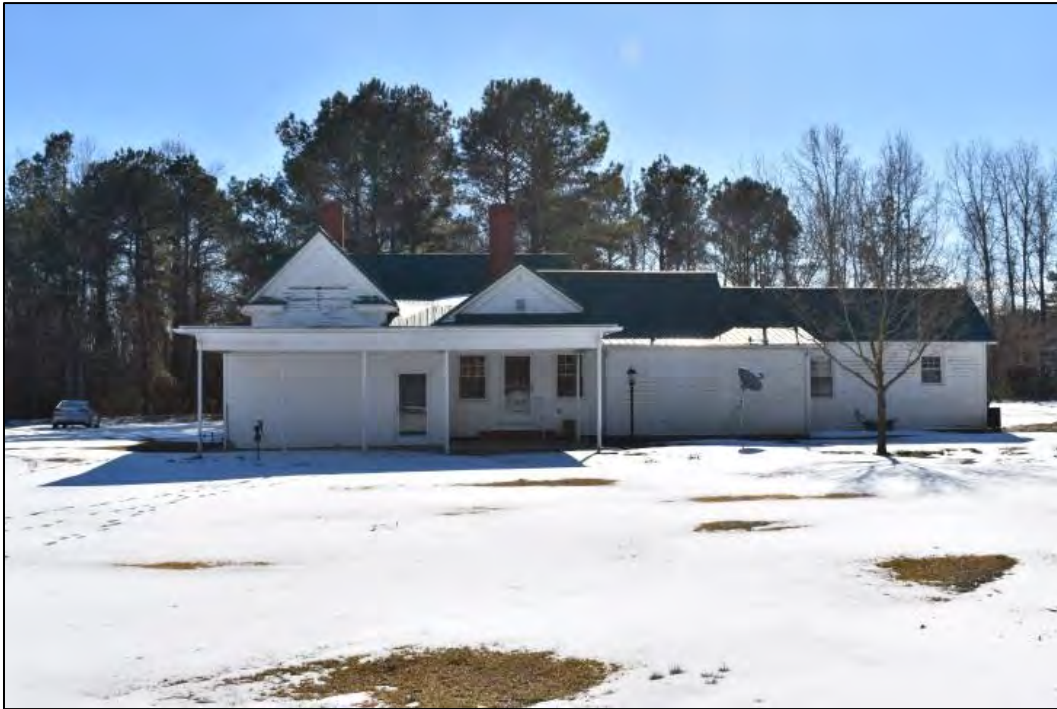
Figure 6: Rear (northwestern elevation).

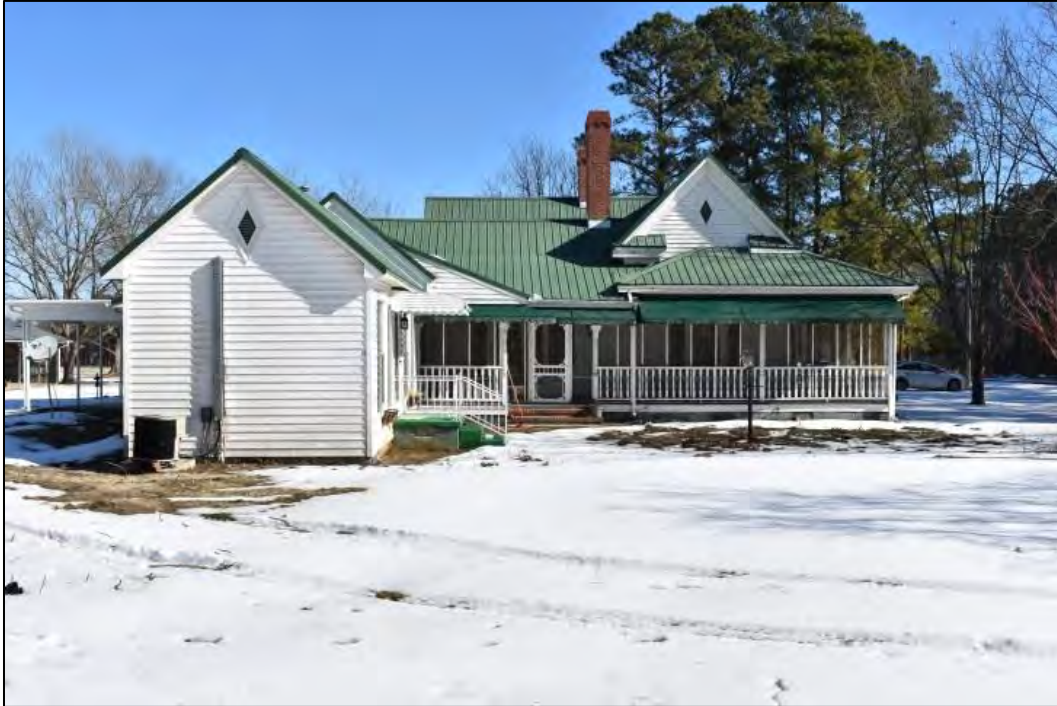
Figure 7: View of side (southwestern) elevation.

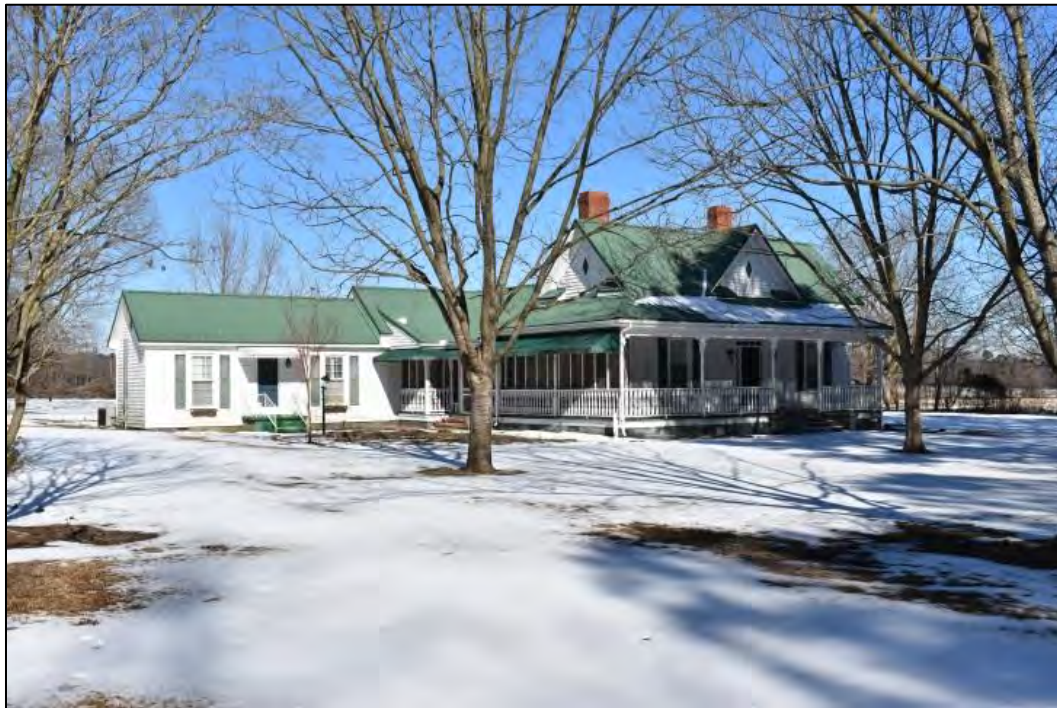
The original U-shaped house is clad in original weatherboard siding, edged with plain wooden cornerboards, and rests on a continuous brick foundation. The cross-gabled roof is topped with replacement standing-seam-metal. The house's gables are heavily trimmed and feature large gable returns. Diamond-shaped ventilators adorn the center of each gable. Two corbelled, brick replacement chimneys pierce the ridgeline of both the rear-ell and the attached kitchen. According to an interview with the homeowner in 1993 by William L. Murphy, the two chimneys are replacement, but modeled after the house's original chimneys. (Jesse H. Jones House (GR0341) SHPO). Originally framing the building's front (southern) elevation, the three-bay front porch was altered during the twentieth century to wrap-around to the building's western side. This western portion has been screened in since the house's previous 1993 survey by Murphy. The original three-bay portion of the porch, embracing the front (southern) elevation, is supported by turned posts featuring foliated brackets and spanned by a turned spindle rail, and appears to be original. The porch deck and ceiling are replacement (Figure 8 and Figure 9).

Figure 8: View of southwest corner.

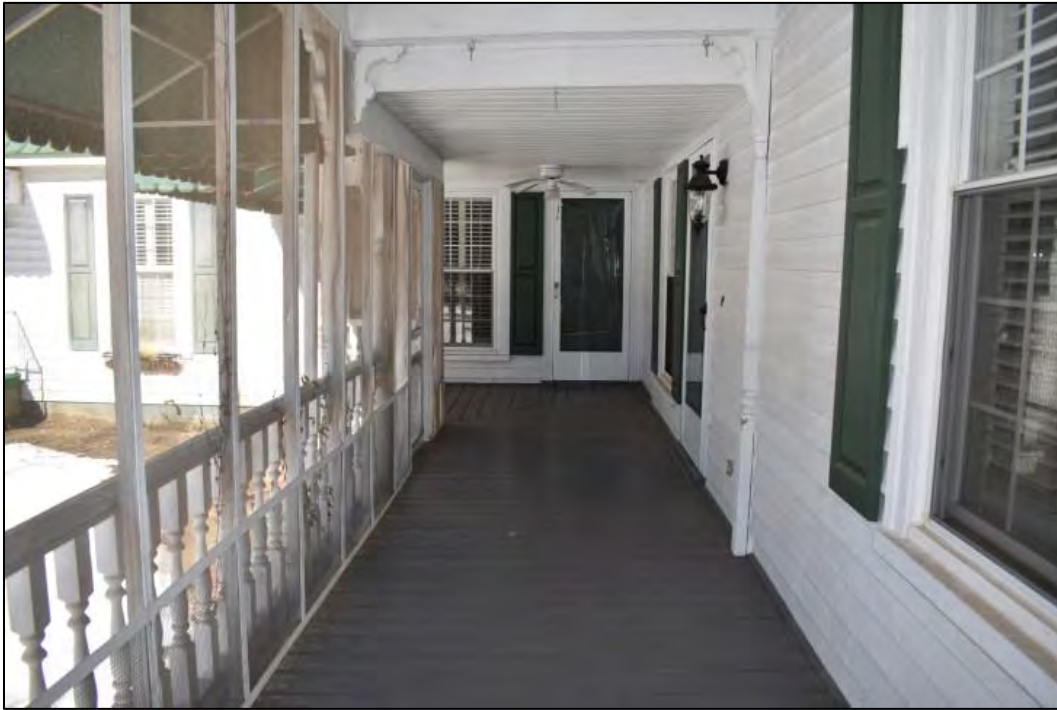
Figure 9: Interior view of western porch addition, looking to northwest. Twentieth-century addition to kitchen can be seen on the left

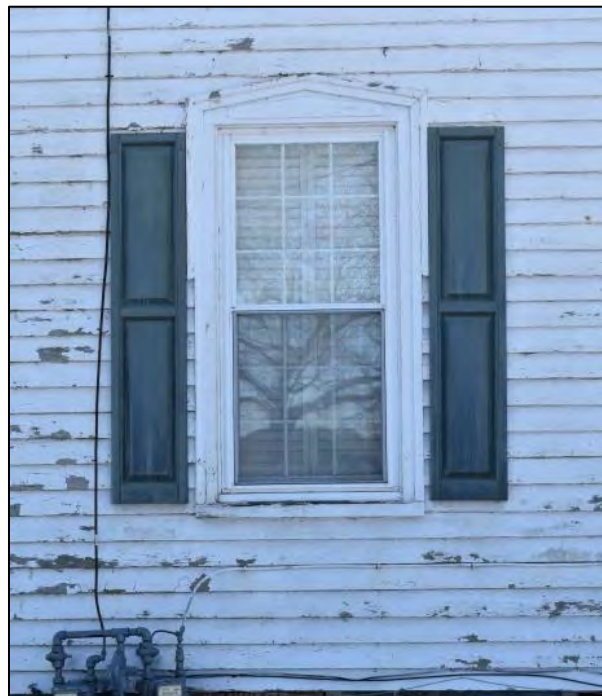
The building's primary entrance is centrally placed on the southern elevation. Although the door has been replaced since the 1993 survey, its original four-over-four light transom, sidelights, and molded surrounds remain. Replacement windows with six-over-six snap-in muntins are framed by surrounds of the same style featuring peaked lintels with raised center panels. All windows are flanked by modern fixed wooden shutters (Figure 10).

Figure 10: Detail view of typical window.

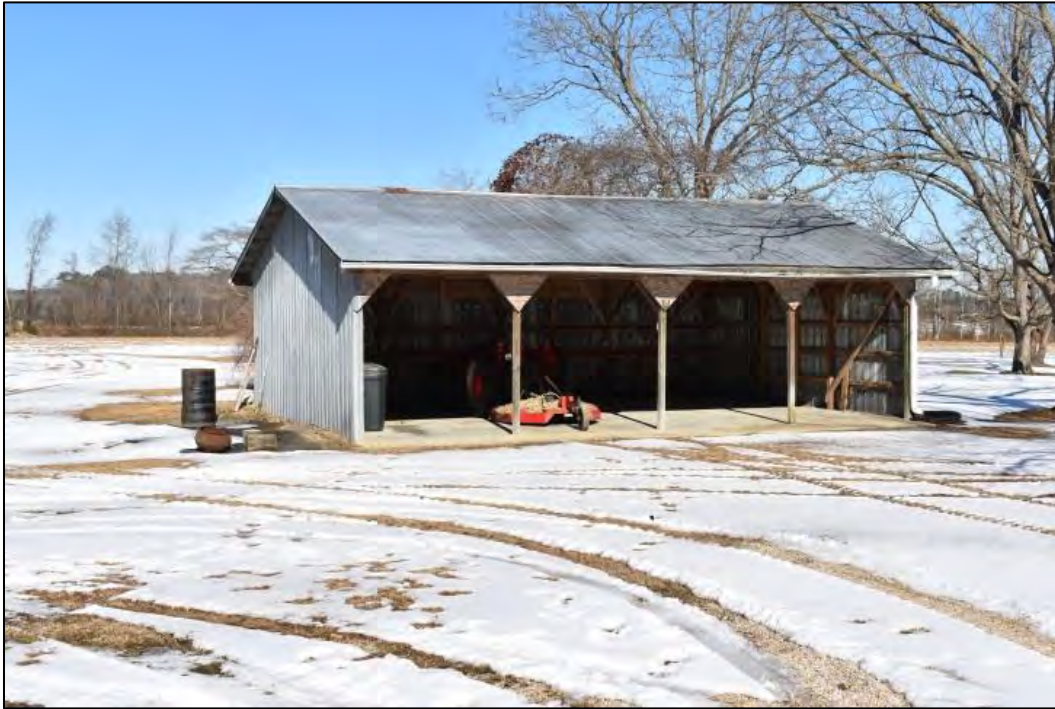
The mid/late twentieth-century, side-gabled, frame shed (Figure 11) sets to the northeast of the Jesse H. Jones House. The shed is clad in vertical wood siding on its northern, eastern, and western sides. Its southern side is open and divided into four bays by large wooden posts and was used for equipment storage.

Figure 11: View of front (southern) elevation.

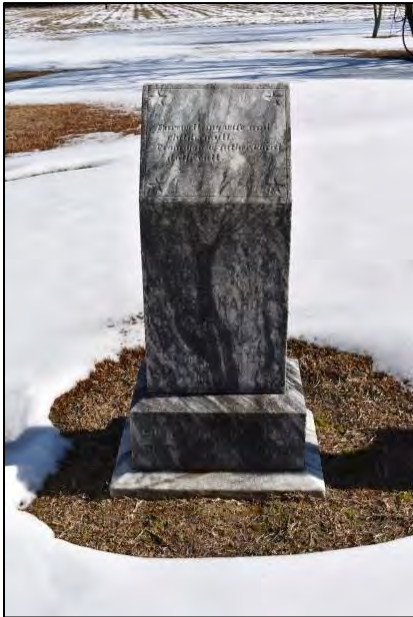
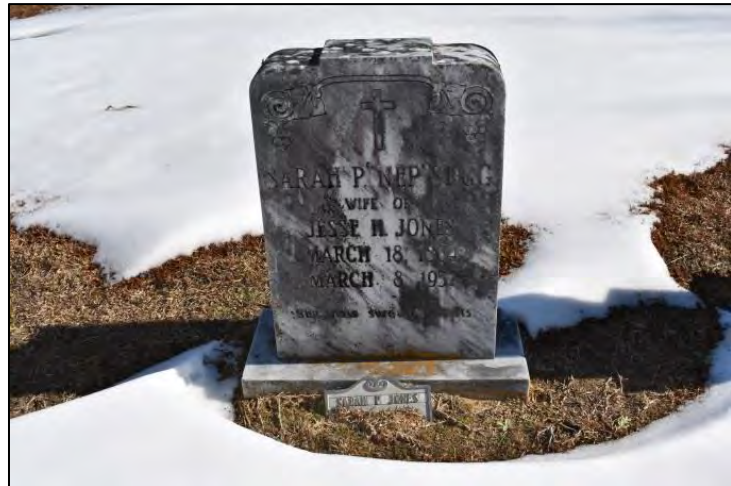
The Jones Family Cemetery lies approximately 60 yards to the northeast of the Jones House. Fourteen headstones are found in the small cemetery, including the graves of Jesse H. Jones, his wife Sarah P. Jones (Figure 12), and the graves of many of their children and grandchildren. Dating to 1912, Jesse's grave is the oldest in the cemetery, the newest being that of William Arthur Jones dated 2016. All of the cemetery's markers are plain in design—rectangular, curved or angled on top—and resting on stone plinths.

Figure 12: Left, headstone of Jesse H. Jones (1859-1912); right, headstone of Sarah “Nep” Sugg Jones (1864-1952).

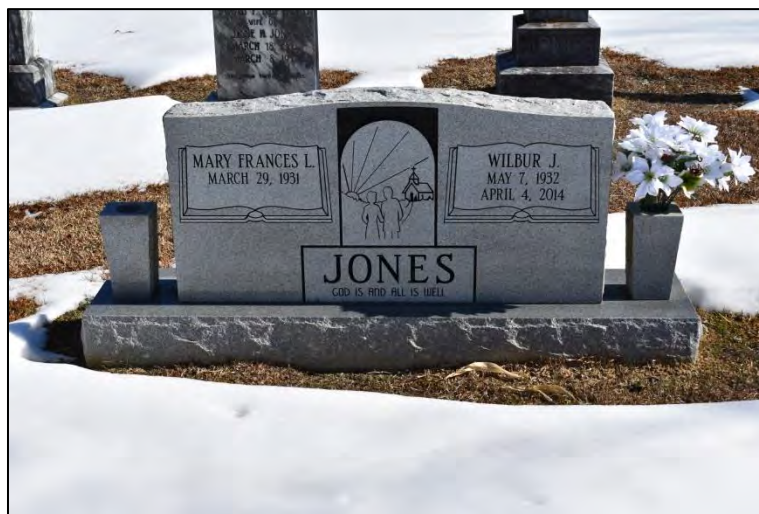
Figure 13: Headstone of Mary Frances and Wilbur J. Jones (1952-2014) which personifies the typical modern headstone found in the Jones cemetery.

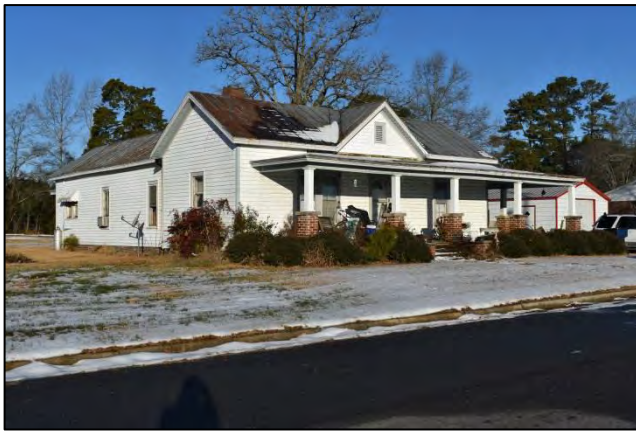
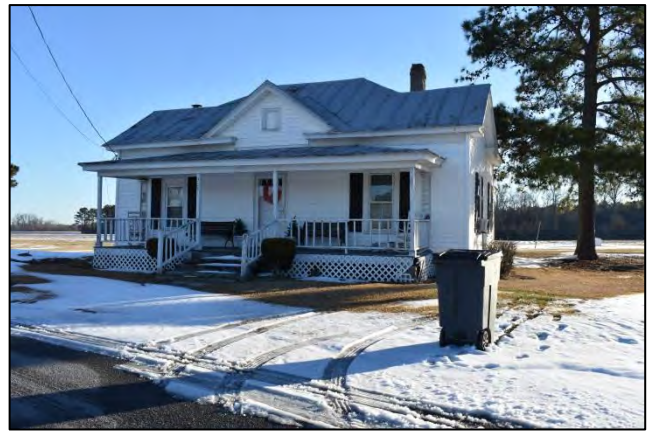
A comparable house identified at 217 S. Main Street in Walstonburg (Figure 14, left) is one-story tall and features a three-bay original block. The building is clad in replacement vinyl siding and features a four-bay replacement porch supported by synthetic columns on its front elevation. Unlike the Jones House, the building at 217 S. Main Street retains most of its original windows, an original ridgeline chimney, and its original three-bay block with rear ell footprint.

The Speight House (GR0082) located at 308 S. Main Street in Walstonburg (Figure 14, right) built ca. 1910-1920 is one-story tall and three bays wide. A replacement porch is found on the primary elevation and the building is clad in replacement vinyl siding. Replacement four-over-four synthetic windows are surrounded by replacement surrounds. Remnants of two original interior chimneys stand on the ridgeline of the roof. Unlike the Jones House, the Speight House retains its original early footprint, with no modern twentieth-century additions.

Figure 14: Left, 217 S. Main Street, Walstonburg; right, the Speight House (GR0082) at 308 S. Main Street, Walstonburg.

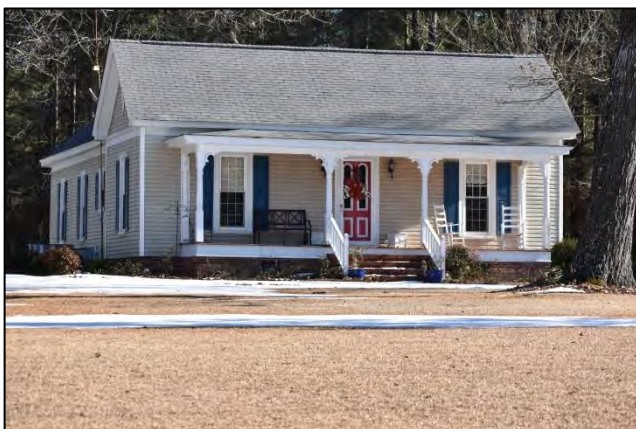
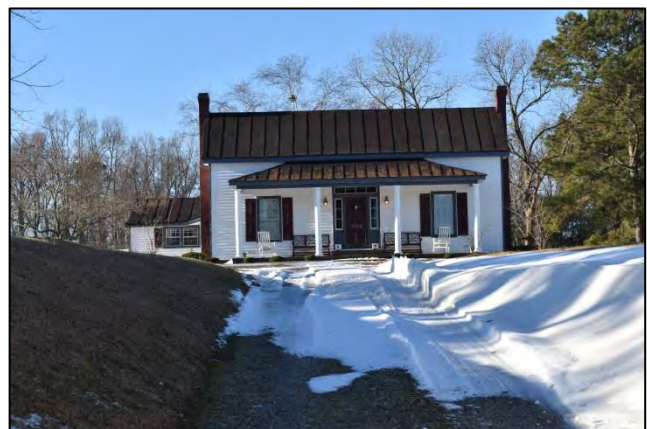
The Paul Jones House (GR0375) located at 64 Coggins Road in Walstonburg (Figure 15, left) was built ca. 1880-1900 and is also a single-story, three-bay frame house. Unlike the Jesse Jones House, the Paul Jones House features an original front porch supported by turned posts and decorative brackets. The house is clad in replacement vinyl siding and features replacement windows and replacement asphalt shingles. In addition to these material losses, the house has also lost its original chimneys.

The Spence-Grantham House (GR0029) ca. 1875 is located at 8725 NC Highway 58 in Stantonsburg (Figure 15, right). The house is clad in replacement vinyl siding, but retains original six-over-six sash windows and original window surrounds. An original door is surrounded by three-light sidelights and topped with a four-light transom. Replacement synthetic columns support a hipped roof porch which is clad with standing-seam-metal. Two original shouldered chimneys embrace either gable end of the house.

Figure 15: Left, the Paul Jones House (GR0375) at 64 Coggins Road, Walstonburg; right, the Spence-Grantham House (GR0029) at 8725 NC Hwy 58, Stantonsburg.

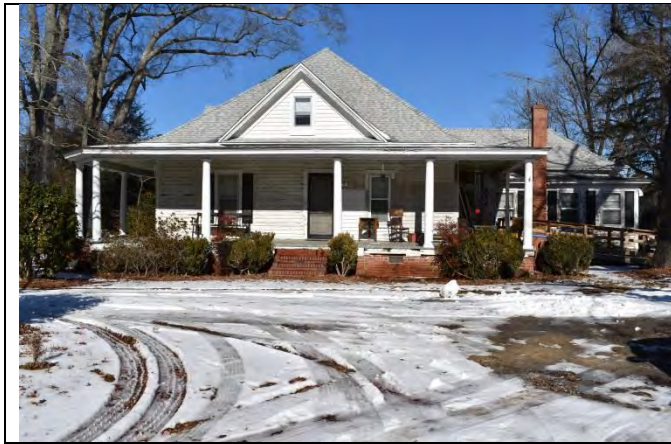
Resource Name	Leon Sutton Farm
HPO Survey Site #	LR0880
Location	3355 US-258, Wheat Swamp vicinity
PIN	306741
Date of Construction	Ca. 1905
Recommendation	Recommended not eligible for NRHP listing

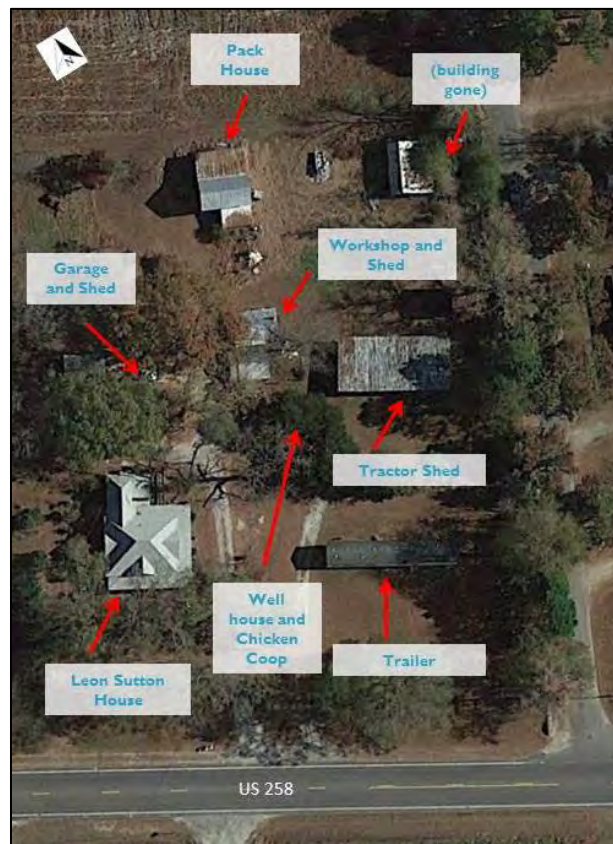
Figure 16: Site plan of the Leon Sutton House (base image courtesy of Googlemaps).

The Leon Sutton House (LR0880) sits on an 11.21-acre lot, almost nine miles north of downtown Kinston. Situated amongst a grove of mature oak trees (Figure 17 and Figure 18), the house fronts the eastern side of US 258 and is accessed by a gravel driveway. According to Jennifer Malpass, great-granddaughter of Leon Sutton, Sutton planted nine oak trees around the house—one in honor of each of his eight children and his wife. The trees serve to screen the house from the road. Behind the house and its accompanying outbuildings the lot is open, comprised of actively cultivated agricultural fields. The parcel is bounded on its northern, eastern, and southern sides by woods and on its western side by US 258.

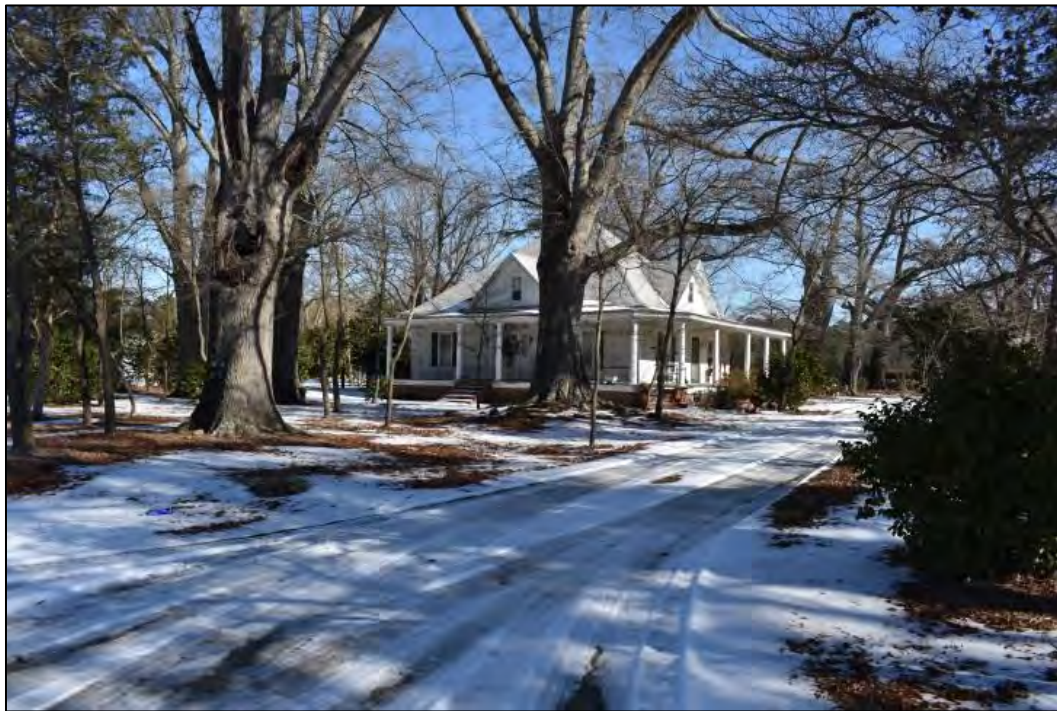
Figure 17: View of front (western) elevation from street.

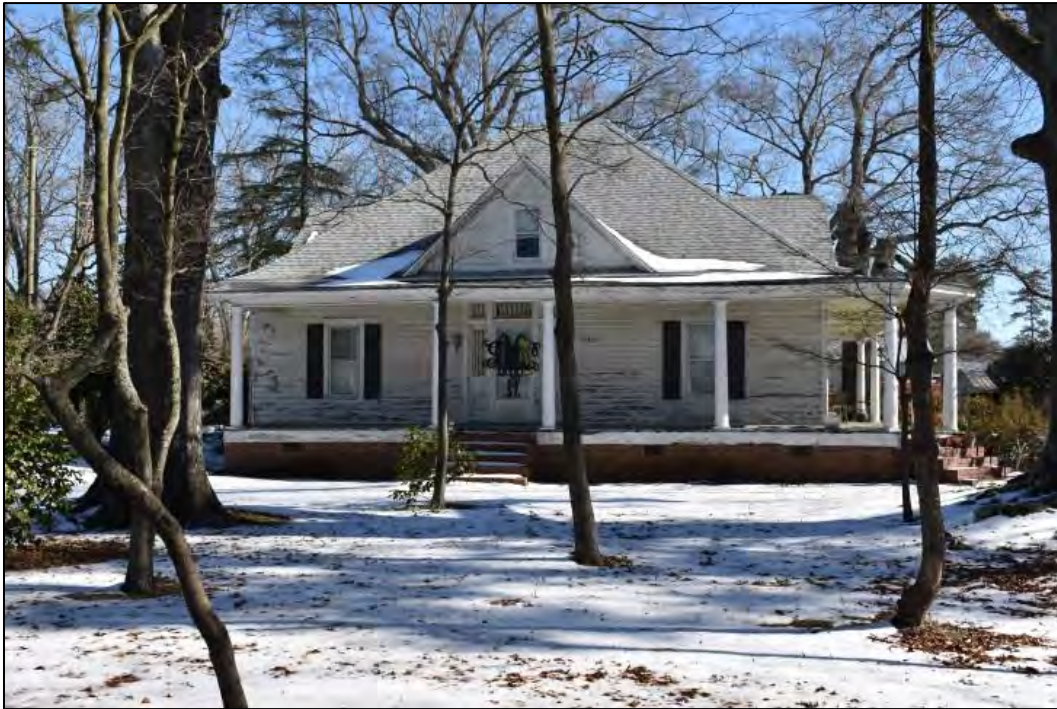
Figure 18: Closer view of front (western) elevation.

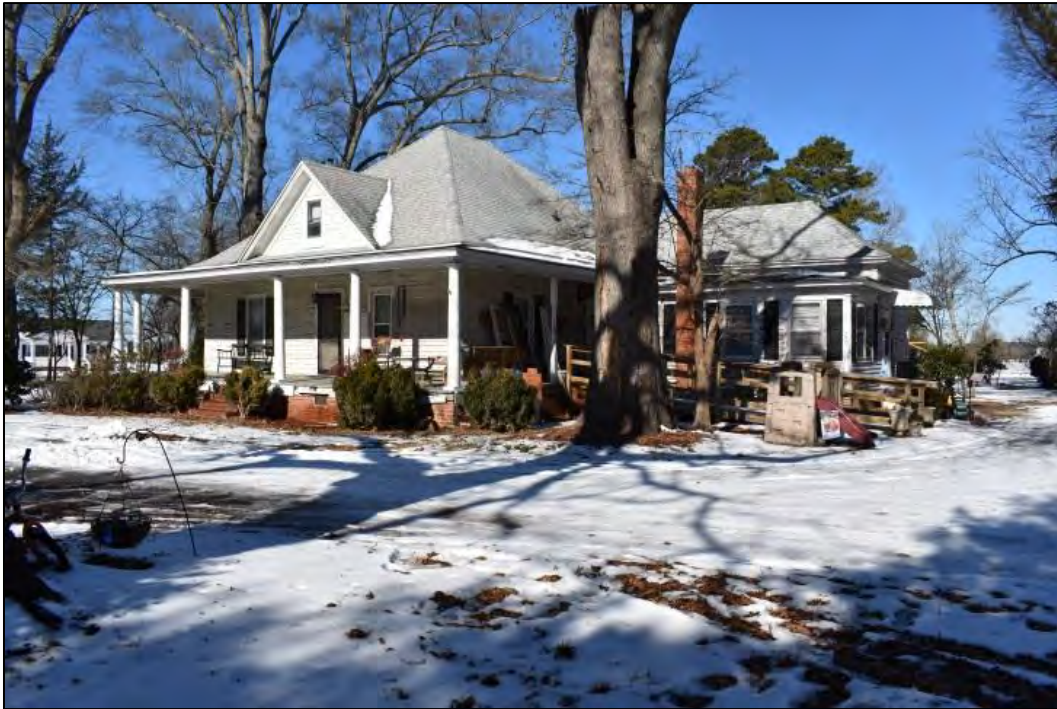
The Leon Sutton House is a one story, frame, pyramidal cottage featuring a center-hall plan. It has a three-bay-wide, two-pile-deep front block with an original one-story rear ell on its northeastern corner (Figure 19). The house is clad in plain weatherboard siding and edged by wooden cornerboards. The building's original piers have been filled in to create a continuous brick foundation. A porch found on the southern side of the rear ell was enclosed in the 1950s (Malpass, 2018) and is the only exterior alteration to the building's original footprint.

Figure 19: View of southwest corner of house.

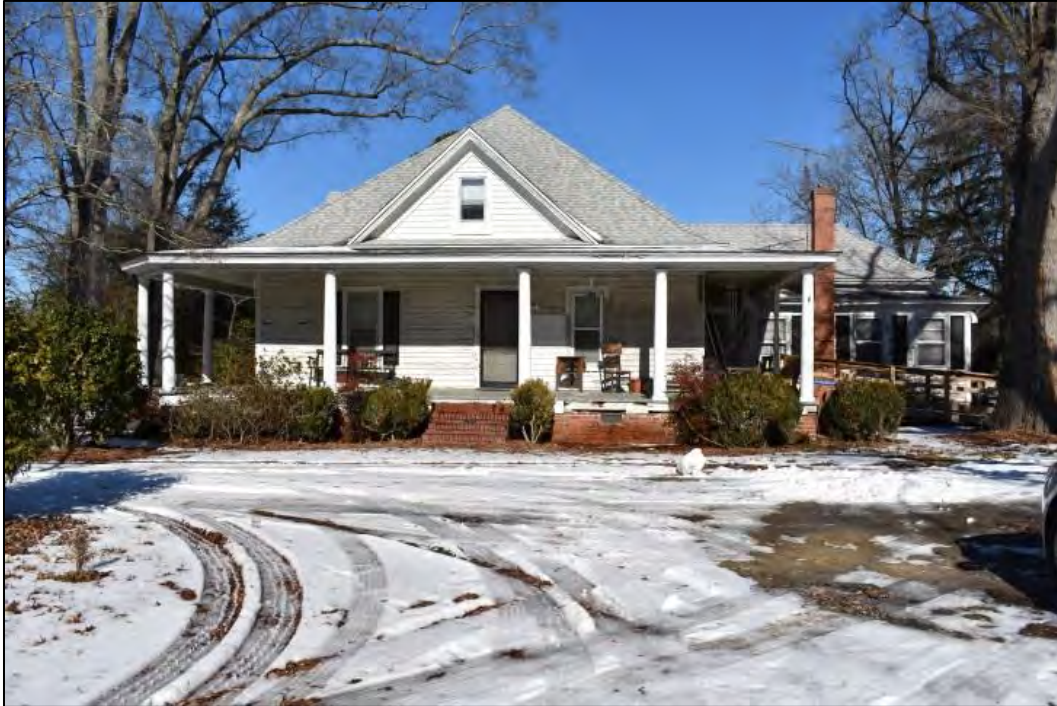
An engaged, recessed, front porch wraps around the western, southern, and eastern sides of the house terminating at the enclosed rear ell. The porch is supported by original wooden Doric columns. A modern wheelchair ramp was added to the western side of the porch, resulting in the loss of an original column. Centrally placed, original, paneled wooden doors, situated between two one-over-one sash replacement windows, are located on the western and southern sides of the house. Both the windows and doors are surrounded by simple wooden surrounds. The primary door, located on the building's western side, is flanked by single-light sidelights and topped by a single-light transom (Figure 20).

Figure 20: View of side (southern) elevation.

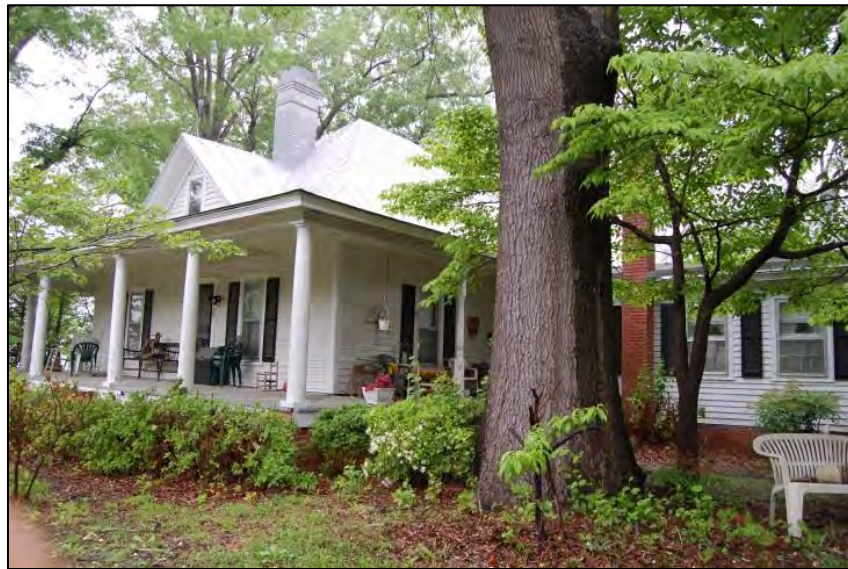
A steep-pitched hipped roof capped with replacement asphalt shingles tops the house. A front-gabled dormer with a centrally placed one-over-one sash window is found on the north, west, and south sides of the roof. Photos from a 2010 survey completed by Marvin Brown reveal that the previous roofing material was standing-seam metal. As part of the roof replacement—which took place between 2010 and 2018—two original interior, brick, ridge chimneys were removed from the original mass of the house; two chimneys of the same style were additionally removed from the rear ell (Figure 21 and Figure 22). The only chimney which remains is a modern, exterior, single-stack, brick chimney attached to the south side of the enclosed ell porch (Figure 23).

Figure 21: View of southeastern corner of main block ca. 2010 (photo credit: Marvin Brown)

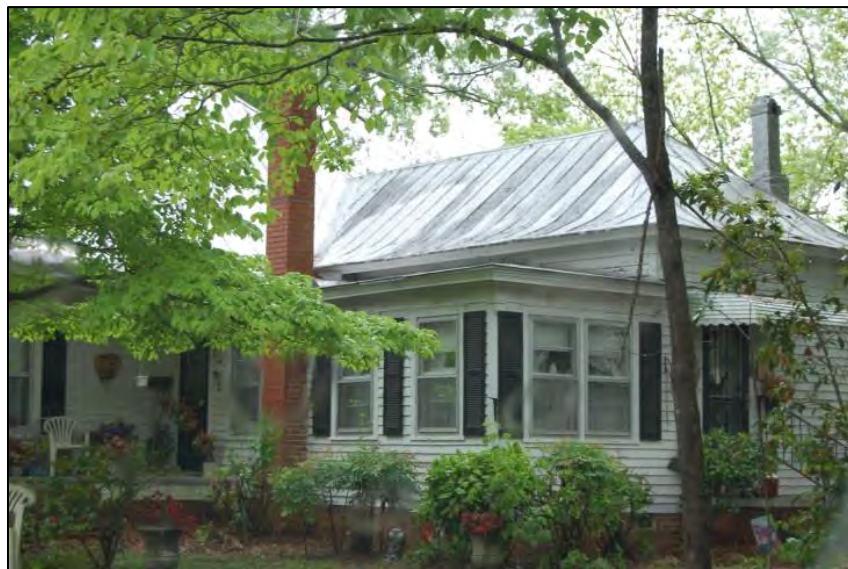
Figure 22: View of the northeastern corner of the enclosed rear ell ca. 2010 (photo credit: Marvin Brown).

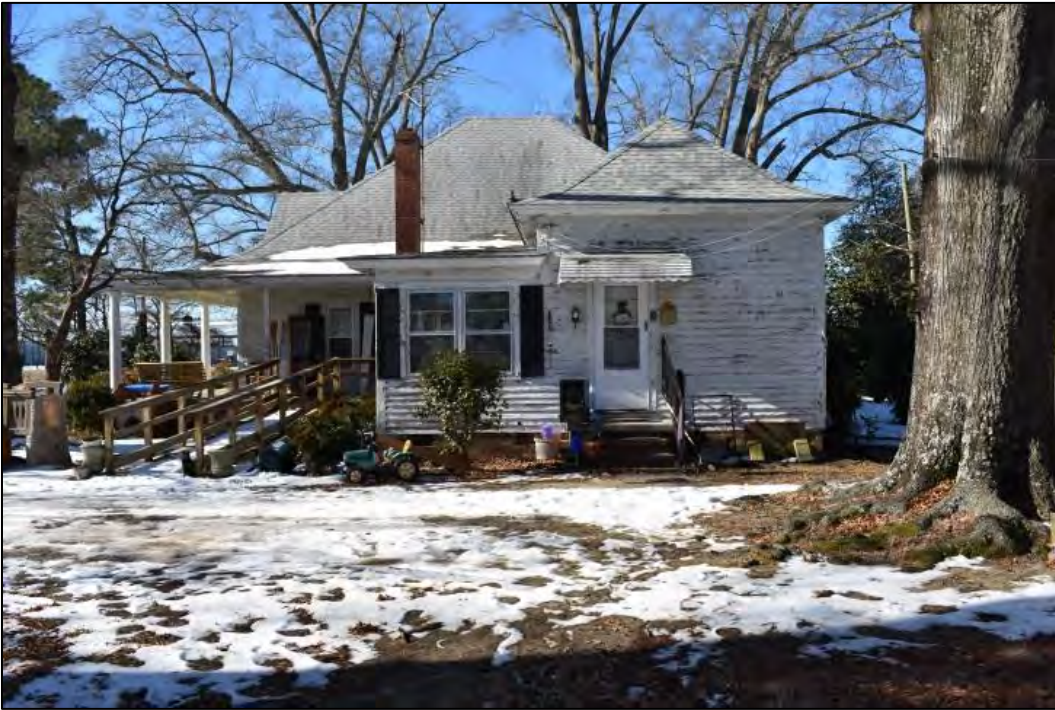
Figure 23: View of rear (eastern) elevation.

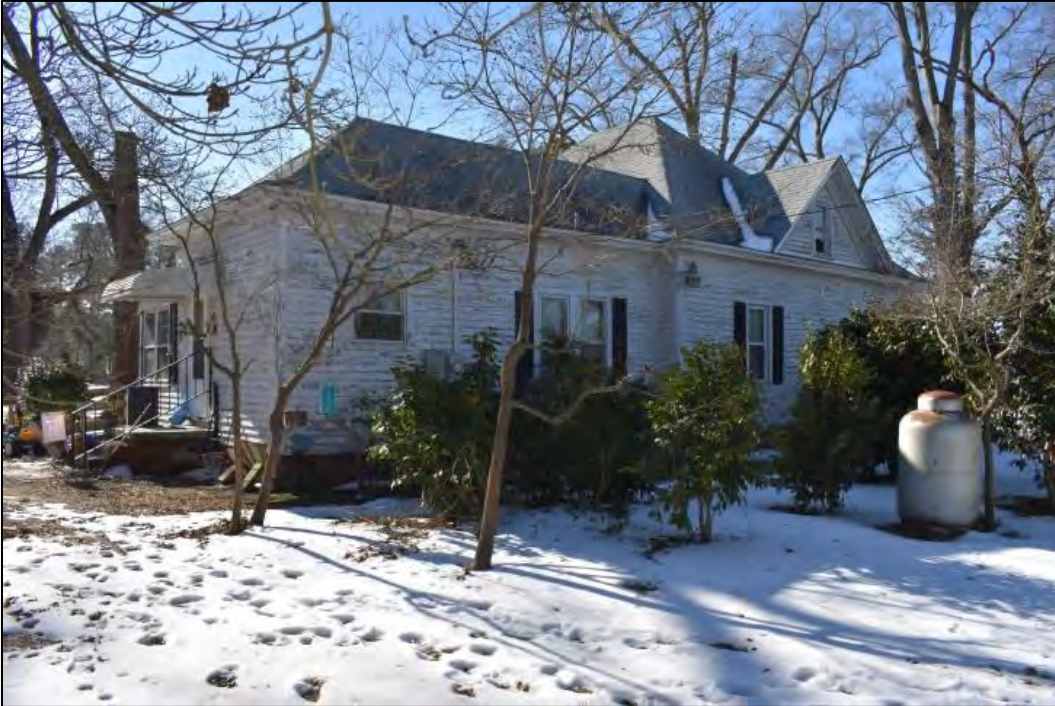
Figure 24: View of northeast corner of house.

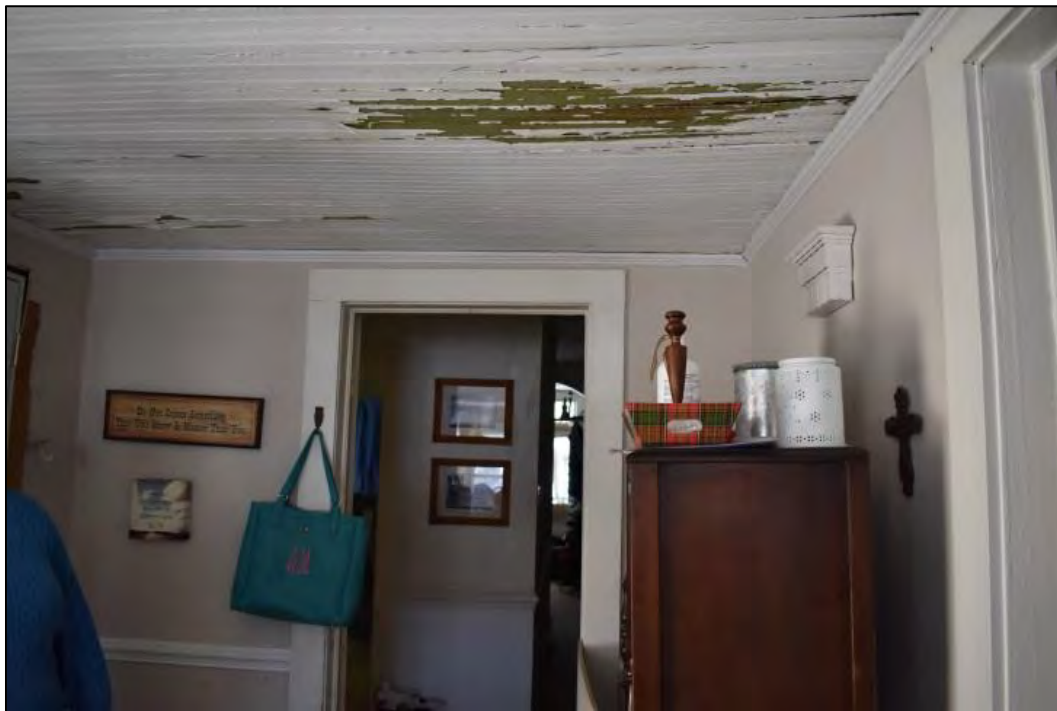
Interior access to the house was limited to the enclosed rear-ell porch. Views of this space revealed carpeted floors throughout the areas of the house observable from this point. Looking through a doorway leading from the enclosed porch to the rear portion of the house, early baseboards and chair rail were visible. The original exterior ceiling of the rear-ell porch (comprised of bead board) was also visible. Additionally an early exterior paneled door (now an interior door) remained in place. Views into the adjacent rear-ell (Figure 25 and Figure 26) revealed this space has been converted to serve as the house's modern kitchen, comprising all original material.

Figure 25: View of interior of enclosed rear-ell porch, looking north toward main block of building.

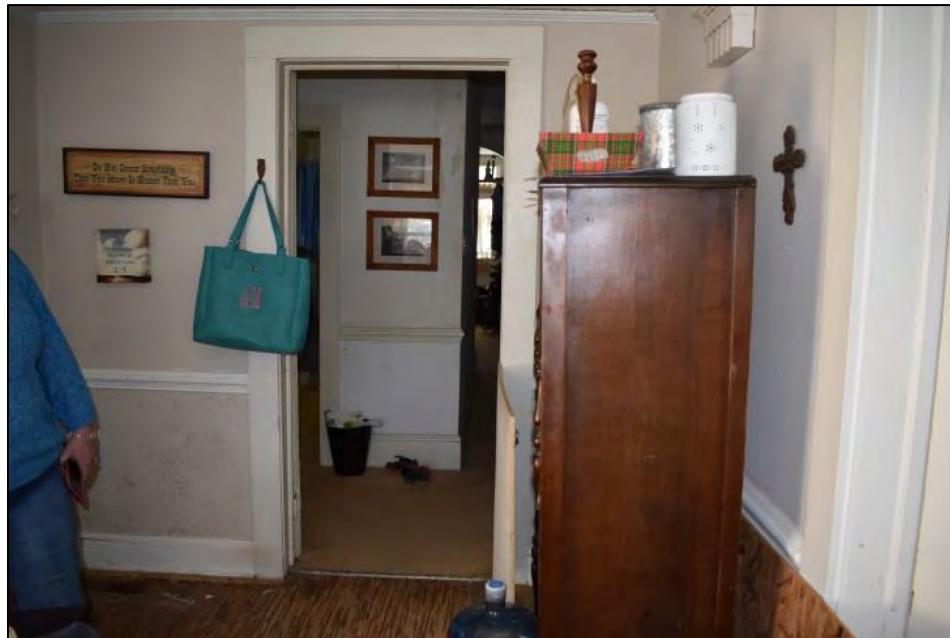
Figure 26: View of interior of enclosed rear-ell porch looking north toward main block of building.

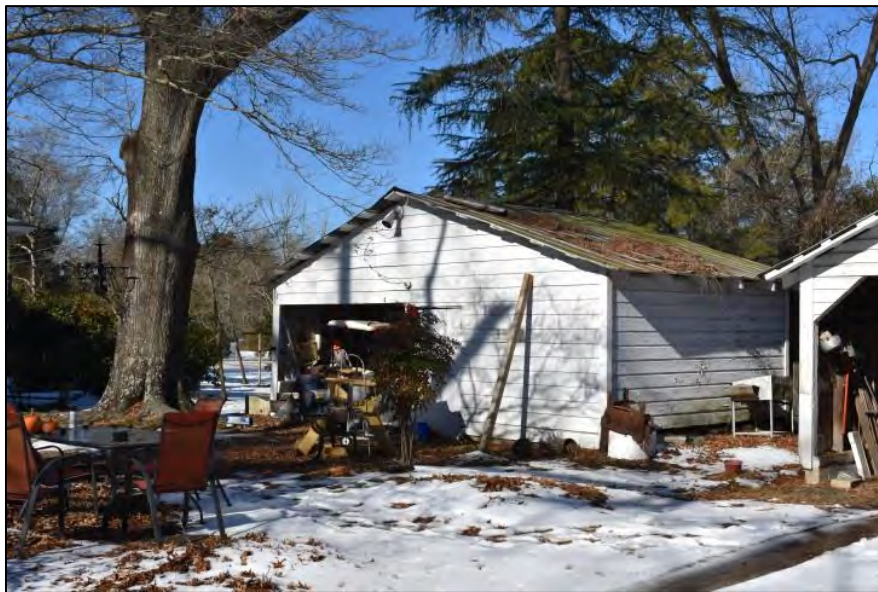
Situated to the east of the Leon Sutton House and oriented to the west, the frame shed building (Figure 27) dates from the mid-twentieth century, post-dating the house. The front-gabled building is clad in weatherboards and edged in plain cornerboards. Exposed rafter ends extend from the roof, which is clad in standing-seam metal. Two openings are located on the building's southern side: a large, doorless opening, suggesting early use as a garage; and a second smaller doorway featuring a wood-batten door.

Figure 27: View of front (western) elevation of shed.

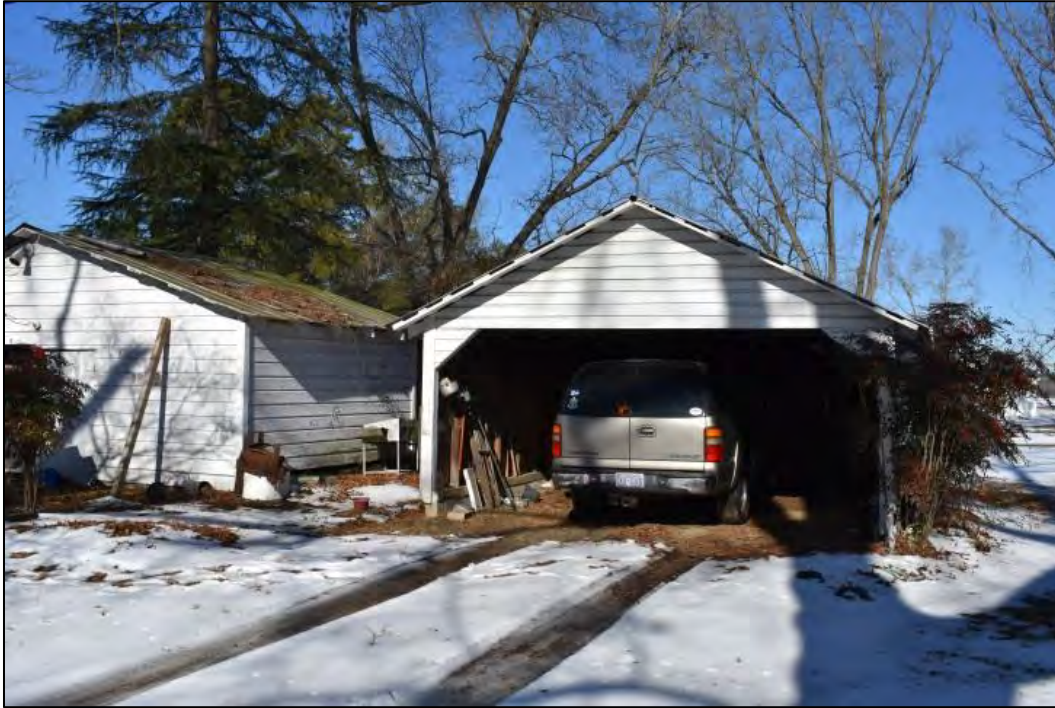
Situated to the east of the house, directly to the south of the shed, and facing west, the frame building (Figure 28) likely dates from the mid-twentieth century, post-dating the house. The garage is clad in weatherboards and stands on a continuous concrete-masonry-block foundation (CMU). The building's front-gabled roof is clad in standing-seam metal and features exposed rafter tails. A large two-bay opening is found on the building's western elevation, suggesting its original use as a garage.

Figure 28: View of front (western) elevation of garage.

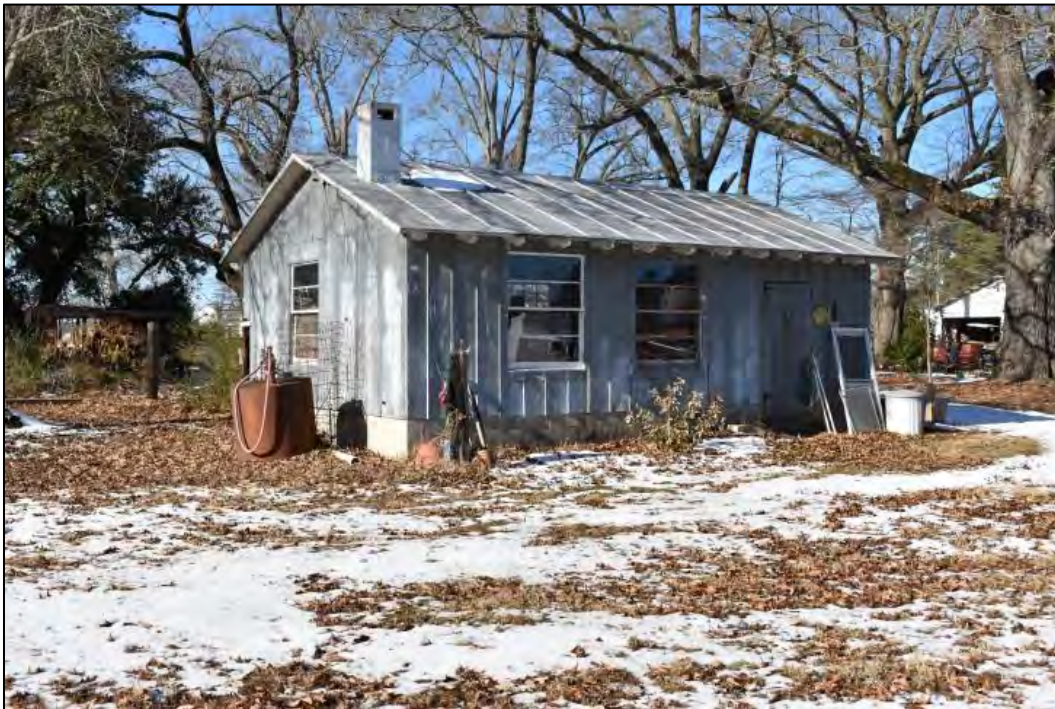
The front-gabled frame workshop (Figure 29) is situated to the southeast of the Leon Sutton House and likely dates from the mid-twentieth century. The workshop sits on a continuous CMU foundation and is clad in vertical board-and-batten siding. Standing-seam-metal and exposed rafter tails adorn the roof. Two large metal French doors are found on the building's primary (northern) elevation. Two-over-two sash windows punctuate the building's eastern, western, and southern elevations, allowing for large amounts of natural light. This suggests the building's original use as a workshop. An interior CMU chimney protrudes from the workshop's northeastern roof.

Figure 29: View of southeast corner of workshop.

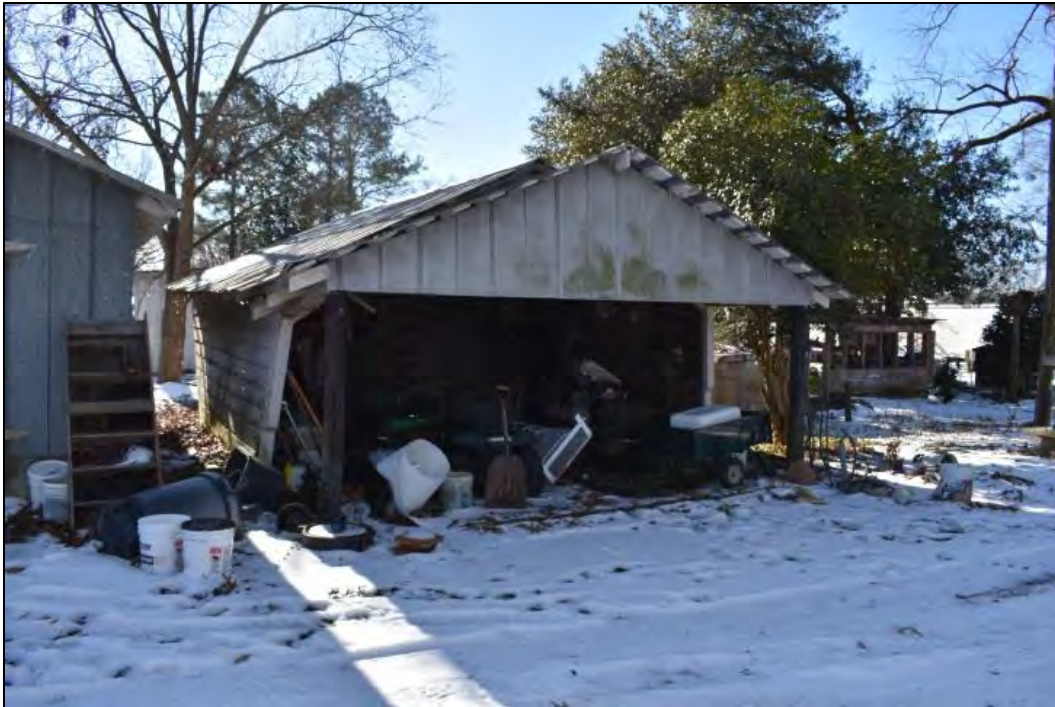
Situated to the direct west of the workshop, the frame shed (Figure 30) likely dates to the mid-twentieth century. The building is clad in weatherboard siding. A front-gabled roof, which has been extended on the building's northern side, is topped with standing-seam metal and features exposed rafter tails. The extension displays the same features, and is supported by large posts on either end. A large two-bay opening is located on the building's primary (northern) elevation, suggesting the building's original use as a machine shed.

Figure 30: View of front (northern) elevation of shed.
