SUBJECT: Historic Structures Survey Report, Widening of US 258 from SR 1101 (Browntown Road) to SR 2010 (C.F. Harvey Parkway), R-5814, PA 17-09-0026, Greene and Lenoir Counties, ER 18-0280

HISTORIC STRUCTURES SURVEY REPORT

**Widen US 258 from SR 1101 (Browntown Road) in Greene County to
SR 2010 (C.F. Harvey Parkway) in Lenoir County**

**TIP # R-5814
WBS # 46985.1.1
PA # 17-09-0026**

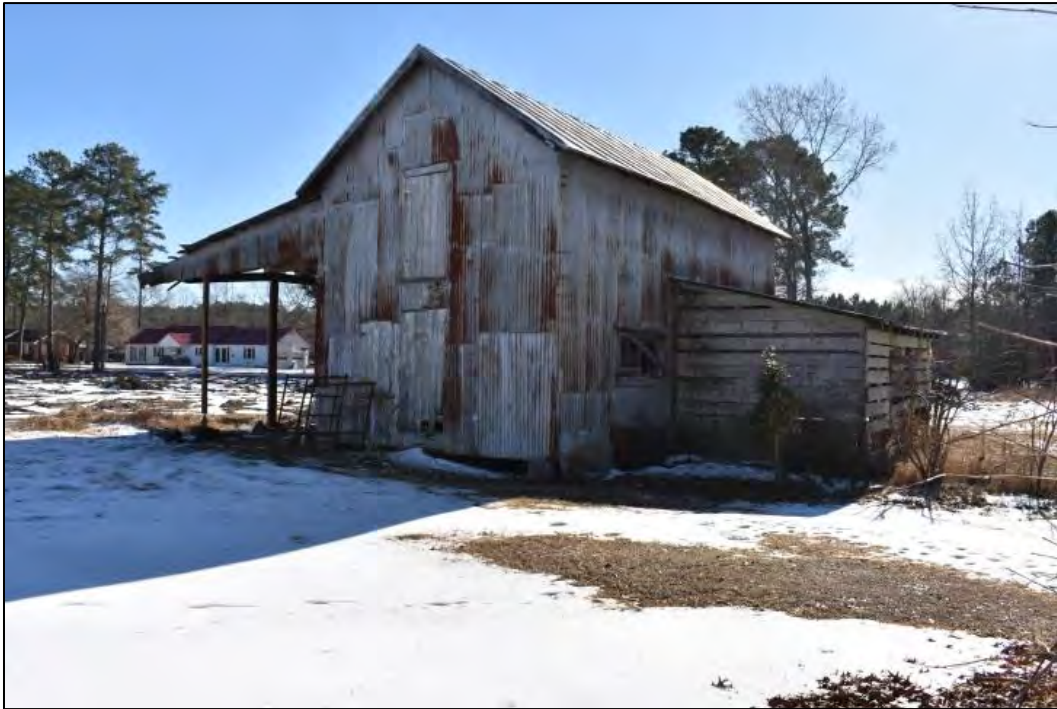
The early/mid-twentieth century frame pack house (Figure 31 to Figure 32) stands to the southeast of the Leon Sutton House, at the western edge of the field. Oriented toward the north, the front-gabled building is clad in replacement corrugated-metal sheathing. An open-air lean-to addition extends off of the building's eastern side. A small one-room, shed-roof, frame addition clad in horizontal wood boards extends from the building's southwest corner.

Figure 31: View of front (northern) elevation.

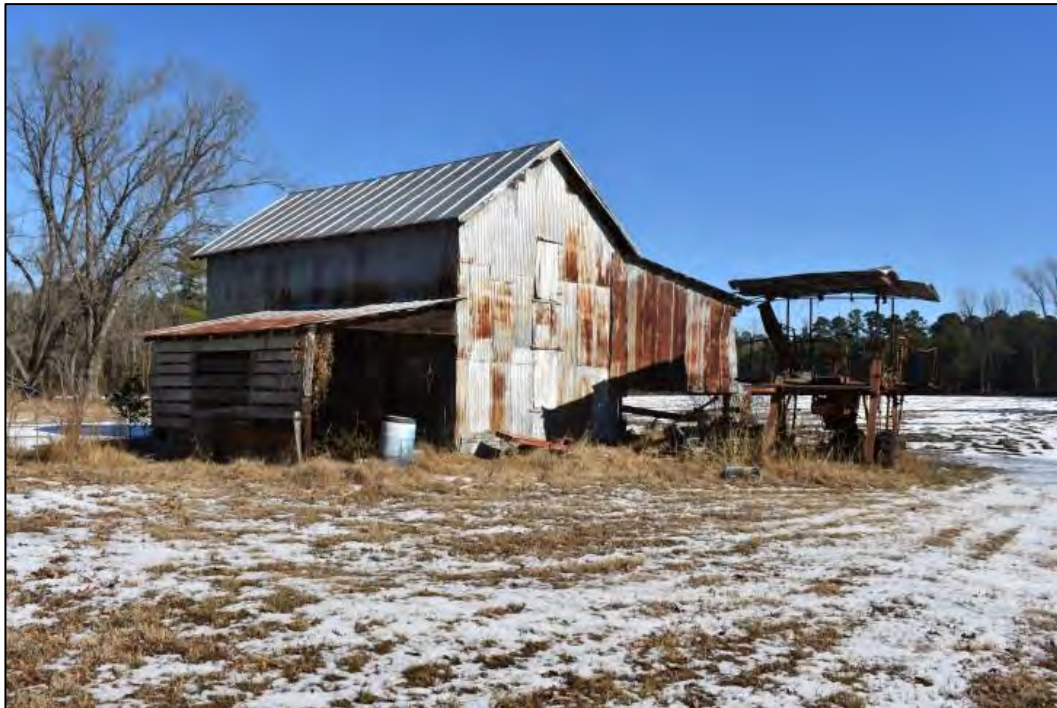
Figure 32: View of southeast corner.

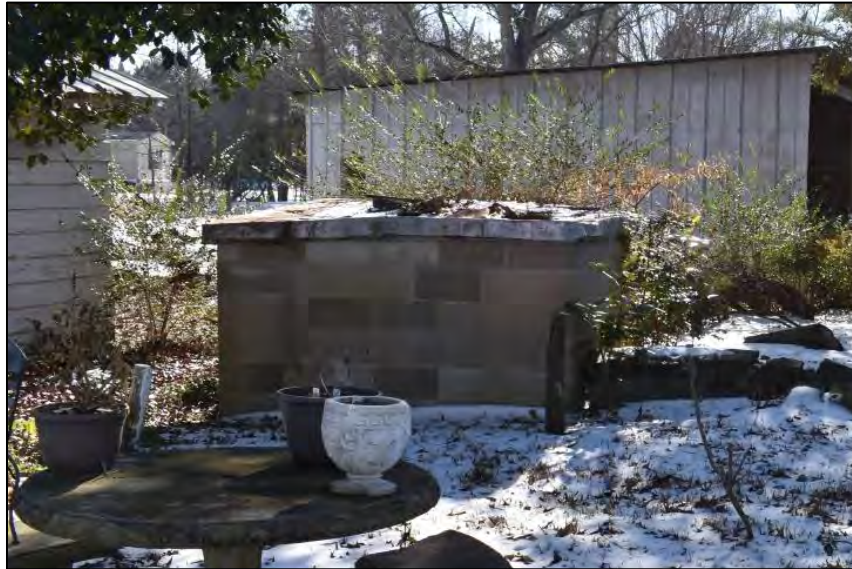
The mid-twentieth-century, rectangular, CMU well house (Figure 33) is located to the west of the shed and workshop. The small building features a flat roof that is capped with standing-seam-metal.

Figure 33: View of northern elevation of well house.

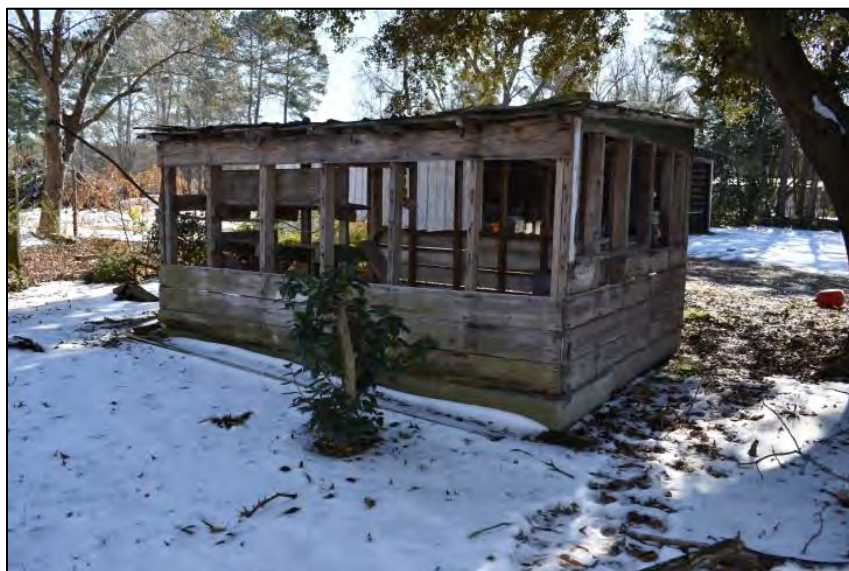
The mid-twentieth century frame chicken coop (Figure 34) is linear in plan, and sits to the south of the Leon Sutton House and the west of the well house. Horizontal wood boards clad the bottom portion of the building. The top of the building is comprised of tall rectangular bays—six on the north and south sides, and three on the east and west sides—all of which were once covered with chicken wire. Standing-seam metal covers the coop's flat roof which features exposed rafter tails.

Figure 34: View of eastern elevation of chicken coop.

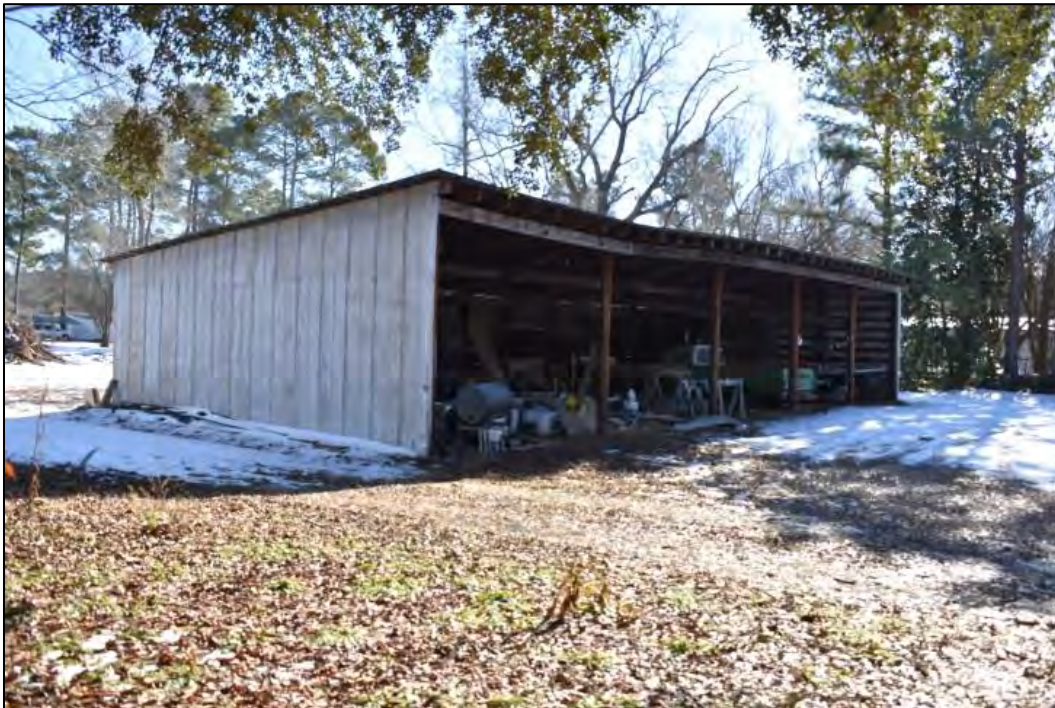
The frame tractor shed (Figure 35) dates to the mid-twentieth century and is linear in. The building is clad in vertical boards on its northern, southern, and eastern sides. Its primary (western) elevation is open, and divided into five bays by large wooden posts. The building's shed roof is topped with standing-seam metal.

Figure 35: View of northwest corner of tractor shed.

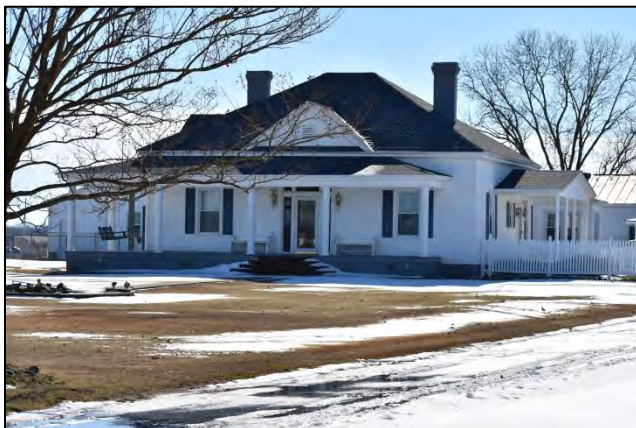
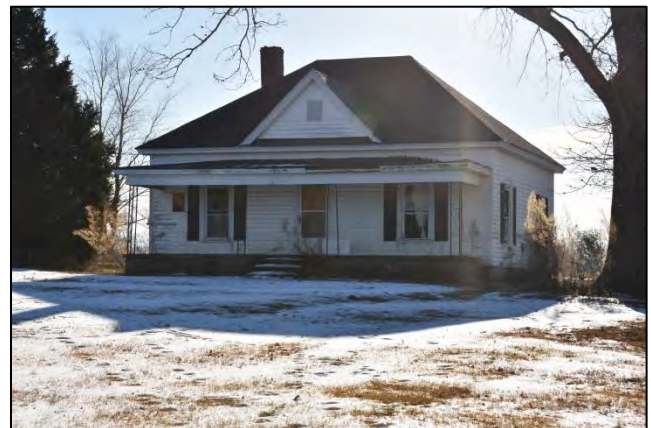
The comparable one-story, three-bay, hipped-roof, double-pile Danny Sutton House (LR0705) stands at 6816 Skeeter Pond Road just outside Grifton (Figure 38, left) and was built ca. 1900-1920 (Danny Sutton House (LR0705) SHPO). The frame house is clad in replacement vinyl siding, features replacement vinyl windows and surrounds, and synthetic columns on its front porch. Unlike the Leon Sutton House, the Danny Sutton House retains its original interior brick chimney stacks. It also retains its original front door, transom, and sidelights. Multiple additions have been made to the rear of the house.

Figure 38: Left, Danny Sutton House (LR0705) at 6816 Skeeter Pond Road, Grifton; right, house at 1355 Apple Tree Road, Stantonsburg

A third comparable to the Leon Sutton House is located at 1355 Apple Tree Road outside of Stantonsburg (Figure 38, right). The original portion of the house is a three-bay double-pile block capped with a hipped roof. Front-gabled dormers are found on the front and rear elevations. The building is clad in replacement vinyl siding, features replacement vinyl windows and surrounds, and a replacement porch. The house retains one of its two original interior brick chimney stacks.
