SUBJECT: Historic Structures Survey Report, Roundabout at US 311 & SR 1918, R-5828,

HISTORIC STRUCTURES SURVEY REPORT

Construct a Roundabout at US 311 (North Main Street) and SR 1918 (First Street) in Walnut Cove Stokes County WBS# 47100.1.1 R-5828

CALYX Engineers and Consultants 6750 Tryon Road Cary, North Carolina, 27518

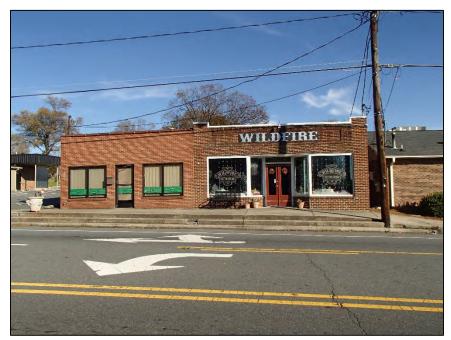
Figure 3: 224 (right) and 226 (left) North Main Street

One-story, traditional brick commercial building. The parapet wall is accented with slightly raised piers at each corner of the building. A brick sign panel extends across most of the façade above the fenestration. The double-leaf, glazed front door is centered in an angled recess. Plate glass fills the storefront windows. (Figure 3)

One-story, traditional brick commercial building. Parapet wall is finished with terracotta coping. The side and rear elevations are concrete block. The façade includes a central entrance with a single-leaf, modern plate glass door. Large plate glass windows flank the front door. (Figure 3)

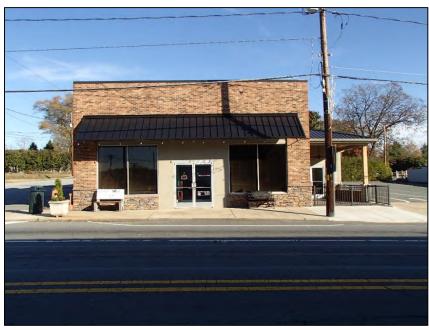
Figure 4: 234 North Main Street

One-story, brick commercial building. Double-leaf plate glass doors are centered on the façade in a section of storefront that has been infilled with faux stucco. Large plate glass windows flank the entrance. A stone veneer kneewall and a shed roof have been added to the front elevation. A hip-roof addition covered in cementicious siding is located on the south elevation and includes a small inset porch. Originally a bank building, this is now El Cabo Restaurant. (Figure 4)

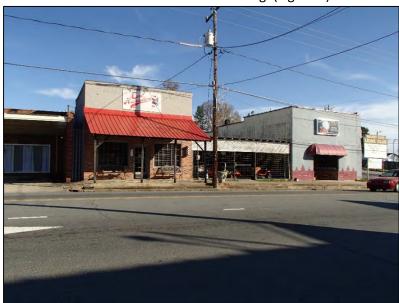
Figure 5: 310 (right), 312 (middle), 316 (left) North Main Street

Two-story commercial building. The west, north, and east elevations are concrete block. The south wall is brick and may have been associated with a building that is no longer extant. The building is windowless and the storefront opening appears to have been filled with concrete block, but the recessed entrance retains an original glazed door. W.L. Nelson owned this property from 1912 to 1946; the building immediately south was also known as the W.L. Nelson Building. That building is no longer standing, but its north wall forms the south wall of this building. (Figure 5)

This shed-roof, open pavilion was added in the mid-1990s and consists of a shed roof on wooden posts. (Figure 5)

Brick, one-story, traditional commercial building. This building has been heavily altered with the addition of a shed roof porch with wooden posts, and brick veneer over the original storefront. Windows and doors on the façade are not original and, together with the brick veneer and shed roof, significantly detract from the building's original character. Above the shed roof, the original brick parapet wall terminates at a narrow, plain cornice created from one course of slightly projecting brick. (Figure 5)

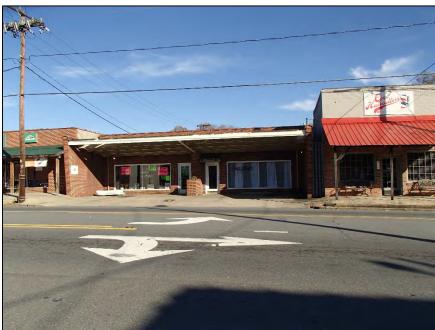
Figure 6: 318 North Main Street

Built around 1960 by brothers Elwood and Fred Young, this one-story brick commercial building is set farther back from the street to accommodate a modest parking area fronting the building. The building contains two storefronts, each with a single-leaf door and a large plate-glass window. A brick knee wall projects from the façade's center to separate the two stores. On both ends of the façade, the side walls project forward and are angled back so that the walls project farther forward at the top. Between these two side walls, a wooden pergola-type roof clad in translucent plastic panels shelters the façade. (Figure 6)

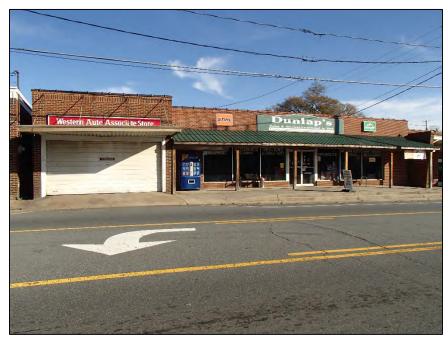
Figure 7: 322 (right) and 324 (left) North Main Street

This one-story, brick commercial building is constructed with concrete block side walls. A double-leaf central entrance is flanked by plate glass windows. (Figure 7)

This small one-story building has had a garage door installed in place of its storefront, but it retains its brick façade, original storefront opening, and a soldier course cornice. (Figure 7)

- 8. Dunlap's Western Auto Garage Should be NC due to alterations. Fenestration of front elevation entirely destroyed.
- 9. Clean Wash Laundry Company What is the date of the hip roof addition? May make building NC.
- 25. Family Pharmacy What is the date of the alteration? It may end up C, if it was done in the Period of Significance.

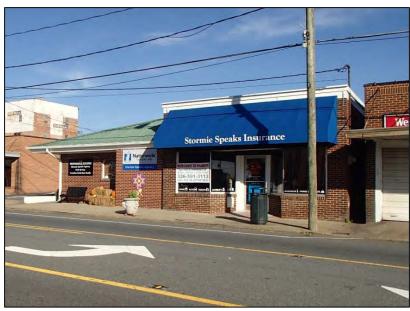
Figure 8: 328-330 North Main Street

One-story, traditional brick commercial building with a plain wooden cornice, plate glass windows, and a single-leaf front door set in a recessed entrance. A hip-roof addition is located on the building's north elevation. (Figure 8)

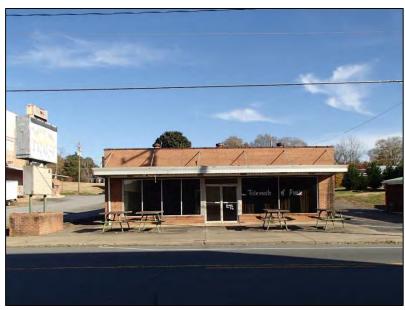
Figure 9: 334 North Main Street

This one-story, brick commercial building is nearly unaltered. It features terracotta coping along the parapet, plate glass windows, a central entrance, and a metal awning. In front of the building, a brick planter forms the base of a sign that has been altered over the years but appears to be original. V.L. DeHart purchased this lot in 1977 from a family that had owned it since the late 1800s, and it appears that DeHart built the existing building around that time. (Figure 9)

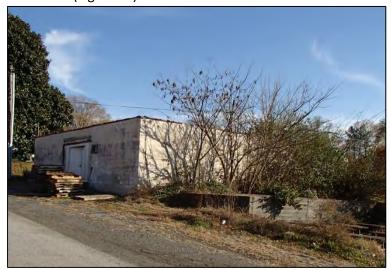
Figure 10: 334 North Main Street, outbuilding

One-story, concrete block storage building and a large double-door bay opening. Between this building and 334 North Main Street is what appears to be two foundations for buildings that are no longer standing. It is not clear that this extant outbuilding was associated with 334 North Main Street, but they are on the same parcel of land. (Figure 10)

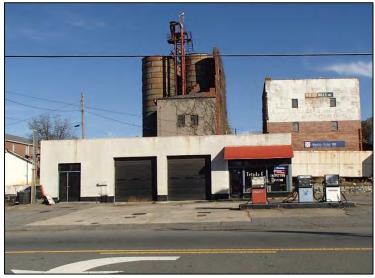
Figure 11: 408 North Main Street

One-story gas station. This concrete block building features a very low brick knee wall, plate glass windows around the west and south elevations of the building's retail portion, and two garage bays on the façade. Gas pumps on a raised concrete island stand in front, and a modern Exxon sign is located on the property's north edge. (Figure 11)

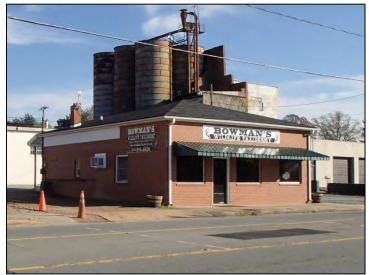
Figure 12: 416 North Main Street

One-story, brick commercial building with a hip roof. Unlike most other businesses in downtown Walnut Cove, this building has a visible roof (no parapet wall) and an asymmetrical façade with and off-center door flanked by plate glass windows and a third window toward the elevation's south end. This property was originally part of Vernon's Exxon. The construction date is based on tax records and supported by the building's modern brick veneer; however, the building's overall form and location relative to the street suggest that this may be the original gas station, possibly dating to the earlier 1900s. (Figure 12)

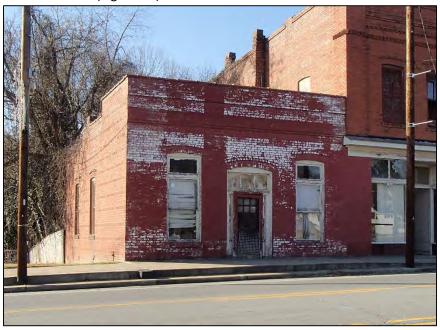
Figure 14: 133 North Main Street

This one-story brick commercial building is in poor condition but retains segmentally arched window and door openings highlighted with slightly projecting courses of headers. Projecting brick courses also form bands in the building's cornice. One-over-one sash windows flank the front door and are topped with transoms. A three-light transom finishes the single-leaf front door. Two two-over-two sash windows are located in the south elevation. (Figure 14)

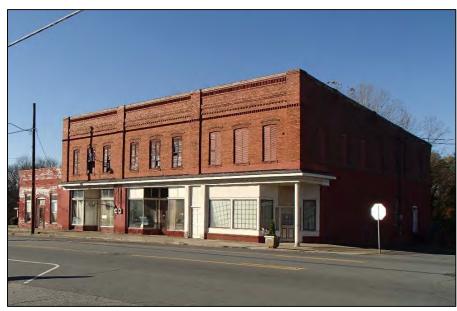
Figure 15: 135 North Main Street

The largest remaining commercial building in Walnut Cove, this imposing two-story building contains three storefronts. Two storefronts face Main Street directly, and both feature large plate glass windows, transoms, and recessed entrances. The northernmost storefront is situated on the building's corner, with the door addressing the corner of Main Street and Second Street. A round metal column supports the corner. A wooden cornice extends along the length of the façade above the storefronts. Above the cornice each section of the building retains three shuttered windows, which are highlighted with segmentally arched header courses. Flat pilasters separate the three sections. Above the windows, a tall cornice features denticulated courses, a solider course with the bricks angled in a saw-tooth pattern, and stepped courses. Throughout its history, this building housed offices for a number of doctors and lawyers with retail businesses, including the Stokes Hardware and Furniture Company at the first floor level. (Figure 15)

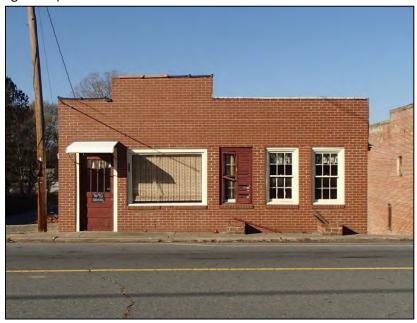
Figure 16: 203 North Main Street

This is a one-story, gable-front, frame commercial building to which a brick storefront was added. The side elevations are clad in weatherboards, while the brick façade features a tall stepped parapet and asymmetrical fenestration with a single-leaf door, a plate glass window, and a pair of six-over-six sash windows. The date for this building is based on the brick façade; the frame section probably dates from the early 1900s. (Figure 16)

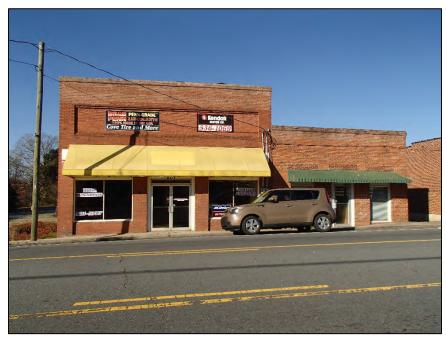
Figure 17: 207 (left) and 209 (right) North Main Street

This one-story commercial building features a parapet wall and sign panel above a modern awning. The awning shelters a symmetrical façade with a double-leaf entrance centered between two plate glass windows. A modest cornice highlights the top of the building. The south elevation features segmentally arched windows at the basement level and a stepped parapet. Attached to the rear is a gable-front, two-bay garage. John G. Fulton established the Stokes Grocery Company in 1909 and built this building before 1914. At the time of the countywide architectural survey in 1981, the interior retained its pressed metal ceiling. (Figure 17)

One-story, brick commercial building. The windows and door in this simple building have been shortened with the upper portions filled in with brick. The door and windows are plate glass and are arranged symmetrically with the door between the two windows. This building had not been built at the time of a 1914 photograph of the adjacent Stokes Grocery Company. (Figure 17)

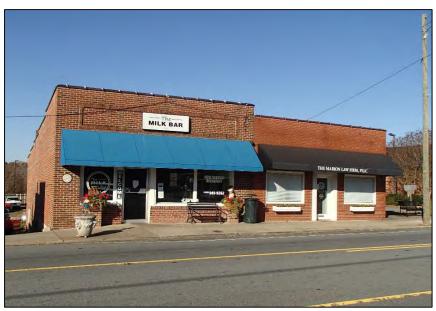
Figure 18: 213 (left) and 215 (right) North Main Street

This one-story commercial building is brick with brick knee walls below plate glass windows and a sign panel outlined with solider courses. Terracotta coping caps the exterior walls. The storefront is asymmetrical with one window on the south side of the door and two windows to the north of the door. (Figure 18)

This is a very plain, one-story, brick commercial building with plate glass windows flanking a centered single-leaf door. A flat parapet wall rises above a modern awning. (Figure 18)

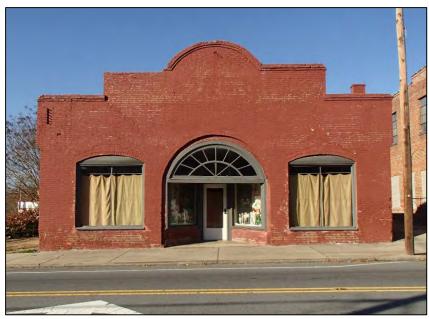
Figure 19: 223 North Main Street

This building was constructed around 1900 as a livery stable. By 1918, owners had converted it for use as a car dealership. The one-story, gable-front building features a broad arched opening with a fanlight below over a recessed entrance, which was added later. A corresponding arched opening on the rear elevation has been bricked in but suggests the building had an open drive-through when it was a livery stable. Segmentally arched window openings flank the center entrance. The stepped roof parapet features a centered arch. Small segmental arch stall windows are bricked up on the north elevation. (Figure 19)

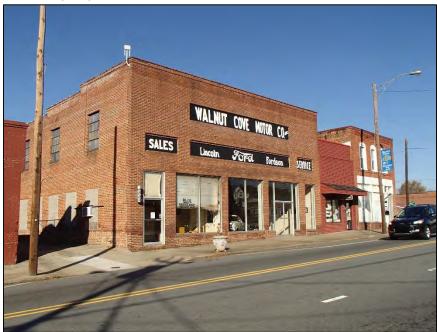
Figure 20: 231 (left) and 233 (right) North Main Street

George Fulton commissioned this building around 1923 for use as a Ford dealership. The two-story, brick commercial building features plate glass windows and doors on the façade, sign panels on the front second-story elevation, a parapet roof, and metal casement windows on the side elevation. (Figure 20)

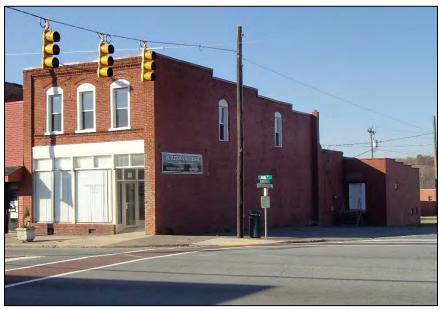
Figure 21: 235 North Main Street

Two-story, brick commercial building constructed in the late 1800s by W. A. Lash. At the ground level, the building has an asymmetrical storefront with a recessed entrance. On the second floor and along the north elevation, the building retains segmental arch window openings, although the original six-over-six sash windows visible in the 1981 architectural survey photographs have been replaced. Arched, projecting header courses highlight the window openings. The cornice is composed of sawtooth bricks and stepped courses. A row of sawtooth bricks also extends across the façade below the second-story window sills. (Figure 21)

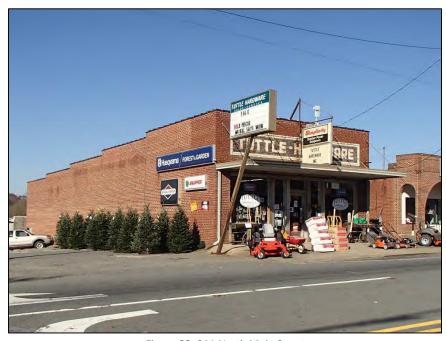
Figure 22: 311 North Main Street

This one-story brick commercial building features a painted sign, a parapet wall that is stepped on the sides, and plate glass windows in either side of a slightly recessed entrance. A flat metal awning extends across the façade. (Figure 22)

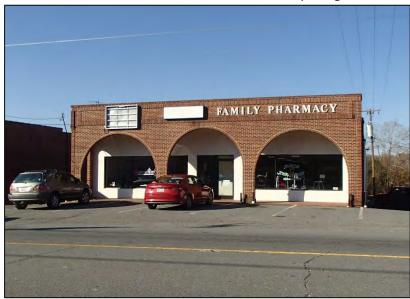
Figure 23: 317 North Main Street

Like several other buildings in the district, this building was constructed after car ownership had become very common so the building is set back from the street to accommodate parking in front. The older building is obscured by a brick façade with arched openings that creates a loggia across the front. Under the loggia, the walls are covered in faux stucco and contain modern plate glass windows. (Figure 23)

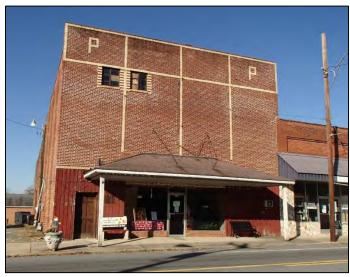
Figure 25: 329 North Main Street

J.J. Booth constructed the Palmetto Theater in 1947. The two-story brick building once housed a movie theater. The red brick is highlighted with yellow brick laid to create three vertical lines on the façade and to outline a cornice area. At each corner, the lighter brick frames the letter P, also executed in the lighter brick. A hipped-roof awning is supported with square posts and shelters an altered first floor. The first floor façade now contains vertical wood siding infill and a recessed central storefront. Two metal casement windows are situated toward the upper left corner of the façade. Pilasters accent the side elevation. (Figure 25)

- 27. Palmetto Movie Theatre Maybe too altered to be C since it is missing the marquee and the first-floor storefront is infilled. The building no longer reads as a movie theatre.
- 32. Llewellyn's Esso This is too altered to be C. The infill of the original window and door openings with stucco, to create smaller window and door openings, is a major alteration.

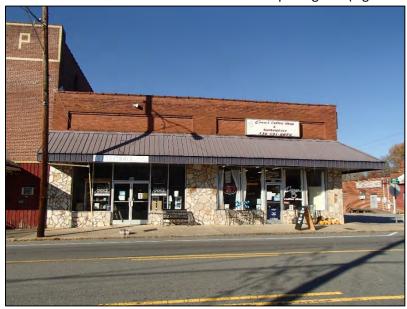
Figure 26: 333 North Main Street

This one-story, brick commercial building is divided into two storefronts. Above a full-width modern awning, the parapet wall is original with two recessed sign panels. Below the awning, the storefronts have been heavily altered with the addition of stone veneer and plate glass. (Figure 26)

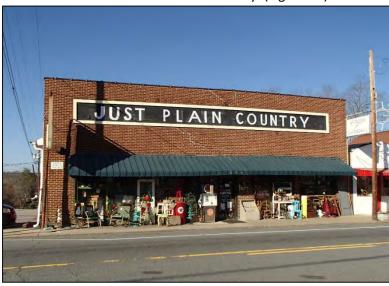
Figure 27: 405 North Main Street

One-story, brick commercial building with a painted sign panel across the façade. A modern awning shelters plate glass windows and a central entrance. A parapet wall hides a gabled roof. To the rear, a brick addition appears to date from the mid-twentieth century. (Figure 27)

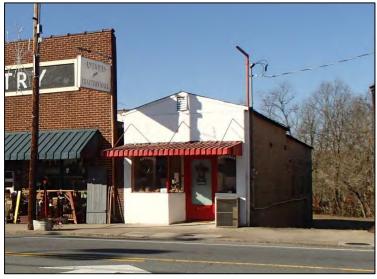
Figure 28: 407 North Main Street

This diminutive building is a gable-front, concrete block building with an off-center, recessed entrance and a metal awning. (Figure 28)

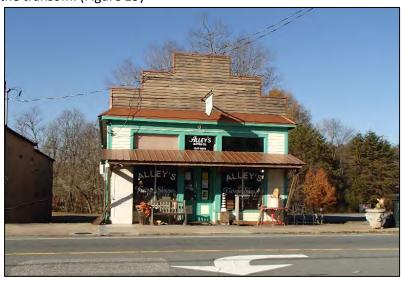
Figure 29: 409 North Main Street

This building housed Alley's Maytag dealership from 1947 to 2002. The gable-front, frame building is a remarkably intact frame commercial building with a stepped parapet, original double-leaf front door, and its original window configuration with tall transoms above the door and windows. A metal awning is mounted between the top of the windows and door and below the transom. A pent roof extends across the façade, above the transom. (Figure 29)

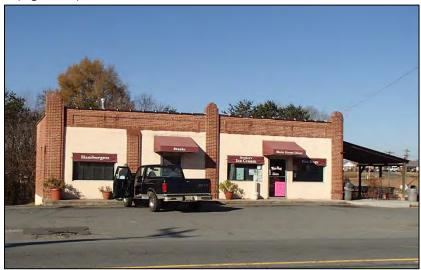
Figure 30: 419 North Main Street

One-story former gas station. This building retains stepped Art Deco pilasters, but the garage bays and storefront have been filled with windows and faux stucco. It remains, however, clearly identifiable as a former gas station. (Figure 30)

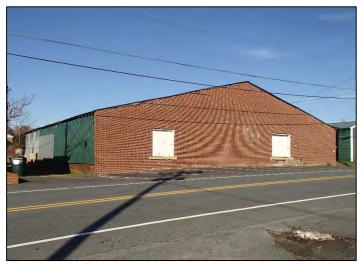
Figure 31: 204 West Third Street

This is a large brick warehouse with two double-width, wooden doors, and metal siding on the side elevations. (Figure 31)

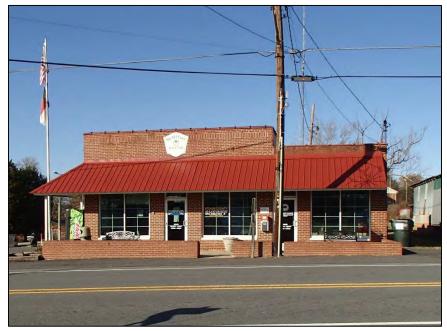
Figure 32: 208 West Third Street

One-story, brick commercial building with two storefronts. One storefront is taller, and the taller one features a solider course cornice. A modern metal awning extends across the entire length of the façade. The windows and doors are modern replacements. (Figure 32)

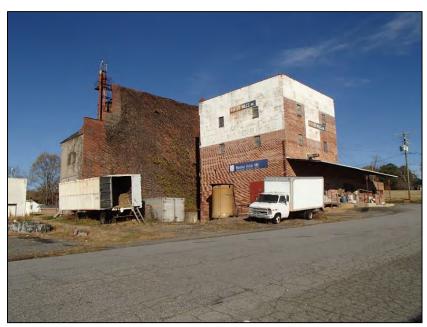
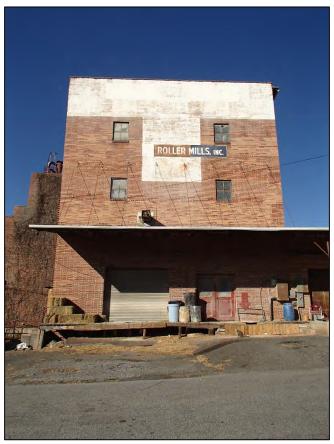
This building replaced an earlier roller mill that burned. The complex includes a three-story brick building with metal frame windows. A flat metal awning shelters a loading dock. A modern garage door and an original double-leaf wooden door are located on the south elevation's loading dock. One-story additions are located on the east elevation and, on the north, a brick fire wall extends beyond the main block to separate the mill from a group of six tall grain storage towers. (Figures 33 and 34)

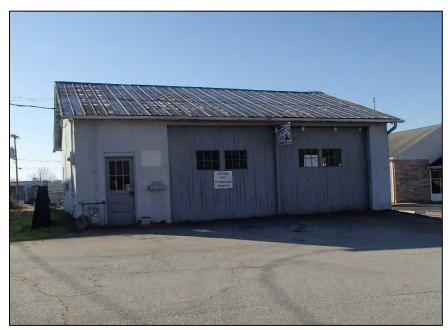
Figure 35: 104 West Fourth Street

This is a one-story, side-gable, concrete block garage with two garage bays, both with wooden garage doors. (Figure 35)

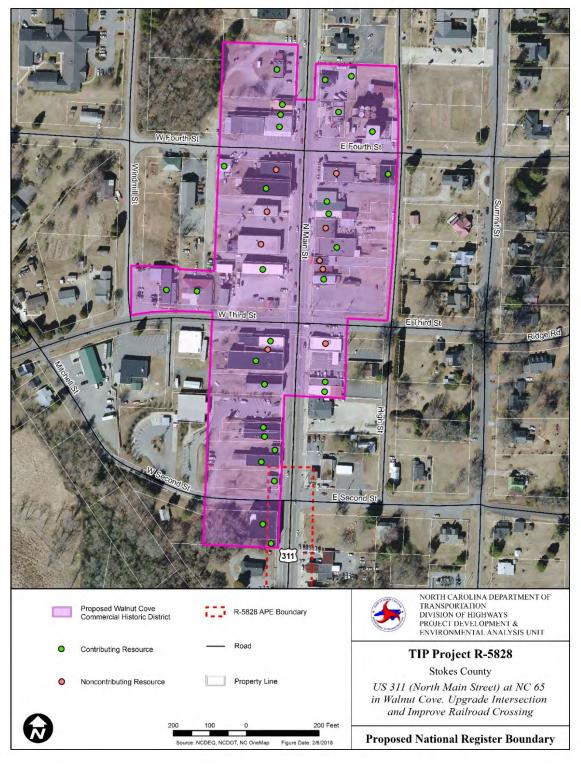
Figure 39: Walnut Cove Commercial Historic District Proposed Boundary

Specifically, within the APE, the boundary follows the eastern edge of pavement where it runs north-south in front of the buildings along Main Street. At the boundary's southeastern-most corner, the boundary extends west from Main Street, following the southern edge of the parcel identified as Stokes County PIN 6962373866. The boundary then turns north, following the western edge of this parcel. From there, it crosses Second Street and continues north, following the rear lot lines of the parcels fronting Main Street. The following map, Figure 39, illustrates the proposed boundary.
