SUBJECT: Historic Structures Survey Report, Replacement of Bridge 263 on SR 1892 over Rocky Creek,
PA 17-05-0021, Iredell County, ER 18-0414

HISTORIC STRUCTURES SURVEY REPORT

**Replace Bridge No. 263 on SR 1892 (Jennings Road) over Rocky Creek,
Iredell County**

**WBS # 17BP.12.R.80
PA # 17-05-0021**

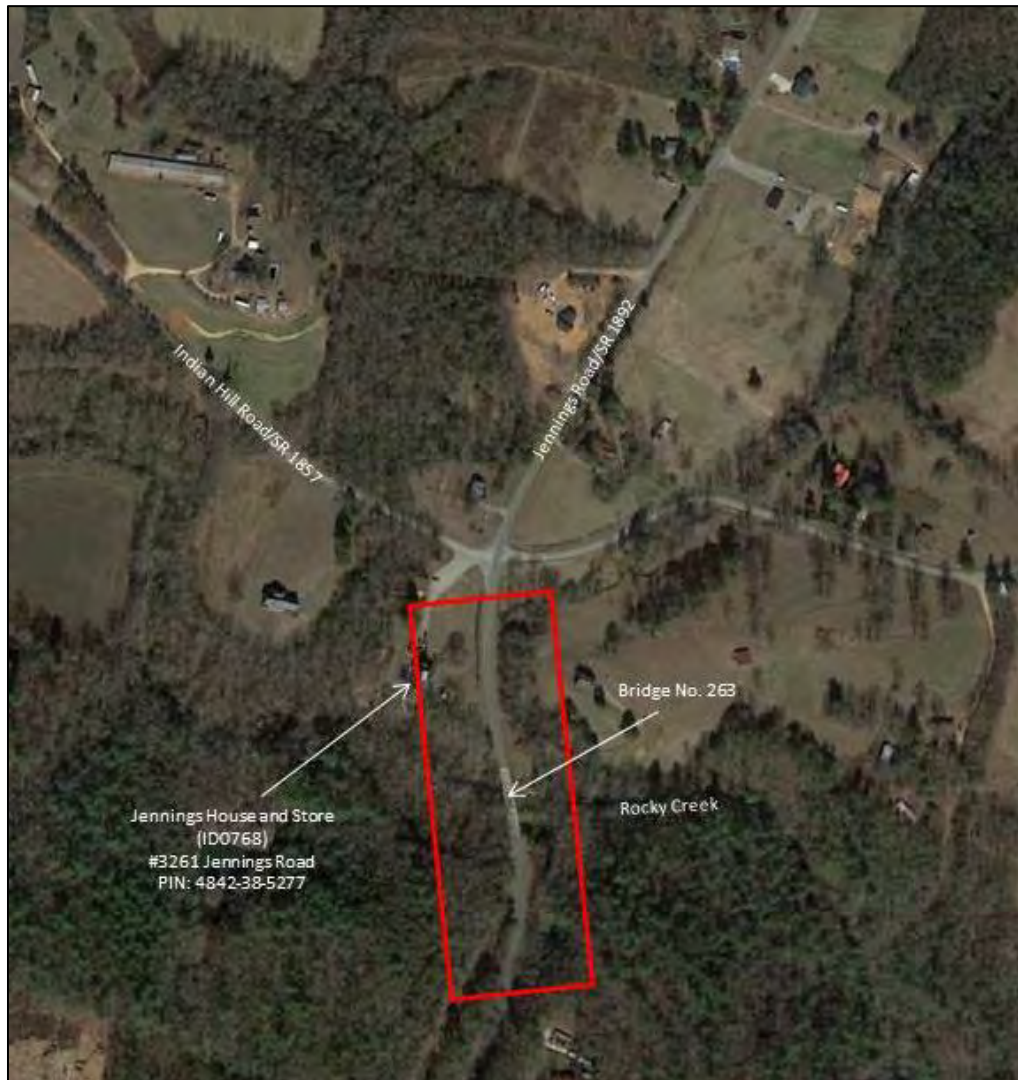
Figure 2: Area of Potential Effects (APE) (basemap source: GoogleMaps).

The project’s Area of Potential Effects (APE) is located in Iredell County, North Carolina. It is depicted in Figure 2 along with the location of the Jennings House. The APE encompasses approximately ten acres, all of which the architectural historians considered as part of this report.

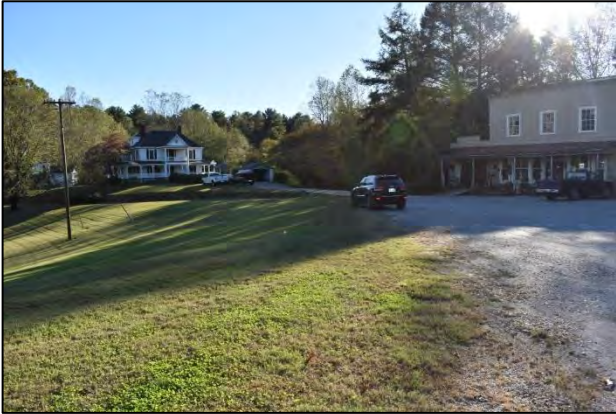
ID0768

3261 Jennings Road, Union Grove vicinity

Ca. 1889, 1910-1915

Recommended NRHP eligible under Criterion A and Criterion C.

The Jennings House and Store (ID0768) sits on the eastern half of a U-shaped, 10.62-acre, rural parcel approximately 20 miles north of Statesville. At the north, the parcel is bounded by Indian Hill Road (SR 1857), to the east by Jennings Road (SR 1892), and to the south by Rocky Creek. The Jennings House and its associated secondary structures sit at the edge of a grassy clearing, on a slight hill overlooking Jennings Road. An unnamed creek running north-south cuts deep into the ground to their west. The property is accessed by a long gravel drive at the crossroads of Indian Hill and Jennings Roads. The Jennings Store stands near the driveway's opening, a short distance from the crossroads.

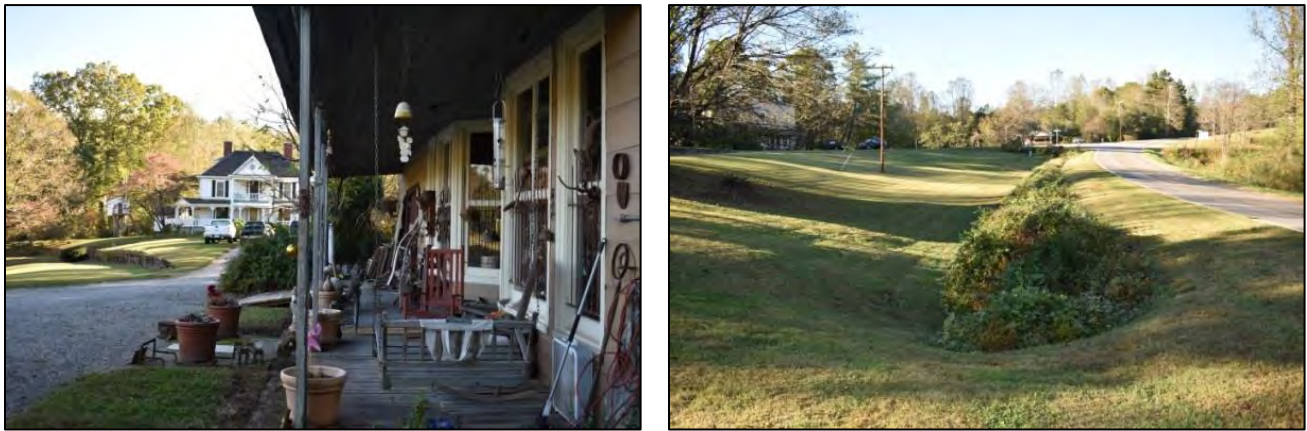
In addition to the house and store, the parcel holds six other resources. To the south of the house are an early-twentieth-century shed and a late-twentieth-century tree house. To the west of the house (south of the store) is a late-nineteenth/early-twentieth-century stone apple house. Located just north of the dwelling are an early/mid-twentieth-century well house and a mid-twentieth-century garage. An early/mid-twentieth-century stone retaining wall extends on a diagonal to the east of the house, from the driveway near the store out toward Jennings Road. A sloping grassy clearing runs between the wall and the road, which is elevated on fill.

Figure 11: Left, view from front porch of the Jennings Store looking south toward the Jennings House; right, view of Jennings Road looking northwest toward the Jennings House.

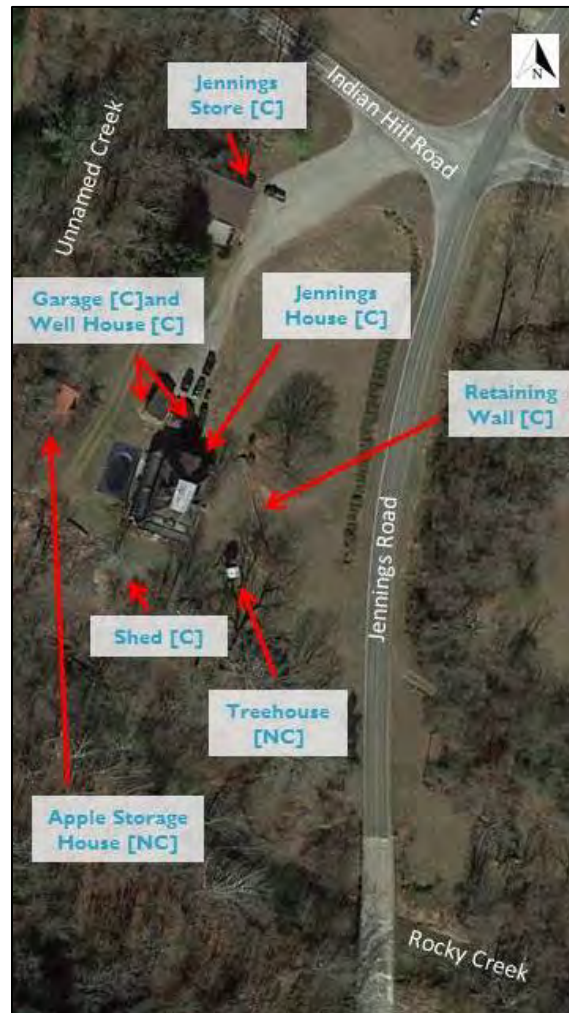
Figure 12: Site plan of Jennings House and Store.

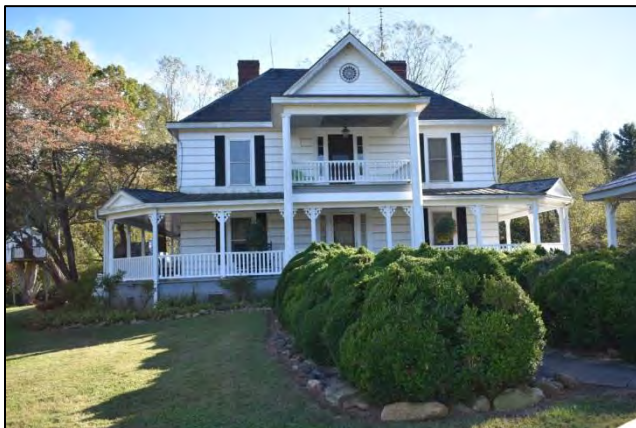
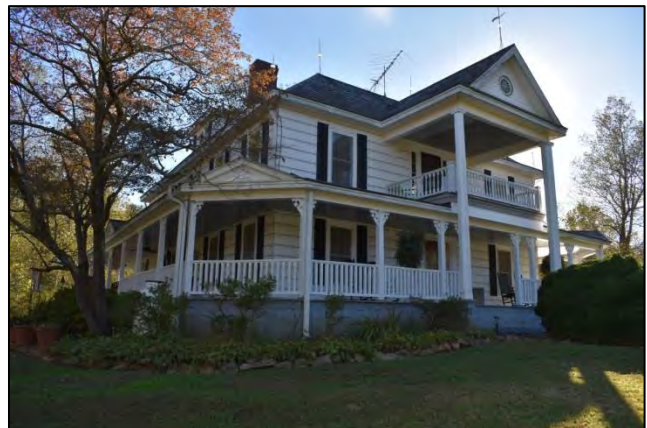
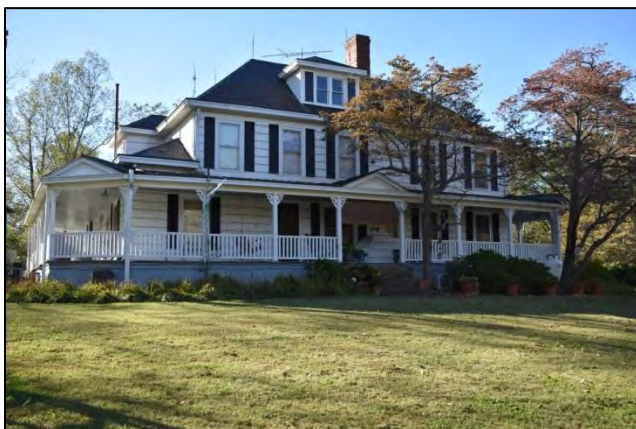
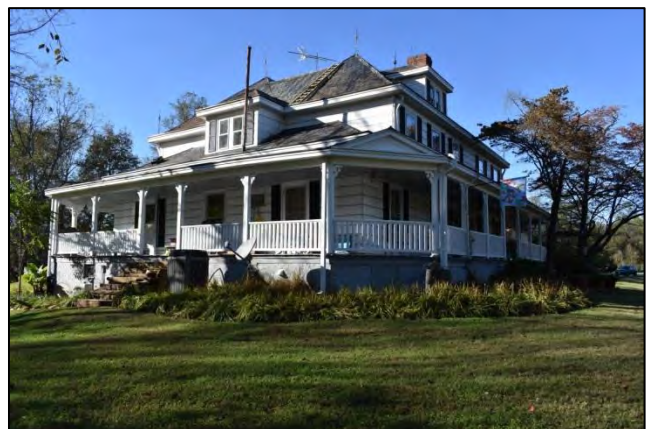
The two-and-a-half-story, frame, transitional Queen Anne/Colonial Revival-style Jennings House, built around 1889, features a center-hall, double-parlor plan and stands three-bays wide by five-bays deep. The house sits atop a continuous brick foundation and is clad in replacement asbestos shingle siding which has been manufactured or painted to imitate wooden shingles. Two corbeled interior brick chimneys project through the building's hipped roof, which is covered in replacement asphalt shingles. Hipped dormers are found on the eastern, western, and southern sides of the roof. Original or early glass-balled lightning rods are found on all corners (Figure 13).

A two-story portico rises at the building's northern elevation, and frames its primary entrance. The portico is supported by full-height, wooden, octagonal posts and is capped with a pediment featuring an ornate sawn-work ventilator. The second-story balcony is bounded by turned wooden balustrades. A one-story porch extends beneath the portico and wraps around the entire house. The porch is supported by simple wooden-boxed posts that are adorned with decorative brackets on either side, and features plain square balustrades. The four corners of the porch are angled, and surmounted by unadorned pediments.

Figure 13: Top left, front (northern) elevation of Jennings House; top right, view of northeast corner of house; bottom left, side (eastern) elevation; bottom right, view of southeast corner.

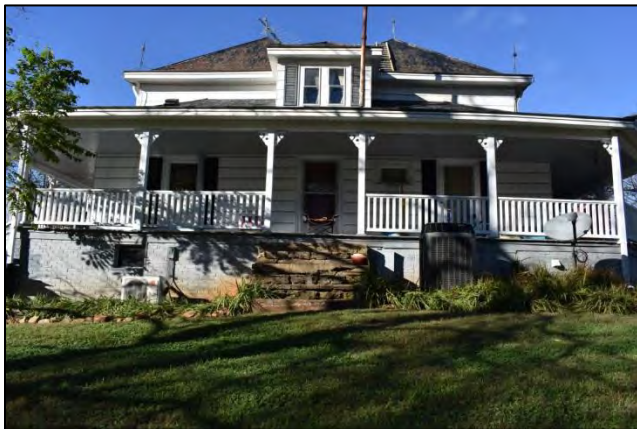
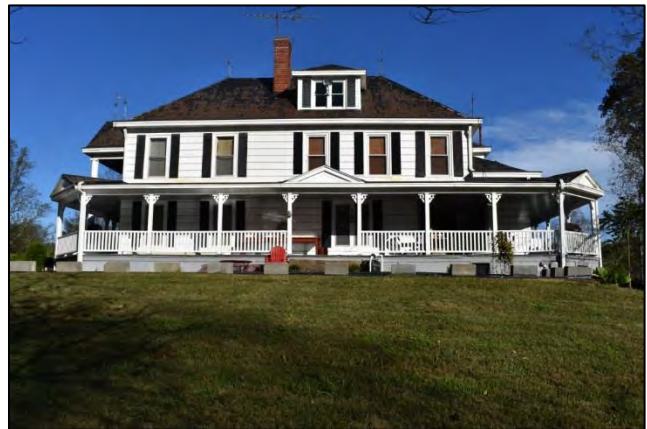
The building's front elevation features symmetrically aligned openings—an original paneled door flanked by sidelights, centrally placed between two one-over-one double-hung windows. The glass of these and the remainder of the house's windows suggests that they are original. Perhaps due to the addition of the rear dormer during the early 1900s, the rear (southern) elevation has no second-floor fenestration. The first floor fenestration pattern of the rear elevation mirrors that of the front of the house. Two additional doors are found on both the first floors on the eastern and western sides of the house—both off-centered between a pair of the same original one-over-one double-hung windows. Five windows are found offset on the second floor on the east and west sides. All windows are flanked with fixed shutters. The asymmetrical design of these elevations is a result of the chimney placement. Rough-cut stone stairs lead to the doors on each of the eastern, western, and southern sides. The front entrance features painted concrete stairs. The exterior of the building does not appear to have undergone any notable alterations since it was last surveyed by Ruth Little in 1978.

Figure 14: Left, rear (southern) elevation of Jennings House; right, side (western) elevation.

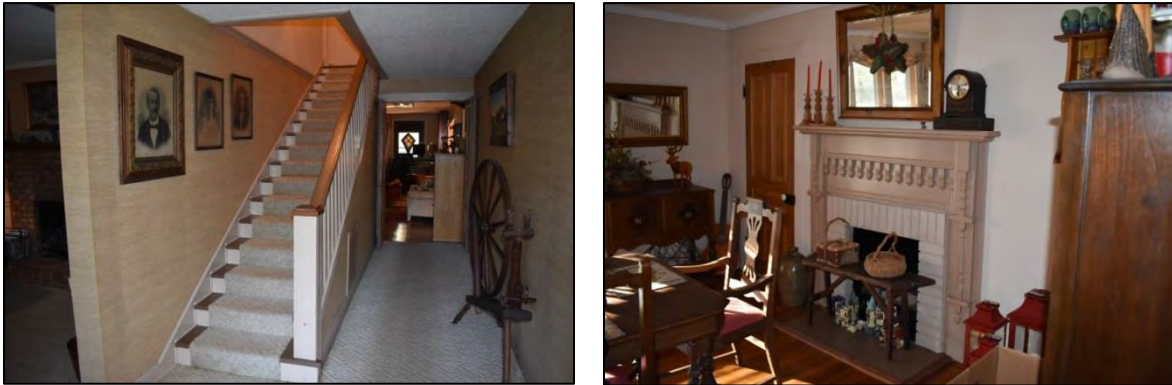
The Jennings House's interior retains many original elements. Original hardwood floors are visible in many rooms; others are carpeted. An original post-and-lintel Queen Anne-style mantle, likely ordered from a millwork factory, remains intact in the dining room. Downward pointing pendants cross its frieze, which is crowned by a molded shelf and pendants, and turned pilasters climb its posts. The front hall features what appear to be the dwelling's original deep-set staircase, handrail, and newel post. Original four-paneled wood doors are found throughout the house. Original door and window surrounds—formed of incised casings that meet at cornerblocks decorated with inset pinwheels—also survive throughout (Figure 15).

Figure 15: Left, view of stair hall, looking south from the front entry toward the back of the house; right, view of original mantel, wood floors, and paneled door in dining room;

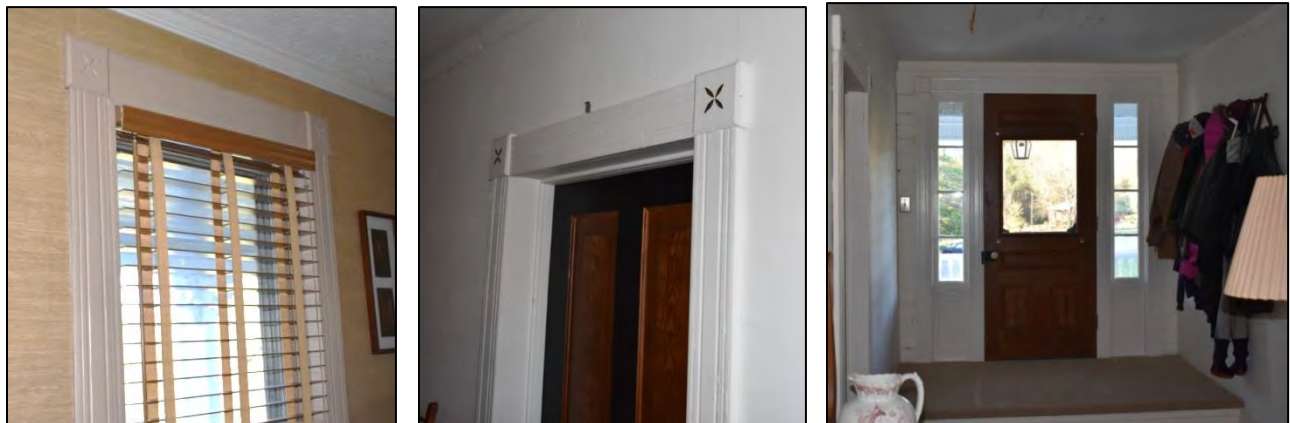
The house is almost entirely intact. It is a contributing building to the historic property.

Figure 16: Left and center, detail views of original window and door surrounds found throughout the first and second floors of the house; right, view of original second floor door and sidelights.

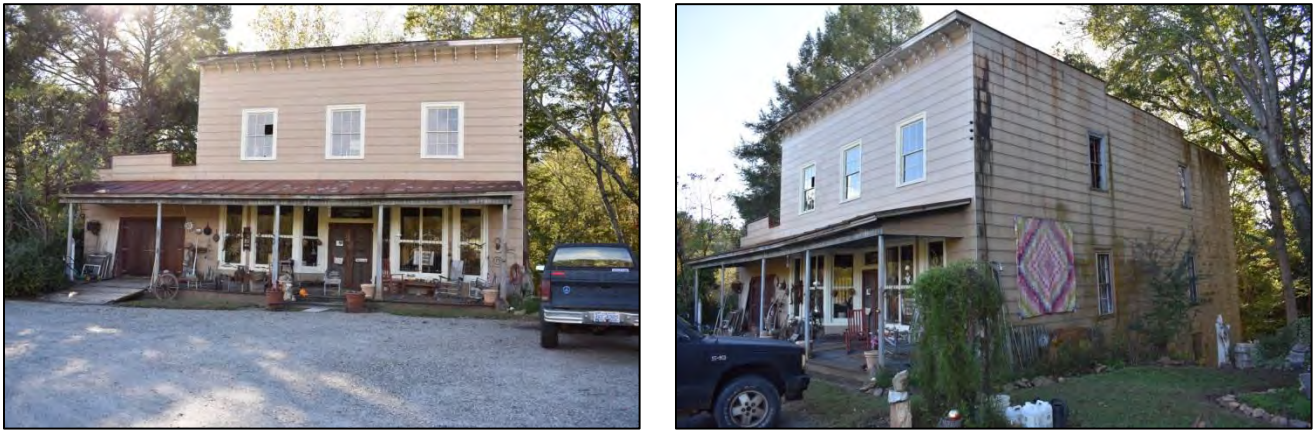
Located to the north of the house, about 200 feet southwest of the crossroads of Indian Hill and Jennings Roads, the Jennings Store is likely contemporary with the Jennings House. Local history suggests that the store was built sometime around 1889 (Little-Stokes 1987), replacing an earlier store on the property used for the first three years of the business (Figure 17).

Figure 17: Left, front (eastern) elevation of Jennings Store; right, view of northeastern corner of store.

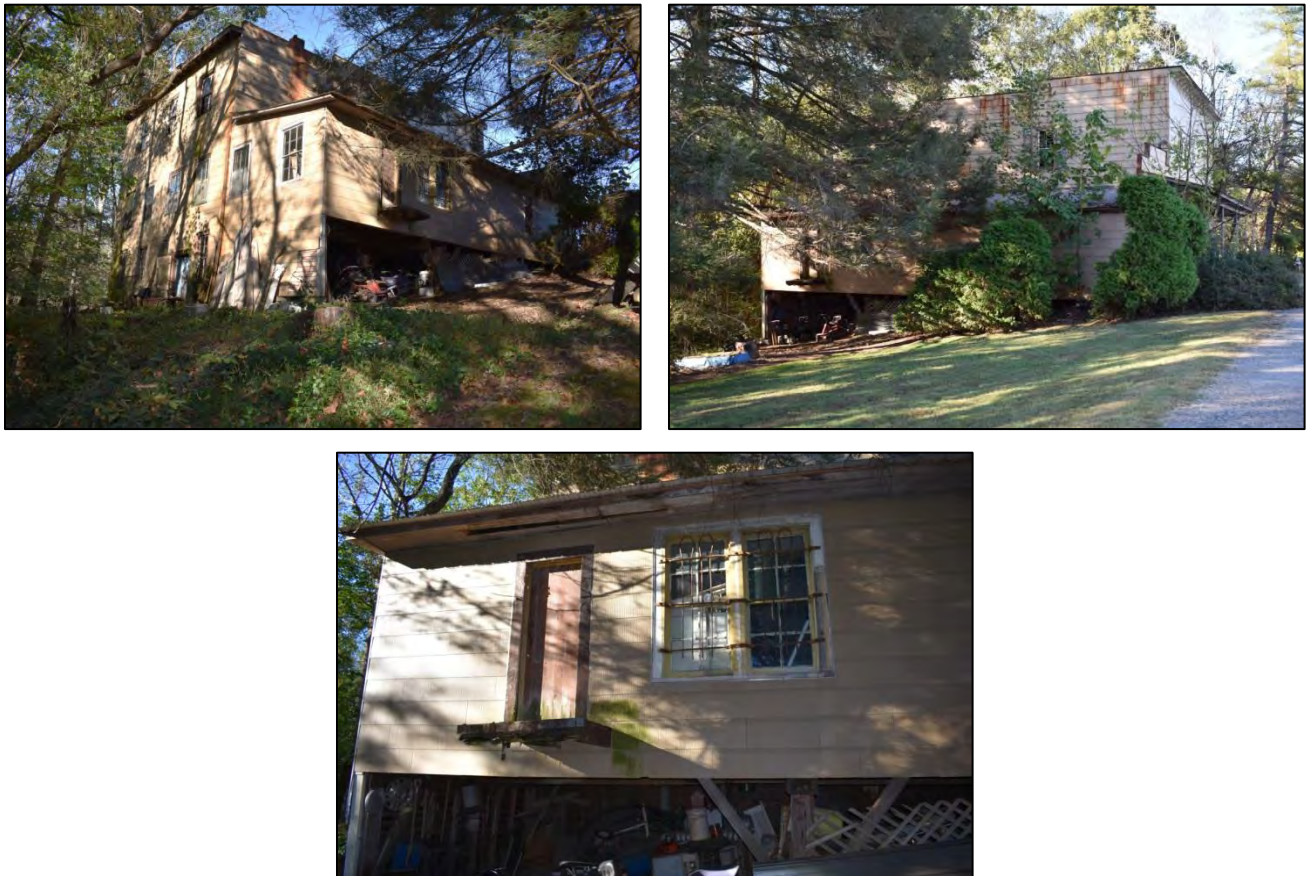
The frame building is divided into two sections: the original, two-story, east-facing store block and a one-story wing on the south (Figure 18). The original store block is three-bays-wide and two-bays-deep. It features a parapet roof edged at the front with decorative brackets. These jigsaw brackets are stylistically similar to those of the Jennings House’s wraparound porch. The building retains its original storefront, set underneath a one-story shed-roofed porch supported by tapered, beaded, wooden columns that Little identified in 1978 as replacements. The porch spans the entire façade of the store and the one-story wing. (This suggests that the wing is original or, alternatively, that the porch was later added). The original storefront is comprised of a centrally placed doorway, which retains its original four-paneled doors, and is topped by a transom in which the name “J.T. Jennings Merchant” is painted on a glazed panel. The large-paned bands of windows that flank either side of the doors appear to be original and are trimmed with heavy, plain, wooden molding. The bottom window panes are covered with metal bars, which also appear to be original. Original six-over-six-light, double-hung windows are evenly spaced above.

Affixed to the south side elevation of the store is a one-story, one-bay-wide by three-bays-deep storage space that may be a later addition. This block is topped by a parapet roof and features a central doorway in which are placed two large, unadorned, wooden doors. In her 1978 survey of the building, Ruth Little noted that the wing was used as storage space and reported that it had thick walls insulated with sawdust. An elevated door is found on the eastern side of the addition, which is thought to have been

used for loading and unloading apples. The insulated walls would have allowed for long-term apple storage (Figure 18).

Figure 18: Left, view of rear (southwest corner) of Jennings Store; right, view of side (southern) elevation; center, detail view of western end of southern elevation/apple storage.

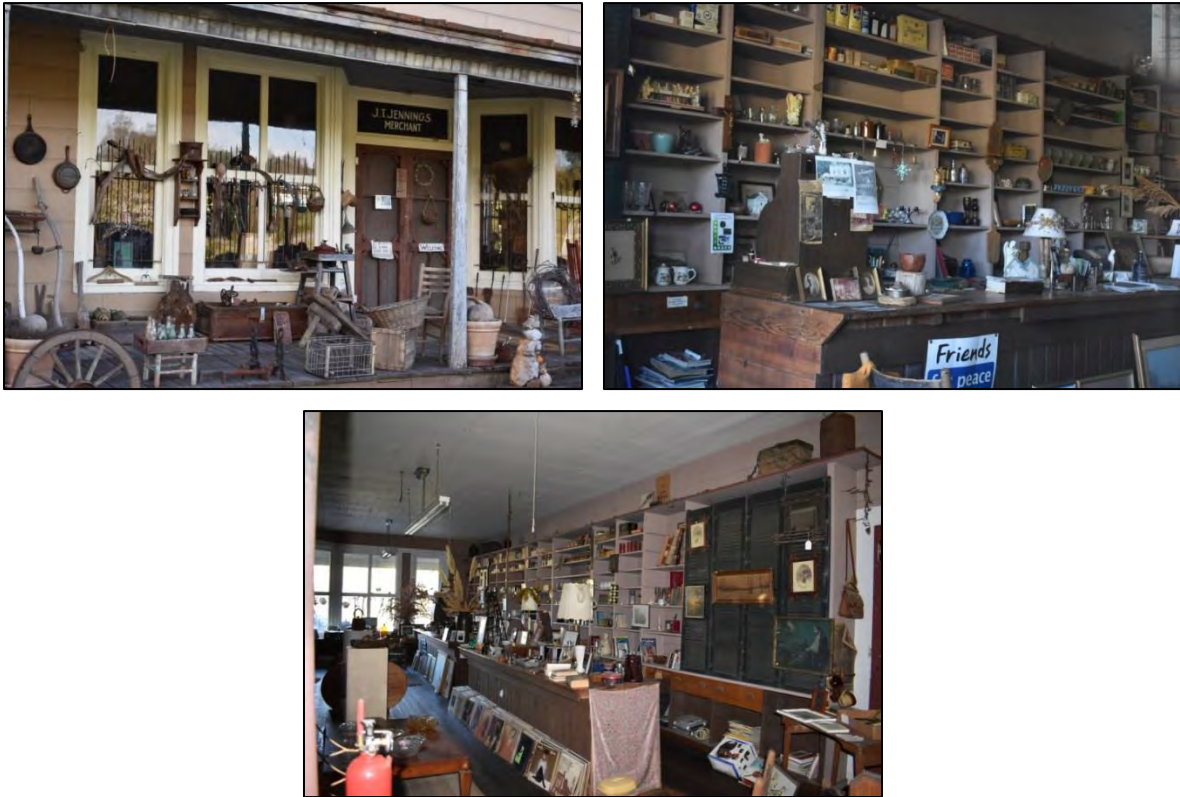
The building's interior is exceptionally intact. It retains original wooden floors and flushboard walls throughout. It further holds nearly floor-to-ceiling shelves that span most of its side walls. Two long, deep, and substantial wooden counters continue to separate the shelves and their goods from the central body of the store. An old cash register also remains in place on one of the counters. Goods of various vintage still fill the shelves (Figure 20).

Figure 19: Left, detail view of front porch; right, interior looking (west) to back of the store; center, interior view looking (east) to front of store.

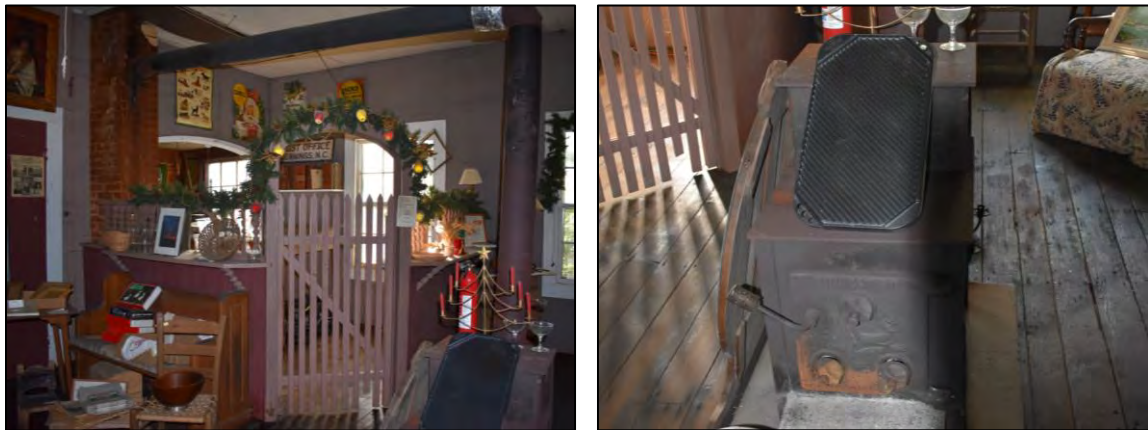
Half-height, beaded-board, partition walls in the southwest corner separate out a space that may have been used as an office. The spindles that support the shelves topping the partitions, and that form short balustrades above them, are nearly identical to those that adorn the house's dining room mantel. This indicates that much of the finish of this section of the room is original. (A picket-fence gate that serves as a door is a later addition.) A small painted sign at the rear wall that reads "Post Office, Jennings, N.C." suggests the original function of the space. A stove pipe runs above the office, out to a wood-burning stove in the body of the store. The boxy steel or iron "Huntsman" stove dates from the late twentieth century (Figure 20).

Figure 20: Left, view of partitioned office space; right, view of Huntsman wood-burning stove.

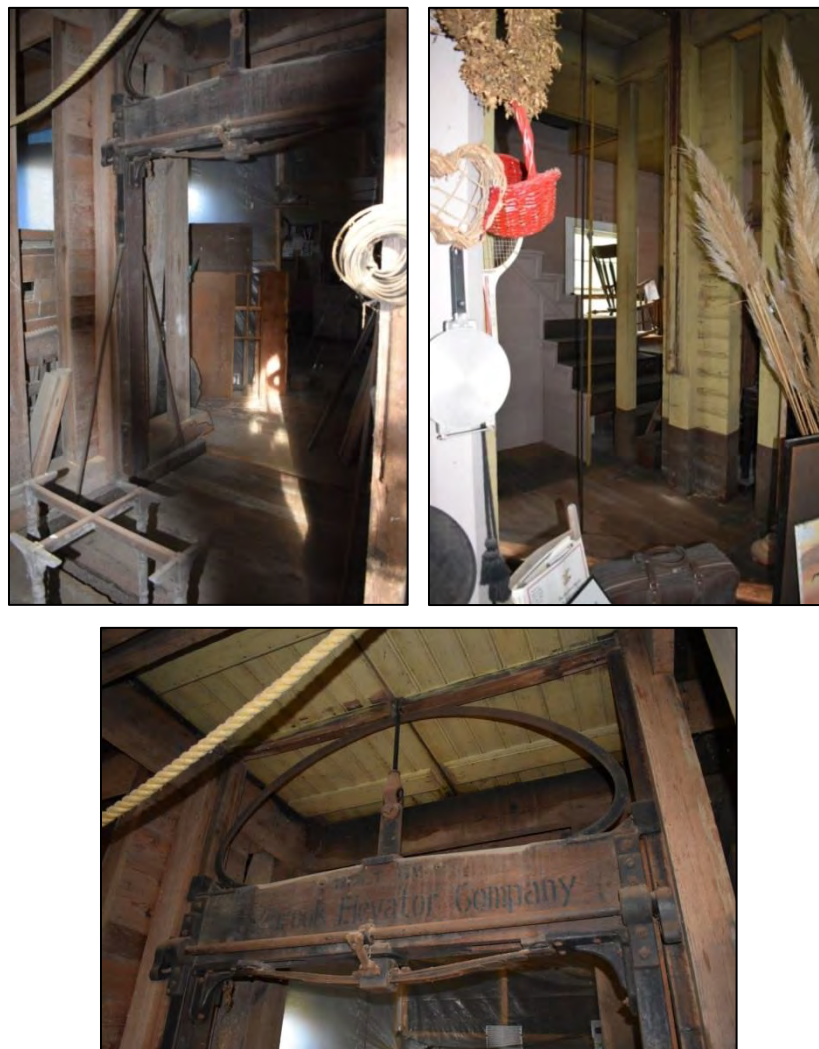
An open early-twentieth-century freight elevator is located at the center rear of the store. It runs between the basement and the first and second floors. Its substantial construction would have allowed heavy items to be moved into and out of all levels of the building (Figure 21). Painted on a heavy wooden cross-member are the words “Westbrook Elevator Company.” The elevator is not original to the store, but was likely an early addition. (The company, which operated in Danville, Virginia, was not founded until 1907 ([Danville] *Bee* April 25, 1950). The design is similar to one pictured in the Sweet’s *Catalog of Building Construction* of 1911, which was designed for “Mercantile Use.”

The store, like the house, is almost entirely intact. It is a contributing building to the historic property.

Figure 21: Left, view of elevator sitting on ground floor; to right, view of elevator opening on first floor; center, detail view of “Westbrook Elevator Company” mark.

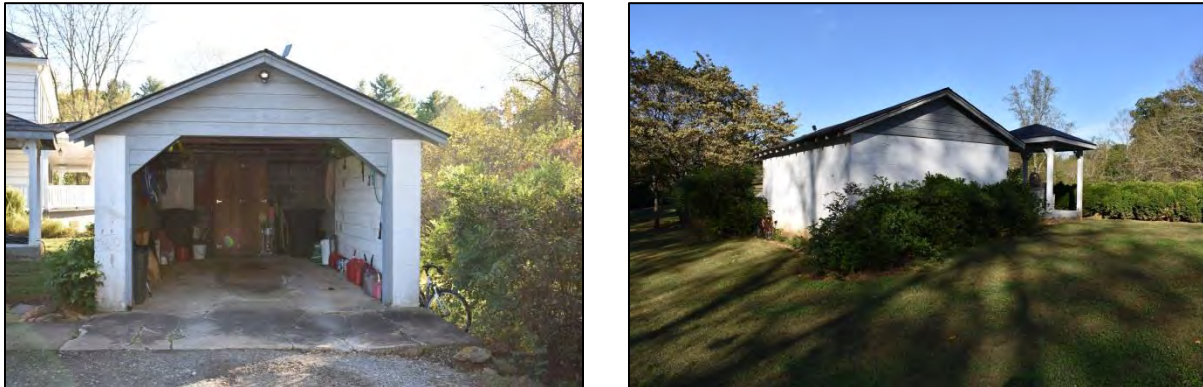
Situated directly north of the Jennings House, this small front-gabled garage is constructed of concrete-masonry-unit blocks and is rectangular in plan. Spanning only one bay, the building's gables are partially clad in beaded weatherboards and its roof in standing-seam metal. The garage likely dates from the mid-twentieth century. The garage was constructed during the historic property's period of significance and is a contributing building (Figure 22).

Figure 22: Front (northern) elevation of garage, at left; at right, north rear and west side elevations of garage with well house to right

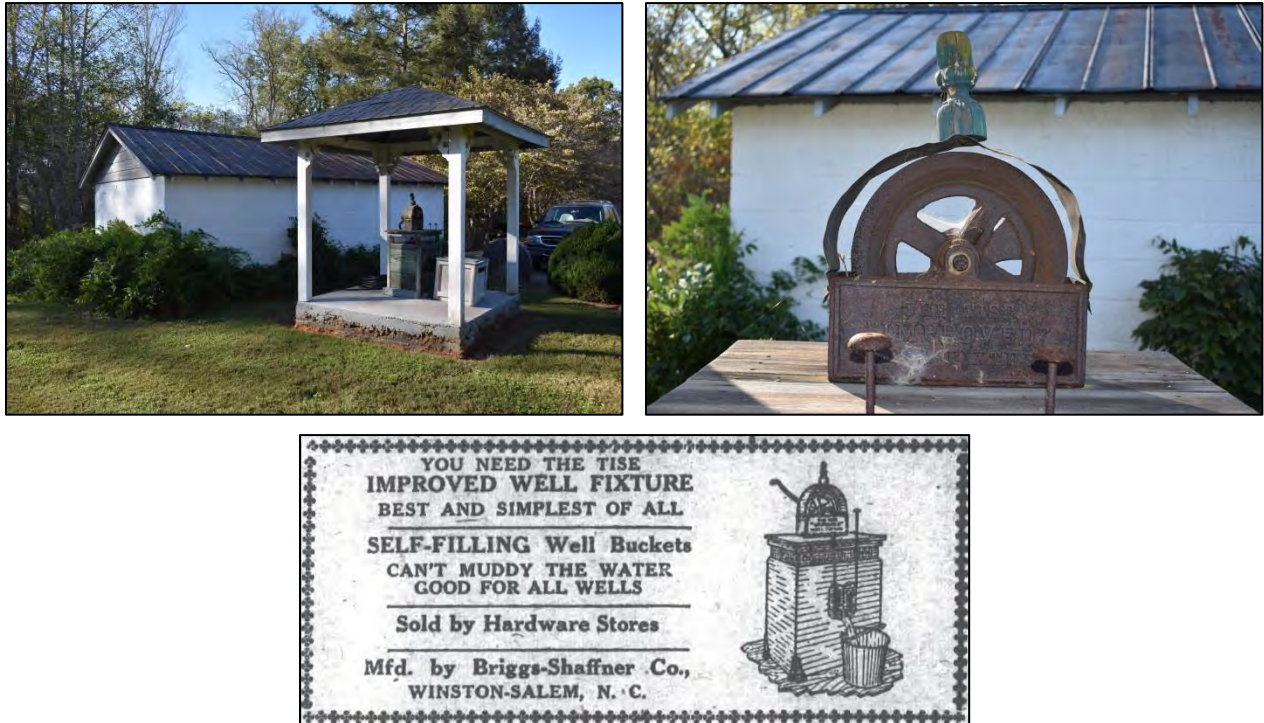
Located to the north of the Jennings House, and to the east of the garage, is small, frame, hip-roofed well house supported by four boxed wooden posts. Decorative brackets, stylistically similar to those used on both the porch of the house and the parapet of the store, adorn the interior sides of the posts. Overhanging eaves protect the posts and brackets. Underneath the decorative tin-shingle-clad roof is a largely intact metal well pump over the well. Embossed on one side of the pump are the words “Manufactured by Briggs-Shaffner Company Founders and Machinists Winston-Salem N.C.” The other side of the pump bears the legend “The ‘Tise’ Improved Well Fixture.” Briggs-Shaffner was founded in Salem in 1897 as a cigarette-rolling-machine company. It expanded its product line, which by the 1920s included its improved version of the Tise well fixture. The company continues to operate in North Carolina (Briggs-Shaffner website at <http://www.bscindustrialservices.com/aboutus.html>). The well house with its early pump retains sufficient integrity to be a contributing building to the historic property (Figure 23).

Figure 23: Left, view of well looking to northwest with garage in background; right, view of Briggs-Shaffner improved Tise well fixture; bottom, November 30, 1920 advertisement (*Tarboro Daily Southerner Daily*).

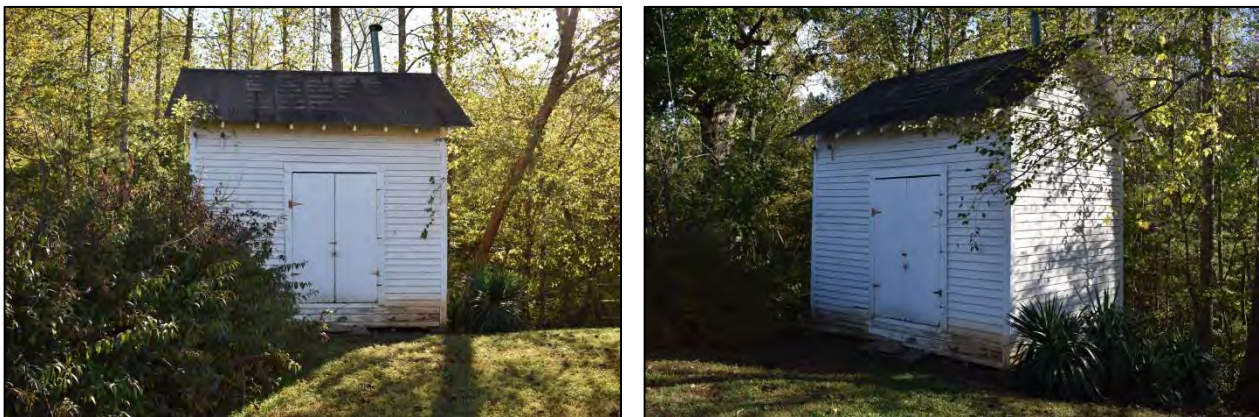
Situated to the north of the house, this small side-gabled frame shed is rectangular in plan and features centrally placed replacement doors on its northern (front) elevation. The building is clad in weatherboard siding, framed with wooden cornerboards, and topped with asphalt shingles. Exposed rafter tails extend from the overhanging eaves. It sits on piers and likely dates from the early twentieth century. The shed retains sufficient integrity to be a contributing building to the historic property (Figure 24).

Figure 24: Left, view of front (northern) elevation of shed; right, view of northwest side.

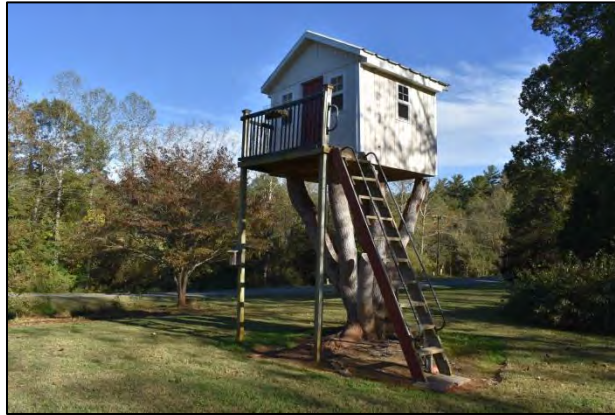
This modern tree house is located to the south of the Jennings House, and is of frame construction. The building features a side-gabled roof, is clad in horizontal synthetic siding, and features multiple windows, all of which are modern snap-in sash. A modern building, the tree house does not contribute to the historic property (Figure 25).

Figure 25: View of tree house looking to southwest.

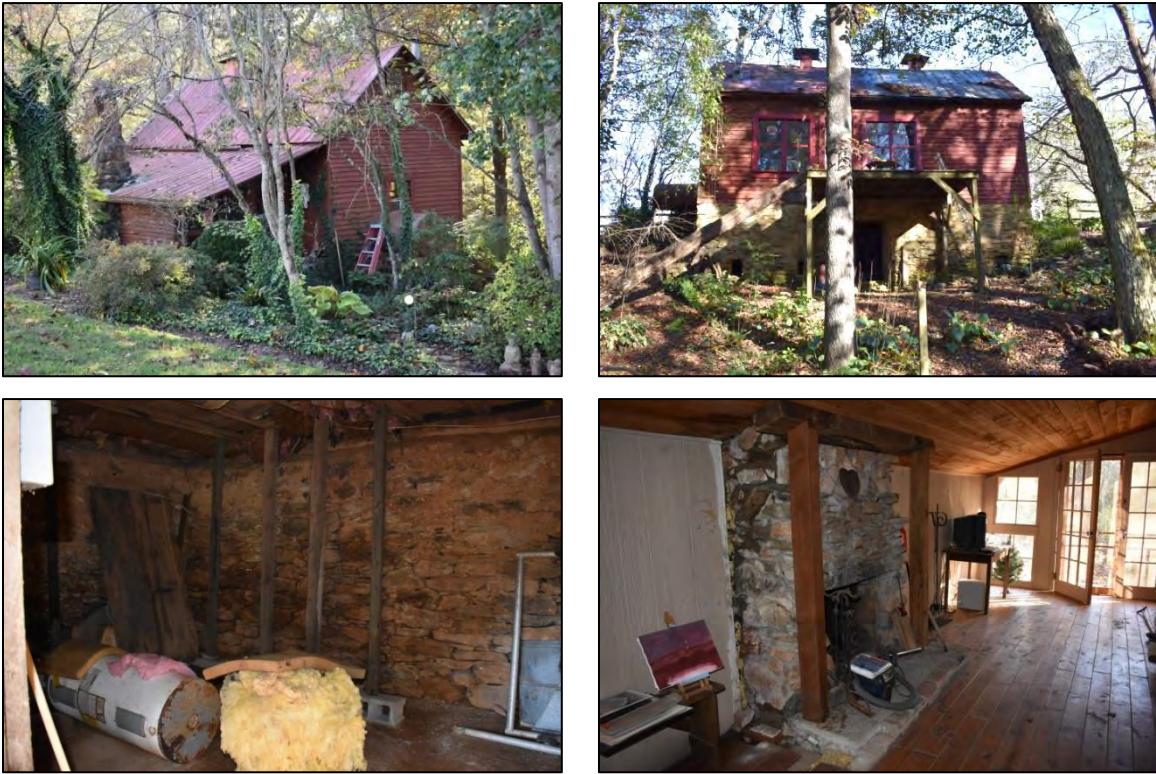
This single-story-over-basement, stone and frame building is clad in weatherboards and features a side-gabled roof topped with standing seam metal. Historically utilized for apple storage, and now as living space, the building is built into the side of a hill, allowing for an exposed basement level on the western side. A frame, shed-roofed lean-to has been added to the eastern side of the building to allow for additional living space and the incorporation of a stone chimney for heat. Additionally, multiple windows have been cut into the western side of the building to allow for natural light. Limited interior access revealed thick stone walls, designed to keep the building cool for storage purposes. These walls were visible in the basement of the building, but have been covered with sheet rock on the first floor to allow for climate controlled living quarters. Due to its many alterations, the apple house has lost its integrity and does not contribute to the historic property (Figure 26).

Figure 26: Top left, view of northeast corner of apple house; top right, view of western elevation; bottom left, view of basement interior, looking to northeast; bottom right, view of interior of first floor.

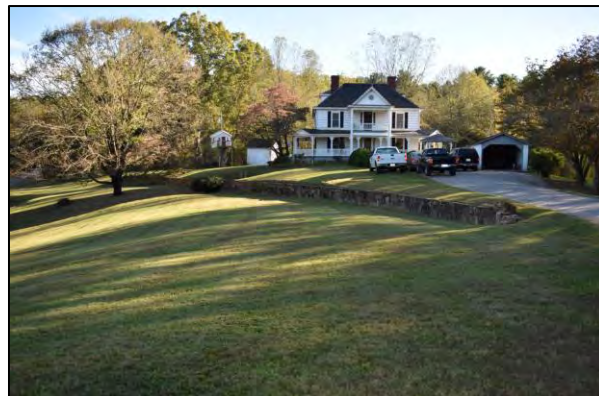
This stone retaining wall is located to the east of the Jennings House and bisects the hill on which the house sets from east to west, running parallel with Jennings Road. The stones are rough-cut and differ from the stones utilized in the construction of the Apple House, suggesting a different period of construction. The wall is likely a late-nineteenth/early-twentieth century addition to the property and is considered a contributing resource.

Figure 27: View of retaining wall, looking to south.

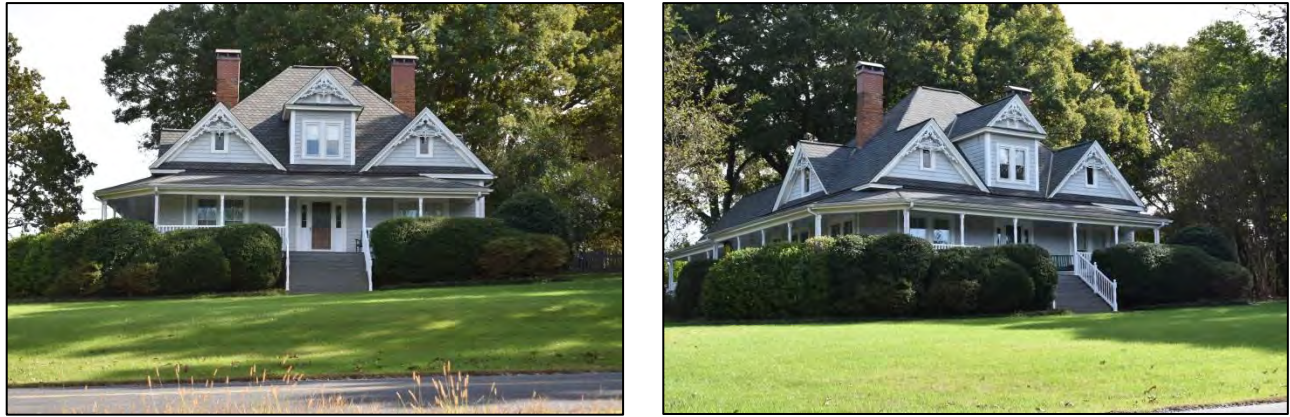
Figure 30: Pinkney Alexander Shinn House (ID0840), 816 Shinnville Road Mooresville, 2017.

The one-and-one-half story frame dwelling has a high hipped roof with a large, pedimented, central dormer on the front slope flanked by cross-gable bays. The gables retain ornate sawn-work and spindle bargeboards and pointed-arch window openings, but the upper story's windows have been replaced. Original two-over-two sash windows light the first story. A wide porch supported by turned posts spanned by a turned balustrade wraps around the façade and north elevation and a one-story gabled wing extends from the east (rear) elevation. The Shinn House has been sheathed with vinyl German siding on the first story and vinyl shakes in the gables since it was photographed in 1977.

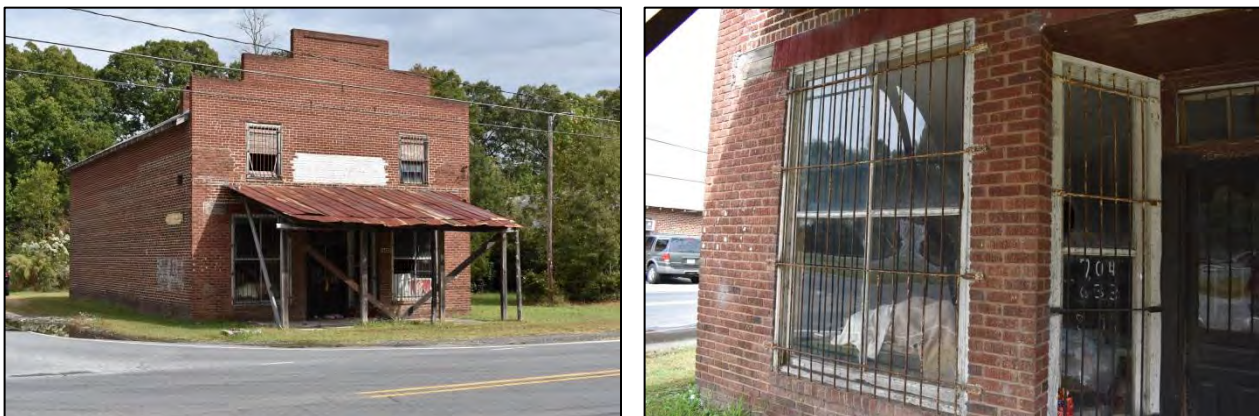
Figure 31: J.W. Honeycutt Store (RW0992) 14025 US 52, Gold Hill, 2017

The two-story, brick building has a stepped parapet, front gable roof with exposed rafters, and an original storefront. The recessed entrance features double-leaf, wood, and glass doors with original screened doors surmounted by a transom, and flanked by fixed sash windows. The entrance is covered by a metal, shed roof porch supported by cedar log posts. Double-hung windows are found on the second floor and on the rear elevation... the side elevations have no window openings...the interior has undergone some alteration including the removal of the pressed tin ceiling. However, the open plan, wooden piers, plaster walls, and concrete and hardwood floors are intact (J.W. Honeycutt Store (RW0992), SHPO).

The store ceased operating around 1960 and appears to be used only for storage. Despite this lengthy period of inactivity, it appears to retain good structural integrity. Unlike the Jennings Store, no known house is associated with the building.

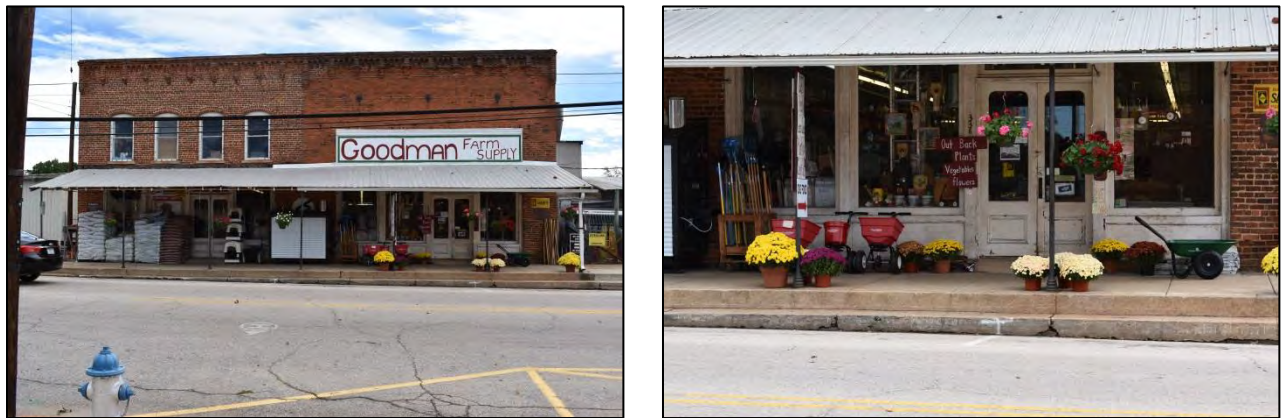
Figure 32: Patterson Manufacturing Company Building (RW0792), 338 N. Main Street, China Grove, 2017

The pair of two story brick buildings were built at different times; however, the projecting cornice was repeated across the later building creating a unified façade...The first story of the southern-most building has an off-center entrance flanked by display windows and surmounted by a wide frieze band. Inside a stair rises to the second story which was also used for selling. An open well, protected by a balustrade visually connected the two floors. The building to the north features pairs of doors flanked by windows on the first story with a four-bay division on the second story.

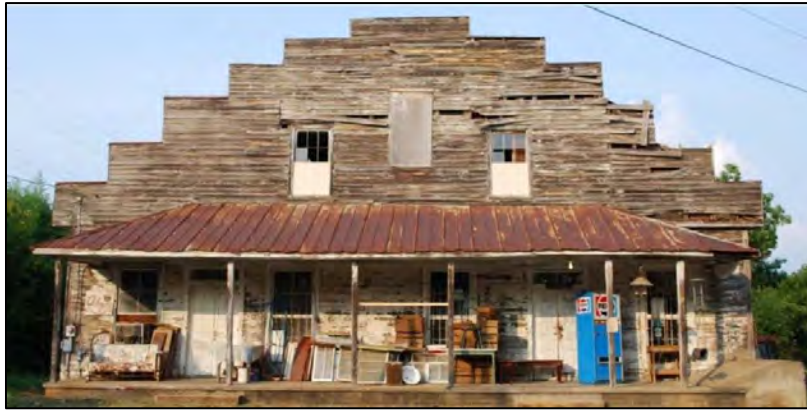
Figure 33: Gold's Store (CL0408) 3700 Polkville Road, Polkville, ca. 2012 (photographer: Heather Fearnbach).

This two- story, front-gable-roof, weatherboarded store is distinguished by a stepped-parapet façade and a full-width, hip-roofed front porch supported by chamfered posts on a replacement poured concrete floor. Two double-leave paneled doors with transoms provide access to the north and south rooms and four large four-over-four sash windows illuminate the first-floor interior. Two six-over-six sash second-story windows, partially covered with metal panels, flank a central metal-sheathed window.

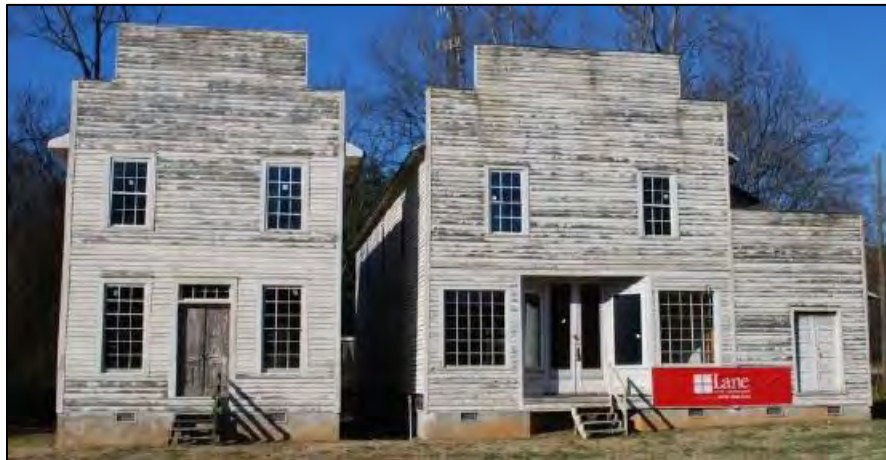
Figure 34: Connelly and McGalliard Stores (BK0385) 6527 Main Circle Street, Connelly Springs, ca. 2012 (photographer: Heather Fearnbach).

Large window openings and stepped-parapet facades characterize both frame stores. The north building is larger due to the one-story shed wing that extends from its north elevation. A double-leaf paneled door on the façade provides access to the wing, while the building's recessed main entrance encompasses a tall, double-leaf, glazed door with a short paneled base. Tall, narrow, plate glass windows flank the door and two large, multi-pane, fixed sash windows complete the storefront. Replacement six-over-six double-hung sash pierce the façade's second story and the secondary elevations.

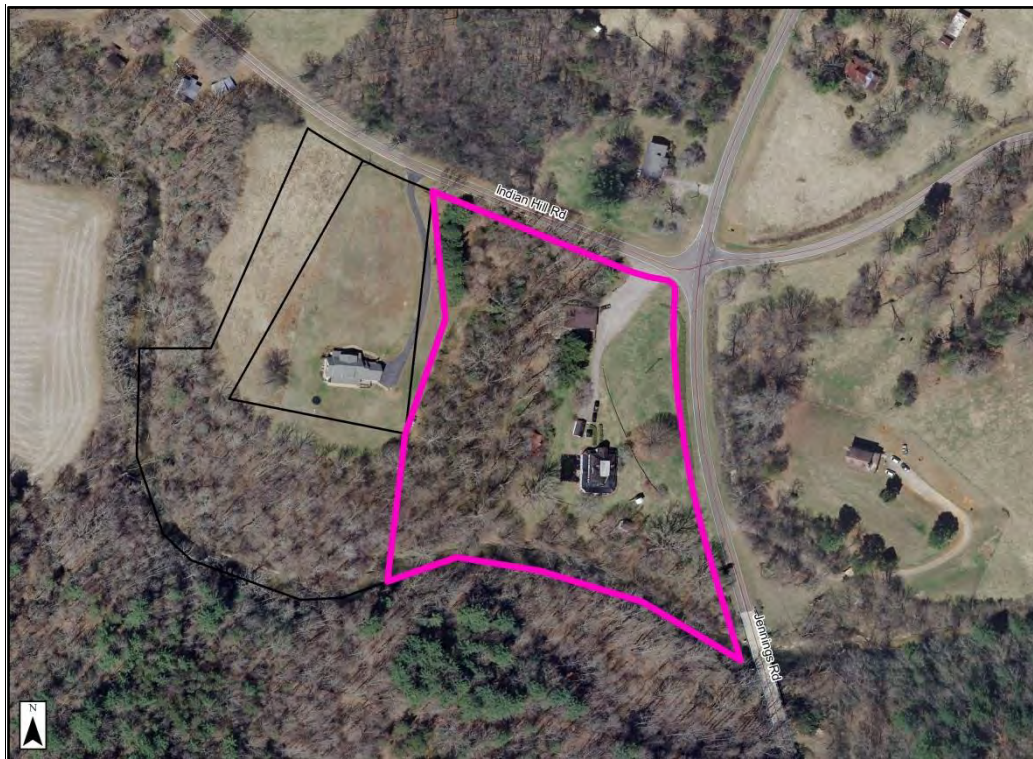
Figure 35: Proposed NRHP Boundary.

The recommended boundary of the Jennings House and Store encompasses approximately one-half of the 10.62-acre tax parcel on which the resource sits. The recommended northern boundary for the resource is consistent with the northern boundary of the parcel, abutting the NCDOT right-of-way along Indian Hill Road. The recommended eastern boundary borders the NCDOT right-of-way along Jennings Road. Given the elevated design of Jennings Road, the right-of-way on the eastern side begins at the bottom of the sloped ditch which appears to be partially maintained by the property owners. The recommended southern border is consistent with the parcel’s southern boundary, and extends to the northern bank of Rocky Creek. The proposed western boundary bisects the Jennings parcel, running along the western side of the woods separating the Jennings House and Store from the neighboring parcel. This boundary provides for the exclusion of a newer house and a clearing which occupy the adjoining lot. This secondary lot was cut from the larger earlier Jennings parcel. The western boundary also excludes woodland and an open clearing that are no longer closely associated with the house and store (Figure 35).
