SUBJECT: Historic Structures Survey Report, Widening of NC 107 from NC 281 to
Shoal Creek, R-5841A, PA 17-07-0005, Jackson County, ER 18-0433

HISTORIC ARCHITECTURE ELIGIBILITY EVALUATION REPORT

TIP# R-5841A: NC107 IMPROVEMENTS FROM NC 281 (CANADA ROAD) TO NORTH OF TUCKASEGEE LAKE, JACKSON COUNTY

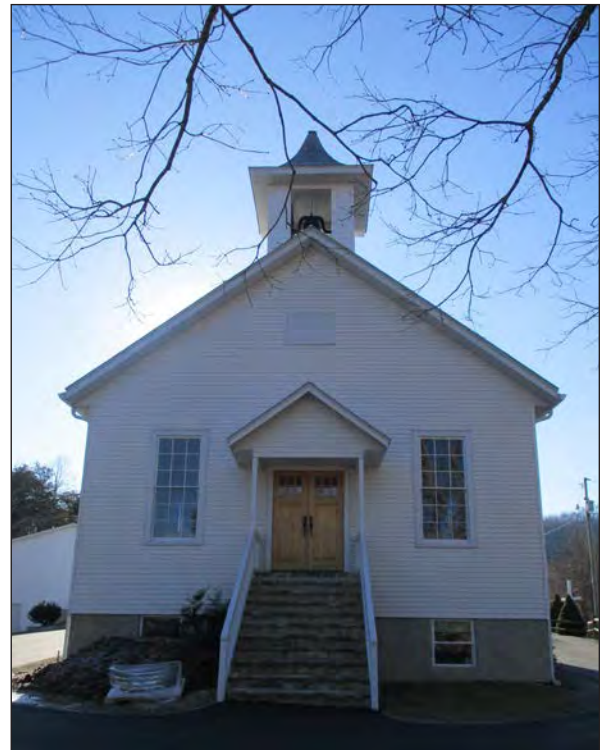
Photograph 1: Façade Tuckasegee Wesleyan church looking southeast. (2018)

The Tuckasegee Wesleyan Church is located on a hilltop high above NC107 in Tuckasegee, Jackson County, North Carolina (Photograph 1). Tuckasegee is an incorporated community at the convergence of the east and west forks of the Tuckasegee River. The Tuckasegee River forms the core of the county, and both the east and west forks feature multiple mountain lakes. The community of Tuckasegee sits at the intersection of NC107 and NC281, just southeast of the incorporated village of Forest Hills. The area is mountainous and was historically flood prone until the first half of the 20th century when new dams were constructed on each fork of the river. Today, Tuckasegee is largely residential, but also features a post office and a few commercial properties.

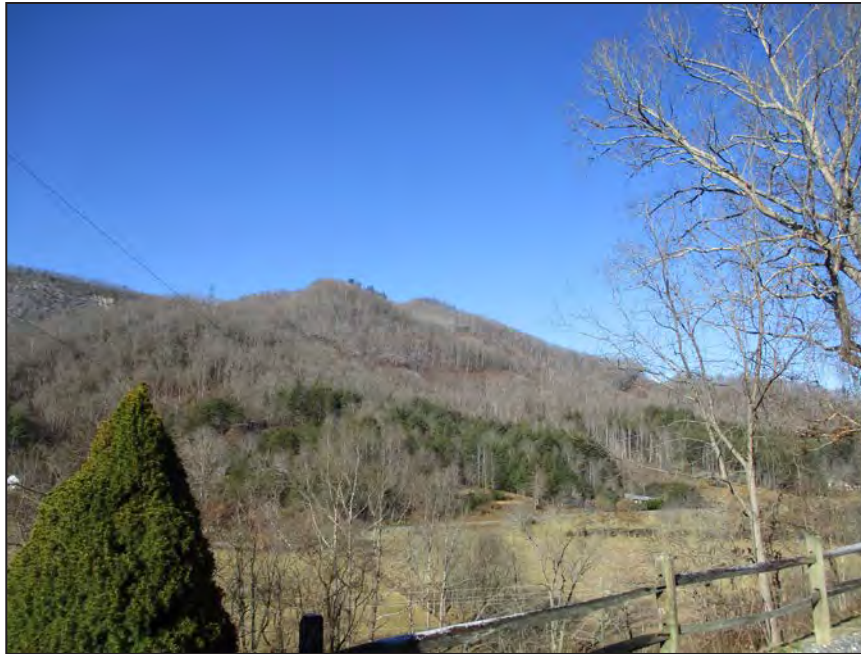
Photograph 2: View of the area surrounding the Tuckasegee Wesleyan Church; looking north. (2018)

The Tuckasegee Wesleyan Church was constructed on a hilltop overlooking NC107 and the Tuckasegee River ca. 1923 (Photograph 2). Currently there are three structures on the property: the original church, a parsonage, and a non-historic fellowship hall. The buildings are accessed by a steep gravel road that turns into an asphalt drive. The church building itself is surrounded by an asphalt-paved circular drive. A cemetery is located to the rear of these buildings and is situated at a higher elevation than the structures. It can be accessed by foot or a separate gravel drive located off Wesleyan Church Road.

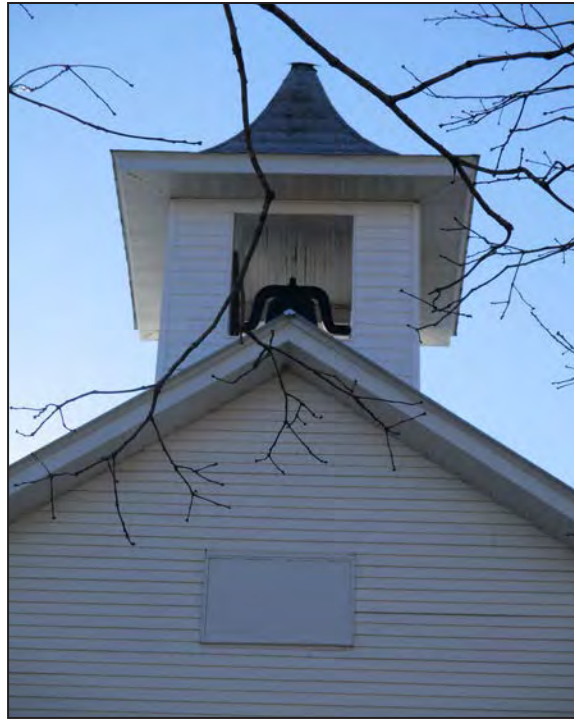
Photograph 3: Detail of Tuckasegee Wesleyan Church's belfry without metal Bible; looking southeast. (2018)

The small frame church, located at the northwestern corner of the property, was constructed ca. 1923. This one-story, rectangular building is capped by a front gable roof covered in standing seam metal. A previous survey conducted in 1991 states the church featured a "tin-shingled gable roof" therefore the current roof is a replacement (Bishir, Martin, & Southern 1999: 361) (HPO 1991: 5). The building sits on a stucco-covered, concrete block foundation, which replaced the original foundation around 1963 when the church dug a full basement to create a fellowship hall (Interview with Pastor Jeff Powell, 29 Jan 2018). The main block is three bays wide by four bays deep, with a partial-width portico attached to the façade (northwest elevation). The portico features a front-gable roof of standing seam metal supported by square wood posts. The church's original weatherboard siding has been replaced with vinyl. An open belfry pierces the front gable roof (Photograph 3). The belfry is topped by a pyramidal roof with widely overhanging flared eaves. According to *A Guide to the Historic Architecture of Western North Carolina*, the belfry was once topped with a "metal replica of an open Bible" (Bishir et al. 1999: 361) (HPO 1991: 5) (Photograph 4). The metal Bible has since been removed.

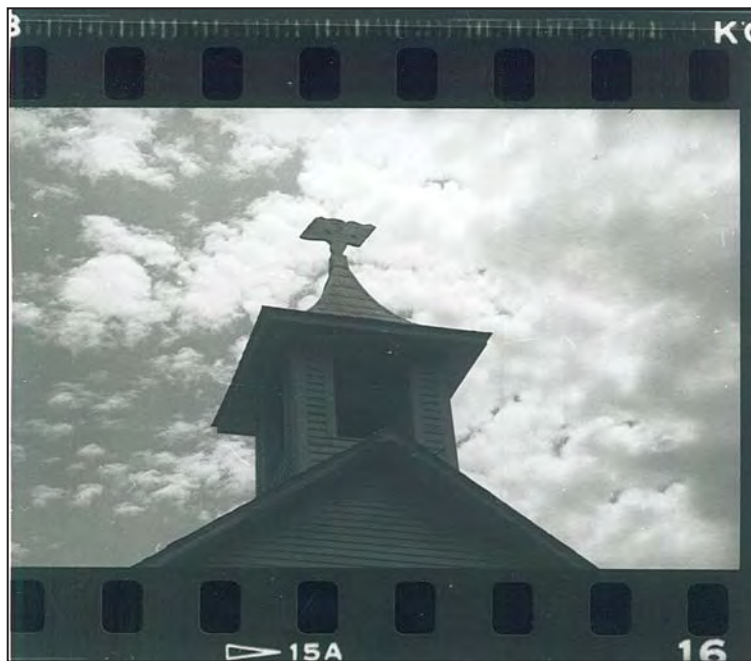
Photograph 4: Detail of Tuckasegee Wesleyan Church's belfry with metal Bible; looking southeast. (Source: HPO 1991)

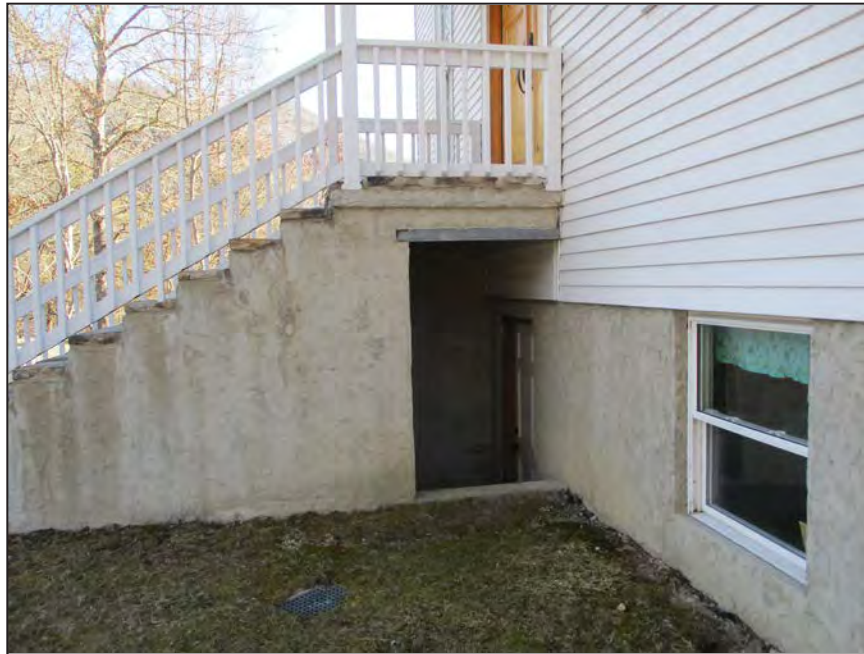
Photograph 5: Detail of basement of Tuckasegee Wesleyan Church; looking east. (2018)

The church's main entrance is centered on the façade beneath the portico and is reached by a set of stone and stucco steps with wood balustrade. The wood balustrade replaced a set of iron railings some time after 1991 (HPO 1991; 5). The original double door opening features replacement wood doors each with a six-light glazing pattern. A vent that has been infilled is located in the gable end and is vertically aligned with the front entrance. Two original nine-over-nine double hung wood sash windows are evenly spaced, one on either side of the entrance. Two, one-over-one double hung vinyl sash windows are located at the basement level and are vertically aligned with the windows on the first story. These vinyl windows replaced metal windows sometime after the 1991 survey of the church (HPO 1991: 5). An entrance to the basement is located in the foundation and is hidden from view by the portico stairs (Photograph 5).

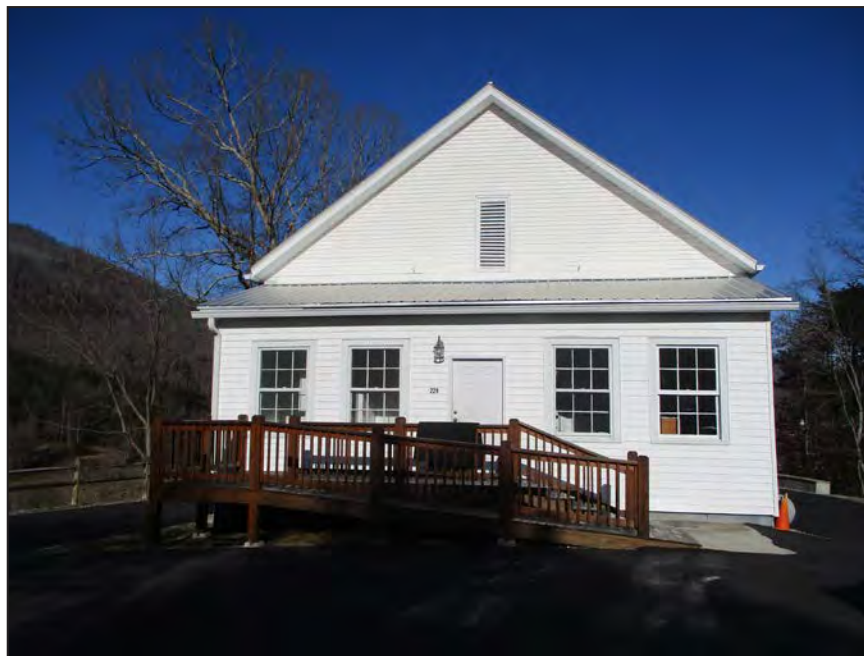
Photograph 6: View of rear (southeast) elevation of Tuckasegee Wesleyan Church; looking northwest. (2018)

The rear (southeast) elevation features a rectangular louvered vent centered in the gable end and is covered in vinyl siding (Photograph 6). A one-story, full-width, vinyl sided addition is located off the rear elevation. It is topped by a shed roof covered in standing seam metal. The addition features a centered entrance with a multi-paneled replacement door. Two evenly spaced six-over-six double hung wood sash windows flank both sides of the rear entrance. A wood ramp to allow for ADA access is constructed off the rear addition and was added sometime after 1991.

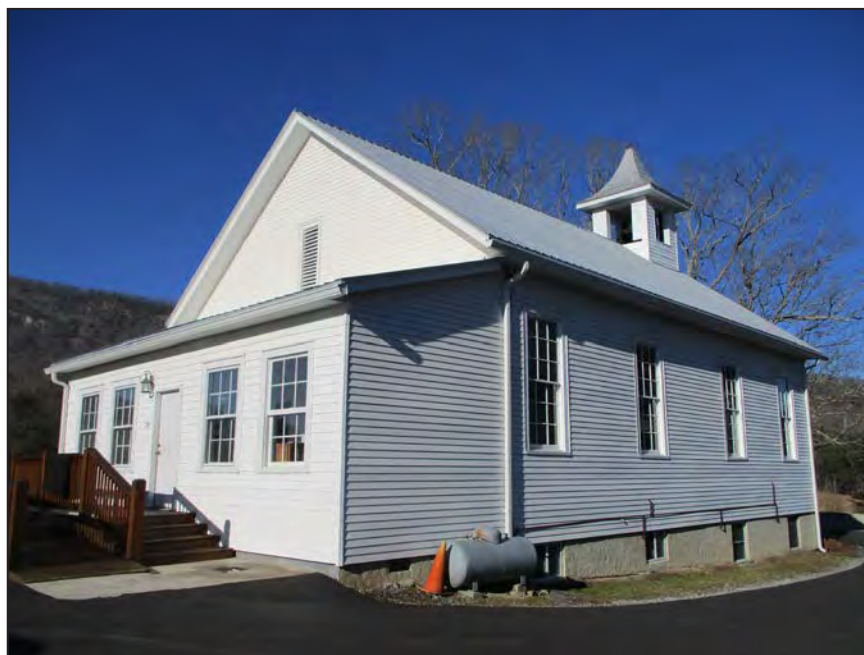
Photograph 7: Oblique view of Tuckasegee Wesleyan Church; looking west. (2018)

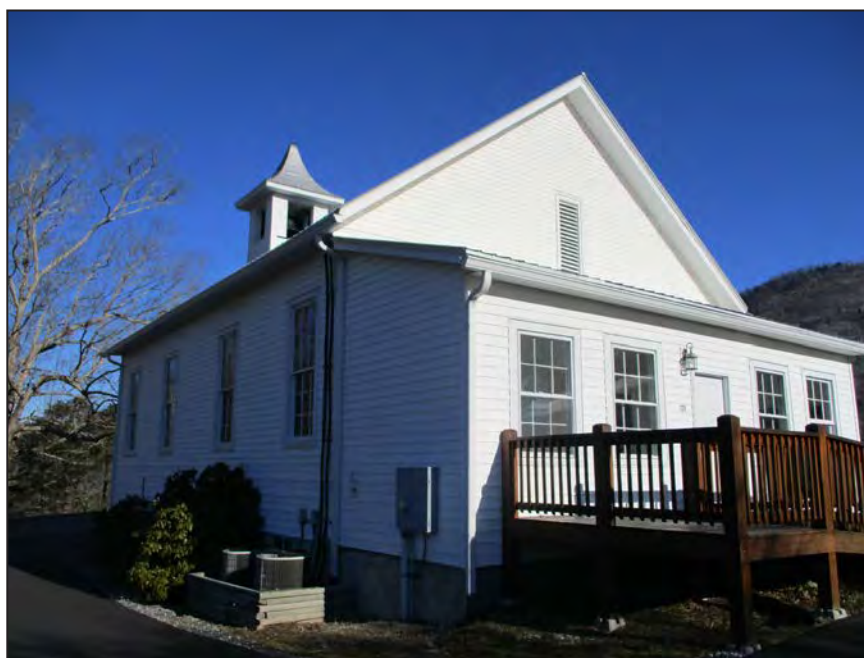
Photograph 8: Oblique view of Tuckasegee Wesleyan Church; looking north. (2018)

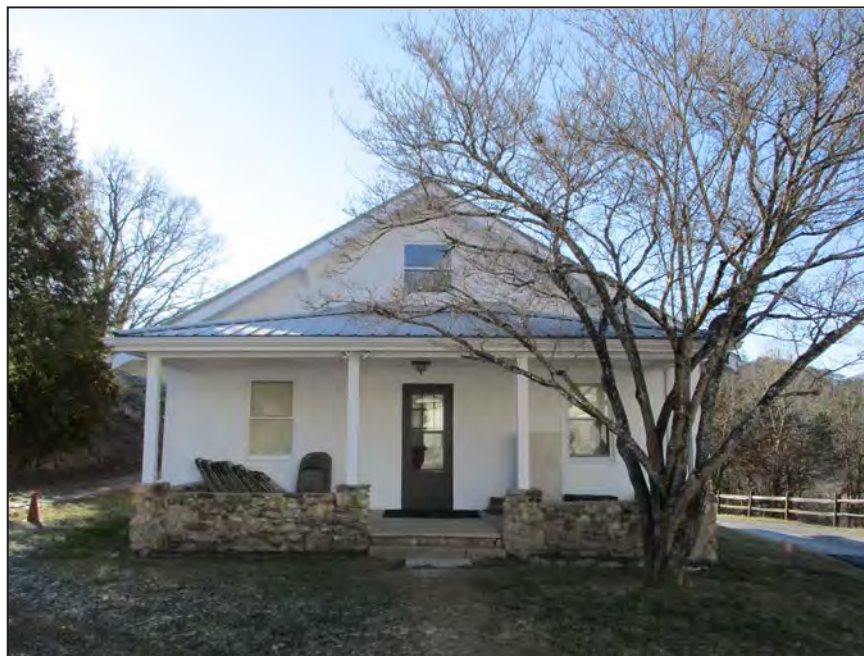
Photograph 9: View of Tuckasegee Wesleyan Church parsonage; looking south. (2018)

A ca. 1935 parsonage was constructed to the south of the church building (Photographs 9 and 10). The original parsonage, constructed ca. 1923 burned down in 1935 and was replaced with the parsonage that still remains today (Hoteling 2013: 1C). The parsonage is a one-story bungalow and is capped by a front-gable roof covered in standing seam metal and features widely overhanging eaves and exposed rafter ends. The parsonage is constructed on a slight slope. As such, the continuous stucco-covered foundation is visible on the west elevation, but not on the east elevation. The building is clad in T1-11 siding (Photograph 11). All windows on the building are one-over-one double hung vinyl sash replacements.

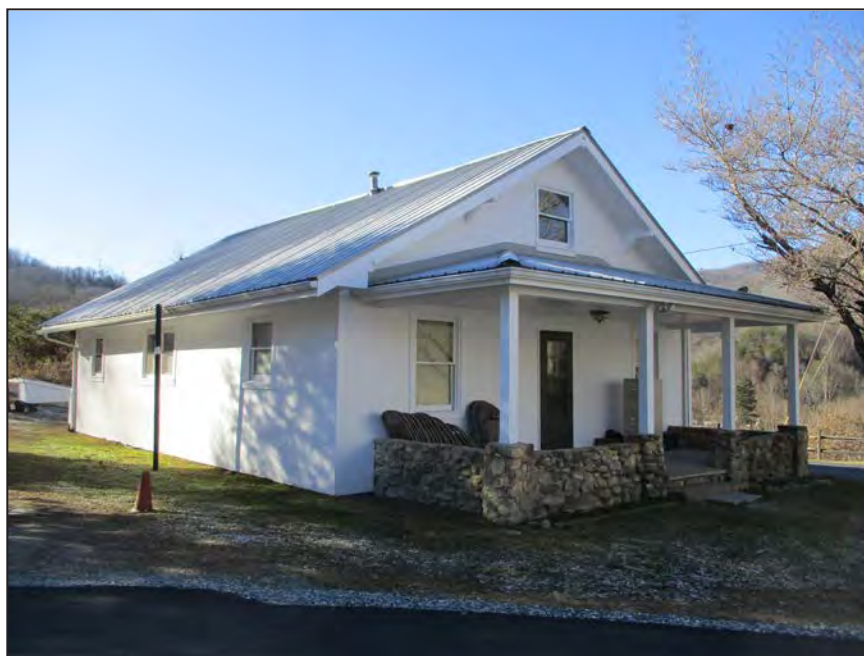
Photograph 10: Oblique view of Tuckasegee Wesleyan Church Parsonage; looking southwest. (2018)

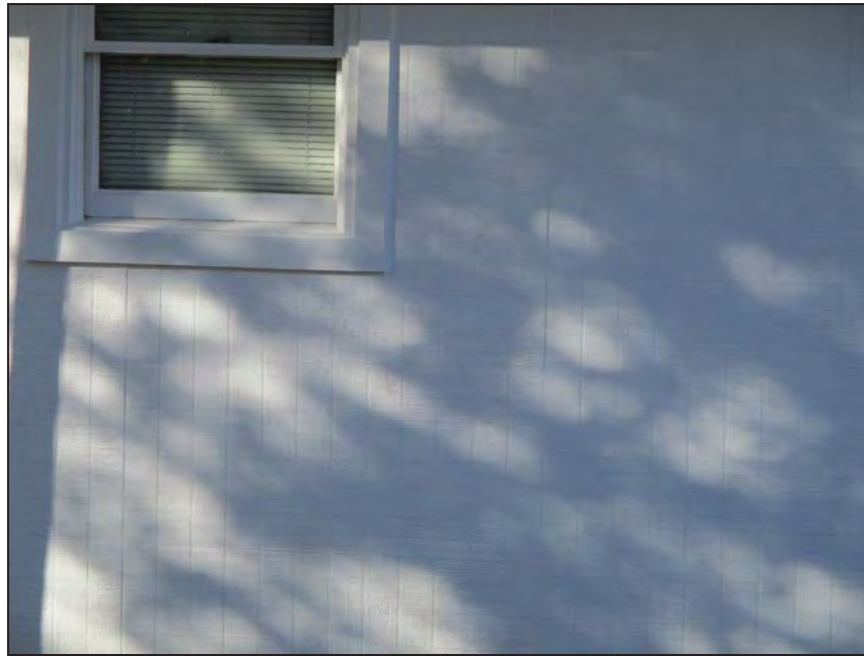
Photograph 11: Detail view of T1-11 siding on Tuckasegee Wesleyan Church parsonage; looking west. (2018)

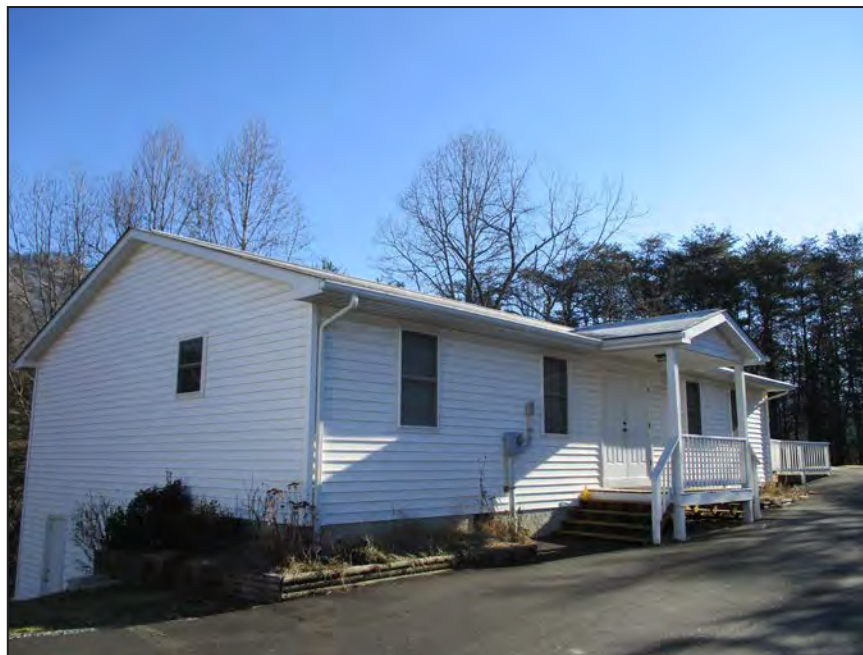
Photograph 12: Oblique view of Tuckasegee Wesleyan Church's Fellowship Hall; looking east. (2018)

Approximately 55 feet southeast of the church building, a fellowship hall was constructed in 2001 replacing the 1960s basement addition (Hotaling 2013: 1C). The one-story rectangular building is built into the side of a hill and rests on a stucco-covered foundation with a basement (Photograph 12). The hall is clad in vinyl siding and is capped by a side-gable roof covered in asphalt shingles. The entrance is centered on the southwest-facing façade and is sheltered by a gabled portico. All windows are one-over-one double hung vinyl sash windows.

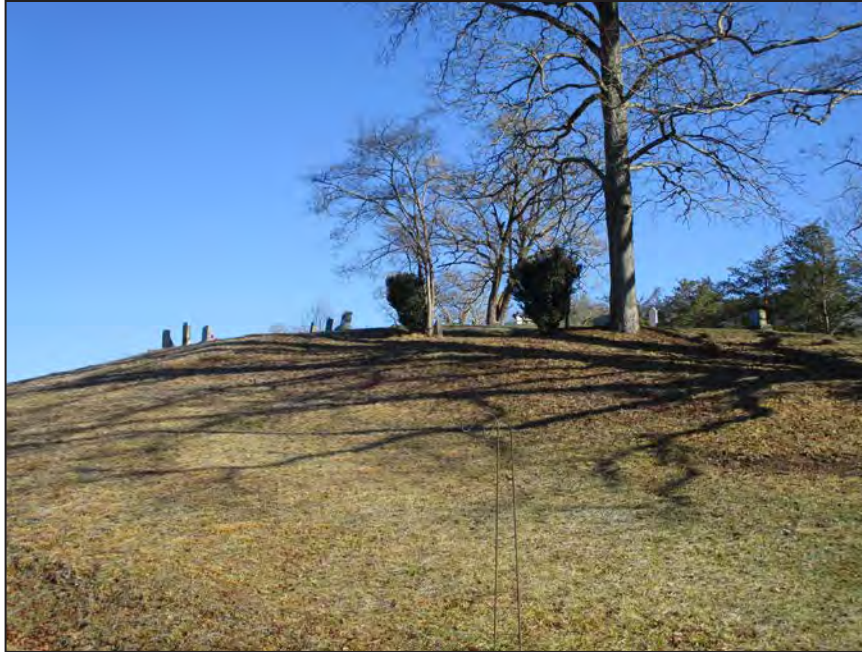
Photograph 13: View of Tuckasegee Wesleyan Cemetery; looking south. (2018)

Approximately 30 feet southeast of the three structures, at the peak of the hill is the Tuckasegee Wesleyan Cemetery (Photographs 13 and 14). The cemetery is sometimes referred to as the Moses Cemetery or as the Powell Cemetery. The oldest burials at the cemetery are Dallas T. Hooper (Jan. 1873- Feb. 1873) and Margaret E. Hooper (1850-1881). These burials, along with others predate the church (Jackson County Genealogical Society 2012: 379). The cemetery can be accessed via steps located at the base of the hill south of the Fellowship Hall or via a gravel drive located off Wesleyan Church Road.

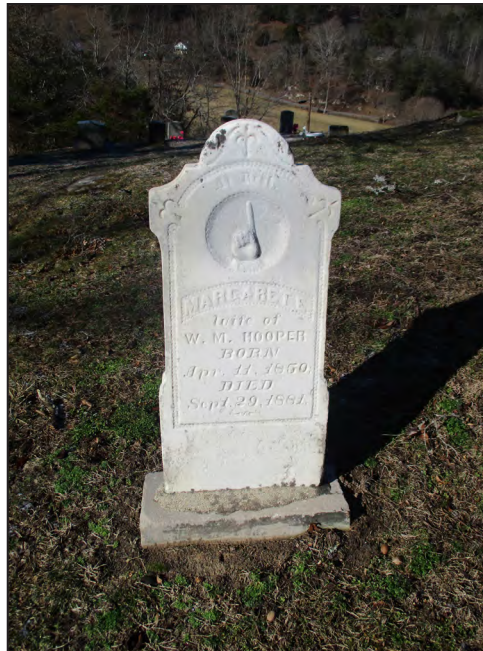
Photograph 14: Detail view of headstone at Tuckasegee Wesleyan Cemetery; looking west. (2018)

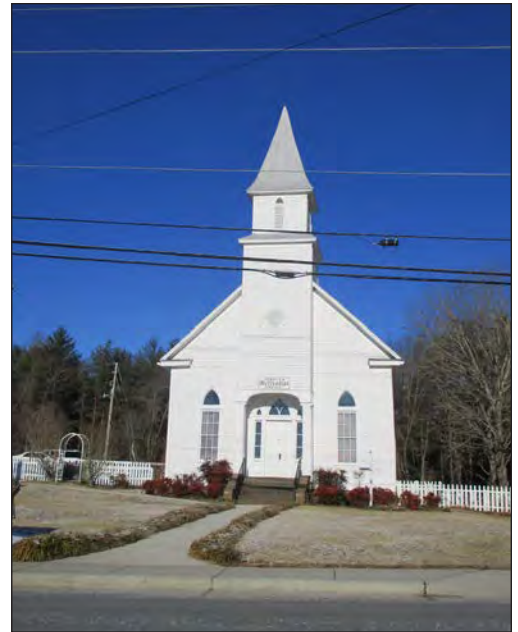
Photograph 15: Webster Methodist Church. (2018)

The National Register nominated Webster Methodist Church, constructed in 1887, reflects the regional form for churches, "but the wealth of detail, both Gothic and classical, make it outstanding" (Humphries 1988: 4) (Photograph 15). The church is located in Webster, Jackson County, North Carolina, approximately 12 miles northwest of the Tuckasegee Wesleyan Church. The congregation was founded 1859 by itinerant preachers who rode hundreds of miles on the Methodist "circuit", but it was not until years later that a physical worship space was constructed. This origin story is similar to that of Tuckasegee Wesleyan's. The Webster Methodist Church is a weatherboarded, gable-roofed rectangular building sited on a slight rise. The church features Gothic elements and Ionic columns. According to the National Register Nomination,

The main architectural interest of the church building is found in the three-bay entrance façade, which is dominated by an engaged bell tower which rises in two stages and culminated in a splayed pyramidal cap which serves as the steeple. Gothic arched vents are centered on all four sides of the tower's second tier, just beneath its cap. A blind fan and a diamond-shaped vent ornament its principal face above the church entrance (Humphries 1988: 2).

The church retains its weatherboard siding and original windows, and as of 2018, no apparent changes have been made to the exterior of the Webster Methodist Church. Comparatively, the Tuckasegee Wesleyan Church also reflects the simple

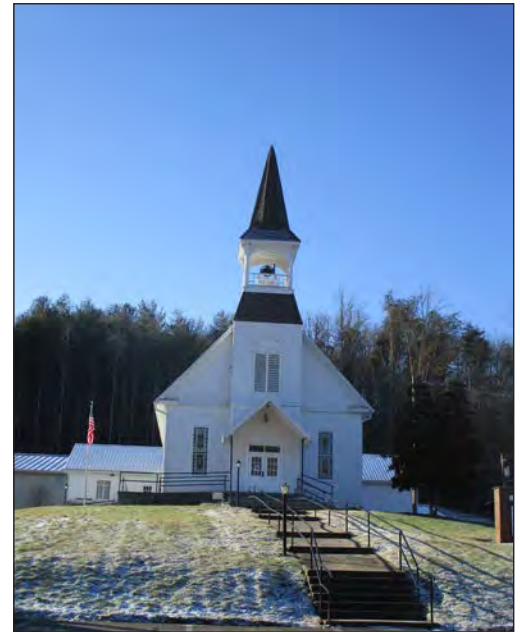
Photograph 16: Webster Baptist Church. (2018)

The National Register nominated Webster Baptist Church, constructed in 1900, is another example of the regional form popular for churches at the turn of the century (Photograph 16). Located in Webster, Jackson County, North Carolina, approximately 12 miles northwest of the Tuckasegee Wesleyan Church, this vernacular decorative frame sanctuary is sited at the top of a small hill on the south bank of the Tuckasegee River. In addition to interior furniture designed by a local master cabinetmaker, the Webster Baptist Church features a unique three-bay façade and bell tower seen nowhere else in Jackson County. According to the National Register Nomination:

The main feature of the building is an engaged bell tower which rises in three stages, the first weatherboarded and the remaining two shingled... On the front facade, the second stage of the bell tower features a double vent with round head over each vent and a round-headed arch, without keystone, over the whole, echoing the main entrance fanlight. The top stage includes an open belfry with railing, brackets and basket arch on each of its four sides, topped by a tapered polygonal, "witch's hat" steeple (Humphries, 1988: 2).

The church sanctuary retains a high degree of architectural integrity, despite the addition of a separate ca.1950-1960 education building located to the rear (south) of the church. Comparatively, the Tuckasegee Wesleyan Church also reflects the simple frame form commonly used in the region at the turn of the century, but without the architectural details that make the Webster Baptist Church unique. In addition, multiple exterior and interior alterations have been made to the Tuckasegee Wesleyan Church including the removal of a metal replica of an open Bible that once topped the belfry. Unlike the changes made to the Webster Baptist Church, those made on the Tuckasegee Wesleyan Church impact its architectural integrity.
