SUBJECT: Historic Structures Survey Report, Widening of SR 1223/1224 (Old Swamp Road) and
SR 1218/1227 (South Mills Road), PA 17-05-0040, R-5717, Camden and Currituck Counties,
ER 18-0453

**HISTORIC STRUCTURES SURVEY REPORT
WIDEN SR 1223/ SR 1224 (OLD SWAMP ROAD) AND
SR 1218/ SR 1227 (SOUTH MILLS ROAD),
CAMDEN AND CURRITUCK COUNTIES,
NORTH CAROLINA**

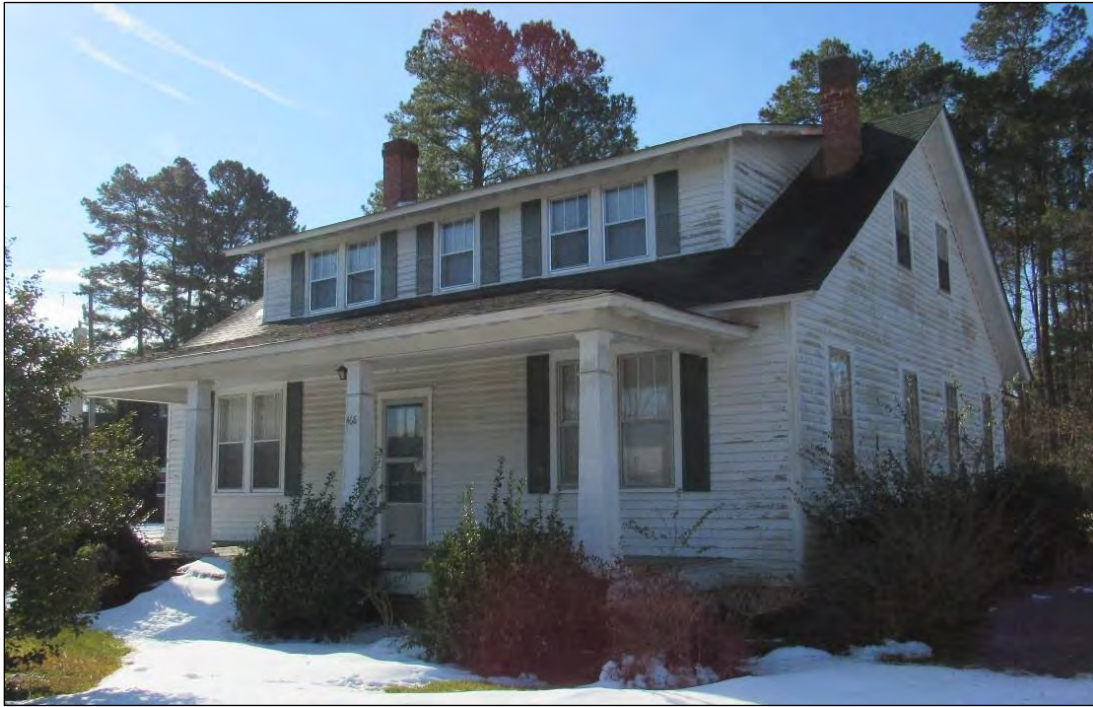
Photo 1: North Oblique of Stafford-Purden House.

The primary resource is a one-and-one-half-story, three-bay, single-family dwelling constructed around 1936 in a bungalow form with Craftsman-style elements (Photo 1, p. 14). The building is set on a brick-pier foundation with brick infill supporting a frame structural system clad in weatherboard siding with cornerboards. It is covered by a moderately pitched, side-gabled roof with wide open eaves featuring exposed rafter tails on non-gabled ends. The roof has been re-sheathed in asphalt shingles. Two partial-width, shed dormers, clad in the same materials as the remainder of the building, span a majority of the façade and the rear (southwest) elevation (Photo 2, p. 14). The dormer on the primary elevation contains two sets of three-over-one, wood-frame, double-hung sash windows flanking a central window of the same form and materials while the dormer in the rear elevation has single and paired double-hung sash windows in the same style and material. An interior-slope brick chimney pierces the dormer in the southeast half at the façade while an interior-end brick chimney is set in the north half of the northwest elevation. An additional interior-end brick chimney is situated in the south half of the southeast elevation.

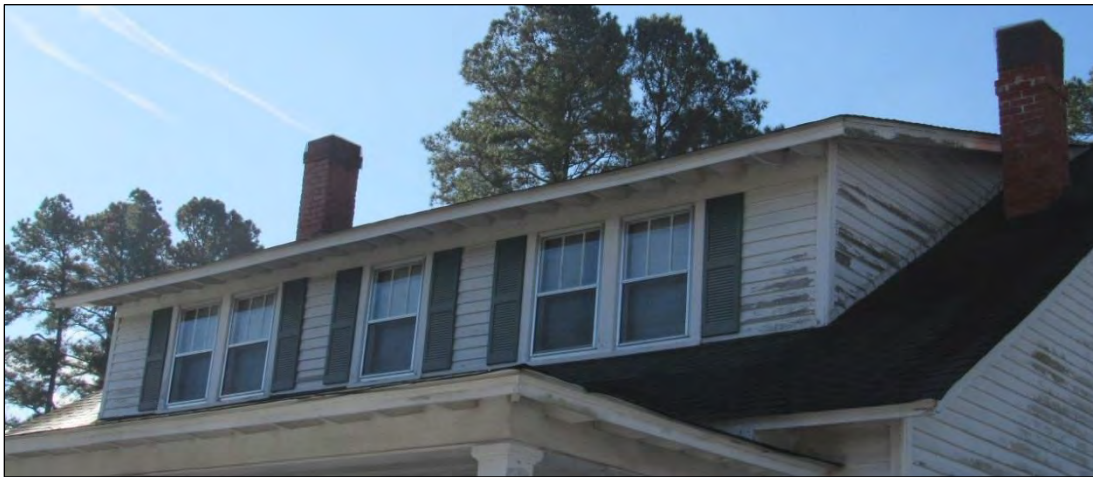
Photo 2: Detail of Dormer Along Façade, Facing South.

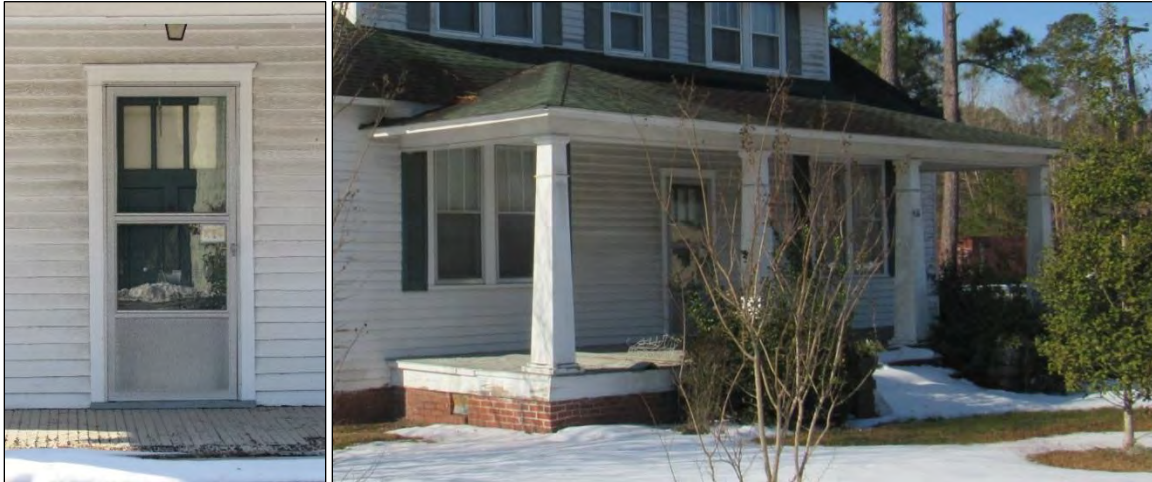
Centered in the façade, the primary entrance is filled with a single-leaf, paneled, wood door with three lights that is covered by a metal-framed storm door (Photo 3, p. 15). The entryway features a simple wood surround. Other fenestration includes single and paired three-over-one, wood-frame, double-hung sash windows with vertical muntins with unadorned wood surrounds. The windows in the façade are flanked by fixed, aluminum, louvered shutters. A one-story, three-bay, full-width porch with a wood deck set on a brick pier foundation with brick infill spans the façade (Photo 3, p. 15). The porch, containing a wood deck, is covered

by a hipped roof with open eaves and exposed rafter tails; the roof is supported by tapered wood posts with beaded detailing towards the cap. It is accessed by a set of brick steps flanked by brick retaining walls with concrete ledges. A single-leaf, wood, three-paneled door with metal-framed storm door is set in the west corner of the southwest elevation.

Photo 3: Detail of Primary Entrance (Left); Detail of Porch Along Façade (Right).

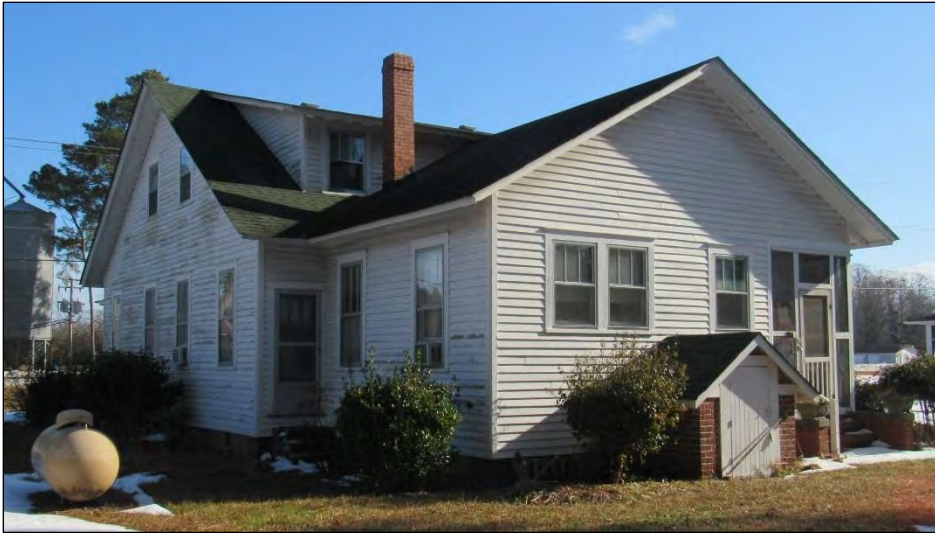
Photo 4: West Oblique of the Stafford-Purden House.

A circa-1940, one-story, gabled, large-scale addition extends from the west half of the southwest elevation (Photo 4 and Photo 5, p. 16). It is constructed in the same materials as the core. The roof also contains exposed rafter tails in the non-gabled ends and is pierced by an interior-slope, brick chimney in the north corner. Fenestration includes similar windows as the original portion of the building has as well as two-over-two, wood-frame, double-hung sash windows with horizontal muntins. The southeast elevation of the addition holds a recessed, full-width, screened-in porch with a wood-frame structural system. A single-leaf, wood-and-screen door is set in the southern corner of the southwest elevation and accessed by set of similar steps observed in front of the primary entrance with an additional wood rail to the west. A late-twentieth-century, small, less than half-story, brick addition protrudes from the center of the southwest elevation of the addition. It is covered by a gabled roof with wide eaves filled with exposed rafter tails that is sheathed in asphalt shingles. A single-leaf, beadboard door is set in the southwest elevation. This may access a cold storage space or house utilities.

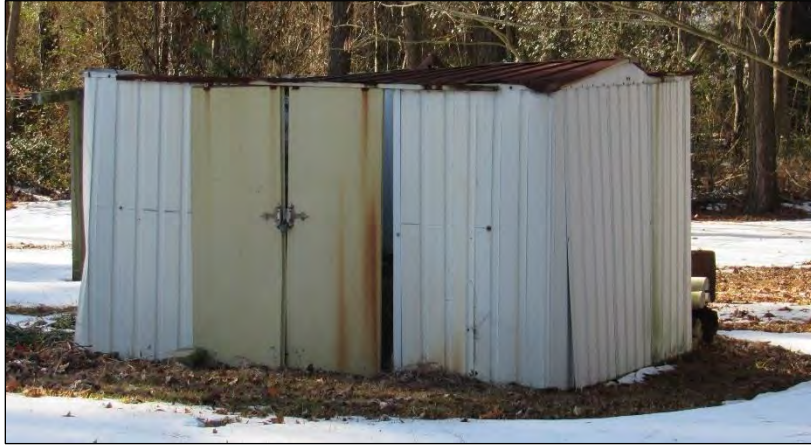
Photo 6: Shed, North Oblique.

A circa-1980, one-story, metal shed is located southwest of the primary resource (Photo 6). The shed features an irregular roof clad in interlocking metal panels, which also covers the walls of the building. A double-leaf, metal door is centered in the southeast elevation.

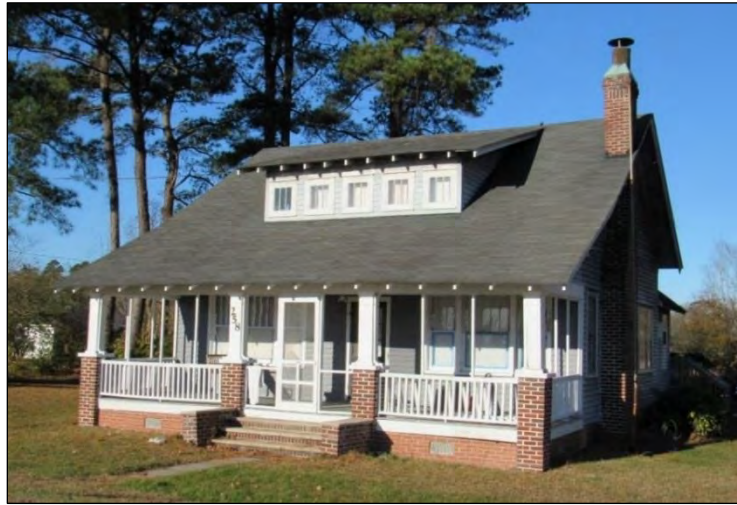
Photo 7: East Oblique of the Creekmore House (CM0074).

To properly evaluate the resource’s NRHP eligibility under Criterion C, it must be compared with similar resources within the area. There are several examples of a one-and-one-half-story, Craftsman-style bungalows in the surrounding area of Moyock as well as nearby counties that are comparable to the Stafford-Purden House. Located about 12 miles from the resource is the Effie and Bruce Creekmore House (Creekmore House) at 258 E. Highway 158 (CM0074) in Camden County (Photo 7, p. 21).²⁹ The Creekmore House is a one-and-one-half-story, three-bay, Craftsman-style bungalow constructed circa 1928.³⁰ The house is clad in weatherboard siding and is covered by a low-pitched, side-gabled roof with wide eaves filled with exposed rafter tails pierced by a central shed dormer, calling to the Craftsman style it represents.³¹ Unlike the Stafford-Purden House, the Creekmore House features ribbons of wood-frame casement windows in the dormer as well as ribbons of multi-light, wood-frame, sash windows at the façade, further exemplifying its architectural style. The shed-roof porch along the primary elevation that extends seamlessly from the roof is supported by wood posts set on squared brick piers. Similar to the Stafford-Purden House, this dwelling is set upon a brick pier foundation infilled with brick. The Creekmore House was determined not eligible in 1994.

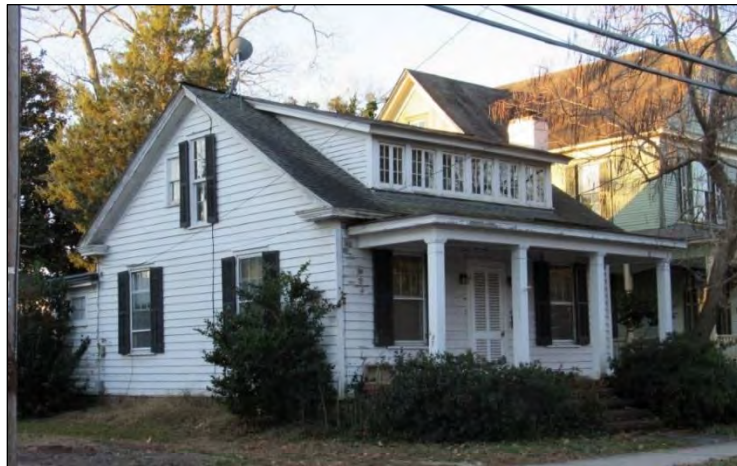
Photo 8: Northeast Elevation of House at 405 W. Main Street.

Another dwelling that contains many similar architectural elements as the Stafford-Purden House is the House at 405 W. Main Street (Photo 8). Built in 1940, the building is located

southwest of Moyock in the more-developed and densely populated Elizabeth City, Pasquotank County, North Carolina. Although this house features Classical Revival-style characteristics such as partial eave returns in the gabled ends of the building and Doric-style columns supporting the porch roof, it is comparable to the Stafford-Purden House in a number of characteristics.³² The single-family dwelling is one-and-one-half stories tall, three bays wide, clad in weatherboard siding, and covered by a low-pitched, side-gabled roof pierced by a central shed-roofed dormer like the Stafford-Purden House, despite being in a more urban area of the eastern part of the state.

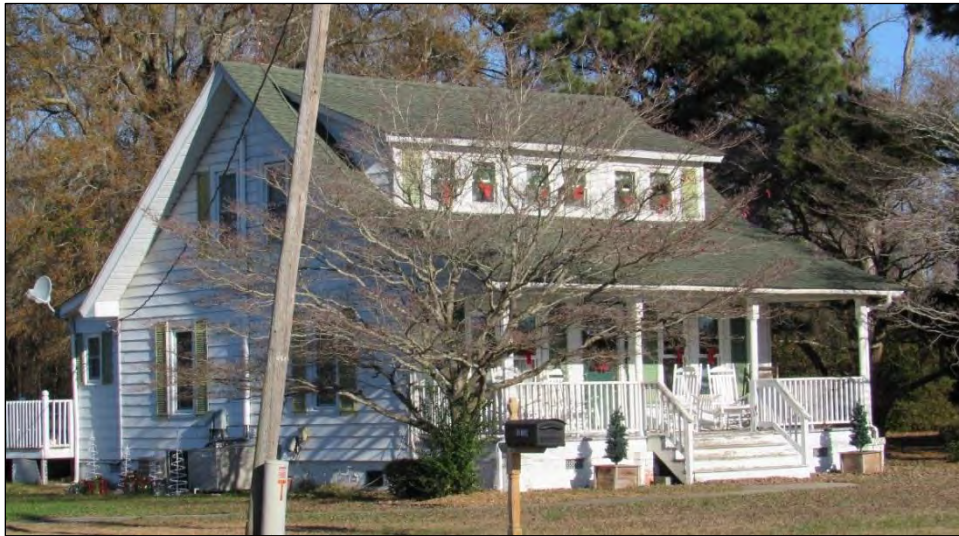
Photo 9: South Oblique of House at 244 Maple Road.

The House at 244 Maple Road in Maple, Currituck County is situated approximately 12 miles south of the Stafford-Purden House (Photo 9). This circa-1939, one-and-one-half-story, three-

bay, bungalow dwelling has a side-gabled roof with a central shed dormer spanning about three-quarters of the façade, similar to the Stafford-Purden House.³³ However, unlike the Stafford-Purden House, this dwelling features replacement materials, such as vinyl siding and windows, and the porch spanning the façade is covered by a shed roof supported by turned wood posts rather than a hipped roof and tapered posts.

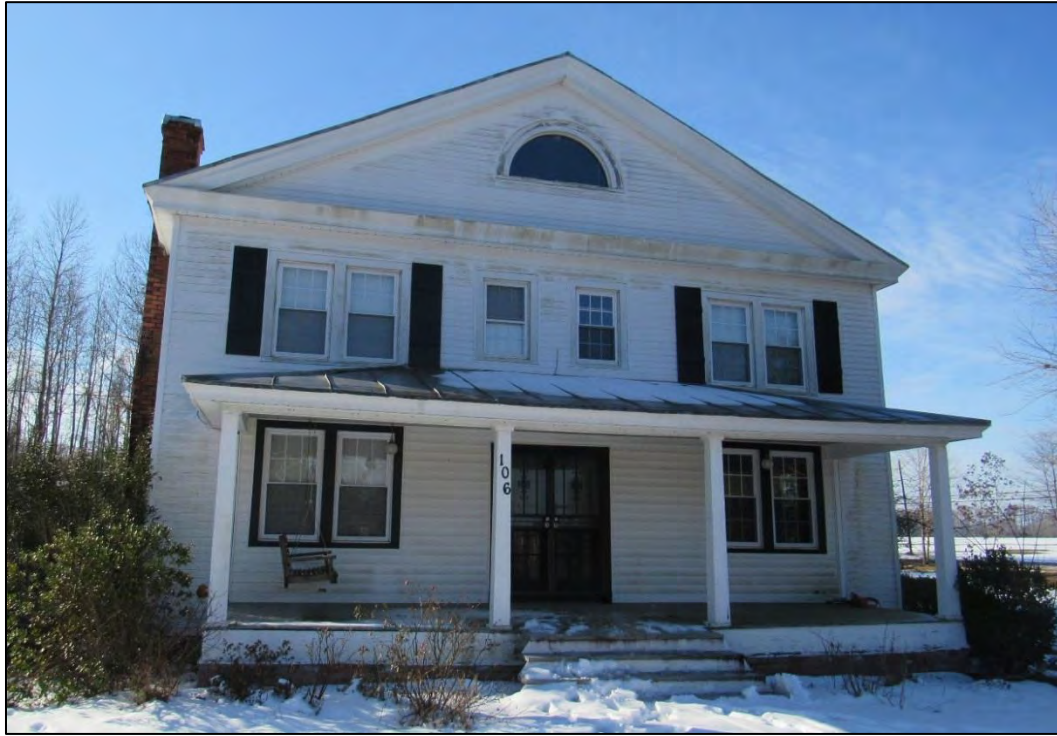
Photo 10: Former Moyock Methodist Church, Northeast Elevation.

The primary entrance is centered on the northeast elevation and is filled with two, side-by-side, single-leaf, paneled doors covered by a double-leaf metal-frame storm door. According to the previous survey, this resource was once used as a duplex and the two doors led to two different apartments; however, subsequent owners converted the building into a single-family residence.³⁸ The door is covered by a one-story, three-bay, hip-roofed front porch supported by square, tapered, wood Tuscan columns. The porch is set upon a continuous foundation clad in brick veneer and is accessed by three wood steps. Paired, one-over-one, double-hung sash, vinyl windows with false muntins meant to mimic six-over-six windows and set within vinyl surrounds flank the primary entrance. Fenestration on the second story of the primary elevation includes paired, one-over-one, double-hung sash, vinyl windows with false muntins meant to mimic six-over-six windows flanked by wood, board-and-batten shutters on the outer bays with two, single, one-over-one, double-hung sash, vinyl windows with false muntins centered on the façade.

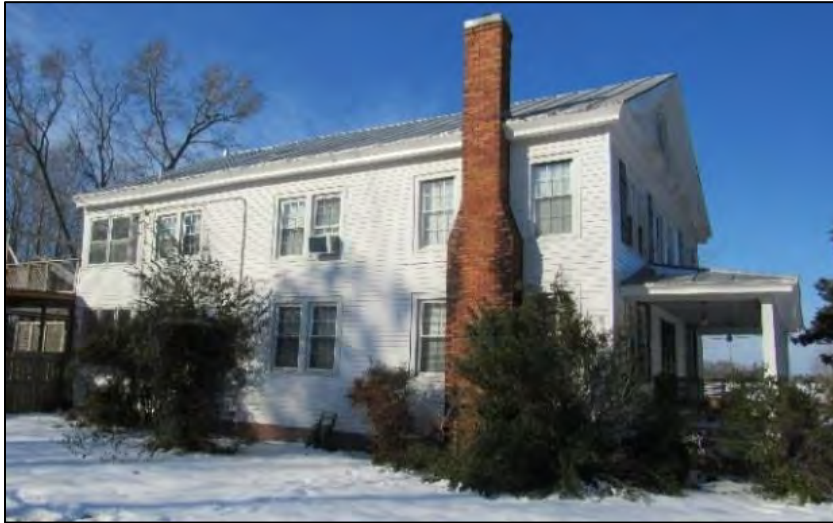
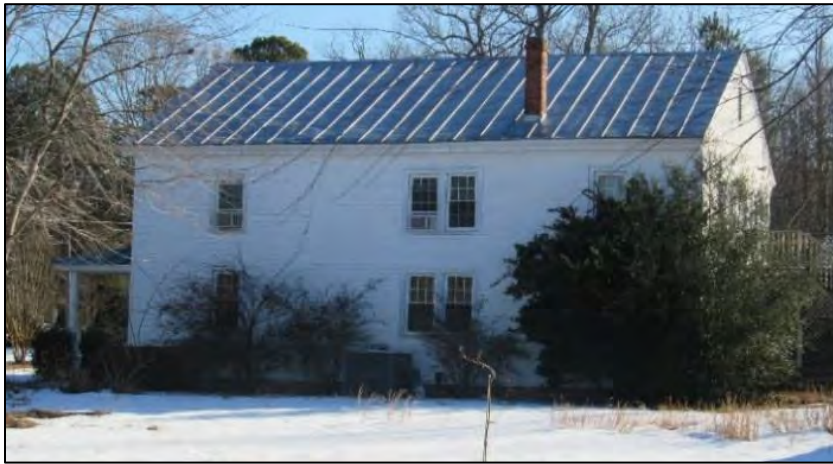
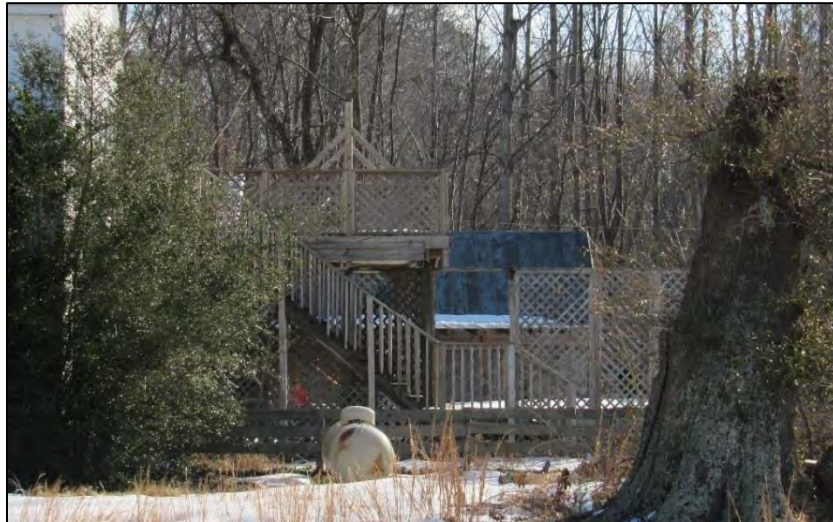
Photo 11: Former Moyock Methodist Church, Southeast Elevation (Top); Northwest Elevation (Middle); Wood Deck Extending Southwest From the Dwelling (Bottom).

Fenestration on both the northwest and southeast elevations includes single and paired, one-over-one, double-hung sash, vinyl windows with false muntins meant to mimic six-over-six windows (Photo 11, p. 28). The southern corner of the dwelling has been modified to contain a sunroom on the second story that features one-over-one, double-hung sash, vinyl windows. A two-story wood deck extends from the rear (southwest) elevation (Photo 11, p. 28).

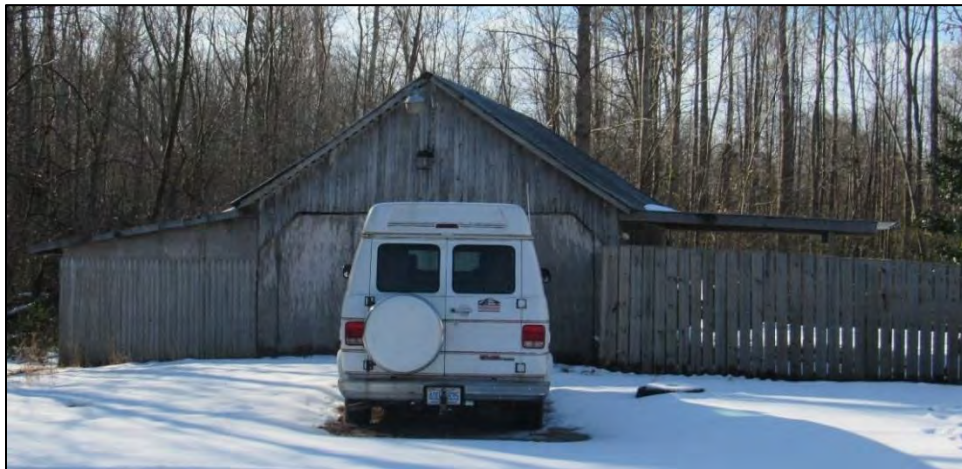
Photo 12: Garage, Northeast Elevation.

A circa-1970, one-story, two-bay garage is located southeast of the primary resource (Photo 12). The frame structural system is clad in vertical wood board and covered by a front-gabled roof sheathed in standing-seam metal. Two wood garage doors are located on the primary (northeast) elevation. The garage is flanked by two, shed-roof additions. The first is an open lean-to that extends from the southeast elevation and is supported by square-wood posts. The other extends from the northwest elevation and is enclosed with plywood.

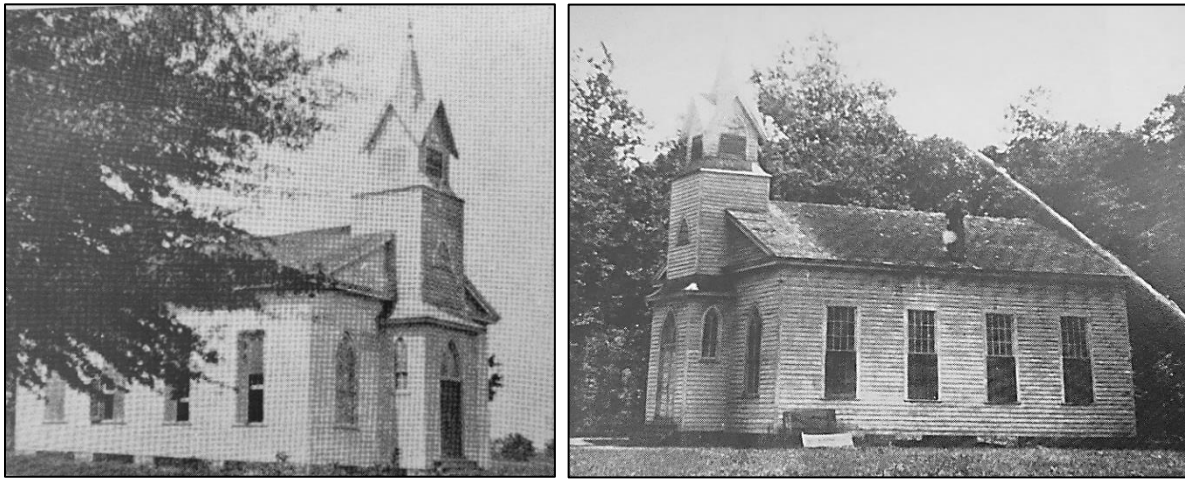
Figure 13: Undated Photo of the Moyock Methodist Church Likely Taken After 1880.⁵⁰

The modifications that took place during the shift from the Greek to Gothic Revival style were mainly concentrated on the façade of the building (Figure 13). The congregation added an engaged, two-story, projecting central tower topped by a steeple, breaking the temple-front roof line. A pent roof divided the first and second stories of the tower which was capped by a belfry with gabled openings on each elevation and a pyramidal steeple. The primary entrance was centered on the tower and filled with a double-leaf, paneled, wood door topped by a lancet transom and flanked by double-hung sash, lancet windows. The congregation thrived while housed in this building. It was noted that it was crowded every Sunday and revivals would often be held at the church.⁴⁹

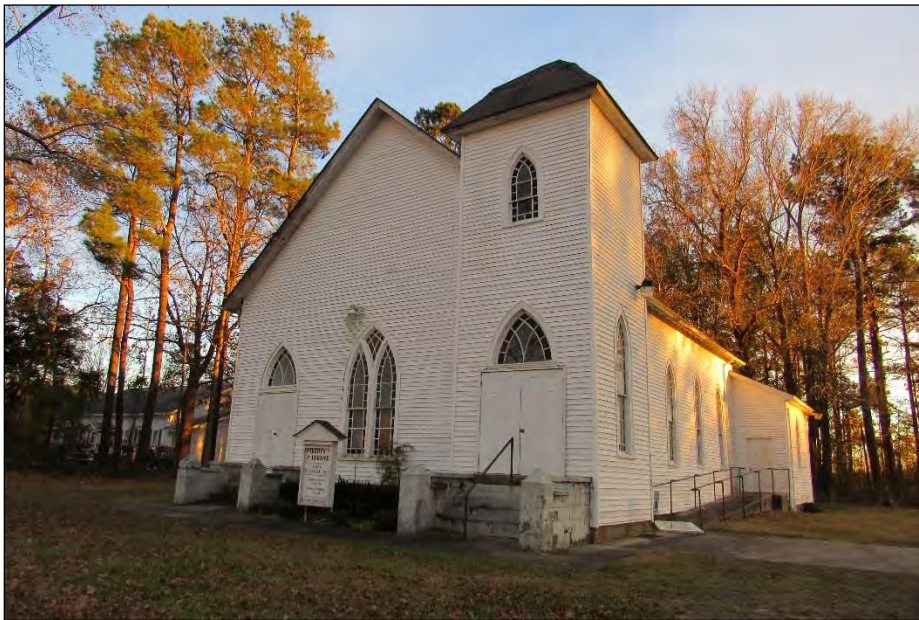
Photo 13: Pilgrim Journey A.M.E. Zion Church (CK0227), Northwest Oblique.

To properly evaluate the resource's NRHP eligibility, it must be compared with similar churches within the area. The Pilgrim Journey A.M.E. Zion Church (CK0227) is a one-story, three-bay, Gothic Revival-style church constructed in 1907 in a linear plan (Photo 13). Though this resource is about 50 years newer than the Former Moyock Methodist Church, it is located in Moyock, has similar massing and form and has experienced similar alterations. This resource features a tall, bell tower as well as lancet, double-hung, stained-glass windows. The Pilgrim Journey A.M.E. Zion Church has experienced several alterations which includes replacement of most of the roof, replacement siding and doors, and an altered belflower due to damage from Hurricane Isabel in 2003.⁶⁰ The church does not appear to still be in continuous use by the congregation. This church has been evaluated for NRHP eligibility by NC-HPO staff and has been found potentially eligible, but due to the importance to the local African American community and its importance to the area's social history.⁶¹

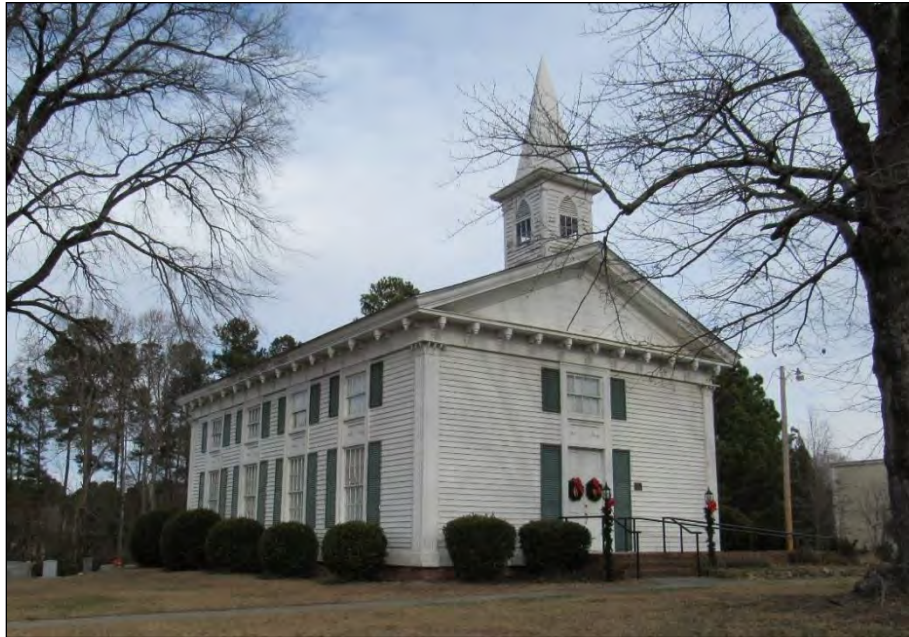
Photo 14: Forestville Baptist Church (WA0182), South Oblique.

A good example of a nineteenth-century church that has been listed in the NRHP is the Forestville Baptist Church in Wake Forest (WA0182) (Photo 14, p. 35). It is a two-story, one-bay, church constructed around 1860 with Greek Revival and Italianate influences in a linear plan. The church is similar in massing and form to the Former Moyock Methodist Church before its many alterations and modifications. The Forestville Baptist Church is clad in weatherboard siding with pilaster corner boards, which is set on a continuous brick foundation and covered by a front-gabled roof with a temple front and decorative brackets in the eaves. The church also features four-over-four and eight-over-eight, double-hung sash, wood-framed windows flanked by louvered shutters and a louvered belfry topped by a pyramidal steeple.

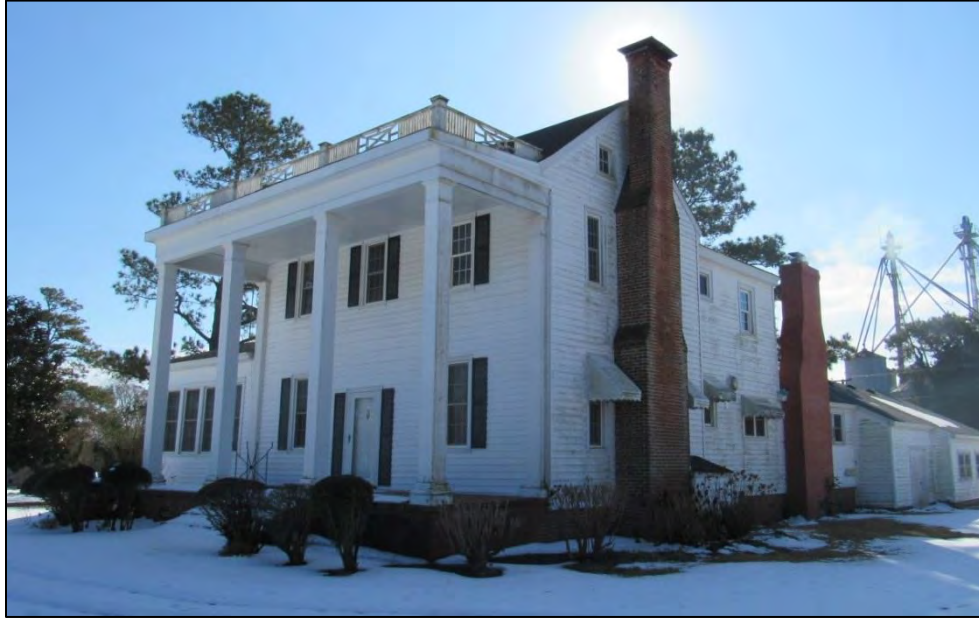
The primary resource is a two-story, three-bay, single-family dwelling constructed around 1833 and reflects some late-Federal influences, but in general lacks much of the high-style ornamentation and elements commonly associated with this architectural style (Figure 18, p. 40; Photo 15, p. 41). The raised, continuous, brick foundation laid in a one-to-three common bond supports a mortise-and-tenon structural system. As recently as 2007 the original weatherboard remained in place; however, within the last 10 years the owners applied vinyl siding. A moderately pitched, side-gabled roof sheathed in asphalt shingles covers the building and exterior-end, double-shouldered, brick chimneys stand at the east and west elevations.

Photo 15: Northwest Oblique of the Primary Dwelling at the W.W. Jarvis Farm.

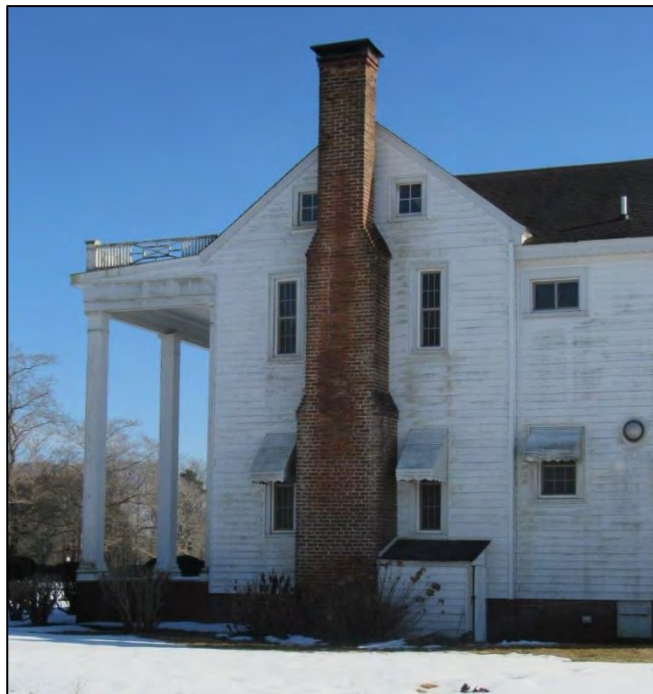
It appears that the chimneys were originally laid in a one-to-three common bond. Over time several areas needed repairs and replacement bricks were laid in a stretcher bond and did not conform to the original configuration (Photo 16).

Photo 16: Double-Shouldered Chimney on the West Elevation.

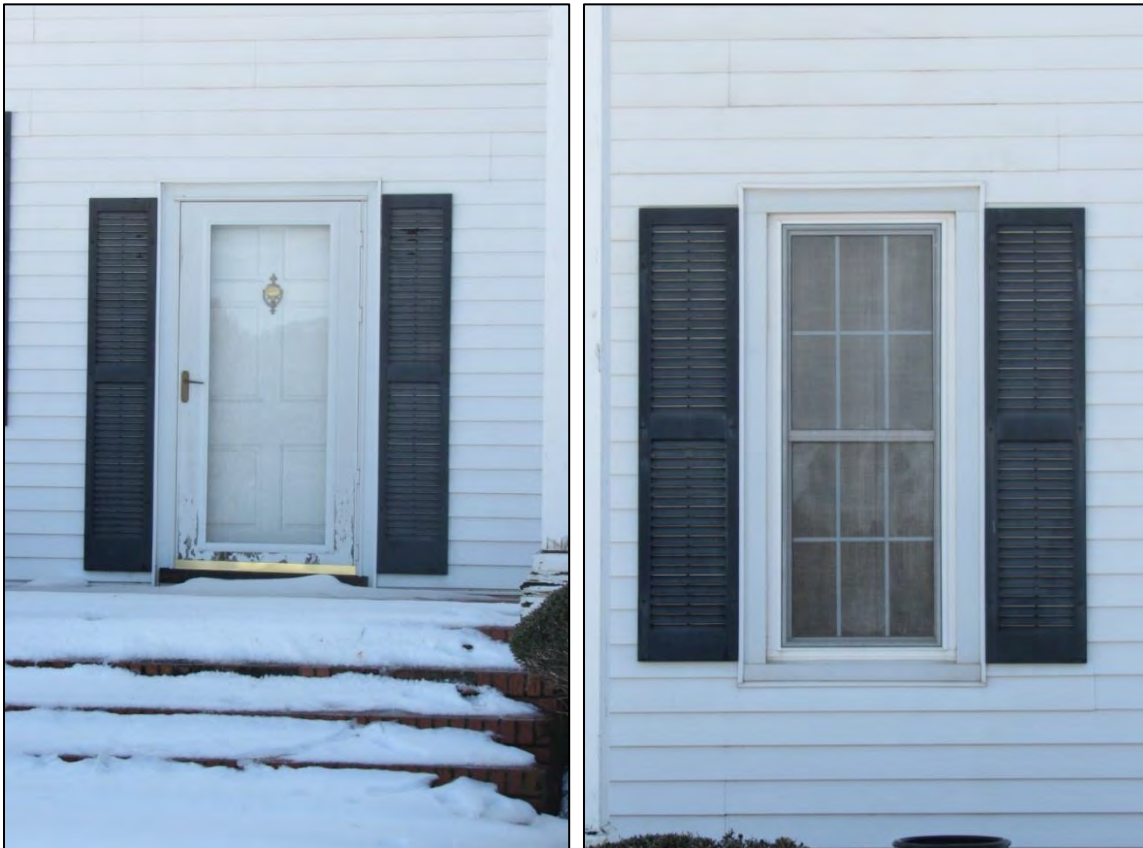
Situated slightly off-centered on the north elevation, the primary entrance is filled with a solid wood door and metal-framed storm door flanked by fixed wooden shutters (Photo 17). Other fenestration includes one-over-one, vinyl, replacement windows which are also flanked by wooden shutters on the primary (north) elevation only (Photo 17). In a previous survey completed in the early-twenty-first century, it was noted that original, wood-framed, double-hung sashes located in narrow window openings on the east and west elevations survived; however, they too have been replaced with vinyl windows. First-story windows on the east elevation feature metal awnings and small, fixed, square-shaped, four-light, wood-framed windows are located on either side of the chimneys in the gable ends.

Photo 17: Primary Entrance (Left) and Vinyl Window (Right) on the North Elevation.

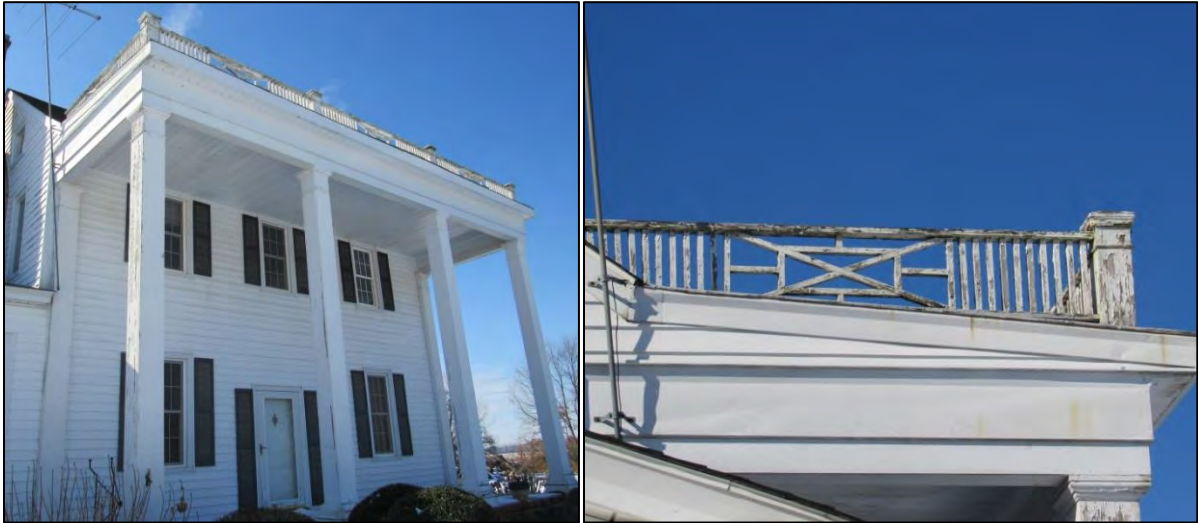
In the mid-twentieth century, owners replaced a one-story porch on the north elevation with full-height, three-bay, Neoclassical-styled porch which remains in place today. The raised brick foundation is accessed by a central set of brick steps and square, wooden columns support the flat roof with a wooden balustrade along the edge (Photo 18, p. 43). A small, shed-roofed, vinyl-clad bulkhead provides access to the cellar. A single-leaf door pierces the south elevation.

Photo 18: Circa-1950 Porch on the North Elevation (Left) and a Detail of the Porch's Balustrade, Looking West (Right).

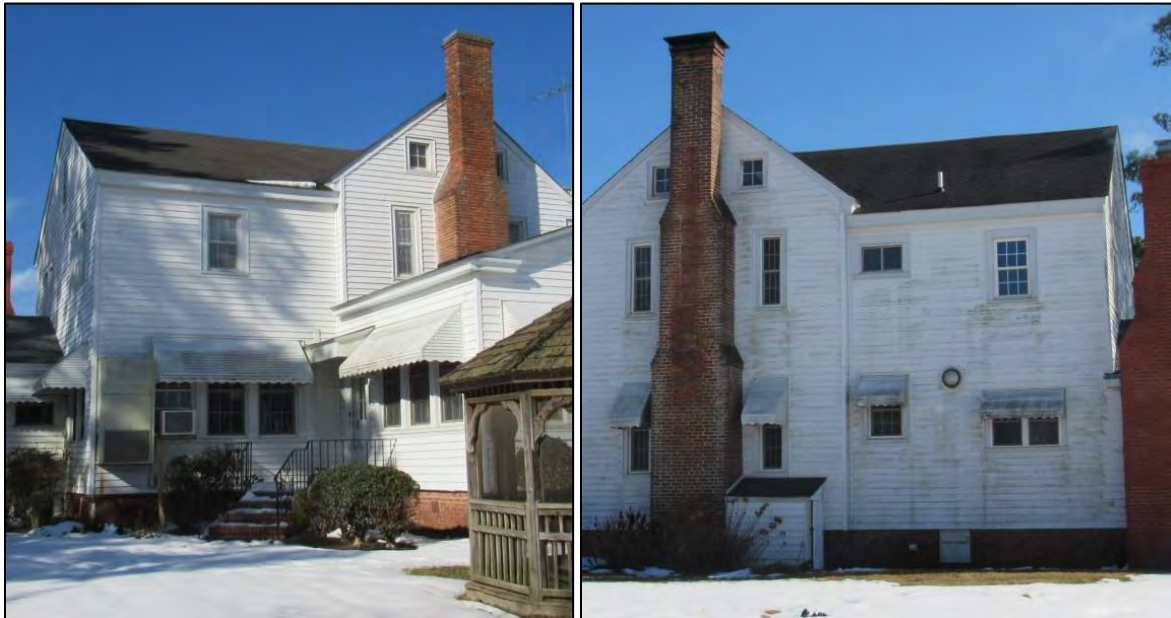
From the original core's south elevation extends a two-story rear ell (Photo 19). Notes from previous surveys on file with the NC-HPO suggest that that the first story was original to the building but later greatly modified with a second-story addition in the mid-twentieth century. Today, the vinyl-clad ell stands on a continuous, raised, brick foundation and features a moderately pitched, gabled roof sheathed in asphalt shingles. All window openings are filled with vinyl replacement sashes and those on the first story are covered with metal awnings.

Photo 19: Rear Ell, East Elevation (Left) and West Elevation (Right).

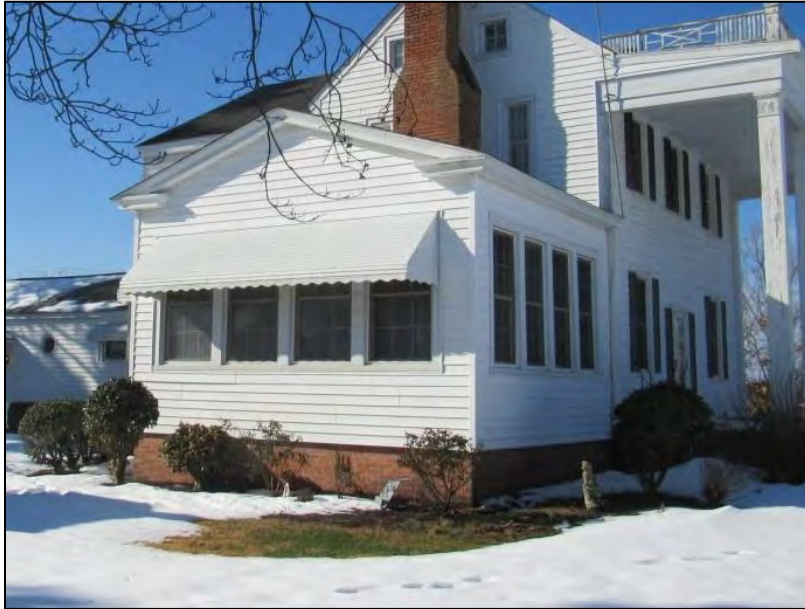
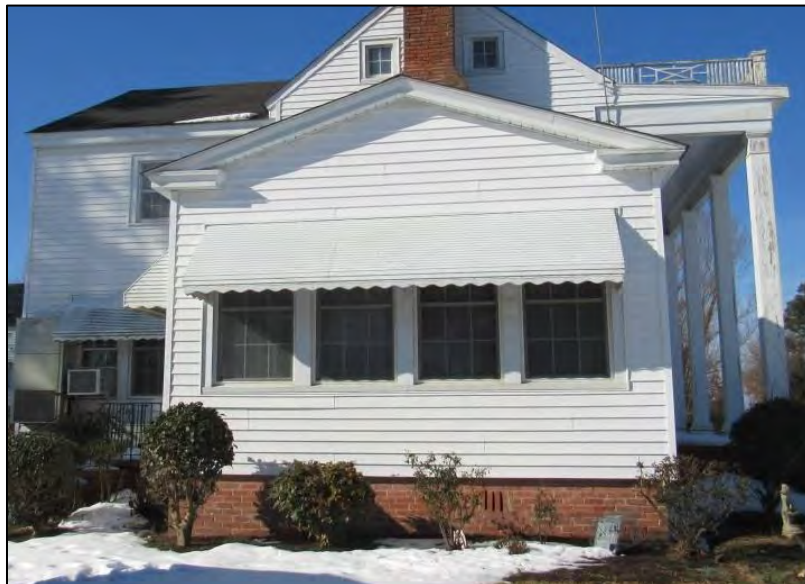
A one-story enclosed sun porch dating to the mid-twentieth century is attached to dwelling's east elevation. Like the circa-1833 core and the ell, this addition has a brick foundation that supports a vinyl-clad structural system. A wooden cornice with return eaves on the gable end lines the low-pitched, side-gabled roof. Situated on the south elevation near where the former porch appends to the original core is a secondary entrance. A brick porch lined with a metal balustrade provides access to this wooden door. Window openings are filled with vinyl sashes (Photo 20 and Photo 21).

Photo 20: Enclosed Side Porch, Northeast Oblique.

Photo 21: Enclosed Side Porch, East Elevation.

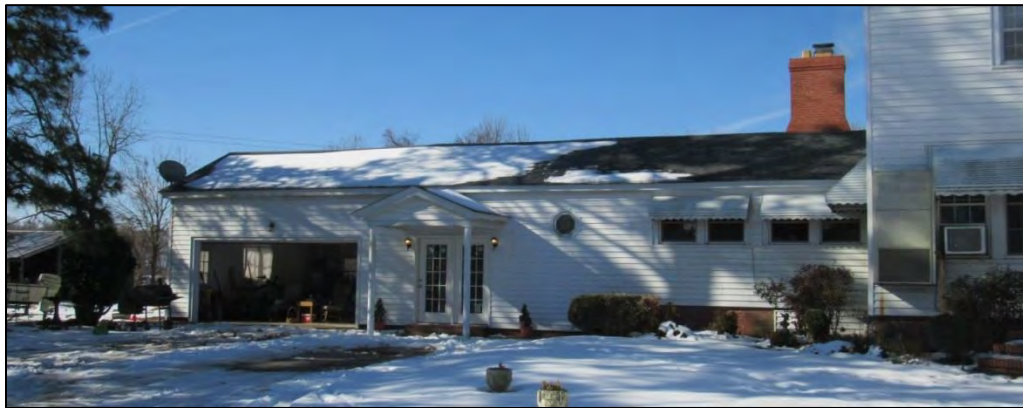
Around 1985, the owners constructed a large, one-story addition to the ell's south elevation (Photo 22 and Photo 23). Set on a continuous brick-veneered foundation, the vinyl-clad structural system is covered by a side-gabled roof sheathed in asphalt shingles. Although the east elevation is a solid plane, the west elevation is stepped, with the narrowest point where the ell meets the addition and the widest near the southern edge. A large, exterior-end, shouldered, brick chimney with a corbelled cap stands at the northernmost edge of the west elevation. There are several entrances on this circa-1985 section, including a 15-light pedestrian door with a fixed 15-light side-light and a large garage door on the east elevation and a double-leaf, wooden door on the middle section of the west elevation. Other fenestration includes one-over-one, vinyl windows.

Photo 22: Circa-1985 Addition, East Elevation.

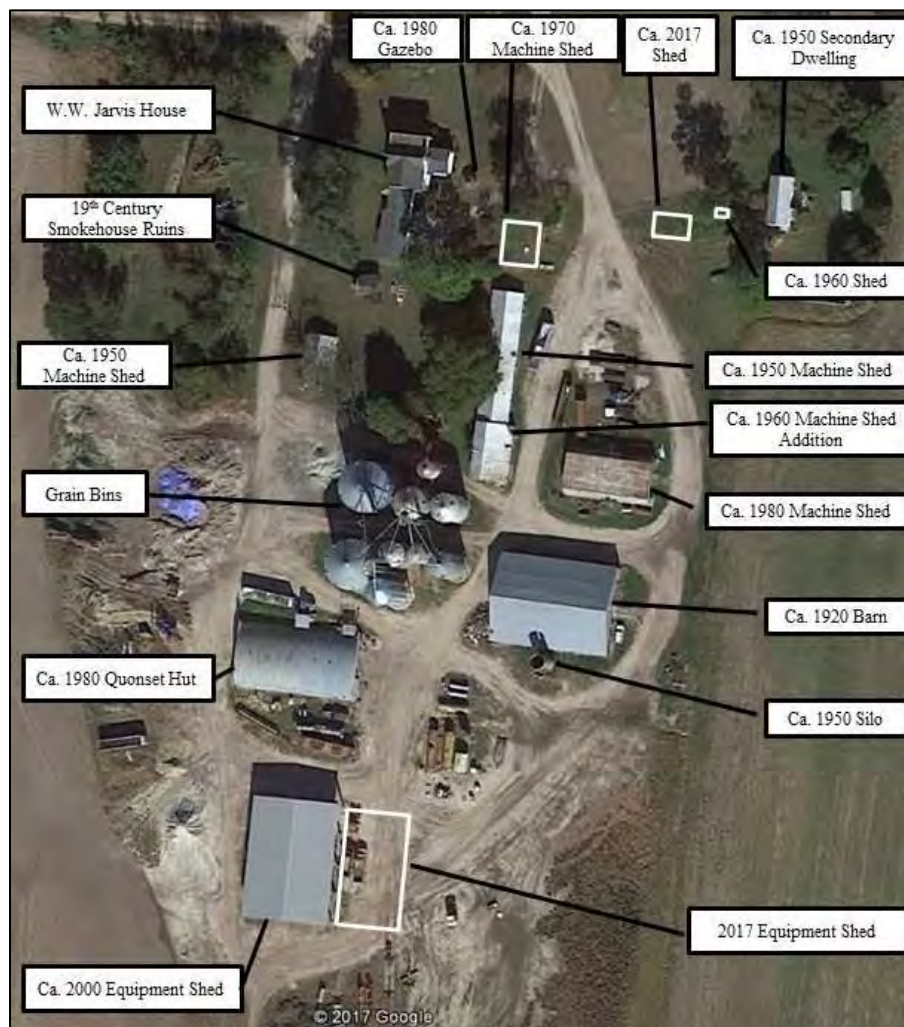
Figure 19: Detailed Site Plan of the Secondary Resources Located South and East of the Primary Dwelling.⁷²

South and southeast of the primary resource is a cluster of outbuildings, most of which are agricultural in nature although there are several currently or historically related to domestic functions (Figure 19).

East of the primary resource and separated by a dirt road are three buildings: a secondary dwelling and two sheds (see Figure 19, p. 46). Constructed around 1950, the vinyl-clad, single-family dwelling stands one story tall and is covered by a front-gabled roof sheathed in v-crimp metal. The primary entrance, filled with a wood door with six fixed lights at the top, is off-centered on the south elevation (Photo 37). A one-story, one-bay, front-gabled entry porch supported by unadorned wood posts surrounds this entrance. Other fenestration includes paired vinyl windows, metal-framed hopper windows, and a wood-framed tripartite window comprising six-over-six, double-hung sashes flanking a large, single, fixed light.

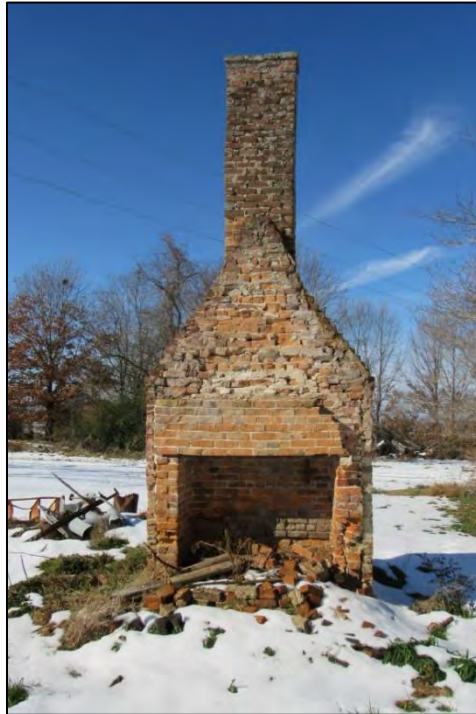
Immediately south of the primary resource's circa-1985 addition is a chimney stack, all that remains of a nineteenth-century smokehouse. The shouldered, brick chimney laid in a one-to-three common bond once stood at the west elevation of the frame outbuilding, which fell down in 2017 (Photo 24). Just southwest of this chimney stands a circa-1950 machine shed of pole-type construction. A front-gabled roof sheathed in v-crimp metal covers the shed, which features open bays on the north and east elevations, while the west and south elevations are clad in narrow, vertically laid, wooden boards. Centered on the south elevation is an open bay used for agricultural machinery or other vehicles (Photo 25).

Photo 24: Chimney Stack Once Associated with a Smokehouse, Looking West.

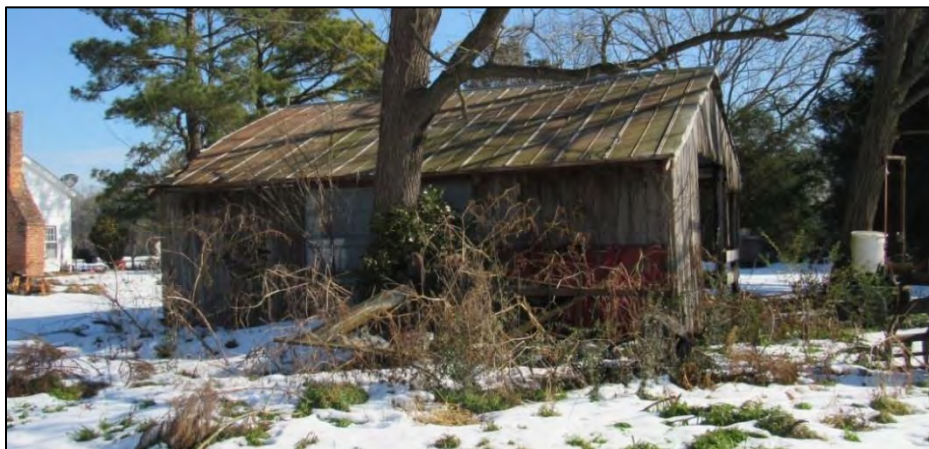
Photo 25: Circa-1950 Machine Shed, Southwest Oblique.

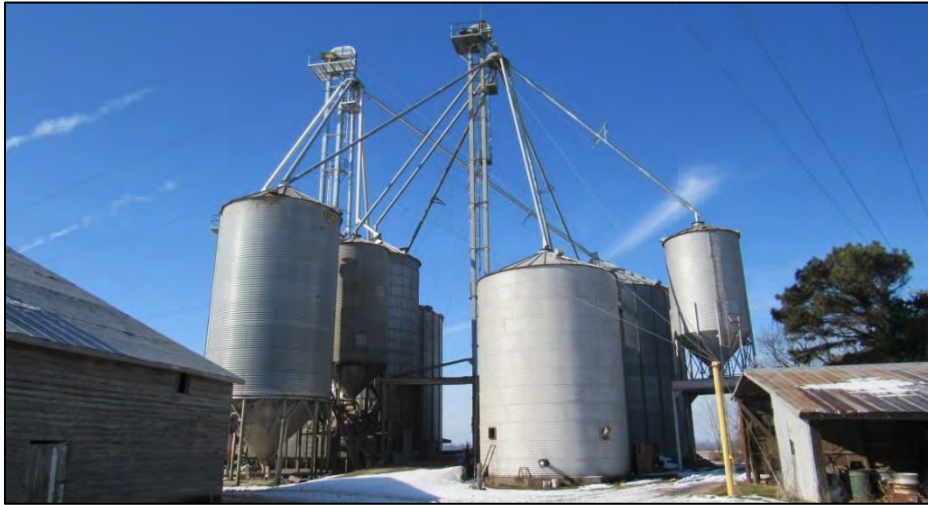
South of the circa-1833 dwelling, smokehouse ruins, and circa-1950 shed is a cluster of metal grain bins. The earliest (likely in the 1980s) are located at the northeast edge of this grouping (Photo 26). Two of these stand on a continuous, concrete foundation while the smallest of the three is raised on metal posts. The remaining grain bins in this cluster were built around 1992 and, like the older three, are a combination of large bins set on a concrete foundation and smaller ones raised on poles made of metal. All of the grain bins are circular in shape and covered by conical roof of the same material. A series of steps and ladders are affixed to each to allow access.

Photo 26: Grain Bins, Looking Southwest.

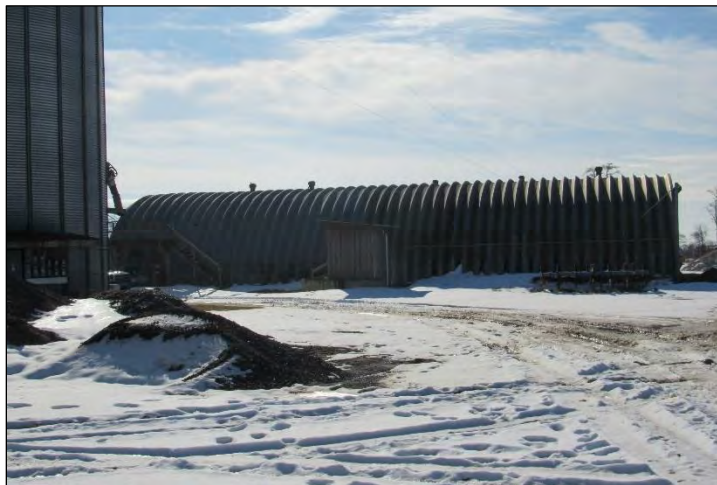
Constructed around 1980, a metal-framed Quonset Hut is located just southwest of the silos. This metal building has a semicircular roof and is accessed by two metal sliding doors: one on both the east and west elevations. Appended to the north elevation is a wood deck platform and stairs and a small, one-story, shed-roofed shed (Photo 27 and Photo 28, p. 49).

Photo 27: Quonset Hut, North Elevation.

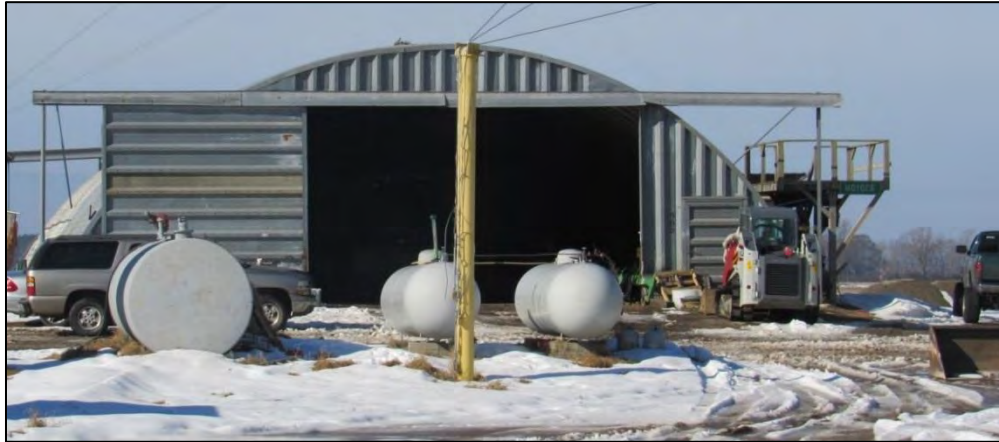
Photo 28: Quonset Hut, East Elevation.

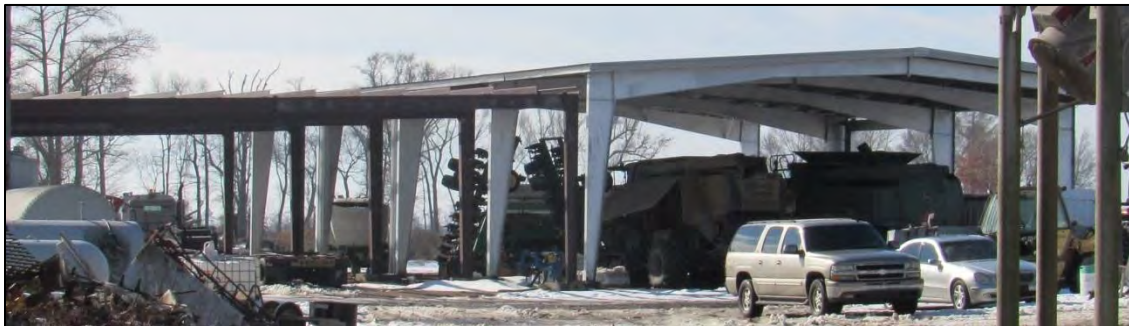
Also associated with this resource are two open-air equipment sheds that stand adjacent to one another. The oldest (westernmost) shed dates to around 2000 and has a metal structural system and is covered by a low-pitched, front-gabled roof. The newest (easternmost) was constructed within the last year. Its metal structural system stands on solid blocks of concrete and is covered by a flat roof (Photo 29 and Photo 30).

Photo 29: View of Circa-2000 (Right) and 2017 (Left) Equipment Shelters, Looking South.

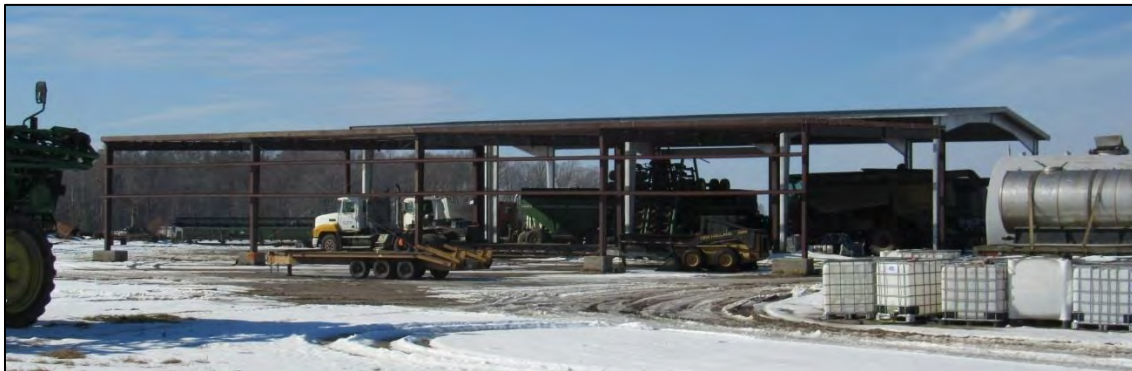
Photo 30: 2017 Equipment Shed (Foreground) and Circa-2000 Equipment Shed (Rear).
