SUBJECT: Historic Structures Survey Report, Widening of SR 1223/1224 (Old Swamp Road) and
SR 1218/1227 (South Mills Road), PA 17-05-0040, R-5717, Camden and Currituck Counties,
ER 18-0453

**HISTORIC STRUCTURES SURVEY REPORT
WIDEN SR 1223/ SR 1224 (OLD SWAMP ROAD) AND
SR 1218/ SR 1227 (SOUTH MILLS ROAD),
CAMDEN AND CURRITUCK COUNTIES,
NORTH CAROLINA**

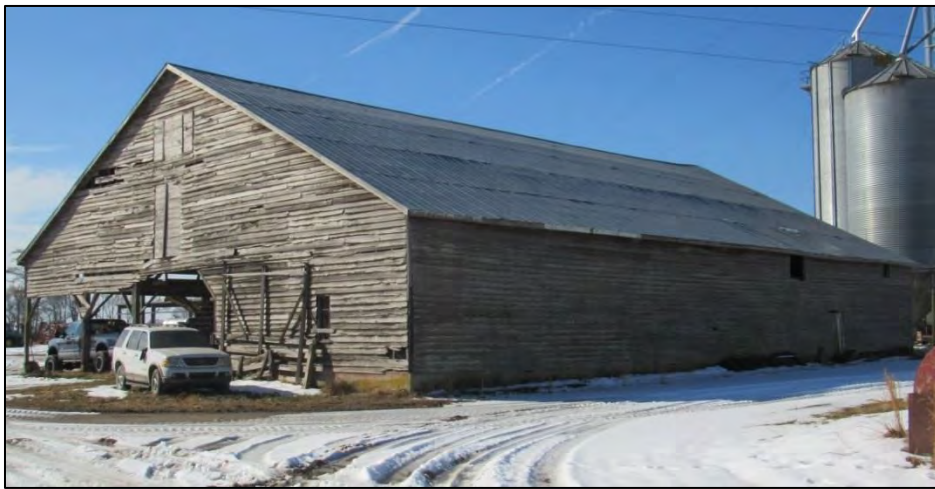
A large, two-and-a-half story, transverse-frame barn stands at the southeast corner of this cluster of outbuildings. According to a previous survey, this building was constructed around 1920 as a cattle barn; however, today it is mostly used for storage. A solid, continuous, poured-concrete foundation supports a weatherboard-clad structural system that is covered by a moderately pitched, side-gabled roof sheathed in v-crimp metal (Photo 31). Historically, there was an opening with clipped corners on the east elevation; although evidence of it remains, this entrance was modified when some of the siding on the east and south elevations was removed to convert this portion of the barn into a vehicle and machine storage space. Other fenestration includes small fixed windows, openings on the east elevation covered over with sheets of metal, and a single-leaf wood door on the north elevation. Just south of the barn is a circa-1950 concrete silo. It is not currently in use and does not have a roof (Photo 32).

Photo 31: Circa-1920 Barn, Northeast Oblique.

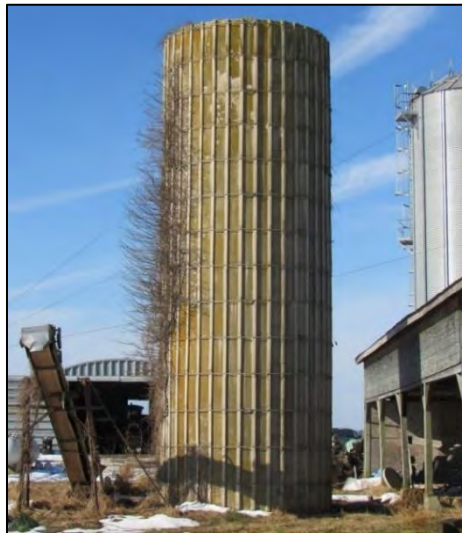
Photo 32: Circa-1950 Silo, Looking West.

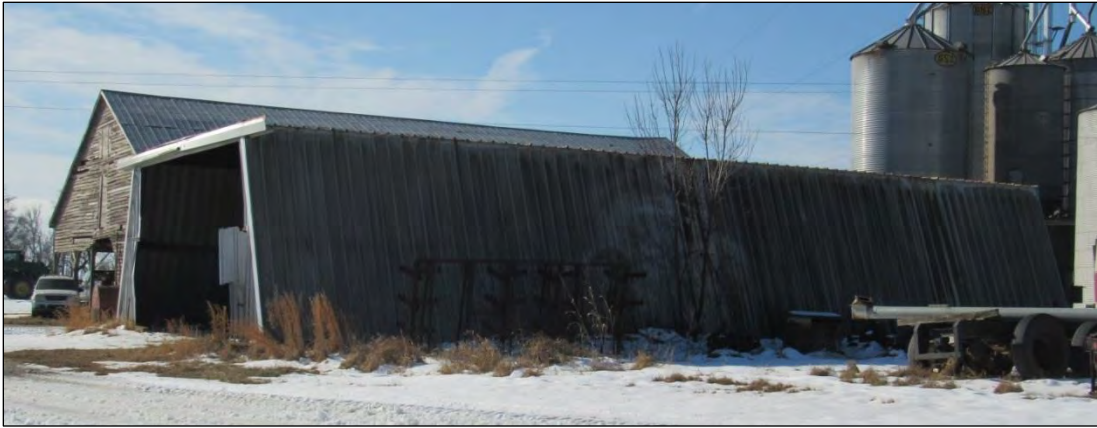
Located near the just north of the circa-1920 barn and circa-1950 silo is a trapezoid-shaped machined shed constructed around 1980 (Photo 33). The building is covered by a flat roof sheathed in standing-seam metal; on the north and south elevations, the roof line extends beyond the eaves and slopes downward to ground level at a slope, forming the building's trapezoid shape. Corrugated metal covers the rear (west) elevation and a large, open bay is located on the east (primary) elevation.

Photo 33: Circa-1980 Machine Shed, Northeast Oblique.

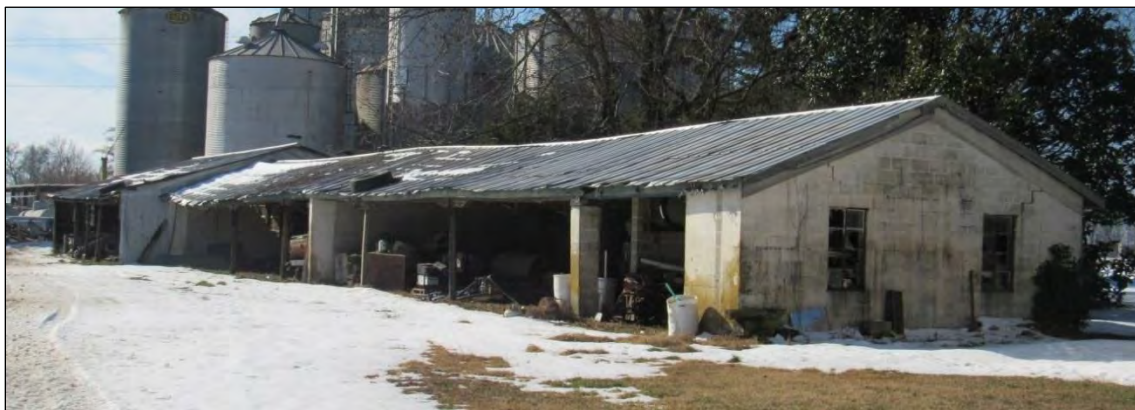
A circa-1950, concrete-block, machine shed stands just southwest of the primary resource (Photo 34). The entire east (primary) elevation is open and supported by three concrete-block walls and wood poles. A side-gabled roof sheathed in v-crimp metal covers the building. Two eight-light, metal-framed windows pierce the north elevation. Attached to the south elevation is slightly later (circa-1965), one-story, four-bay, frame, machine shed (Photo 35, p. 52). This building is clad in corrugated metal and covered by a gabled roof also sheathed in metal. Like the earlier concrete-block portion, the east elevation is open and the roof on this side is supported by wood poles. There is also a large opening on the south elevation to allow big pieces of machinery to enter and exit.

Photo 34: Northeast Oblique of the Circa-1950 Machine Shed. The circa-1960 machine-shed addition can be seen on the left side of the photograph.

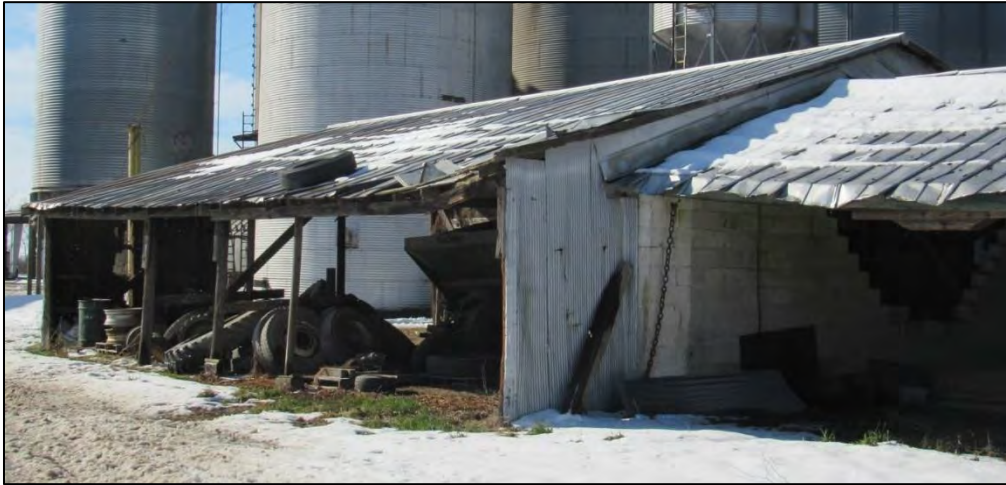
Photo 35: Circa-1965 Machine-Shed Addition, Northeast Oblique.

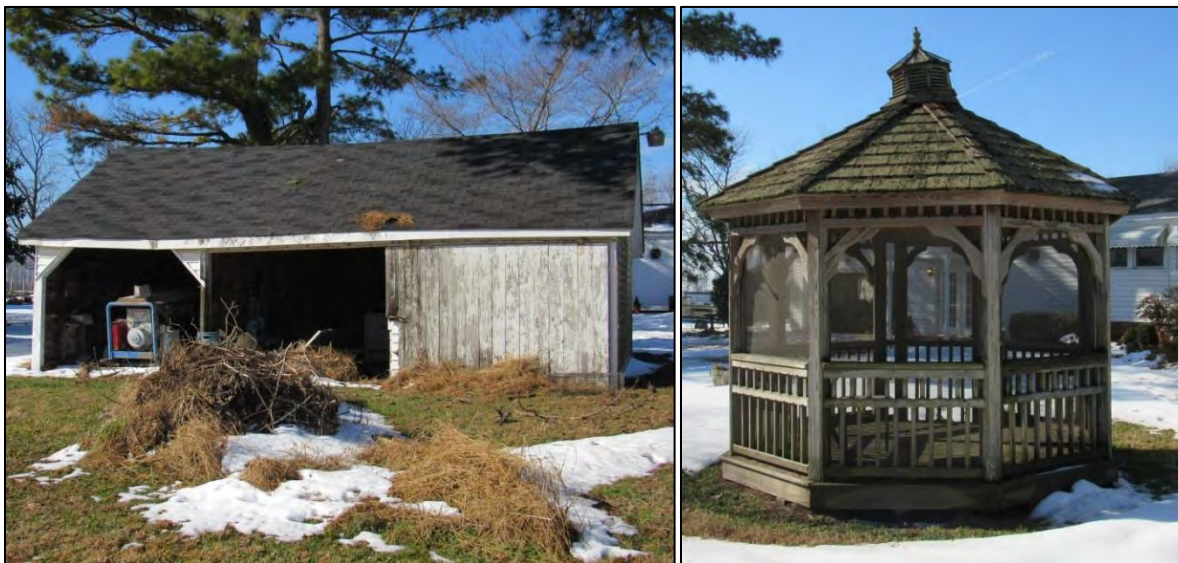
Two secondary resources are located west of the circa-1833 dwelling: a circa-1970 machine shed and a circa-1990 gazebo (Photo 36). The one-story, frame, machine shed is clad in weatherboard with vinyl siding placed on top of it and covered by a side-gabled roof sheathed in asphalt shingles. Only two openings on the east (primary) elevation were visible at the time of the survey: an open bay with clipped corners and a large opening with a wood sliding door suspended from a metal track. The wood-framed gazebo constructed around 1990 is located just north of this machine shed. A balustrade made of wood lines the octagonal-shaped structure, which is covered by a wood-shingled roof supported by square posts and brackets. The gazebo is enclosed with a mesh screen and accessed by a screen door on the southwest elevation.

Photo 36: Circa-1970 Machine Shed, East Elevation (Left) and Circa-1990 Gazebo, Looking Southwest (Right).

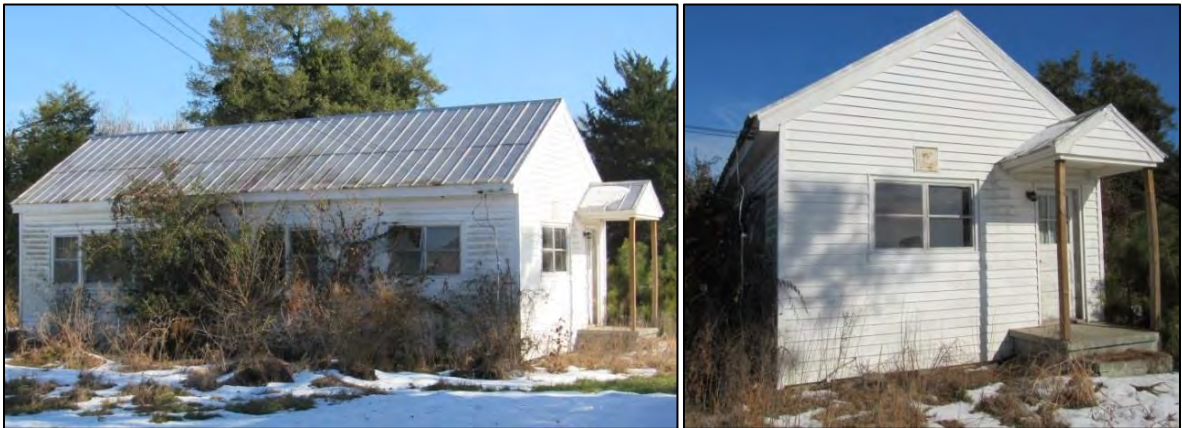
East of the primary resource and separated by a dirt road are three buildings: a secondary dwelling and two sheds (see Figure 19, p. 46). Constructed around 1950, the vinyl-clad, single-family dwelling stands one story tall and is covered by a front-gabled roof sheathed in v-crimp metal. The primary entrance, filled with a wood door with six fixed lights at the top, is off-centered on the south elevation (Photo 37). A one-story, one-bay, front-gabled entry porch supported by unadorned wood posts surrounds this entrance. Other fenestration includes paired vinyl windows, metal-framed hopper windows, and a wood-framed tripartite window comprising six-over-six, double-hung sashes flanking a large, single, fixed light.

Photo 37: Circa-1950 Secondary Dwelling, Southwest Oblique (Left) and South Elevation (Right).

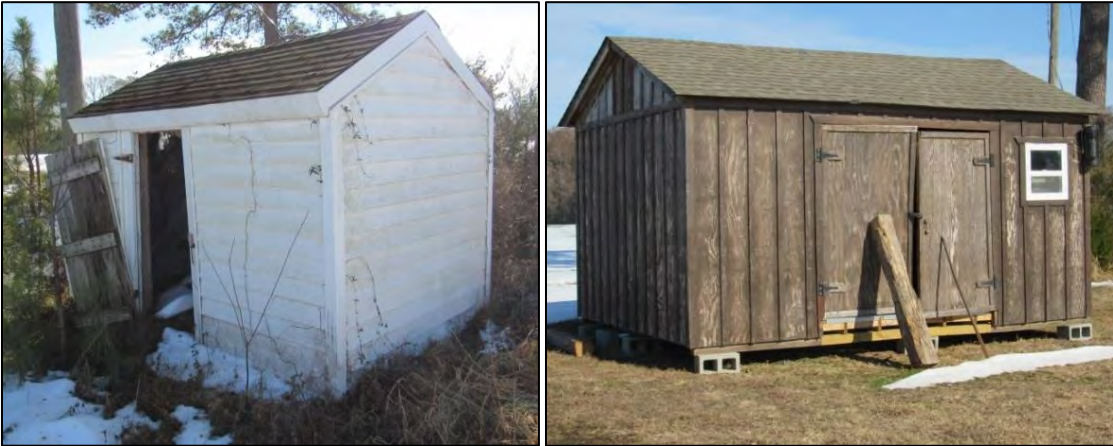
Immediately southwest of the dwelling is a circa-1960 shed. This frame building was likely once clad in wooden siding, possibly weatherboard; however, in recent decades the owners affixed aluminum siding to the original (Photo 38, p. 54). Covering the building is a moderately pitched, side-gabled roof sheathed in asphalt shingles. Off-centered on the north elevation is a single-leaf wood, vinyl-clad door attached by a metal-strap hinge. A recently-constructed, one-story shed stands just west of the shed and dwelling. This building currently sits on concrete-blocks and is covered in board-and-batten siding and capped by a side-gabled roof. A large, double-leaf, wood door fills the south elevation's central bay and just east of this door is a fixed vinyl window (Photo 38, p. 54).

Photo 38: Circa-1960 Shed, Northwest Oblique (Left) and Circa-2017 Shed (Right).

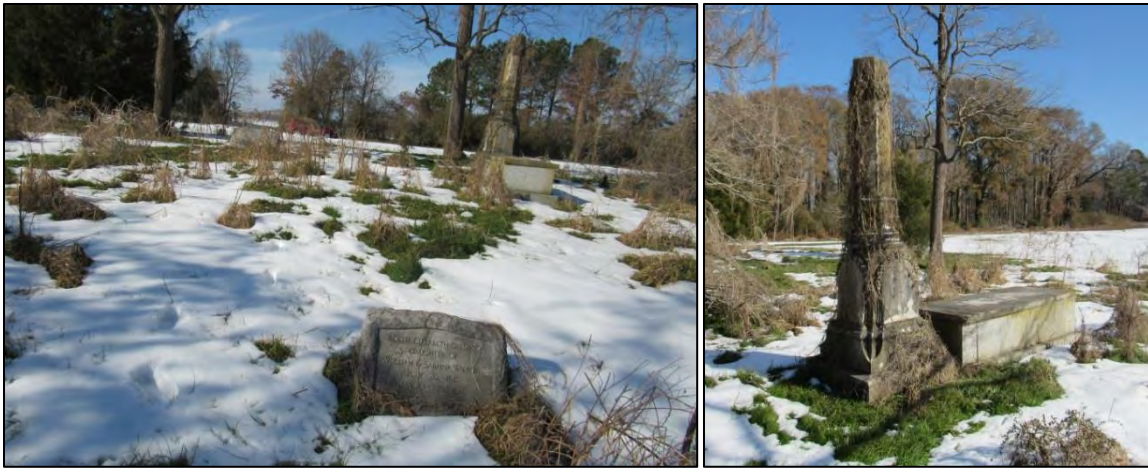
Two secondary resources are located north of the primary dwelling (see Figure 17, p. 39). The first is a small, unenclosed family cemetery comprising approximately 15 interments and range in date from 1859 to 1932 (Photo 39, p. 54). Although most of the granite markers are small, unadorned, and set in the ground, there is one four-sided, tall headstone decorated with detailed granite work in the form of flowers built in memory of Mrs. Maggie A. Lindsey (1839–1959) (Photo 39, p. 54).

Photo 39: Family Cemetery, Looking West (Left) and Mrs. Maggie A. Lindsey Grave Detail, Looking Northeast (Right).

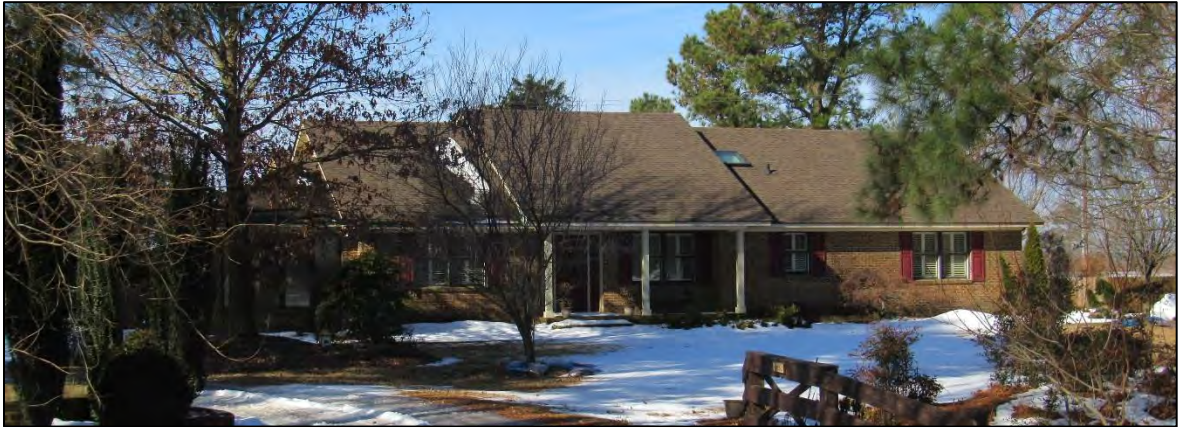
The remaining resource is a one-story, circa-1985, single-family dwelling. A moderately pitched, side-gabled roof sheathed in asphalt shingles covers the brick-veneered structural system (Photo 40, p. 55). Fenestration includes a single-leaf wood door on the east (primary) elevation and single and paired, double-hung sash windows flanked by shutters. Surrounded the entrance on the east elevation is an engaged one-story, two-bay porch supported by square columns. Full access to this dwelling was not granted during this survey.

Photo 40: Circa-1985 Secondary Dwelling, East Elevation.

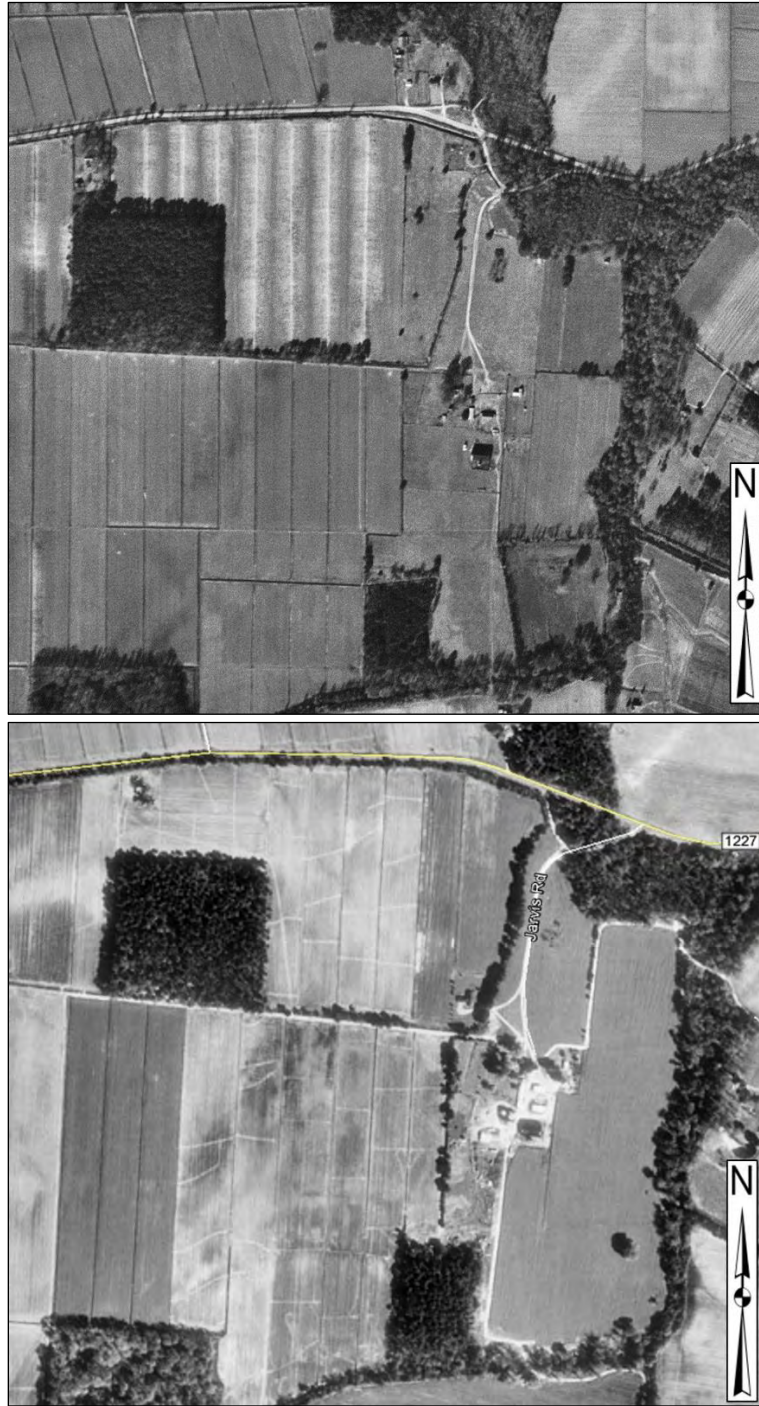
Historic online aerials indicate that crop field patterns as well as vegetation boundaries have remained unaltered for over 60 years since the ownership of Billy Jarvis (Figure 23, p. 62).¹¹⁶ However, several buildings on the property appear to be no longer extant including two in the northern half of the property along South Mills Road and in the northeast corner nearest to the tributary feeding into Shingle Landing Creek (Figure 24, p. 63). Likewise, the type of farming conducted on the W.W. Jarvis Farm property had moved historically from beef cattle farming at the turn of the twentieth century to primarily crop/grain farming in the twenty-first century. Although the Jarvis family was considered a group of innovative farmers, there is no primary resource documentation suggesting that they were the first or only of Currituck County or the region to use a particularly groundbreaking agricultural technique, introduce a new livestock breed or use a little known profitable crop species. It had been found that the Jarvis Farm has been one of the largest family farms in the county; however, this fact does not in itself warrant NRHP eligibility. In sum, the W.W. Jarvis Farm is recommended not eligible under Criterion A as it lacks integrity to reflect the period of time in which W.W. Jarvis made notable contributions to the area’s agricultural history.

Figure 23: Similar Field Patterns of the W.W. Jarvis Farm Visible in Aerials from 1953 (Top) and 1990 (Bottom).¹¹⁷ Obvious changes are noted in the built environment surrounding the primary resource as well as along Old Swamp Road.

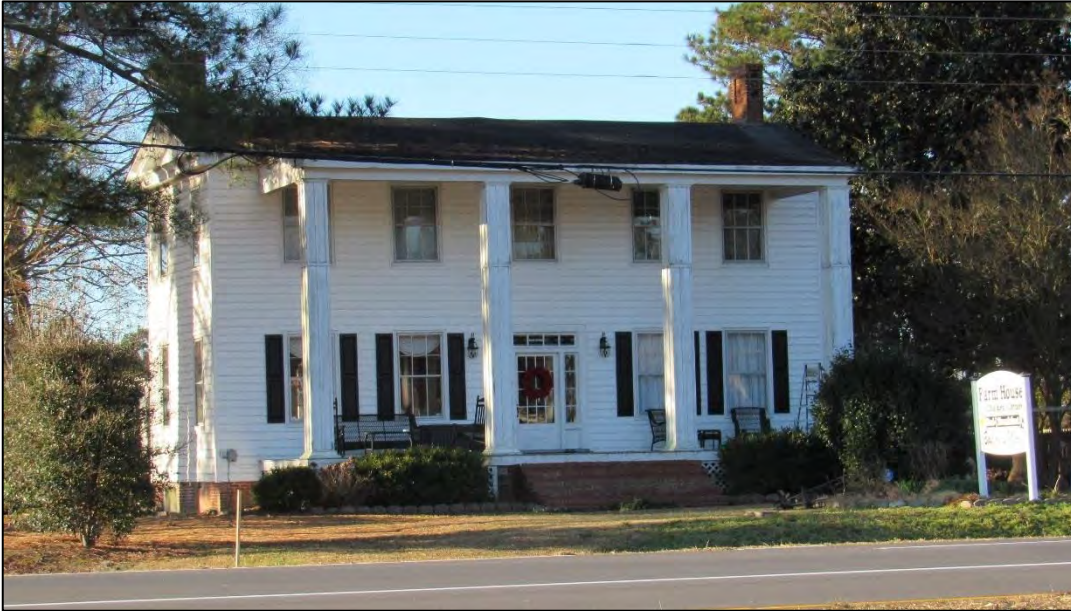
architectural style in which the building was constructed featuring “moldings with peaked and crossetted lintels” as well as ornamental plaster ceiling medallion in the main parlor.¹²¹ The dwelling, which is currently being operated as a bed and breakfast, was placed on the Study List in 1987.

Photo 41: Primary (Northeast) Elevation of the Whitehurst-Smithson House (PK0998).

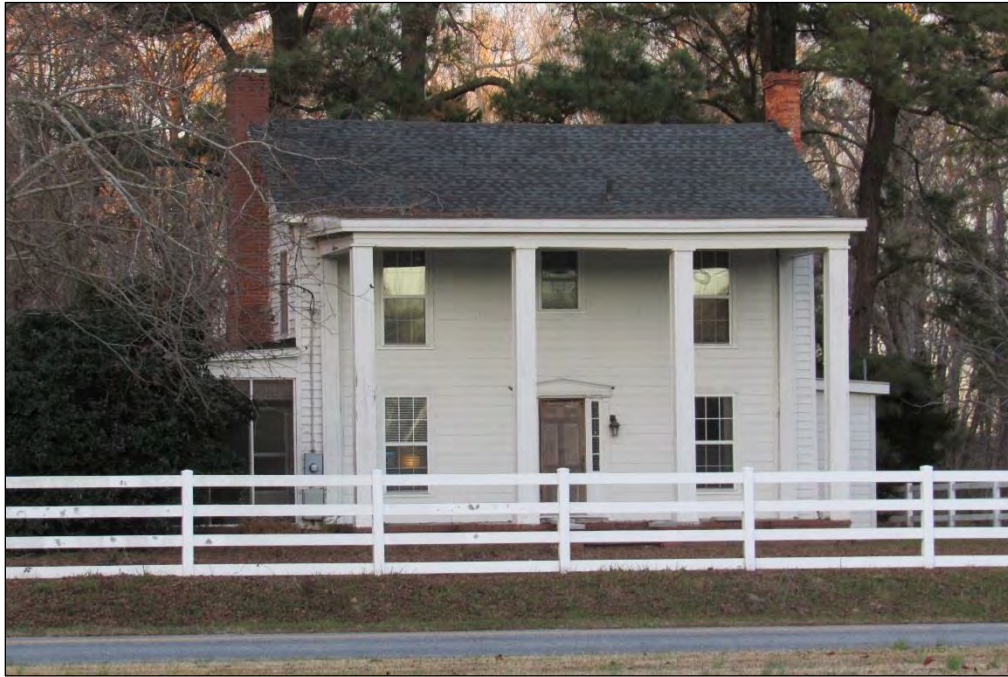
The House at 407 Tulls Creek Road (CK0435) in Moyock of Currituck County is an example of a two-story, side-gabled dwelling constructed with Federal attributes (Photo 42, p. 65). The house, located 1.8 miles east of the current resource, is a two-story, three-bay, frame dwelling built around 1890 with flanking exterior-end, brick chimneys and replacement siding and fenestration, akin to the primary dwelling of the W.W. Jarvis Farm.¹²² Although constructed outside of the period of popularity for the style, the dwelling features several Neoclassical elements such as the dominant full-height porch supported by squared Doric-like columns and pilasters and a pedimented surround for the primary entrance with side lights and squared Doric-like pilasters, possibly added at a later date.¹²³ The resource was determined not eligible by NC-HPO staff in 2006. Currently the house sits on a 1.8-acre parcel but whether it was once associated with more land was not discernable with the brief revisit completed as a part of this effort. The surrounding landscape had become increasingly residential over the last decade, replacing agricultural fields that once marked the area.¹²⁴

Photo 42: Looking Northeast at the House at 407 Tulls Creek Road (CK0435).

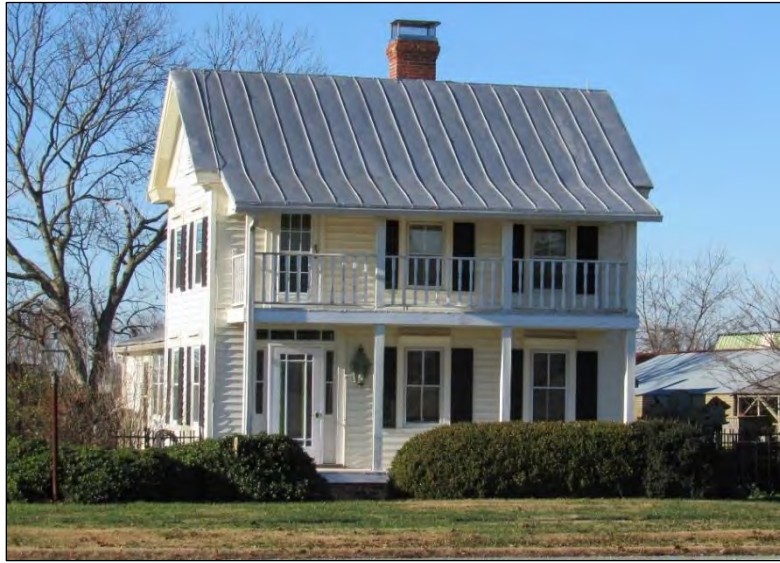
Another example of an early- to mid-nineteenth-century, two-story dwelling is the Simmons-Morris House (CK0331) at 3784 Caratoke Highway in Barco of Currituck County, approximately 14 miles southeast of the current resource (Photo 43, p. 66). The modest dwelling is three bays wide featuring a side-passage plan and is clad in vinyl siding. The side-gabled roof contains partial returns in the gabled ends and a rear ell as well as addition gabled extensions extend from the rear (west). Unlike the house at the W.W. Jarvis Farm, the porch is two stories with squared, aluminum-clad posts with the second story being lined with a turned rail. According to a previous survey, the dwelling's interior is "relatively intact and features original heart of pine floors, four-paneled doors and parlor fireplace surround with fluting, scrolled brackets and central molded, incised panel."¹²⁵ The resource was placed in the Study List in 2007. The former survey did not, however, note the agricultural buildings associated with the Simmons-Morris House (Figure 25, p. 66). A recent visit to the property showed that the agricultural complex immediately north of the resource are called "Morris Farm Market," further relating it to the dwelling. Visible from the public right-of-way and current online aerials, the complex includes a produce salesroom warehouse and a larger warehouse with ridge ventilators that appear to be of recent construction to the north and several historic buildings to the west such as a barn and silo. In a 1953 aerial, it appears that a minimal amount of associated outbuildings are indeed historic, similar to the current state of the W.W. Jarvis Farm.¹²⁶

Photo 43: Southeast Oblique of Simmons-Morris House (CK0331).

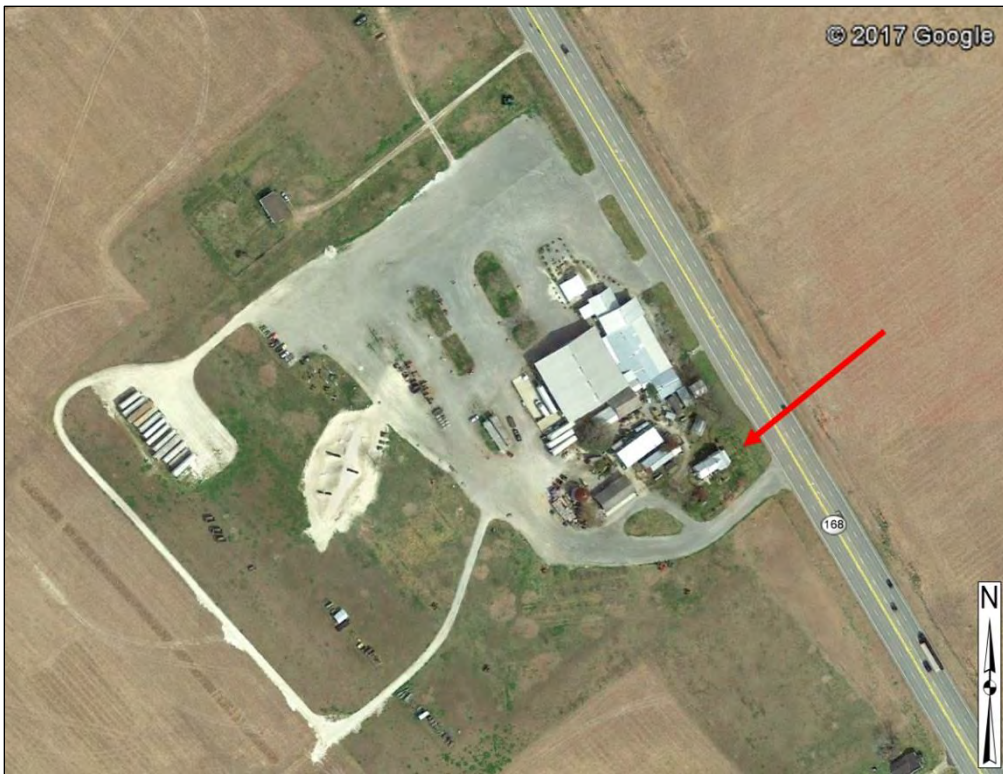
Figure 25: Current Aerial View of the Simmons-Morris House (CK0331) (denoted by red arrow) and Presumed Associated Agricultural Outbuildings.¹²⁷

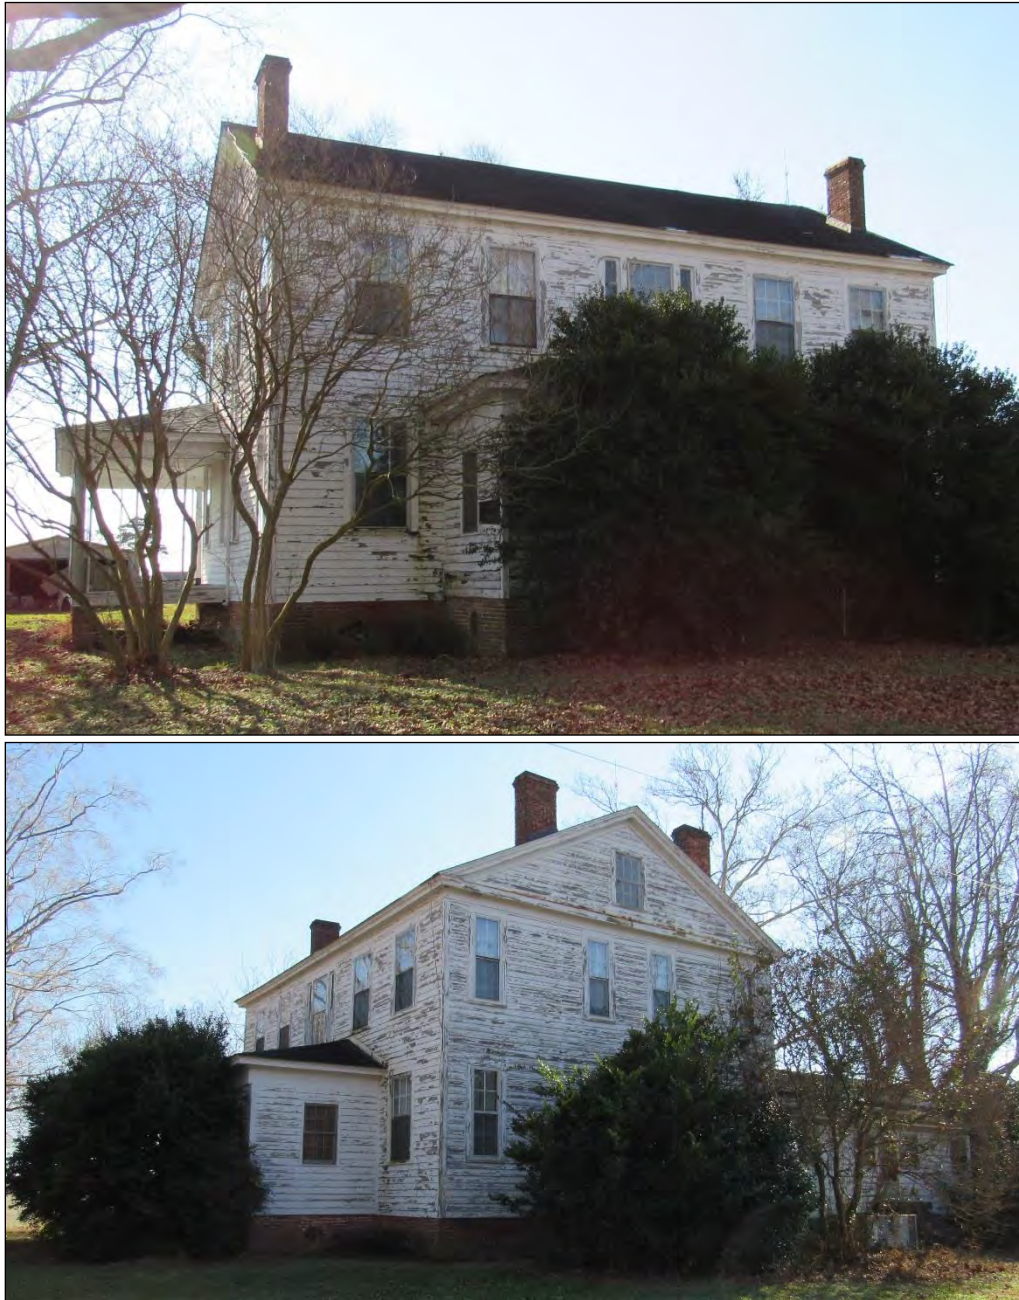
The primary resource is a two-story, five-bay, single-family dwelling built around 1855 in the Greek Revival style (Photo 44, p. 71). The continuous brick foundation with decorative vents is laid in a six-to-one common bond and supports the frame structural system that is clad in weatherboard. The dwelling is covered by a moderately pitched, side-gabled roof sheathed in asphalt shingles with full wood returns and closed eaves. Four interior-end brick chimneys with corbeled caps pierce the roof slope: two on the northern slope along the east and west elevations and two on the south slope on the east and west elevations.

Photo 44: Northern-Cox House, North Elevation (Top) and Northwest Oblique (Bottom).

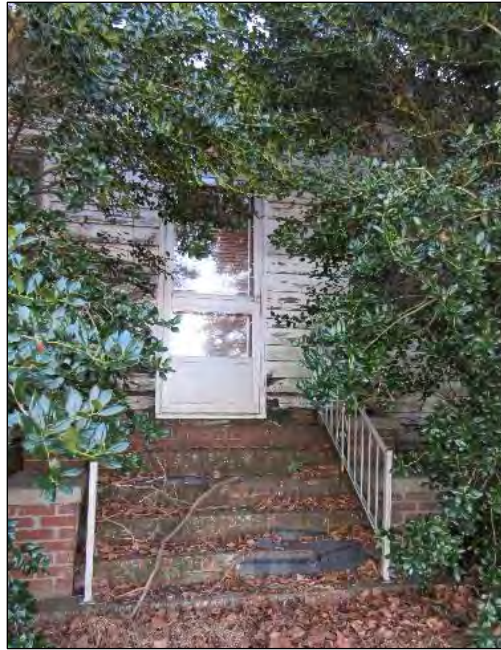
The primary entrance is centered on the north elevation and is filled with a modern, single-leaf, louvered, wood door covered by a metal-framed storm door (Photo 45, p. 72). The door is located on a one-story, three-bay, enclosed, entry porch that replaced an earlier porch supported by Tuscan columns (Figure 28, p. 72). The porch is set on a continuous brick foundation, is clad in weatherboard, and is covered by a hipped roof sheathed in asphalt shingles. The door is flanked by paired, six-over-six, double-hung sash, wood-framed windows and is accessed by a set of six brick steps with metal railing that lead to a landing in front of

Photo 45: Northern-Cox House, Primary Entrance Detail.

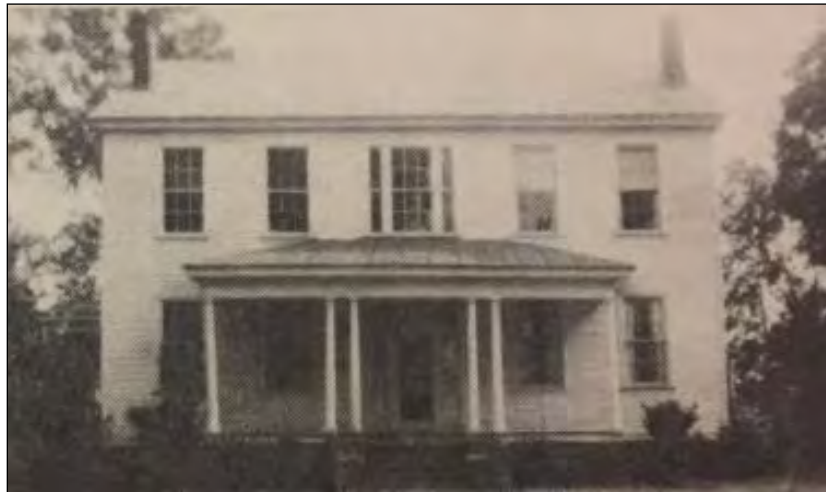
Figure 28: Undated Photo of Northern-Cox House Showing Original Porch.¹³³

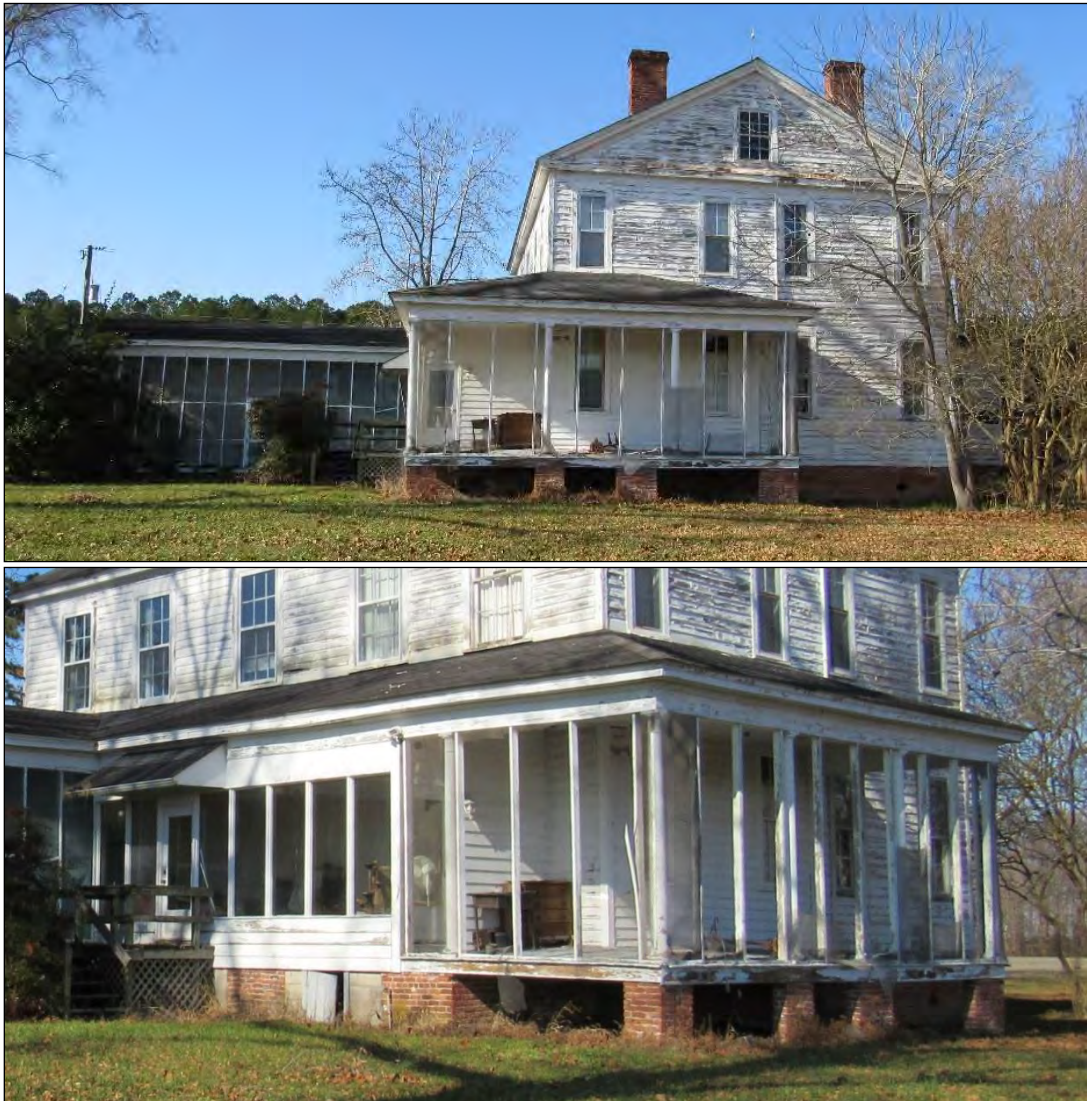
This resource features three large additions that all appear to date around the turn of the twentieth century (Photo 46). The first is a wrap-around porch which stretches from the west elevation around to the south elevation (Photo 46). The porch is set on brick piers, some of which feature concrete-block infill. The eastern portion of the porch is screened—likely a more recent alteration, and supported by small, Tuscan columns and the southern section is enclosed and features weatherboard and fixed ribbon windows with a single-leaf vinyl door providing interior access between the two. The entire porch is covered by a hipped roof sheathed in asphalt shingles. A single-leaf vinyl door with a large fixed light at the center is located within the enclosed porch portion. A set of wood stairs with wood railing lead to the door and the entrance is covered by a pent roof sheathed in asphalt shingles.

Photo 46: Northern-Cox House, East Elevation (Top) and Rear (Southeast Oblique) Wrap-Around Porch Addition Detail (Bottom).

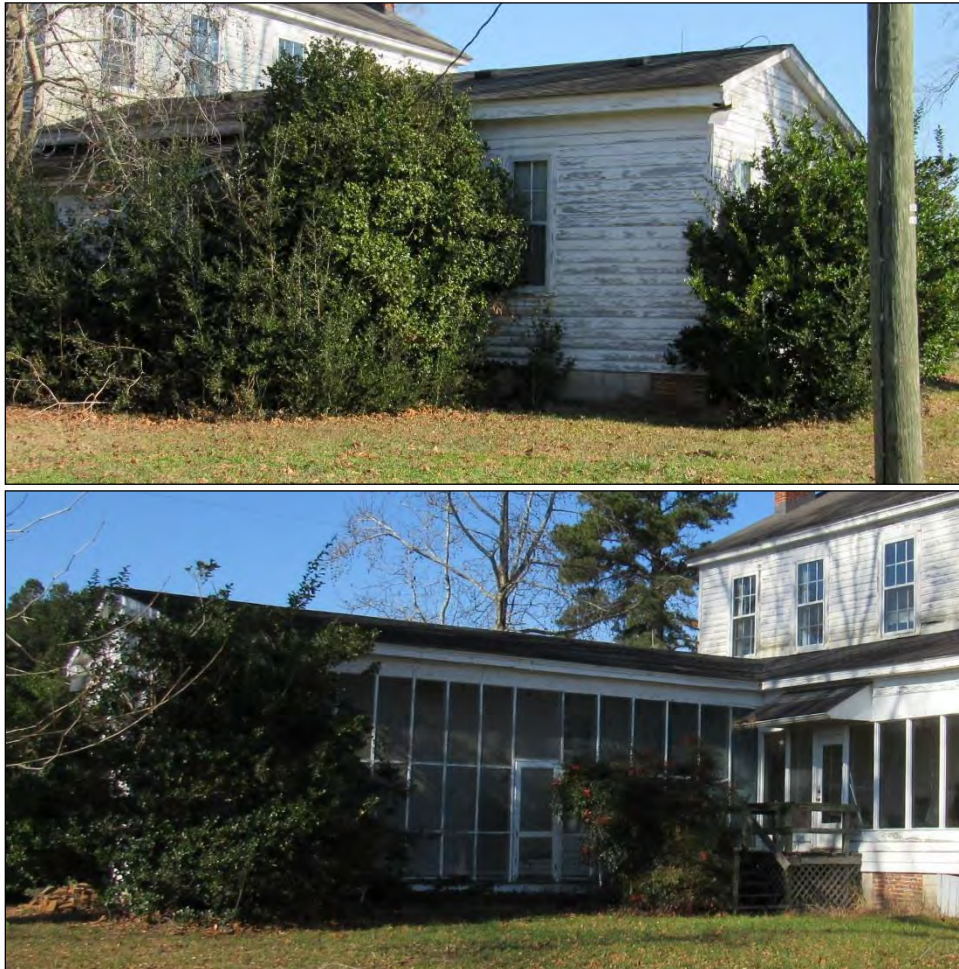
The second is a one-story, rear-ell addition that extends from the western portion of the south elevation (Photo 47). This addition was previously recorded as containing the kitchen.¹³⁴ The foundation, which is on brick piers with concrete-block infill, supports the frame structural system that is clad in weatherboard. The gabled roof is sheathed in asphalt shingles and features partial wood returns. Fenestration along the west elevation is composed of four-over-four, double-hung sash, wood-framed windows. The east elevation features a shed-roofed, screened porch—likely a more recent alteration. Access to this addition is gained through a single-leaf, paneled vinyl door covered by a metal-and-glass storm door located on the north elevation.

Photo 47: Northern-Cox House, Rear Ell Addition, Southwest Oblique (Top) and East Elevation (bottom).

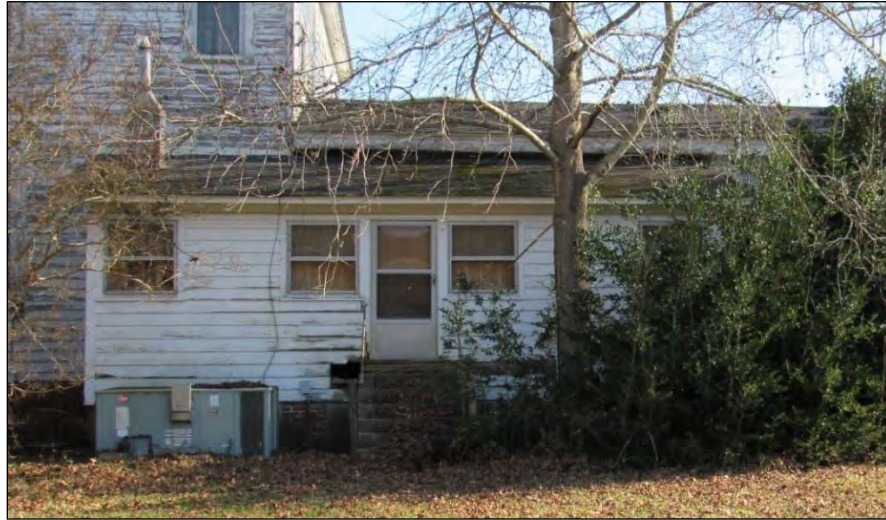
The final addition stretches across the west elevation of the primary resource and the rear ell addition (Photo 48, p. 75). The one-story, five-bay addition is situated on brick piers, is clad in weatherboard, and is covered by a shed roof with exposed rafter tails sheathed in asphalt shingles. An interior-end brick chimney topped by a metal flue is located on the south

elevation. The primary entrance is centered on the west elevation and is filled with a single-leaf, flush wood door covered by a metal-framed storm door. A set of six stairs constructed of concrete blocks with metal railing supported by wood posts leads to the door. Other fenestration includes one-over-one, double-hung sash, metal windows.

Photo 48: Northern-Cox House, Addition Detail, West Elevation.

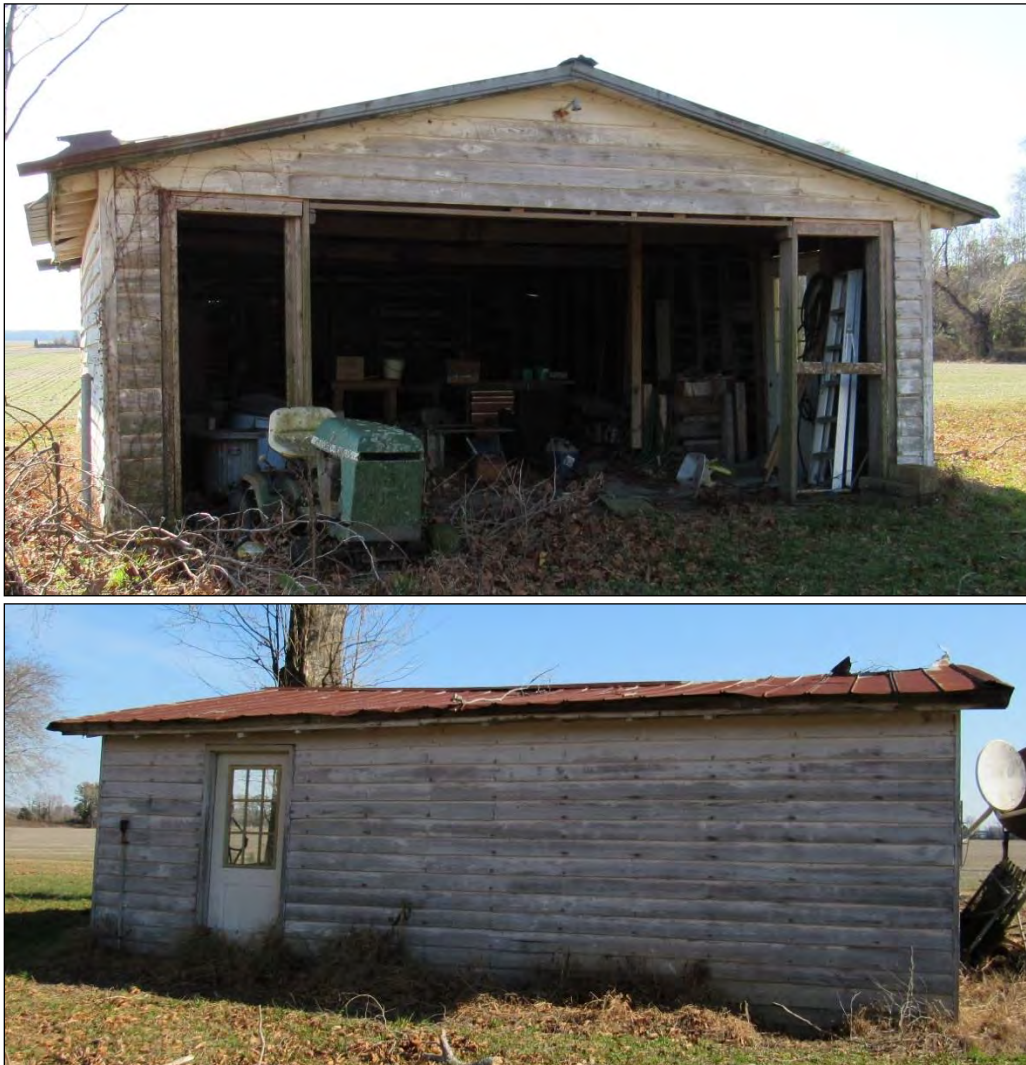
Three secondary resources are associated with this dwelling. They all appear to date from the first half of the twentieth century and are located to the south of the primary resource. A circa-1950, one-story garage is located about 60 feet south of the primary resource (Photo 49). The frame structural system is clad in weatherboard and is covered by a front-gabled roof sheathed in v-crimp metal. A large, open-bay, vehicular entrance is centered on the primary (north) elevation and is flanked by two, single-leaf, open-bays. A secondary entrance located on the west elevation is filled with a single-leaf, two-paneled, half-glazed, vinyl door.

Photo 49: Garage, North Elevation (Top) and West Elevation (Bottom).

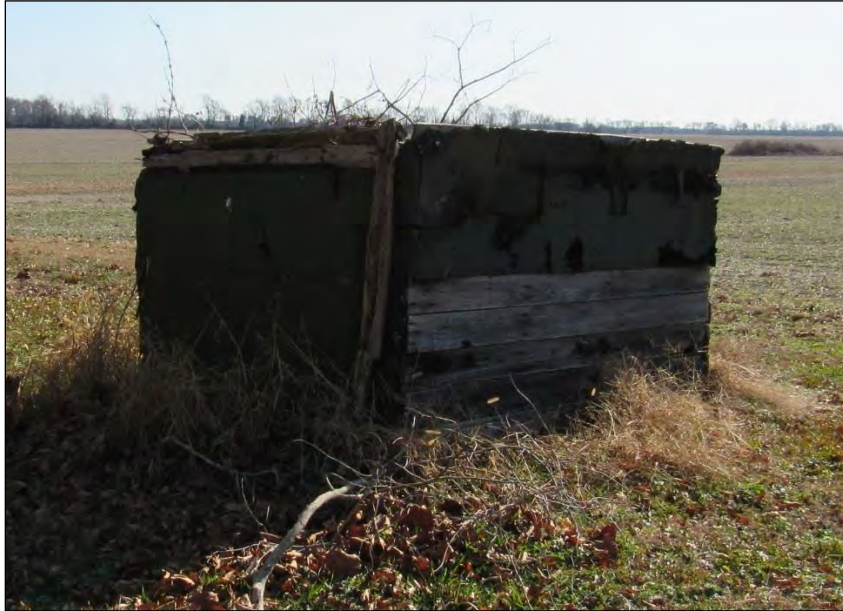
A circa-1950, one-story, well enclosure is located about 60 feet south of the primary resource (Photo 50, p. 79). The frame structural system is clad in weatherboard and tar paper and the resource does not have a roof. A modern metal tank is located within the structure. A circa-

Photo 50: Well Enclosure, Northeast Oblique.

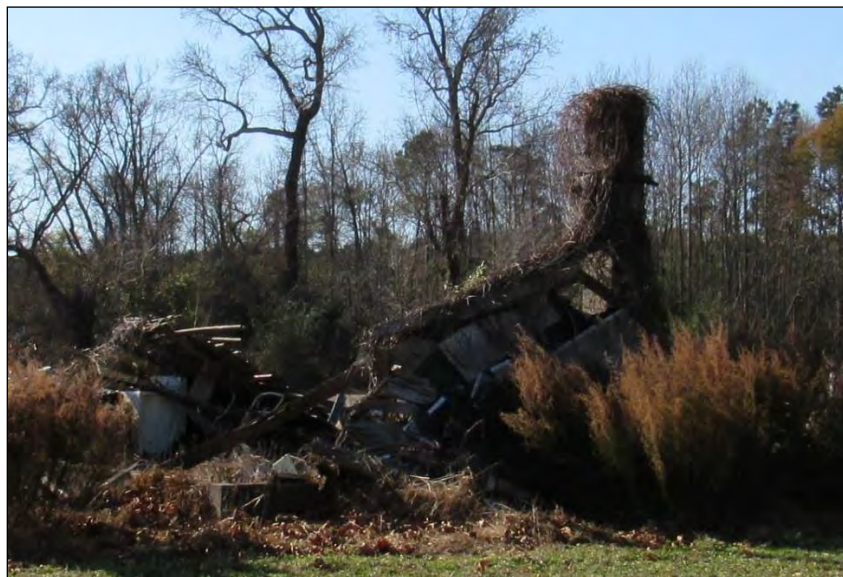
Photo 51: Frame Building Ruins, Looking Southeast.

1920 set of building ruins is located about 170 feet southwest of the primary resource (Photo 51). The resource appears to have been frame and clad in weatherboard with a gabled roof. A brick chimney with a corbeled cap is located on the north end of the ruins.

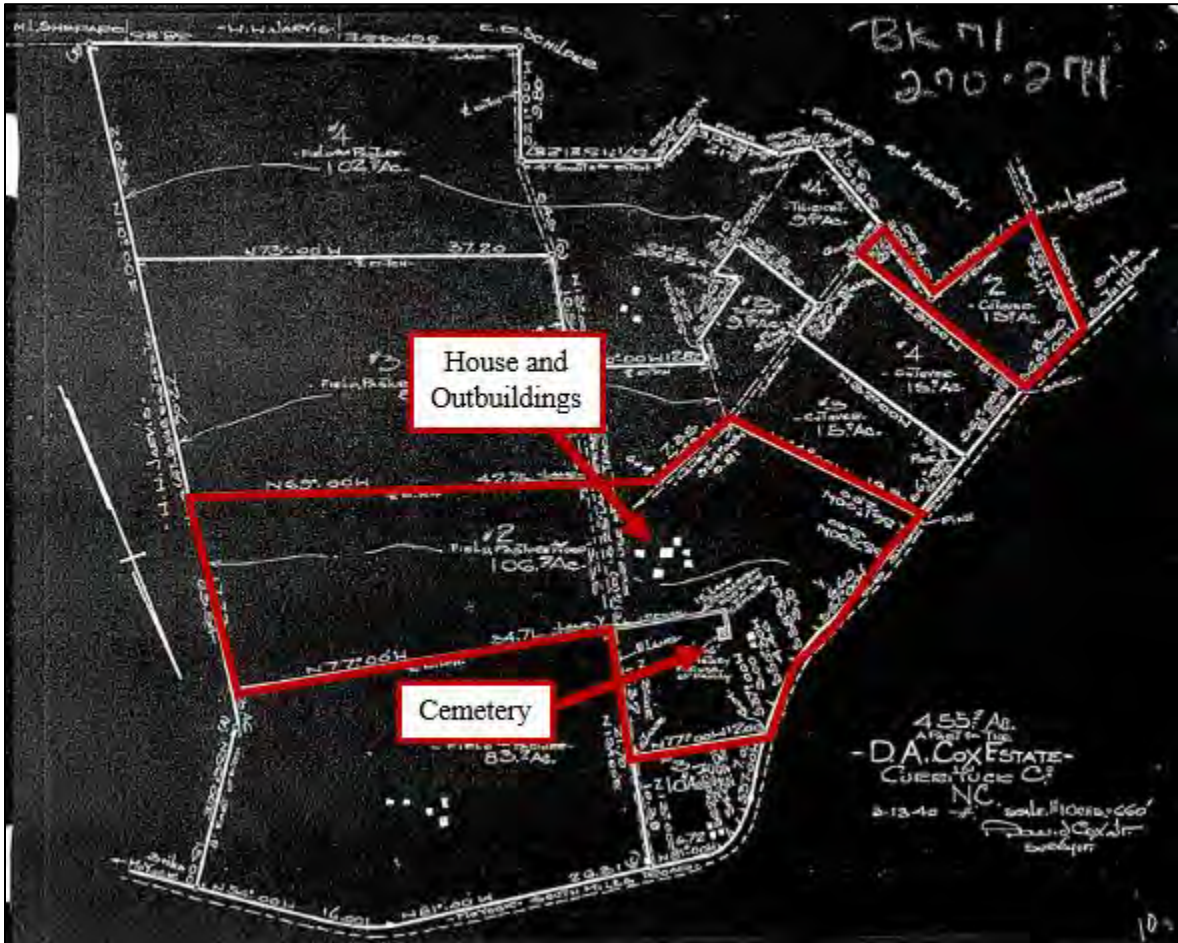
Figure 31: Plat of a Part of The D.A. Cox Estate.¹⁶⁰ Note the two parcels designated as “#2” as well as the house and outbuilding cluster and the cemetery.

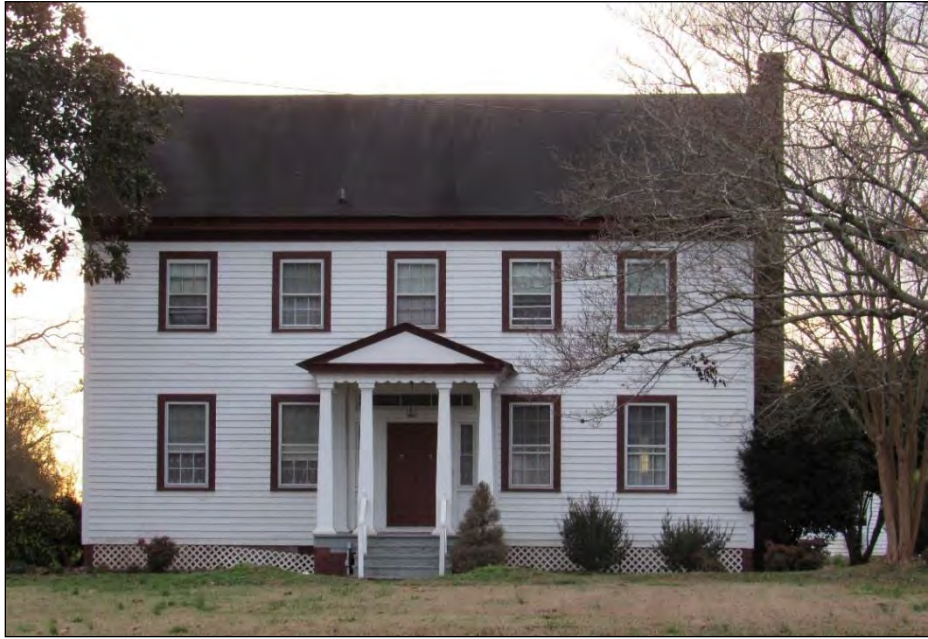
Photo 52: Samuel Wilson House (CK0021), East Elevation.

farm complex with multiple outbuildings, like the Northern-Cox house, are no longer extant.¹⁶⁶ The Samuel Wilson House remains in excellent condition, with only one small rear addition, and was noted as one of the best surviving example of the Greek Revival style in Currituck County.¹⁶⁷

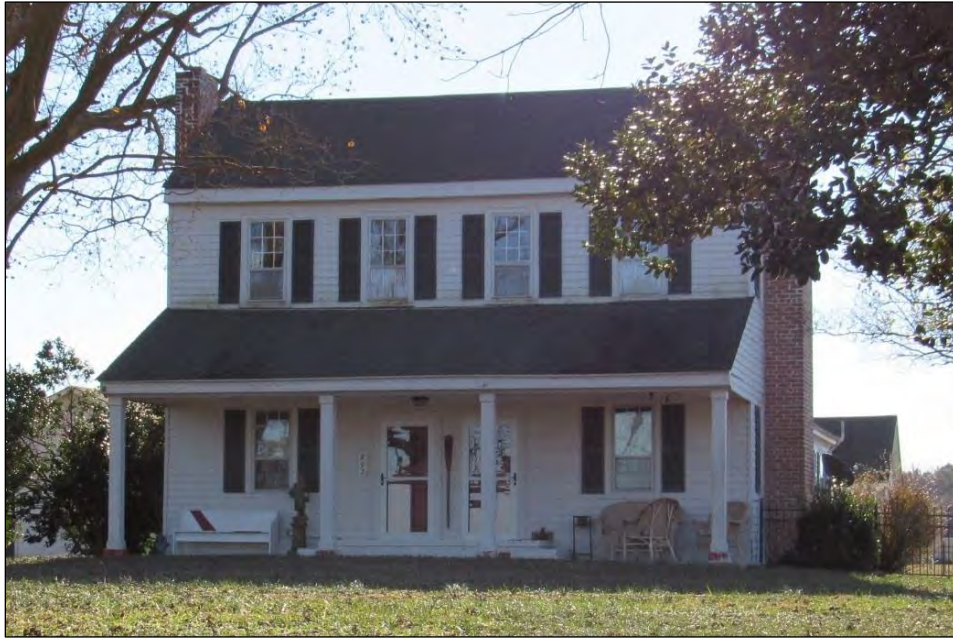
Photo 53: J.P. Morgan House (CK0352), Northwest Elevation.

The J.P. Morgan House (CK0352) is a two-story, four-bay, single-family dwelling constructed in the first quarter of the nineteenth century (Photo 53, p. 85). The resource is clad in vinyl siding and covered by a side-gable roof sheathed in asphalt shingles. This house features a one-story, full length, shed-roof porch and one-over-six, double-hung sash, wood-framed windows flanked by louvered shutters. The J.P. Morgan House is one of two remaining dwellings with a primary entrance featuring two doors in the county.¹⁶⁸
