SUBJECT: Historic Structures Survey Report, Widening of SR 1223/1224 (Old Swamp Road) and
SR 1218/1227 (South Mills Road), PA 17-05-0040, R-5717, Camden and Currituck Counties,
ER 18-0453

**HISTORIC STRUCTURES SURVEY REPORT
WIDEN SR 1223/ SR 1224 (OLD SWAMP ROAD) AND
SR 1218/ SR 1227 (SOUTH MILLS ROAD),
CAMDEN AND CURRITUCK COUNTIES,
NORTH CAROLINA**

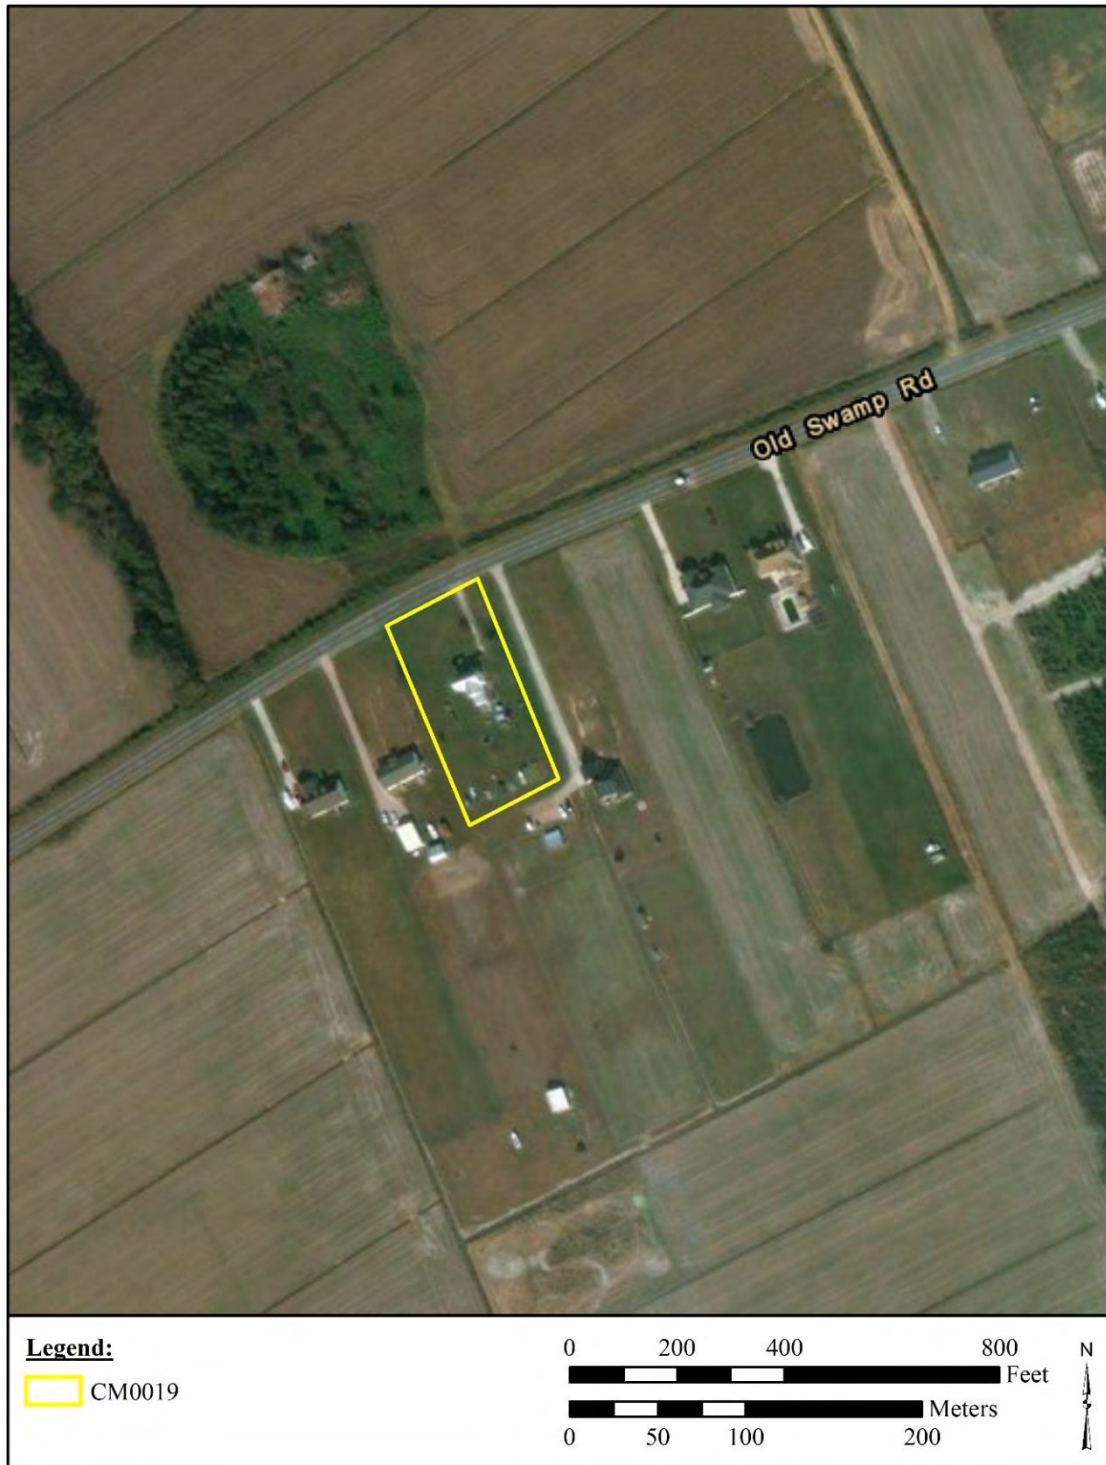
Figure 32: Location and Parcel Boundaries of the Pritchard House (CM0150).¹⁷²

The Pritchard House at 581 Old Swamp Road (SR 1224) is located in a moderately populated area about 4.2 miles northeast of the unincorporated community of South Mills, Camden County, North Carolina (Figure 32 and Figure 33, pp. 87–88). The resource was believed to be newly recorded as a part of this effort; however, the Eastern Office of the NC-HPO notified Dovetail that it was identified during a county-wide survey conducted in 2015.¹⁷¹ It was not given a resource name at that time; therefore, its name is derived from archival research that suggests the house was most likely constructed by D.T. Pritchard and primarily owned by members of the Pritchard family. The property comprises a rectangular lot measuring approximately 1.25 acres covered in a grass lawn lined by Old Swamp Road to the north, residential properties to the east and west, and a small horse farm to the south. The property is speckled with immature trees and the façade (northeast elevation) is lined by small plantings. Additional resources associated with the primary resource includes four sheds and a chicken coop. The property is accessed by an unpaved driveway that extends from the road towards the east side of the dwelling. Access to the interior of the house was not obtained during this survey.

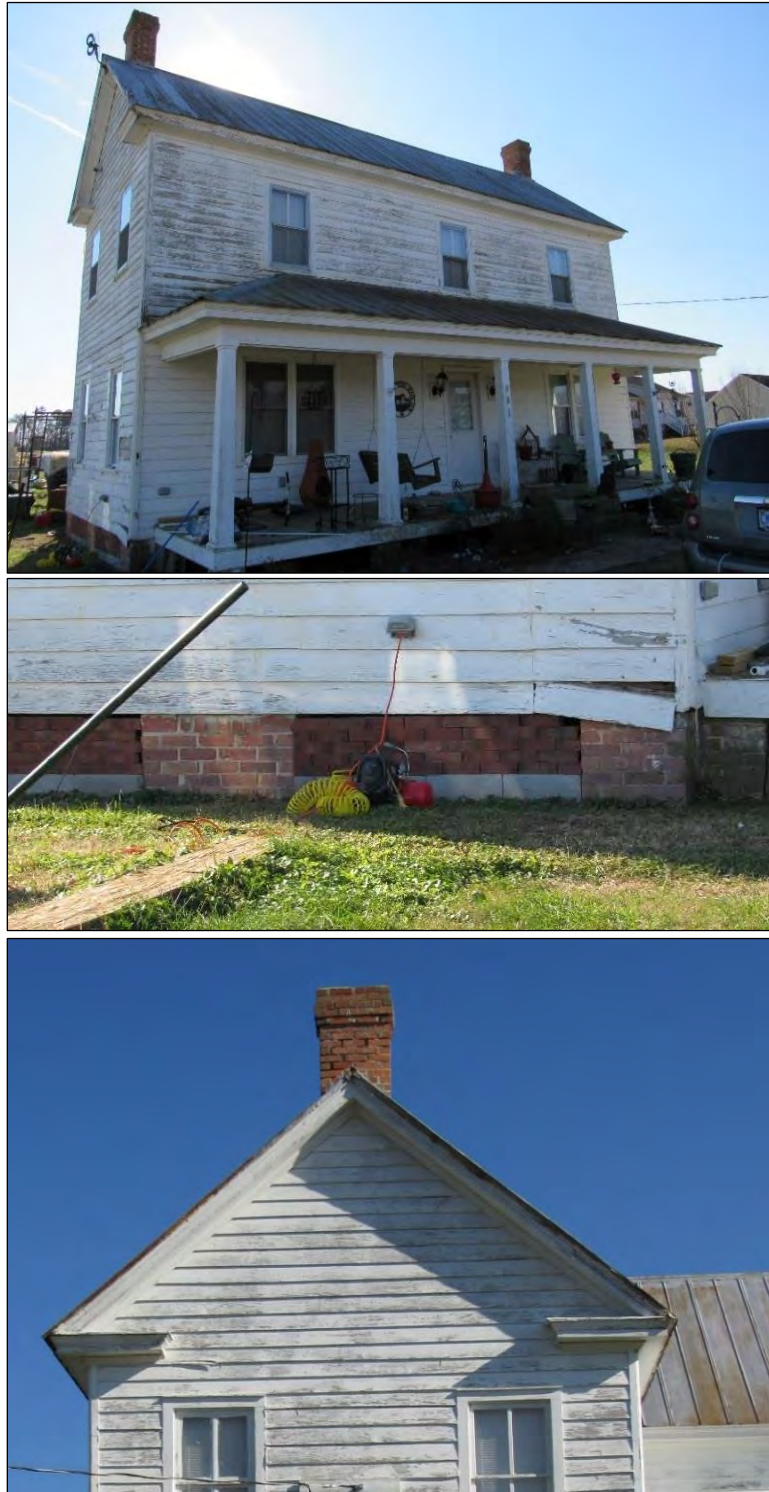
Photo 54: Northwest Elevation of the Pritchard House, Facing Southwest (Top); Detail of Foundation of Pritchard House, Northeast Elevation of Pritchard House (Middle); Detail of Gabled Returns and Chimney Flue, Southwest Elevation of Pritchard House (Bottom).

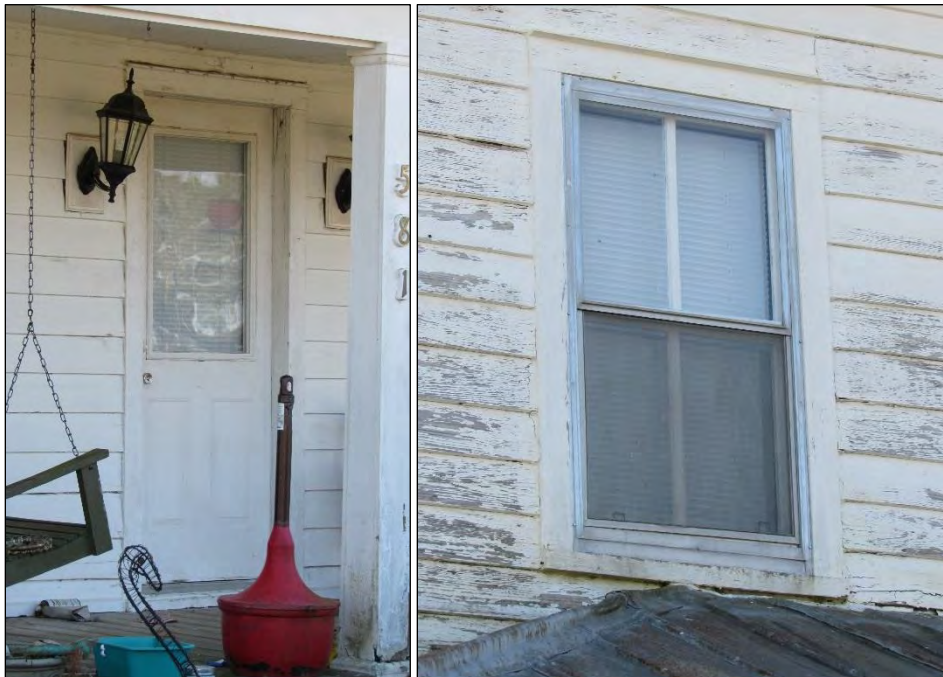
Photo 55: Detail of Replacement Door in Primary Entrance of Pritchard House (Left); Detail of Original Window in Northwest Elevation (Right).

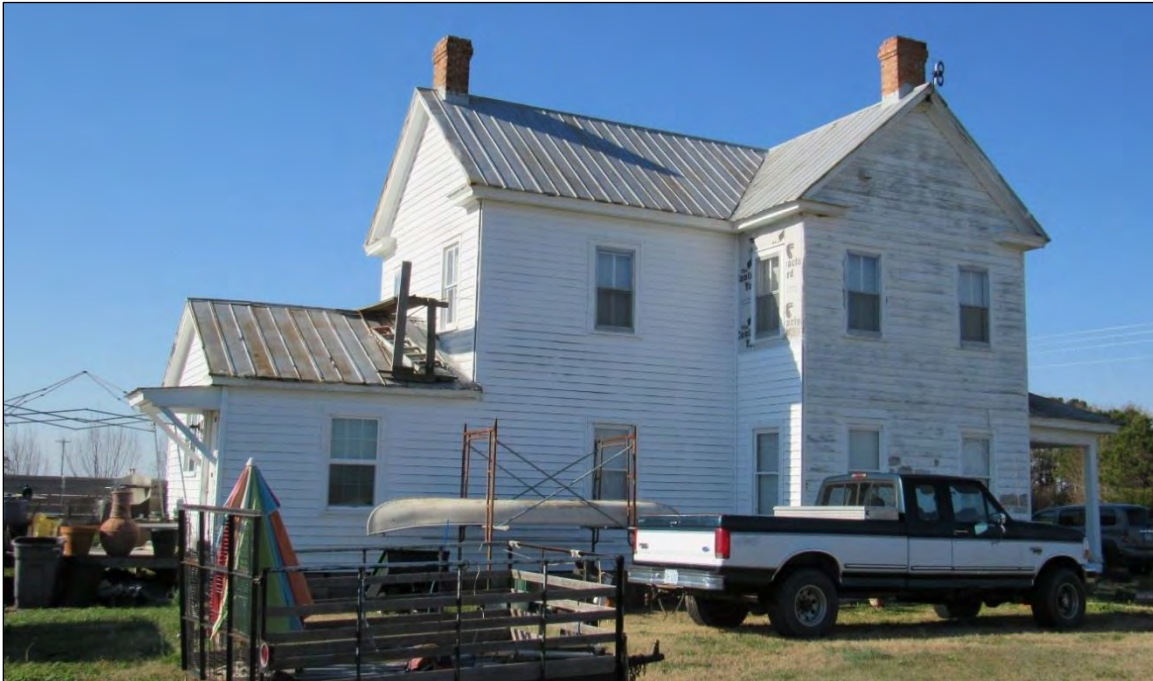
Photo 56: Northeast Elevation of the Pritchard House, Looking West.

A circa-1930, one-story, gabled addition set on a brick pier foundation with concrete-block infill extends from the southeast elevation of the rear ell (Photo 56, p. 91). The frame addition is primarily clad in new vinyl siding that is still in the process of being applied and the roof, which features small partial returns in the southeast elevation, is clad in v-crimp metal, similar to the core of the building. Windows have been replaced by one-over-one, vinyl, double-hung sashes with faux muntins and an entrance in the east half of the southeast is filled with a single-leaf, multi-light, metal door and covered by a shed awning supported by wood brackets. A circa-2000 wood deck, which appears to be a more recent addition, partially lined with a squared wood rail extends from the southeast elevation from the one-story addition.

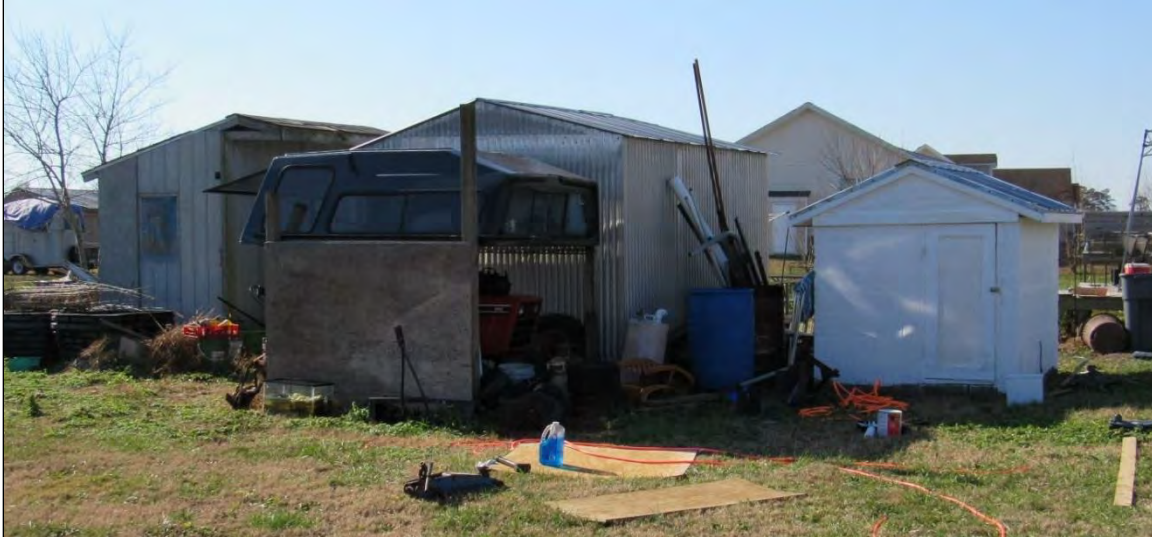
There are several secondary resources associated with the dwelling, most of which are situated in a cluster immediately southeast while two secondary resources are located approximately 115 feet south. A circa-1990 one-story, concrete-block shed sits within the cluster of outbuildings nearest to the primary resource (Photo 57, p. 92). It is covered by a front-gabled roof sheathed in v-crimp metal and a single-leaf, plywood door is set in the east elevation. Immediately south of the concrete-block shed is a circa-1980, frame storage shed clad in corrugated metal and covered by a front-gabled roof sheathed in v-crimp metal (Photo 57, p. 92). An entrance was not visible during the time of survey. A circa-1990, pre-fabricated, frame storage shed is directly south of the frame and concrete-block storage sheds (Photo 57, p. 92). The building is clad in T1-11 siding and covered by a shed roof with a pent roof along the north elevation; the entire roof is sheathed in asphalt shingles. A single-leaf, plywood door is set in the north elevation and a window opening is visible in the east.

Photo 57: Cluster of Outbuildings Associated with the Pritchard House, Looking West. From left to right: circa-1990 frame shed, circa-1980 storage shed, and circa-1990 concrete-block shed.

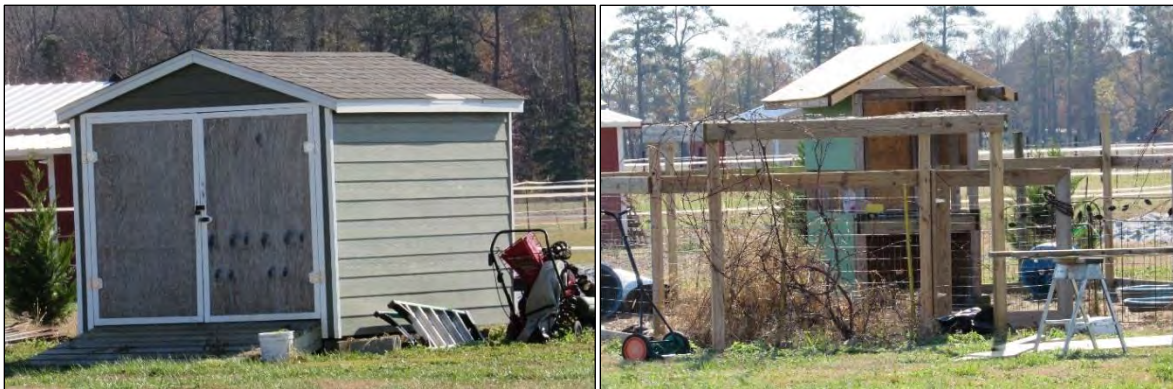
One of the outbuildings situated outside of the cluster of secondary resources is a circa-2000, prefabricated, gable-roofed shed. It is clad in Hardi-plank and the roof is sheathed in asphalt shingles (Photo 58, p. 92). A double-leaf, plywood door is set in the north elevation and is accessed by a wood ramp. The other outbuilding set away from the cluster of secondary

resource is a circa-2000, frame chicken coop (Photo 58, p. 92). It is partially clad in plywood siding and covered by a front-gabled roof partially sheathed in asphalt shingles. Surrounding the coop is chicken wire-and-wood post fence with a gate of the same materials to the north.

Photo 58: Circa-2000 Pre-Fabricated Shed, North Oblique (Left); Circa-2000 Chicken Coop, Looking South (Right).

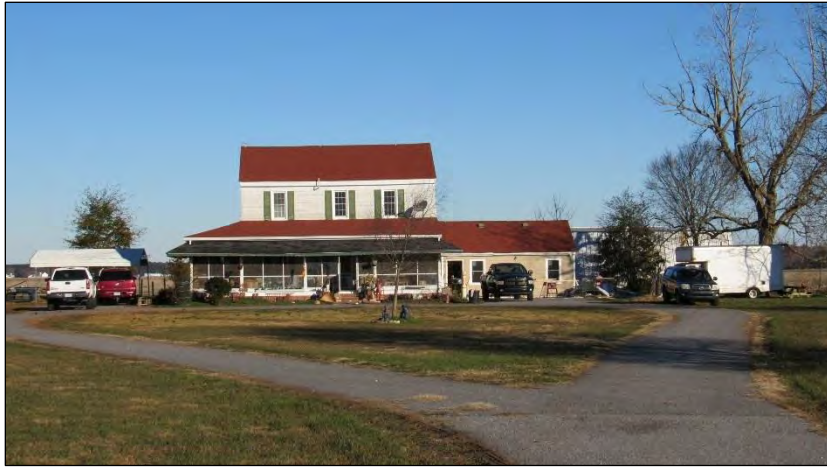
Photo 59: South Elevation of the Rose S. and Eddie C. Bell House (C0087).

The Rose S. and Eddie C. Bell House (CM0087) is located at 124 Whitehurst Lane in the Belcross vicinity of Camden County, approximately 11 miles south of the Pritchard House. The heavily modified, two-story, three-bay, frame, single-family I-house, was constructed between 1829 and 1831 as a part of a farmstead (Photo 59, p. 99). The dwelling, surveyed and determined not eligible for the NRHP by NC-HPO staff in 2013, features many replacement materials such as siding and fenestration as well as overwhelming additions including the screened-in porch that spans the entire façade and wraps around to a side elevation.

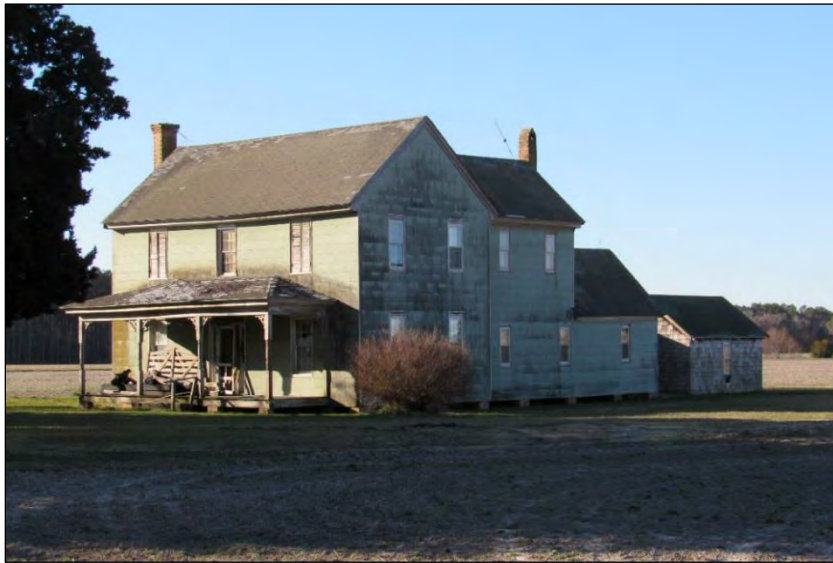
Photo 60: North Oblique of the Roberts House (CK0271).

Roberts House (CK0271), located approximately 13 miles southeast from the resource at 164 S. Indiantown Highway in Shawboro of Currituck County, is a circa-1860, vernacular, two-story, three-bay, frame, I-house (Photo 60, p. 99). The plain building is very similar in massing and plan as the Pritchard House; however, unlike the Pritchard House, the Roberts House features replacement asbestos siding, remains on a pier foundation, and has a partial-width, hipped roof centering on the façade. A two-story ell as well as a one-story, rear addition are

elements of the Roberts House also shared with the Pritchard House. Unlike the current resource, the Roberts House features an exterior-end chimney flue in the core of the building as well as the rear ell. Although the dwelling itself appears neglected and in poor condition in comparison to the Pritchard House, it does retain its primarily agricultural setting. The resource was most recently surveyed around 2006; however, it has not received a formal eligibility determination from NC-HPO staff.

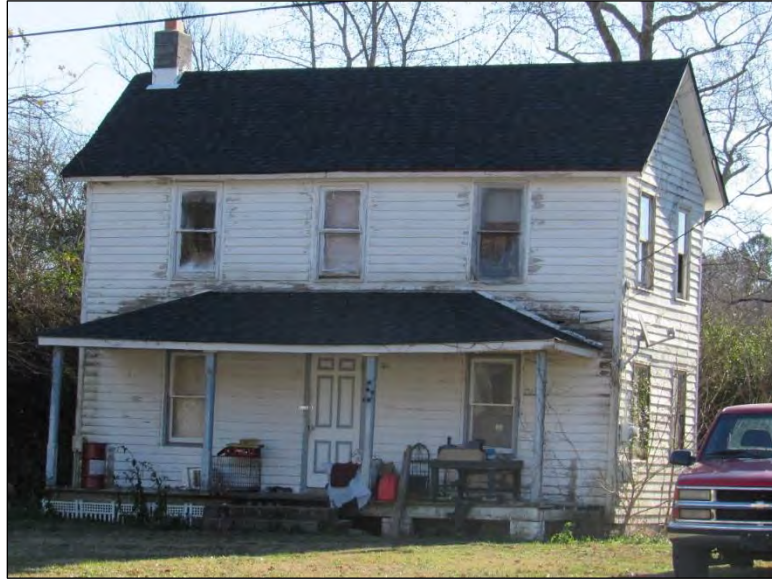
Photo 61: South Elevation of the Boswood House (CK0188).

The Boswood House (CK0188), located about 15.5 miles southeast off of Maple Road in Currituck County, is a two-story, three-bay, frame I-house constructed between 1860 and 1880 with little ornamentation (Photo 61). Although a bit older than the Pritchard House, there are many similarities including the brick pier foundation with infill; weatherboard siding; the one-story, full-width, hipped porch on the façade; and the side-gabled roof. Some differences

include a recently constructed interior-end, concrete-block chimney, replacement fenestration, and lack of rear ell. The resource, which has had no formal eligibility determination, was last surveyed in 2006.²⁰⁷

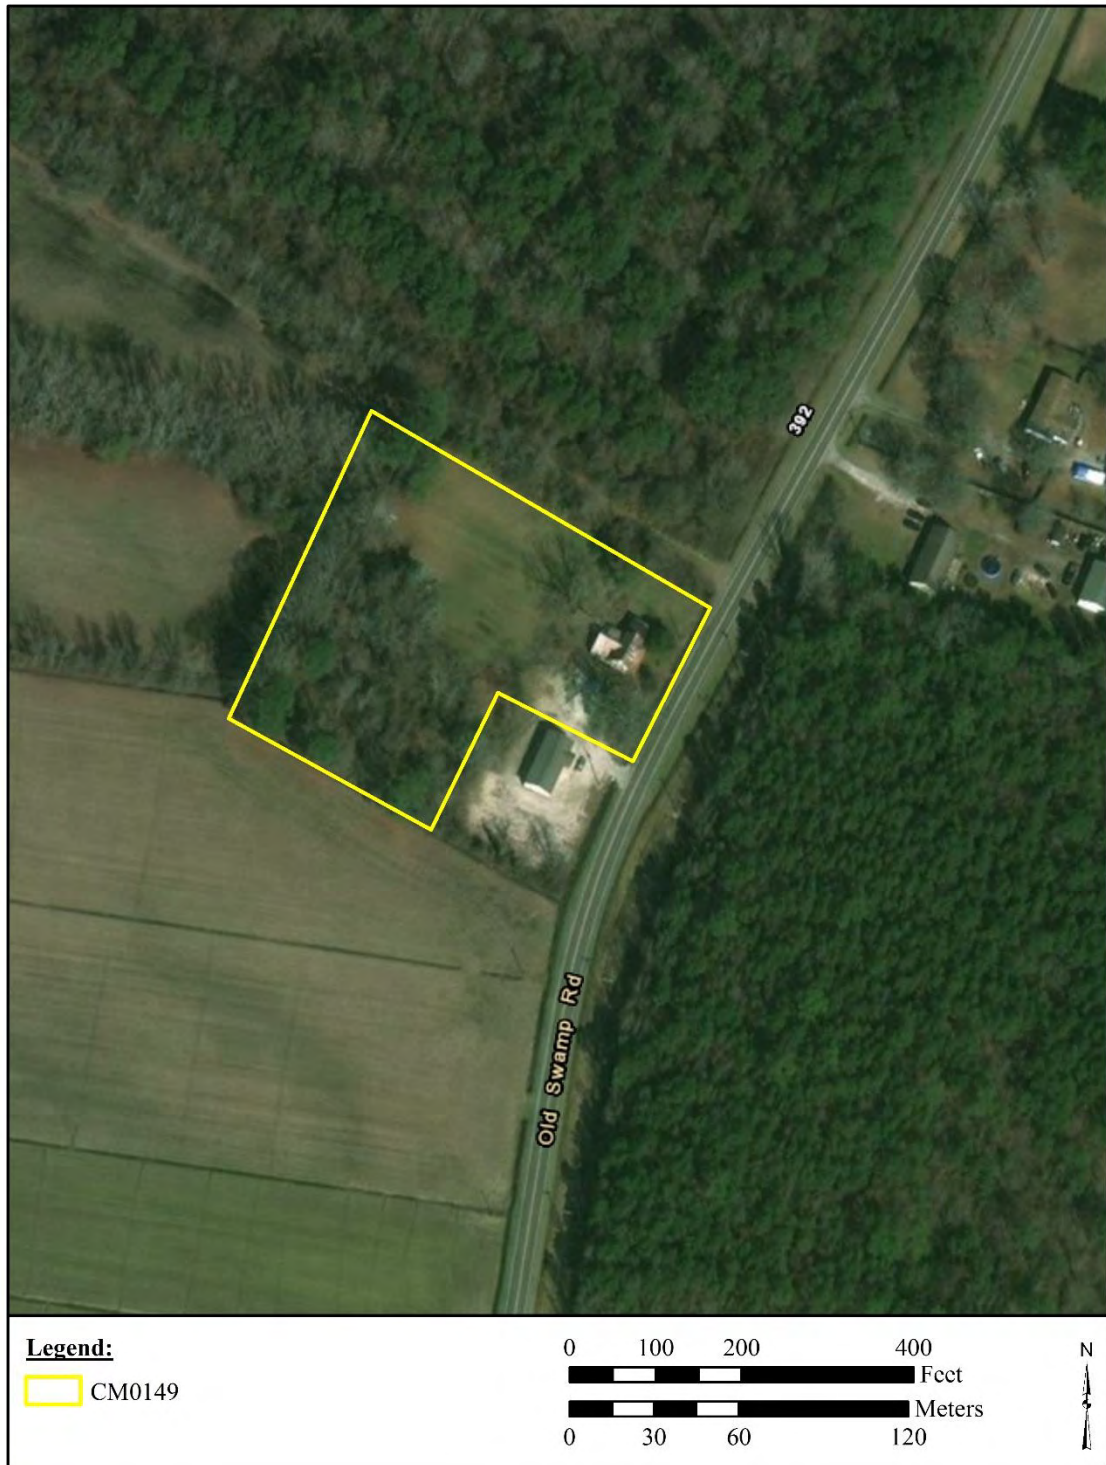
Figure 38: Location and Parcel Boundaries of the Griffin House (CM0419).²¹²

The Griffin House at 368 Old Swamp Road (SR 1224) is located in a moderately populated area about 2.5 miles northeast of the unincorporated community of South Mills, Camden County, North Carolina (Figure 38 and Figure 39, pp. 103–104). The resource was believed to be newly recorded as a part of this effort; however, the Eastern Office of the NC-HPO notified Dovetail that it was identified during a county-wide survey conducted in 2015.²¹⁰ Because it was not given a property name at the time, Dovetail derived its name from archival research that suggests the house was primarily occupied by members of the Griffin family. The property comprises an L-shaped lot measuring approximately 2.02 acres covered in a grass lawn lined with matured deciduous and coniferous trees on all sides save for the east boundary, which is lined with a ditch and Old Swamp Road. A large concentration of trees is situated in the western corner of the parcel and a smaller concentration is directly northeast of the primary resource, a single-family dwelling. The lot is bounded by agricultural fields to the west and south as well as an additional residential property to the south and a wood lot to the north. Additional resources associated with the dwelling include ruins of a former outbuilding and a family cemetery which is partially lined with metal picket fencing. The property is accessed by a set of two wood, half-round posts that traverse the ditch, providing a bridge leading from the road towards the primary entrance of the dwelling. Access to the interior of the house, was not obtained during this survey; however, some interior details were discernable from the exterior of the building.

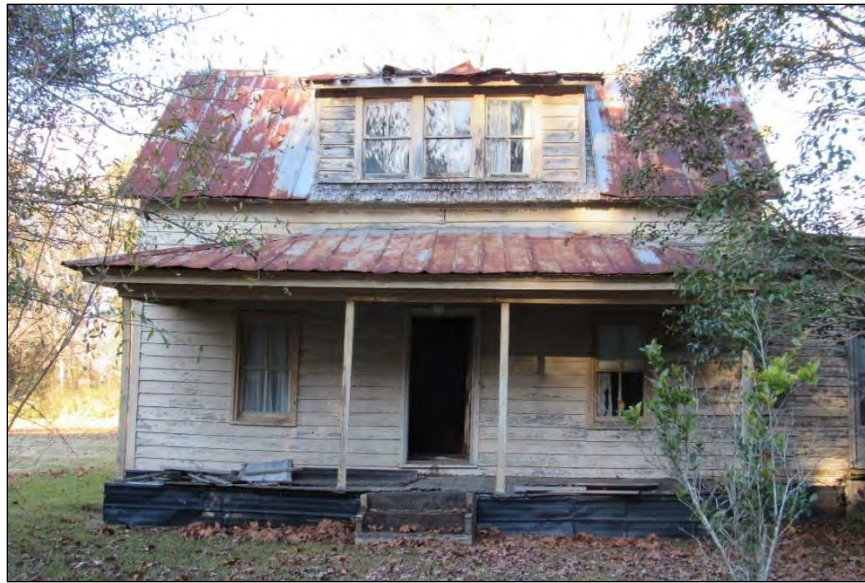
Photo 62: East Elevation of the Griffin House.

The primary resource is a one-and-a-half-story, three-bay, single-family dwelling constructed around 1920 in a vernacular bungalow form with several Craftsman-style attributes (Photo 62, p. 105). The building is set on a brick pier foundation covered by pressed aluminum and the frame structural system is clad in lapped weatherboard siding with cornerboards. The dwelling is covered by a moderately pitched, side-gabled roof with open eaves on non-gabled ends containing wood rafter tails along the east and west elevations, commonly seen in Craftsman-style dwellings.²¹¹

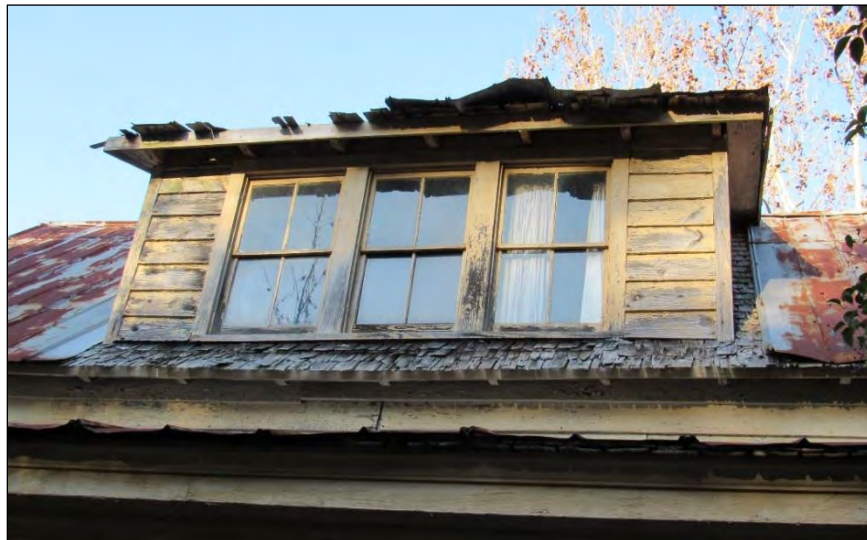
Photo 63: Detail of Dormer in the East Elevation of the Griffin House.

The roof is sheathed in v-crimped metal with original wood-shake shingles visible in the east elevation below the central shed dormer (Photo 63). The dormer contains a ribbon of two-over-two, wood-framed, double-hung sash windows with vertical muntins (Photo 63). The core of the building does not appear to contain a chimney. The dormer, with a wide eave lined with a fascia board centered in the façade (east elevation), an element typical to side-gabled Craftsman bungalows; it is clad in the same materials as the core of the building.²¹³

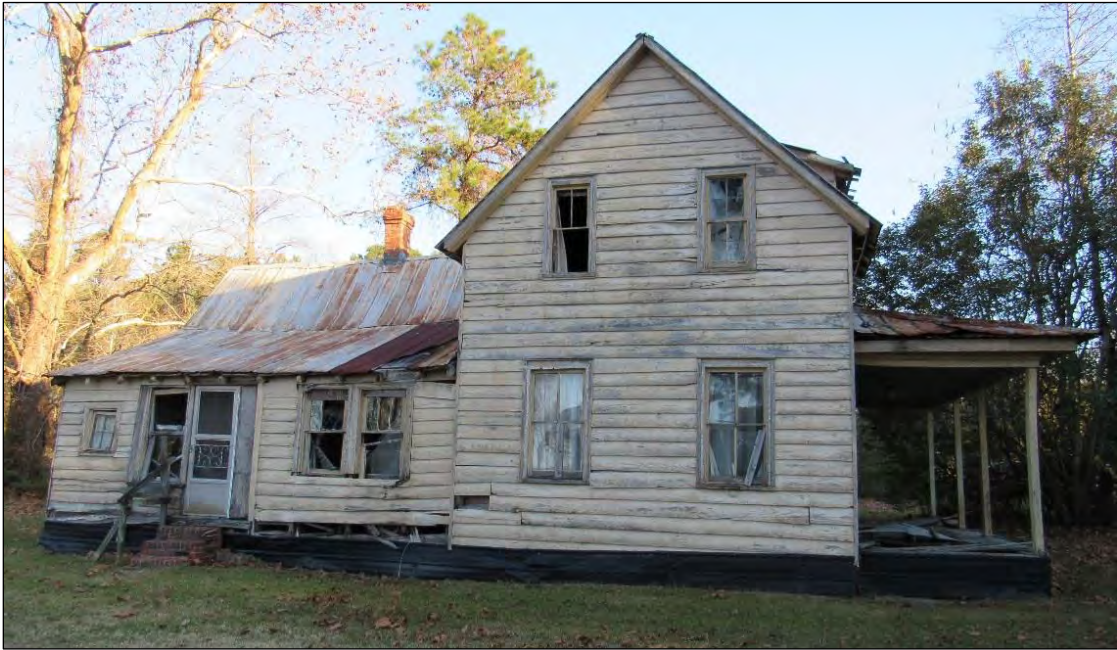
Photo 64: South Elevation of the Griffin House.

This resource features multiple additions, three of which are believed to be constructed shortly after the core of the building and the other was likely constructed around the mid-twentieth century. The first is a one-story, gabled addition that extends from the center of the west (rear) elevation (Photo 64, p. 107). An interior-ridge, brick chimney with a corbeled cap is centered in the addition. A one-story, shed-roofed addition spans the south elevation of the gabled addition while a partial-width shed-roofed addition is set along the north elevation (Photo 64, p. 107). These shed-roofed additions contain exposed rafter tails in their open eave. All three additions feature the same building materials and construction methods as the core. Fenestration includes four-over-four and three-over-one, wood-frame, double-hung sash windows; a four-light, wood-frame, casement window; and open window bays with portions of windows left therein. A secondary entrance, filled with a single-leaf wood door and metal storm door, is set in the south elevation in the southern shed addition and is accessed by a set of brick steps with a wood rail.

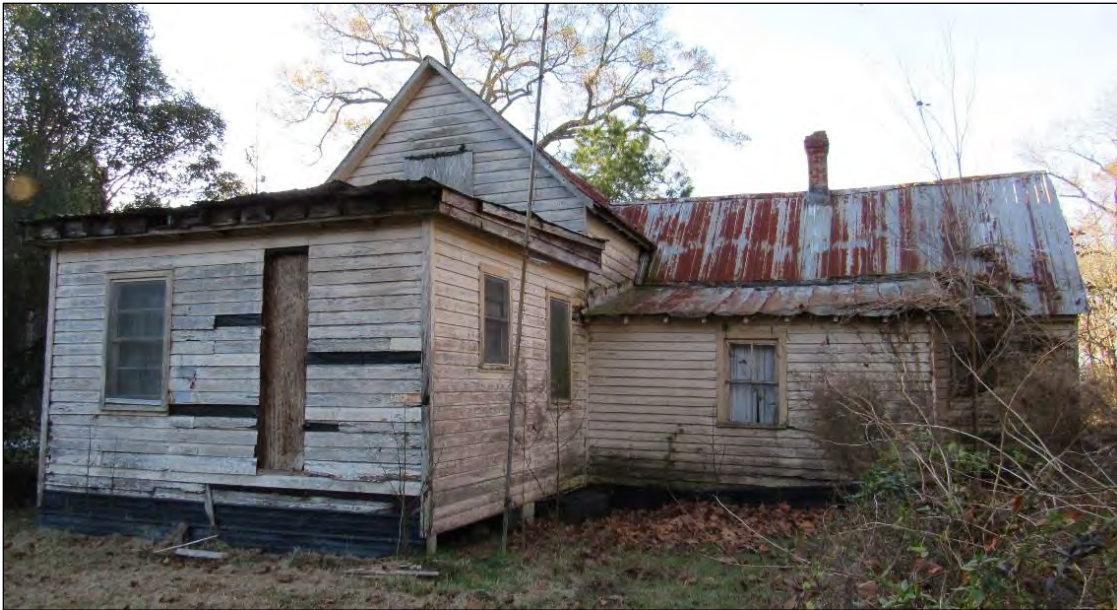
Photo 65: Northwest Oblique of Griffin House.

A mid-twentieth-century, one-story, shed addition extends from the north elevation of the building's core (Photo 65, p. 107). It is set on concrete-block piers and the frame structural system is clad in a combination of clapboard and simple-drop wood siding with wood cornerboards, a small section of which was missing in the north elevation. The low-pitched, shed roof with open eaves is sheathed in v-crimp metal. A secondary entrance, filled with a single-leaf, paneled, wood door and metal storm door, is set in the east elevation and accessed by a set of steps composed of concrete block. Other fenestration includes two-over-two, wood-frame, double-hung sash windows with horizontal muntins. A fairly recent, concrete-block box was constructed in the northwest corner of the gabled addition. Its purpose is not entirely clear; however, it may have been used for storage.

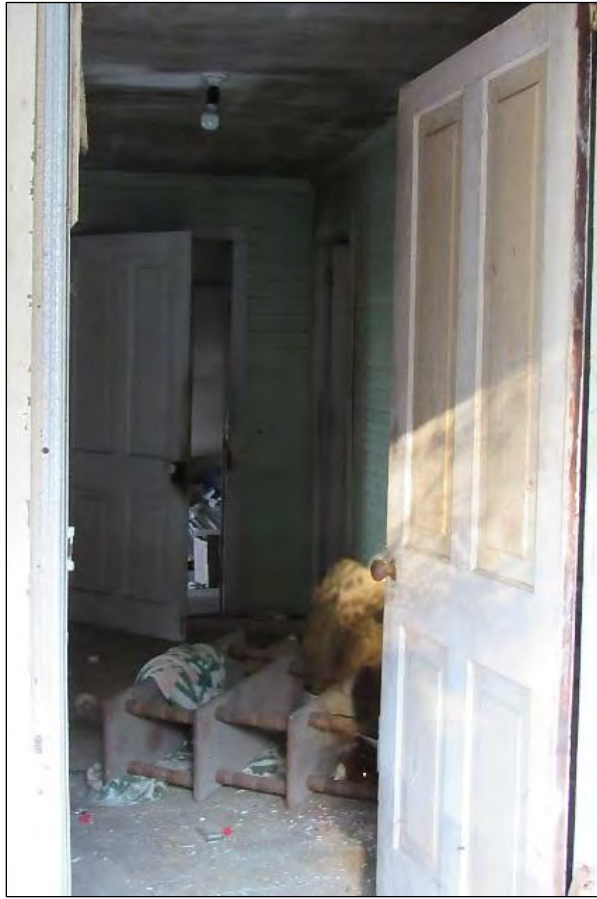
Photo 66: Primary Entrance on the East Elevation of the Griffin House.

The interior of the building was not accessible; however, the front door was open during the time of survey and some details of the interior were discernable (Photo 66, p. 108). The primary entrance opens to a central hall that extends west with peeling linoleum flooring and beadboard covering the walls. The hall ends at a single-leaf, four-paneled, wood door that opens into a rear (west) room. A similar door is situated in the east half of the south wall of the hall while another is in the west half of the north wall, each of which lead into separate rooms. Since only few details were gathered about the interior of the dwelling during this effort, a floor plan was not completed.

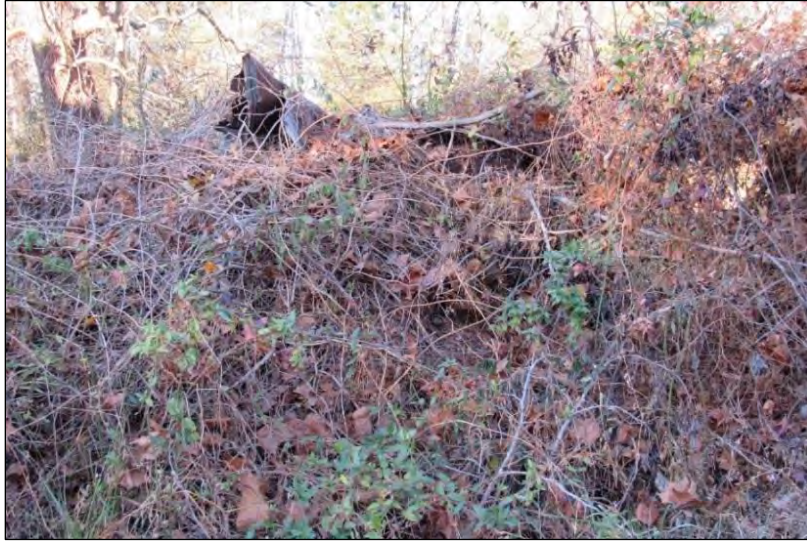
Photo 67: Outbuilding Ruins, Looking West.

Ruins of an undated, frame outbuilding are located approximately 45 feet northwest of the dwelling (Photo 67, p. 109). Situated 210 feet west of the dwelling is a small, unenclosed, family cemetery (Photo 68, p. 109). The cemetery includes 12 interments dating from 1976 to 2017, all of which face east. The interments are mainly marked by flat, rectangular, lawn-level grave markers, at least four of which appear to be full-length, while two others are headstones. The markers are composed of stone or marble. One headstone (Ernest Linwood Griffin, d. 2007) features a squared base with an arched tablet and rusticated sides while the other headstone (Earvin McCoy Evans, d. 2015) is a simple, arched tablet. The interments include members of the Griffin, Sawyer, Saunders, McPherson, Harvey, Evans, and Roach families.

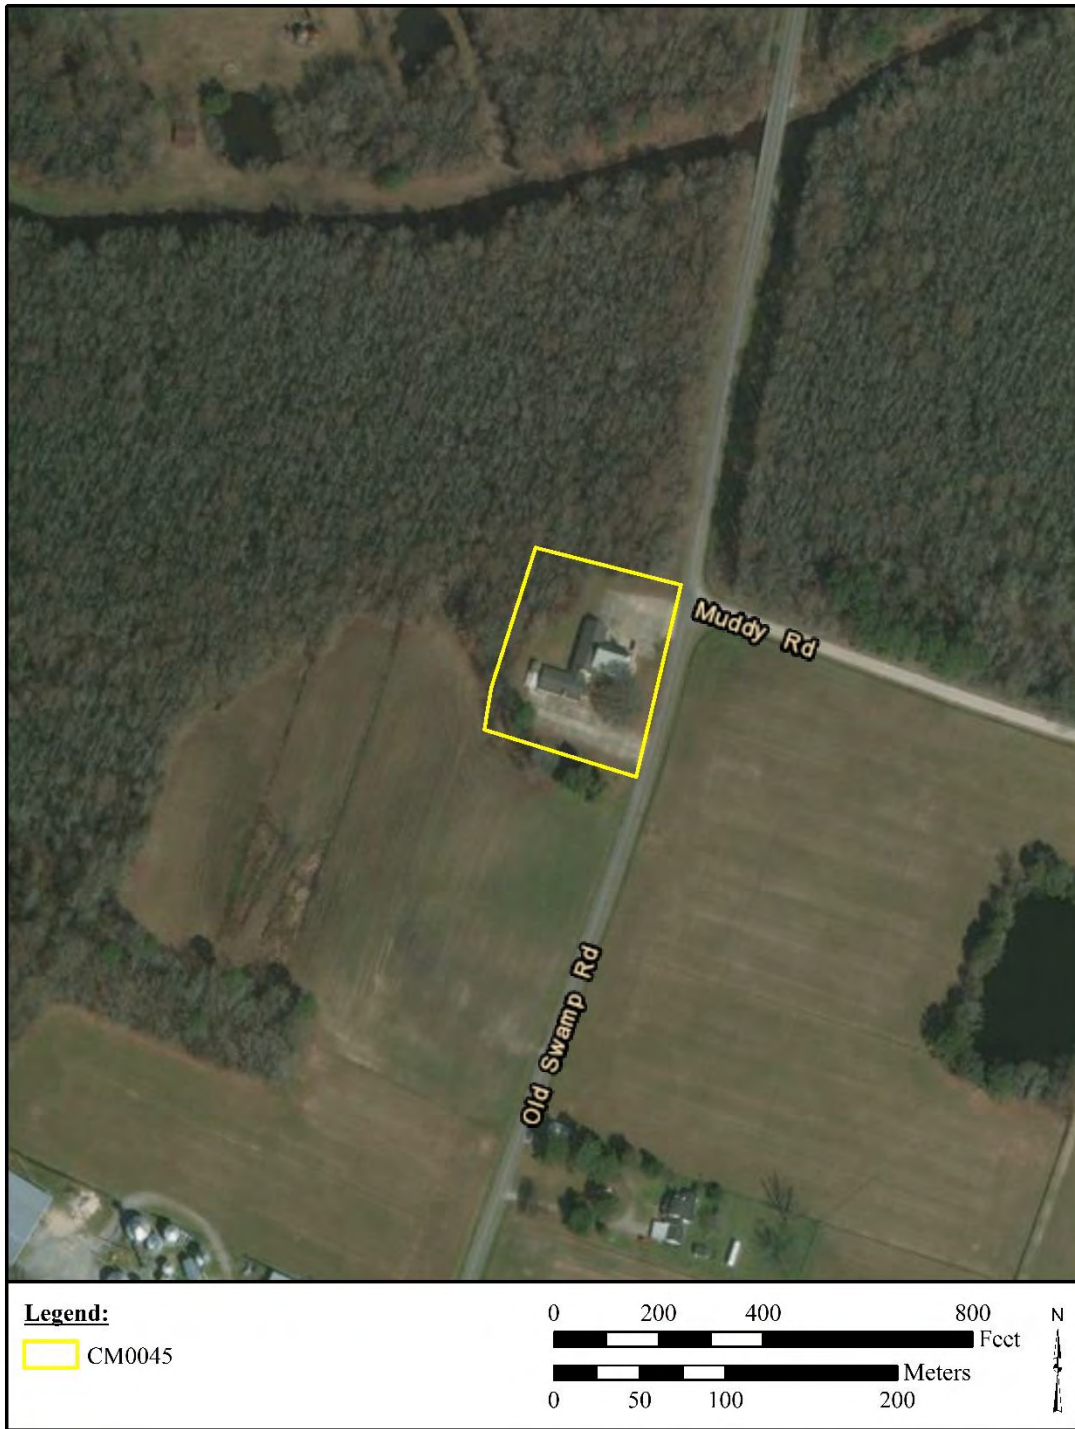
Figure 42: Location and Parcel Boundaries of the McBride United Methodist Church (CM0045).²⁴⁹

McBride United Methodist Church (historically known as McBride's Chapel, McBride Methodist Episcopal Church, and McBride Methodist Church) is located on the west side of Old Swamp Road in a rural area about 1.7 miles east of the unincorporated community of South Mills in Camden County, North Carolina. The resource was previously recorded in the 1970s and was revisited as a part of this effort. Built on a small, rectangular parcel measuring 1.2 acres, the resource is immediately surrounded to the southeast and northwest by a manicured grass lawn and paved parking lots to the southwest and northeast (Figure 42 and Figure 43, pp. 117–118). The resource faces southeast and is accessed directly from the road via the parking lots. The parcel is bordered by densely forested areas to the north and west, a cultivated agricultural field to the south and Old Swamp Road to the east. A metal carport, prefabricated shed, wood playset and a sign are all associated with this resource. Access to the interior of the house, was not obtained during this survey.

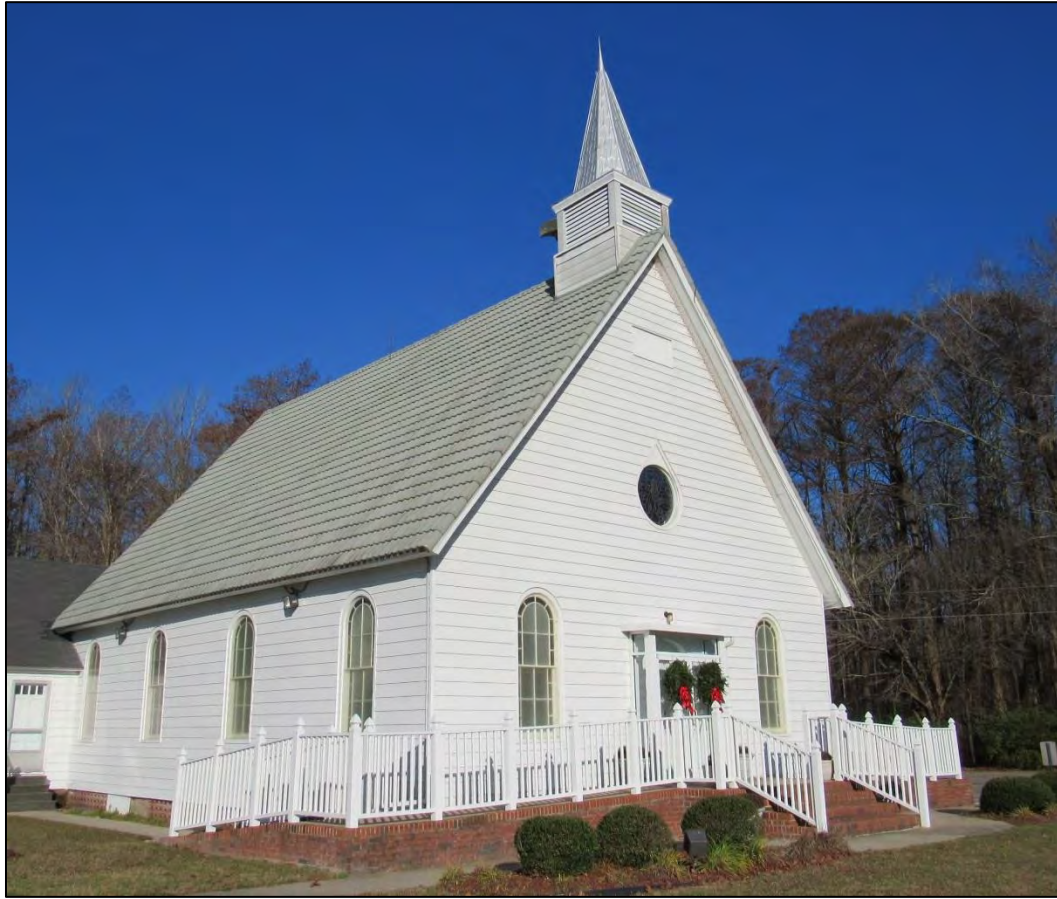
Photo 69: McBride United Methodist Church, South Oblique.

The primary resource is a one-story, three-bay church built in 1889 in the Gothic-Revival style with a linear plan (Photo 69, p. 119). The foundation, composed of brick piers with bricks laid in a lattice pattern as infill, supports the frame structural system that is clad in aluminum siding. The church is covered by a steeply pitched, front-gabled roof sheathed in composite shingles made to mimic slate with wide, overhanging eaves. A square steeple sits at the roof's ridgeline near the southeast elevation. The base of the steeple is clad in vinyl and is topped by a louvered belfry that is covered by a pyramidal roof sheathed in decorative metal shingles.

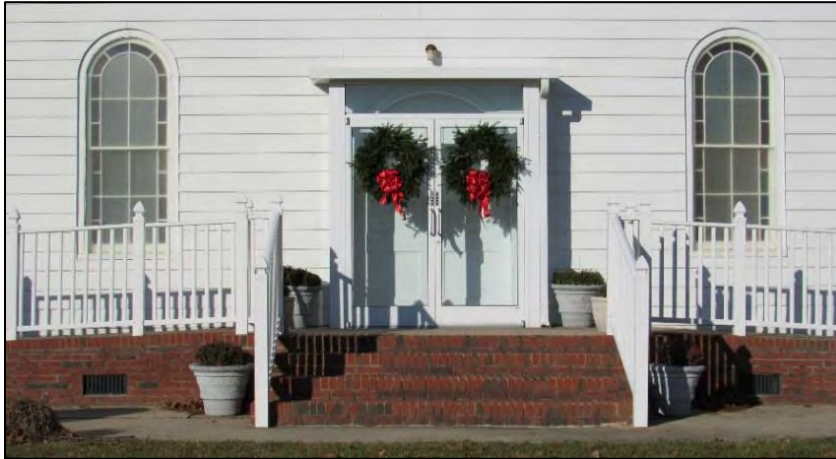
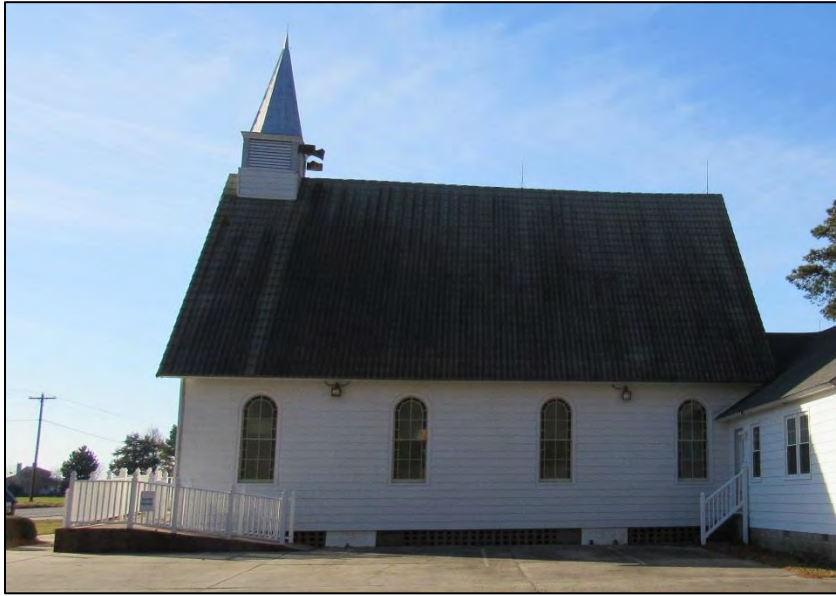
The primary entrance is centered on the southeast elevation and is filled with a double-leaf, three-paneled, rounded, wood door within an unadorned wood surround (Photo 70, p. 120). The door is covered by a shed-roofed entry porch enclosed in glass and supported by square, metal posts with double-leaf, metal-and-glass doors providing access. A set of four brick stairs and a ramp that stretches from the northeast to the southwest elevation, both lined with vinyl railing, lead to a landing in front of the primary entrance. The door is flanked by four-over-four, double-hung sash, rounded, wood-frame windows outlined by decorative stained glass panes. The windows are located within simple vinyl surrounds and are covered by storm windows. Above the door is a decorative, circular, stained-glass window with a “Jesus Praying in the Garden” motif.²⁵⁰ A marble plaque is located within the gable end that reads “McBride M.E. Church. Erected A.D. 1792. Rebuilt 1837. Remodeled & Rebuilt 1882.” The northeast and southwest elevations of the resource mirror each other and both feature four, four-over-four, double-hung sash, rounded, wood-frame windows outlined by decorative stained glass panes. The windows are located within vinyl surrounds and are covered by vinyl storm windows.

Photo 70: McBride United Methodist Church, Primary Entry Detail (Top) and East Elevation (Bottom).

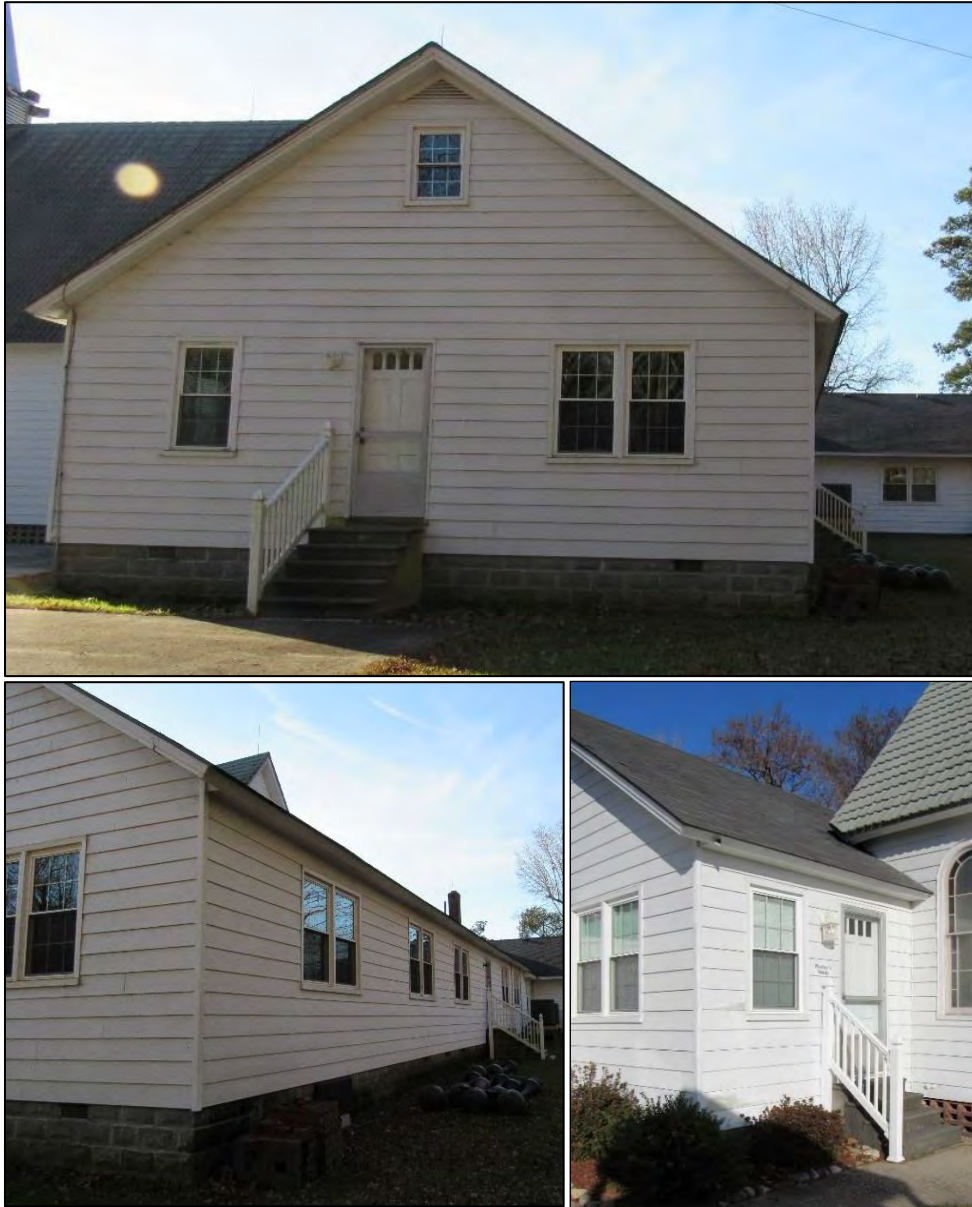
Three additions are associated with this resource. The first is a one-and-a-half-story, three-bay, circa-1950, Sunday School addition that extends from the northwest elevation of the main block, creating a T shape (Photo 71, p. 121). The continuous, rusticated, concrete-block foundation supports the structural system that is clad in aluminum siding. It is covered by a gabled roof sheathed in asphalt shingles. This addition features three entrances, one centered on the northeast elevation, another centered on the northwest elevation, and the last located to the south of the southeast elevation. All are filled with matching single-leaf, four-paneled, wood doors with four lights at the top and covered by a metal-frame storm door. Other fenestration include single and paired, one-over-one, double-hung sash, vinyl windows with false muntins.

Photo 71: McBride United Methodist Church, Circa-1950 Sunday School Addition, Northeast Elevation (Top), Southeast Oblique (Bottom Left), and North Oblique (Bottom Right).

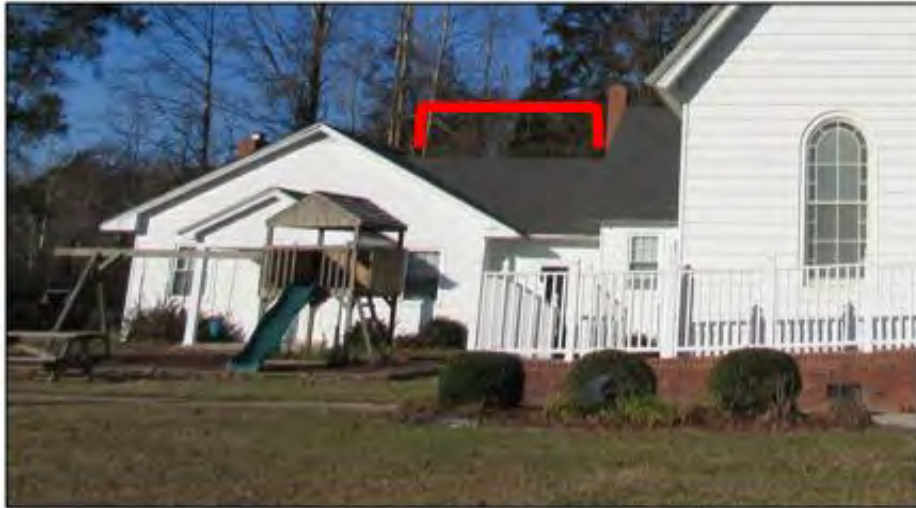
Photo 72: McBride United Methodist Church, Circa-1990 Addition, Southeast Addition.

A circa-1990, side-gabled addition extends from the southwest elevation of the previous addition and acts as a connector between the Sunday School addition and the third addition (Photo 72, p. 122). The continuous, rusticated, concrete-block foundation supports the structural system that is clad in aluminum siding. It is covered by a side-gabled roof sheathed in asphalt shingles. An interior-slope brick chimney is located on the southeast roof slope. The entrance is located on the southeast elevation and is filled with a single-leaf, vinyl door covered by a metal-frame storm door.

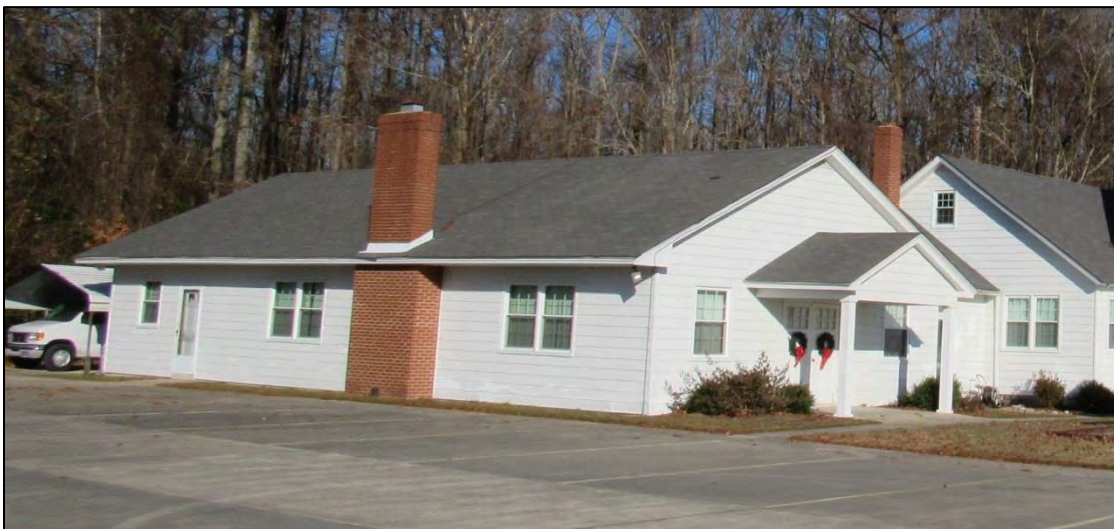
The third addition was also constructed around 1990 and extends from the southwest elevation of the Sunday School addition (Photo 73). The foundation is not visible and supports the structural system that is clad in aluminum siding and covered by a front-gabled roof sheathed in asphalt shingles. An exterior-end brick chimney is located along the southwest elevation. The entrance to this addition is centered on the southeast elevation and is filled with a double-leaf, paneled, wood door topped by six fixed lights. The door is covered by a front-gabled entry porch supported by square Tuscan columns and features aluminum in the gable end. Other fenestration include single and paired, one-over-one, double-hung sash, vinyl windows with false muntins.

Photo 73: McBride United Methodist Church, Circa-1990 Addition, South Oblique.
