SUBJECT: Historic Structures Survey Report, Widening of SR 1223/1224 (Old Swamp Road) and
SR 1218/1227 (South Mills Road), PA 17-05-0040, R-5717, Camden and Currituck Counties,
ER 18-0453

**HISTORIC STRUCTURES SURVEY REPORT
WIDEN SR 1223/ SR 1224 (OLD SWAMP ROAD) AND
SR 1218/ SR 1227 (SOUTH MILLS ROAD),
CAMDEN AND CURRITUCK COUNTIES,
NORTH CAROLINA**

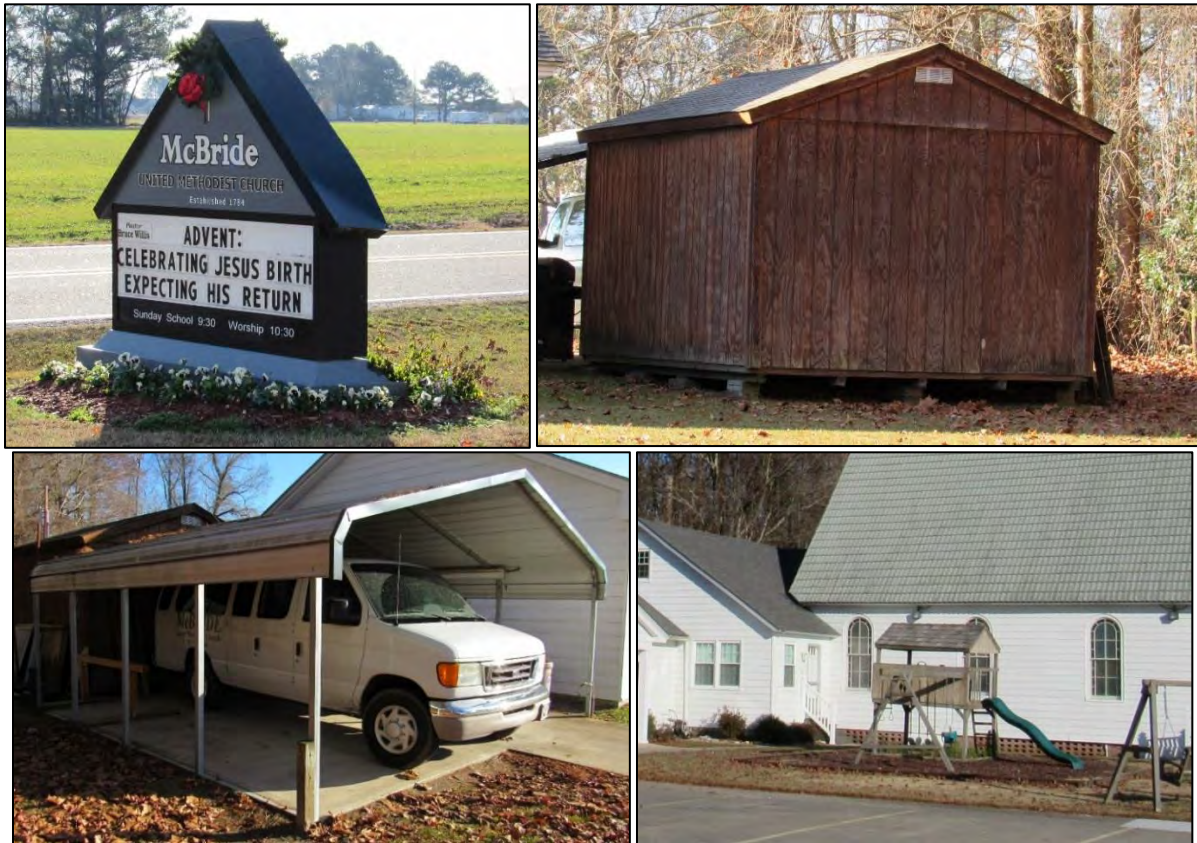
Four secondary resources are associated with this dwelling. They are all relatively modern and were erected within the last 20 years (Photo 74). A circa-2000 sign is located east of the primary resource. Built on a poured-concrete foundation, the metal-framed sign features a backlit plastic board with shallow plastic trays that hold letters printed on plastic sheet. A circa-2005, one-story, open-bay carport is located west of the primary resource. The front-gabled roof is sheathed in pressed metal and supported by metal poles. A circa-2015, one-story shed is located west of the primary resource. It is set on concrete-block piers and clad in T1-11 siding. The resource is covered by a front-gabled roof sheathed in asphalt shingles. A circa-2015 wood play set is located southeast of the primary resource. It features a wood swing set and a vinyl slide.

Photo 74: Outbuildings Associated with the McBride United Methodist Church Sign, Looking East (Top Left); Shed, North Oblique (Top Right); Carport, West Oblique (Bottom Left); and Wood Playset, Looking Northwest (Bottom Right).

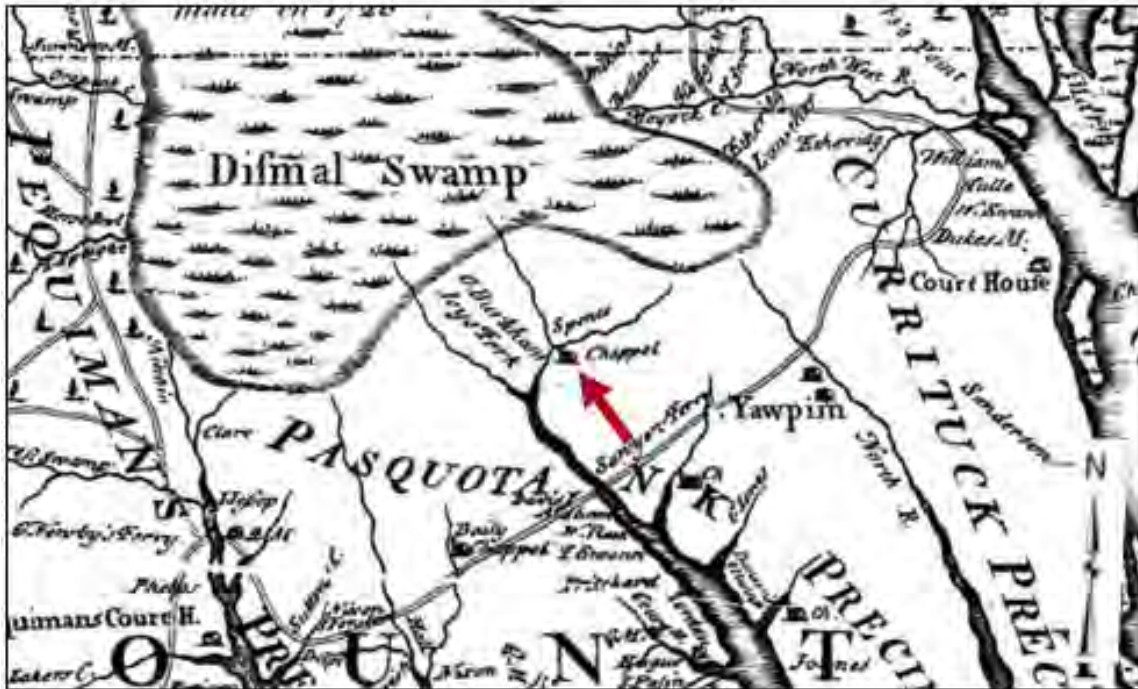
Figure 44: Detail from “A New and Correct Map of the Province of North Carolina” by Edward Moseley in 1733.²⁵⁴ Note “Chappel” in red. Map not to scale.

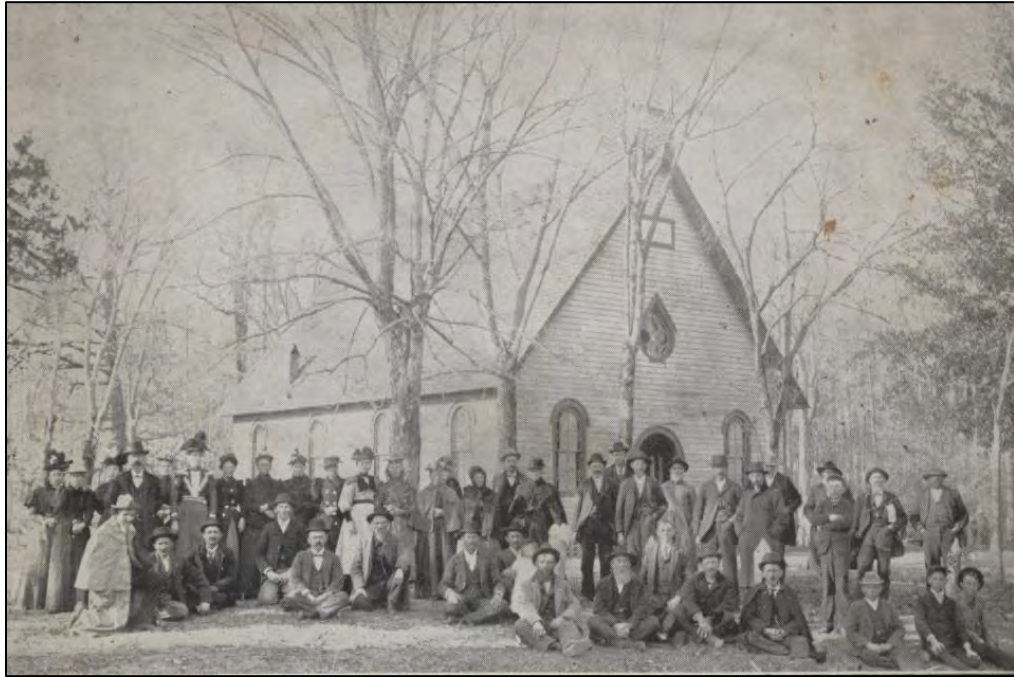
In 1882 a decision was made to finance and construct a new church building, which resulted in the current church on the site. The church minutes for a meeting held about the new church in February 1882 stated that “the building as decided upon is to be 6 feet narrower with same length as the present House, recess added in the rear for pulpit purposes, and a cut off in the front of the present length of 8 ft. for vestibule purposes and suspension roof.”²⁶⁶ The church solicited funds from members as well as non-members throughout South Mills. Many donated including Nelson Chamberlin who devised to the congregation a farm to be held in perpetuity, for the revenue to be used to pay the pastor’s salary.²⁶⁷ A gallery was to be built above the vestibule to increase the church capacity, but also to accommodate the African American congregants who were segregated from the white church members. While the new building was being constructed, church services were held in the schoolhouse.²⁶⁸ The building was completed in late 1882 (Figure 45, p. 127). Of the interior of the new church, a congregant remembered that:

Figure 45: Undated Photo of the McBride United Methodist Church That Appears to Have Been Taken Shortly After Construction of the Current Church Building.²⁷²

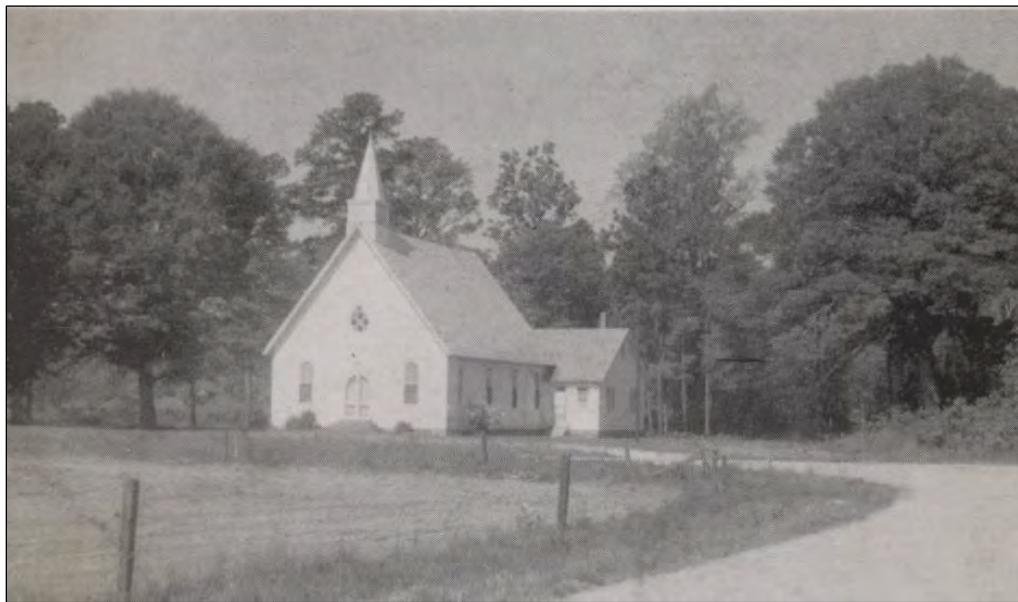
The church remained mostly unchanged until the 1950s when the Sunday School annex addition was built upon the rear of the church to provide updated classrooms (Figure 46, p. 127).²⁷⁰ It was also around this time that it was brought to the attention of the church that the 99-year lease that was signed on behalf of the Methodist Society had expired in 1891. To gain legal possession of the land, church trustees went before the Superior Court in 1956 and were granted a fee-simple deed based on the fact that they had been in open ownership of the property for more than 30 years prior to the request to a clear title as long as “the premises shall be used, kept, and maintained as a place of Divine worship of the Methodist Ministry”.²⁷¹

Figure 46: Circa-1957 Photo of the McBride United Methodist Church. Note the rear addition.²⁷³

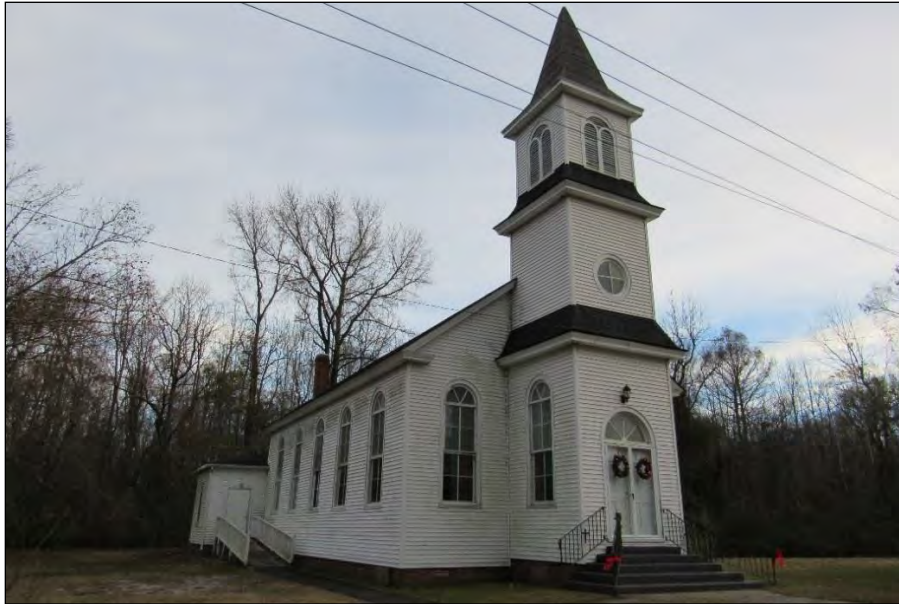
To properly evaluate the resource’s NRHP eligibility, it was compared with similar churches within the area. The New McBride AME Zion Church is a one-story, three-bay, Gothic Revival-style church constructed around 1900 in a linear plan (Photo 75, p. 129). This resource

features a tall bell tower as well as rounded, double-hung, stained-glass windows. The church has experienced minimal alterations which includes a small rear addition and replacement siding and is located in a rural area near South Mills. The church does not appear to still be in continuous use by the congregation, but likely serves as a space for revivals and special services.²⁸⁰ This church has not been surveyed or evaluated for NRHP eligibility by NC-HPO staff.

Photo 75: New McBride Zion AME Church, North Oblique.

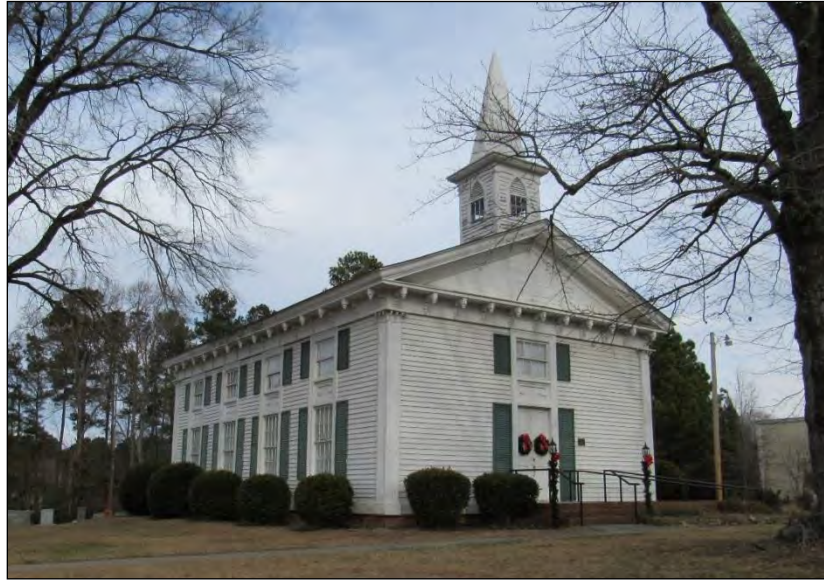
A good and similar example of a nineteenth-century church that has been listed in the NRHP is the Forestville Baptist Church in Wake Forest (WA0182) (Photo 76, p. 130). It is a two-story, one-bay church constructed around 1860 with Greek Revival and Italianate influences in a linear plan. The church is clad in weatherboard siding with pilaster corner boards which is set on a continuous brick foundation and covered by a front-gabled roof with full wood returns and decorative brackets in the eaves. The church also features four-over-four and eight-over-eight, double-hung sash, wood-framed windows flanked by louvered shutters and a louvered belfry topped by a pyramidal steeple. The church is still actively used by a small congregation. Forestville Baptist was listed in the NRHP in 1984 under Criteria A and C stating:

Photo 76: Forestville Baptist Church (WA0182), South Oblique.

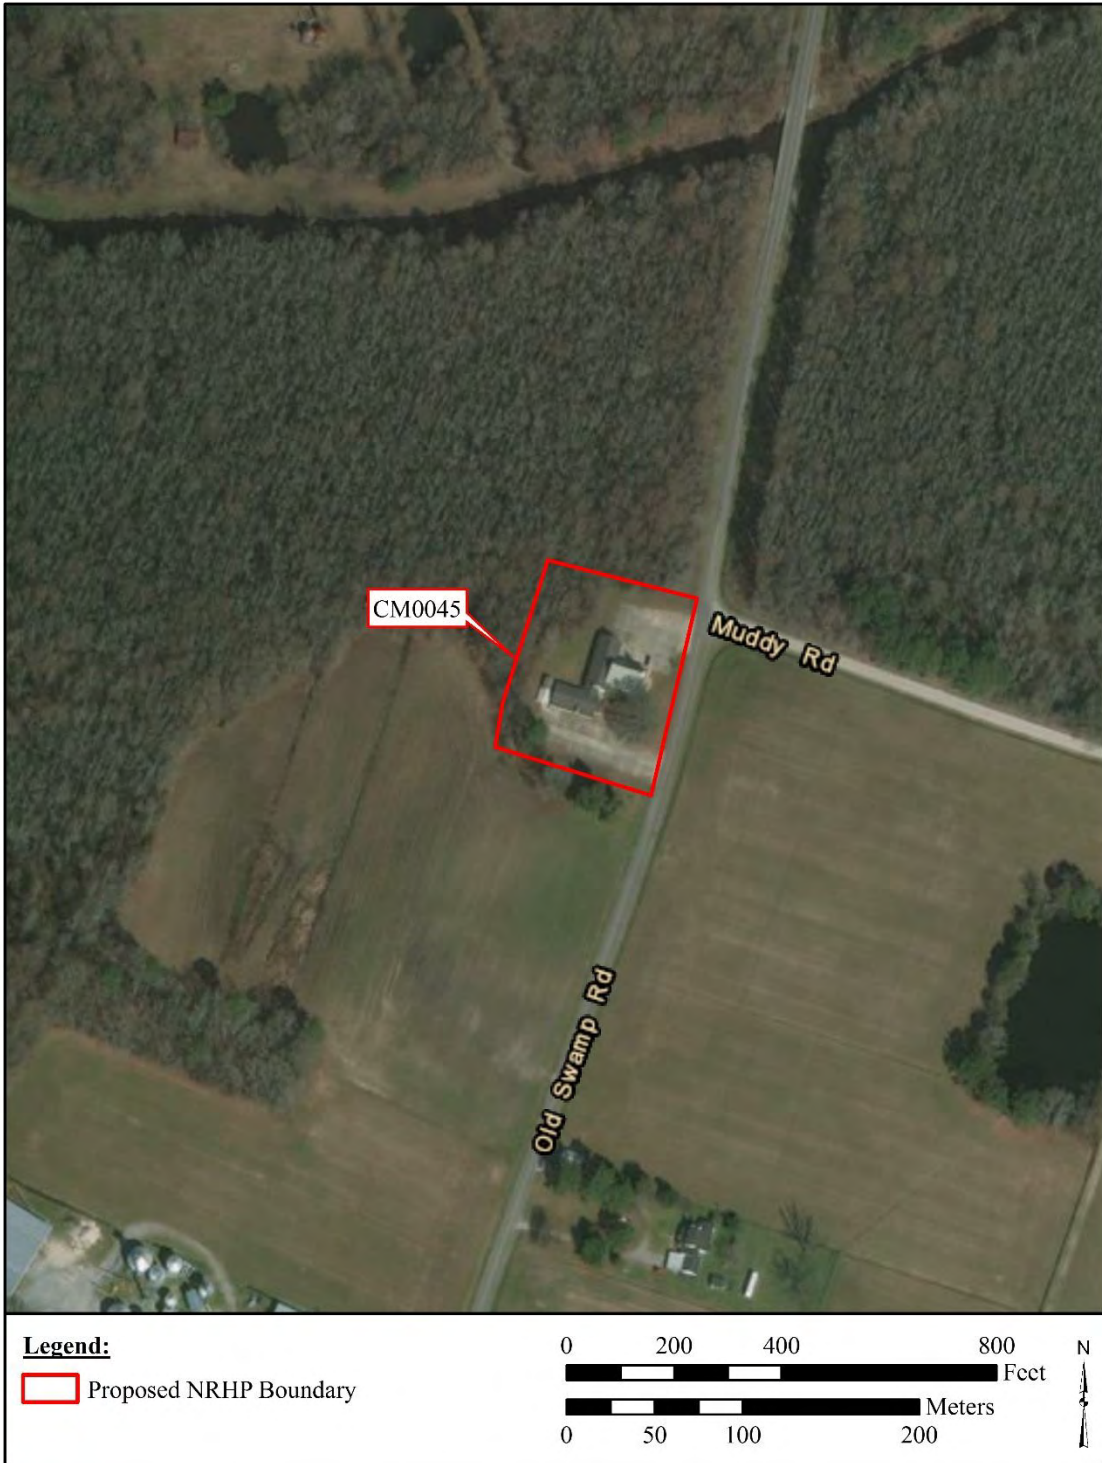
The proposed period of significance for this resource is from 1882 to 1950, the date the resource was built until the date of construction of the larger additions to the building. The proposed NRHP boundaries for McBride Methodist Church, as determined during the current investigations, conform to the existing tax parcel which extends down to the public right-of-way (Figure 47, p. 132).²⁸⁶

Figure 47: Proposed NRHP Eligibility Boundaries of McBride United Methodist Church (CM0045).²⁸⁷

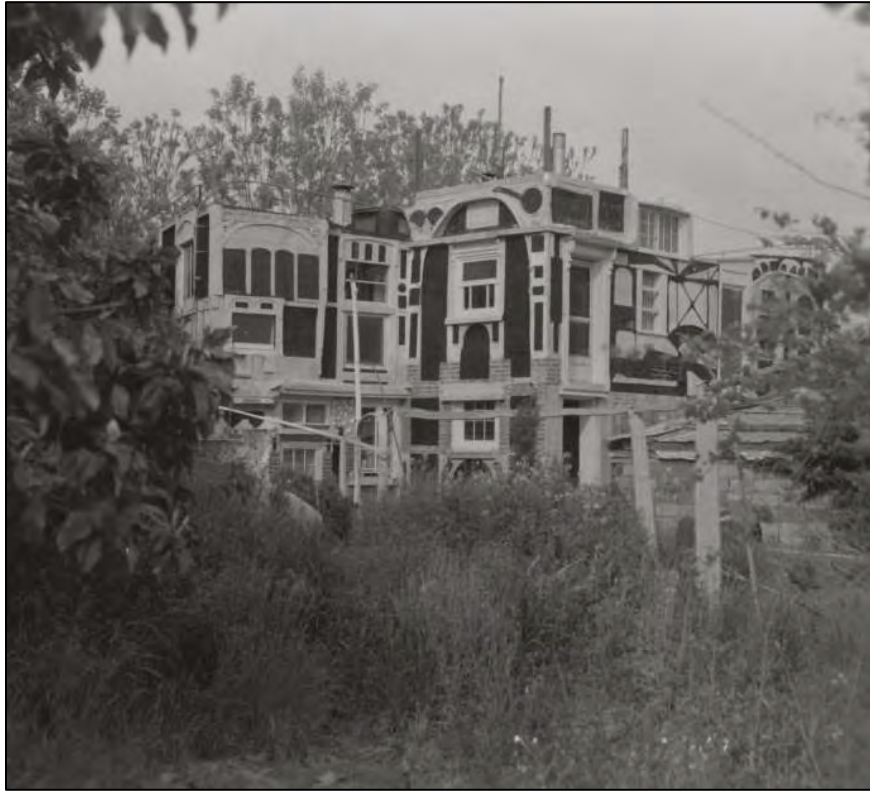
The demolished Butt House was an eclectic two-story building that featured a wide array of window, door, and siding types, all made of recycled materials and was surrounded by a landscaped garden (Figure 49, p. 135). The house was a known folk art site and featured found objects and quotes from literature and history.

Figure 49: Circa-1980 Photograph of the Butt House.²⁹⁰

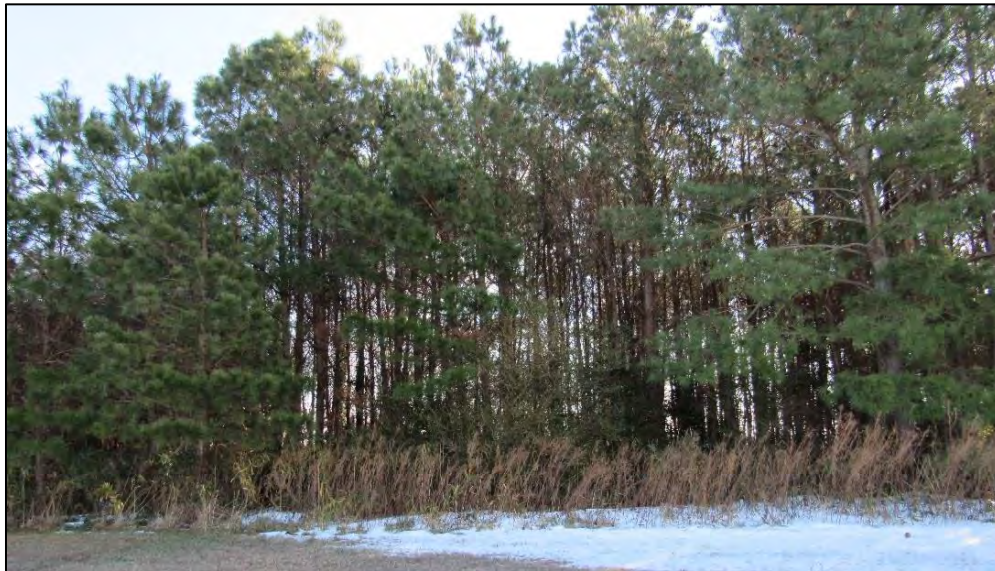
According to a 1975 survey of the resource, the Butt House, also referred to as the Junk House, was built around 1940 of recycled materials and was located on the parcel (Photo 77, p. 135). This building was not used as the dwelling for the Butt family. Secondary sources indicated that there was a “modest house” built circa 1923 where the Butts resided; however, this too is no longer extant.²⁸⁸

Photo 77: View of Butt House Site, Looking Southeast.

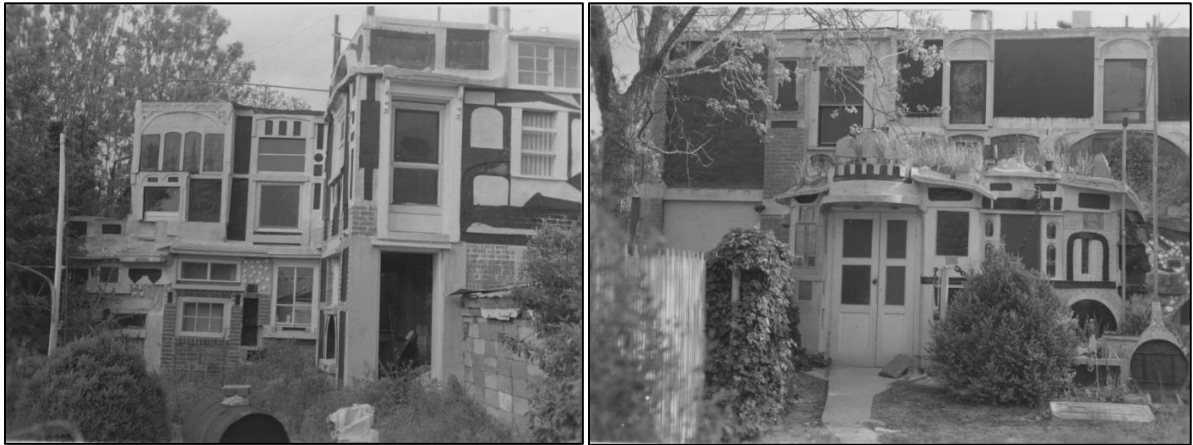
In 1938, C.L. and Rose Albertson sold a 10-acre plot of land, surrounding the Butt parcel to the east and south, to W.T. Stafford.²⁹⁵ W.T. Stafford sold one acre of that parcel to the Butts in 1942 that stretched to the southwest of the first lot and completed the 2-acre parcel that exists today. It was likely around this time that James Butt commenced working on what was previously recorded as a “Junk House,” but what was known locally as his “Dream House.”²⁹⁶ The house, which was a work in progress for his entire life, was constructed of recycled and discarded materials and was surrounded by a landscaped garden (Figure 51 and Figure 52, pp. 137–138). James was influenced by history and his dreams in the design of the house and he would imbed found objects and artifacts into the walls, ceilings, and floors and cover them in glass to preserve them. The house became known as a folk art site and a visitor noted that the house was:

Figure 51: Circa-1980 Photographs of the Butt House.²⁹⁸

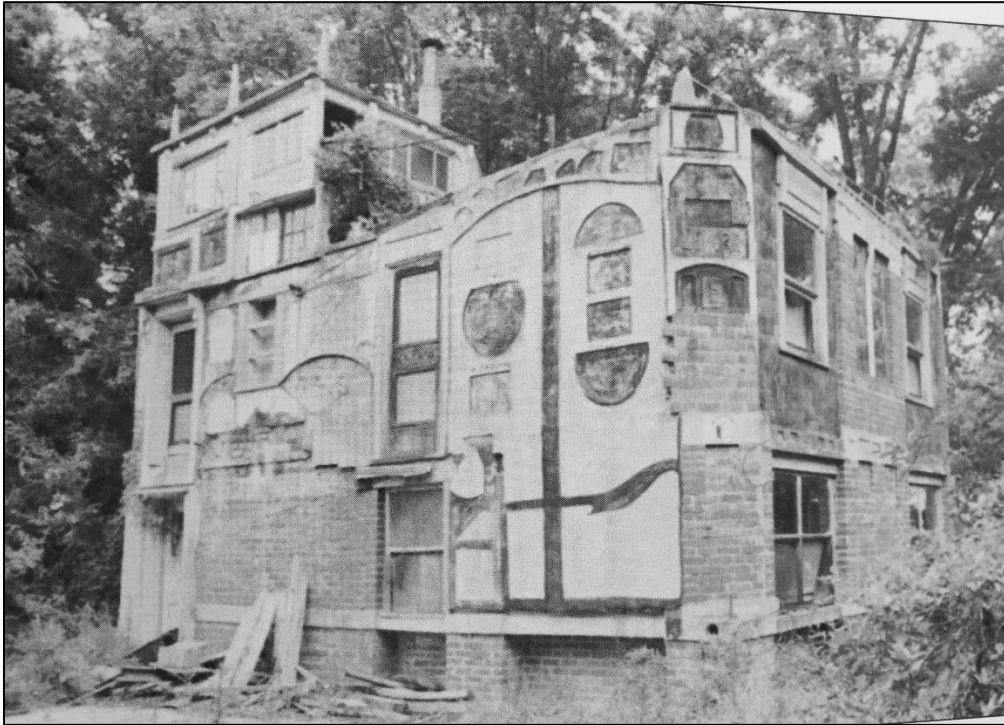
Figure 52: Circa-1998 Photo of the Butt House.²⁹⁹

Rena and their son, Justus Cramer, both passed away in the 1960s. When James Butt died in 1973 the property was left to Justus Cramer Butts window, Merl Z. Butt. She likely did not live on the property and the Dream House started to fall into disrepair and the gardens became unruly (Figure 53, p. 139).³⁰⁰ In 1986 she sold the house to her son, James Carroll Butt, of Lone Star, South Carolina.³⁰¹ He continued to live in South Carolina during his ownership of the property and the house continued to deteriorate. In 1998 he sold the lot to Jarvis R. Albertson and his wife, Hazel Albertson.³⁰² Jarvis was the son of the C.L. Albertson who sold the property to the Butts in 1923. The Dream House and the modest house appear to have been demolished shortly after the Albertson's bought the property and a vacant, wooded lot covers the parcel today.³⁰³

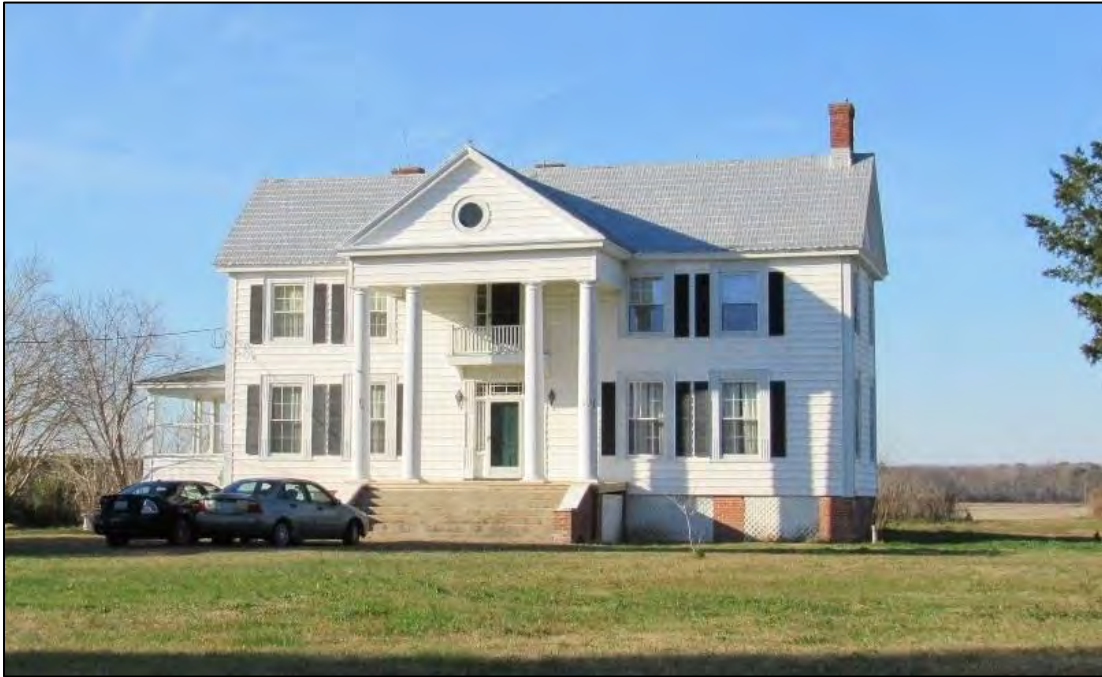
The William Riley Abbott House does not appear to have been modified since it was listed in the NRHP in 1978. The primary resource is a two-and-a-half-story, five-bay, single-family dwelling constructed around 1845 in the Greek Revival style and with an L-shaped plan (Photo 78, p. 143). The brick-pier foundation with wood-lattice infill supports the frame structural system that is clad in weatherboard. The dwelling is covered by a moderately pitched, side-gabled roof with pedimented gable ends sheathed in pressed-metal shingles. An interior-end coursed brick chimney is located on the south end of the roof ridge and two interior-slope, coursed, brick chimneys flank the rear ell.

A two-and-a-half-story, one-bay, front porch that was added in the 1920s covers the primary entrance.³⁰⁶ The porch is supported by Tuscan columns and is covered by a front-gabled roof with a pedimented gable end and a single-light round window centered on the gable. Other fenestration includes six-over-six, double-hung sash, wood-framed windows located within fluted wood surrounds, flanked by paneled-wood shutters on the primary elevation. A one-story, screened, side-porch addition that appears to have been constructed in the 1920s extends from the south elevation of the resource. It is supported by brick piers with lattice infill and is covered by a hipped roof.

Photo 78: William Riley Abbott House, East Elevation.

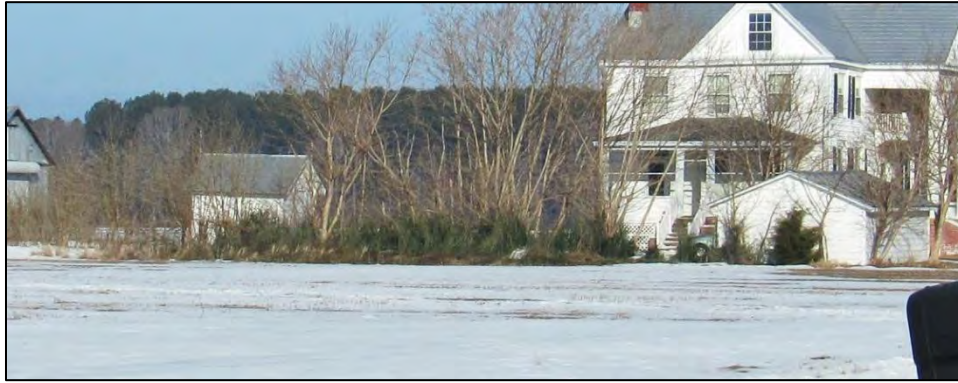
Five outbuildings are associated with this resource. As noted in the NRHP nomination, none of them were built contemporaneously with the primary resource and all appear to date to the mid-twentieth century. A circa-1950, one-story, one-bay garage is located about 45 feet south of the primary resource (Photo 79, p. 144). The frame structural system is clad in vinyl siding and covered by a front-gabled roof sheathed in v-crimp metal. An overhead garage door is centered on the primary (north) elevation. A circa-1950, one-story, one-bay, small domestic outbuilding is located about 30 feet west of the primary resource (Photo 79, p. 144). It is clad in vinyl siding and covered by a front-gabled roof sheathed in v-crimp metal. A single-leaf door is centered on the primary (east) elevation.

Photo 79: Domestic Outbuilding (Left) and Garage (Right), Looking Northwest.

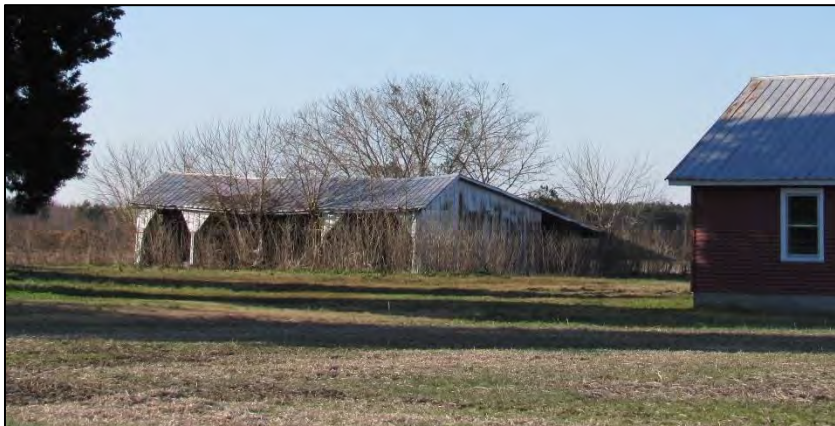
A circa-1950, one-story, open-bay loafing shed is located about 100 feet west of the primary resource (Photo 80). The frame structural system is clad in vertical wood board and is covered by a shed-roof with a pent that is clad in v-crimp metal. Multiple open bays are located along the east elevation.

Photo 80: Loafing Shed, Northeast Oblique.

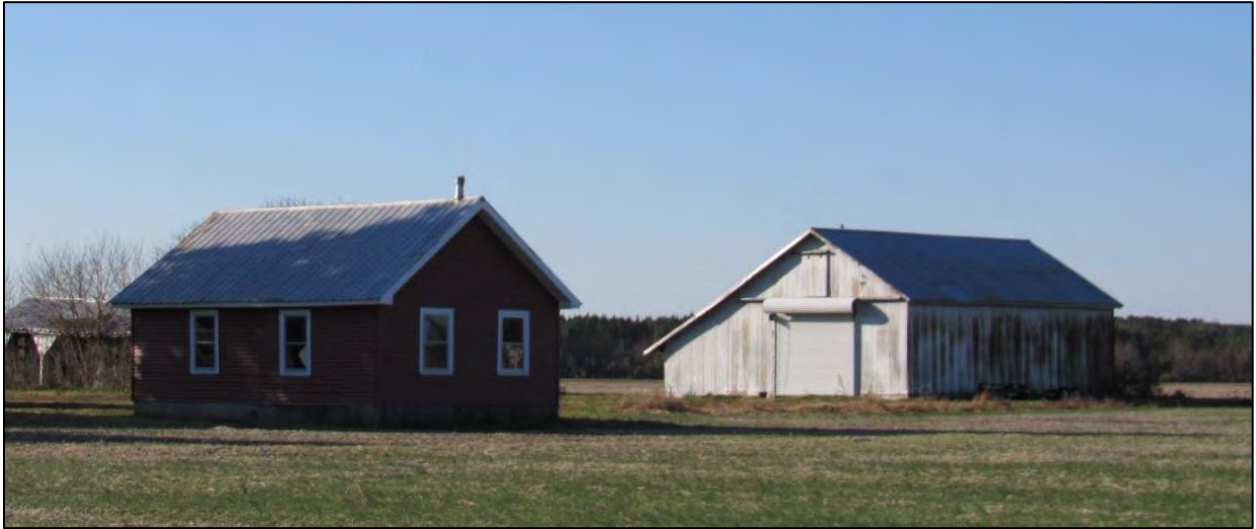
A circa-1950, one-and-a-half-story, one-bay agricultural outbuilding is located about 150 feet northwest of the primary resource (Photo 81, p. 145). The frame structural system is clad in pressed metal and covered by an off-centered gabled roof sheathed in v-crimp metal. A roll-up metal door with a small boarded up window above it in the gable end are both located on the primary (east) elevation. A one-story, one-bay, domestic outbuilding constructed circa 1950 is located about 90 feet north of the primary resource (Photo 81, p. 145). The continuous concrete-block foundation supports the structural system that is clad in weatherboard. It is covered by a gable roof that is sheathed in v-crimped metal with a metal flue piercing the north end of the ridgeline. This resource featured one-over-one, double-hung sash, vinyl windows.

Photo 81: Domestic Outbuilding (Left) and Agricultural Outbuildings (Right), Looking Southwest.

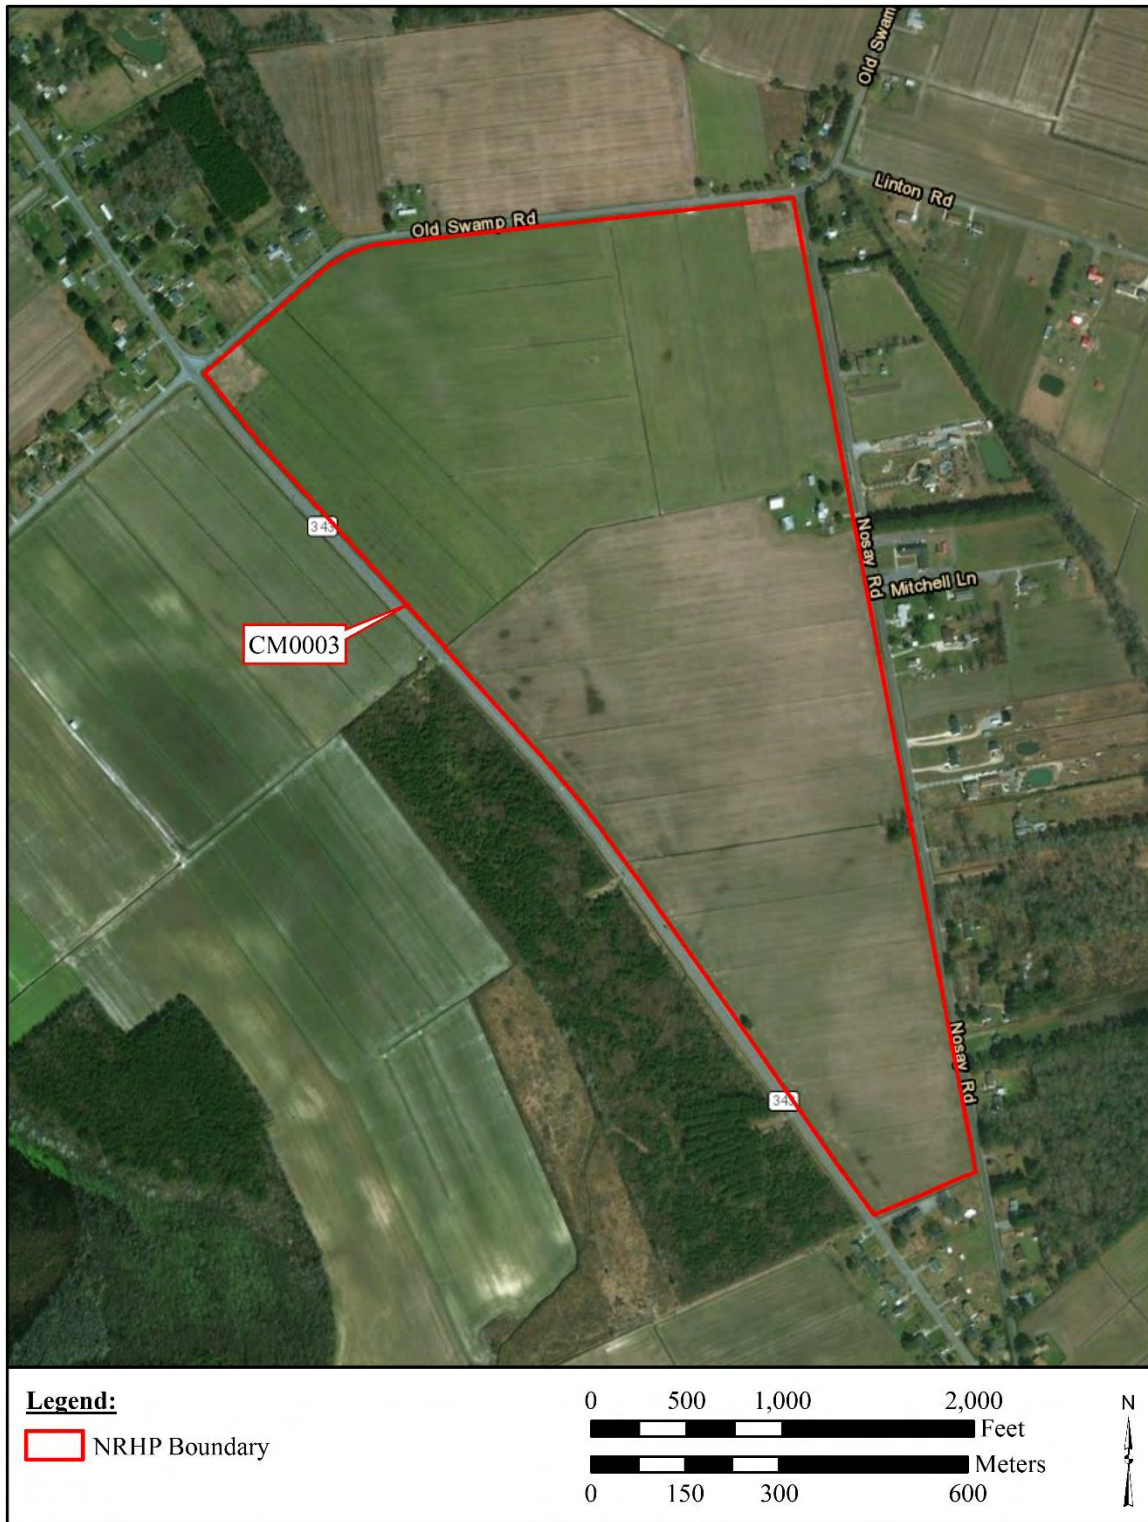
During the current survey, Dovetail revisited the property to provide data on its continuation for NRHP listing (Figure 56, p. 147). Following a close examination of the nomination and a field visit, it appears that the dwelling continues to embody the characteristics that made it eligible for the NRHP in 1978 under Criteria A and C. It has not undergone extensive alterations and retains many of its original character defining features that made it significant. The building also remains an excellent example of a vernacular Greek Revival antebellum dwelling in Camden County. As such, it is **recommended that this resource remain listed in the NRHP.**

Figure 56: NRHP Boundaries for the William Rile Abbott House (CM0003).
