SUBJECT: Historic Structures Survey Report, Improve US 70 E between US 70 from US 70 Goldsboro Bypass to West of SR 2314, Princeton, PA 18-03-0014, R-5829, Wayne and Johnston Counties, ER 18-0563

TIP No. R-5829
WBS No. 47101.1.1
PA No. 18-03-0014

Historic Structures Survey Report
Upgrading of U.S. 70 to Interstate Standards
from U.S. 70 Goldsboro Bypass to West of SR 2314 (Pondfield Road)

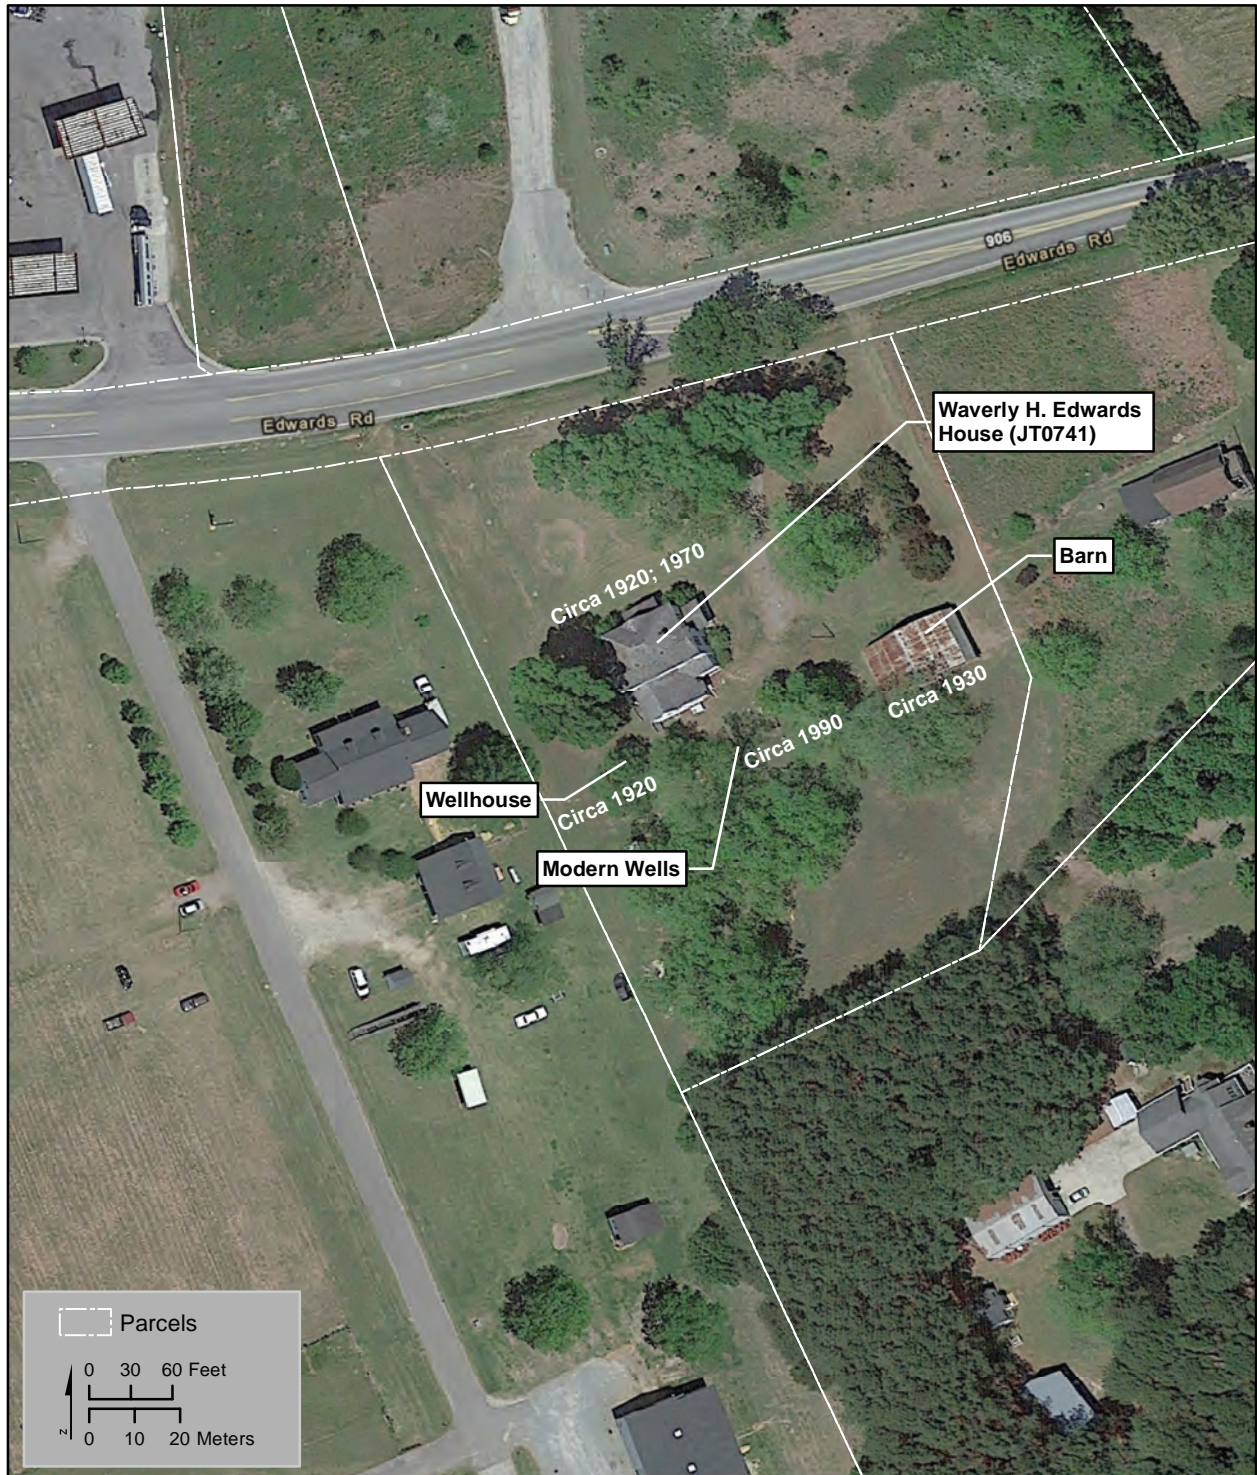
Figure 3.1. Waverly H. Edwards House Site Plan

The 2.46-acre parcel containing the Waverly H. Edwards House is situated on the south side of Edwards Road (SR 2372) 0.17 mile east of U.S. 70 in Boon Hill Township in eastern Johnston County (see Figure 2.1). The Edwards House is 0.65 mile east of Princeton’s historic commercial center. The parcel is bounded on the north side by Edwards Road and by residential parcels on the east, west, and south sides. This part of the county, east of Princeton and just west of the Wayne County line, is characterized by vacant farmland that is slowly returning to a forested state. Around the house, several large oaks are planted in the yard. Approximately seven pecan trees are in the rear (south yard). There are five resources on site: the circa 1920 dwelling, the circa 1920 old wellhouse west of the house, the modern well southeast of the house, and a circa 1935 barn east of the house (Figure 3.1). An unpaved driveway accesses the parcel from Edwards Road.

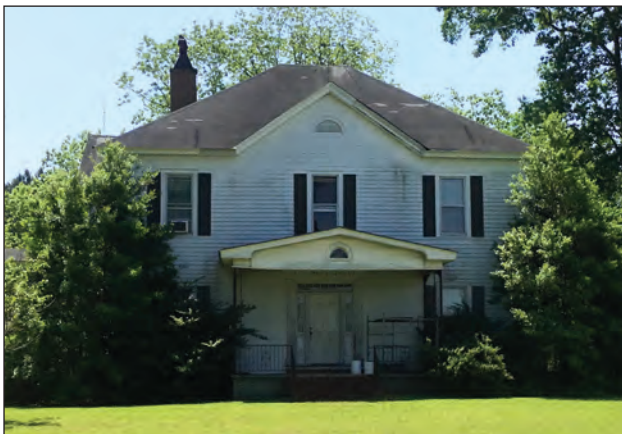
Figure 3.2. Façade (North Elevation)

The circa 1920 Waverly H. Edwards House is a 3,500 square-foot, two-story altered Colonial Revival house (Figures 3.2 through 3.7). The exterior walls and trim are covered with vinyl siding. The windows are the original one-over-one sashes, with the openings slightly reduced in size by vinyl window trim and storm windows. The roof is covered with composite shingles. A brick interior chimney rises from the east roof slope. The foundation is brick.

The main block has two-story, double-pile, hipped roof massing and a decorative front gable. Integrated into the rear roof slope and projecting from each side elevation is a two-story wing with a gable roof. The rear elevation has a one-story gabled wing with enclosed shed porches on both sides and a shed addition across the rear wall of the main block, which may also be an enclosed porch (Figures 3.4 and 3.5). The house's original one-story, wrap-around porch was removed around 1970 (Butchko 2016; Jimmy Tart, personal communication 2018). The original porch was replaced with two porches on the front and east sides. These porches have shallow-pitched, gabled

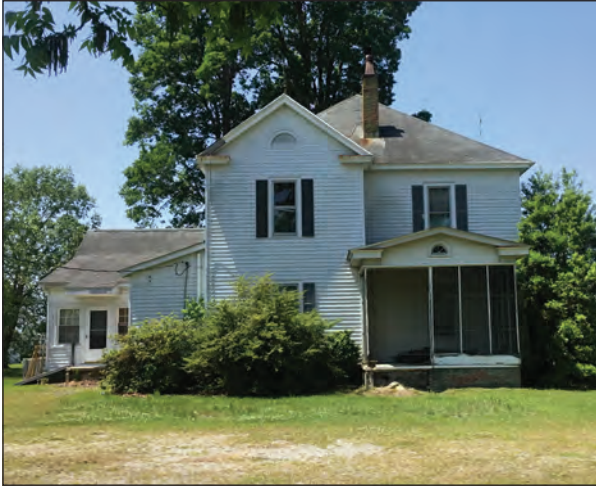
Figure 3.6. East Elevation

roofs with returns and scrolled metal porch posts. Both porches have a lunette window in the gable (Figures 3.6 and 3.7). The main entry is under the front porch. Its sidelights and transom are set within a Colonial Revival door surround with fluted pilasters and a dentilated cornice (Figure 3.7). Access to the interior was not permitted by the landowner.

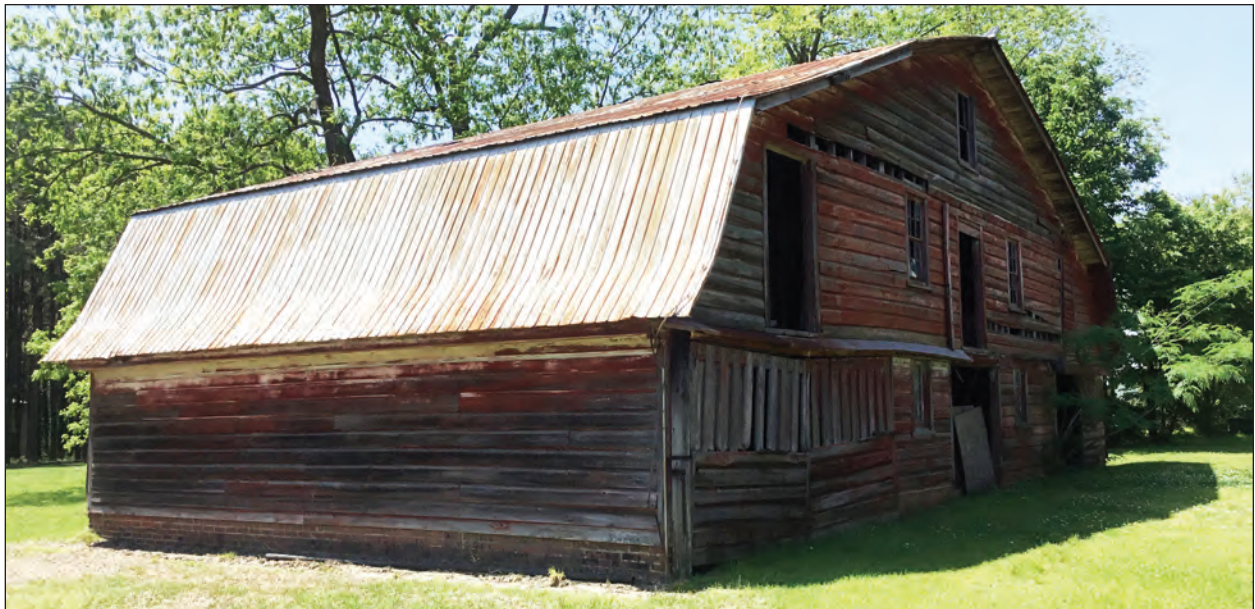
Figure 3.8. Barn, Circa 1930

Approximately 90 feet east of the house is a front-gable frame barn with a modified gambrel roof line (Figure 3.8). The first floor has spaces for work, storage, and livestock. A massive hay loft takes up the second floor. The barn is covered with weatherboard siding, painted red, and has a sheet metal roof.

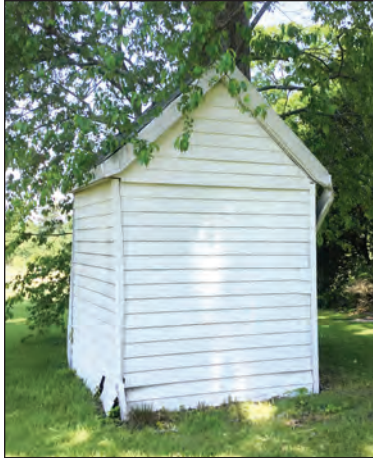
Figure 3.9. Well House, Circa 1920

Approximately 15 feet west of the house is a side-gabled frame well house with a steeply pitched roof (Figure 3.9). The entry is on the east side, facing the house; however, the vertical board door has become detached and is lying on the ground. The exterior walls are covered with vinyl siding. The roof is covered with metal sheets. The well house sits on a poured concrete foundation. The interior is sheathed with flush horizontal boards. The well has been capped with concrete.

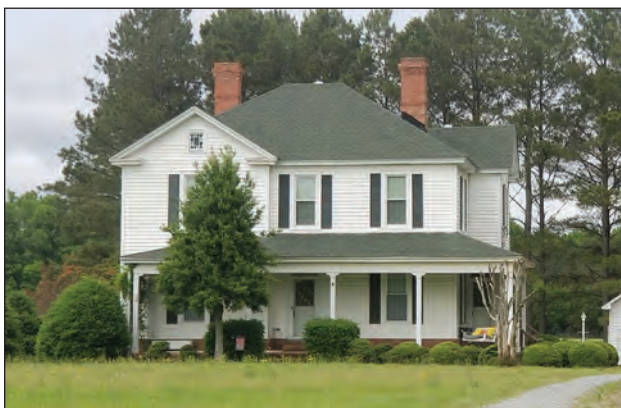
Figure 3.13. Howard Oliver House, Boon Hill

rural Colonial Revival dwelling is the Howard Oliver House (JT 0895) in Boon Hill Township, located on U.S. 70 approximately four miles northwest of the Edwards House (Figure 3.13).

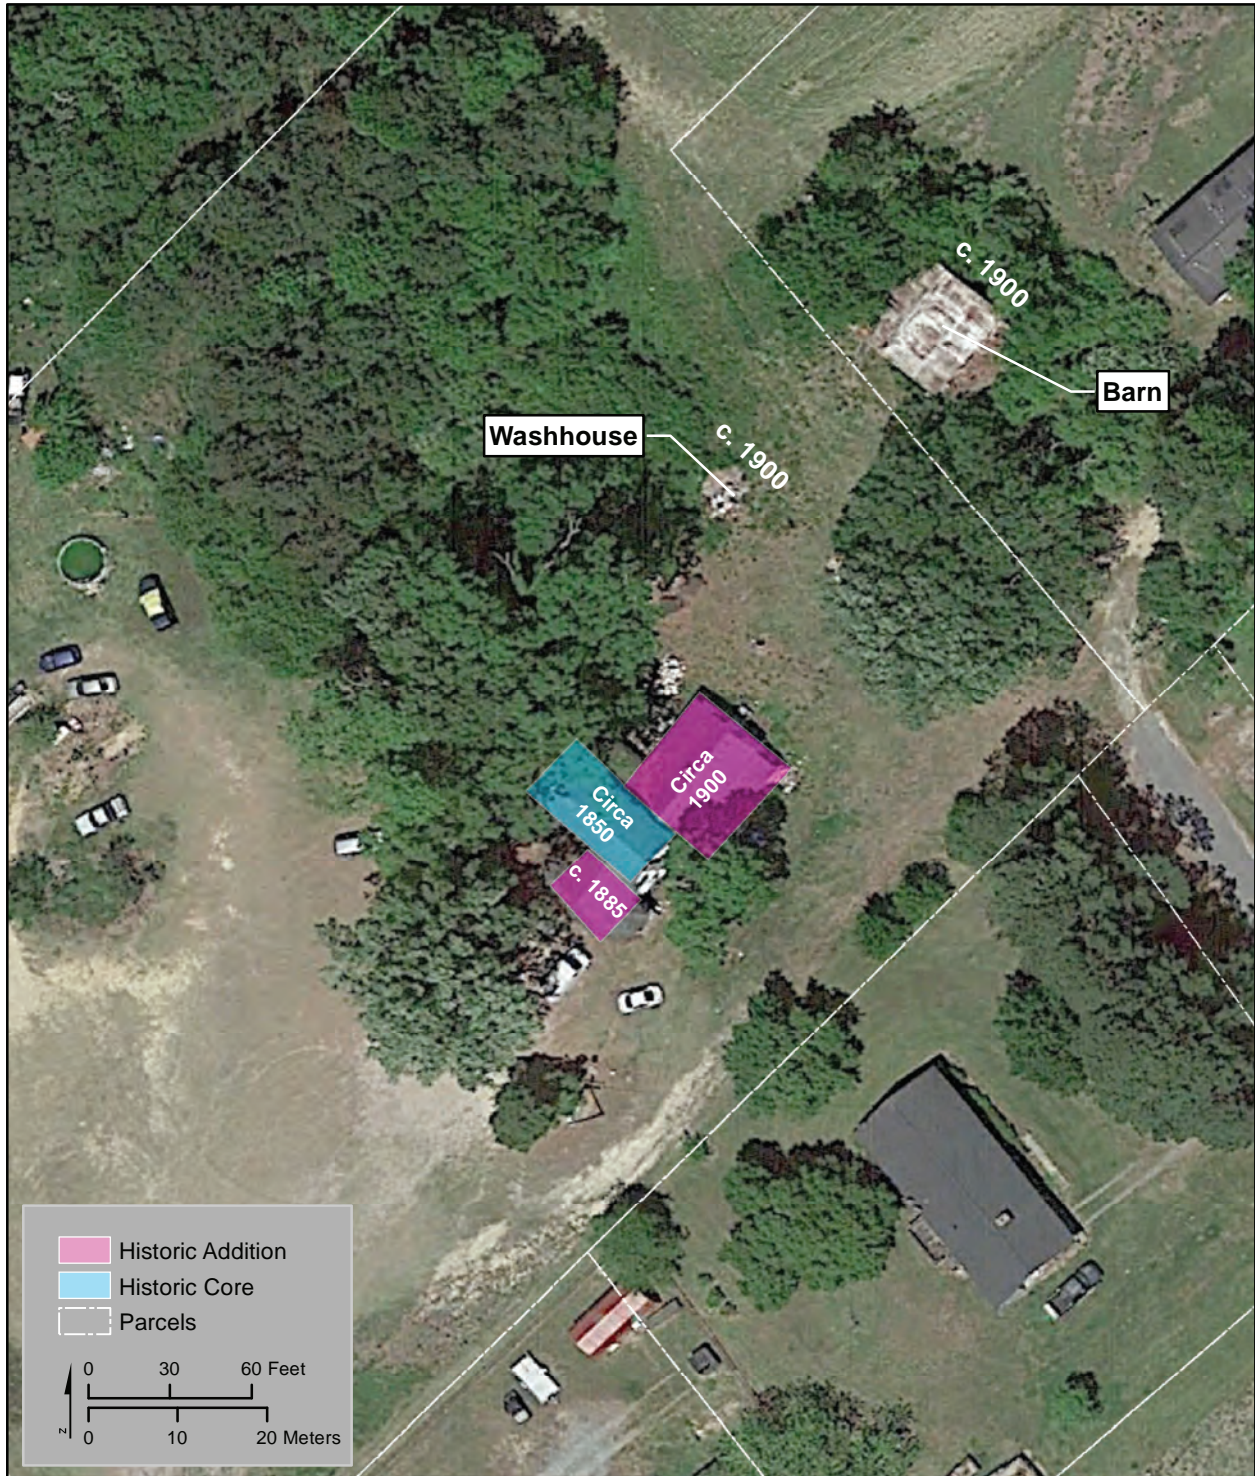
Figure 4.1. West Massey House Site Plan

The West Massey House is an altered I-House constructed in the late 1850s and located in a rural portion of Johnston County, North Carolina (Figure 4.1). Standing on a 12.49-acre lot and surrounded by a grove of mature oaks, the former farmhouse is situated in an area typified by agricultural fields and low-density residential development. The house is approximately 2,300 feet northwest of the heavily-trafficked highway of U.S. 70 on Old Cornwallis Road, a curvilinear country two-lane thoroughfare winding past farms, forested lots, and single-family dwellings toward a quarry.

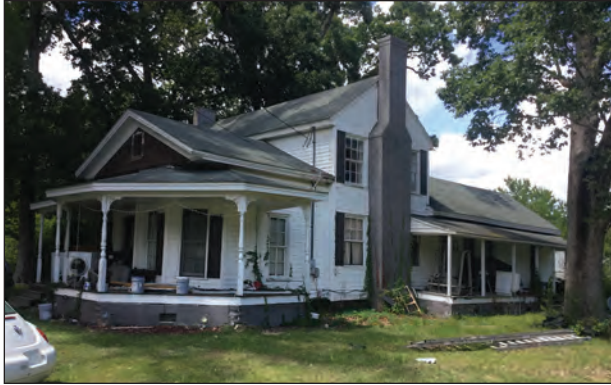
Figure 4.2. Oblique View, Facing North

clad in weatherboard siding (Figure 4.2). The brick pier foundation has been infilled with concrete block. The house has a side gable roof and exterior brick chimneys on the gable ends (Figure 4.3). Asphalt shingles cover the roof of the house and additions. A circa-1885 single-story, gable-roof addition projects from the front elevation of the house (Figure 4.4). Fish scale shingles are on the additions front gable, turned spindle supports, and along the wrap-around front porch. These shingles lend elements of the Folk Victorian style to the house's primary façade. A circa 1900 shed roofed addition and gable-roofed ell extend from the rear of the house, with an open-framed side porch spanning the southeast side of the ell (Figures 4.5 and 4.6). Now enclosed, a shed-roofed porch once spanned the southwest side of the rear ell and a non-historic wooden deck addition stands near the house's northeast corner (Figures 4.7 and 4.8). Windows on the historic core of the house are wood-framed six-over-six double hung sashes while the front addition features similar units in a four-over-four arrangement. Both six-over-six and two-over-two wood framed windows are located on the rear of the house. Interior access to the house was not permitted by the landowner.

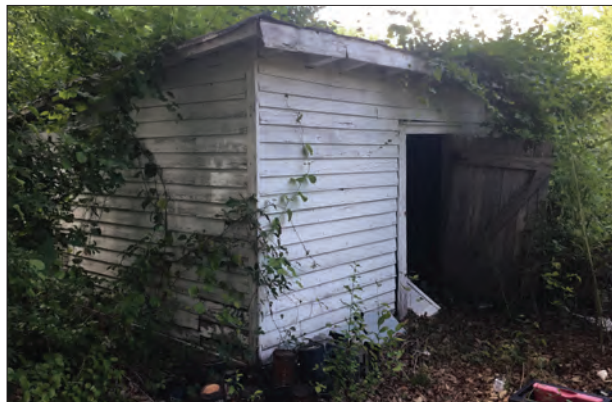
Figure 4.9. Wash House

A shed-roofed washhouse with horizontal wood siding sits approximately 50 feet to the rear (north) of the West Massey House (Figure 4.9). The washhouse sits on a concrete slab foundation and a vertical board door covers the entrance.

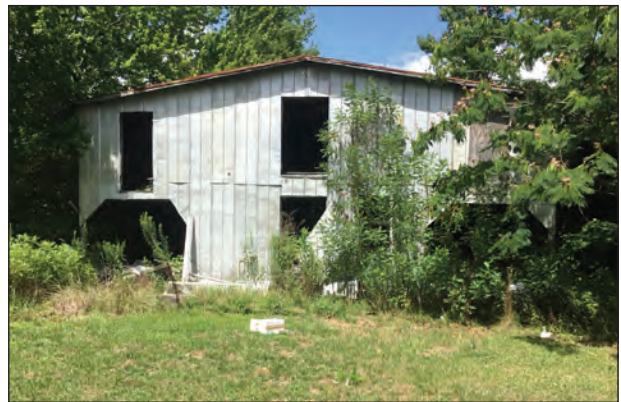
Figure 4.10. Barn

A two-story barn standing on a concrete slab foundation, sheathed in metal panels, and covered by a gable roof is located approximately 150 feet north of the house (Figure 4.10). The barn appeared to be unused at the time of field investigations, but the first floor has spaces for work and storage while the second floor is a hay loft.

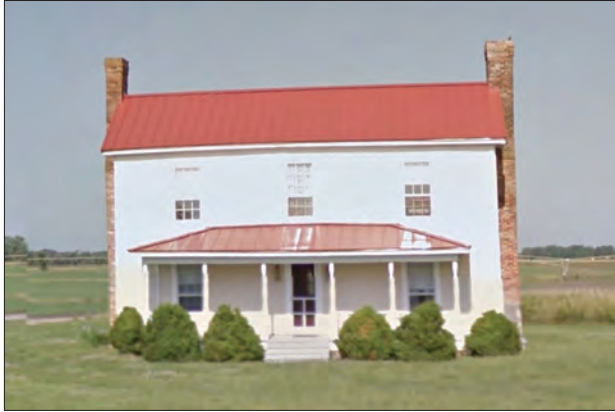
*Figure 4.11. Joseph Dixon (GR0506),
Edwards Bridge Road, Greene County*

The 1890s Joseph Dixon house (GR0506) on Edwards Bridge Road in Greene County is another intact example of the I-House form that retains its historic form. The hipped roof front porch does not mask the simple design of this traditional house plan.

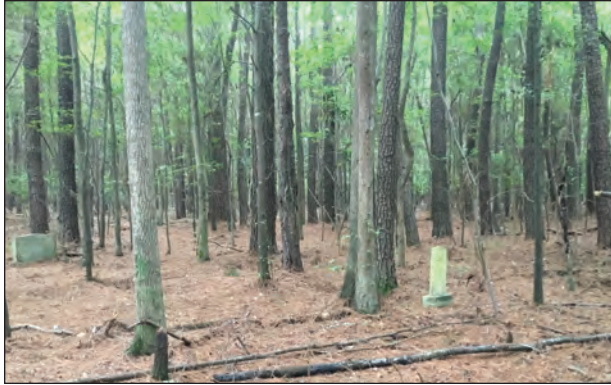
Figure 5.6. Cemetery, Facing South

South of the school building and in the woods is an African American cemetery that was established on the public school property (Figure 5.6). The cemetery is roughly bounded on the north and south by approximately two-foot tall brick pillars and is somewhat overgrown. The cemetery most likely contains dozens of interments; however, less than 20 markers are extant. Now abandoned, the cemetery was in use from around 1934-1961.

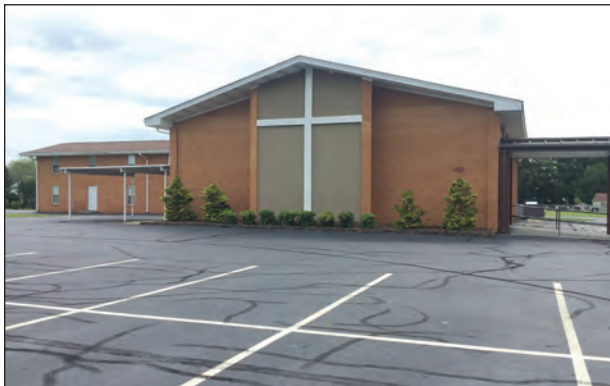
Figure 6.2. 1968 Church Building, Facing East

Much of the history of the property is derived from personal communication with Stuart Coffman, who has served as the pastor of Grace Church since 2012. The one-story gable-roofed sanctuary is the oldest building on the property (Figure 6.2). The sanctuary sits on a concrete slab foundation and is clad in a brick veneer. The asphalt-shingled roof terminated in deep eaves with a non-historic vinyl fascia, soffit, and cornice returns. The western, Barden Street-facing elevation features brick pilasters and courses with projecting headers alternating the rows of stretcher bond brick along the exterior wall (Figure 6.3). A prominent concrete cross is set within a recess infilled with stucco. This recess historically served as the church's main entrance and was infilled in 2013. The north and south elevations of the sanctuary are fenestrated with non-historic fixed windows in vinyl frames (Figure 6.4). Older windows present on the building are metal-framed one-over-one double-hung sashes. On the south side of the sanctuary, near the southwest corner, one window has been replaced with glass doors set in metal frames (Figure 6.6). These doors, installed in 2013, serve as the primary entrance to the sanctuary. An interior brick chimney is located near the building's southeast corner.

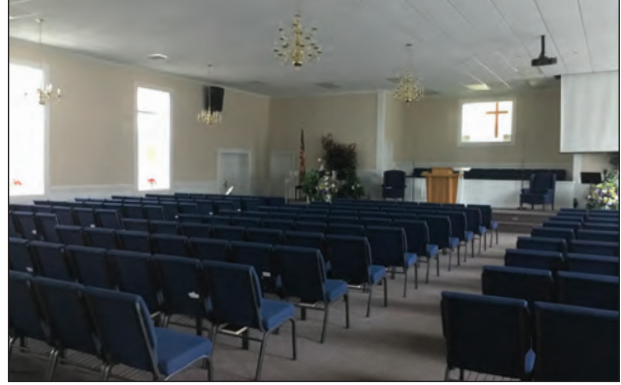
Figure 6.7. Interior View of Sanctuary

The sanctuary's interior was renovated around 1995 and is sparsely decorated (Figure 6.7). Wainscoting surrounds the large room and a choir loft, baptistry, and pulpit are located at the sanctuary's south end. The church's historic wooden pews have been replaced with modern chairs.

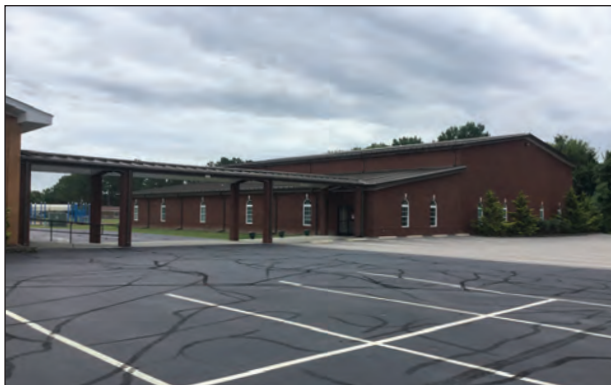
Figure 6.8. Auditorium, Facing Southeast

The non-historic auditorium is a one-story aluminum pre-fabricated building on a concrete slab foundation (Figures 6.8 and 6.9). The auditorium portion, taller in height than the historic sanctuary,

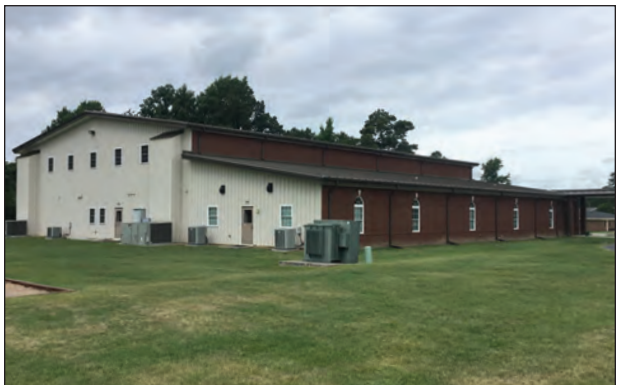
Figure 6.9. Auditorium, Facing Southwest

is covered by a metal gable roof. A shed-roofed addition on the building's north side is used for Sunday school classes. The building is partially clad in a brick veneer and fenestrated with vinyl-framed windows. A covered walkway between the sanctuary and auditorium was constructed in circa 2013.

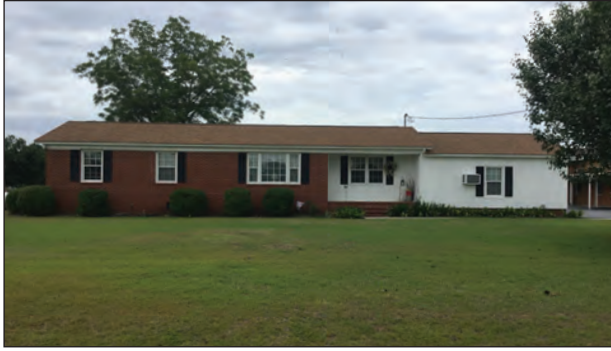
Figure 6.10. Façade of Parsonage, Facing East

The Grace Church parsonage is a one-story house with a side-gabled roof (Figure 6.10). The house rests on a concrete slab foundation and is clad in brick and non-historic vinyl board-and-batten-style siding. Windows are non-historic double-hung sashes set in vinyl frames. A garage on the house's east end has been enclosed to provide additional living space.

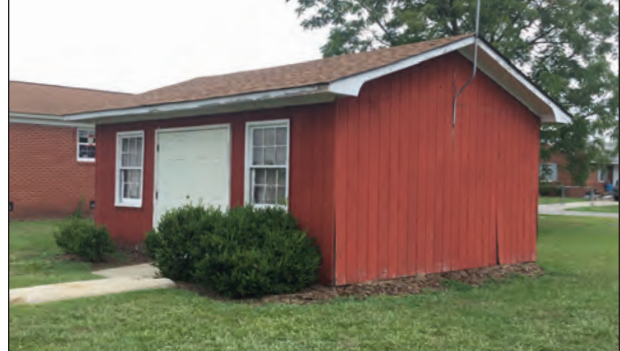
Figure 6.11. Shed, Facing Northwest

Clad in vertical wooden siding and resting on a concrete slab foundation, a shed located behind the parsonage is used for storage (Figure 6.11). The building features replacement metal doors, wood-framed six-over-six double hung sash windows, and a side-gable roof.

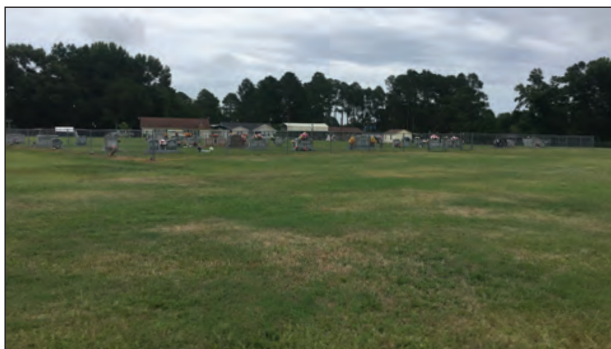
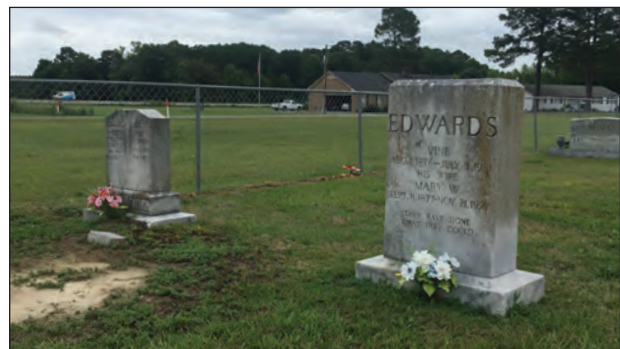
Figure 6.12. Cemetery, Facing Southeast

The Grace Baptist Church Cemetery is a vernacular cemetery of semi-formally arranged graves (Figures 6.12 and 6.13). Tablet, composite, and flush markers are present within the cemetery. The

cemetery is surrounded by a chain-link fence and landscaping is minimal. Grace Baptist Church continues to use the cemetery for burials.

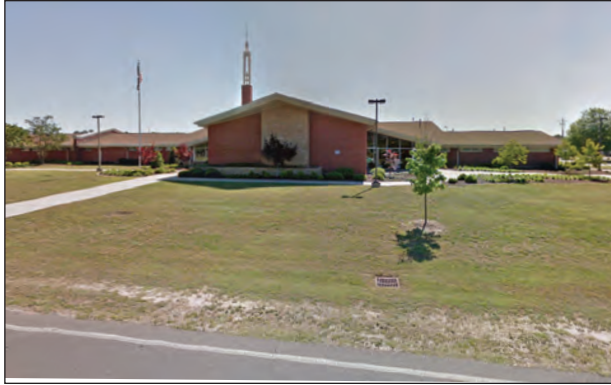
Figure 6.14. 1961 Church of Jesus Christ of Latter Day Saints, Goldsboro, Wayne County

While the Grace Baptist Church is minimally stylized, other churches in Johnston County more clearly demonstrate elements of the dominant Modernist architectural style of the mid-twentieth century. The 1961 Church of Jesus Christ of Latter Day Saints in Goldsboro features a prominent street-facing sanctuary, a curtain wall entrance with clerestory windows reminiscent of the work of Joseph Eichler, and an antennae-like steeple (Figure 6.14).

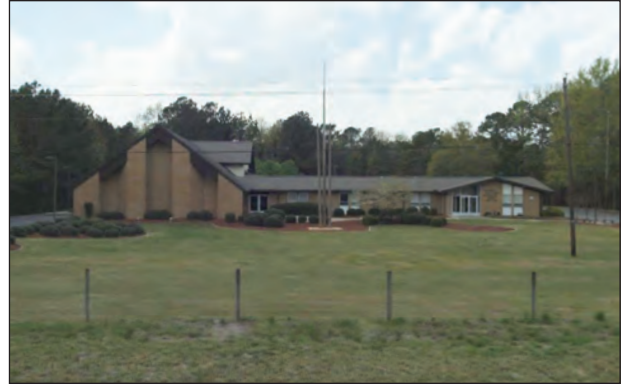
Figure 6.15. 1965 Church of Jesus Christ of Latter Day Saints, Mt. Olive, Wayne County

In Mount Olive, the Church of Jesus Christ of Latter Day Saints, a 1965 building in a semi-rural location, is also typified by a large gable-roofed sanctuary with distinctive pilasters, deep eaves, and a broad fascia (Figure 6.15). A steeple-like sculpture, three staves arranged on a concrete foundation, further reflects the streamlined, abstract designs prevalent in Modernist architecture.

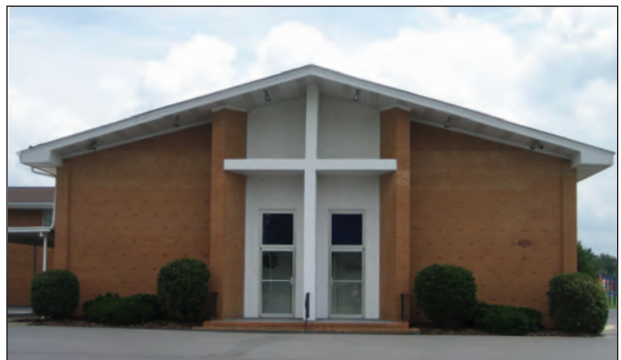
Figure 6.16. Grace Baptist Church, Pre-Renovation

To be considered eligible for inclusion on the NRHP, a property must possess integrity of location, design, setting, materials, workmanship, feeling, and association. The Grace Baptist Church retains integrity in the area of location only. Alterations and non-historic additions have impacted the building's original massing, thereby impacting the property in the area of design. The use of non-historic vinyl on the church's fascia and soffit and the replacement of historic windows reduces integrity in the areas of materials and workmanship. Connected to the sanctuary by a walkway, the modern auditorium building impacts the setting of Grace Baptist Church by altering the historic arrangement of the property. Grace Baptist Church no longer retains integrity

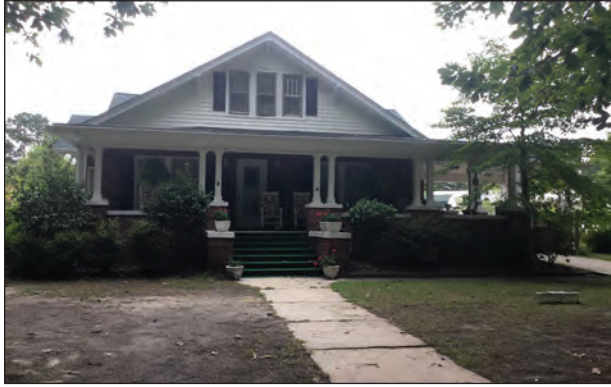
Figure 7.2. Façade, Facing Northeast

The 1928 house at 201 Donnie Jones is a one-and-a-half-story Craftsman Bungalow with a wraparound front porch (Figure 7.2). The frame house sits on a concrete slab foundation and is clad in a brick veneer, with a decorative string course near the foundation. The cross-gable roof is covered in asphalt shingles and an interior brick chimney rises from the center of the house. A non-

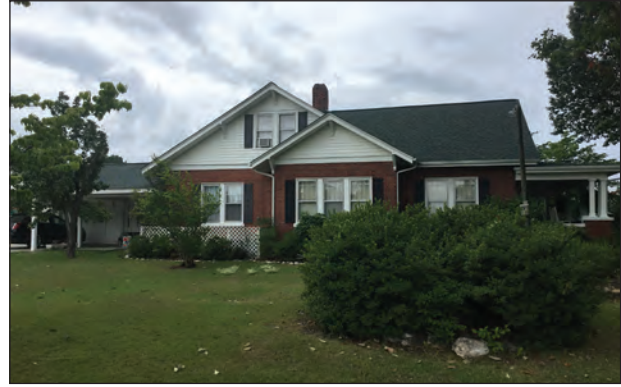
Figure 7.3. Northwest Elevation, Facing Southeast

historic multi-light wooden door serves as the primary entrance to the home. Windows along the front and side are Craftsman-style eight-over-one double-hung sashes set in wood frames (Figures 7.3 and 7.4). Craftsman details such as the knee braces, square porch supports, and deep soffits have been replaced with non-historic aluminum or vinyl (Figure 7.5). A poured concrete driveway leads from Donnie Jones Boulevard to an attached porte-cochère on the east side of the house (Figures 7.6 and 7.7). Wood-framed windows are located in the gable ends of the upper half-story. A non-historic garage addition at the building's rear is covered in vinyl siding and is thought to have been constructed in the 1970s (Figures 7.8 and 7.9). Wooden and vinyl-framed additions are located on the rear of the garage. Interior access was not permitted by the property owner.

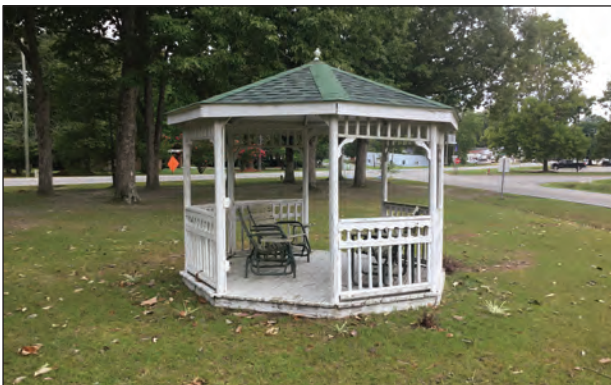
Figure 7.10. Gazebo,

A pyramidal-roofed open-framed wooden gazebo stands in property's grassy yard (Figure 7.10). A spandrel, balustrade, and finial add ornamentation to this outbuilding.

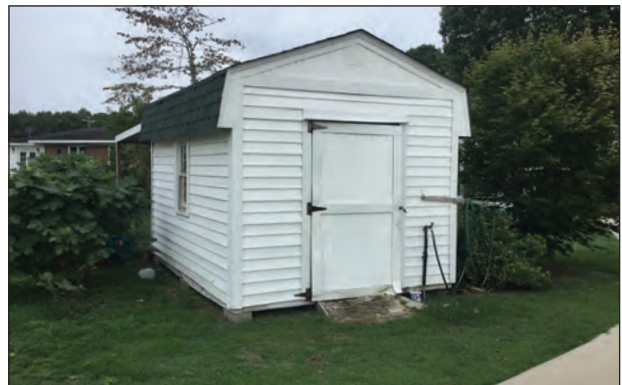
Figure 7.11. Circa 1980 Shed, Facing Southeast

A prefabricated vinyl-sided shed on concrete blocks is used for storage (Figure 7.11)

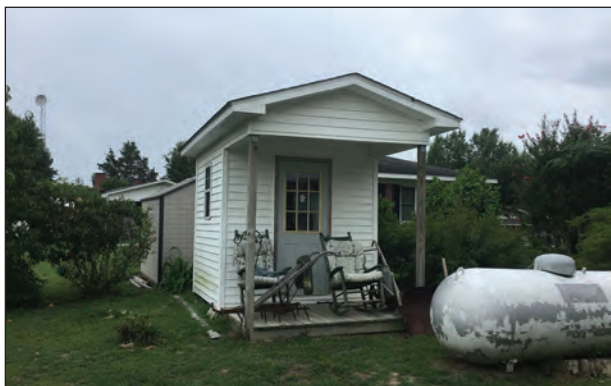
Figure 7.12. Circa 1990 Shed, Facing East

A vinyl-sided, gable roofed shed with a small wooden front porch is used for storage (Figure 7.12)

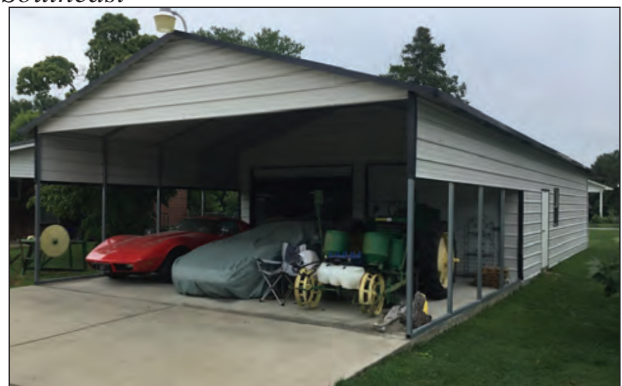
Figure 7.13. 1990 Garage, Facing South

An aluminum-sided, partially enclosed garage on a concrete slab foundation is used for automotive storage (Figure 7.13).

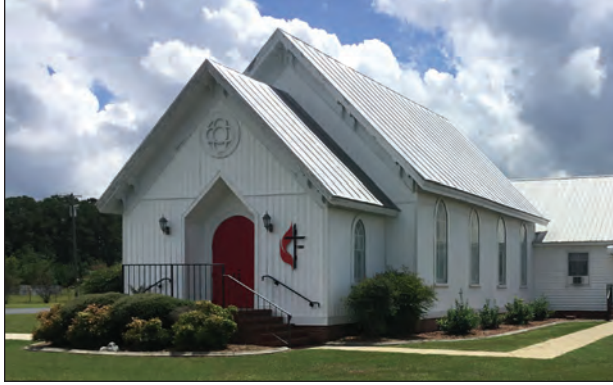
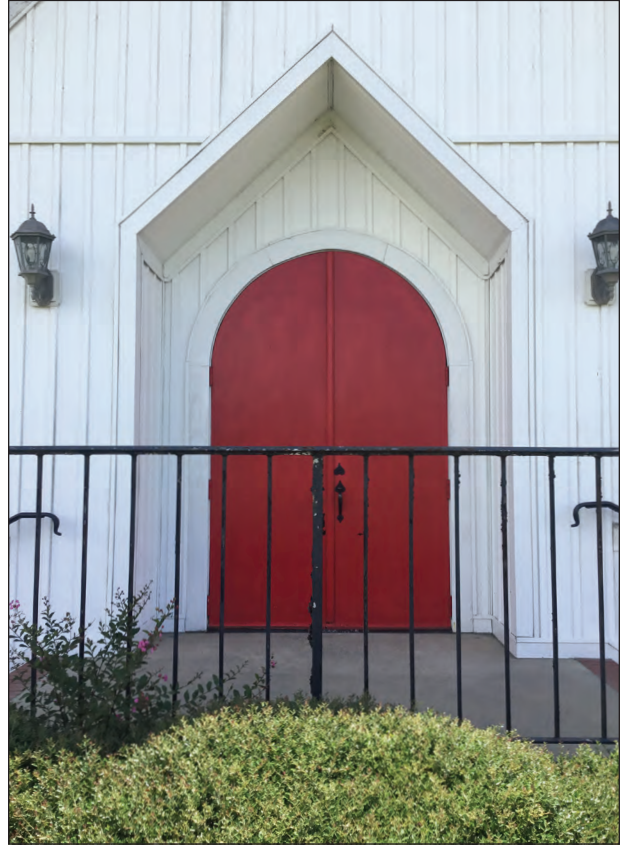
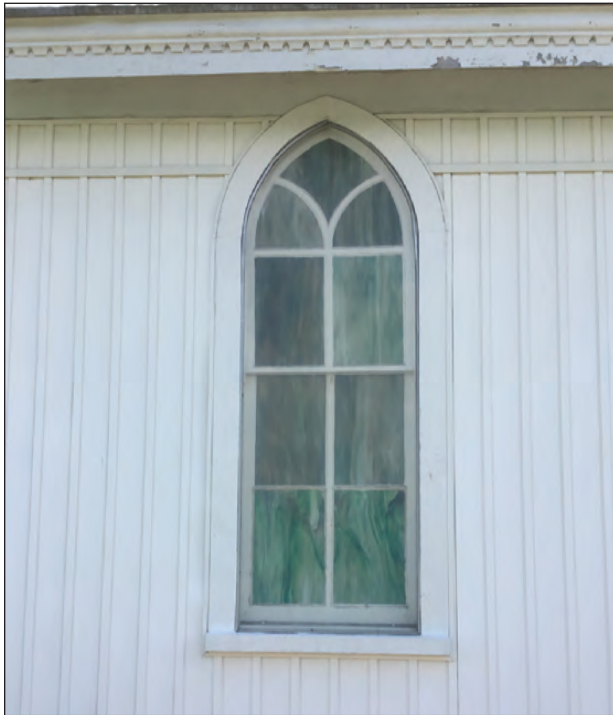
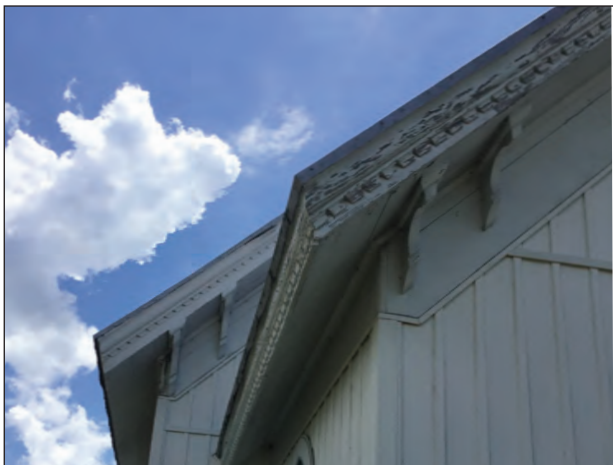
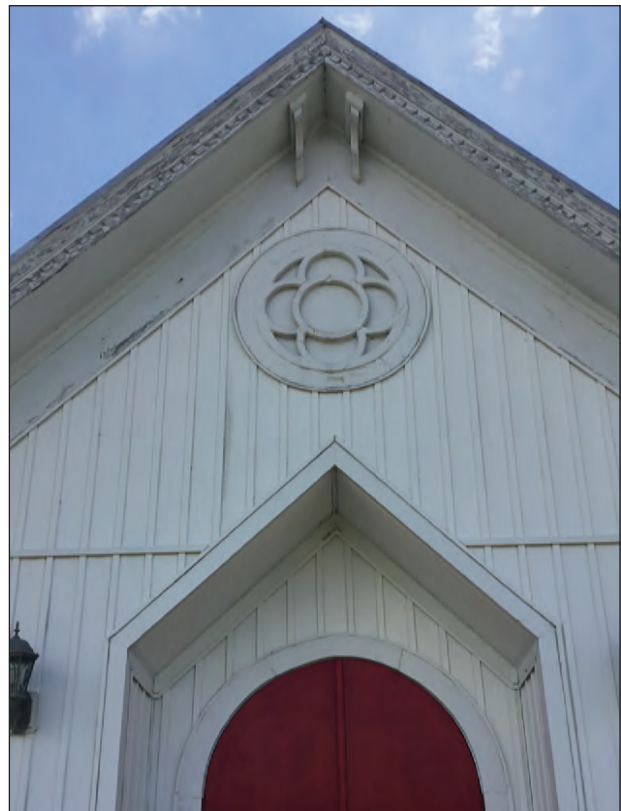
The Ebenezer United Methodist Church is an example of a Carpenter Gothic style church. Constructed in 1879-1880, the historic core of the church has a rectangular plan, is topped by a gable roof clad in standing seam metal, and sets on a brick pier foundation with brick in-fill (Figures 8.2 through 8.6). During fieldwork, it was observed that the original board and batten siding has been either covered or replaced with vinyl siding molded to resemble board and batten siding. As noted in *Glimpses of Wayne County, North Carolina: An Achitectural History*, the original front gable vestibule has been replaced by a taller and wider one that features the church's original round arch double doors, recessed within a triangular archway (Figure 8.3). A sawnwork rosette was moved from its original location in the church roof's gable end and placed above the door when the vestibule was altered (Pezzoni 1998) (Figure 8.6). The lancet arch double hung sash stained glass windows are located along both side elevations and appear to be original to the building (Figure 8.4). Additional architectural details include a raking cornice, dentils, and decorative brackets, all of which also appear to be original to the church building.

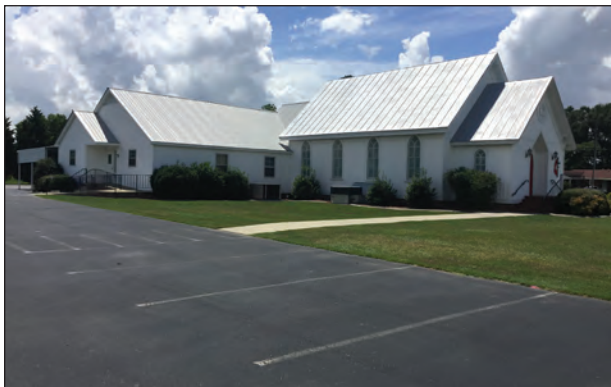
Figure 8.7. Church and East Rear Wing, Facing Southwest

Multiple, large additions have been constructed on the rear of the church, giving the church an almost cross-shaped plan (Figures 8.7 and 8.8). The non-historic additions are all frame construction with metal gable roofs, brick foundations, and vinyl siding. Interior access to the interior was not permitted.

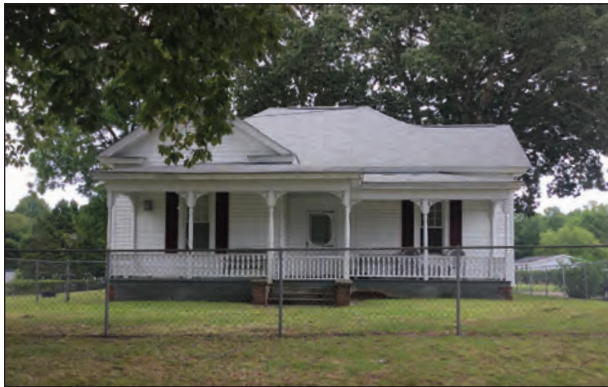
Figure 9.2. Façade, Facing East

The residence at 208 Capps Bridge Road is a Queen Anne cottage of frame construction with a hip roof and projecting gable ends on the front, rear, and south elevations (Figures 9.2 through 9.5). The house has an irregular plan, sits on a brick pier foundation, and is clad in vinyl siding. Metal sheathing was installed between the brick piers. The full-width front porch is comprised of a hip roof supported by spindlework posts with a spindlework balustrade and spandrels (Figures 9.6 and 9.7). The house has raking cornice, cornice returns, and vents in the gable ends and nine-over-one double hung vinyl sash windows throughout. A frame addition extends off the rear of the house and

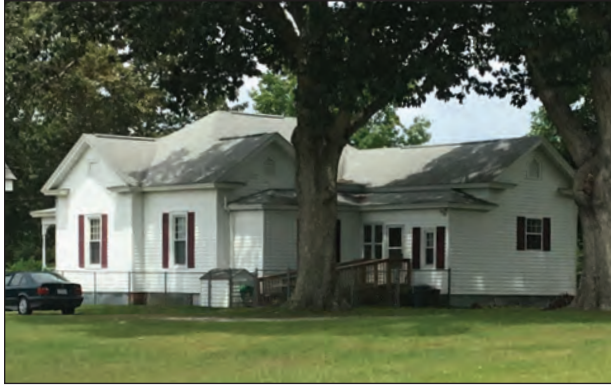
Figure 9.8. Rear Oblique, Facing Northwest

has a gable roof, vinyl siding, and a six-over-six double hung sash window. It also appears what was a back porch has also been enclosed (Figure 9.8). The surveyor did not obtain access to the interior of the property at the time of the survey.

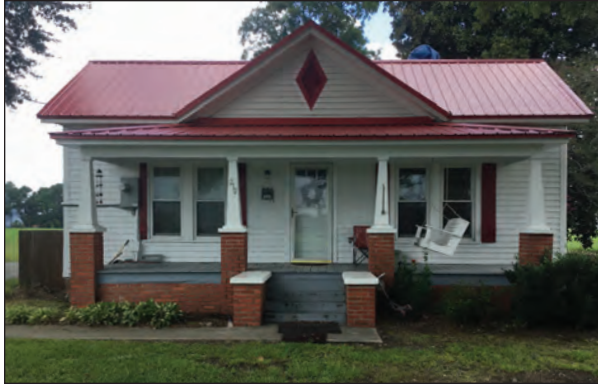
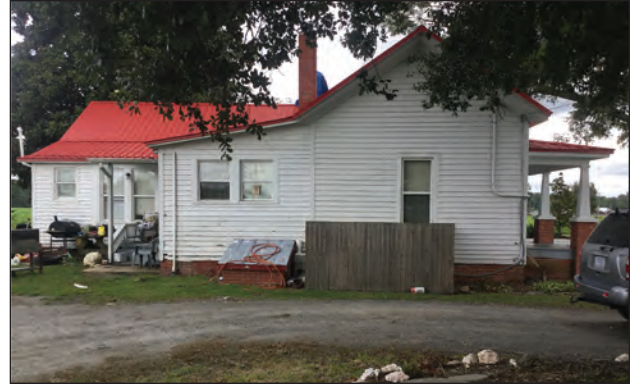
210 Ebenezer Church Road is a one-story central hall house commonly referred to as a “Triple-A” dwelling (Figures 10.2 through 10.4). Historically resting on brick piers, the house now sits on an infilled continuous brick foundation. The house is clad in weatherboard siding and covered by

a non-historic standing seam metal side-gabled roof. An interior brick chimney is located at the rear of the house's south-facing gable end. A dominant front gable-roofed dormer with a diamond-shaped vent extends over the house's central entrance. A hipped roof, covering the front porch, extends from beneath the front gable projection. The wooden-floored porch rests on a continuous brick foundation and brick piers support battered wooden columns, which in turn support the roof. A paneled wooden door with fixed divided lights and covered by a storm door serves as the house's primary entrance. All windows are replacement one-over-one double-hung sash set in metal frames. Windows along the front elevation are surrounded by wooden shutters.

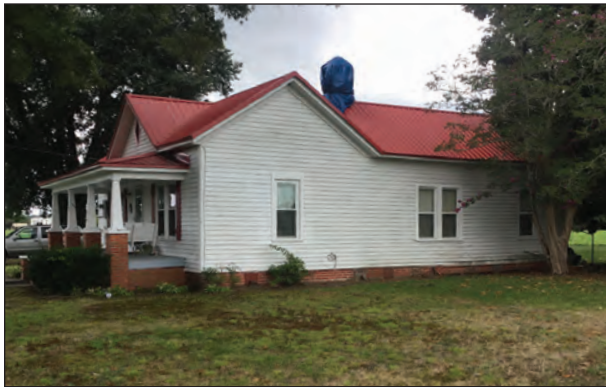
Figure 10.4. Northeast Elevation, Facing Southwest

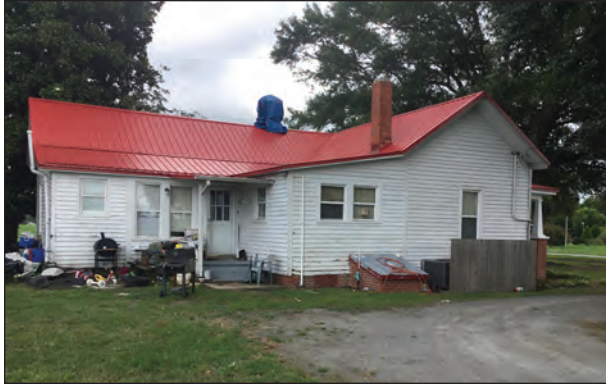
Changes to the original house extending from the rear elevation include a gable-roofed ell and a shed-roofed addition. A shed-roofed porch, now enclosed, is attached to the rear ell. An interior chimney, obscured by a tarp at the time of the survey but assumed to be brick, is located along the ridgeline of the rear ell. Foundation, cladding, and roofing materials on the additions match those on the original house and a wooden paneled door with divided fixed lights leads into the enclosed porch. A cellar entrance is located at the base of the shed-roofed rear addition. Interior access was not permitted, although a resident present during field investigations indicated that the property owner remodeled the inside of the house approximately five years ago, in 2013.

Figure 10.6. Rear Porch Oblique, Facing East

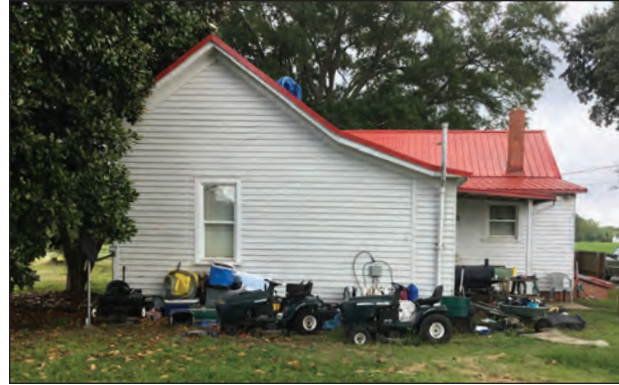
Figure 10.7. Northwest Elevation, Facing Southeast

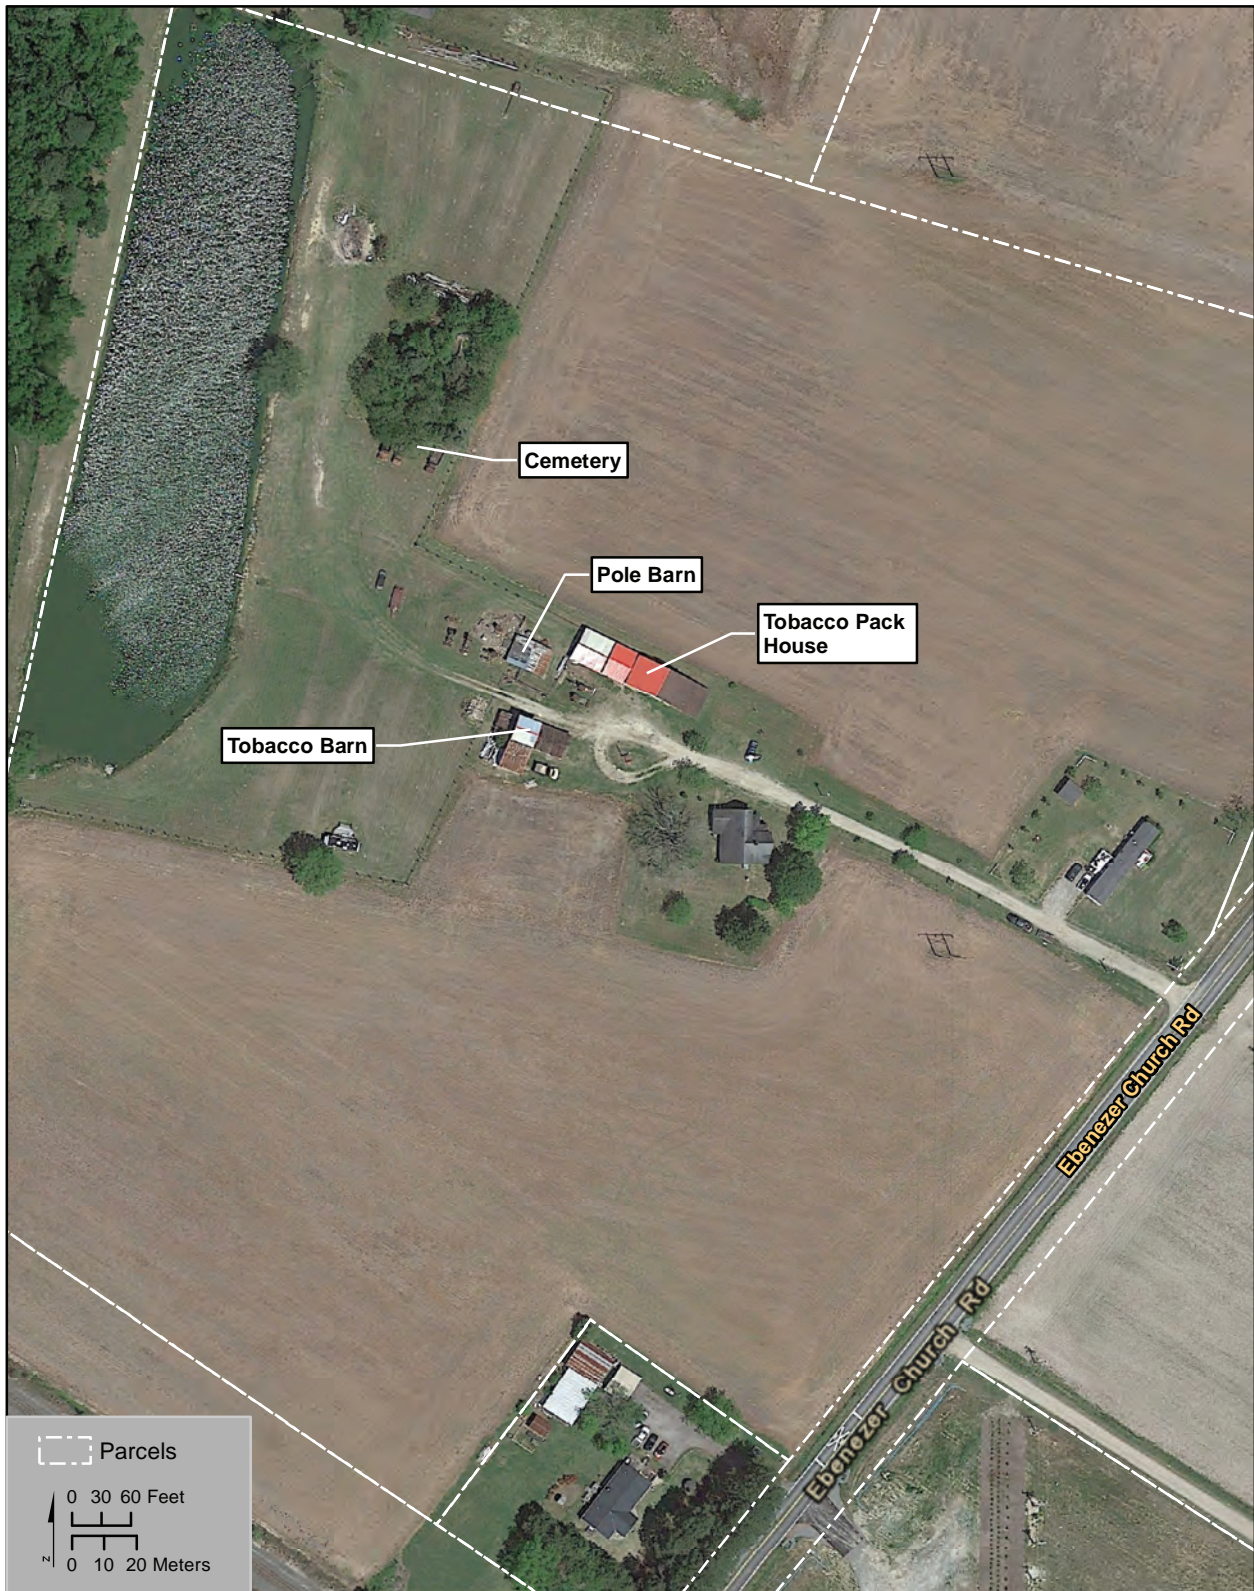
250 Ebenezer Church Road is a 26-acre farmstead located in a rural portion of Wayne County, North Carolina. With a deep, 375-foot setback from Ebenezer Church Road and 1,700 feet southeast of the heavily-trafficked U.S. 70, the property retains a pastoral setting. Five historic resources are located on the property: a circa 1900 dwelling, a circa 1930 tobacco packhouse, a circa 1930 tobacco barn, a circa 1950 pole barn, and the abandoned I.S. Smith cemetery with marked graves dating between 1872 and 1951. 250 Ebenezer Church Road is typified by acres of cleared fields, an approximately 525-foot long unimproved driveway, and an irrigation pond. Shade trees surround the house and the cemetery is located in an area of dense vegetation. This section of Ebenezer Church Road is sparsely populated with a few historic and non-historic houses and mobile homes situated among the cultivated fields between U.S. 70 and the bed of the North Carolina Railroad.

Figure 11.1. 250 Ebenezer Church Road Site Plan

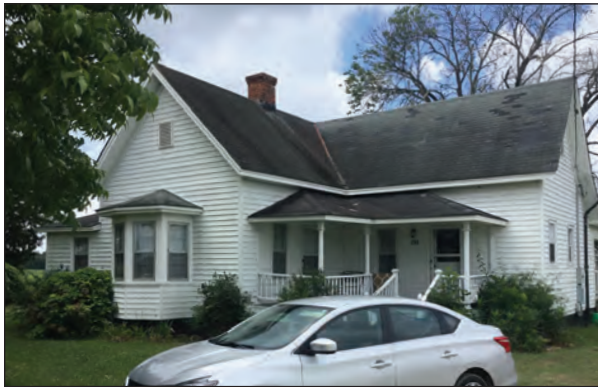
The circa-1900 House at 250 Ebenezer Church Road is a 1,482-square foot, one-story house. The core of the building is T-shaped, with two side-gable roofed portions meeting at a 90-degree angle (Figure 11.2 and 11.3). The house sits on brick piers with poured concrete now filling the space between each piling. The entire house is clad in non-historic vinyl siding and asphalt shingles cover the roof.

Figure 11.2. Façade Oblique, Facing Southwest
