SUBJECT: Historic Structures Survey Report, Improve US 70 E between US 70 from US 70 Goldsboro Bypass to West of SR 2314, Princeton, PA 18-03-0014, R-5829, Wayne and Johnston Counties, ER 18-0563

TIP No. R-5829
WBS No. 47101.1.1
PA No. 18-03-0014

Historic Structures Survey Report
Upgrading of U.S. 70 to Interstate Standards
from U.S. 70 Goldsboro Bypass to West of SR 2314 (Pondfield Road)

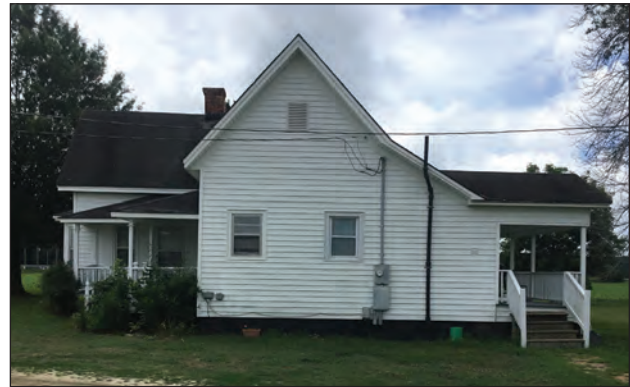
The circa-1900 House at 250 Ebenezer Church Road is a 1,482-square foot, one-story house. The core of the building is T-shaped, with two side-gable roofed portions meeting at a 90-degree angle (Figure 11.2 and 11.3). The house sits on brick piers with poured concrete now filling the space between each piling. The entire house is clad in non-historic vinyl siding and asphalt shingles cover the roof.

Figure 11.3. North Elevation, Facing South

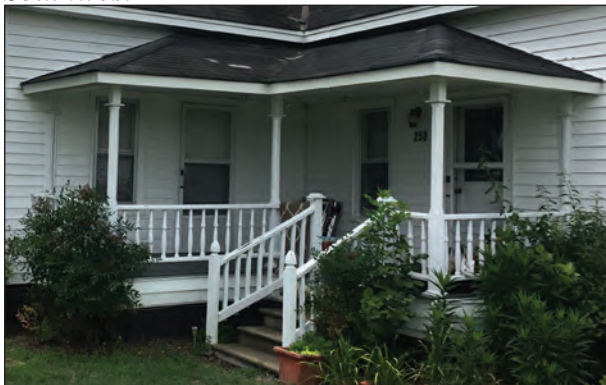
Two doors serve as entrances at the house's front, in the southeast corner of the building where the two main wings join: one faces east and another north (Figure 11.4). The historic east-facing entrance is a paneled wooden door with a large fixed light. The south-facing door appears to be a non-historic unit made of composite fiberboard. Double-hung sash four-over-four windows in wood frames are adjacent to each front door. The entrances are covered by an L-shaped hipped-roof porch. The wooden-floored porch stands on brick piers infilled with concrete and the roof is supported by chamfered wooden posts. A spindlework balustrade surrounds the porch. A variety of windows fenestrate the house, including six-over-six, four-over-four, and two-over-two double-hung sashes in wooden frames. The north facing elevation of the house features a non-historic

Figure 11.4. Porch Detail, Facing Southwest

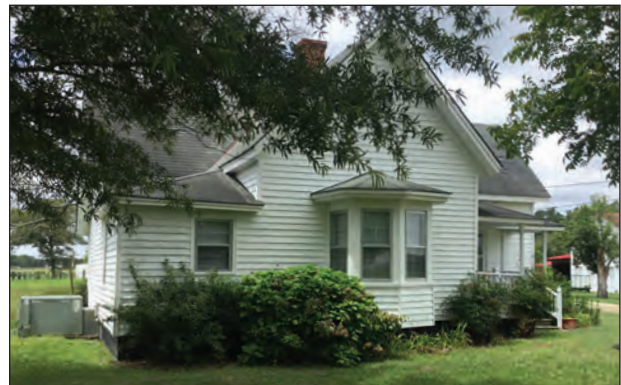
Figure 11.5. East Elevation, Facing West

one-over-one double-hung sash in a vinyl frame. Other than the spindlework and posts along the front door, the house is sparsely ornamented. Rectangular louvered vents at each gable end and an east-facing projecting bay window with a conical roof are among the few other decorations present on the building (Figure 11.5).

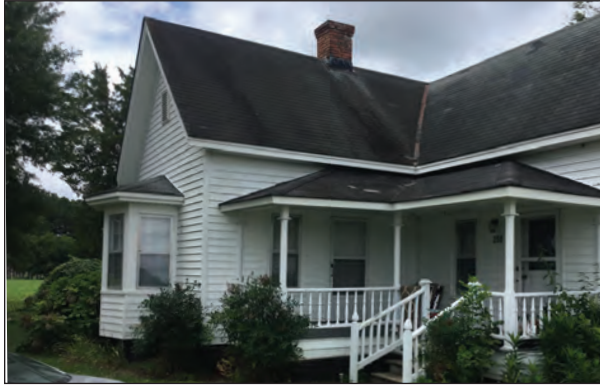
Figure 11.6. East Facing Addition, Facing Southwest

Multiple additions have been added to the house. The current building is L-shaped, with two side-gable roofed portions meeting at a 90-degree angle. The oldest portion of the house appears to be a side-gable roofed building oriented roughly north-south. An east-facing gable-roofed addition features an internal brick chimney along the ridgeline of the roof (Figure 11.6). A hipped-roof addition is located in the southwest corner of the house; this addition is diminutive in height compared to the two gable-roofed wings (Figures 11.7 and 11.8). A shed roof addition extends across the west side of the house (Figure 11.9). These aforementioned additions appear to have been constructed during the historic period, as they all rest upon brick piers. A western-facing porch seems to be the most recent addition to the house (Figure 11.9). This porch rests on a concrete block foundation and is covered by a gable roof. Square wooden posts support the porch roof and a simple balustrade surrounds the open-frame addition. A non-historic solid wooden door with a single fixed light serves as a rear entrance to the property. Interior access was not granted by the property owner.

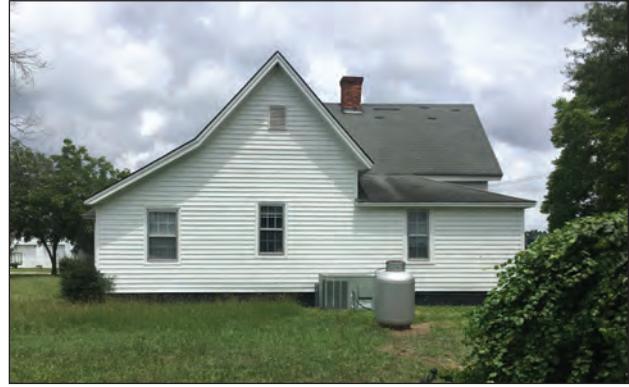
Figure 11.7. South Elevation, Facing North

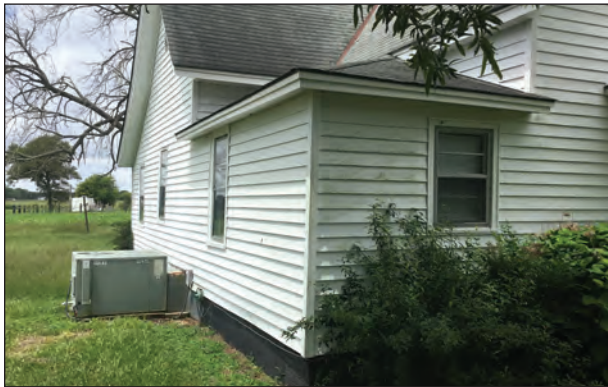
Figure 11.8. Hipped Addition, Facing Northwest

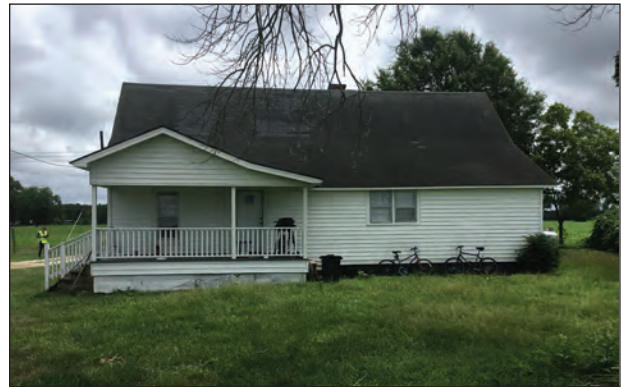
Figure 11.9. West Elevation, Facing East

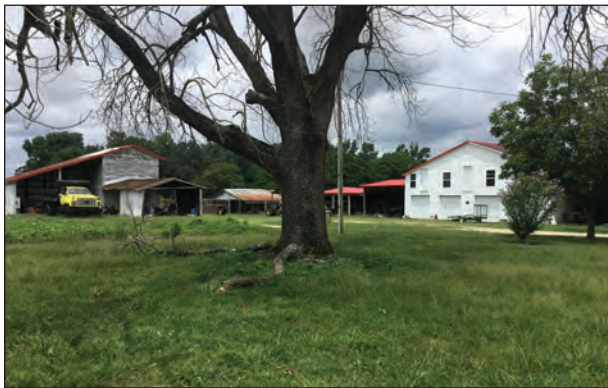
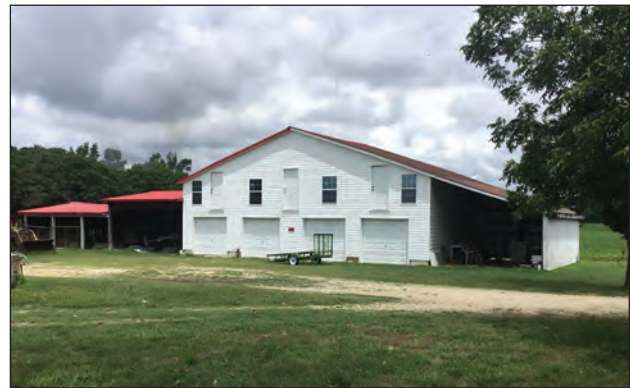
Approximately 150 feet northwest of the house stands a tobacco packhouse (Figures 11.10 and 11.11). The packhouse stands on a concrete block foundation and is covered by a standing seam metal gable roof. While the sides and rear are clad in vertically hung weatherboard, the south-facing primary façade of the packhouse is covered with horizontal vinyl siding. Four bays with non-historic overhead garage doors are located on the first floor of the packhouse. The second story is fenestrated with four six-over-six double hung sash windows. Three non-historic composite fiberboard doors allow access to the packhouse's second story loft. Storage shed additions are located on the east and west sides of the packhouse. Each of the three additions is sheathed in corrugated metal with no covering on their south-facing sides.

Figure 11.10. Tobacco Packhouse, Facing North

Figure 11.11. Tobacco Packhouse, Facing North

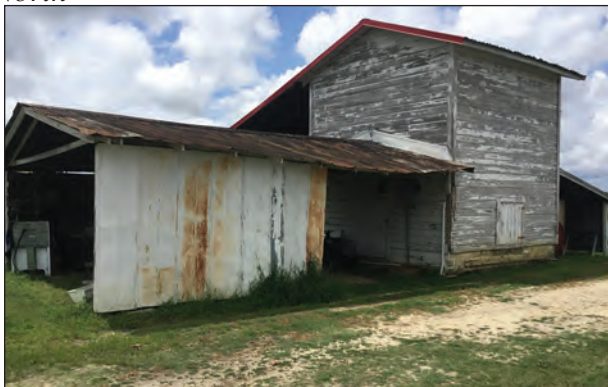
A two-story flue-cured tobacco barn is located approximately 200 feet west of the house (Figure 11.12). The barn stands on a concrete block foundation and is clad in weatherboard. A standing seam metal roof covers the barn. Storage shed frame additions covered with metal roofs and partially sheathed in corrugated metal panels are located at the south, west, and east of the barn.

Figure 11.12. Northeast Elevation, Facing Southwest

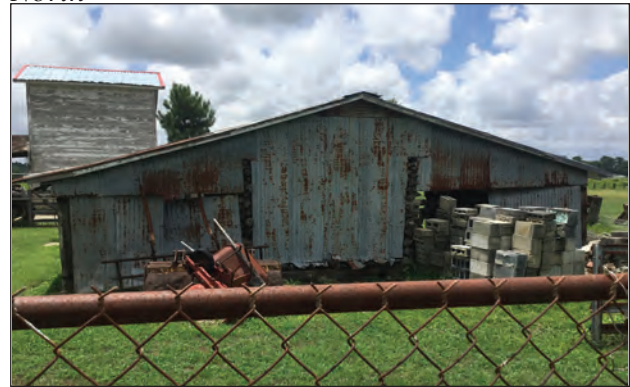
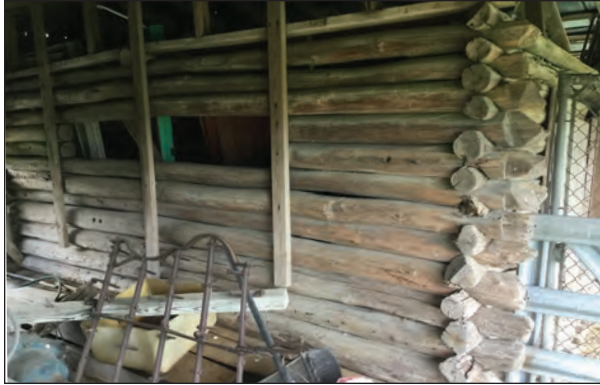
Figure 11.13. Window Detail, Facing Southwest

Figure 11.14. Log Pen in Interior of Pole Barn, Facing Northeast

A frame pole barn covered with a standing seam metal roof stands approximately 200 feet northwest of the house (Figures 11.13 and 11.14). The barn is partially clad in corrugated metal panels along the rear, northwest-facing elevation but remains unclad on other sides. A historic log construction inside the pole barn serves as a pen or crib. The structure's log walls are joined at the corners with saddle notches. The pole barn appears to be used primarily for storage.

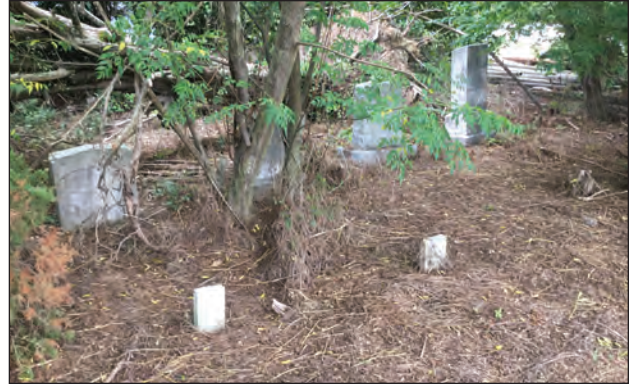
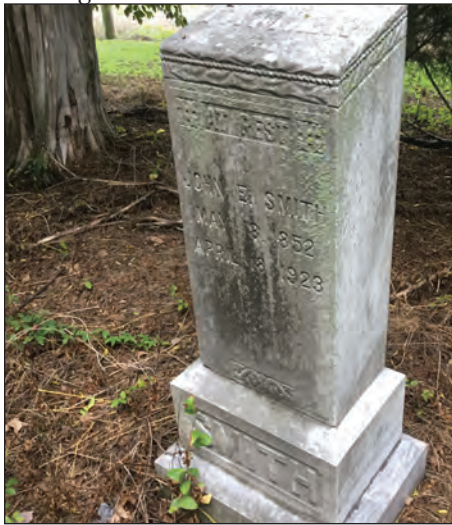
Figure 11.15. Cemetery, Facing Northwest

Figure 11.16. Headstone of John E. Smith

The I. S. Smith Cemetery is an informally arranged family cemetery with seventeen individual grave markers (Figures 11.15 and 11.16). The cemetery is located approximately 460 feet northwest of the house. The names of individuals buried in the cemetery are listed in Volume IV of the *Wayne County, North Carolina Cemeteries Book*. Immediate family members are buried together in linear clusters. Farm workers have left the area surrounding the resource wooded and uncleared, however there does not appear to be any regular upkeep within the cemetery.

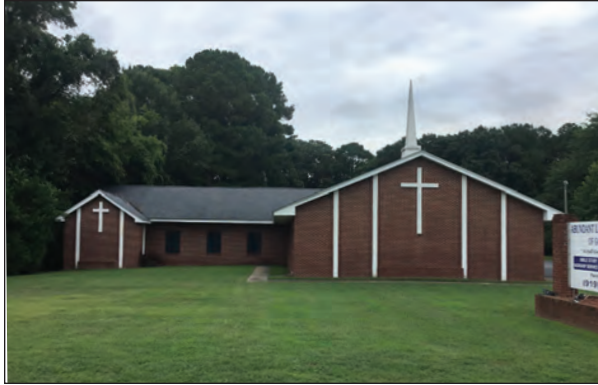
Figure 12.2. Façade, Facing Northeast

Abundant Life Church is a one-story gable-roofed church resting on a concrete slab foundation and clad in a brick veneer. The building is roughly oriented on a north-south axis, with the gable end facing U.S. 70, set back approximately 100 feet from the highway. Covered in asphalt shingles, the roof is topped along the ridgeline at the south end with a pyramidal aluminum steeple. The roof features non-historic aluminum boxed cornice returns, an aluminum fascia, and a vinyl soffit. The street-facing south side of the church's sanctuary (the building's historic core) is adorned with a concrete block cross, concrete pilasters, and a brick planter (Figures 12.2 and 12.3). Fixed stained glass windows in metal frames fenestrate the building's east and west sides and wooden flush doors are located along the eastern elevation, near the corners of the church. The door frame near the southeastern corner has been infilled with non-historic vinyl siding.

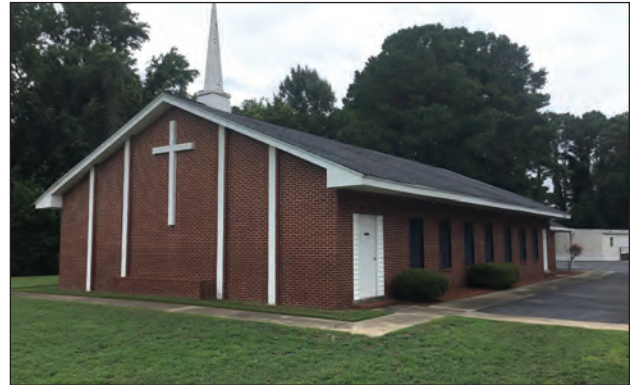
Figure 12.3. Oblique of Southeast Corner, Facing Northwest

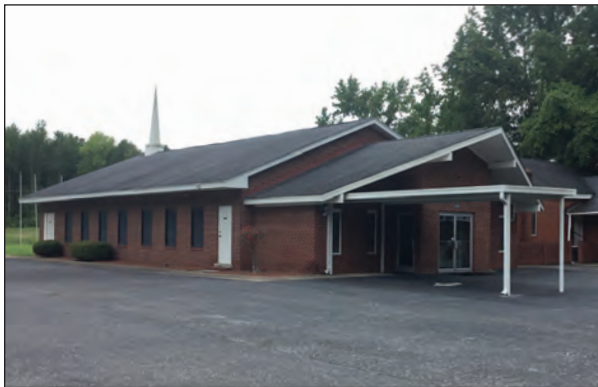
The church's primary entrance is located on the north side through a vestibule addition constructed in circa 1980 (Figure 12.4). Clad in brick and sitting on a slab foundation, the vestibule is covered by a distinctive gable roof. The open gable-end is supported by aluminum exposed rafter tails as the roof projects over the entrance (Figure 12.5). The angular vestibule roof is pitched slightly
