SUBJECT: Historic Structures Survey Report, Upgrade NC 107, R-5600, PA 17-04-0026,
Jackson County, ER 18-1087

SUBJECT: R-5600 Upgrade NC107, PA 17-04-0026, Jackson County

Resource Name	The Queen House
HPO Survey Site #	JK379
Location	53 Woody Hampton Road, Sylva, North Carolina (Jackson County)
PIN	7641-67-3073
Date(s) of Construction	c.1910, c.1950, c.1980, c.1990
Recommendation	Not Eligible

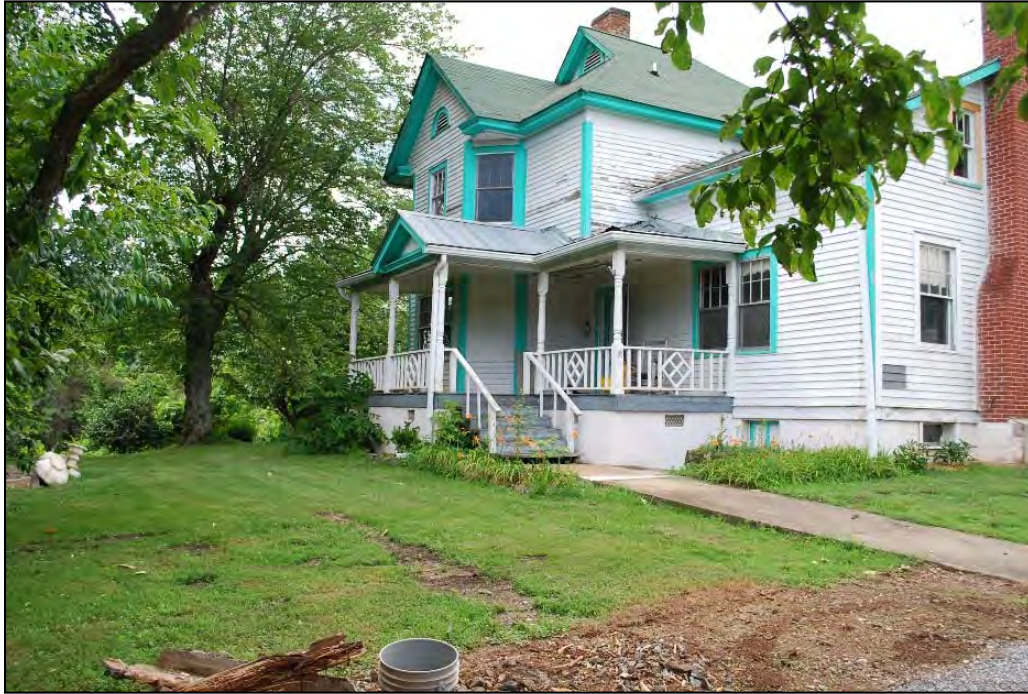
Photograph 3. The Queen House (c.1910), looking northwest

The *Queen House* was reportedly constructed c.1900 and is a well-preserved representation of a Queen Anne-style dwelling. The two-story, frame residence is irregularly massed and features weatherboard siding and a multi-gabled roof with asphalt shingles. According to the present property owner, the house originally rested on a foundation of locust wood posts. The basement was added during the late 1970s, at which time the present continuous concrete block foundation was completed.⁷

The residence is comprised of a 2-story, L-shaped massing with a 1 ½-story, gabled wing projecting on the east elevation. A gable on hip is centered on the roof ridgeline towards the front (south) of the dwelling and features an arched, wood-louvered vent. The roof features overhanging boxed eaves and a plain wood cornice surrounds the house beneath the eaves. Primary windows are replacement 6-over-1, double-hung wood sash. The house includes two interior brick chimneys and an exterior brick chimney is located on the east elevation and constructed in 1980. According to the property owner, the *Queen House* once boasted six coal fireplaces.

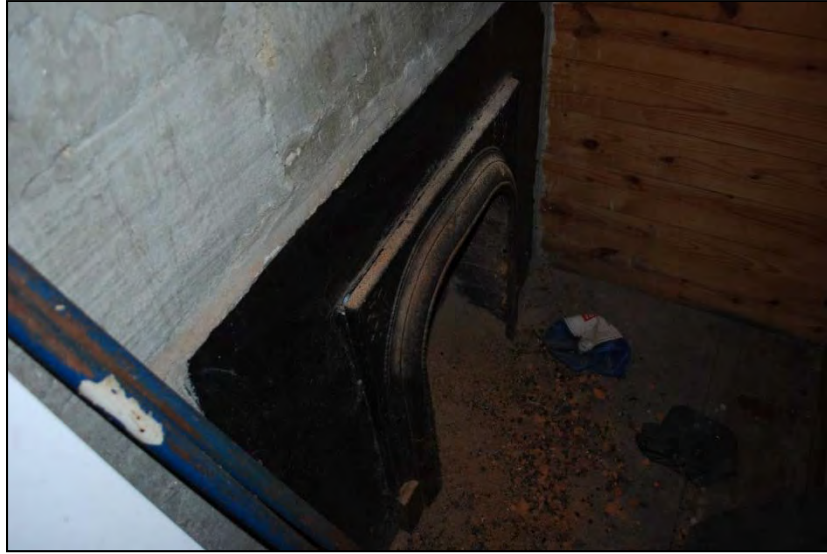
Photograph 13. Coal Burning Fireplace in Enclosed Wall

The first floor of the *Queen House* features a wide central hall with modern fiberboard paneled walls. The stairwell is located on the west side of the hall. A parlor flanks either side of the central hall. The east parlor is accessed via a set of French doors. According to the property owner, the parlor was originally larger in size and featured a coal burning fireplace. However, when electricity was installed in the house, the northern end of the parlor was enclosed to house the electrical equipment. The coal burning fireplace survives within the walls.

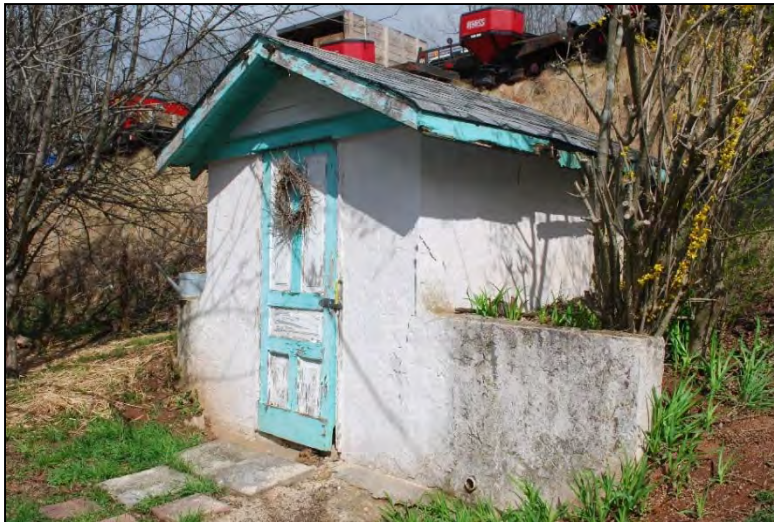
Photograph 17. Well House (c.1910), looking northwest

The well house is likely contemporaneous with the construction of the *Queen House*. The small building features front gable roof and a stuccoed exterior. A paneled wood door is centered on the façade (south elevation). The building appears to be constructed into the bank. A low stuccoed wall extends from the house to form a garden bed.

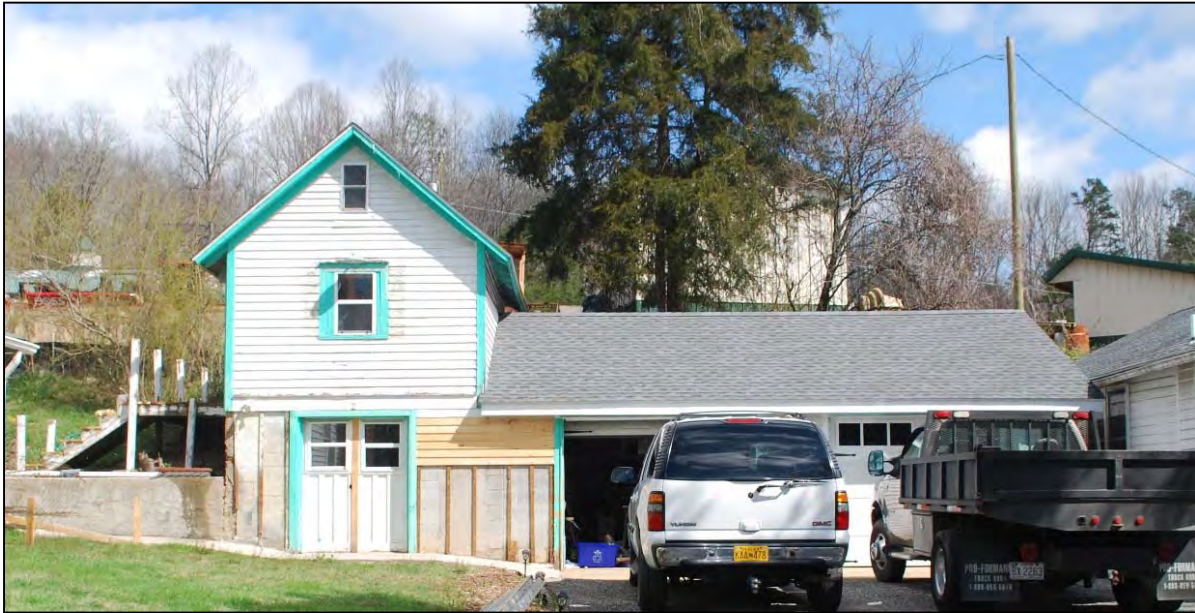
Photograph 18. Carriage House, looking northeast

The carriage house is a single bay, two-story frame building with weatherboard siding and a gable roof. The raised concrete foundation houses the garage. The original garage bay is a single opening. It has since been enclosed with two glazed and paneled doors. Above the garage is a single unit apartment. A modern 1-over-1, double-hung, vinyl sash window is above the garage bay. The apartment is accessed by wood steps leading to the west elevation. A c.1970s two-car garage addition extends to the east. The addition features a low-pitched side-gabled roof.

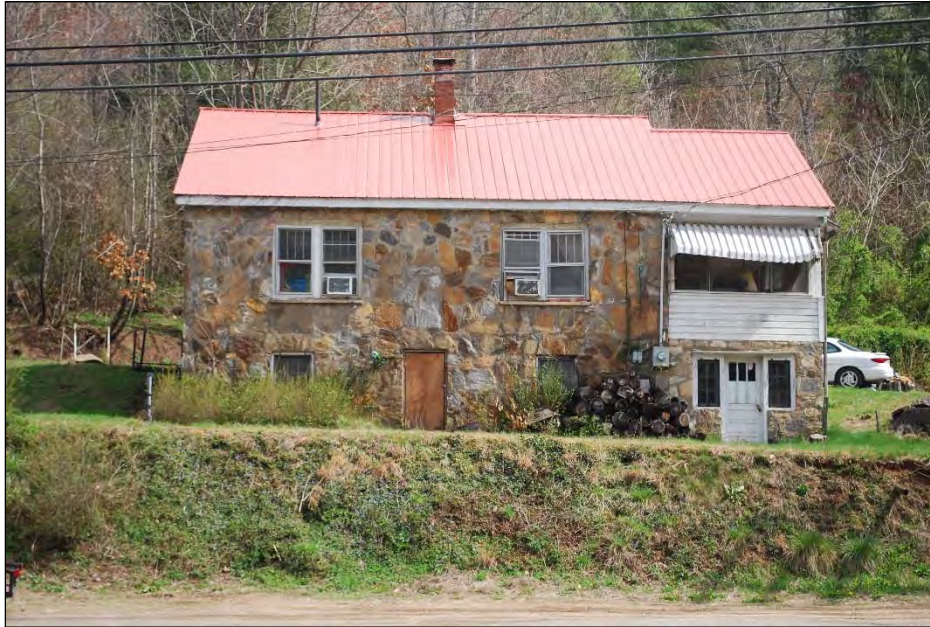
Photograph 25. Stone House No. 1, Façade (West Elevation), looking east

Constructed c.1945, Stone House No. 1 is a front-gabled bungalow, historically facing south towards Stormy Cove. The building is comprised of a one-story, front-gabled massing on a raised basement, and a partial-width enclosed entry porch. The roof is covered in modern corrugated metal and an interior brick chimney is centered on the ridgeline. Gable ends are clad in beveled wood siding. The exterior of the house is covered in what appears to be random-coursed Crab Orchard stone veneer. Crab Orchard stone veneer was a popular building material occurring frequently throughout the community during the mid-20th century. The basement level of the enclosed porch is also stone; however, it is not clear whether Crab Orchard stone was employed. The later construction of Stone House No.2 fronting NC 107 did not employ Crab Orchard stone; however, it does exhibit a similar variegated stone veneer.

The façade (West elevation) of the principal massing is symmetrical with three (W, D, W) bays on the first floor, or raised basement, and two bays of paired windows on the second. First floor windows are six-light, fixed wood sash. Whereas, the upper floor windows are four (vertical)-over-one, double-hung wood sash. The original centered entry door is replaced with a temporary plywood door. The west elevation of the enclosed porch features a Craftsman-style entry door with vertical lights and horizontal panels. The entry door is centered on the basement level and flanked by six-light, fixed windows. Above the entry door and stone veneer of the basement level, the porch is enclosed with large sliding windows and beveled siding. An aluminum extends above the windows.

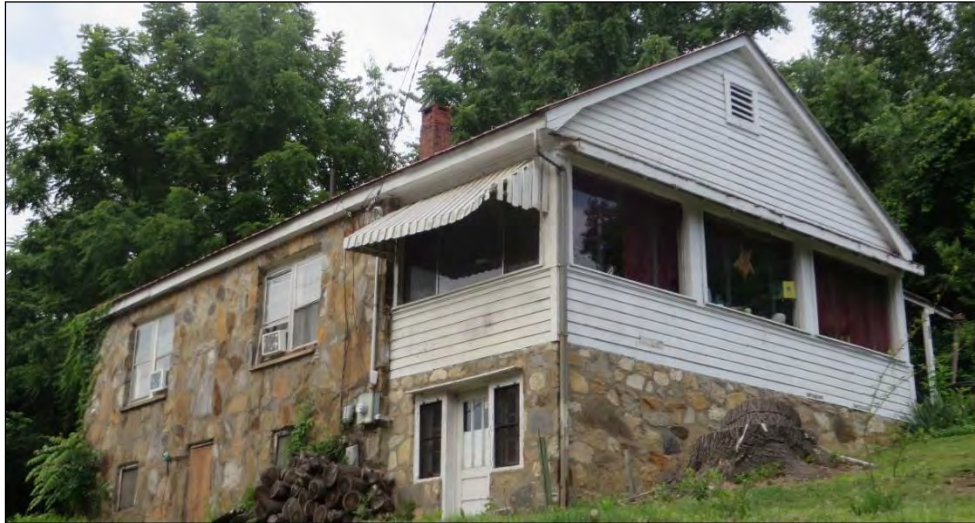
Photograph 26. Southwest Oblique of Stone House No. 1, looking northeast

Stone House No. 1 is a late representation of a bungalow featuring a stone veneer exterior with modest Craftsman-style detailing. The use of rustic building materials such as stone or wood shingles often distinguishes Craftsman-style dwellings, as is the case with the stone veneer exterior of the Stone House No. 1. Other Craftsman-style elements enhancing Stone House No. 1 are multi-light windows and doors.

The south elevation of house dominated by the enclosed porch. The stone veneer applied to the raised basement is continued on the south elevation. Similarly, the beveled siding and wide, sliding windows are continued as well. Access to the east elevation of the dwelling was not permissible. However, the raised basement does not continue along this elevation. A door flanked by fixed lights appears to lead into the porch. A flat roof extends from the door above a concrete patio. An entry door is centered on the primary massing with six-light fixed windows on either side.

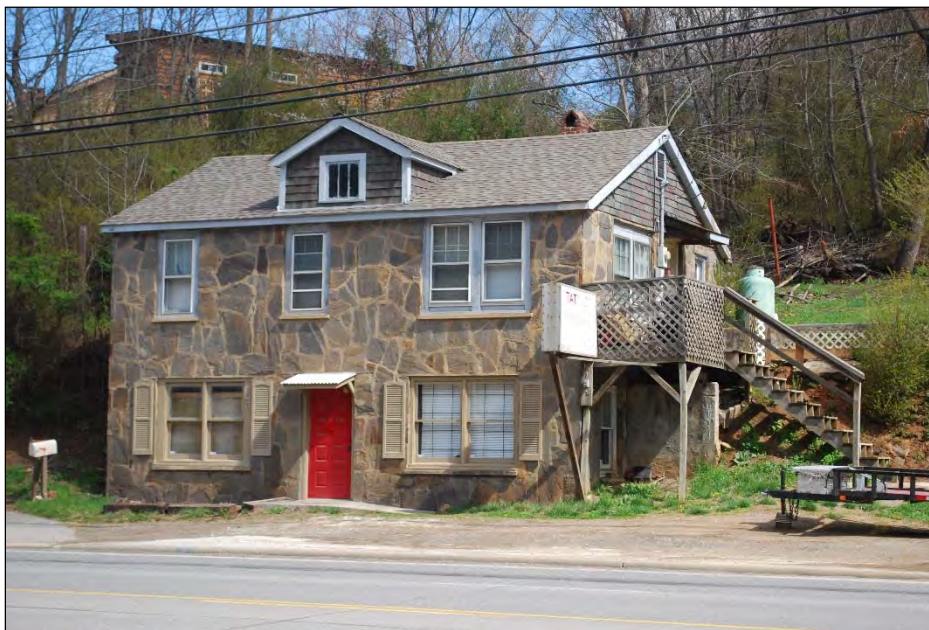
Photograph 28. Stone House No. 2, looking northeast

Constructed c.1955, Stone House No. 2 is a two-story dwelling located at street level; however, its rear is built into the side bank of a hill. It is unclear whether the building was planned as a multi-family residence. At present, the first floor is a vacant commercial space and the second floor is an apartment. At first glance from NC 107, its design and materials are similar to the c.1945 bungalow. However, the dwelling does not appear to conform to a defined residential architectural form or academic architectural style. The building is wood frame construction with an exterior of variegated stone veneer. The low-pitched, side-gabled roof and gable ends are covered in asphalt shingles. A low-pitched gable dormer is centered on the front roof slope. It is clad in asphalt shingles and a three (vertical) light fixed wood sash window is centered on the façade (west). The façade of the building is three bays with a modern replacement entry door centered on the wall. The first floor of the façade features paired one-over-one, double-hung wood sash windows on either side of the entry door. The second floor of the façade is occupied by three window bays. The third window bay is a set of paired windows. Second floor windows on the building are six-over-one, double-hung wood sash.

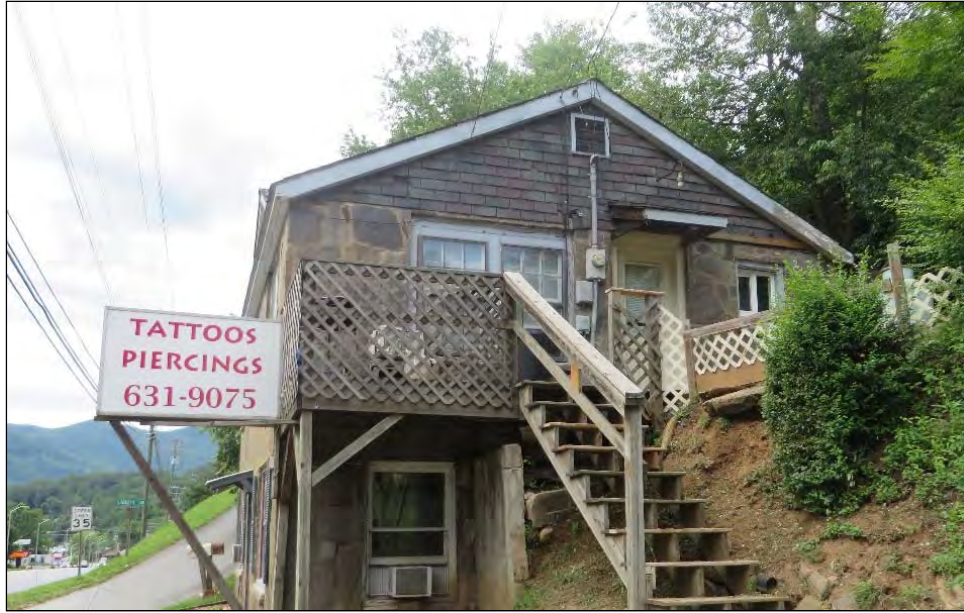
Photograph 29. Stone House No.2, South Elevation, looking north

The south elevation of Stone House No. 2 reveals the construction of the building into a side bank. A single window is located on the first floor toward the façade. A concrete retaining wall projects from the side of the house right of window. The second floor of the south elevation features paired windows, an off-centered, glazed entry door, followed by a square casement window. A wooden deck supported by wood posts extends from the second floor. Wooden steps lead from the deck and follow alongside the hillslope. Access to the rear of the house was not permitted.

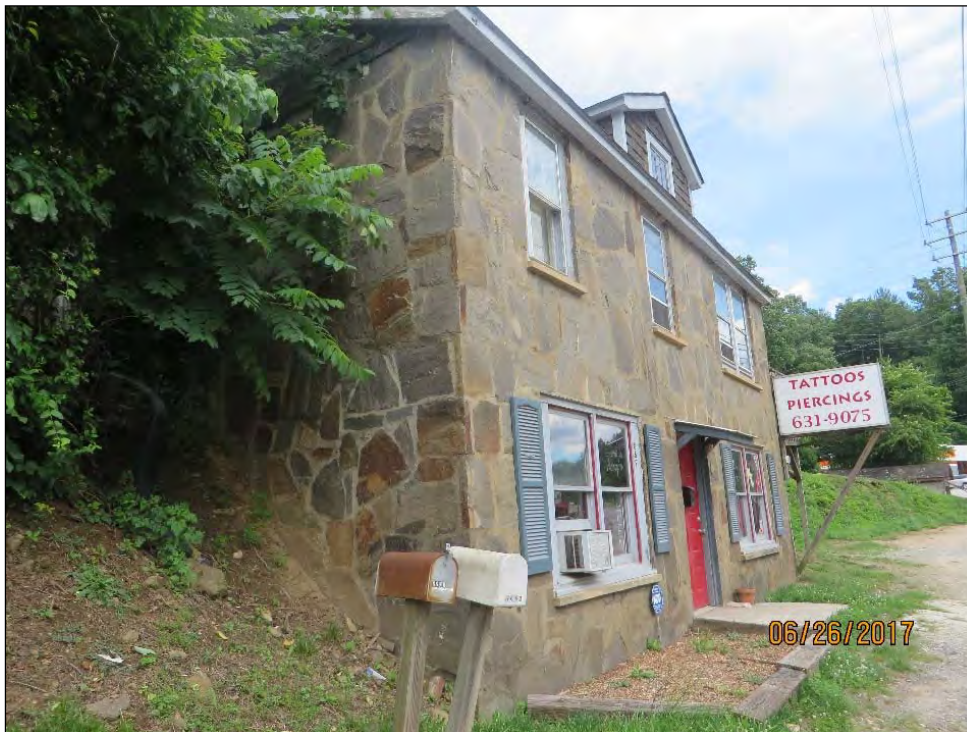
Photograph 30. Stone House No. 2, Northwest Oblique, looking southeast

The majority of the first floor of the north elevation is built into the bank. As such, there are no window or door openings at street level. Overgrown vegetation conceals much of the upper floor; however, two windows appear to be present.

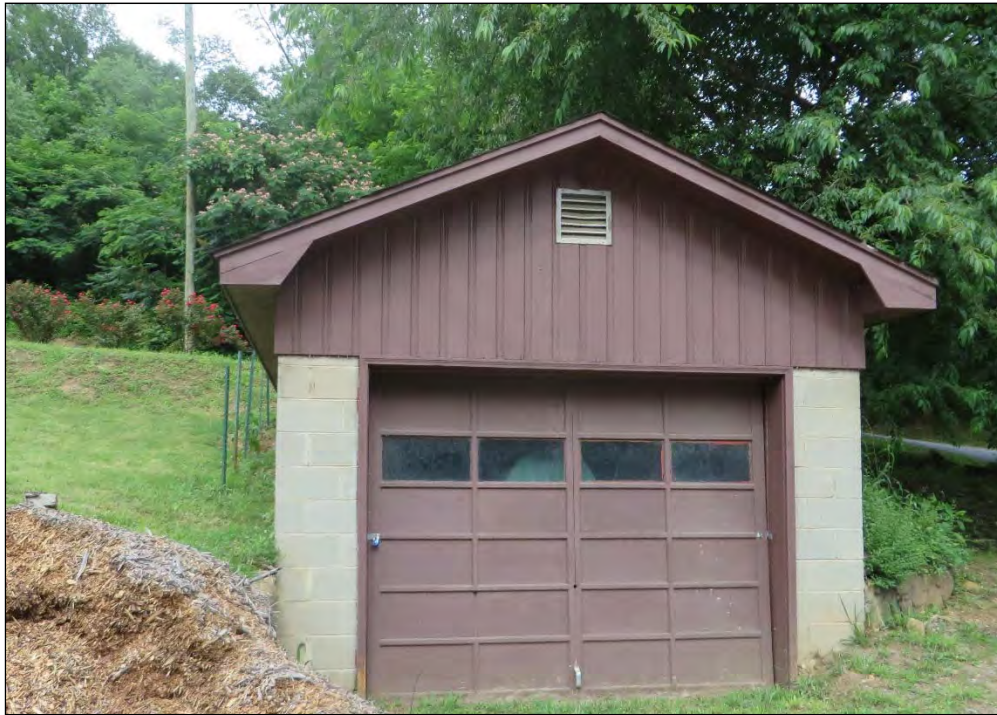
Contemporaneous with Stone House No. 2, the garage is concrete block construction with a gabled roof covered in standing seam metal. The gable end is covered in vertical wood panels. The building fronts NC 107 and features a single, swing out-type garage door.

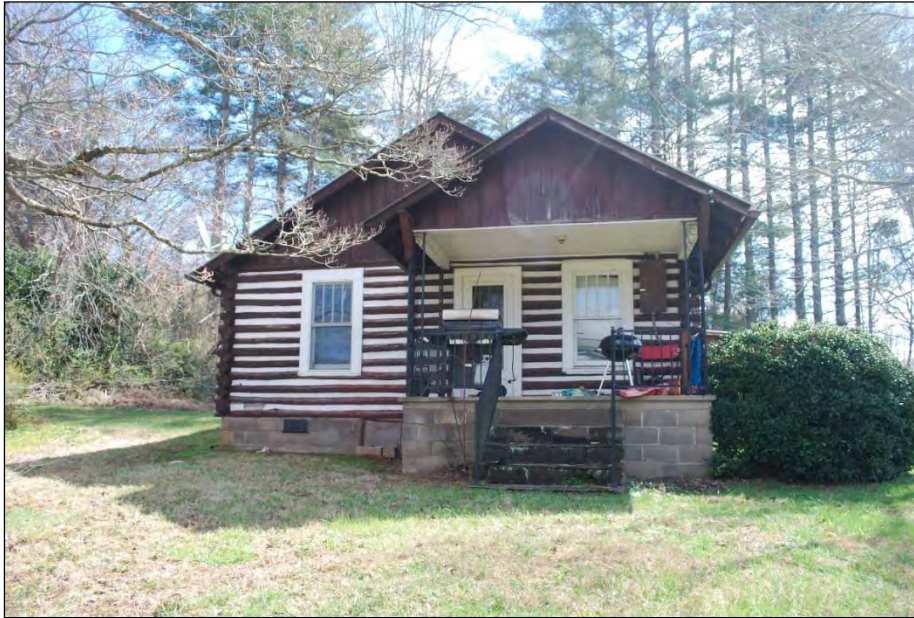
Photograph 37. *Parker House* Façade (North Elevation)

Constructed c.1940, the *Parker House* is a Rustic Revival-style bungalow featuring a front-gabled roof with wide overhanging eaves. The one-story bungalow features an exterior of dark, round hewn logs with saddle notching and a contrasting bright white chinking. The roof is standing seam metal. The house is comprised of the original bungalow form (two rooms wide and three rooms deep), a full-width, concrete block extension along the rear, followed by a concrete block two-car garage. When the rear addition and garage were added, the orientation of the front of the house was altered to front NC 107. Further, the additions transformed the character of the house from its original Rustic Revival-style bungalow form to a mid-century Ranch house. Figure 12 shows the general composition and massing of the *Parker House* based on exterior field observations.

The original façade (northwest elevation) is three bays wide (W, D, W) with an off-centered entry door and two windows. Primary windows of the original massing are four (vertical)-over-one, double-hung wood sash. A partial-width, front-gabled porch is off-centered and features replacement decorative metal posts. The gable ends of the façade and porch feature board-and-batten siding.

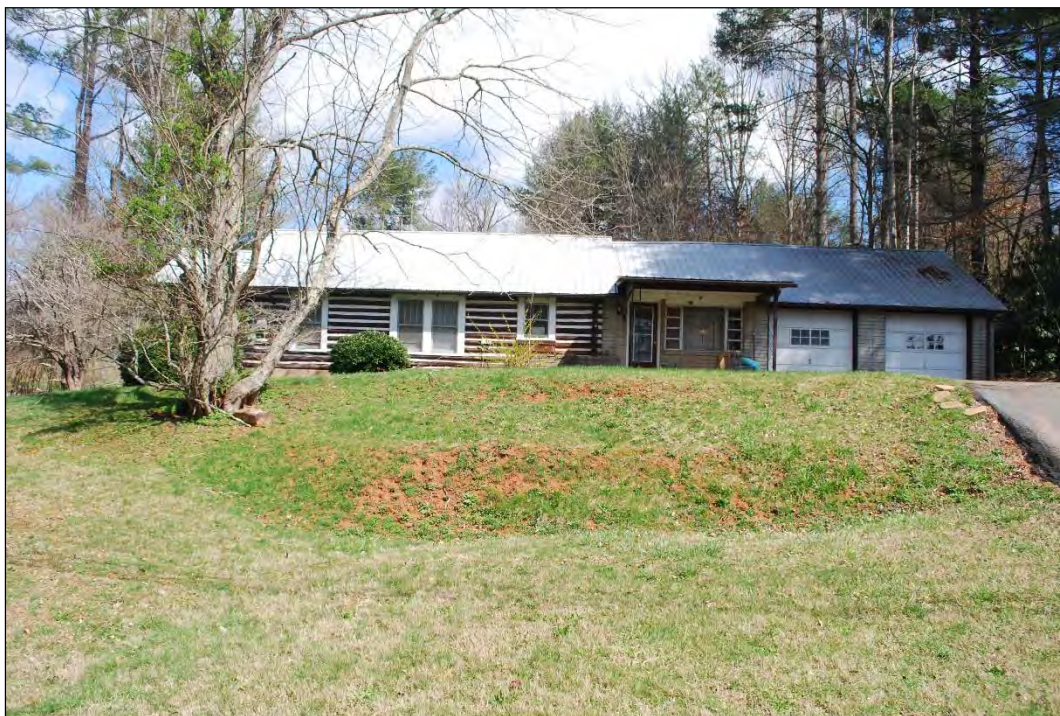
Photograph 38. *Parker House* (JK720), west elevation

The west elevation of the dwelling reflects the various building phases. This elevation of the original bungalow features a single window, paired windows, followed by another single window. The extension to the south, along with the garage addition appear to be contemporaneous and share the same roof. The addition features a coursed white brick veneer. The west elevation of the extension features a single entry door with glass louvers and a large, single pane picture window flanked on either side by four-light awnings. A shed roof above concrete patio extends along the addition. The roof is supported by the same decorative metal posts as those on the front porch of the bungalow. The two garage bay doors are paneled with eight fixed lights.

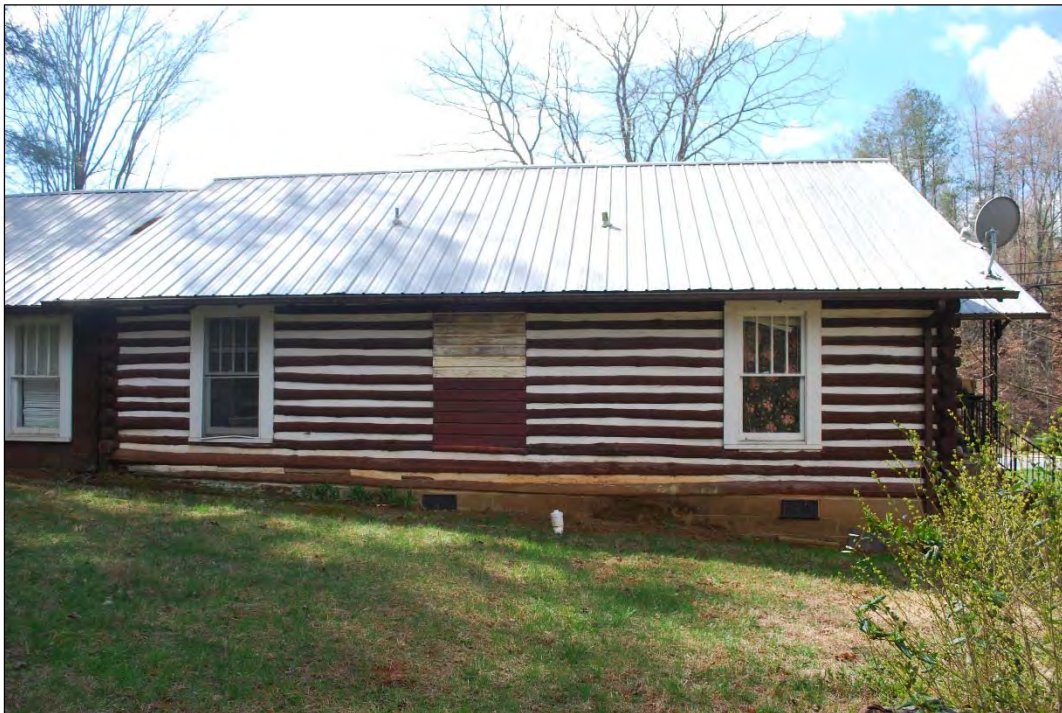
Photograph 40. *Parker House* (JK720), west elevation of original massing

The south elevation of the Parker House features exposed concrete block construction and a three-light metal awning window. The west elevation of the original bungalow features three symmetrical window openings. The middle window has been removed and infilled with flush board siding. Left (south) of the original massing is the 1960s extension. This bay of the extension includes a single window, which appears to be the window removed from the bungalow. Left of the concrete block bay extension is a door and a two (horizontal)-over two (horizontal), double-hung metal sash window. This section of the extension appears to be clapboard-sided. The east elevation of the garage addition features two metal awning windows.

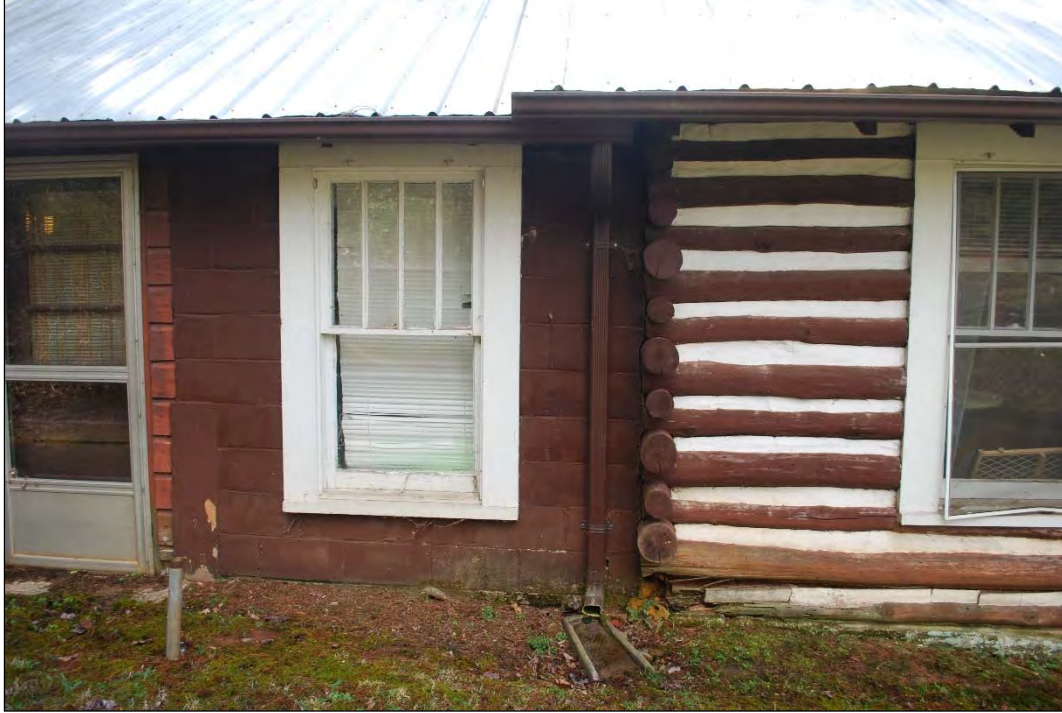
Photograph 41. *Parker House (JK720)*, concrete block extension

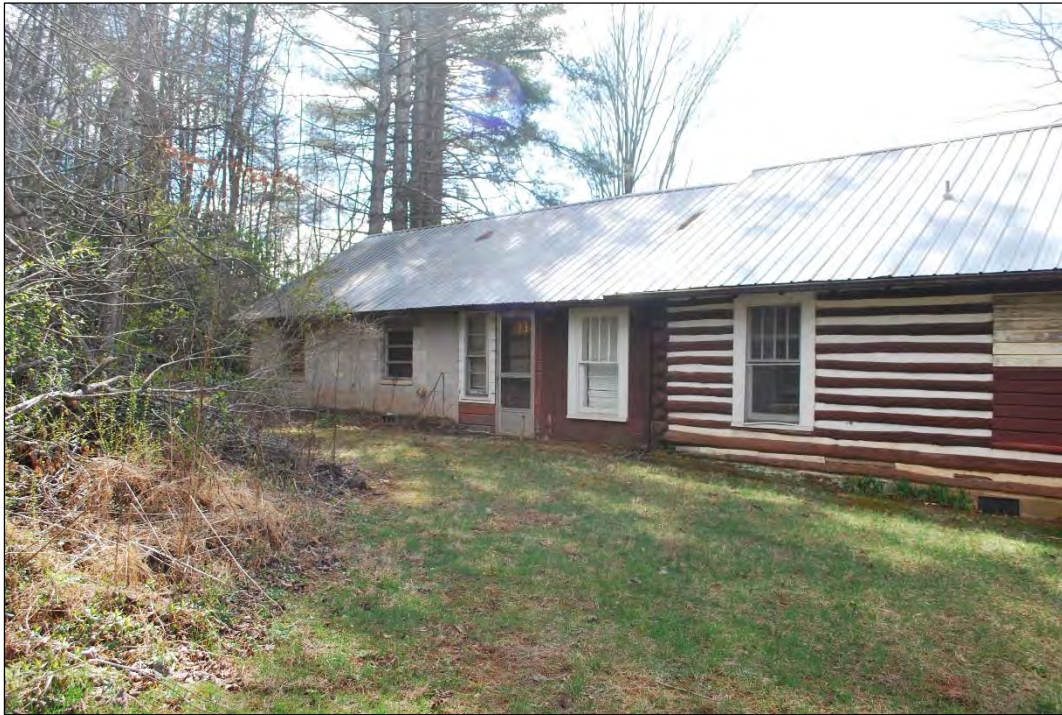
Photograph 42. *Parker House (JK720)*, east elevation

Upon first sight, the intended Rustic Revival design of the house is apparent. With the exception of the replacement porch posts and the removal of the window on the east elevation, the original bungalow massing appears intact. However, the c. 1965 addition to the rear reoriented the façade of the house toward NC 107, creating the appearance of a Ranch house.

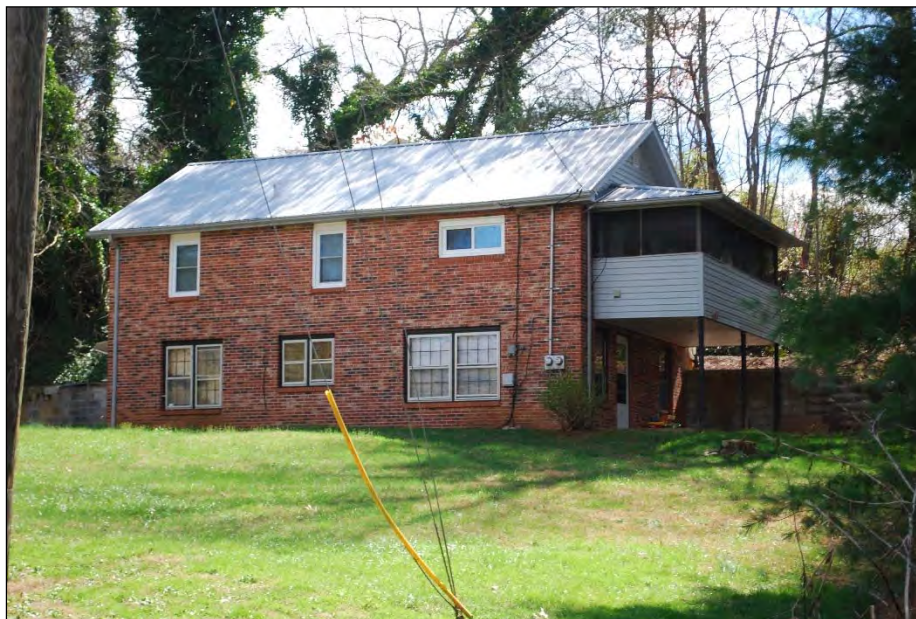
Photograph 43. Two-Story Duplex, looking southeast

Constructed c.1975, the two-story duplex features a low-pitched side-gabled roof and a brick veneer exterior. The façade (north elevation) is three bays. The first floor of the façade includes three sets of paired double-hung wood sash windows. The upper floor includes two single, double-hung windows and a clerestory window set high on the wall. Access to each unit is from both side elevations. A second-story, screened porch with hipped roof is on the west elevation and supported by metal posts.

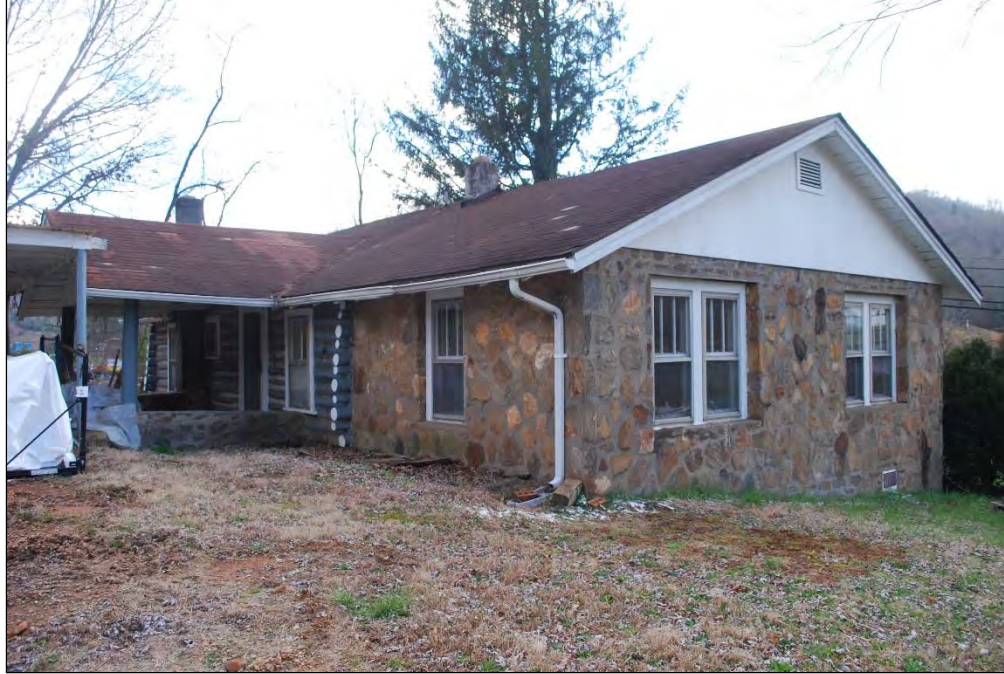
Photograph 45. Gunter House (JK721), facing southeast

Despite the lack of previously documented Rustic Revival-style dwellings in the Sylva area, a windshield survey conducted in the vicinity of the *Parker House* identified one comparable example, the *Gunter House* (JK721). Constructed in 1941, the *Gunter House* (JK721), located within the APE, is an illustration of a Rustic Revival bungalow characterized by its use of what appears to be Crab Orchard stone veneer as well as round logs with saddle notching and neutral-toned chinking. The contrasting materials create a sense of pioneer nostalgia enhanced by a mid-20th century variation to a traditional Rustic Revival stone veneer exterior. Its employment of large stone slabs, rather than the smaller, rough course stones of traditional Rustic Revival cabins, suggests an attempt to retain a picturesque aesthetic while demonstrating a degree of wealth. Although the exterior of the *Gunter House* (JK721) is intact, its interior lacks design elements characteristic of the Rustic Revival. Further, its original interior design elements are compromised.

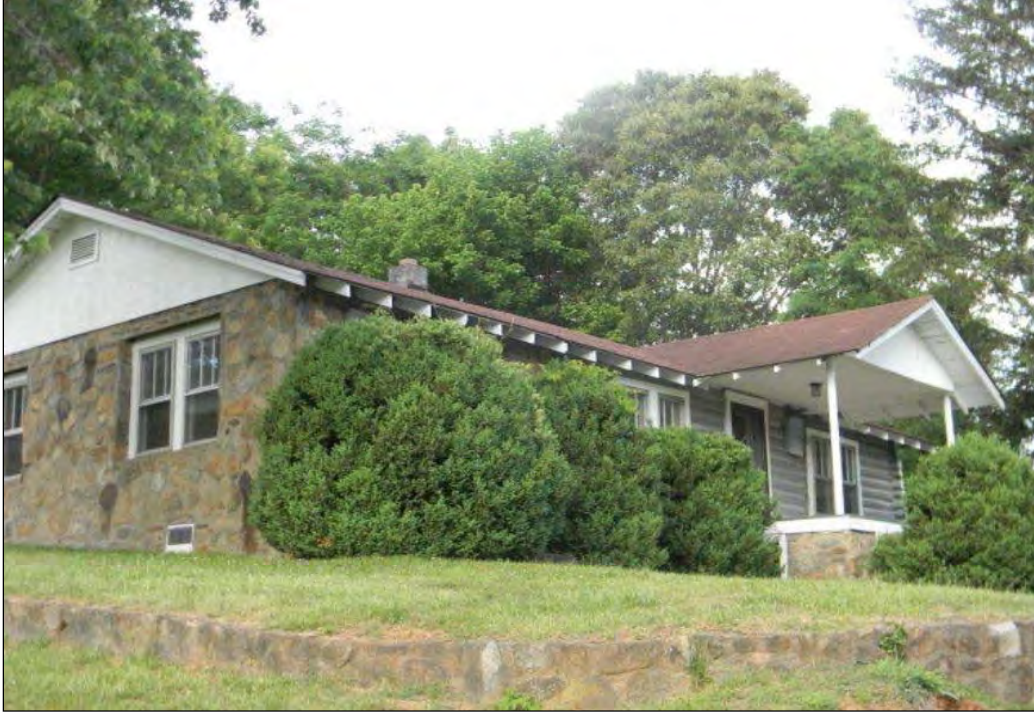
Photograph 50. *Gunter House* (JK721), northeasterly view of low stone retaining wall

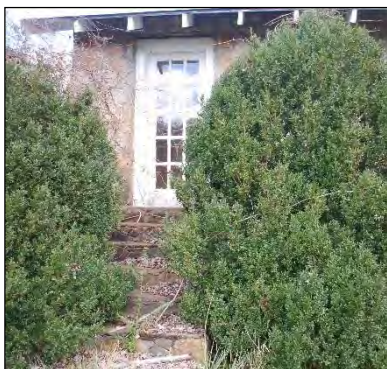
Photograph 51. Multi-Light Door at North End of Facade

The façade (southwest elevation) of the *Gunter House* is asymmetrical and five bays wide (D, W, 2W, D, 2W). The first two bays (from left to right) occupy the stone veneered section of the house. The first bay is a narrow, multi-light door opening to stone steps leading to the front yard. To the right of the door is a single, double-hung wood sash window. To the east (right), the log exterior portion of the dwelling features paired windows on either side of an entry door. The entry door features a large single light with horizontal panels below. It contains molded wood frame with corner blocks. A partial-width, front-gabled porch extends from the façade of the log section of the dwelling. The porch features overhanging eaves with exposed rafter ends, tapered round wooden posts, and vertical flush board in the gable end. The porch foundation is stone. A four-light fixed window occupies the porch foundation on its east.

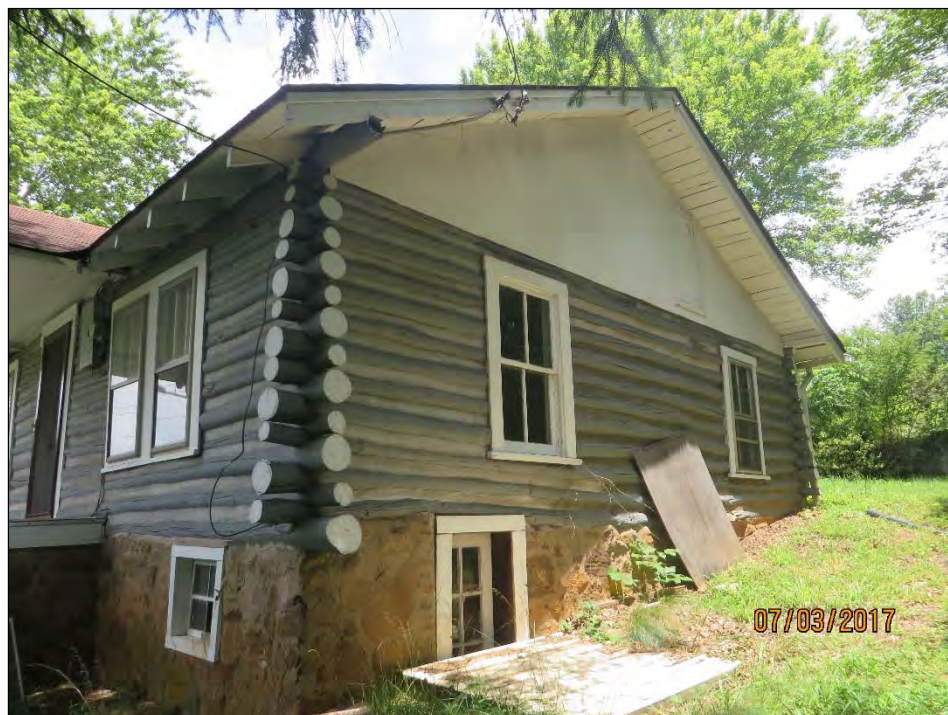
Photograph 54. *Gunter House* (JK721), southeast oblique

The southeast elevation is log construction and contains two single windows. Both windows are two (vertical)-over-two (vertical), double-hung wood sash. The gable end features flush board siding. The stone basement is partially above-ground on this elevation and features a small, multi-light entry door. The rear elevation (northeast) of the *Gunter House* is similar to the front of the dwelling. The stone veneered section contains a single three (vertical)-over-one sash window. Whereas the two primary windows on the log exterior section are two-over-two. The entry matches the door of the façade of the house. Adjacent to the rear entry door, however, is a small four-light, fixed window set high on the wall. Left of the window is an exterior concrete block chimney. As with the front of the house, a gabled porch extends from wall. It is supported by fluted round columns resting on a low, stone knee wall. An open, metal carport with flat roof was added to the rear of the property in 2010, attaching slightly to the porch gable. The northwest elevation of the *Gunter House* features two sets of paired windows set into the stone veneer exterior wall.

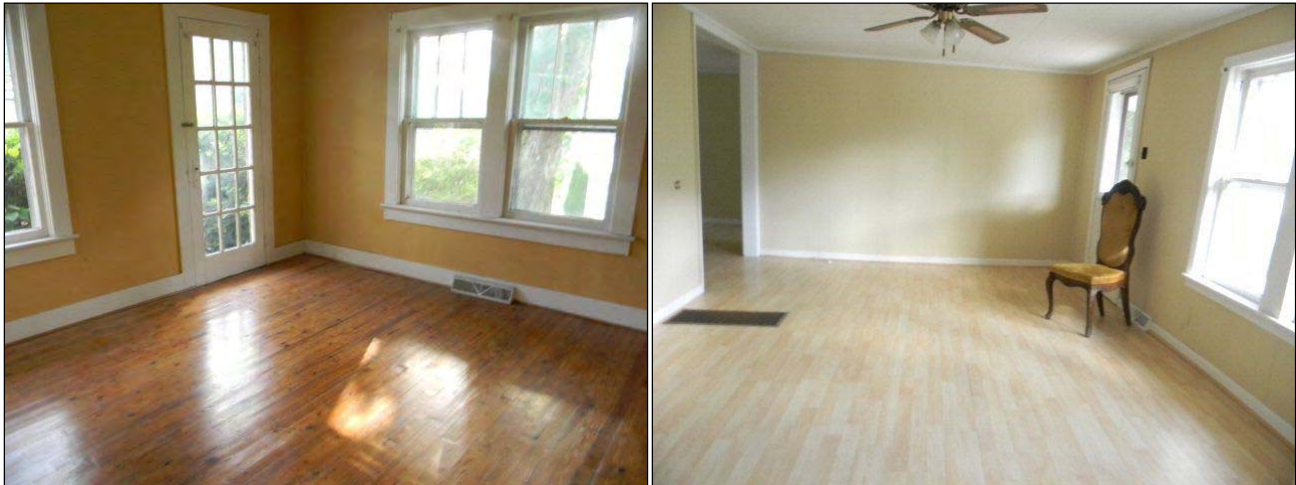
Photograph 56. Northeast Bedroom (LEFT) and Front Living Room (RIGHT) of the Gunter House (JK721)

The interior of the *Gunter House* was inaccessible. However, photographs retrieved from Realty.com online, which were taken in 2013, assist with an interior evaluation. Two bedrooms appear to occupy the stone veneered section of the dwelling. Based on the photographs, the rooms feature original hardwood flooring, wood window and door frames, and a plain wood baseboard. The interior, wood-paneled doors are likely original to the house. Upon entry from the front porch, an open living space features replacement flooring. Opposite the entry door is a wide door opening leading to the rear of the house and a hallway.

The opening is likely not original to the house, but widened to create a more open floor plan. A small bedroom located at the southeast corner of the house is carpeted. The layout of rooms occupying the rear of the house is unknown.

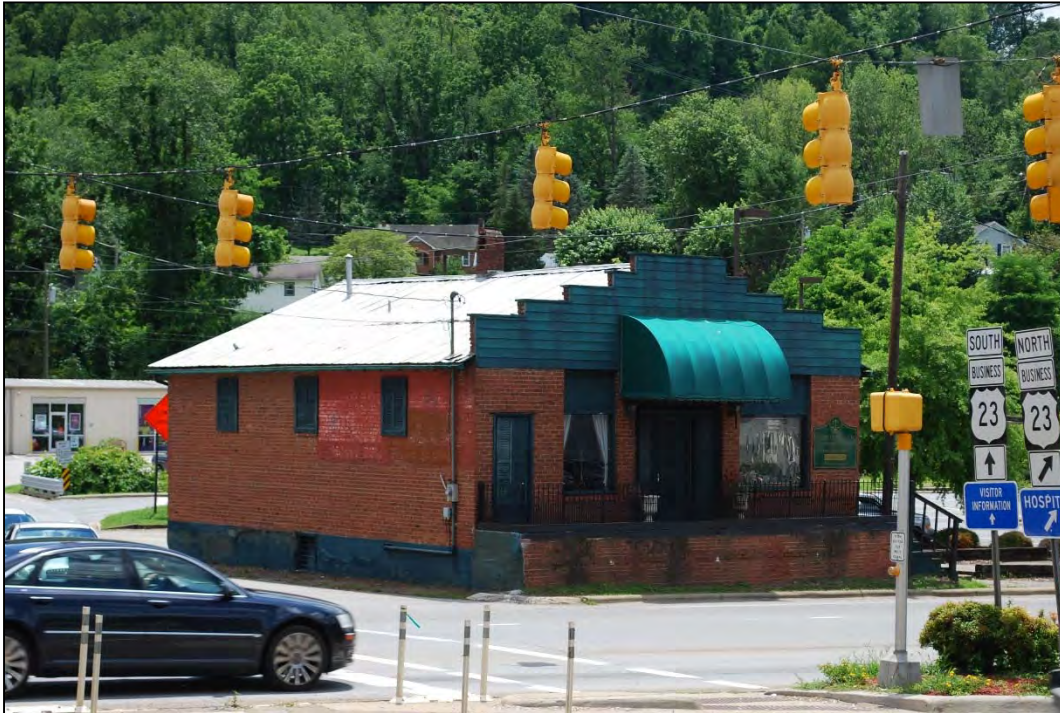
Photograph 60. *Old Ensley Store*, looking southwest

Constructed in 1943, the *Old Ensley Store* (JK722) is a one-story, free-standing brick commercial building fronting the south side of E. Main Street/NC 107. The building features a low-pitched, front-gabled roof clad in standing seam metal. A small brick chimney straddles the ridgeline and a stepped brick parapet accents the façade (north elevation). Weatherboard siding is applied to the face of the parapet. The exterior bricks are laid in a five-course American bond pattern. The foundation is stuccoed.

Located at the east end of the façade of the *Old Ensley Store* is a narrow door concealed by a two-leaf, wood-louvered screen door. The primary entry door is centered on the façade. The door is a modern replacement flanked by wood-louvered screens. A single pane, fixed window with a boarded over transom above is located on either side of the entry door. The window to the west of the door is wider than its counterpart. A full-width, narrow brick porch extends the width of the façade. A metal balustrade surrounds the porch.

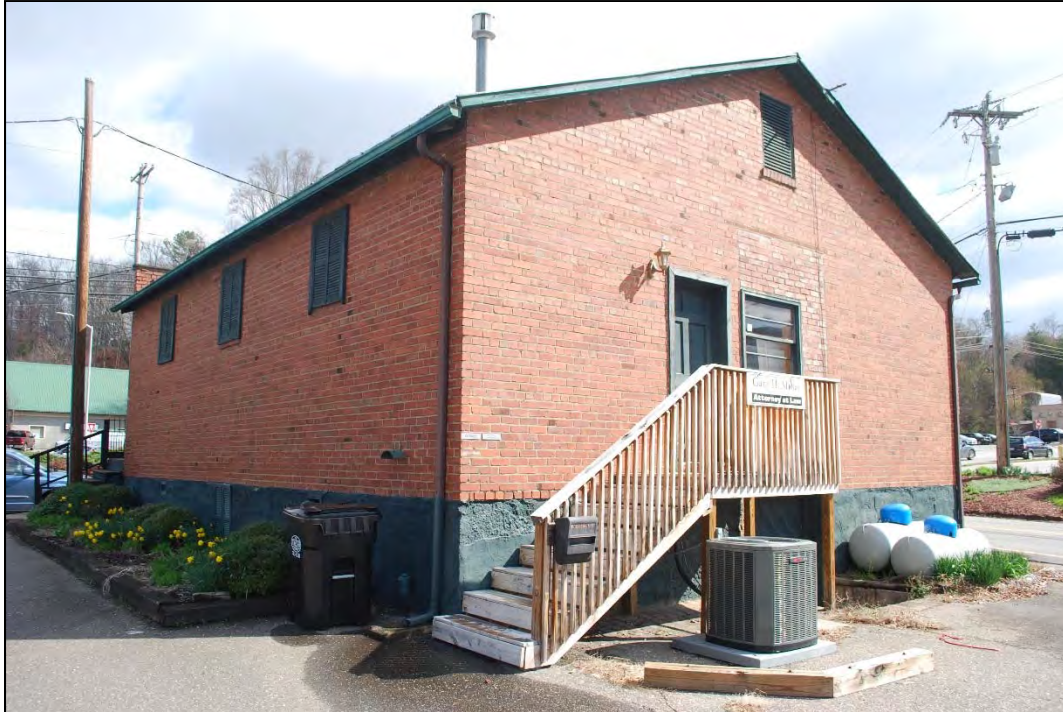
Photograph 61. Southwest Oblique of the *Old Ensley Store*, looking northeast

The east and west elevations of the store are identical, with each containing three fixed windows concealed by a wood-louvered screen. The windows are set high on the wall. The rear of the building features a wood-louvered vent in the gable end. Ghost marks of a large, square window is centered on the rear wall. It is apparent that the window was removed and infilled with brick. A two (horizontal)-over-two (horizontal), double-hung wood sash window is installed in the former opening. Adjacent to the window on the west is a paneled wood door that opens to a wooden deck with steps leading to the parking lot. A raised basement is accessed from the rear via concrete steps. A two-leaf door leads into the basement.

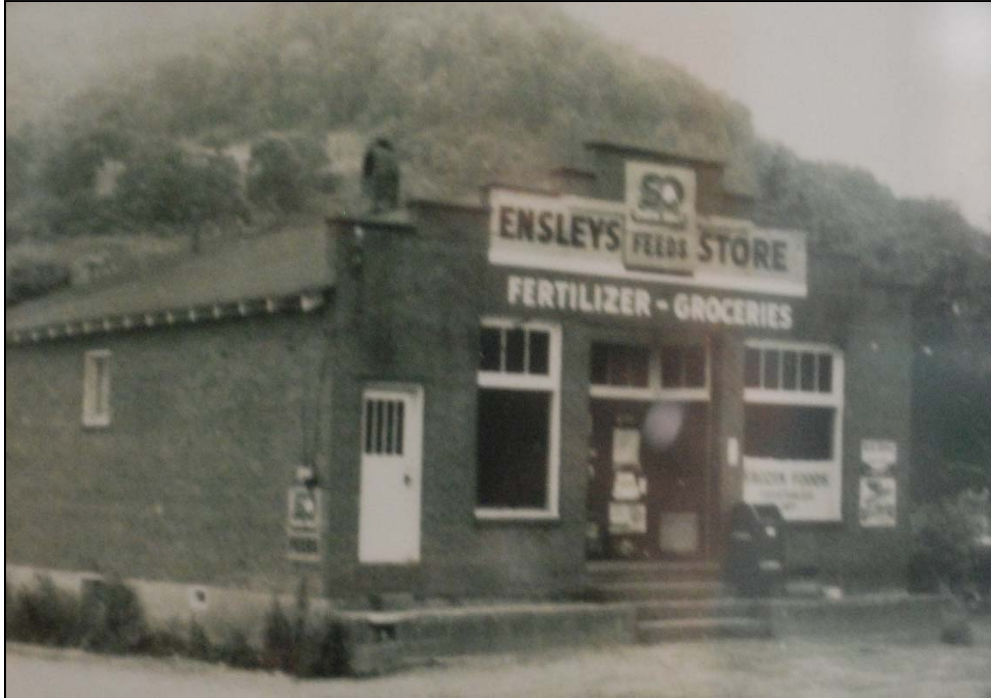
Photograph 63. Historic Photograph of the *Old Ensley Store*, nd

A historic photograph of the *Old Ensley Store*, which hangs on the interior wall of the store, confirms that the exterior of the building has undergone considerable alterations to its original design elements. According to the photograph, the original principal entry door was recessed. Multi-light transom windows were located above the entry door and flanking windows. The narrow door located on the east end of the façade wall featured vertical lights. A modern wood fascia conceals the once exposed rafter ends. In addition, the wall of the brick parapet is covered in modern siding. The present front porch replaced the original concrete steps leading from a dirt sidewalk. Finally, the historic photograph indicates that the east elevation of the store featured a square window. The two additional windows presently located on the east wall are modern installations.

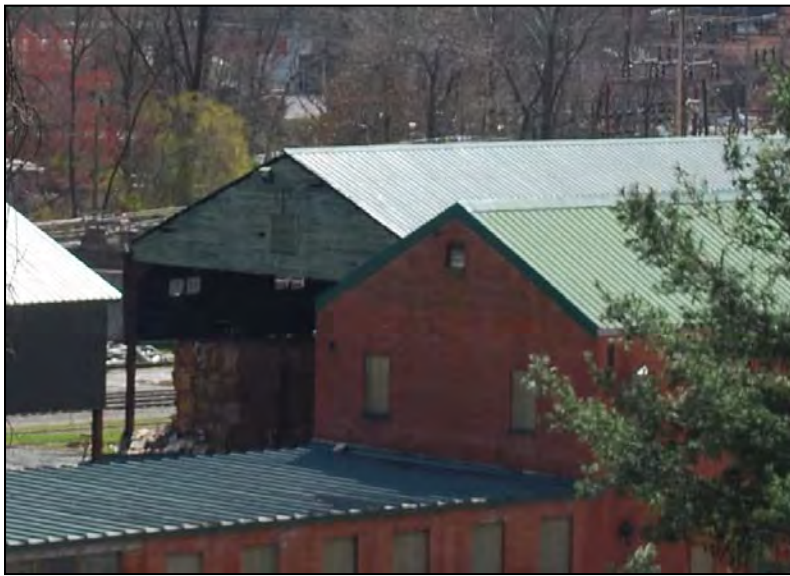
Photograph 73. Tannery Building No. 1 (JK165), looking southeast (resource is in the rear)

Tannery Building No. 1 (JK165) has changed considerably since it was surveyed in 1989. According to the survey, the frame building with clerestory windows was in a severely deteriorating condition. Based on field observations from Allen Street, the building no longer retains its exterior walls. The gabled roof and upper portions of the original walls, including the clerestory windows, are supported by wood posts. Beneath the roof, the space is used for bale storage.

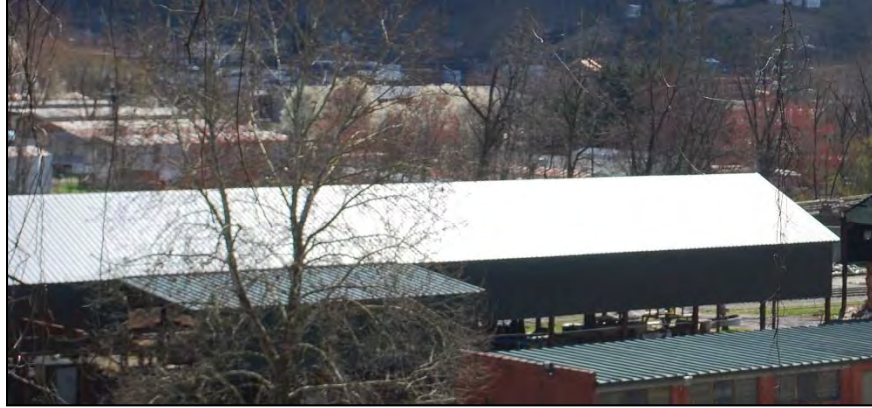
Photograph 74. Replacement of Tannery Building No. 2 (JK166/Not Extant), looking southeast

Tannery Building No. 2 (JK166) is no longer extant. According to the 1989 survey of the complex, Tannery Building No. 2 was a long, rectangular frame building featuring a gabled roof. The building contained clerestory windows, as well as paired, six-pane fixed windows. At the time of the 1989 survey, the building was “deteriorating rapidly,” and its interior was fully gutted. The building is no longer extant. In its place is a long, open structure with a gabled roof supported by wood posts. It is partially clad in metal siding.

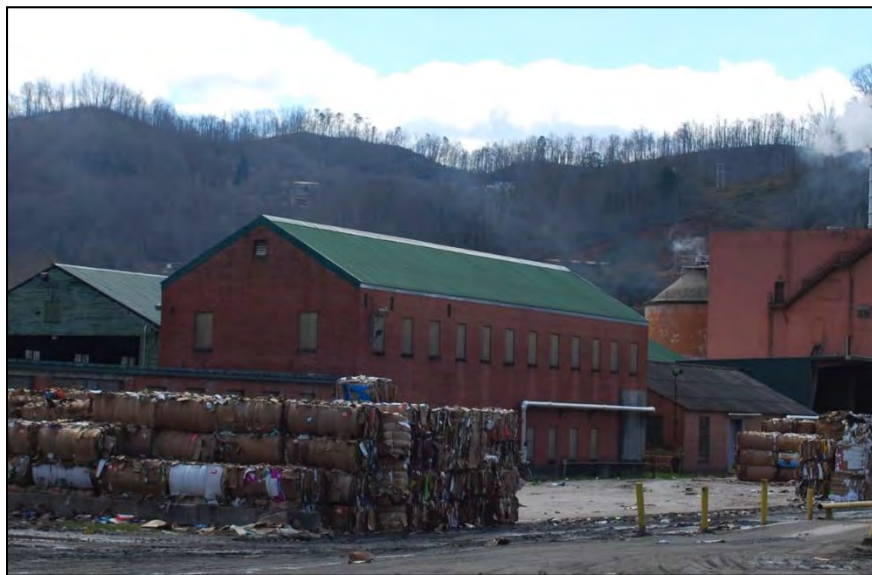
Photograph 75. Tannery Building No. 3 (JK167), c.1910, looking southeast

Constructed c.1910, the Tannery Building No. 3 is a two-story brick building, rectangular in shape with a front gable roof. According to the 1989 survey, the building featured 6-over-6, double-hung wood sash windows, symmetrically placed along the long side elevations of the building. In addition, the entirety of the interior was gutted prior to the 1989 survey. The windows appear to be boarded over at present. A large, single-story addition extends from the north elevation. The addition is historic, likely constructed in the 1940s. It features clerestory windows comprised of glass blocks and metal awnings. It is unknown what the building is presently used for.
