SUBJECT: Historic Structures Survey Report, Upgrade NC 107, R-5600, PA 17-04-0026,
Jackson County, ER 18-1087

SUBJECT: R-5600 Upgrade NC107, PA 17-04-0026, Jackson County

Resource Name	The Queen House
HPO Survey Site #	JK379
Location	53 Woody Hampton Road, Sylva, North Carolina (Jackson County)
PIN	7641-67-3073
Date(s) of Construction	c.1910, c.1950, c.1980, c.1990
Recommendation	Not Eligible

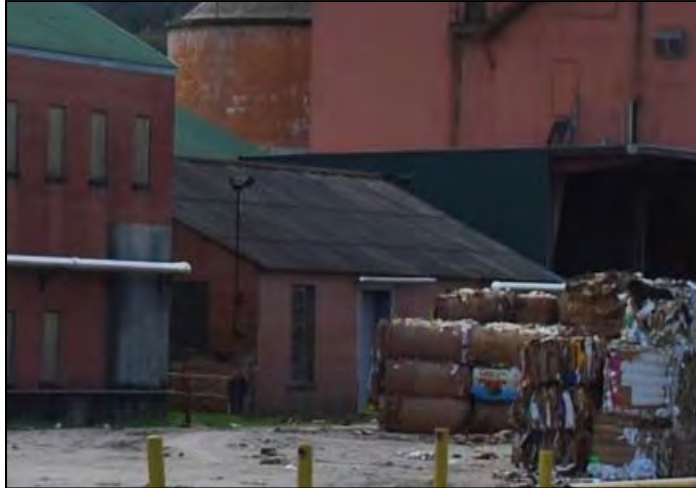
Photograph 78. Tannery Building No. 4 (JK168), looking southeast

Tannery Building No. 4 is a single story, rectangular building of brick construction. The façade faces south. According to the 1989 survey, the building features a double, central entrance flanked by large multi-light factory windows. The 1989 survey photographs confirm that a number of the window openings were empty at that time. At present, the west elevation displays its original windows; however, it appears that a side entry door is a non-historic replacement. The present use of the building is unknown.

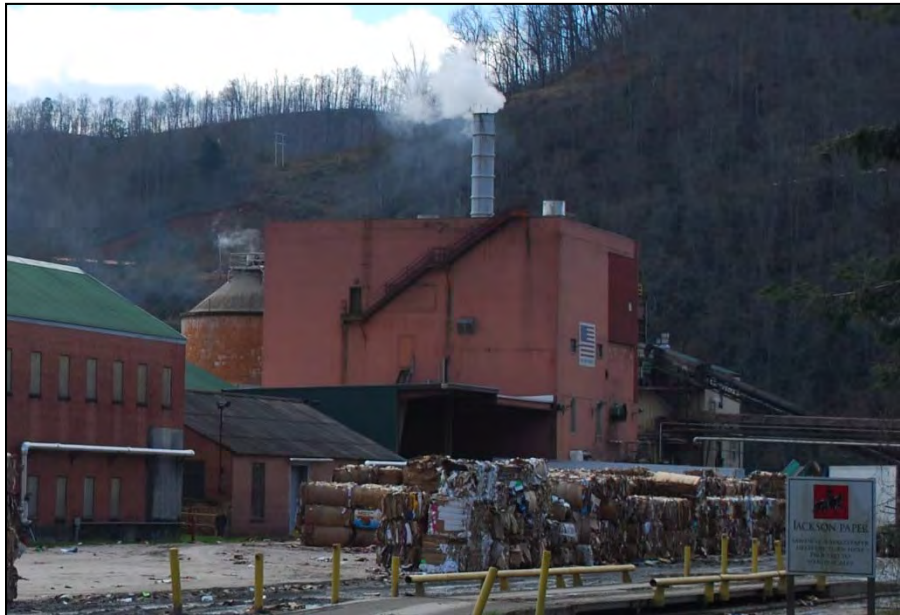
Photograph 79. Rear Elevation of the Sylva Paperboard Company Boiler House (JK169), looking southeast

The boiler house was constructed in 1940 for the Sylva Paperboard Company. The building appears to be a square massing with a flat roof and concrete construction. The building appears to be unadorned; however, according to the 1989 survey, the front of the facility (not accessible) features engaged pilasters. Windows were boarded over during the 1989 survey.

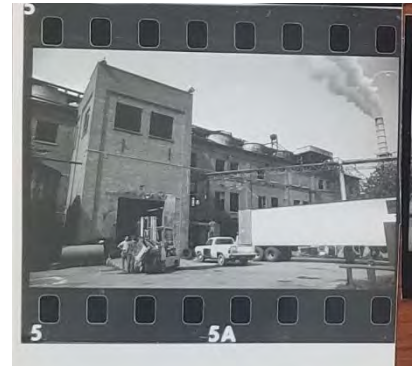
Photograph 82. JK164 from 1989  
Survey File

The digester building was constructed in 1927 for the Sylva Paperboard Company for the digestion of wood chips into pulp. The original building was an impressive, T-shaped, three-story structure, approximately 200 feet in length. It featured a flat roof, capped by squat, poured-concrete cylinders. The building featured paired steel industrial windows. Little of the once massive building survives. In fact, other than the smokestack, what survives is heavily modified. Likely the entirety of the former digester building no longer survives.

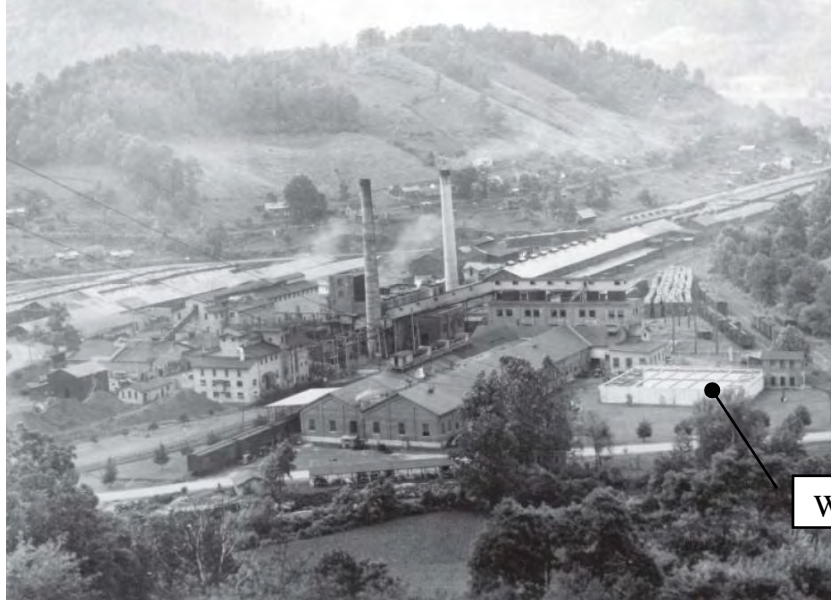
Photograph 84. Sylva Paperboard Company Aerial Photograph, c.1925, looking north

Although not previously surveyed, the water storage basin was constructed prior to the 1940s, and is likely associated with the Sylva Paperboard Company operation of the complex. The water storage basin appears in a c.1925 photograph, directly east of the Paper Machine Building (JK170). The water basin appears to be rectangular concrete structure with no roof. Its interior is filled with tanks of water separated by concrete walls into approximately 10 basins. The structure appears to contain considerable pumping equipment. Three circular water towers located to the north and south of the basin do not appear in aerial photographs prior to c.1945. The construction of the maintenance and storage warehouse (Resource 10 on the site plan), joined the water basin to the main building. Based on historic aerial photographs, it is probable that the towers were constructed in the 1950s.

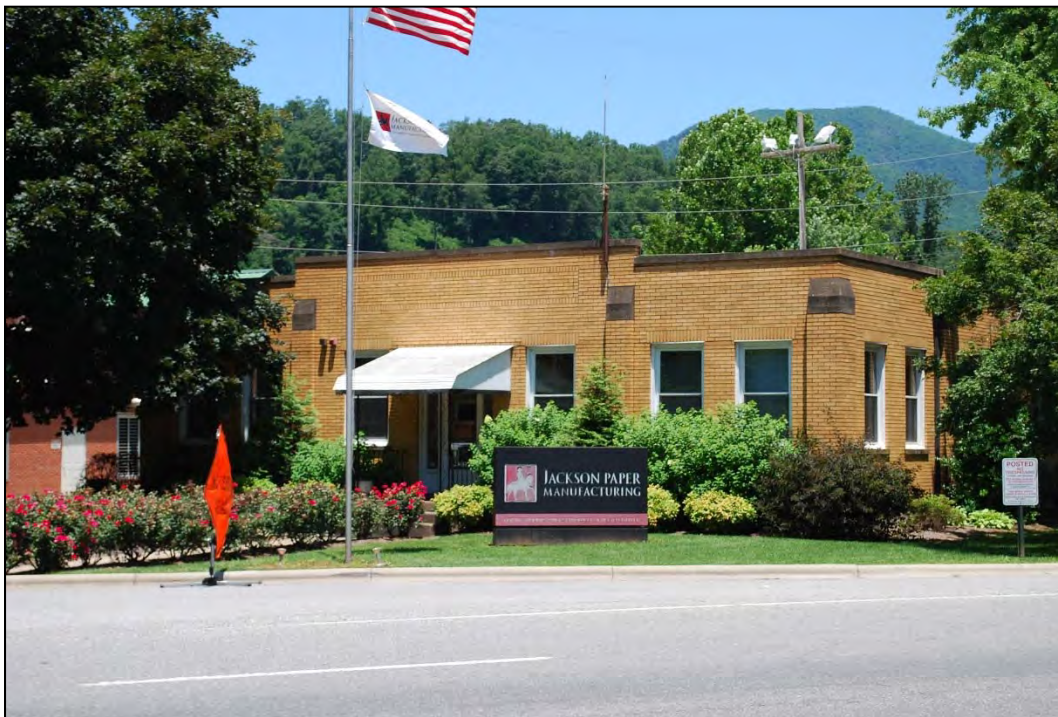
Photograph 86. Mead Company Office (JK171), looking northwest

Constructed in 1940 as an administrative office for the Mead Company, the building is a one-story square massing with a flat roof. It is faced in buff-colored stretcher bond brick and features original one-over-one, double-hung wood sash windows. The façade (south elevation) is symmetrical with step parapet capped with concrete. The façade is 7 bays (W, W, W, D, W, W, W); however, engaged pilasters creates the appearance of a central massing with lower side wings. The entry door is centered on the façade and features a metal awning supported by decorative metal posts. According to the 1989 survey, the interior of the building is modified. However, the exterior appears to retain good integrity.

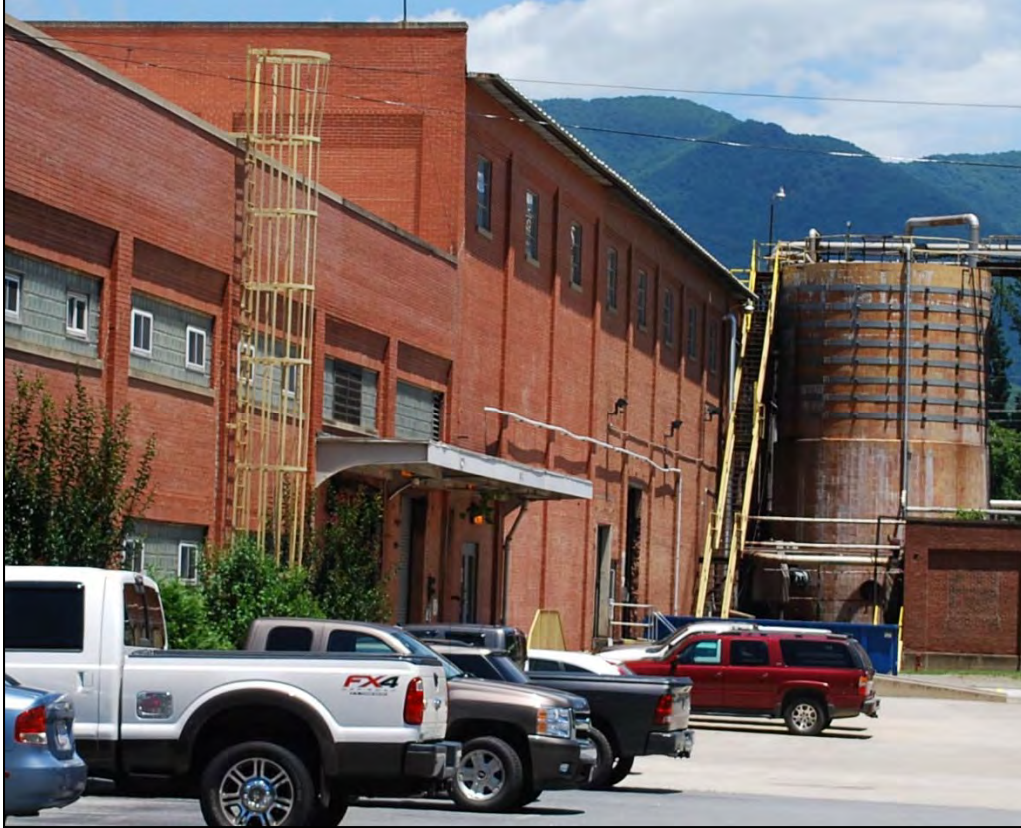
Photograph 87. Maintenance and Storage Warehouse (east elevation), looking north

The exact date of construction of the warehouse is not known. However, based on a review of aerial photographs between c.1925 and c.1945, it appears that the two-story warehouse was constructed c.1940. The large building features a gable roof and extends the length of the Paper Machine Building (JK170). It is brick construction and features double-hung windows with concrete sills. The windows are set high on the wall of the second floor.

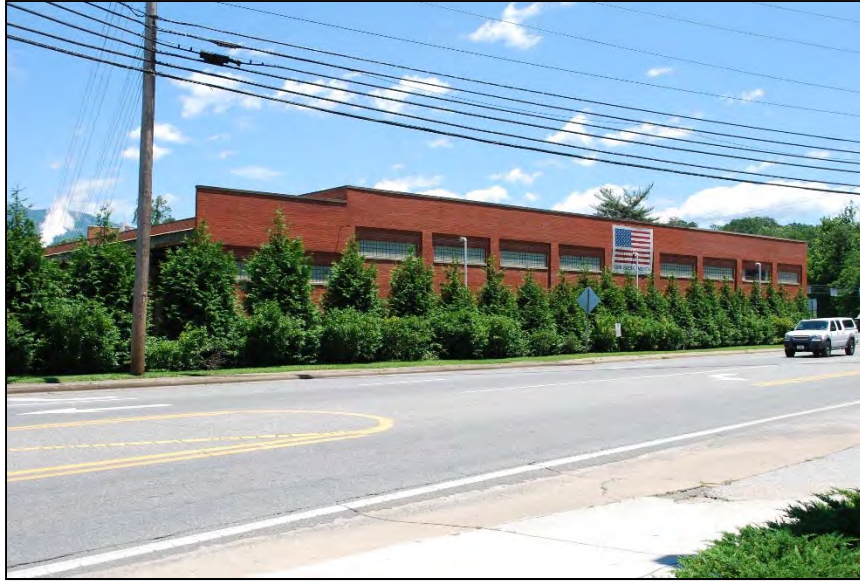
Photograph 88. Shipping Warehouse South Elevation, looking northeast

The two-story shipping warehouse is among the most recent additions to the complex. The massive building extends the width of the Paper Machine Building (JK170) and the c.1940 Maintenance Warehouse. The building is the most visible resource on the complex from the public right-of-way. It is simple in design and features a flat roof. Bays are separated by modest brick pilasters. Each bay on the south elevation features four rows of glass box windows set high on the wall of the second floor. This pattern continues along the east elevation. However, two-light sliding windows are inset into each bay. A two, two leaf entry doors with awnings are located on the first floor of the east elevation. It appears that when the building was constructed, the railroad shipping dock was extended from the Paper Machine Building. A shed roof extends from the west elevation of the Shipping Warehouse above the railroad dock and a “façade” added to the south elevation to conceal the loading dock from public view.

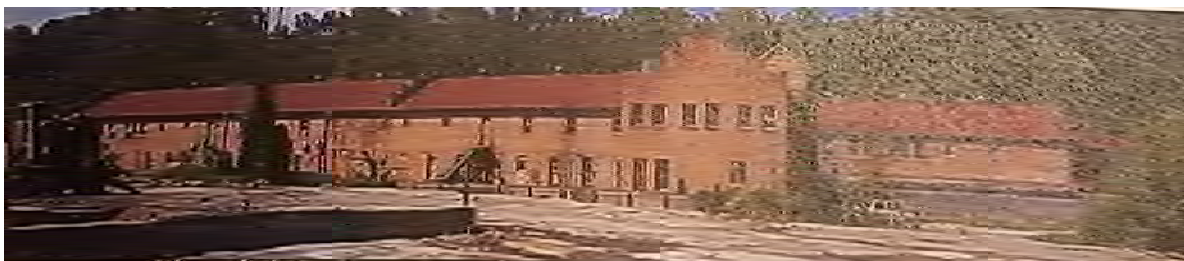
Photograph 91. River Arts Station, 2012 (taken from 2012 draft Historic Structures Report for Asheville River Arts District, on file at NCHPO western branch)

A review of *A Guide to the Historic Architecture of Western North Carolina* makes reference to a few known tanneries within the region. However, the only two tanneries with multiple historic resources surviving are the *Hans Rees Tannery* (BN414) and the *C.J. Harris Tannery* (JK723). The Transylvania Tanning Company in the Brevard vicinity retains only its original smokestack. The Hans Rees Tannery was study-listed in 2012 and recommended eligible for the NRHP. It boasts 14 surviving large-scale industrial-related buildings. Among those are three impressive two-story brick buildings presently known as Riverview Station in Asheville's River Arts District. The former tannery appears unaltered since the 2012 recommendation of eligibility.

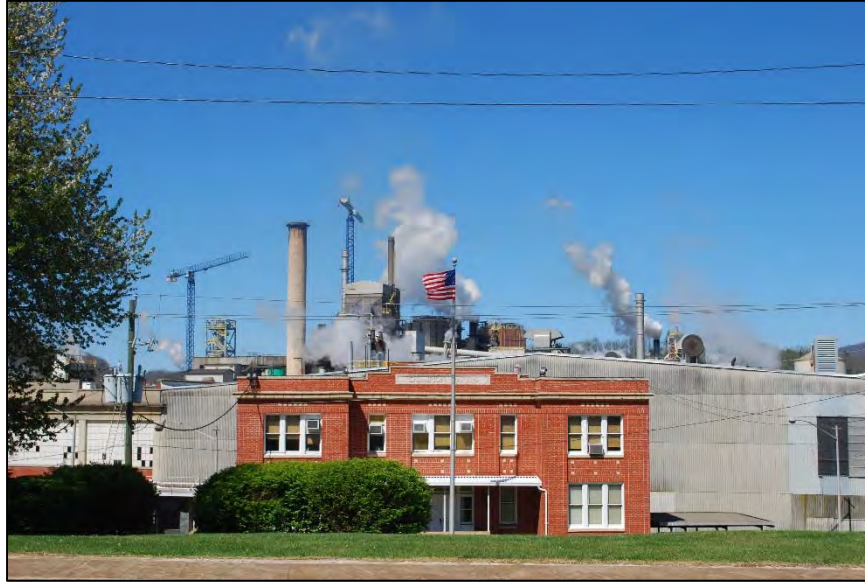
Photograph 93. Champion Fibre Company Office Building (HW168)

cornice, and one-over-one, double-hung wood sash windows. The building appears to retain good integrity. According to *A Guide to the Historic Architecture of Western North Carolina*, the plant comprises structures from various development phases. Large brick buildings ranging from three to seven floors, with towers and monitor roofs survive, as do a number of other mills, warehouses, smokestacks, and loading platforms.
