SUBJECT: Historic Structures Survey Report, Widen NC 73 from SR 2693 to US 29,
R-5706 A&B, PA 17-09-0005, Cabarrus and Mecklenburg Counties, ER 18-1310

Historic Structures Report
TIP No. R-5706A&B, WBS No. 46378.3.2, PA No. 17-09-0005
Widen NC 73 from SR 2693
(Davidson-Concord Road) to US 29
Cabarrus and Mecklenburg Counties, North Carolina
S&ME Project No. 4213-18-054

Historic Structures Report

Tip No. R-5706 A&B; WBS No. 46378.3.2

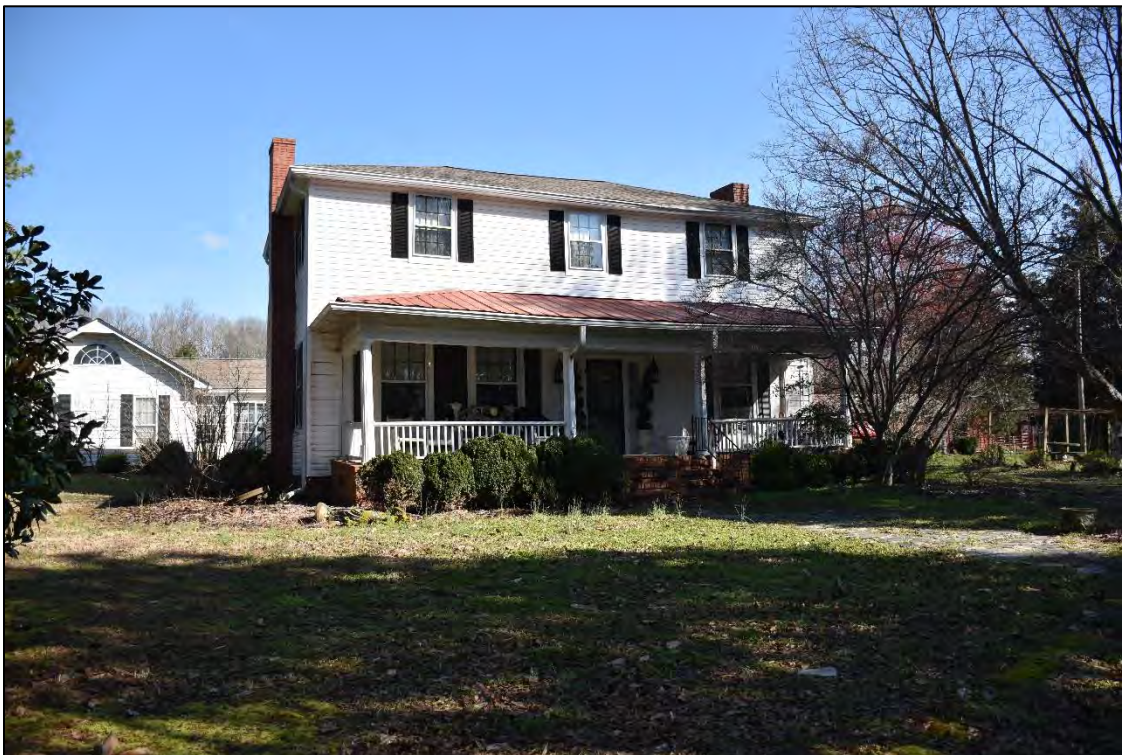
Figure 2.1. View of the Blackwelder-Litaker House, facing north.

The house is a two-story, single-pile, frame structure with a low-pitched hipped roof; it rests on a brick pier foundation that has been infilled with newer brick. The front elevation has a full-width, hipped roof porch that is

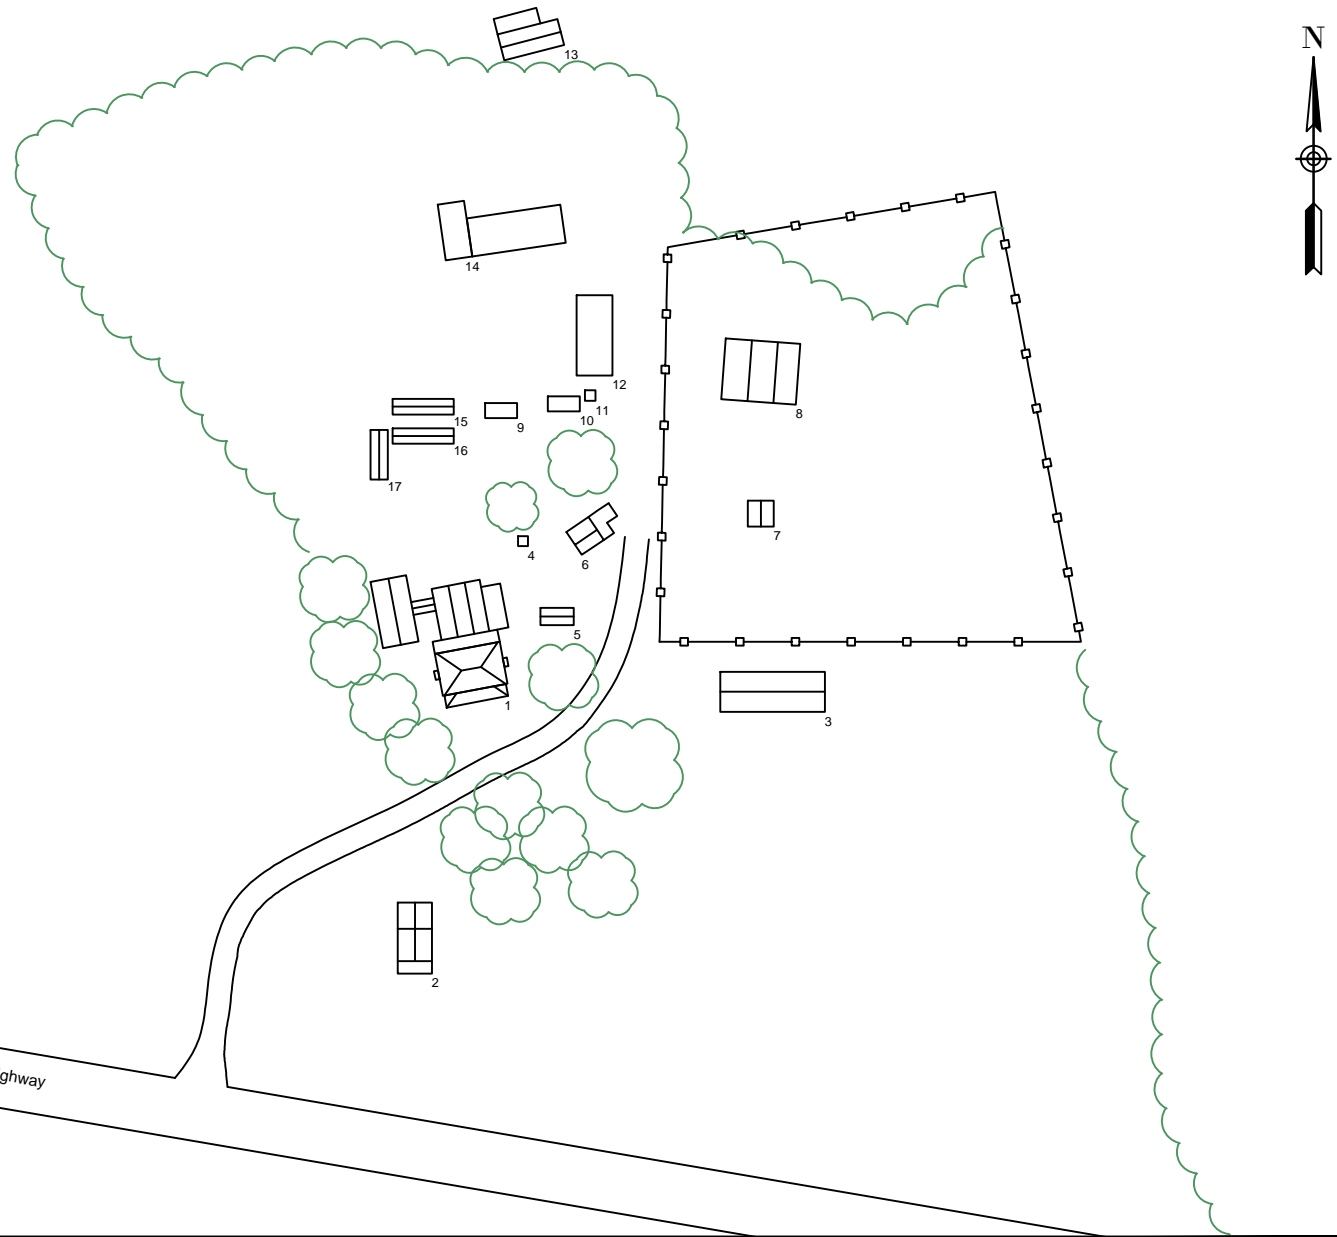
Blackwelder-Litaker House (CA0309) - Site Plan

- 1 - Blackwelder-Litaker House (CA0309)
- 2 - Barn (circa-1900; moved)
- 3 - Current Storage Building (circa-1920; moved)
- 4 - Well House (circa-1930)
- 5 - Shed (circa-1930)
- 6 - Smokehouse (circa-1900)
- 7 - Storage Building (circa-1920; moved)
- 8 - Barn (circa-1920)
- 9 - Chicken Coop #1 (circa-1930s)
- 10 - Chicken Coop #2 (circa-1930s)
- 11 - Outhouse (circa-1960s)
- 12 - Metal Storage Building (1950s)
- 13 - Tenant House (circa-1920s)
- 14 - Open Storage (circa-1970s)
- 15 - Modern Storage Building
- 16 - Modern Storage Building
- 17 - Modern Storage Building

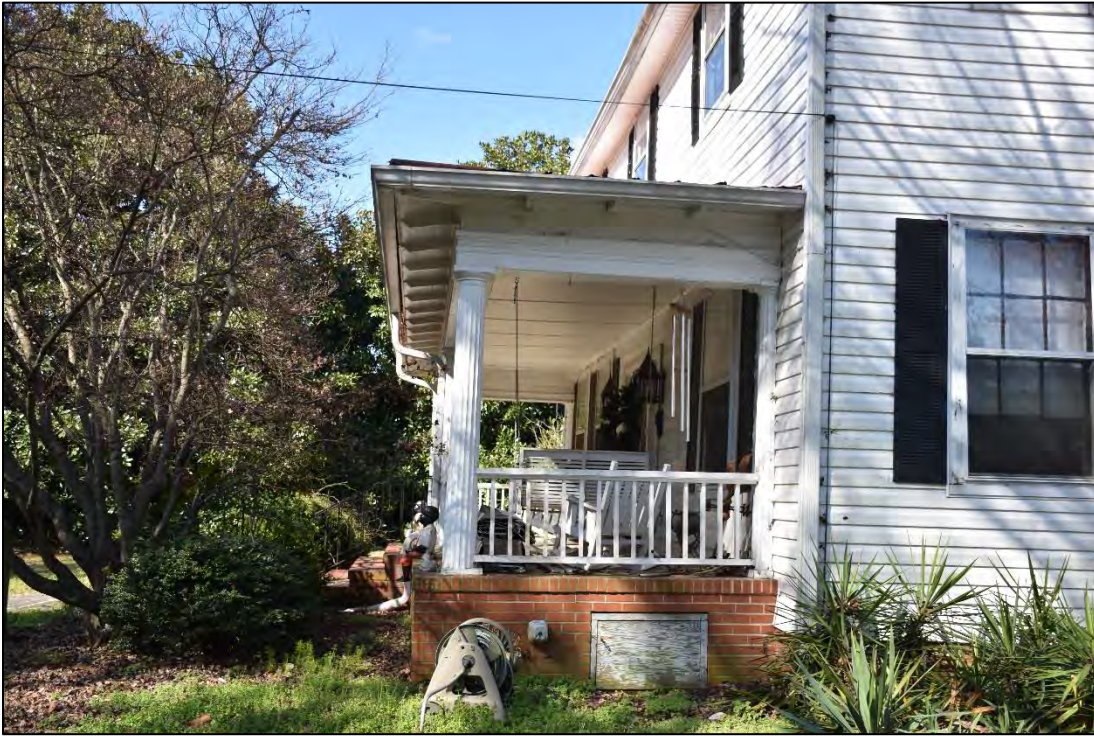
Figure 2.3. Blackwelder-Litaker House, porch detail, facing west.

supported by fluted Doric columns with a plain frieze; the wide eave overhang of the porch roof features exposed rafter tails that are mostly hidden behind the porch's gutter system (Figure 2.3). The porch foundation is modern brick. The slightly off-center door has a simple surround and three-pane sidelights. To the east of the door is a single six-over-six, double-hung, wooden sash window, while to the west is a pair of six-over-six, double-hung, wooden sash windows; these first story windows have Greek Revival window surrounds with corner blocks, which are the only exterior details that remain from the original mid-nineteenth century construction of the house. The upper story has three symmetrically placed six-over-six, double-hung, wooden sash windows, which are smaller in size than those on the lower story. The roof is composition shingle and the eaves have a slight overhang that is covered with a vinyl soffit; the exterior of the original section of the house is sheathed in wooden weatherboard.

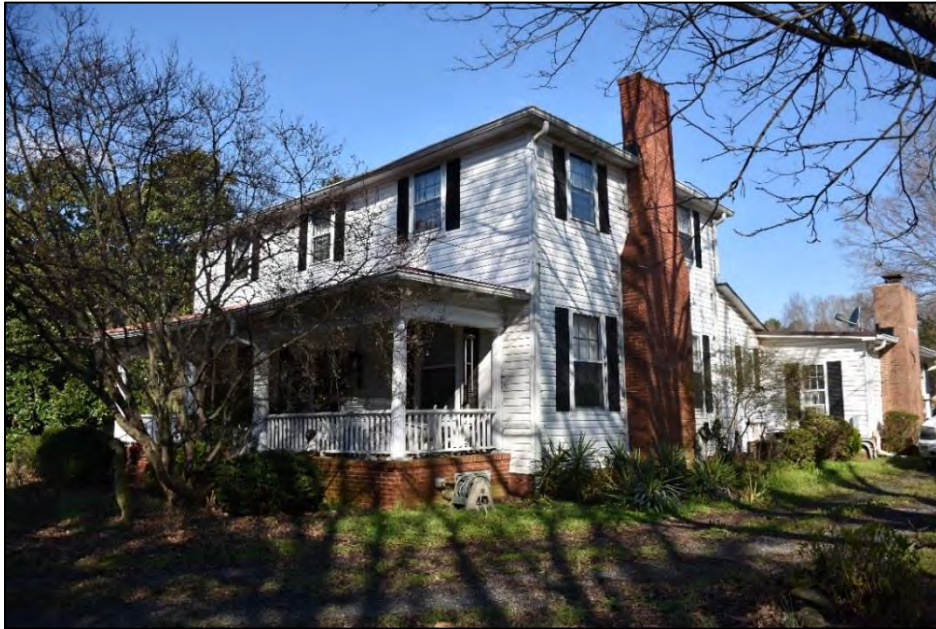
Figure 2.4. Blackwelder-Litaker House, facing northwest.

The house is two bays deep, with an exterior brick chimney centered along the east elevation, flanked by single six-over-six, double-hung, wooden sash windows on both the lower and upper stories; like along the front elevation, the upper story windows are smaller than those on the lower story (Figures 2.4 and 2.5). The western elevation of the original house has the same configuration as the eastern elevation (Figure 2.6). A shed-roofed porch along the rear elevation has been enclosed and has a single six-over-six double-hung, wooden sash window on both its east and west elevations (Figures 2.5 and 2.6).

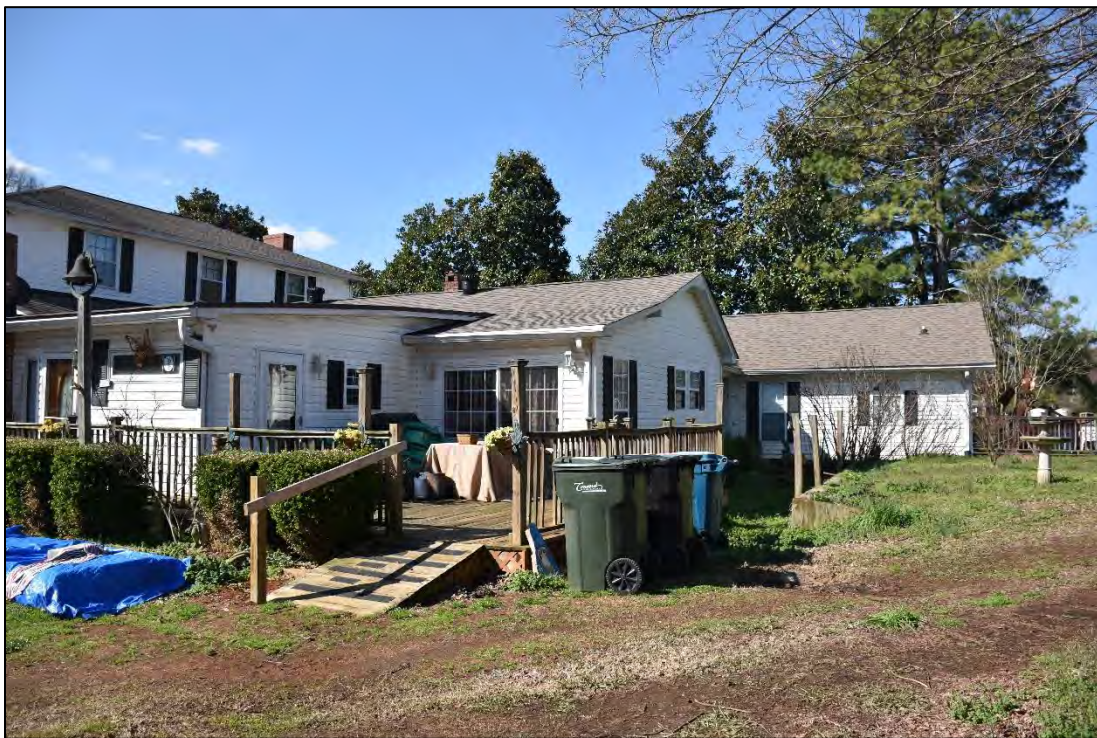
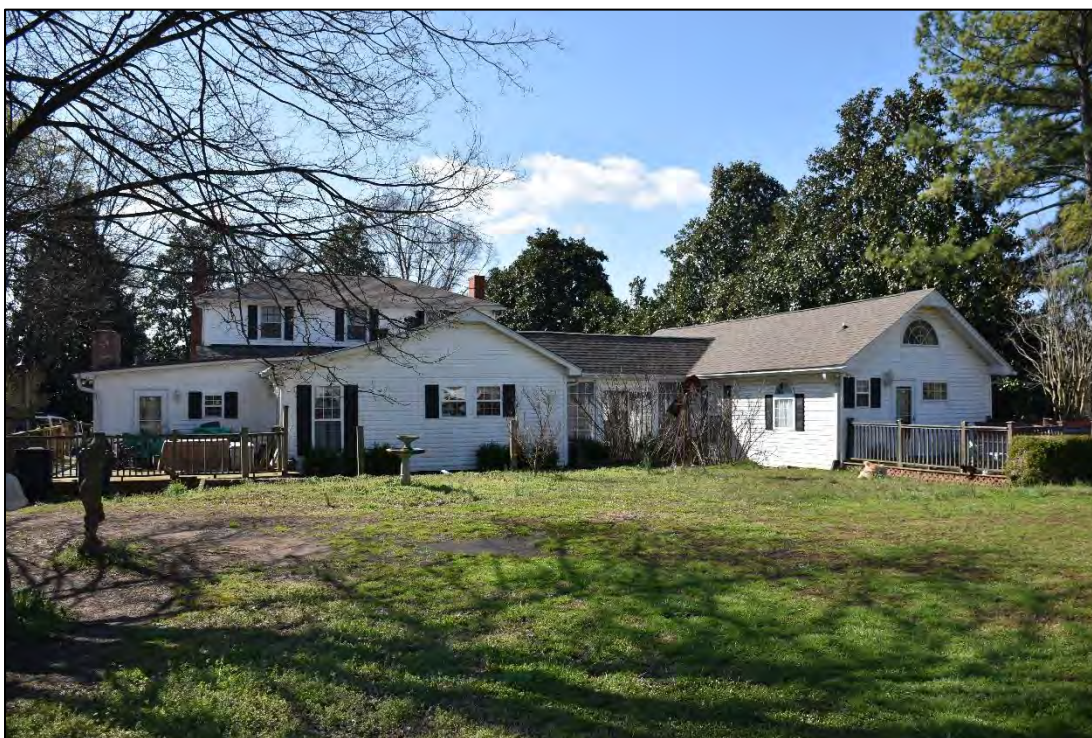
Attached to the rear of the enclosed porch are multiple other additions, dating from the mid-to-late-twentieth century (Figures 2.7–2.9). A single story, gabled, rear ell extends back from the enclosed porch and has a pent-roofed addition to its eastern side, which is attached to an open wooden deck and has a modern entry door and prominent exterior brick chimney. Both of these additions are covered with vinyl siding and have modern, vinyl sash windows of differing pane configurations, including six-over-six and nine-over-nine. There are two brick chimneys, one interior and one exterior, visible above the roof of the rear ell addition, suggesting that it may have

Figure 2.7. Blackwelder-Litaker House, facing southwest.

Figure 2.8. Blackwelder-Litaker House, facing south.

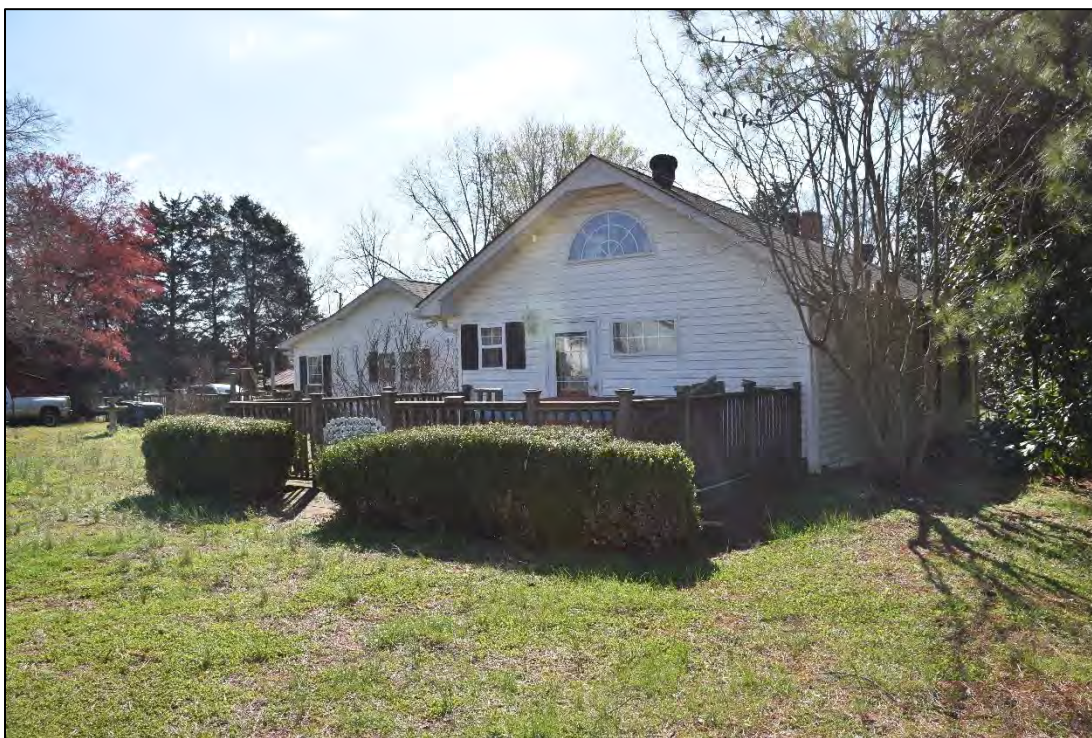
Figure 2.9. Blackwelder-Litaker House, facing southeast.

formerly been a detached kitchen that was attached to the house and enclosed with more modern framing. Along the west elevation of the rear ell, there is a side-gabled hyphen, enclosed primarily with large, multi-pane vinyl windows and French doors, which connects to a circa-1980s single story, gabled addition. This late-twentieth-century addition has vinyl siding and various configuration of vinyl sash windows, including four-over-four, eight-pane casement, nine-over-nine, six-over-nine, and semi-circular arched (Figures 2.9 and 2.10).

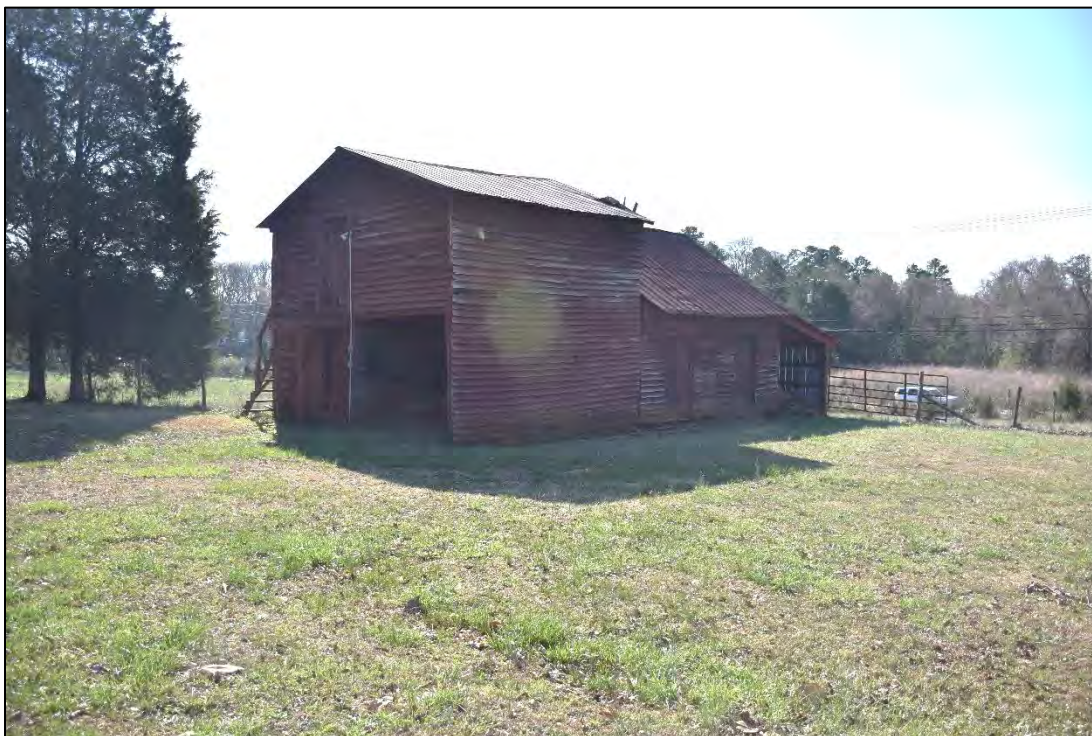
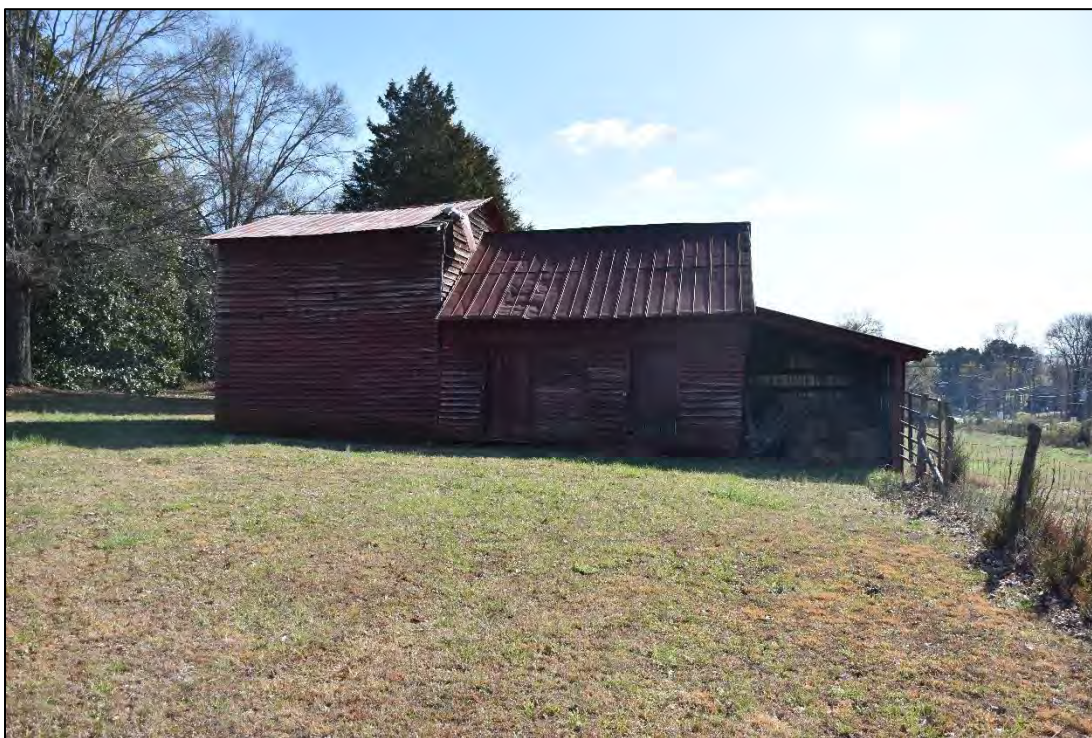
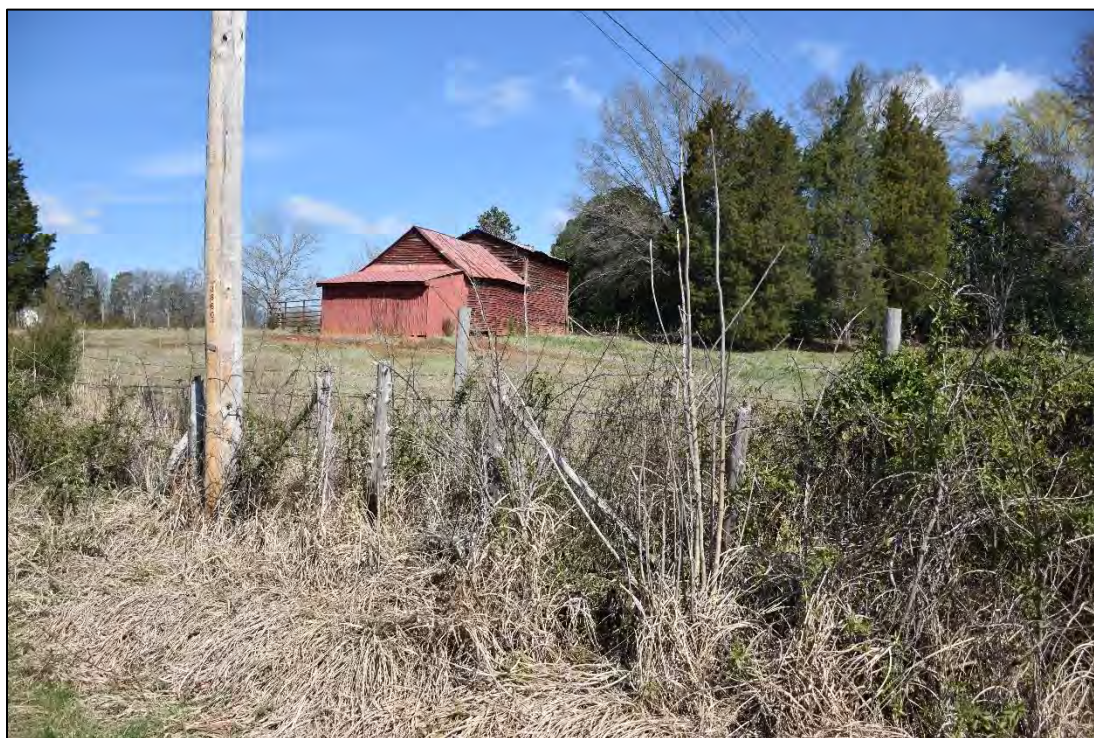
South of the house, east of the driveway leading from the road, is a circa-1920s barn. The barn has multiple sections that may represent separate building periods or possibly, that more than one building was combined to create the current structure (Figure 2.11). The majority of the barn is wooden-framed, sheathed in wooden siding, covered with a standing-seam metal roof, and has visible rafter tails. The northern section of the barn is two-stories with a gabled roof. The western bay is open and there is a loft door on the upper story that is accessed by a wooden stairwell. The central section is one story tall, with a gabled roofline that has a steeper pitch than the northern section (Figure 2.12). The western elevation has two single entry doors. The southernmost section is wooden framed, but is more modern than the other two sections, with a shed roof and standing-seam metal used as siding; the western elevation of this section is open (Figure 2.13).

Figure 2.11. Barn, circa-1900, facing southeast.

Figure 2.12. Barn, circa-1900, facing east.

Figure 2.13. Barn, circa-1900, facing northwest.

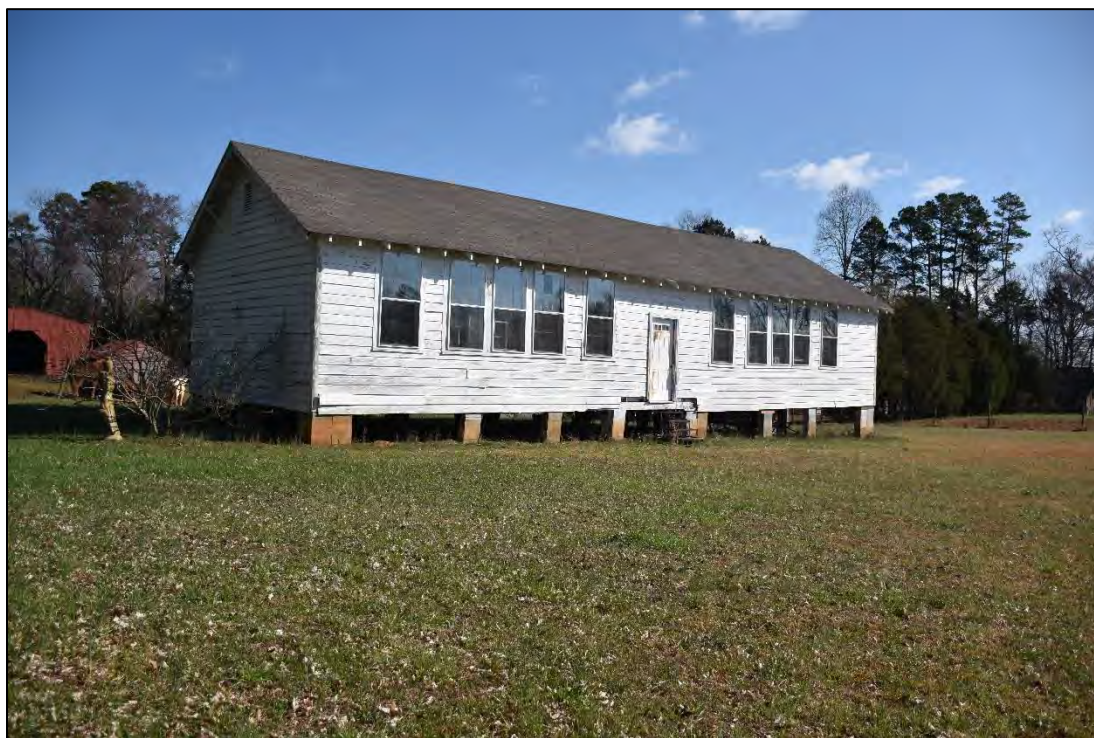
Figure 2.14. Current storage building, circa-1920, facing northeast.

East of the house and the grove of magnolia trees, is a circa-1920 structure that is currently used as storage but may have originally had a different function, potentially a tenant house or school building (Figure 2.14). It is one-story, of frame construction, and has a side-gabled roofline and visible rafter tails along the eaves and curved brackets along the gable ends (Figure 2.15). The central doorway is a modern metal door, which is flanked by bands of five six-over-six, double-hung, wooden sash windows on either side. The rear elevation has two symmetrical doorways, one covered by a gabled hood that is supported by triangular bracing (Figure 2.16). The gable ends each have a rectangular attic vent as their only exterior opening. The structure sits on a modern concrete block foundation and appears to have been moved to this location. The form of the structure, except the lack of windows on all but the front elevation of the building and the addition of doors on the rear elevation, is similar to Rosenwald Community School Plan Number 3, suggesting a former use as a school, although no interior access was granted to determine the floorplan of the structure.

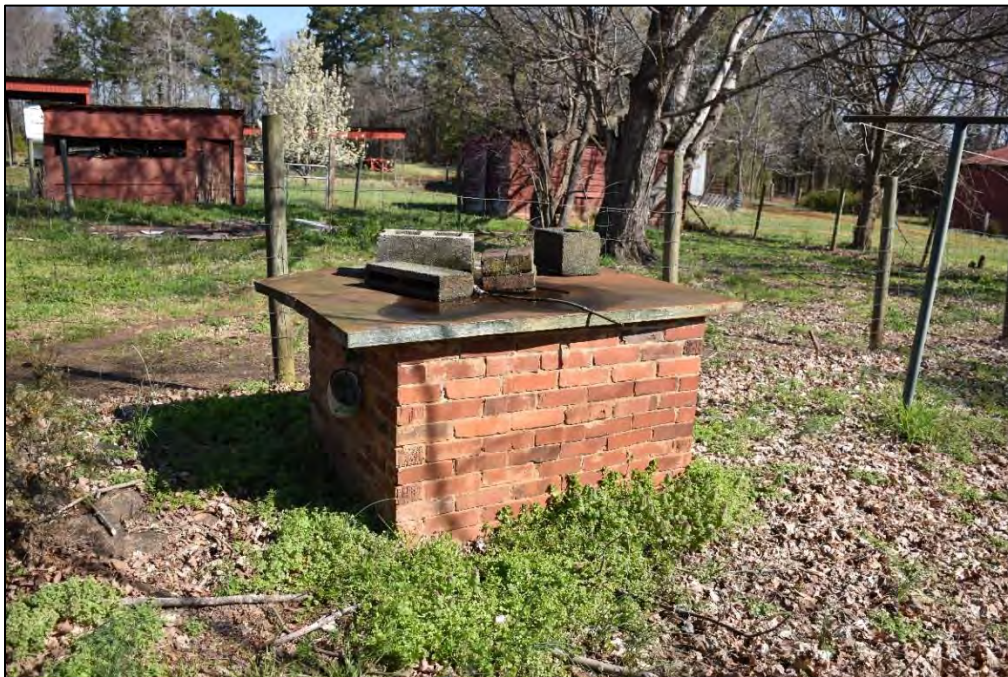
Figure 2.17. Wellhouse, circa-1930s, facing north.

Additional outbuildings are located to the north and northeast of the house. Just north of the house is a circa-1930 wellhouse that is of brick construction and has a flat concrete top (Figure 2.17). East of the house, along the driveway, is a circa-1930s shed. The one-story structure is of frame construction, with a gabled roof, wooden weatherboard siding, standing-seam metal roof, and visible rafter tails (Figure 2.18). The western elevation has a single entry door centered in it and the south elevation also has a doorway; there is a square casement window in the second story of the east elevation. Northeast of the circa-1930s shed is a circa-1900 smokehouse. The smokehouse is a two-story, wooden frame structure with a gabled roof that overhangs the front and is supported by wooden bracing (Figure 2.20). The exterior of the smokehouse is covered with horizontal wooden siding and the roof is standing-seam metal. The front has two symmetrically placed entry doors; the rear elevation has a small, square casement window centered within it. The south elevation has a single story, shed-roofed addition that has a central double entry door on its south elevation (Figure 2.21). This addition is also covered with horizontal wooden siding and has a standing-seam metal roof. The rear of the smokehouse has two flat-roofed additions, of frame construction with standing-seam metal used as siding (Figure 2.22).

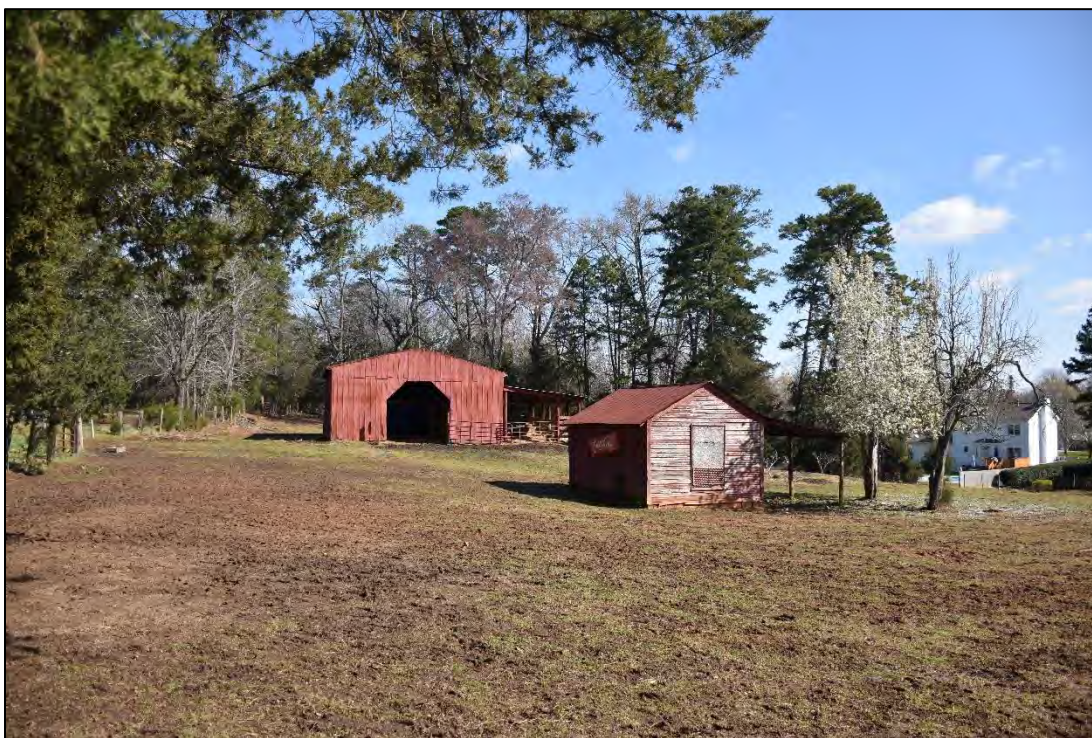
Figure 2.23. Barn and storage building, circa-1920, facing northeast.

Northeast of the house, located in a fenced pasture used for horses, are two wooden-framed outbuildings, a barn and a storage building that date from the early-to-mid-twentieth century (Figure 2.23). The storage building is located to the south of the barn and is a single-story, gabled-roof structure that sits on a block foundation. The exterior is covered with horizontal wooden siding and the roof is covered with standing-seam metal. Along the southern elevation is a former window-type opening that has been enclosed with plywood and metal grating (Figure 2.24). The corners of the structure have vertical trim boards (Figure 2.25). To the north is a two-story, lofted barn structure that has a low-pitched gable roof and has both walls and roof covered with standing-seam metal (Figure 2.26). There is a large opening centered in the southern elevation and a smaller opening, covered by a tarp, in the northern elevation (Figure 2.27). Along the eastern side, a shed-roofed open extension, supported by timber posts, holds hay.

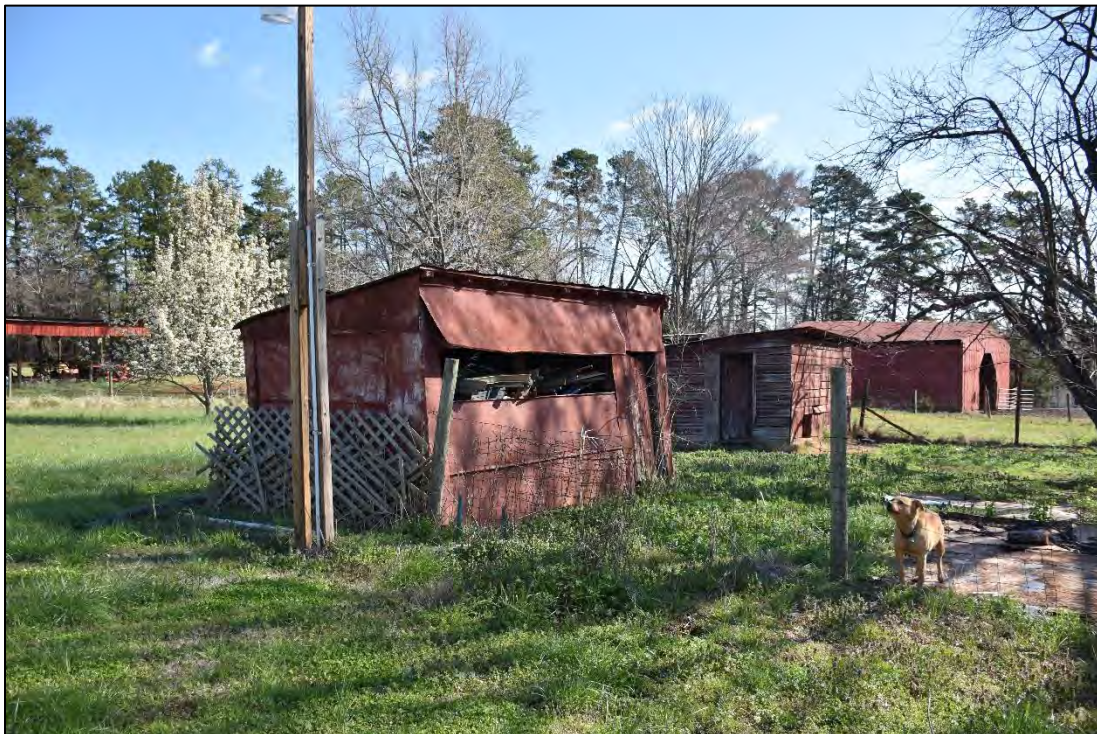
Figure 2.28. Chicken coops, circa-1930s, facing northeast.

North of the smokehouse is a grouping of four early-to-mid-twentieth century outbuildings that are arranged roughly in an L-shape (Figures 2.28–2.30). Along a dirt extension of the property’s driveway, there is a circa-1930s wood-framed, pent-roofed storage building; it has horizontal wooden siding, a standing-seam metal roof, and visible rafter tails (Figure 2.28). The western elevation of this building has a single entry door. West of this storage structure is a second wood-framed, pent-roofed building that has the same form, size, and basic detailing as the first. Its exterior has been covered with plywood and metal panels. The two structures appear to have been originally used as chicken coops, although now they have been converted to storage and a dog enclosure. Northeast of this structure is a small, wood-framed, pent-roofed outhouse building that is in disrepair; it has horizontal wooden siding and a standing-seam metal roof (Figure 2.29). North of the outhouse is a rectangular, flat-roofed storage building that has a corrugated-metal exterior covering and a standing-seam metal roof (Figure 2.30).

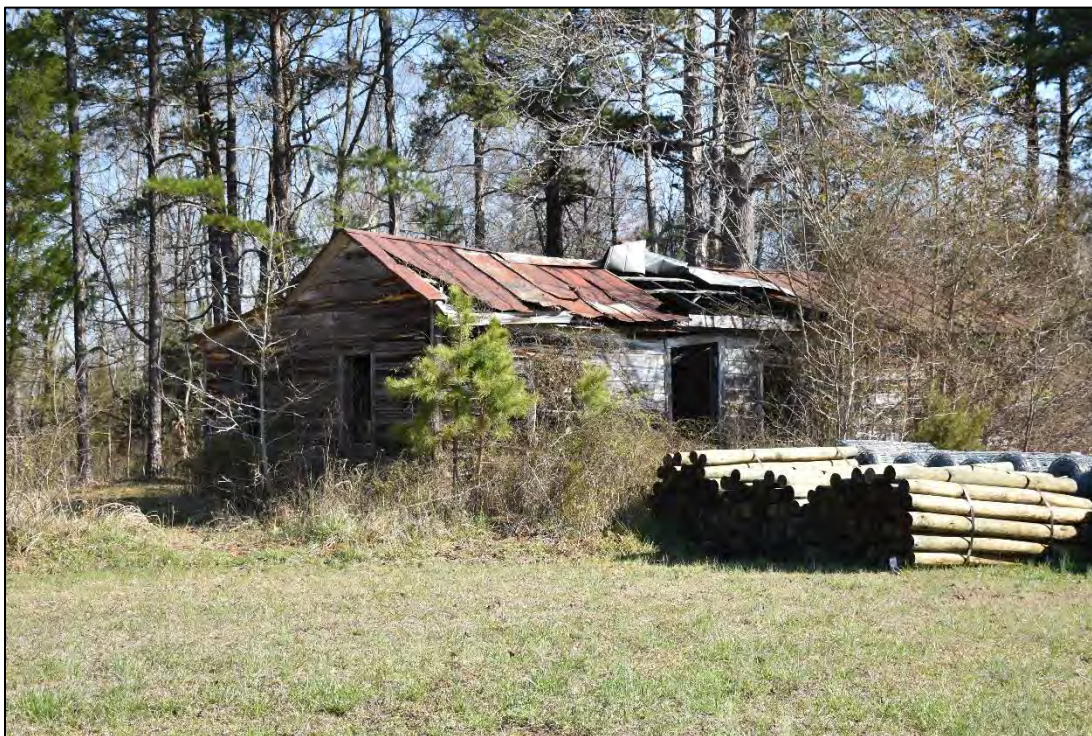
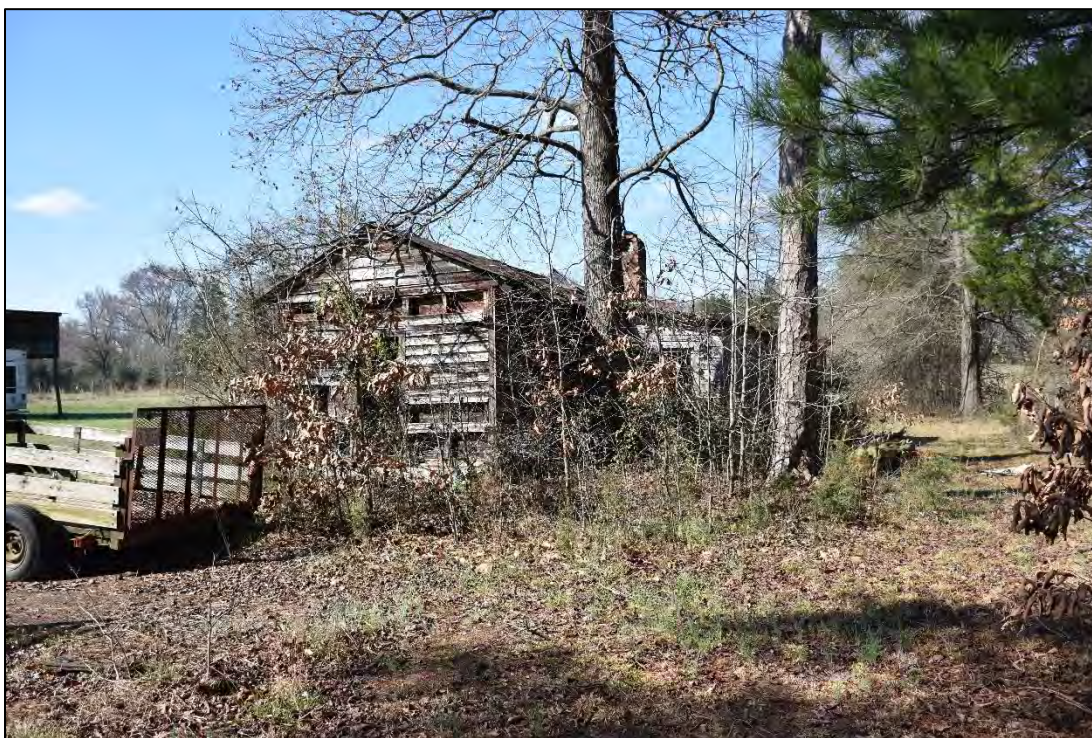
At the northern edge of the property is the remains of an early-twentieth-century structure that may have been a tenant house (Figure 2.31). Although in significant disrepair and overgrown with vegetation, the house appears to have been a duplex-style residence, with a side-gabled roofline and shed-roofed extension along the rear elevation (Figures 2.31 and 2.32). There are two door-sized openings in the front elevation, along with at least three window openings; the east and west elevations each have a window opening as well. A chimney is visible above the roof of the rear extension. The roof of the house is covered with standing-seam metal and the exterior is sheathed in horizontal wooden siding.

Figure 2.31. Tenant house, circa-1920s, facing northeast.

Figure 2.32. Tenant house, circa-1920s, facing southwest.

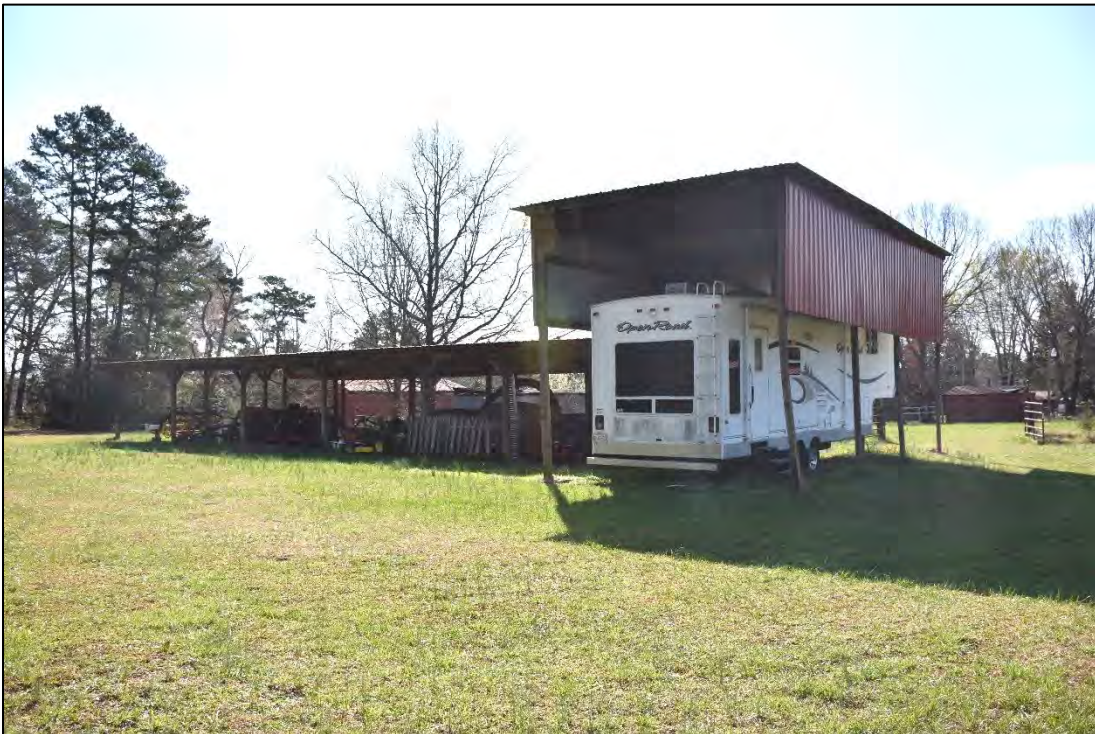
Located north of the house and west of the earlier outbuildings is a group of four late-twentieth to early-twenty-first-century outbuildings. The northernmost structure is a circa-1970s open storage area, with a flat roof supported by square wooden posts, and corrugated metal along a portion of it (Figure 2.33). Two modern storage buildings, oriented east-west, are located south of the open storage structure (Figure 2.34). One is a modern wooden building, with a gambrel roof, vertical wooden paneled exterior, and a garage door bay on its eastern elevation. The second is a prefabricated gabled structure, with a garage door bay on its eastern elevation and four four-over-four, vinyl windows and a central double door on its southern elevation (Figure 2.35). West of these two structures is another modern wooden building, with a gambrel roof, standing-seam metal roof, and wooden paneled exterior; it is oriented north-south and has a barn-style door bay on its southern elevation.

Figure 2.33. Open storage, circa-1970s, facing south.

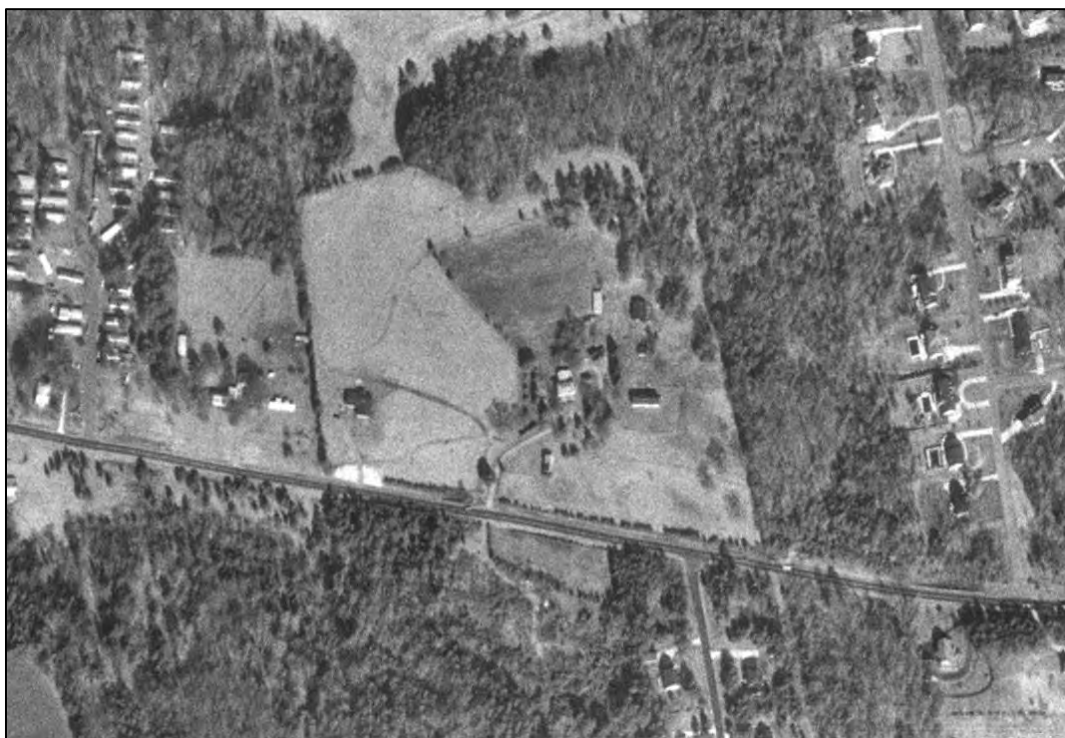
Figure 2.40. USGS aerial photograph (1993) showing Blackwelder-Litaker House and property.

Historic aerial photographs and USGS topographic maps from the 1940s through the 1990s show the evolution of the farm property during the mid-twentieth century. The 1948 photograph shows the house located within a grove of trees; the chicken coops, storage buildings, smokehouse, tenant house, and barn are also visible, as are an outbuilding along the road and one across the street (Figure 2.37). There also appears to be a portion of the circa-1920s barn located south of the house, although the later alteration to the driveway configuration makes it difficult to tell; however, the storage building in the horse pasture is not shown in its current location and the current storage building that has the appearance of a school is not shown. A 1949 USGS topographic map also depicts an outbuilding along NC 73, southwest of the house. By 1965, the Blackwelder-Litaker House had less tree cover surrounding it, showing that the gabled rear ell had already been added (Figure 2.38); the majority of the current outbuildings are present in this photograph, including the storage building in the horse pasture and the metal storage building, while the outbuilding near the road is no longer there. The current storage building that has the appearance of a school is not in this photograph, nor is it in the aerial photograph from 1976 (Figure 2.39). A USGS topographic map, photorevised to 1988, shows a structure in the location of the current storage building that has the appearance of a school, indicating that it was likely moved to the property sometime between 1976 and 1988; the structure is clearly visible on a 1993 aerial photograph (Figure 2.40).

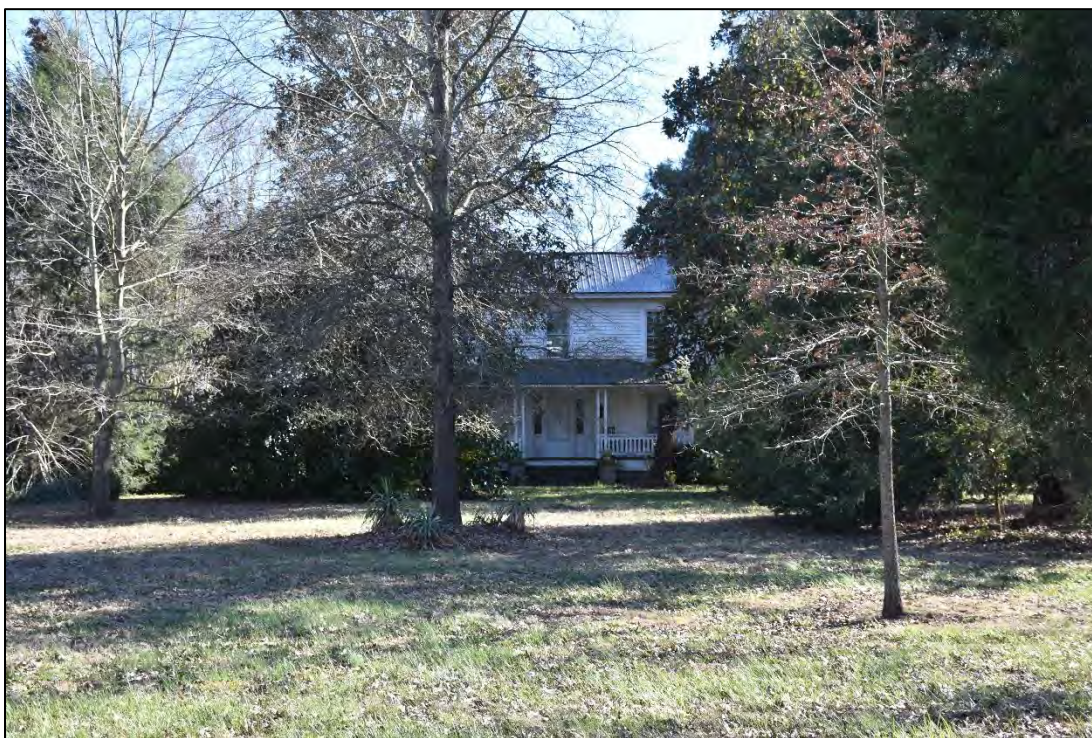
Figure 2.44. Marcus and Nancy Caldwell House (MK2444), facing south.

eight miles to the west in Mecklenburg County, is similarly situated along NC 73; it exhibits the same architectural form and styling but was determined ineligible for the NRHP in 2007 (Figure 2.44).

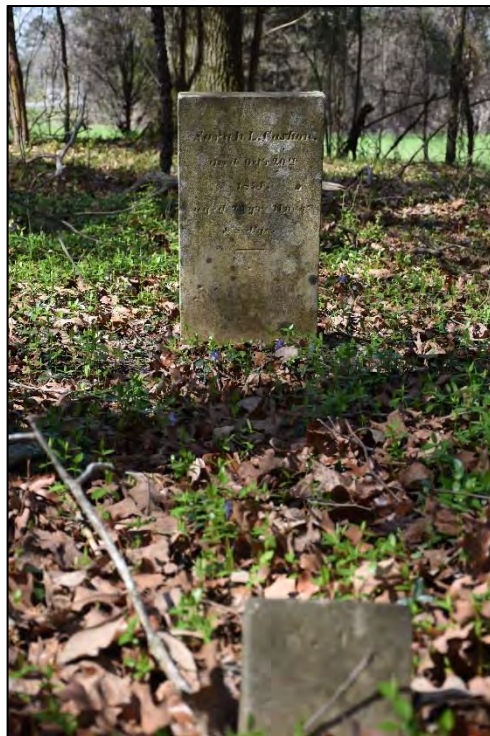
Figure 2.53. Cashion and Moore Family Cemetery, Sarah L. Cashion headstone, facing west.

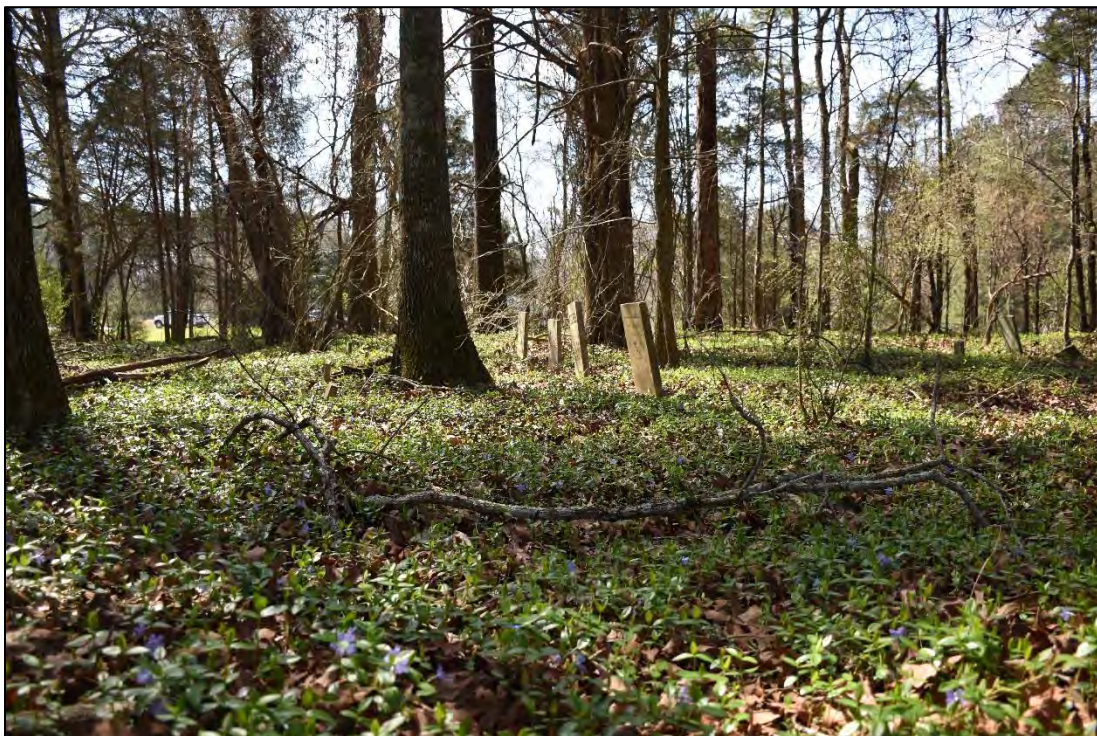
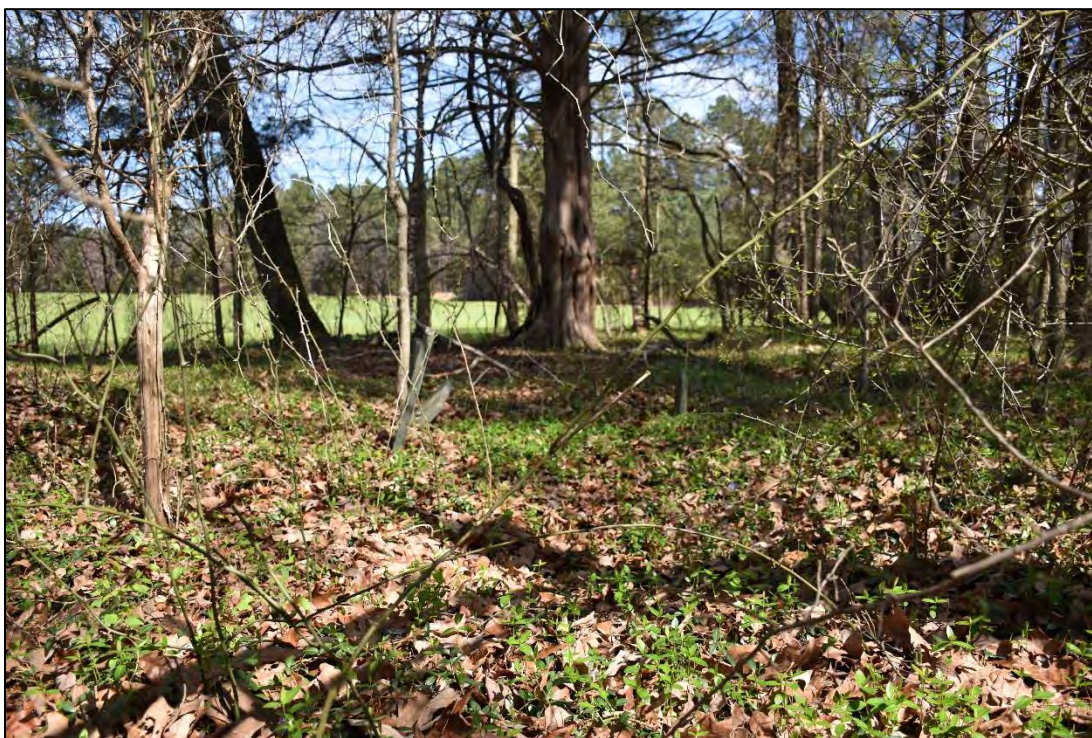
Figure 2.54. Cashion and Moore Family Cemetery, potential grave depression, facing southwest.

Figure 2.59. Cashion and Moore Family Cemetery, potential grave depression, facing north.
