SUBJECT: Historic Structures Survey Report, Widen NC 73 from SR 2693 to US 29,
R-5706 A&B, PA 17-09-0005, Cabarrus and Mecklenburg Counties, ER 18-1310

Historic Structures Report
TIP No. R-5706A&B, WBS No. 46378.3.2, PA No. 17-09-0005
Widen NC 73 from SR 2693
(Davidson-Concord Road) to US 29
Cabarrus and Mecklenburg Counties, North Carolina
S&ME Project No. 4213-18-054

Historic Structures Report

Tip No. R-5706 A&B; WBS No. 46378.3.2

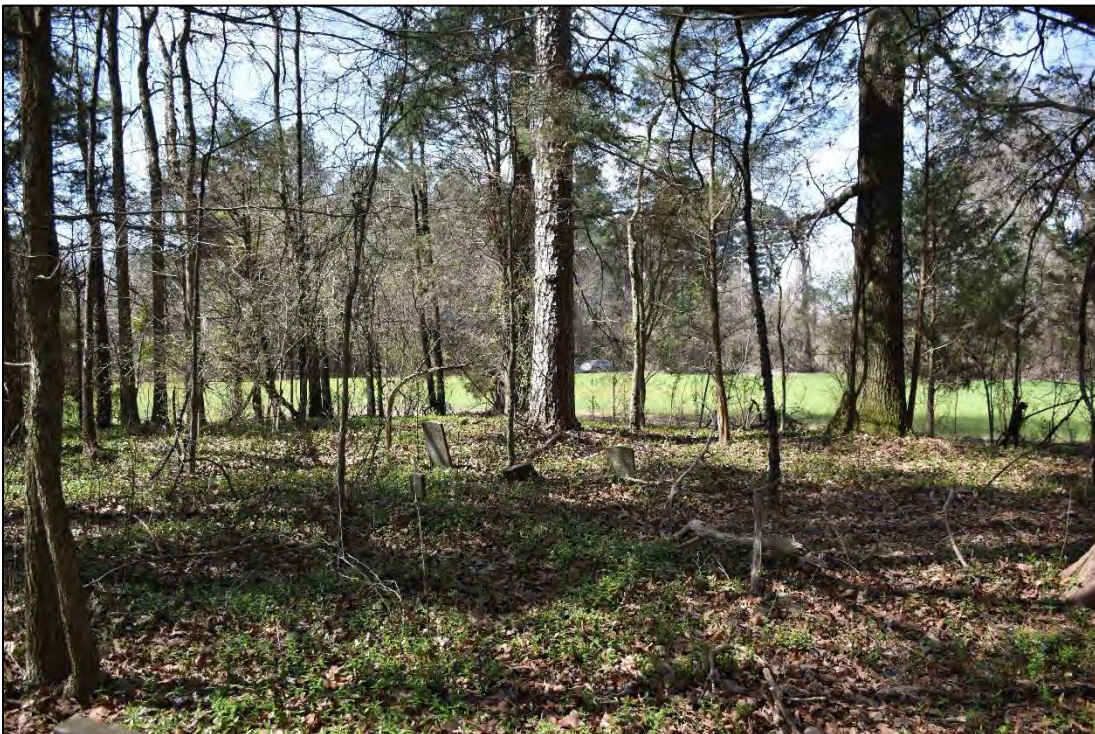
North of the row of Cashion family burials is a second row of marked interments. This row contains three marked graves, belonging to members of the Moore/More family (south to north): Mary Moore (died 1854), unknown (died 1852), and Juliann More (died 1853). The two unbroken stones in this row belong to children and, based on birthdates on the stones, Mary Moore and Juliann More were twins. In addition to the marked burials, there are two grave-sized depressions in this row, both oriented east-west, with one located south of Mary Moore's burial and one located north of Juliann More's burial (Figures 2.55–2.59). The graves of the Moore/More family are simpler than those of the Cashion family. Only the unknown grave has both head and footstones, while the graves of the two children have only headstones. The headstones for both Mary and Juliann Moore/More are simple slabs with slightly pitched tops, basic carving, and no decorative detailing (Figures 2.56 and 2.58). The stones list the birthdate, death date, and ages of both girls; Juliann's stone has a corrected misspelling of "MEMORY", suggesting that the stone was likely not carved by a professional carver and also that it may have been placed later, instead of at the time of her burial. The unknown burial has a broken headstone, with the missing top contain the name of the interred; the remaining portion of the stone suggests that it was similar in form and carving to the stones of the two Moore/More girls (Figure 2.57). The location of this burial, between the two girls, and similarity of the stones indicate a familial relationship; the age of the deceased (38) and the date of death (eight days after the birthdate of the twins) suggest that the burial may be the girls' mother.

Figure 2.55. Cashion and Moore Family Cemetery, Moore family burials, facing southwest.

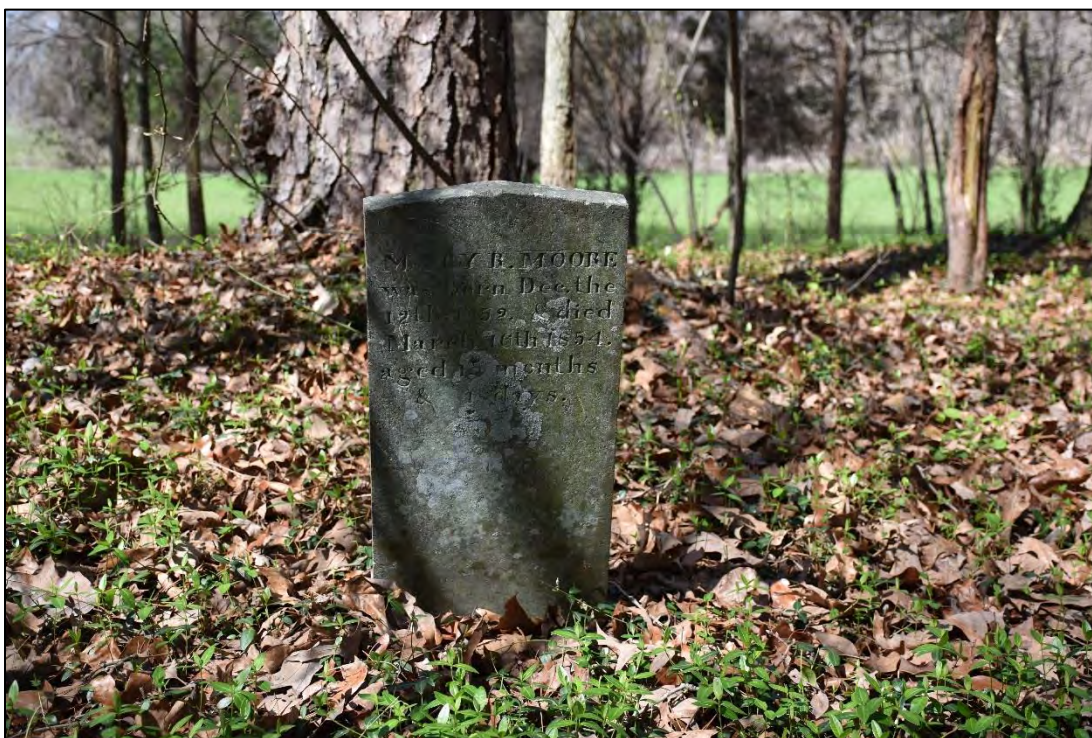
Figure 2.56. Cashion and Moore Family Cemetery, Mary Moore headstone, facing west.

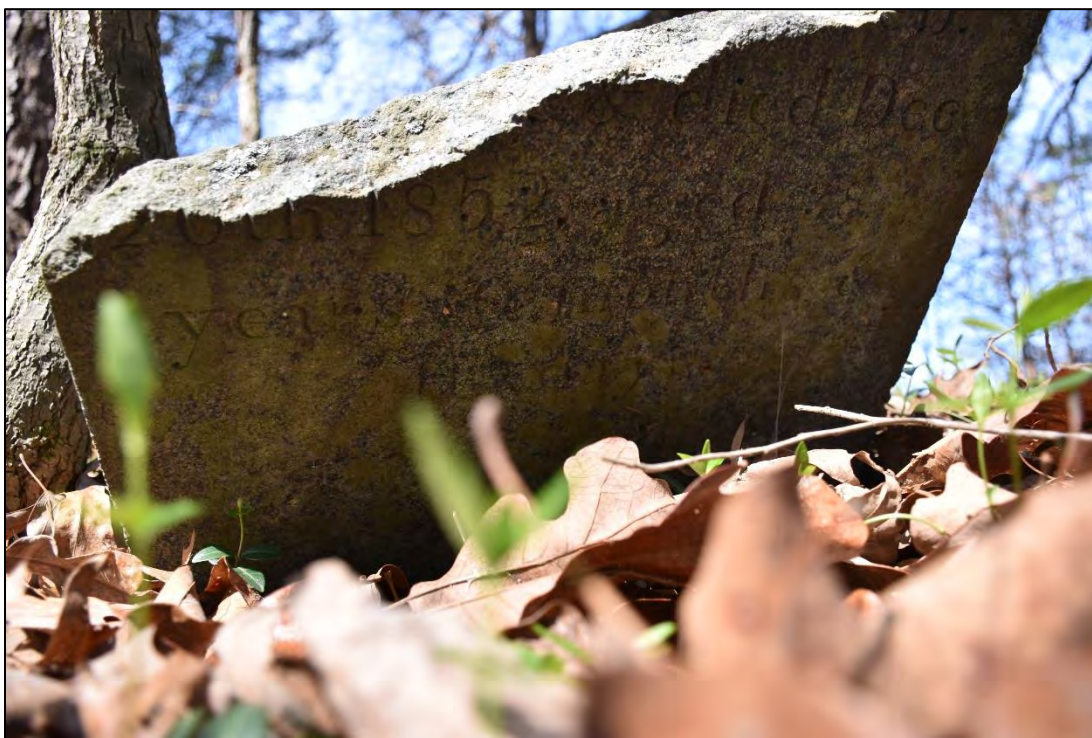
Figure 2.57. Cashion and Moore Family Cemetery, unknown headstone, facing west.

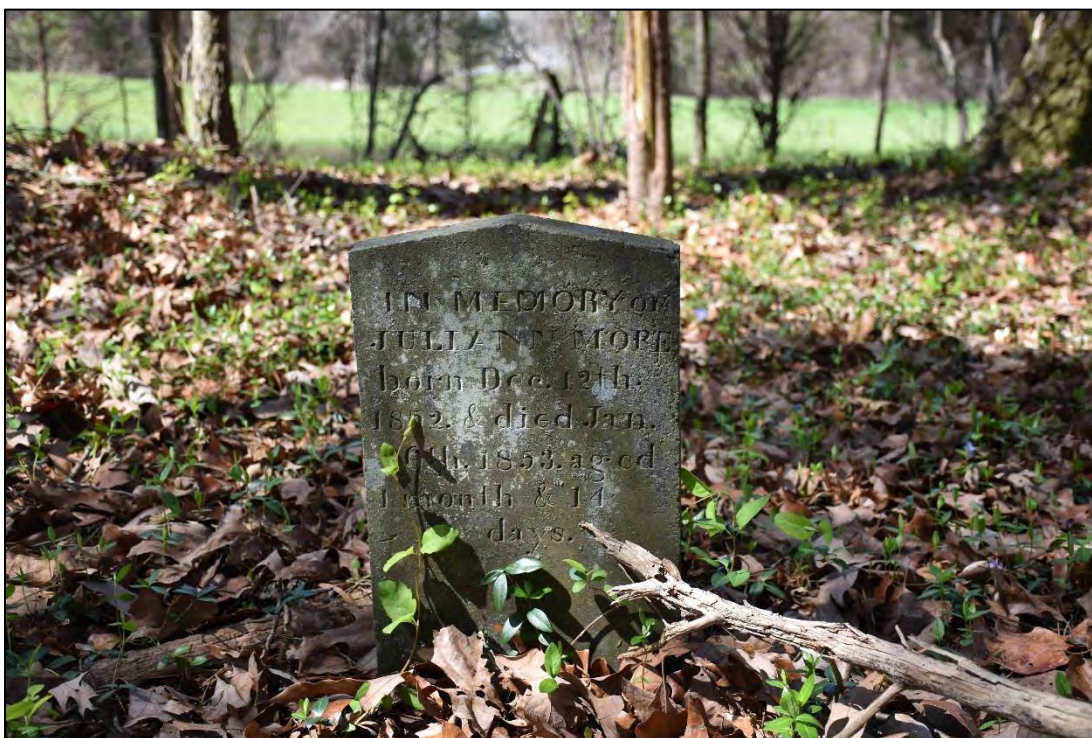
Figure 2.58. Cashion and Moore Family Cemetery, Juliann More headstone, facing west.

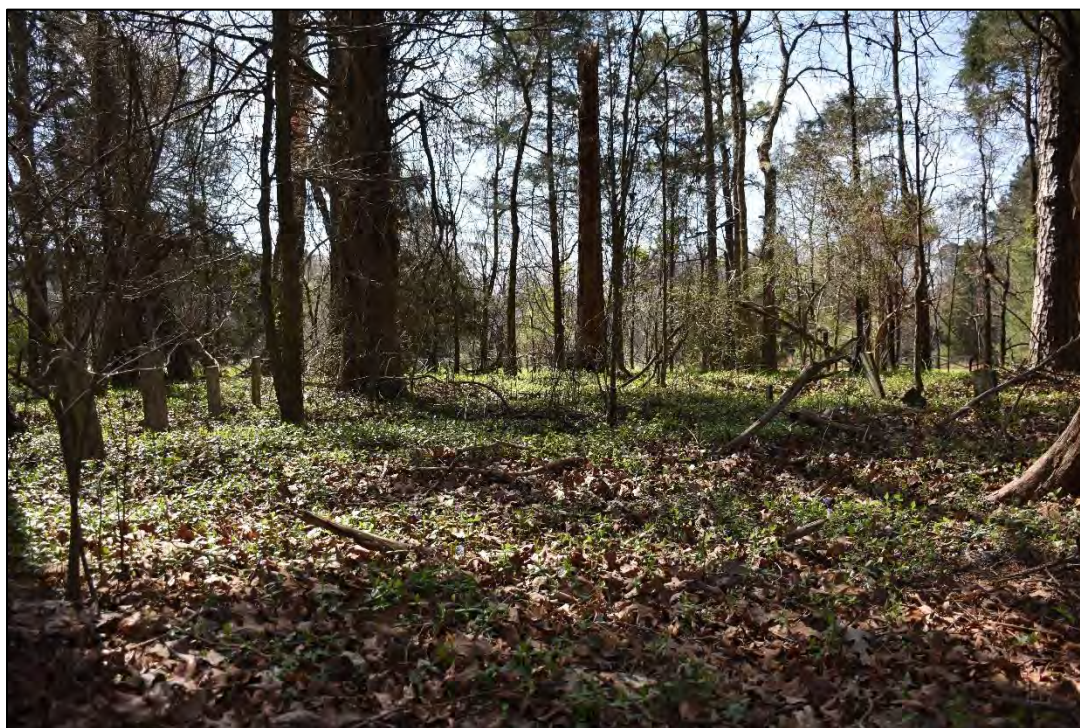
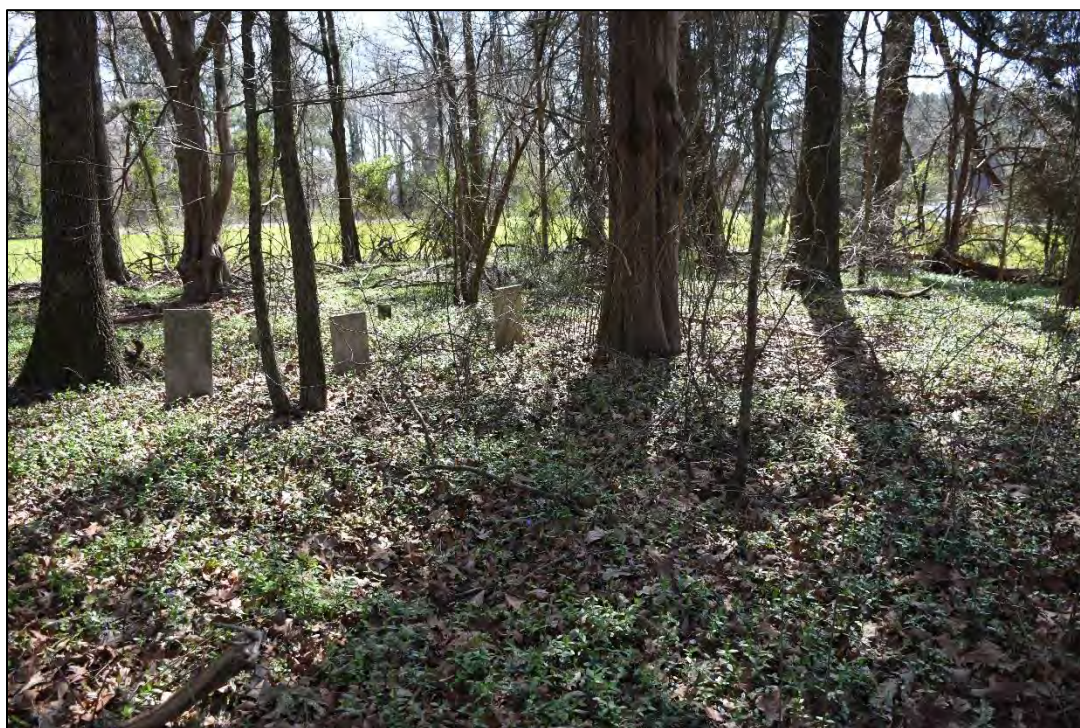
Between the two rows of marked burials is a space that contains four depressions that could potentially indicate an additional, unmarked row of graves. These depressions are each the approximate size of the surrounding burials and they are oriented east-west, like the marked burials. Although difficult to see in photographs, the depressions were pronounced and easily recognizable in the field (Figures 2.60 and 2.61)

Figure 2.60. Cashion and Moore Family Cemetery, row of potential grave depression, facing south.

Figure 2.61. Cashion and Moore Family Cemetery, row of potential grave depression, facing southeast.

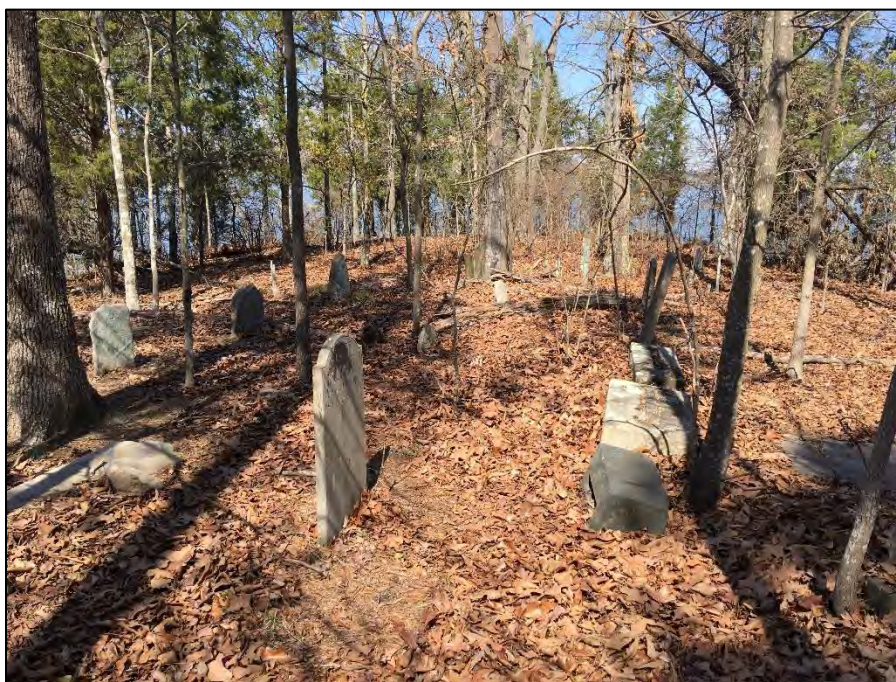
The Mason Cemetery (NSN) is a family cemetery located in southern Mecklenburg County (Figure 2.62). Although larger than the Cashion and Moore Family Cemetery, it has burials that date to around the same time period (Figures 2.63 and 2.64). Many of these stones are simply carved (Figure 2.63), similar to those in the Cashion and Moore Family Cemetery, but others exhibit more decorative detailing, such as the weeping willow tree (Figure 2.64), indicating a higher social status for some of the persons interred in the Mason Cemetery. The Tunis-Hood Cemetery (MK2311), formerly the second Philadelphia Presbyterian Church Cemetery, is a larger, more formal cemetery than the Cashion and Moore Family Cemetery, with a delineated stone wall boundary. However, it does contain graves dating from through mid-nineteenth century, which aligns with the same time period as the Cashion and Moore Family Cemetery (Figure 2.65). These grave markers also range from simply carved rectangular stones to more elaborately carved stones (Figures 2.66 and 2.67). Similarly, the Phifer Cemetery (CA1591), although located in Cabarrus County, is eight miles east of the Cashion and Moore Family Cemetery and located along the NC 73 corridor, putting it in similar geographical range as the Cashion and Moore Family Cemetery. Its earliest burials date from the late-eighteenth century, but it also contains graves dating to the mid-1800s. It is also larger than the Cashion and Moore Family Cemetery, with delineated boundaries, but has similar styles of grave markers (Figures 2.68 through 2.70)

Figure 2.62. Mason Cemetery (NSN), facing north.

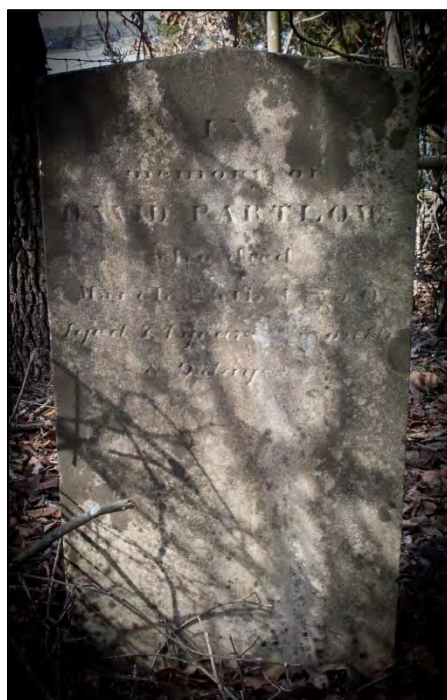
Figure 2.63. Mason Cemetery, headstone of David Partlow (died 1850), facing west.

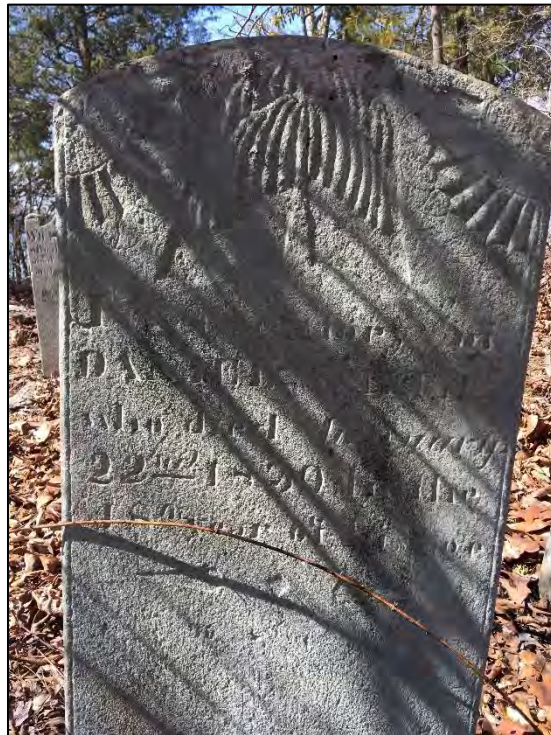
Figure 2.64. Mason Cemetery, headstone of Daniel Smith (died 1859), facing west.

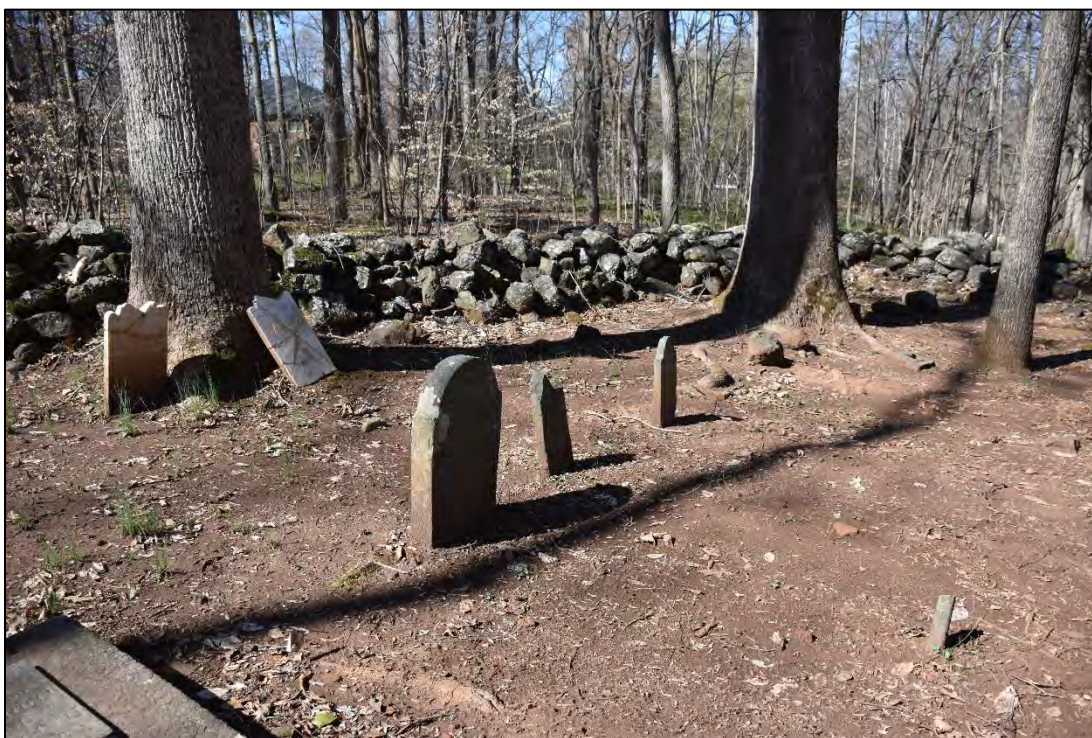
Figure 2.68. Phifer Cemetery (CA1591), facing northwest.

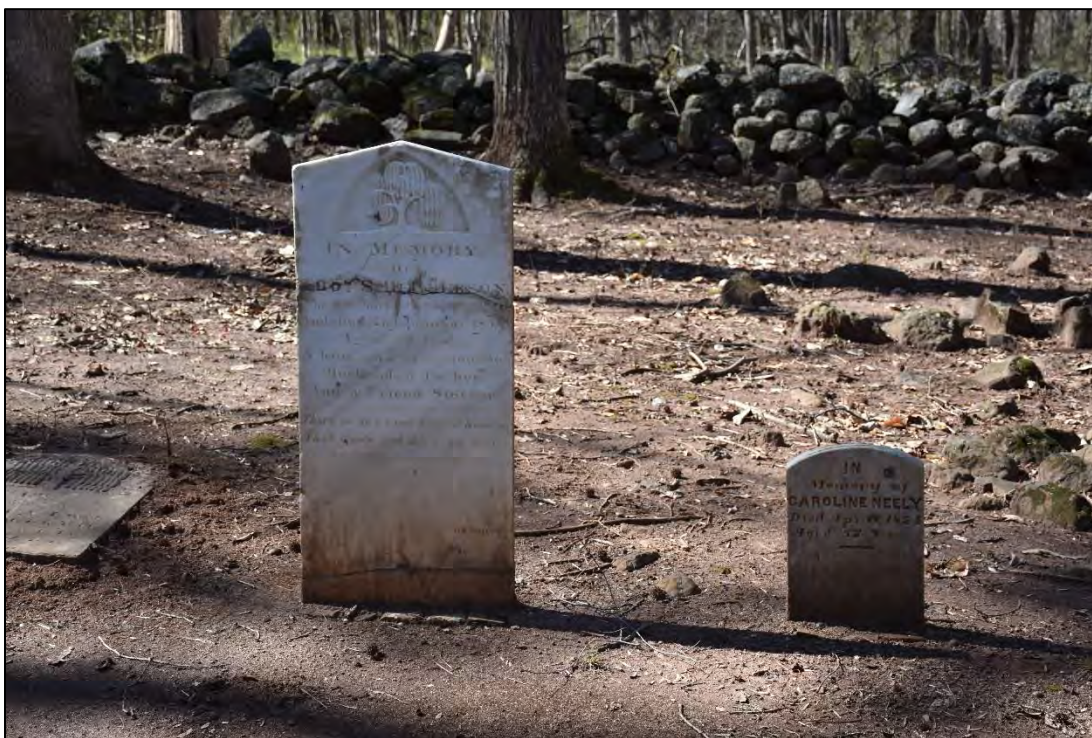
Figure 2.69. Phifer Cemetery (CA1591), grave markers, facing west.

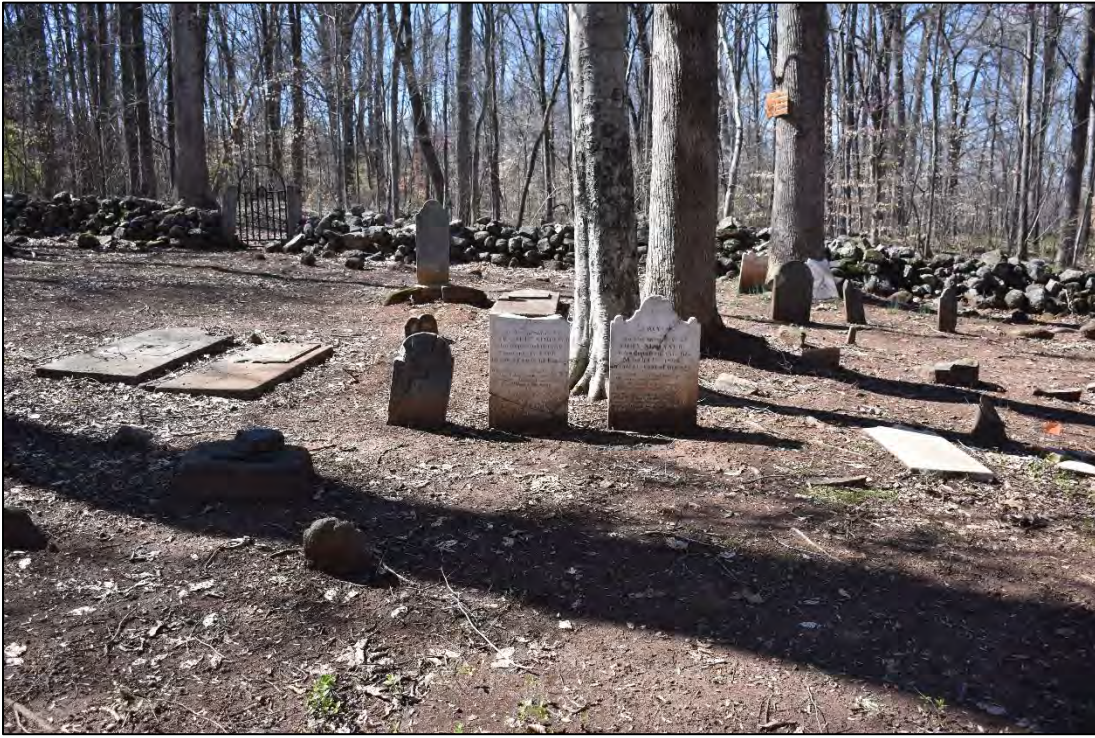
Figure 2.70. Phifer Cemetery (CA1591), grave markers, facing west.

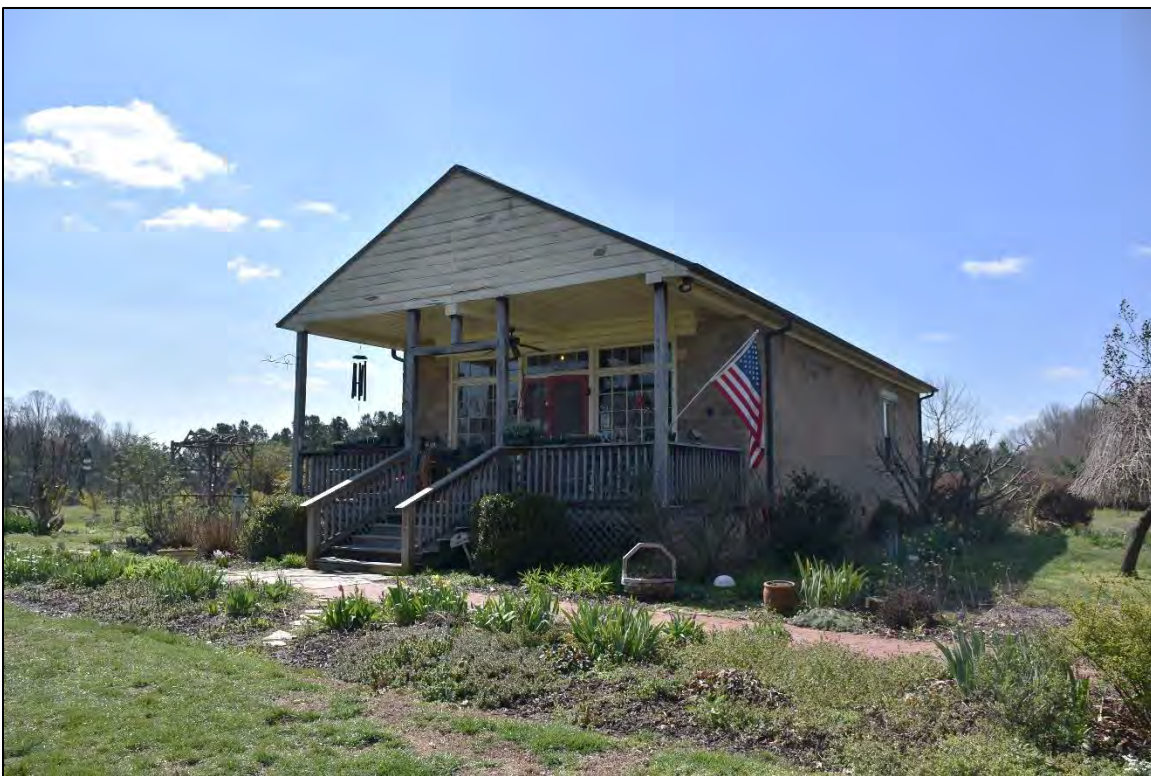
Figure 2.71. Bradford Store (MK2811), facing southeast.

The Bradford Store retains its basic form, however, it apparently has undergone changes to its exterior, primarily through the moving of the building to its new location. No longer a ground-level structure, it sits on a raised foundation and is accessed by a newly installed stairway to its porch overhang.

The Bradford Store retains its concrete-block construction, although a new foundation was added when it was moved in 2006. The weatherboard siding and window framing on the store appear to be original, as do the floors, ceiling, and supports on the interior, as well as the front entry door and display windows. The front porch supports, which were likely not original in 2002 when the Bradford Store was designated a local landmark, have been altered to accommodate the central stairway necessary for access to the newly lifted structure.

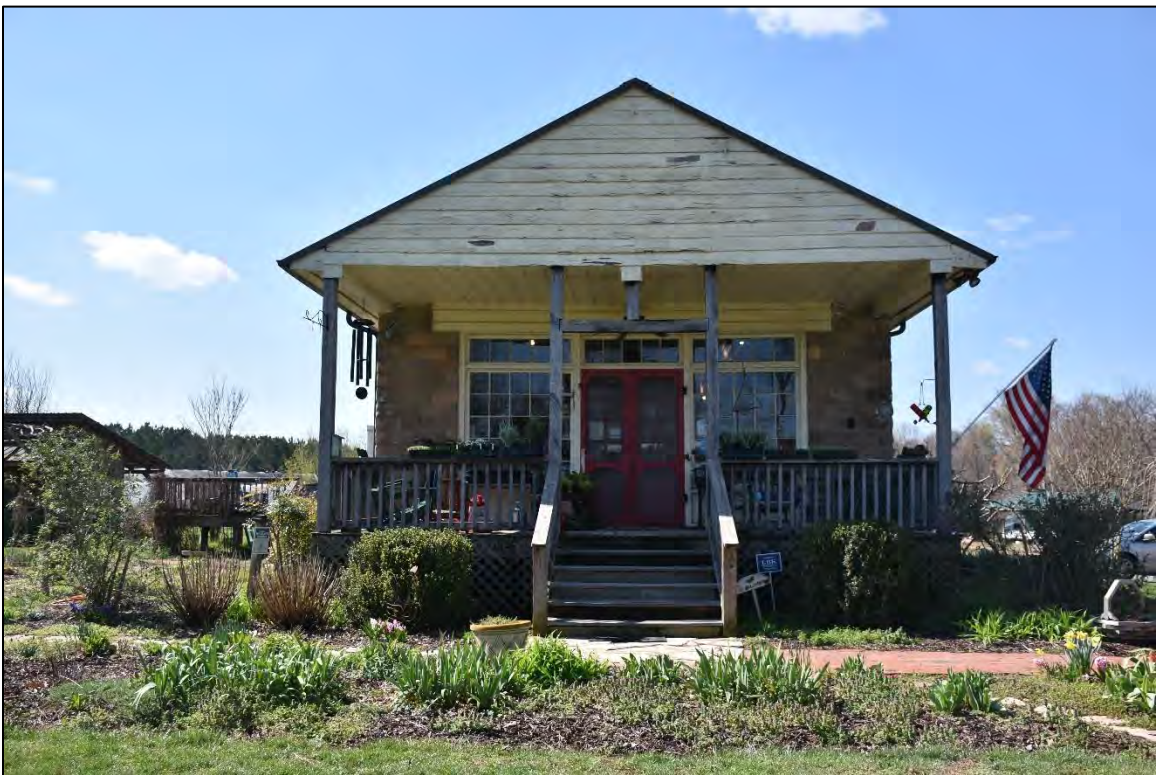
The Bradford Store is a concrete block building, with a rectangular plan and gabled roofline; the concrete block on the overall structure is plain-faced, but the corner blocks are rusticated. The front elevation of the structure has a wide overhang of the main roofline that creates a porch that is supported by square posts and is accessed by a central stairway (Figure 2.72). The gable end of the structure is covered with weatherboard siding and the porch ceiling is tongue-and-groove boards. The central double doorway is flanked by 25-pane, wooden-framed display windows and there are three five-pane transoms that cover the entire door and window combination. Along the east elevation, there is a porch addition and an entry door, along with foundation vents (Figures 2.73 and 2.74). The rear elevation has two single one-over-one, vinyl-sash windows that have wooden lintels and frames (Figure 2.75). The rear gable end is also covered with wooden weatherboard and has a rectangular attic vent centered within it. A single one-over-one, vinyl-sash window is located on the west elevation of the store (Figure 2.76).

Figure 2.72. Bradford Store, facing south.

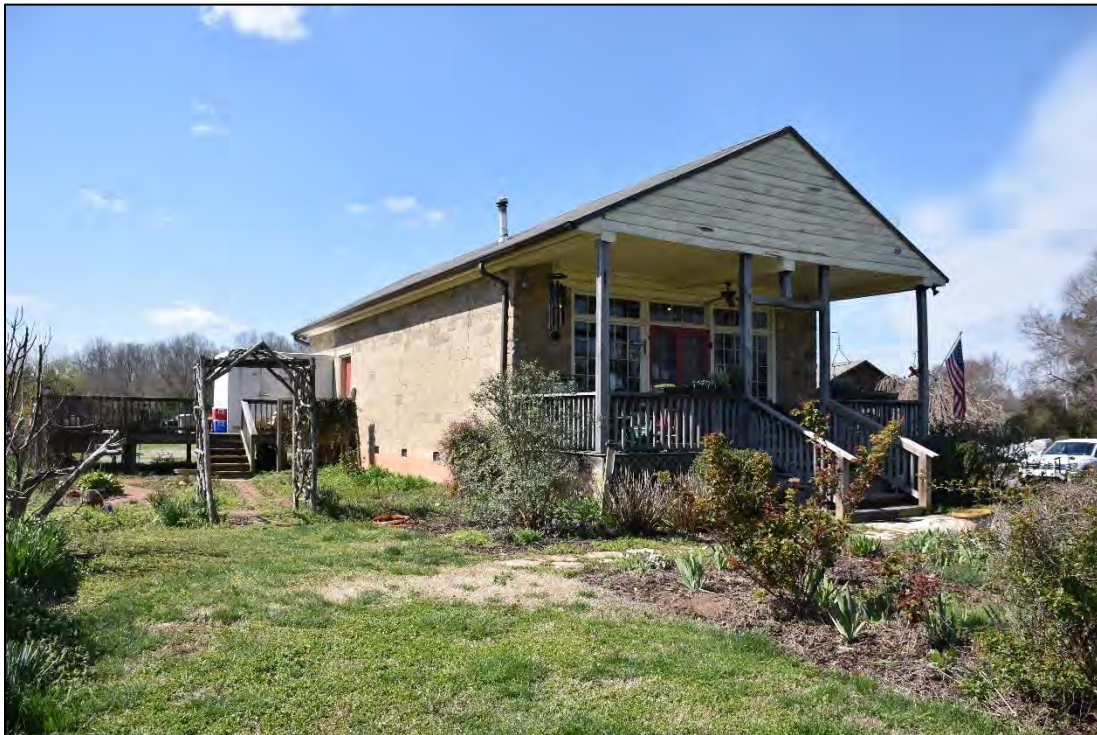
Figure 2.73. Bradford Store, facing southwest.

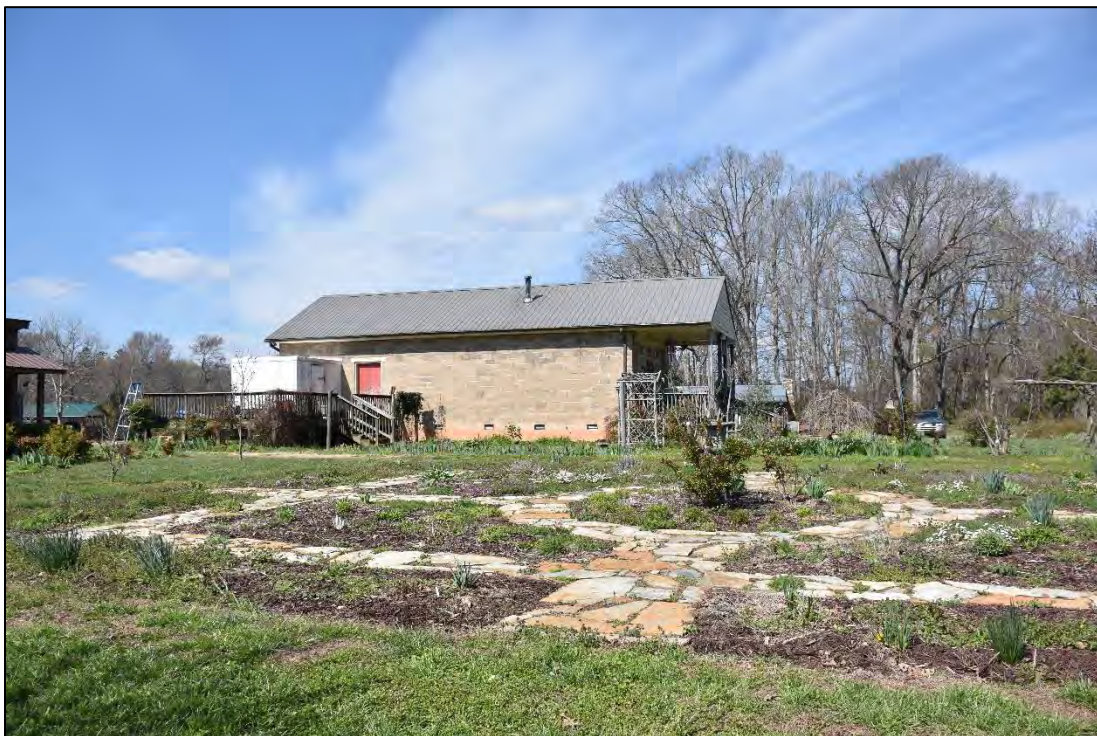
Figure 2.74. Bradford Store, facing west.

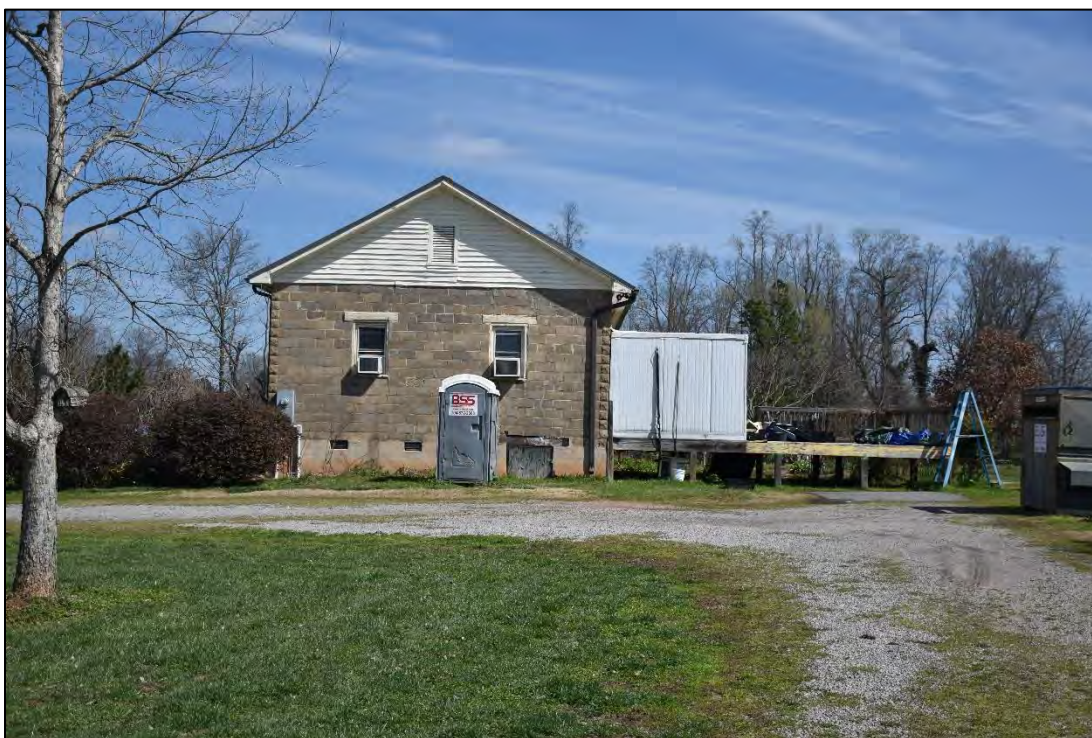
Figure 2.75. Bradford Store, facing north.

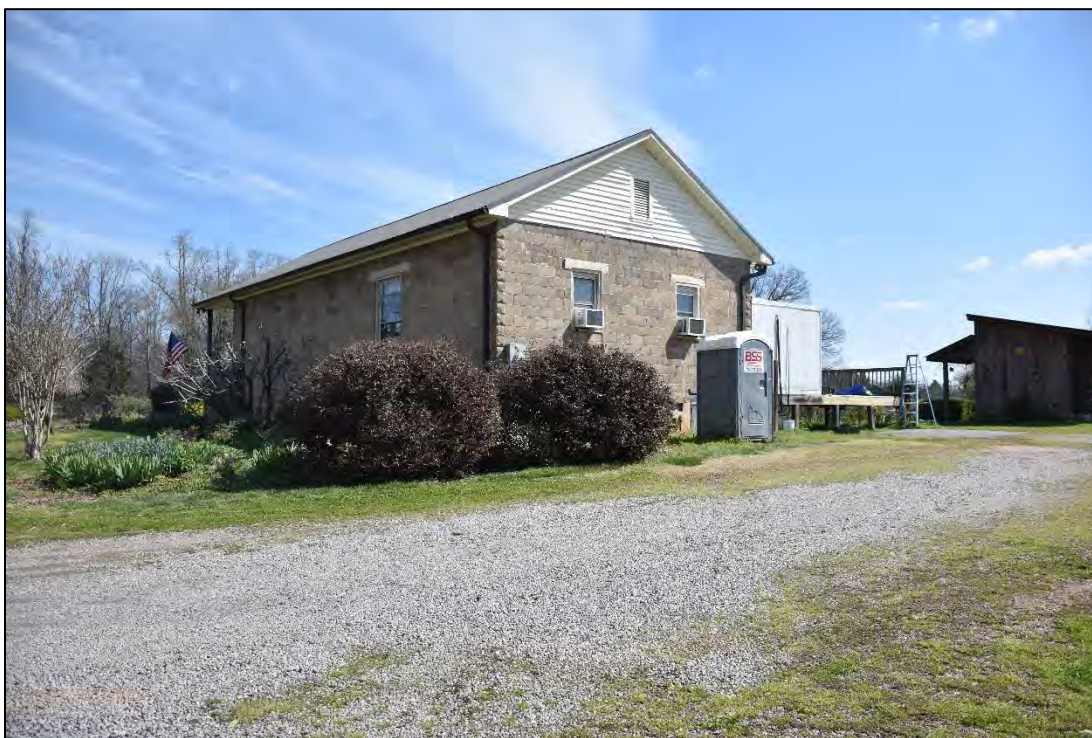
Figure 2.76. Bradford Store, facing northeast.

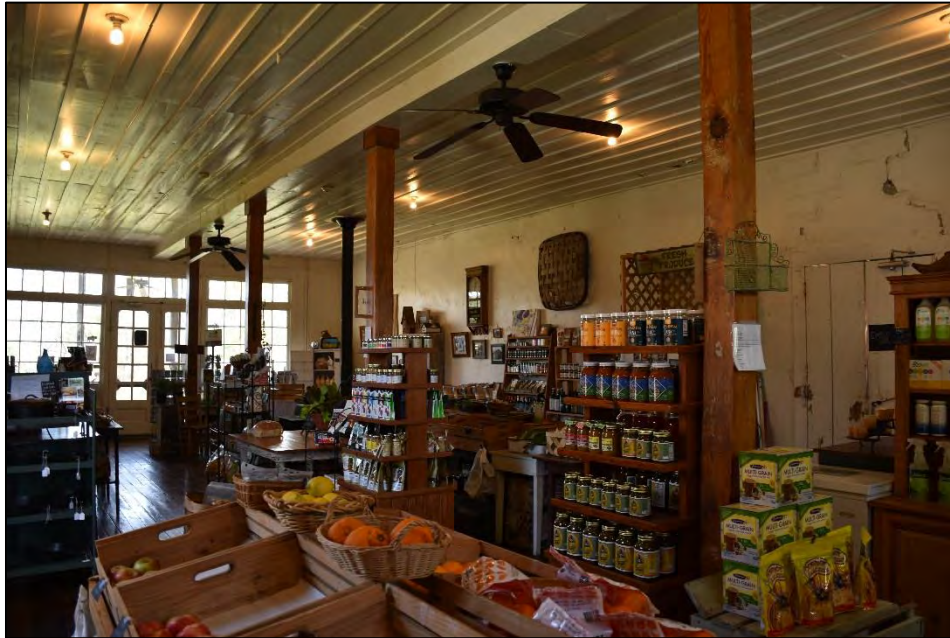
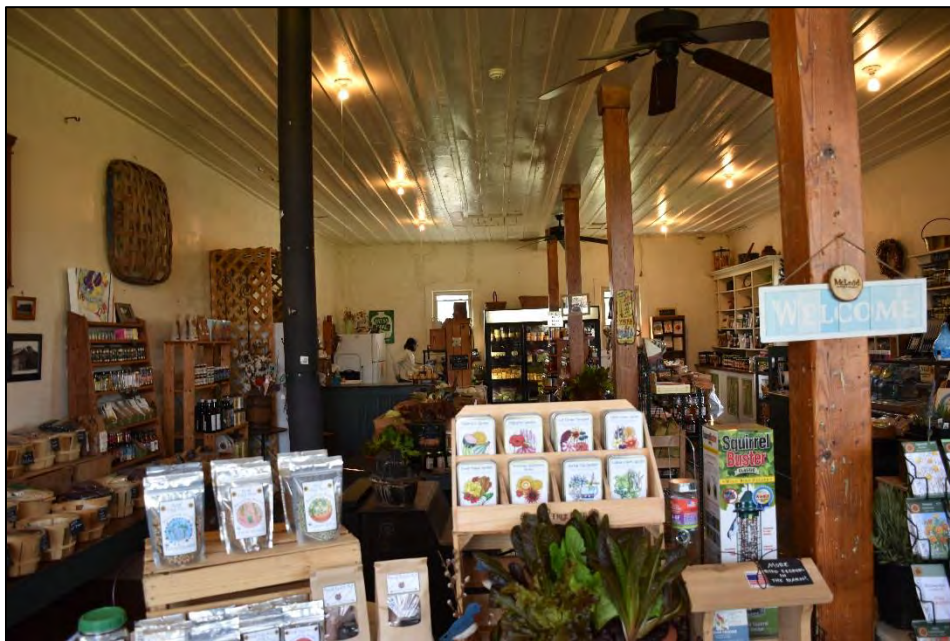
The interior of the Bradford Store is a single, open room. The ceiling, which is covered with wooden board-and-batten sheathing, is supported by a central row of square posts attached to a central beam (Figures 2.77 and 2.78). East of center, there is a coal-burning stove that vents through the ceiling. Although most of the display space in the store is non-fixed, along the western wall there is an attached shelving unit and a non-moveable display counter (Figure 2.79).

Figure 2.77. Interior view of the Bradford Store, facing northeast.

Figure 2.78. Interior view of the Bradford Store, facing south.

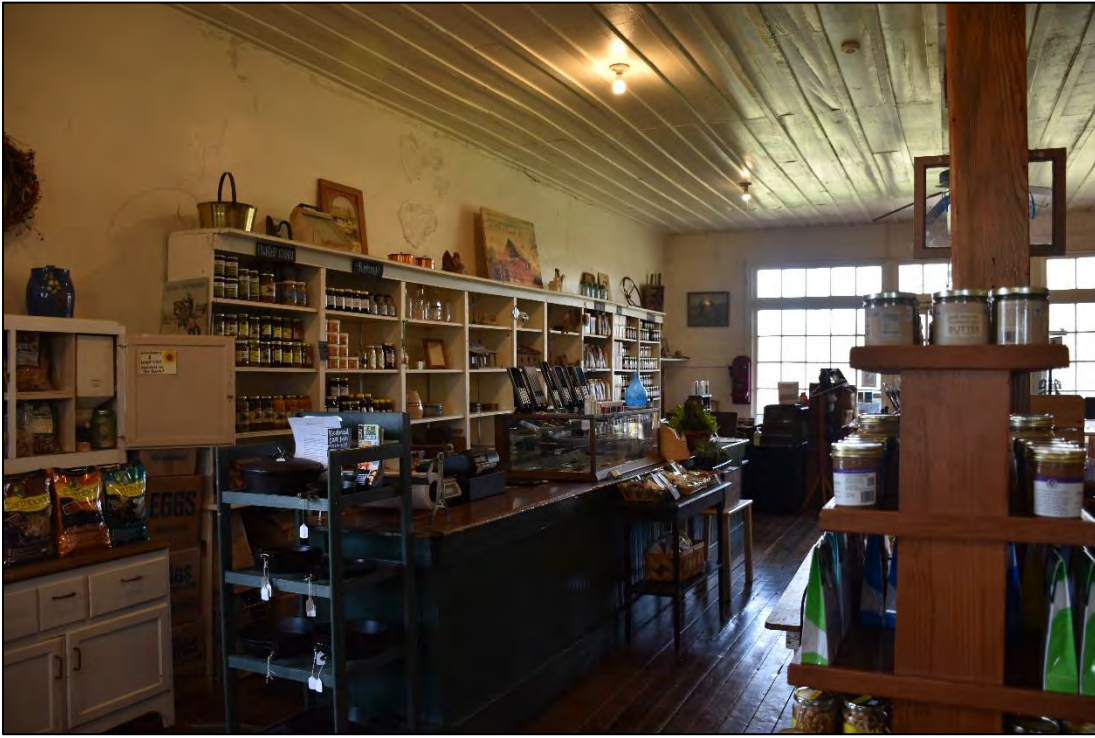
Figure 2.79. Interior view of the Bradford Store, facing northwest.

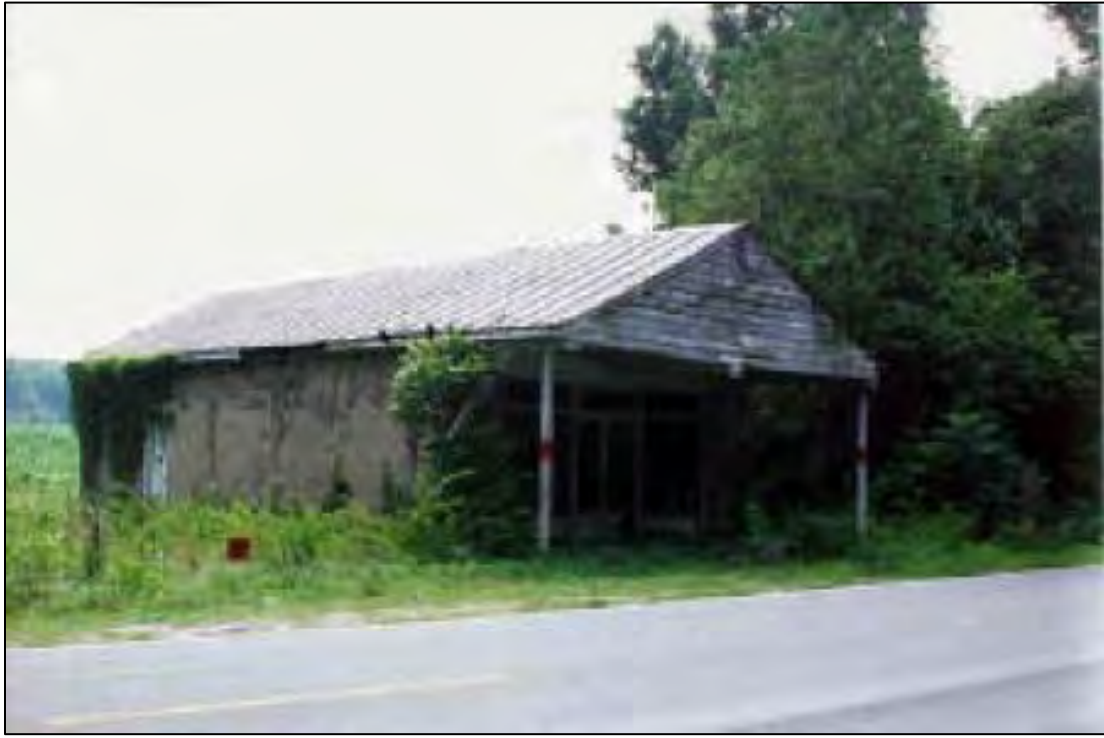
Since it was surveyed in 1988 and designated a local landmark in 2002, the Bradford Store has undergone some significant alterations. The most significant alteration was the 2006 change in location of the store. Although the building remains on the same property as it was originally situated, to accommodate improvements to NC 73, the store was moved southwest of its original location. The store formerly sat along the southern edge of NC 73, while it currently is set approximately 250 feet back from the road. As part of the move, the Bradford Store was also placed on a raised foundation, to accommodate the topography of the new location, and a staircase was constructed to access the front entryway. The construction of the central staircase required the restructuring of the supports of the roof overhang, which originally had three equally spaced supports, with one being located in the center of the façade (Figure 2.80).

Figure 2.80. View of the Bradford Store, circa 2002, facing southwest.

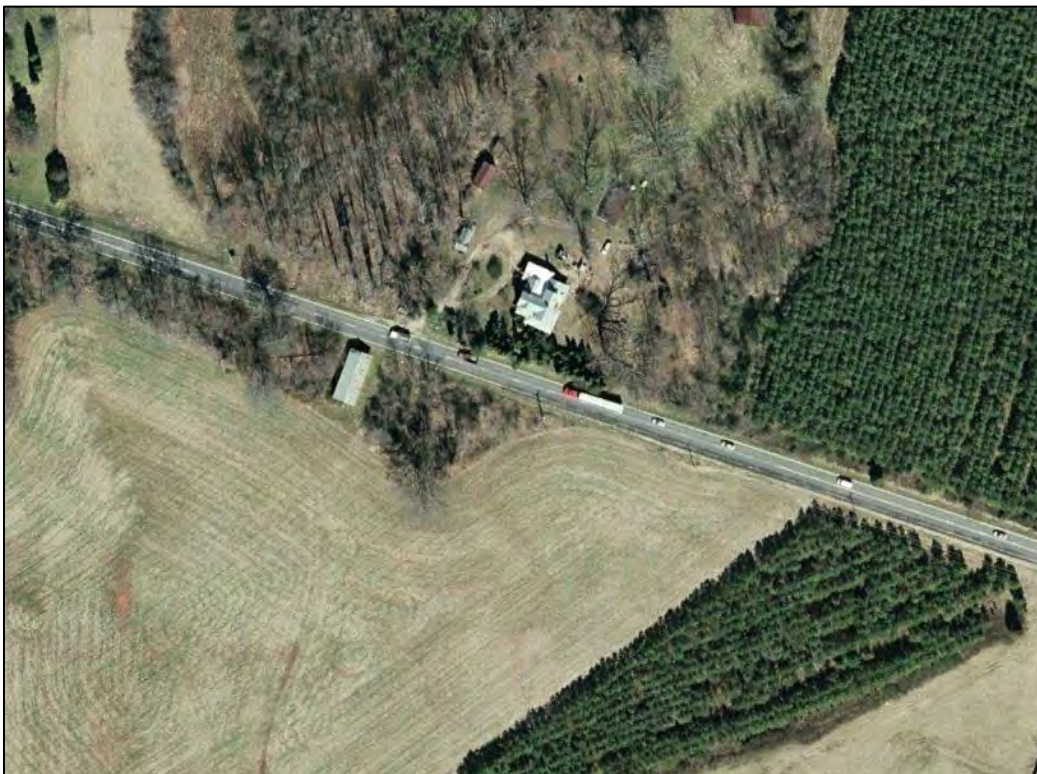
In 2006, the Bradford Store was moved back from its original location along the roadway, to accommodate improvements to US 73 (Figures 2.80 and 2.82).

Figure 2.82. Aerial photograph (2005) showing original location of the Bradford Store.
