Re: Evaluation of Bridge and Culvert Structures at Coweeta Hydrologic Laboratory, Nantahala Ranger District, Nantahala National Forest, Macon County, ER18-1786

**Historical Documentation and National Register of Historic Places Evaluation
of Bridge and Culvert Structures at Coweeta Hydrologic Laboratory,
Nantahala Ranger District, Nantahala National Forest,
Macon County, North Carolina**

Field Report

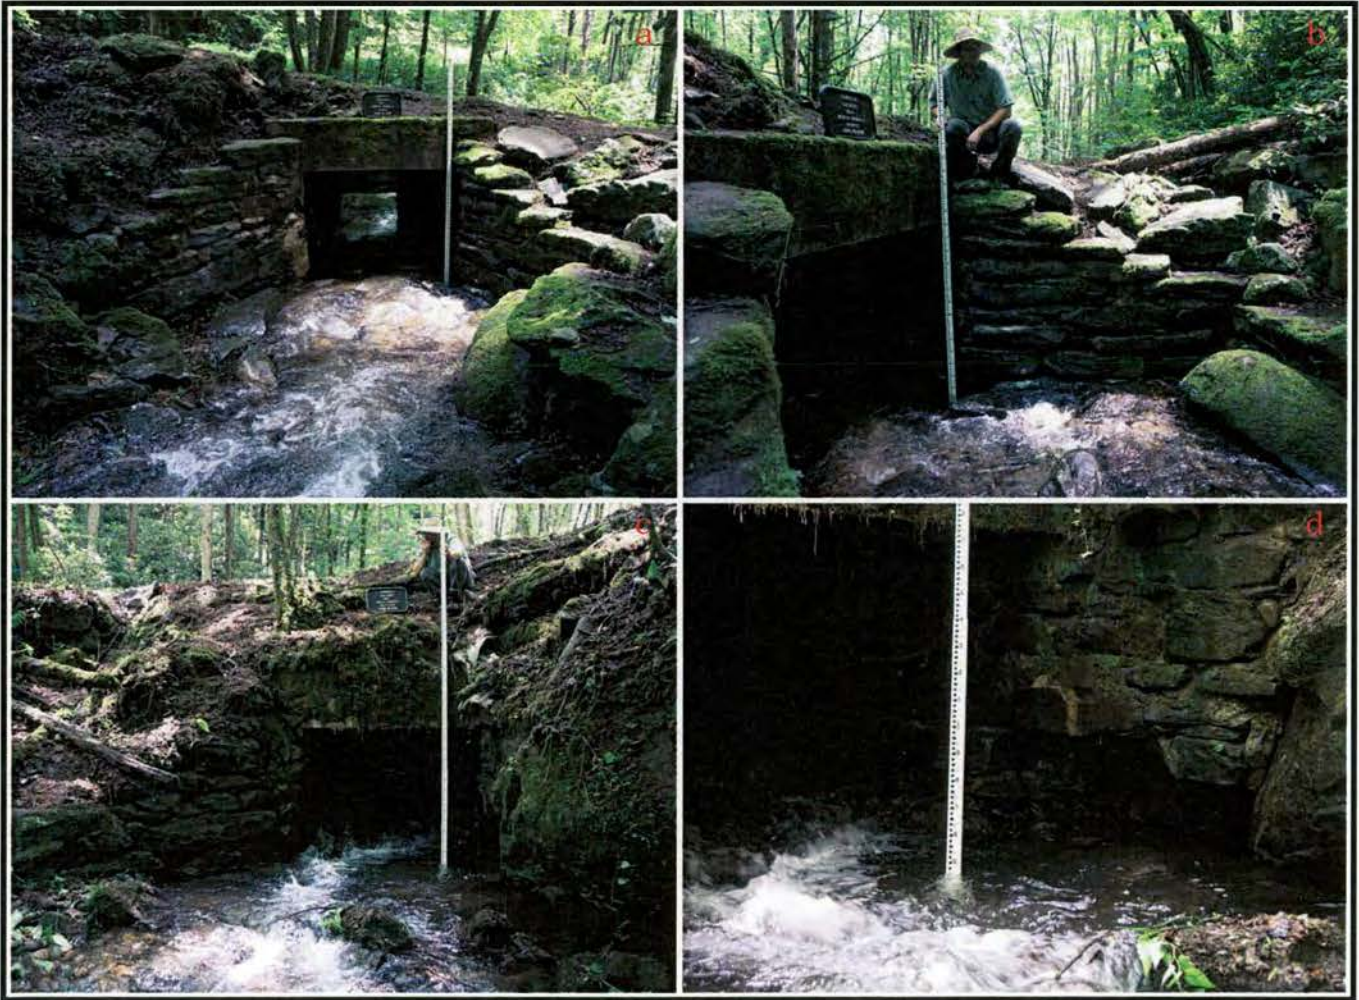
Condition Overall: good		
Headwall: largely intact; some weakening and erosion of mortar		
Outflow Wall: some weakening and erosion of mortar; loss of stones in lower portion of northwest wing wall; eroding slope above box culvert; discarded, crushed metal drain pipe above (not associated; non-functional)		
Research Potential: fair; partially realized through present study		
NRHP Recommendation: eligible (as contributing element of larger district)

Figure 8. Overview photographs of Culvert No.1 on Shope Fork: a) intake and wing walls, view to northeast; b) close-up of southeast wing wall of intake, view to east; c) outflow and wing walls, view to south; d) loss of stones at base of west wing wall of outflow, view to southwest.

culvert and Figure 8d offers a close-up view of the cavity formed by the loss of stones at the base of the northwest wing wall.

A comparison of the June 2018 condition of the head and outflow walls of Culvert No. 1 to their condition recorded in August of 2014 (cf. Shumate and Hanson 2014) suggests that there has been little if any change to the headwall portion of this box culvert or to its adjacent wing walls. According to conversation with an unnamed Coweeta Hydrologic Laboratory employ who had first-hand knowledge of the 2016 flood damage to this culvert and to FR 751, a fallen tree washed downstream and blocked the headwall entrance to Culvert No. 1, thereby forcing the stream out of its channel along its eastern bank and down the road until it reentered the normal creek channel a few dozen meters below the outflow of Culvert No. 1. Despite the shift of the normal flow of water to the area of the southeastern wing wall of the headwall portion of Culvert No. 1, no apparent damage to the wing wall occurred (see Figure 8b). Unfortunately, the same cannot

be said for a portion of the outflow wall and its adjacent northwest wing wall. During the 2014 reconnaissance of this structure, a few stones were noted as missing from the lowest courses at that point where the supporting interior wall of the culvert meets the northwest wing wall. The 2018 inspection of this portion of the outflow indicates that at least a few more stones have been lost. While the overall integrity of the structure is not currently threatened, loss of any additional stones should be avoided, and the necessary repairs made.

repairs in keeping with the existing forms and materials are recommended at both site locations. However, should any proposed repairs to these structures call for significant alteration to their historic fabric or should plans call for their removal, then more intensive documentation at the level of HABS-HAER standards will be warranted. If Bridge No. 1 is to be repaired and preserved in place, then a realignment of the current stream channel slightly to the east may be necessary to avoid future impacts to the CSP liner and northeast wing wall.

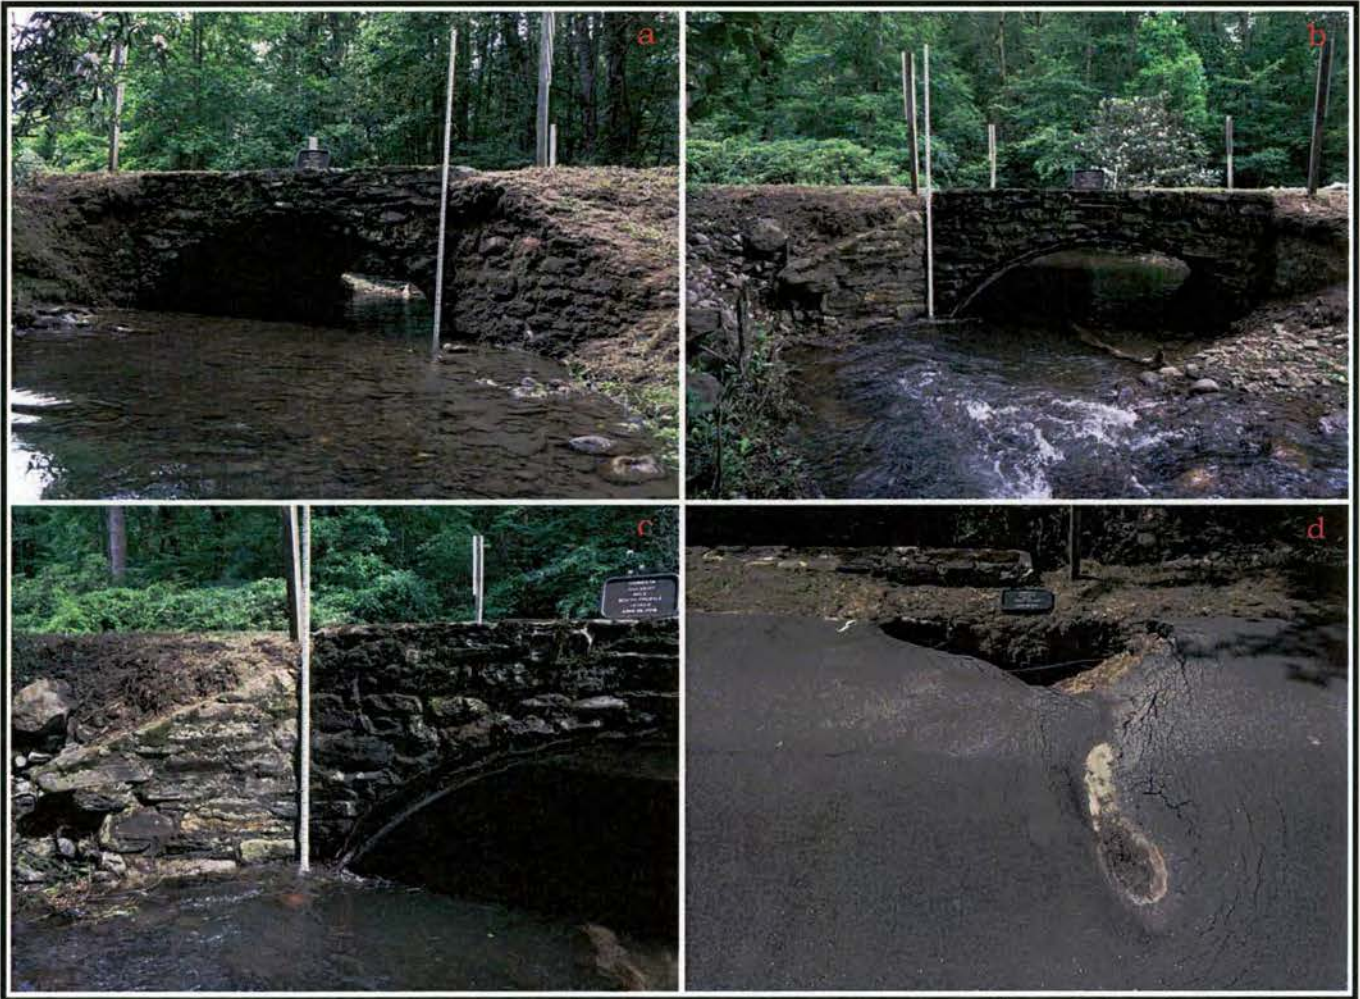
Location (UTM's @ NAD WGS 84): Zone: 17 @ Easting: 278484 Northing: 3882388 (at center of headwall/intake)		
Elevation: 2,235 feet AMSL		
Adjacent Roadway: FR 83 (Ball Creek Road) @ Mile Post: BMP ~0.027 ~50 meters southwest of intersection of FR 83 and FR 751		
Orientation (flow of stream): ~160° NW-SE		
Principal Drainage: Shope Fork		
Construction Details: mortared natural stone headwall, outflow wall & flanking wing walls; lap-seamed, riveted corrugated steel pipe (CSP) arch support below; stone & soil fill above CSP & below asphalt roadway		
	Headwall & Outflow Wall	Corrugated Steel Pipe
Max. Height:	~7.2 feet (2.2 meters)	~5.2 feet (1.6 meters; @ center)
Max. Width:	1.5 feet (0.45 meters)	~13.1 feet (4.0 meters; @ base)
Max. Length:	15 feet (4.6 meters)	~20.2 feet (6.15 meters)
Condition Overall: fair		
Headwall: largely intact; loss of a few stones at base of NE wing wall; CSP intact, but has slipped off its foundation on NE corner; tree roots forcing separation

Figure 9. Overview photographs of Bridge No. 1 near confluence of Shope Fork and Ball Creek: a) outflow and wing walls, view to north; b) headwall and wing walls, view to south; c) damaged northeast wing wall and CSP liner, view to southeast; d) Forest Road 83 failure, view to north.

seams form a semi-circular arch that supports the largely earthen fill on which a single layer of asphalt has been poured to span the length of the bridge. As summarized above, the headwall or upstream portion of Bridge No. 1 that channels a portion of Shope Fork beneath FR 83 includes a semi-circular opening that measures approximately 13 ft (4.0 m) wide at its base by 5.2 ft (1.6 m) tall at its center (from creek bottom to top of steel arch). Above this corrugated steel arch the headwall or intake wall and its adjacent wing walls are formed by irregularly or random-spaced tabular stones that are at best roughly dressed, if at all altered from their natural state. The mortar bond between these stones is also roughly dressed, but more uniformly applied than observed at Culvert No. 1. The stonework of the headwall measures 15 ft. (4.6 m) long (ne-sw) and rises approximately 2.1 ft (0.65 m) above the center of the steel arch and extends only a few inches (and in places not at all) above the surface of the roadway and the grassy margin that separates the two surfaces. The adjoining wing walls do not rise as high as the head wall and their top surfaces slope downward on angles of approximately 45 degrees. These wing walls are not of equal size and a soil and grass mantle over the northwest wing wall make it difficult to measure accurately. Minimally, the northwest wing wall measures 4.1 ft (1.25 m) long by 3.9 ft (1.20 m) tall. The northeast wing wall is better exposed and measures 6.1 ft (1.85 m) long by 4.8 ft (1.45 m) tall and 2.5 ft (0.75 m) tall at its low end. The dimensions of the outflow wall and its supporting corrugated steel arch are the same or very nearly so as those of the headwall and its steel casing. Adjoining wing walls of the outflow wall are similarly sloped and at least in the case of the southeast wing wall measure slightly longer and taller than those on the north side of the road. The southwest wing wall is particularly difficult to measure as it is almost completely covered by soil and grass. As in the case of the headwall, the stones of the outflow wall may be characterized as tabular in shape and were likely cut from a nearby quarry or roughly dressed from even more local sources. On average, the stones of the outflow wall and its adjoining wing walls appear slightly smaller in size than those of the headwall and its associated wing walls.

Bridge No. 1 on Ball Creek Road was not inspected during the 2014 reconnaissance of similar structures in the Coweeta Hydrologic Laboratory project area (cf. Shumate and Hansen 2014). As such, no comparison can be made to any earlier condition of Bridge No. 1. As in the case of Culvert No. 1 on Shope Fork Road, significant storm damage occurred to the Bridge No. 1 roadway in 2016, and damage to the northeast wing wall and steel arch supports on the headwall side also likely occurred at this time or were at least aggravated in 2016. As illustrated in Figure 9b and 9c above, storm waters have resulted in the loss of some of the lowest stones of the distal end of the northeast wing wall, while the mortar bond of at least one of the lowest stones on the eastern side of the headwall has failed. At least some of this damage may predate the 2016 storm event as an earlier attempt to harden with riprap the eastern bank of Shope Fork in the area of the northeast wing wall was observed. Though not confirmed by any below-water inspection, it

appears that the northeast corner of the foundation on which the CSP liner or arch of Bridge No. 1 has failed and resulted in its separation from the stone headwall above. This separation is worsened by the growth of tree roots in the gap formed between the stonework and the steel casing. The size of the largest of these tree roots suggests that this separation may have occurred earlier than 2016. Nevertheless, it was apparently the storm waters associated with an extended 2016 rain event that undermined a portion of FR 83 above the CSP lining of Bridge No. 1 (see Figure 9d). These storm waters created a cavity measuring a maximum of 7.5 ft (2.3 m) long (ne-sw) by 2.1 (0.65 m) wide and more than 3.3 ft (>1.0 m) deep. Erosion of those soils situated between the CSP lining and the asphalt paving resulted in a complete collapse of the paving in the area defined above and a subsidence of pavement measuring 9.5 ft (2.9 m) long (nw-se) in an area extending from the northeast end of the cavity. The south outflow wall and its adjoining wing walls do not appear to have been affected by recent or past storm waters to any significant degree. There is no separation of the CSP liner or arch support on this end of Bridge No. 1 and no loss of stones or mortar. An inspection of the CSP liner does not reveal any major rust, holes, or separation at joints.

Ball Creek Road (83-0.027). Work at this site will include the removal of tree roots from the historic CCC rock bridge facing; the installation of a flowable fill material to close the gap between the metal culvert and the historic rock bridge facing; installation of a rip rap diversion on the NE corner of the stream to divert water from the historic headwall; and repair the roadway above the bridge. To ensure No Adverse Effect to historic properties, FHWA will employ the following mitigation measures: (a) Use of hand tools to remove tree roots and make repairs between the historic headwall and the culvert; (b) Return any fallen rock pieces to their exact location.
