Re: Cultural Landscapes Inventory, Portsmouth Village Historic District, Cape Lookout National Seashore, Core Banks, Carteret County, H22 (SERO-CRD), ER 18-1797

National Park Service
Cultural Landscapes Inventory
2018

Portsmouth Village Historic District
Cape Lookout National Seashore

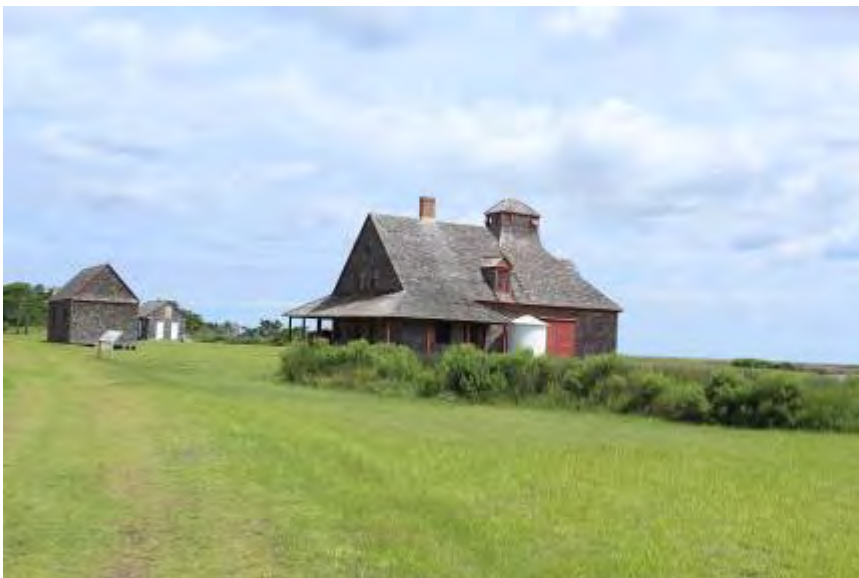
FIGURE 24. The same view as **Figure 23** toward the Portsmouth Life-Saving Station, illustrating the loss of buildings, such as, from left to right, the carriage or cart house, boathouse, oil house, and privy (far right), as well as the board fencing around the station precinct. The summer kitchen and stables survive.

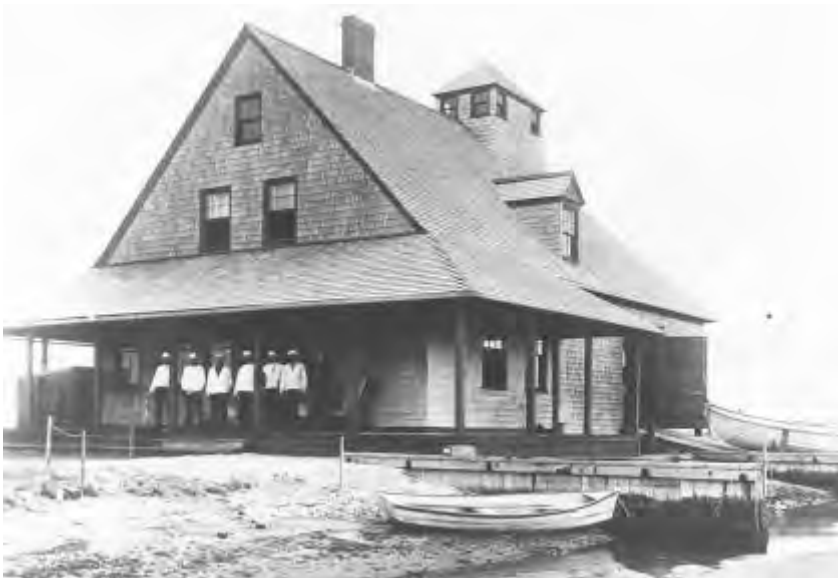
FIGURE 26. Looking north toward the Portsmouth Life-Saving Station. The Coast Guard crew stands on the southeast porch, circa 1903–1915.

The Life-Saving Station, also known as the Coast Guard Station, Signal Corps, and Station 188 Seventh Coast Guard District, was constructed in 1894, and designed by federal architect George R. Tolman, who worked for the Life-Saving Service from 1891 to 1896. Located on the east side of the historic district, the Life-Saving Station is rectangular in plan with a modified hip roof (Figures 22, 23, 24, 25, 26, and 27). A hip roof porch is located at the south end of the station, wrapping around to the east and west sides. The exterior wall and roof surfaces are covered with wood shingles. Most of the windows are double-hung units with divided lights. The building is supported on wood posts, and there is a central brick chimney. The doors and trim are painted a dark red. The building has a lookout tower at the north end of the roof, affording a 360-degree view of the station's surroundings, including the ocean. There are concrete ramps that lead from the double doors on the northwest and southeast sides of the building to the ground that are in fair condition.

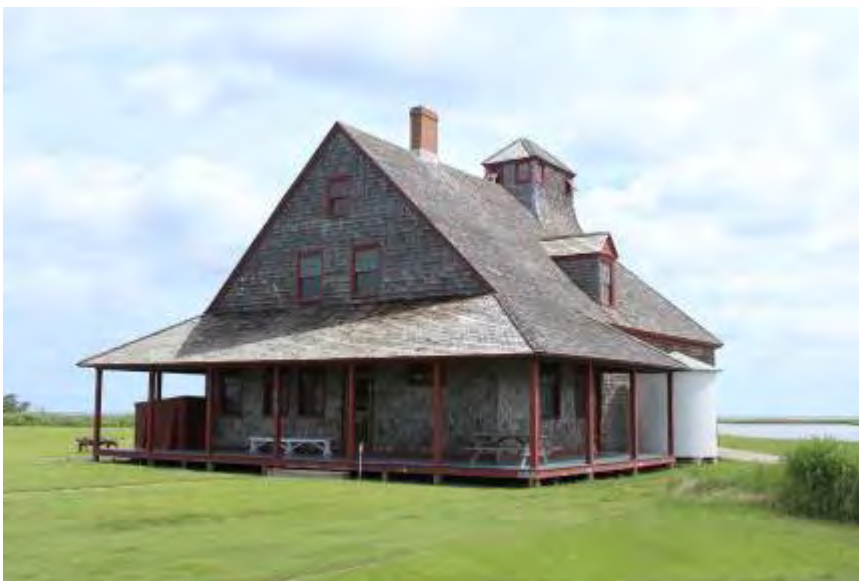
FIGURE 27. The same view as [Figure 26](#) toward the Portsmouth Life-Saving Station, indicating the filling of Coast Guard Creek that has occurred. This building is one of ten surviving examples of numerous Quonochontuag-style stations built during the late nineteenth/early twentieth centuries.

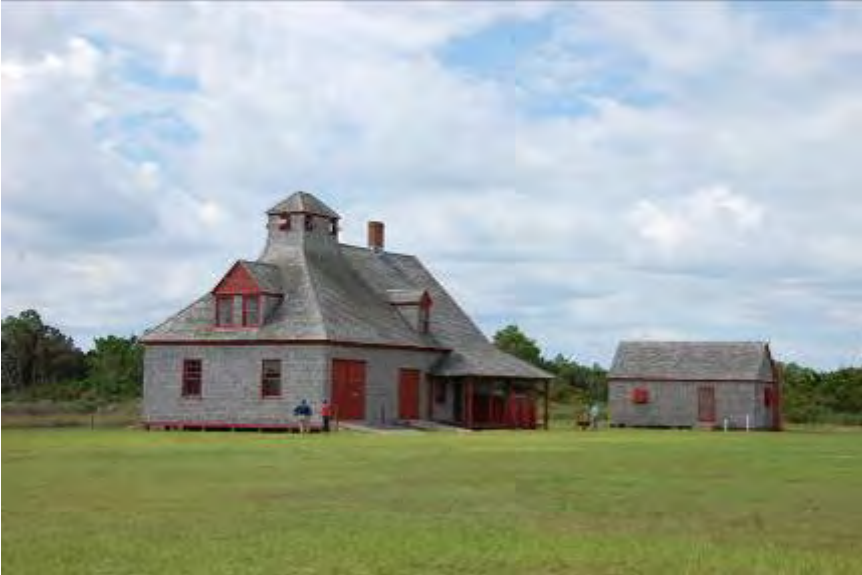
FIGURE 28. The associated summer kitchen is visible to the right of the Life-Saving Station.

The associated Life-Saving Station Kitchen, also known as the Sugar Shack or Summer Kitchen, was likely constructed in 1908 as a single-room structure (Figure 28). In 1942, the building was extended to include a dining room addition to its east. The addition was finished with shiplap siding after construction, while the older part of the structure had shingled exterior walls. The summer kitchen was rehabilitated by the NPS in 1978–1984, including installment of wood shingles over the entire building. It is a one-story rectangular structures with a brick chimney on the northwestern side. Like the Life-Saving Station, the summer kitchen has dark red trim.

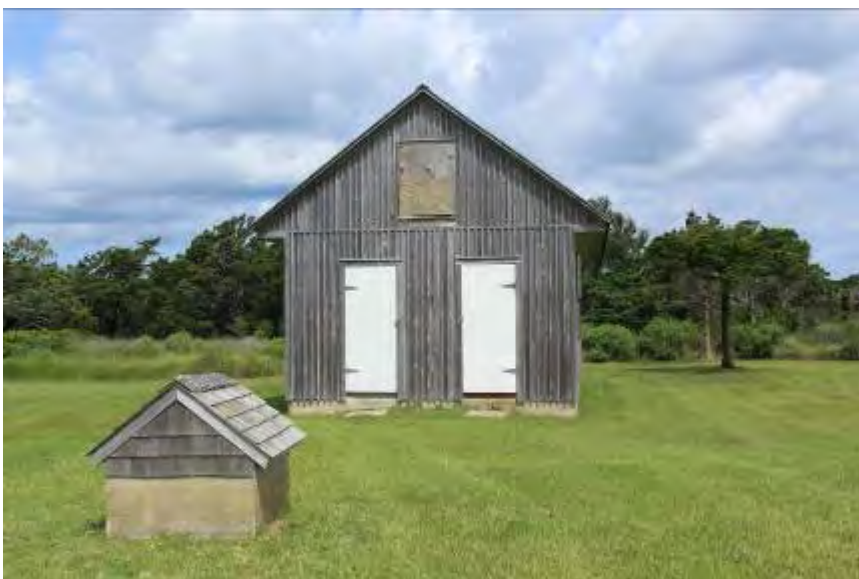
FIGURE 31. The same view as [Figure 30](#) toward the Portsmouth Life-Saving Station Stable, showing the 1928 stable built in the same location as previous stables. This view illustrates the loss of the four-board fencing associated with the use of the building as an active stable for horses (seen in [Figure 29](#)).

Also associated with the Life-Saving Station, the Life-Saving Station stable, also known as the Portsmouth Life-Saving Station shed, was constructed circa 1928 northwest of the Life-Saving Station, across the airstrip (Figures 29, 30, and 31). This building replaced an earlier stable that had been destroyed during a hurricane. After horses left the station in 1932, the building was used for storage and as a garage. The stable was altered between 1960 and 1969. The LCS documentation prepared in 2006 noted damage from Hurricane Ophelia in 2005 to exterior siding, sills, and wall framing, and the need for repair of three windows and doors at this building. The stable is a one-story gable roof structure set atop a continuous concrete foundation. The roof is clad in wood shingles and the walls are board and batten. The doors and windows were boarded over at the time of survey.

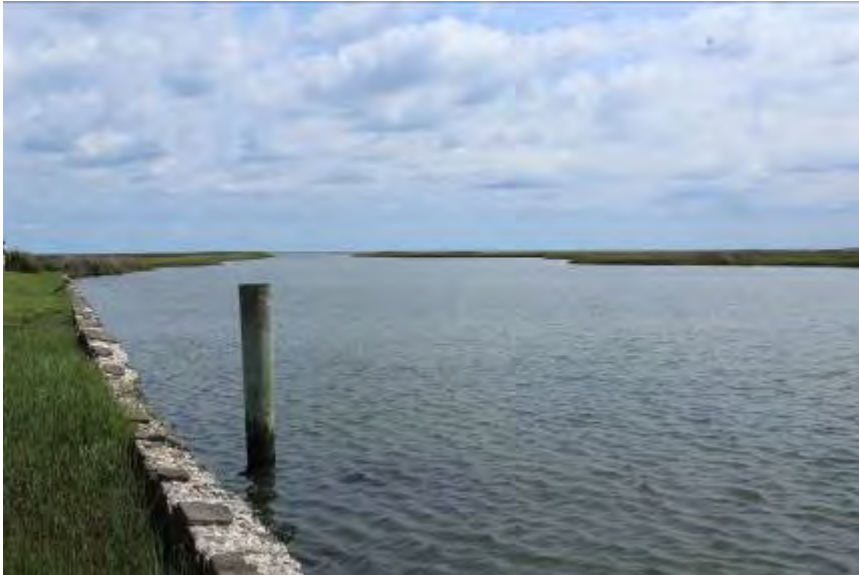
FIGURE 32. View along the concrete seawall and wooden mooring posts in Coast Guard Creek at the Portsmouth Life-Saving Station.

A concrete seawall with a cap of flat stones embedded in a mortar slurry with seashell aggregate edges Coast Guard Creek in proximity to the east and north sides of the Life-Saving Station (Figure 32). This wall was cast-in-place, as were three concrete boat ramps that extend from the Life-Saving Station. The ramps and seawalls were constructed circa 1914–1918. Portions of the wall have become embedded in marshland and silt. The ramps are evidencing some deterioration and are in fair condition. There is vegetative growth in some of the control joints and chipping of the concrete. Some cracking and chipping is in evidence on the seawall.

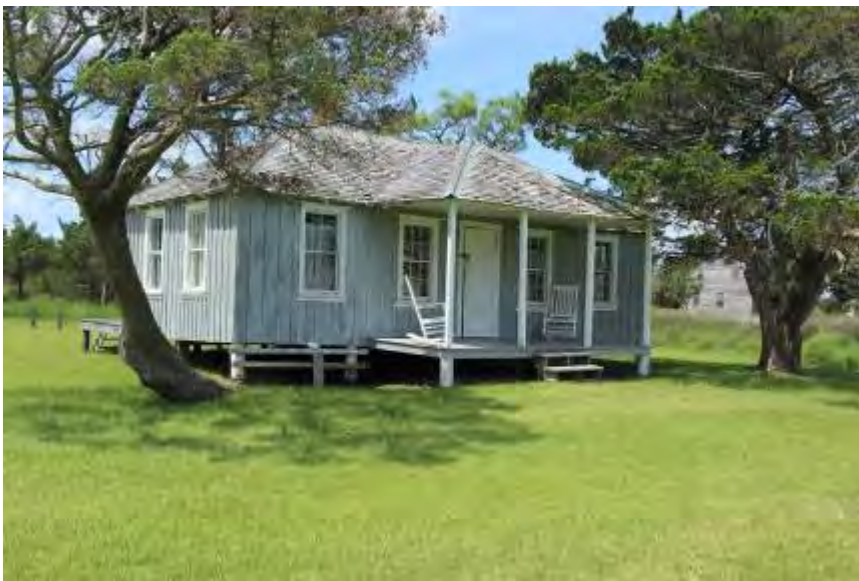
FIGURE 33. The Lionel and Emma Gilgo House.

The Lionel and Emma Gilgo House is located south of Village Road (Figure 33). The Lionel and Emma Gilgo House, also known as the Roy Robinson House and the Robinson-Gilgo House, was constructed circa 1926 on the foundation of the U.S. Marine Hospital and moved to its current location by 1935. The Lionel and Emma Gilgo House is a one-story, hip roof structure supported on wood posts. The house is rectangular in plan with a hip roof porch extension along the north front and an open platform porch at the southeast rear corner. The walls are board-and-batten siding painted a light grey-blue. The double-hung windows are generally two over two, aside from two windows at the front porch which are six over six. The roof is wood shingle, with a

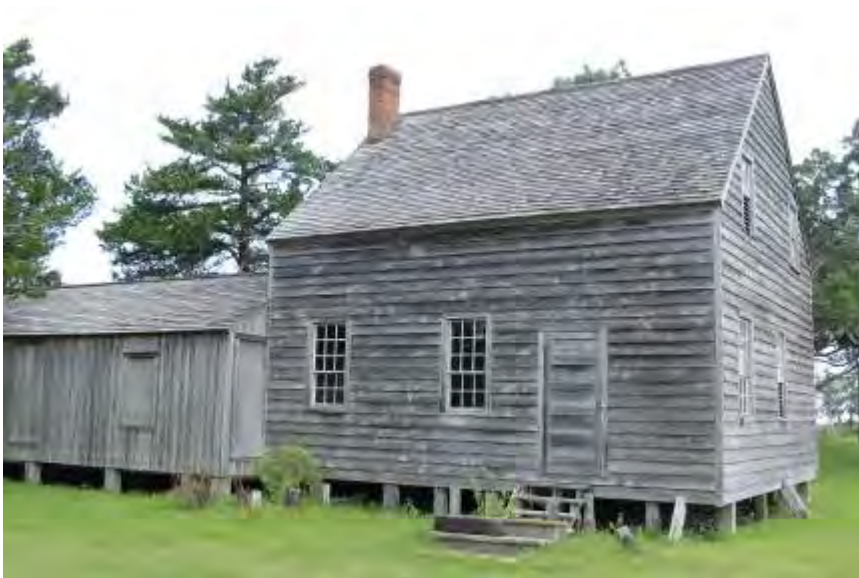
FIGURE 35. The Washington Roberts House in 2017 is no longer boarded up and the addition has been reconstructed. Many of the trees around the house have been lost, however.

Southwest from the Lionel and Emma Gilgo House is the Washington Roberts House. Constructed in the late 1840s, with a kitchen/dining room wing added circa 1910, this house is likely one of the oldest surviving structures within the village (Figure 34 and Figure 35). According to Chester Lynn, the traditional house on the island is known as a “story and a jump,” that is, one-and-one-half stories. The Washington Roberts House is one of the surviving examples of this house type.

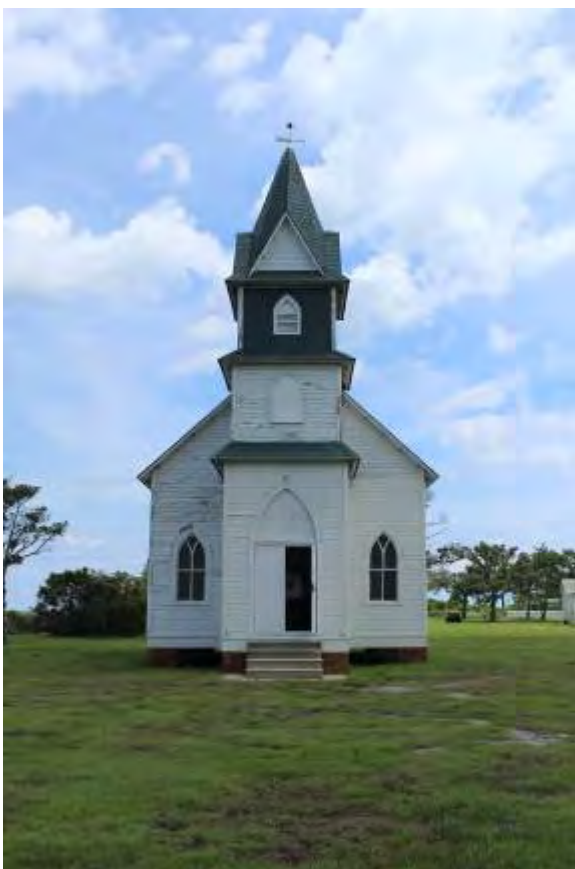
FIGURE 39. The front façade of the Portsmouth Methodist Church.

Heading north from the Lionel and Emma Gilgo House, on the north side of Village Road is the Portsmouth Methodist Church, also known as the Methodist Episcopal Church (Figures 36, 37, 38, 39, and 40). The original Methodist Church, established on the island as early as 1840 on land acquired from Dr. Samuel Dudley, was destroyed in a storm in 1913. The location of the original church is not currently known, although it is possible the existing church occupies the same site. The current church building was completed to replace the earlier structure by 1915. This wood building survives today and occasionally hosts services and ceremonies; services became irregular after 1950. The building is listing towards the southeast, causing separation of some of the window frames from the interior walls.

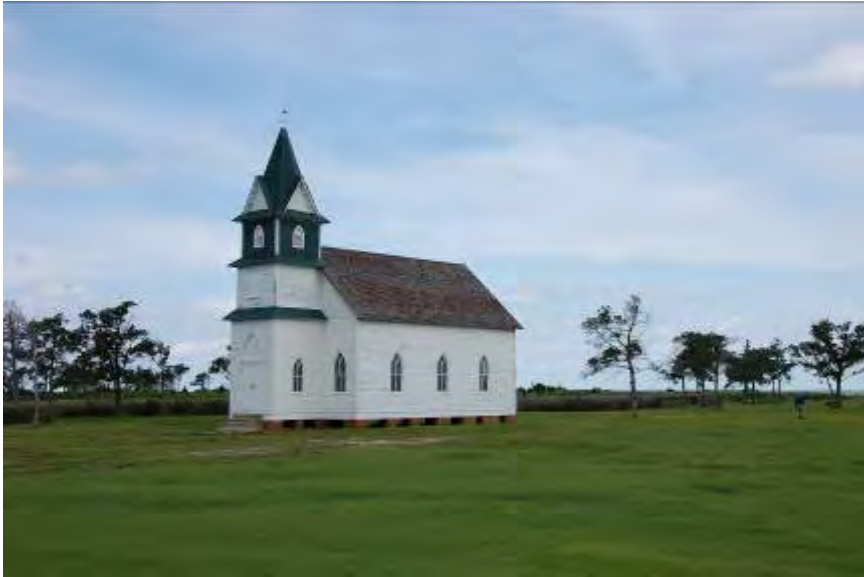
FIGURE 40. The Portsmouth Methodist Church.

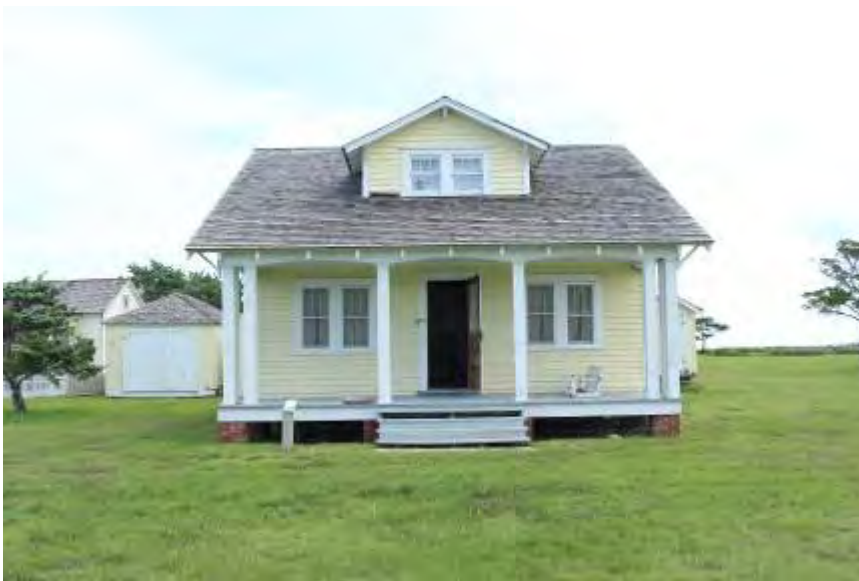
FIGURE 45. The Jesse and Lillian Babb House is very similar to its earlier appearance in [Figure 44](#), although the picket fence is missing. Note also the loss of vegetation behind the house.

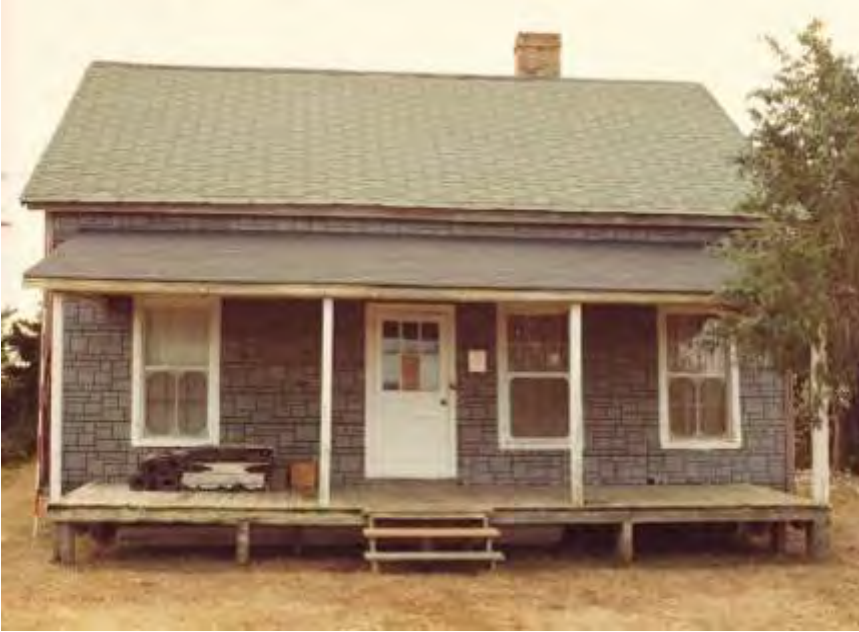
FIGURE 47. The same view of the Harry and Lida Dixon House as **Figure 46**. Note the loss of the decorative trellis on the porch, the pickets along the side addition, the low fencing in front of the house, and the change in mortar associated with the brick.

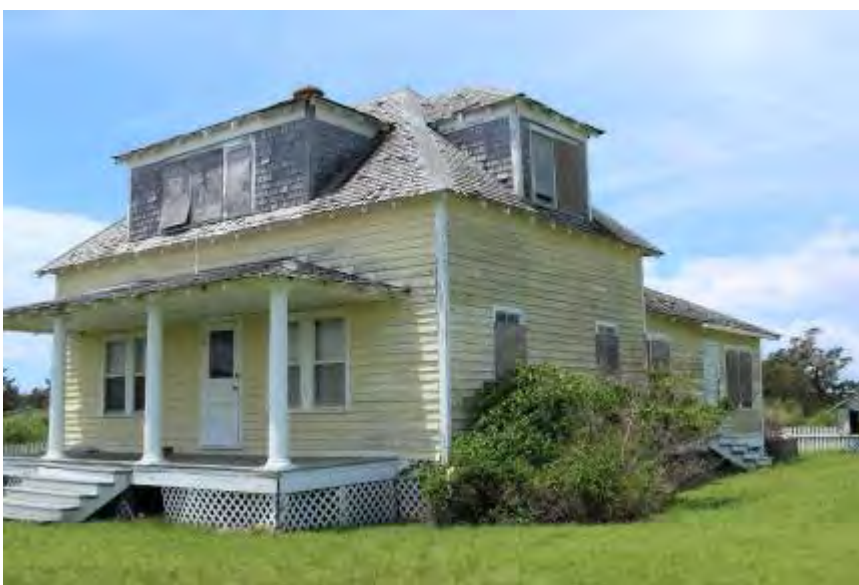
FIGURE 54. The Styron and Bragg House. The second story has been shingled, and the lattice under the porch has been altered, a picket fence has been added, and there has been some loss of vegetation since previous documentation.

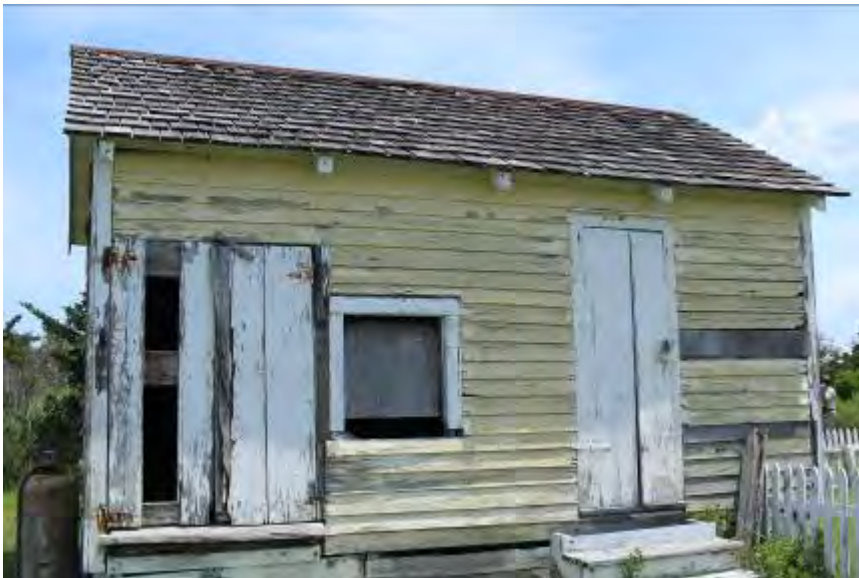
FIGURE 57. The Styron and Bragg cool house on left in background and shed on right in background. Note the loss of vegetation around the house precinct.

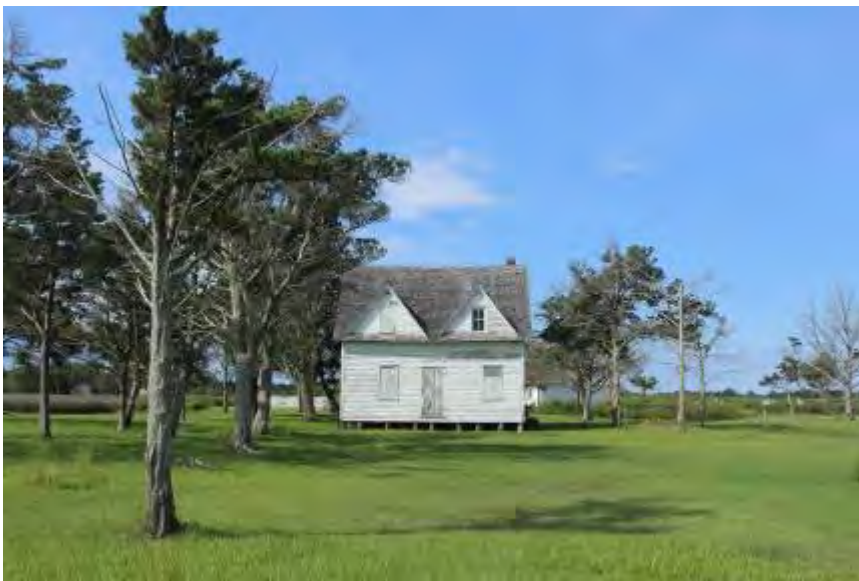
FIGURE 60. The Theodore and Annie Salter House, demonstrating the change in vegetation.

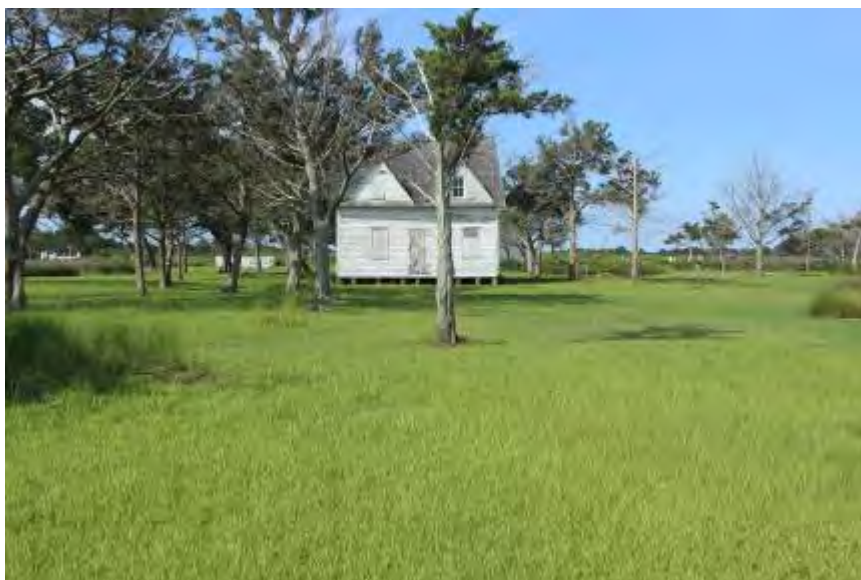
FIGURE 63. The Walker and Sarah Styron House, illustrating changes in vegetation, and the loss of the long building extension (kitchen wing) to the right of the Walker and Sarah Styron House. Note the replacement of the central dormer with two dormers and alteration of the porch posts and railing. Woodwork beneath the porch is no longer present.

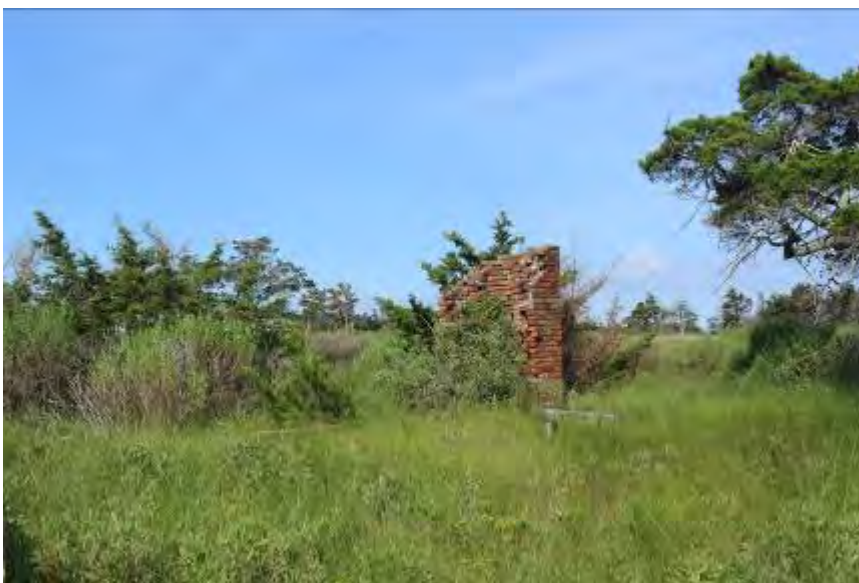
FIGURE 67. Brick chimney remnant associated with the Henry Babb house site.

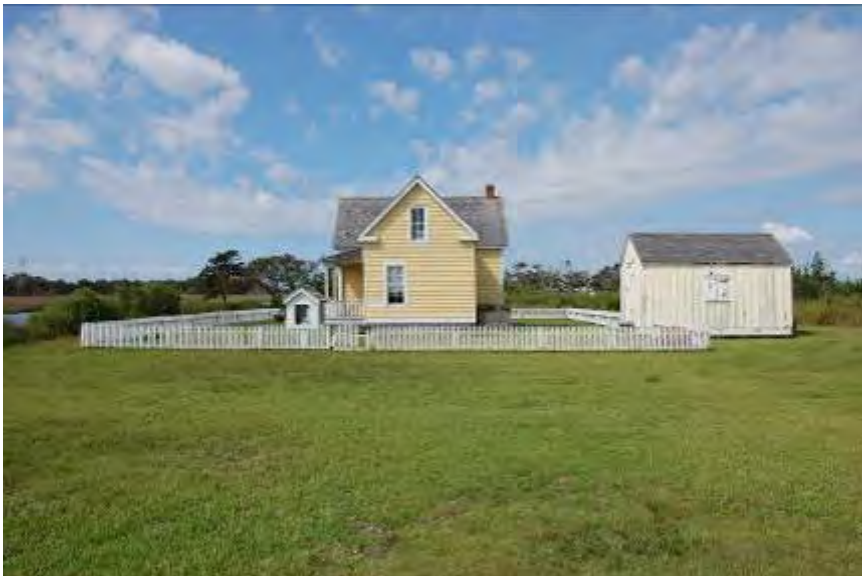
FIGURE 70. The view toward the Henry Pigott House, illustrating changes to the property such as the loss of the chimney on the outbuilding and the tree along the fence, deterioration of the cool house, and replacement of the pink paint.

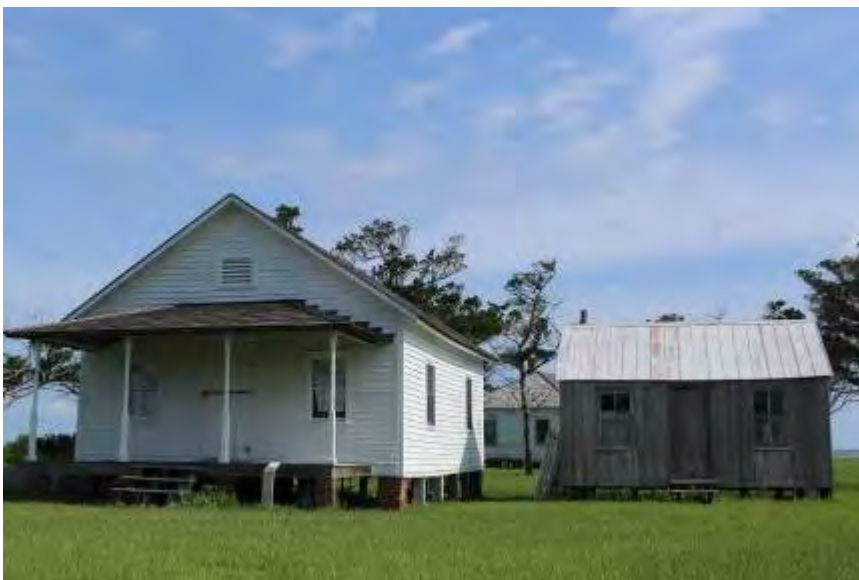
FIGURE 75. Carl Dixon House and summer kitchen. Changes since 1979 include loss of the front porch, replacement of the roof, and a change in paint color. Changes to the summer kitchen includes the boarded window, different cladding of the shed, the addition of a vent pipe, replacement of the door, addition of wooden steps, and lack of paint.

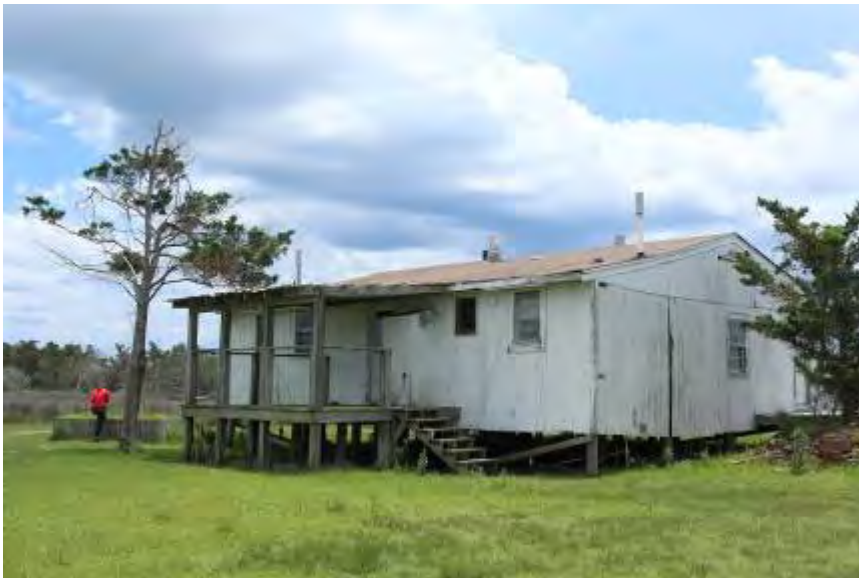
FIGURE 80. The T.T. Potter House. There is an addition to the building along its rear facade, the screen porch has been removed, and the siding has been replaced.

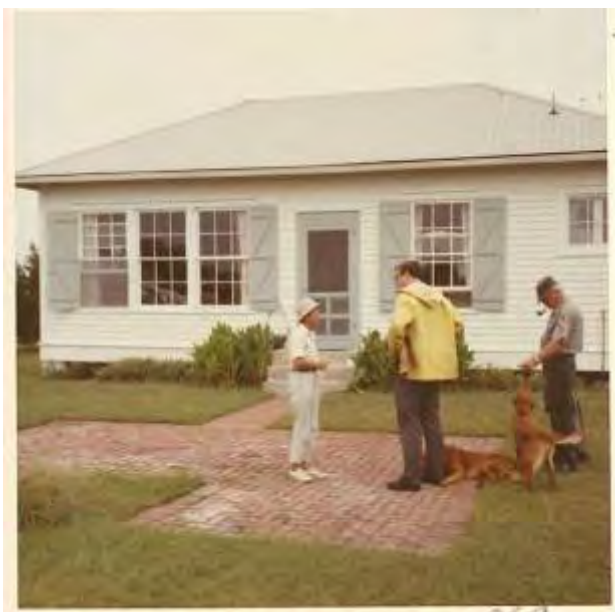
FIGURE 82. The Cecil and Leona Gilgo House.

South of the historic district core, on the east side of Old Straight Road, where it intersects with Haulover Point Road, are the Cecil and Leona Gilgo House and the Portsmouth Schoolhouse. The Cecil and Leona Gilgo House is also known as the Ben Salter House (Figure 82). Constructed circa 1936, it is believed the house was built from materials salvaged from a circa 1905 structure on Sheep Island. Funding was requested to stabilize the house in 2003, including replacement of foundation pilings and repair of sills, studs, and siding, and reconstruction of the roof of the front porch.

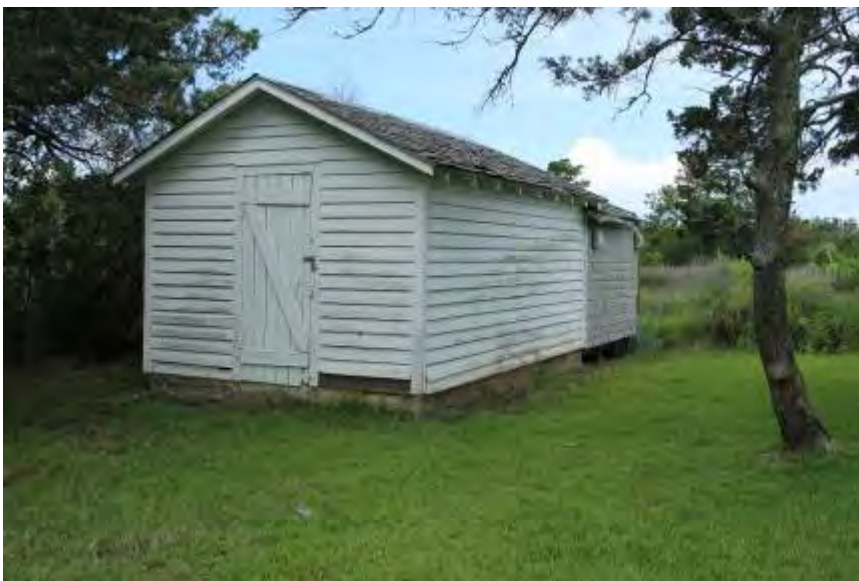
FIGURE 87. The same view as [Figure 86](#) of the schoolhouse shed. Although the door appears to have been replaced and the roof re-shingled, the shed looks very similar today.

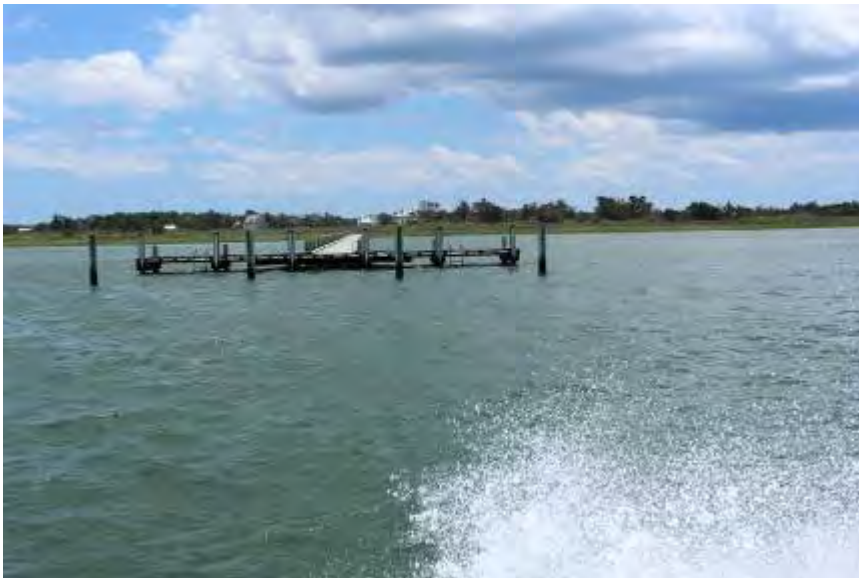
FIGURE 88. The T-shaped dock and boardwalk at Haulover Point.

Haulover Point is the primary boat landing site at Portsmouth Village with a thirty-five foot long T-shaped dock and boardwalk. The other main dock is near the T.T. Potter House. There was previously a dock at the Styron and Bragg House that is damaged and no longer in use. A small dock extends into Doctor’s Creek behind the Henry Pigott House but is not a common means of accessing the village. None of the docks date to the period of significance.

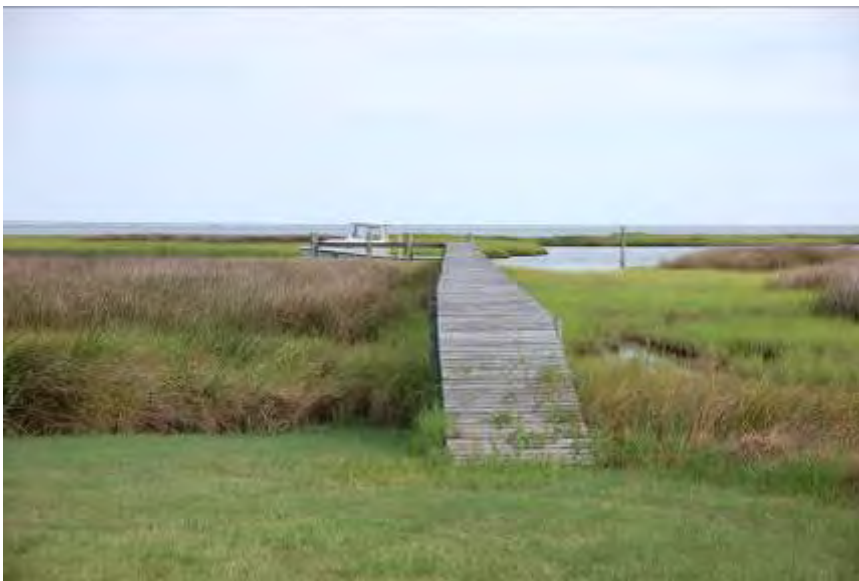
FIGURE 89. View of the L-shaped boardwalk at the T.T. Potter House.

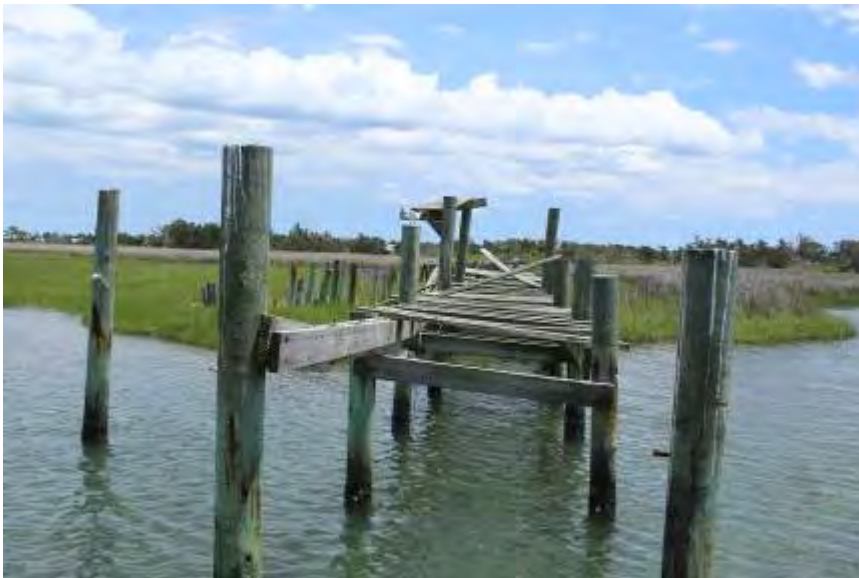
FIGURE 90. View of the damaged dock and boardwalk behind the Styron and Bragg House.

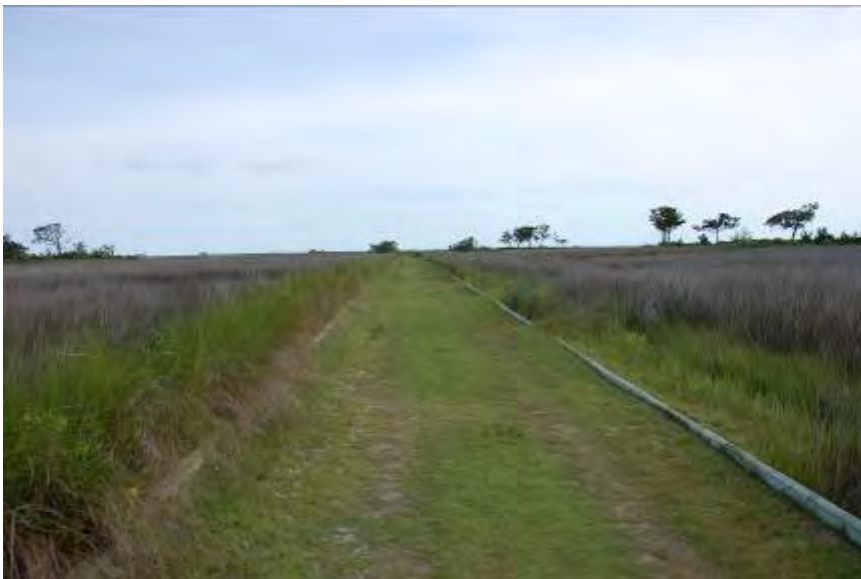
The Haulover Point Road is a long, straight, sand road that extends south between Haulover Point at the northern end of the island to the core of the village, where it continues south as the Old Straight Road (Figure 92 and Figure 93). The northern portion of the road frequently floods and can remain wet. The road is generally in good condition, except for where ponding occurs near the boardwalk.

FIGURE 92. View north along Haulover Point Road.

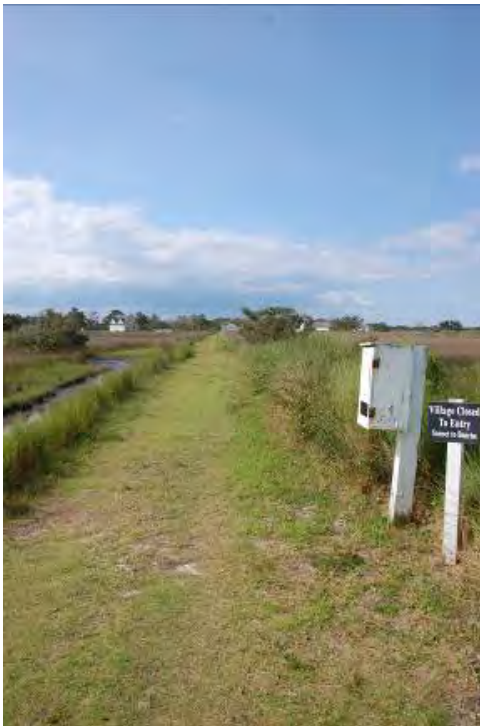
FIGURE 93. View south along Haulover Point Road.

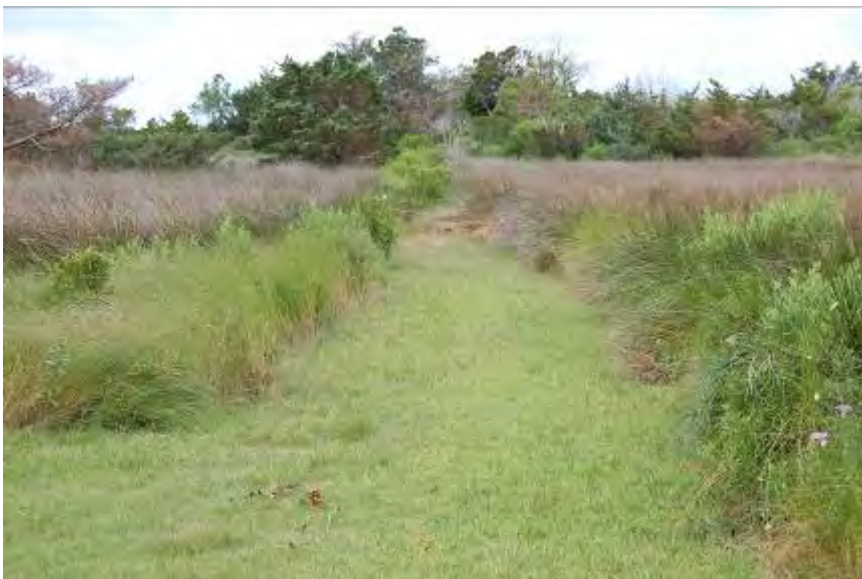
The Old Straight Road is the historic route of travel between Portsmouth Village and the Middle Community. It joins Haulover Point Road around the core of the historic district. This route has a mown grass surface. The portion of the road that is interpreted within the historic district is in good to fair condition, although it requires constant maintenance to remain unobstructed by vegetative growth. Beyond the historic district boundary, heading south past the Schoolhouse, the road is difficult to follow and overgrown due to vegetation. There is a chained gate on Old Straight Road northwest of the Schoolhouse, to the south of which the road is overgrown, although the track is still evident (Figure 94).

FIGURE 94. Old Straight Road is no longer maintained south of the chained gate near the Portsmouth Schoolhouse.

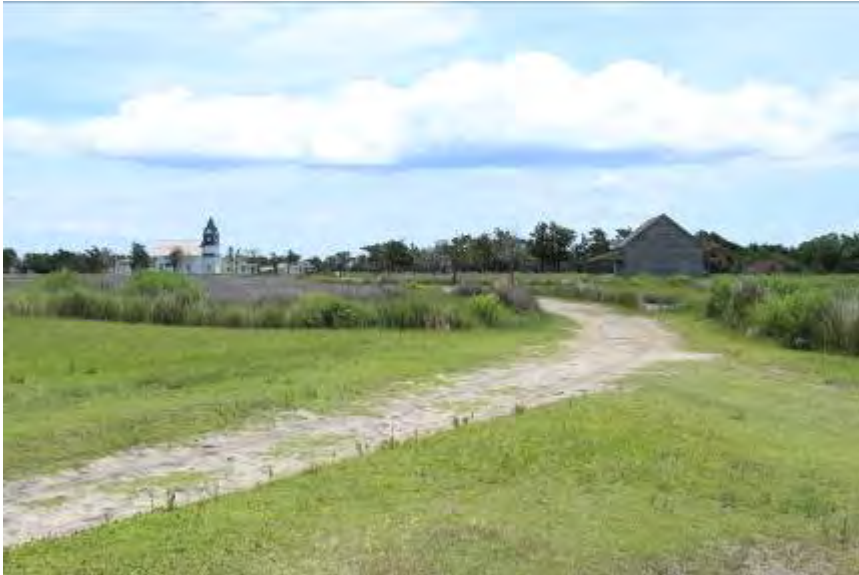
At the core of the historic district, Haulover Point Road intersects the Village Road, which is the primary east/west trending road that extends on the west side to the Styron and Bragg House (and associated former dock) (Figure 95 and Figure 96). To the east, the road extends to the Portsmouth Life-Saving Station. This road crosses various tidal creeks and drainages, with wooden bridges serving as water crossings. This road is generally in good condition, although sections near the Methodist Church appear to experience ponding.

FIGURE 95. Village Road looking east with Portsmouth Church on left and Washington Roberts House on right.

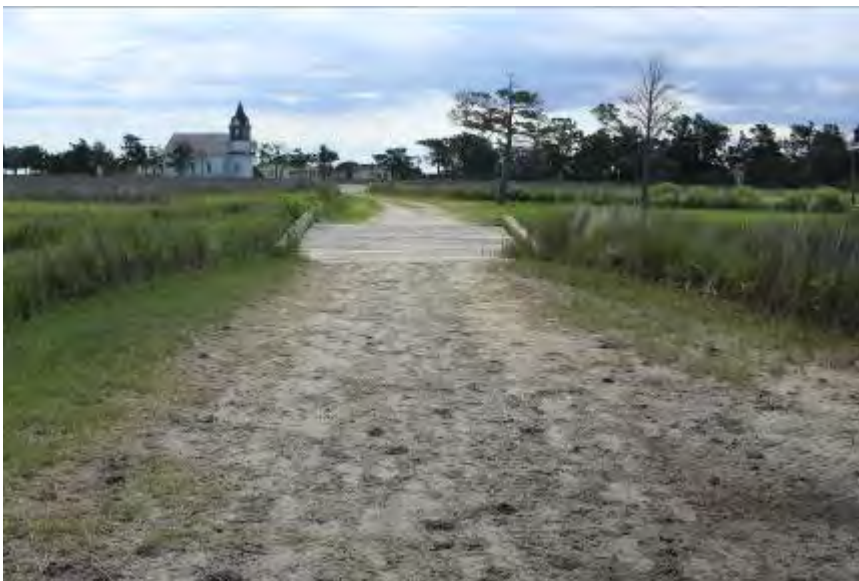
FIGURE 96. Village Road and wooden bridge over Doctor's Creek with Portsmouth Church on left side.

Existing non-historic bridges include three wooden bridges along Village Road. The Village Road crosses wet areas, creeks, and channels in three locations. Each crossing is associated with a V-shaped wood bridge, constructed of tightly set timbers laid perpendicular to the road, and edged by 6 inch by 6 inch wood timbers nailed to their good condition.

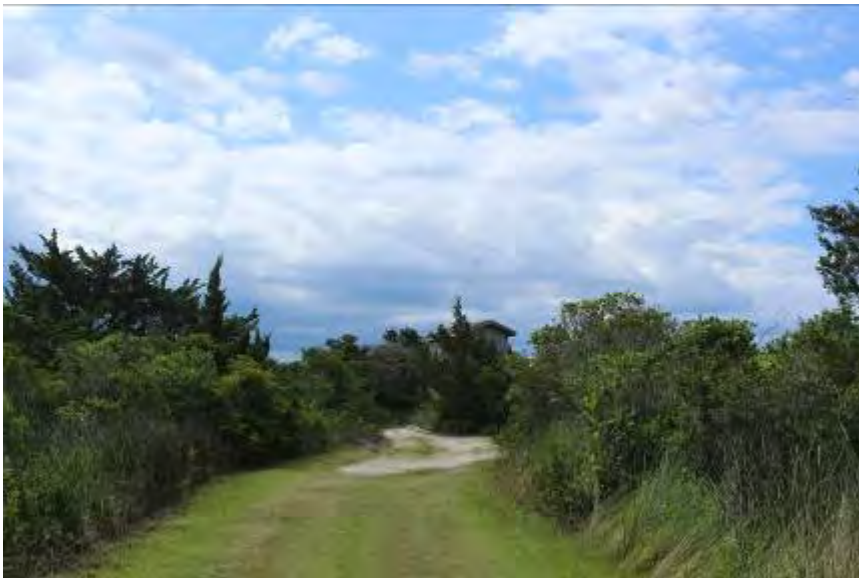
Past the Life-Saving Station on the east side of the district, the Village Road veers south and becomes the Road to the Beach that accesses the beach and tidal mud flats that edge the historic district (Figure 97). This road is variously surfaced with graded sand and mown grass. Past a steel gate to the south of Coast Guard Creek, an access road leads northeast from the Road to the Beach to the two seamen's graves. This access road is generally in good condition.

FIGURE 97. Road the Beach with the comfort station in the background vegetation.

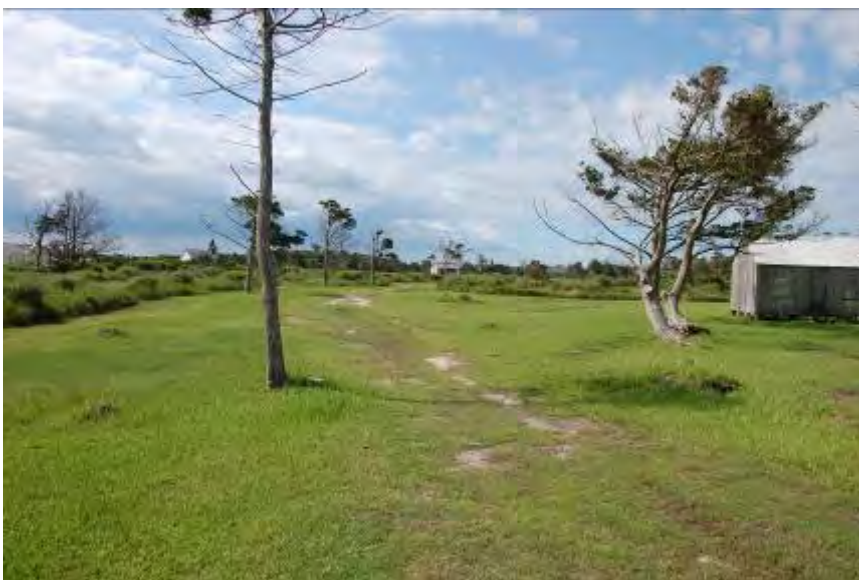
Heading east from Haulover Point Road, also north of Village Road intersection, an access road leads northeast to the Carl Dixon and Frank Gaskill houses at the northern end of the island (Figure 98). The access road has a mown-grass surface and is generally in good condition. One arm of the access road heads north to the Frank Gaskill shed on the coastline, while another arm veers west along the south side of the Carl Dixon House.

FIGURE 98. Access road to the Frank Gaskill and Carl Dixon houses (Carl Dixon summer kitchen visible on right).

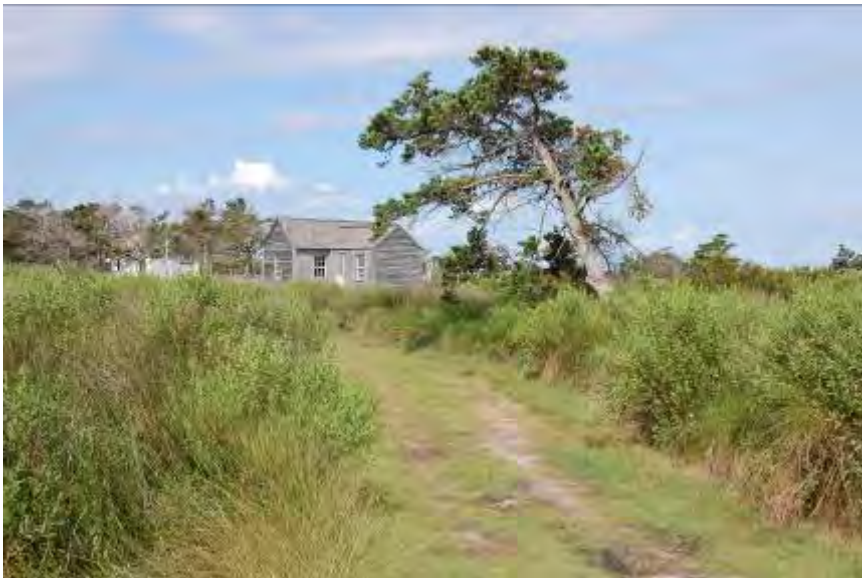
South of the two previously mentioned access roads, a road leads east/northeast from the intersection of the Village Road and Haulover Point Road to Walker and Sarah Styron House, Tom and Lucy Gilgo House, and extends to the Henry Pigott House on Doctor's Creek (Figure 99). The road has a mown-grass surface and is generally in good condition. The road partially parallels the access road to the Carl Dixon and Frank Gaskill houses and a small northwest-

FIGURE 99. Access road to the Tom and Lucy Gilgo House.

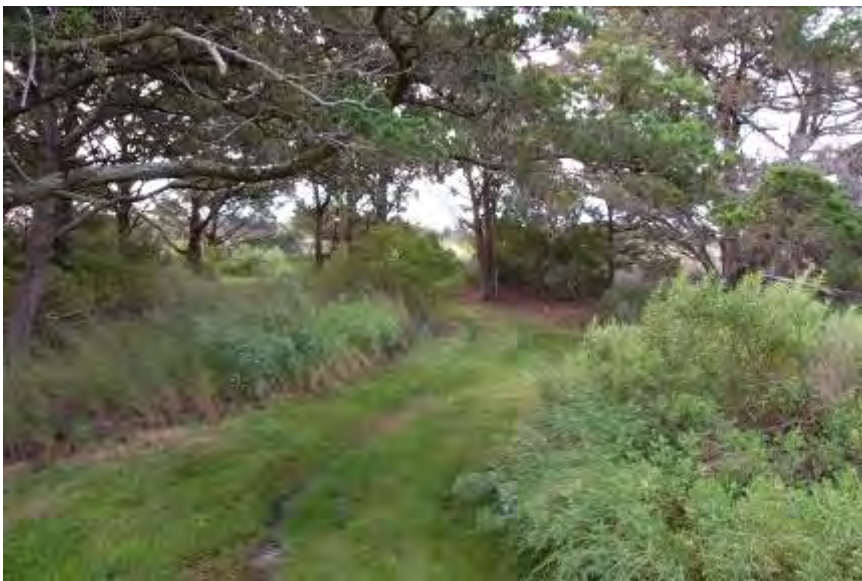
On the west side of the historic district and west of the Haulover Point and Village Road intersection, a road leading towards the T.T. Potter House, associated dock, and Keeler-Styron Cemetery arises just east of the Styron and Bragg House and leads southwest away from the Village Road. The sand- and grass-surfaced road splits with one branch leading south to the Keeler-Styron Cemetery and the other leading northwest to the T.T. Potter House (Figure 100 and Figure 101). This road is generally in good condition.

FIGURE 100. Access road to the Keeler Cemetery.

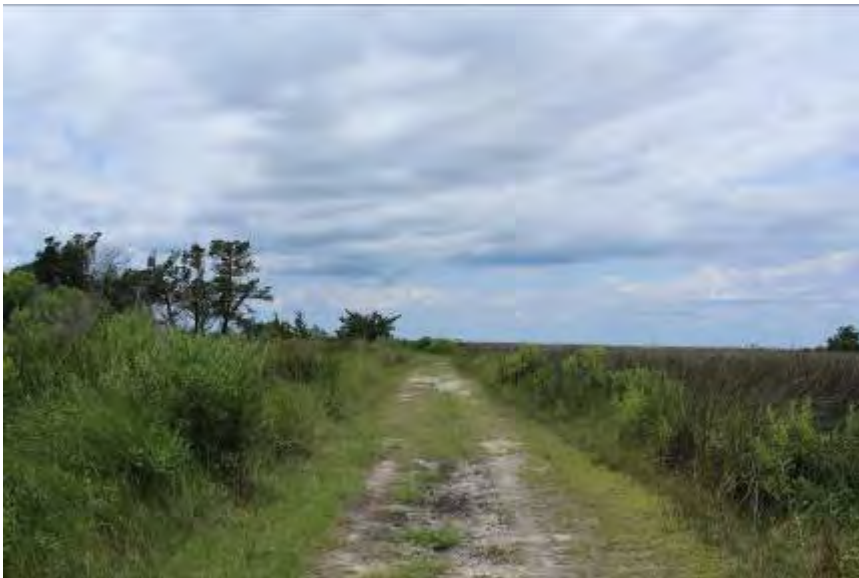
FIGURE 101. Access road to the T.T. Potter House.

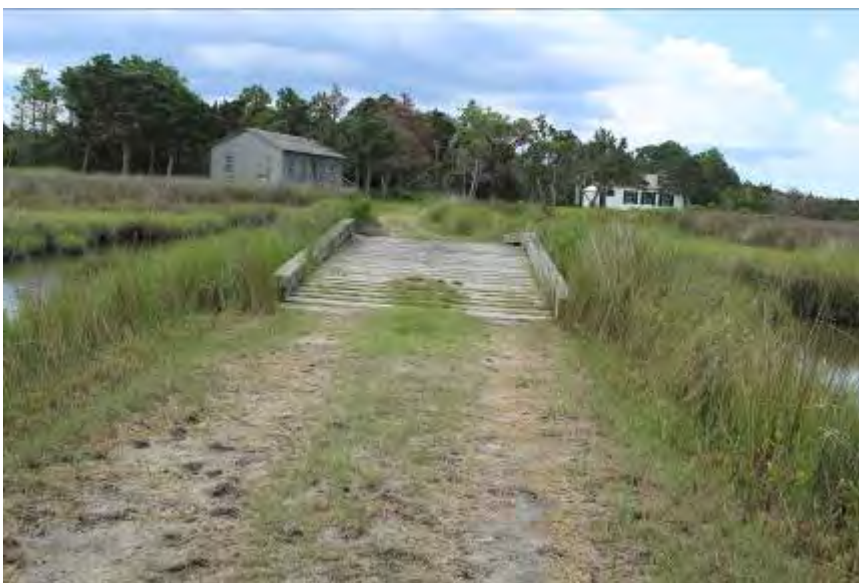
Old Straight Road travels directly south from the village core. There is a short access road off of Old Straight Road that leads to the Cecil and Leona Gilgo House and the Portsmouth Schoolhouse (Figure 102). This road is generally in good condition, although there is vegetation along its perimeter in some areas that must be maintained to keep the road passable. Further south of this precinct the Old Straight Road is no longer maintained.

FIGURE 102. Access road and bridge to the Cecil and Leona Gilgo House and the Portsmouth Schoolhouse.

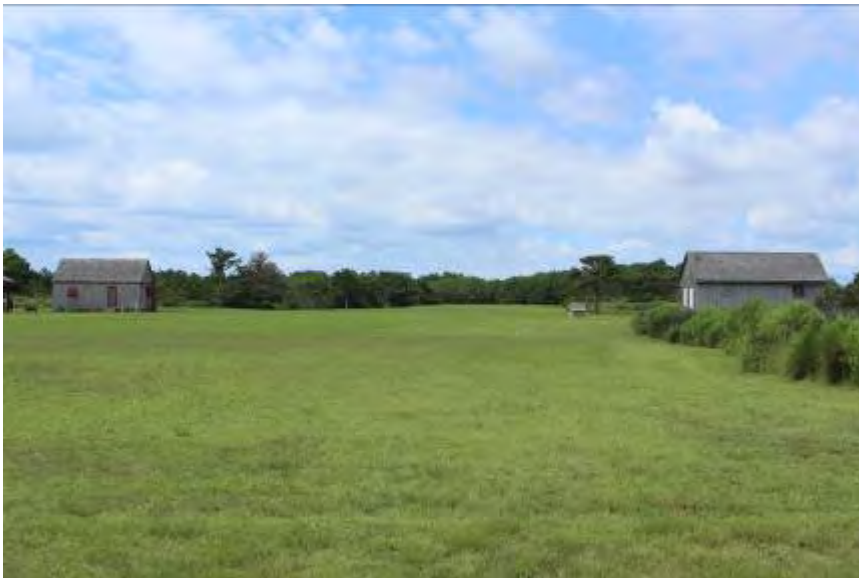
The 1940s northeast-southwest trending airstrip adjacent to the Life-Saving Station is said to have been built to support access to the hunting, fishing, and gun clubs present on the island (Figure 103). It is no longer in use. It has a mown-grass surface and extends between the edges of the marshland to the north of the Life-Saving Station in a southwesterly direction for approximately 1,600 feet. It crosses between the Life-Saving Station and the Life-Saving Station Stables building. This feature is generally in good condition.

FIGURE 103. View southwest along airstrip with the Life-Saving Station summer kitchen on left and stable on right.
