Re: Cultural Landscapes Inventory, Portsmouth Village Historic District, Cape Lookout National Seashore, Core Banks, Carteret County, H22 (SERO-CRD), ER 18-1797

National Park Service
Cultural Landscapes Inventory
2018

Portsmouth Village Historic District
Cape Lookout National Seashore

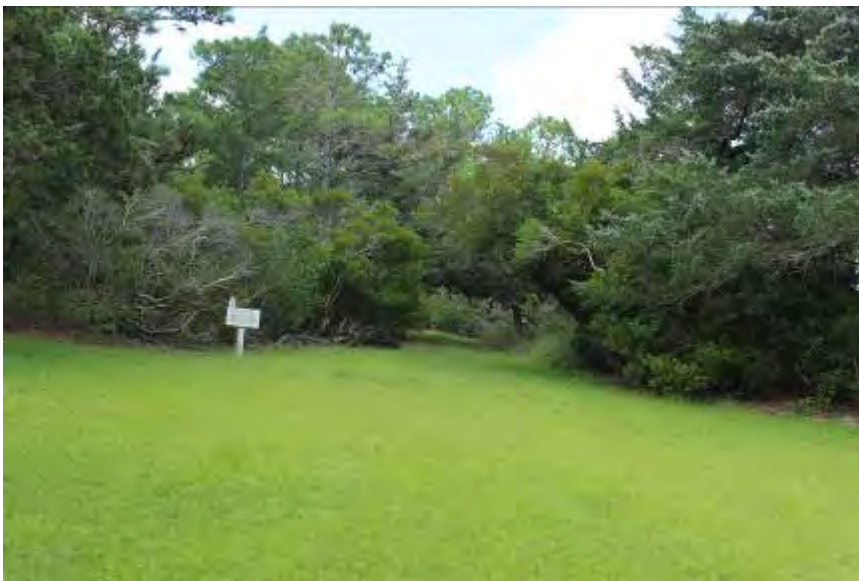
A footpath known as the Schoolhouse Trail leads from the southern side of the airstrip through the woods and emerges on the south side of the Schoolhouse (Figure 104). The footpath is marked with a wood sign at the trail entrance near the Schoolhouse.

FIGURE 104. The Schoolhouse Trail access point south of the Portsmouth Schoolhouse.

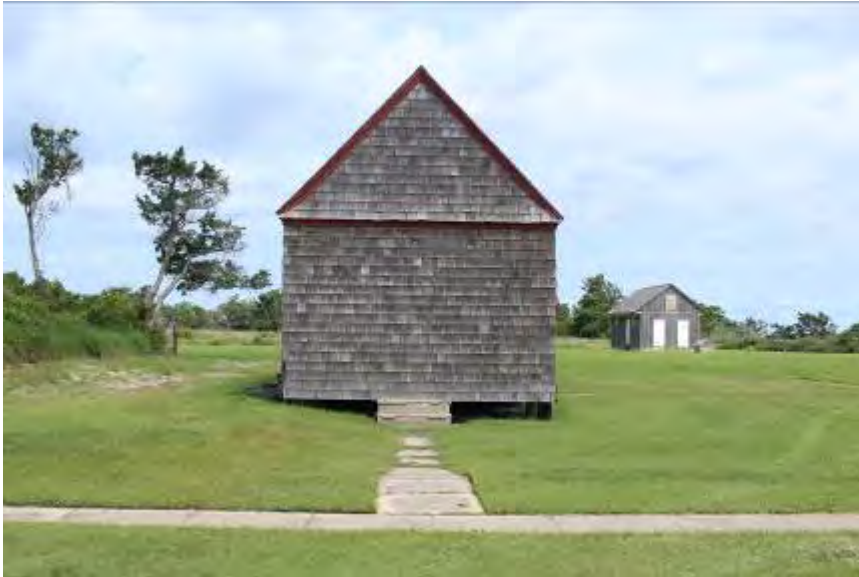
FIGURE 105. Concrete walks extend between the Portsmouth Life-Saving Station and summer kitchen, as well as into the landscape.

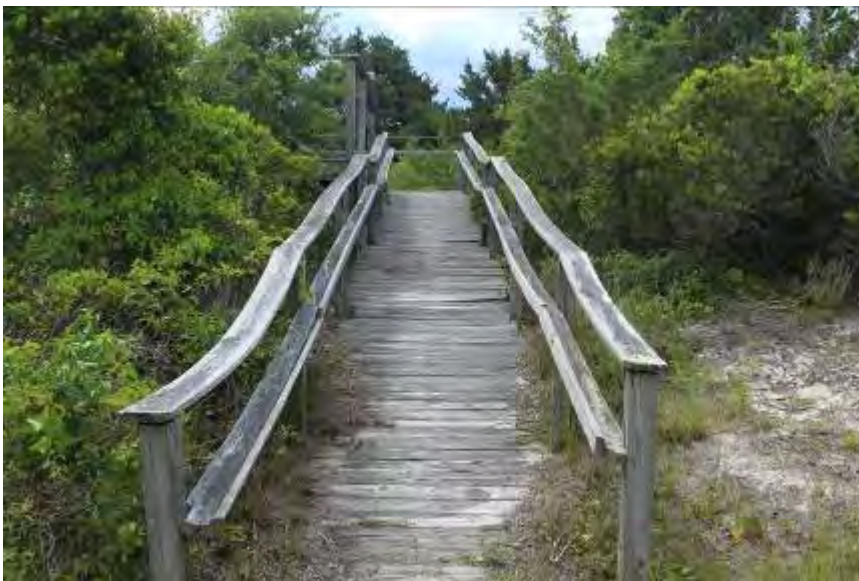
FIGURE 106. Wooden ramp and steps leading to the comfort station along the Road to the Beach.

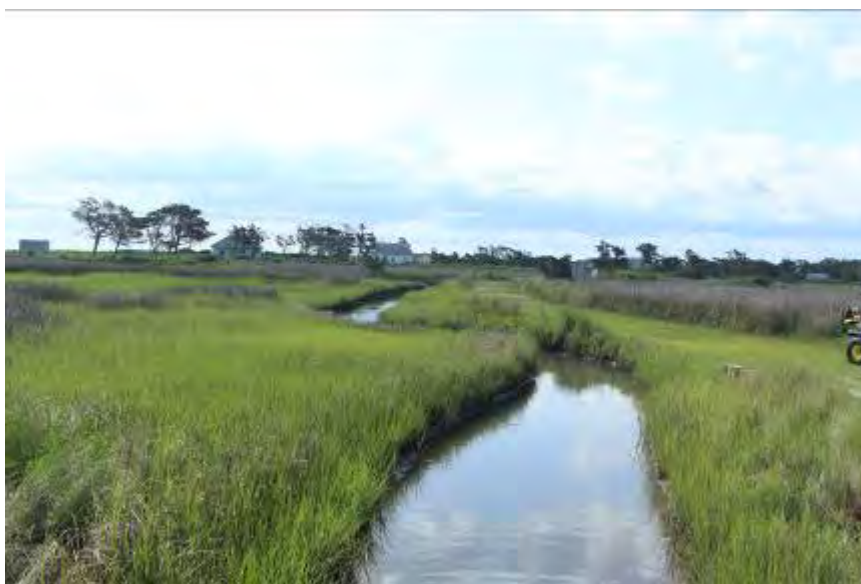
FIGURE 107. Drainage channel along the northern portion of Haulover Point Road by the WPA for mosquito control.

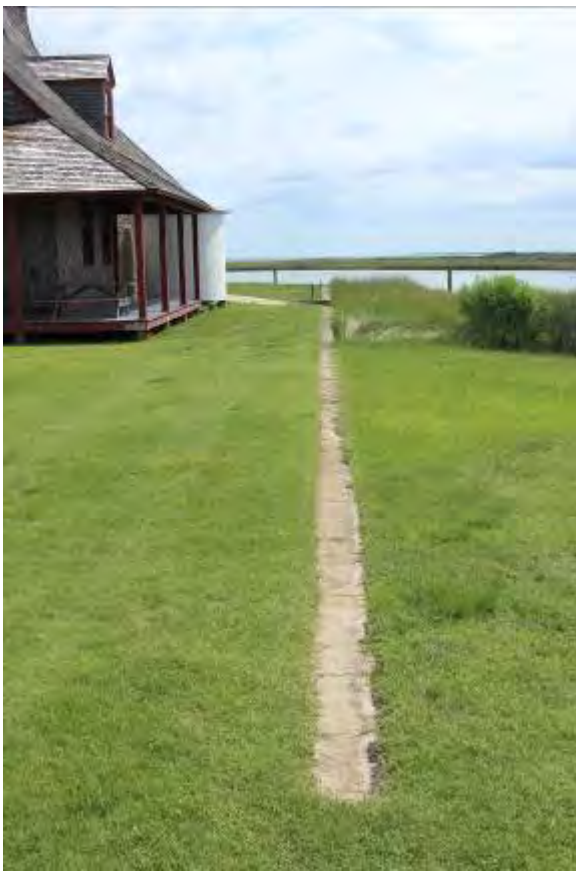
FIGURE 113. View northeast along the seawall and ramp that afforded access to Coast Guard Creek for Life-Saving Station needs.

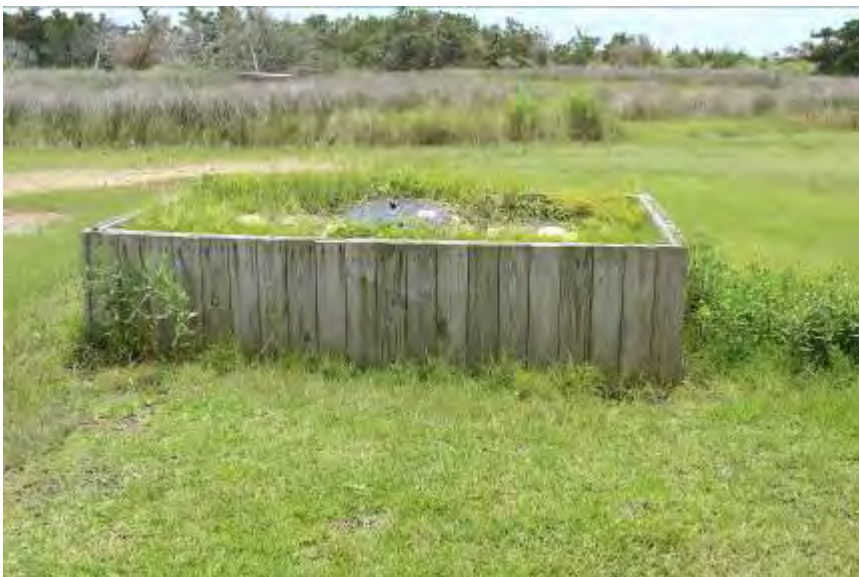
Lastly, many of the dwellings on Portsmouth Island have above-ground septic tanks for managing and treating effluent (Figure 114). These tanks are generally located in close association with the houses and enclosed within low wood fencing, which obscures much of the view of the feature but does not impede maintenance access. Given the high water table on the island, these tanks are likely an important adaptation to existing conditions.

FIGURE 114. Above-ground septic systems, such as this one associated with the T.T. Potter House, are typically used for wastewater treatment and management in association with most buildings in the district.

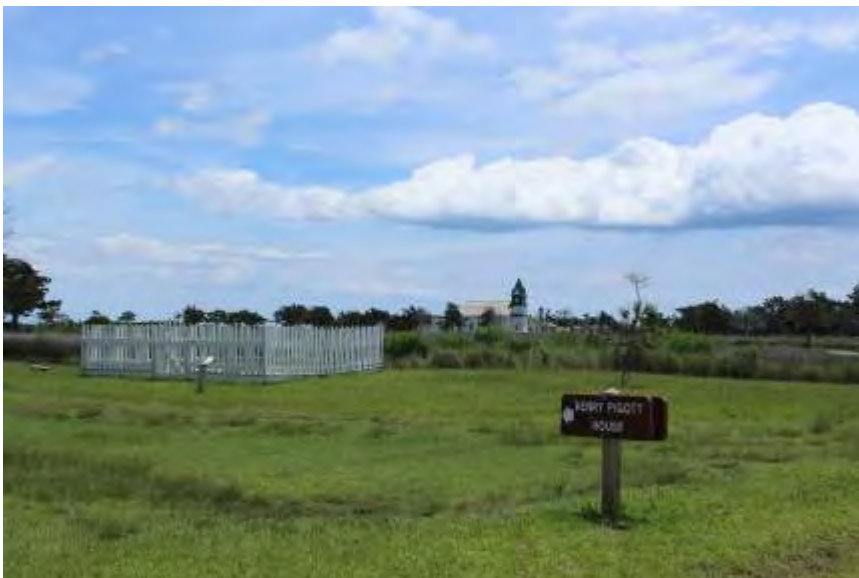
FIGURE 116. Grace Cemetery, taken in 2017. Note the loss of much of the vegetation seen behind the cemetery in **Figure 115**, the addition of a small interpretive marker in front of the picket fence, and the repair and painting of the fence.

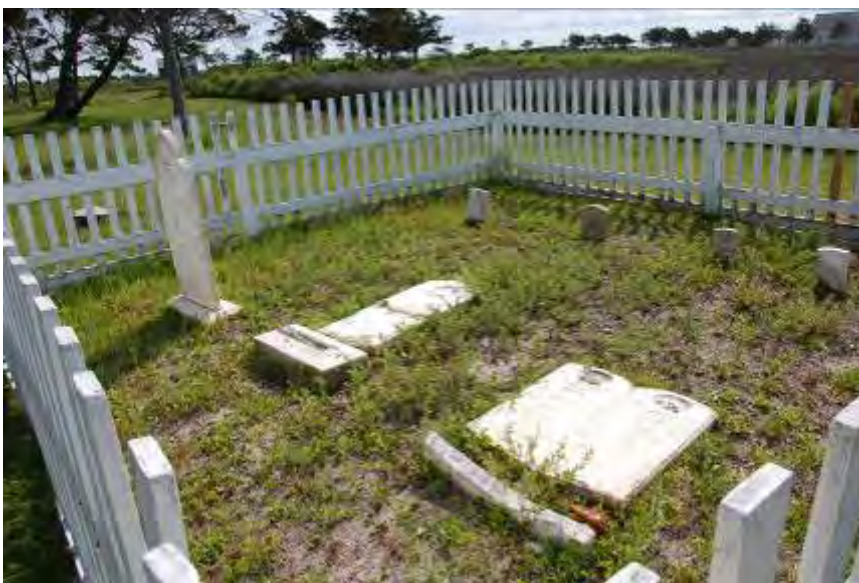
FIGURE 117. Headstones lying on the ground in Grace Cemetery.

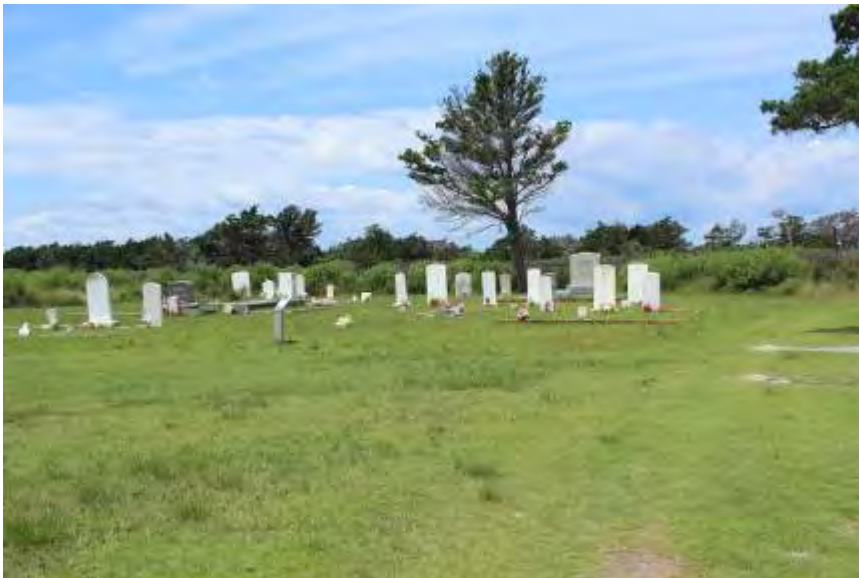
FIGURE 120. Although the Community Cemetery appears to have changed little since the 1978 view, the vegetation behind the cemetery has changed dramatically.

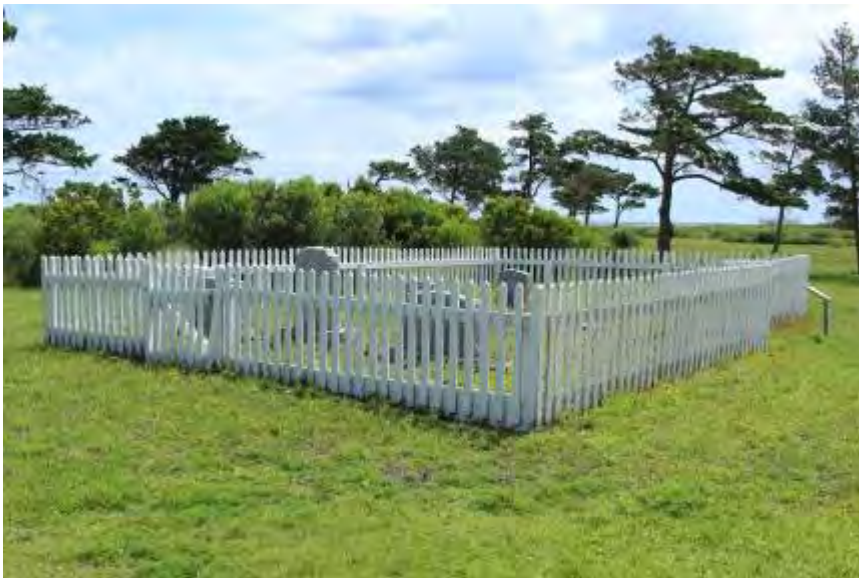
FIGURE 122. The Babb-Dixon Cemetery, taken in 2017. The cemetery is very similar in appearance although the vegetation behind the cemetery is no longer present.

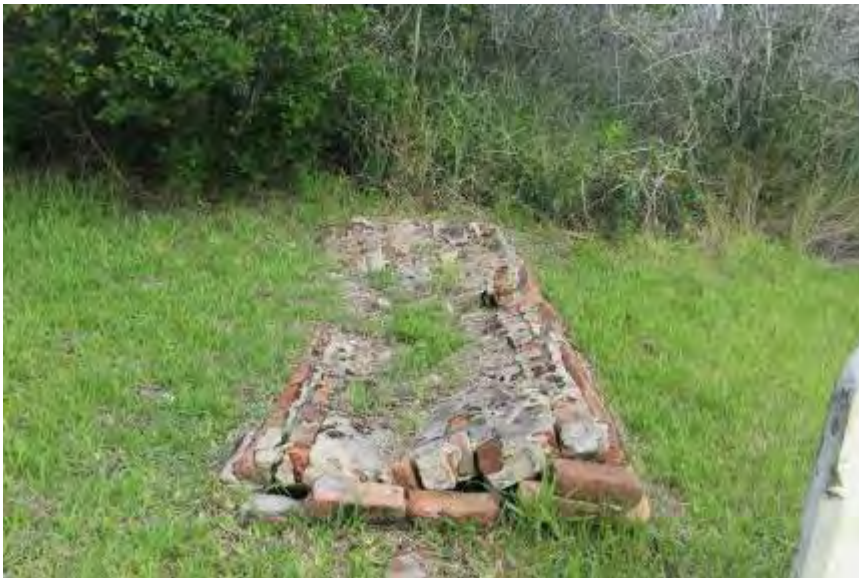
FIGURE 124. Brick crypt at the Keeler-Styron Cemetery.

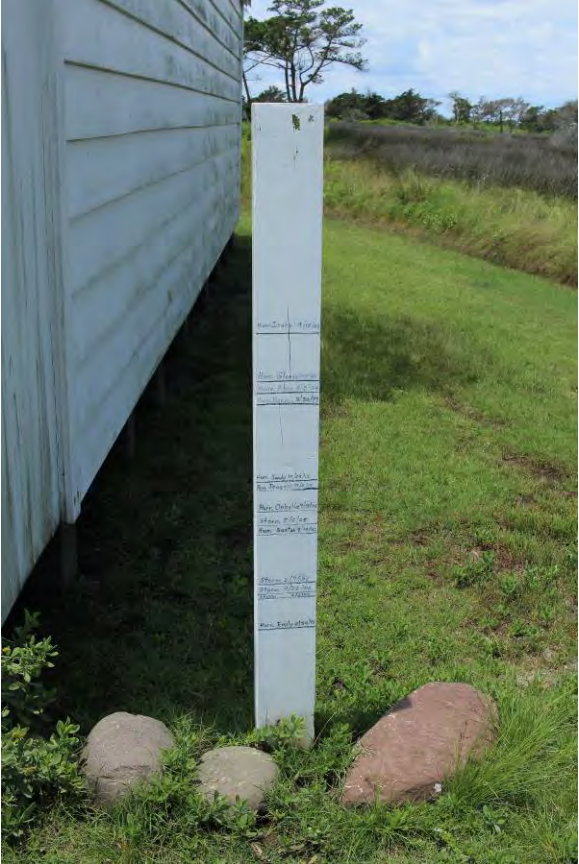
FIGURE 134. High water mark sign adjacent to the Post Office.

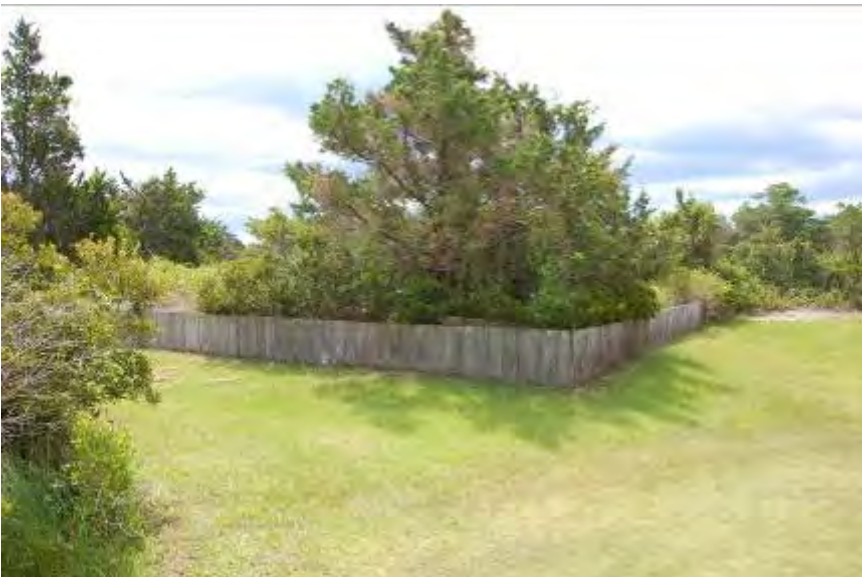
FIGURE 135. Septic leach field with wood surround, located southwest of the Life-Saving Station.

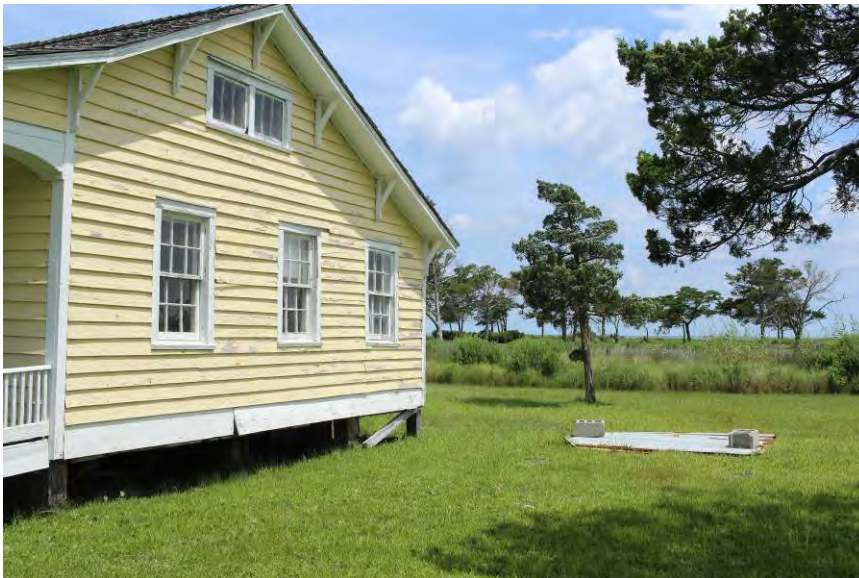
FIGURE 136. The Harry and Lida Dixon House metal septic cover on right.

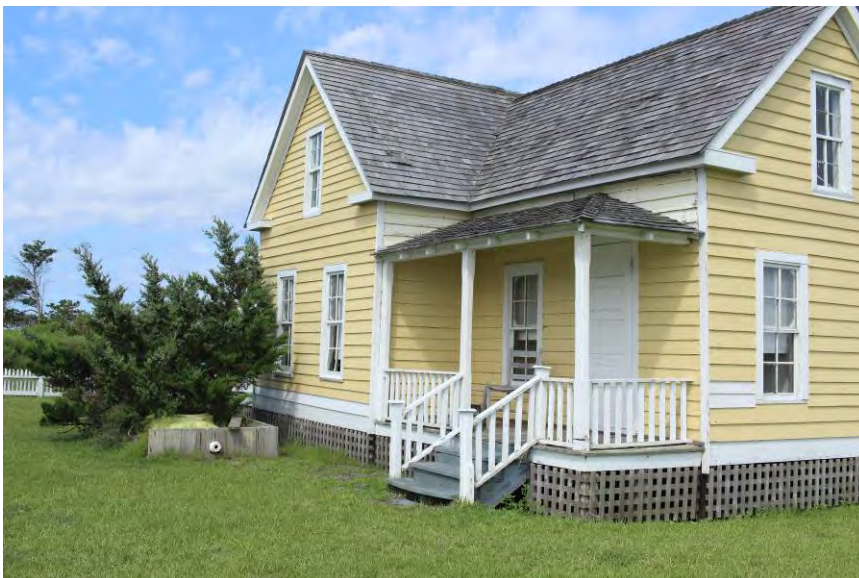
FIGURE 137. An above-ground septic tank and wooden enclosure at the Henry Pigott House.

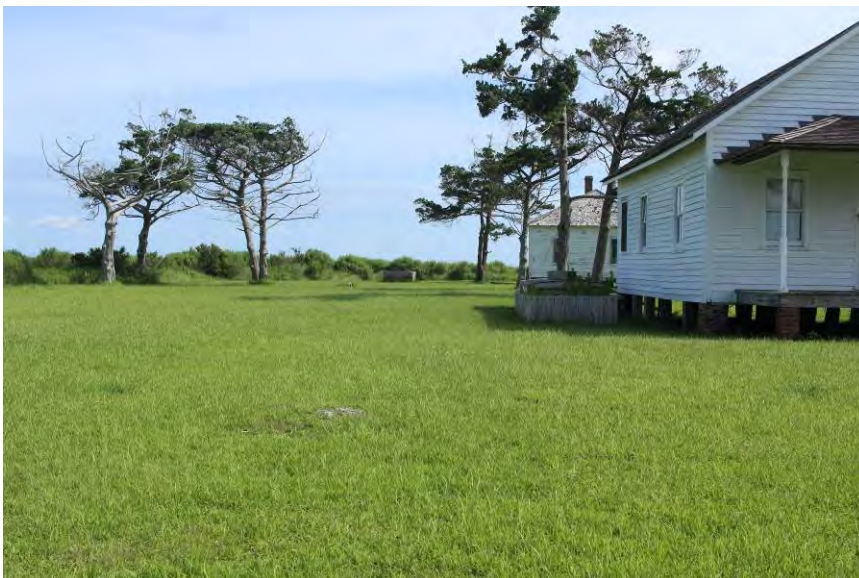
FIGURE 138. An above-ground septic tank and wooden enclosure at the Carl Dixon House.

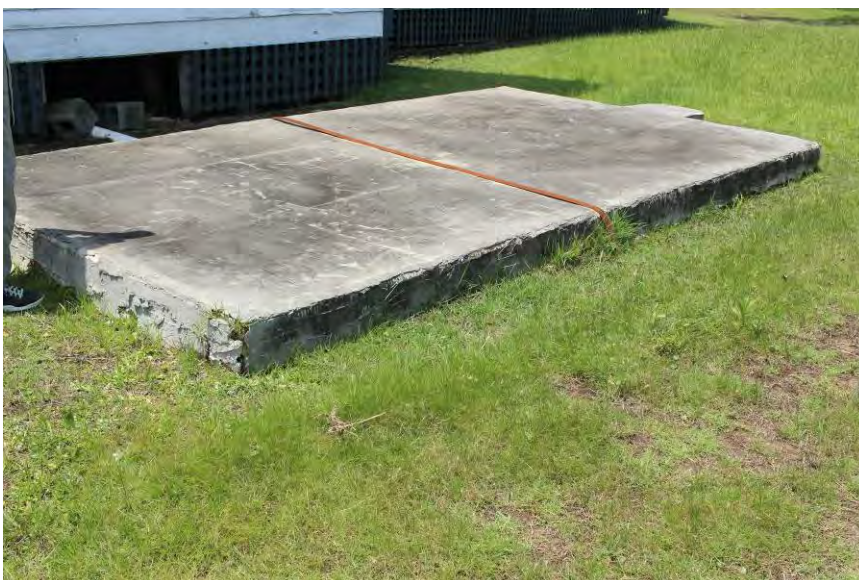
FIGURE 139. Rectangular concrete slab north of the Theodore and Annie Salter House that covers a septic tank.

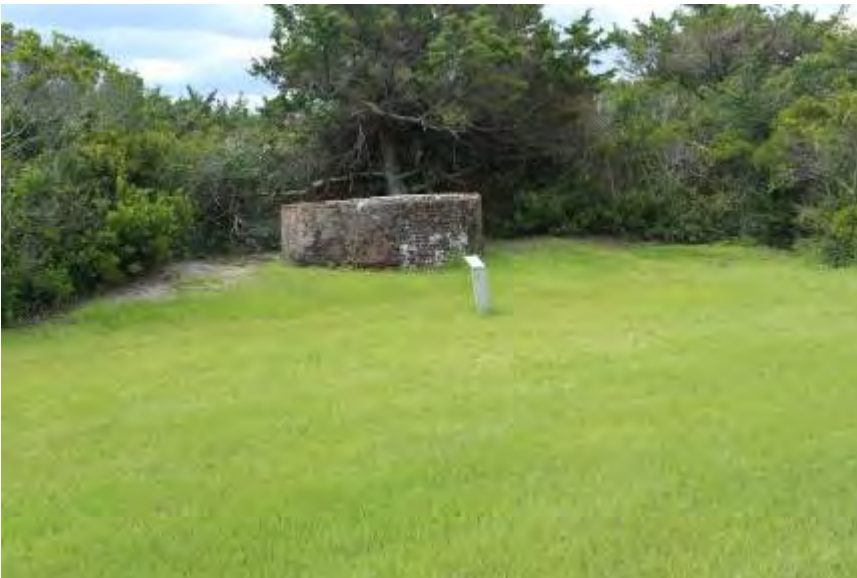
FIGURE 140. Cisterns like the U.S. Marine Hospital structure shown here were used to store rainwater on the island and are the primary source of fresh water.

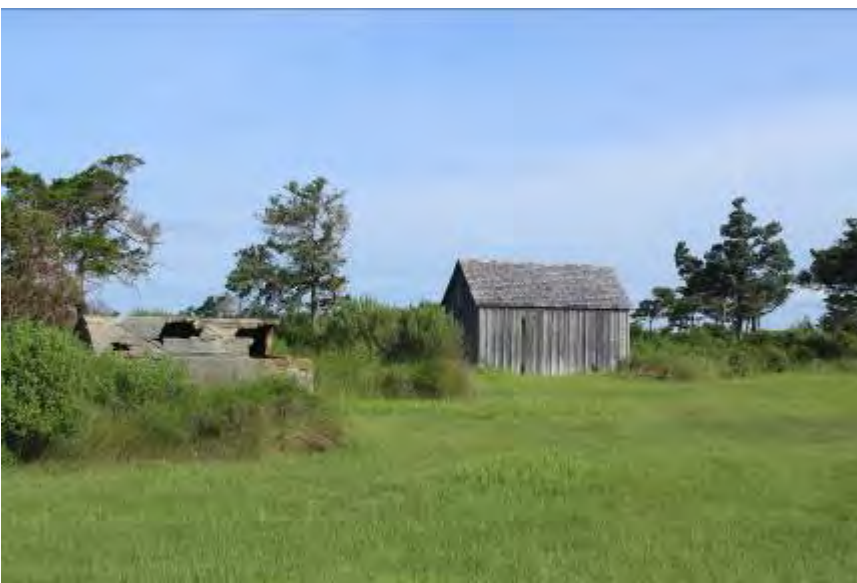
FIGURE 141. Henry Babb cistern ruins and adjacent shed.

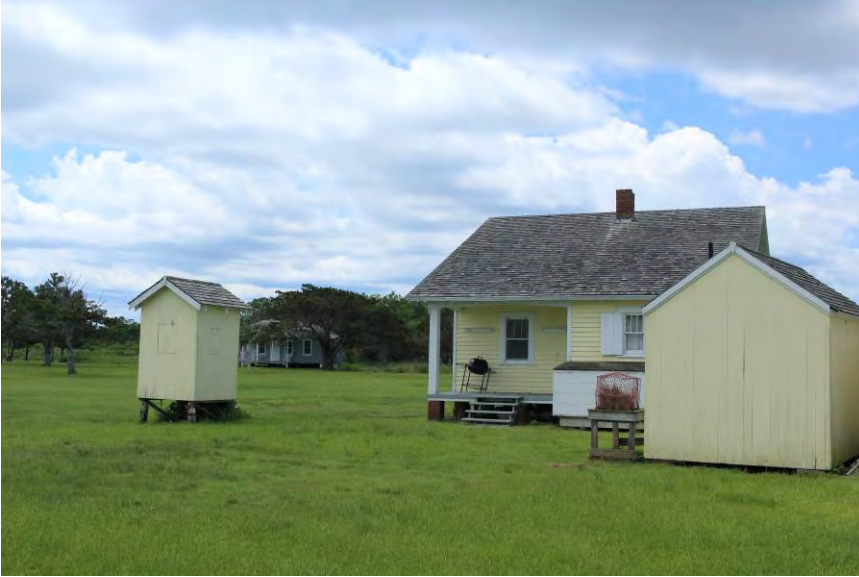
FIGURE 142. The Jesse and Lillian Babb water box is visible attached to the back of the house, to the right of the rear porch stairs.

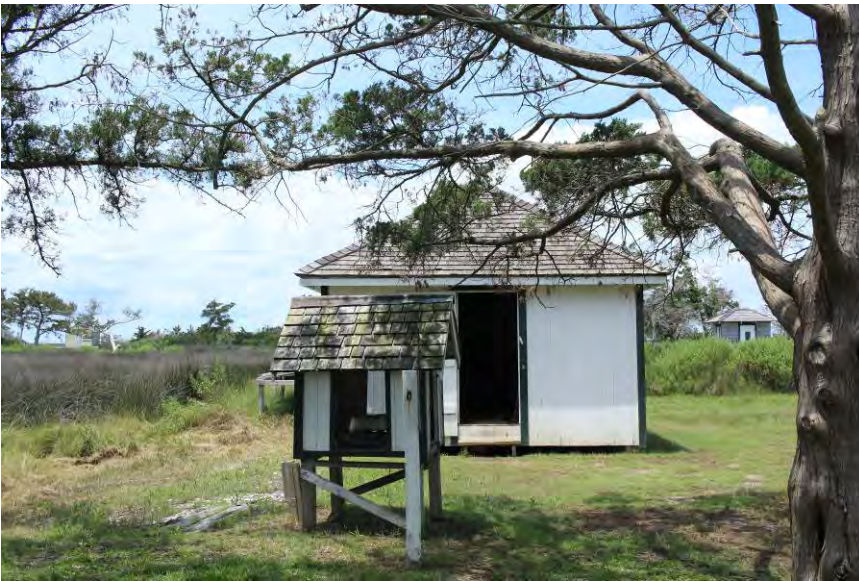
FIGURE 143. The cool house associated with the Theodore and Annie Salter House.

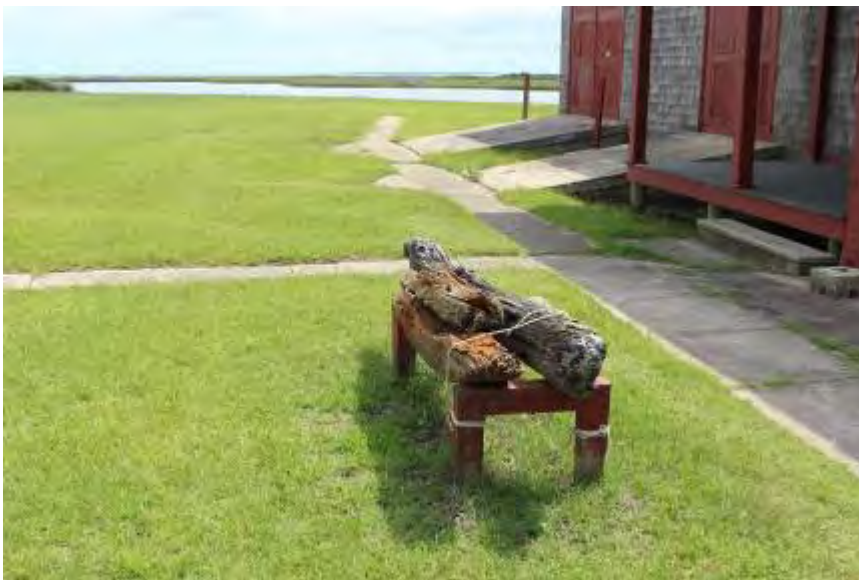
There are several wood posts associated with the Portsmouth Life-Saving Station. Within Coast Guard Creek on the east side of the seawall, there are two square wooden posts set into the ground. The posts may be used to secure boat lines and are in good to fair condition. On the northwest side of the Life-Saving Station area four wooden posts. Also on the west side of the Life-Saving Station building area artifacts associated with a boat wreck ([Figure 144](#)). The remains are bolted to two wood posts. The exhibit is in good condition.

FIGURE 144. A shipwreck relic displayed near the Portsmouth Life-Saving Station.

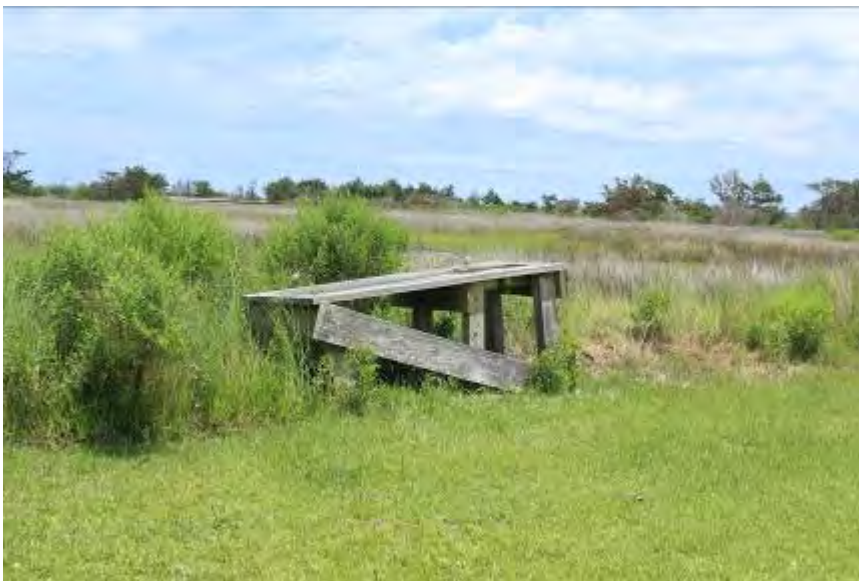
At the T.T. Potter House, the larger shed located behind the main house is edged by a simple wooden platform. A large plastic tank is stored on the platform. The platform appears to be in good condition. Additionally, a wood work table with in-set metal sink and faucet sits on the side of the yard of the house ([Figure 145](#)). The table was likely used to clean fish. The table is collapsing and in poor condition. On the west side of the T.T. Potter House, an eastern red cedar is growing out of a pile of bricks ([Figure 146](#)). The corners of the former brick structure are still visible, though many of the bricks are scattered about.

FIGURE 145. Next to the T.T. Potter House is a fish cleaning table with a sink.

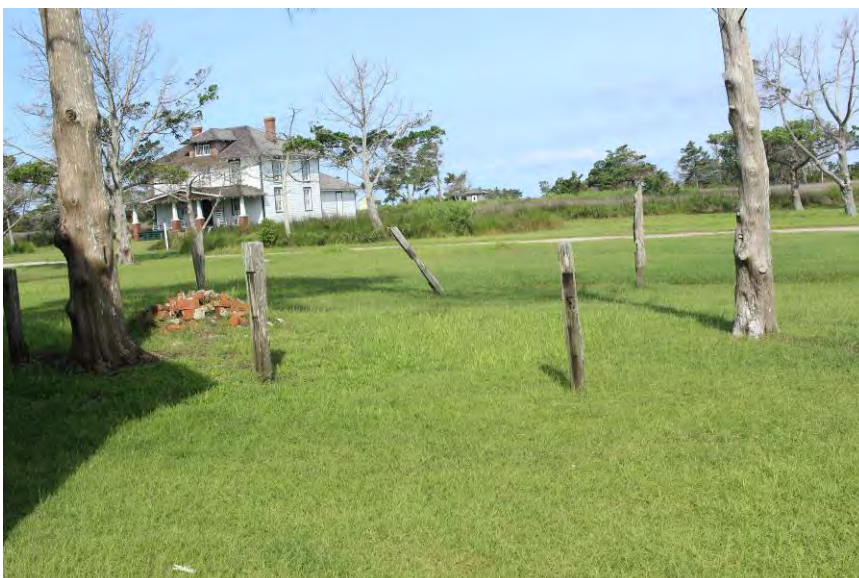
Attached to the west side of the Walker and Sarah Styron House is the base of a brick chimney, with five to six courses of brick still present. To the west of the house are several posts creating a rectangular outline, with a pile of bricks at one end (Figure 147). Similarly, to the southeast of the Harry and Lida Dixon House are several short posts, likely a foundation, and remnants of a brick chimney (Figure 148). There is also a wood post foundation of the former boathouse associated in the Life-Saving Station complex on the west side of the airstrip.

FIGURE 147. Wood posts and pile of bricks adjacent to the Walker and Sarah Styron House.

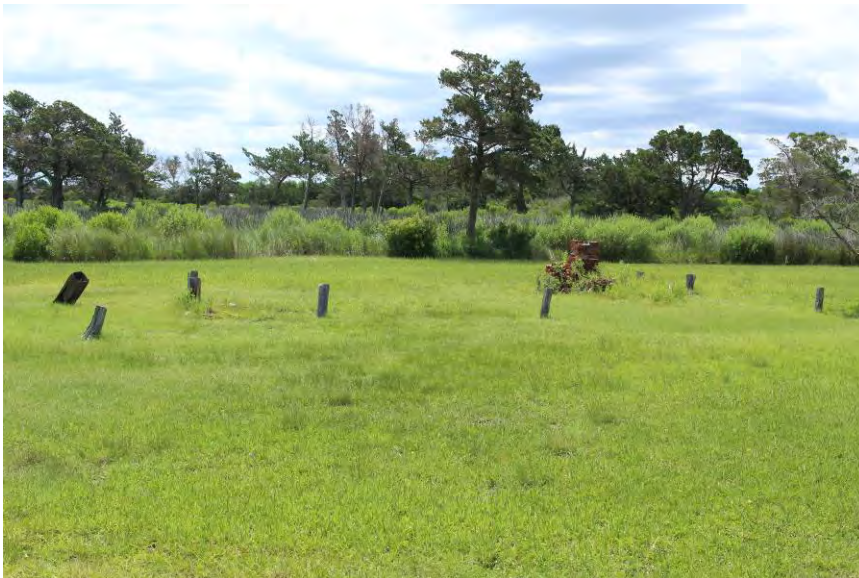
FIGURE 148. Wood posts and brick chimney remnant adjacent to the Harry and Lida Dixon House.

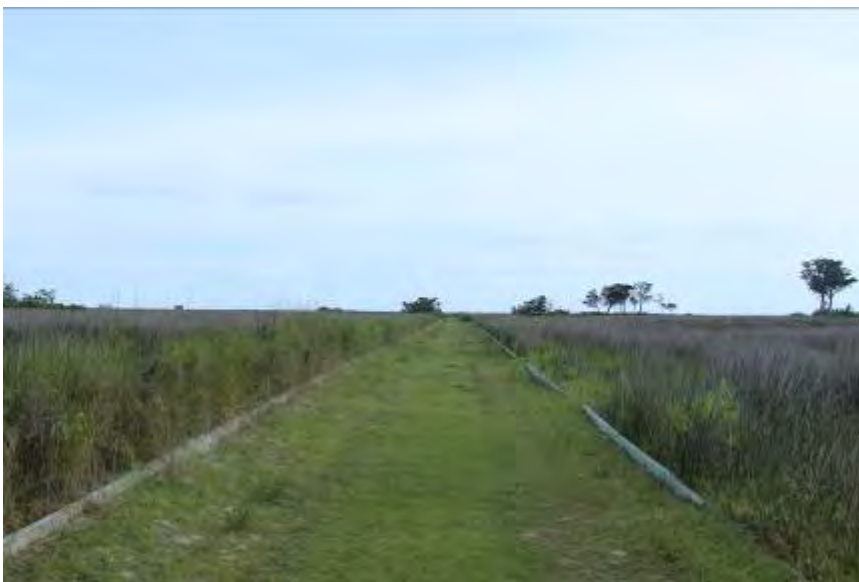
Additionally, Haulover Point Road and Village Road are lined with lumber on both sides for portions of the road (Figure 149).

FIGURE 149. Sections of Haulover Point Road are wood lined on both sides.

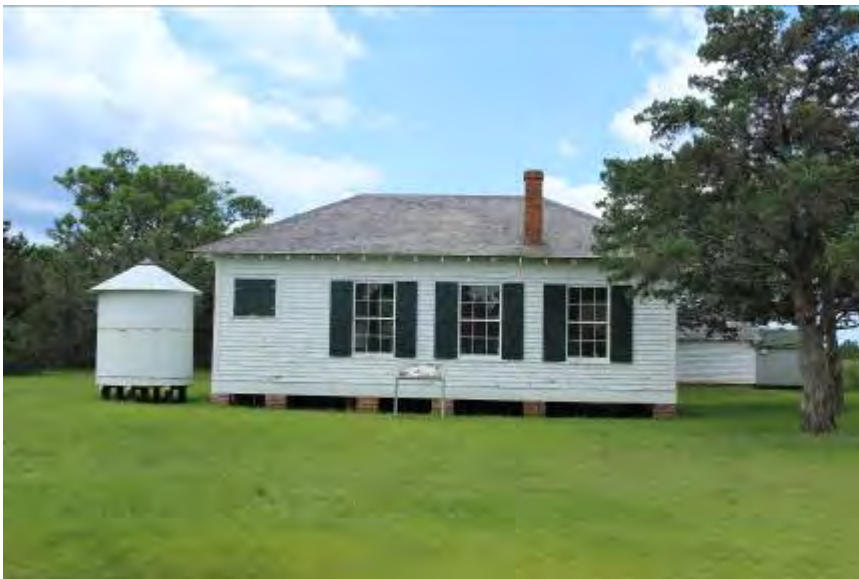
The current entrance to the Schoolhouse faces southwest, away from the existing access road to the building (Figure 152). The original entrance to the building was located on the east facade, behind the existing cistern.

FIGURE 152. The original entrance to the Schoolhouse was at the end wall where the cistern is now located. This former entrance was closed up when the building was converted to living quarters circa 1940s.

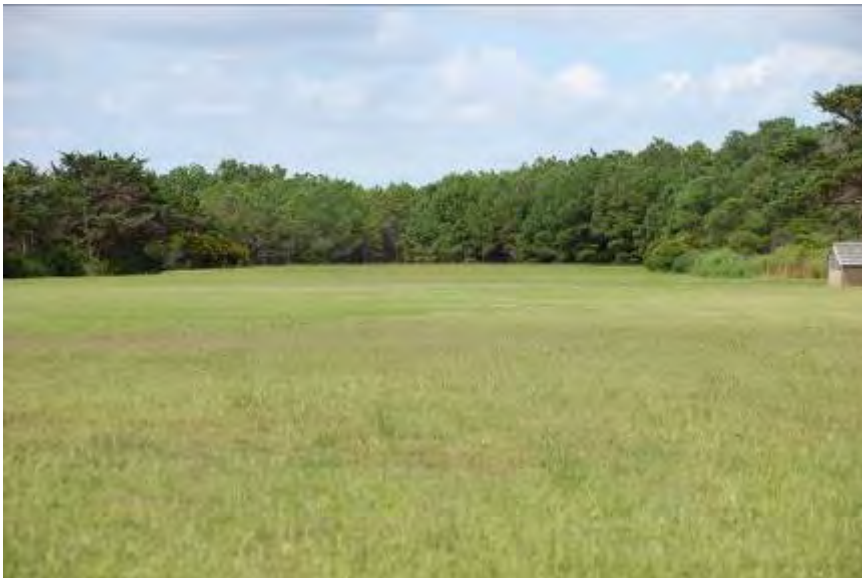
An example of man-made changes to the topography includes the airstrip. Personal communication with local residents suggests that the relatively level expanse of the airstrip was established through minor grading during the 1940s ([Figure 154](#)). This landscape feature continues to be maintained in mown grass and is in good condition.

FIGURE 154. View southwest along the island's airstrip established in the 1940s with limited grading.
